# Characterization of the Bathymetry, Hydrodynamics, Water Quality, Infrastructure, and Channel Condition of the Old Erie Canal from DeWitt to its Junction with the Current Erie Canal in Verona, near Rome, New York, 2018–19

Open-File Report 2021–1125

U.S. Department of the Interior  
U.S. Geological Survey

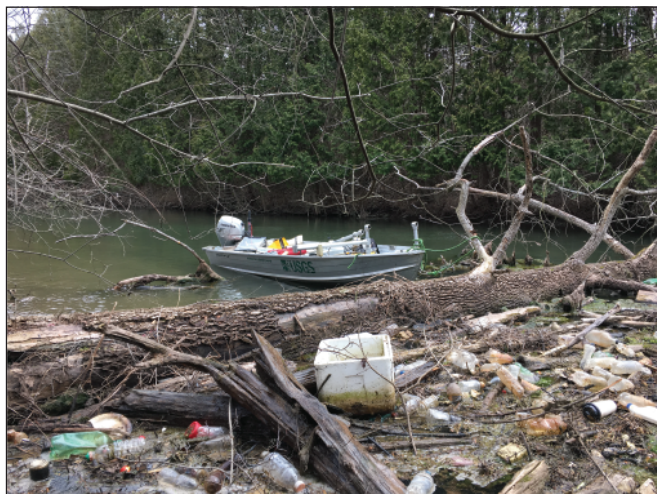
The effect of downed trees on the canal system is difficult to quantify, but the obstruction by downed trees and vegetation throughout the canal will lead to a decrease in flow in the Old Erie Canal.

**Figure 20.** Photograph of a large, downed tree downstream from the Cowaselon aqueduct on the Old Erie Canal, New York.

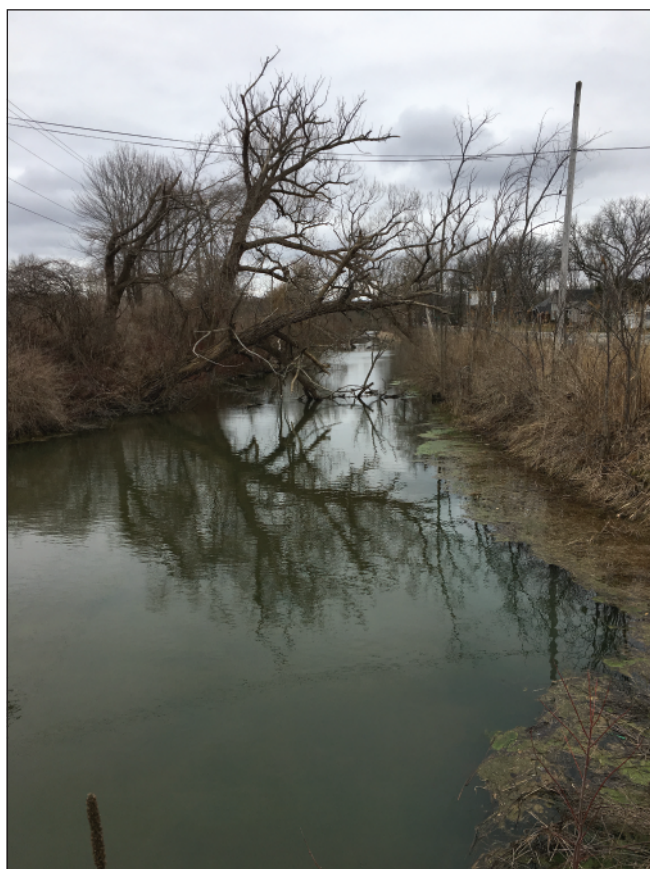
**Figure 21.** Photograph of several downed trees in a row in a reach of the Old Erie Canal north of the Durhamville aqueduct, New York.

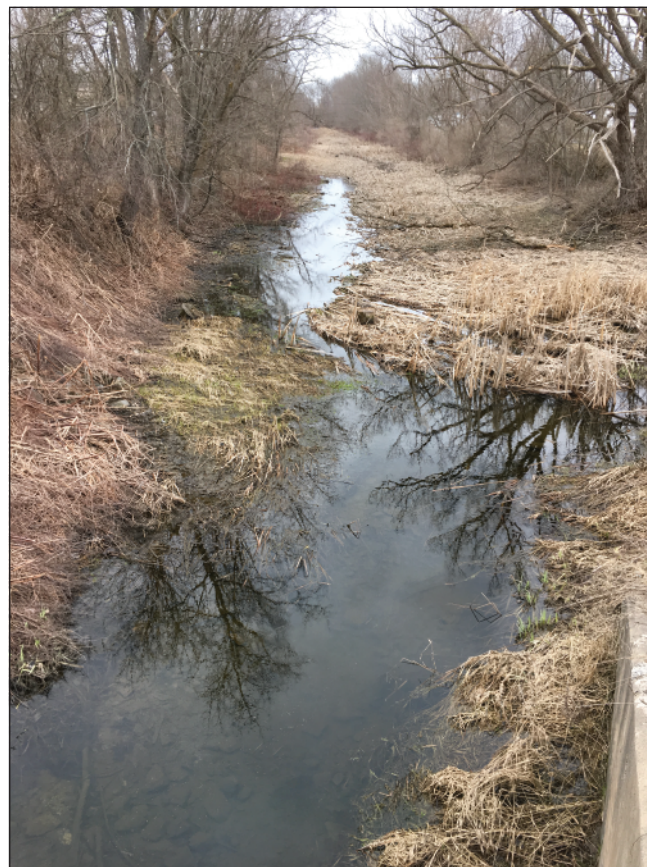
**Figure 22.** Photograph of the Old Erie Canal clogged with aquatic vegetation near where it enters the Erie Canal in Verona, New York.

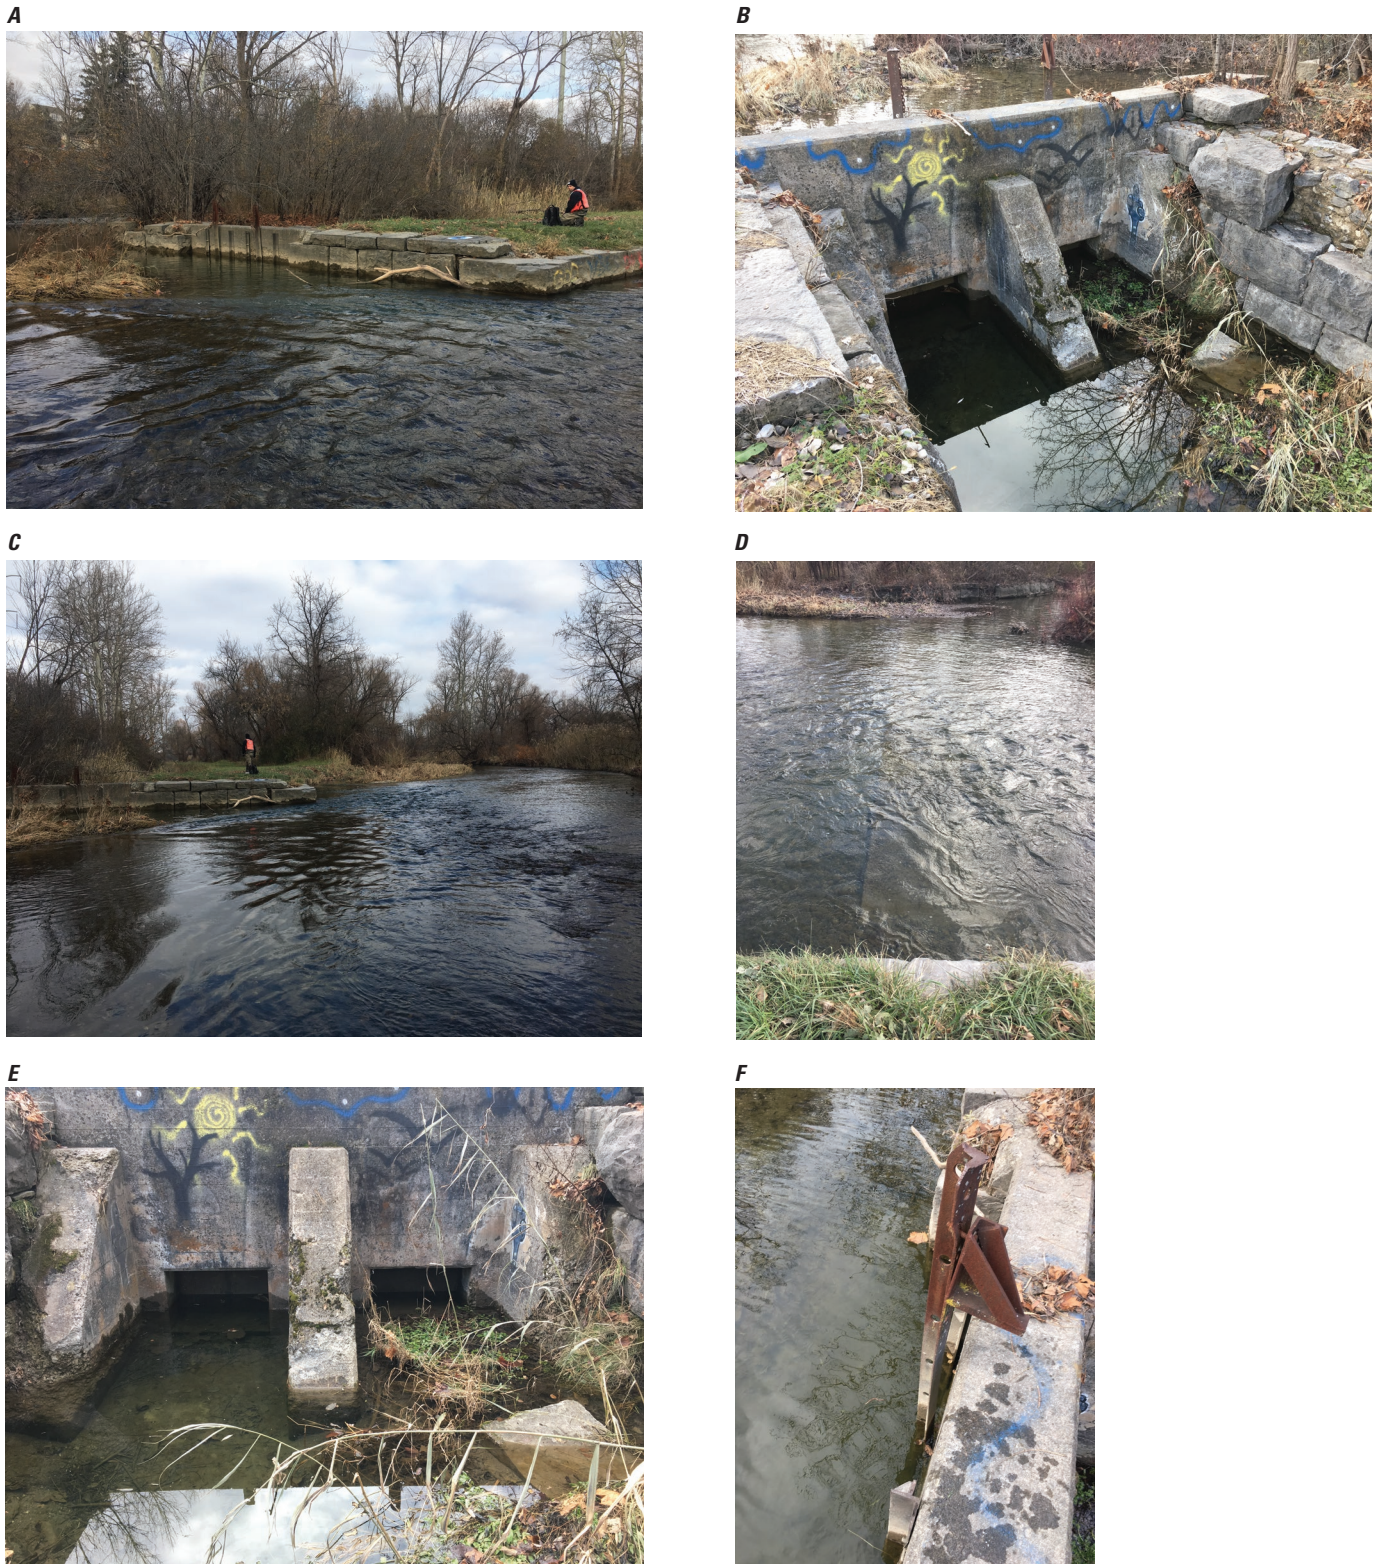
**Figure 3.1.** Photographs of the Butternut sluice gate at the junction of Butternut Creek and Butternut feeder. *A*, Upstream side of Butternut sluice gate; *B*, Downstream side of Butternut sluice gate; *C*, Butternut sluice gate with Butternut Creek on right; *D*, Top of weir in Butternut Creek visible in foreground; *E*, Butternut sluice gate openings; and *F*, Butternut sluice gate with metal lift bar, broken locking mechanism, and outer brackets shown.

The feeder system has the potential for increasing flow into the Old Erie Canal and possibly flushing the system more regularly if repairs were made to the sluice-gate mechanisms, sediments were removed near the sluice gates, weirs were replaced, and debris, vegetation, and sediment were removed from the feeder channels. Sluice-gate openings could be adjusted and locked for seasonal variations in flow in the creeks that supply water to the Old Erie Canal. A 1996 report on the New York State Canal System from Madison County (Welch and Madison County Planning Department, 1996) provides a contemporary history of the status of all three sluice gates and provides an example of recent repairs to improve the feeder system which support the idea that more water could be directed into the canal if repairs were made. The report states that Butternut Creek is no longer diverted into Butternut feeder, but it does not specify the date when that diversion ended. The report states that a small volume of water from Limestone Creek is diverted into the Old Erie Canal from the sluice gate into the Limestone feeder, but also that the sluice gate had not been adjusted within at least the past ten years. Finally, the report describes the diversion of some of the Chittenango Creek flow into the Old Erie Canal through the sluice gate. Although the gate had previously not been adjusted for many years, it had been rebuilt around the time of the report, the inlet channel had been cleaned, and the gates were opened, adjusted, and closed every year as needed.

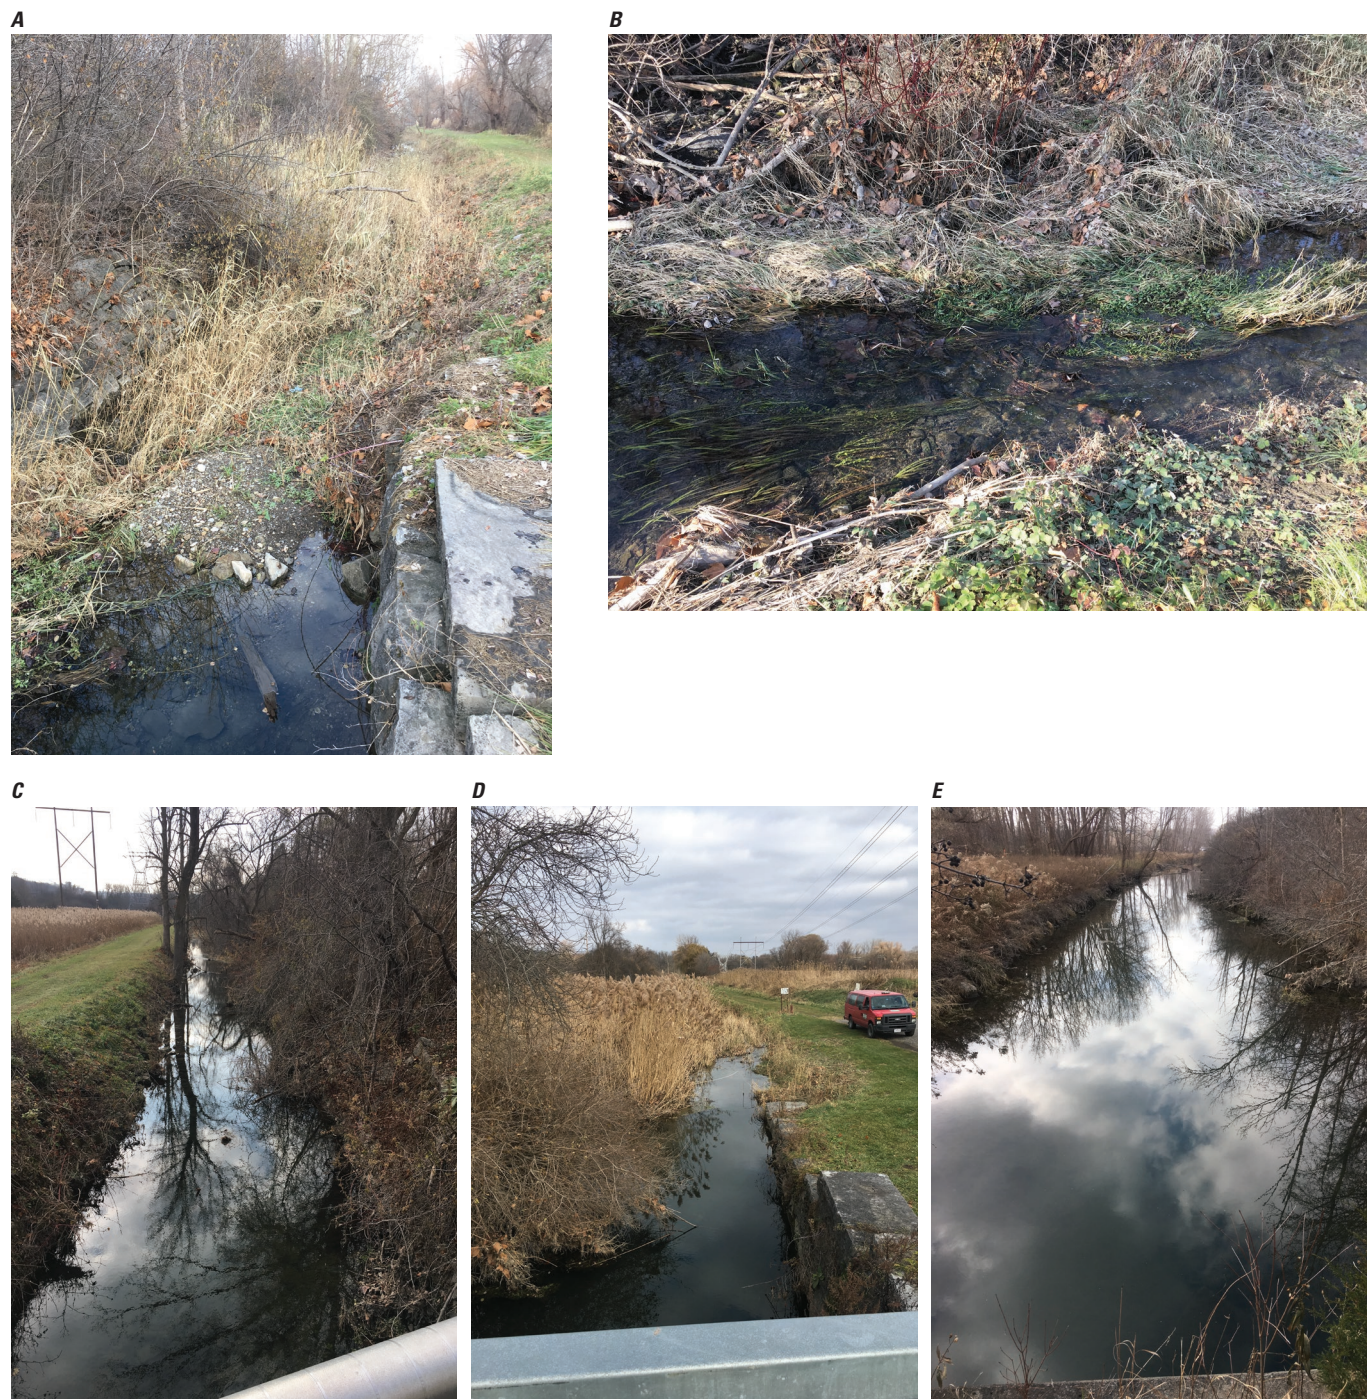
Butternut feeder ([fig. 3.2A](#)) currently receives no flow inputs from the sluice-gate openings, and yet flow visibly increased from zero flow at the sluice gate to a small stream by the time it passed under Andrews Road. The increase in flow likely is attributed to groundwater seepage into the feeder ([fig. 3.2B](#)). Evidence of flow overtopping the feeder levee walls during times of high flow in Butternut Creek was noted in two areas: a small area of backwater just to the west of the sluice gate, and a short distance downstream over the levee wall. Drift lines of leaves and debris in the feeder channel itself indicate that the water level can increase by several feet when it receives overbank flow from Butternut Creek over the levee walls. The feeder is narrow near the sluice gate ([figs. 3.2A](#), [3.2B](#), and [3.2C](#)) but widens downstream from Andrews Road ([figs. 3.2D](#) and [3.2E](#)). The feeder has been affected by sedimentation over time but is also open along its entire length except for an area of dense phragmites, an aggressive wetland grass, immediately downstream from Andrews Road ([fig. 3.2D](#)). Meadow Brook ([figs. 3.3A](#) and [3.3B](#)) is a natural stream that supplies additional unregulated flow through the Butternut feeder before it enters the canal through a culvert near DeWitt, N.Y.

**Figure 3.2.** Photographs of Butternut feeder. *A*, Butternut feeder immediately downstream from sluice gates; *B*, Butternut feeder upstream from Andrews Road showing groundwater contribution to flow; *C*, Butternut feeder viewed from Andrews road looking upstream; *D*, Butternut feeder viewed from Andrews Road looking downstream, with dense phragmites; and *E*, Butternut feeder upstream from Butternut culvert looking upstream.

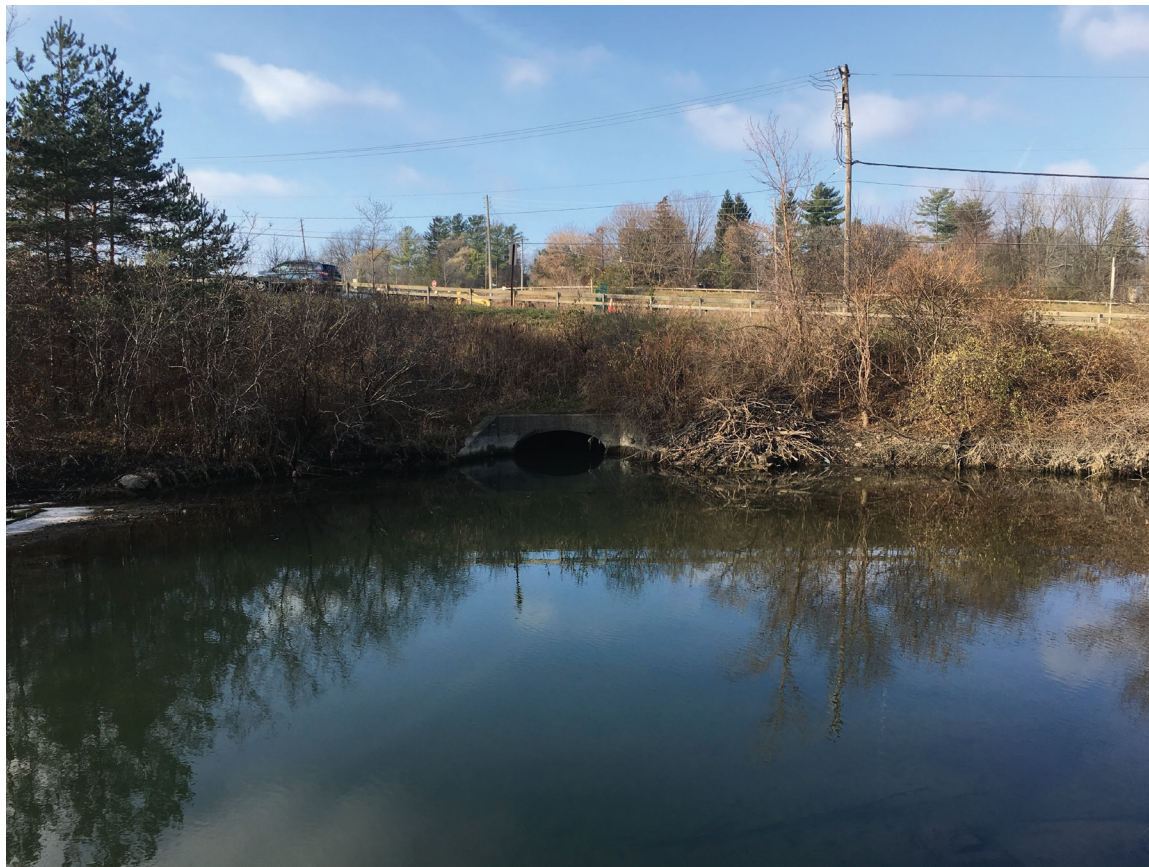
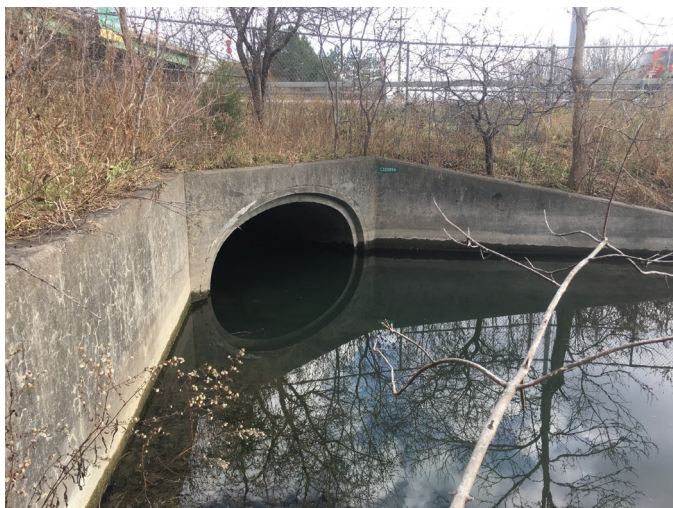
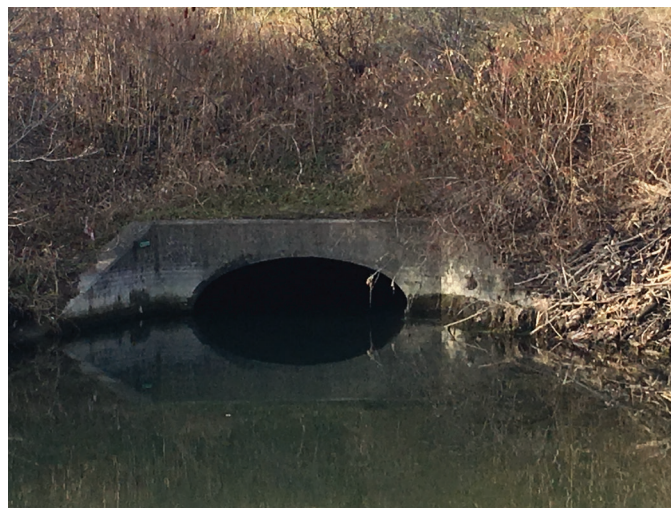
Water from the Butternut feeder enters the Old Erie Canal through the Butternut culvert ([fig. 3.4A](#)). The oval-shaped concrete culvert measures 6.5 ft high and 9.4 ft wide at the entrance (upstream side; [table 6](#); [fig. 3.4B](#)) and 5.5 ft high and 9.0 ft wide at the exit ([table 6](#); [fig. 3.4C](#)). Both the entrance and exit were free of debris and were found in good condition.

**Figure 3.4.** Photographs of Butternut feeder culvert. *A*, Butternut feeder culvert entering canal; *B*, Upstream face of Butternut feeder culvert before it enters canal; and *C*, Downstream face of Butternut feeder culvert as it enters canal.

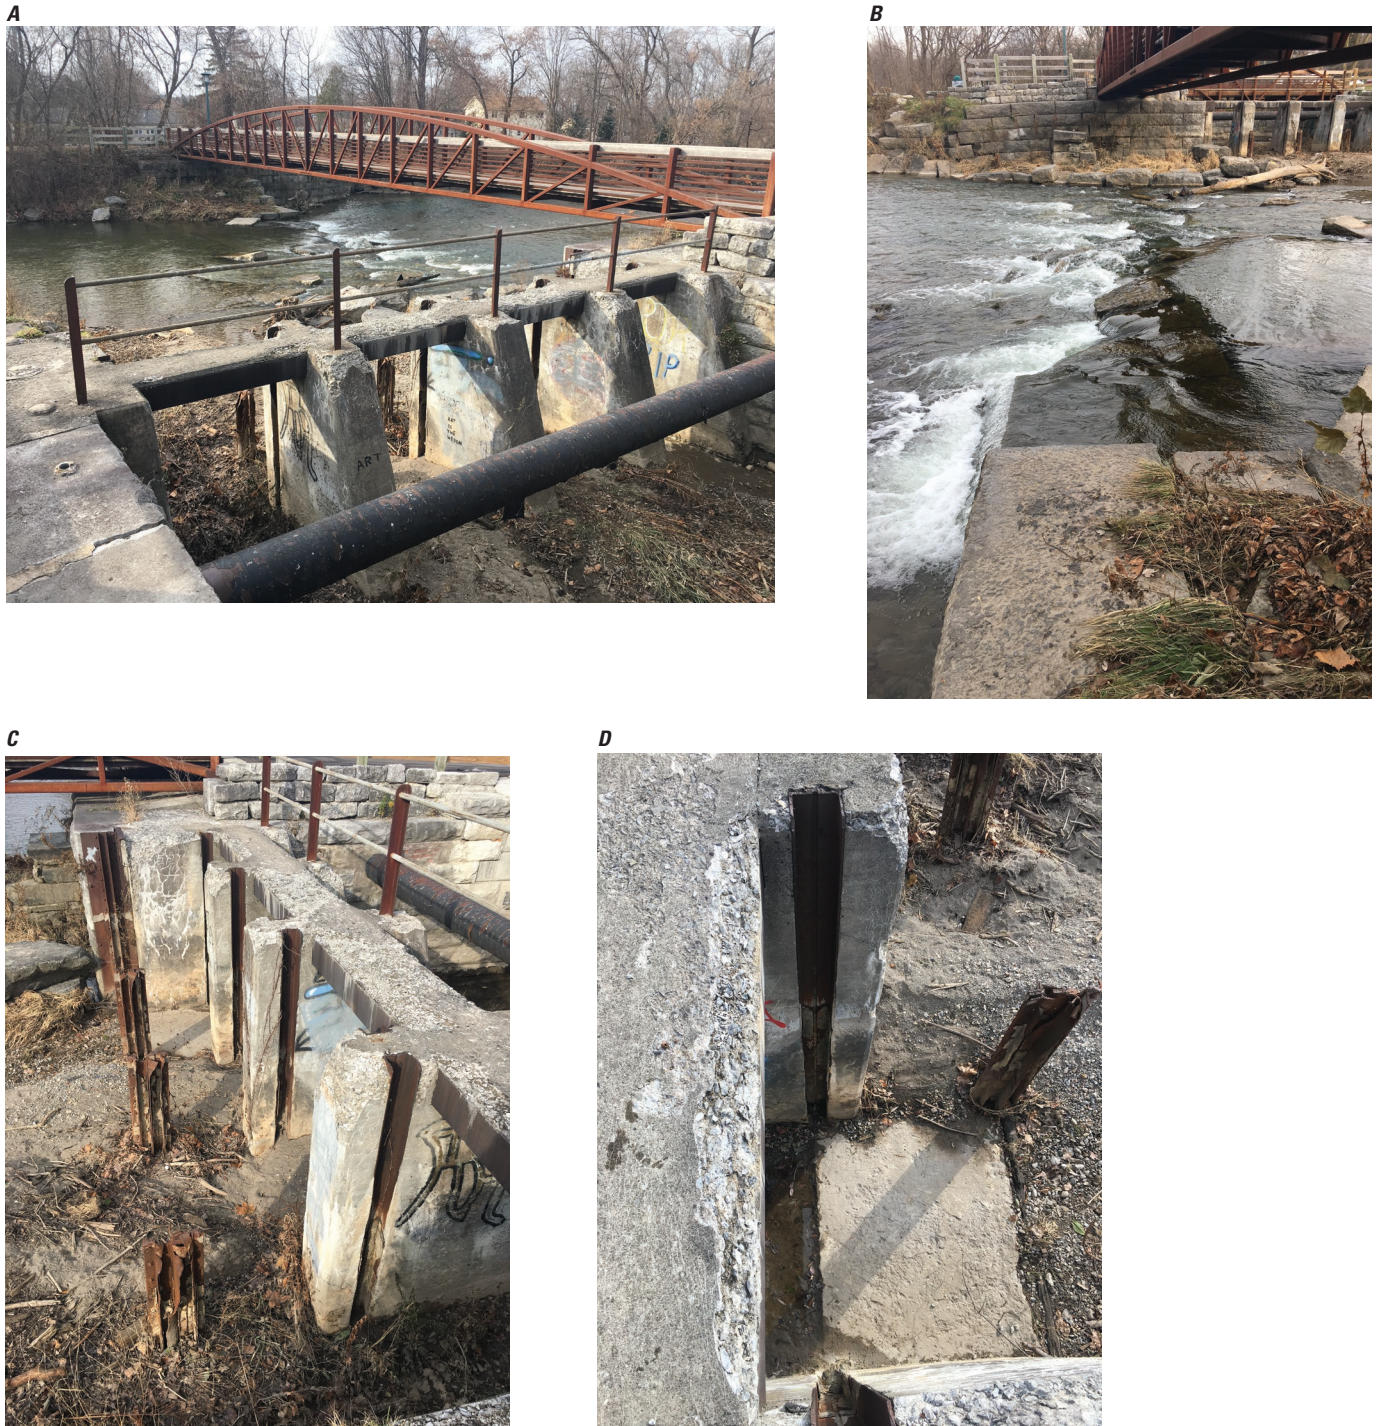
**Figure 3.5.** Photographs of the Limestone sluice gate at the junction of Limestone Creek with Limestone feeder. *A*, Limestone sluice gate with Limestone Creek in the background; *B*, Remnants of removed weir in Limestone Creek with sluice gate visible in background; *C*, I-beams set in front of sluice gate designed to accept flashboards; and *D*, I-beams set integral to sluice gate designed to accept flashboards.

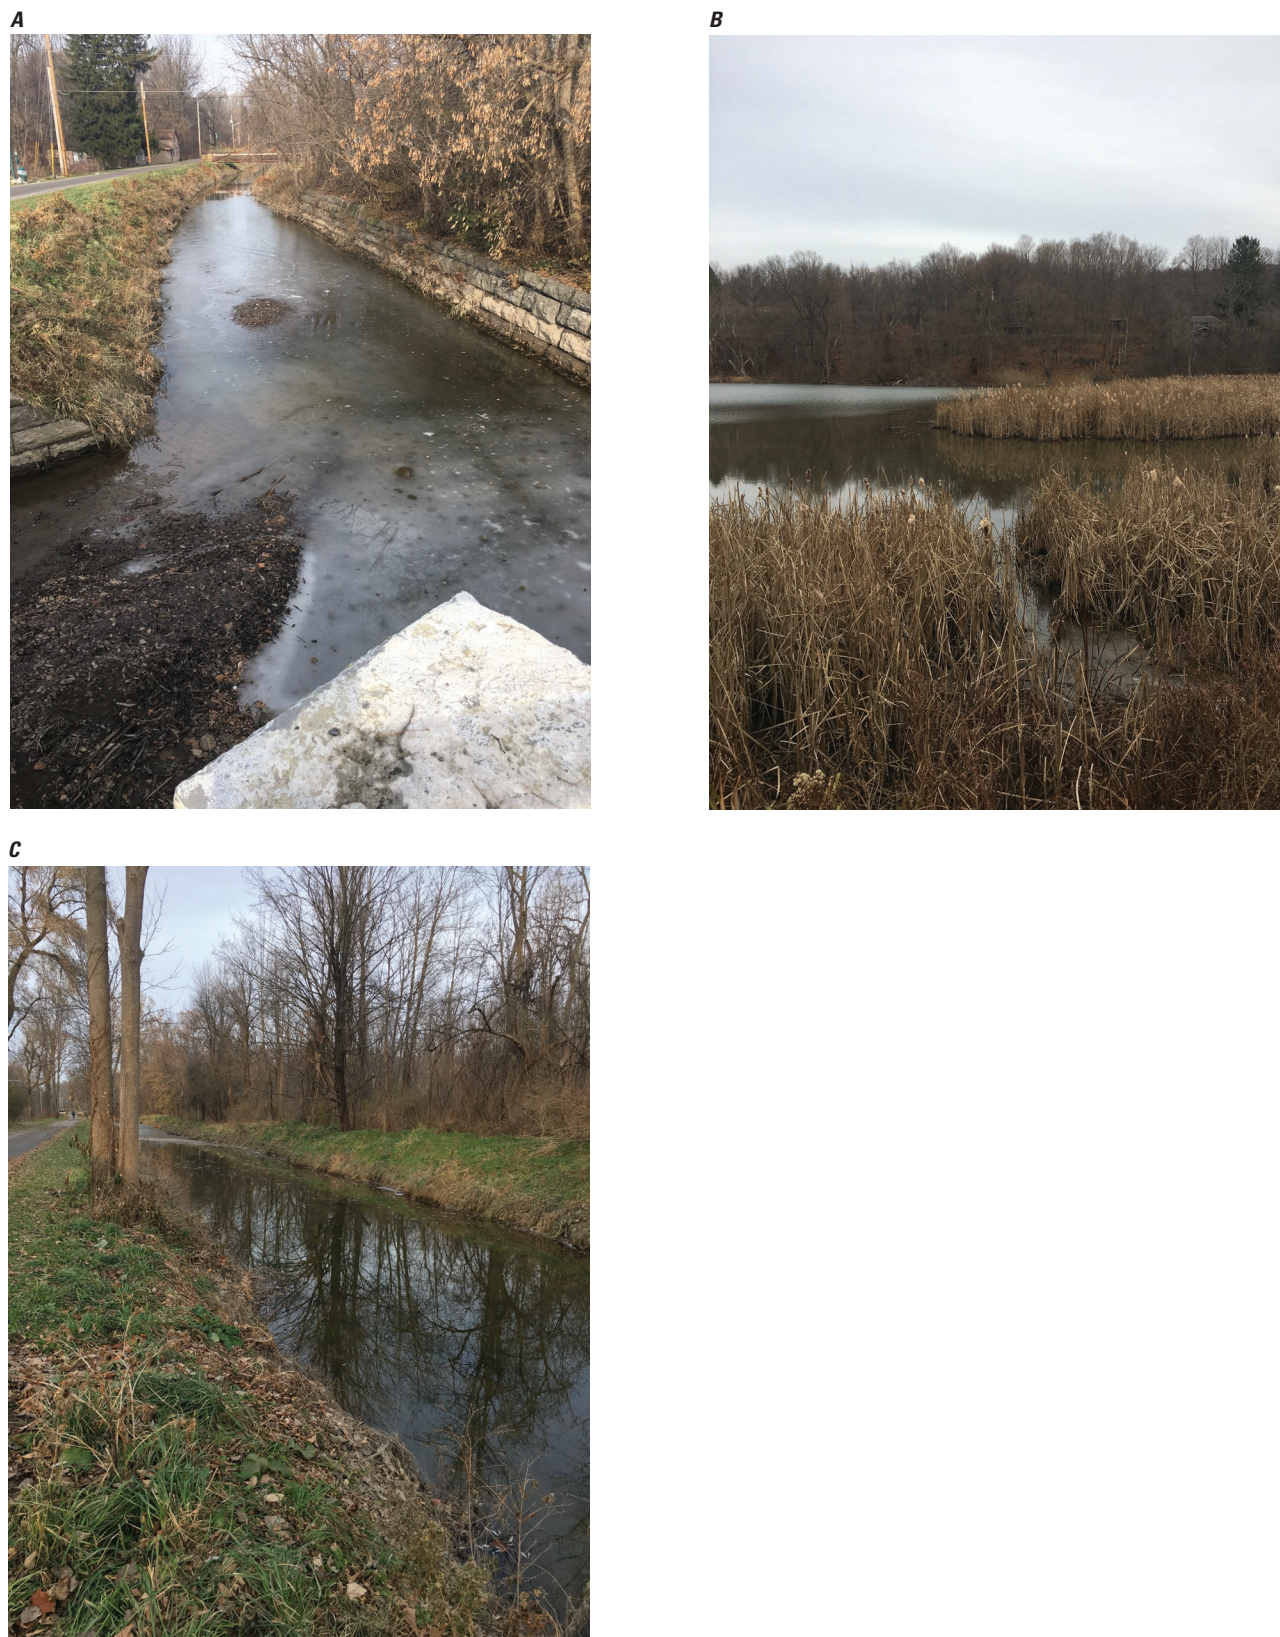
Limestone feeder (fig. 3.6A), which enters the canal in a marshy area just downstream from Limestone aqueduct (fig. 3.6B), was found generally clear of debris (fig. 3.6C) and in good condition to convey flow. At the time of inspection, water in the feeder consisted of backwater from the canal.

**Figure 3.6.** Photographs of Limestone feeder. *A*, Limestone feeder directly downstream from Limestone sluice gate; *B*, Limestone feeder where it enters the canal; and *C*, Limestone feeder channel.

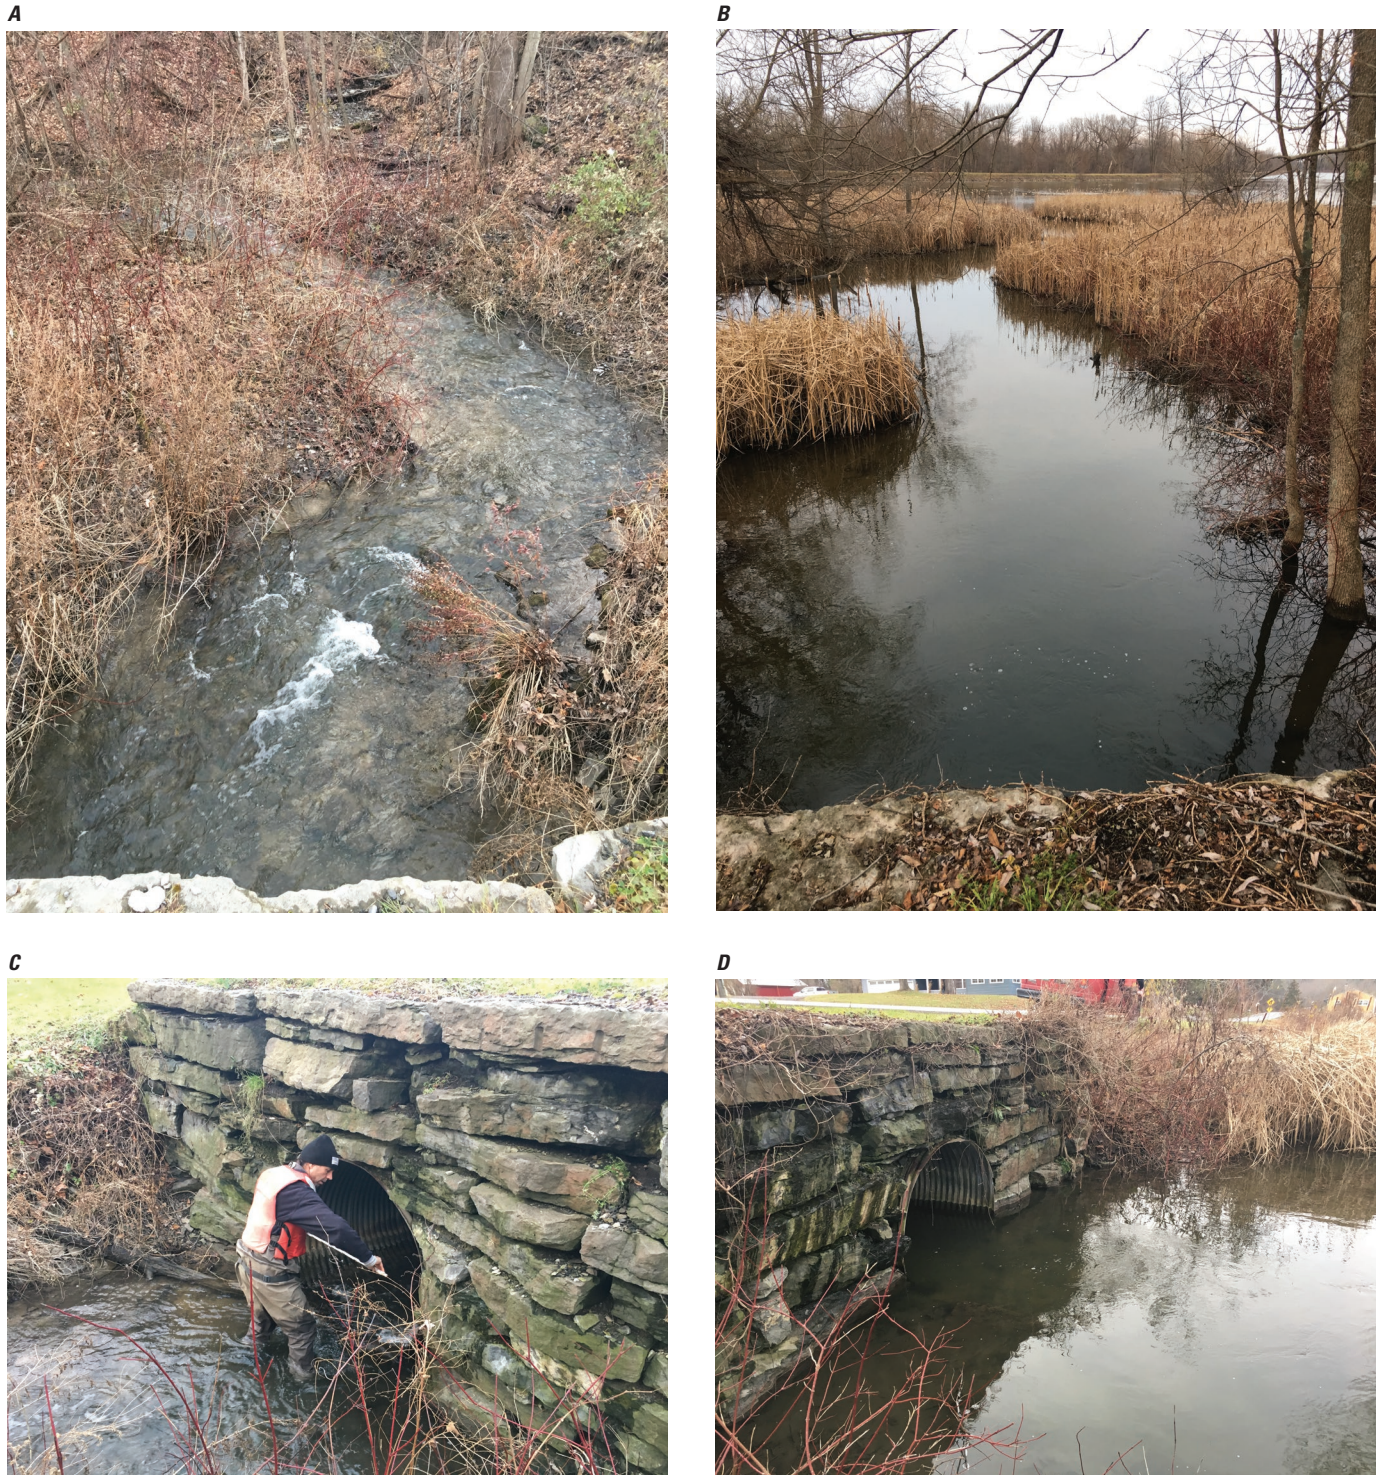
Pools Brook is a small stream (fig. 3.7A) whose full flow enters the canal naturally (unregulated) through a small steel culvert that passes underneath North Poolsbrook Road in a marshy area between Limestone and Chittenango aqueducts (fig. 3.7B). The circular culvert measures 4.9 ft high and 5.0 ft wide at the entrance (upstream side; fig. 3.7C) and 4.9 ft high and 4.8 ft wide at the exit (fig. 3.7D). Both the entrance and exit were found free of debris and in good condition.

**Figure 3.7.** Photographs of Pools Brook where it crosses beneath North Poolsbrook Road and enters the Old Erie Canal. *A*, Pools Brook, pictured upstream from the road, is a nonregulated stream which directly enters the Old Erie Canal; *B*, Pools Brook, pictured downstream from the road, enters the Old Erie Canal in a marshy area between Limestone and Chittenango aqueducts; *C*, Upstream face of circular culvert, underneath North Poolsbrook Road, where Pools Brook enters the Old Erie Canal; and *D*, Downstream face of circular culvert, underneath North Poolsbrook Road, where Pools Brook enters the Old Erie Canal.

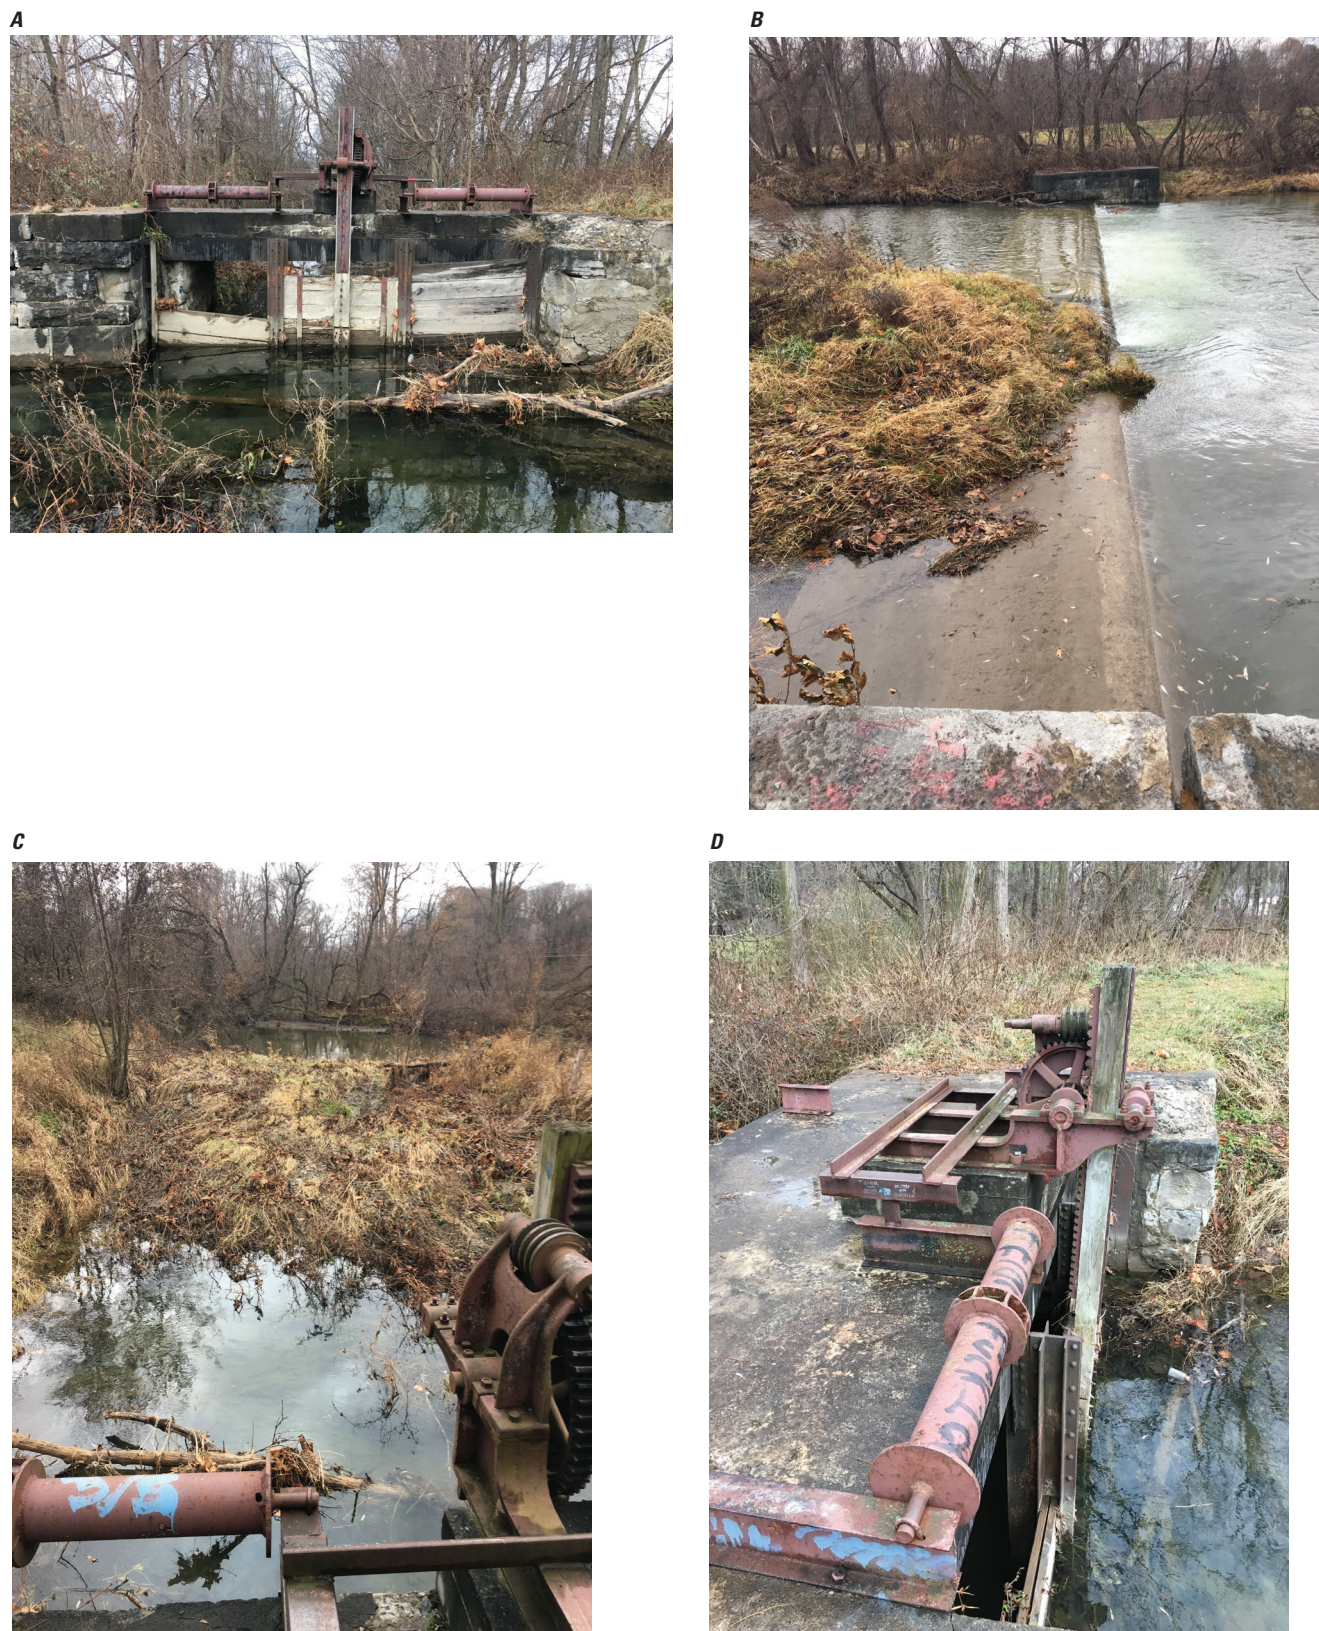
**Figure 3.8.** Photographs of the Chittenango sluice gate at the junction of Chittenango Creek and Chittenango feeder. *A*, Upstream face of Chittenango sluice gate as viewed from Chittenango Creek; *B*, Weir on Chittenango Creek; *C*, Vegetated bar seen blocking flow from Chittenango Creek, viewed from top of sluice gate; and *D*, Chittenango sluice gate gears, lifting bar, outer brackets and installed flashboards.

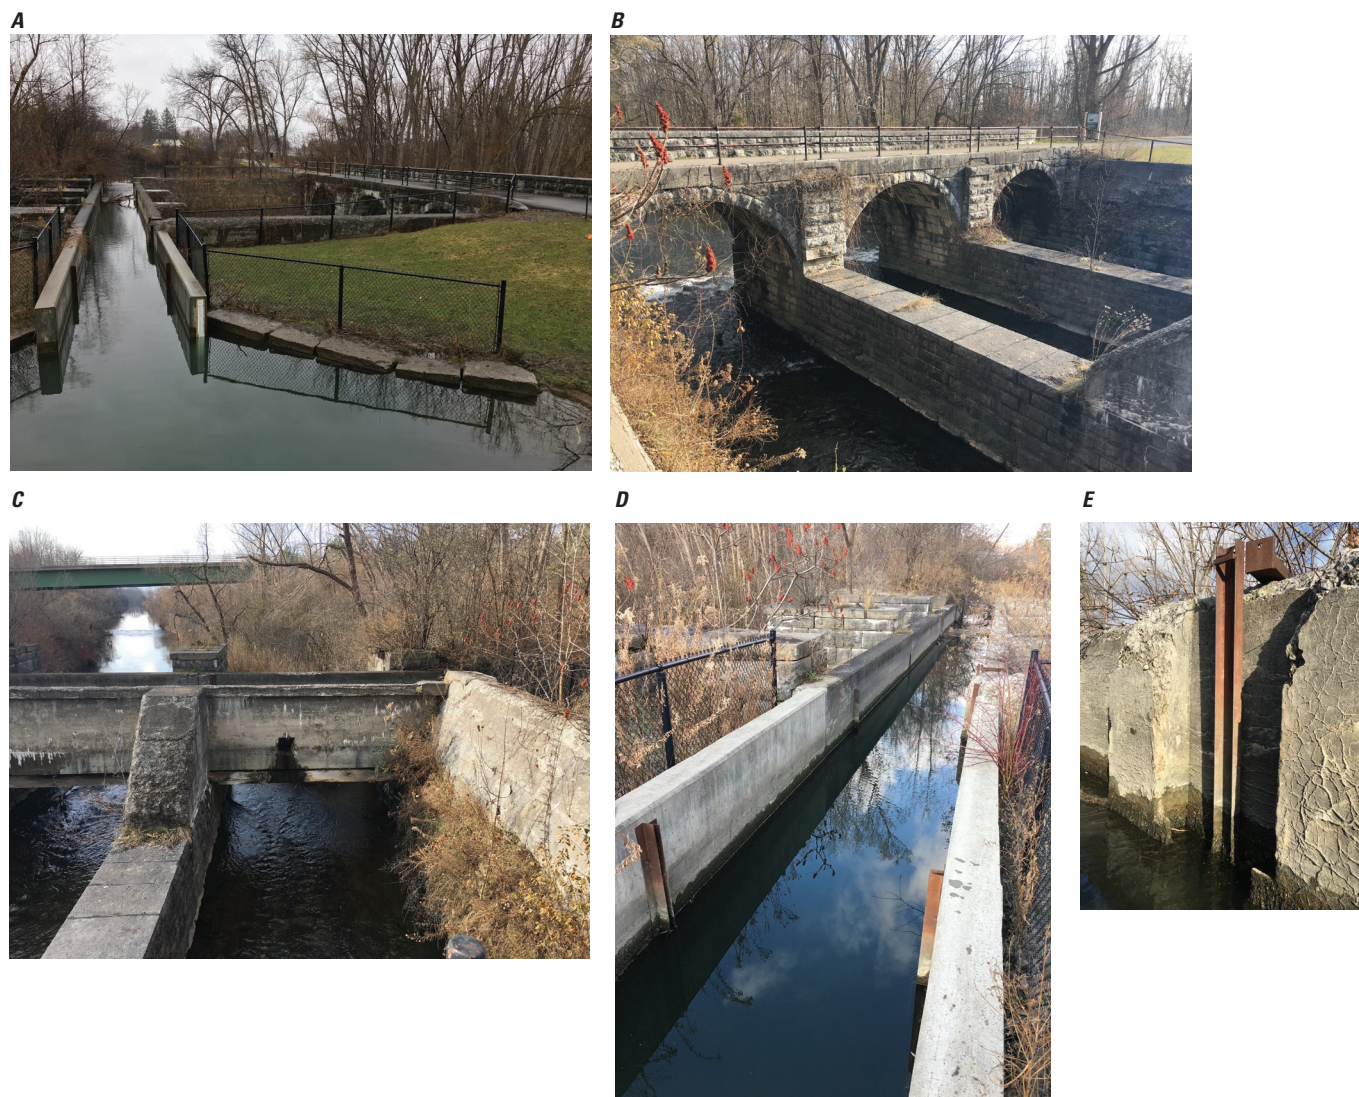
the canal width both upstream and downstream from the aqueduct. This narrow channel was built sometime after canal navigation ceased to keep water moving. The aqueduct is no longer navigable by larger boats due to the narrow width. Remnants of the original aqueduct are still visible between the newer concrete channel and the towpath (fig. 4.1B). The narrow aqueduct measures 7.1 ft wide by 5.9 ft high at the entrance and 7.0 ft wide by 7.2 ft high at the exit. The aqueduct itself is in fair condition and conveys water very well when the entrance is open; the narrow width, however, can cause a buildup of debris that retards flow. There are two outfalls beneath the water surface located on the north side of the structure very near the bottom of the aqueduct. Both outfalls are capable of discharging water into Butternut Creek (fig. 4.1C). The outfalls are currently in the closed position with minimal leakage. Each outfall has an outfall gate recessed into the concrete with metal guides on either side (fig. 4.1D), each of which measures 1.6 ft by 1.6 ft. The downstream gate has a lifting bar with a bracket on top that can be locked closed. The upstream gate lacks both the lifting bar and locking bracket. The metal guides and lifting bar are in serviceable condition, the top bracket is in good condition except for the crumbling concrete into which it is set. More detailed conditions of the gates are unknown, except for the fact that they are leaking. Additionally, there are two sets of metal brackets on both the upstream and downstream sides of the aqueduct that can accept flashboards (fig. 4.1E). These flashboards were designed to hold water back so that the canal could be separated into different sections that allowed for individual dewatering of those sections (upstream, downstream, or in between the flashboards), and thus permit work to be done in the canal. These metal brackets were found in good condition and appeared to be functional.

**Figure 4.1.** Photographs of structures at Butternut aqueduct. *A*, The narrow concrete channel of Butternut aqueduct conveys flow over Butternut Creek; *B*, Remnants of old structure that supported original aqueduct, towpath seen in background; *C*, One, of a total of two, small square outfall openings, seen in the center of the image, with the capability to discharge into Butternut Creek; *D*, One, of a total of two, metal brackets which accept flashboards to separate the canal into sections for dewatering; and *E*, Outfall gate structure recessed into concrete. Lifting bar, metal guides, and top bracket visible.

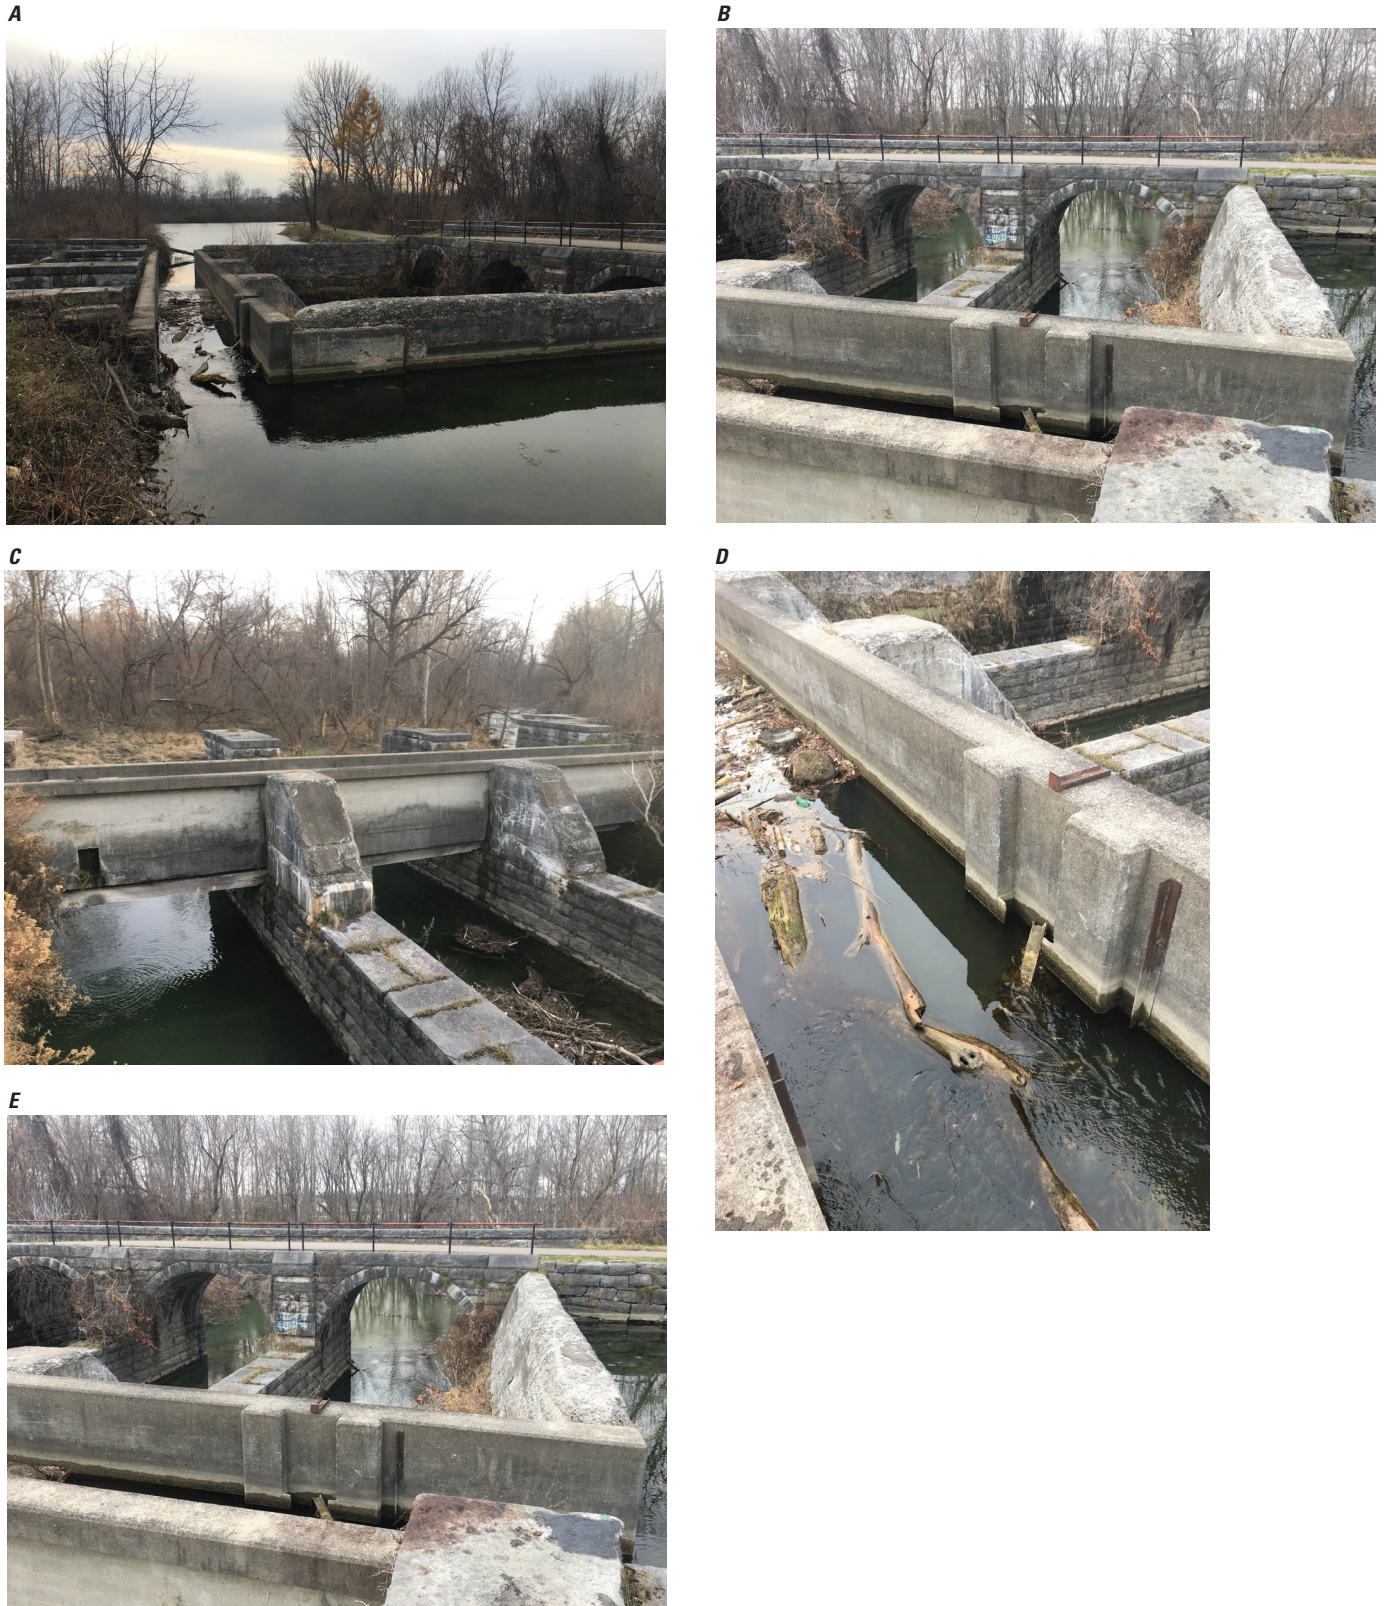
Limestone aqueduct is similar to Butternut aqueduct: it also conveys water over Limestone Creek through a narrow, rectangular concrete channel that is not part of the original aqueduct (fig. 4.2A). Remnants of the structure that supported the original aqueduct are visible between the newer aqueduct and the towpath (fig. 4.2B). The narrow aqueduct measures 6.9 ft wide by 6.9 ft high at the entrance and 7.9 ft wide by 7.2 ft high at the exit. The aqueduct is in fair condition and conveys the flow well, but is prone to debris buildup that can retard the flow because of the narrow width of the channel. A single outfall beneath the water surface is located very close to the bottom of the aqueduct structure. This outfall is on the northwest side of the structure, and it can be used to discharge water into Limestone Creek (fig. 4.2C). The outfall was found in the closed position with minimal leakage into Limestone Creek. The outfall gate is recessed into the concrete with metal guides on either side (fig. 4.2D). A lifting bar that had been used to raise the outfall gate was found severely rusted and damaged. A bracket on top of the aqueduct used to lock the closed lifting bar was found in good condition. One set of metal brackets on either side of the concrete channel wall on the downstream end of the aqueduct is designed to accept flashboards (fig. 4.2E). When installed, these flashboards

**Figure 4.2.** Photographs of structures at Limestone aqueduct. *A*, The narrow concrete channel of Limestone aqueduct conveys flow over Limestone Creek; *B*, Remnants of old structure that supported original aqueduct, towpath seen in background; *C*, Square outfall opening, seen on the left, with the capability to discharge into Limestone Creek; *D*, Outfall gate structure recessed into concrete. Broken lifting bar, metal guides, and top bracket visible; and *E*, Metal brackets, visible to the right of concrete gate structure, designed to accept flashboards to separate the canal into sections for dewatering.
