# Characterization of the Bathymetry, Hydrodynamics, Water Quality, Infrastructure, and Channel Condition of the Old Erie Canal from DeWitt to its Junction with the Current Erie Canal in Verona, near Rome, New York, 2018–19

Open-File Report 2021–1125

U.S. Department of the Interior  
U.S. Geological Survey

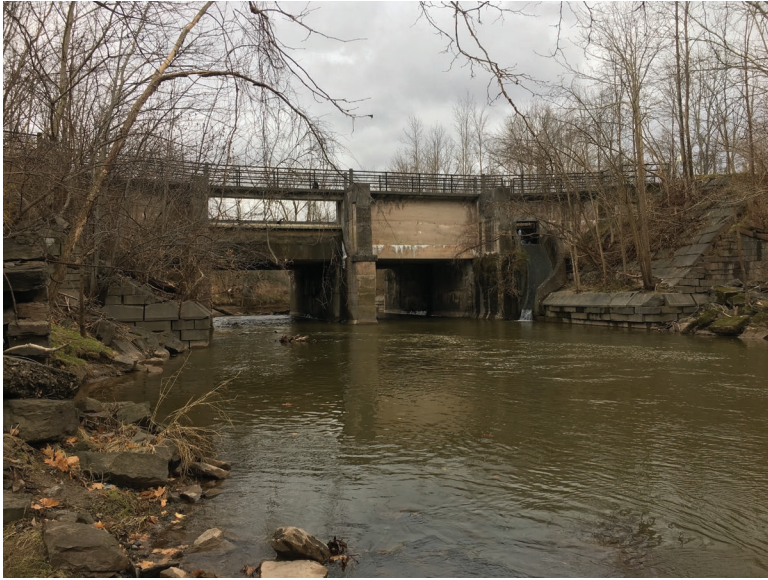
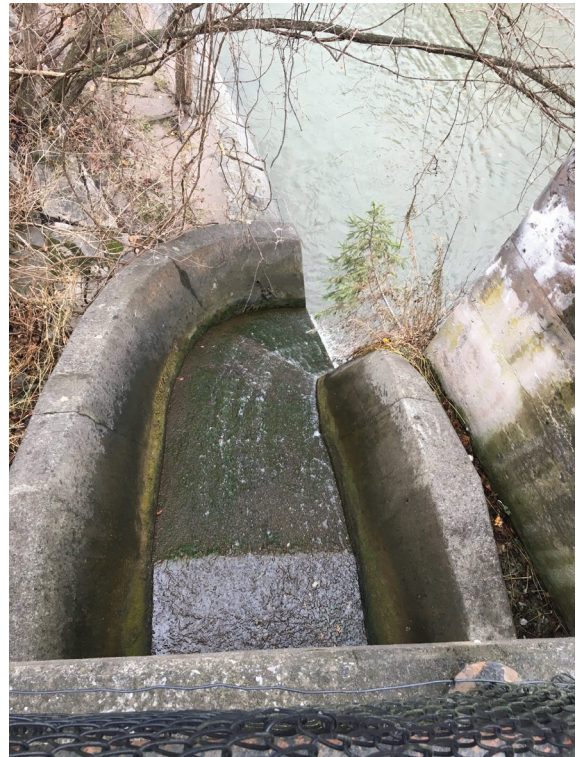
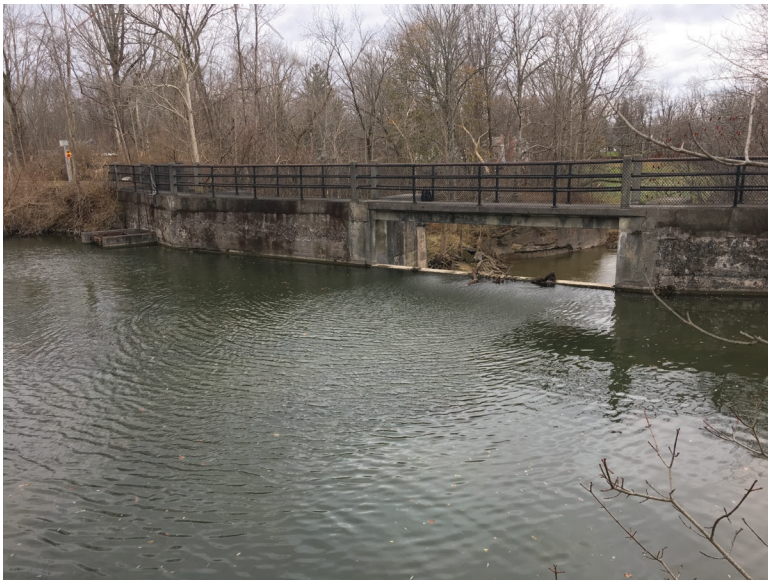
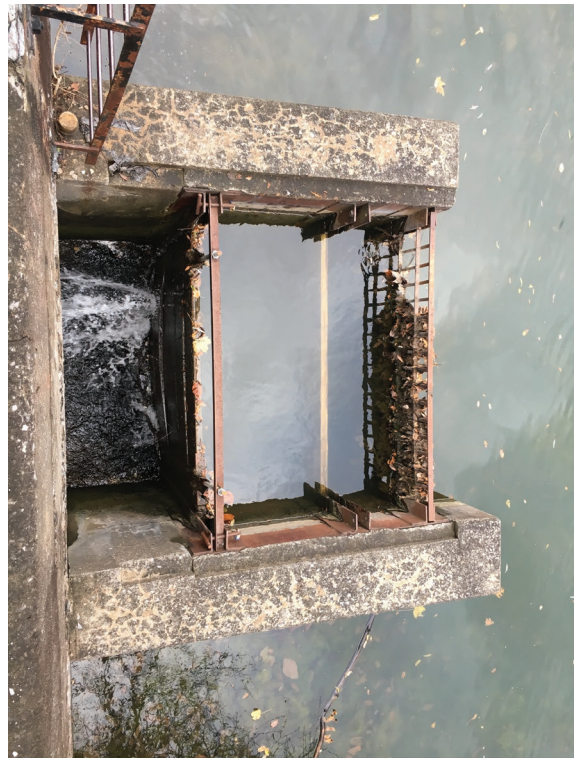
**Figure 4.6.** Photographs of structures at Durhamville aqueduct. *A*, Durhamville aqueduct conveys the canal over Oneida Creek (foreground); *B*, The spillway of Durhamville aqueduct discharging into Oneida Creek; *C*, The large rectangular outfall of Durhamville aqueduct is capable of discharging into Onieda Creek; and *D*, Spillway outfall structure with metal screen and two sets of flashboards installed. Flashboards are seen bowing and leaking water.
