# The Alaska Earthquake

# Effects of the Earthquake Of March 27, 1964 At Anchorage, Alaska

*A description and analysis of the damage resulting from seismic vibration, ground cracks, and especially landslides in Alaska's largest city*

GEOLOGICAL SURVEY PROFESSIONAL PAPER 542-A

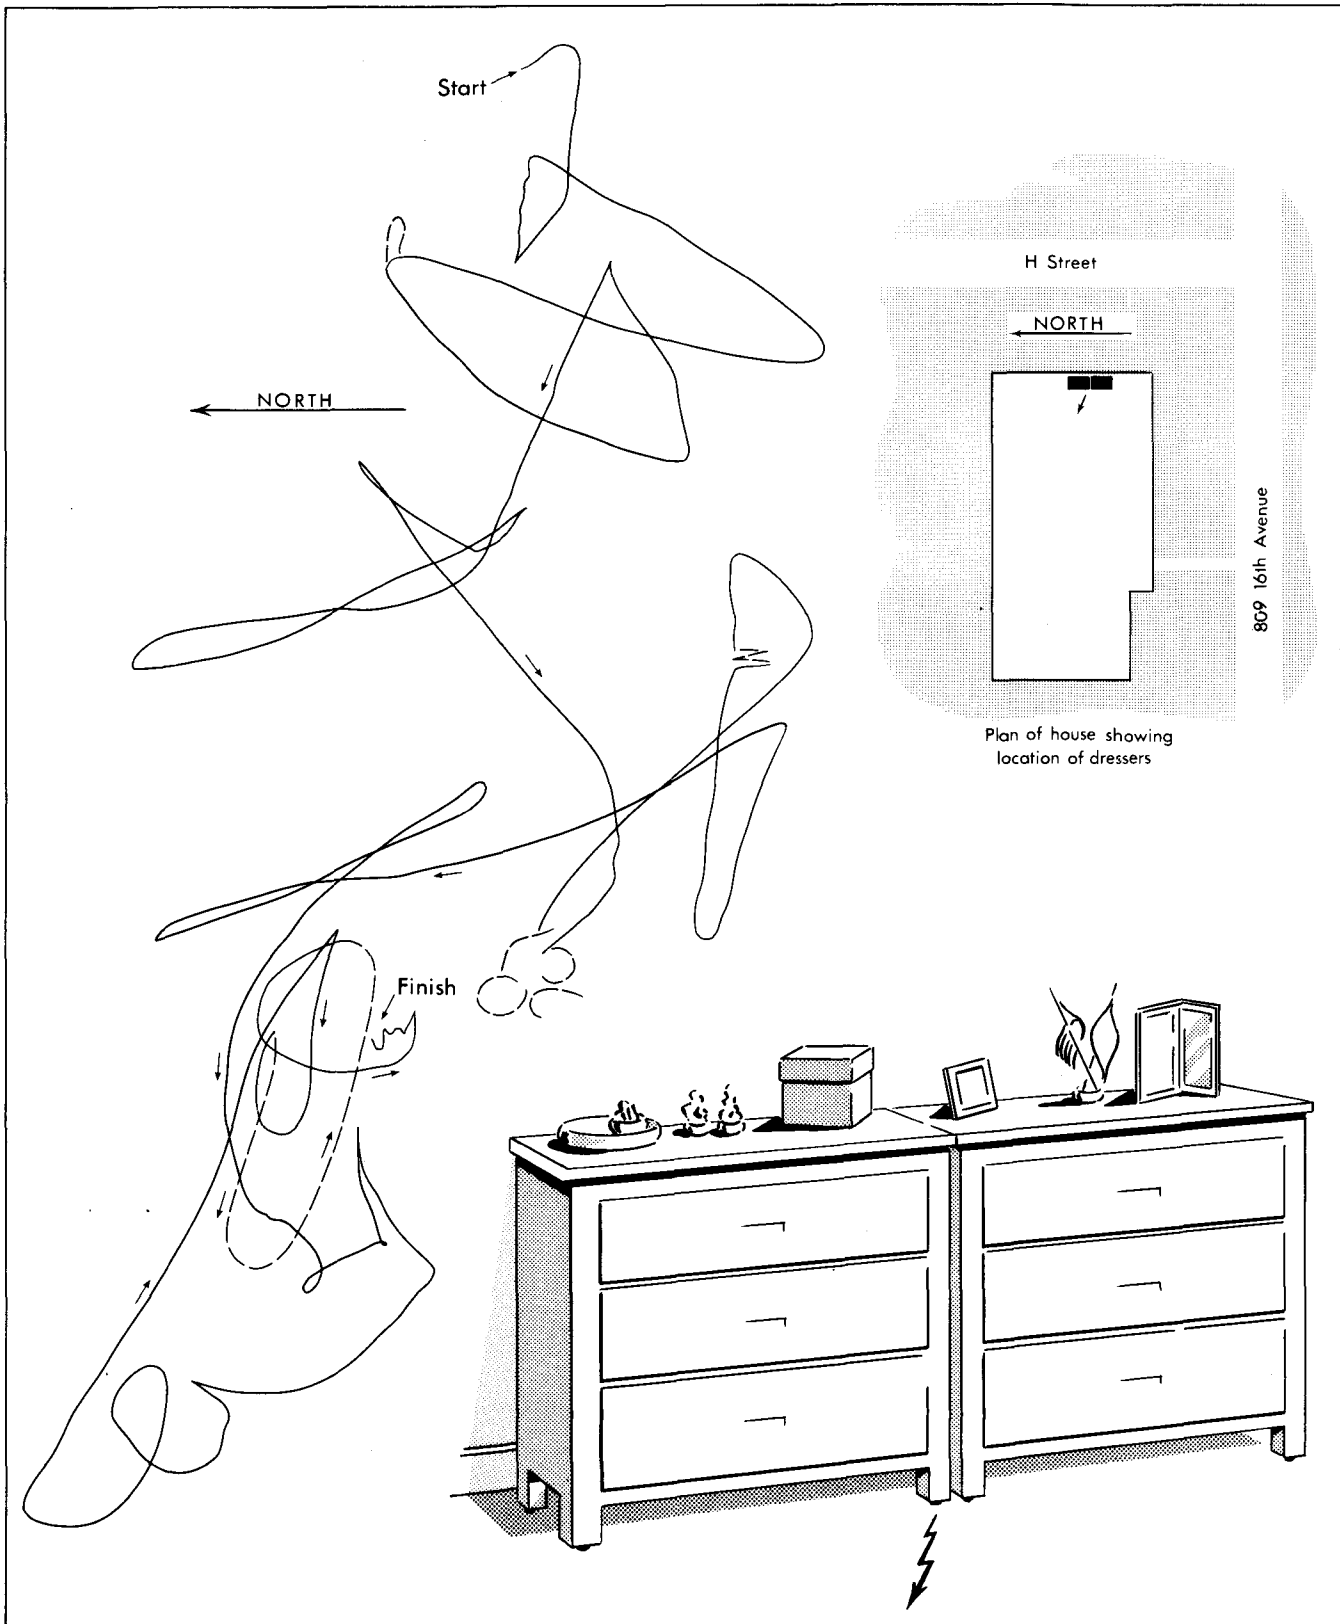
2.—Horizontal trace on asphalt tile flooring left by dresser leg during earthquake. Net movement of dresser was about N. 75° W. Other legs left nearly identical traces. Sundry items on dresser tops were little disturbed. Trace reproduced by Oliver V. Kola, published by permission of Dr. M. A. Sozen. Scale of trace,  $\times \frac{1}{2}$ .

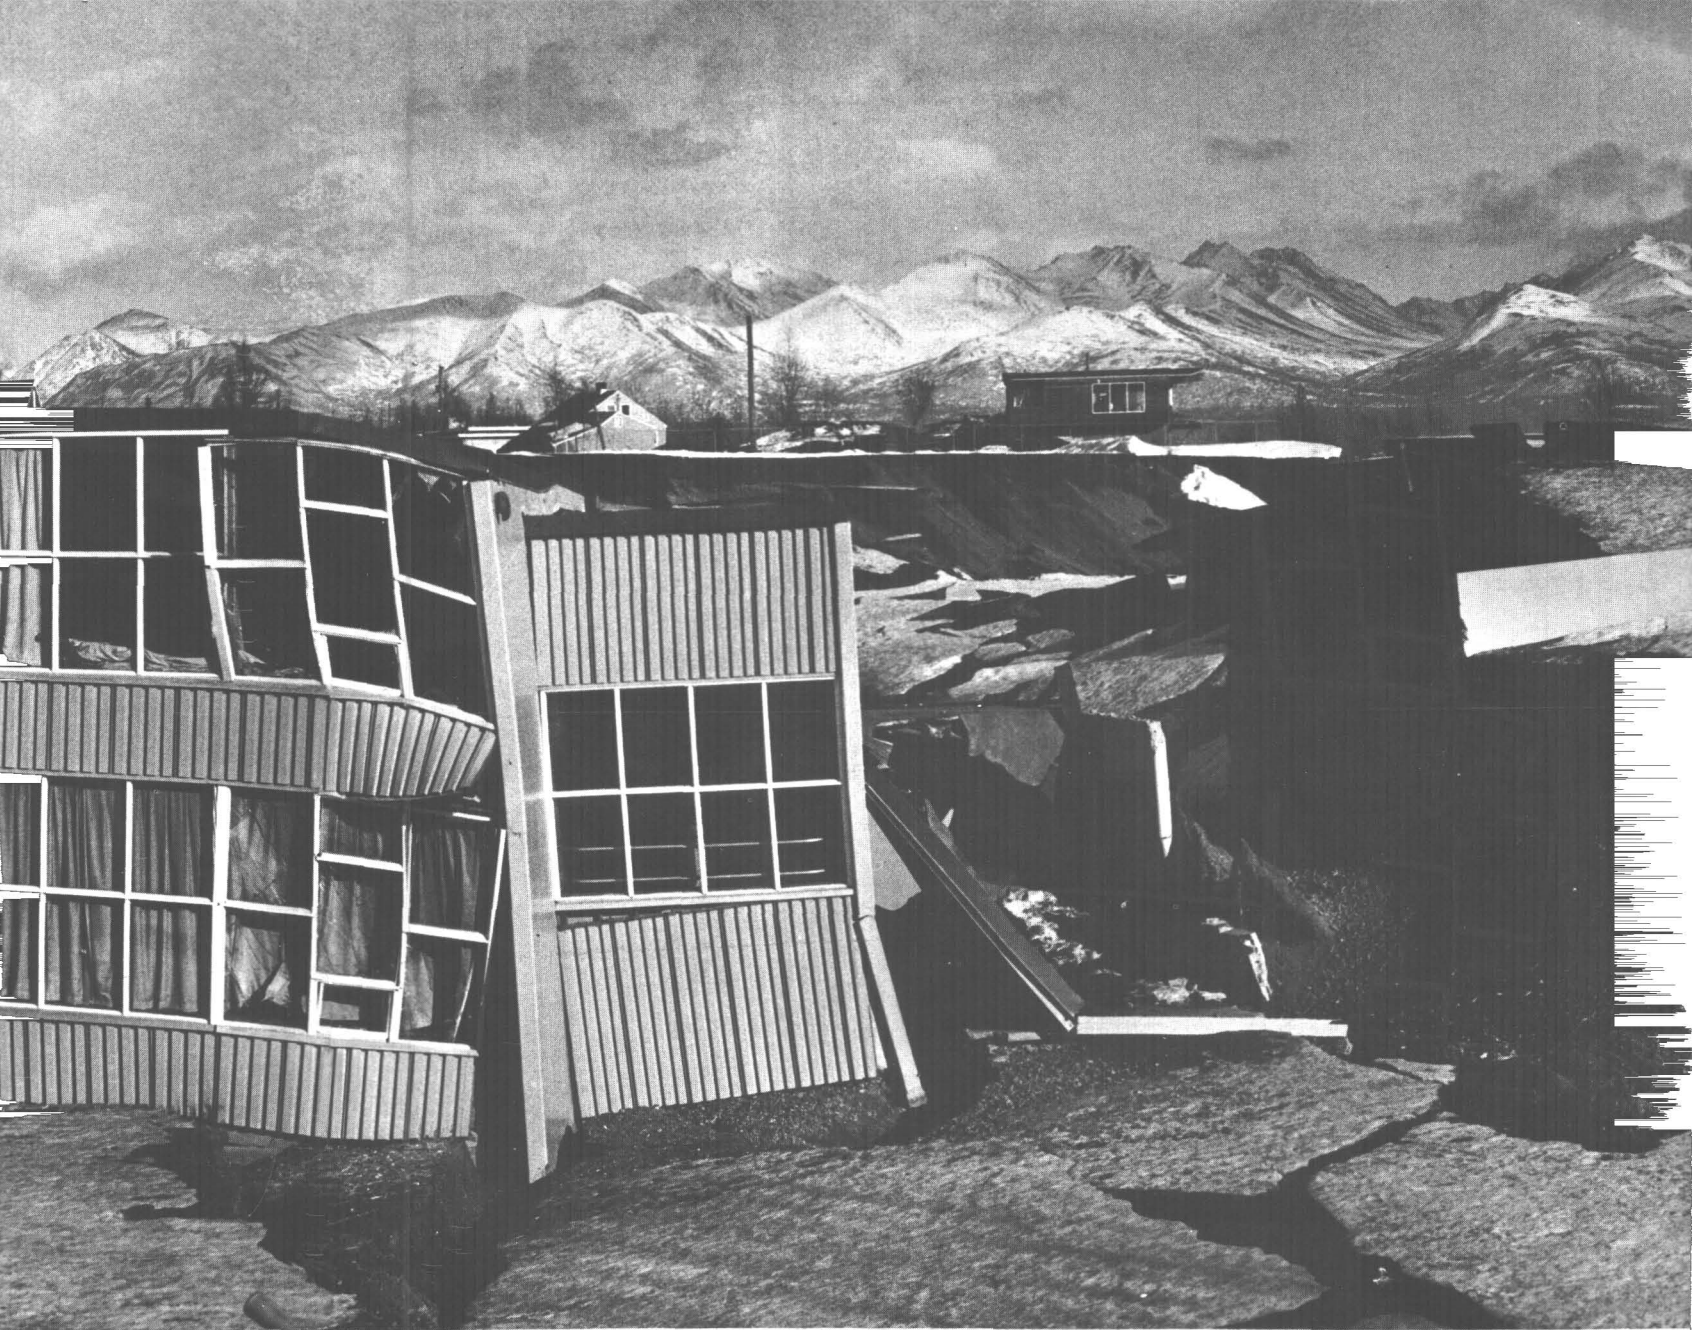
3.—Wreckage of Government Hill School. The south wing of the building, shown here, collapsed into a graben at the

head of the slide. Net slip of the graben block is shown by the displacement of the roofline. Photograph by M. G. Bonilla.

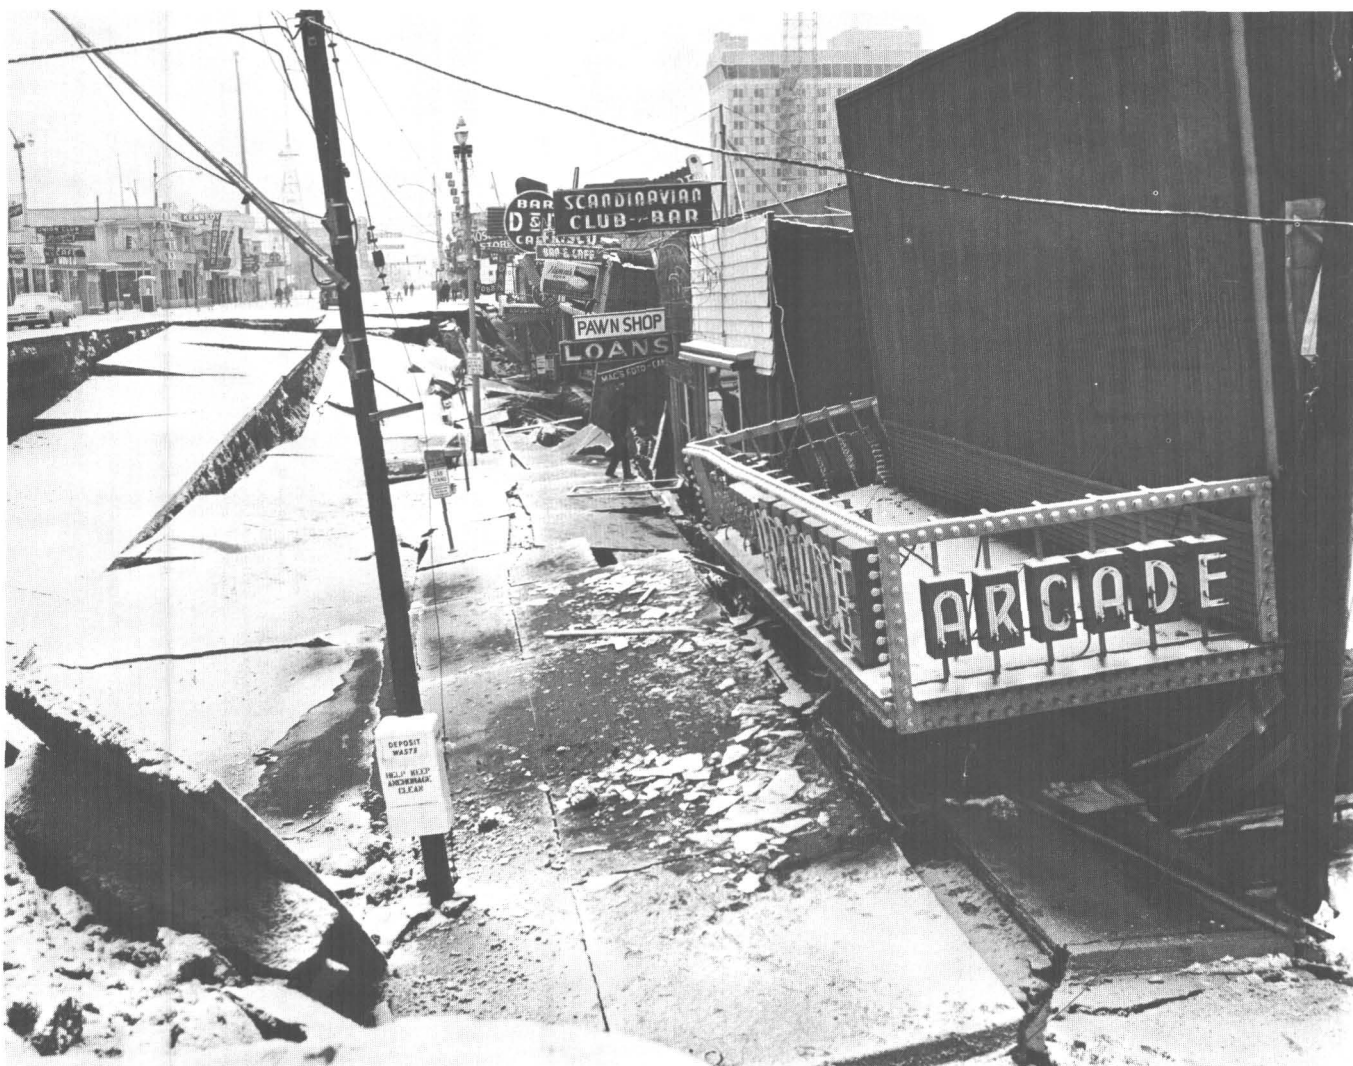
In downtown Anchorage (the L Street and Fourth Avenue landslide areas), about 30 blocks of dwellings and commercial buildings were destroyed or severely damaged (fig. 4). A new six-story apartment building, the Four Seasons, was razed. A new five-story department store (J. C. Penney Co.) was damaged beyond repair by seismic shaking and had to be torn down (fig. 5). Many automobiles in the downtown area were struck by falling debris. Twin 14-story apartment buildings, though a mile apart, sustained massive, nearly identical vibratory damage, much of it in response to vertical shearing forces caused by oscillation. Many other multistory or large-area buildings were severely damaged.

4.—View west along Fourth Avenue at head of landslide. North (right) side of street has collapsed into a graben. Vertical displacement is about 10 feet. Photograph by Mac's Foto, Anchorage, Alaska.

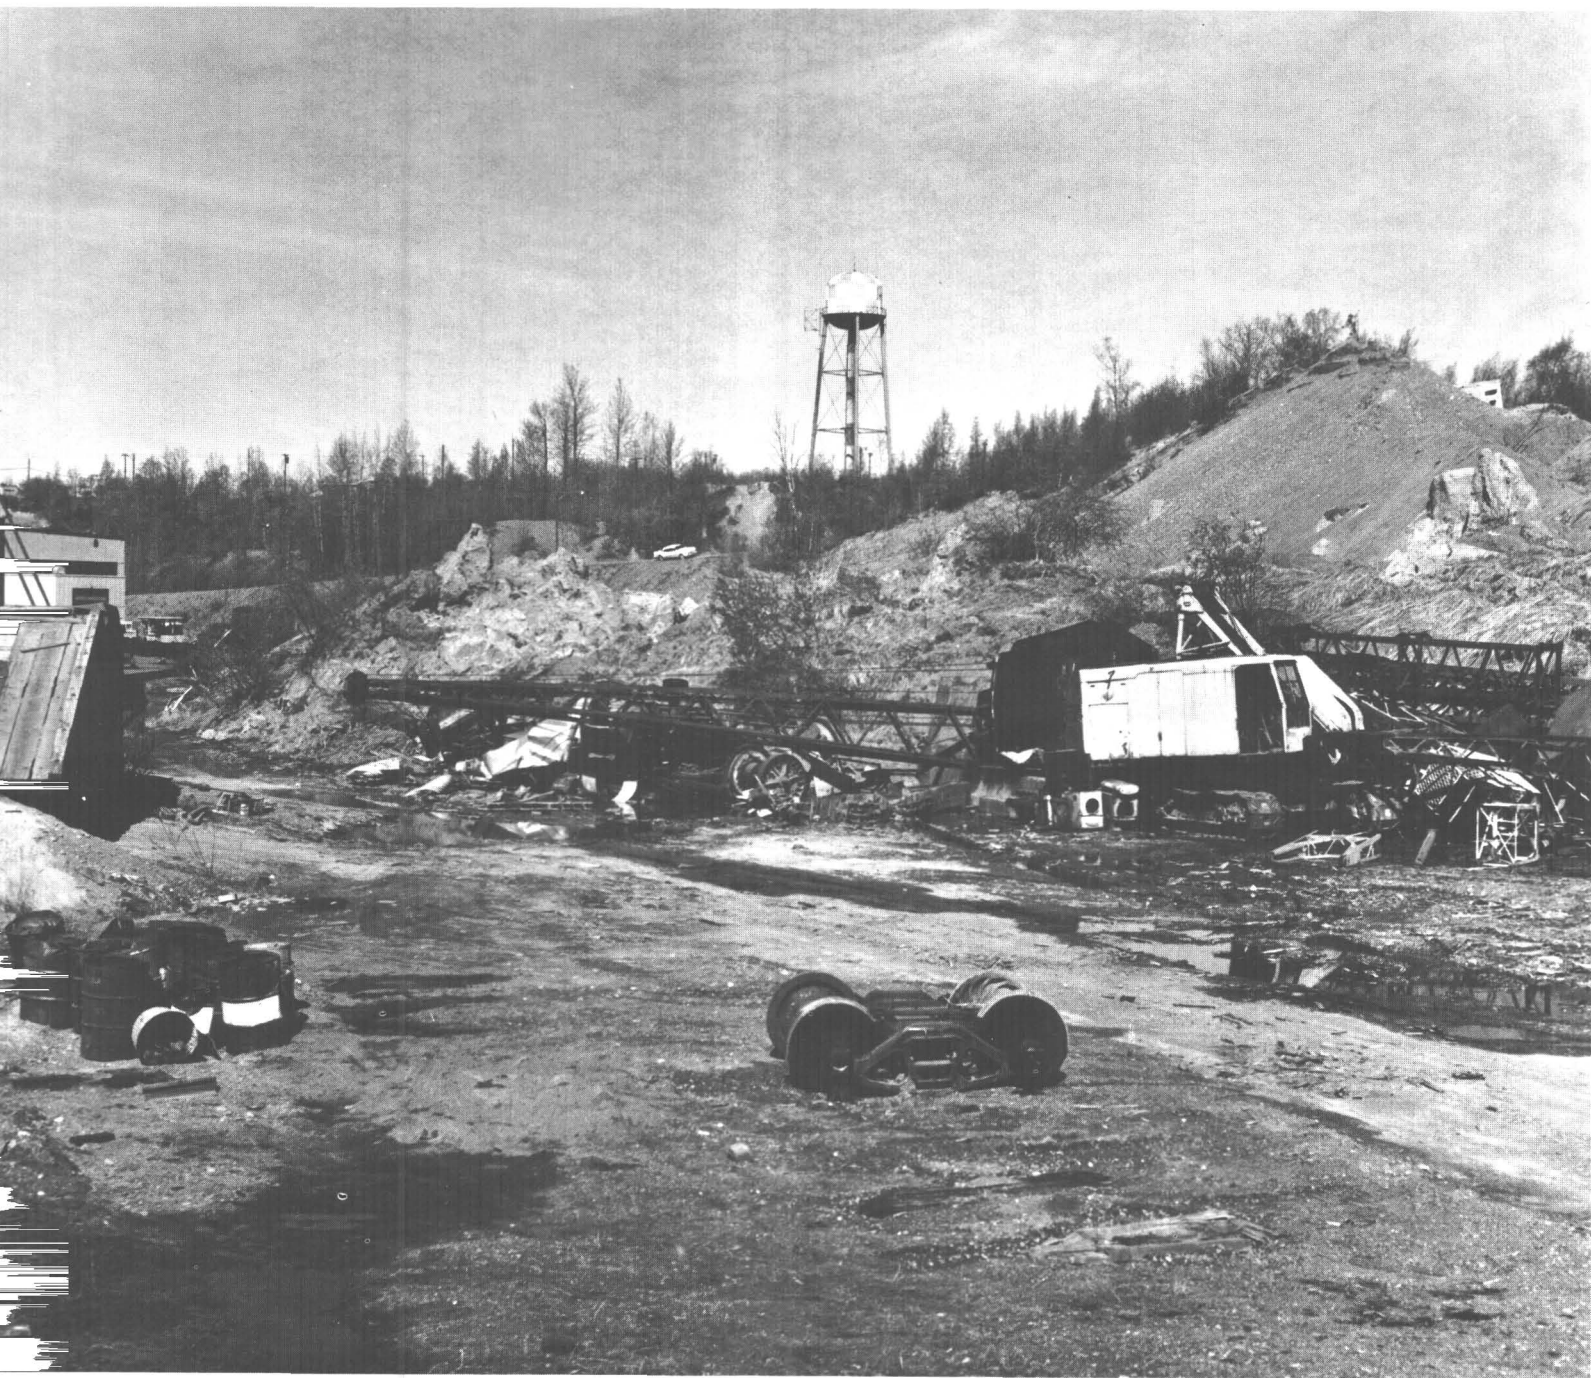
6.—Damage to yards of The Alaska Railroad, looking northwest, caused by earthflow at toe of Government Hill slide. Note undamaged water tank in background.

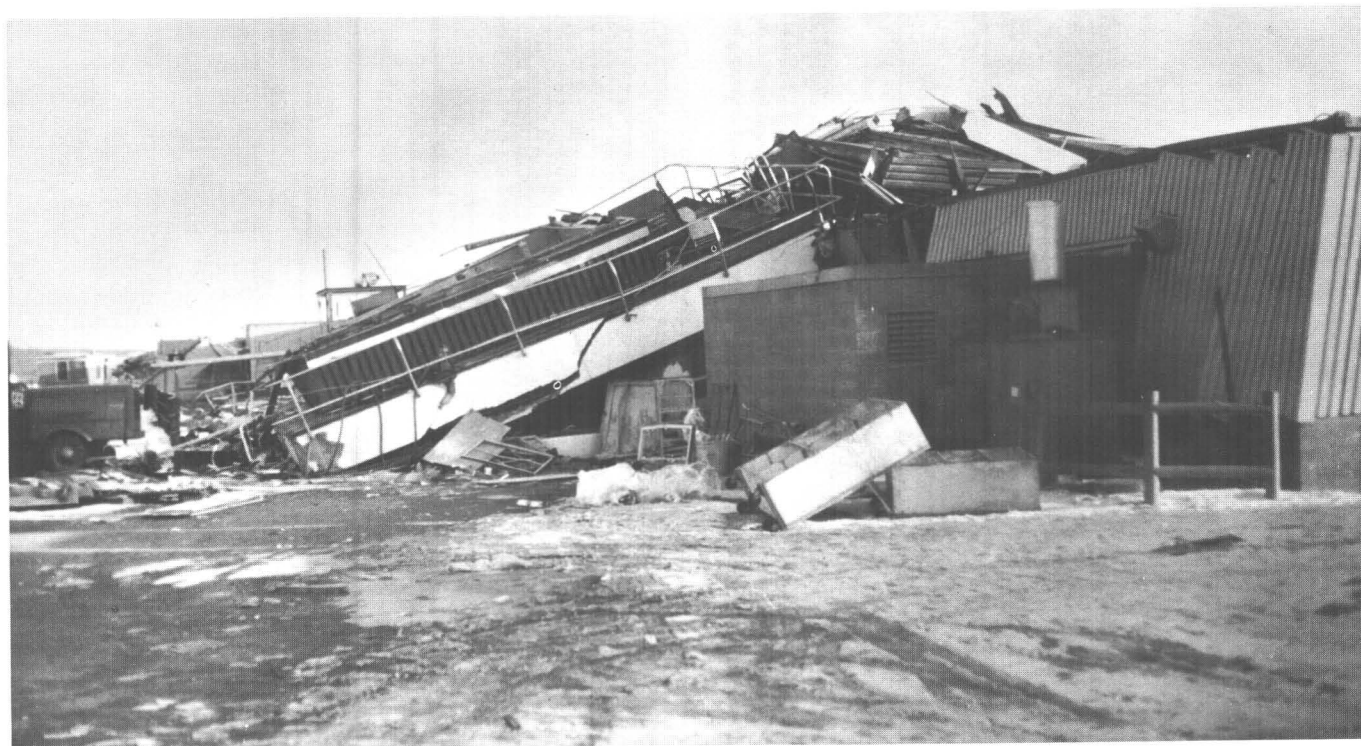
At the Anchorage International Airport, the control tower failed under seismic vibration and collapsed to the ground (fig. 7), killing one occupant and injuring another. The airport terminal building, although tied structurally to the tower, was only slightly

7.—Wreckage of control tower at Anchorage International Airport. Six-story tower failed under sustained seismic shaking. Photograph by George Plafker.

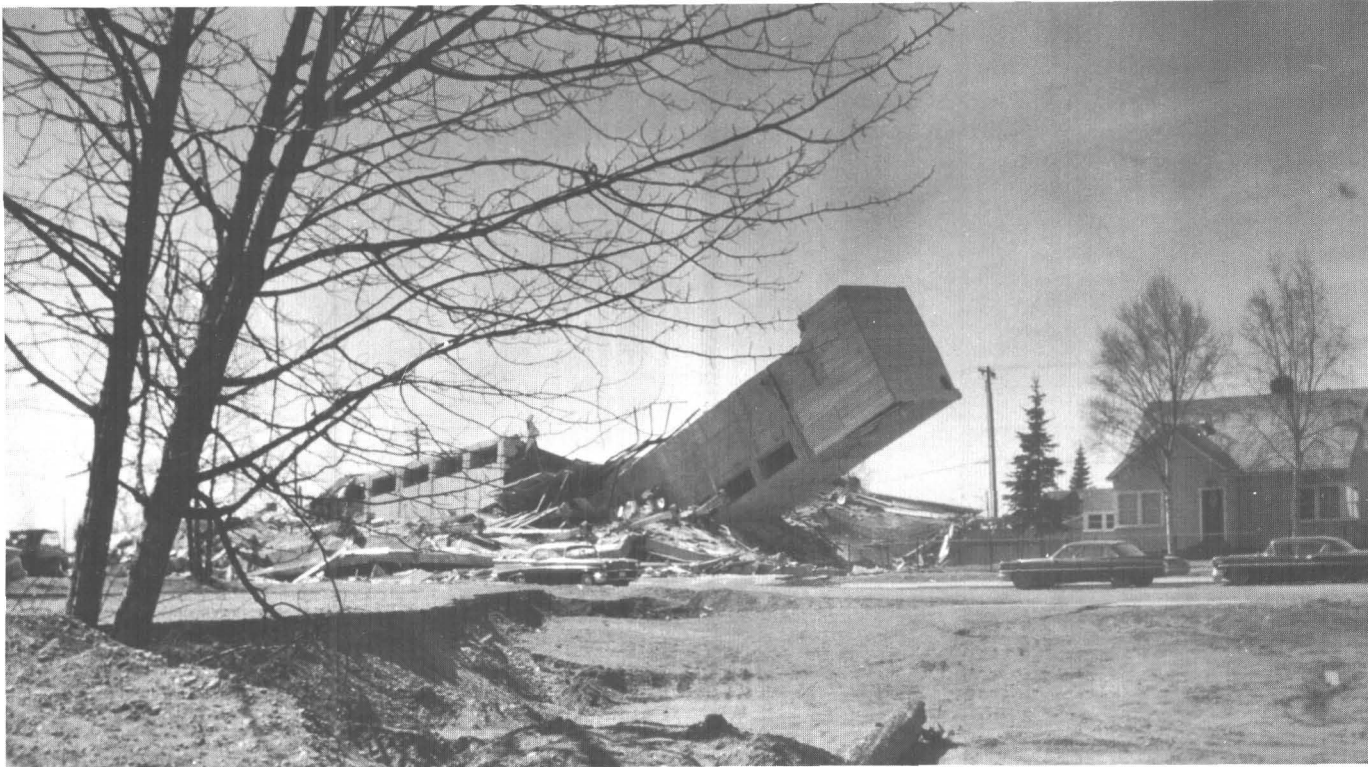
The effects of seismic vibration in areas of cracked ground cannot always be separated from the effects of ground displacement. The collapse of the Four Seasons Apartment Building (fig. 13), a case in point, has been attributed to seismic vibration. Perhaps vibration was the dominant factor in the building's failure. The building, however, was close to the L Street graben at West Ninth Avenue and M Street, and a large subsidiary fracture, trending about west-northwest, passed directly under the building. In the chaotic pile of rubble left after the

13.—Wreckage of six-story Four Seasons Apartment Building, Anchorage, Alaska. Canted elevator shaft at center. Large crack in foreground, filled in on M Street to restore traffic, passed beneath building.

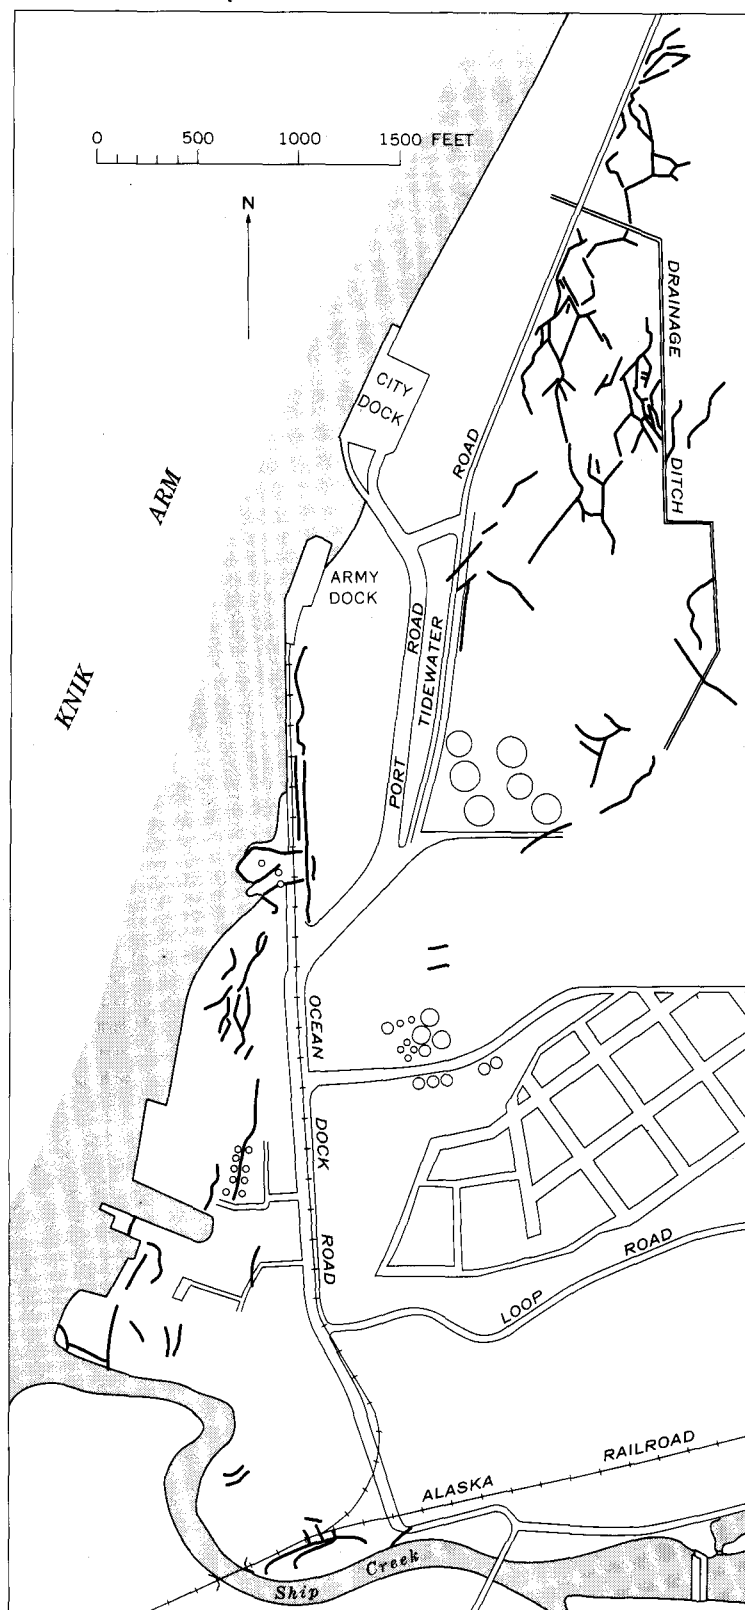
14.—Ground cracks, Port of Anchorage and vicinity. Anchorage, Alaska. Many of these cracks spouted mud, particularly those east of City Dock. Base by city of Anchorage, Office of City Engineer.

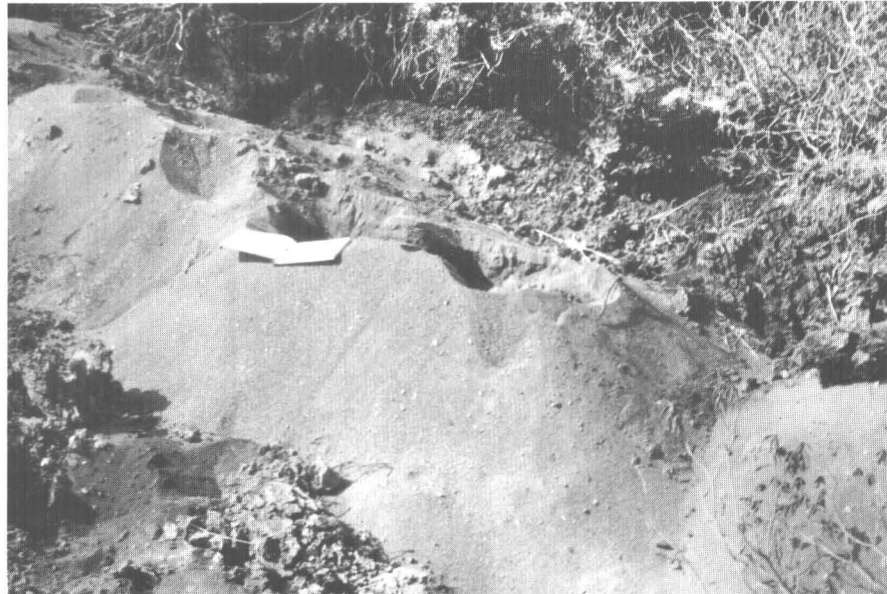
15.—Part of a sand boil, Turnagain Heights slide area. Ridges 2 to 3 feet high and 100 feet long or more were formed as fountains of water were ejected through frozen outwash.

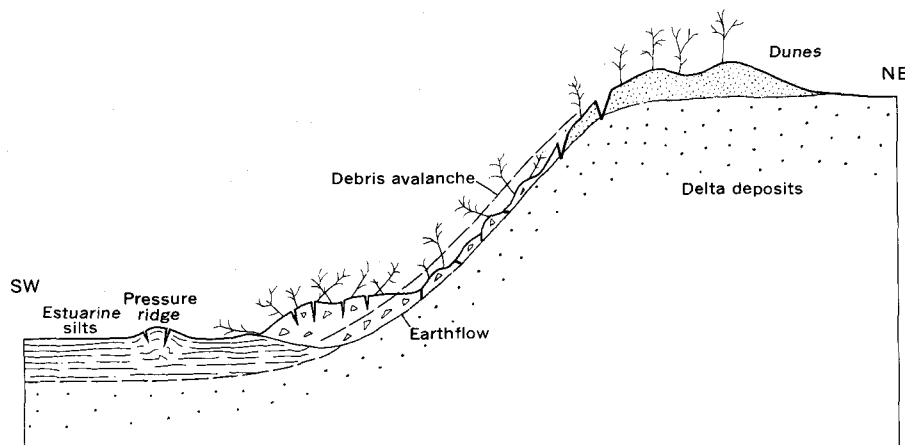
16.—Diagrammatic section near Point Campbell, showing mode of failure along bluff line overlooking Turnagain Arm.

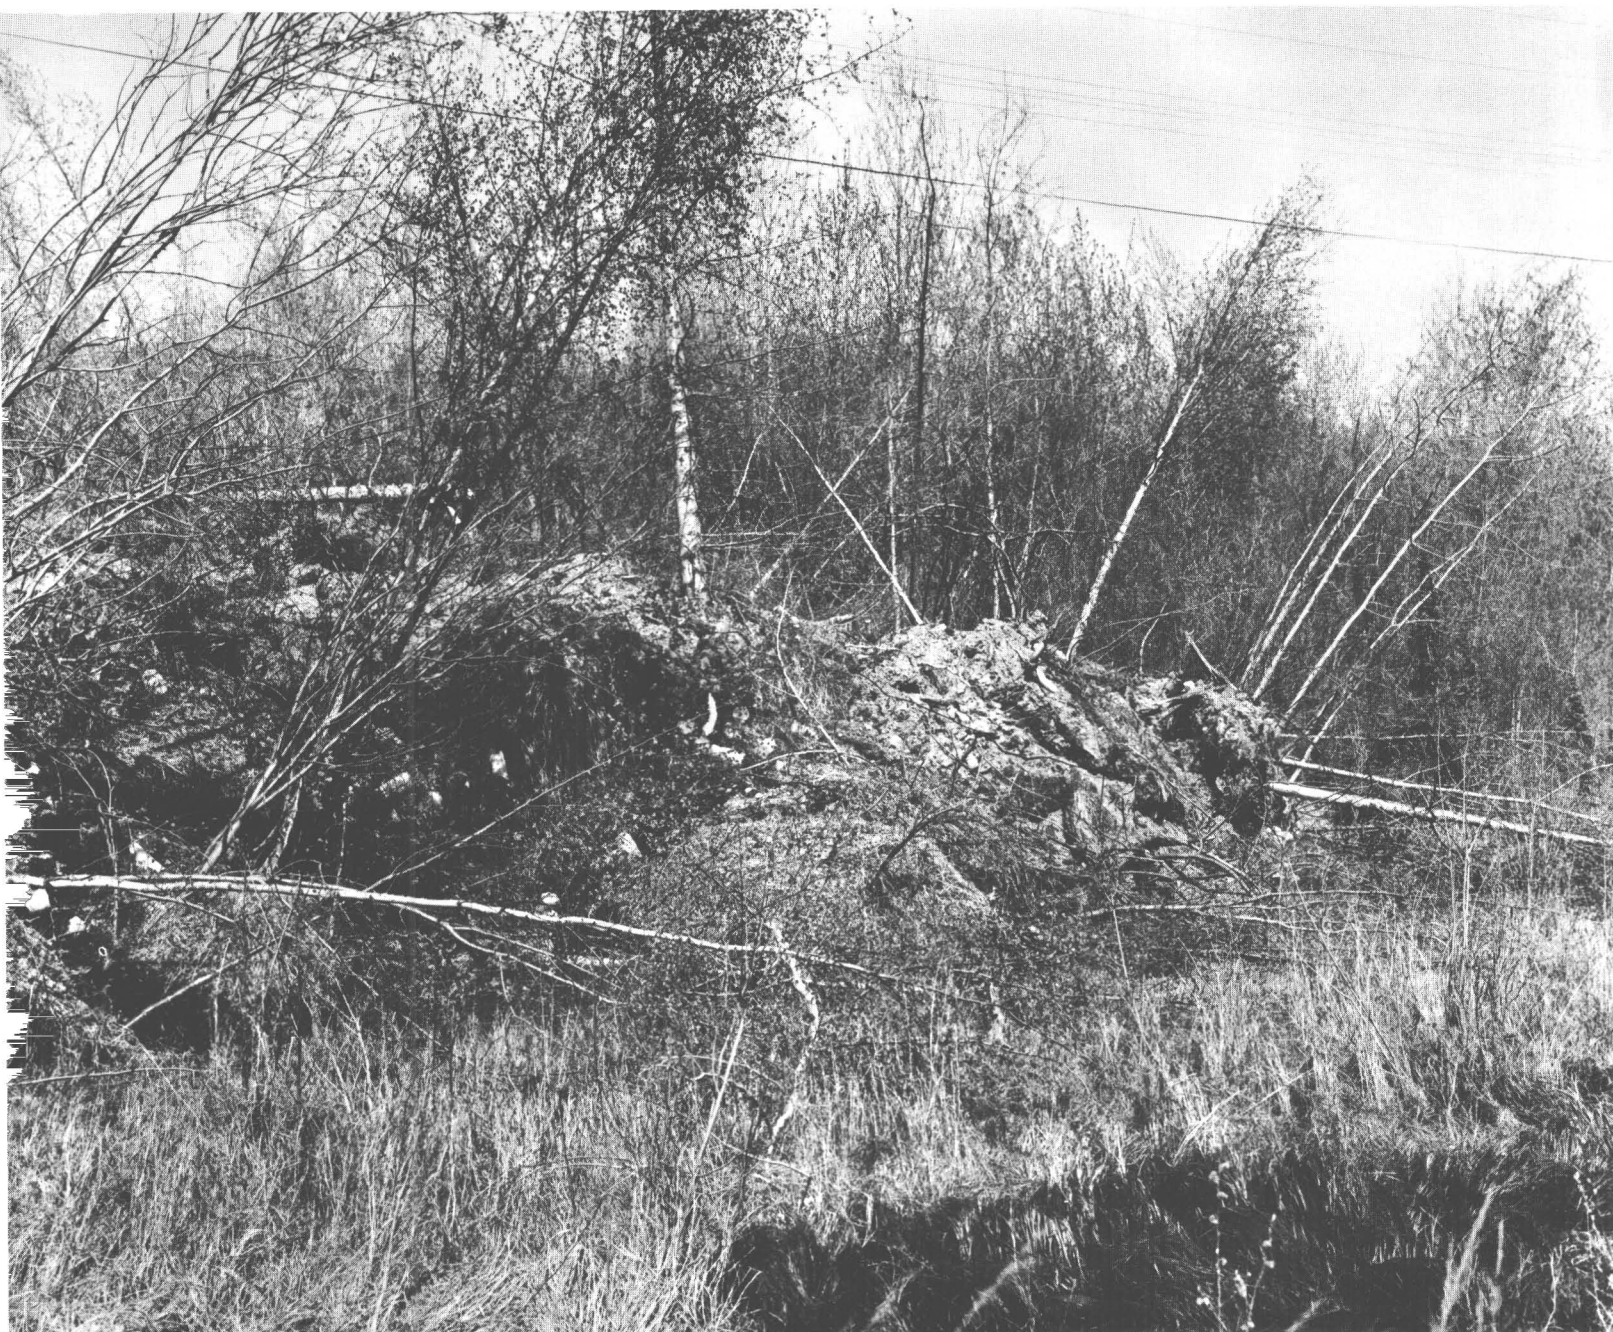
21.—Chaotic pressure ridge at toe of rotational slide, Bluff Road.. In part, toe surged forward as an earthflow. Compare with figure 22.

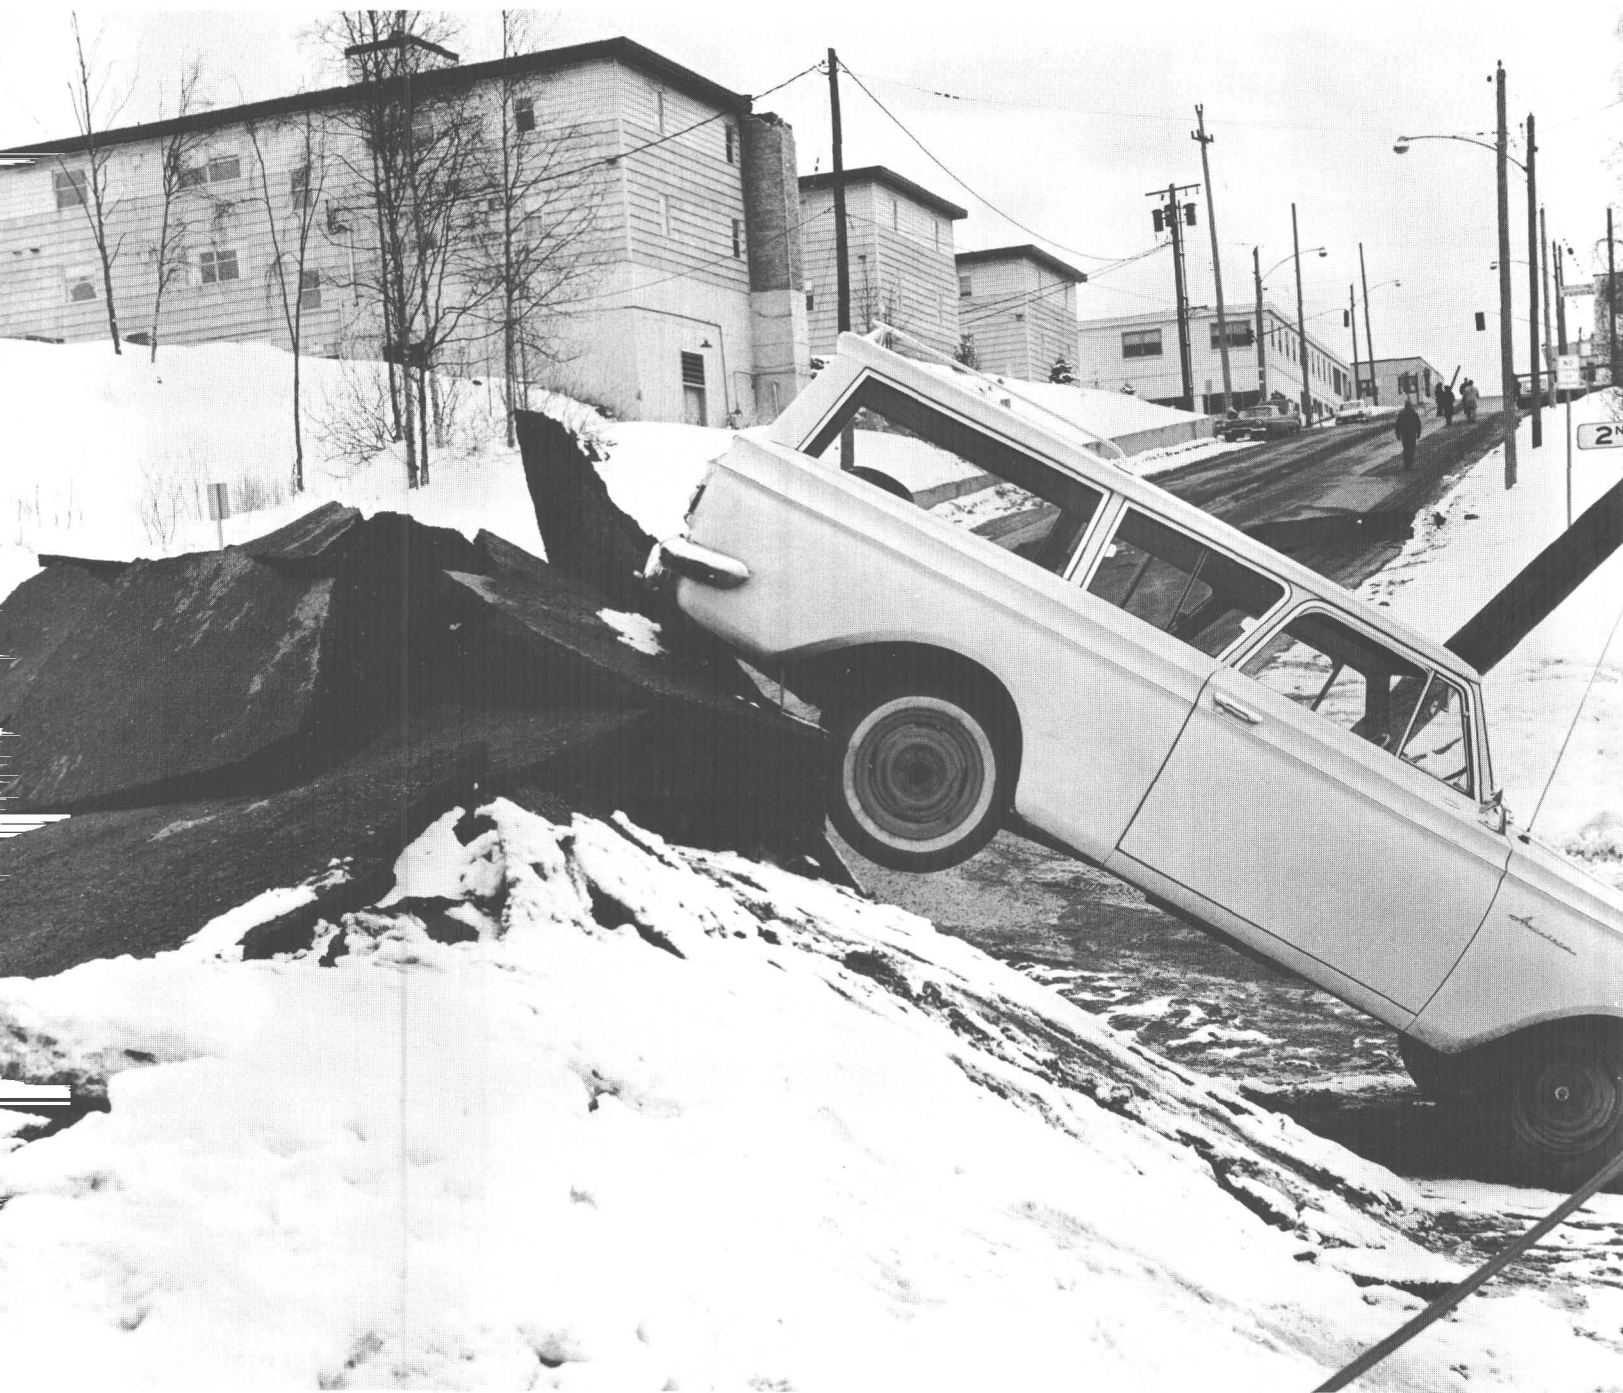
26.—Sharp-crested pressure ridge at Second Avenue and C Street, Anchorage. Probably caused by shallow translation of frozen surface layer. Note smaller pressure ridge in street part way up block and toppled chimney of building behind car. Photograph by Mac's Foto, Anchorage.

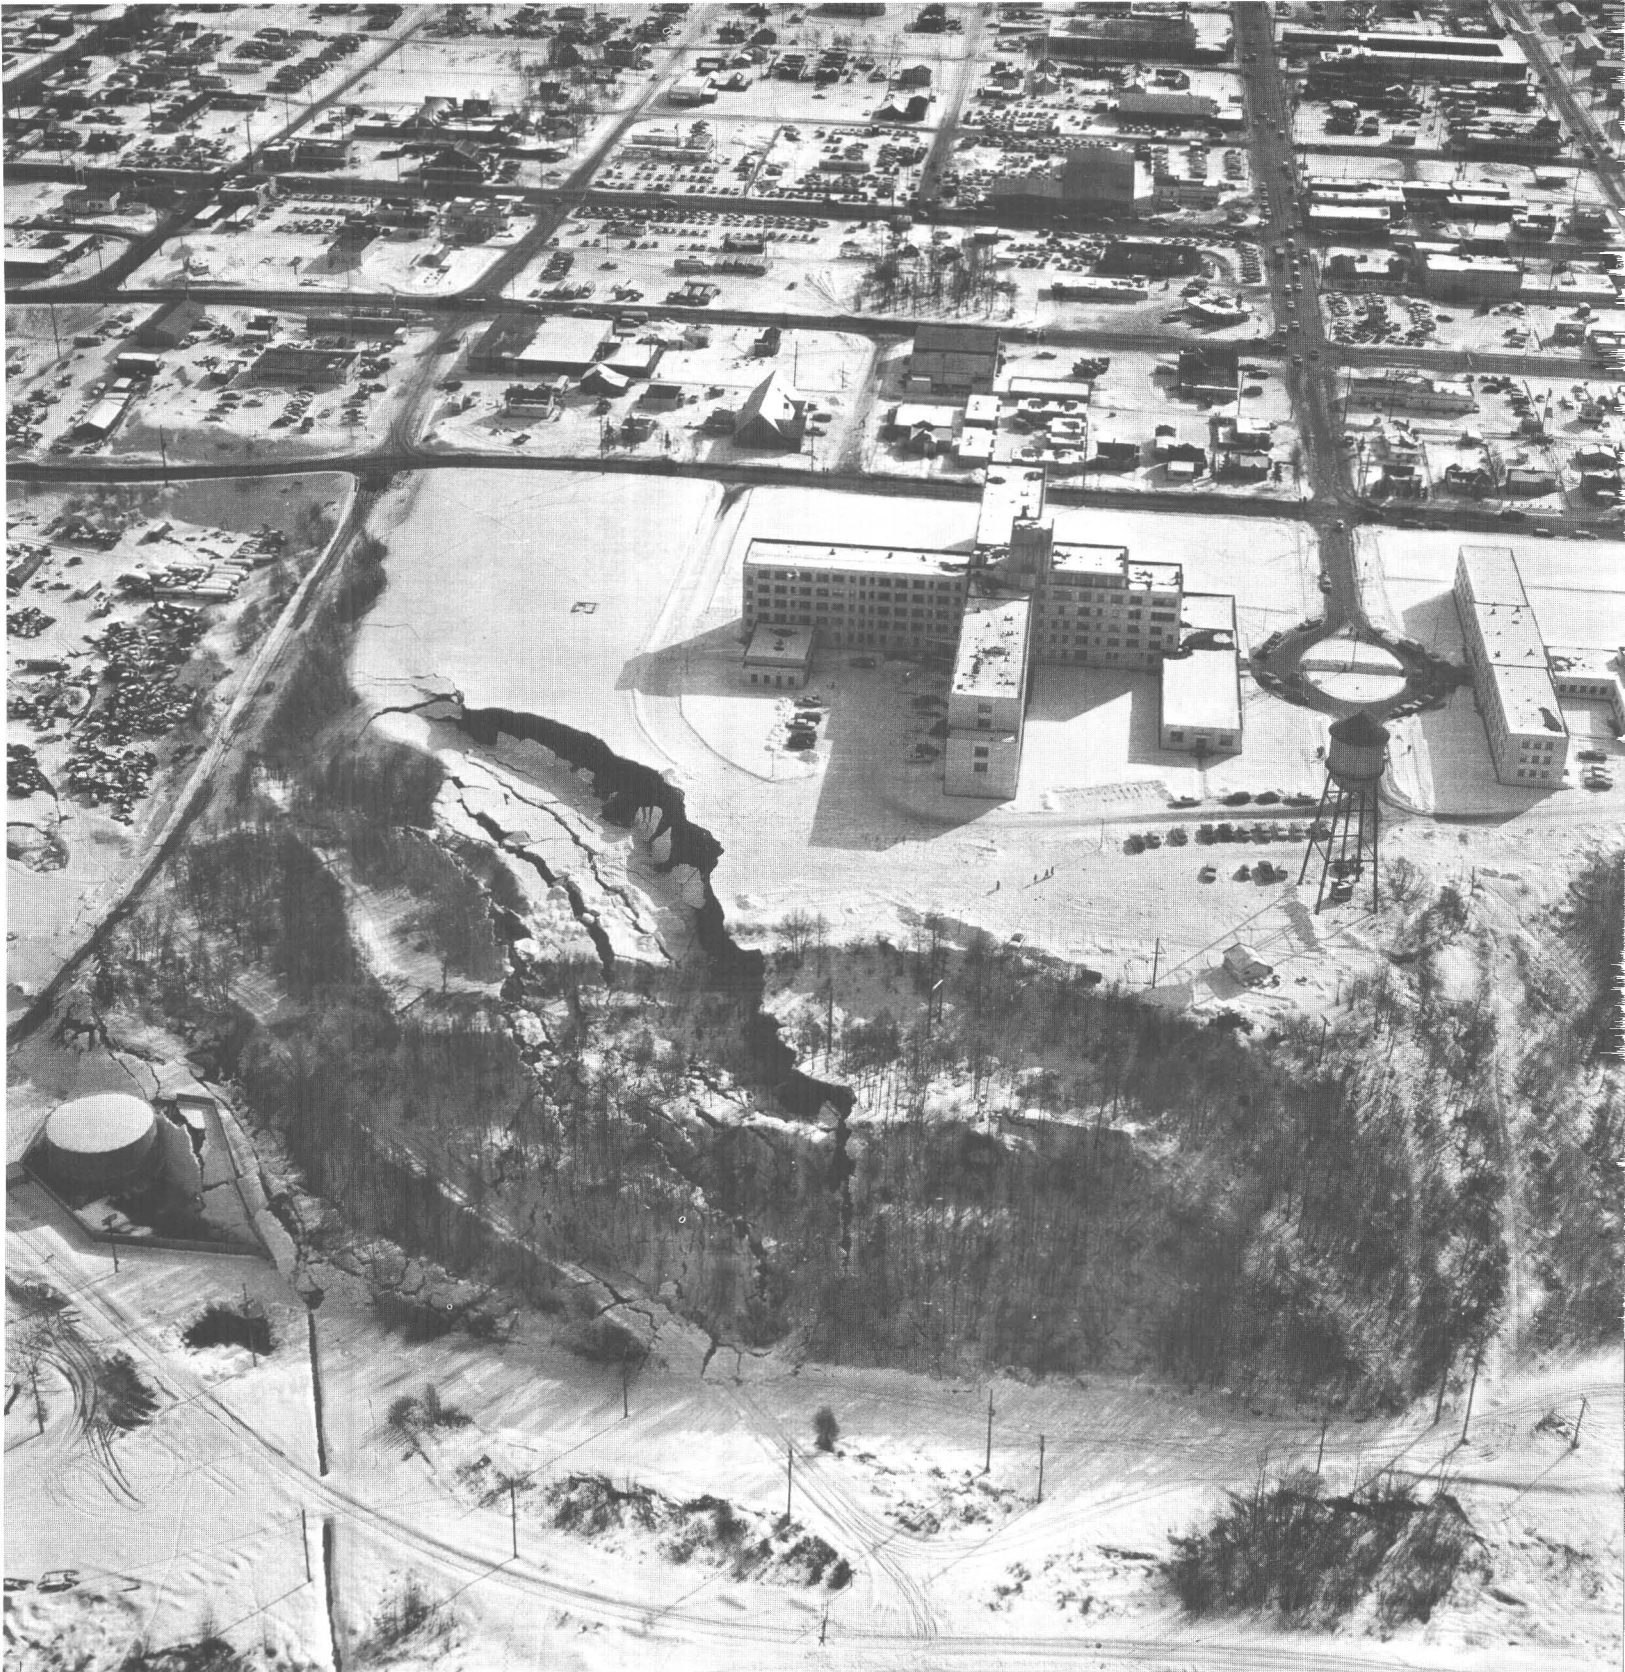
32.—Air view (looking south) of Native Hospital slide showing graben and pressure ridge. The scar of an older landslide is transected by the slide of March 27, 1964. Photograph by U.S. Army.

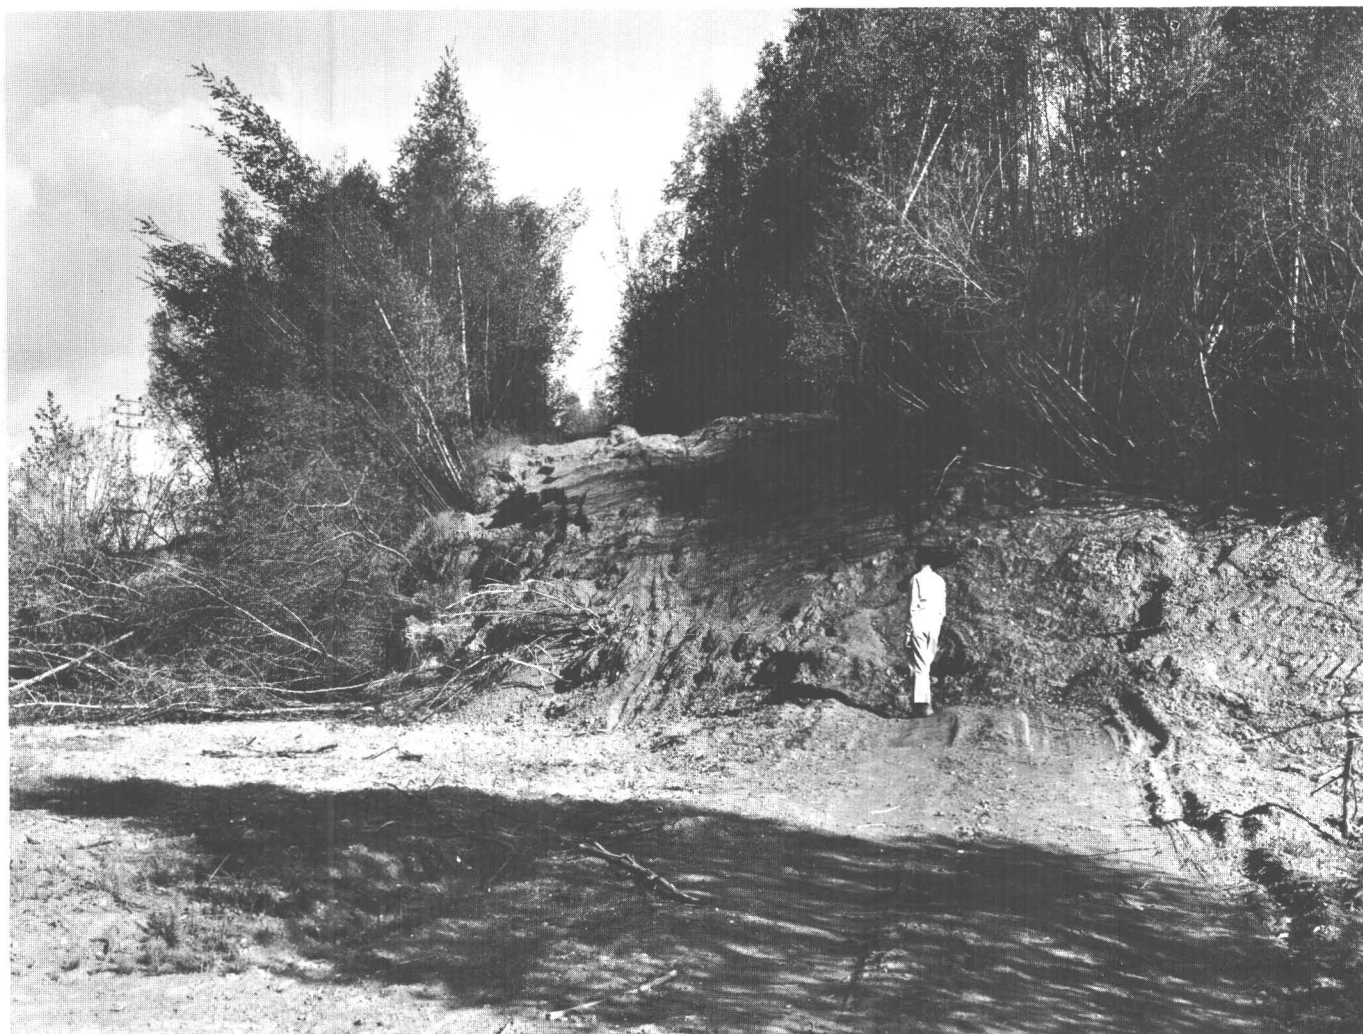
34.—Overthrust toe of Native Hospital slide. Road is bulged up and displaced about 12 feet laterally. Note overridden trees at left.

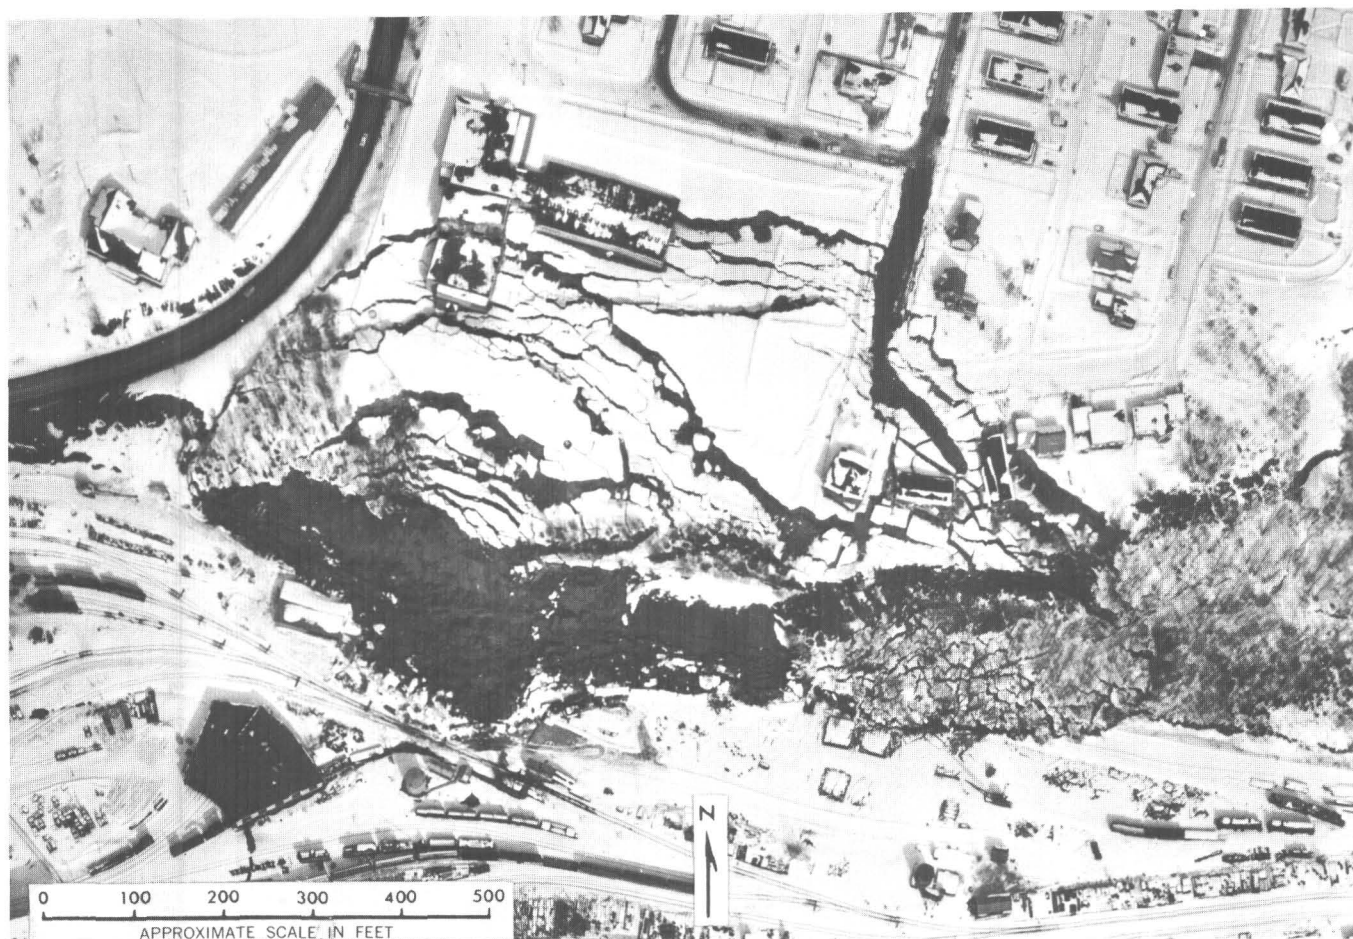
35.—Air view of Government Hill slide, Anchorage, Alaska. Graben plainly discernible. Compare with figure 38. Photograph by Air Photo Tech, Anchorage, Alaska.
