# The Alaska Earthquake

# Effects of the Earthquake Of March 27, 1964 At Anchorage, Alaska

*A description and analysis of the damage resulting from seismic vibration, ground cracks, and especially landslides in Alaska's largest city*

GEOLOGICAL SURVEY PROFESSIONAL PAPER 542-A

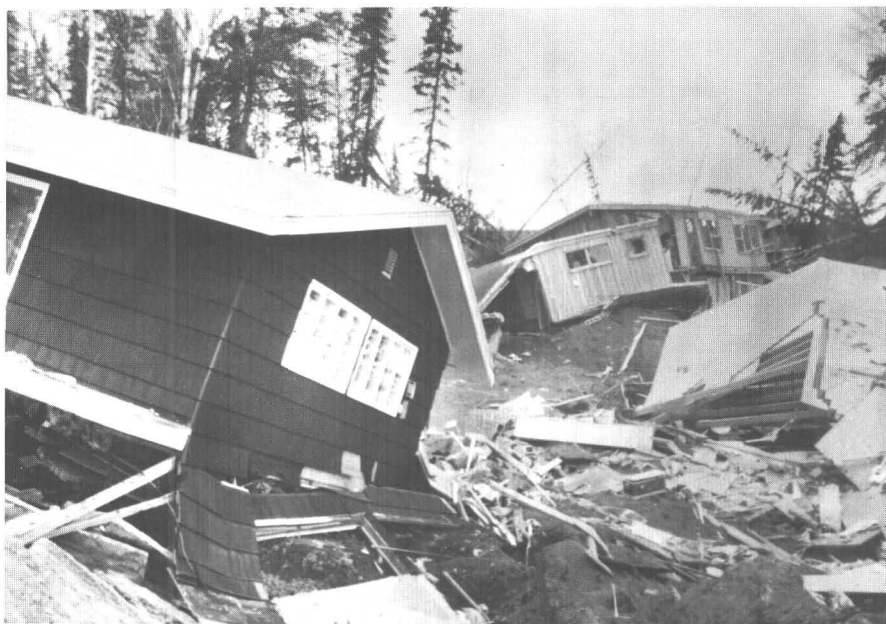
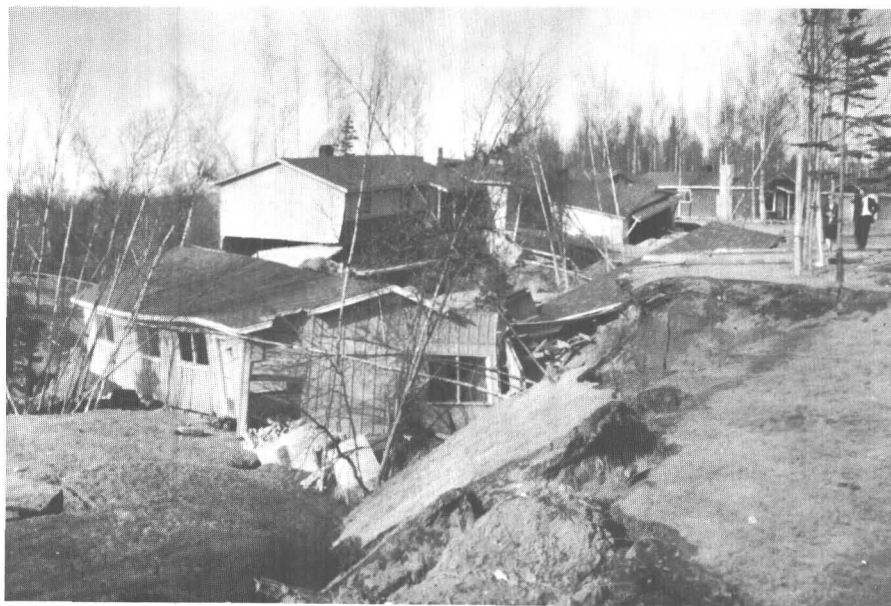
39.—Homes devastated by Turnagain Heights slide; deep within slide area, upper; at main scarp, lower. About 75 homes were destroyed.

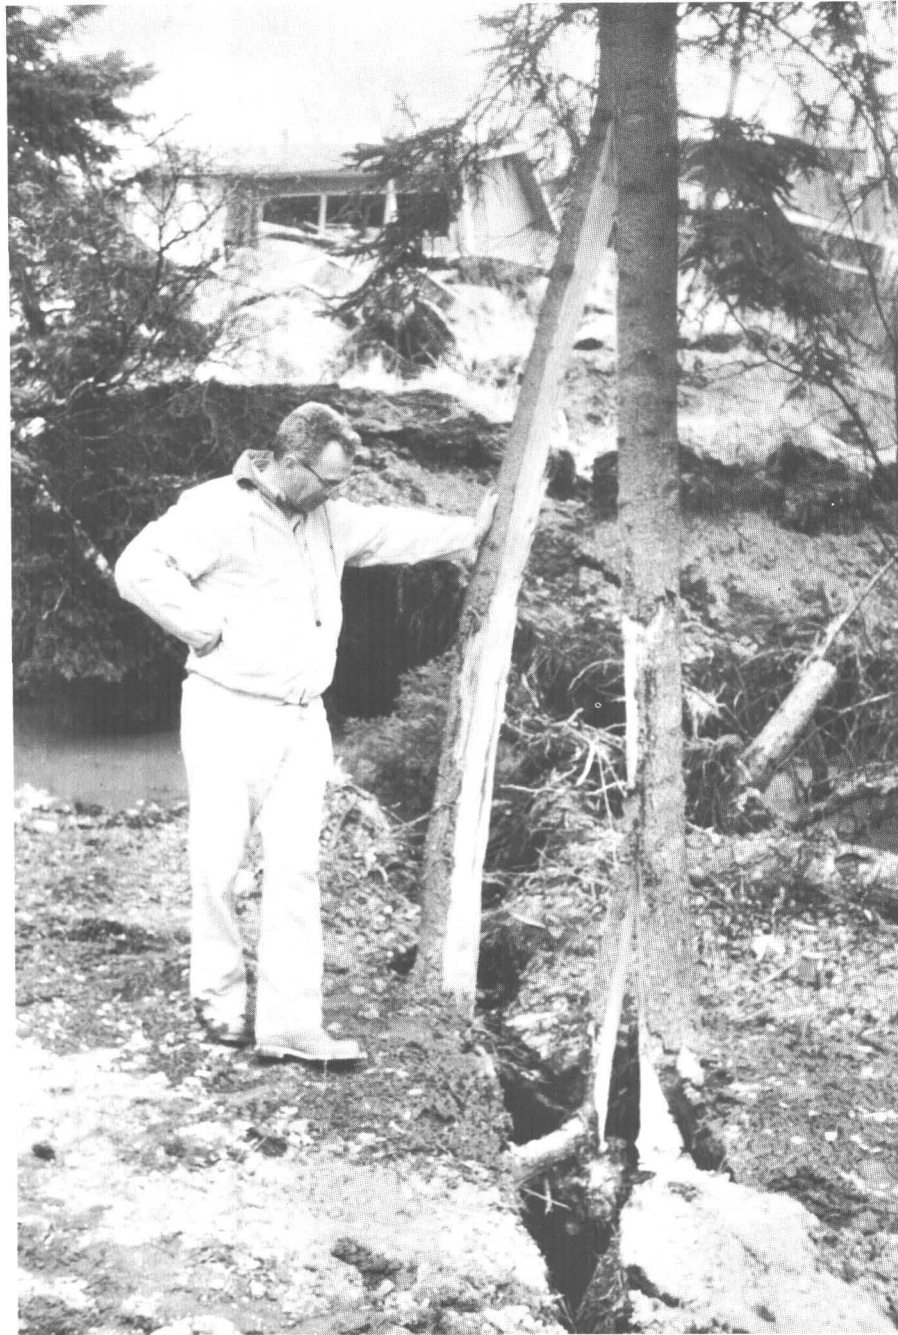
40.—Tree trunk split by tension fracture, Turnagain Heights slide. Many trees were similarly damaged because their roots were firmly embedded in the frozen ground.

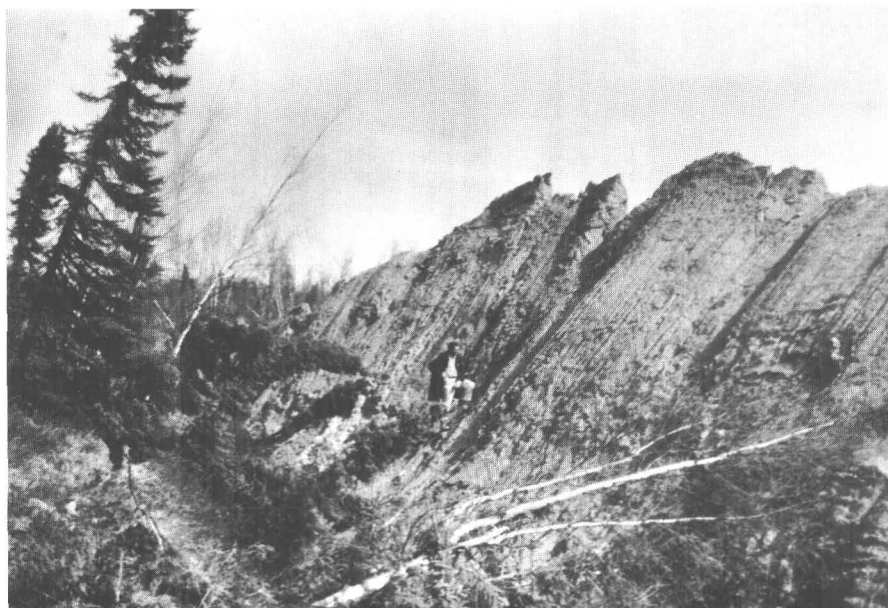
41.—Furrowed, slickensided clay ridge, Turnagain Heights slide. Ridge is about 20 feet high. Tilted collapsed block at left. Compare with figure 42.

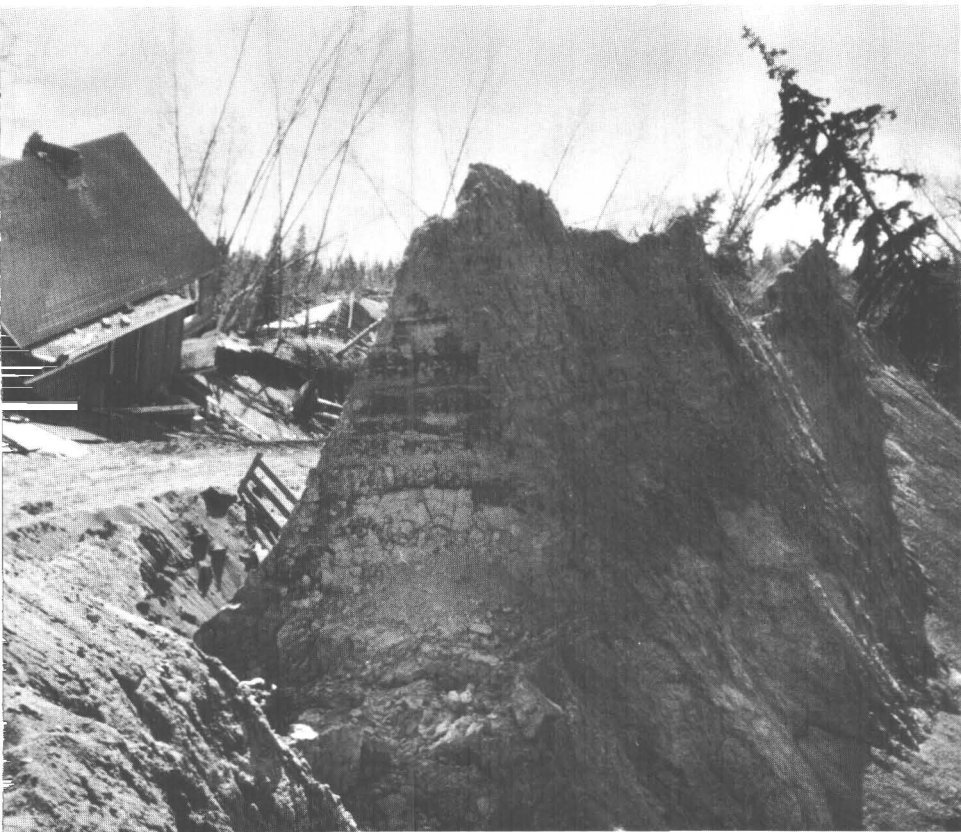
42.—Sharp-crested clay ridge, Turnagain Heights slide. Collapsed blocks tilted toward ridge on both flanks. Note horizontal stratification in ridge. Compare with figure 41.

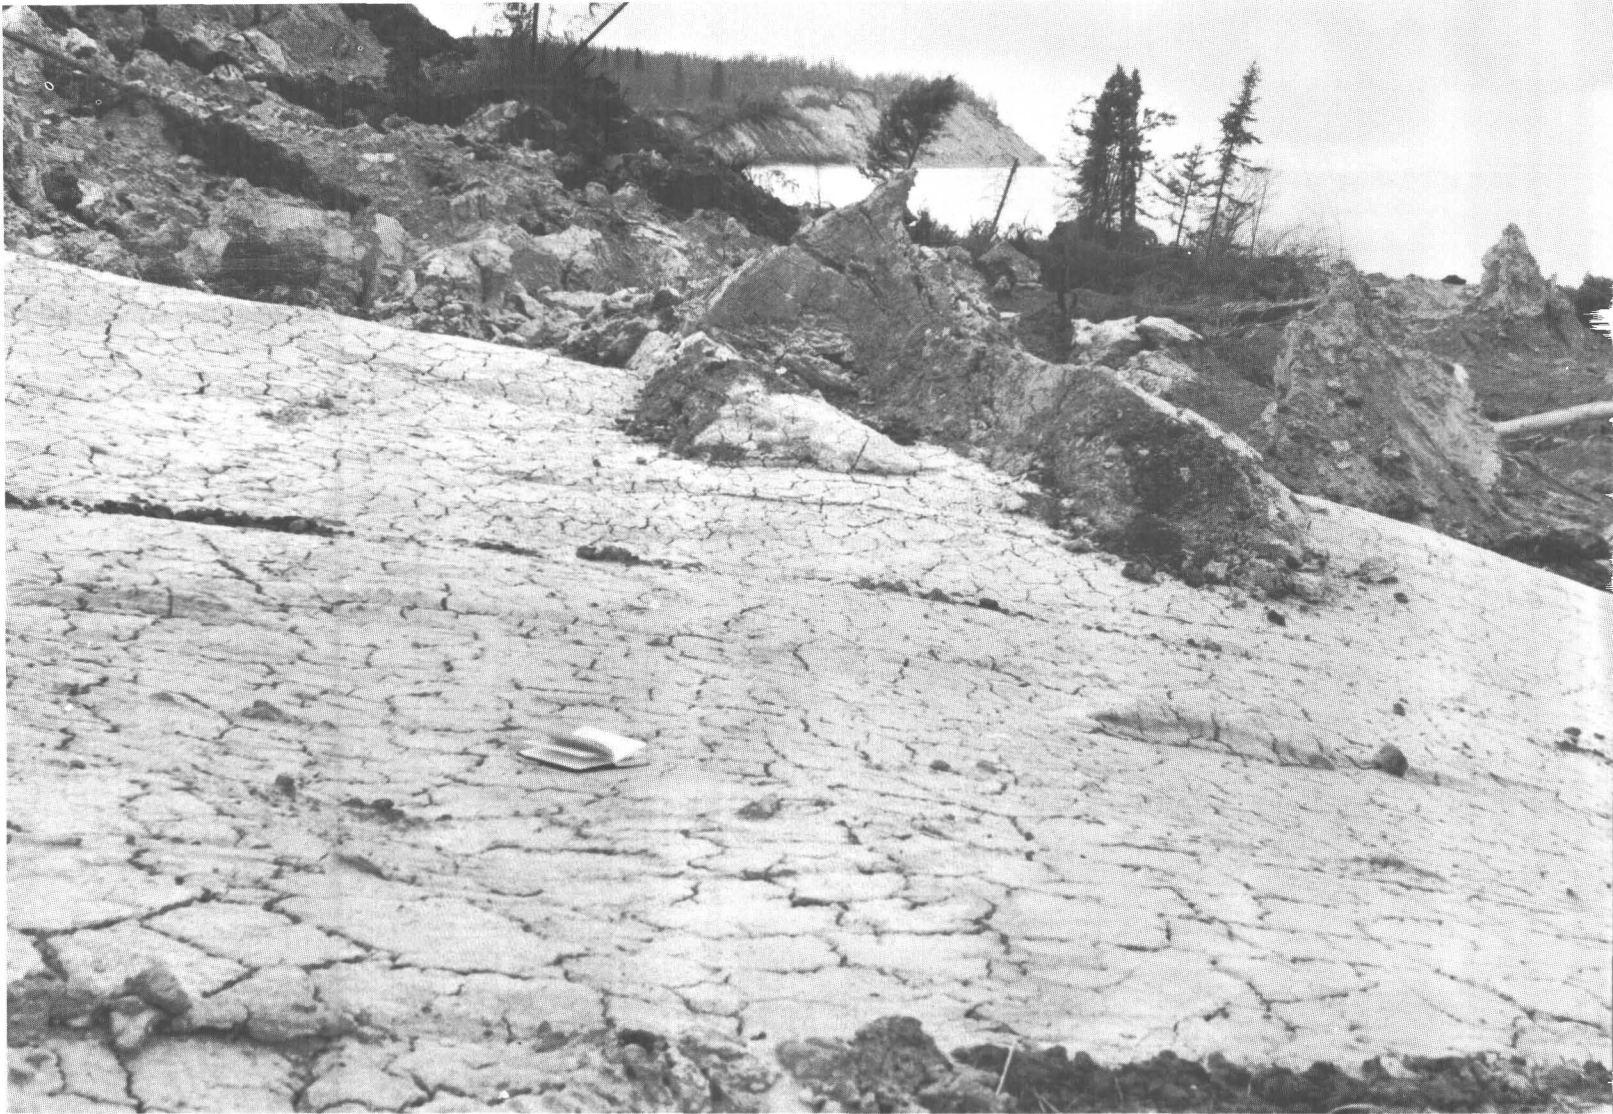
43.—Slip surface of Turnagain Heights slide exposed near west margin of slide. Furrows and welts still well preserved despite desiccation and weathering. Point Woronzof and Knik Arm in distance.
