The Alaska Earthquake

Effects of the Earthquake Of March 27, 1964 At Whittier, Alaska

By REUBEN KACHADOORIAN

GEOLOGICAL SURVEY PROFESSIONAL PAPER 542-B

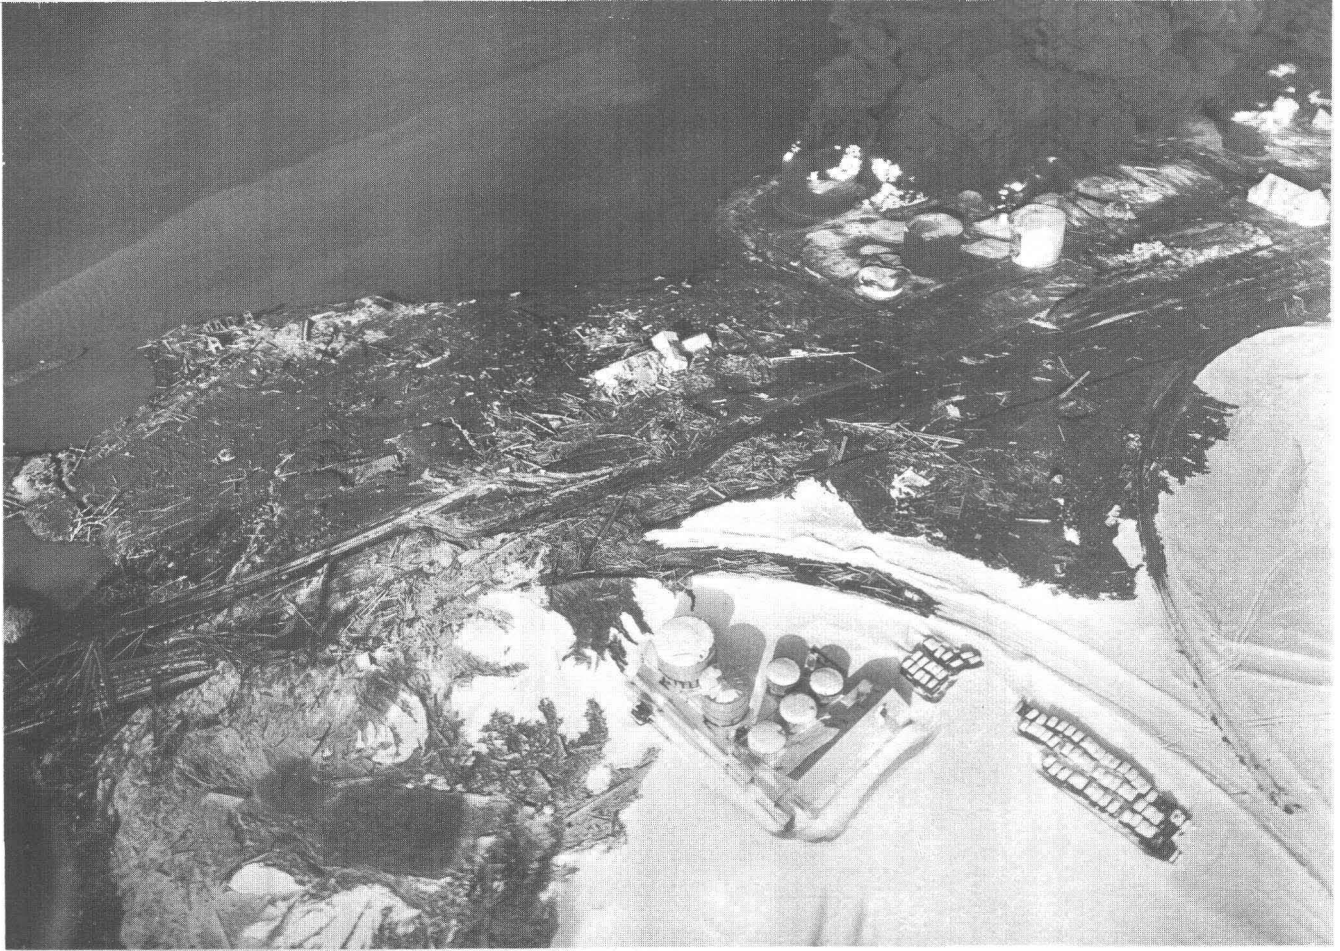
During the earthquake a fire started in the Union Oil Co. and U.S. Army tank-farm area (fig. 5) and burned until March 31; it completely destroyed the fuel-storage tanks.

5.—Aerial view, looking northeast, of Union Oil Co. and U.S. Army fuel-storage tanks burning. Note high-water mark where waves washed away snow cover. Photograph by U.S. Army, March 28, 1964.

Fire was chiefly responsible for destruction of the Union Oil Co. and the U.S. Army fuel-storage tanks at the Whittier waterfront. Fire, together with damage by wave and seismic action, completely destroyed the tanks. The

cause of the fire is not known, but there are at least two possible explanations: (1) seismic motion may have snapped a live powerline in the area, or (2) fuel from a damaged tank may have flowed into a boiler that was operating in the area.

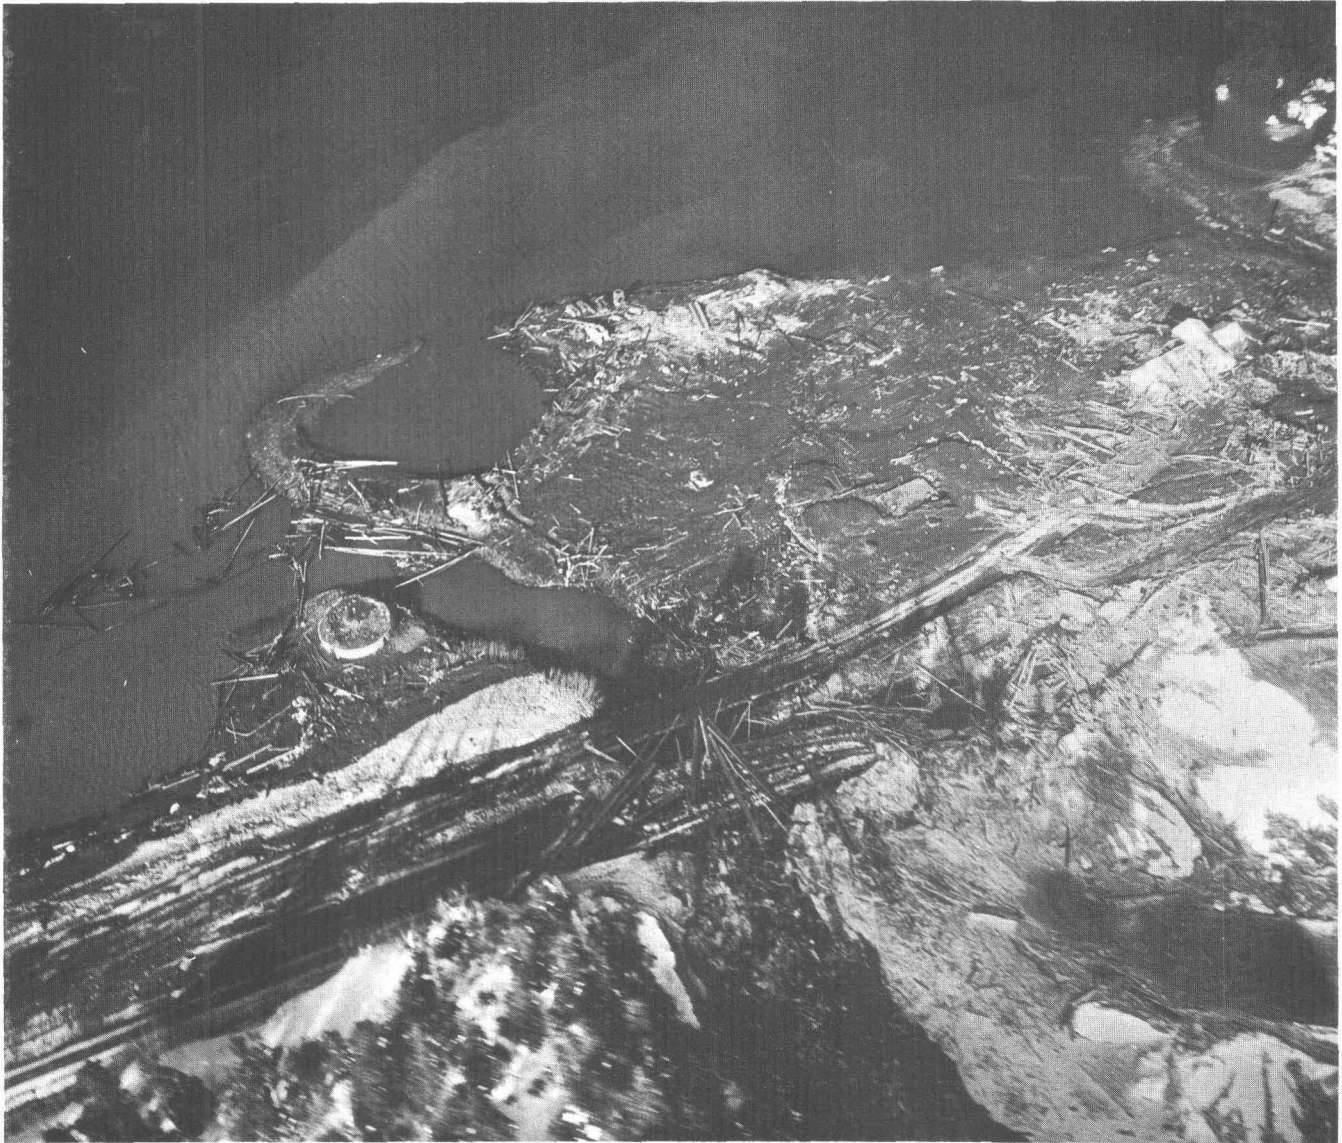
Thirteen lives were lost at Whittier as the result of wave action. Eyewitnesses state that 10 of the persons lost and presumed dead had gone into the home of one of the Columbia Lumber Co. workers a few minutes before the earthquake struck. The waves totally destroyed both the company's industrial buildings and the homes of the workers (figs. 6 and 7). Two other persons associated with the company are missing and presumed dead. None of the 12

7.—Postearthquake aerial view, looking north, of destruction of Columbia Lumber Co. Photograph by U.S. Army, March 28, 1964.

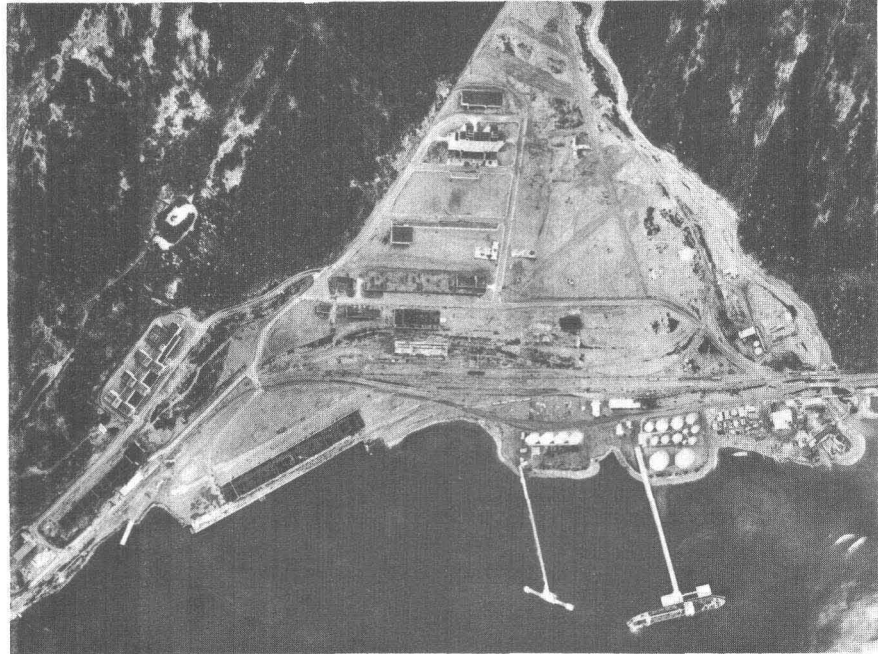
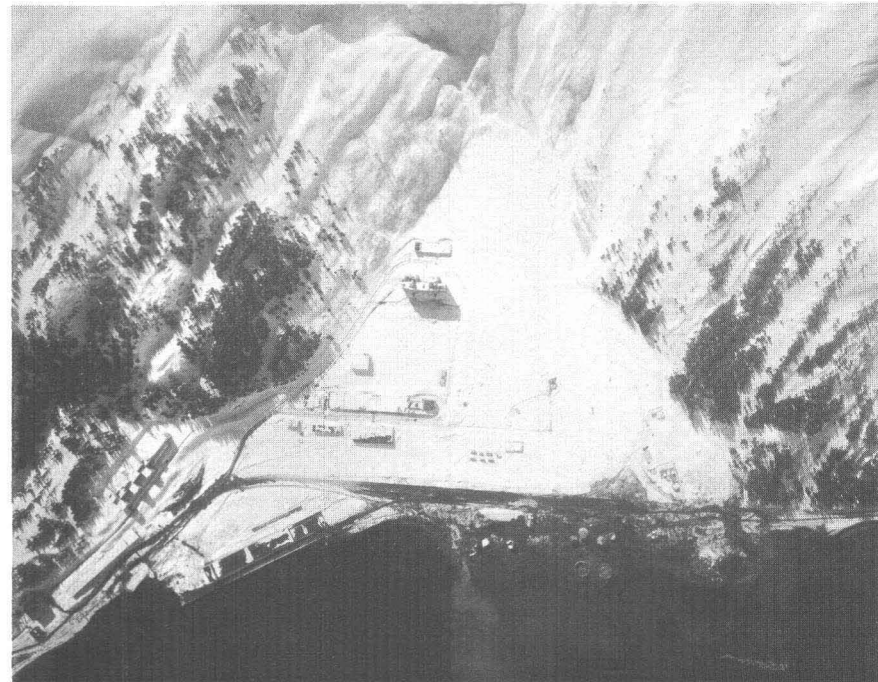
Studies by the U.S. Geological Survey and the U.S. Coast and Geodetic Survey determined that tectonic subsidence of the land-mass at Whittier was 5.3 feet during the earthquake. Residents of Whittier estimate that only 20 percent of the prequake tidal zone is now exposed during low tides (compare pls. 2 and 3). High tides now inundate some of the delta area at the head of Passage Canal, much land leased by the Two Brothers Lumber Co., and about 350 feet of the eastern end of the airstrip (fig. 10). The 5.3-foot subsidence is not wholly responsible for the change in exposure of the tidal zone; landslides

8.—Vertical aerial photographs of Whittier. Top, Prequake; composite of photographs by Bureau of Land Management, September 23, 1963. Bottom, Postquake; photograph by U.S. Army, March 28, 1964.

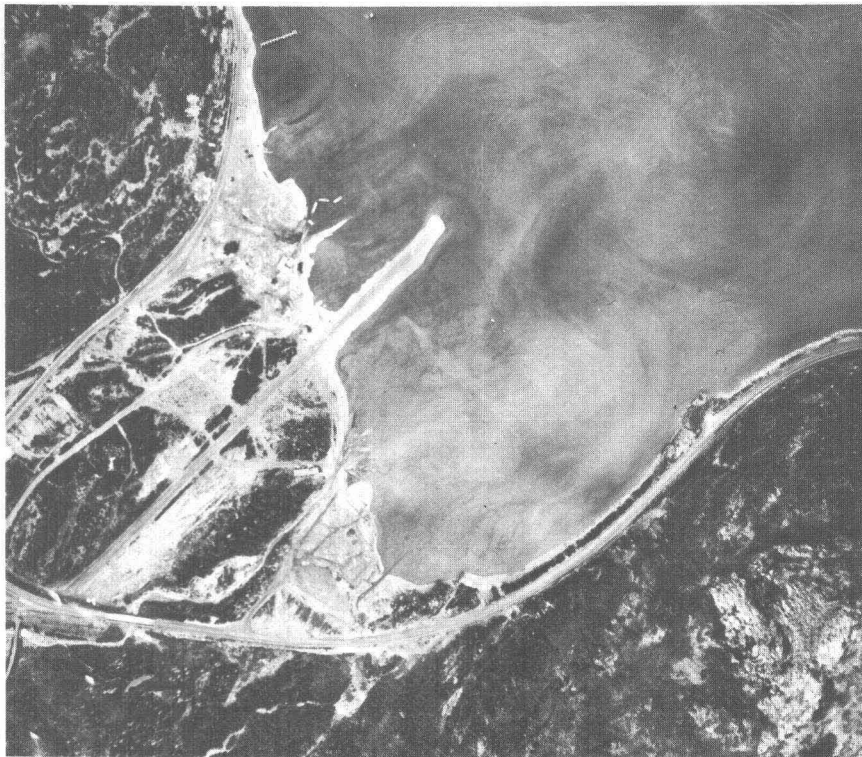
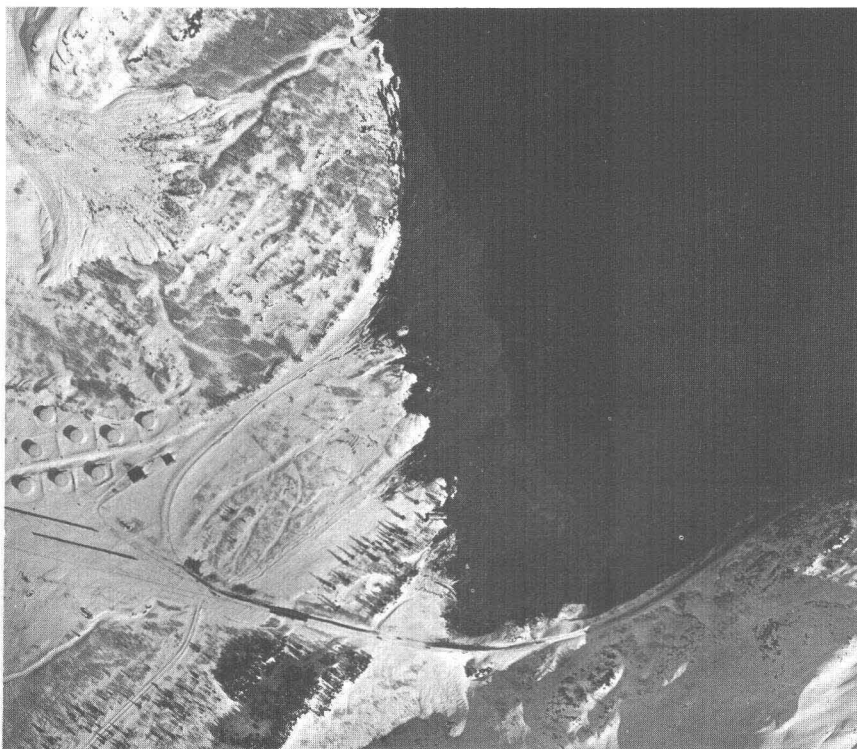
9.—Vertical aerial photographs of delta at west end of Passage Canal. Top, Pre-quake; photograph by Bureau of Land Management, September 23, 1963. Bottom, Postquake; photograph by Air Photo Tech, Anchorage, April 1, 1964.

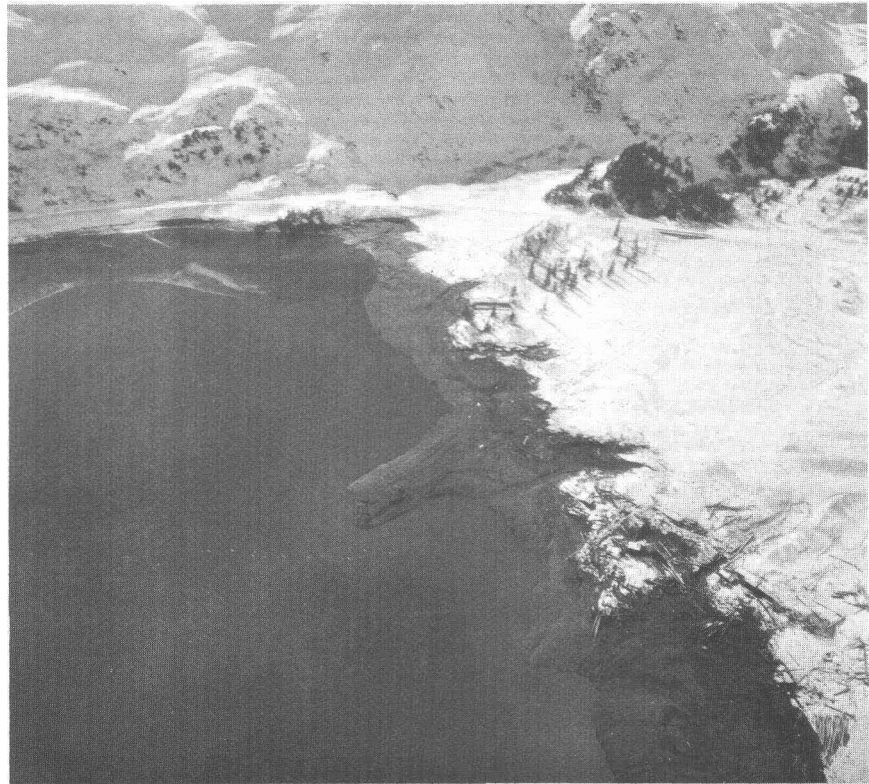
10.—Aerial photograph, looking south, of delta at head of Passage Canal. Remains of Two Brothers Lumber Co. in right foreground. Projecting into the water is the airstrip. Note high-water mark indicated by snow. Photograph by U.S. Army, March 28, 1964.

The only structures damaged by landslides (pl. 1) were the FAA station (fig. 17), a section of the railroad, a small pier near the FAA station, and the extreme eastern end of the airstrip (fig. 10). The slip tower at the car-barge slip dock may have been destroyed by the landslide at the marginal wharf.

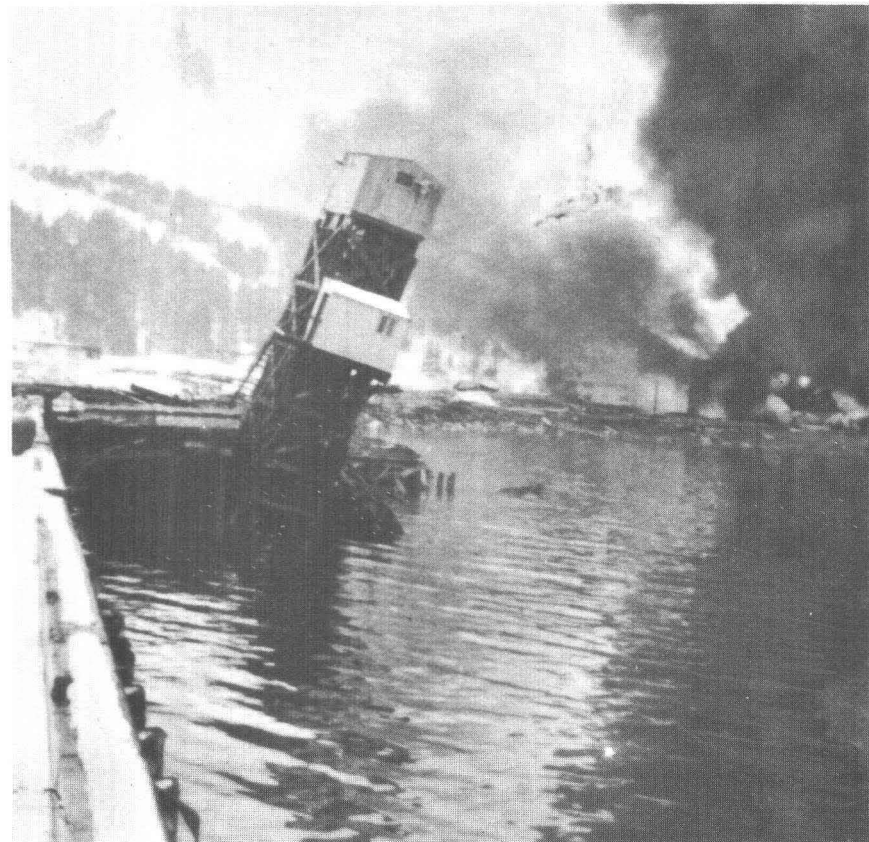
11.—View, looking west, of remains of car-barge slip dock. Slip tower only part of structure left. Photograph by The Alaska Railroad, 1964.

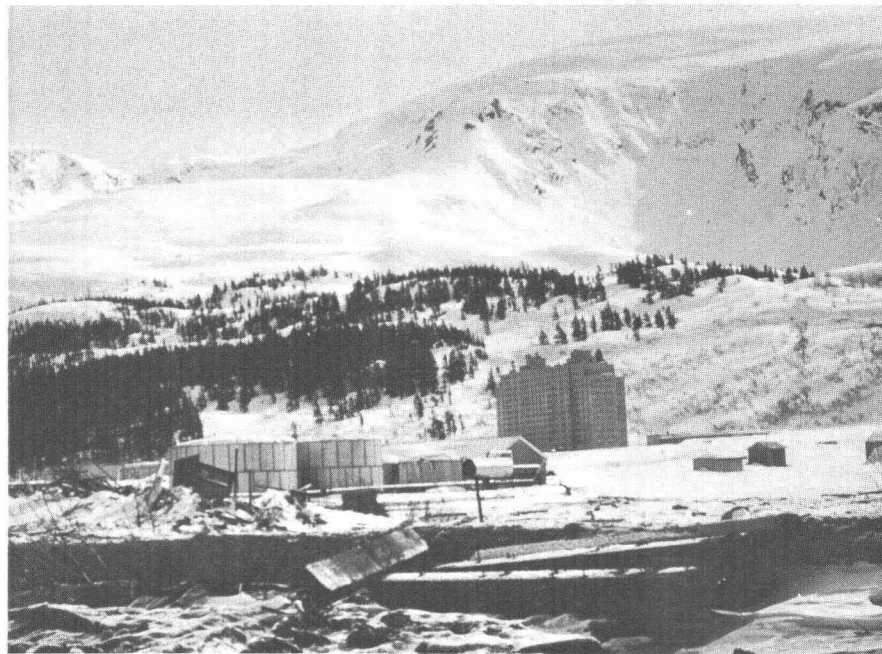
12.—View, looking southeast, of Hodge Building. Photograph taken April 4, 1964.

road bridges crossing Whittier Creek. Beyond the inundated zone there was moderate damage to the Hodge Building (fig. 12), the composite shop, and part of the station storage warehouse (fig. 13). The Buckner Building (fig. 14), gymnasium, fire station, telephone building, ACS (Alaska Communication System) building, powerhouse, and the railroad bridge near the airstrip were slightly damaged.

the expansion joints were perpendicular to the motion. During the earthquake the individual units banged against each other, the weather seals popped out, and the jumper plates were curled. Damage to the structural connections (weather seals, jumper plates, and spandels) was progressively more intense upward in the structure owing to the larger horizontal component of movement. Jumpers on the top floor were shortened 4 inches by curling, whereas on the third floor they curled only a quarter of an inch.

The interior partition walls of the Hodge Building were constructed of concrete block. Damage to the walls was also greater in the upper floors. The walls on the 13th and 14th floors either collapsed or were cracked. On the fourth floor the blocks were loosened, except near the expansion joints where some of the blocks were dislodged. The exterior of the building was not substantially damaged, even where the units

The Hodge Building received substantially less damage than buildings of comparable height at Anchorage—a city about twice as far from the epicenter as Whittier. At least three geologic factors are responsible for this marked difference of damage: (1) the Hodge Building rests on a small area of unconsolidated deposits as compared to the structures at Anchorage, where a plain several miles wide is underlain by at least several hundred feet of clay, silt, sand, and gravel; (2) the deep fine-grained sediments that underlie Anchorage magnified the seismic amplitudes substantially more than the shallow coarse-grained sediments that underlie Whittier; (3) because the higher frequency components of ground motion attenuate with distance

more rapidly than the lower frequency components, the tall structures at Anchorage were more nearly attuned to long-period ground motion. Thus, these structures suffered a proportionately greater degree of damage than the 14-story Hodge Building at Whittier.

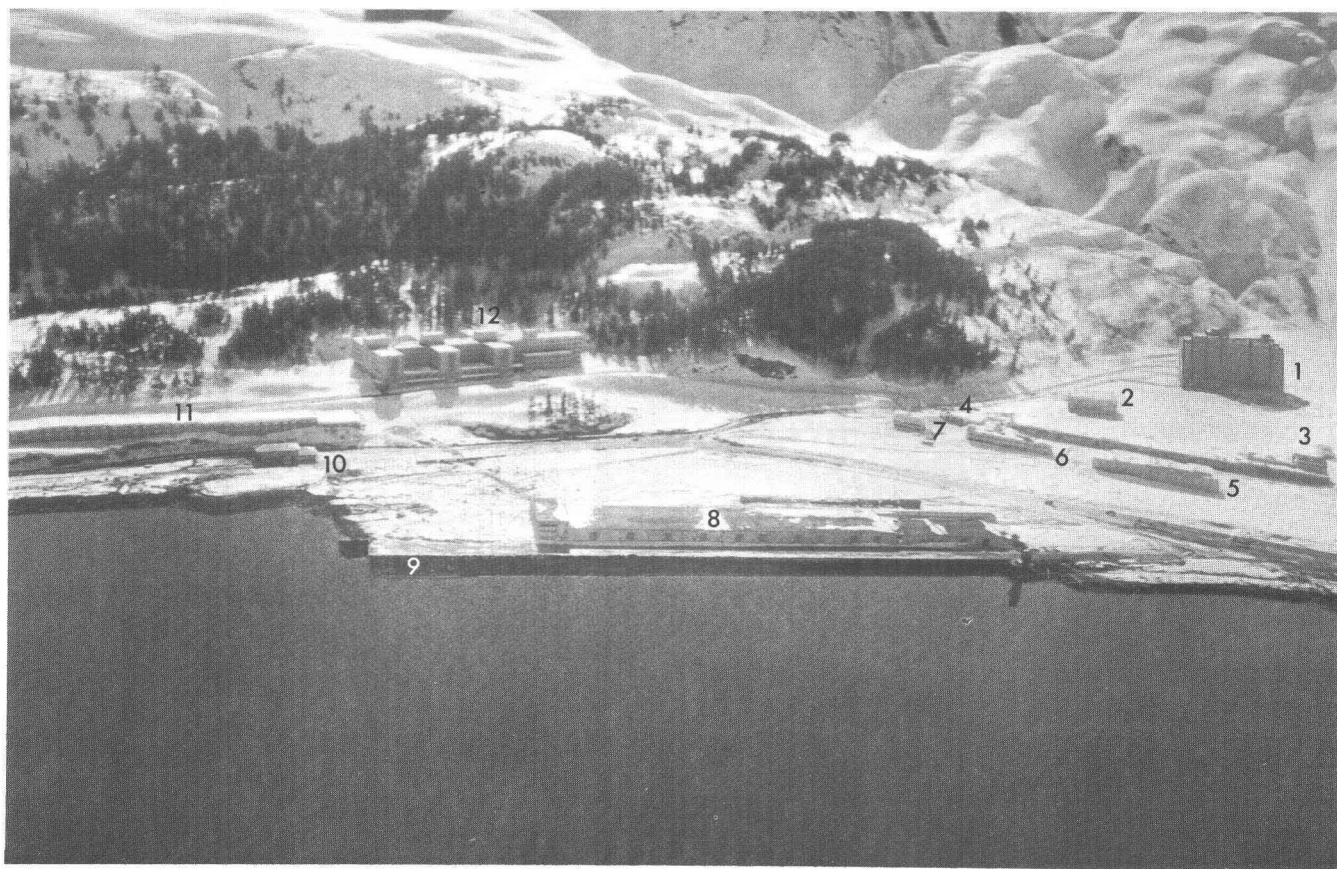
13.—Aerial view, looking south-southeast, of part of postquake Whittier. 1 Hodge Building, 2 gymnasium, 3 composite shop, 4 fire station, 5 station storage warehouse, 6 telephone building, 7 ACS building, 8 intransit storage shed, 9 marginal wharf, 10 The Alaska Railroad depot, 11 FHA housing, and 12 Buckner Building.

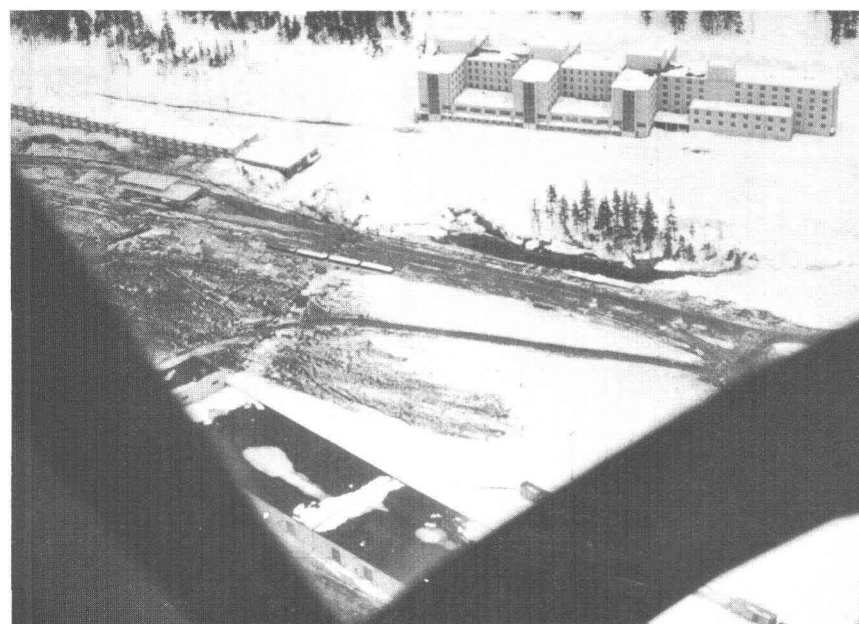
The largest building in Whittier, probably the largest in Alaska, is the Buckner Building (figs. 14, 15, and 16). It is a six-story reinforced-concrete structure about 500 feet long and 50–150 feet wide. The long dimension of the structure runs northeast-southwest, oblique to the seismic motion of the earthquake. The building rests on bedrock and did not receive any significant structural damage. The steam powerhouse near The Alaska Railroad depot also rests on bedrock and was not damaged by seismic motion.

14.—Aerial view, looking southeast, of Buckner Building; building in foreground is intransit storage shed; long structure at left of photograph is FHA housing; structure north of FHA housing is depot. Note high-water mark of wave on snow. Photograph taken April 4, 1964.

The intransit storage shed, which rests upon several feet of fill on top of delta sediments, was slightly to moderately damaged by the combined effects of seismic shaking, subsidence, and wave action. In places the walls of the structure moved as much as 7 inches; subsequently, the building appeared to have been stretched by the earthquake effects.

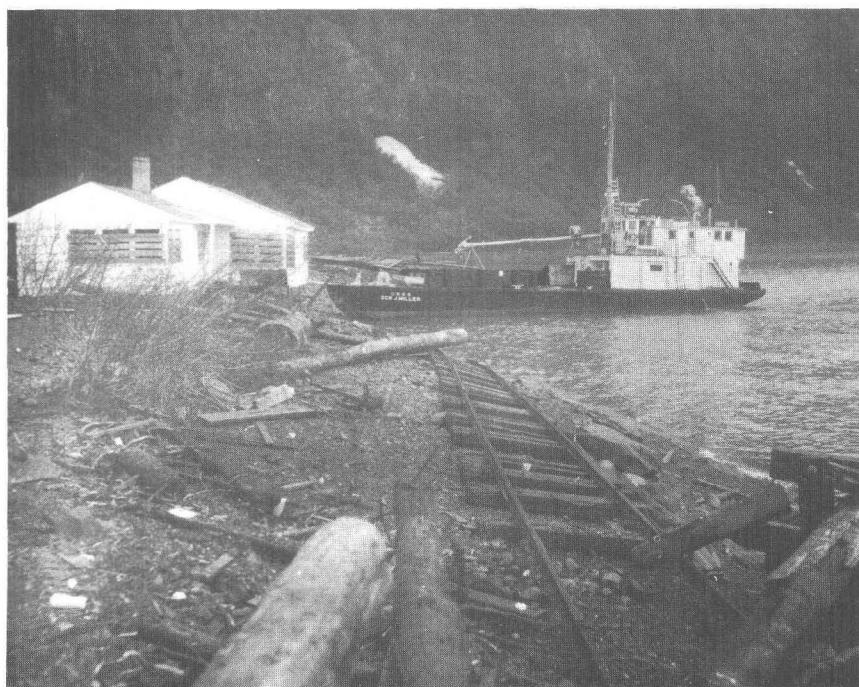
17.—View, looking north, of FAA station. Track destroyed by landslide. Bow of boat resting on scarp. Photograph by G. D. Hanna, 1964.

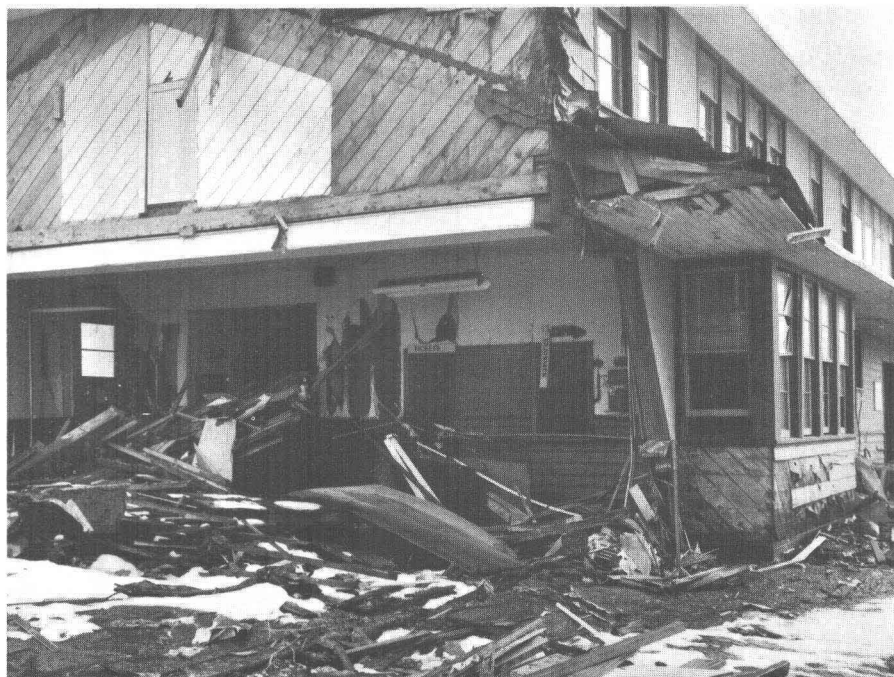
formed during the earthquake near The Alaska Railroad depot. This fracture extends beneath the structure and appears to follow the contact between the cut and fill made during the construction of the depot. Minor fracturing in fill occurred near the intransit storage shed. Near the FAA station, a series of cracks parallel to the shore extends about 100 feet inland.

19.—View, looking south, of The Alaska Railroad depot. Wave destroyed waiting room of the depot. Photograph taken April 7, 1964.

Wave damage in the Whittier area is shown on plate 1. The wave completely destroyed (1) the small-boat harbor, (2) the stub pier, (3) the car-barge slip dock, (4) the waiting room of The Alaska Railroad depot (fig. 19), and (5) the Columbia Lumber Co. structures (fig. 5 and 7). Many facilities were damaged by a combination of destructive forces: (1) the Army tank farm by fire, seismic shaking, and waves, (2) the Union Oil Co. fuel tanks by fire

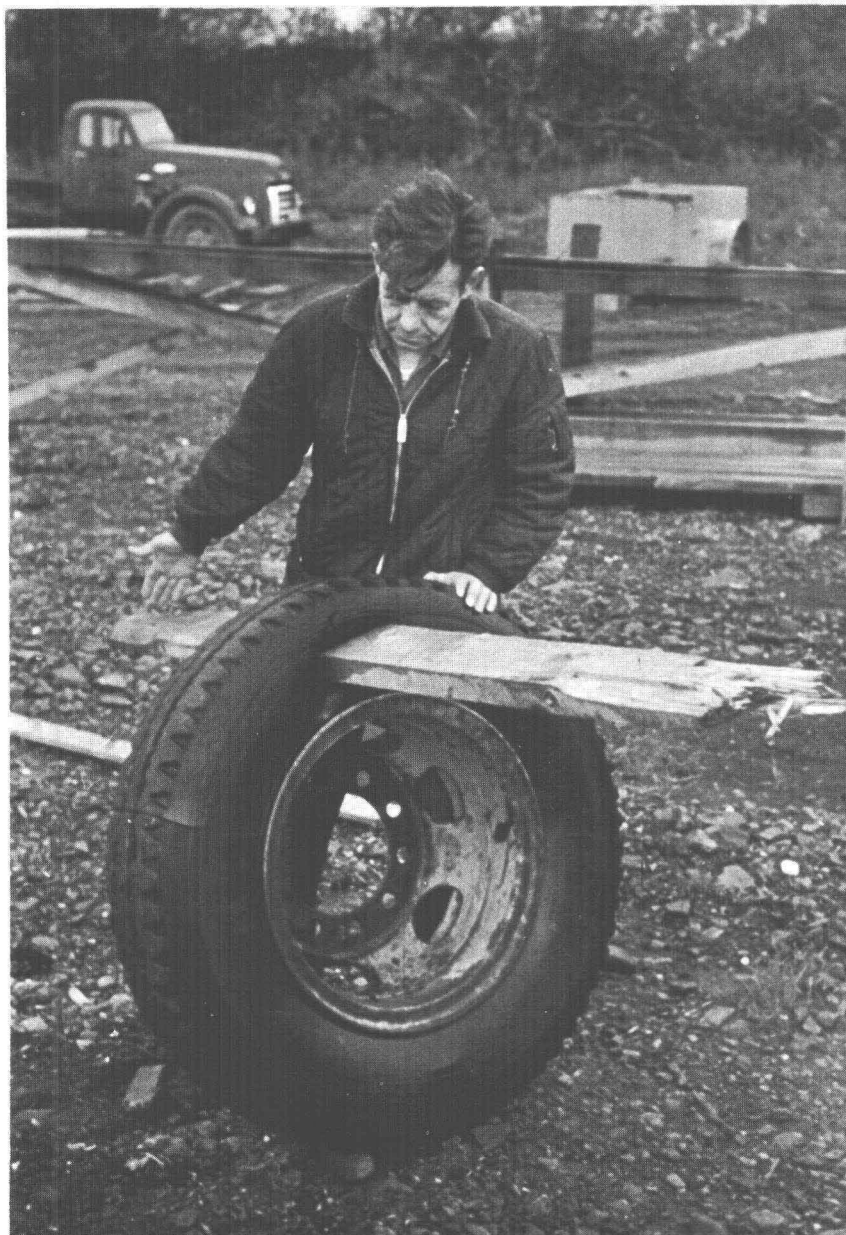
20.—Photograph of 2- by 6-inch plank driven through a 10-ply tire by wave.
