# The Alaska Earthquake

# Effects of the Earthquake Of March 27, 1964 At Valdez, Alaska

By HENRY W. COULTER and RALPH R. MIGLIACCIO

GEOLOGICAL SURVEY PROFESSIONAL PAPER 542-C

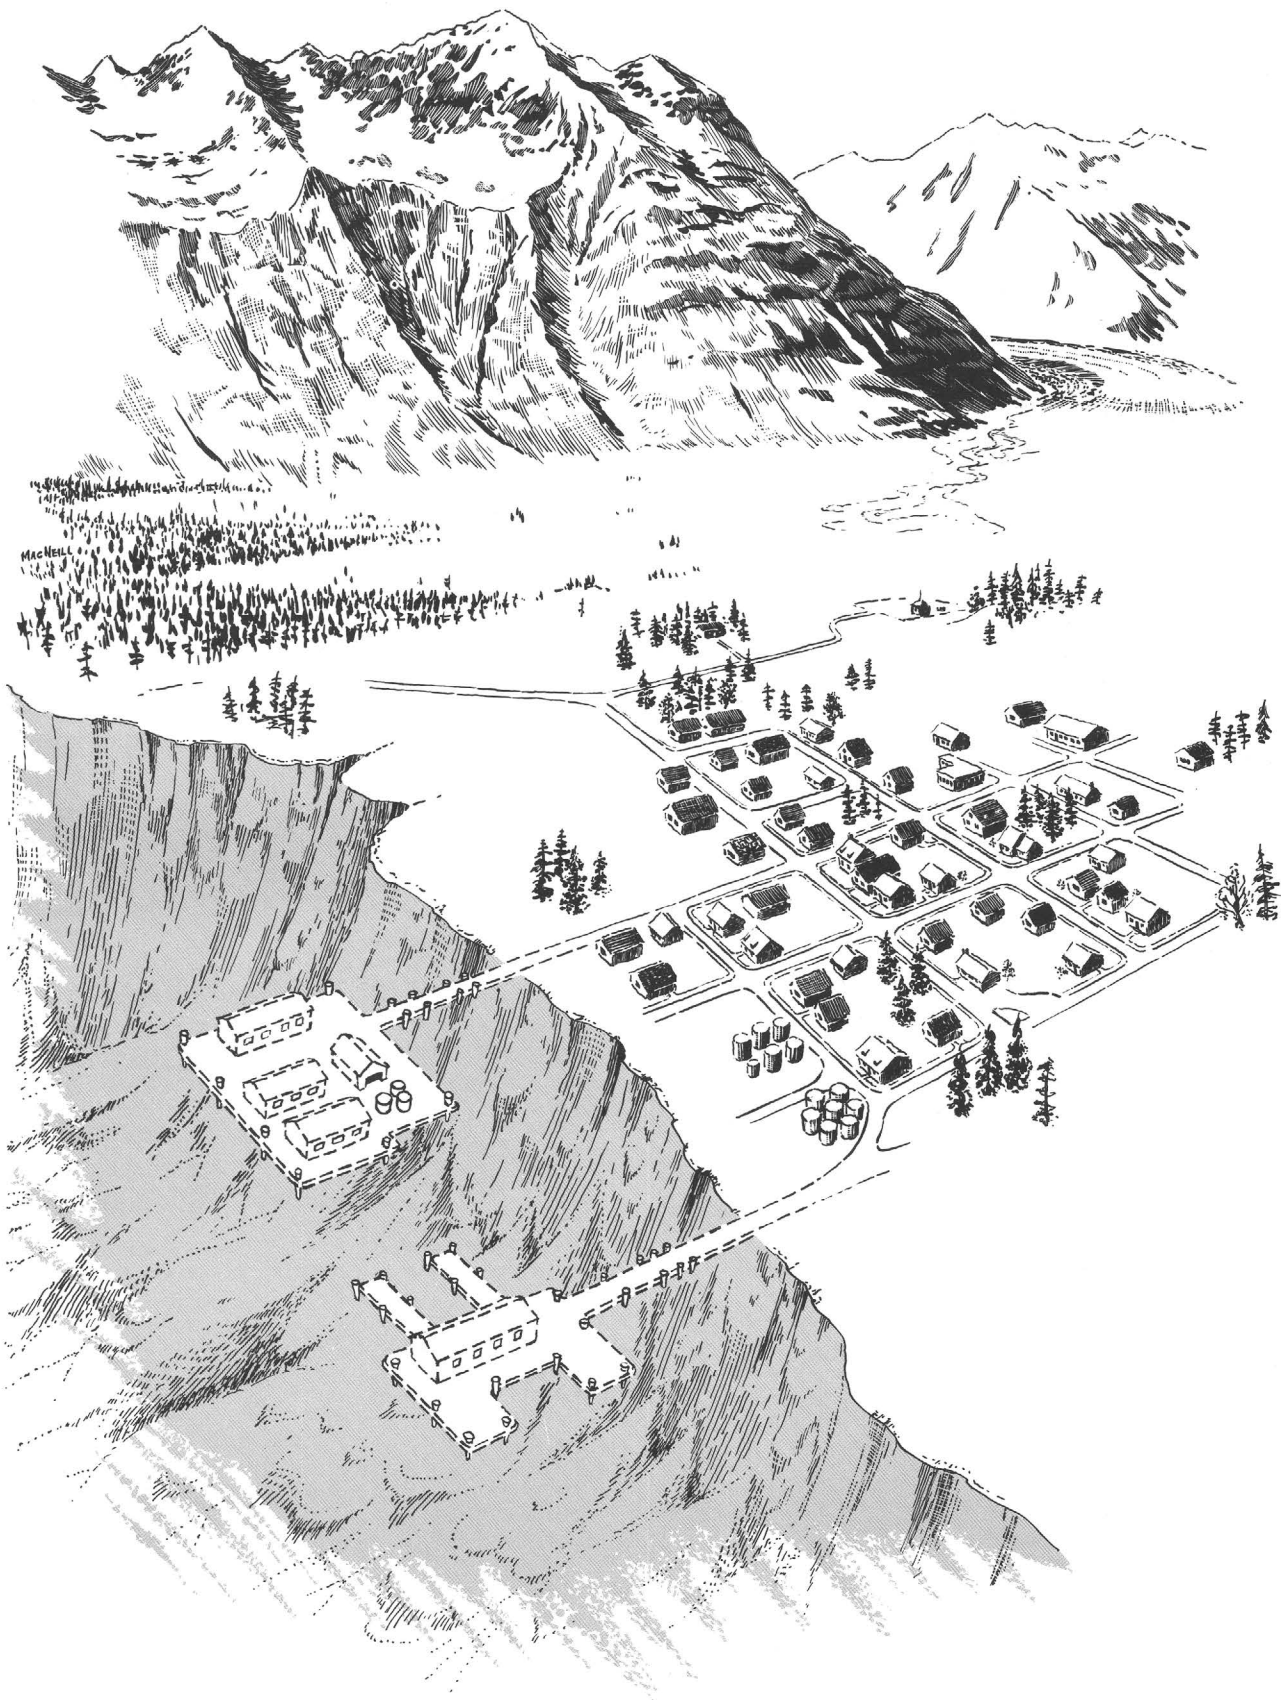
4.—Submerged slide area at Valdez. Dashed lines indicate dock area destroyed in earthquake. Sketch by David Laneville, Alaska Department of Highways.

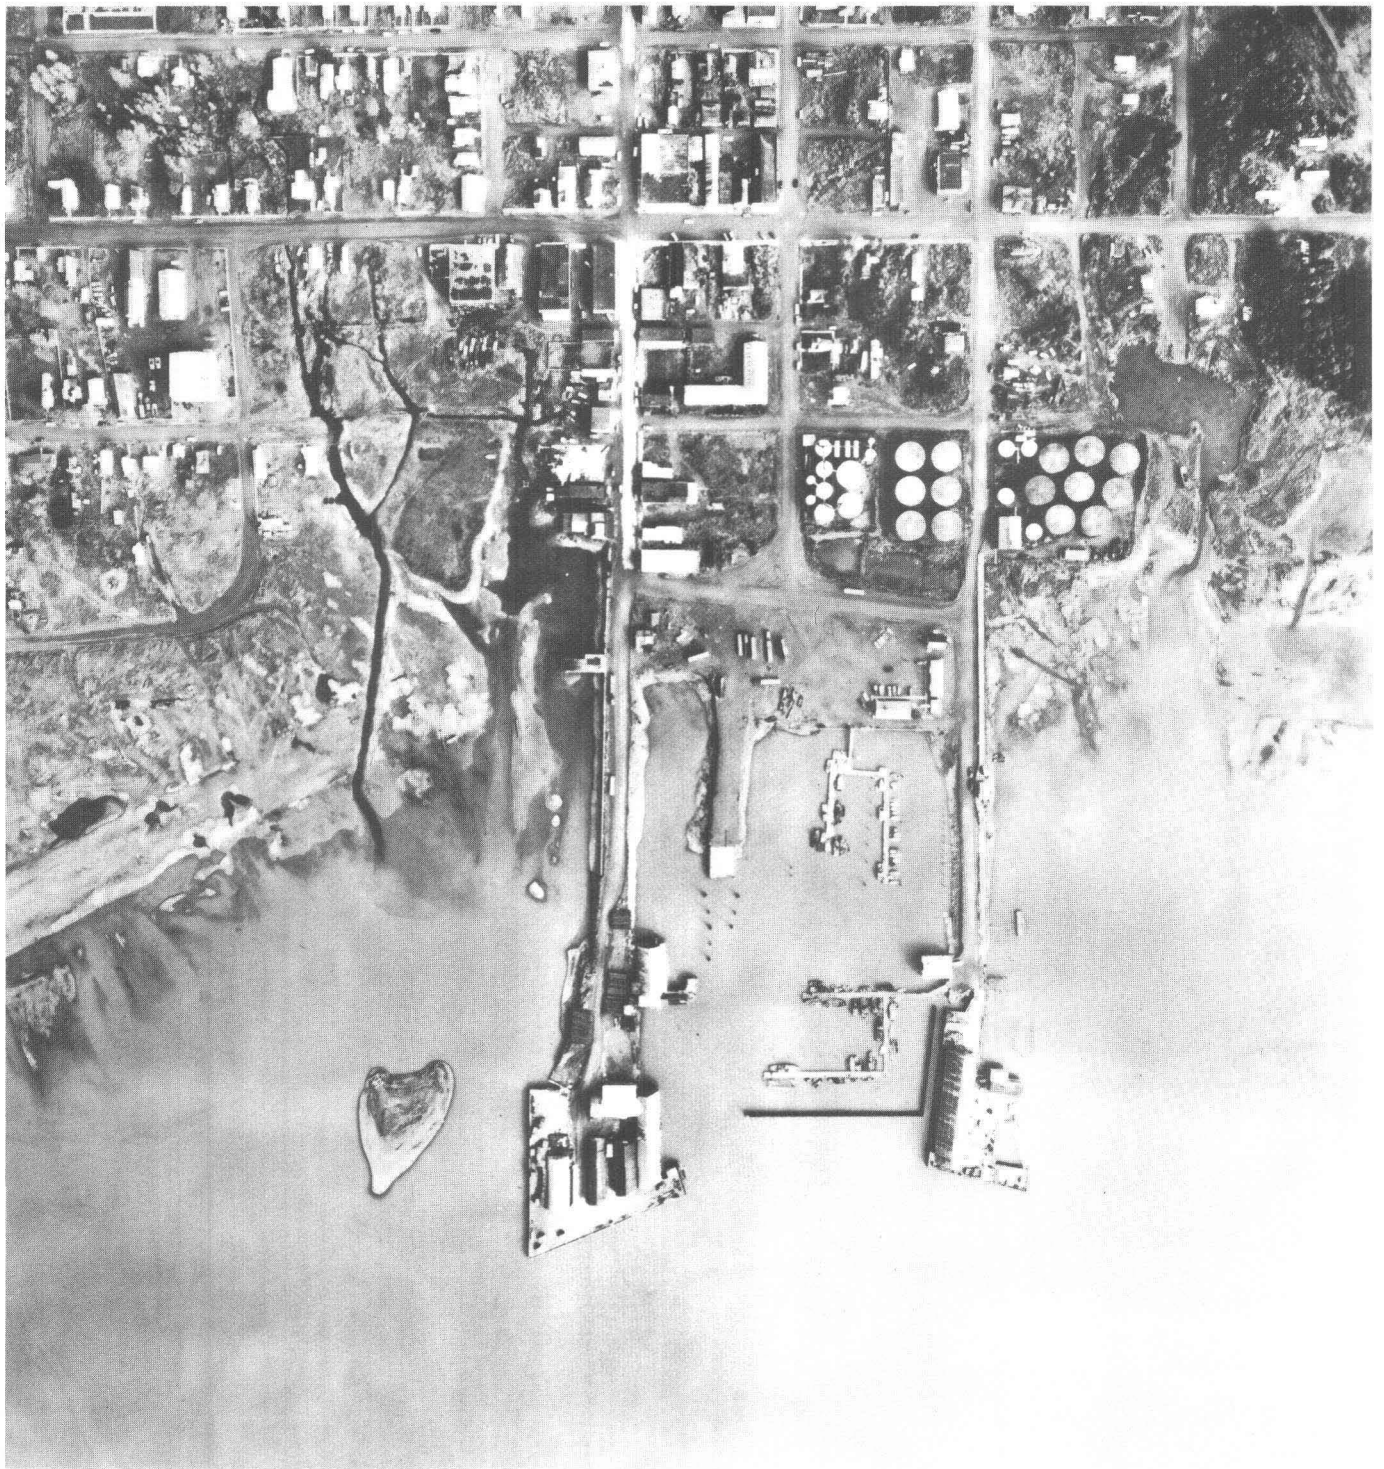
damage in the city as well as the destruction of all docks and associated facilities (figs. 5 and 6).

5.—Valdez dock area, September 23, 1965. Photographed by U.S. Bureau of Land Management.

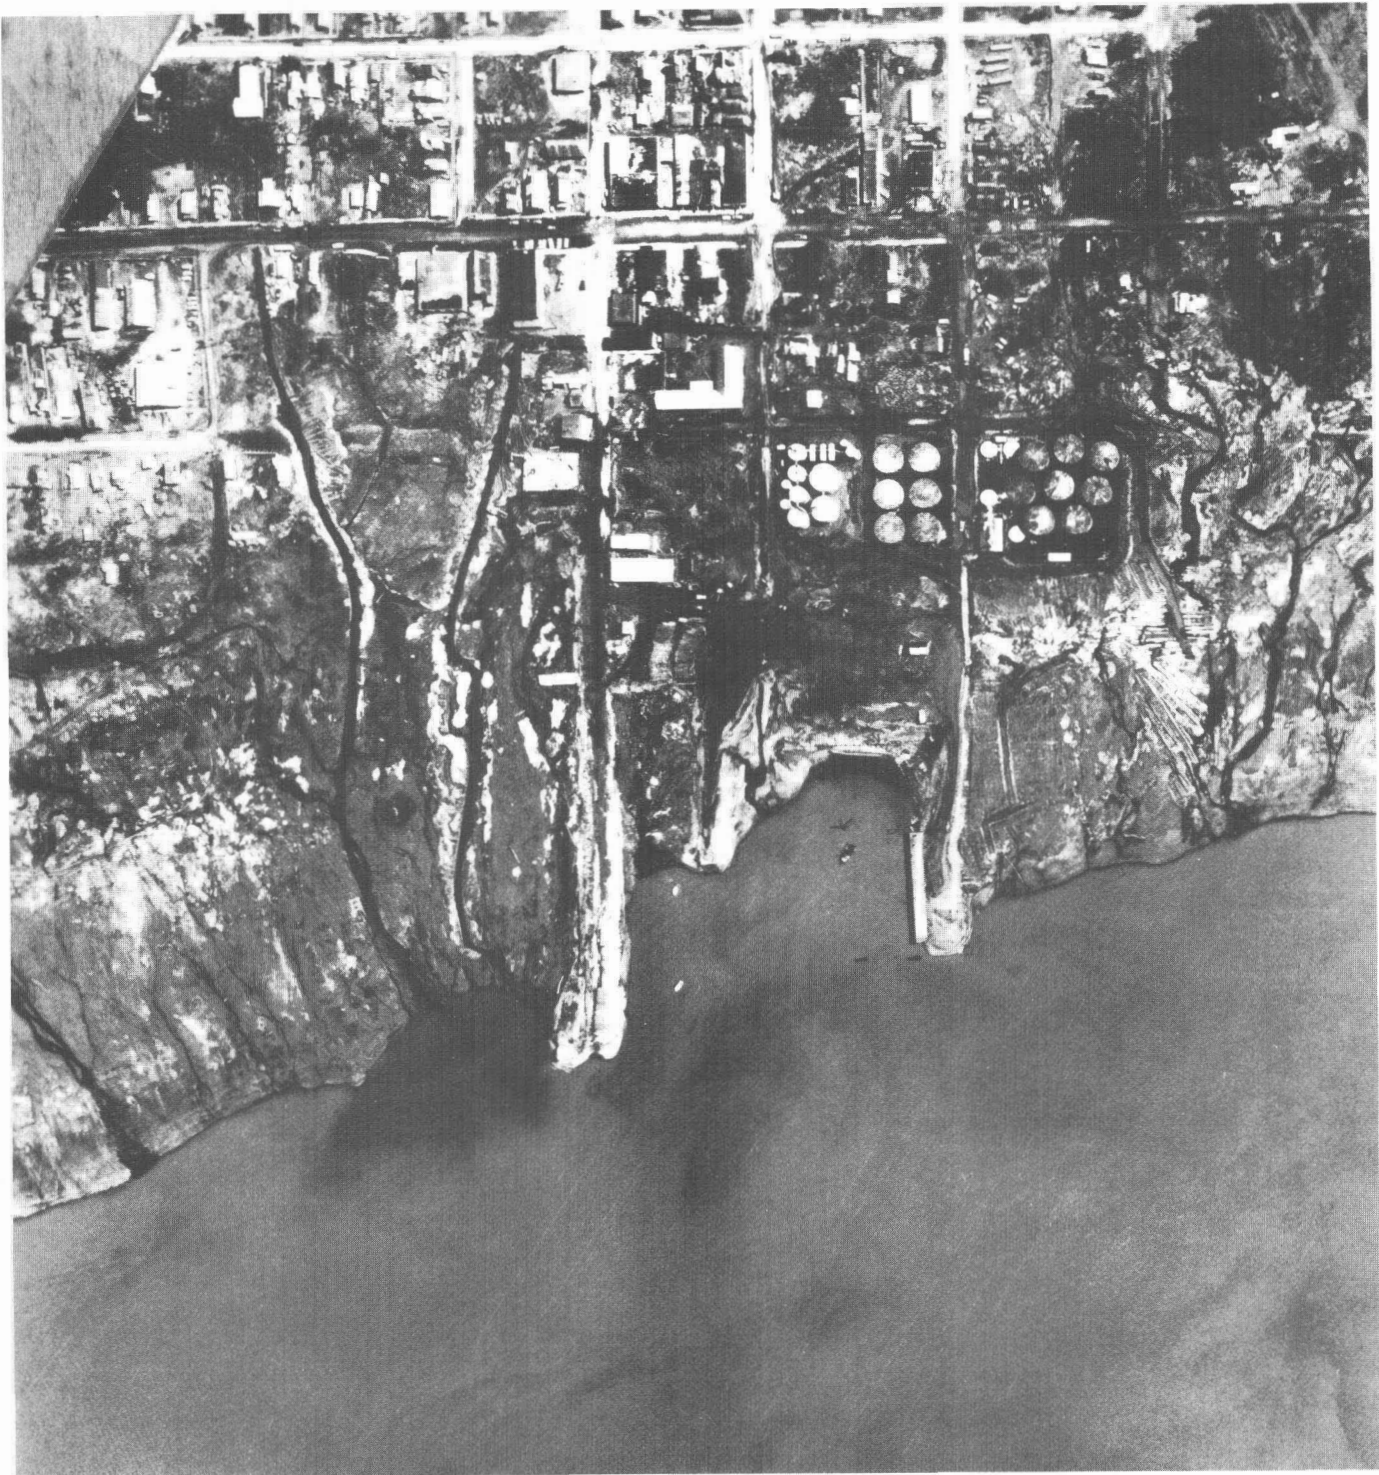
6.—Valdez dock area, June 13, 1964. Photograph by Air Photo Tech, Inc.

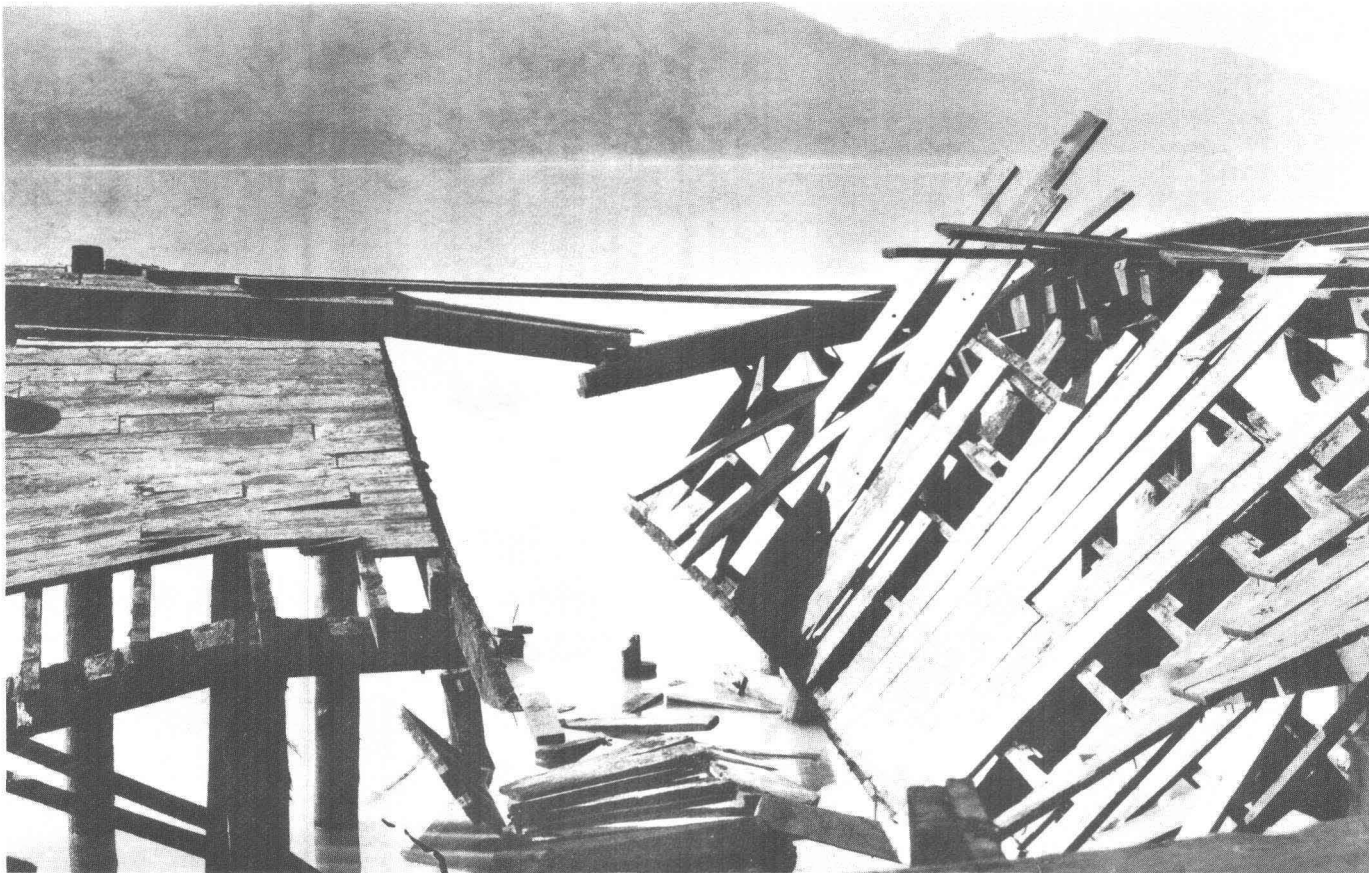
The second dock failure occurred in the late 1920's and is illustrated by figure 7. In this failure there is no record of heavy loads on the dock at the time of failure. Note that the failed section is tipped shoreward.

7.—Dock failure in late 1920's. Note that failed section has tipped shoreward. Photograph courtesy of James Derringer.

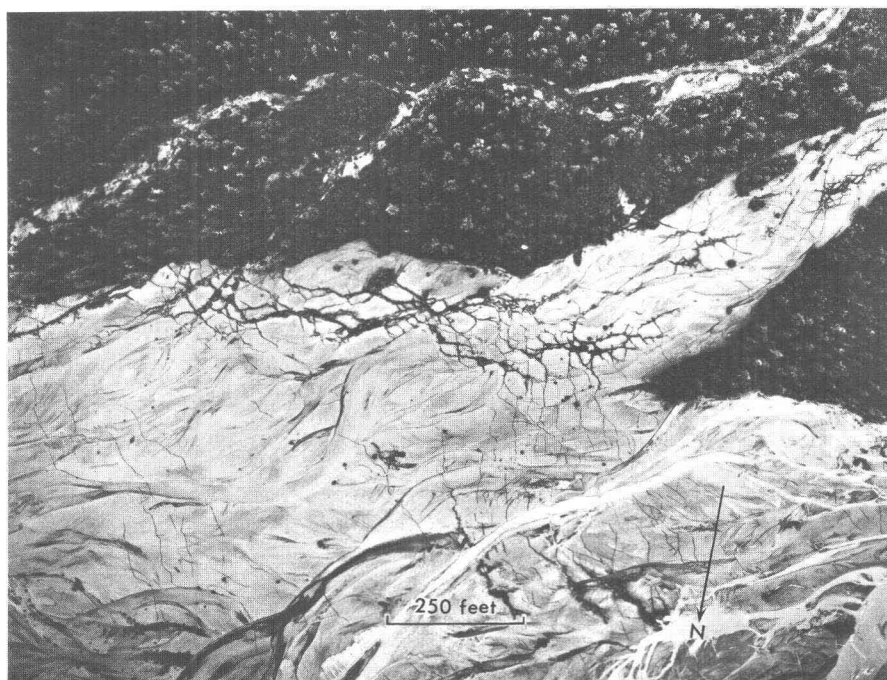
8.—Vertical aerial photograph showing fissures on the flood plain of the stream from the Valdez Glacier. Photograph by Air Photo Tech, Inc.

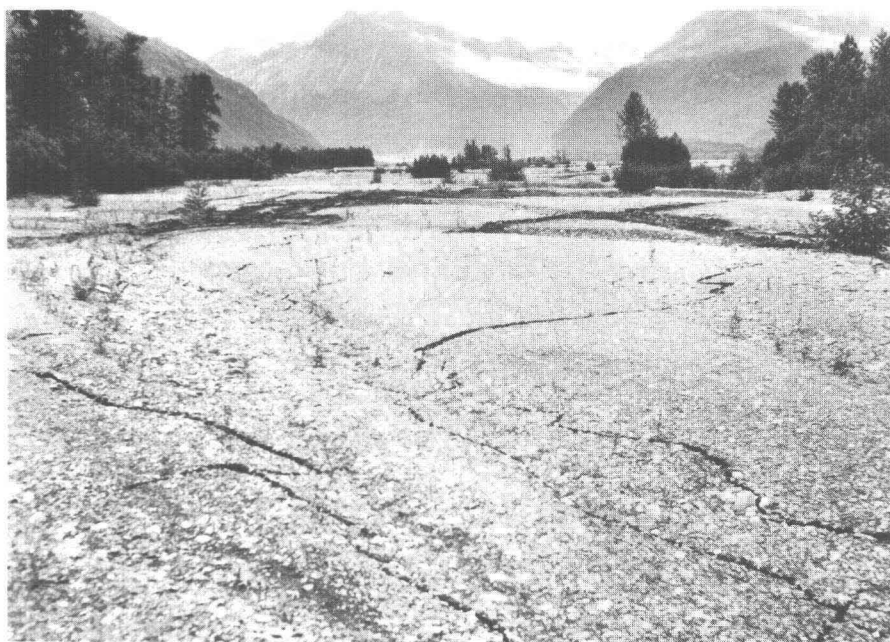
9.—Transverse fissures (foreground) and longitudinal fissures (in the middle distance). Ridges of ejected material (silt and sand) border the longitudinal fissures.

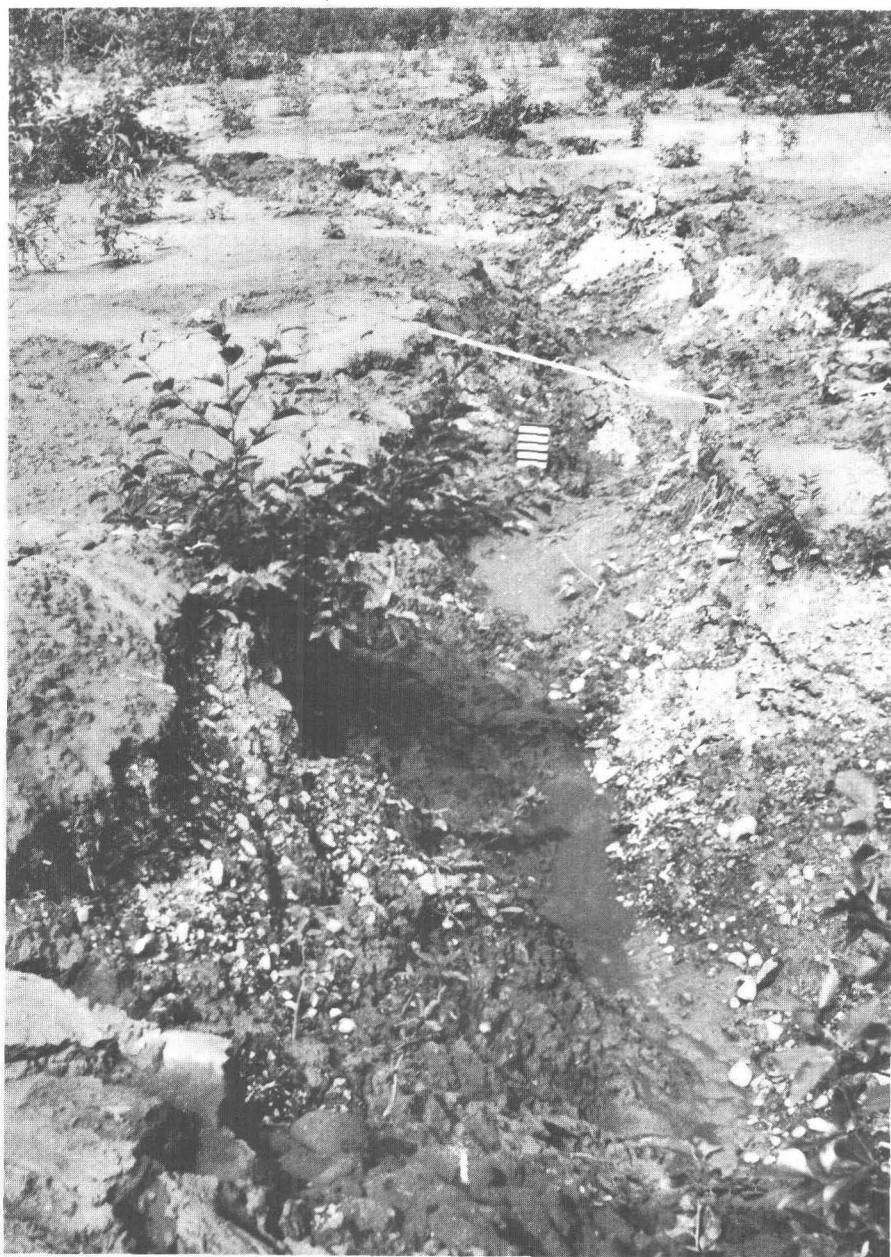
The largest individual longitudinal-fissure segment observed was located 1,500 feet east of Dike Road and 800 feet north of Richardson Highway. It was 6 feet

wide, 4 feet deep, and approximately 250 feet long (see fig. 10). Although some parts of the walls of the fissure apparently had collapsed during the spring thaw, the overall width does not appear to have been increased appreciably. A large volume of fine sand and silt was ejected from this fissure.

10.—Large longitudinal fissure. Surrounding area covered by ejected sand and silt. Carpenter's rule across fissure is 6 feet long; vertical scale below it is 1 foot high.

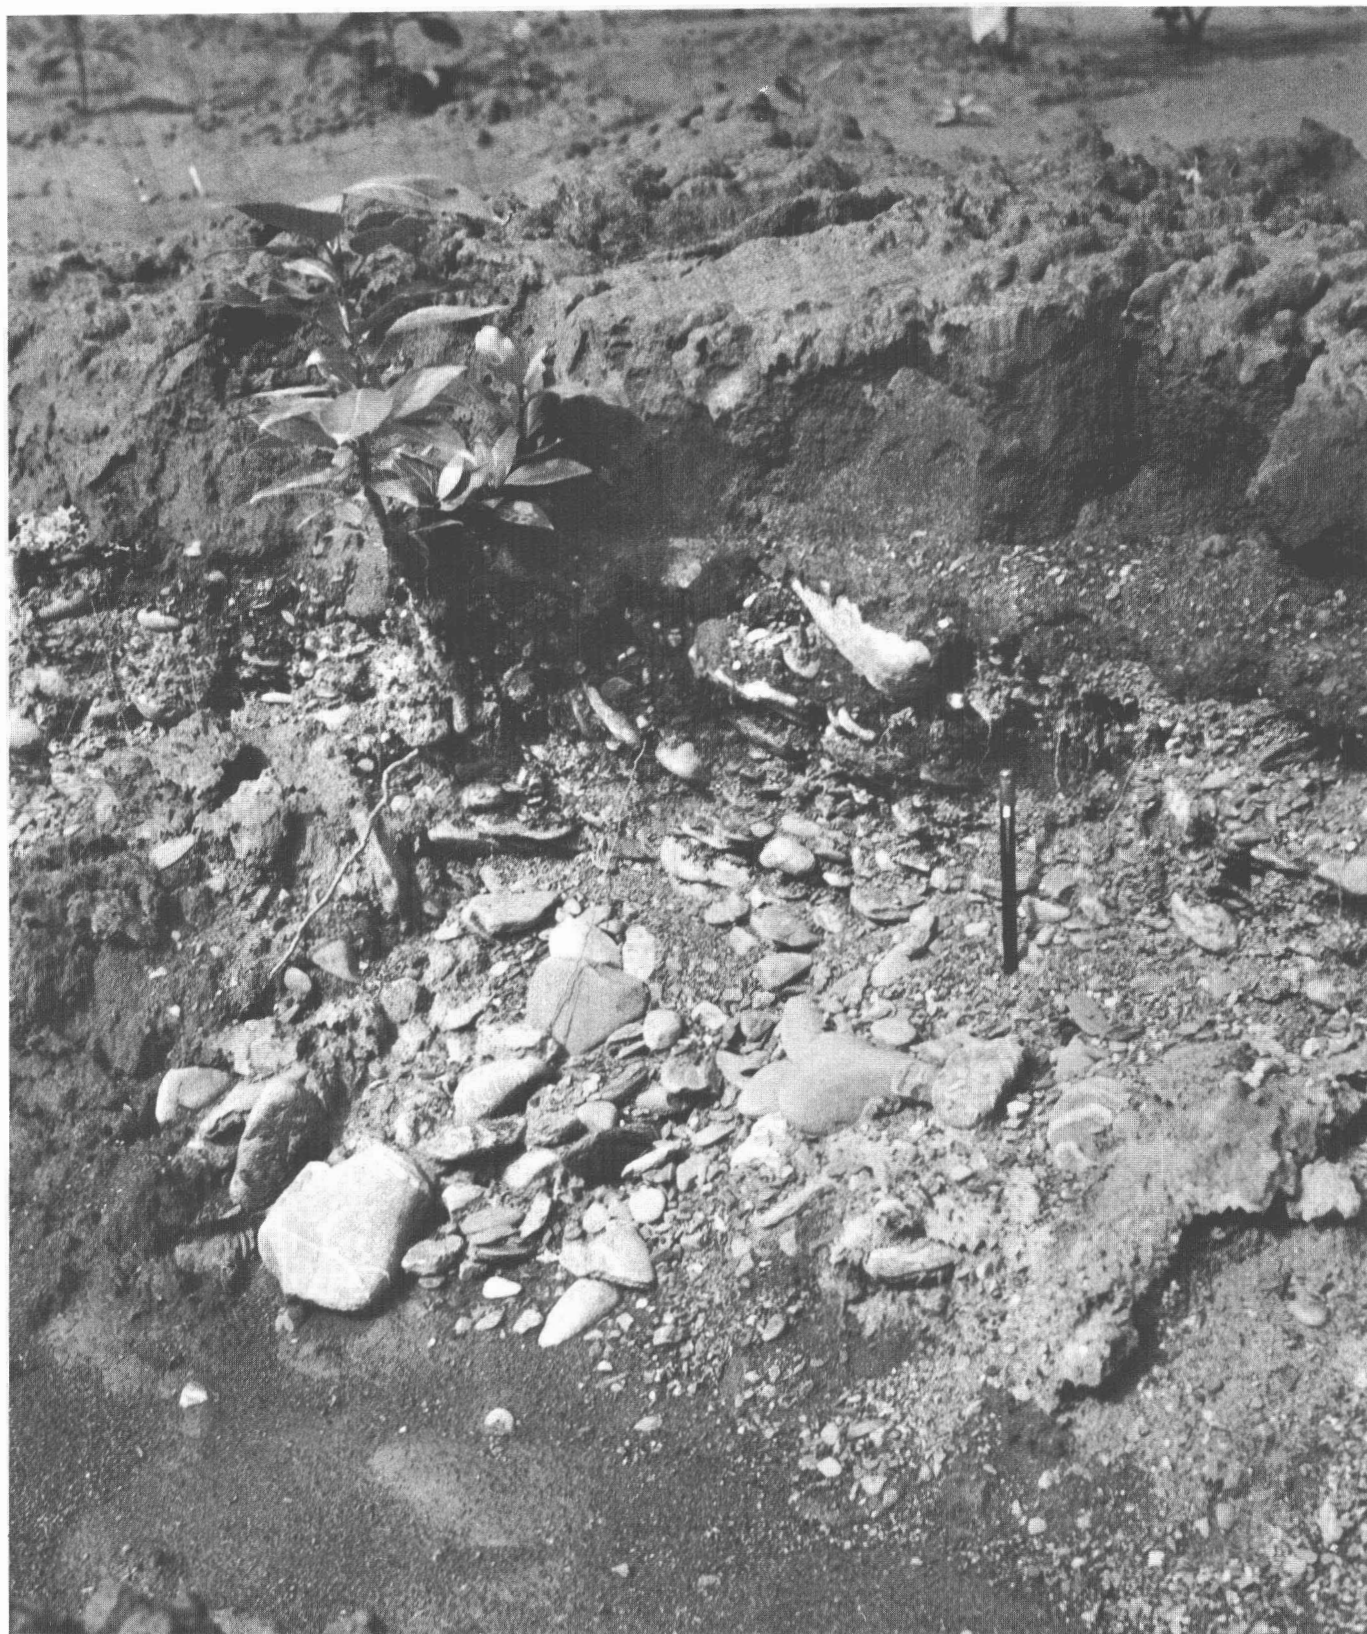
Figure 11 shows the fissure wall and approximately 2 feet of ejected material overlying the original surface. The thickness of this blanket of ejecta decreases away from the fissure on both sides to a feathered edge approximately 100 feet from the centerline of the fissure. The volume of material ejected is roughly estimated as 2,000 cubic yards.

11.—Longitudinal-fissure wall showing concentration of fines in ejected material. Original surface at pencil top.

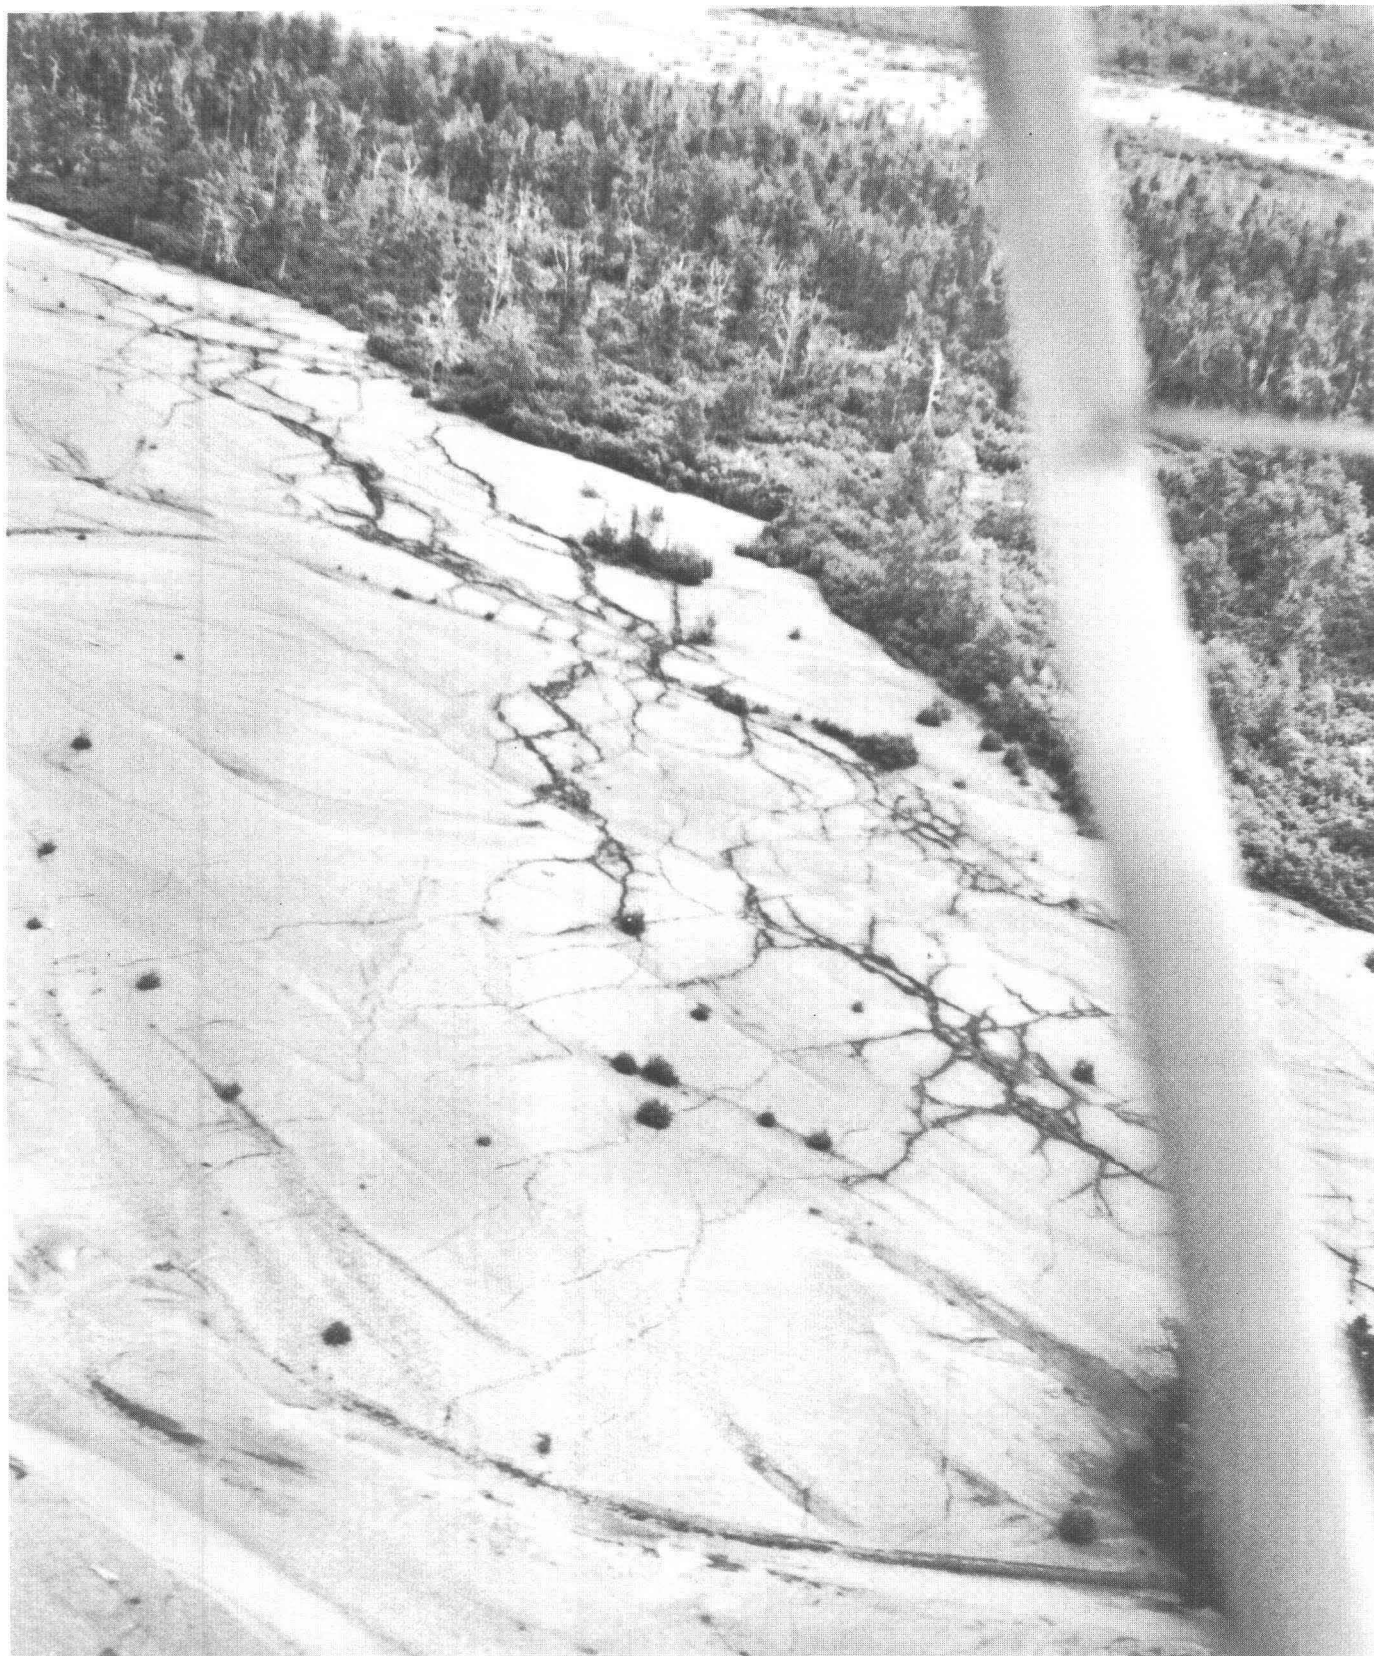
12.—Flood plain of the stream from the Valdez Glacier showing the intersection of a set of transverse fissures with a set of longitudinal fissures. The longitudinal set appears darker because of ejected silt and sand.

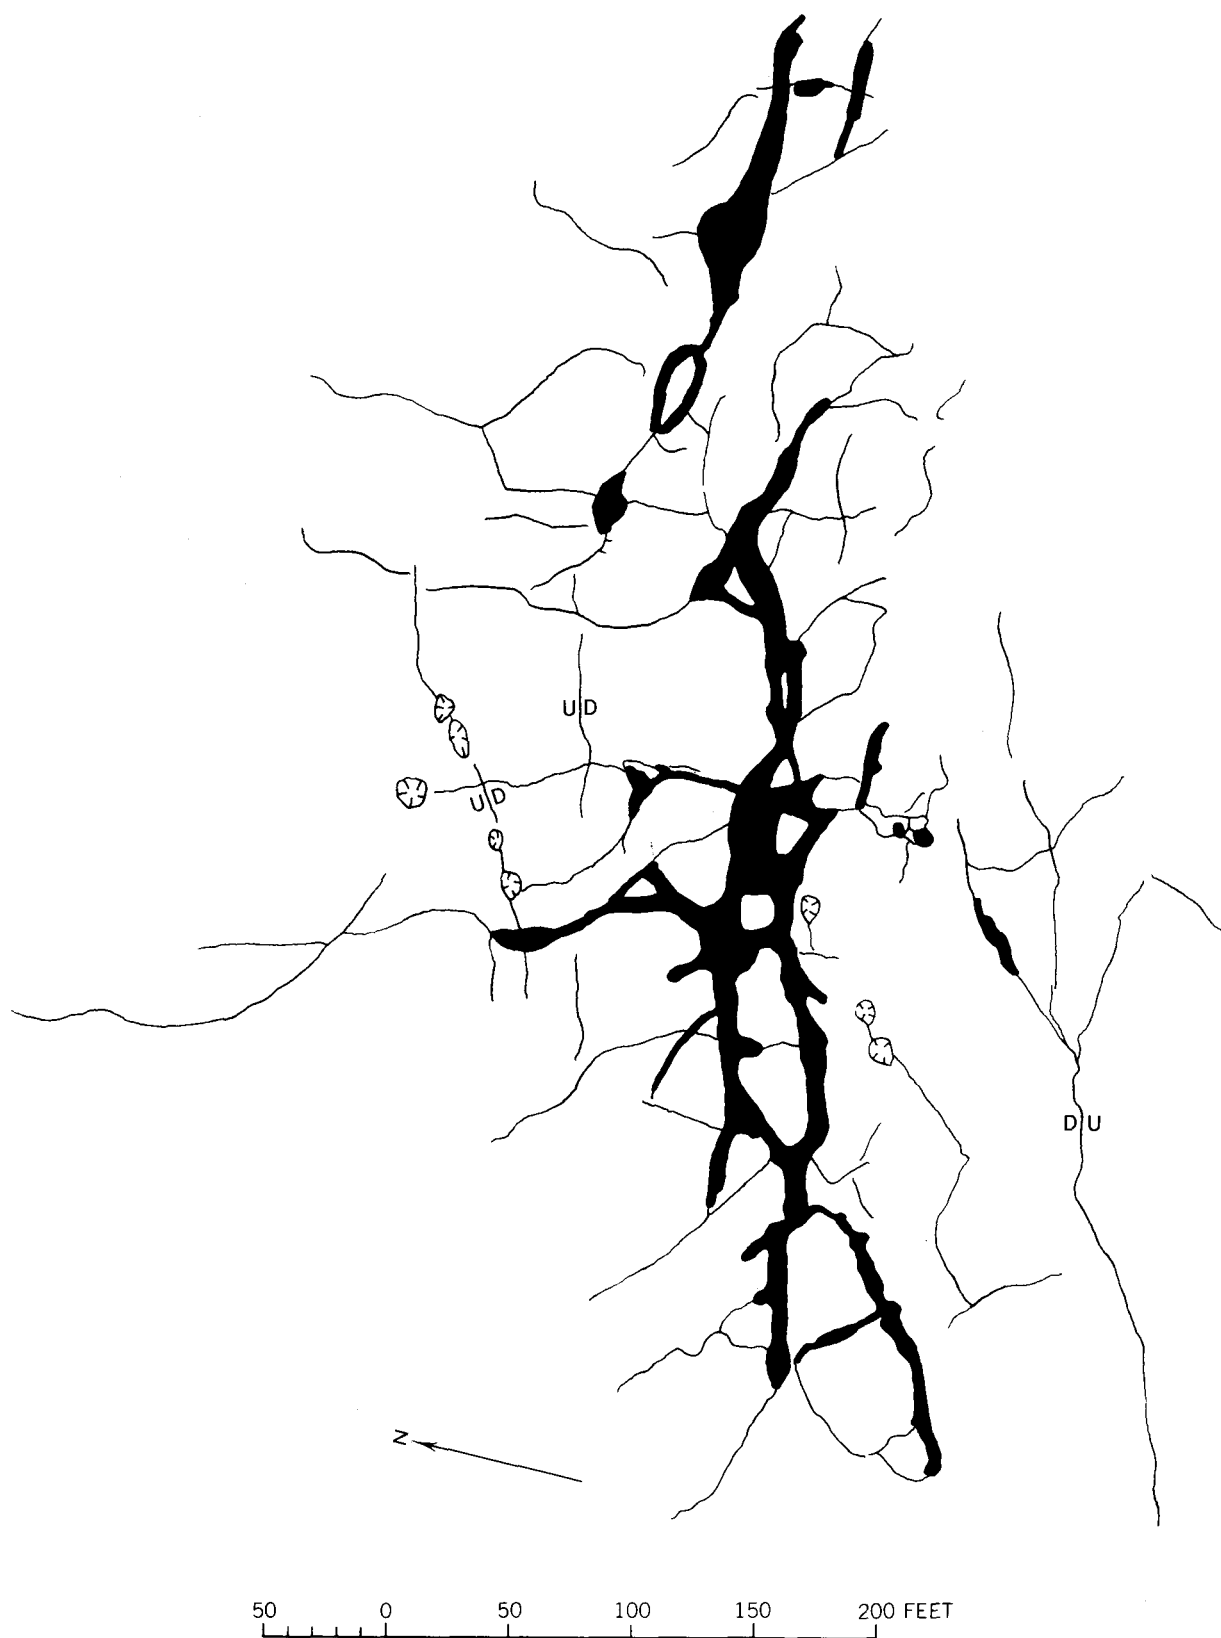
13.—Map showing details of fissures shown on figure 12.

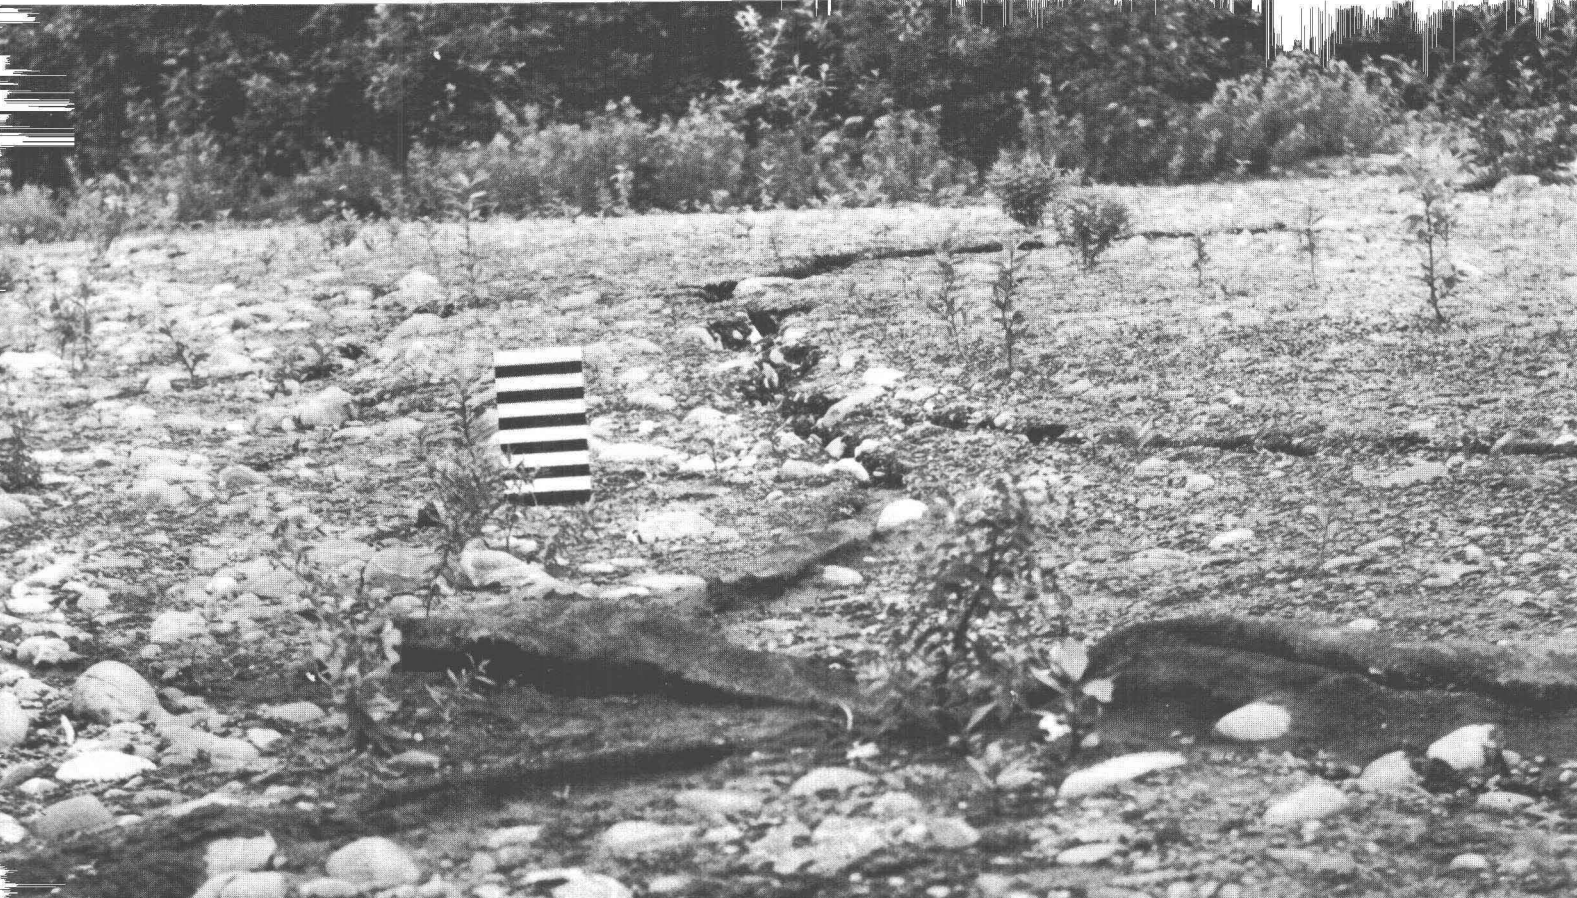
Tabular ridges of silt and sand stand in relief along some of the narrower fissures (fig. 14). These ridges were at first interpreted as extrusions indicating final compressive stress along these particular fissures. However, the fact that many of these ridges intersect almost at right angles argues against their origin by compression. The absolute lack of plasticity of the granular materials comprising these ridges also militates against this explanation; it appears that the ridges are not extrusions but are accumulations of ejected material deposited in fissures that were propagated up into the snow cover; and that the ejecta were left standing in relief after the snow melted.

14.—Zone of intersection between longitudinal fissures (foreground) and transverse fissure (background). Note increasing evidence of sand ejection along transverse fissure as it approaches longitudinal-fissure complex. Scale is 1 foot.

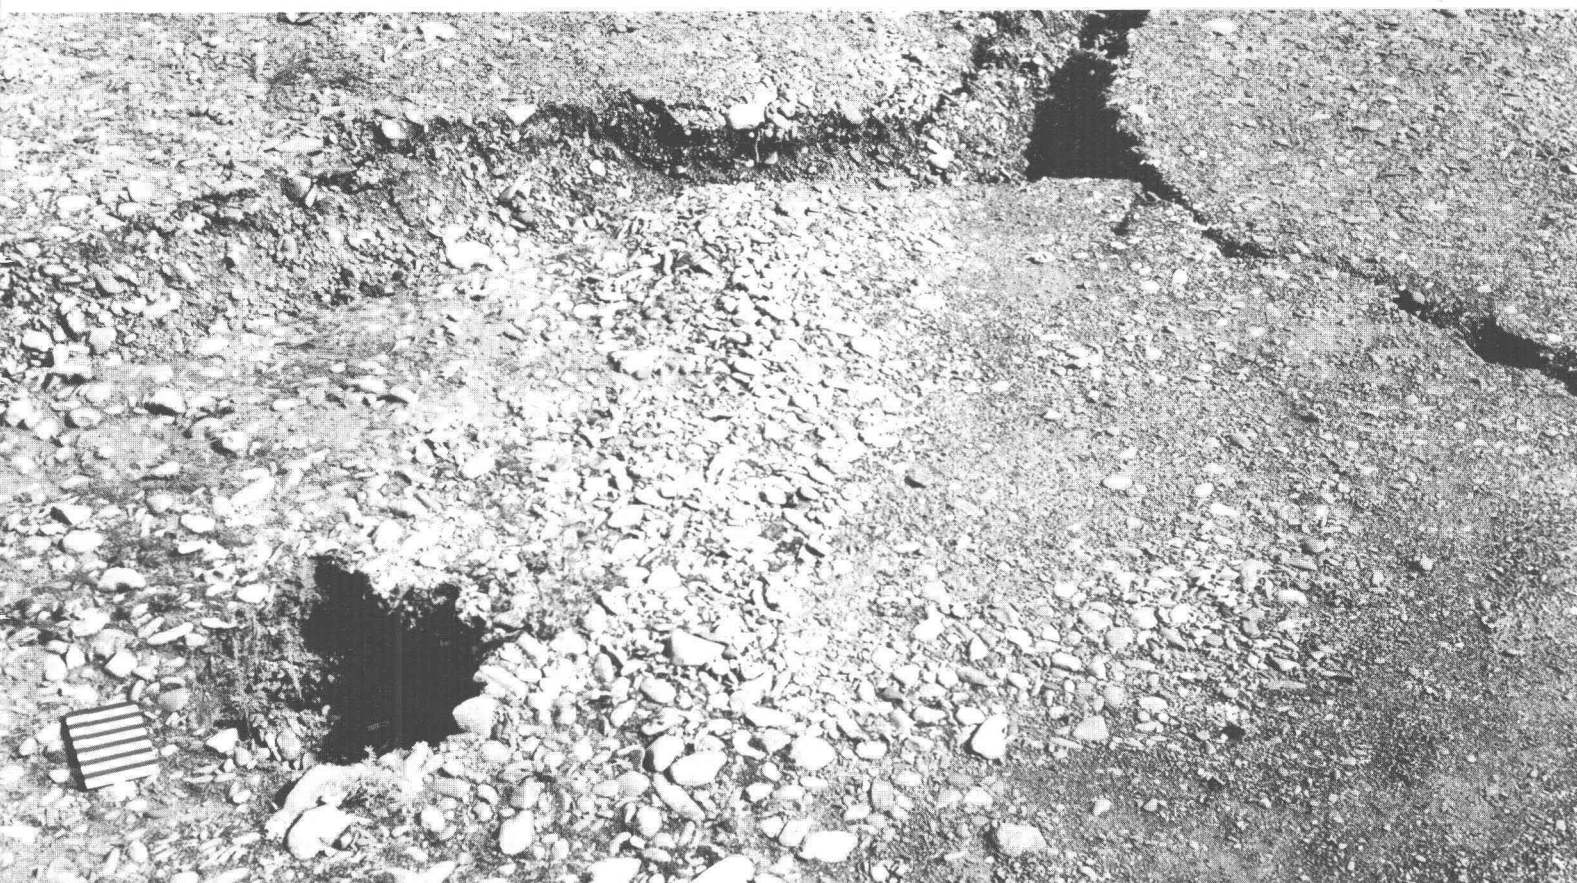
15.—Collapse pit in a graben on the flank of a set of longitudinal fissures. Scale is 1 foot.

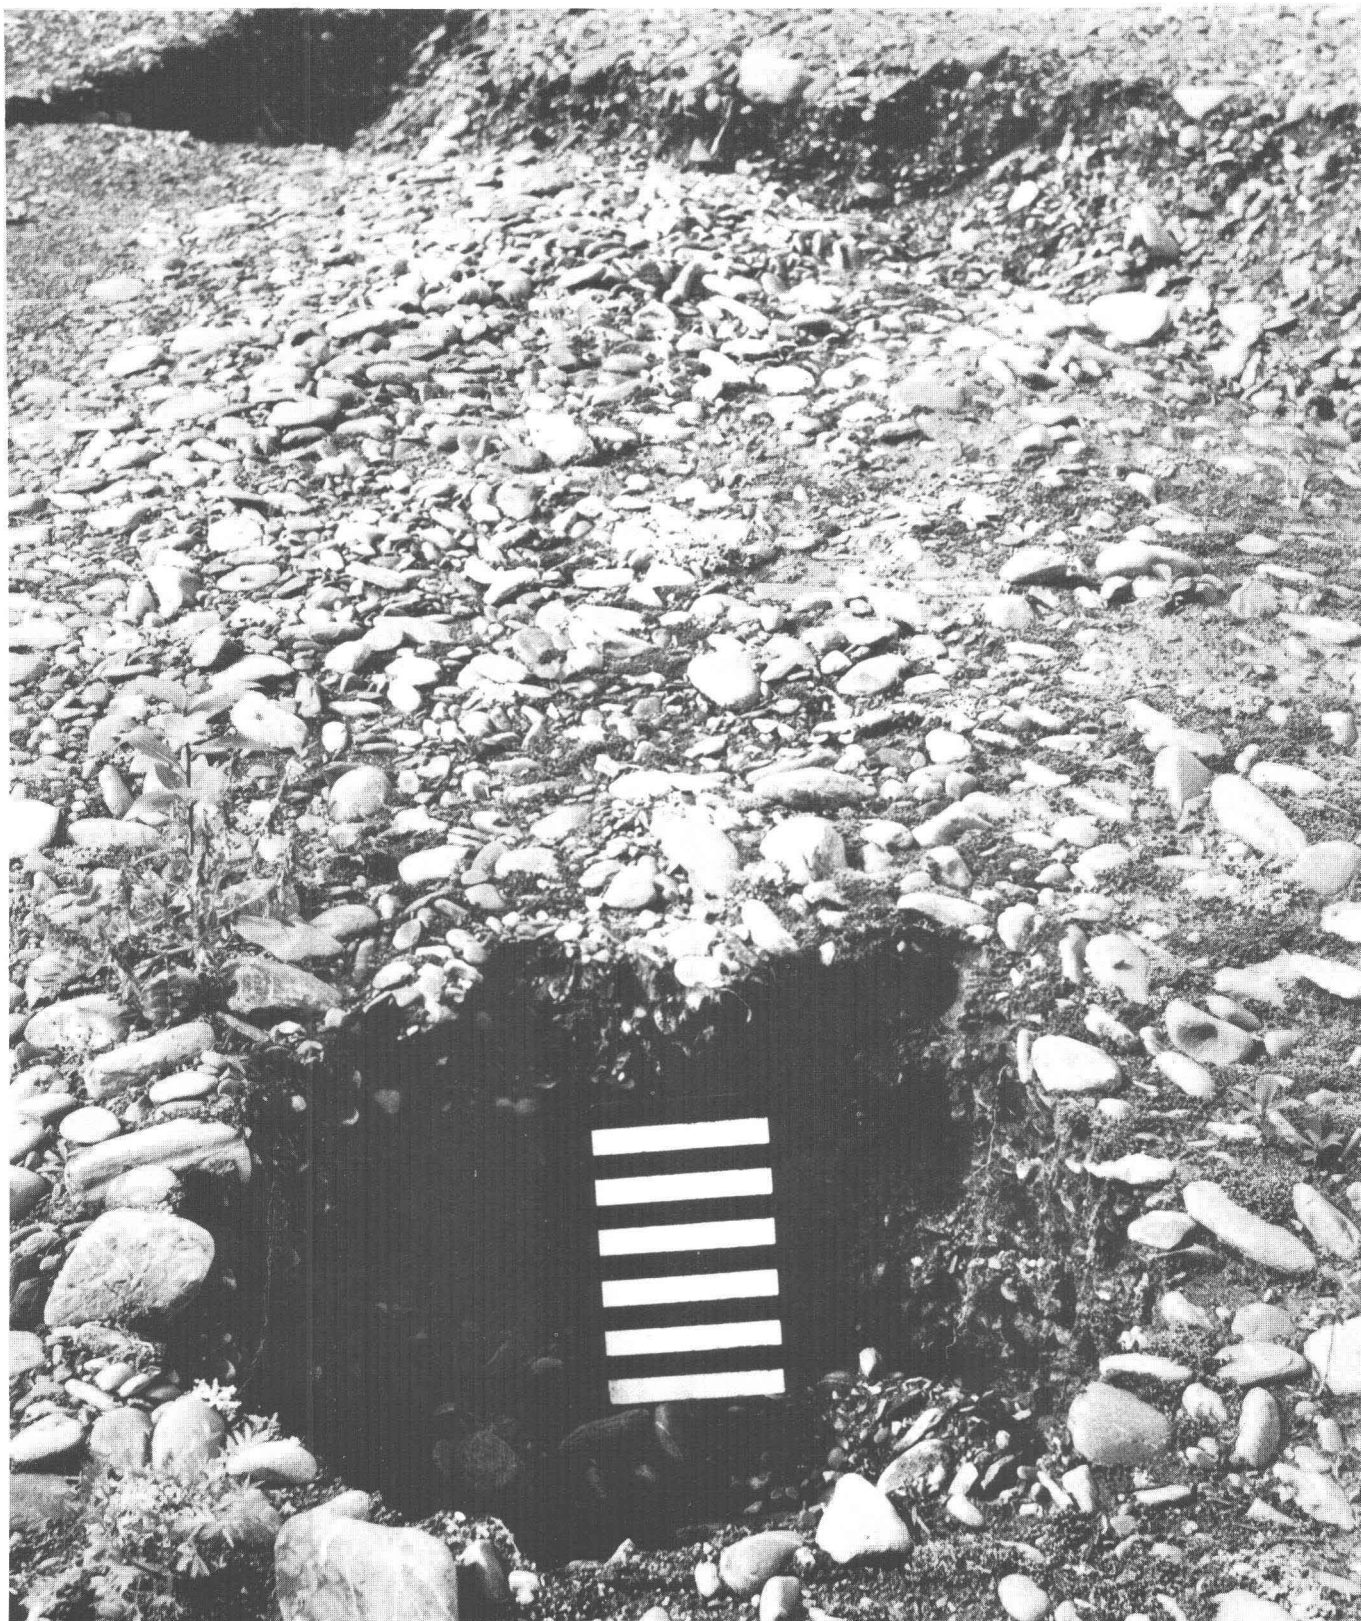
16.—Collapse pit on the flank of a set of longitudinal fissures. Scale is 1 foot.
