# The Alaska Earthquake

# Effects of the Earthquake Of March 27, 1964 At Valdez, Alaska

By HENRY W. COULTER and RALPH R. MIGLIACCIO

GEOLOGICAL SURVEY PROFESSIONAL PAPER 542-C

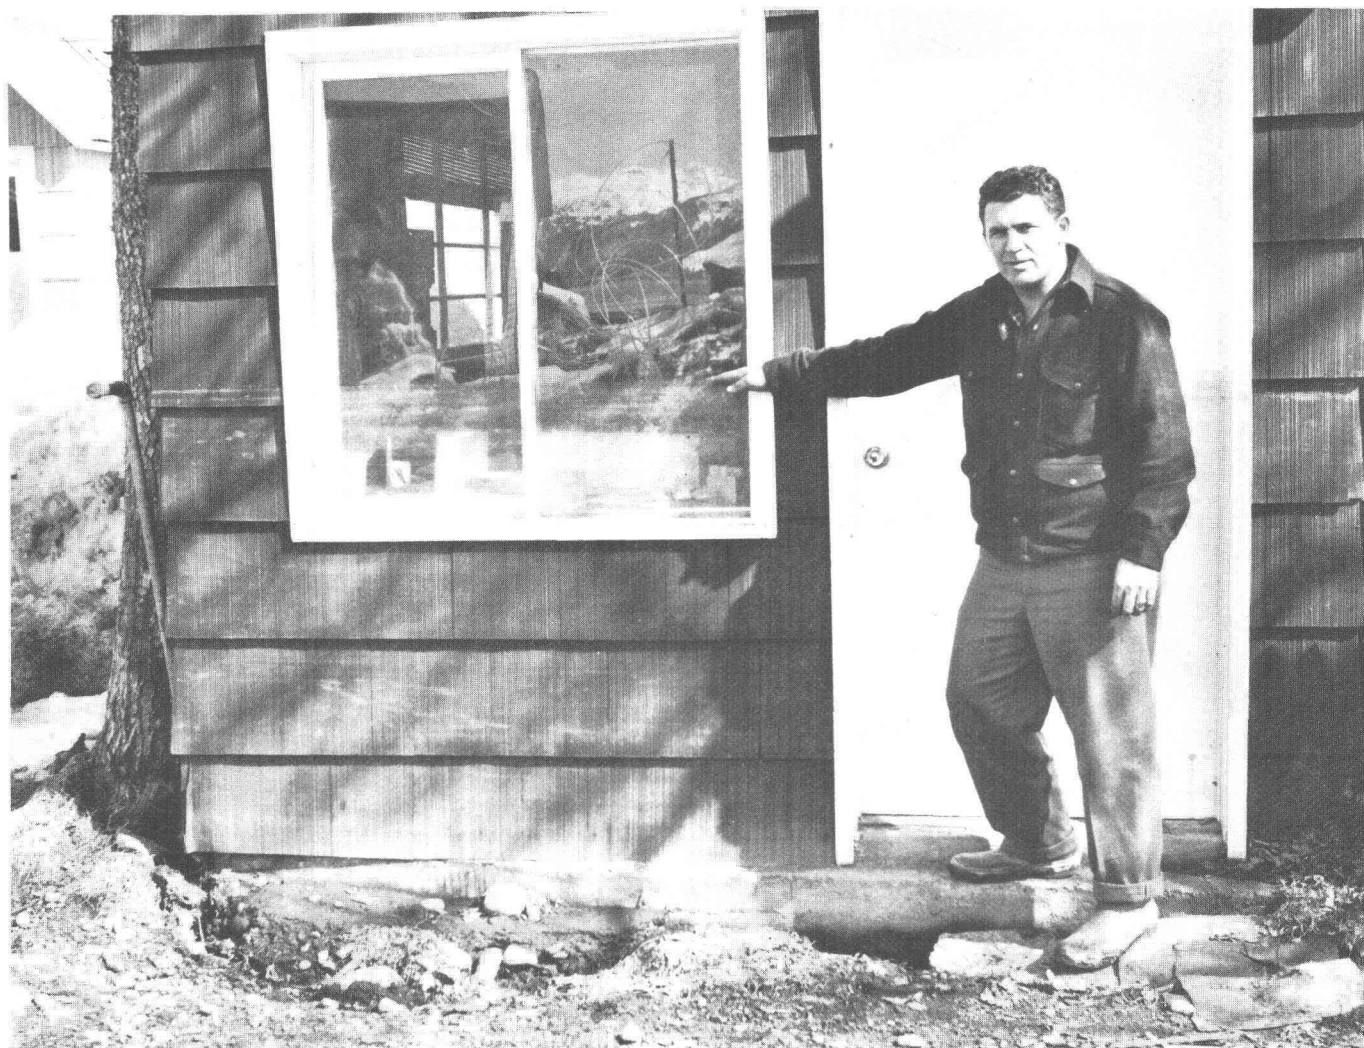
17.—High-water mark from the early-morning wave, about 1:45 a.m., March 28, 1964, on a building on the east side of North Front Street between Rudolph Alley and Dike Street.

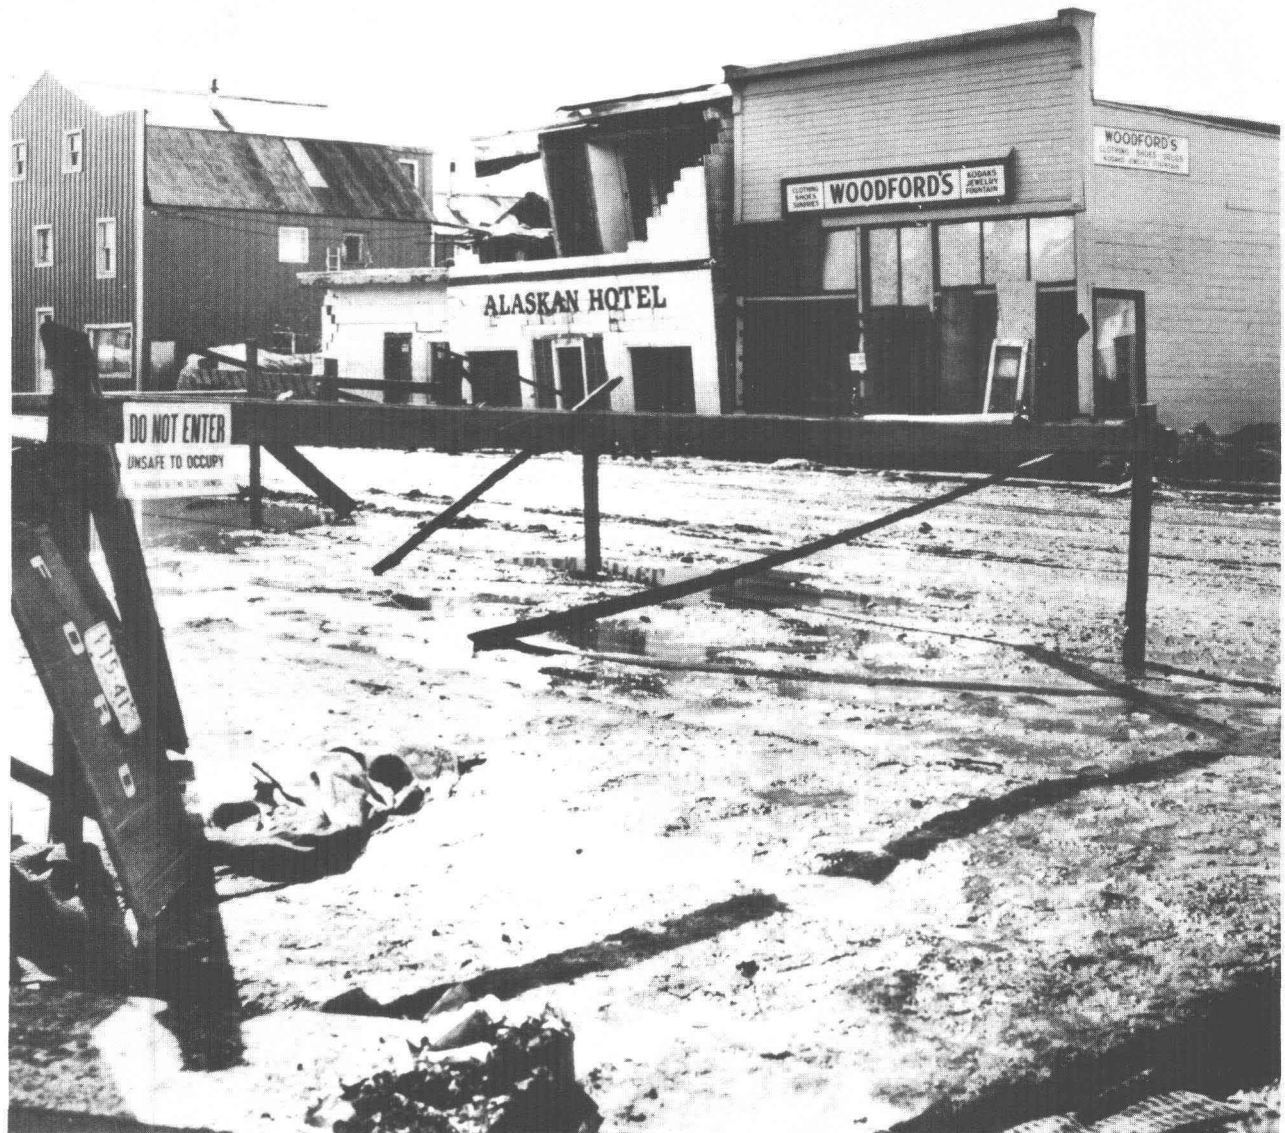
18.—Damage to the Alaskan Hotel on McKinley Street between Alaska Avenue and Broadway. The foundation of this building was intersected by four fissures. Photograph by T. L. Péwé.

tion of the foundations by fissures resulted in the pumping of large volumes of silt and sand into the cellars and crawl spaces. The effects on the commercial cinder-block structures are more apparent (fig. 18).

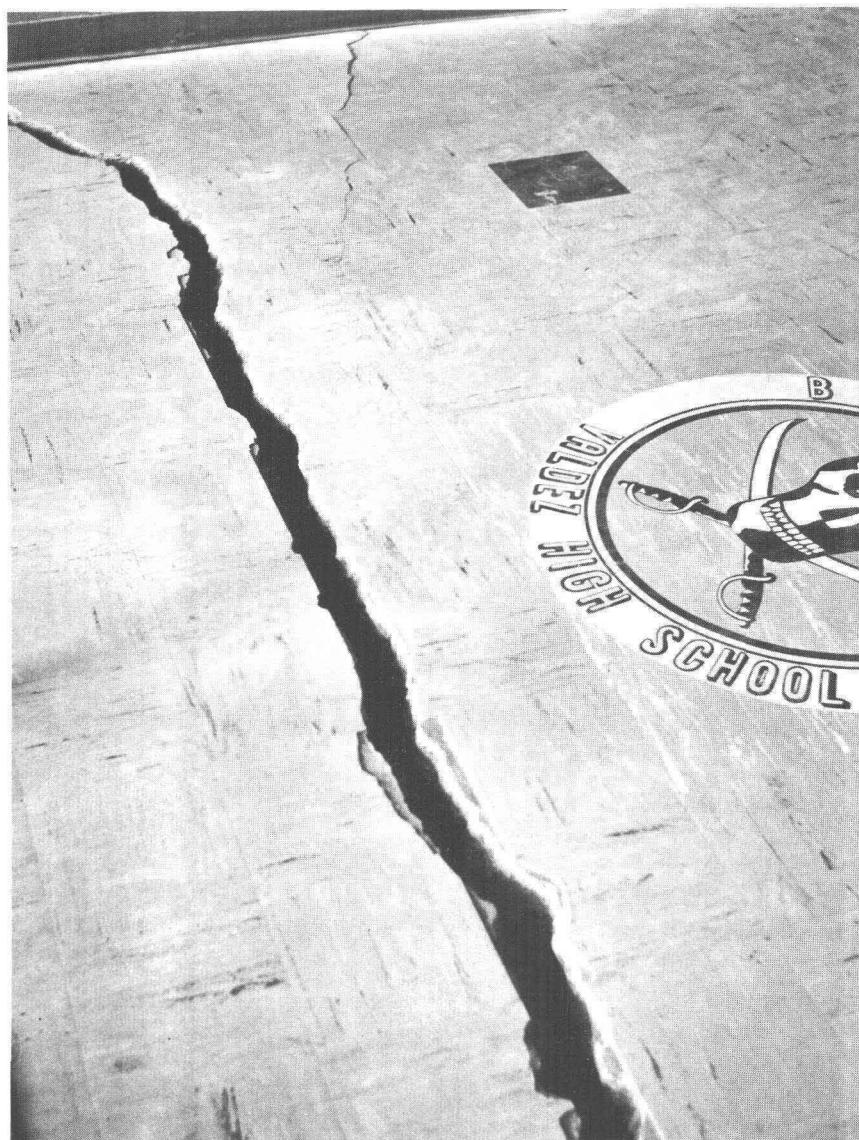
19.—Transverse fissure through the concrete foundation slab of the Valdez High School, Sherman Street and Empire Avenue.
