# The Alaska Earthquake

# Effects of the Earthquake Of March 27, 1964 In the Homer Area, Alaska

By ROGER M. WALLER

GEOLOGICAL SURVEY PROFESSIONAL PAPER 542-D

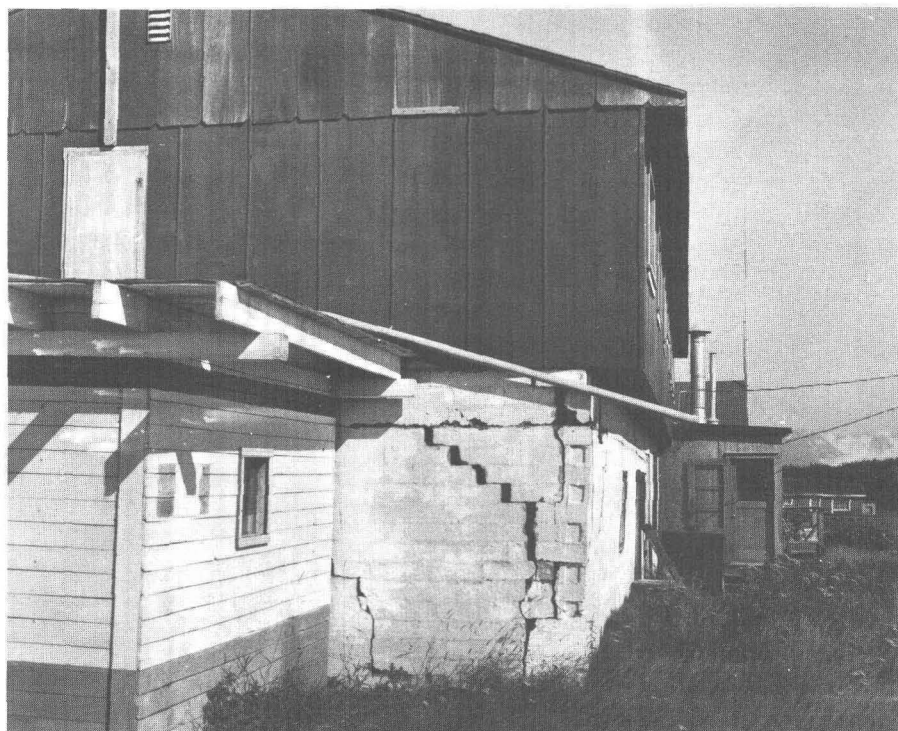
or only minor damage. At least five chimneys were knocked down, a few plate-glass windows were broken, and several foundations

(fig. 3) and concrete-slab floors were cracked or fissured. Dishes and glassware were broken in many homes and business estab-

3.—Damage to foundation walls of the Inlet Inn Hotel. Unreinforced concrete-block construction.

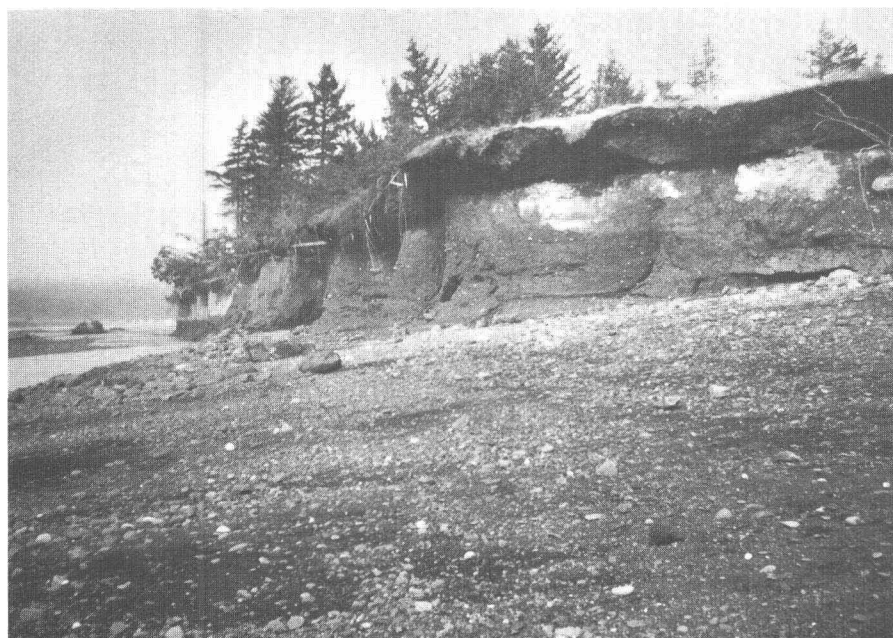
4.—Postearthquake erosion at Munson Point as of April 13, 1964. About 5 feet of the overhanging vegetal mat attests to recent erosion of the underlying glacial till as a result of higher water levels relative to land.

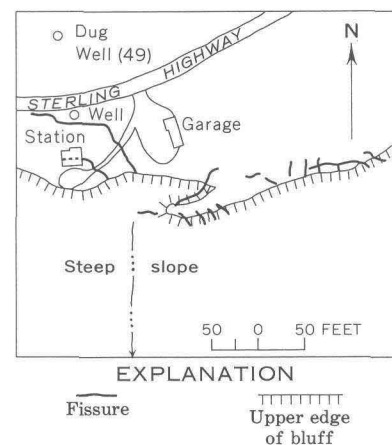
The landslide (easternmost in sec. 1, fig. 2) debris covers an area about 600 feet long and 100 feet wide. The material that slid stood previously as a promontory along a bluff eroded into the Kenai Formation. The slide area is near a fault in sec. 2 mapped by Barnes and Cobb (1959, pl. 18), but there is no evidence that this fault moved in 1964. Landslide hazards exist in comparable situations near Homer—and indeed anywhere that promontories extend out from precipitous bluffs and cliffs. Bluff Point, north of Homer (fig. 2) is an example. A field station of the U.S. Bureau of Land Management is situated about 50 feet from the edge of a 700-foot bluff. Numerous fissures (fig. 5) developed during the

5.—Sketch map of the ground-fissure pattern at the U.S. Bureau of Land Management field station near Homer. Traced from field compilation on aerial photograph by K. A. Roddy, U.S. Bureau of Land Management, May 1, 1964.

earthquake on the surface above the bluff, some of them several inches wide. A few could be traced about 20 feet down the bluff face. One earth fissure extended across the area of a field-station building and cracked the basement floor of the structure. Areas above and close below promontories where earthslides might occur must remain suspect as sites for any building.

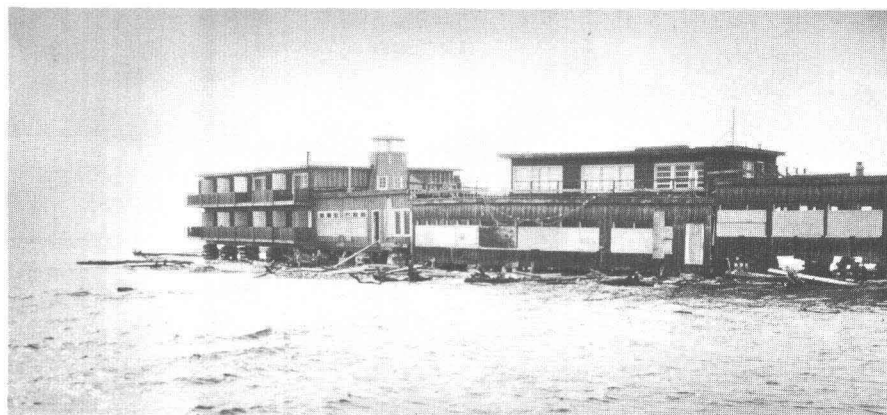
Some of the specific damage to structures caused by the flooding may be seen in figure 8 (on next page), which shows the Land's End Hotel elevated on jacks to raise it above the postearthquake high-tide level. Figure 9 (p. D10) shows other scenes of the effects of the high tides. During the high tide of about 19 feet that occurred the night following the earth-

quake, material salt-water damage was done to the hotel, to the Porpoise Room, the Salty Dawg Saloon, two seafood-processing plants, and the Standard Oil Co. tank farm.

8.—Land's End Hotel jacked up 8 feet to avoid inundation by high tides. View from Homer dock looking west. View during first 20-foot tide. Middle part of hotel not yet raised.

Fortunately the mid-April high tides were not accompanied by strong winds, and most of the facilities survived the first onslaught with only salt-water damage. Some structures that could not be raised on jacks were protected against further flooding by hurriedly built embankments. The only land not inundated at the end of the spit was the storm berm around the perimeter of the spit, older storm berms of the beach, and the spoil pile from the original dredging of the small-boat harbor (fig. 6). The asphalt-covered highway was eroded away near the base of the spit by normal wave action at high tide. The dock had only about 1 foot of freeboard, the oil tanks were in water as much as 6 feet deep, water flowed through the windows of the Salty Dawg, one small warehouse building broke up, and the oil-tank farm warehouse tilted; all this indicated differential subsidence.

It was apparent that, in addition to repairs, remedial measures were needed to avoid future storm-wave damage as well as damage from normal high tides. Such measures were started immediately by some concerns, whereas others awaited aid from the Government, through the Federal Disaster Act, authorized under Public Law 81-875. As of August 30, 1964, the Office of Emergency Planning had authorized reconstruction projects totaling \$1,565,000 to replace or rehabilitate public facilities damaged by the earthquake and tides

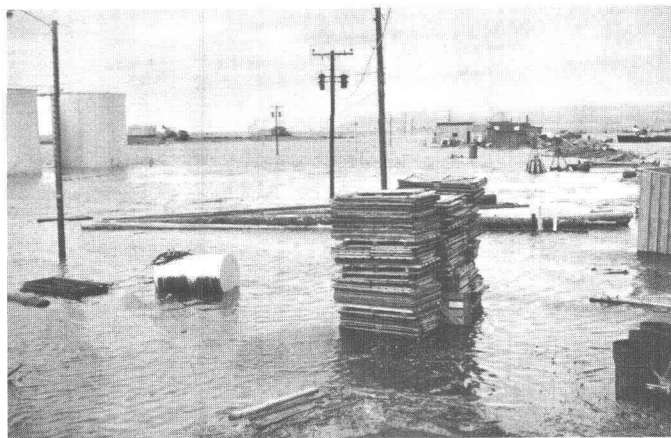
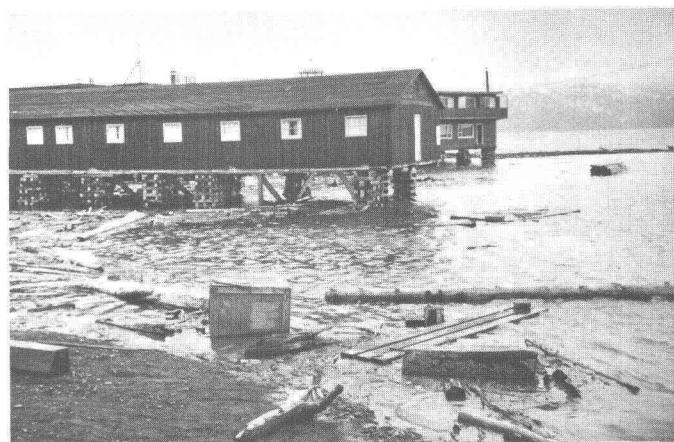
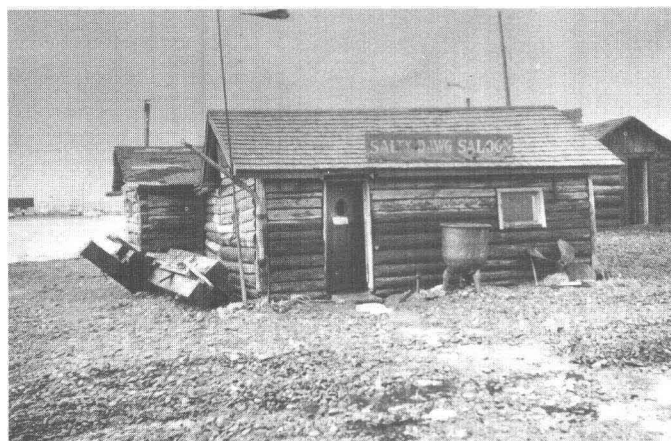
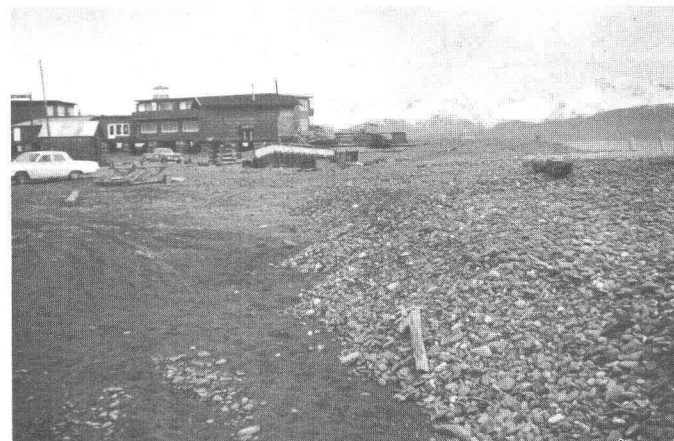
9.—Effects of the high tides submerging the end of Homer Spit on April 12, 1964. A, Standard Oil Co. tank farm awash in as much as 6 feet of water. B, Lands End Hotel raised on jacks. C, Water rose high enough to flow through the windows of the Salty Dawg Saloon. D, New storm berm encroaching on spit southwest of the Land's End Hotel.

covered in a matter of days by a new berm (fig. 9D) that prevented observation.

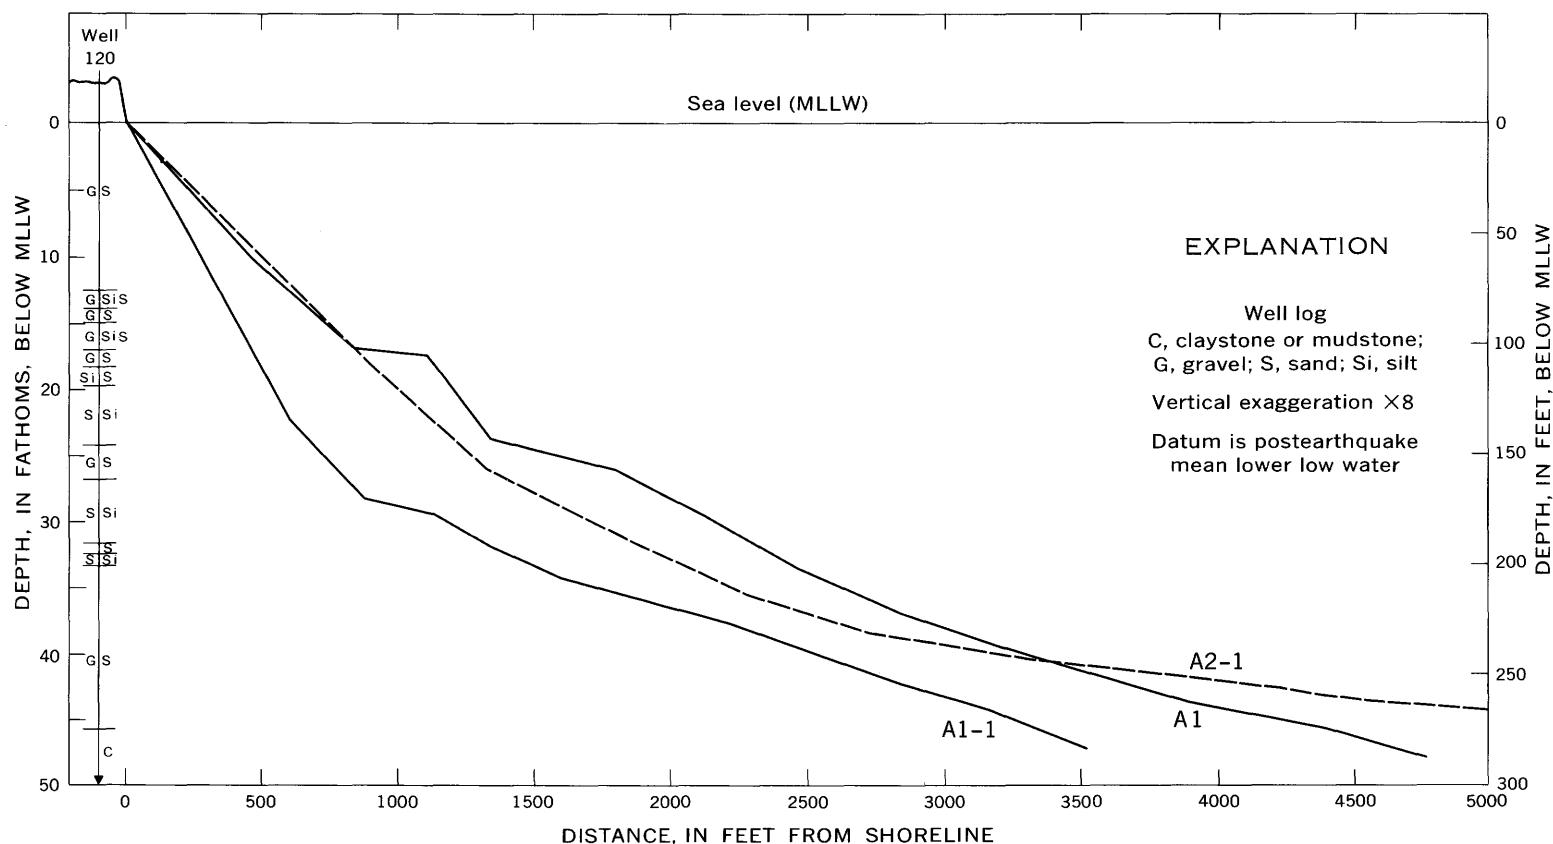
10.—Offshore profiles showing the slope off the end of the Homer Spit. Lines of profiles plotted on plate 1. Data from U.S. Army Corps of Engineers. Profile A1 is the easternmost of the two shown on plate 1.

is also shown (fig. 10) to indicate the seeming coincidence of silty zones beneath the spit with offshore bulges or plateaus on the bathymetric profiles.

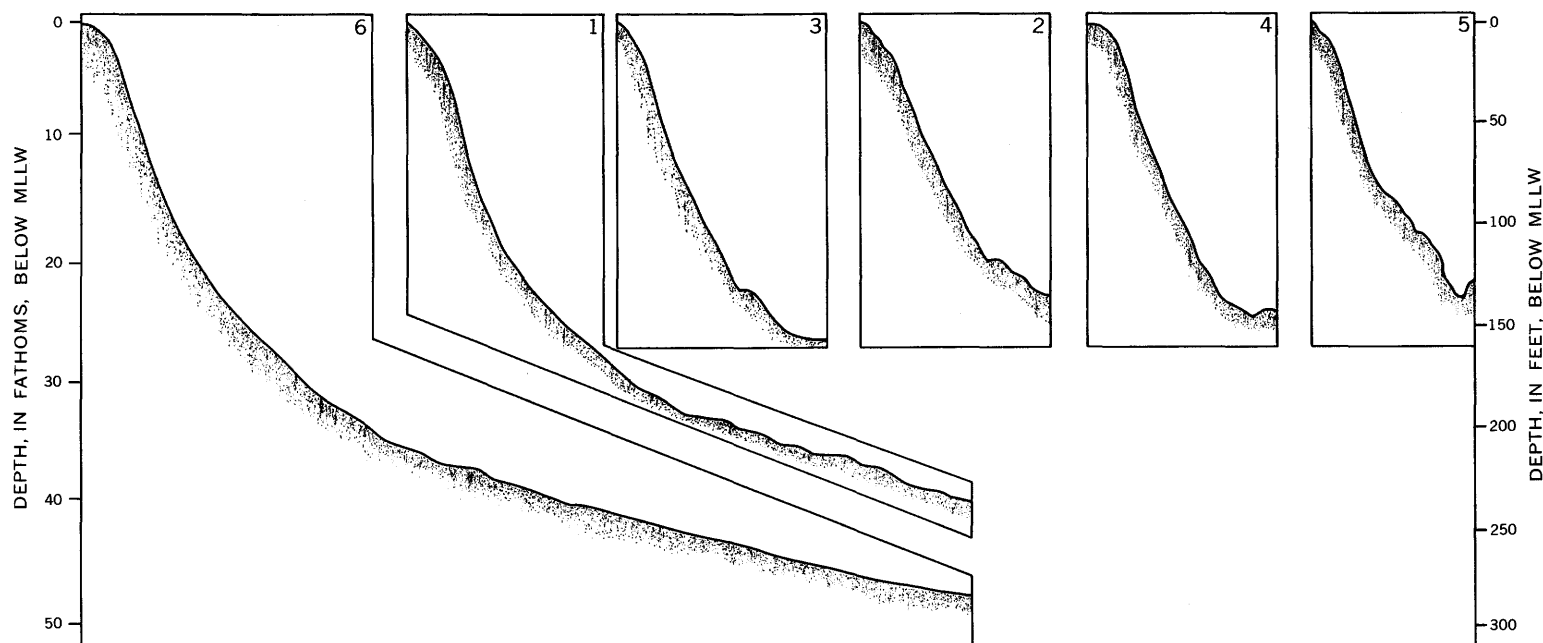
11.—Fathometer profiles showing the slope off the end of Homer Spit. Lines of profiles plotted on plate 1. Line 6 approximates line A2-1 of figure 10.

bathymetric survey was not feasible at the time, so a portable fathometer (used successfully by other Survey geologists in determining subaqueous slides in Kenai Lake and elsewhere) was used to run a few continuous profiles offshore to try to determine slide areas (locations on plate 1). Although the runs were hampered by the writer's inexperience with the instrument, the results are believed to confirm the presence of another slide west of the Land's End Hotel.

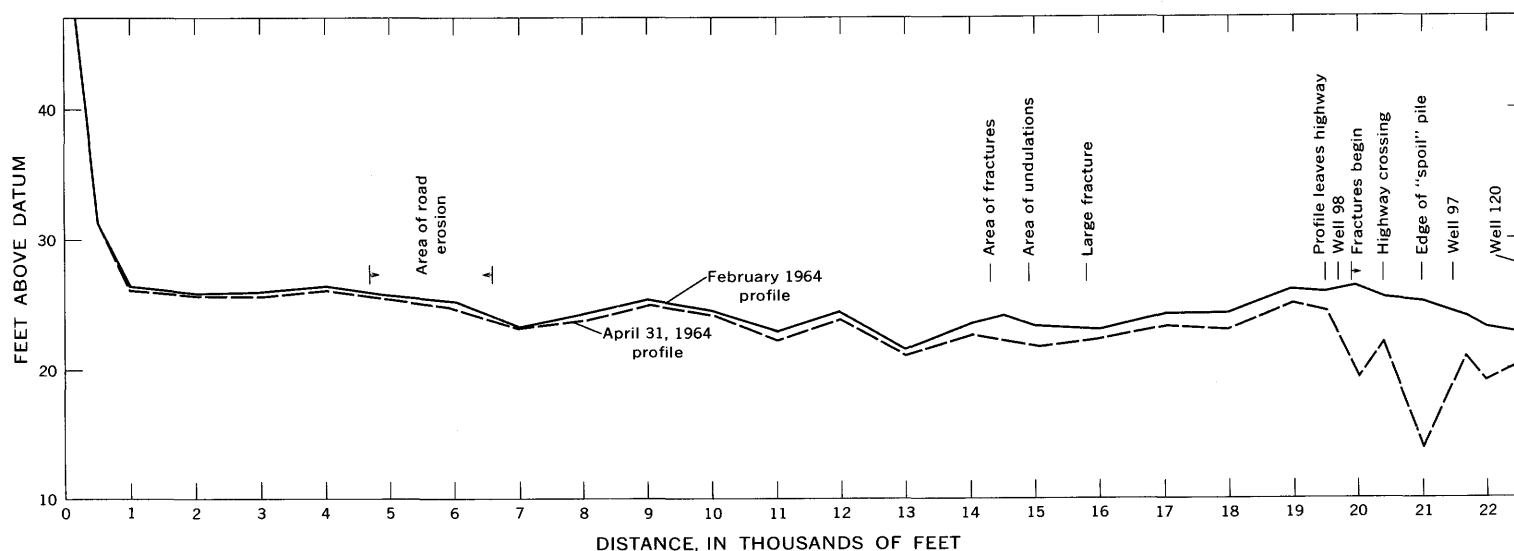
ments, has been determined at tidal bench marks (table 1) by the U.S. Coast and Geodetic Survey (1964b) and the Alaska Highway Department resurvey. The area of greatest subsidence, about 10 feet, is in the vicinity of the spoil pile formed by excavation of the small-boat harbor. Undoubtedly this material became compacted much more than the natural spit material. However, this area is adjacent to the breakwater slide, and the subsidence may be related to differential compaction or lateral spreading behind the submarine landslide. Release of pore pressure in a compacting silt accompanied the slide, and "progressive liquefaction" could have

12.—Profiles of Homer Spit surveys by the Alaska Highway Department. Datum is U.S. Bureau of Public Roads temporary bench mark 20, 70.25 feet above (preearthquake) datum. Vertical exaggeration  $\times 200$ .

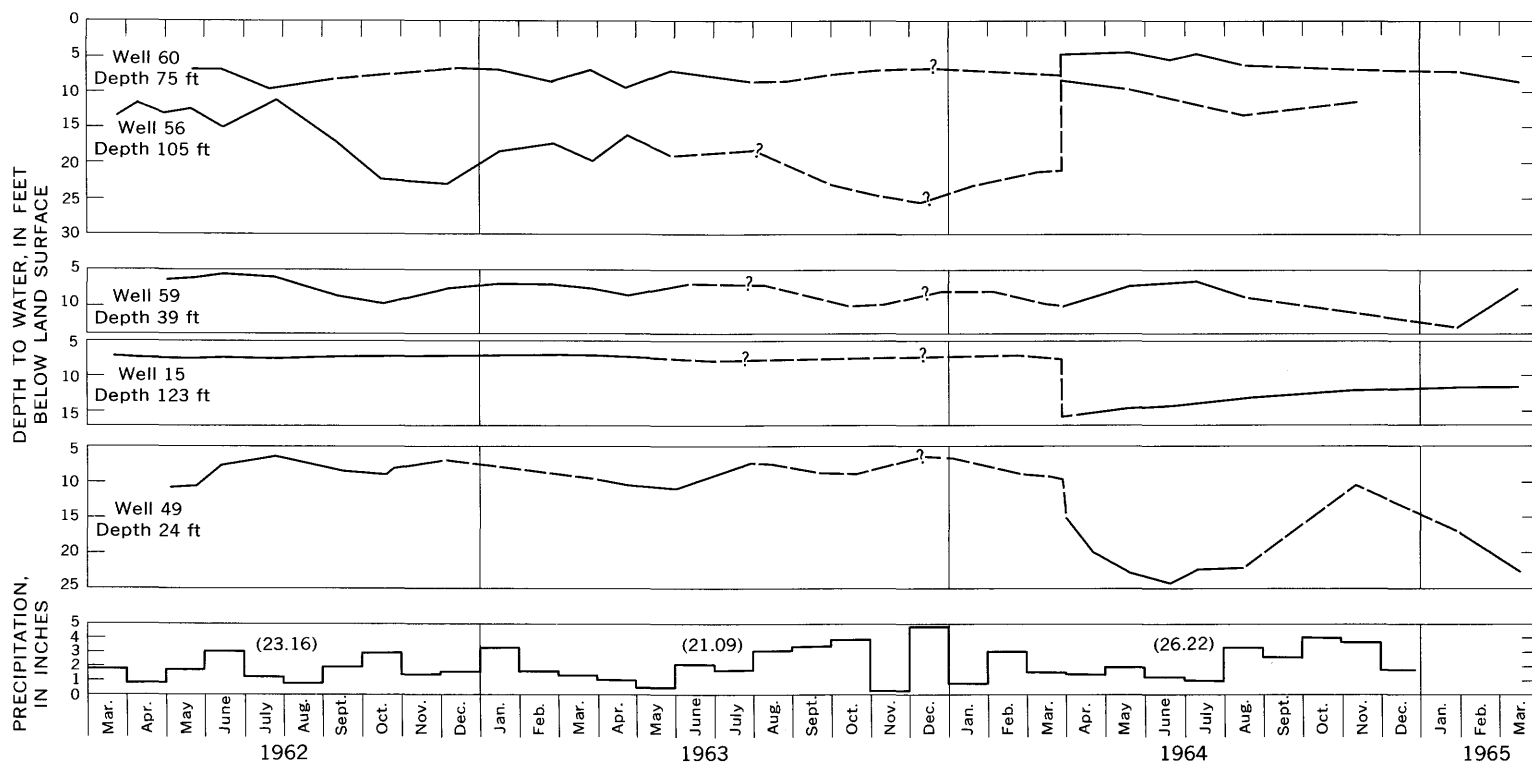
The failures of some of the well systems resulted from sanding or silting of the pump due to agitation of the wells and differential movement of well casings and the surrounding rock. Most of the wells are unscreened and have 1 to several feet of uncased hole (Waller, 1963, table 1). These conditions readily lend themselves to caving or slumping of the walls under earthquake stress. Hence, pumps turned on or automatically activated when electric power was restored pumped this material into the system and caused turbid water or malfunction of the pump. Other wells that have pumps requiring a full pipe of water for a prime probably lost their prime owing to surging in the well. Thus, reports of dry wells were common, as they usually are after most earthquakes.

13.—Hydrographs of five Homer wells showing long-term effects of the earthquake. Locations of wells shown on figure 2.

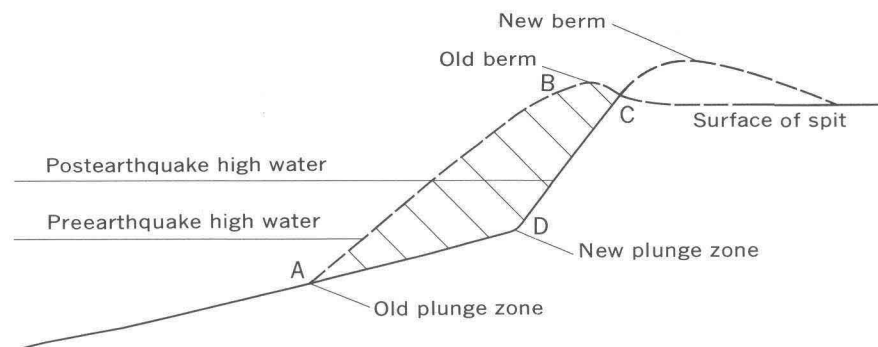
17.—Beach-face recession diagram showing the preearthquake upper foreshore slope (line *AB*) and the postearthquake slope (line *CD*). After subsidence, material within *ABCD*, as a result of the higher water level, was scoured and in part carried onto the spit where it formed a new frontal berm.

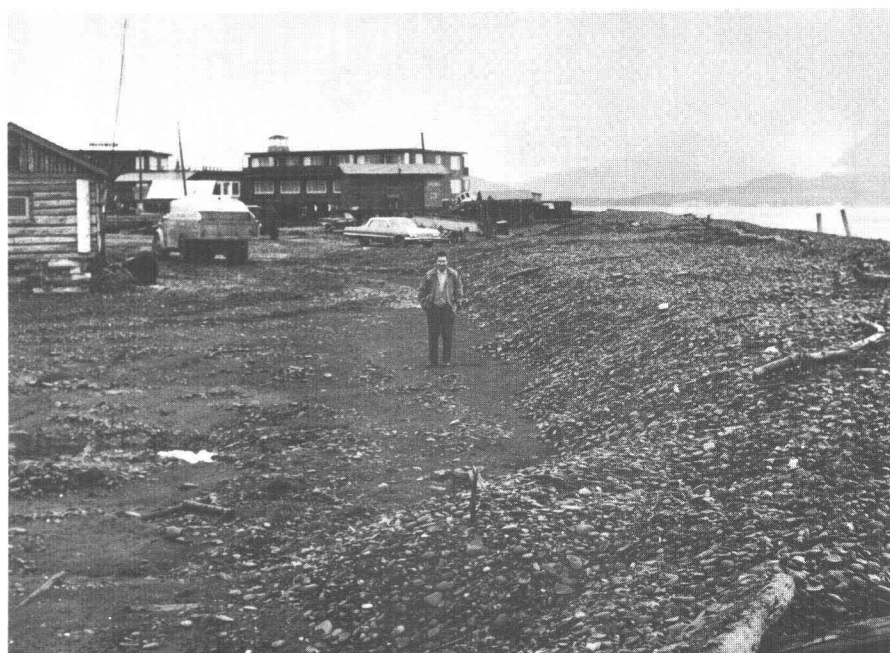
18.—Storm berm developed along spit within 6 months after subsidence. Berm before subsidence was less than 3 feet high and 4–5 feet wide at the base.

As an illustration of berm growth, the preearthquake berm at the distal end of the spit was less than 3 feet high, and 4–5 feet wide at the base. Six months after the earthquake, the berm, as shown by figure 18, had built up to 6 feet in height and had widened to nearly 60 feet. The same berm after another 6-month period had widened an additional 20 feet. Elsewhere the berm has migrated around buildings and covered and blocked roads.

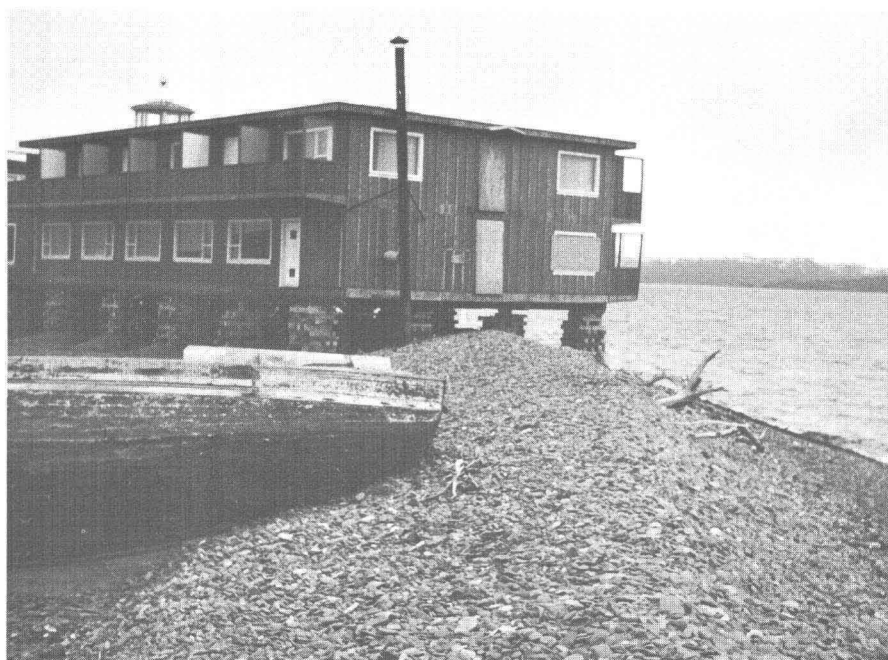
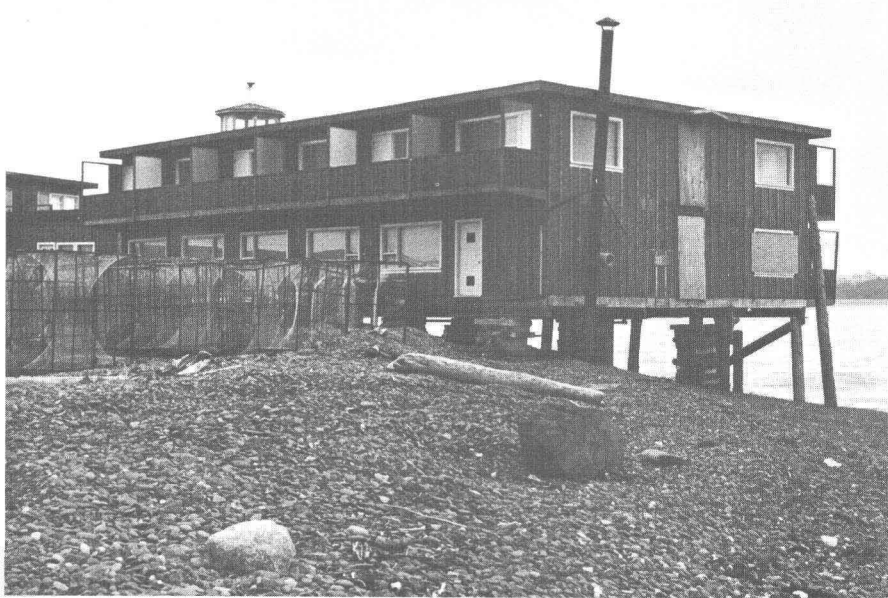
The size of the new berm is not in proportion to material lost from, nor to the recession of, the adjacent beach face. Figure 19

19.—Photographs taken 6 months after subsidence (top) and a year after subsidence (bottom) show that the size of frontal berm is not proportional to the recession of the beach face.

shows an example of this disparity. Such examples show that a large part of the material scoured from the beach face was not carried onto the spit and deposited as part of the berm. According to King (1959, p.

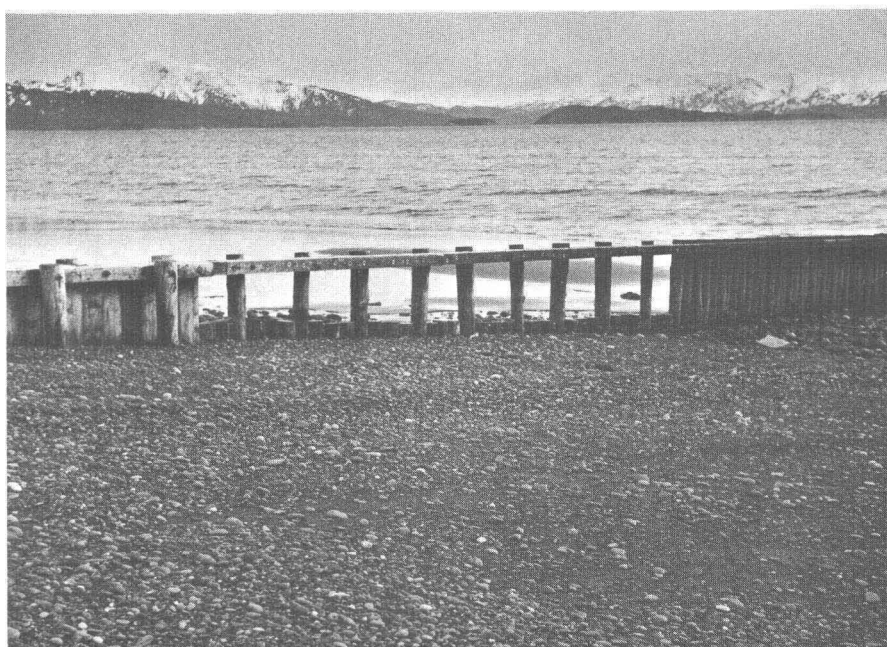
20.—Section removed from seaward end of groin to allow bypassing of material.

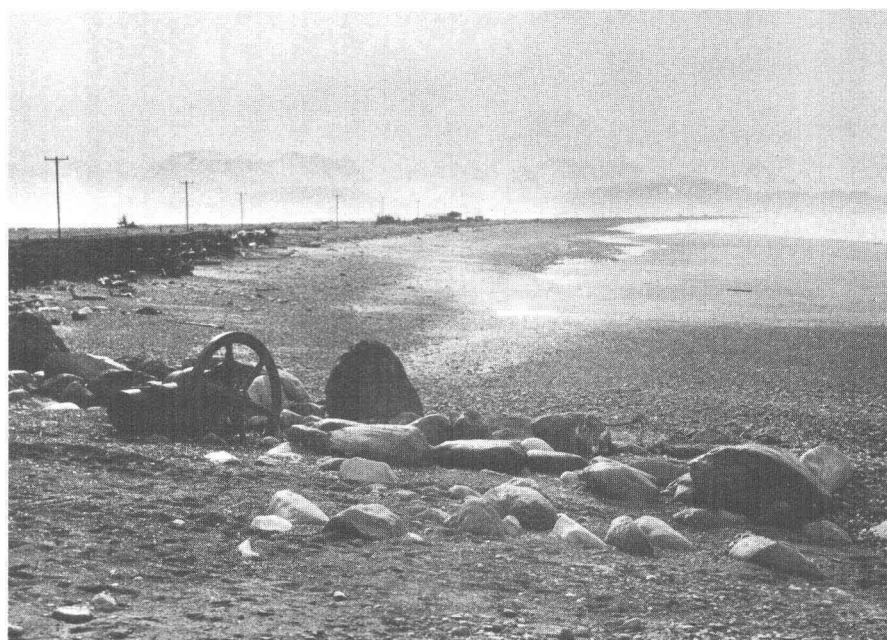
21.—Erosion on the lee side of the last of a series of four groins, a few days after the earthquake.

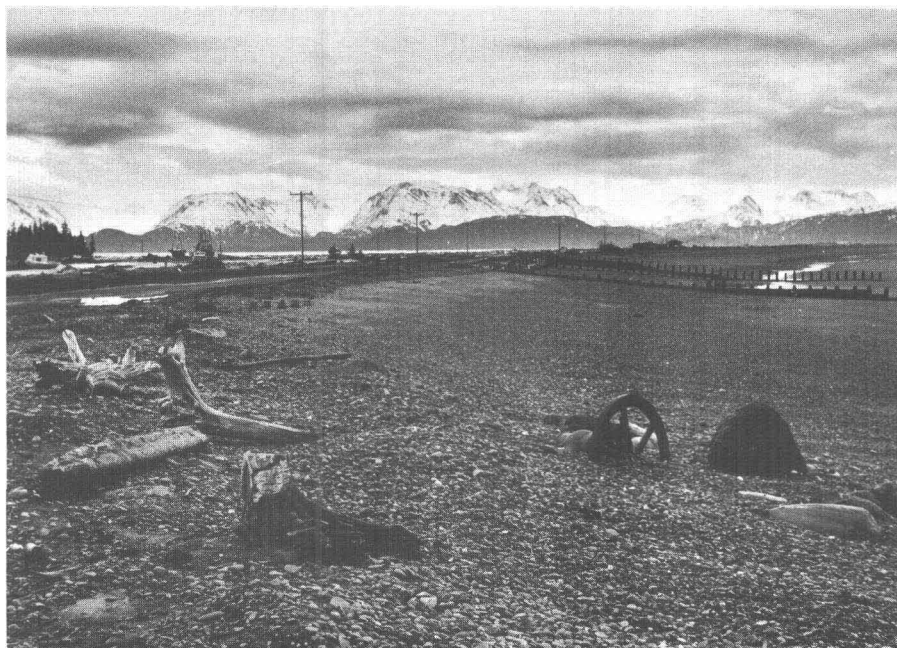
22.—The same area as shown in figure 21, 1 year later, after construction of two new groins (right background).

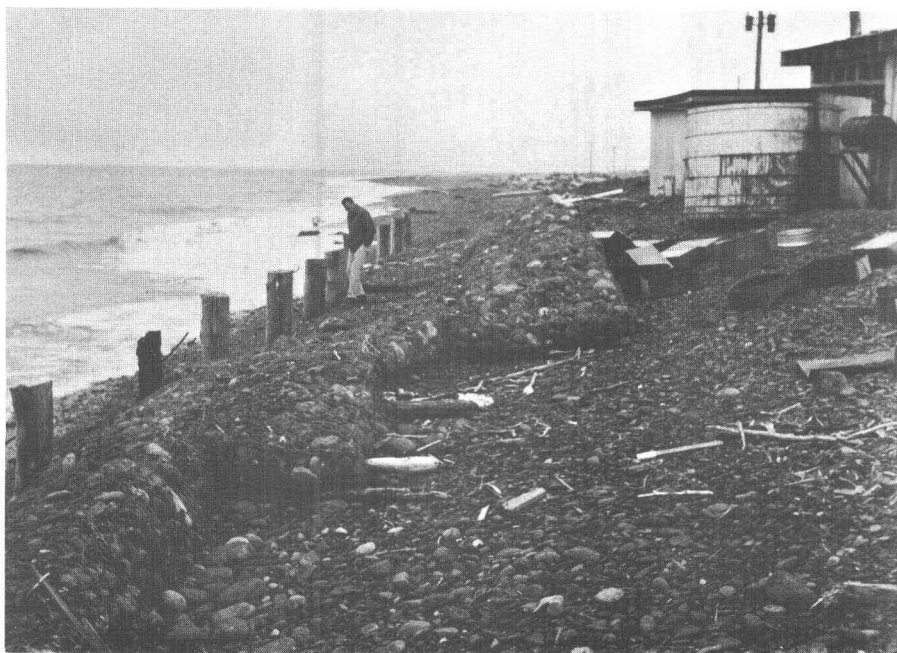
23.—Cobble-filled baskets placed on beach face to prevent erosion.

At one location a small cannery was endangered by undermining. Specially manufactured and prefabricated wire baskets were filled with cobbles and placed along the beach face (fig. 23). After 1 year the beach has built up and has shown no tendency to scour in front of the cobble-filled baskets.

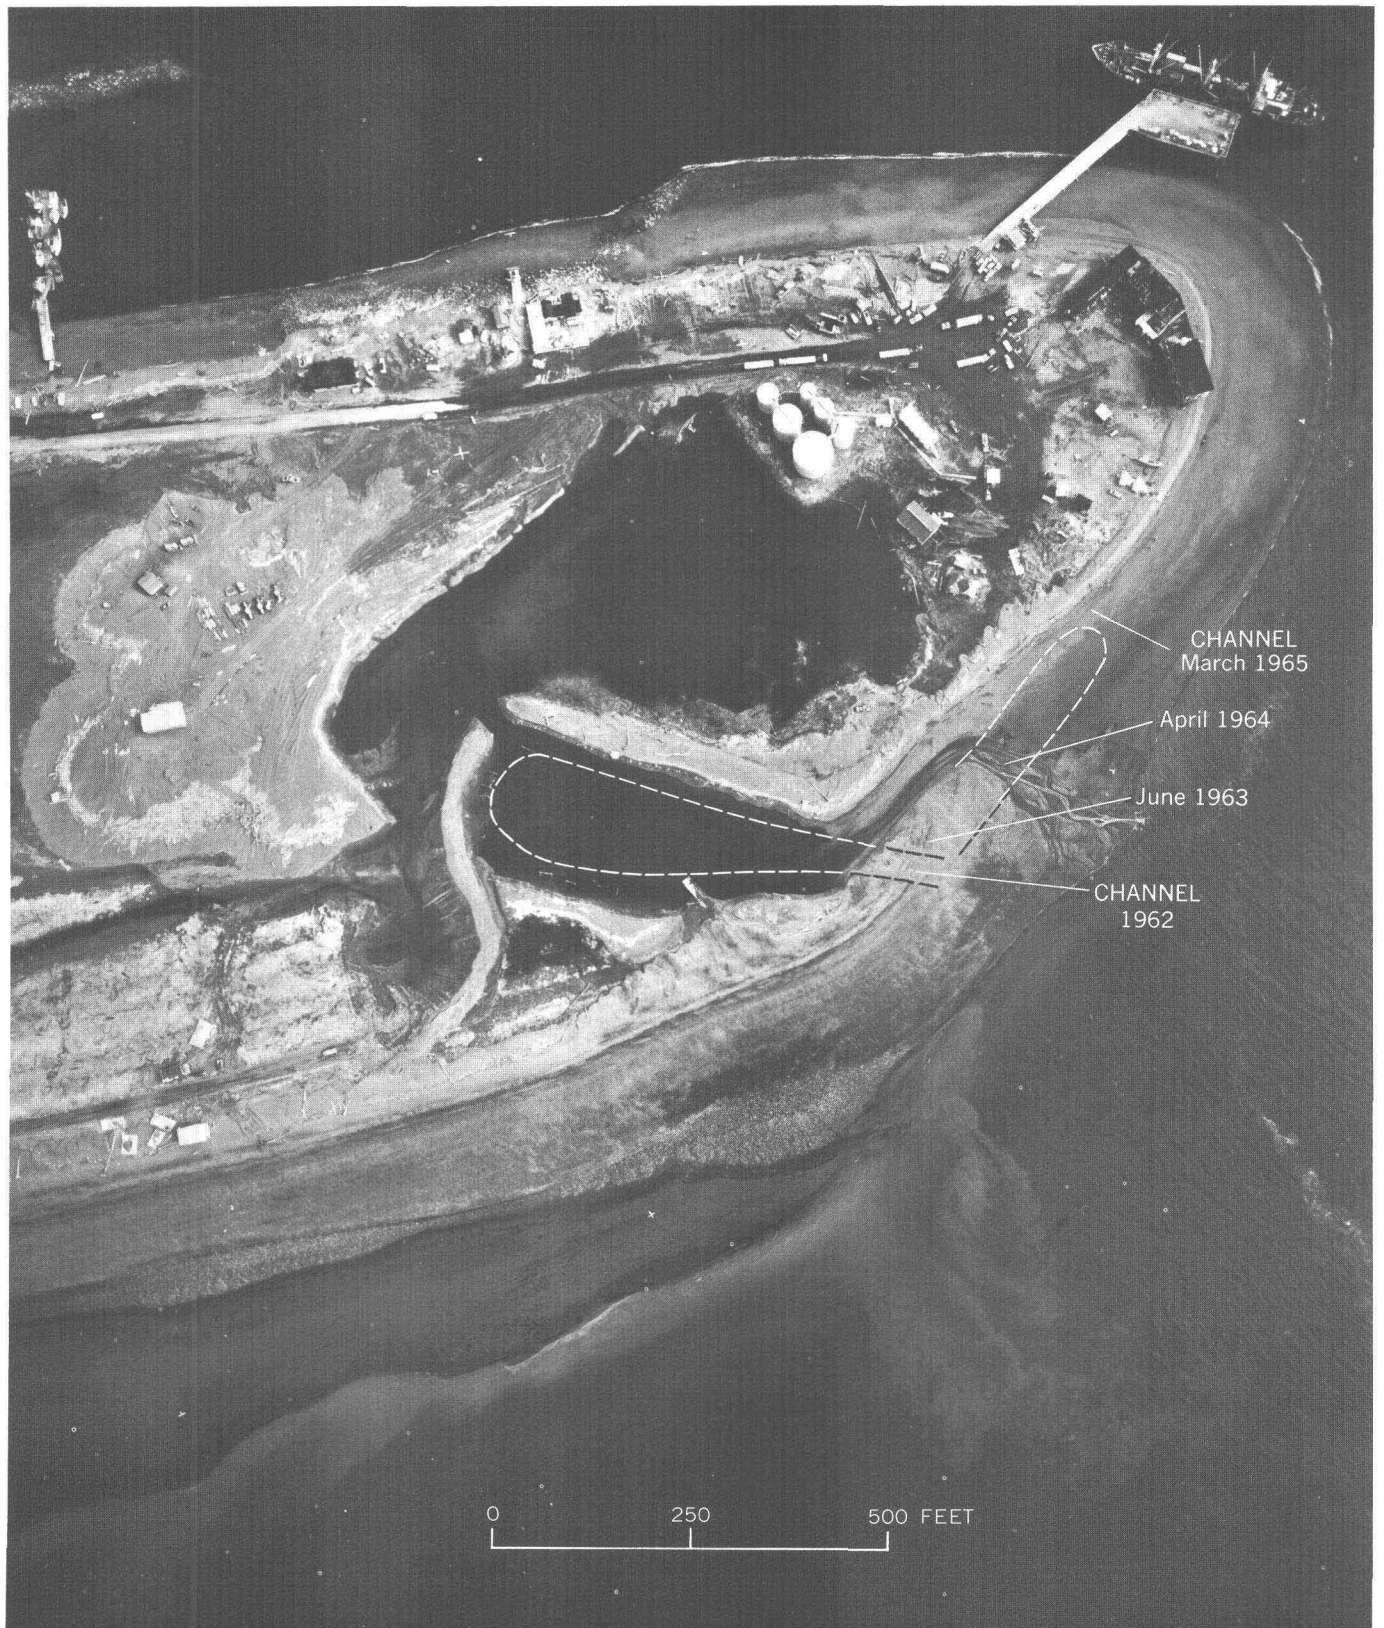
24.—Bar being built across the entrance of a tidal inlet at distal end of Homer Spit. Photograph by U.S. Army Corps of Engineers, April 30, 1964.
