THE ALASKA EARTHQUAKE, MARCH 27, 1964:
EFFECTS ON COMMUNITIES

Effects of the Earthquake Of March 27, 1964, At Seward, Alaska

BY RICHARD W. LEMKE

GEOLOGICAL SURVEY PROFESSIONAL PAPER 542-E

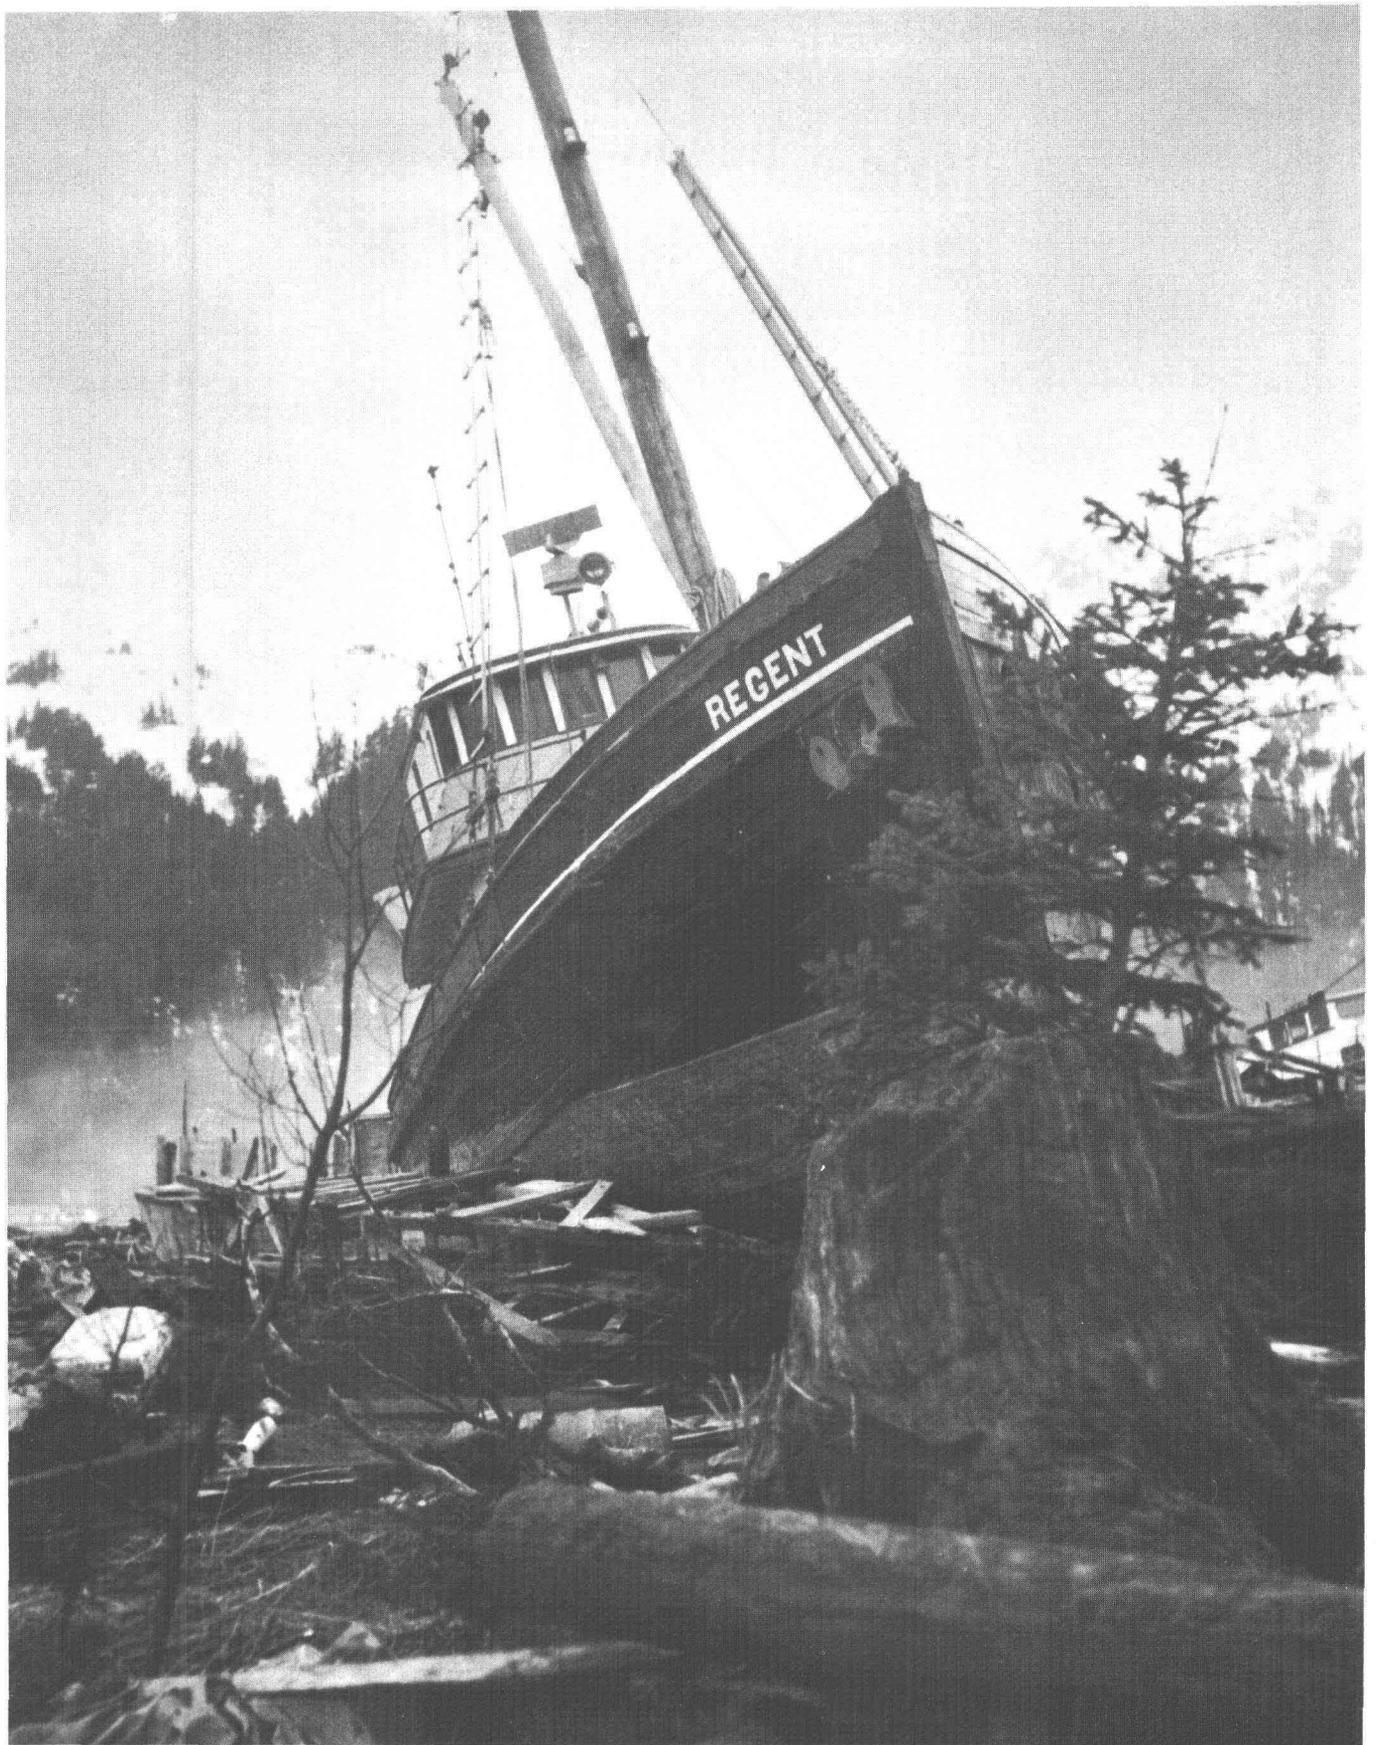
Fishing boat beached several hundred feet inland from the head of Resurrection Bay by seismic sea waves.

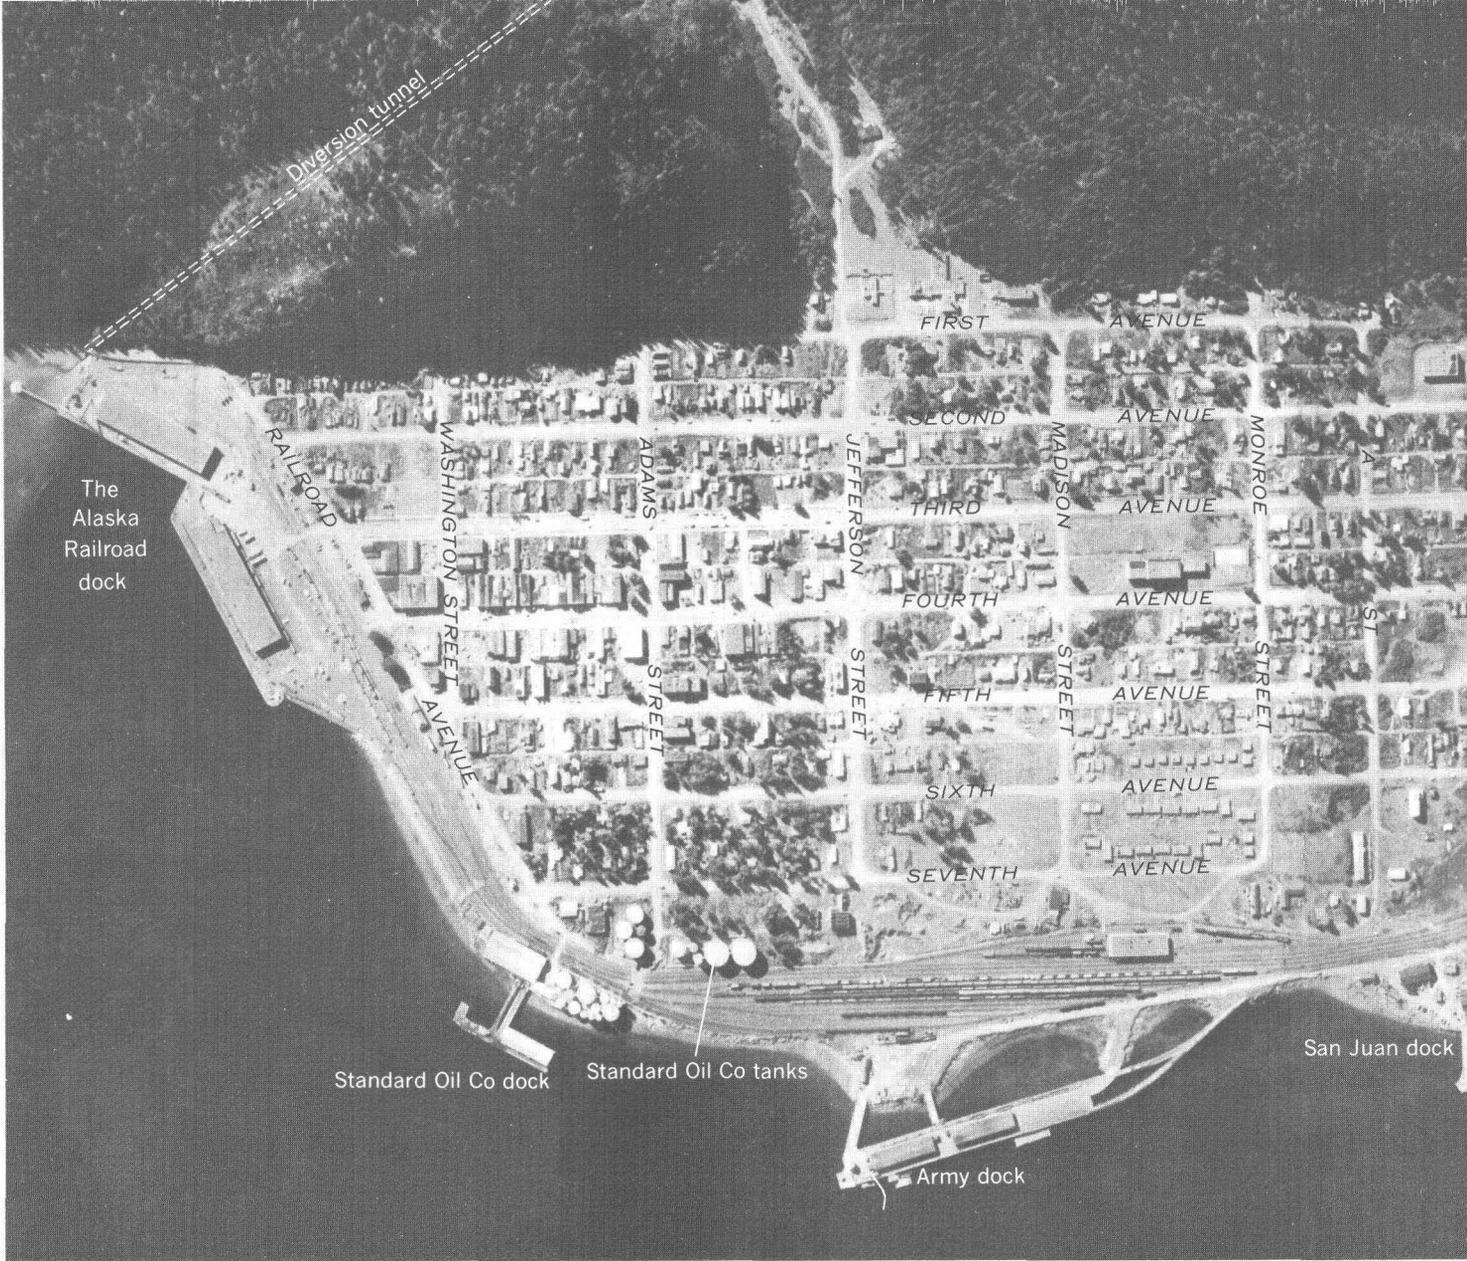
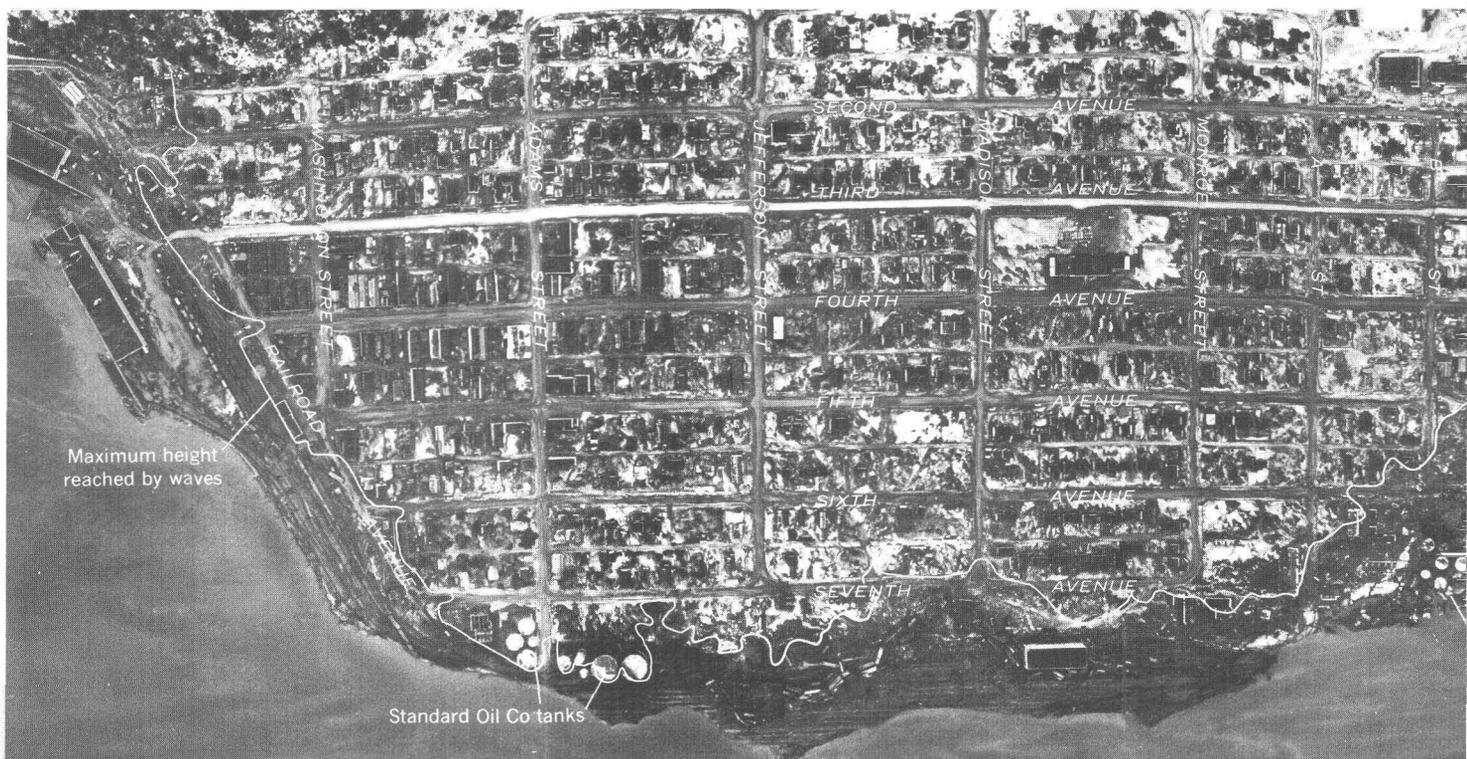
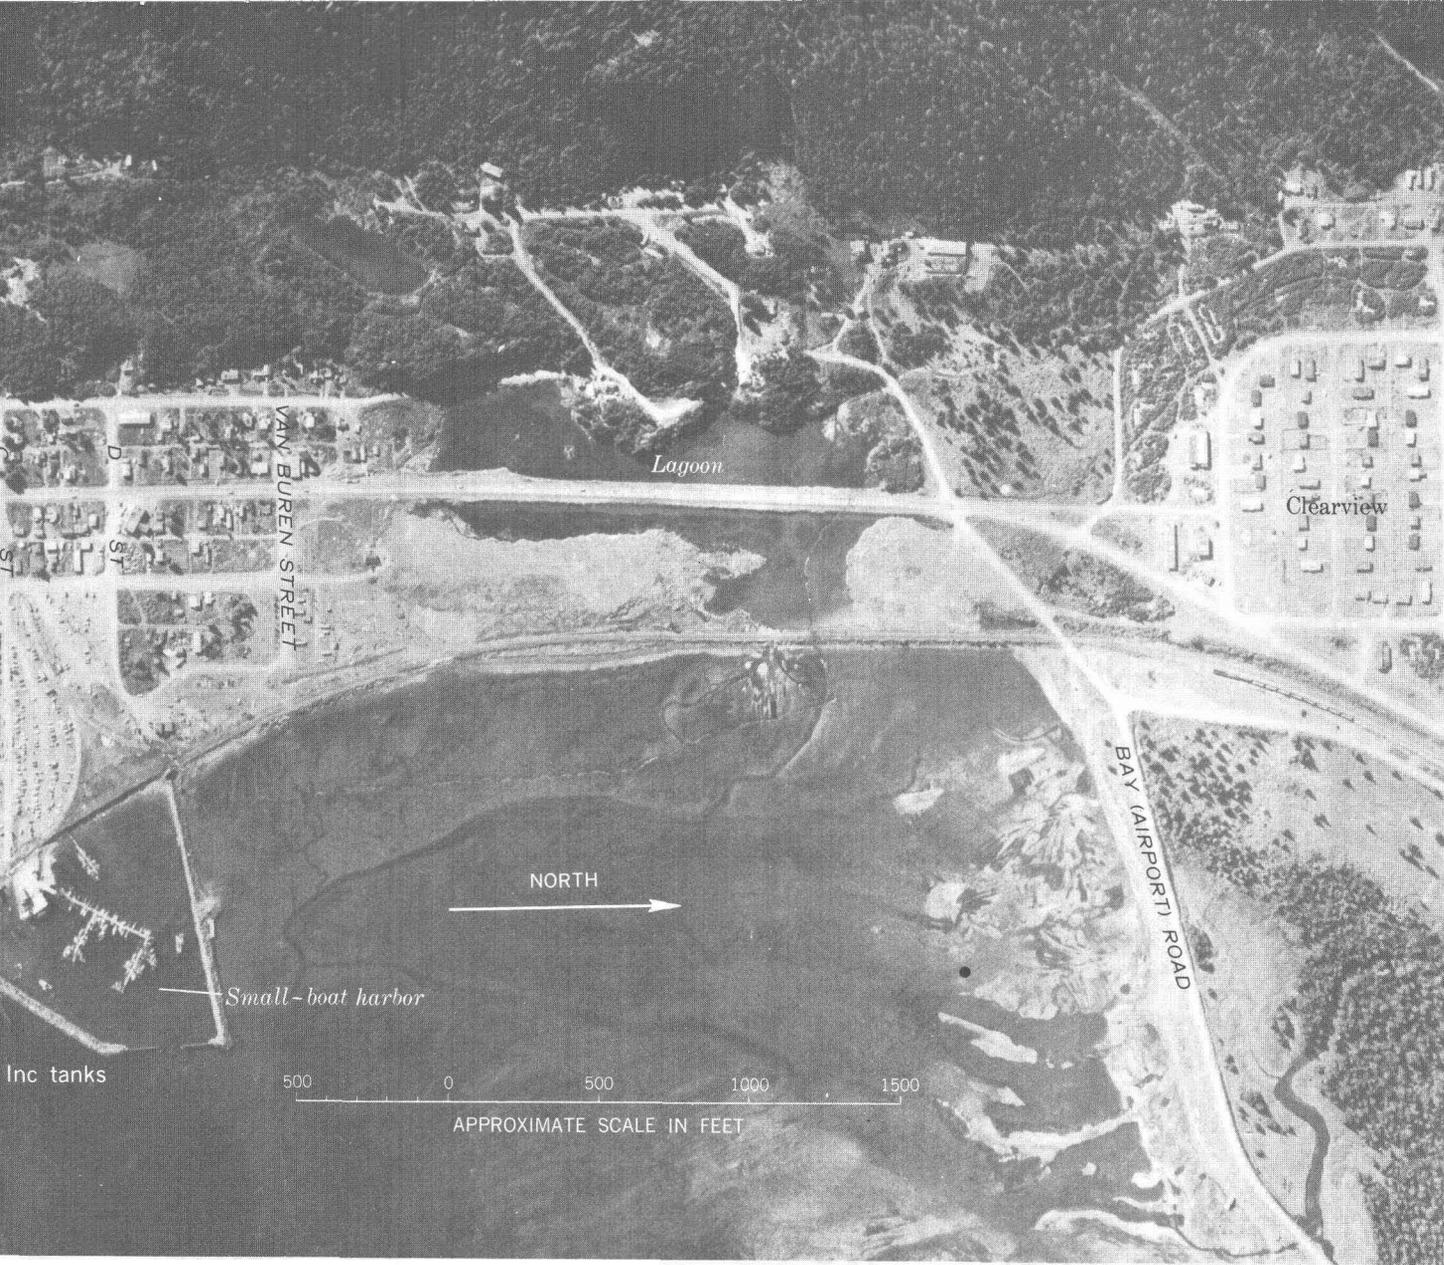
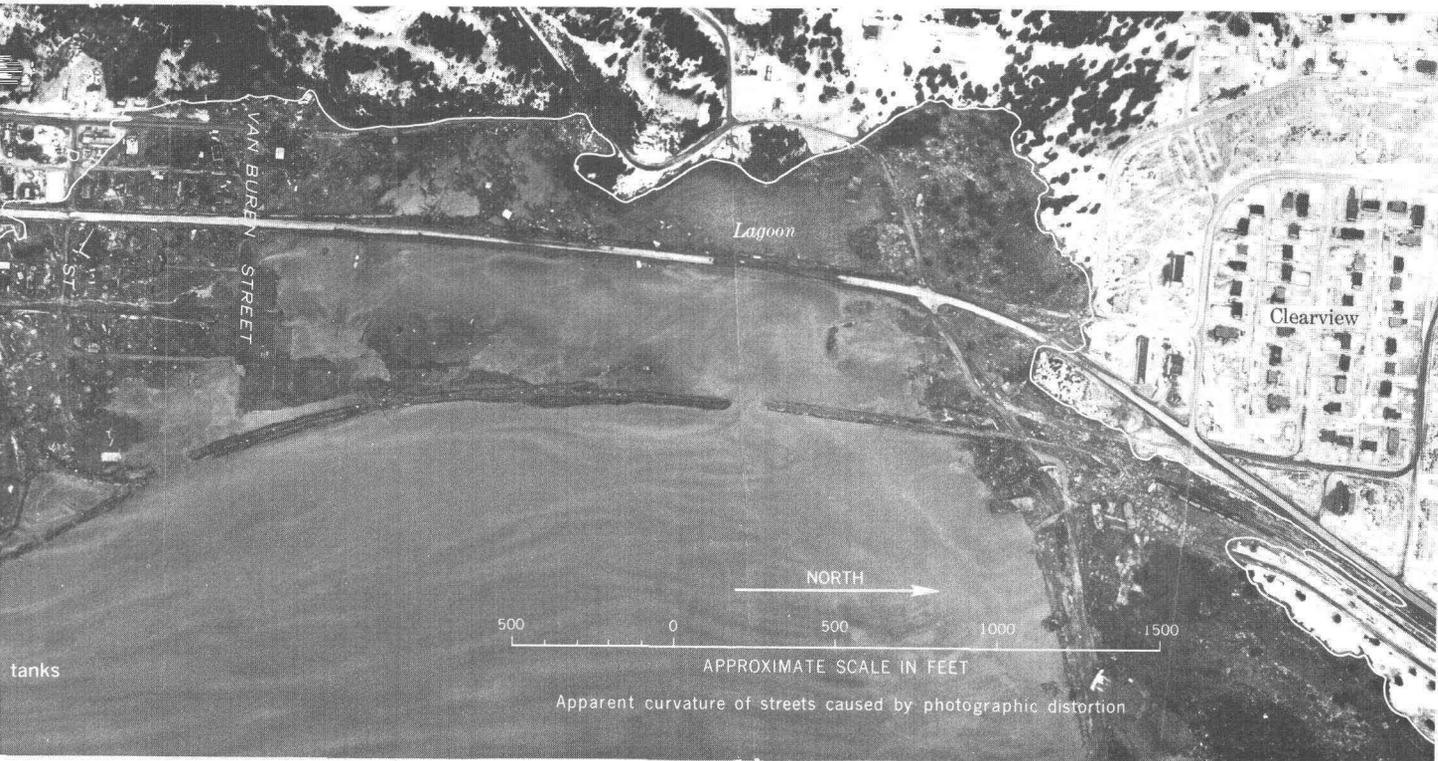
gressively as shaking continued, until a strip of harbor area 50–500 feet wide had disappeared into the bay (fig. 2, p. 6). Large fractures broke the ground surface behind the slide area and extended several hundred feet inland as shaking continued (figs. 3, 4, p. E8, E10). Some fractures near the Texaco tanks reportedly opened and closed repeatedly during the shaking; some were at least 20 feet deep. They filled quickly with water and, as the shaking continued, spewed muddy water at intervals. When the shaking ceased, fracturing had reached its maximum extent and the shoreline had receded to the position shown in figure 2 (bottom).

2. Seward before and after the earthquake. Top, before the earthquake of March 27, 1964. Bottom, 1 day after the earthquake.

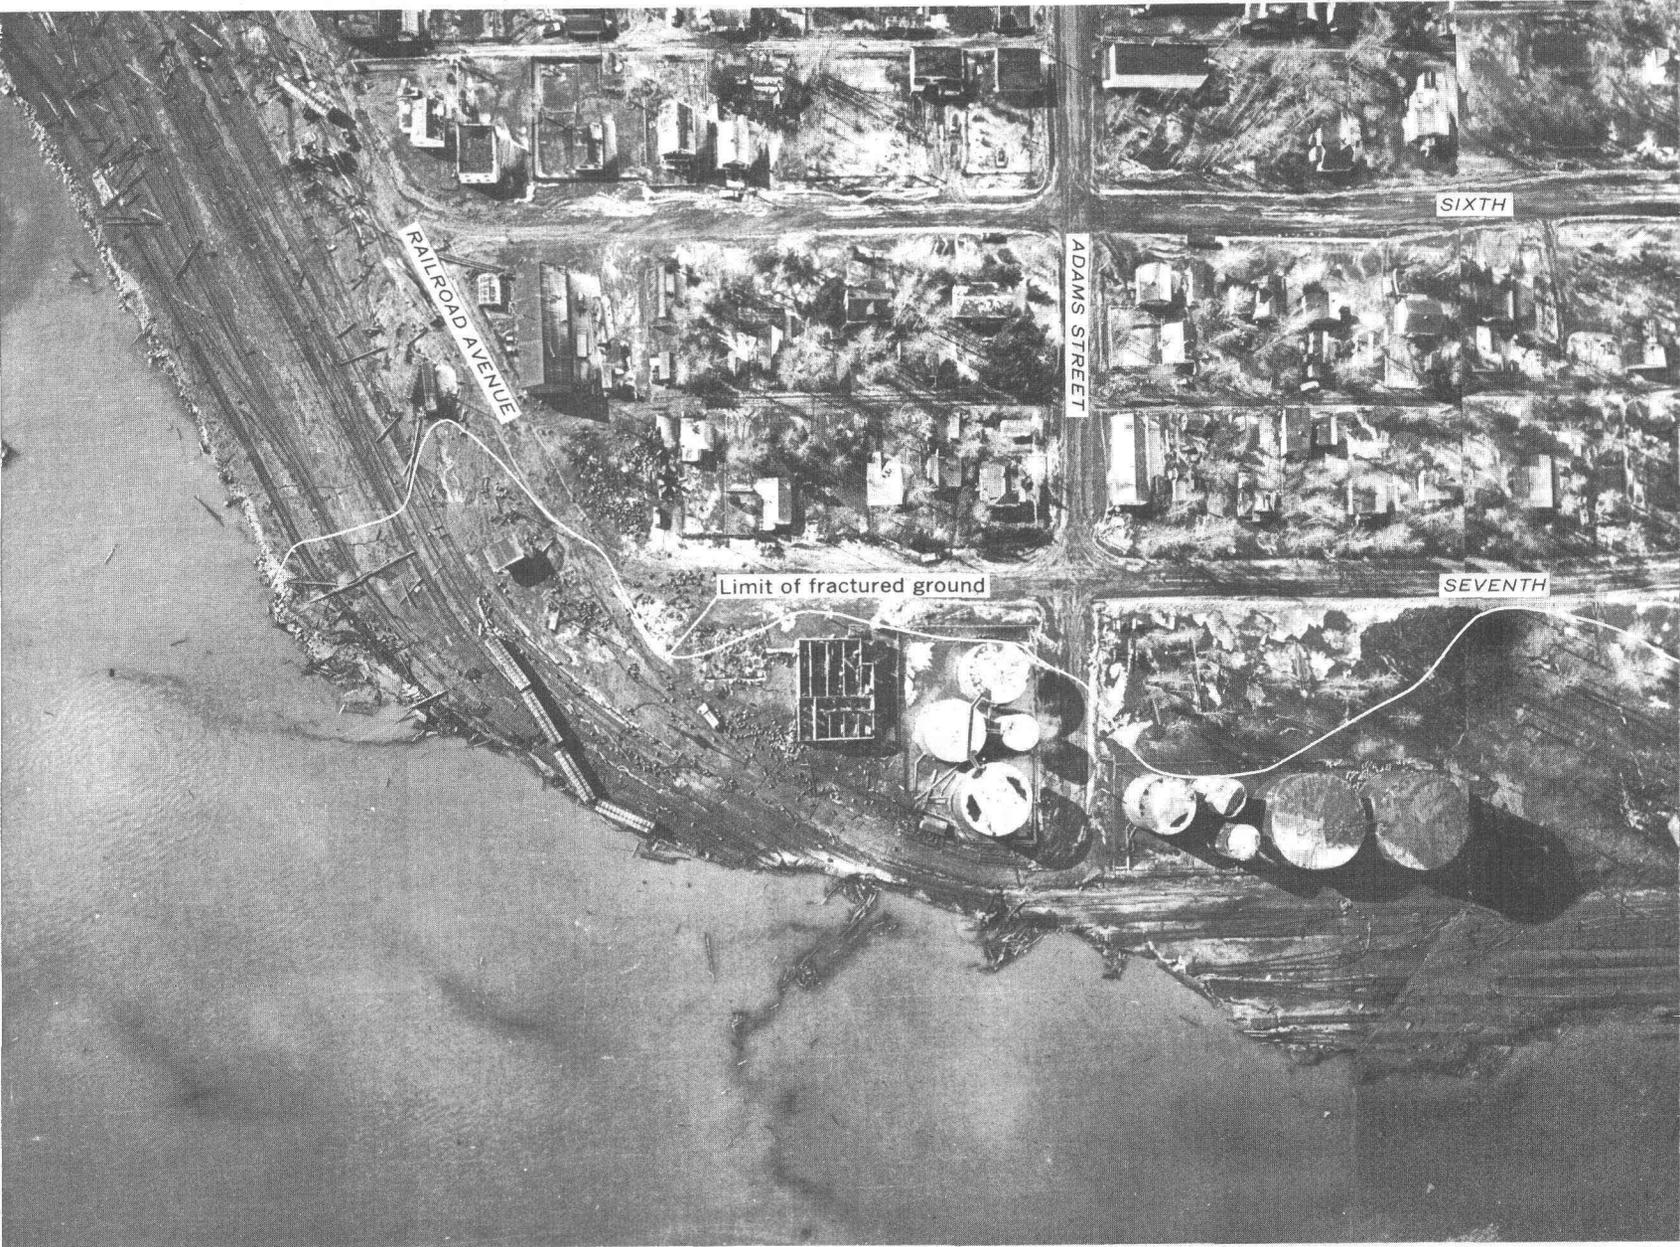
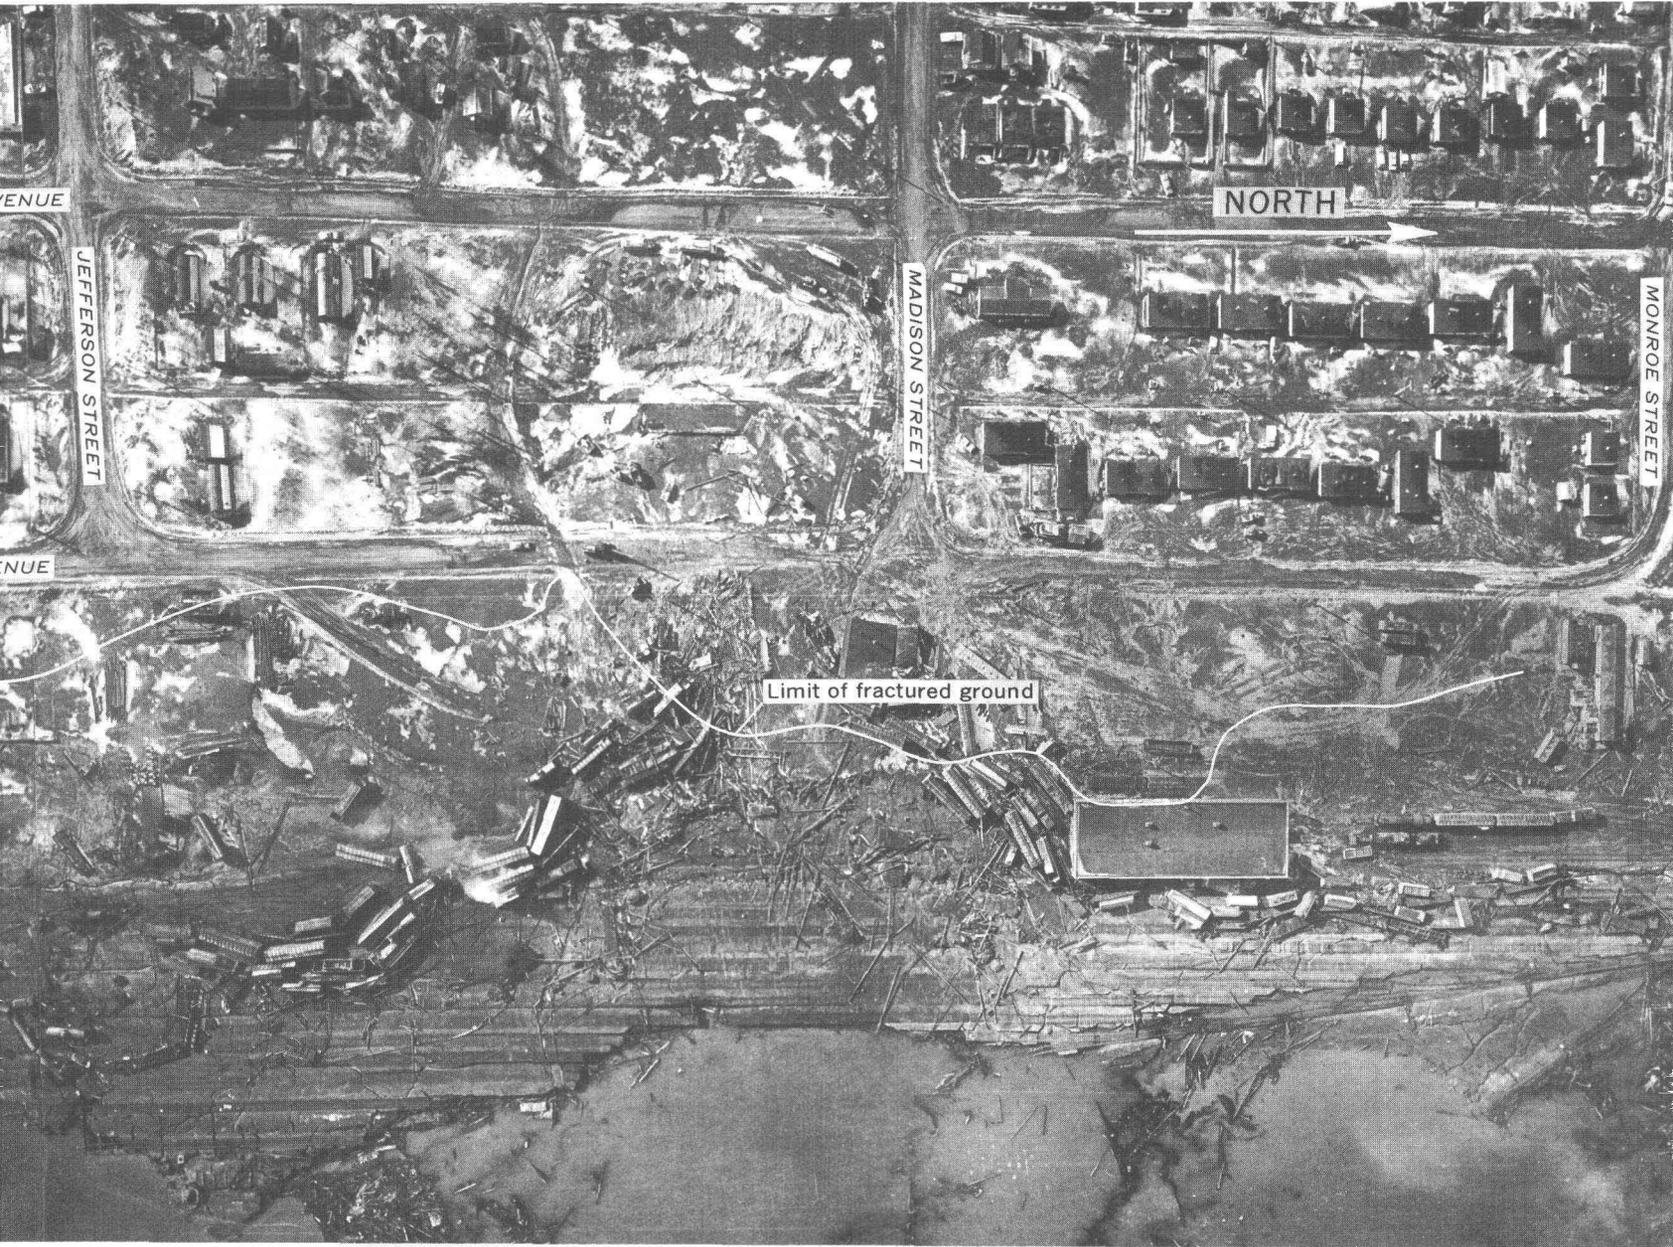
3. Aerial view of the southern part of the Seward waterfront showing extent of ground fracture and earthquake damage. Photographed by the U.S. Army Corps of Engineers.

Ground fracturing along the Seward waterfront (figs. 3, 4) is believed to be closely related to on-shore and offshore landsliding in that area. Horizontal translation and vertical displacement of the ground seaward, as sliding progressed, apparently was the dominant cause of fracturing.

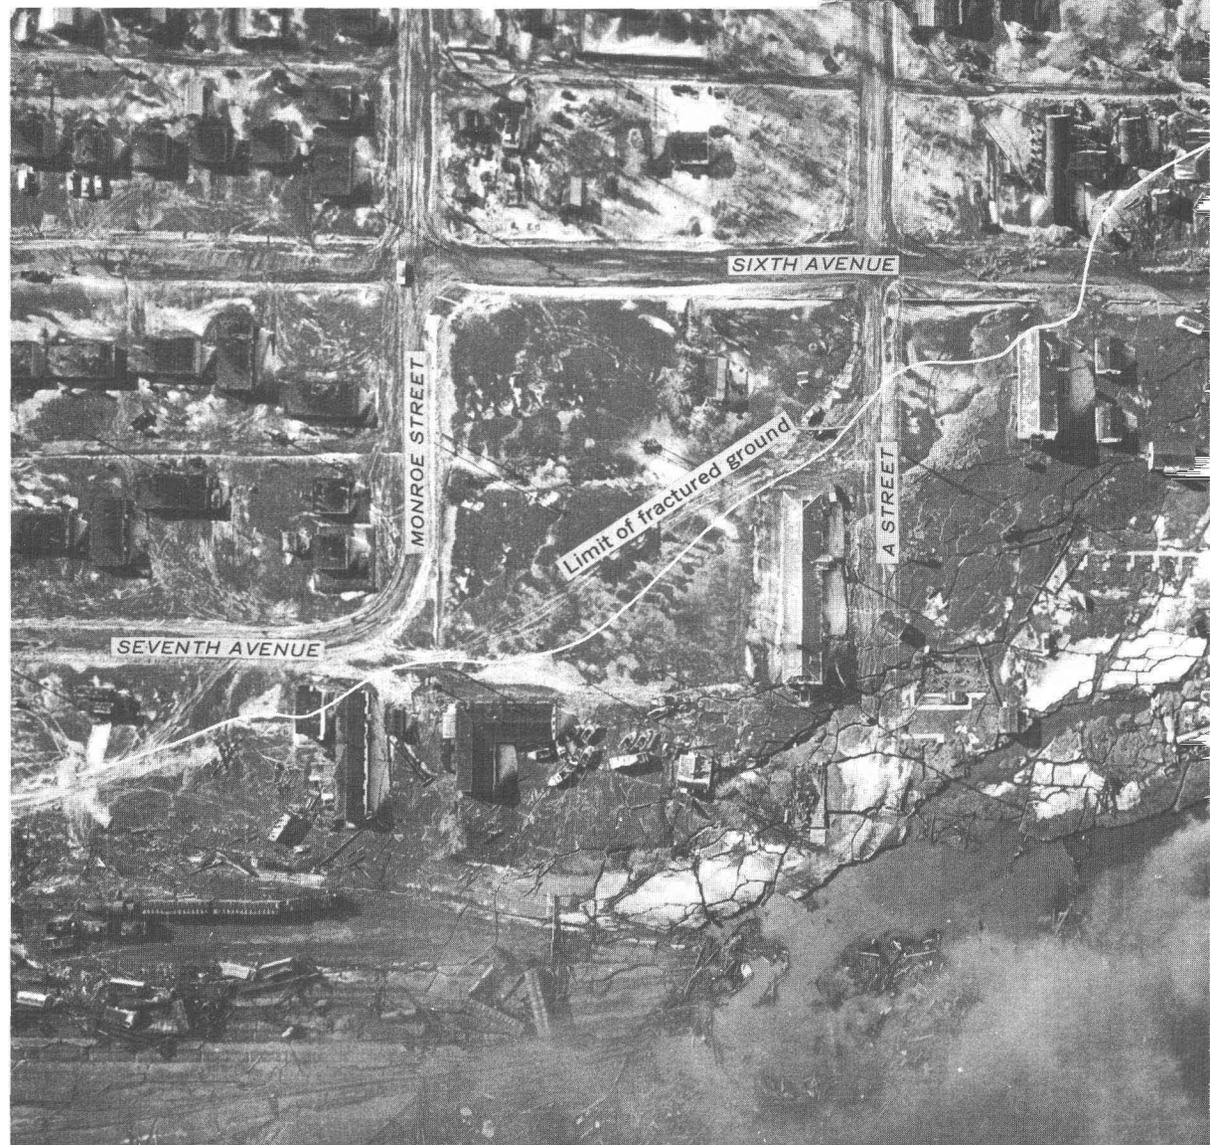
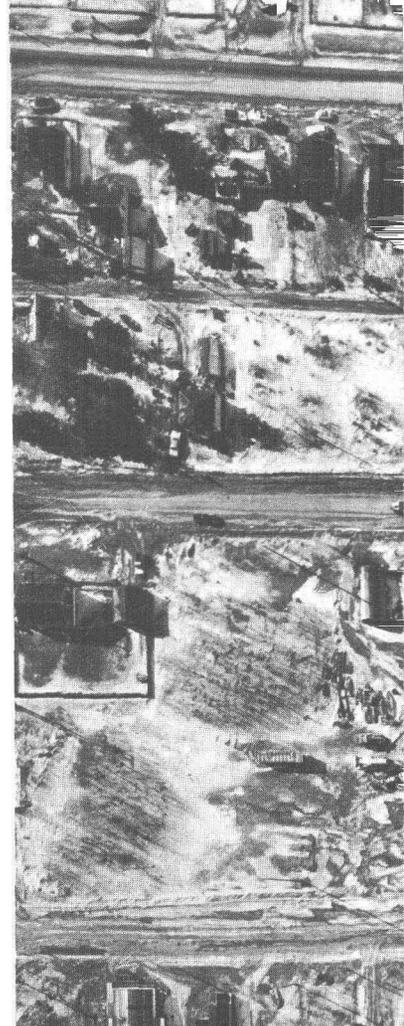
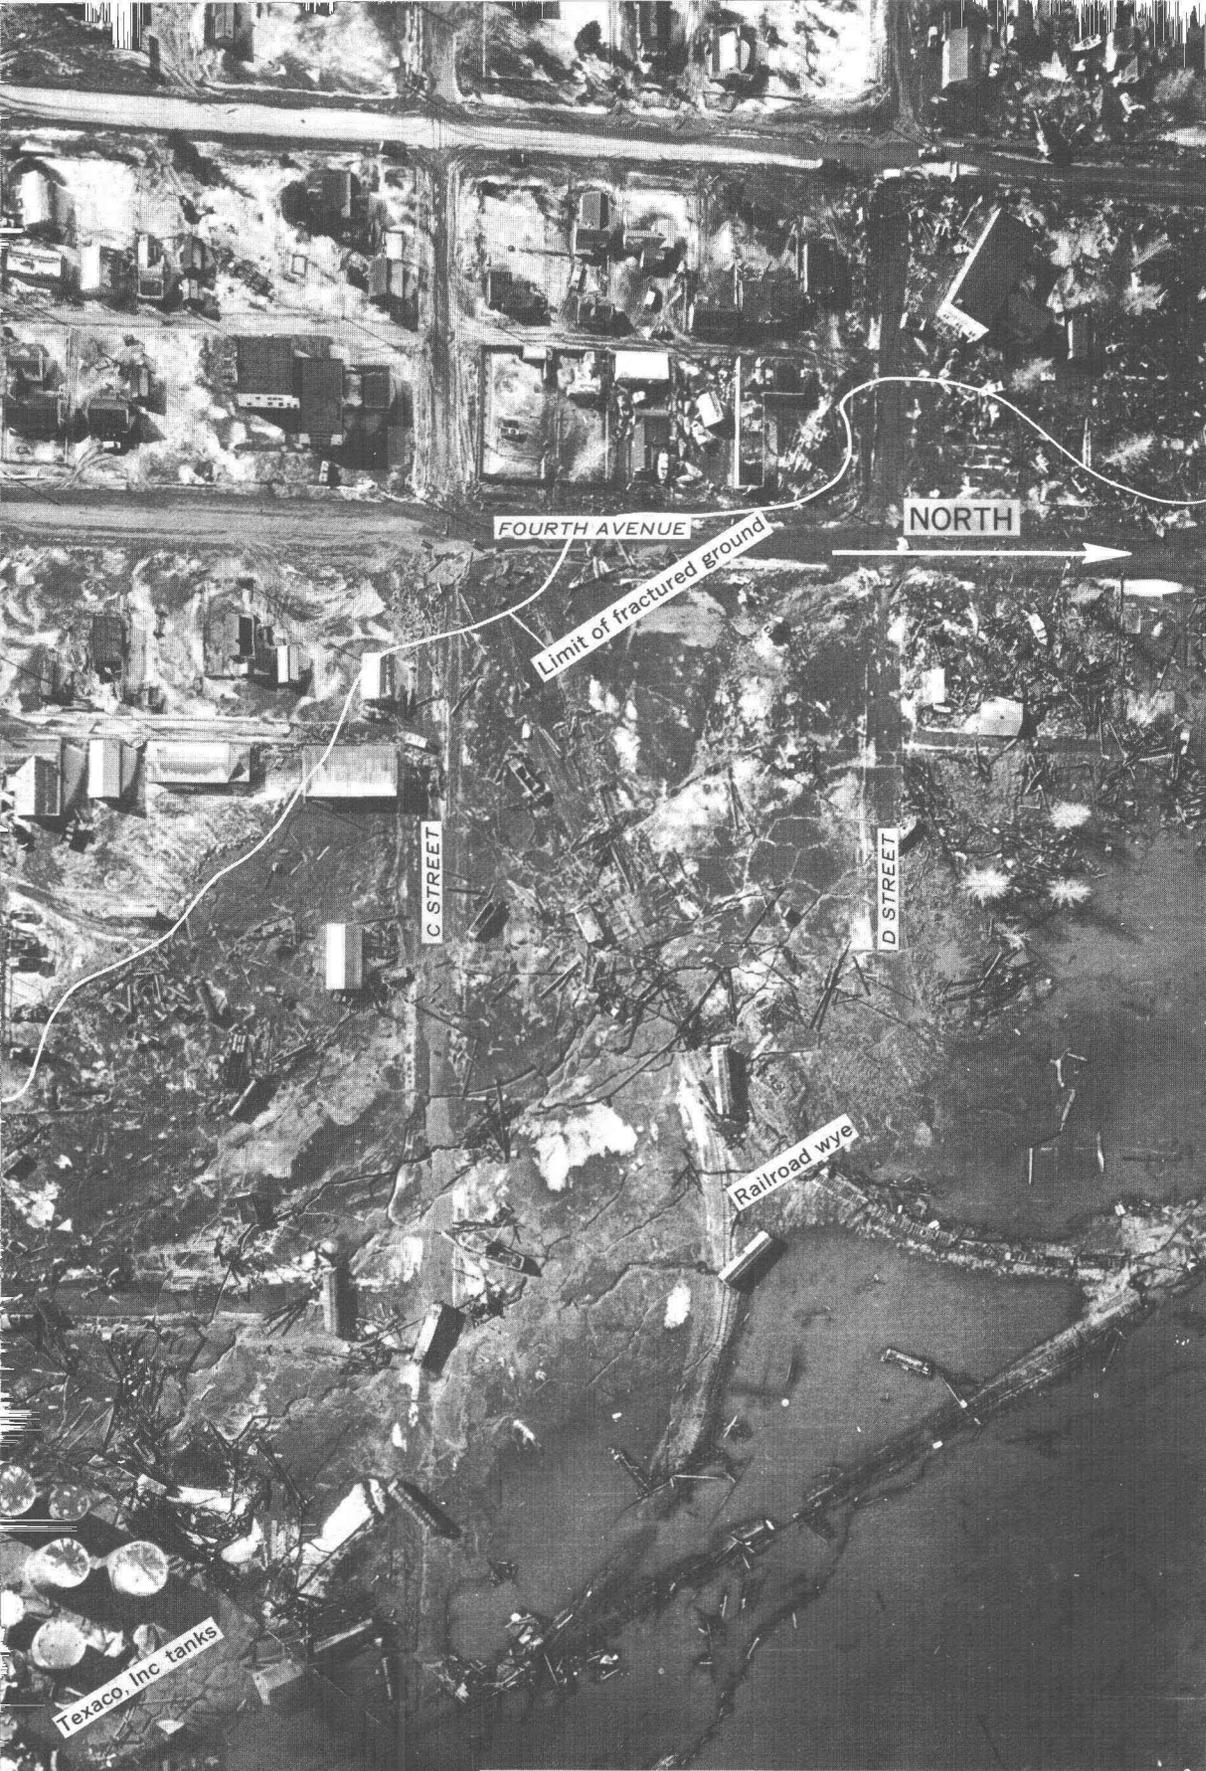
4. Aerial view of the northern part of the Seward waterfront showing extent of fractured ground and earthquake damage. Photograph by U.S. Army; mosaicked by U.S. Geological Survey. Index map (upper left) shows relation of figures 3 and 4.

The total amount of horizontal and vertical displacement in the area of fractured ground could not be determined accurately. It undoubtedly was greatest in the area of the Texaco tanks and became progressively less toward the Standard Oil Co. tanks. Two weeks after the earthquake, the fractures in the area of the Texaco tanks were commonly 0.5–2 feet wide, and a few were as wide as 4 feet. In general, the dominant fracture systems were roughly parallel to the shore. Intersecting transverse fracturing commonly produced a roughly polygonal pattern (fig. 4). In most places, the decreasing width of the fractures

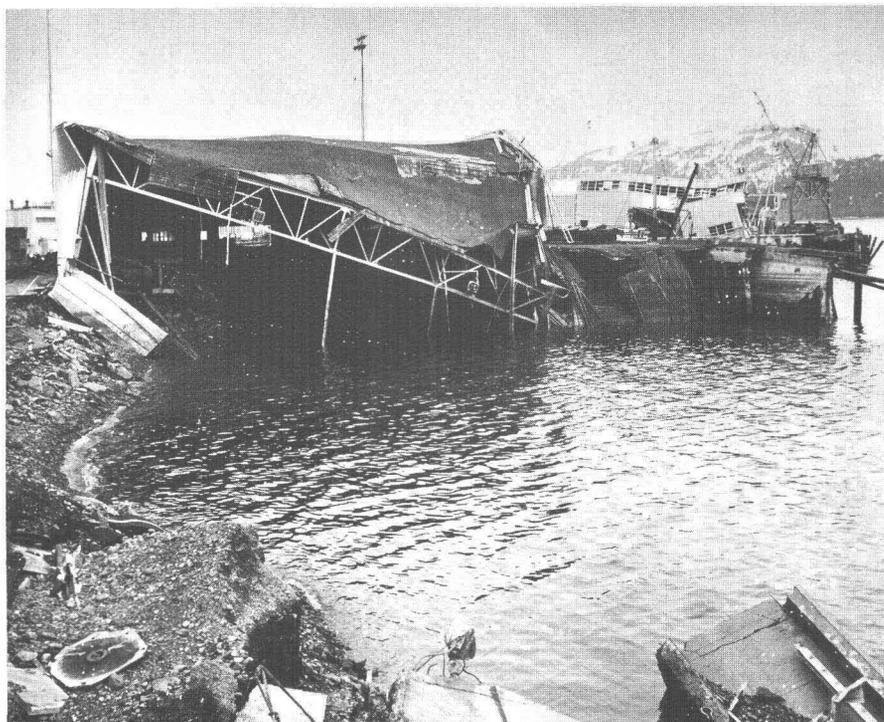
The water surged back from the mound toward the southwest part of the Seward waterfront also. A large swell broke over The Alaska Railroad dock area (fig. 5, p. 12), lifting flat cars off the tracks and picking up several vehicles. Its crestline at Railroad Avenue was nearly as high as that of any later wave. As this wave hit the shoreline at the Standard Oil Co. tanks, burning oil was carried back onto shore. An 80-car freight train on the tracks between the Standard and Texaco tanks was just ready to start moving north. Its last 40 cars were filled oil tankers and as the fire swept onto shore, the tankers caught fire in a chain reaction of exploding cars down the track toward the Texaco yard. Reportedly several minutes elapsed before the Texaco tanks caught fire, even though oil from ruptured

5.—Damage caused by water waves to old Alaska Railroad dock and facilities. Photograph by U.S. Army.

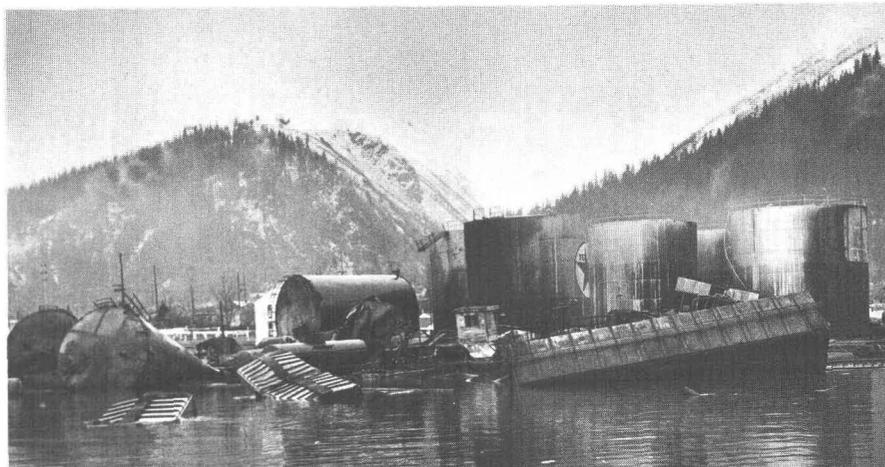
6.—Earthquake damage along Seward waterfront in area of Texaco, Inc., tanks. Photograph by U.S. Army.

Harbor facilities in the waterfront area between the Standard Oil and Texaco tanks were almost completely destroyed, and other parts of the waterfront were heavily damaged (fig. 6). The Standard Oil dock, 13 oil tanks, the Army dock, and the San Juan dock, on which a cannery was located, disappeared completely into the bay. Several Texaco tanks were destroyed by fire.

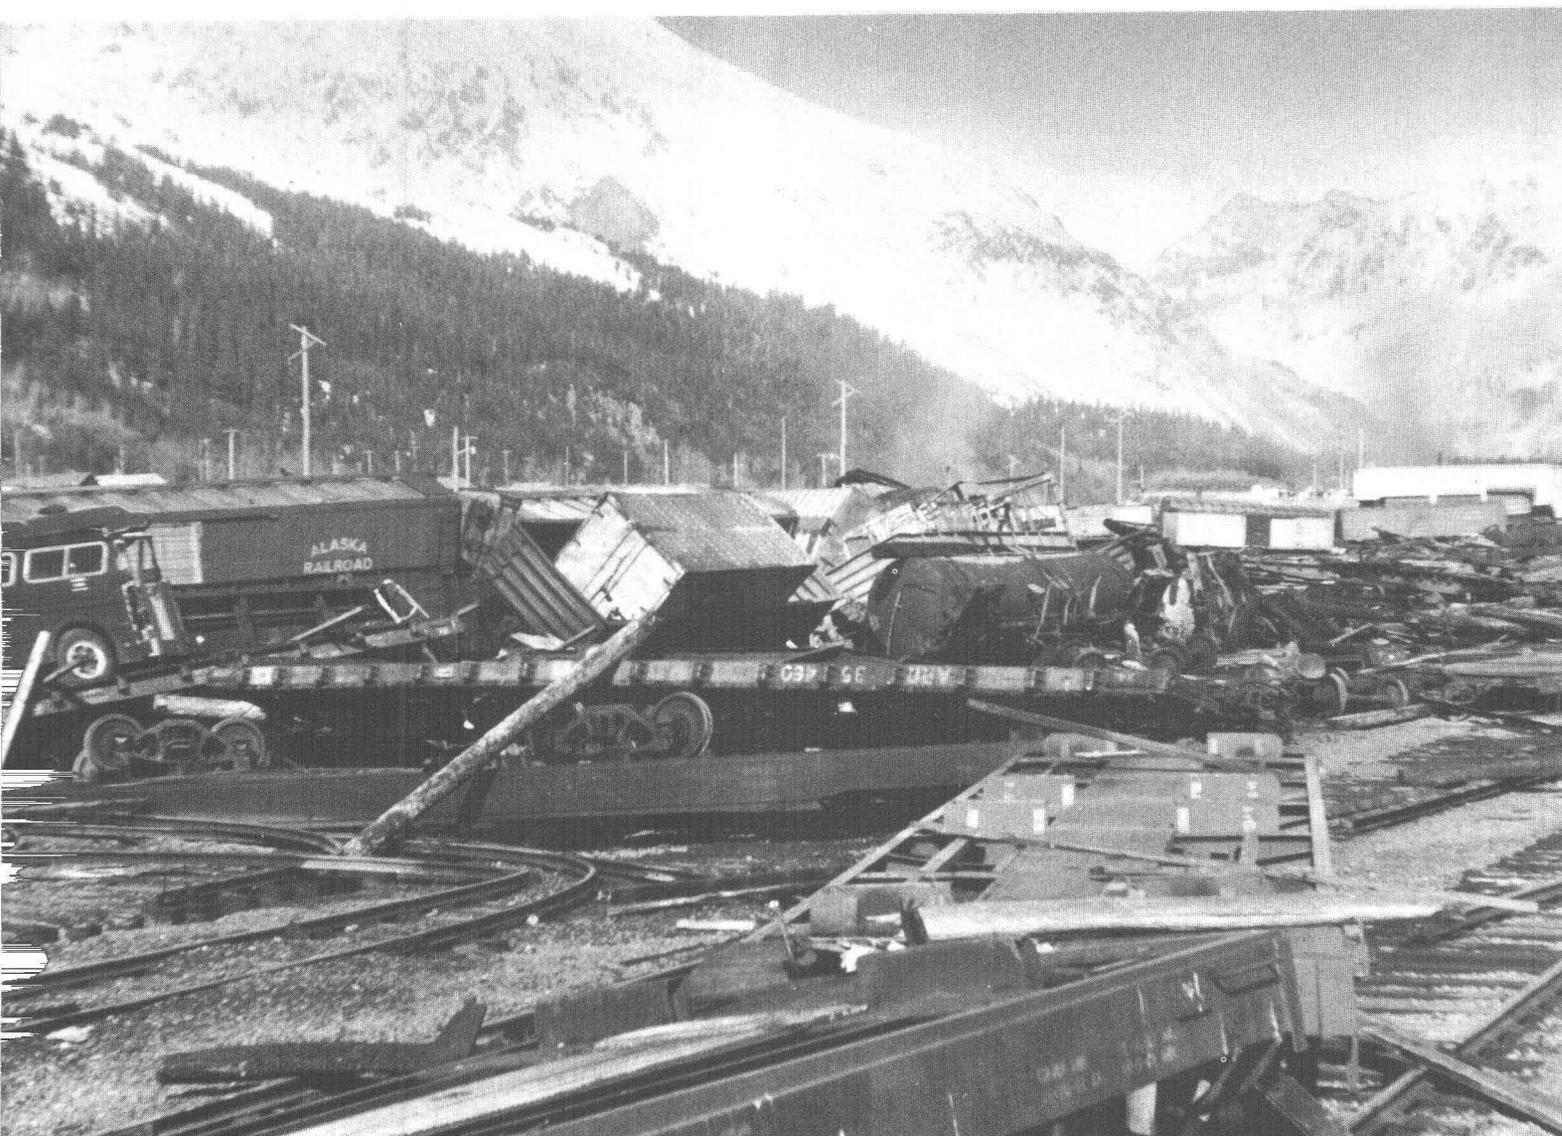
7.—Wave damage in the area of railroad marshalling yards.

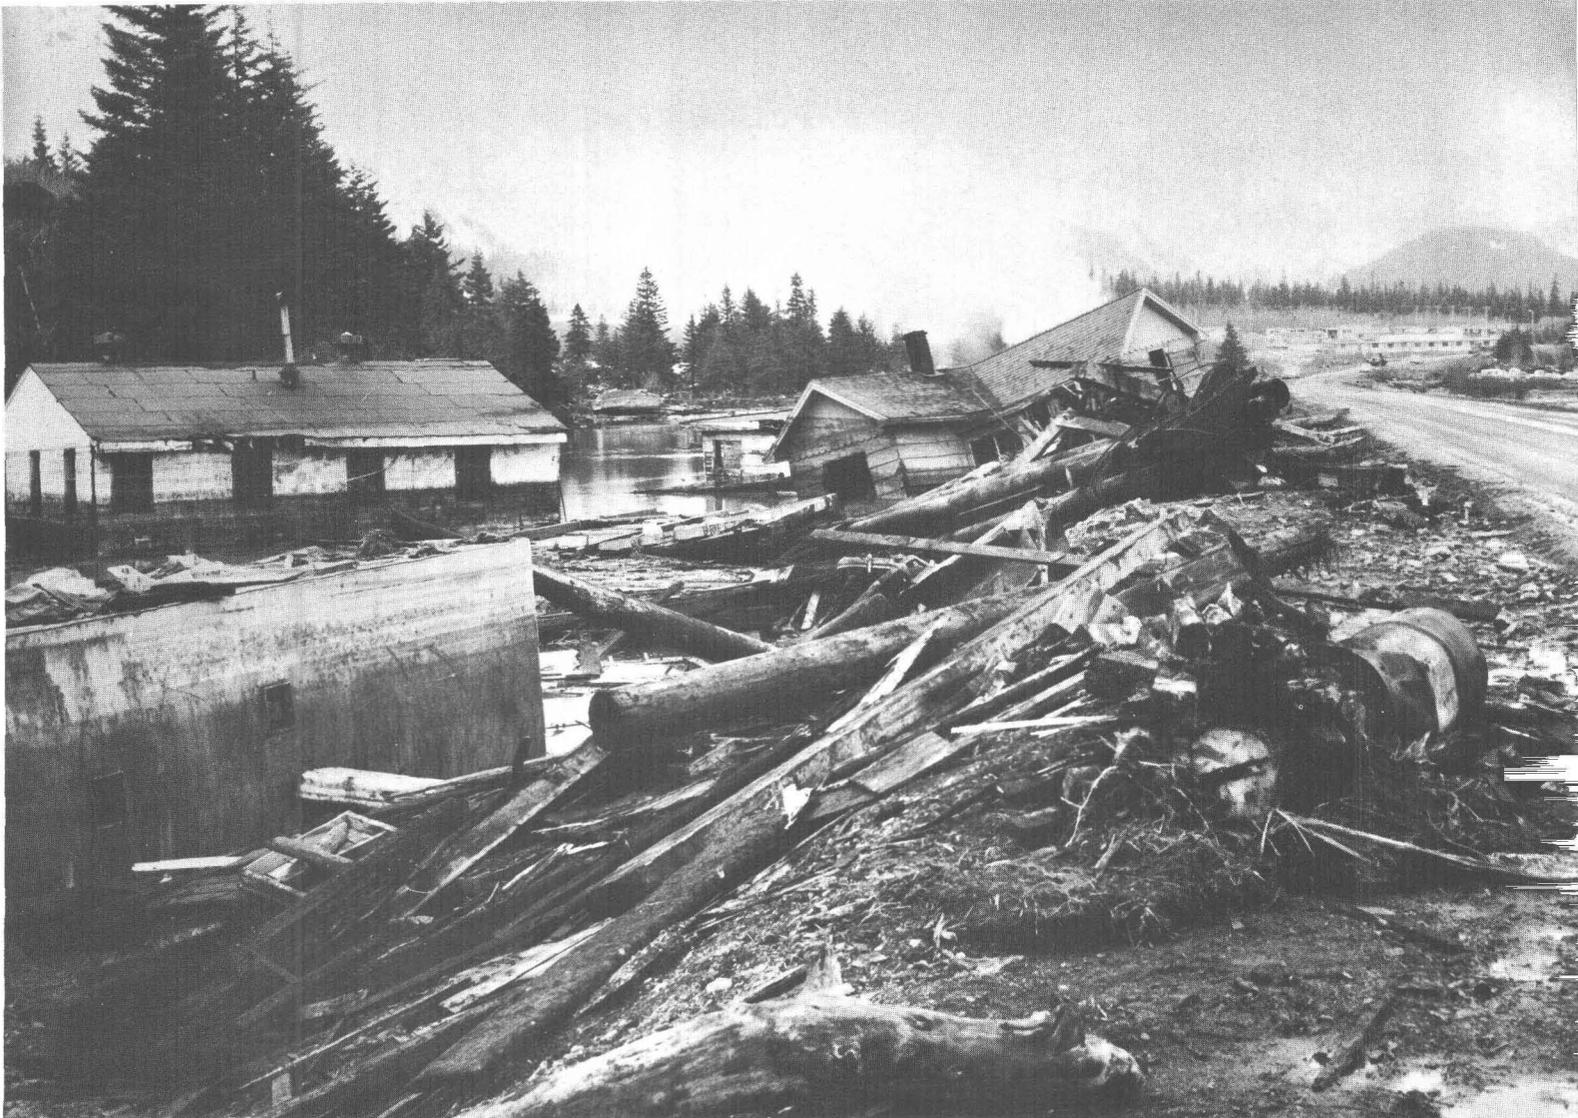
Eighty-six houses were totally destroyed and 269 were heavily damaged (James W. Harrison, Mayor, oral commun., 1964); water waves caused nearly all the destruction. Homes in the area between the Texaco tanks and the lagoon were swept completely off their foundations, and most were washed into the lagoon (fig. 8, p. 15).

8.—Houses and other debris carried by waves into the lagoon area at the north end of Seward. Main road leading north out of town shown in right-hand part of photograph. Photograph by U.S. Army.
