THE ALASKA EARTHQUAKE, MARCH 27, 1964:
EFFECTS ON COMMUNITIES

Effects of the Earthquake Of March 27, 1964, At Seward, Alaska

BY RICHARD W. LEMKE

GEOLOGICAL SURVEY PROFESSIONAL PAPER 542-E

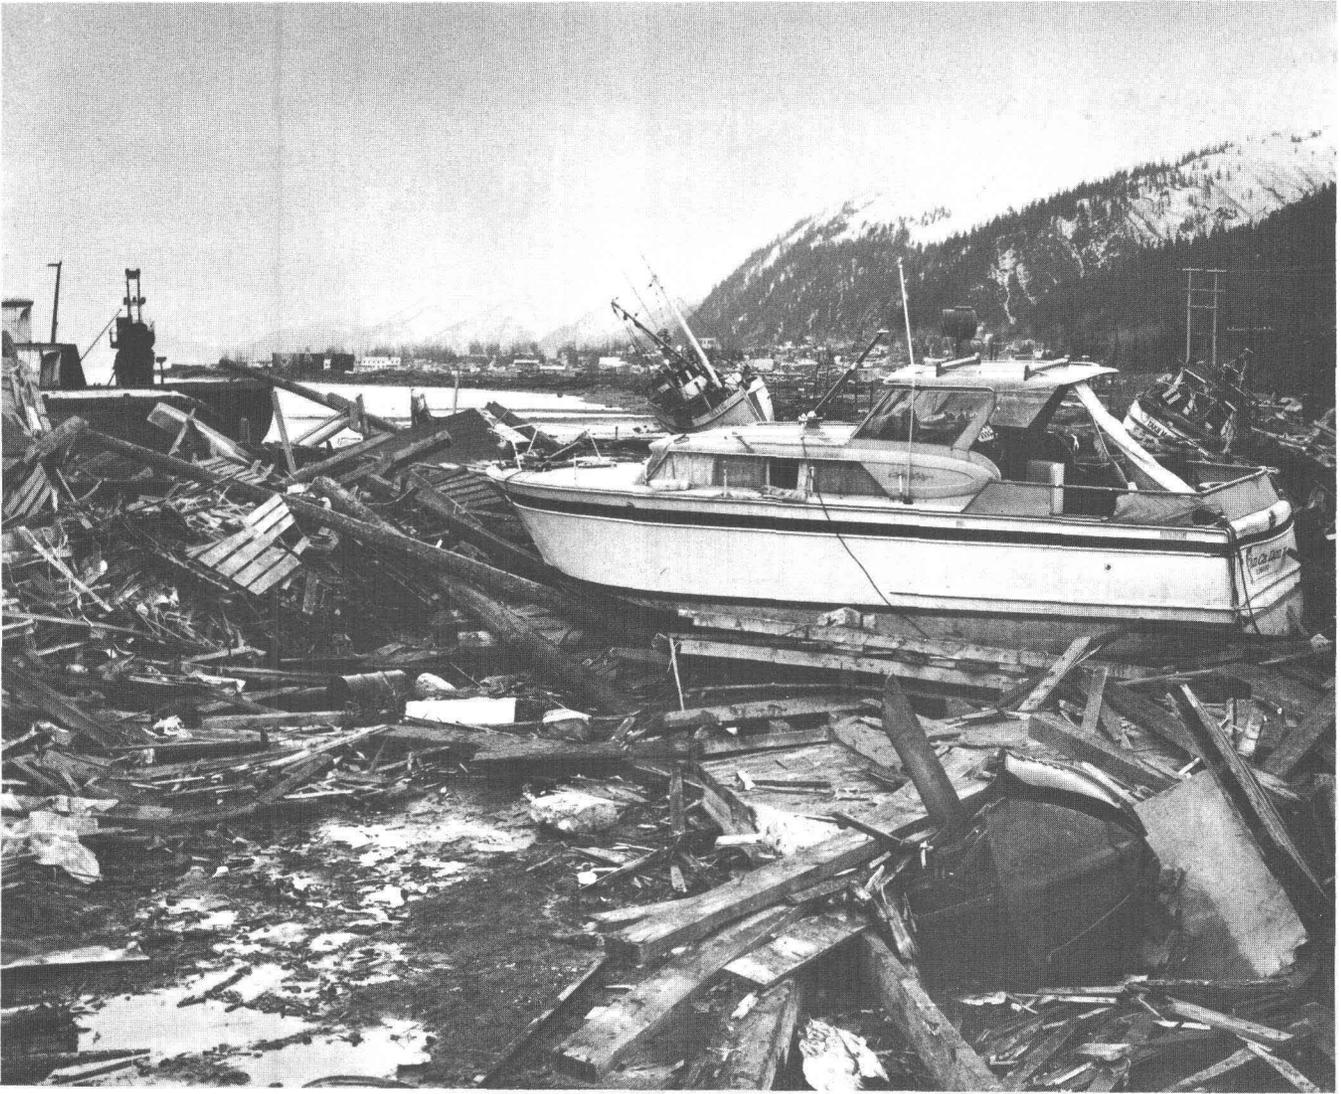
10.—Wrecked boats and other debris beached by waves at the northwest corner of Resurrection Bay. Photograph by U.S. Army.

One of the first large programs started by the Corps of Engineers after the earthquake was the massive cleanup job along the Seward waterfront, at the head of the bay (fig. 10), and in the bay itself. Onshore, what was salvageable was

saved; the rest of the debris was burned or otherwise disposed of. In the bay, hazards to navigation, such as boxcars, tankers, oil tanks, piling, rails, and remains of buildings, were removed to a minimum depth of 40 feet; this work was done in two stages: (1) cleanup of the lagoon area and the land area at the head of the bay and (2) cleanup of the railroad area and the bay. Not long after the initial cleanup was completed, reconstruction of public facilities was undertaken by the Corps of Engineers (George and Lyle, 1966).

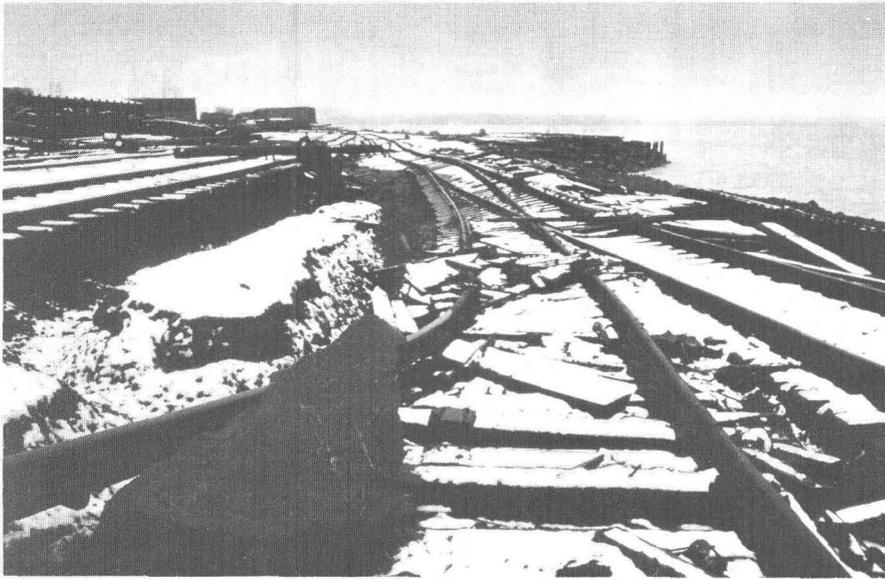
Along the Seward waterfront, a strip of land approximately 4,000 feet long and 50-500 feet wide slid into the bay concomitantly with offshore submarine landsliding. Behind the scarp marking this large submarine slide, the ground was intricately fractured for distances of 100-800 feet (figs. 3, 4). Near the northern end of the landslide scarp, some of the fractured ground subsided several feet and rotated as landslide slump blocks (fig. 12).

12.—Incipient landsliding along northern part of Seward waterfront. Fractured ground has subsided and rotated as landslide slump blocks.

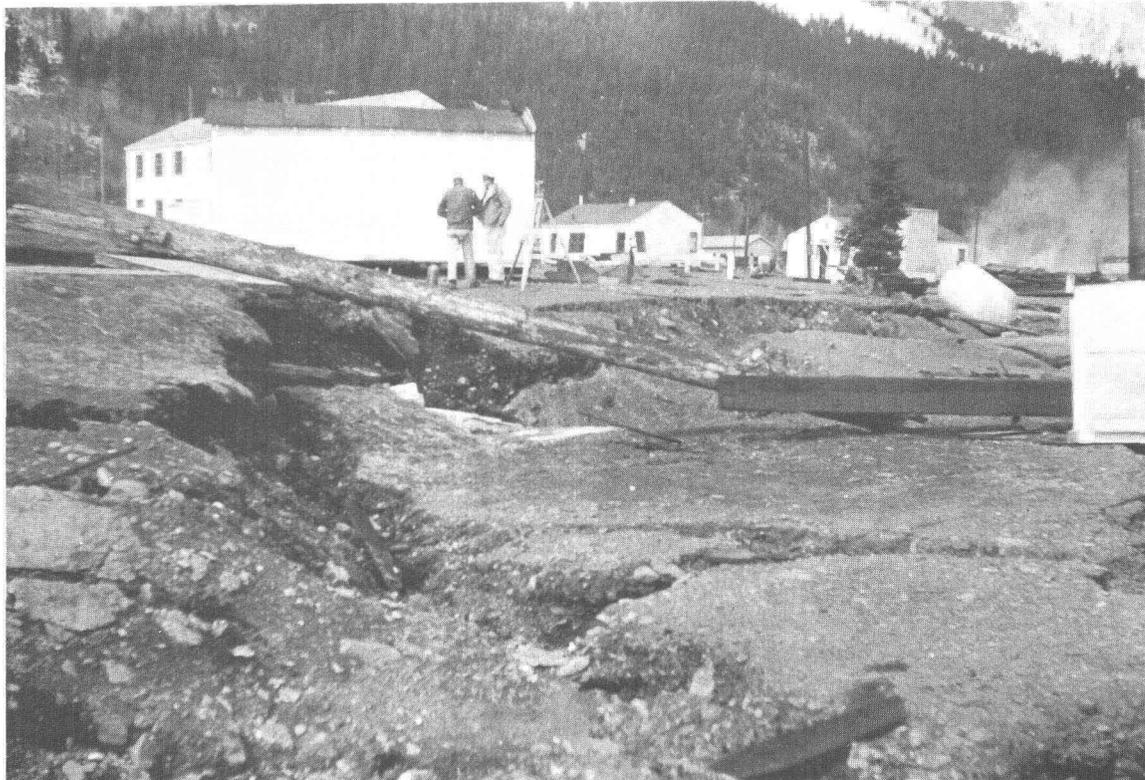
13.—Ground fracture near east end of A Street, about 100 feet from present shoreline, showing vertical displacement of about 4 feet. Downthrown side is toward Resurrection Bay.

away from the shore reflected a decrease of lateral spread of the ground in that direction. Where the fractures were offset vertically, the downthrown side was generally toward the bay (fig. 13). Vertical offsets were confined largely to the near-shore area and to the fractures paralleling the shore. Along the shore at the eastern extension of Monroe Street, vertical offsets of as much as 5 feet marked margins of blocks tilted with their surfaces sloping landward. In most places, however, there was no evidence of rotation of the ground between fractures. Vertical offset decreased southward so that in the vicinity of the Standard Oil tanks little or no vertical displacement was discernible. The sharpness and linearity of fracturing probably can be attributed to the fact that the ground was frozen to a depth of about 0.5 foot. Such a

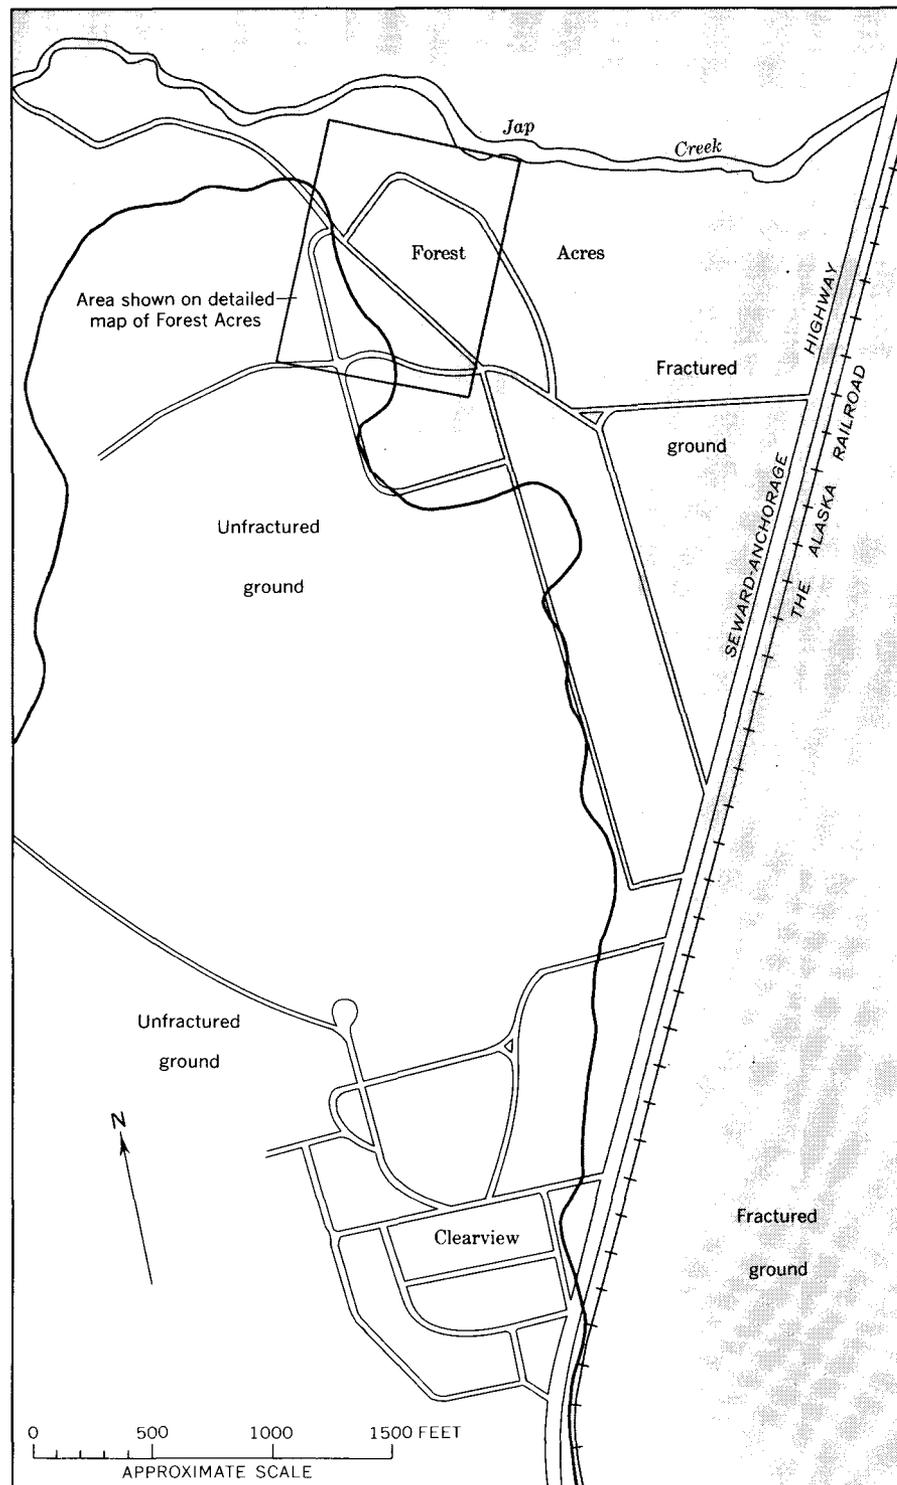
14.—Map of general area of Forest Acres and Clearview subdivisions of Seward showing extent of ground fractured as a result of the earthquake of March 27, 1964.

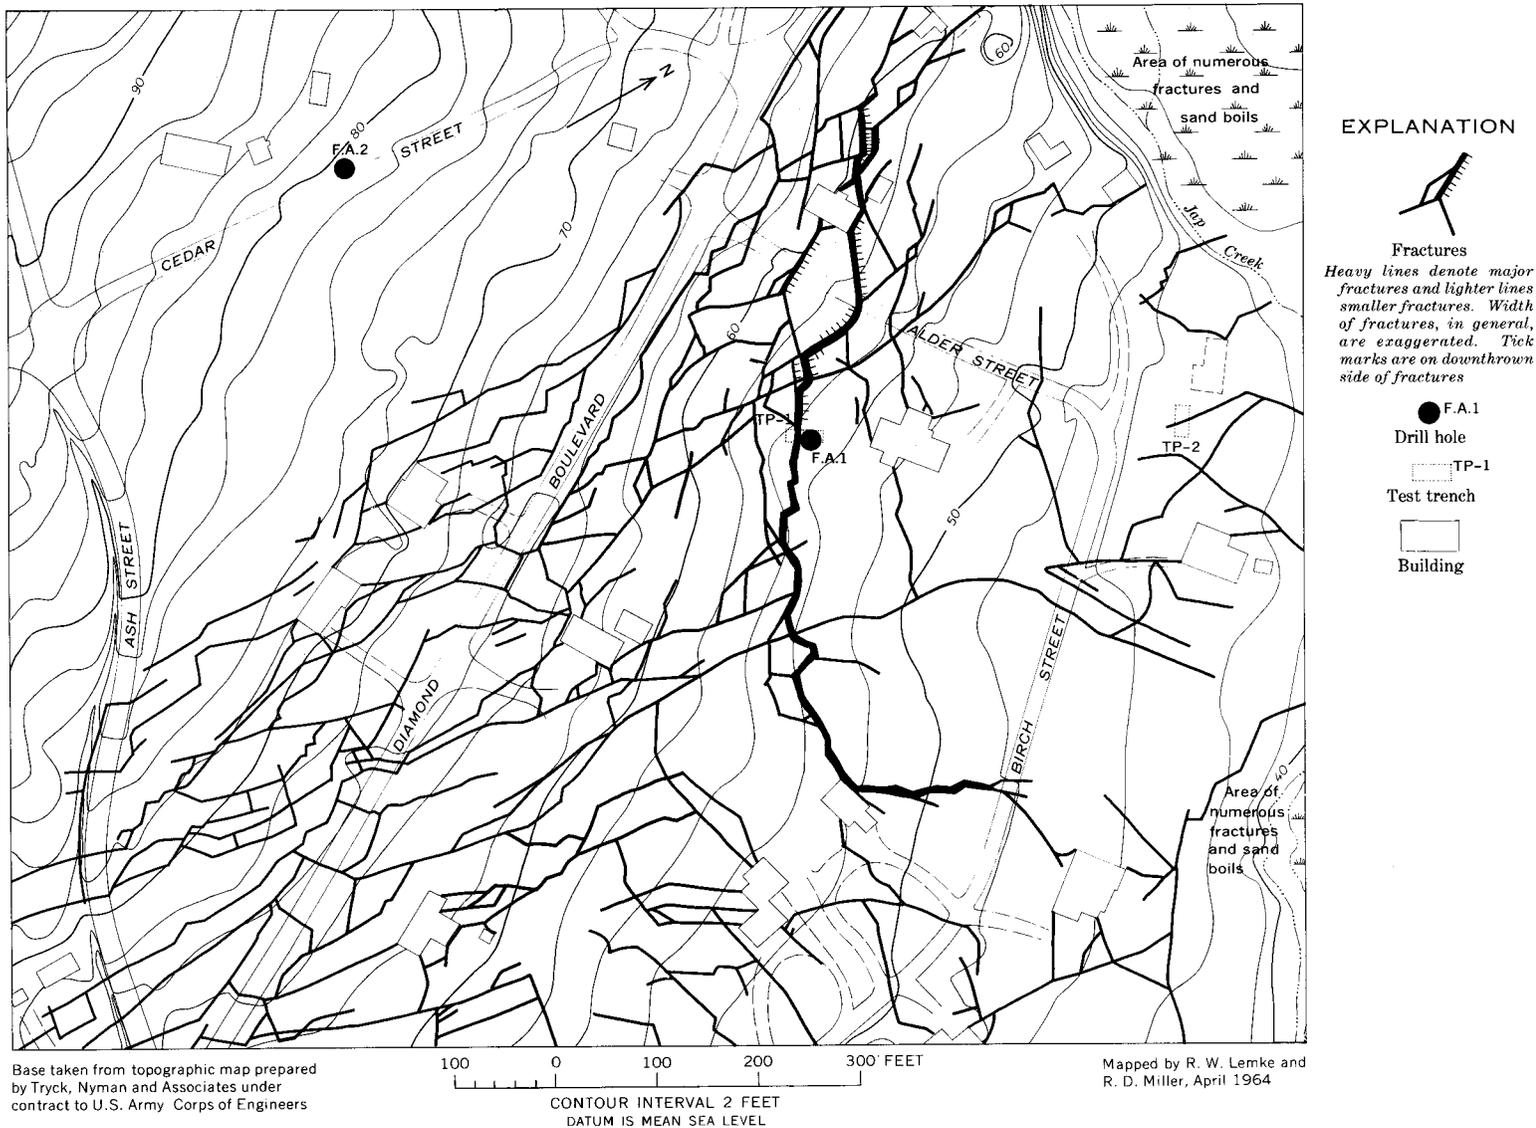
15.—Map of the Forest Acres subdivision showing fractures induced by the earthquake of March 27, 1964.

although in both places the major fracture system (heavy line on fig. 15) and many other long linear fractures roughly parallel the contours. In general, the fracture-bounded areas in Forest Acres are more elongate in plan. Many fractures die out along their extensions (fig. 16). Several fractures intersect at right angles to each other, and otherwise remarkably linear fractures commonly make right-angle turns. Only a few are arcuate in plan. Many fractures

Along the main fracture system shown on figure 15, the fractures commonly were 2–3 feet wide at the surface at the time of mapping

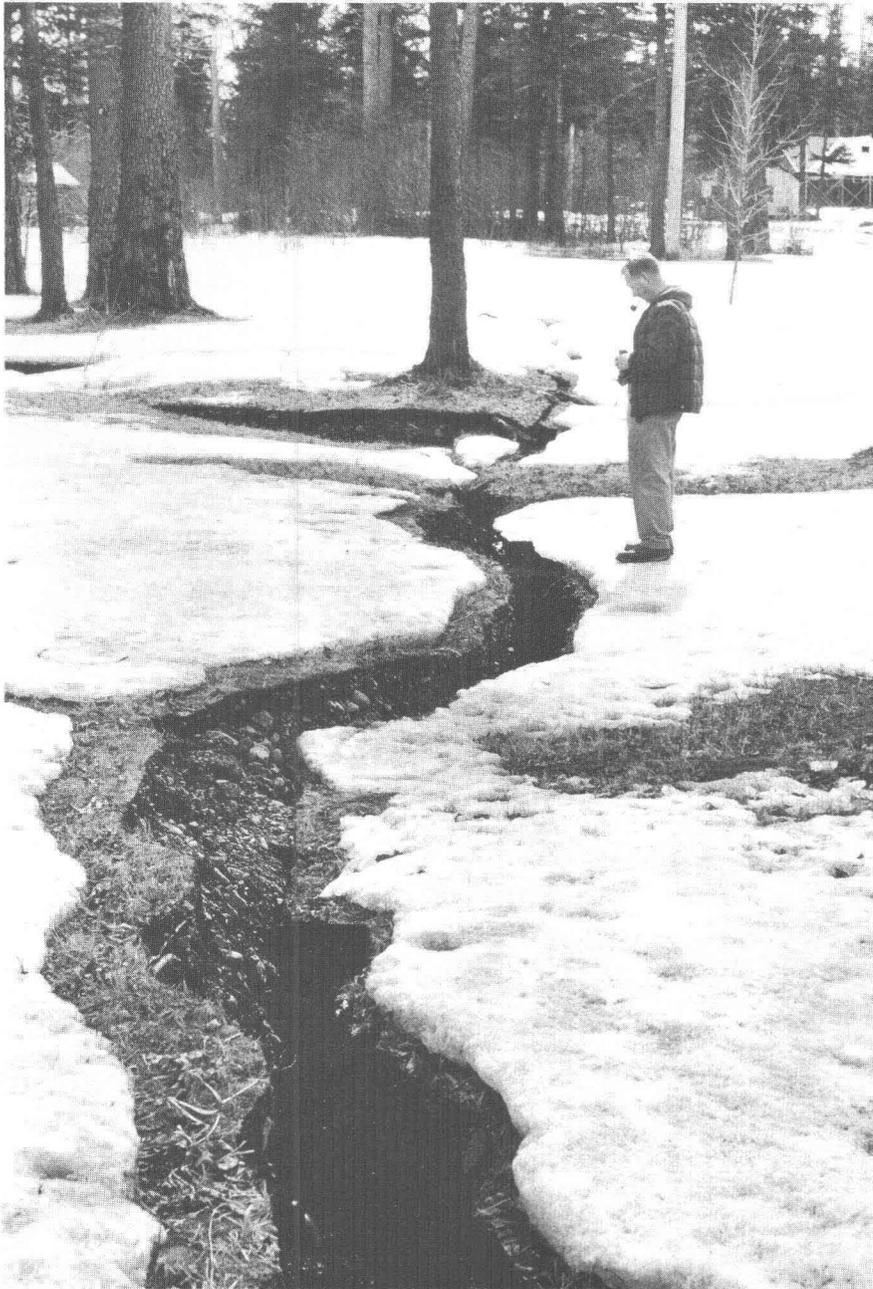
16.—Ground fracture in Forest Acres area. Fracture is about 2 feet wide in the foreground. Photograph by R. D. Miller, April 1964.

depth observed was 11 feet. The widths of the fractures in general decrease upslope toward Diamond Boulevard from the main fracture system. Widths of 3–4 inches were common, and many fractures were only hairline cracks that broke the hard-packed snow, which covered much of the area to depths of 1–3 feet. West (upslope) from Dia-

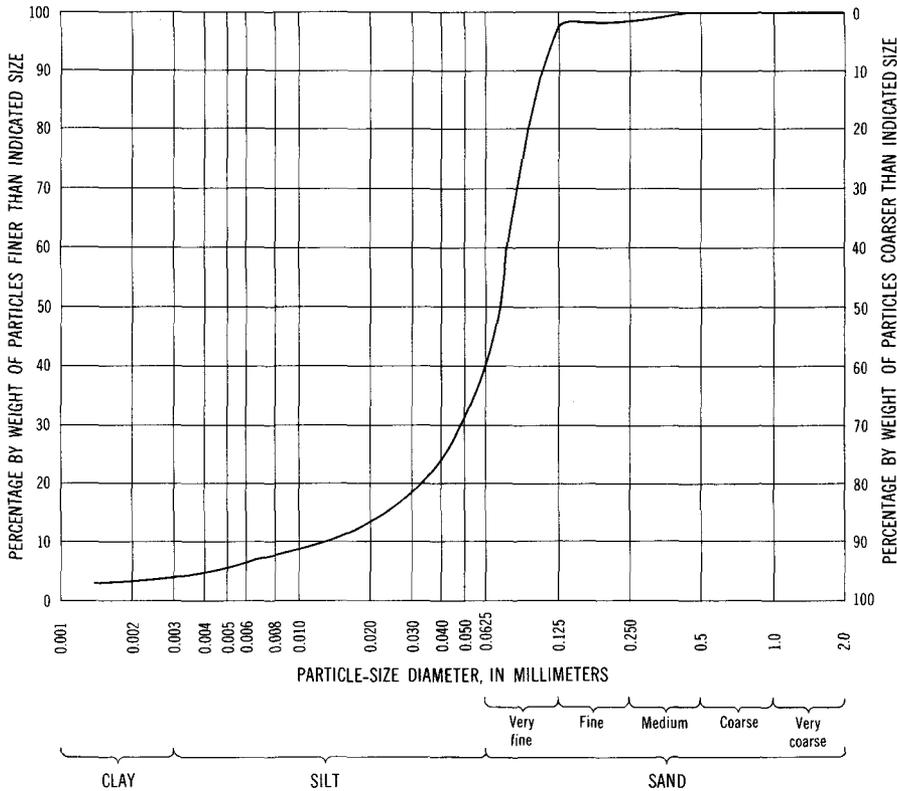
The ejected material was everywhere remarkably uniform in size and consisted of a dark-gray, very fine sand (0.0625–0.125 mm),

17.—Grain-size analysis of material from a sand boil, Forest Acres area. Analyst George S. Erickson; sample 4-346.

lesser quantities of silt, and minor clay. Figure 17 shows a grain-size analysis of a typical sample taken near trench TP-2.
