THE ALASKA EARTHQUAKE, MARCH 27, 1964:
REGIONAL EFFECTS

Surface Faults On Montague Island Associated with the 1964 Alaska Earthquake

By GEORGE PLAFKER

GEOLOGICAL SURVEY PROFESSIONAL PAPER 543-G

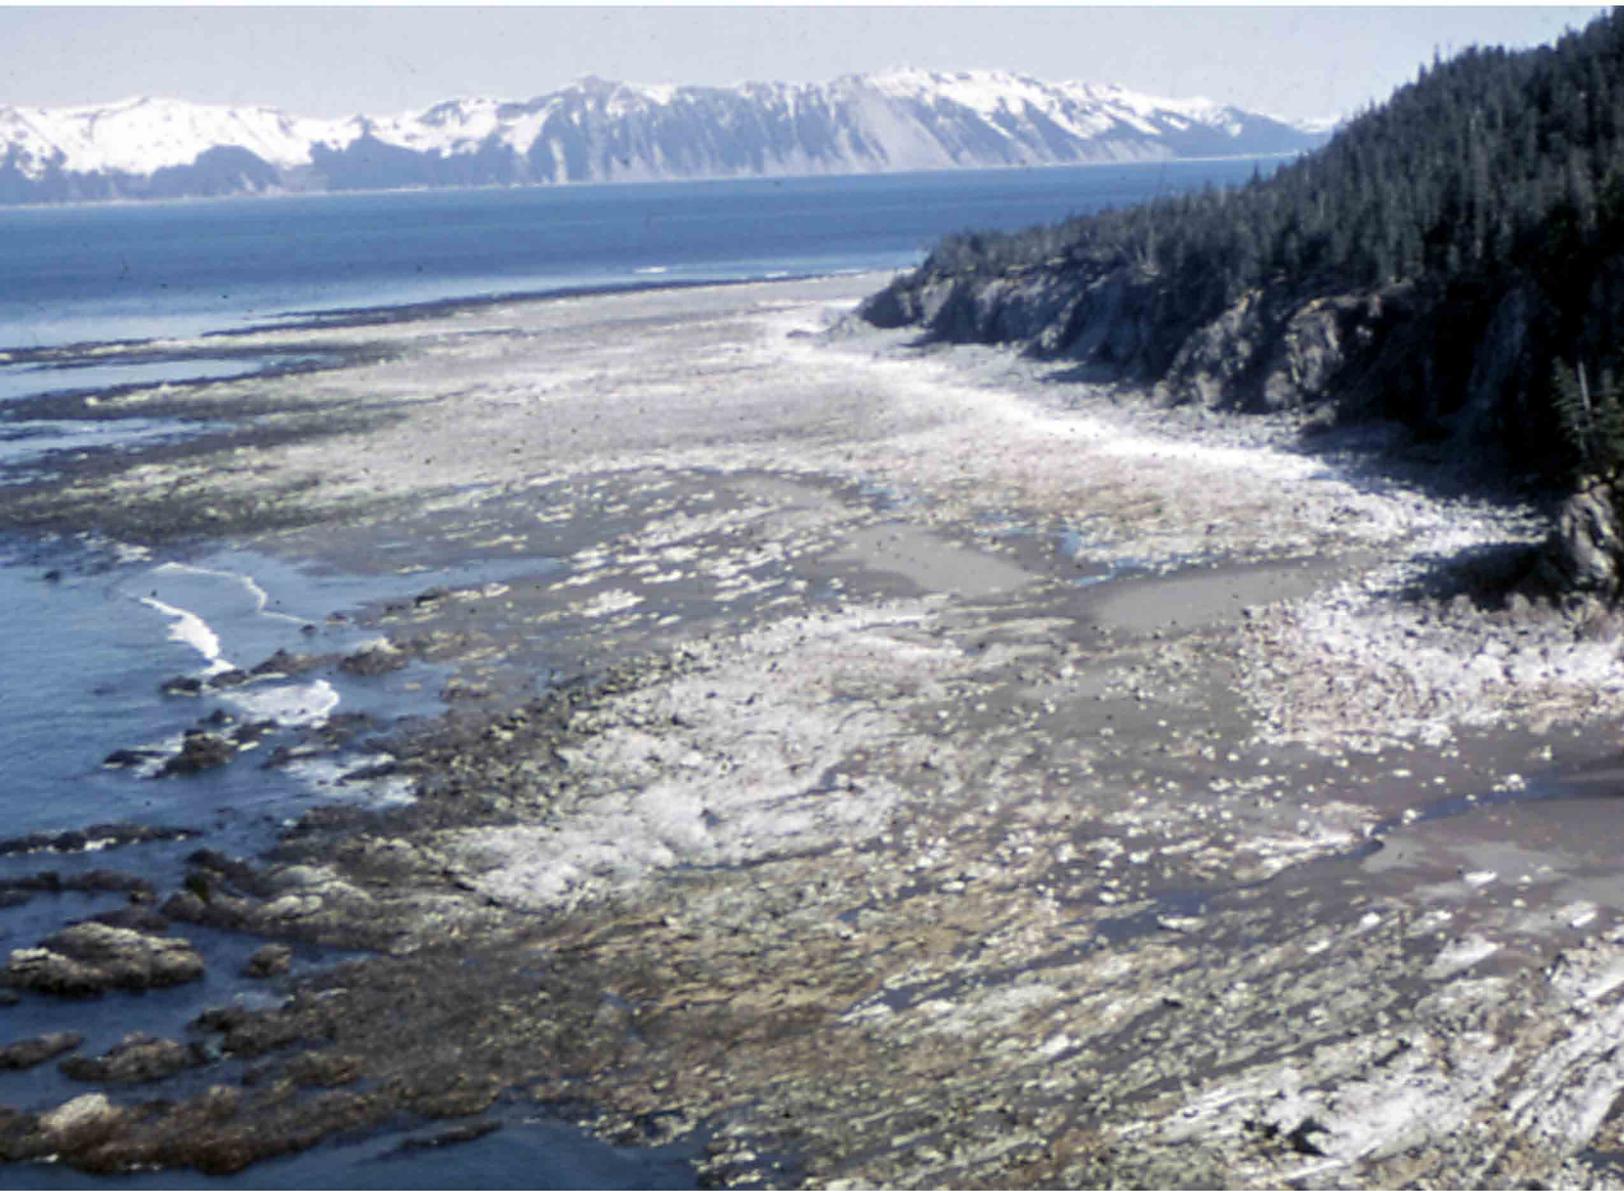
Former sea floor at Cape Cleare, Montague Island, Prince William Sound, exposed by 26 feet of tectonic uplift. The surf-cut surface, which slopes gently from the base of the sea cliffs to the water, is about a quarter of a mile wide. The white coating on the rocky surface consists mainly of the desiccated remains of calcareous algae and bryozoans. Photograph taken at about zero tide stage, May 30, 1964.

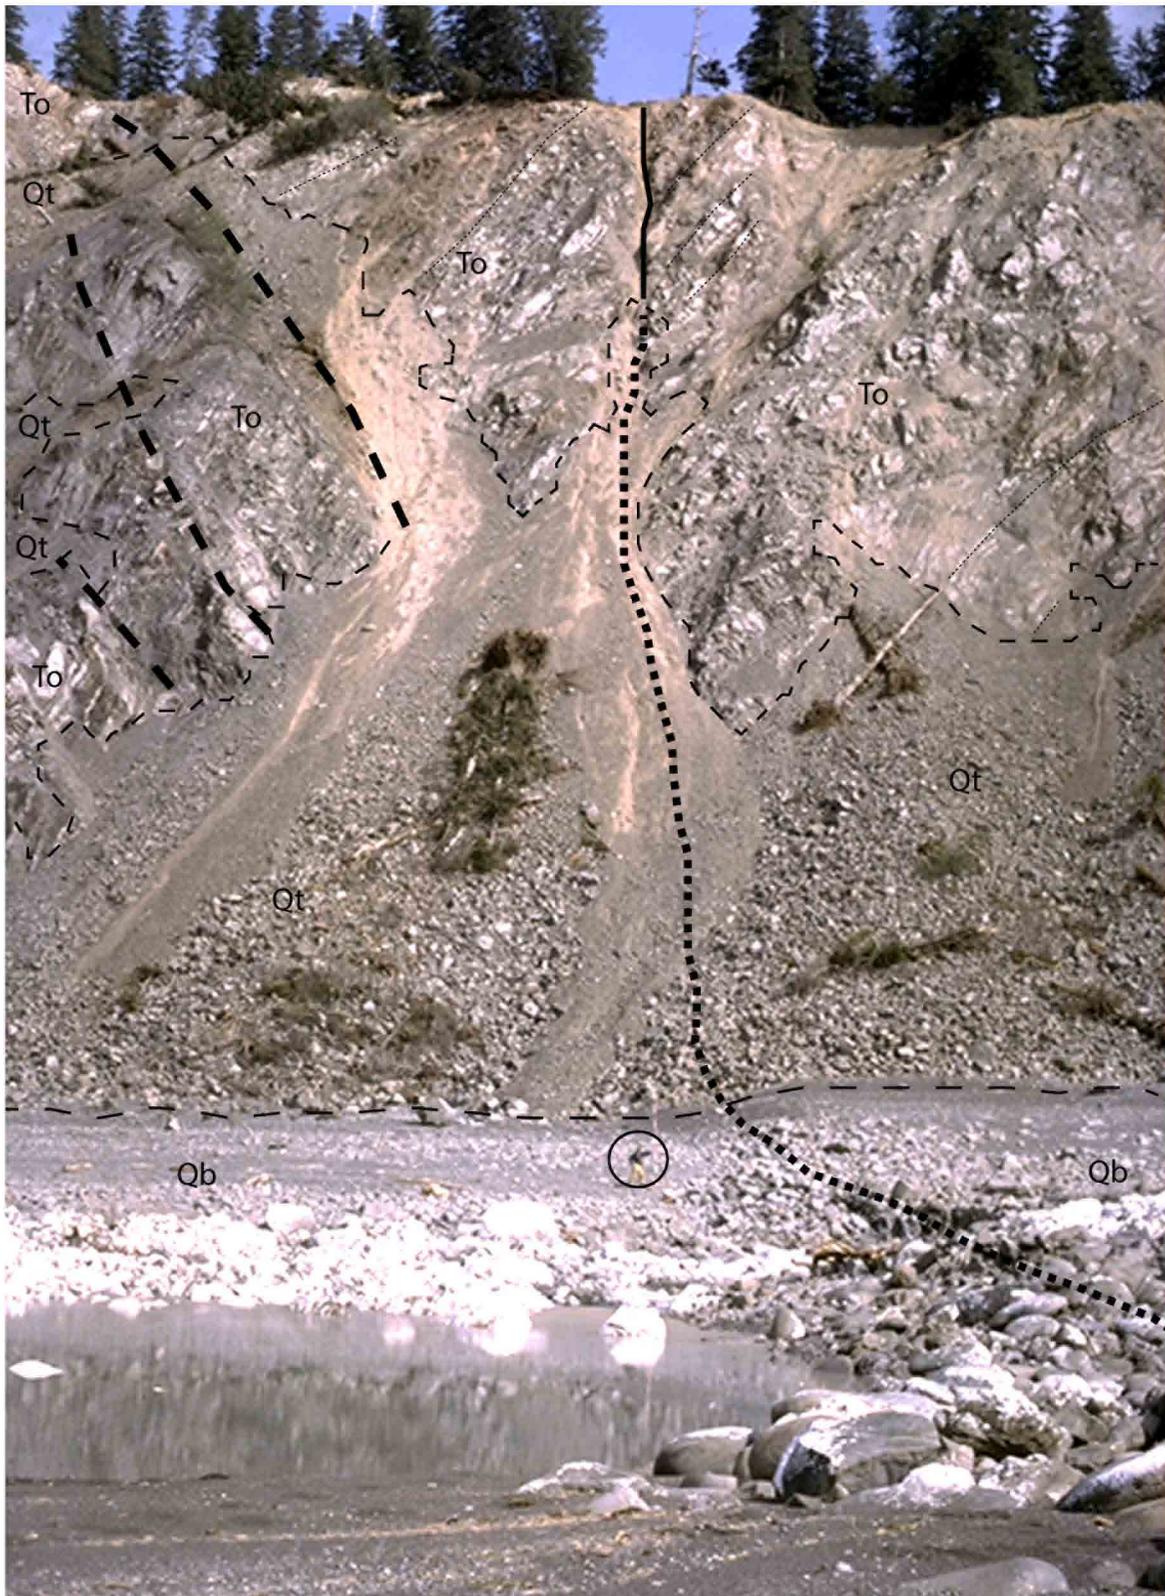
3.—Patton Bay fault (heavy solid and dotted line) at the beach and sea cliff near Jeanie Point. Note the vertical offset of contact between beach deposits (Qb) and talus (Qt). The man (circled) is standing at the base of a scarp 8½ feet high. Light dotted lines are bedding traces in the Orca Group (To); heavy dashed lines are probable fault traces on which there apparently was no movement during the earthquake. Location shown in figure 6.

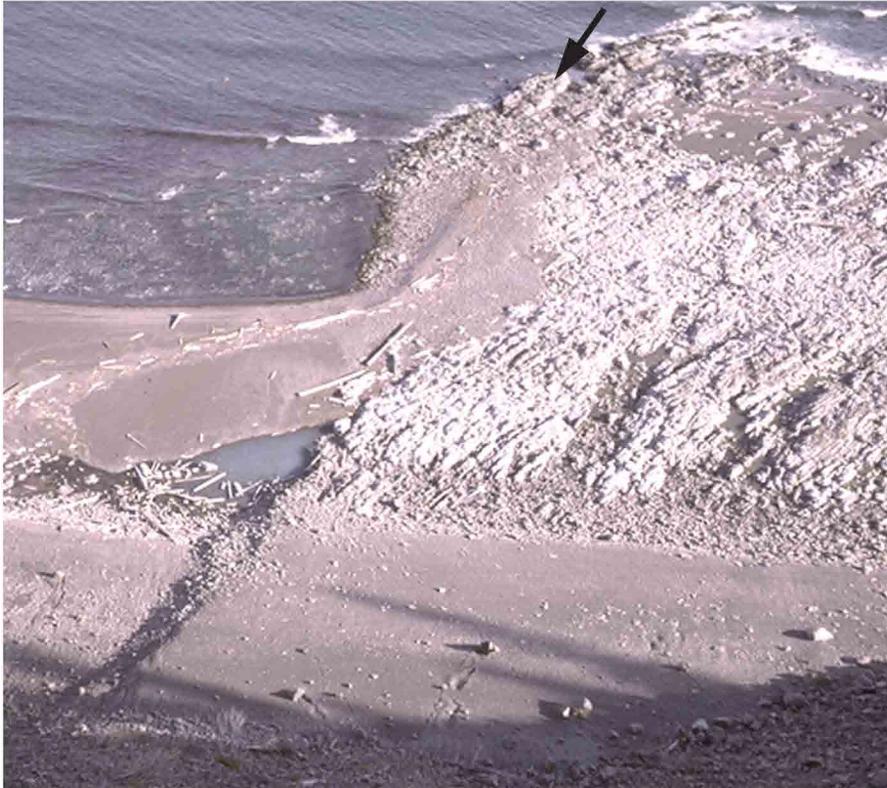
4.—View south from top of the sea cliff in figure 3. Arrows indicate fault trace which displaces the elevated beach prism and cuts obliquely across bedrock structures in the surf-cut platform on the upthrown block. The lower part of the scarp was partially obliterated with newly deposited marine sand and gravel by the time this photograph was taken in August 1965.

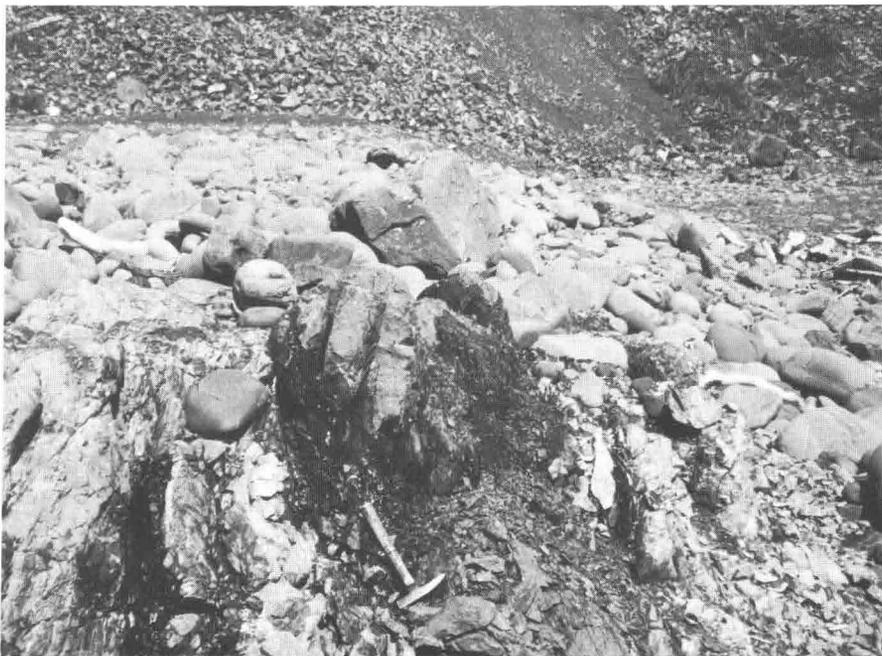
5.—Near-vertical zone of sheared quartz-veined argillite and graywacke along the Patton Bay fault trace at the shore. Location shown in figure 6.

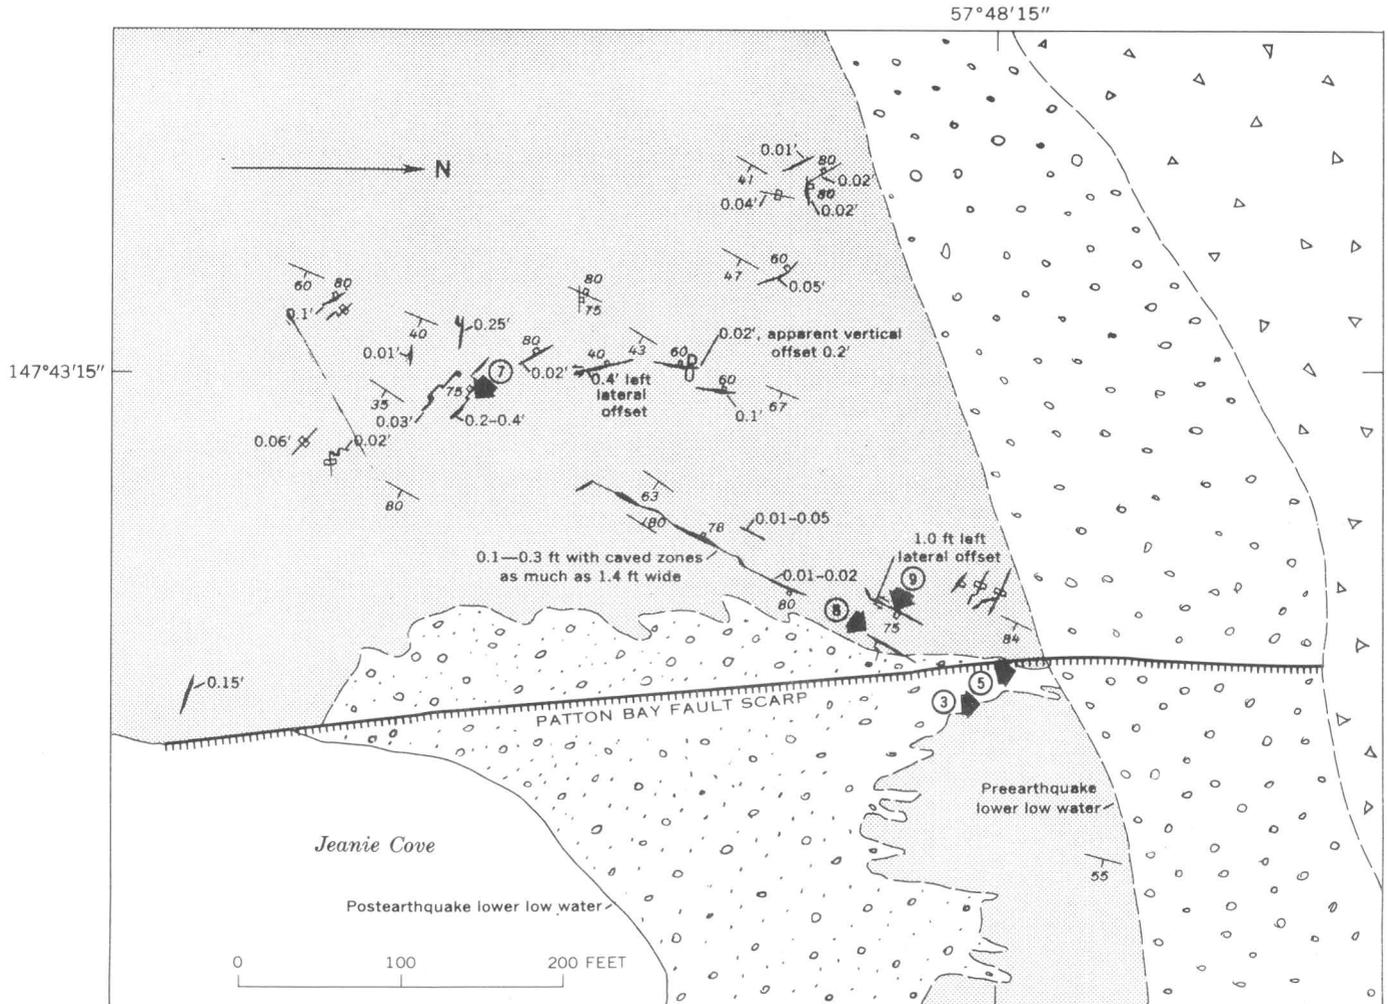
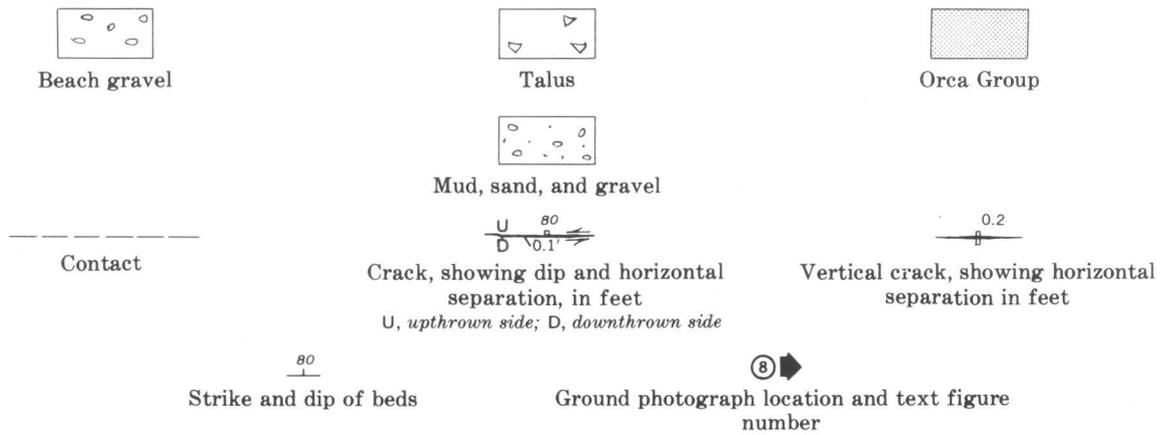
6.—Sketch map of the scarp and open cracks in the upthrown block of the Patton Bay fault at the shore near Jeanie Point.

The open cracks that occur in the reef on the upthrown block are probably tension cracks associated with the downwarping near the fault. Left-lateral displacements observed on two of these cracks suggest a possible small strike-slip component of movement of less than 1½ feet on the Patton Bay fault at this locality. No conclusive evidence for horizontal offset of the preearthquake beach strand lines that cross the fault scarp was found on the ground, although an apparent slight tendency for left-lateral bending of these lines was noted on the large-scale vertical aerial photographs.

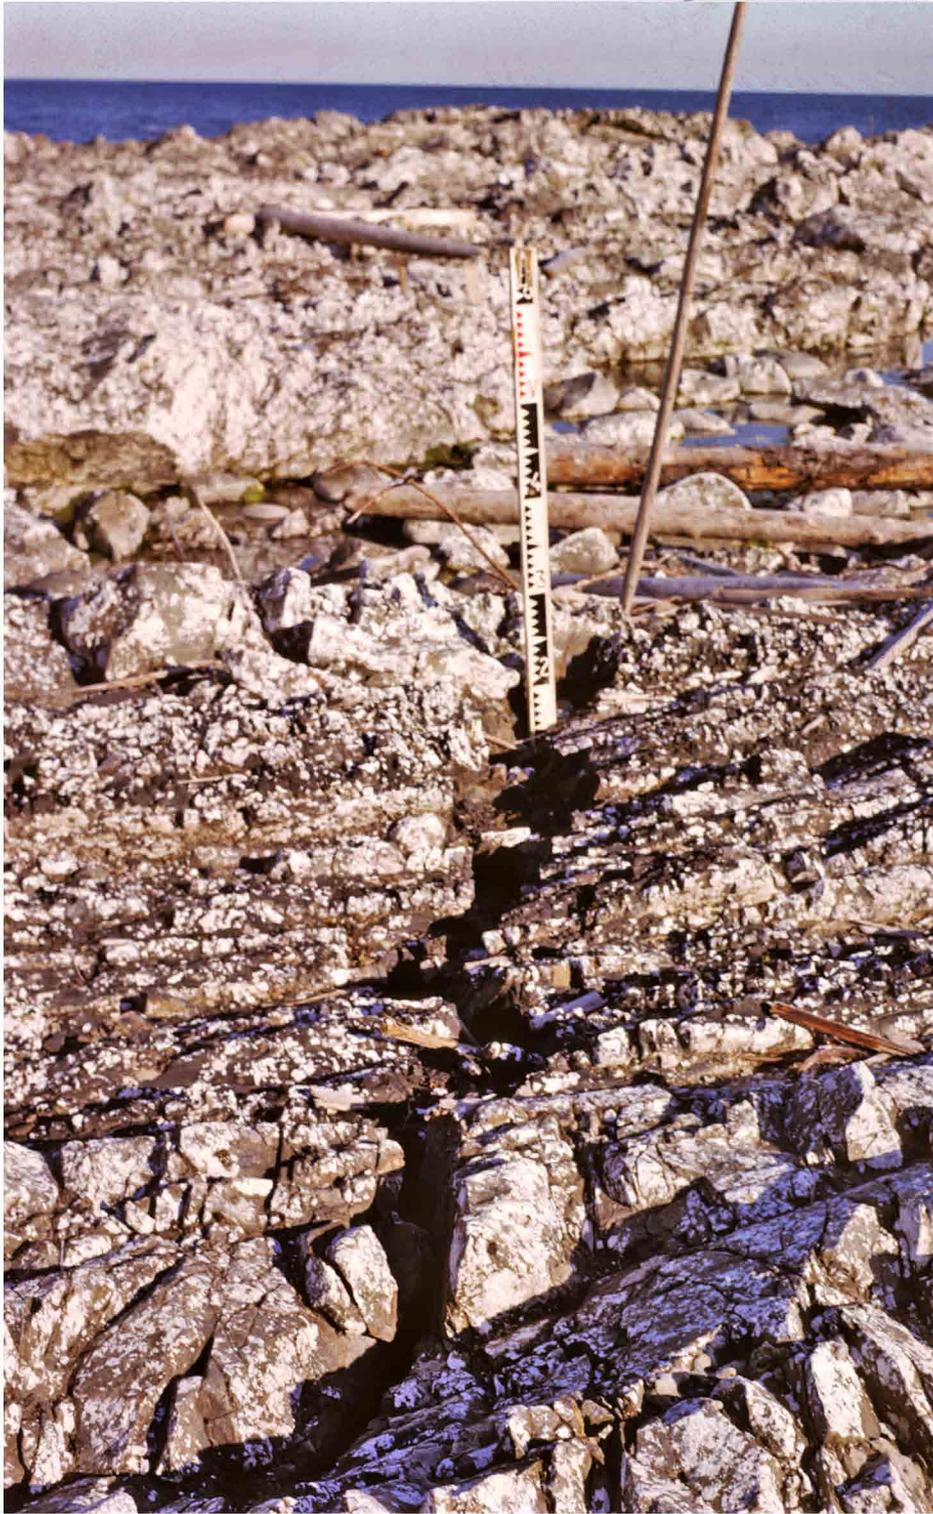
7.—Crack 0.2 to 0.4 foot wide and at least 2 feet deep in the warped relatively up-thrown block of the Patton Bay fault. Crack follows preexisting bedding and joint planes. Location shown in figure 6.

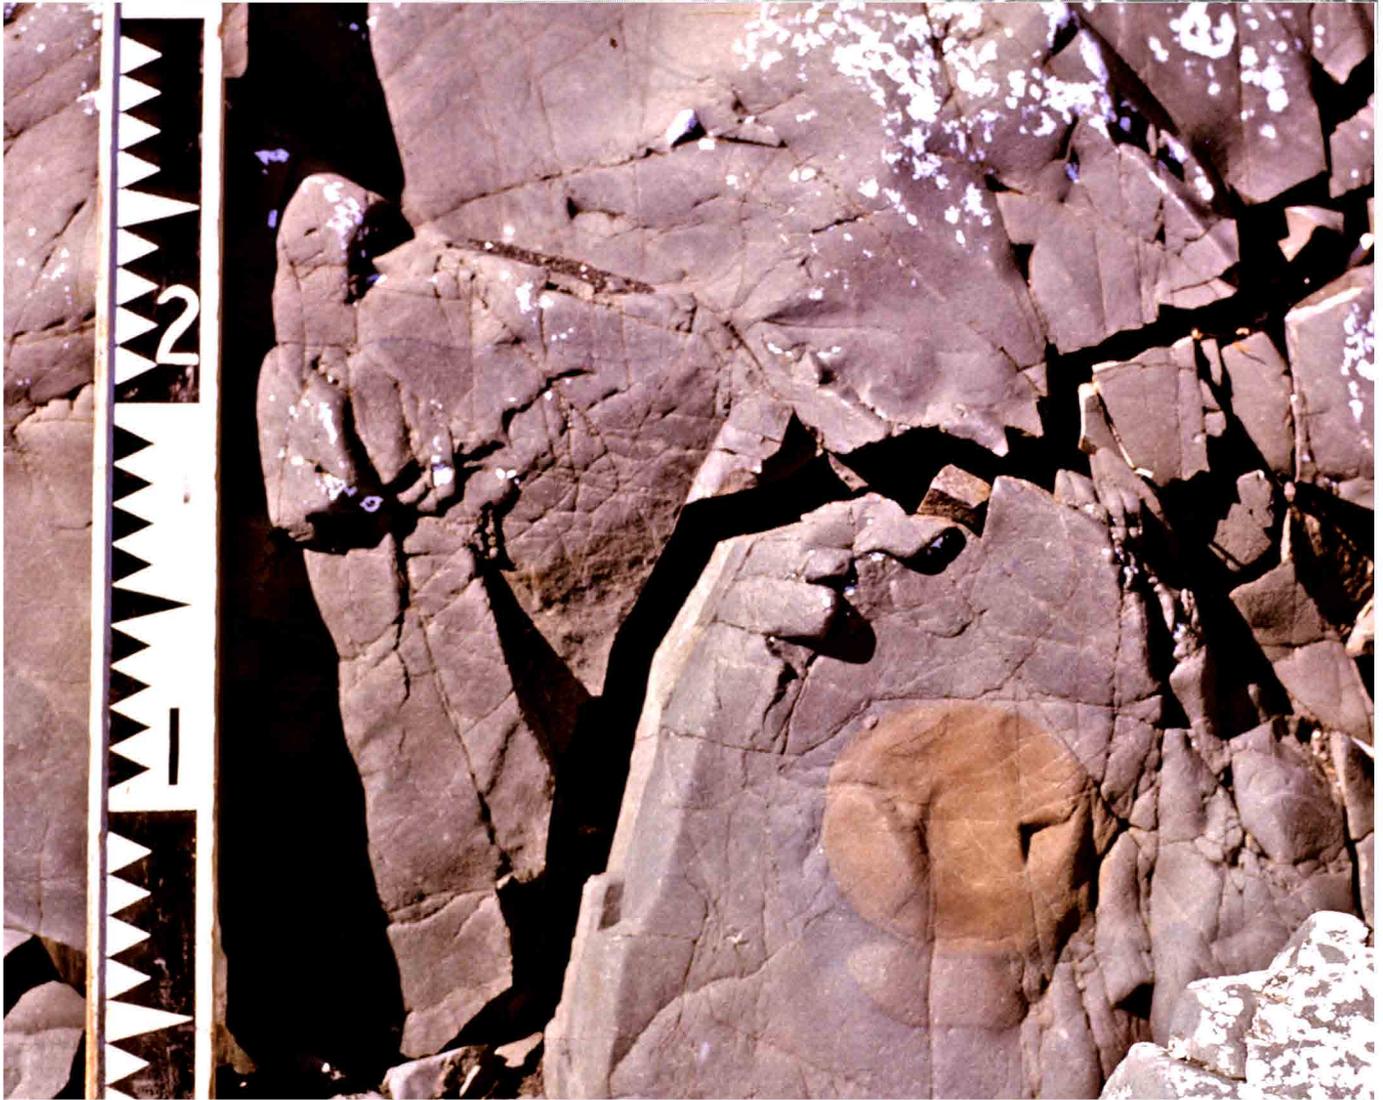
8.—Looking down on vertical crack 0.01 to 0.015 foot wide along preexisting joints in a hard graywacke bed. Location shown in figure 6.

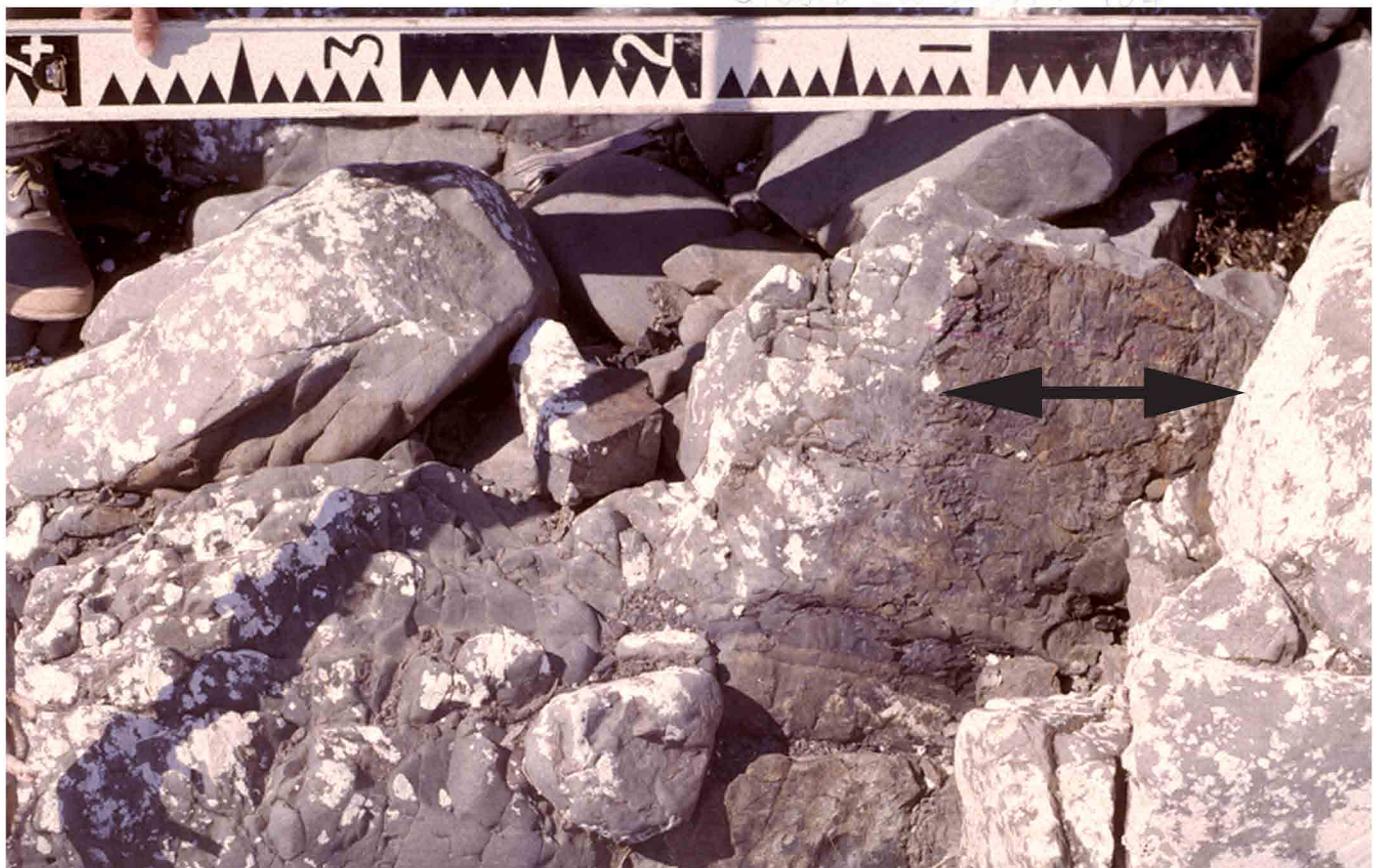
9.—Crack along bedding plane in massive indurated sandstone; 1 foot of left-lateral separation. Location shown in figure 6.

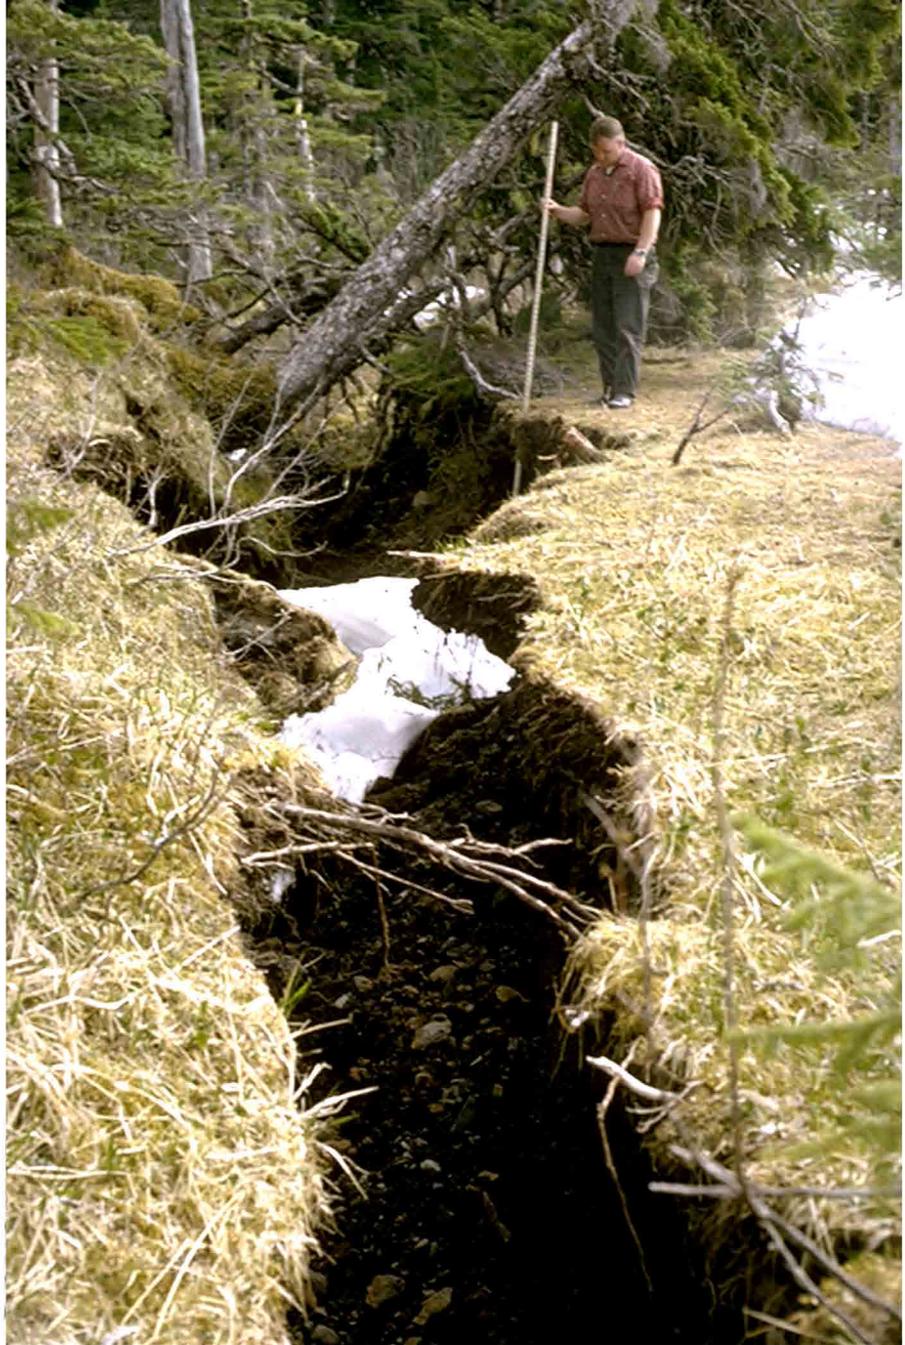
10.—One of the larger fissures along the trace of the Patton Bay fault. The fissure, which is 3 feet wide and 7 feet deep, is in unconsolidated glacial till.

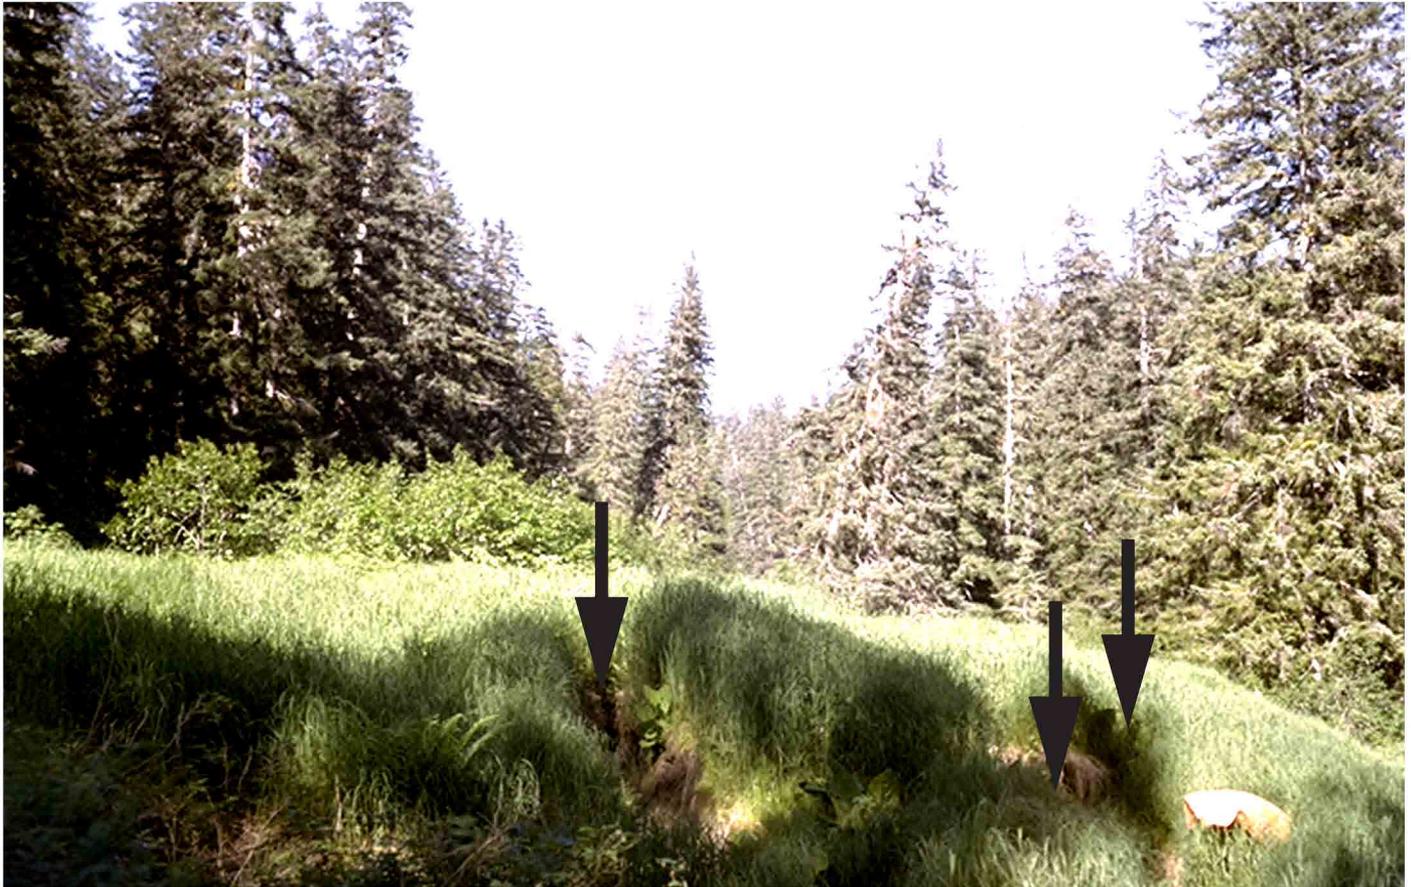
12 (above right).—Warped and fissured muskeg surface along the Patton Bay fault trace. West (left) side of this formerly flat meadow is uplifted 16½ feet relative to the east side. Tilted trees in the background are along the flexure zone that marks the fault trace. Note the characteristic tilt of tree crowns toward the downthrown block. Arrows indicate fissures.

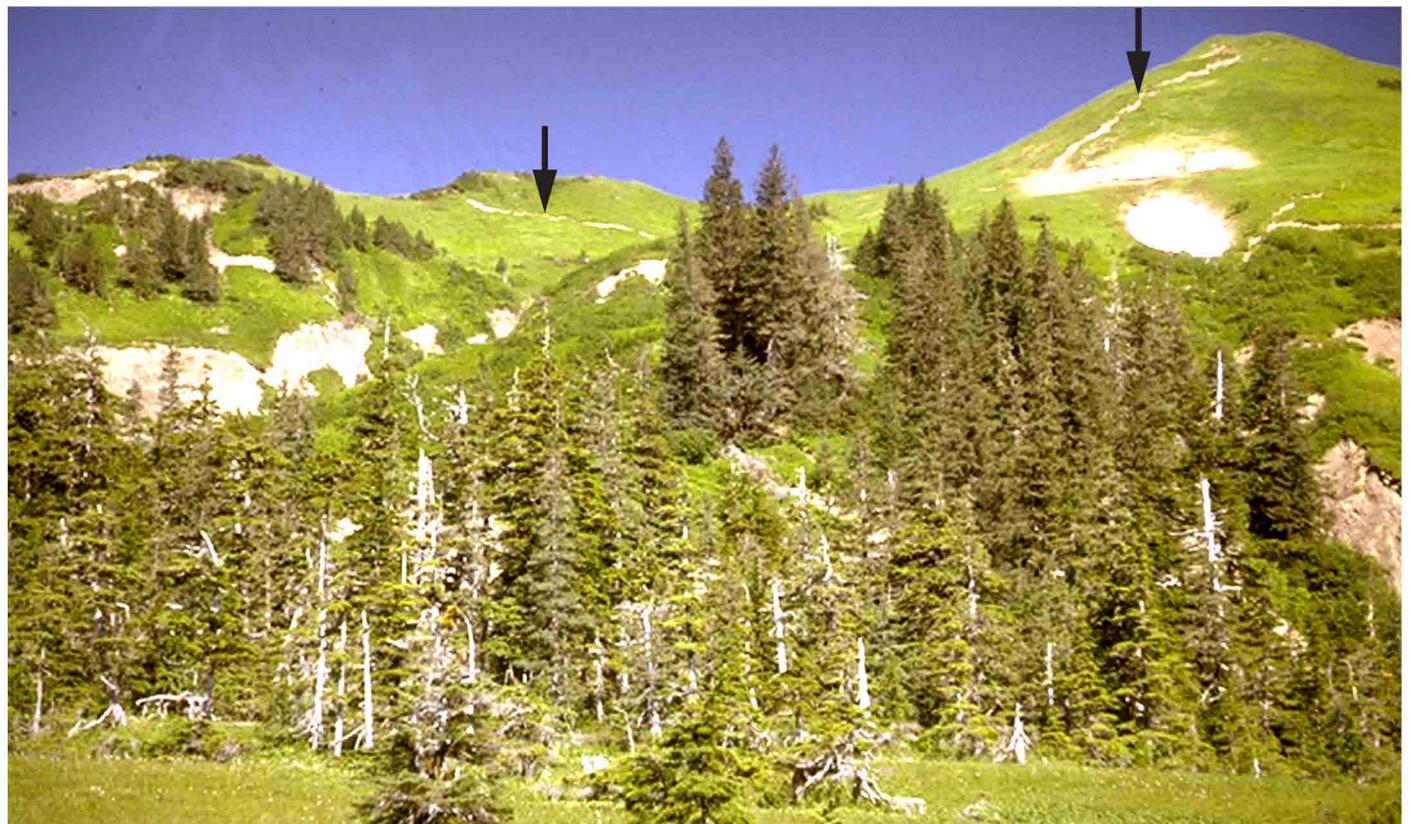
13 (bottom right).—Part of the zone of tectonic fissures north of Tortuous Creek. Two of the larger laterally persistent fissures (arrows) that trend obliquely across the slopes are visible above the brush line. The cracks and scars below the brush line result from earthquake-induced landslides and soil flows. Photograph by M. G. Bonilla.

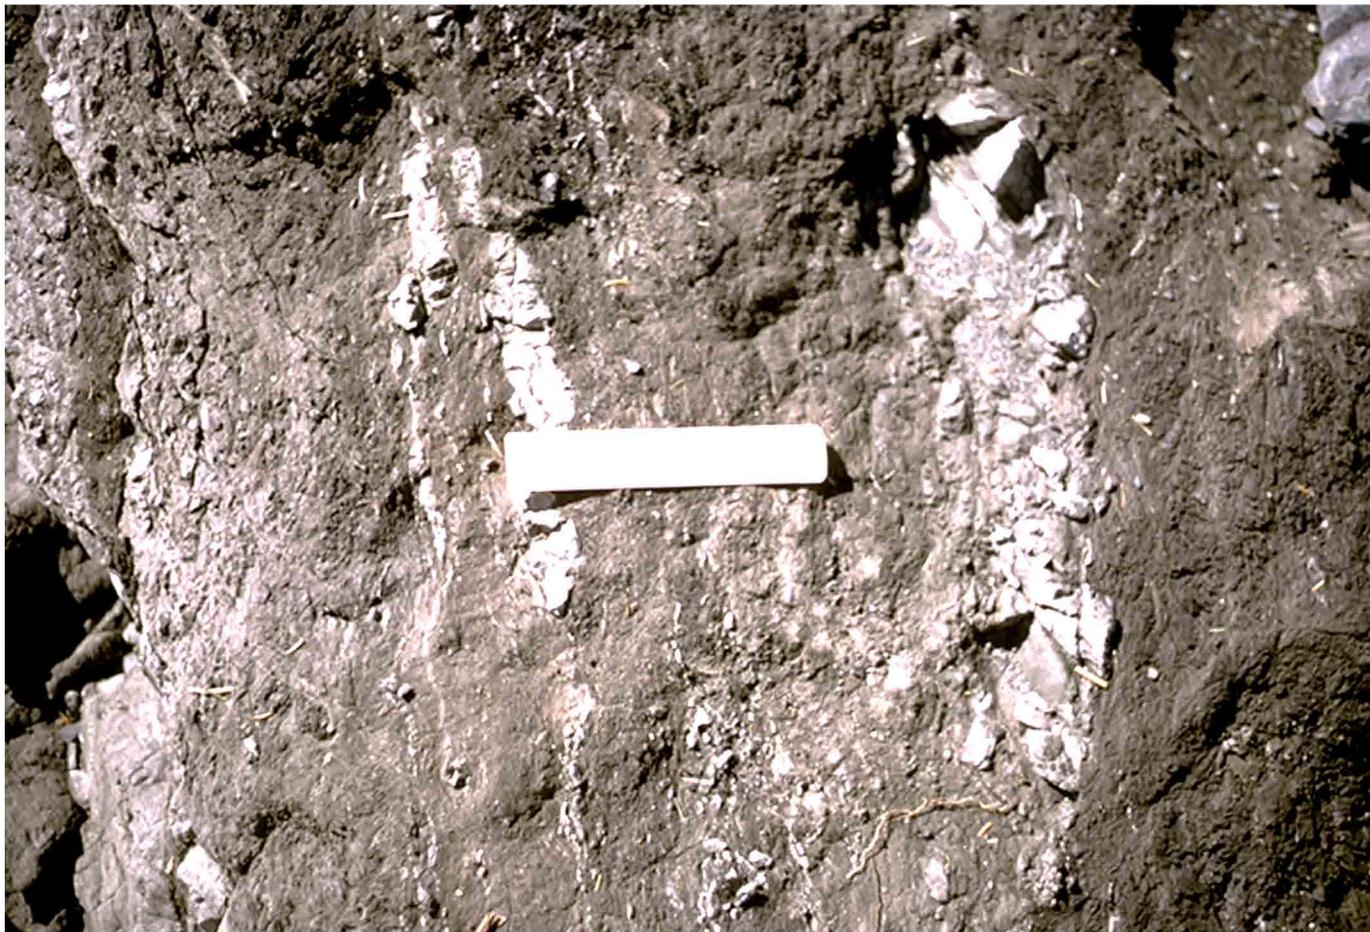
18.—Shattered lenticular boudins of light-gray indurated sandstone in a matrix of sheared black argillite dipping 75° to 85° northwest along the Patton Bay fault at Jeanie Creek. *Alaska Earthquake 112*

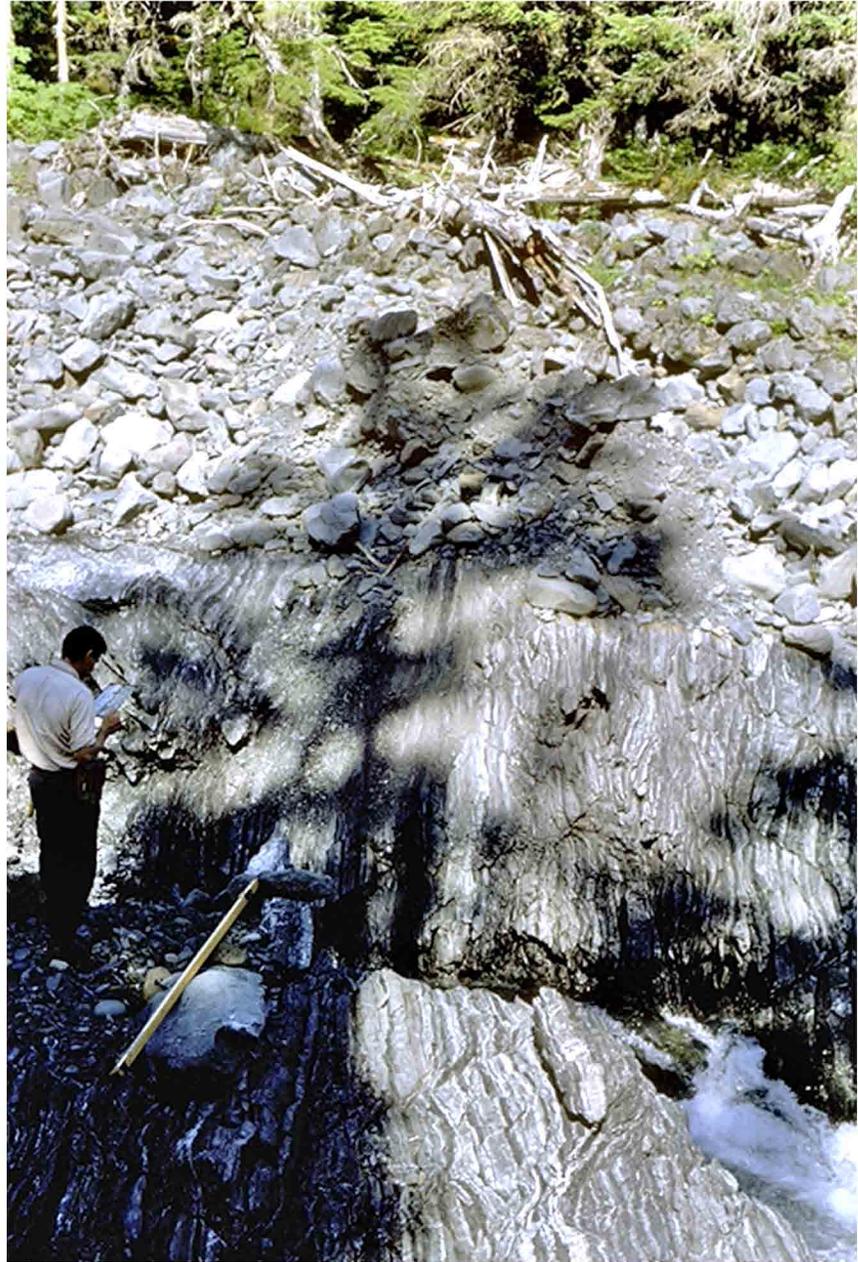
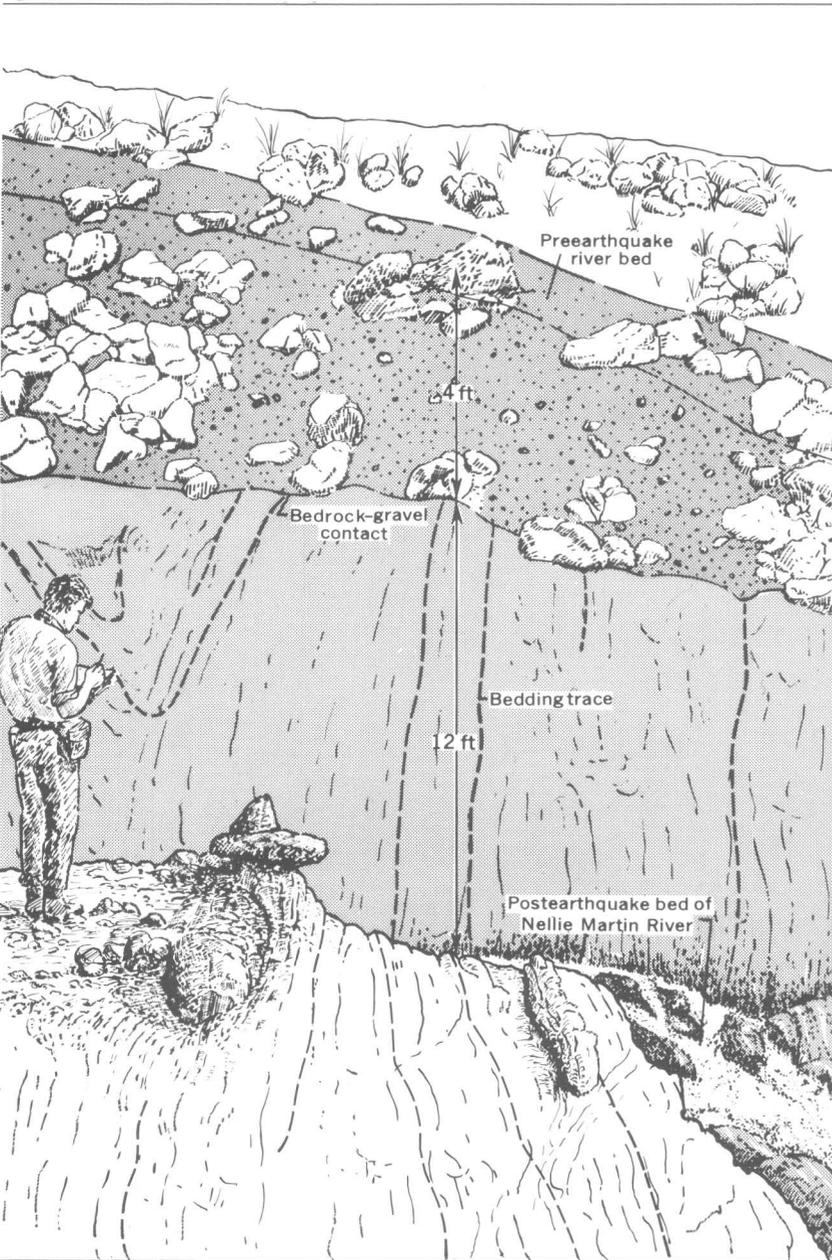
19.—Incised channel of the Nellie Martin River immediately upstream from the gravel and 12 feet of bedrock at this locality between March 27, 1964, and August

Patton Bay fault scarp. The rejuvenated river has eroded about 4 feet of boulder
1965. Photograph by L. R. Mayo.

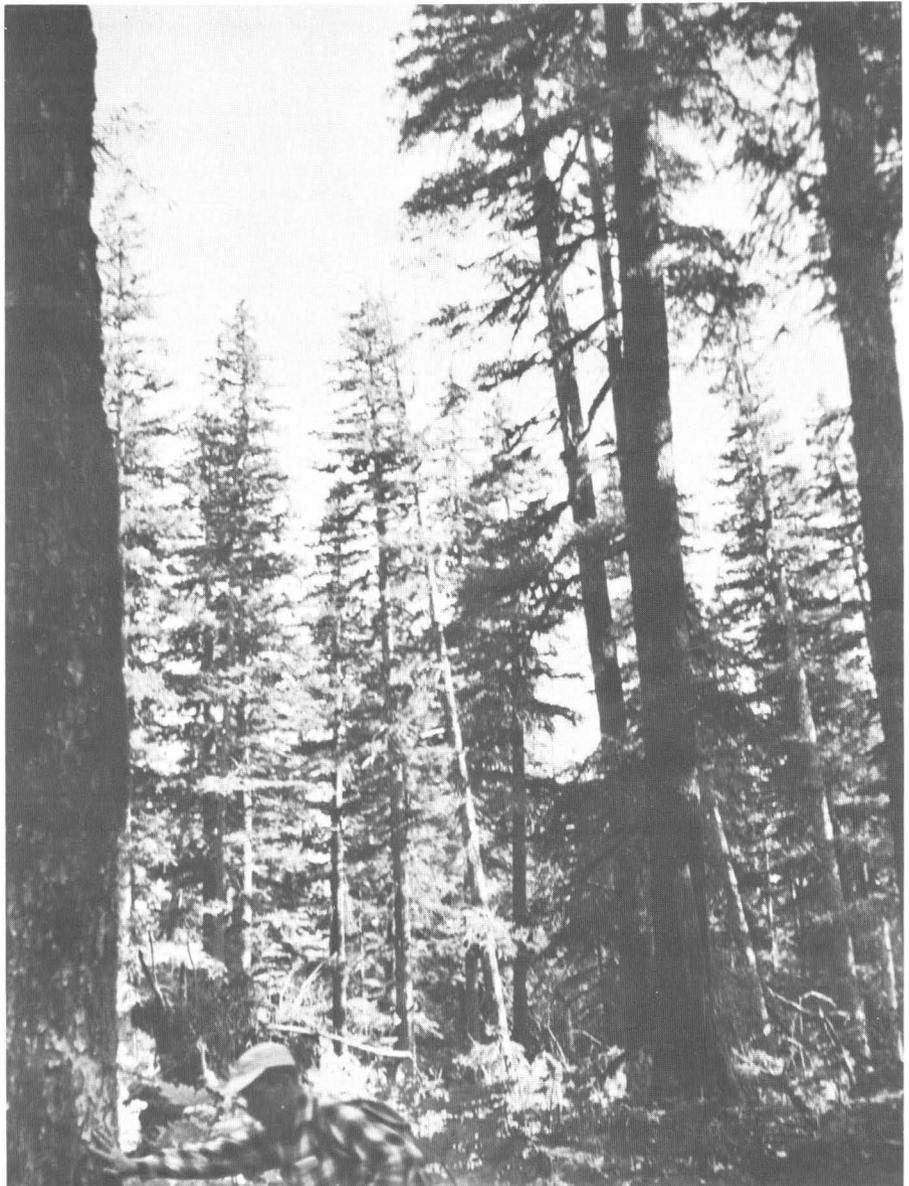
20.—Looking southwest along the Patton Bay fault in the alluviated valley of Patton River. The fault trace is indicated by the tilted giant Sitka spruce trees and by ground fissures that roughly parallel the zone of tilted trees.

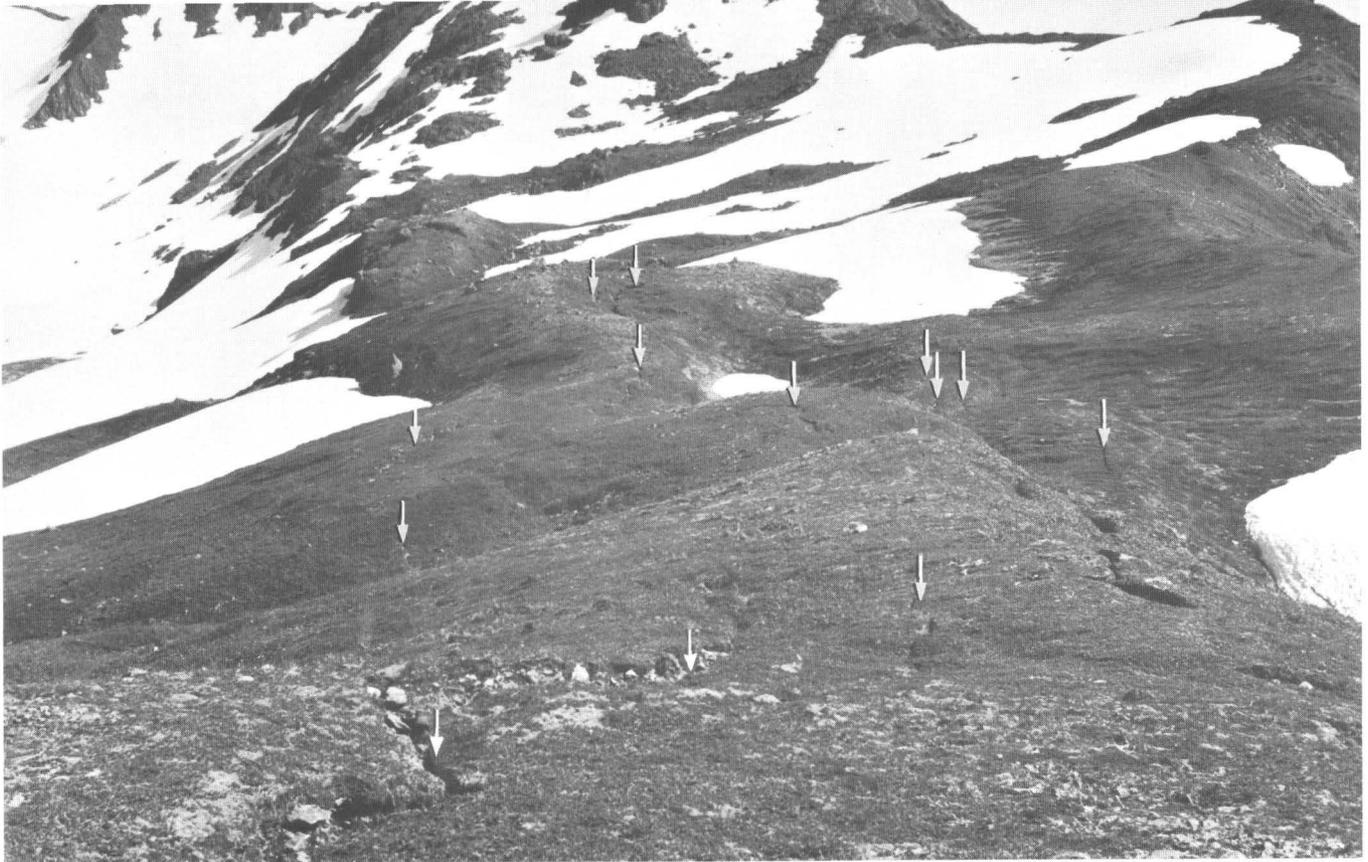
21.—Part of the zone of tectonic fissures at 3,000 feet altitude on the ridge summit north of Patton River. The fissures, some of which are indicated by arrows, could be traced almost continuously to the northeast through the peak (center of photograph) and the notch on the skyline to the left of the peak. *Alaska earthquake 115*

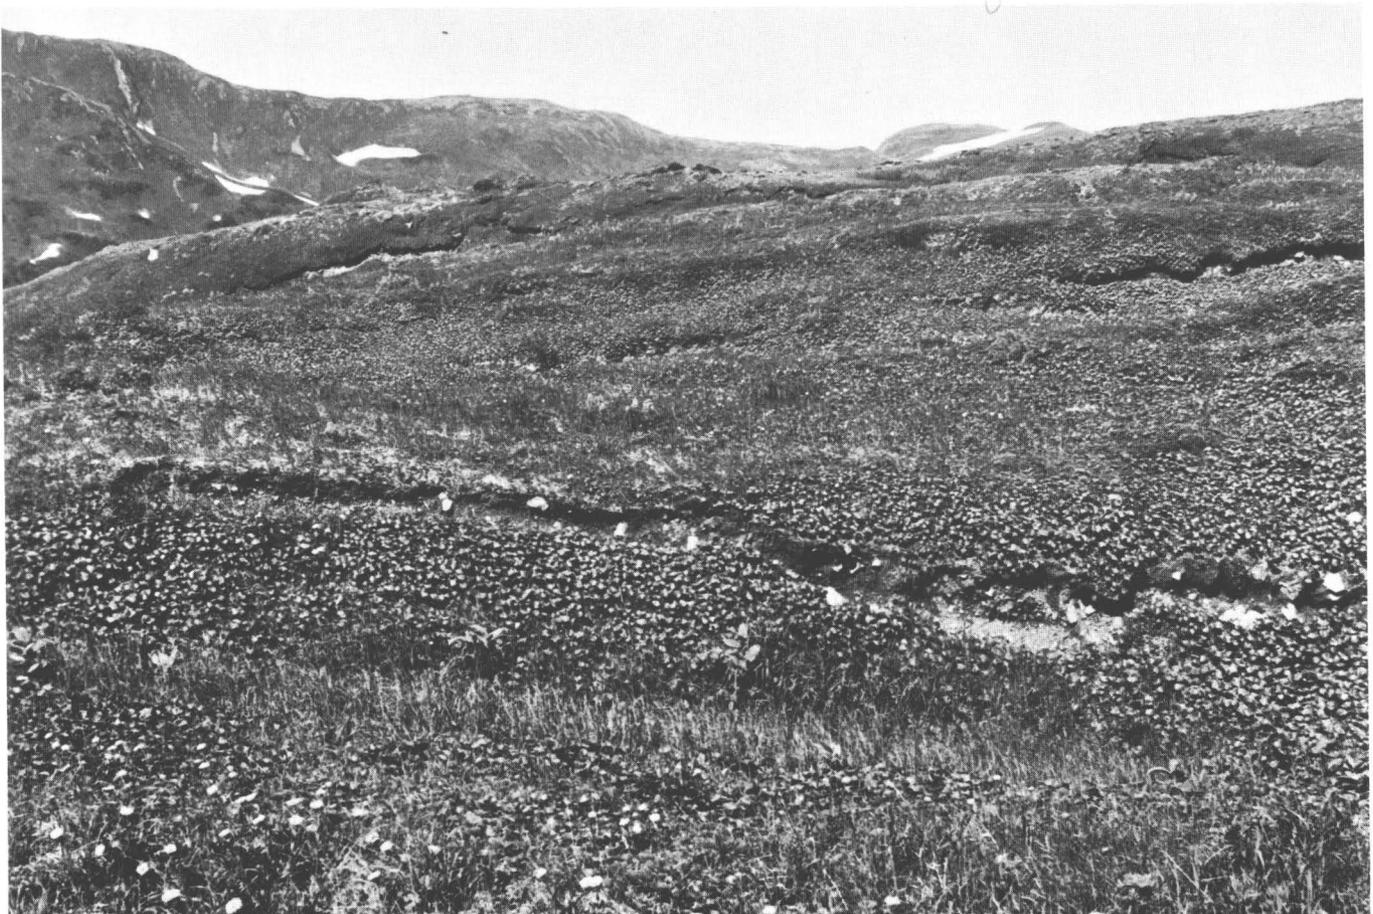
22.—Subparallel minor normal faults within the area shown in figure 21. Note that some of these fissures coincide with pre-existing linear scarps. *Alaska earthquake 116*
