THE ALASKA EARTHQUAKE, MARCH 27, 1964:
REGIONAL EFFECTS

Surface Faults On Montague Island Associated with the 1964 Alaska Earthquake

By GEORGE PLAFKER

GEOLOGICAL SURVEY PROFESSIONAL PAPER 543-G

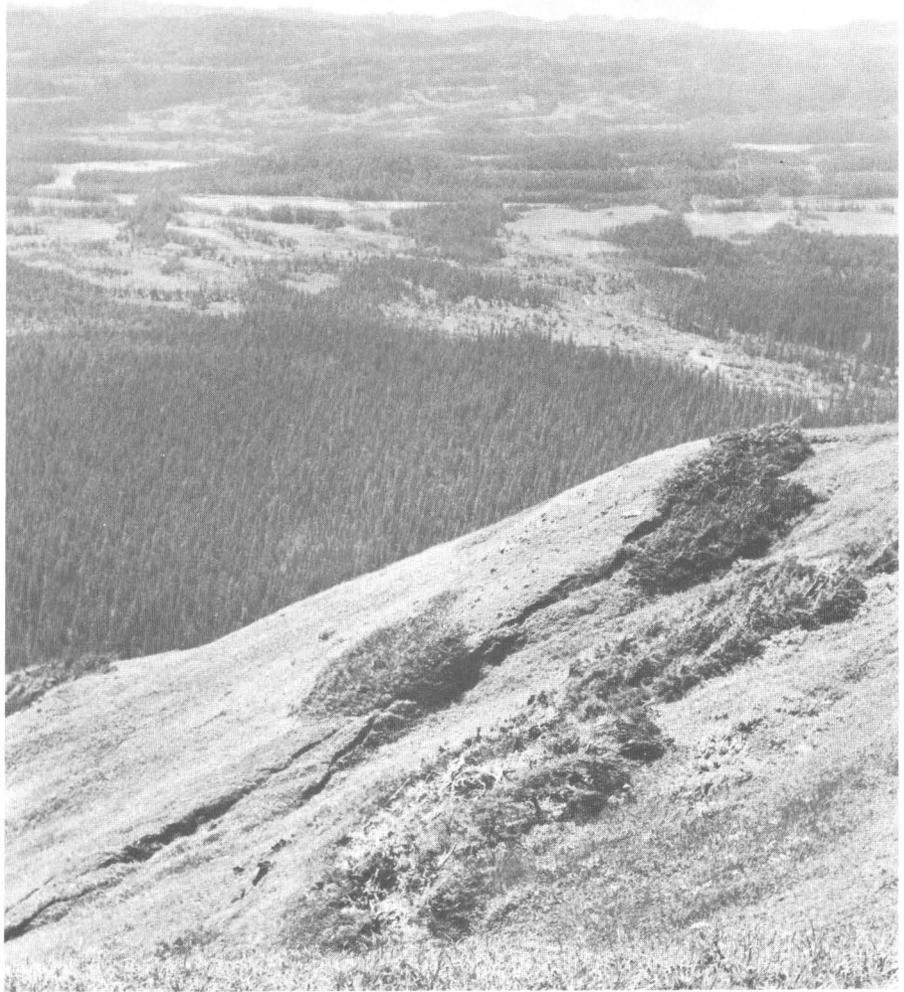
23.—Minor normal faults along a preexisting linear groove on a steep ridge slope. The downhill side is uplifted 16 inches. Patton River valley visible in the background.

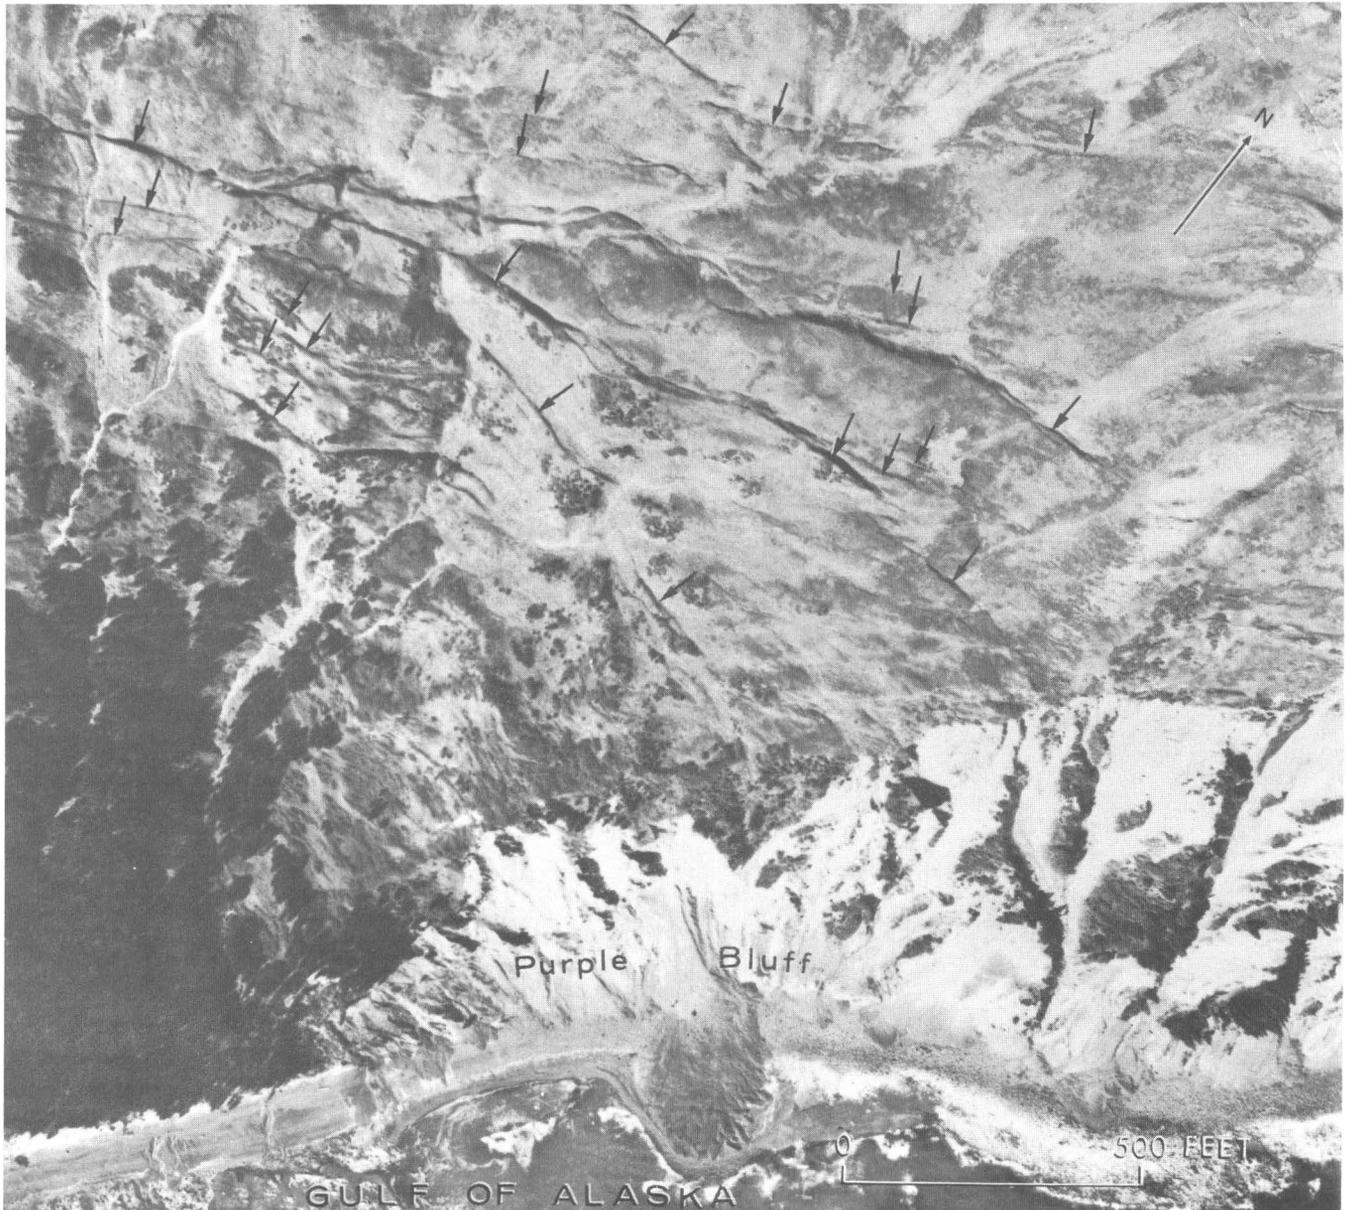
24.—Vertical aerial photograph in the vicinity of Purple Bluff showing conspicuous lineaments (arrows) along the inferred northeastward extension of the Patton Bay fault. Renewed displacement occurred on some of these lineaments after the 1964 earthquake. A large earthquake-induced landslide may be seen at the base of the high bluff at bottom center. Photograph by U.S. Coast and Geodetic Survey, August 25, 1964.

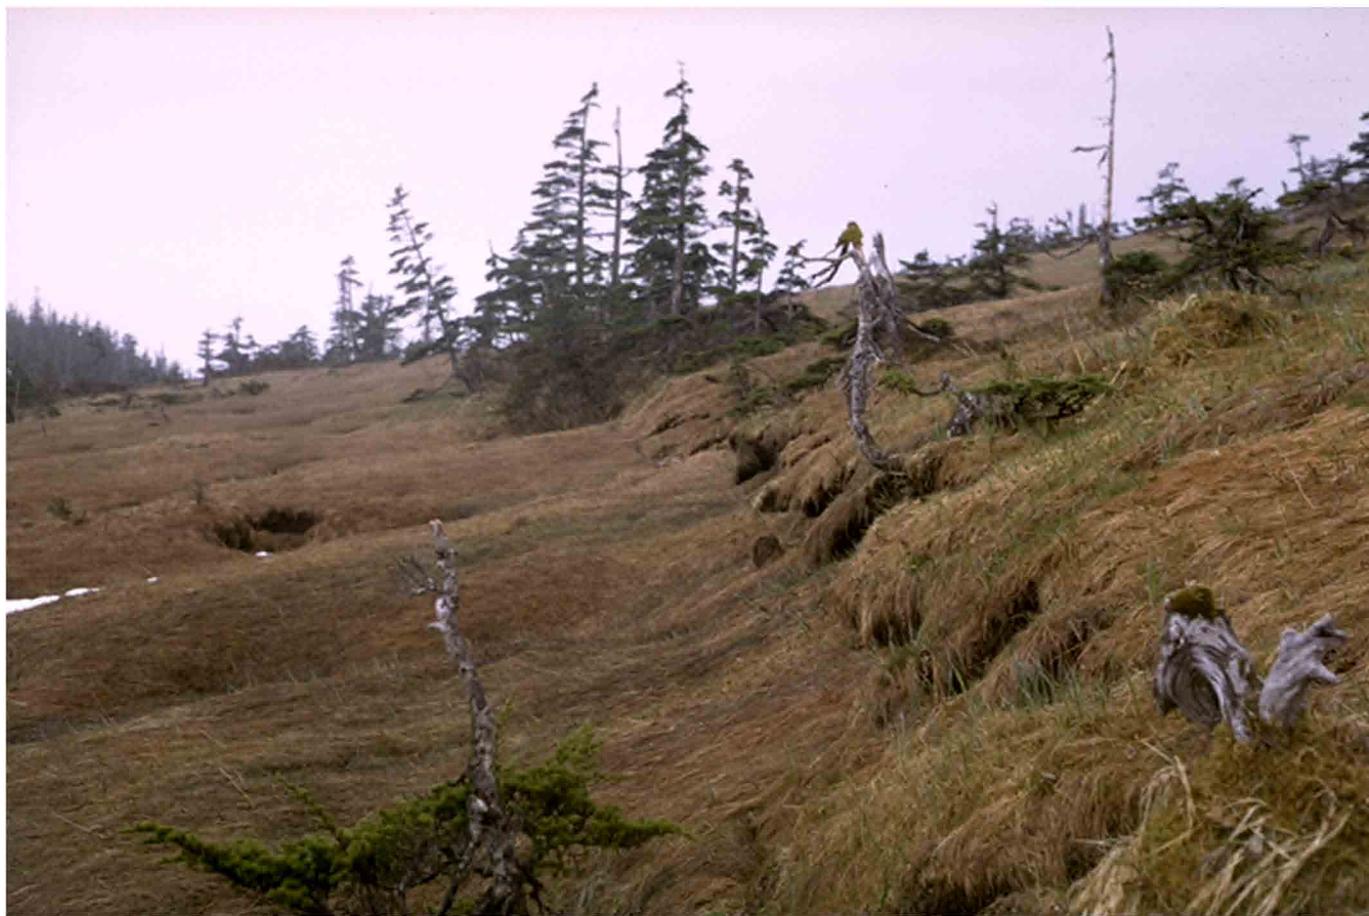
25.—View southwest along Hanning Bay fault. Northwest block (right) has overthrust the southeast block. Note warped surface and overhanging muskeg mat on the scarp in the foreground. Tree in the background has been tilted by the overthrusting. Location shown in figure 27.

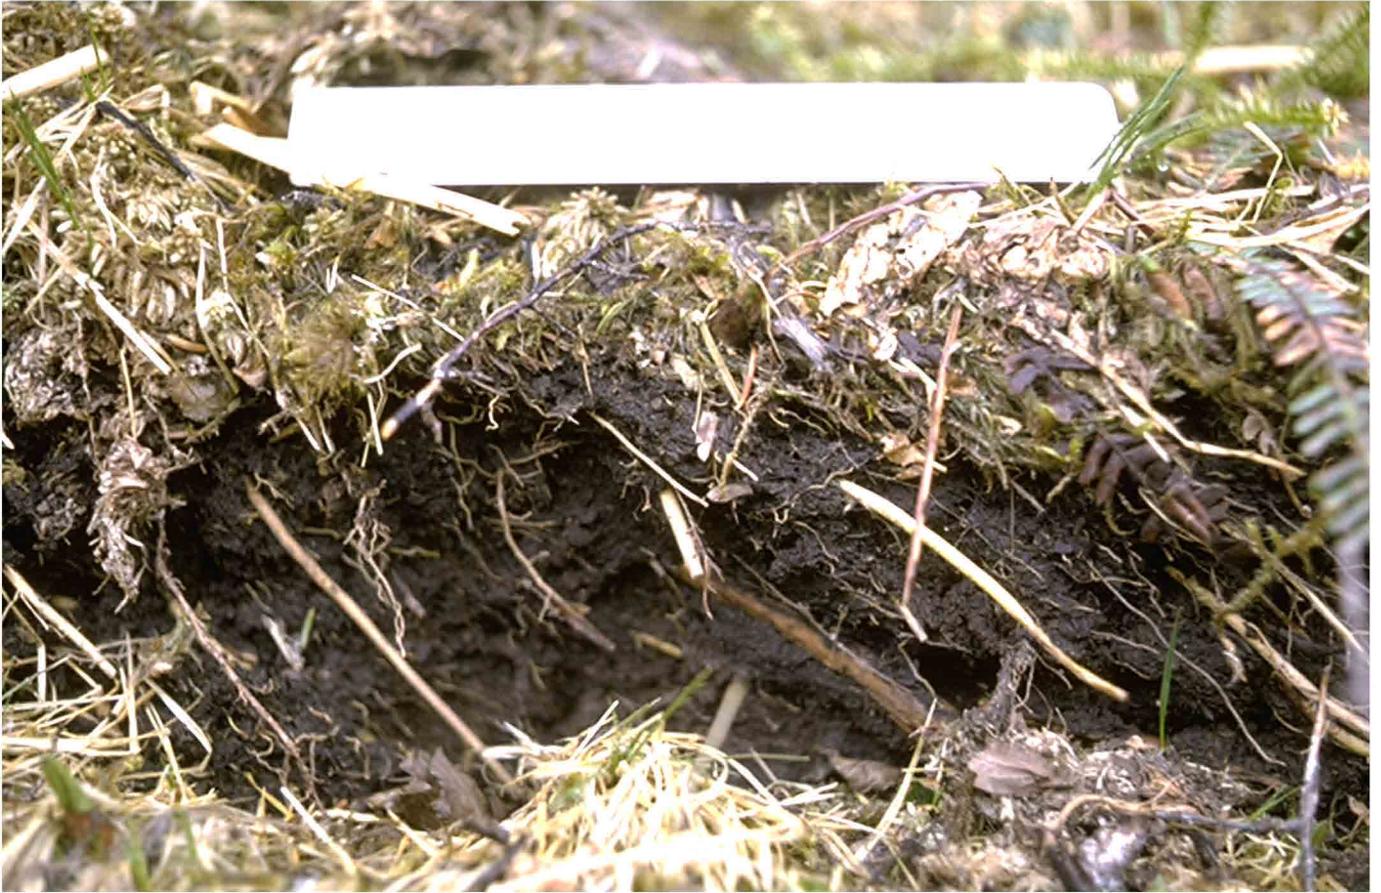
26.—Overhanging scarp of Hanning Bay fault in glacial till dipping 80° northwest. About 4 inches of left-lateral displacement is indicated by the rake of roots extending across the scarp. Scale is $6\frac{1}{2}$ inches long. Location shown in figure 27.

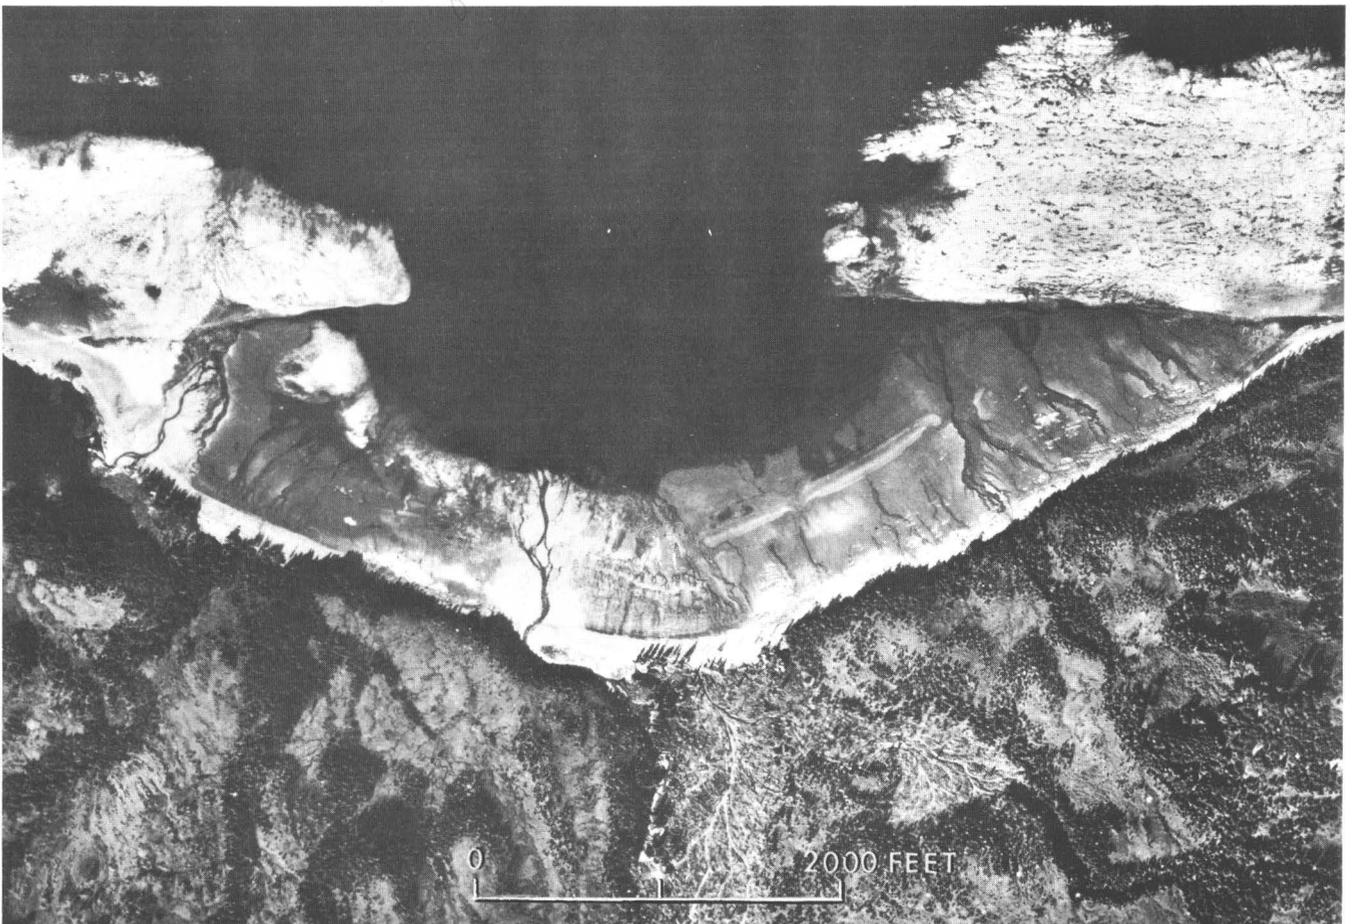
28.—Pre- and postearthquake high-tide shorelines at Fault Cove. The cove was formed by relative uplift of the former sea floor northwest of the fault scarp. The white color on the elevated bedrock surface northwest of the fault results from dessication of calcareous algae and other calcareous marine organisms. Upper photograph by U.S. Forest Service, June 8, 1959; lower photograph by U.S. Coast and Geodetic Survey, April 17, 1964.

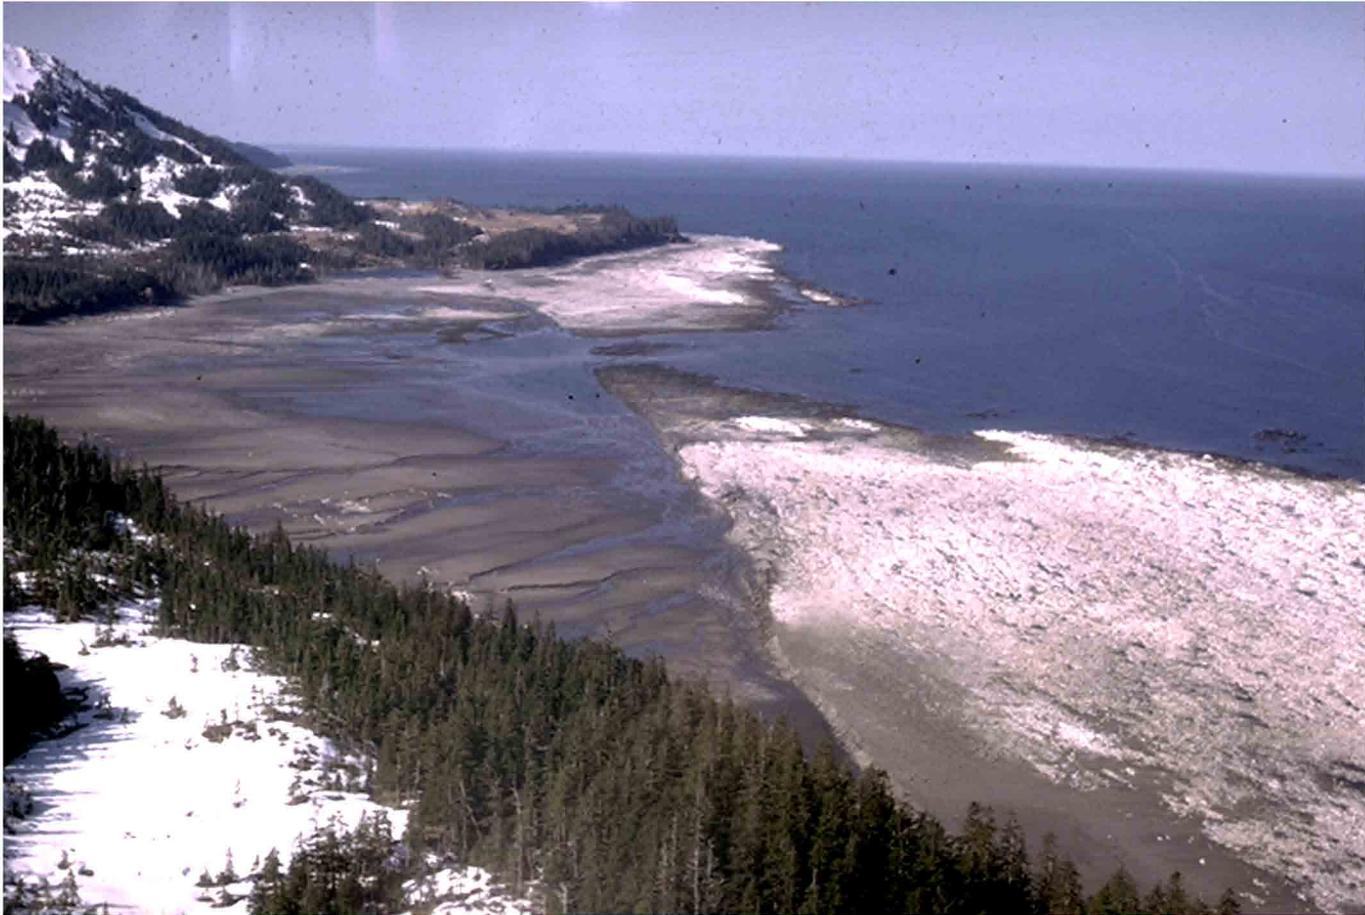
29.—Hanning Bay fault at Fault Cove approximately at low tide. The northwest (right) block is uplifted as much as $16\frac{1}{2}$ feet relative to the southeast block. Both blocks are uplifted relative to sea level. As a consequence, the cove is virtually dry at low tide, and the elevated beach and former offshore deposits are deeply dissected by streams. Veneer of unconsolidated deposits on the former submarine part of the downthrown block accumulated behind a preexisting fault scarp.

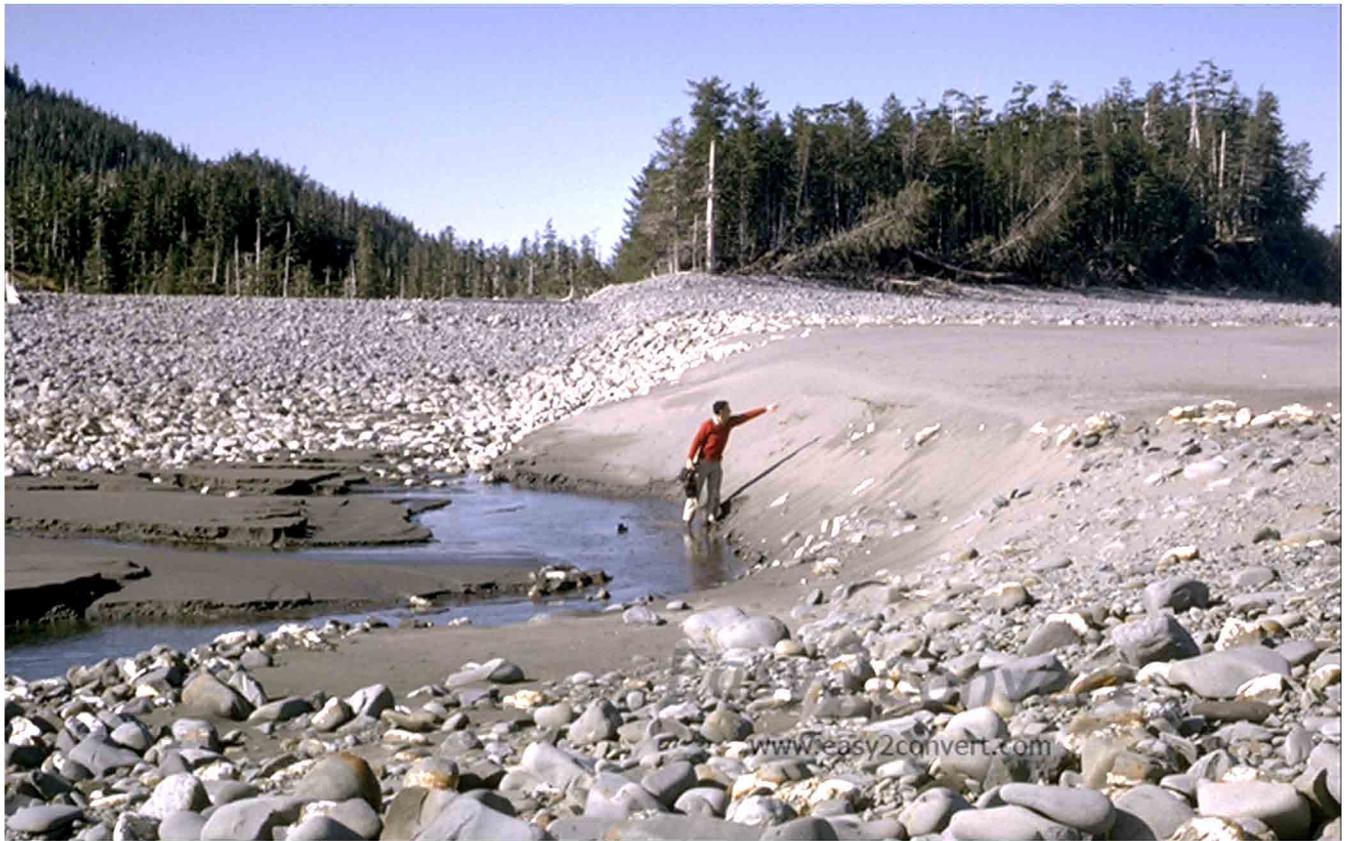
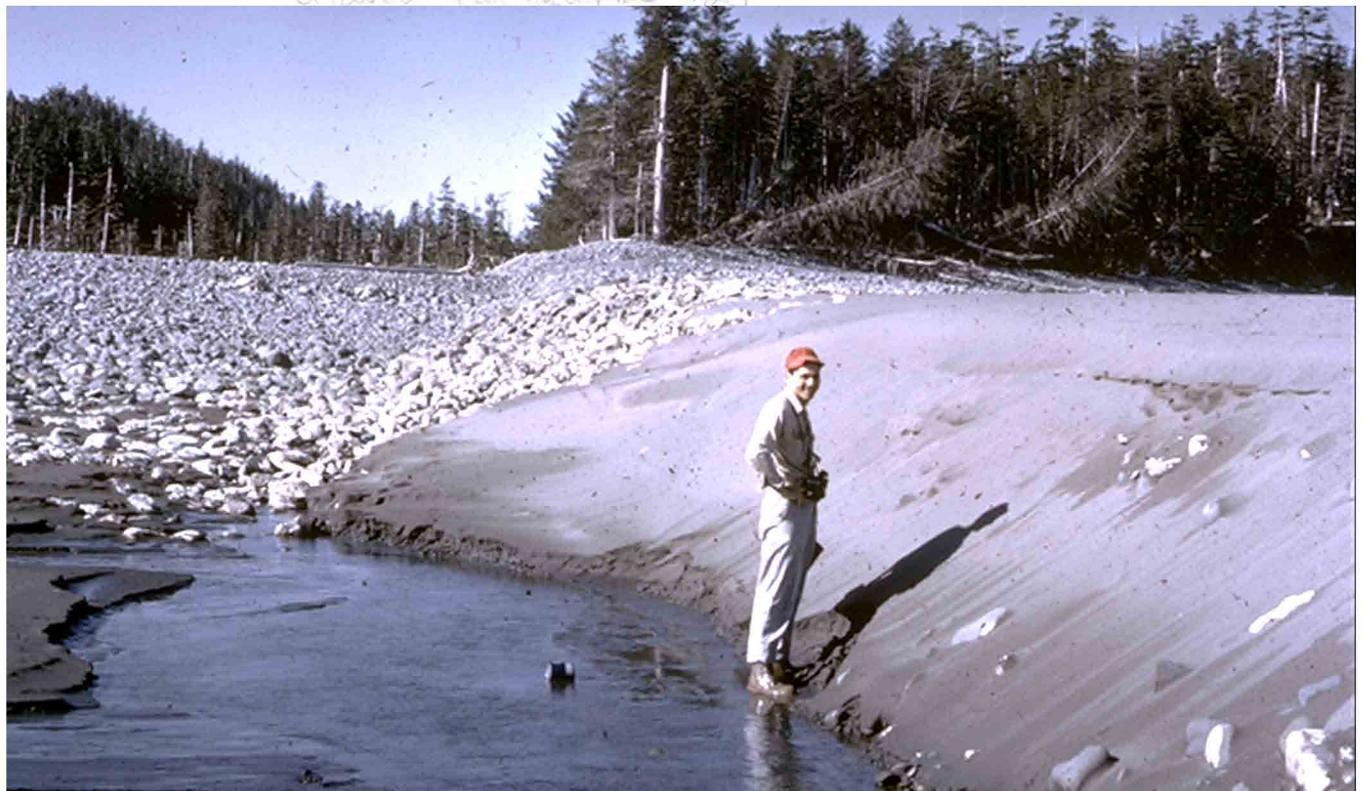
30.—View southwest along Hanning Bay fault. Scarp $8\frac{1}{2}$ feet high has displaced the elevated beach at south side of Fault Cove, and beach deposits draped across the scarp conceal the fault plane. Comparative photographs show that modification of the scarp was negligible between May 30, 1964 (above), and August 4, 1965 (below). Bottom photograph by M. G. Bonilla.

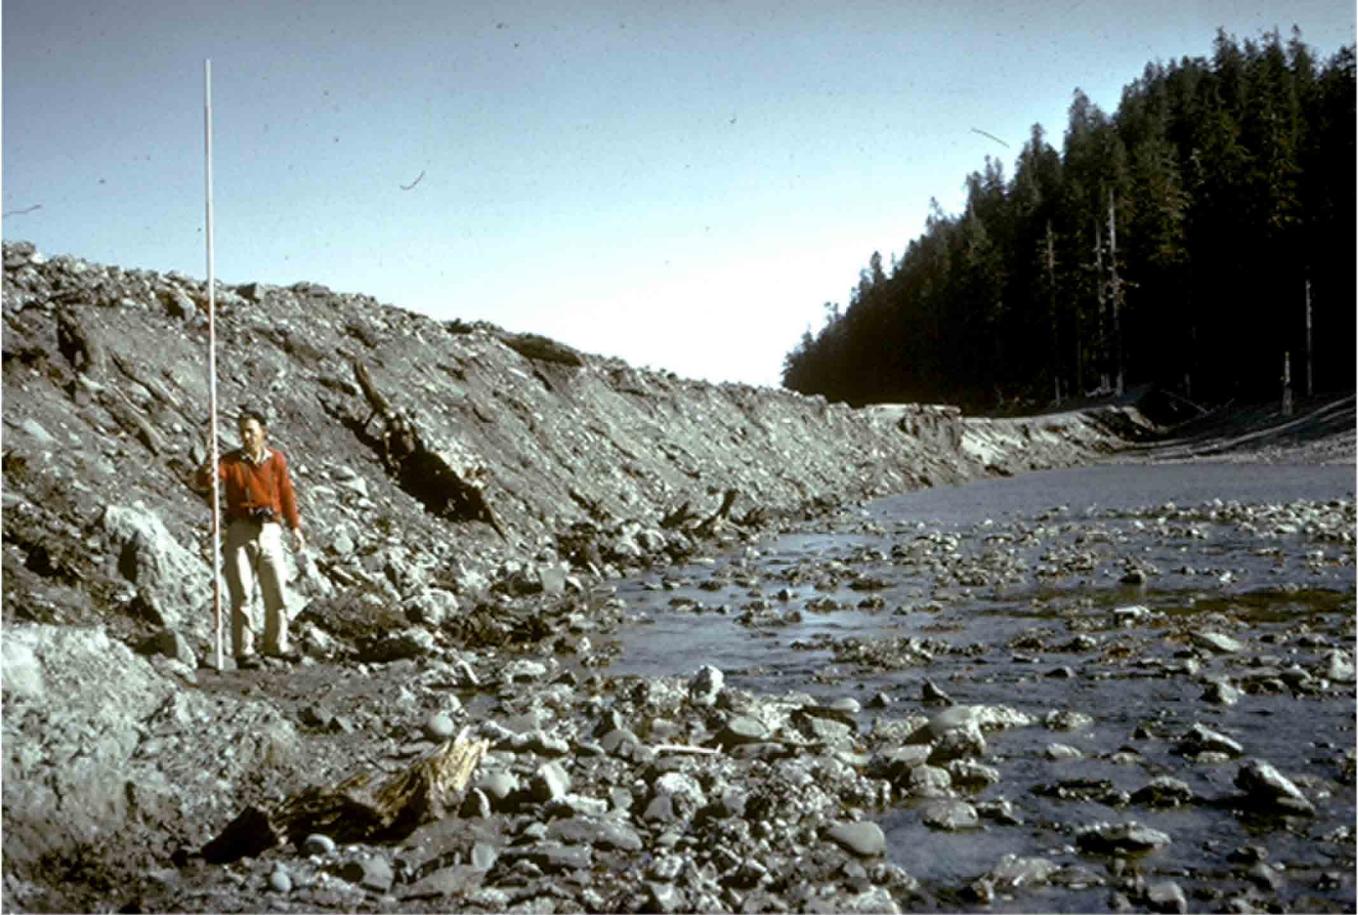
31.—Hanning Bay fault scarp $13\frac{1}{2}$ feet high in bedrock at north side of Fault Cove. The fault dips at about 55° NW. (left), but slumping along the trace has formed a scarp that is nearly vertical or dips steeply southeast. The slumping process is accelerated by erosion along the base of the uphill-facing scarp. Location shown in figure 34.

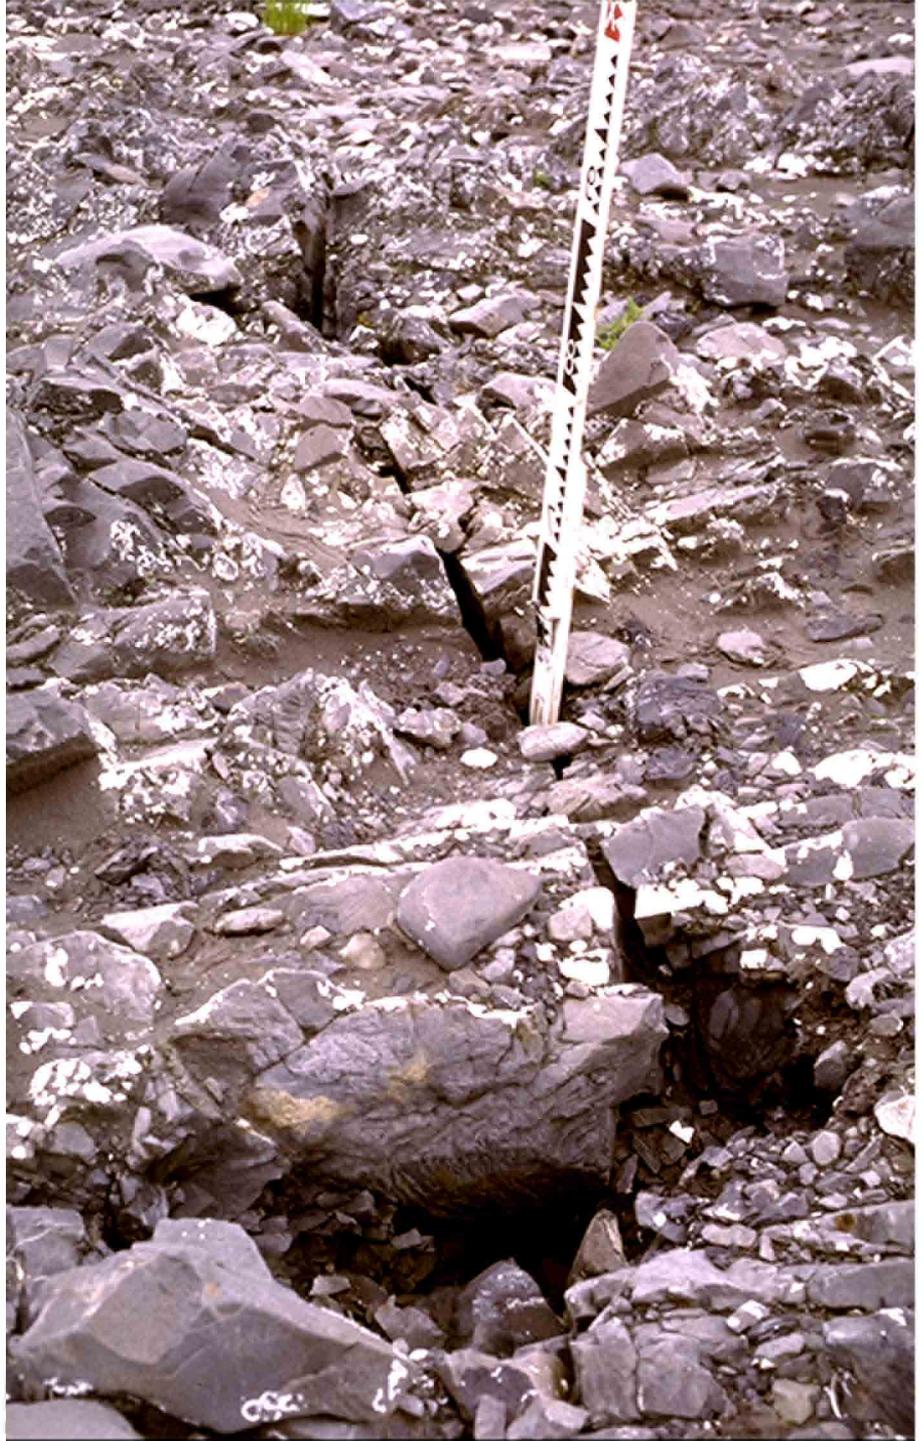
33.—Near-vertical extension crack on uplifted block of Hanning Bay fault at Fault Cove. Crack is 0.2 foot wide and at least 7 feet deep. Hole in foreground is caused by local caving at the intersection of two cracks. Location shown in figure 34.

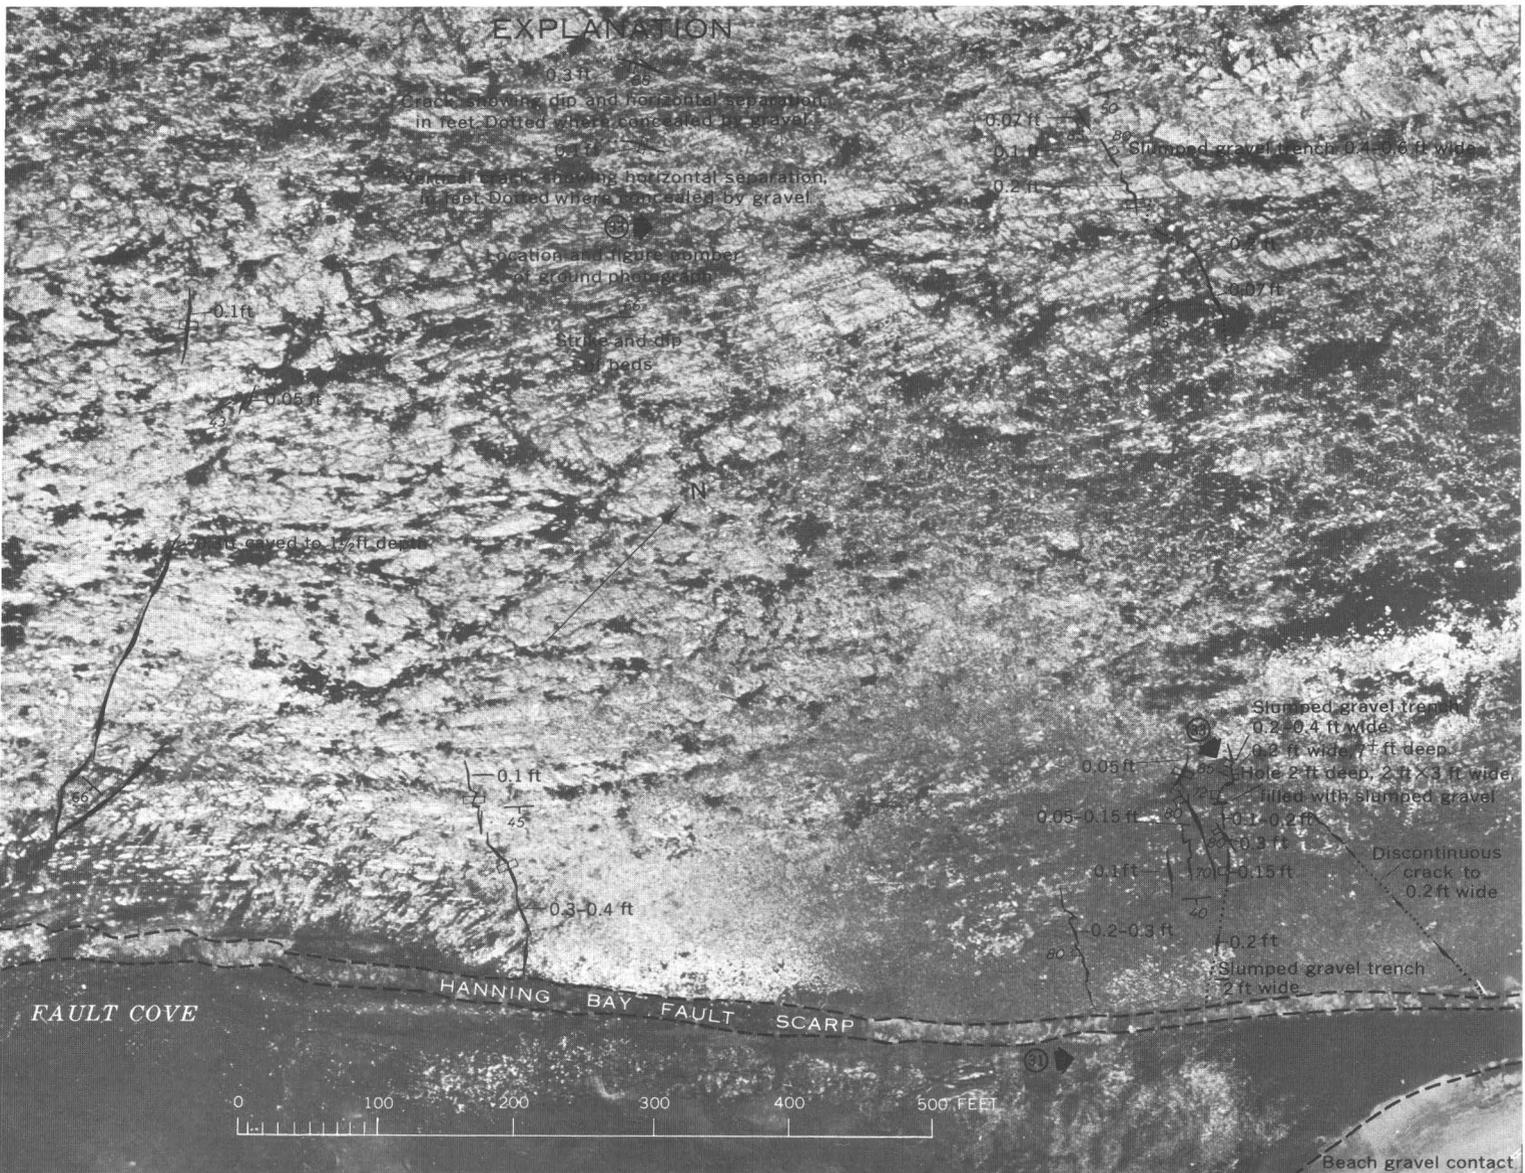
34.—Sketch map of the larger tectonic cracks in the upthrown block of the Hanning Bay fault at Fault Cove. Numerous smaller cracks in the same general area are not plotted. Location of photograph is shown on plate 2. Geology by M. G. Bonilla and George Plafker August 1, 1965. Base photograph by U.S. Coast and Geodetic Survey, July 28, 1964.

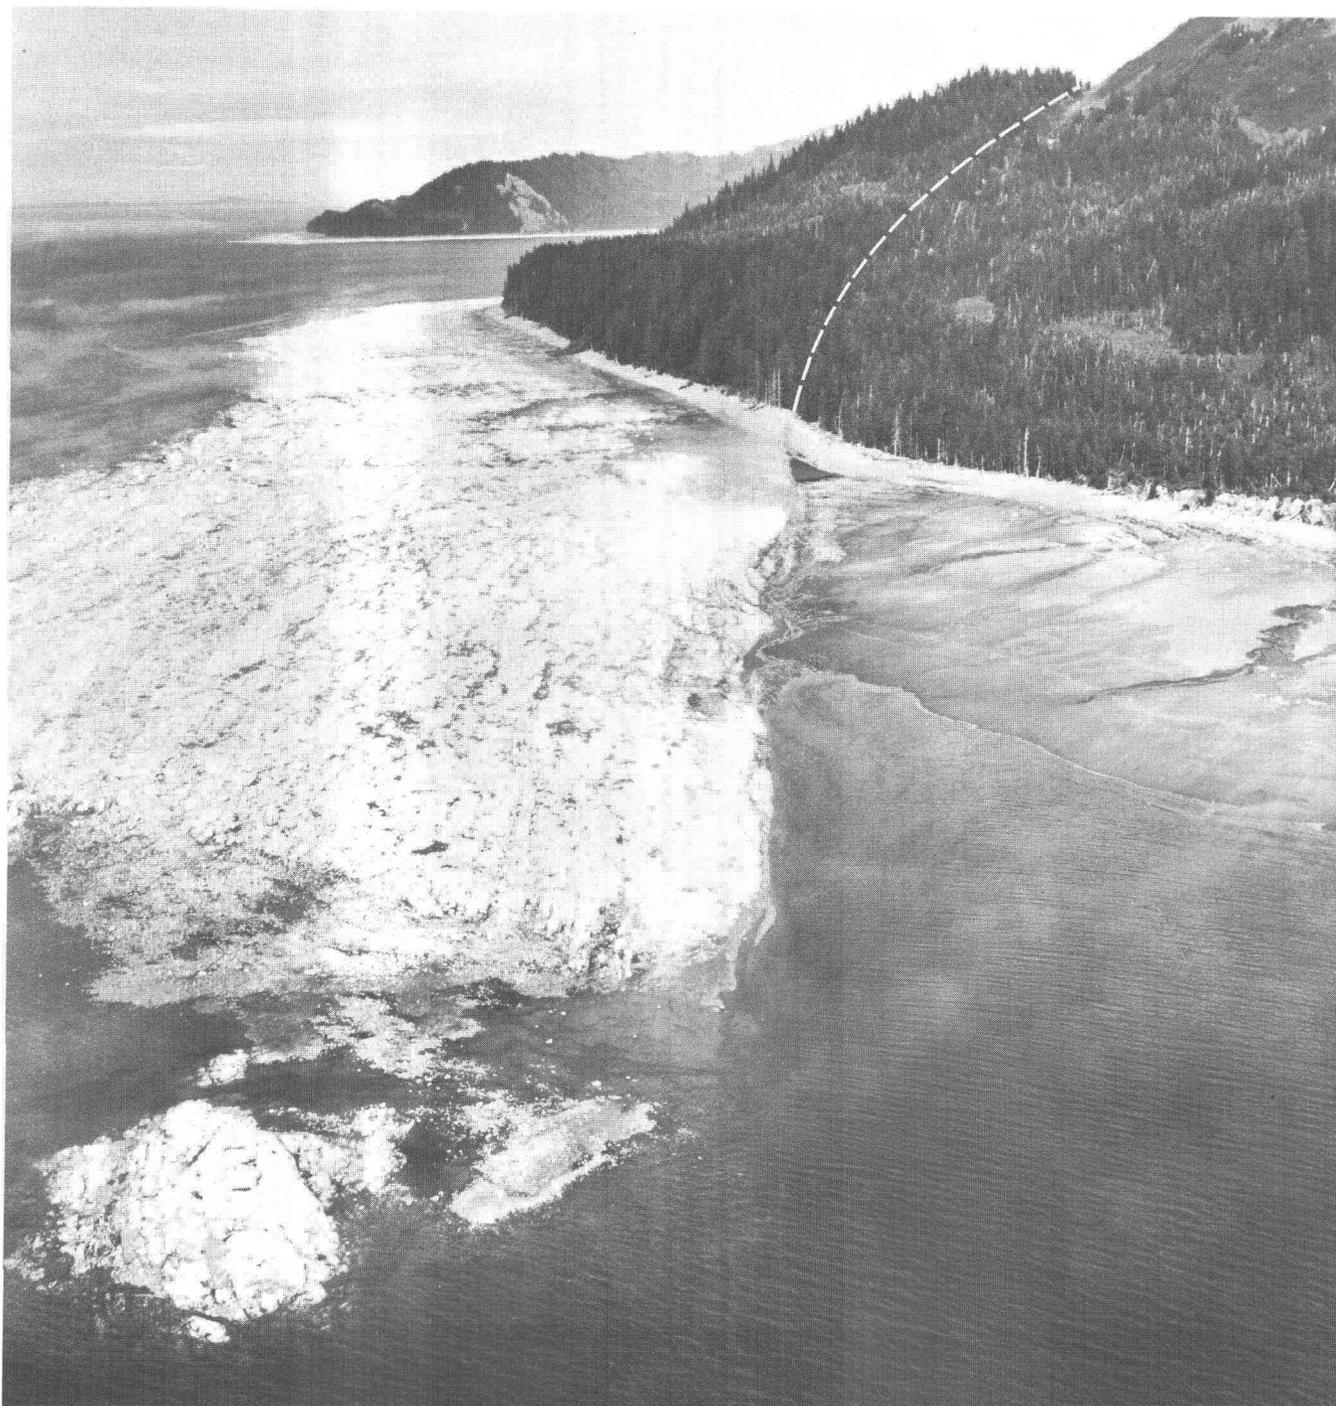
35.—Hanning Bay fault north of Fault Cove. The average 65° -NW. (left) dip of this segment of the fault causes the trace (dashed) to be deflected uphill (right) as it crosses the 850-foot-high ridge between Fault Cove and Hanning Bay. The pond, at the intersection of the fault scarp and the former beach ridge, occupies a closed tectonic depression in the downthrown block.

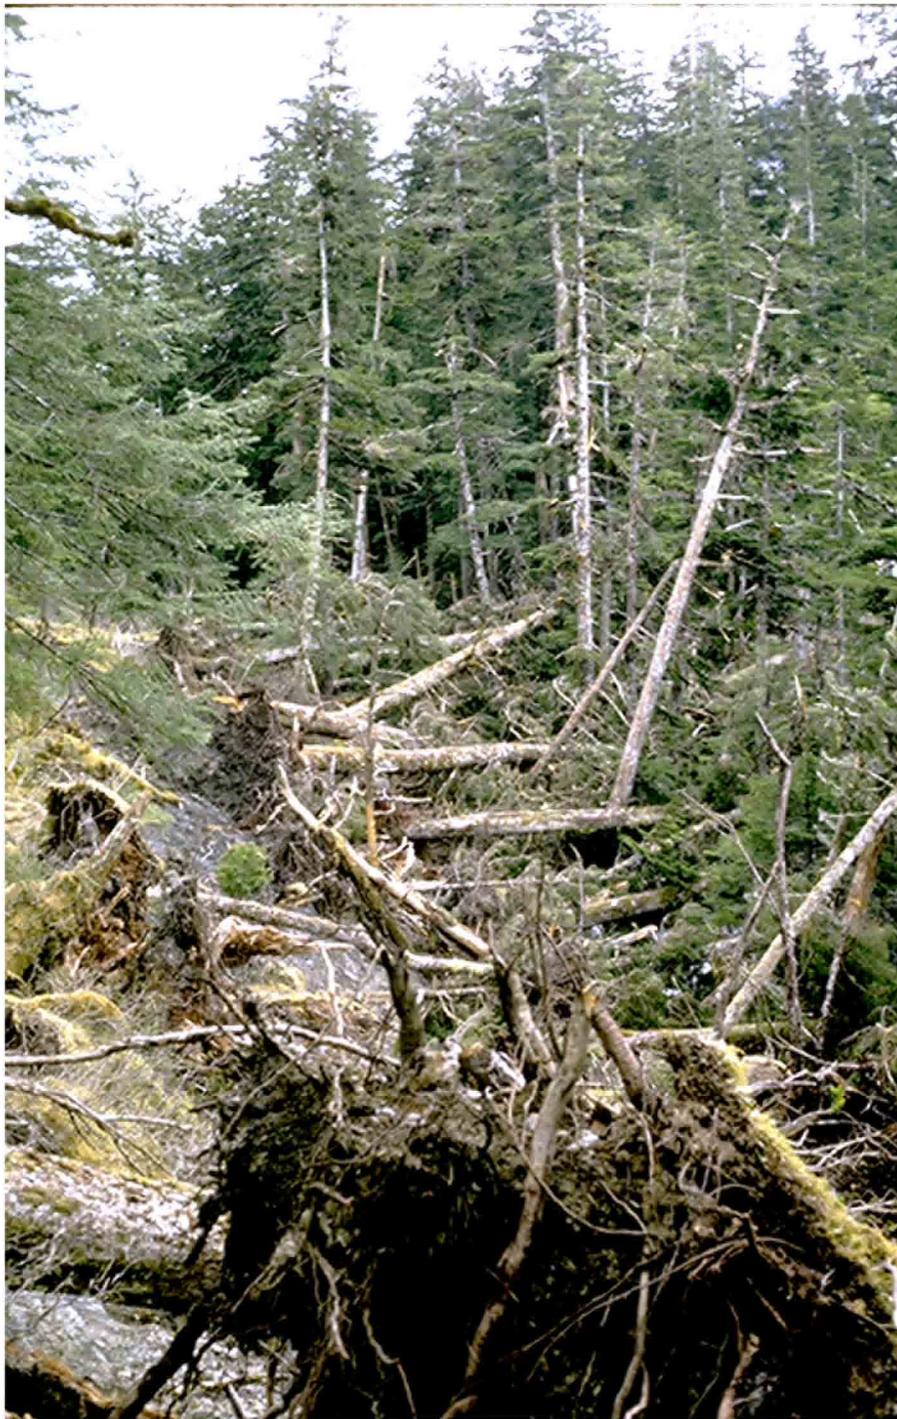
36.—A typical swath of tilted and fallen trees in timbered areas along the Hanning Bay fault. The upthrown block was overthrust from left to right.

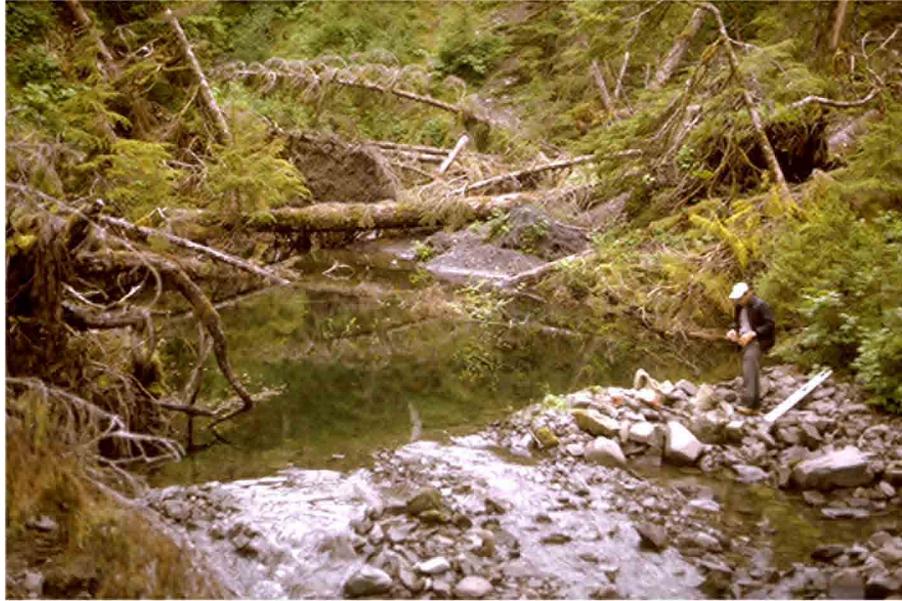
37.—Pond more than 10 feet deep formed where a stream flows across the uphill-facing fault scarp (arrows). Streamflow is toward the observer. Rubble and tangle of fallen trees slid from the steep valley walls.

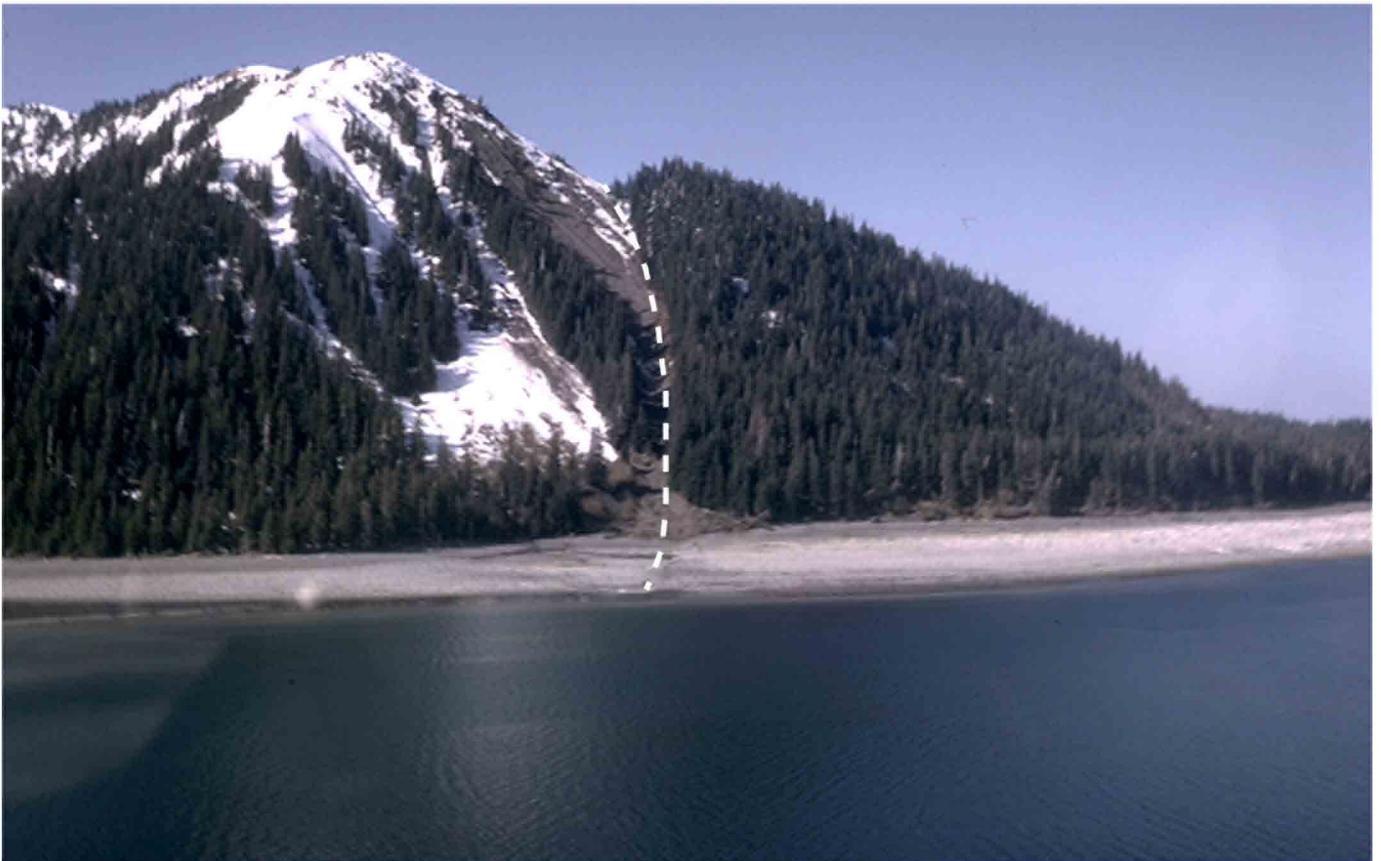
38.—Hanning Bay fault looking southwest from the bay. The fault trace on the ridge is marked by active landslides.

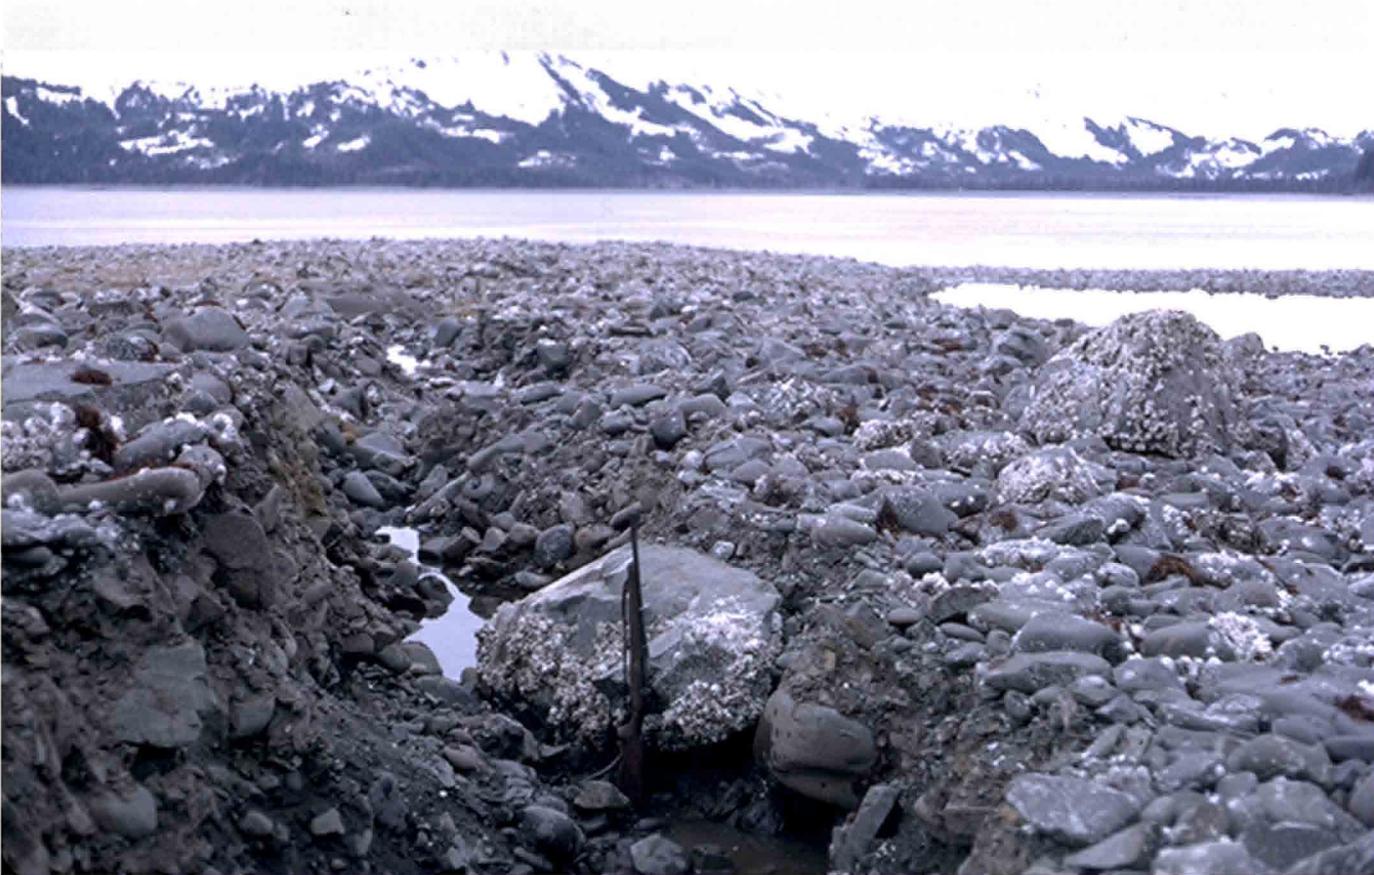
39.—Flexure and scarp with net vertical displacement of 7 feet in boulder-gravel beach along the Hanning Bay fault at south shore of Hanning Bay. Scarp 4 feet high in foreground is at the upper margin, and pond at right side of view is dammed against the base. The fault does not reappear on the north shore of Hanning Bay, which is visible in the background.
