THE ALASKA EARTHQUAKE, MARCH 27, 1964:
EFFECTS ON THE HYDROLOGIC REGIMEN

Effects of the March 1964 Alaska Earthquake On the Hydrology Of the Anchorage Area

By ROGER M. WALLER

GEOLOGICAL SURVEY PROFESSIONAL PAPER 544-B

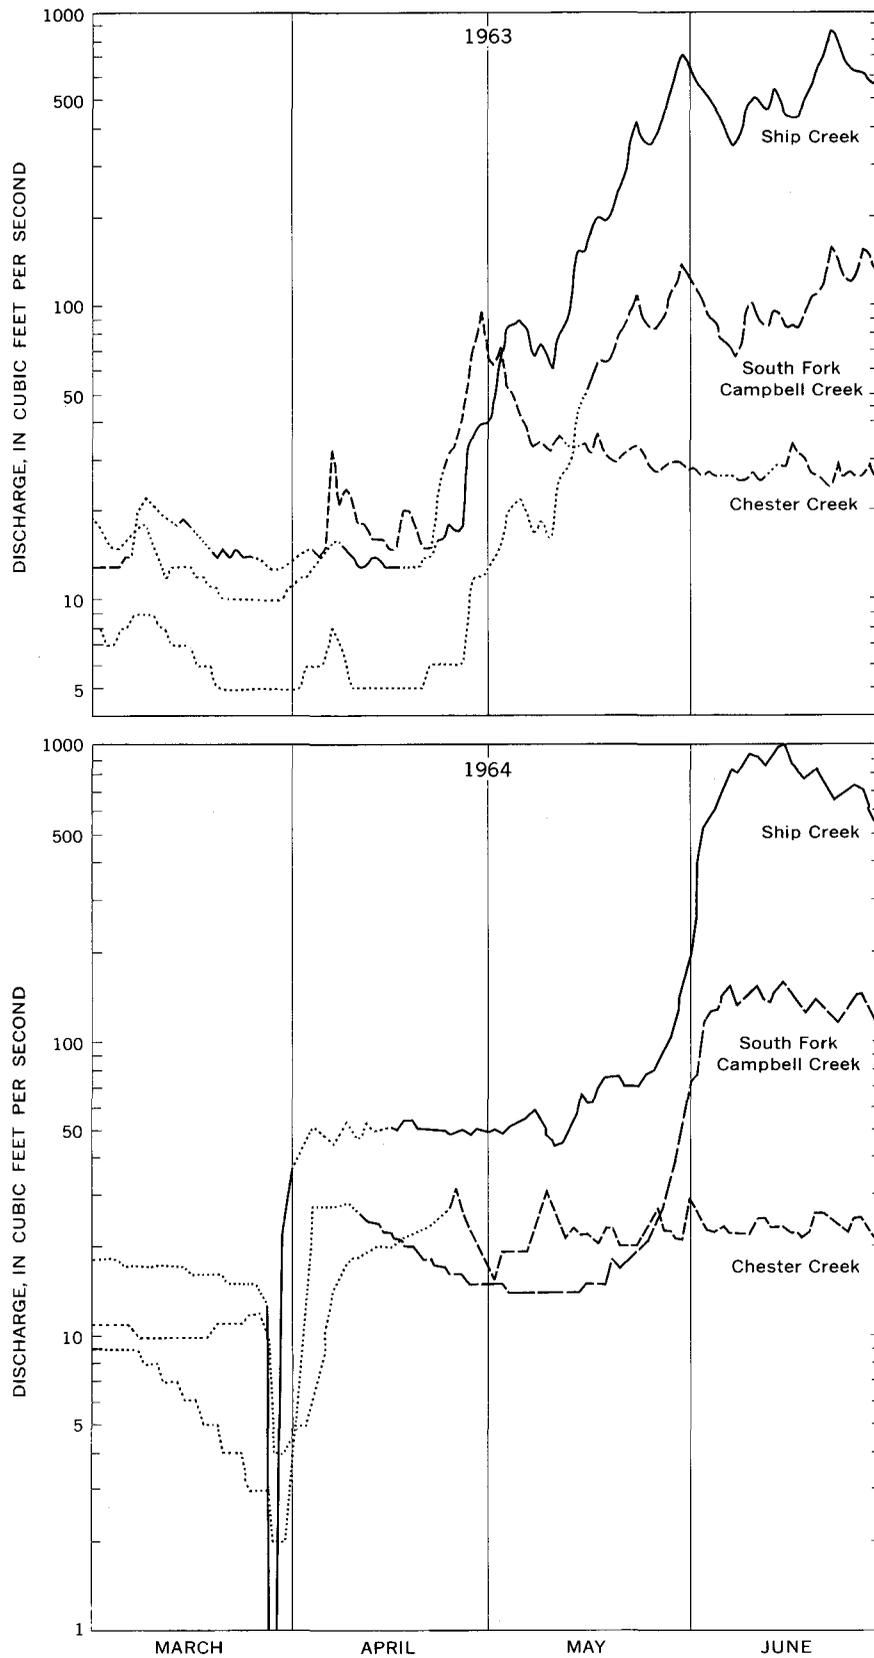
The discharge of Ship Creek, South Fork Campbell Creek, and Chester Creek during the periods March-June in 1963 and 1964, respectively, is shown by hydrographs (fig. 1). The 1964 discharge pattern differs from the discharge pattern for 1963 and indeed for the preceding 10 years. For example, the prequake discharge of Ship Creek was about 15 cfs (cubic feet per second). After recovering from the effect of the snowslide, discharge in-

creased abruptly and reached a plateau at about 50 cfs. This rate of flow was maintained for about 6 weeks, and then discharge increased normally as a result of increasing snowmelt in the mountains. The earthquake therefore temporarily increased the rate of discharge by about 200 percent until the normal discharge pattern was resumed.

Discharge records of the South Fork Campbell Creek show nearly the same pattern (fig. 1) as that for Ship Creek. Preearthquake discharge records for South Fork Campbell Creek are not as dependable as those for Ship Creek, but the increased flow related to the earthquake apparently was between 20 and 25 cfs. The plateau on the discharge hydrograph is similar to that of Ship Creek, and was maintained for about 6 weeks until snowmelt greatly increased the discharge. Differences between the Campbell Creek and Ship Creek hydrographs probably are dependent, at least in part, upon locations of the gaging stations (pl. 1). The South Fork Campbell Creek gage is more than 2 miles from the mountains, and within this distance the stream has cut through glacial till and has deposited an alluvial fan (Miller and Dobrovolny, 1959; Cederstrom and others, 1964), whereas the Ship Creek station fronts the bedrock mountain. Thus, the additional discharge recorded at the South Fork Campbell Creek station during the early part of April probably was derived from ground water.

1.—Hydrographs of three Anchorage streams, March-June, 1963 and 1964.

The postearthquake pattern of discharge from Chester Creek differs from that of previous years (fig. 1). The 1963 hydrograph shows the normal increase in discharge which is greater than that of Ship Creek owing to early meltwater contribution in the lowland; the two sharp peaks on the hydrograph in April illustrate this meltwater contribution. In 1964, discharge from Chester Creek did not exceed that of Ship Creek and it did not produce normal peaks. The reduced artesian pressures and the fractured ground in and adjacent to the stream both probably influenced streamflow during April and May by allowing greater loss of water through percolation to the ground.

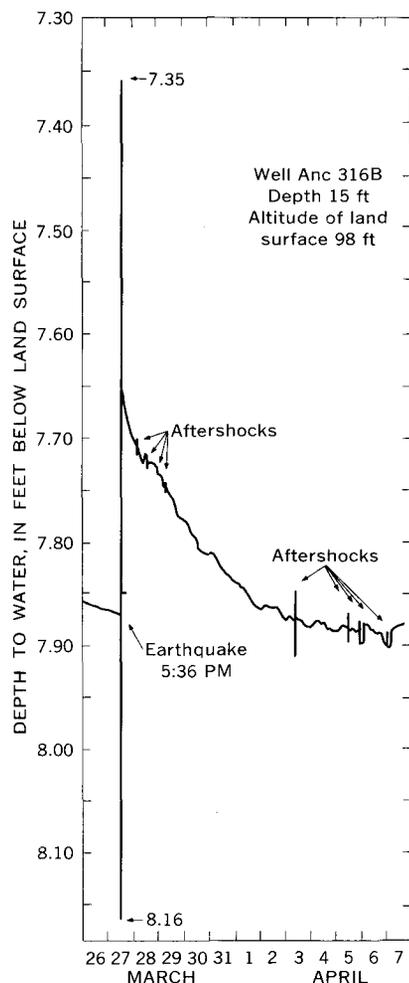
Evidence that a confining layer may determine the degree of response is provided by the record of well Anc 316B (pl. 1; fig. 10), which taps a water-bearing sand extending from 7.8 to 15 feet below the land surface. The depth of frozen ground in the vicinity of this well probably was not more than 5 feet at the time—hence, there was about 3 feet of unsaturated sand between the bottom of the frozen zone and the water table, so the aquifer was not confined. The record (fig. 2) shows that in this well the water level fluctuated less than 1 foot because there was no restrictive confining layer in the aquifer. This well is probably typical of the en-

2.—Hydrograph of water-table well Anc 316B from March 26, 1964, to April 7, 1964. (See fig. 10 for locations.)

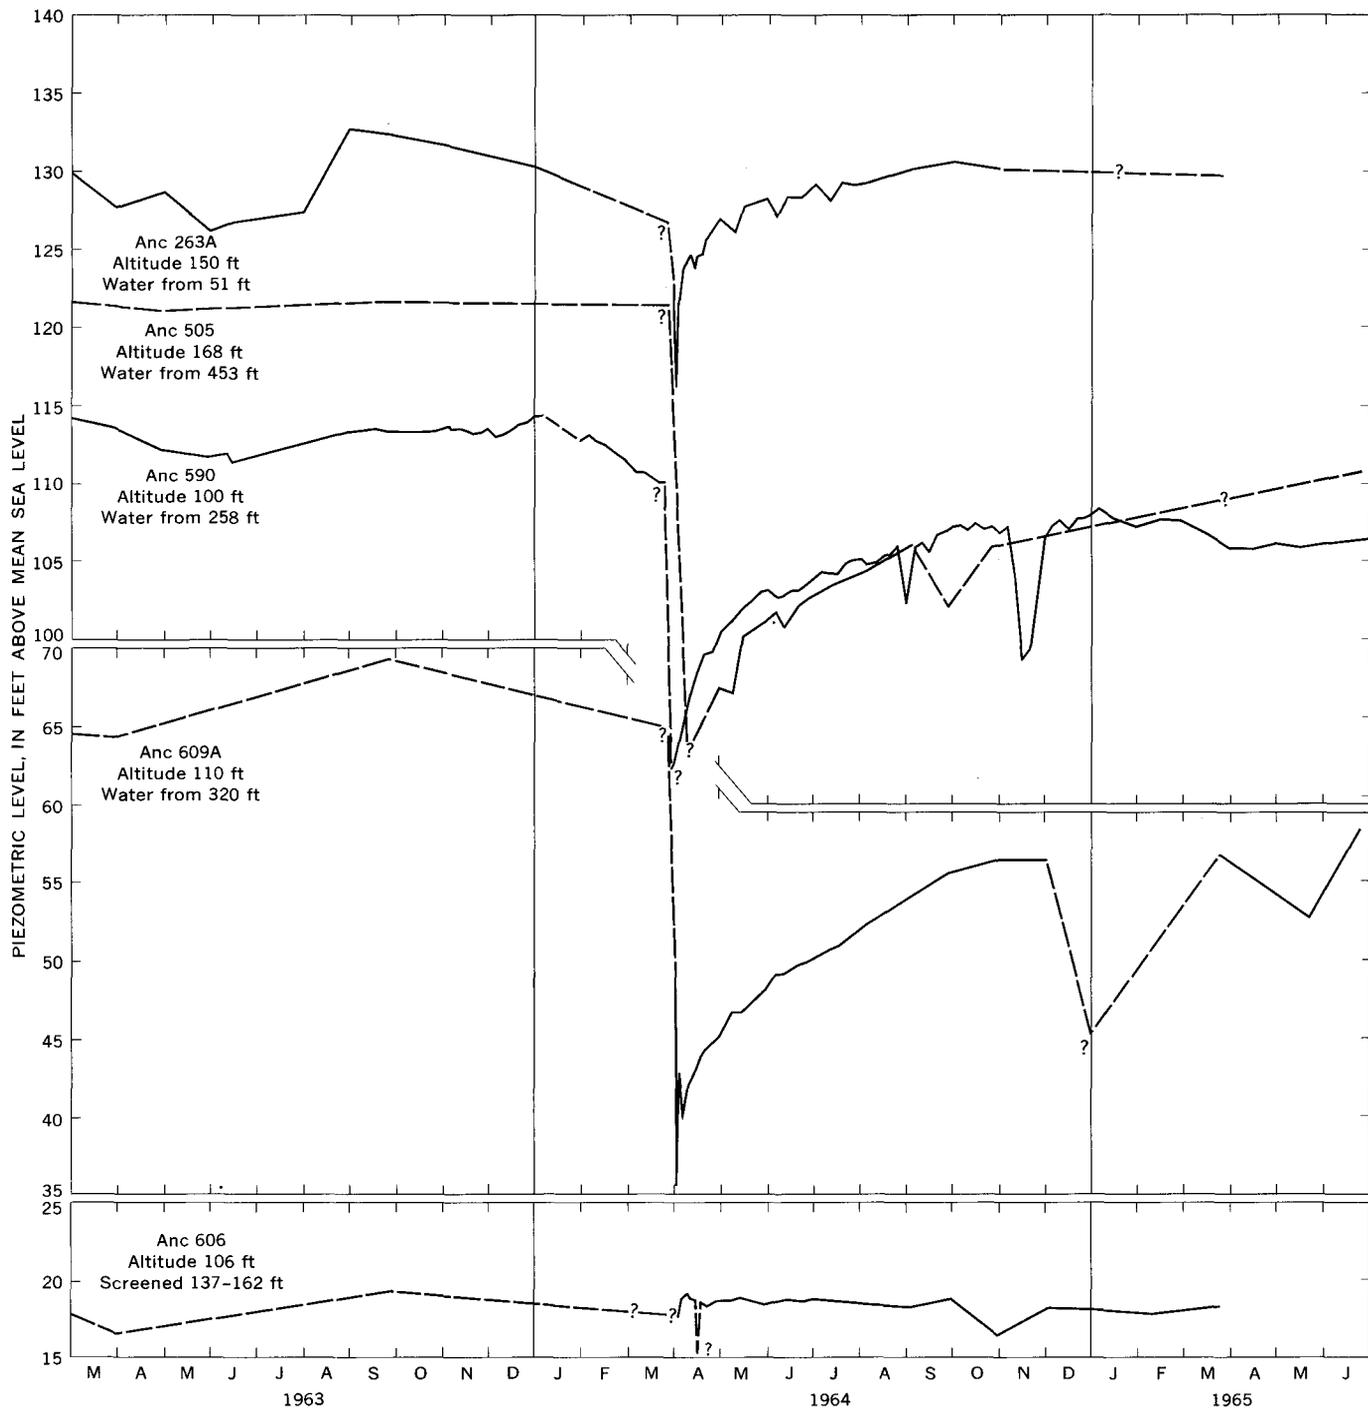
3.—Hydrographs, 1963-65, of five wells in the Anchorage area but probably outside the area influenced by pumping of city and military wells. The graphs show, by yearly comparison, the residual changes in artesian water levels after the earthquake. (See figs. 6 and 10 for locations.)

Although the hydrographs (fig. 3) are thought to represent effects on wells that are outside the area of influence of the city well field, earlier studies (Waller, 1964, p. 30) showed that the area of influence may extend 3-4 miles from the city well field. Well Anc 590 lies within this distance. Furthermore, pumping wells in a nearby housing development probably caused some of the drawdown observed in Anc 590 after the earthquake. Nearby pumping may also be responsible for as much as 8 feet of drawdown in Anc 609A and about 5 feet in Anc 263A. Water

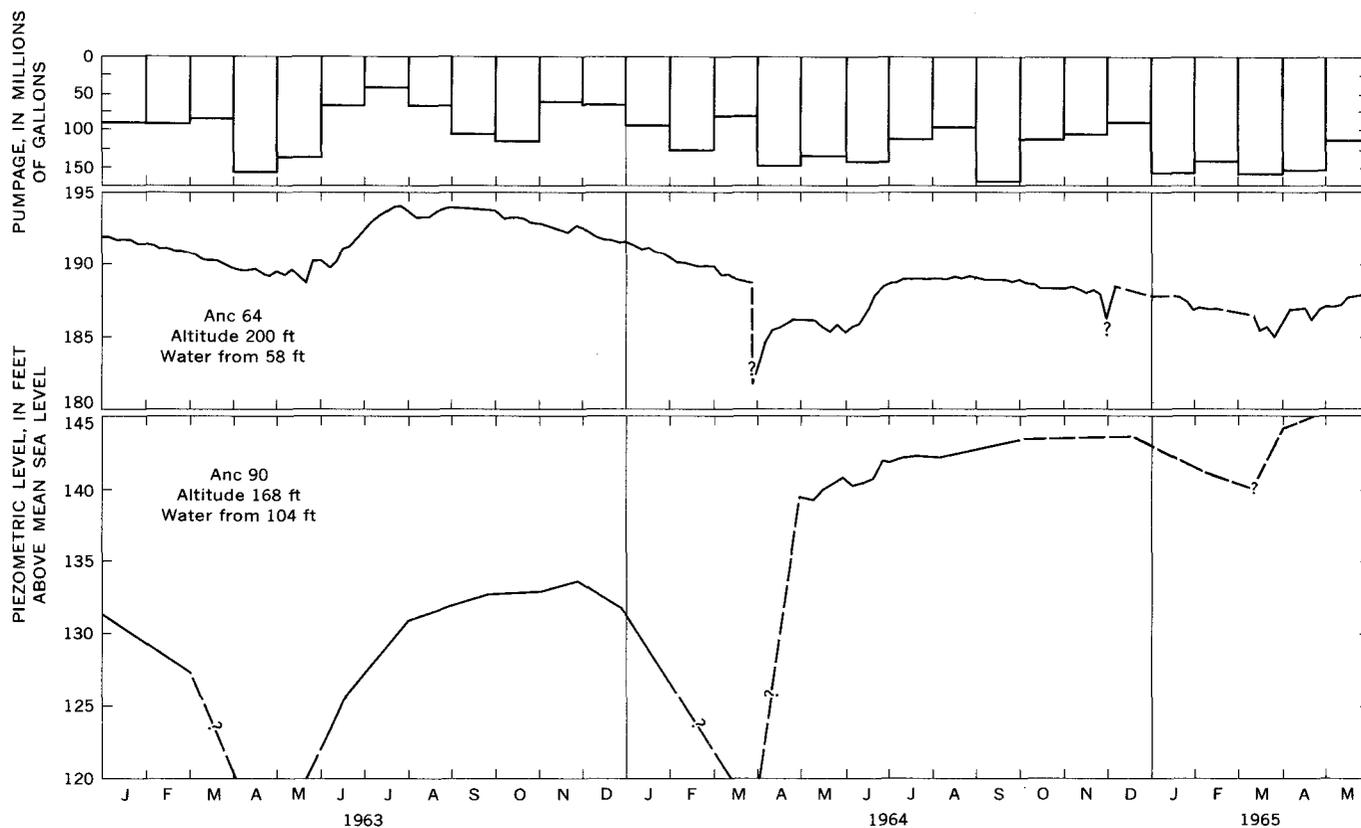
4.—Hydrographs of wells Anc 64 and Anc 90, and graph of Anchorage pumpage for 1963-65. (See fig. 6 for locations.)

Because pumping was resumed at greatly increased rates when electric power had been restored after the earthquake, the artesian-pressure levels were also greatly affected by pumping. Postearthquake pumpage and comparable preearthquake (1963) pumpage is shown on figure 4. The postearthquake increase of about 2 mgd (million gallons per day), together with increased military pumpage during April, undoubtedly extended the area of reduced artesian pressure not only far beyond the limits of effect noted during the previous year, but also beyond that determined in an earlier study when total pumpage was about 8 mgd (Waller, 1964, pl. 3).

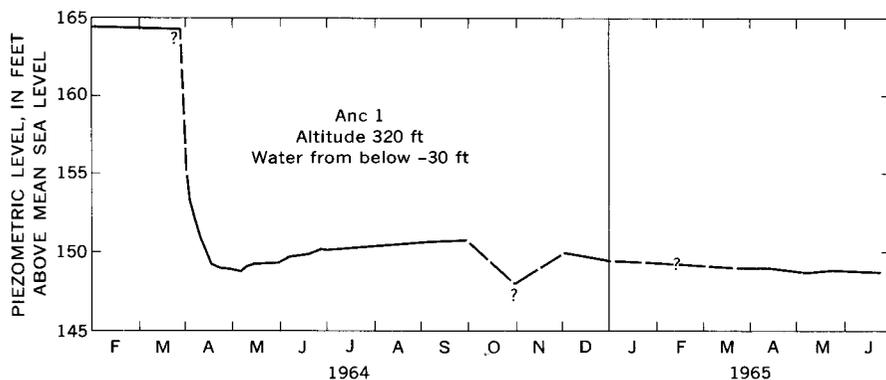
5.—Hydrograph of a well in Tertiary bedrock at Anchorage, 1964-65. (See pl. 1 for location.)

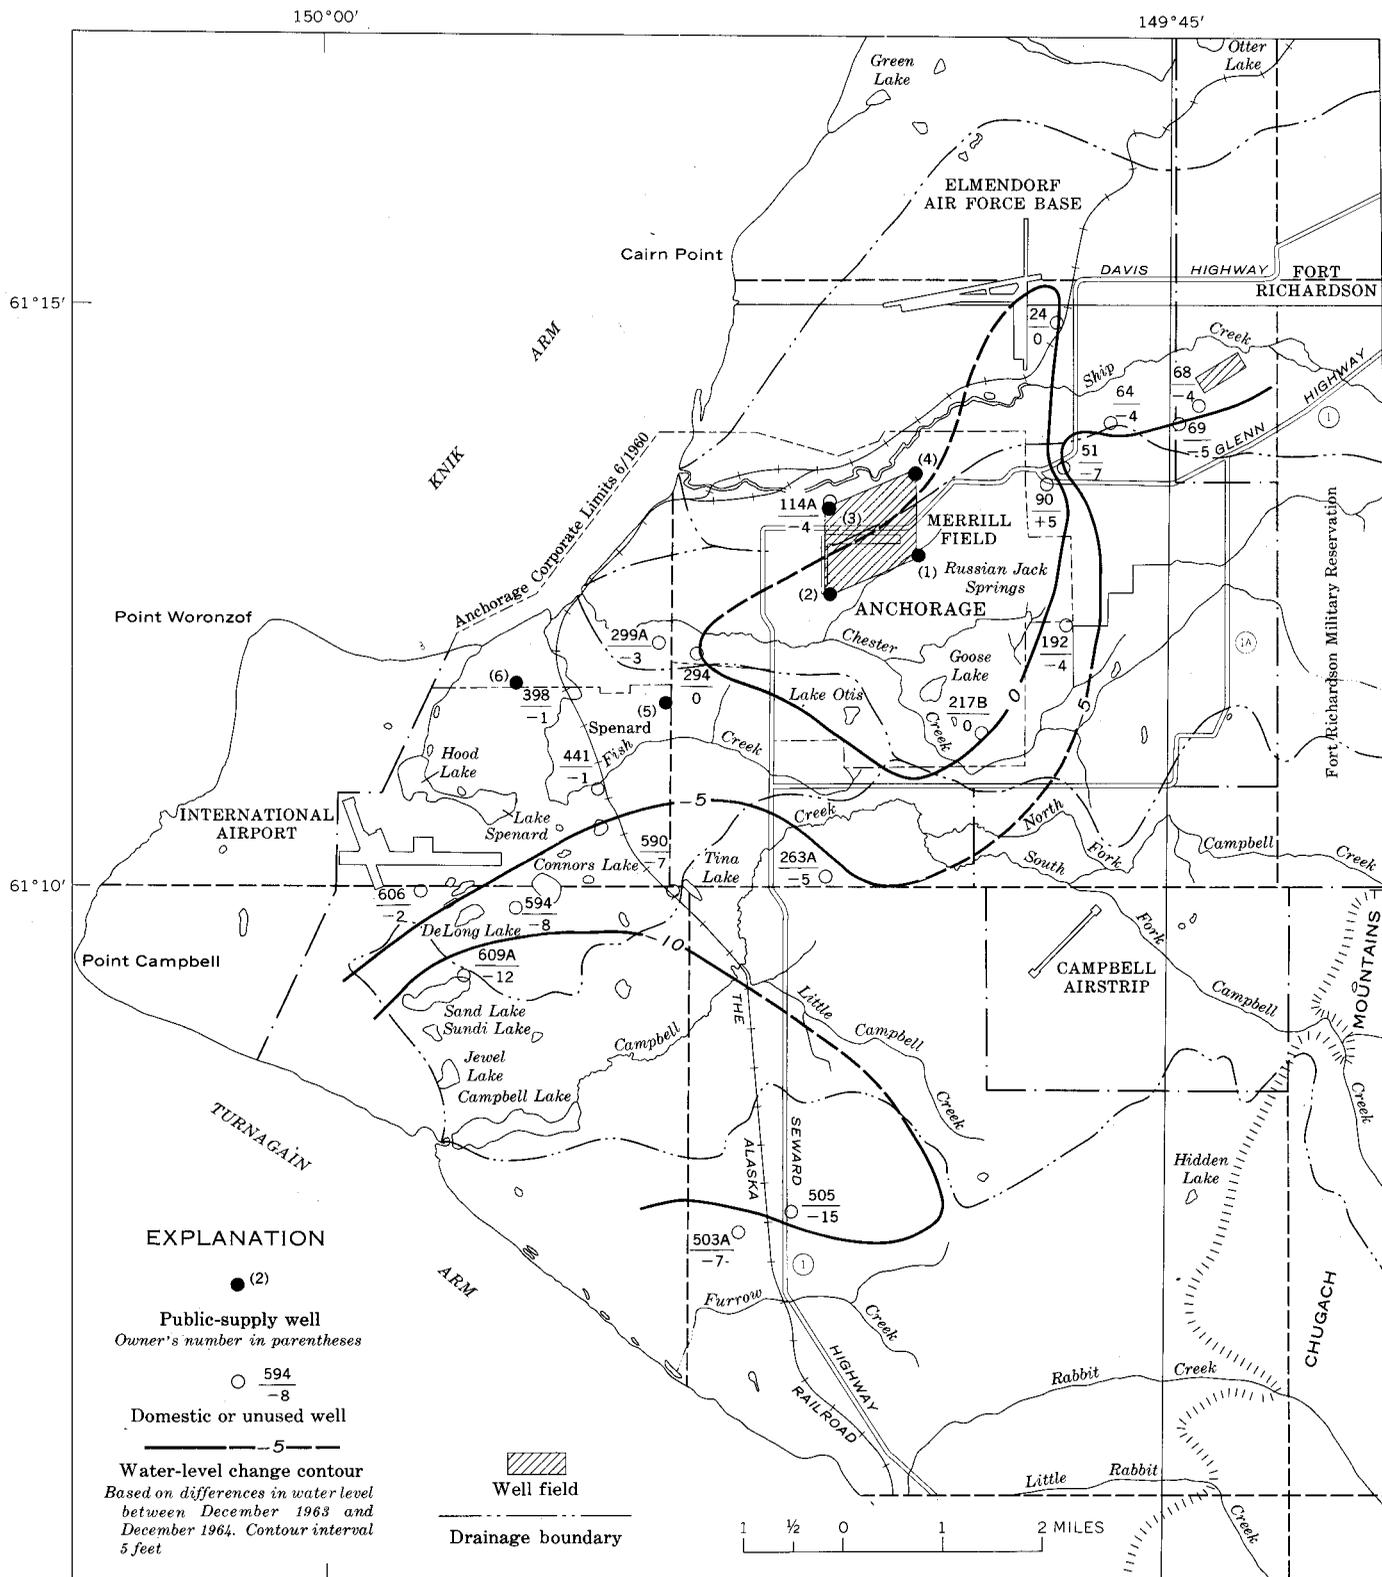
Measurements for a full year after the earthquake showed that the general lowering of the artesian-pressure level in the Anchorage area persisted. The pattern of seasonal fluctuation remains as it was before the quake. Thus, recharge to the system occurs at the same time of the year, and discharge from the aquifers continues as before. The areal distribution of water-level changes is plotted on figure 6.

6.—Areal distribution of artesian-pressure changes in the Anchorage aquifer system. Numbers above line are well numbers; numbers below line are changes in water level, in feet.

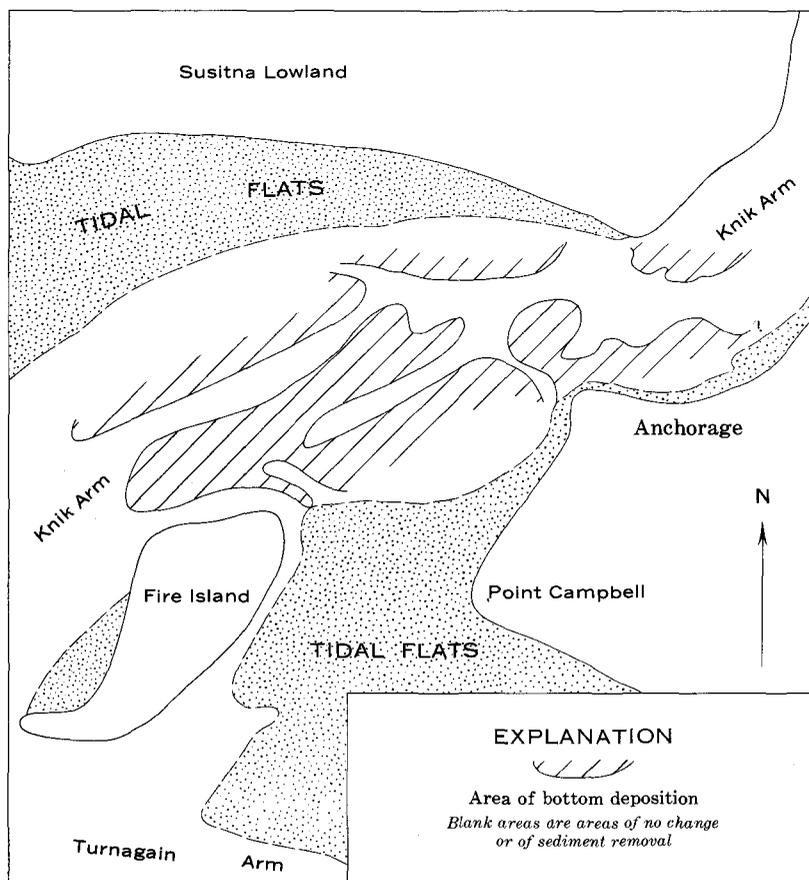
There is no direct evidence that the earthquake caused the redistribution of bottom sediments in Knik Arm as indicated in figure 7. The well-known effects of seismic waves upon unconsolidated water-saturated materials, especially those resting on unstable slopes, suggest, however, that the redistribution was indeed caused by the quake.

7.—Changes in distribution of bottom sediments in the Knik Arm of Cook Inlet, 1963–64. Plotted by T. N. V. Karlstrom from U.S. Coast and Geodetic Survey data.

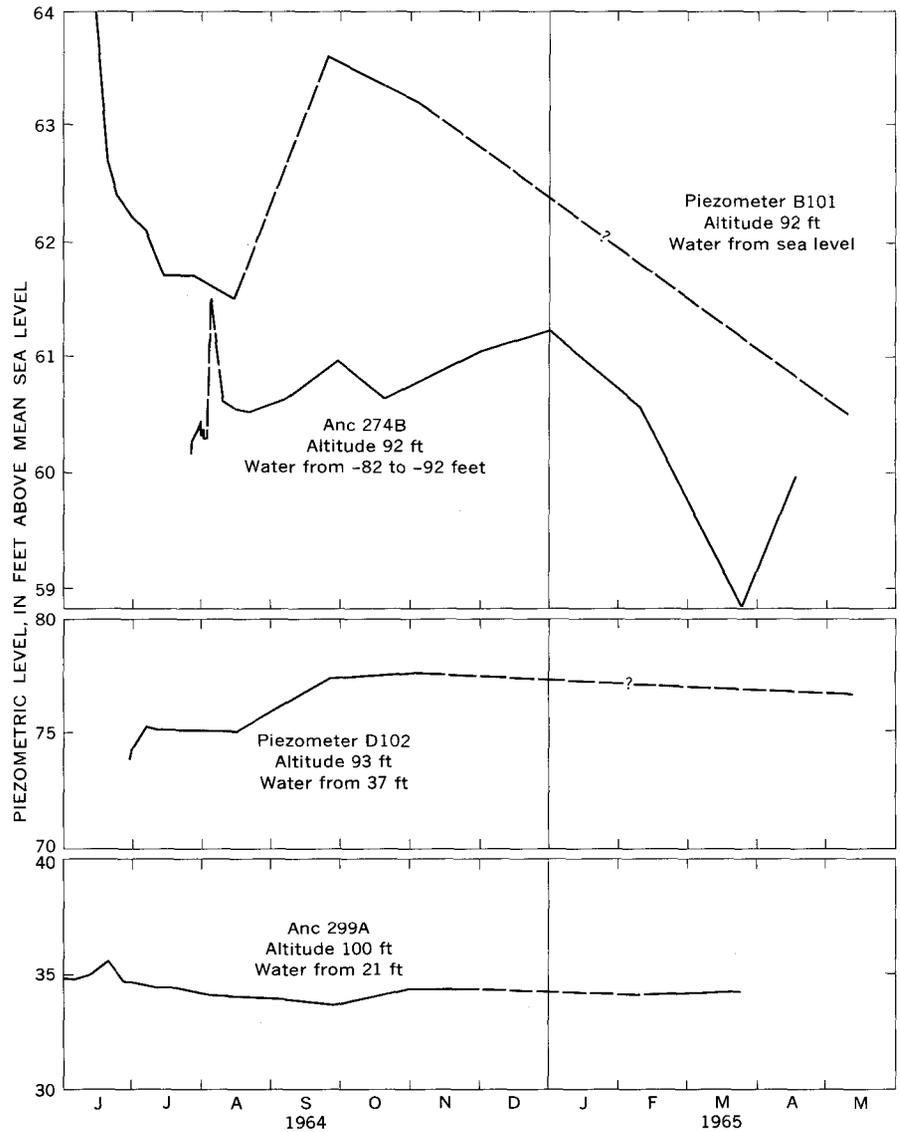
8.—Hydrographs of pore pressures (piezometers B101 and D102) versus artesian-aquifer pressures (wells Anc 274B and 299A) at sites near the West High School and L Street slides. (See fig. 10 for locations.)

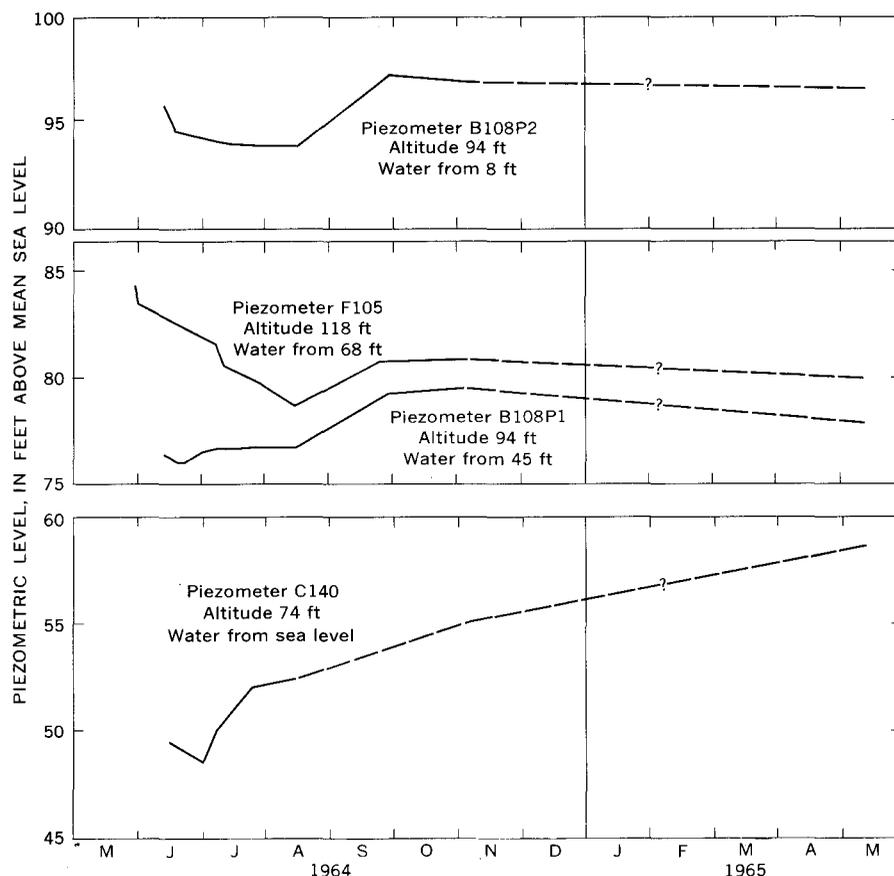
1964) until August 1964. Since then, the Geological Survey has measured the pore pressures in most of the piezometers at irregular intervals. Pore pressures generally decreased in the months following the earthquake, but there was little uniformity. The pressures varied from stratum to stratum within the formation and from place to place at equivalent depths. However, according to M. M. Marcher (oral commun., Oct. 6, 1965), pore pressures in many of the piezometers had declined to levels that were equivalent to or less than piezometric levels measured at the same time in wells tapping the main artesian aquifers of the area. This decline implies that the seismically induced pore pressures may have gradually returned to a natural state. In a few piezometers, however, pore pressures remained significantly higher than the artesian-aquifer piezometric level. The possibility exists that those high readings reflect piezometer tubes that are plugged. Figure 8 shows a possible correlation of pore pressures and piezometric levels of artesian aquifers at two sites. The patterns of representative pore-pressure fluctuations from June 1964 to May 1965 are shown in figure 9.

9.—Hydrographs of piezometer observations from June 1964 to May 1965. (See fig. 10 for location.)

Reduction of pore pressures in the Bootlegger Cove Clay is being attempted by partial dewatering of the formation in areas where pressures are relatively high and the danger of future land-

slides is great. Dewatering is presumably desirable for engineering stability, but it may affect adversely the ground-water supply of the Anchorage area. If the formation is dewatered by pumping the sand and gravel aquifers

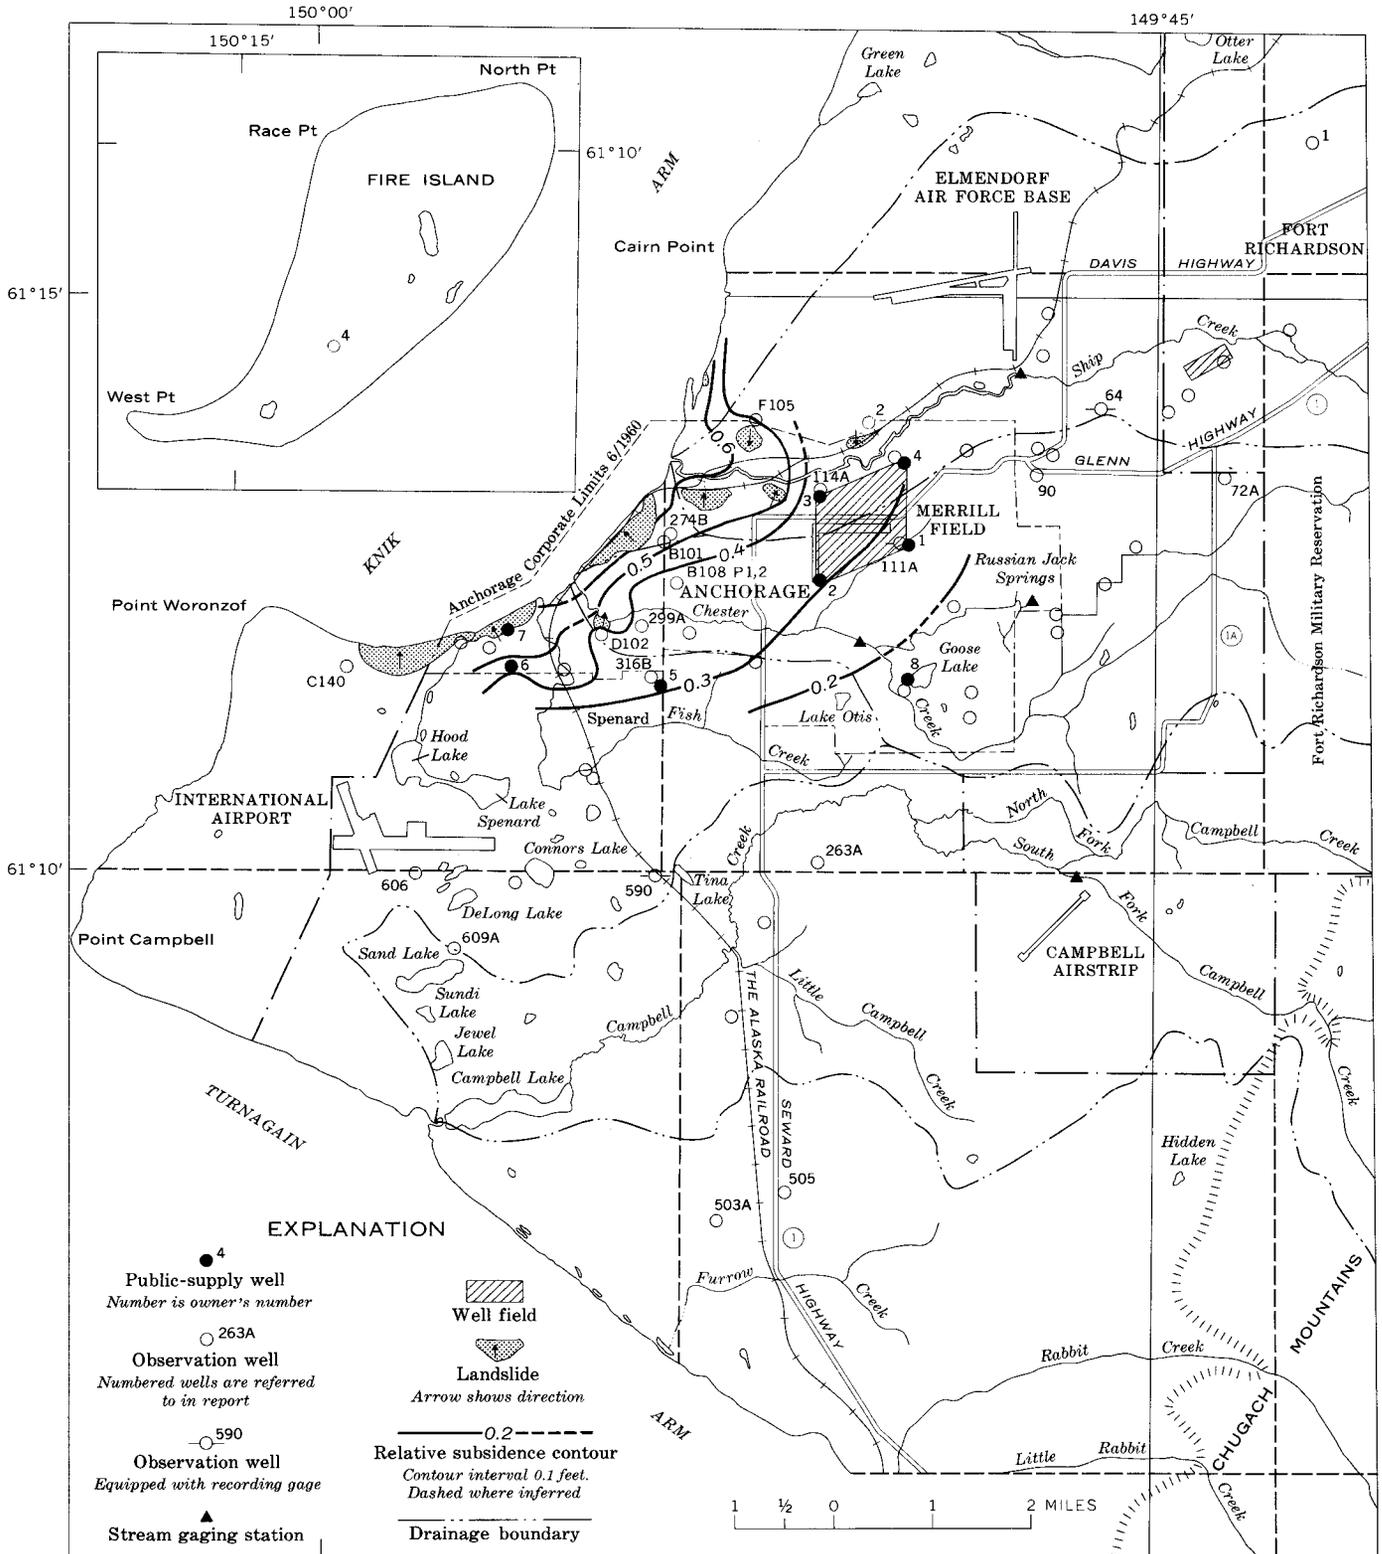
Anchorage lost three wells (The Johnson National Drillers' Journal, 1964). At well 1 (fig. 10) the casing was bent when artificial fill failed, but the well was repaired. Well 7 at the edge of the Turnagain slide was damaged beyond repair. Well 6 was abandoned because of its low yield.

10.—Map showing relative subsidence, landslides, and well locations in Anchorage.

The parallelism of contour lines showing differential subsidence to the bluff line (fig. 10) suggests that the compaction occurred in the fine sand and silt lenses in the Bootlegger Cove Clay, including those associated with the landslides, and the slide investigations showed that liquefaction did take place in these lenses (Shannon and Wilson, Inc., 1964). According to Terzaghi's (1956) description of the process of compaction during liquefaction and slope failure,
