The Alaska Earthquake

Eklutna
Power Project

Effect of the Earthquake
Of March 27, 1964, on
The Eklutna Hydroelectric
Project, Anchorage, Alaska

GEOLOGICAL SURVEY PROFESSIONAL PAPER 545-A

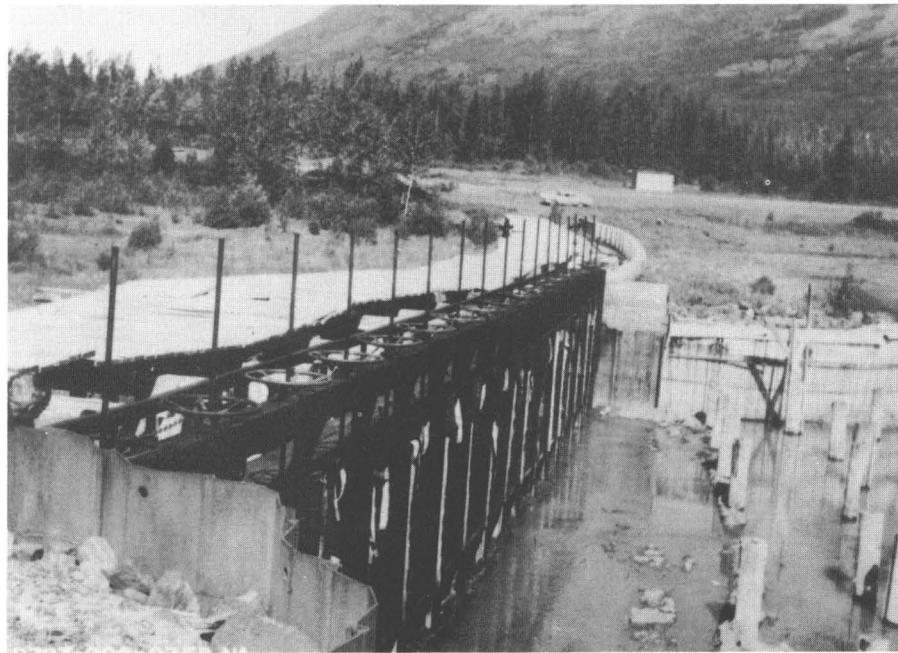
5.—Spillway gate structure.

gate structure (fig. 5) began to subside into the underlying void. This movement did not take place to any noticeable extent until early in July 1964. At this time, two cracks approximately 1 inch wide formed—one in the base of the spillway slab and one in the sill of the gate structure. In addition, a large part of the spillway base slab had been deprived of foundation support by the densification that caused the void. The gate structure was then declared unsafe for impounding water. All gates were locked open, pending reconstruction of the dam.

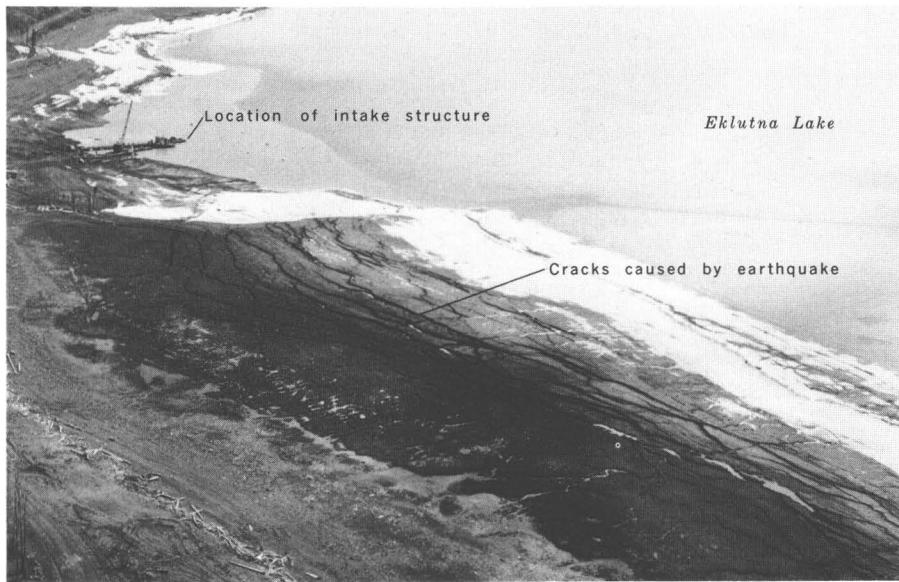
6.—View of Eklutna intake area, showing intricate network of cracks caused by the earthquake along the shore of the lake.

Earthquake-induced densification of materials in Eklutna Lake (fig. 6) caused the intake structure to move approximately 44 inches toward the lake. Principal movement was in a horizontal direction, but was accompanied by a lesser amount of vertical displacement.

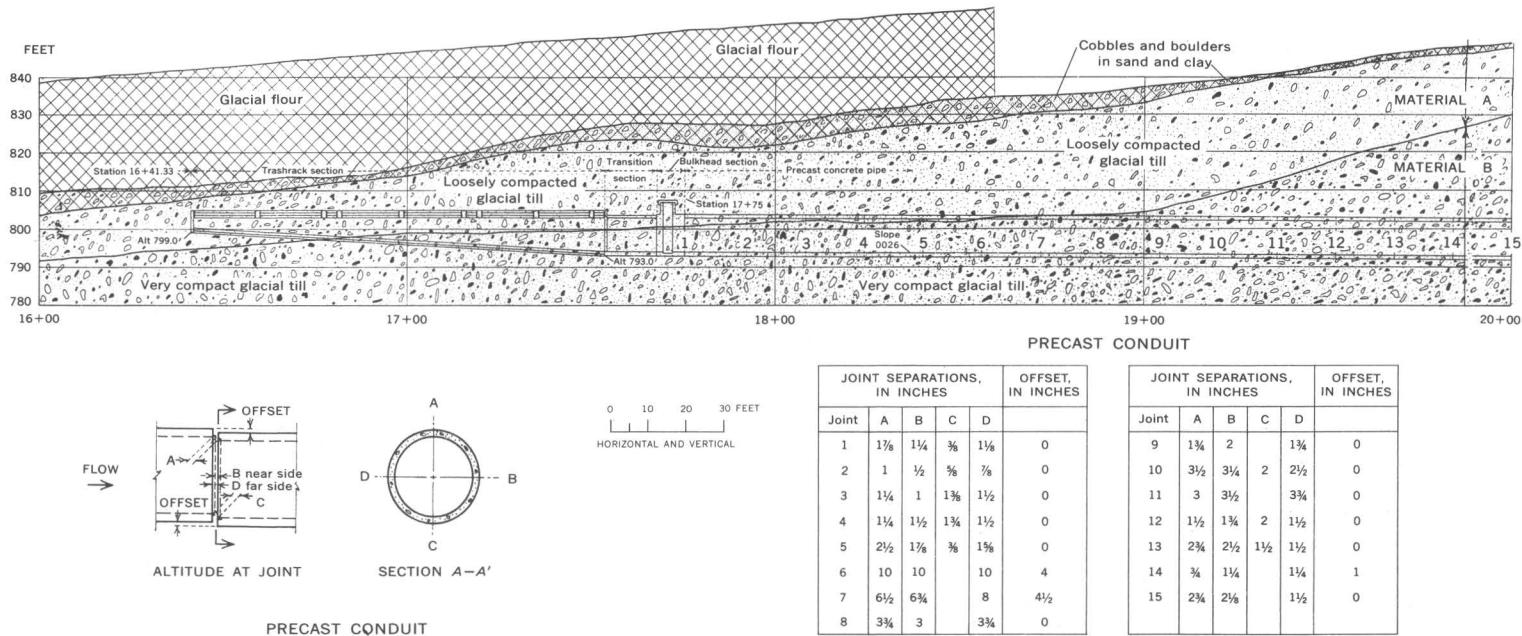
Tensional forces produced by the horizontal shift caused separation along joints in the precast conduit, as shown in figure 7. Unconsolidated sediments, ranging in size from fine sand to cobbles the size of a football, funneled through these ruptures. An elliptical cone-shaped depression, approximately 40 feet in maximum dimension, formed at the edge of Eklutna Lake over the conduit alignment near station 18+55, and numerous cracks were present along the lakeshore on either side of the conduit.

7.—Geologic section showing location of earthquake damage to intake structure. Rupturing of joints in the precast conduit occurred at the numbered locations. Amount and direction of movement is shown in the table. Failure on or within the bedding material, induced by the earthquake, is believed to have caused the damage to the intake structure. No earthquake damage in the glacial till foundation was detected.

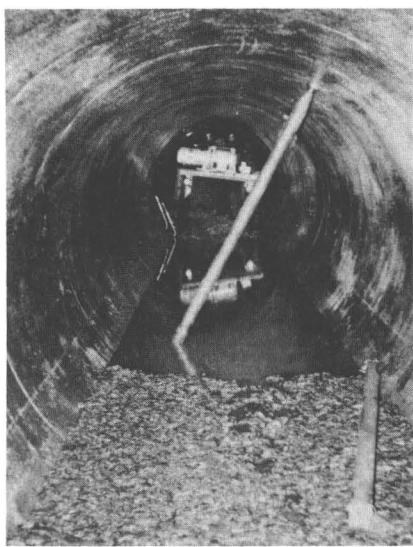
9.—Debris in Eklutna tunnel, typical of that deposited throughout the initial 3½ miles of tunnel as a result of the earthquake.

tunnel invert. The debris consisted predominantly of rock fragments 1 inch in diameter, but ranged in size from sand to an occasional fragment 14 inches across. The debris (fig. 9) was 12–18 inches deep and was uniformly distributed from the gate shaft at station 27+25 to near Station 103+00. From station 103+00 to station 235+00, debris was deposited in gravel bars of varying depths. The last mile of tunnel was relatively free of material. No structural damage to the tunnel was found.

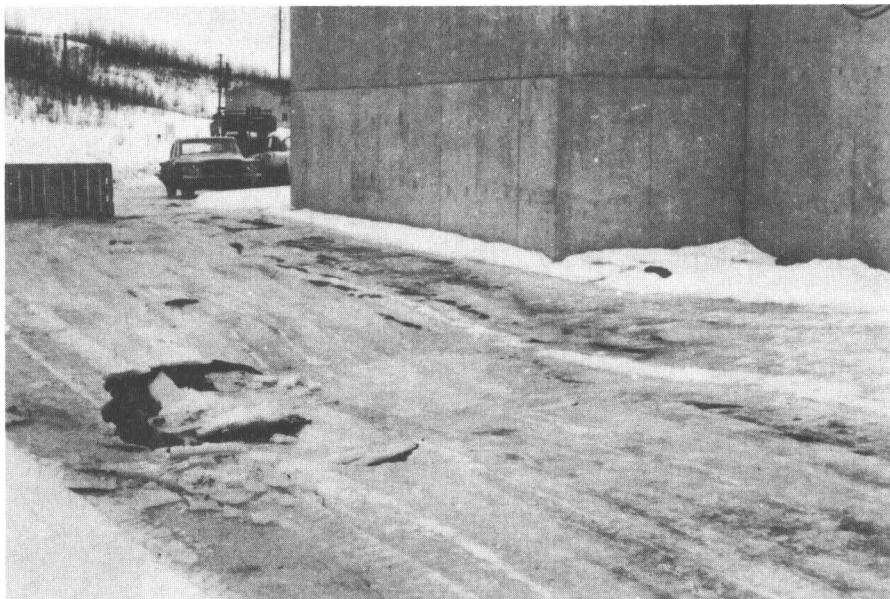
The penstock, surge tank, pile-supported anchor block, and powerhouse evidently oscillated as an integral unit during the earthquake. Very little relative movement occurred between these features although backfill in the anchor-block area subsided (fig. 13).

13 (left).—Earth settlement over the penstock anchor block directly behind the powerhouse. This settlement did not appear until 2 weeks after the earthquake. Presumably, the bridging effect of the blacktop and ground frost concealed the settlement during this period.

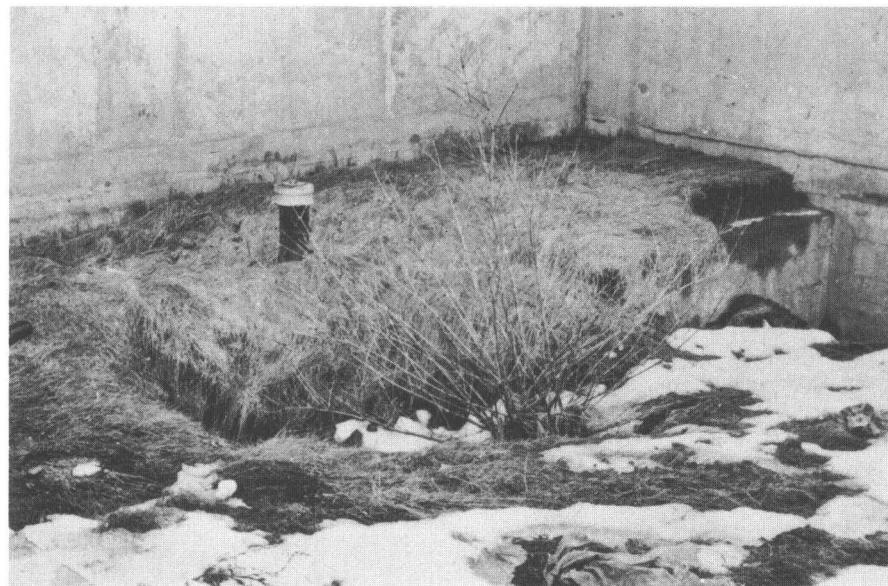
The principal area of damage occurred between the powerhouse and machine shop along the 1-inch cork-filled expansion joint. The two structures oscillated at different intensities, and the interconnecting drainage and electrical systems were sheared. The differential horizontal displacement between buildings was three-fourths of an inch, but the vertical displacement was negligible. Backfill around the entire periphery of the plant and under the machine shop settled erratically from a few inches to a few feet (figs. 17-19).

17.—Typical ground settlement resulting from the earthquake. Settlement is near the northeast corner of the powerhouse at the location of the septic tank.

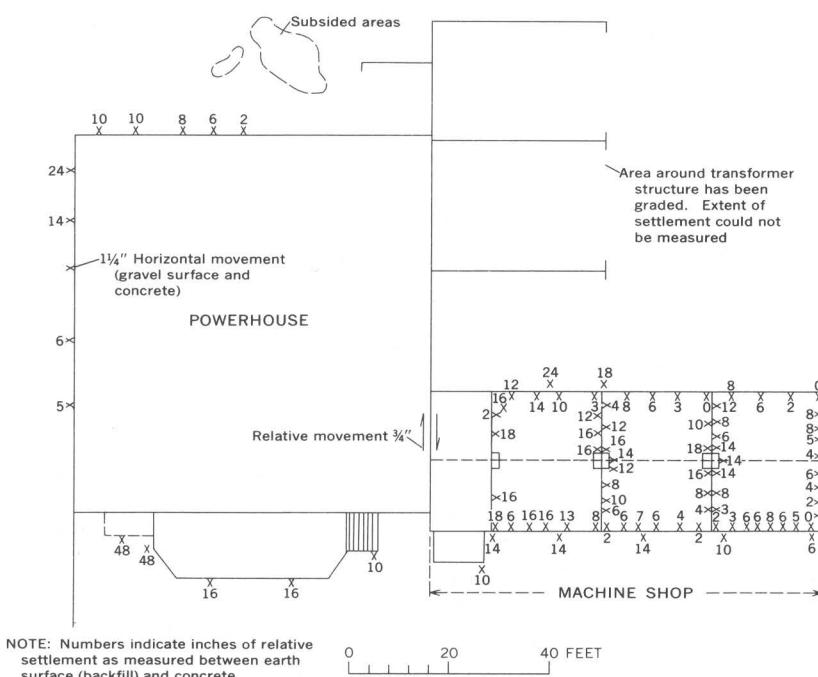
18.—Measurements of settlement and deflection at the powerplant.

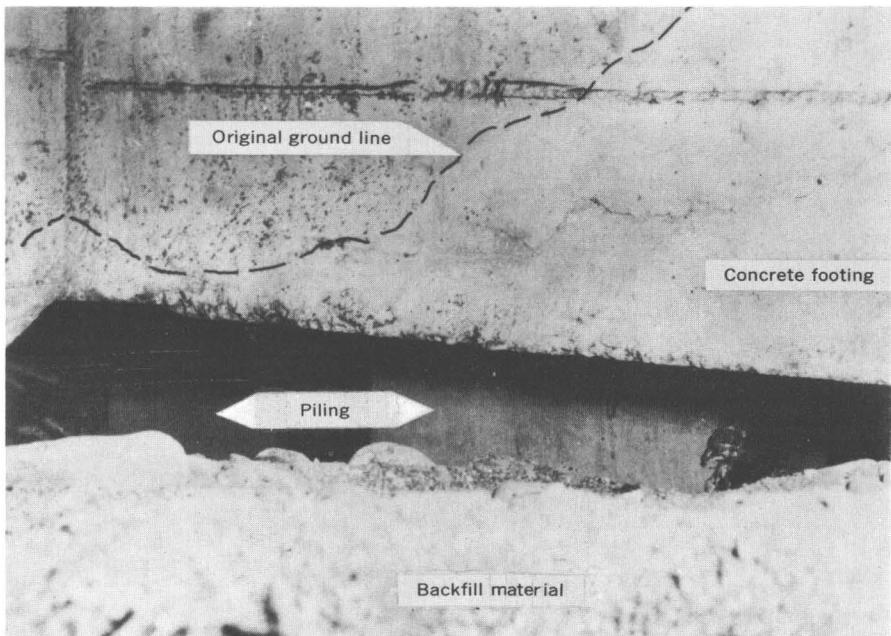
19.—Machine-shop foundation showing the separation of backfill material from the concrete footing. Approximately 1.5 feet of H-section pile is now exposed as a result of settlement caused by the earthquake.

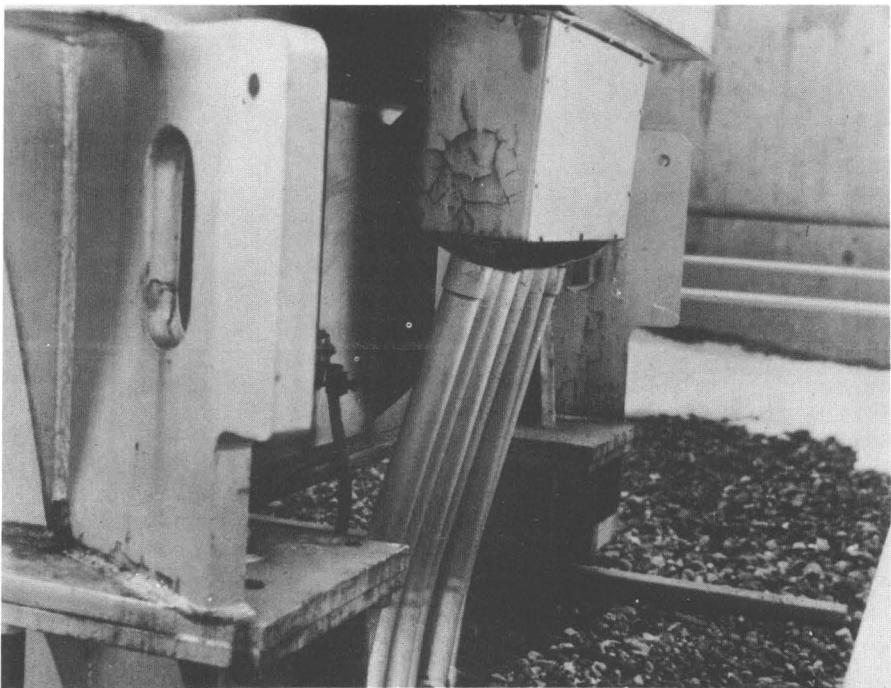
20.—The 20,000-kva transformer conduit and terminal box damaged by movement of the transformer during the earthquake. Rail stops consisted of a $\frac{1}{4}$ - by 1-inch-wide bar tack-welded to the rail. The tack-welds broke and allowed the transformer to move on the rails.

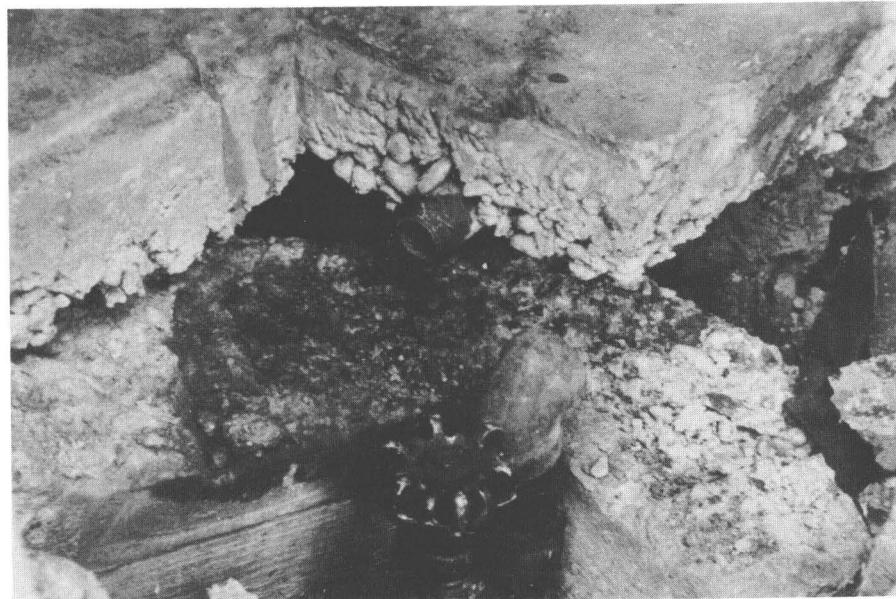
21.—Damage to the heating-system piping in the floor of the automotive repair shop caused by the earthquake.

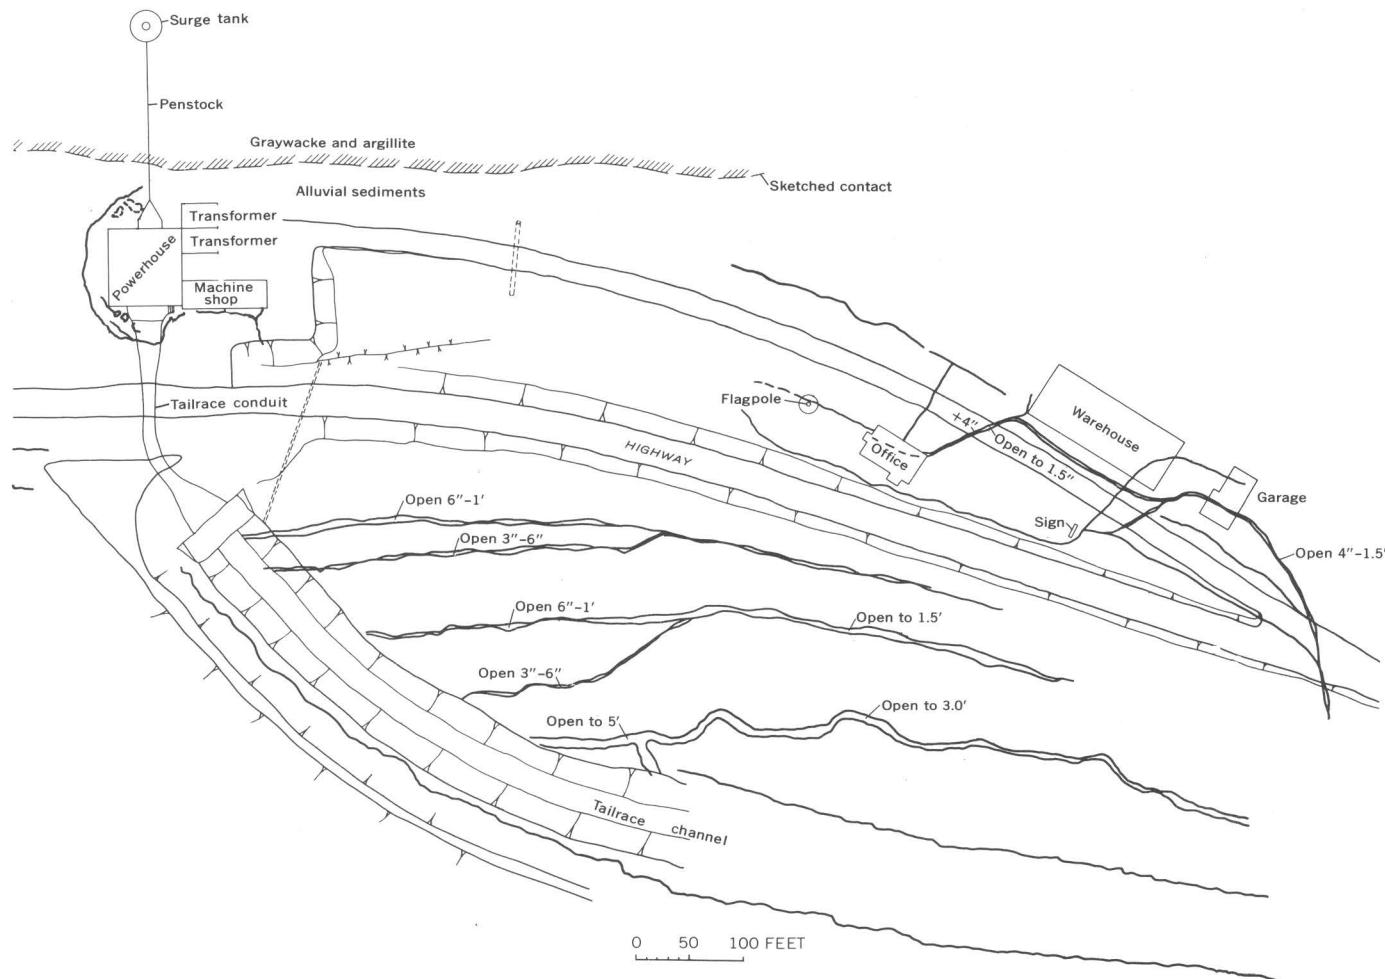
From a point west of the garage, cracks as much as a foot wide and several feet deep (figs. 22, 23) extended eastward adjacent to the north wall of the warehouse and crossed the roadway to the project office building. Cracks also extended from the garage to the southwest corner of the warehouse.

22.—Location of major earthquake cracks in the powerplant area.

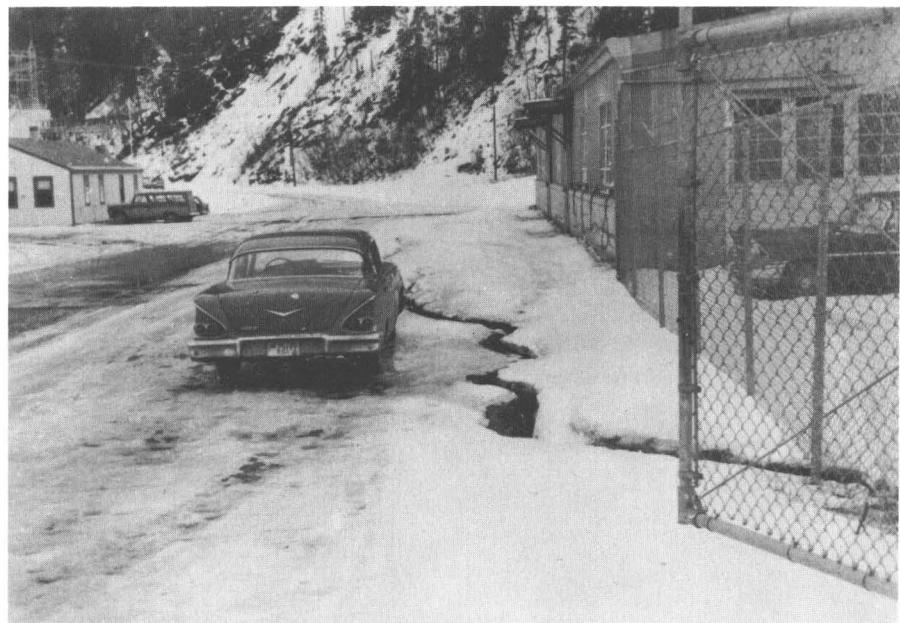
23.—Pavement damage caused by the earthquake. Cracks extend from the garage east along the north wall of the warehouse (right of photograph) and thence across the road to the project office (left of photograph).

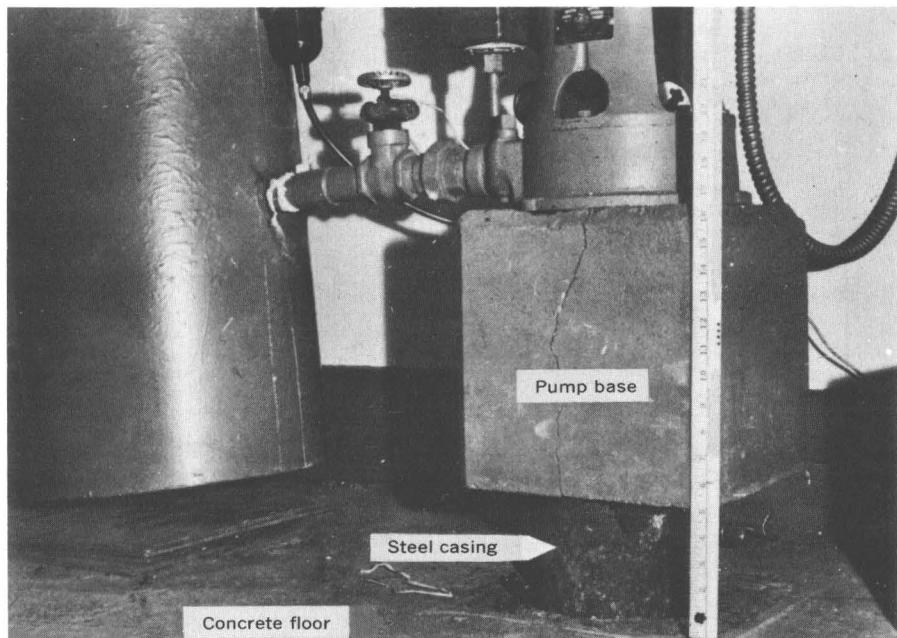
24.—Pump in Eklutna project office showing the effect of the earthquake. Base of pump is now approximately 5 inches above the floor.

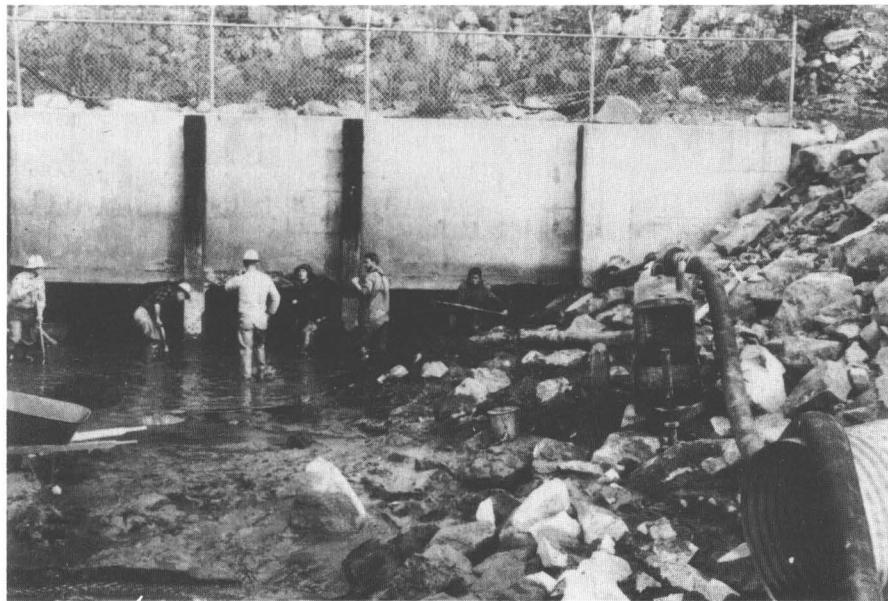
When the powerplant was shut down for repair of the intake (fig. 26), the 209-foot-long pressure tailrace conduit was inspected and cleaned. About 110 cubic yards of rock and mud had been deposited in the conduit, presumably after the break in the precast pipe section of the tunnel intake. The inspection also revealed considerable shifting of the sections nearest the powerplant (fig. 27). Regional subsidence raised the high-tide water level approximately 3 feet.

26.—Cleaning-up operation at the outlet of the tailrace conduit. Debris was deposited following the rupture of the tunnel intake at Eklutna Lake during the earthquake.

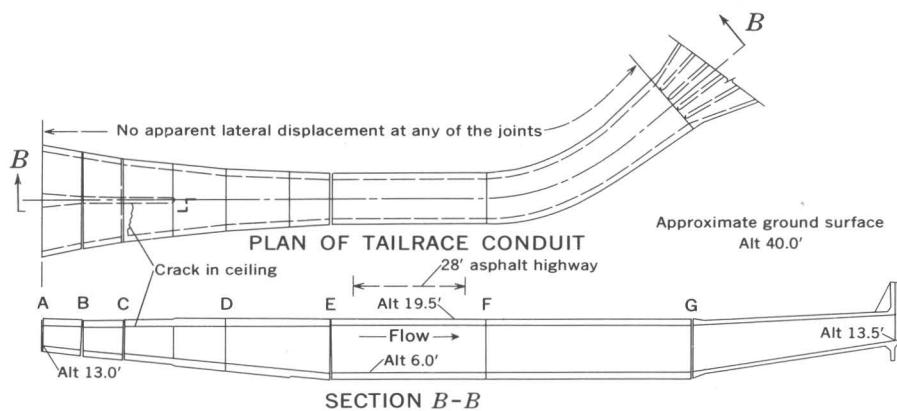
27.—Summary of damage to tailrace conduit.

TAILRACE CONDUIT	
Joint	Remarks
A	Joint open $2\frac{1}{4}$ in. on top, open $\frac{3}{4}$ in. on bottom Waterstop torn for about 1 ft, gravel visible above tear
B	Joint open $\frac{3}{4}$ in. on top, open $1\frac{1}{2}$ in. on bottom with 3 in. vertical offset, downstream side lower. Larger leak on left side of left unit near floor
C	Joint closed on top, open $1\frac{1}{2}$ in. on bottom with $1\frac{1}{4}$ in. vertical offset, upstream side lower
Between C and D	Crack in ceiling, right unit
D	Joint closed
E	Joint open evenly $1\frac{1}{4}$ in. all around with $2\frac{1}{2}$ in. vertical offset, upstream side lower
F	Joint closed
G	Joint open 1 in. all around with $\frac{3}{4}$ in. vertical offset, upstream side lower. Leaking at top

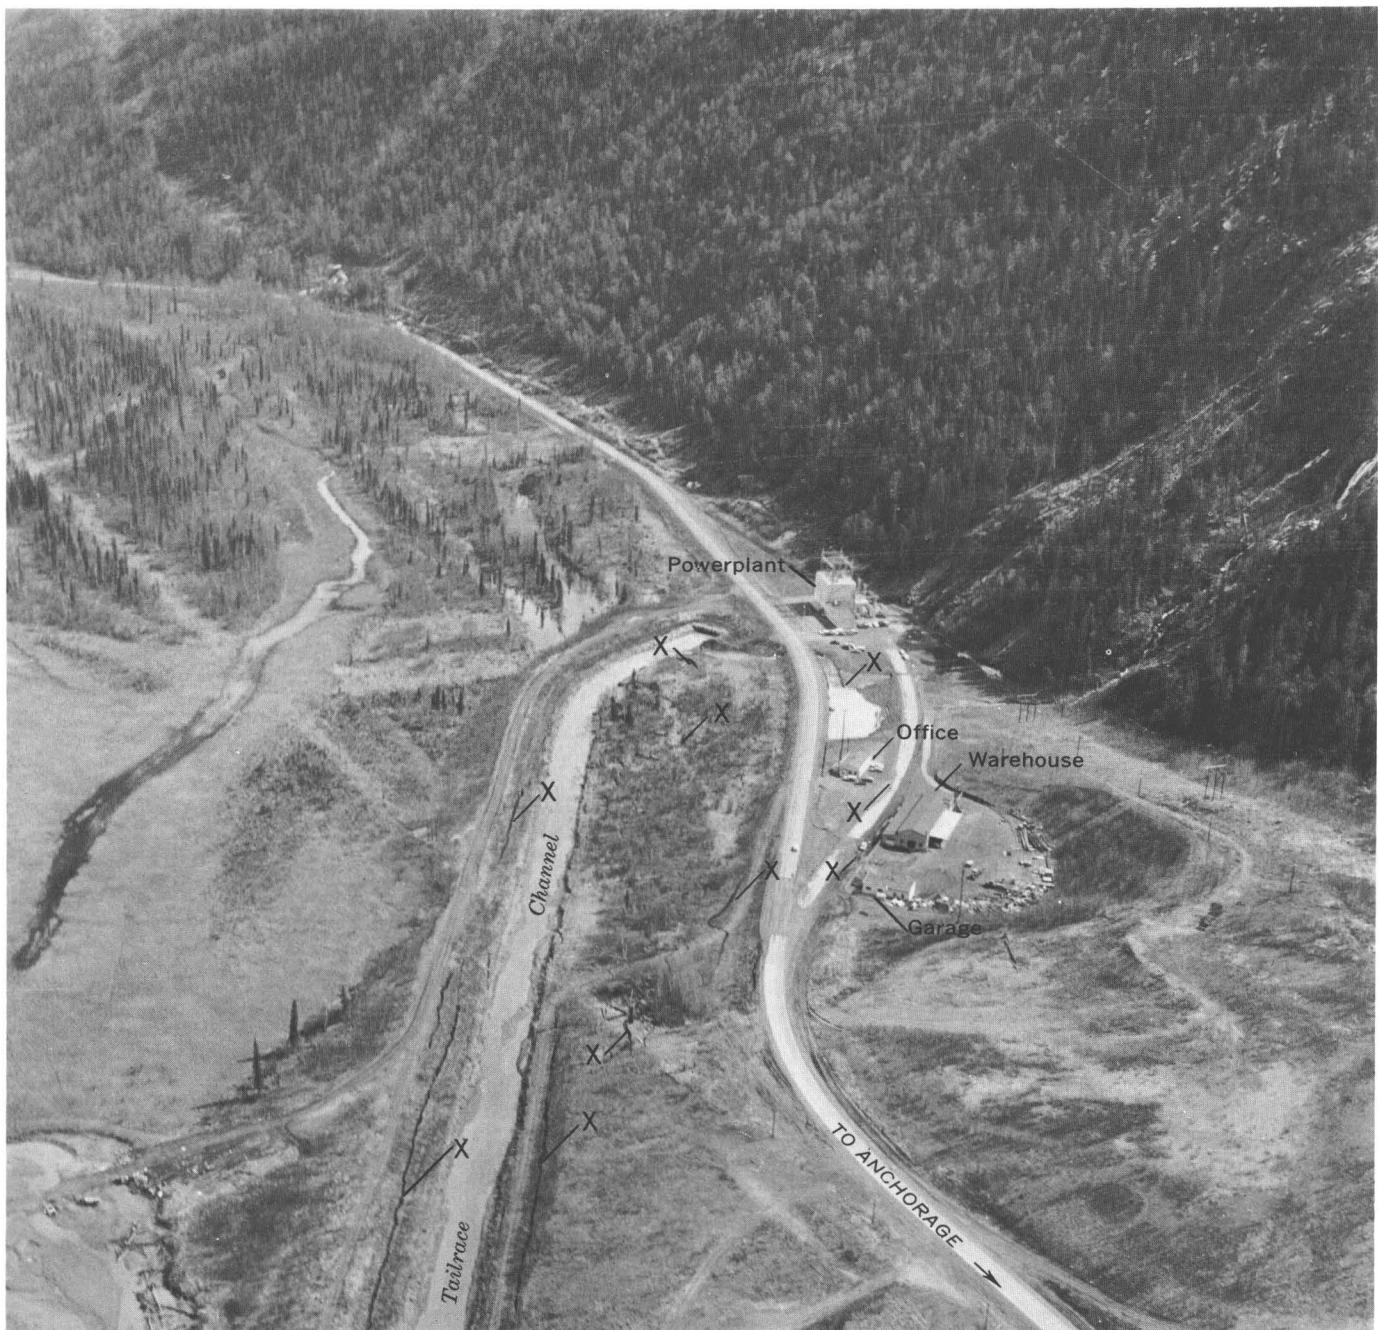
28.—Location of ground cracks in the vicinity of the powerplant.

The ground surface was severely cracked (fig. 28) in the area adjacent to, and parallel with, the 2,000-foot-long open canal section of the tailrace. The cracks ranged in width from a few inches to 5 feet and had the effect of squeezing in the sides of the channel. The invert was irregularly mantled by gravelly debris ranging in depth from a few inches to several feet.

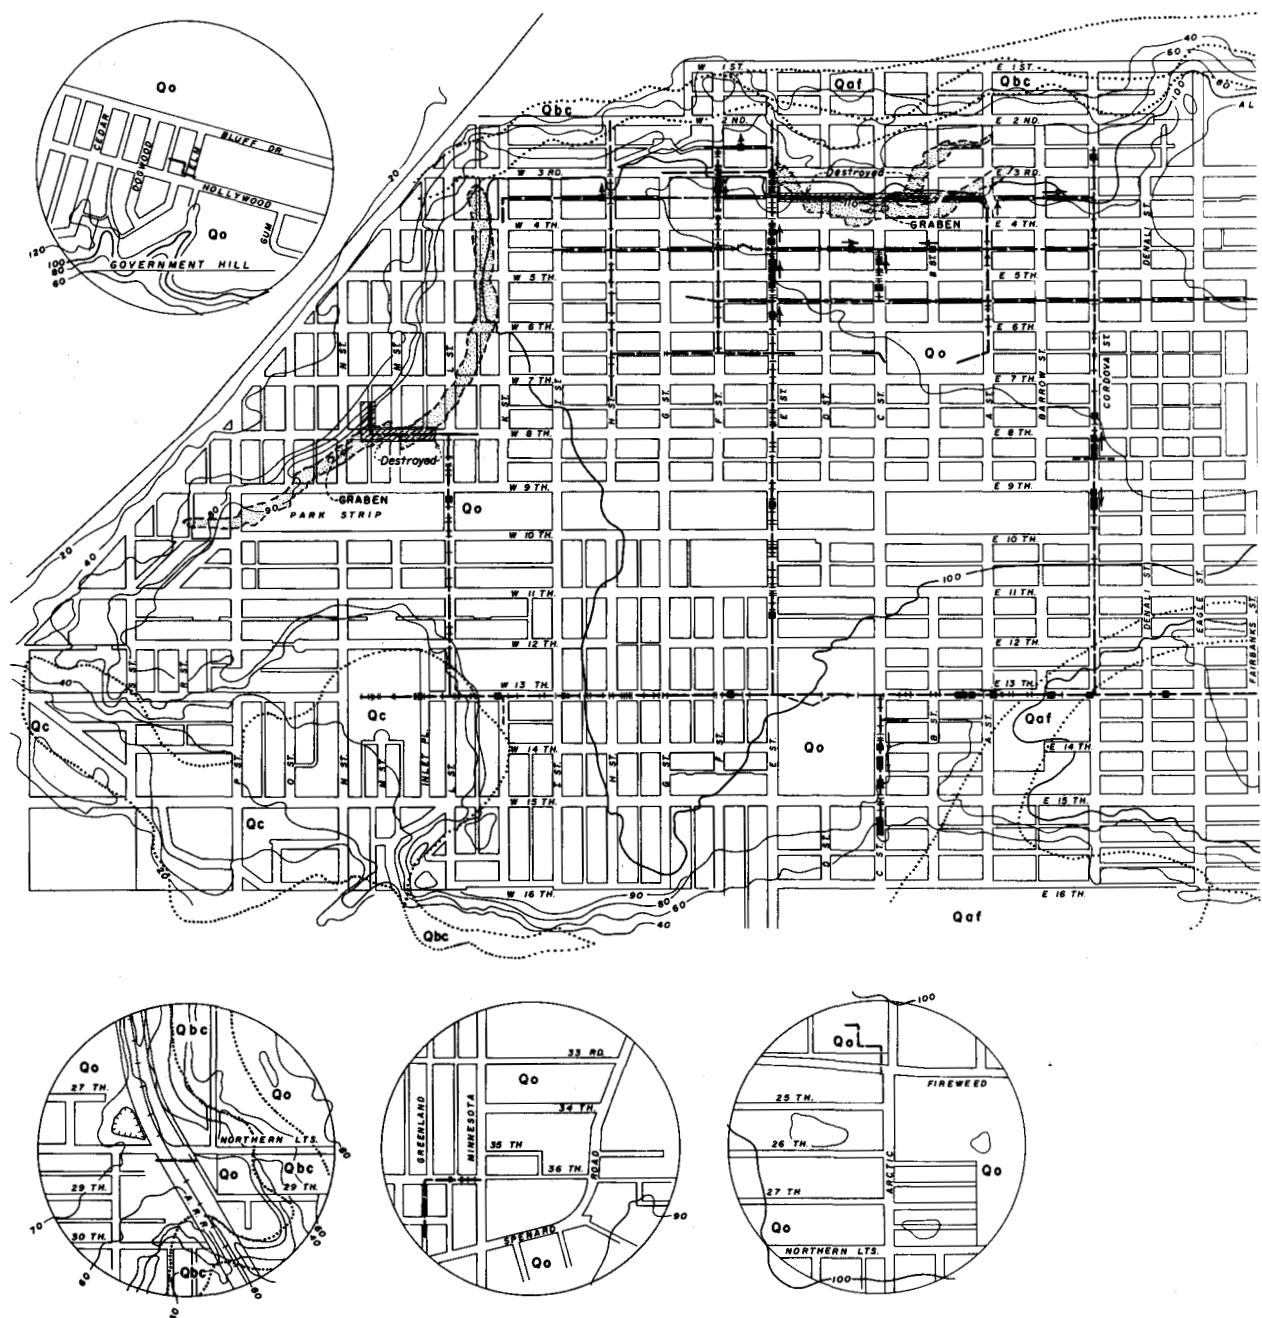
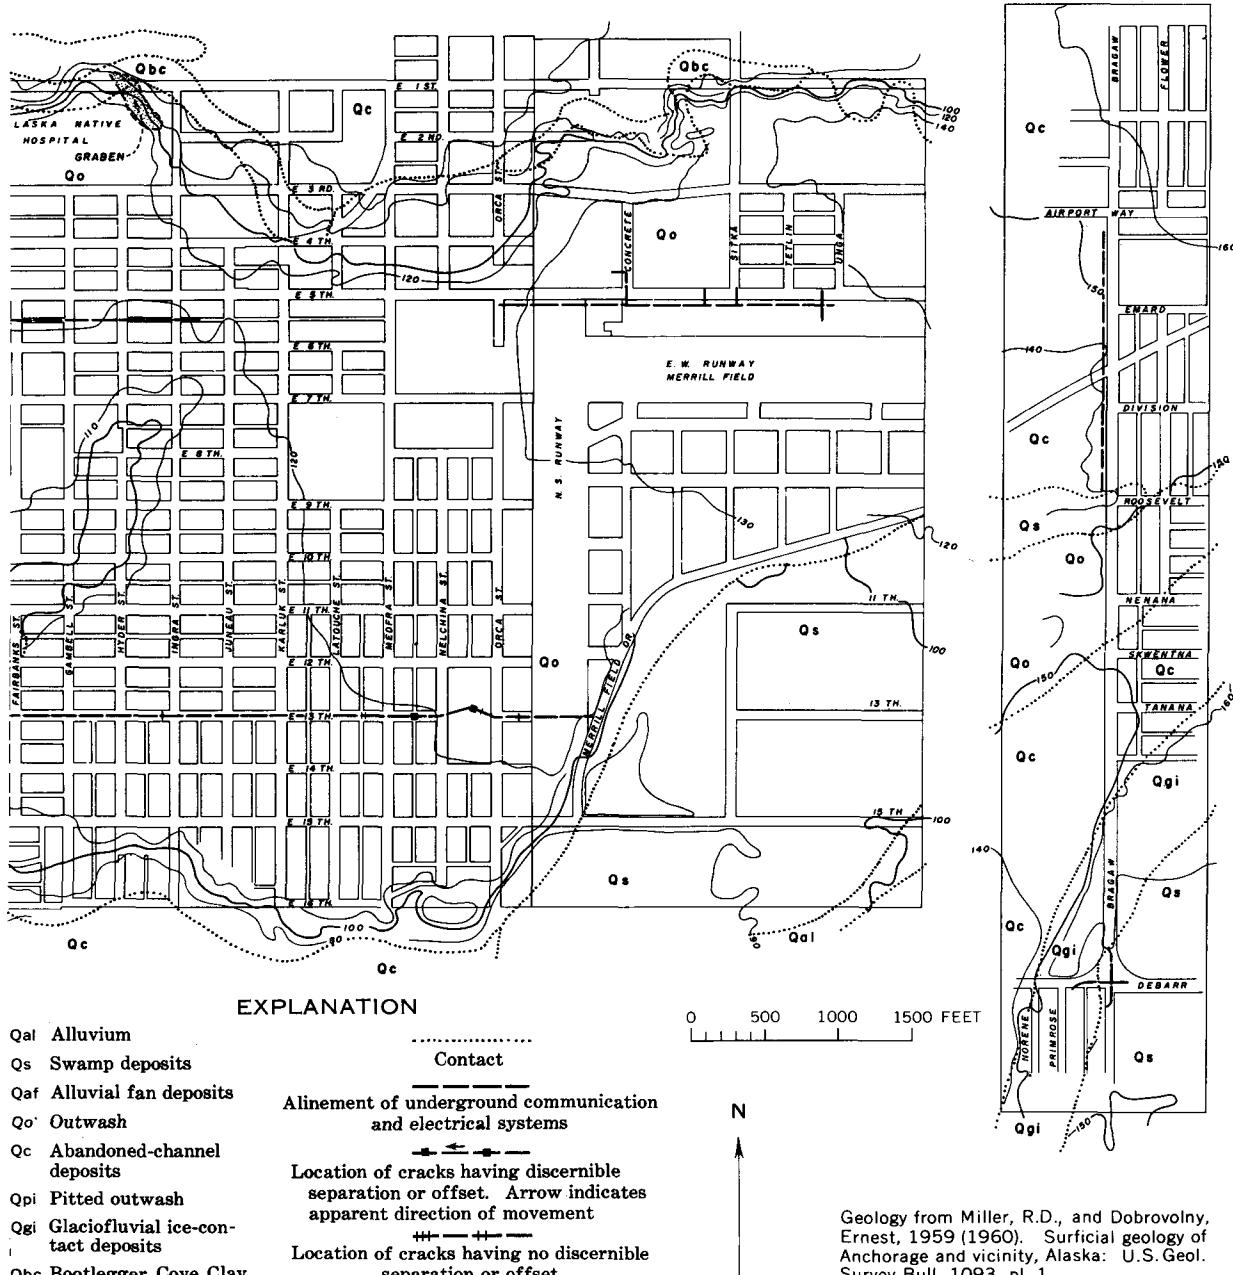
33.—Topography, surface geology, and location of fractures

in underground communication and electrical systems.

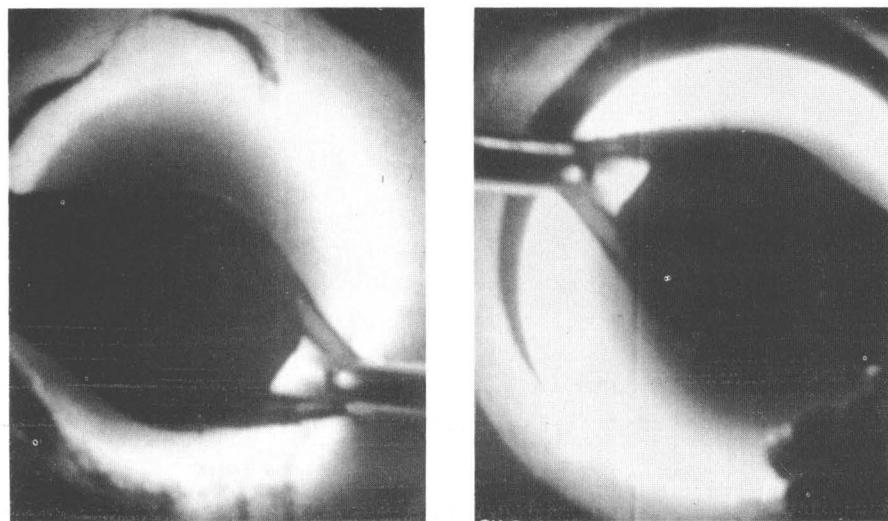
34.—Axial views of breaks in the ducts, as seen on the television monitor screen.

observed at 52 locations. Photographs of two such fractures, as viewed on the monitor screen, are shown in figure 34. The maximum displacement noted was 1 inch, although most were in the $\frac{1}{16}$ - to $\frac{1}{4}$ -inch range. Soil and water had entered the ducts through many such openings, and water was found in some areas where only hairline cracks were present.
