THE ALASKA EARTHQUAKE, MARCH 27, 1964:
EFFECTS ON TRANSPORTATION, COMMUNICATIONS, AND UTILITIES

Effects of the Earthquake of March 27, 1964, on the Alaska Highway System

By REUBEN KACHADOORIAN

GEOLOGICAL SURVEY PROFESSIONAL PAPER 545-C

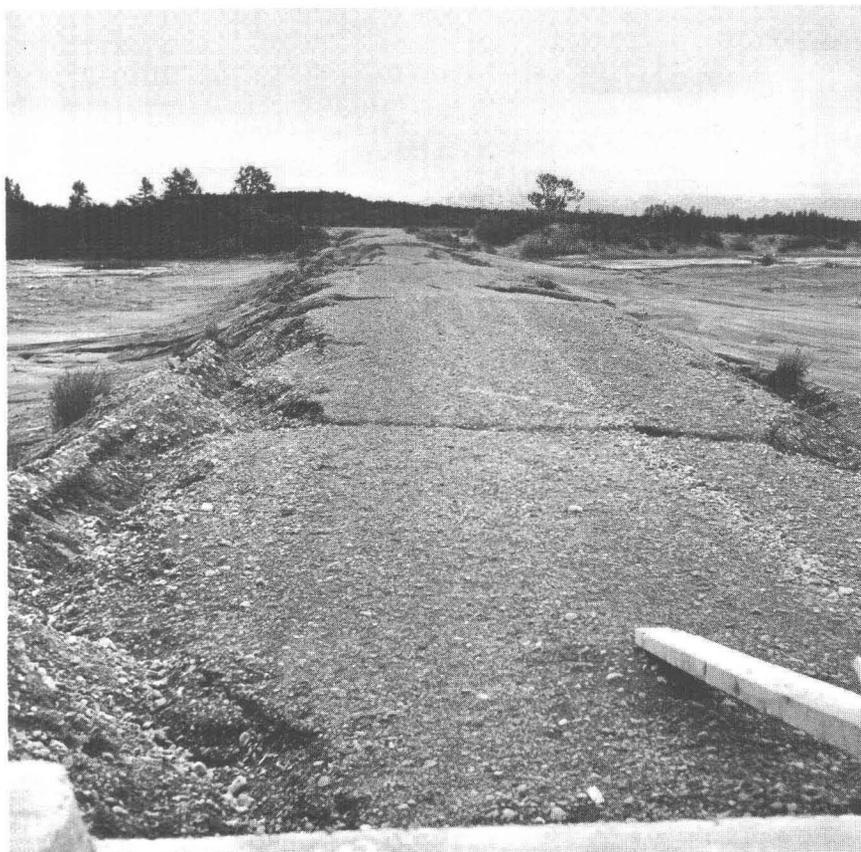
15.—Fractures normal to and along highway edge, Copper River Highway. Looking east from Copper River bridge 2, mile 27.1. Approach subsided 3 feet and fractured.

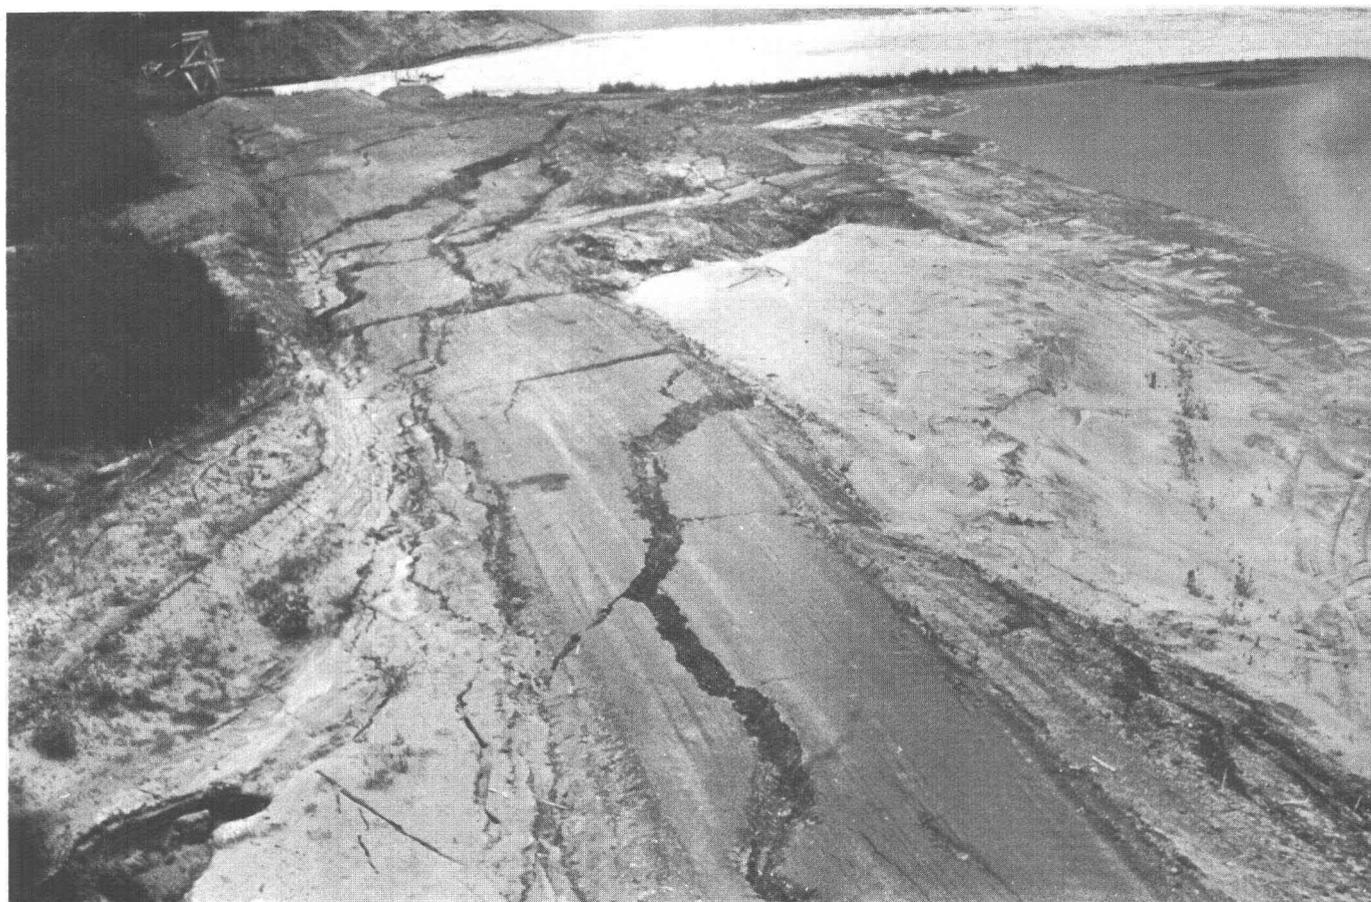
16.—Complex fractures with relatively large lateral and vertical displacements, produced by movement of saturated fine sand and silt toward free faces. View north near mile 58.5, Copper River Highway. The Allen River, which drains Allen Glacier, is in the background.

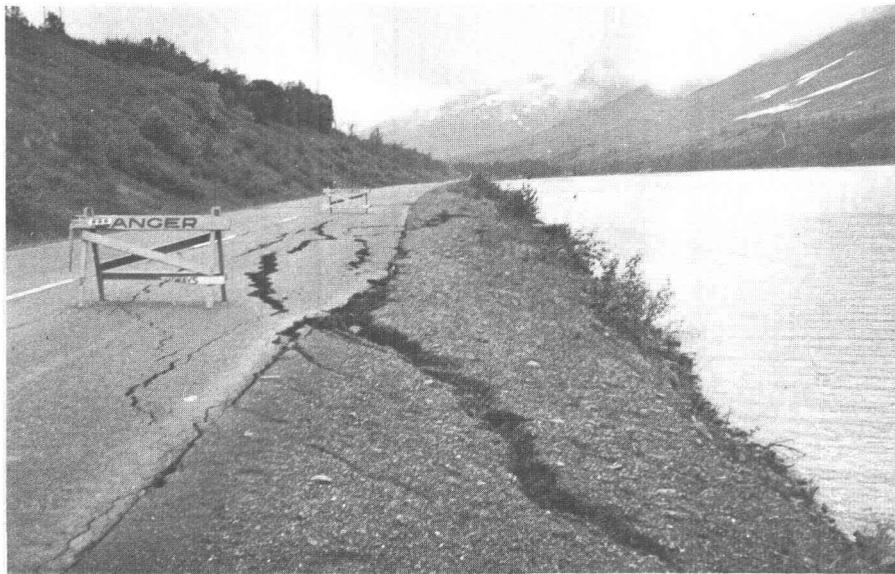
24.—Small landslide on Seward-Anchorage Highway near mile 44.5, along shore of Summit Lake.

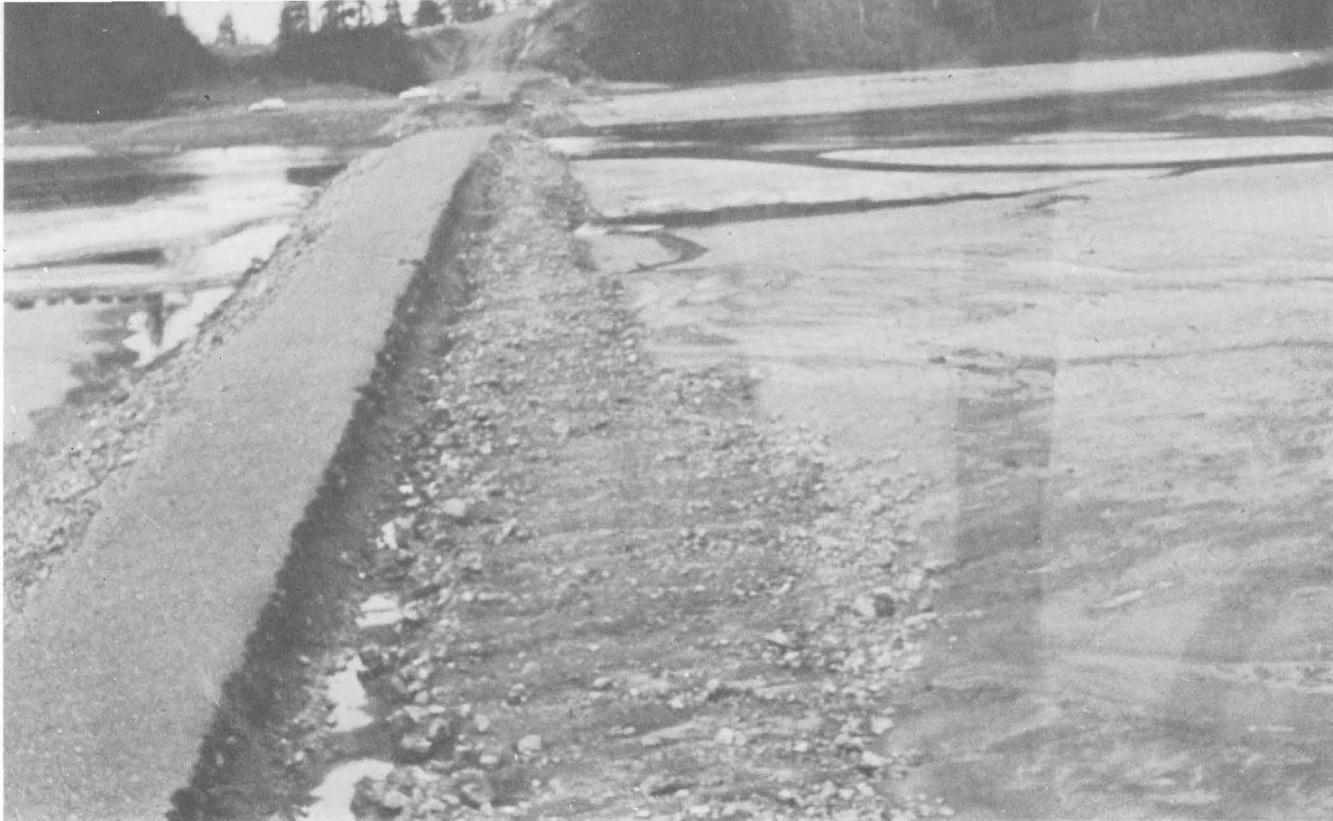
26.—Right side of Point Whitted Road destroyed by seismic sea waves. Waves advanced over roadway from the left and cut sharp edge on right side of roadway. View northeast; Hartney Bay is to the right.

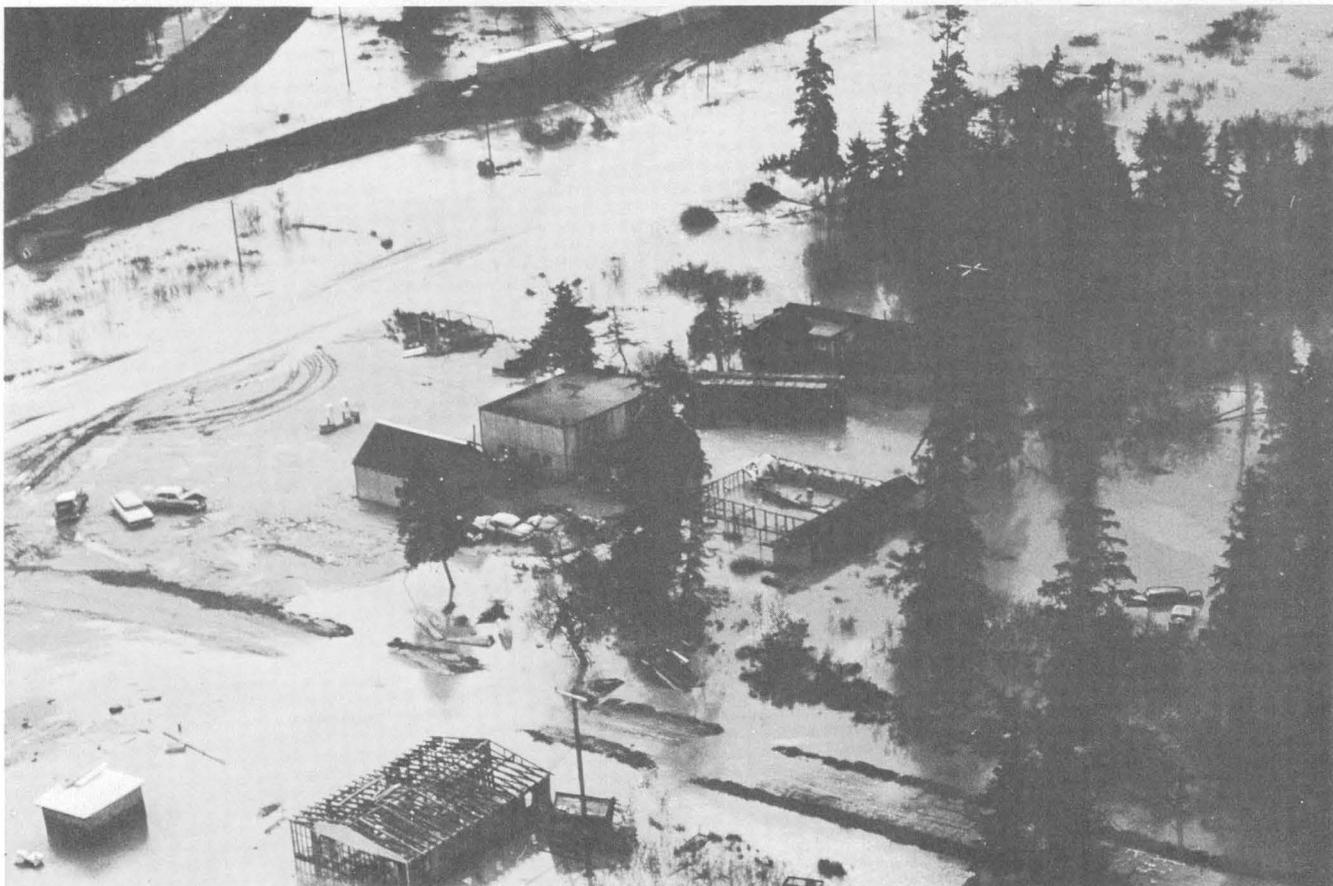
27.—View of Portage on Seward-Anchorage Highway during 28-foot tide, after regional subsidence caused by the earthquake. Highway is under water, just below railroad grade in far background. Photograph taken August 10, 1964.

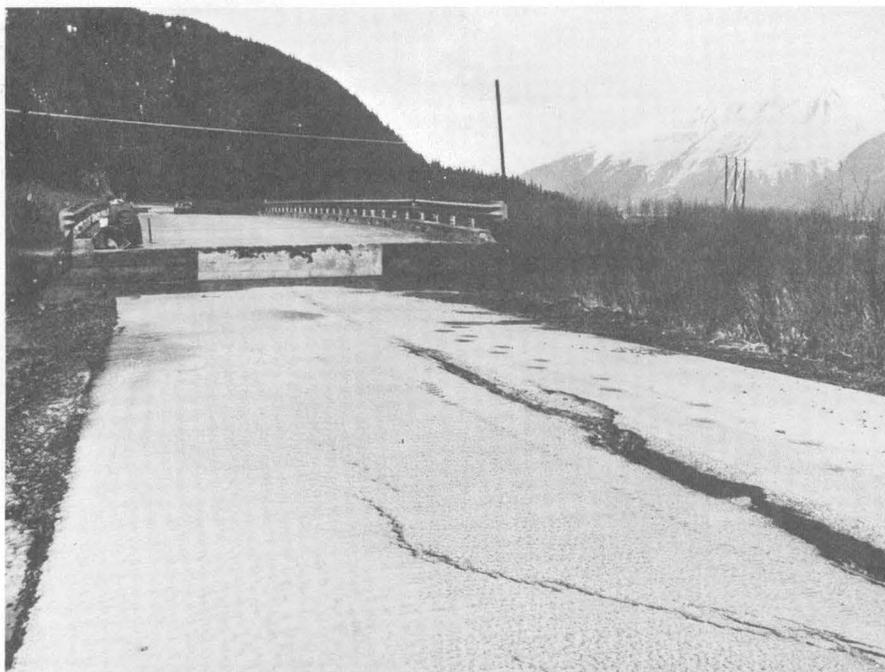
30.—Subsidence of bridge approach fill at Tidewater Slough 2 bridge, mile 76.4, Seward-Anchorage Highway. View is west. Photograph by Helen Foster.

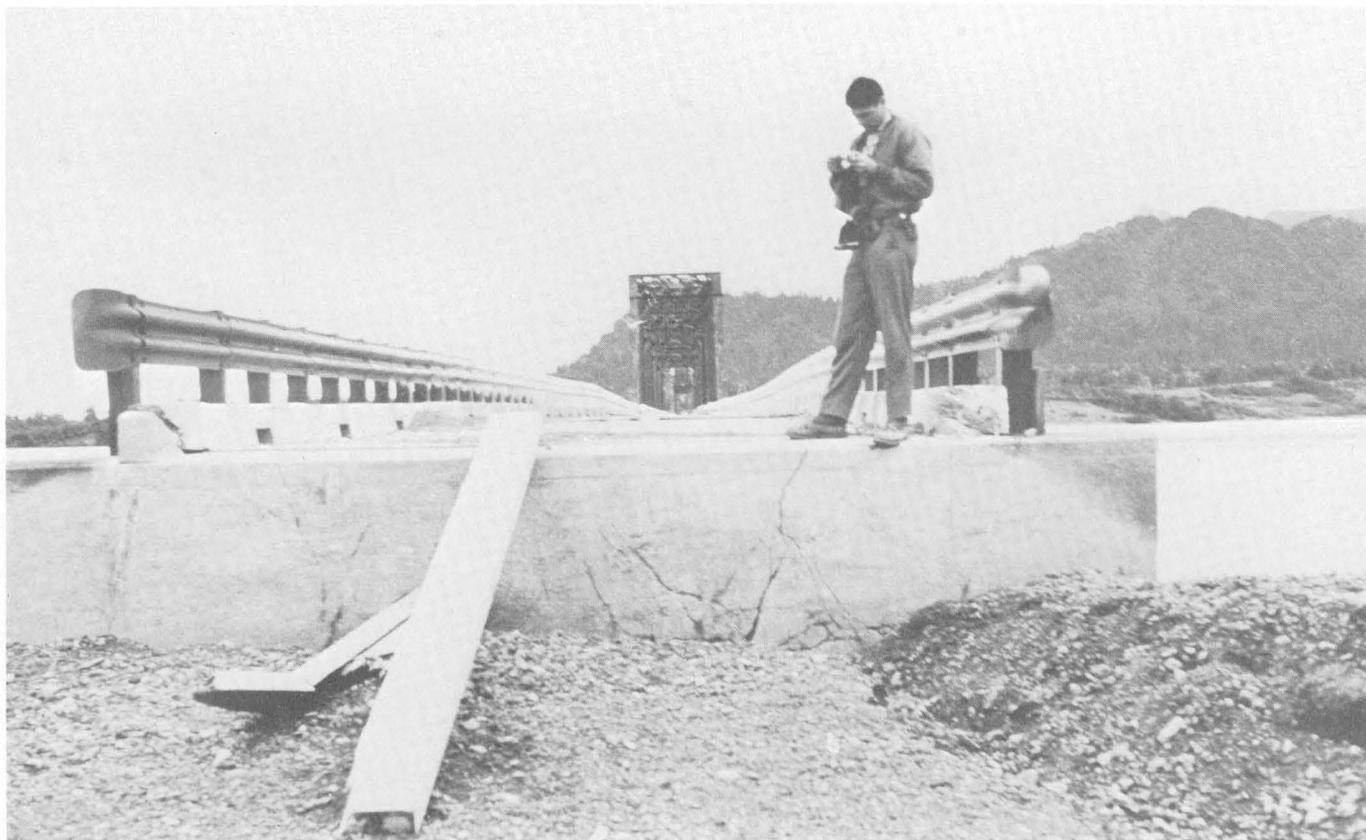
31.—View looking west, Copper River bridge 2, mile 27.1, Copper River Highway. Approach subsided 3 feet as a result of seismic shaking.

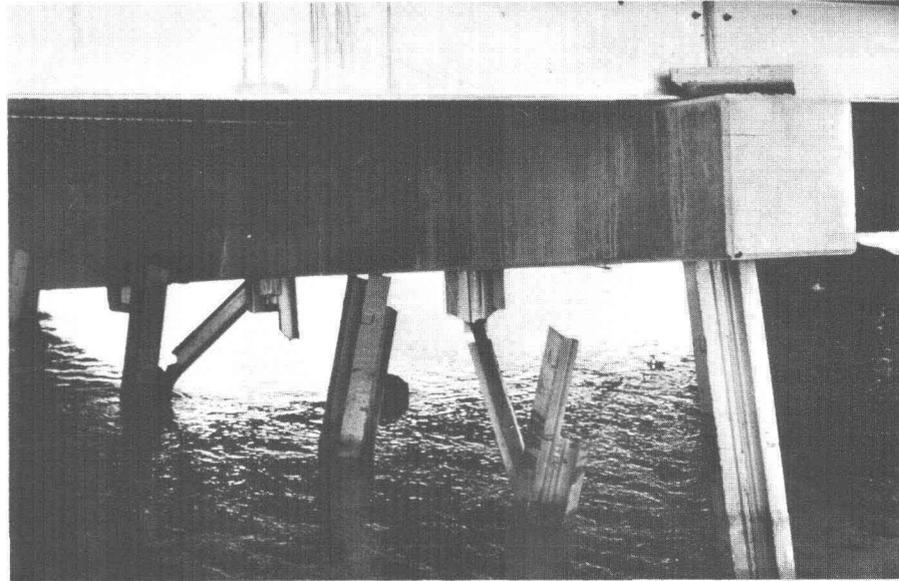
38.—Broken rail piles on Scott Glacier 6 bridge, mile 5.9, Copper River Highway.

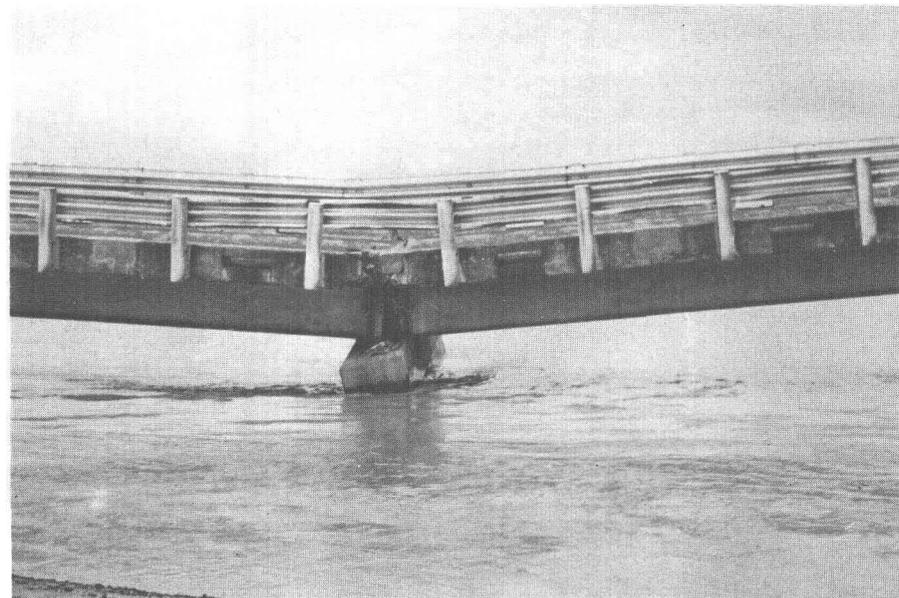
39.—Collapsed bent and deck of Copper River 5 bridge, mile 35.0, Copper River Highway.

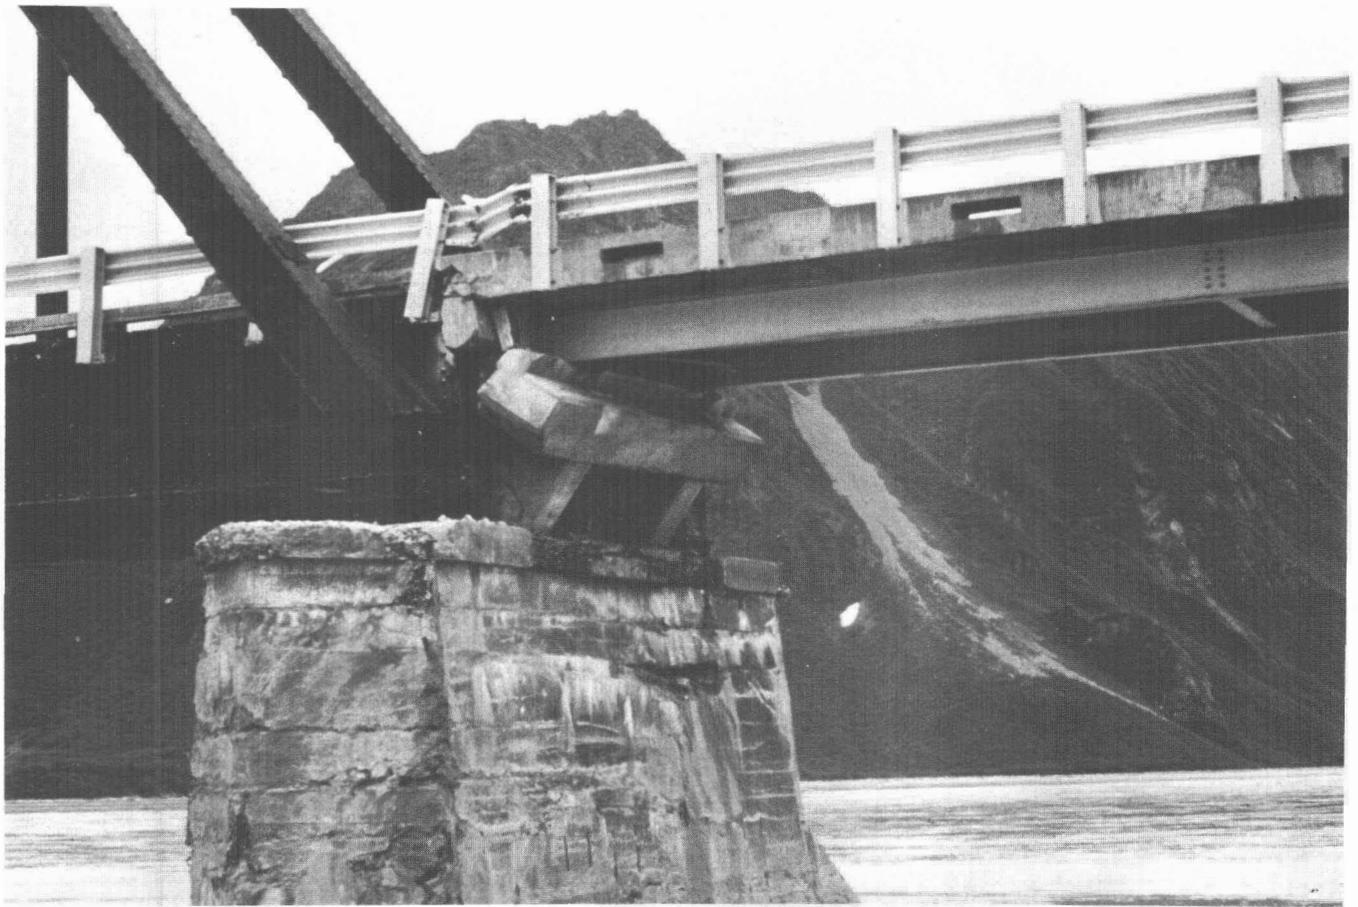
41.—Contact between steel truss and concrete deck on pier 26, Copper River 2 bridge, mile 27.1, Copper River Highway.
