# The Alaska Earthquake

# Effects of the Earthquake Of March 27, 1964, on The Alaska Railroad

By DAVID S. McCULLOCH and MANUEL G. BONILLA

GEOLOGICAL SURVEY PROFESSIONAL PAPER 545-D

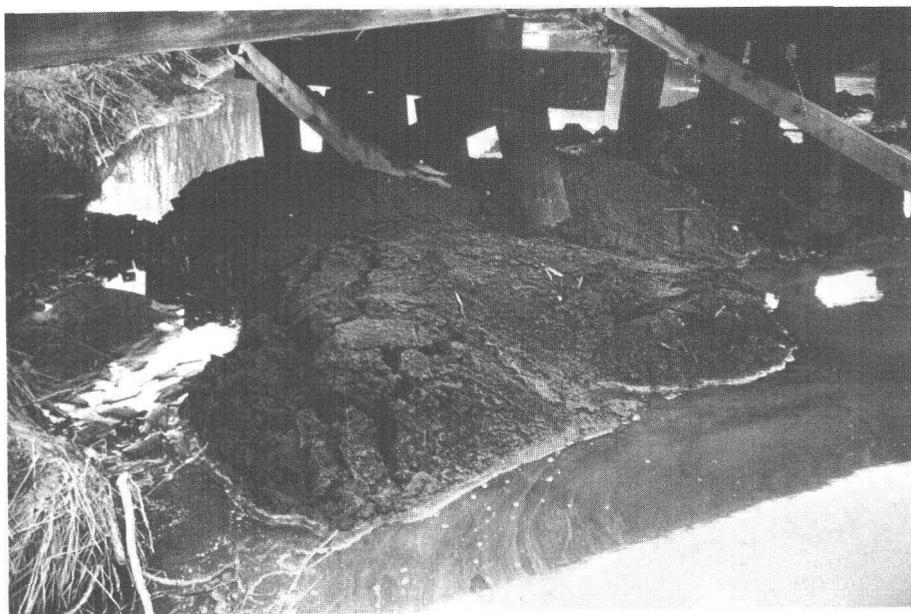
17.—Mounds of sand ejected with ground water from cracks in the floor of the stream at bridge 34.7 on Hunter Flats.

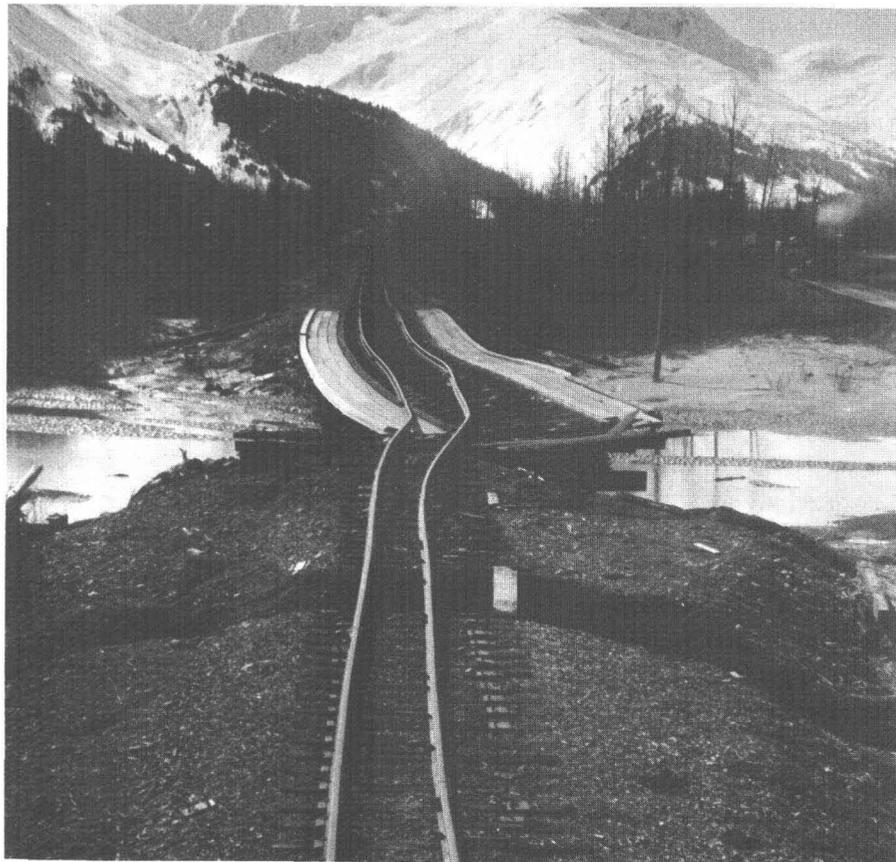
18.—View to the south of bridge 63.0. Compression, which deflected the deck 8 feet to the east in a sharp kink, broke the stringers. A wide tension fracture in the foreground broke the embankment; it shifted to the right at the fracture and skewed the bridge.

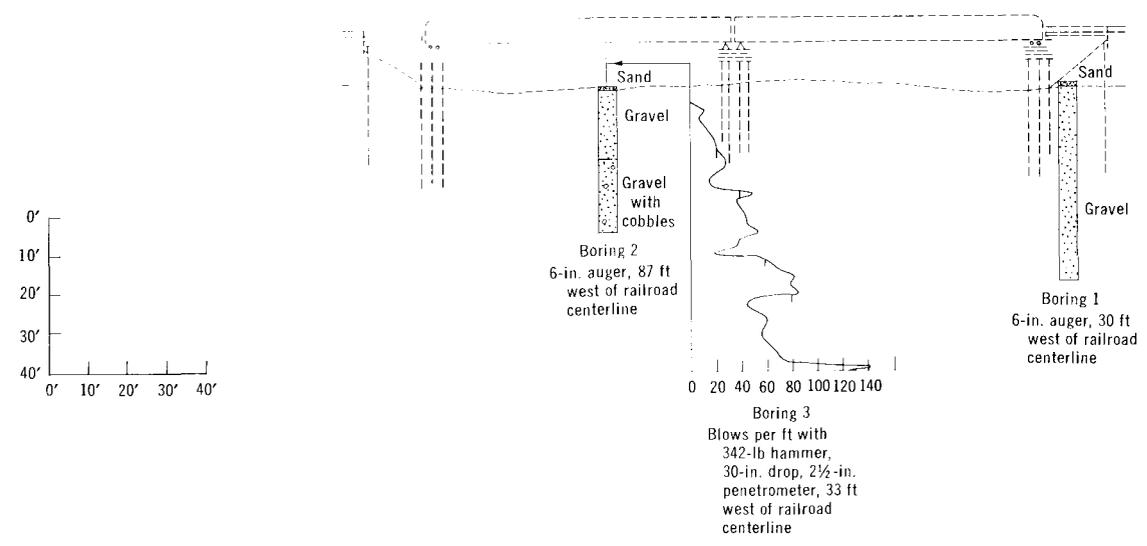
29.—Bridge 3.0; construction, damage, and subsurface information. Subsurface data projected to rail line at proper altitude.

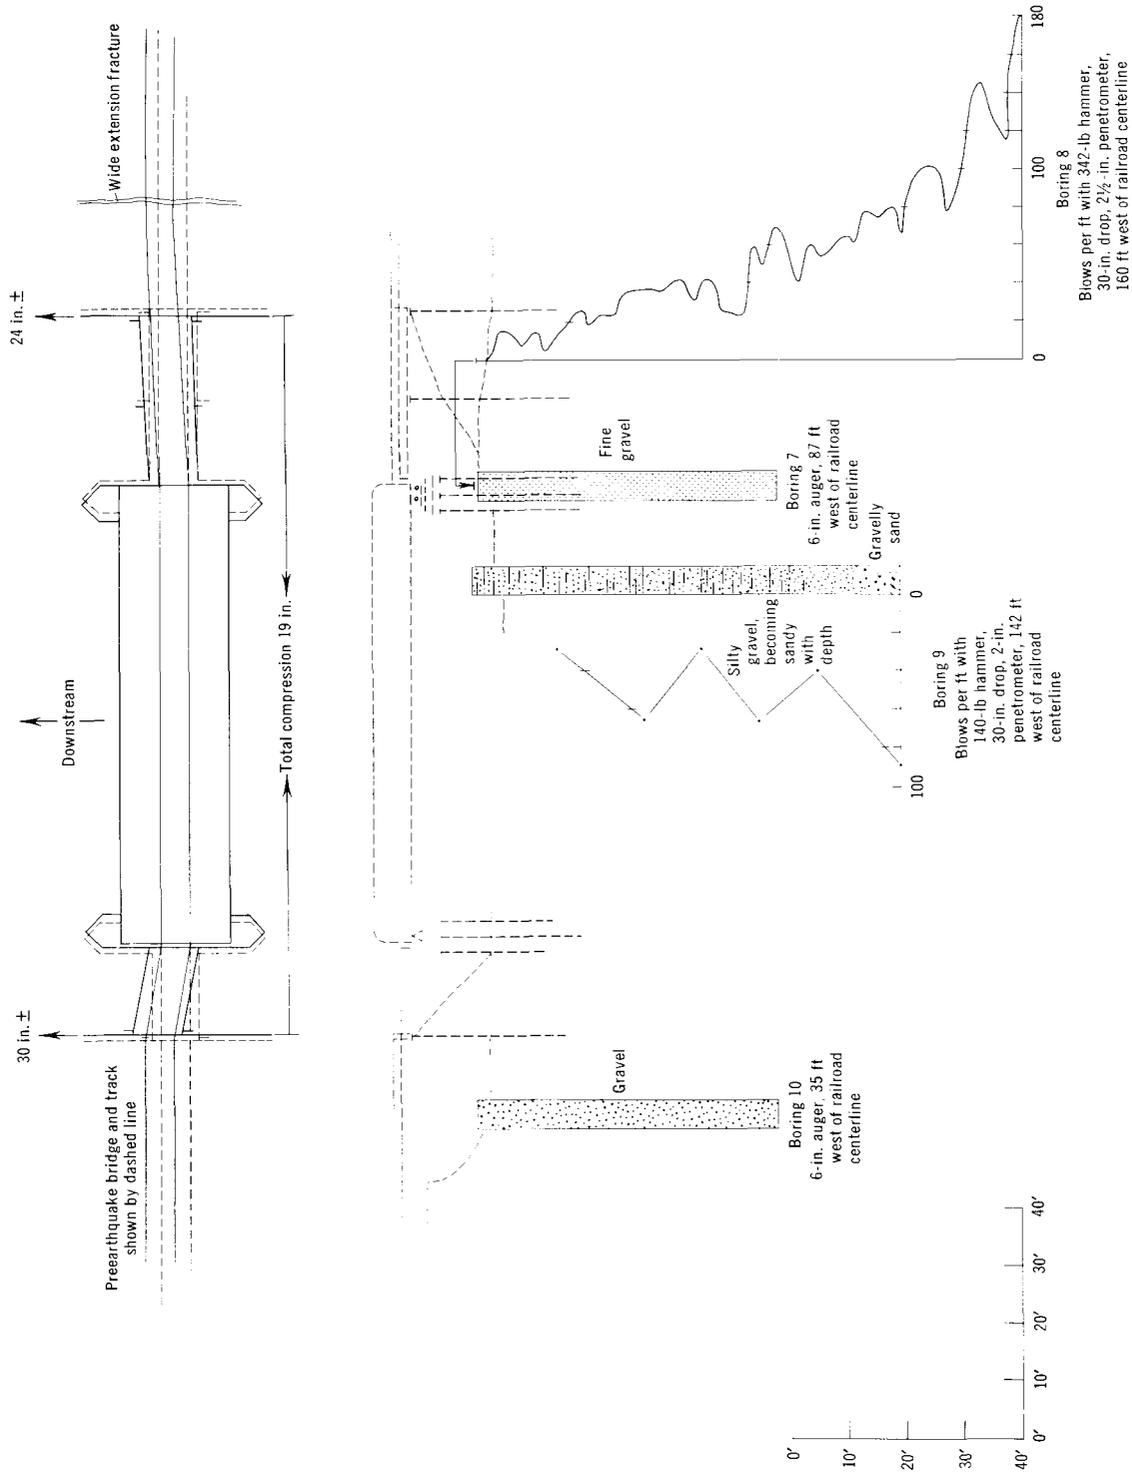
32.—Bridge 3.3; construction, damage, and subsurface information. Subsurface data projected to rail line at proper altitude.

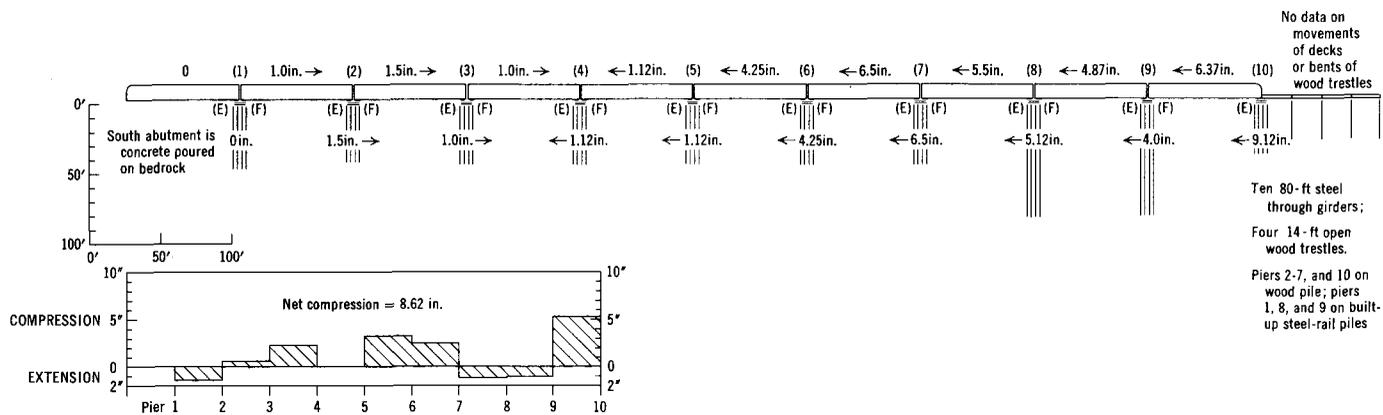
39.—Construction of and damage to Knik River bridge (146.4).

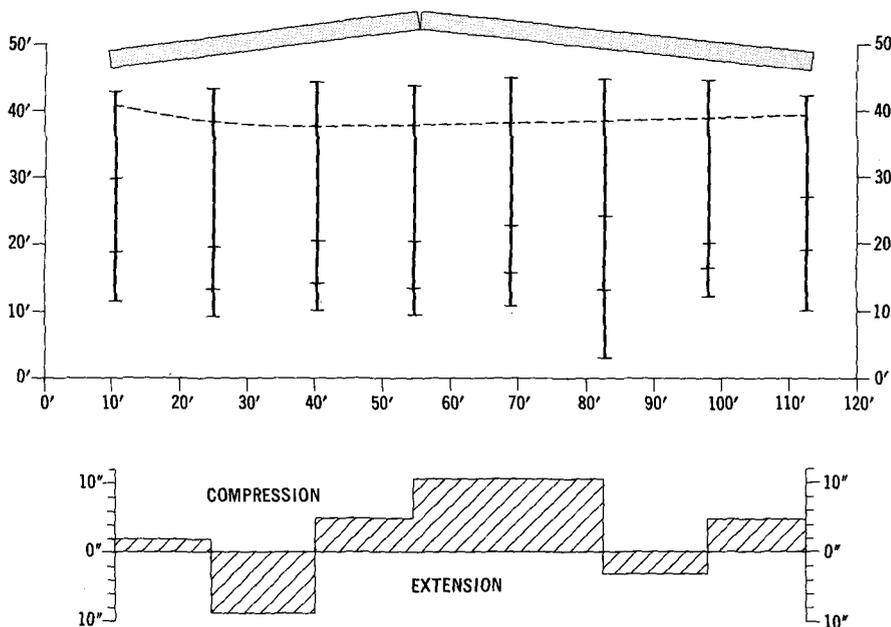
42.—Postearthquake positions on bents and deck of bridge 34.5. Relative interbent movements shown in graph.

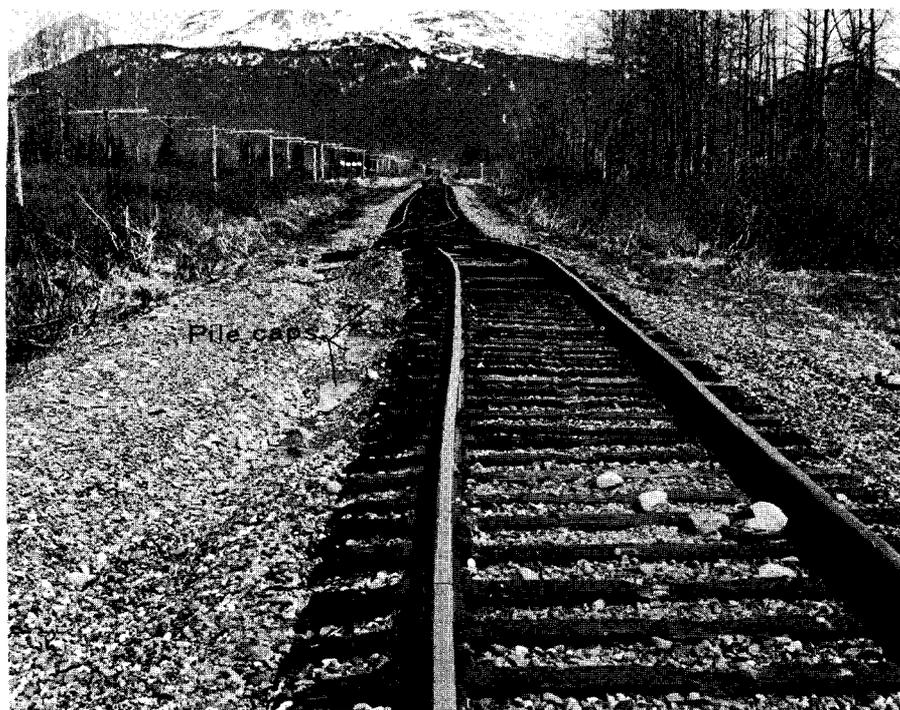
60.—Lateral offsetting and compression at the end of filled-over bridge (looking north toward bridge 62.3). Note the ends of pile caps exposed to left of the ties.

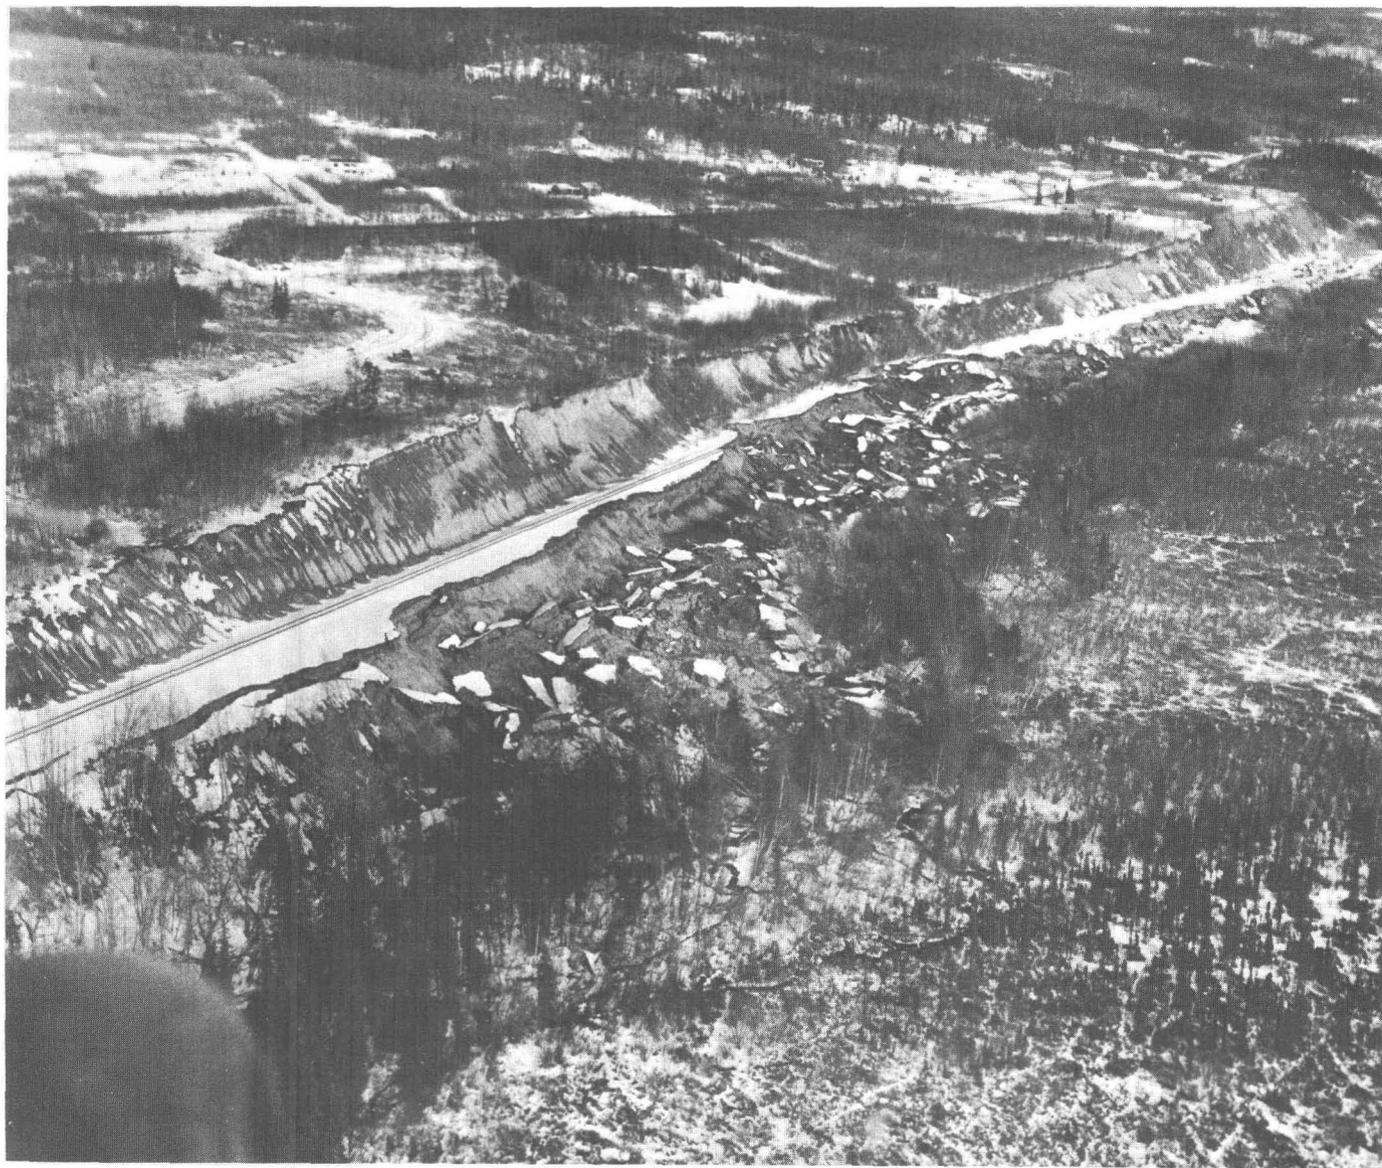
65.—View of Potter Hill slides. Note the overthrusts in the low-lying tidal flat in the foreground, and dark strata of water-saturated sediments in the slide scarps. Photograph by The Alaska Railroad.

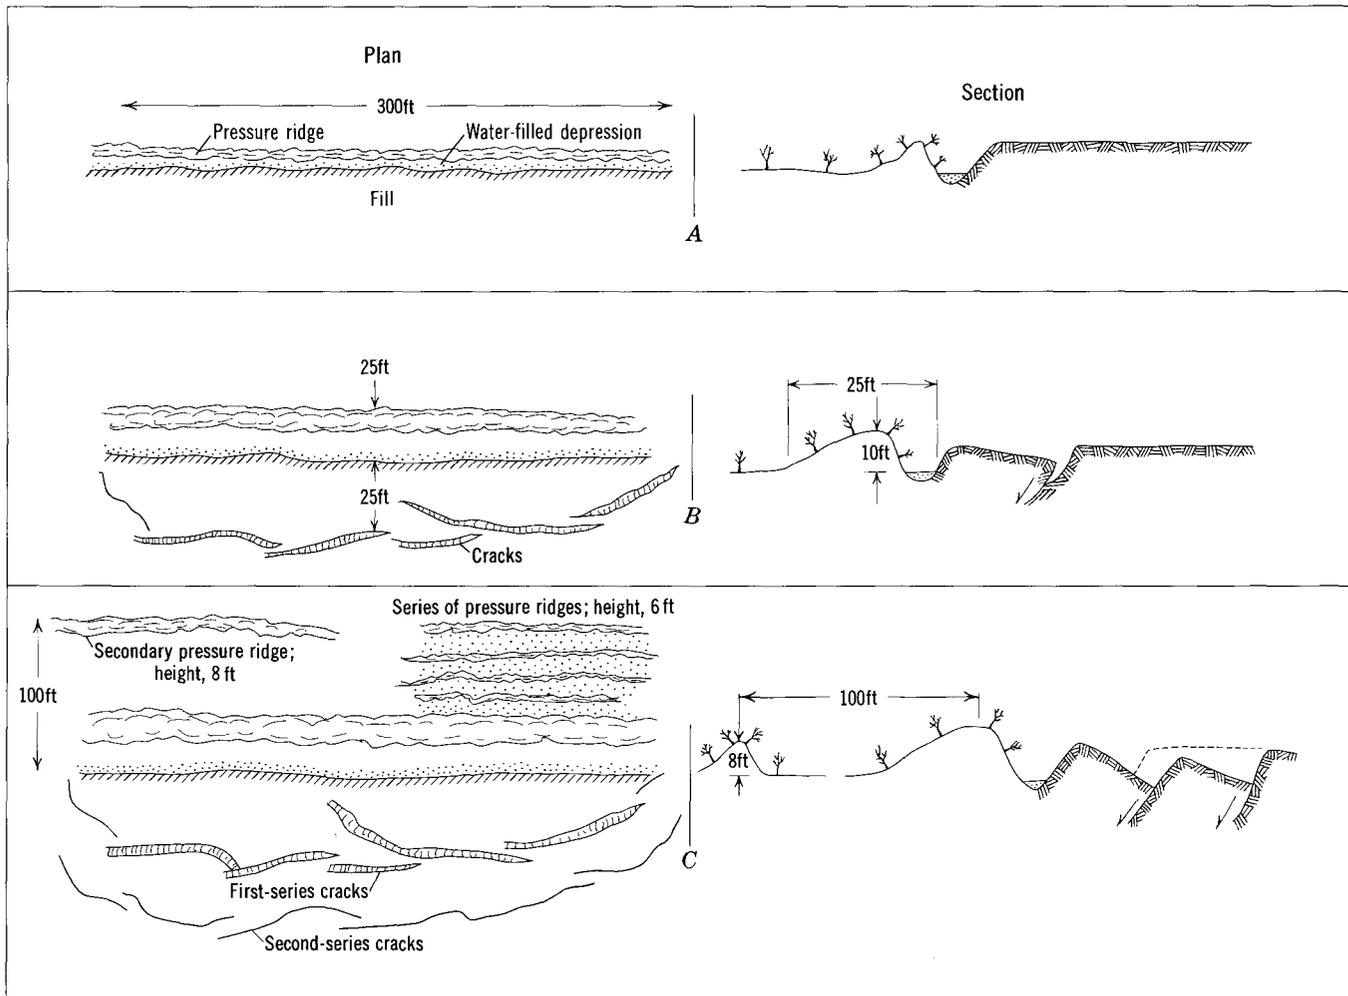
67.—Field sketches of successive failures that occurred in a spoil area and adjacent tidal flat at the toe of Potter Hill slides during reconstruction. Sketches redrawn from Dan K. Conger, Clair A. Hill and Associates.

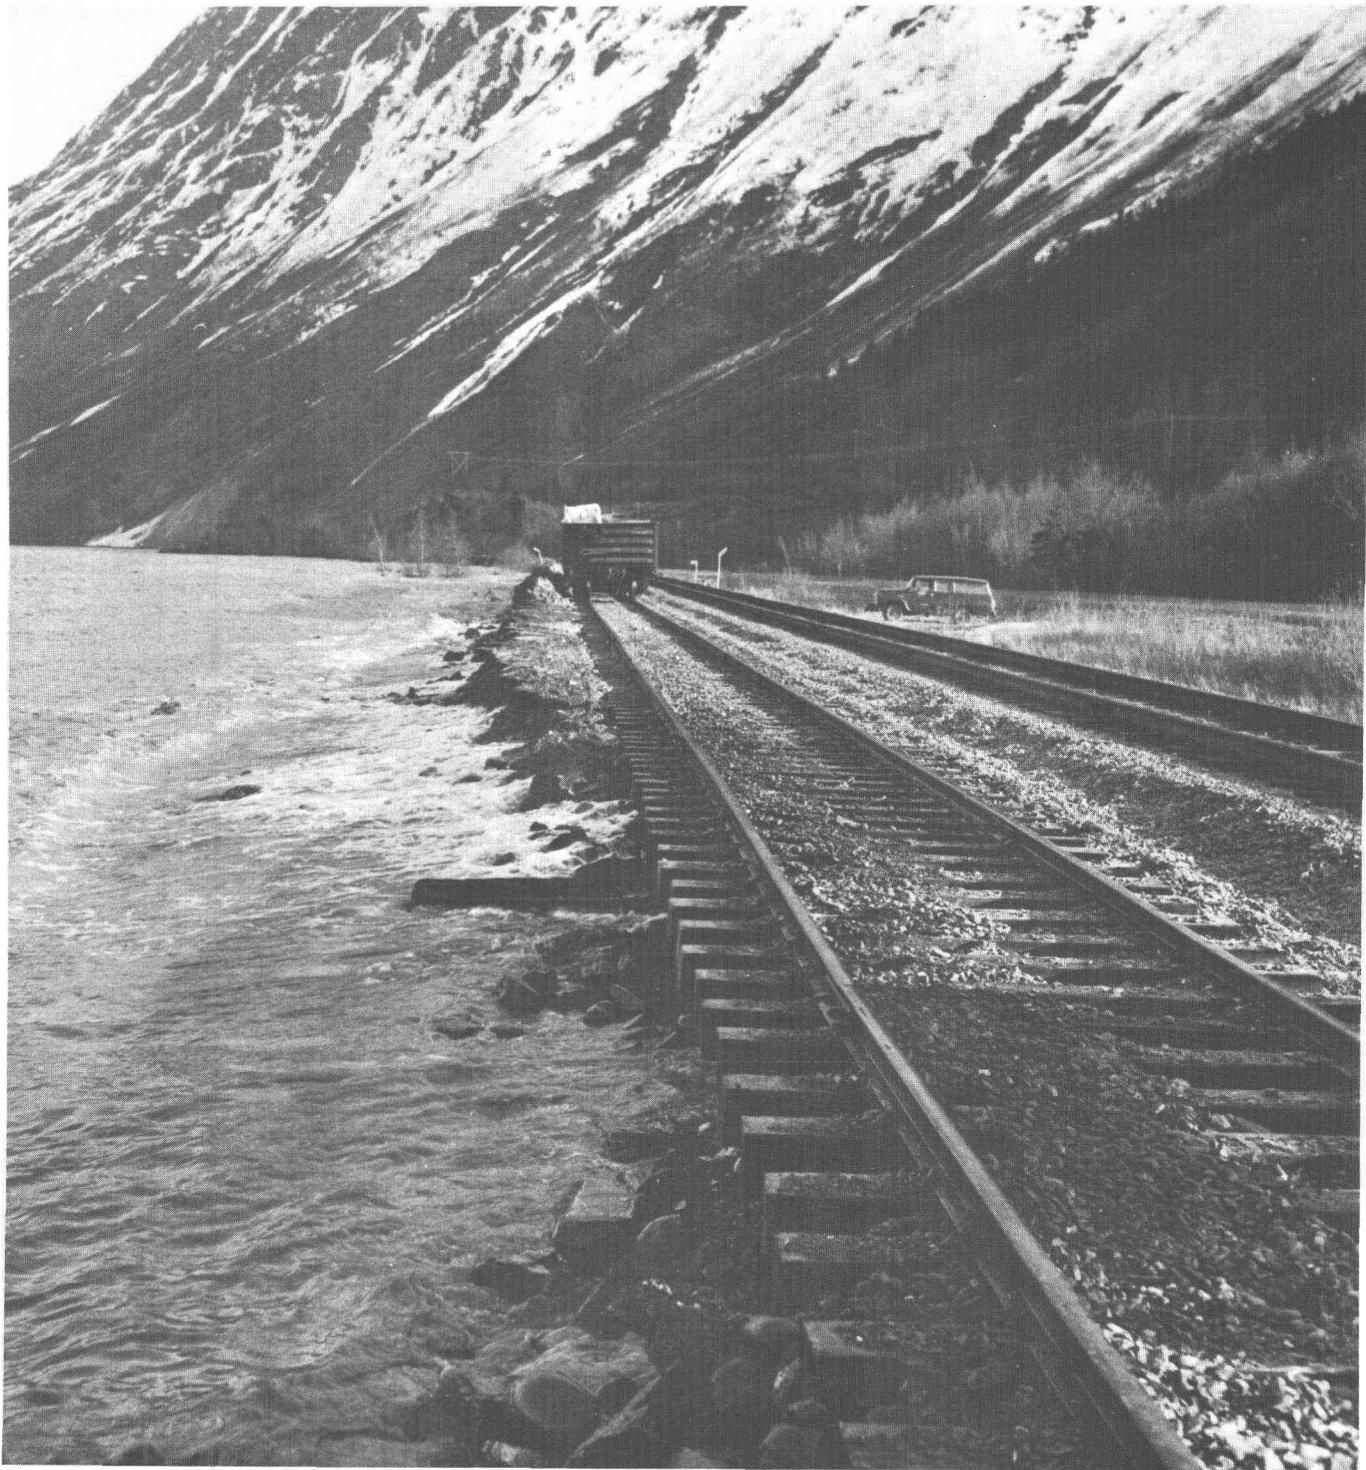
76.—Waves eroding the railroad embankment lowered by tectonic subsidence along Turnagain Arm. Photograph by The Alaska Railroad.

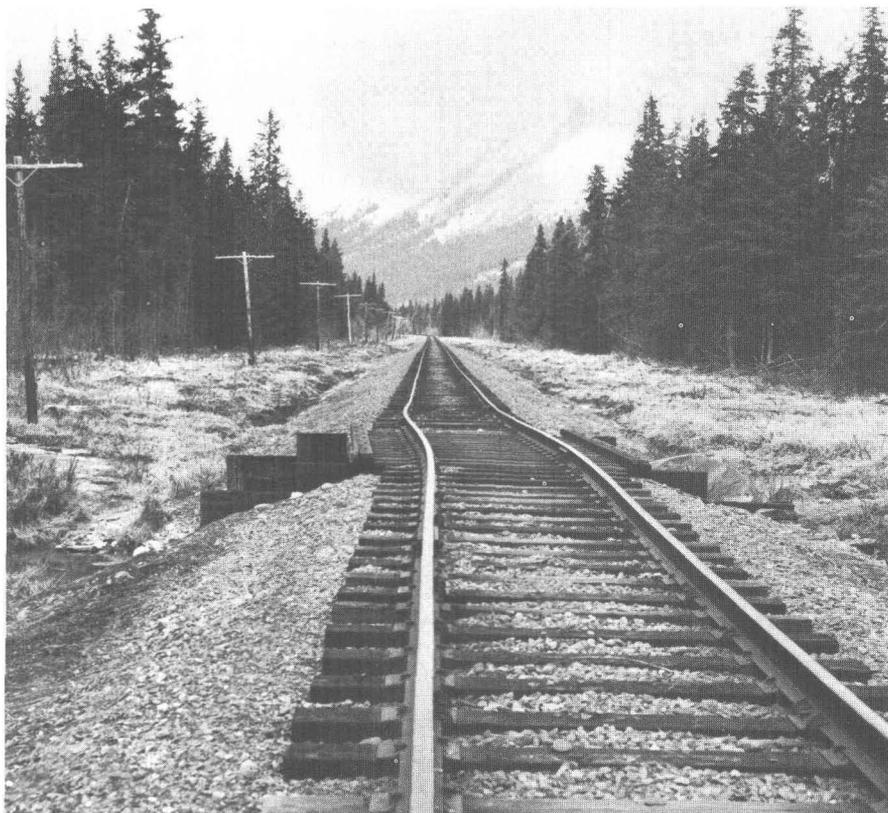
82.—View north over bridge 15.2 on the inactive floodplain terrace of Snow River. Approximately 950 feet of the embankment north of the bridge shifted about  $1\frac{1}{2}$  feet to the west toward an abandoned stream channel 220 to 230 feet to the west, in the tree-covered area.

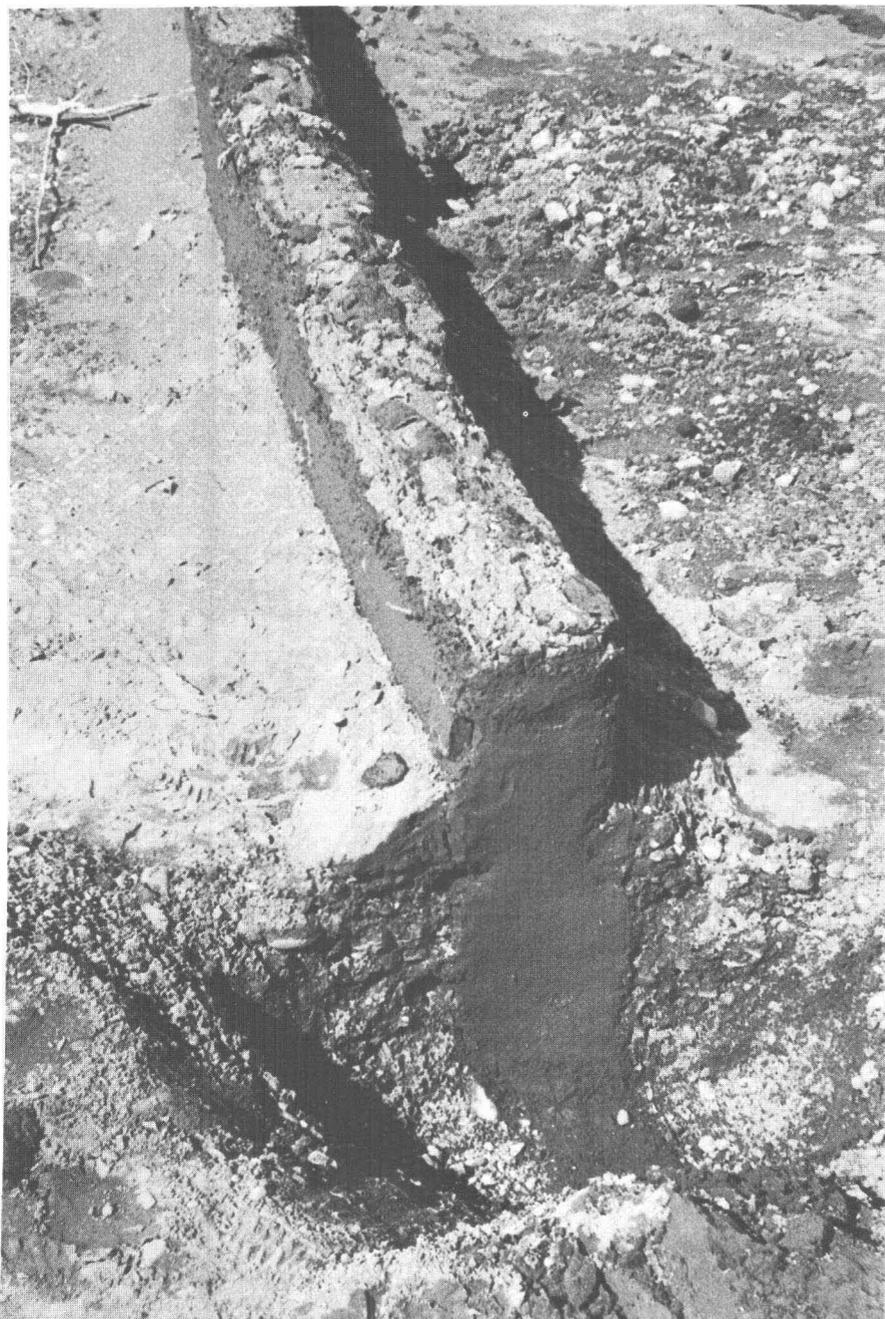
89.—A clastic dike on Snow River delta composed of sediments that were injected into a crack in the frozen delta sediments and overlying lake ice that was frozen to the delta surface. The top of the dike is about a foot above the ground surface.

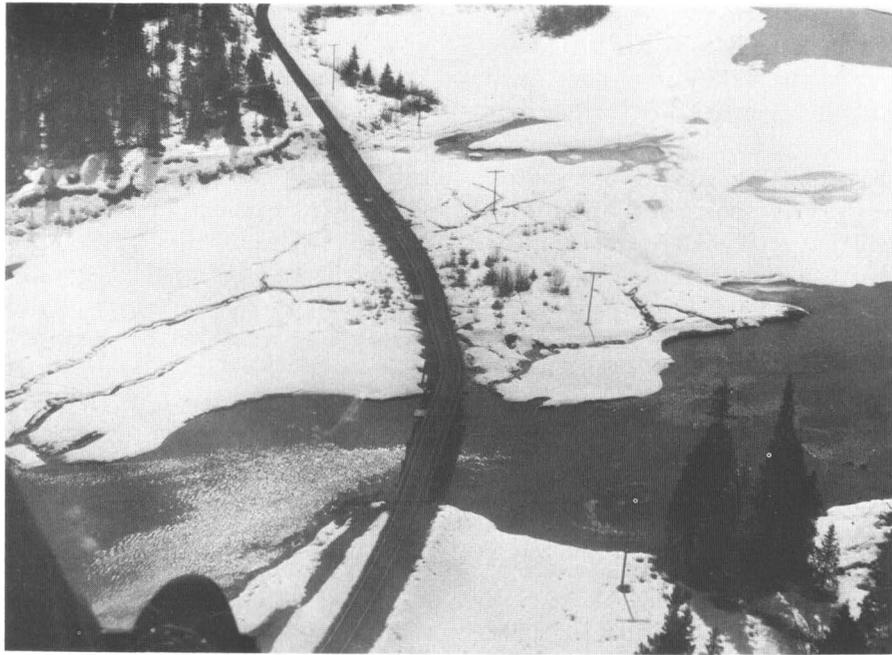
93.—View south over bridge 33.0 at the north end of Upper Trail Lake. Compression buckled the bridge deck laterally. Note the large ground cracks in the flood-plain sediments. Photograph by The Alaska Railroad.

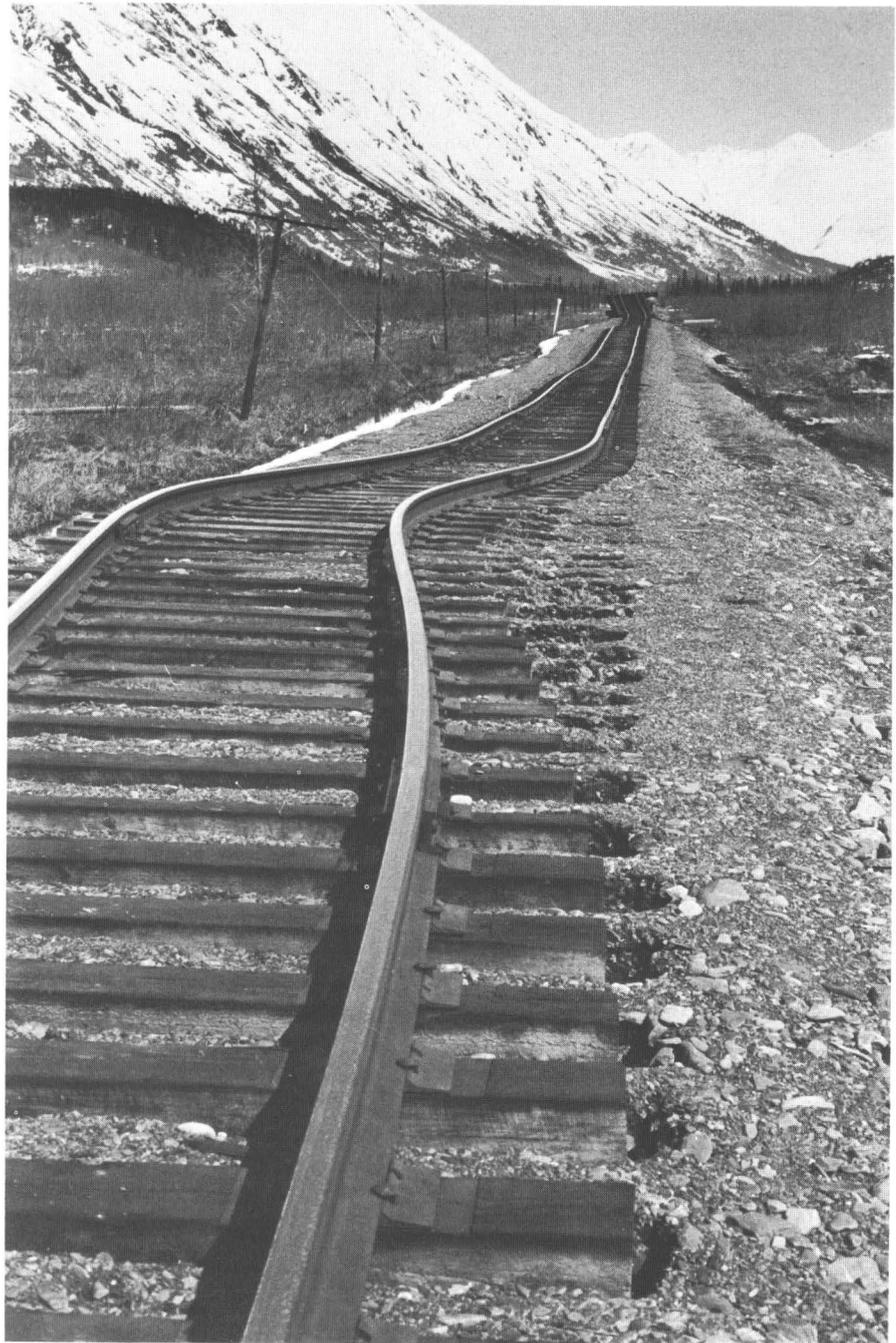
94.—A lateral buckle in the track at mile 34.3, possibly a result of longitudinal compression of the roadbed fill. Bridge 34.5 is visible in the background.

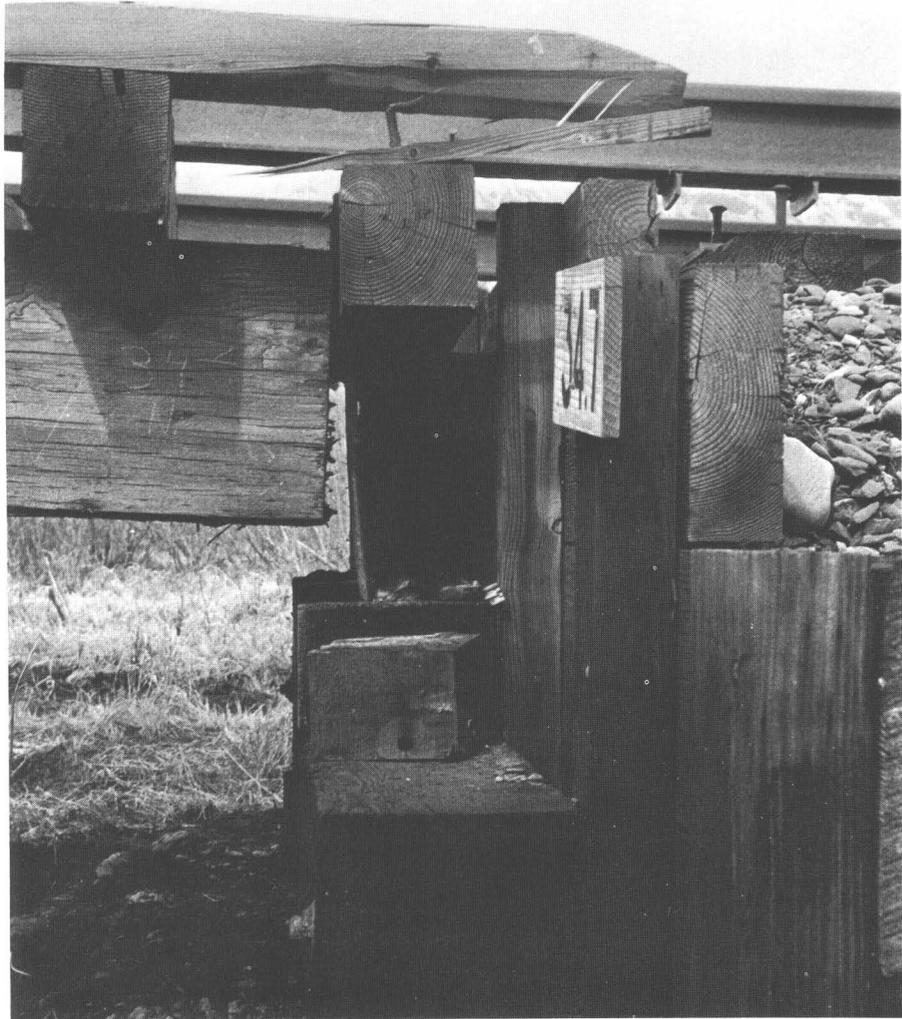
97.—Stringers of extended bridge 34.7 that were pulled  $4\frac{1}{2}$  inches away from the north bulkhead and cantilevered  $5\frac{1}{2}$  inches up off the bulkhead bent.

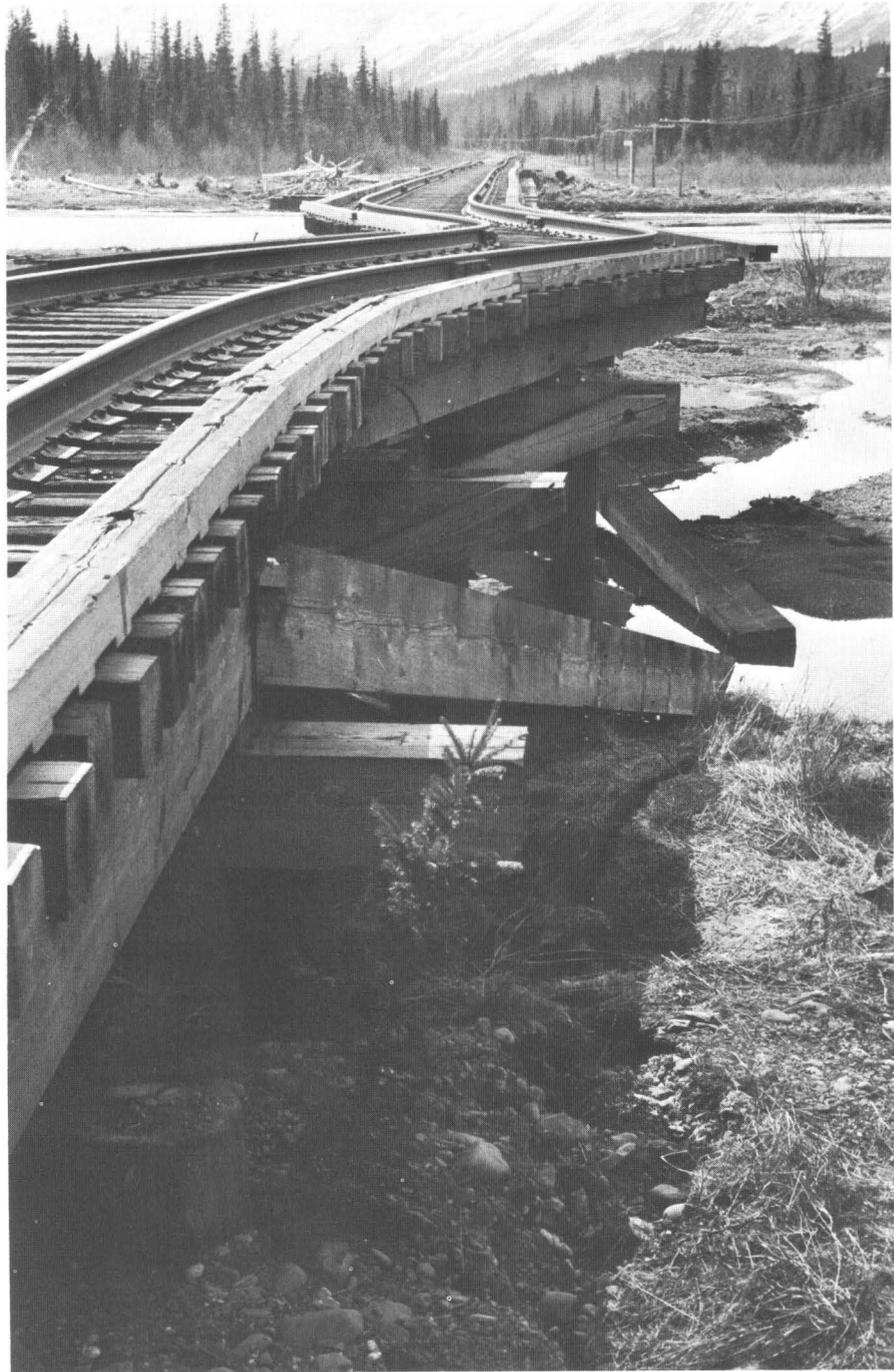
99.—Laterally buckled deck of bridge 37.0, on Hunter Flats. The buckling stringers broke free of some bents and pulled others (at apex of bend) laterally through the sediments.

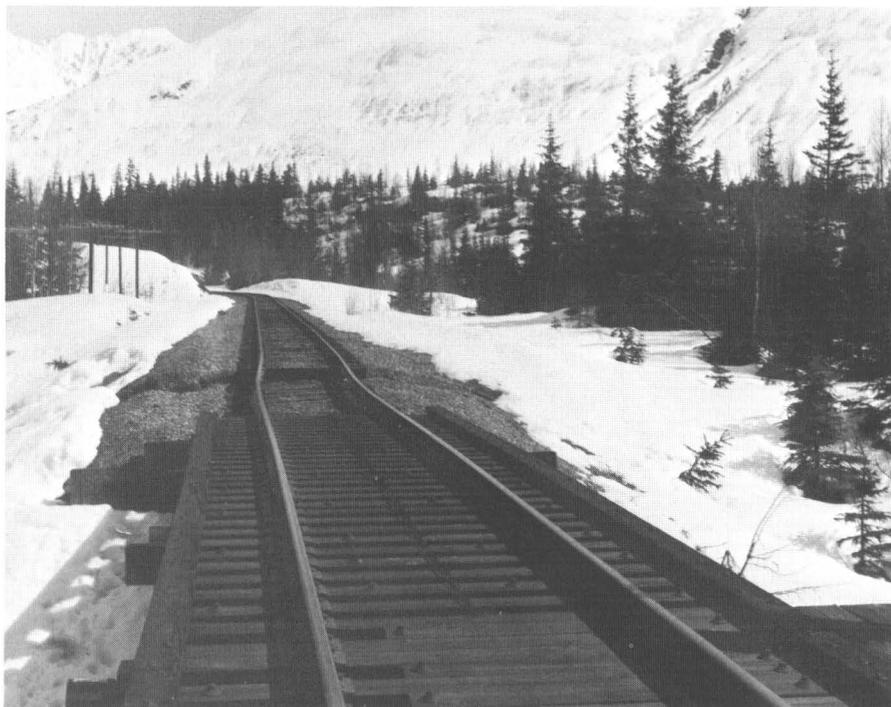
102.—View north over bridge 41.6, where 18 feet of the approach fill was lowered about 1.5 feet. Photograph by The Alaska Railroad.

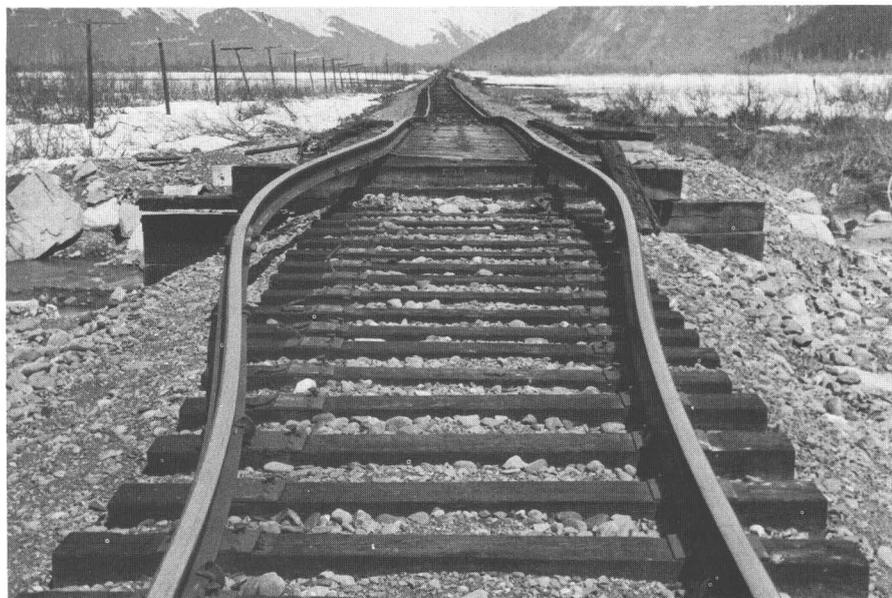
104.—View north over bridge 59.6, showing the lowering of the embankment relative to the bridge, compressive bowing of the rails, skewing of the deck, and horizontal displacement of the embankment toward the low ground to the left of the roadbed. The ties were frozen in the ballast, and the rails pulled free of the fish plates.

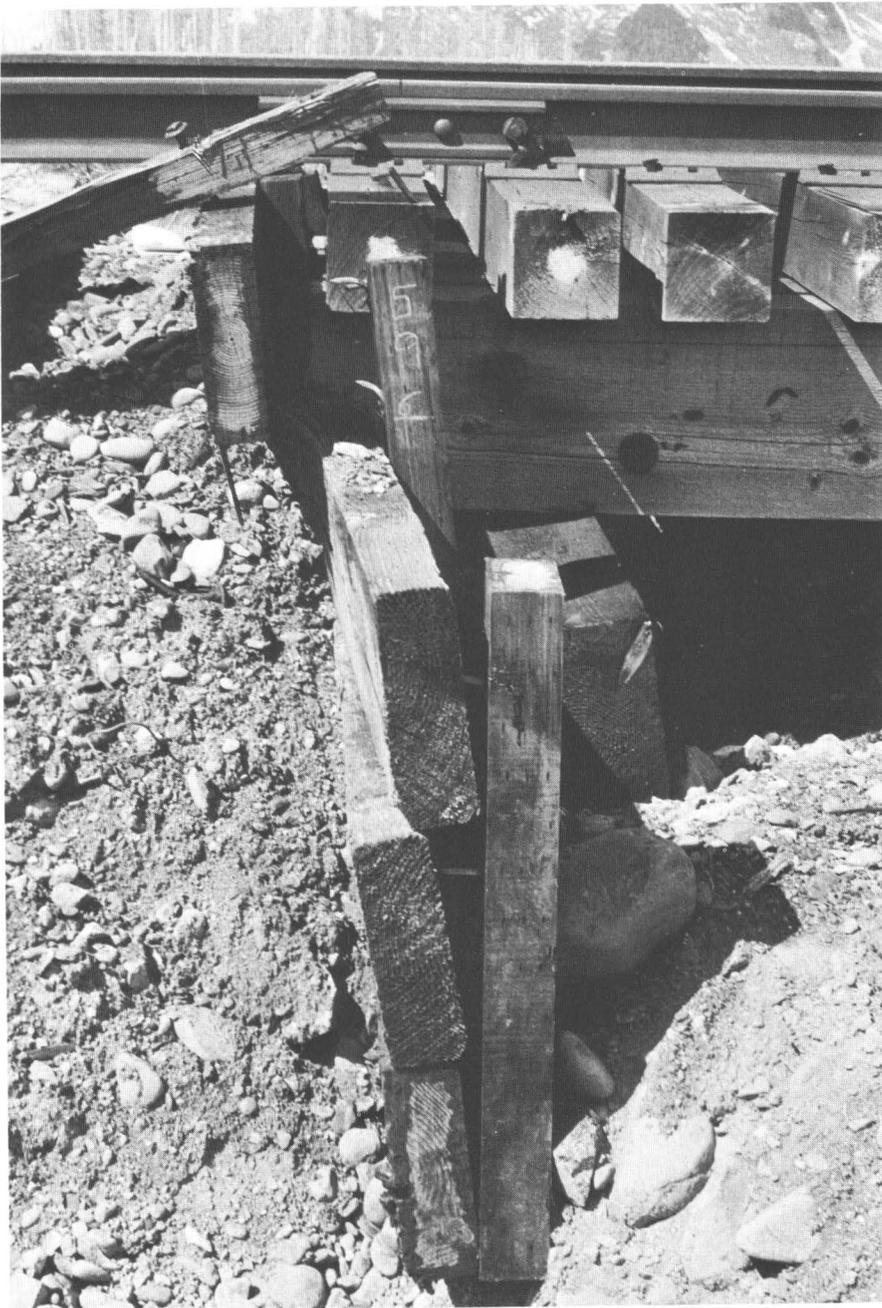
105.—The stringers of bridge 59.6 driven into and through the bulkhead planks.

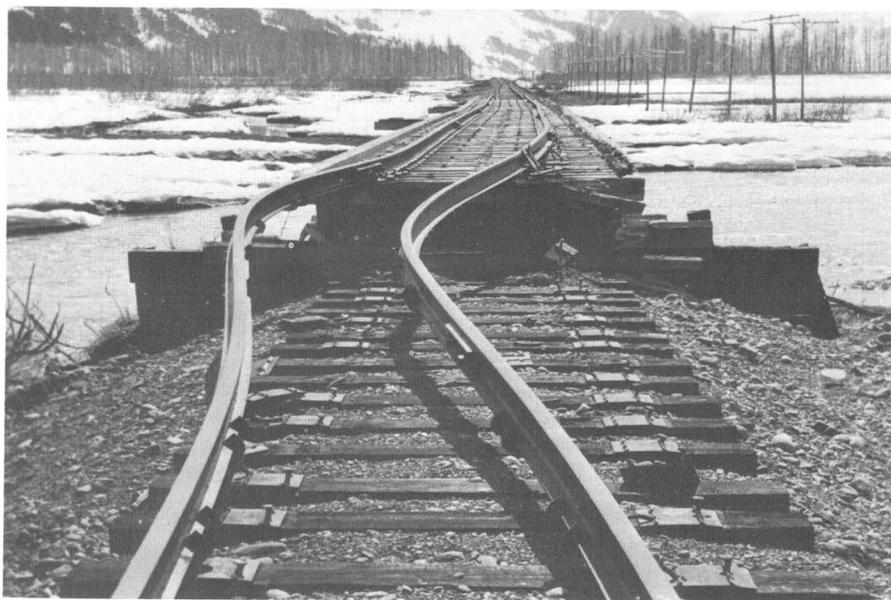
106.—View north over bridge 59.9 on Skookum Creek flood plain. It shows the lowered embankments, rails buckled by compression, and horizontal displacement of the embankment that produced a skew of about 3 feet in the bridge deck (see fig. 56).

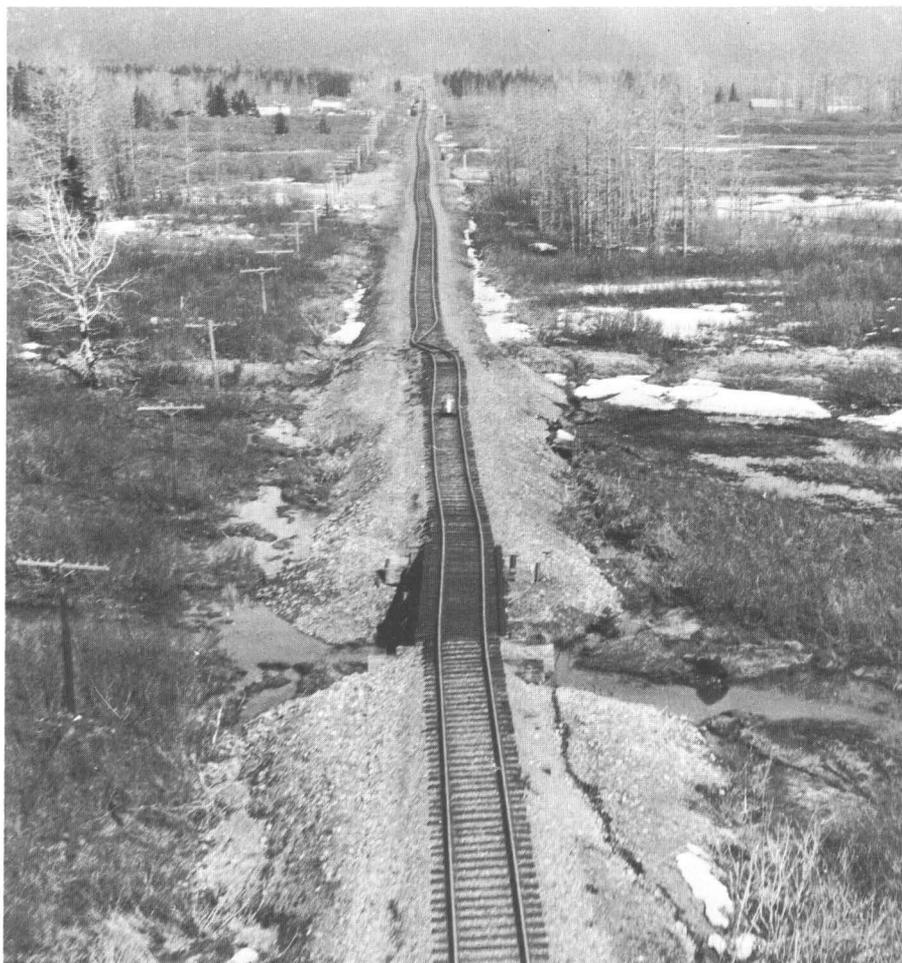
116.—Broken and laterally displaced embankment north of bridge 62.3. Photograph by The Alaska Railroad.

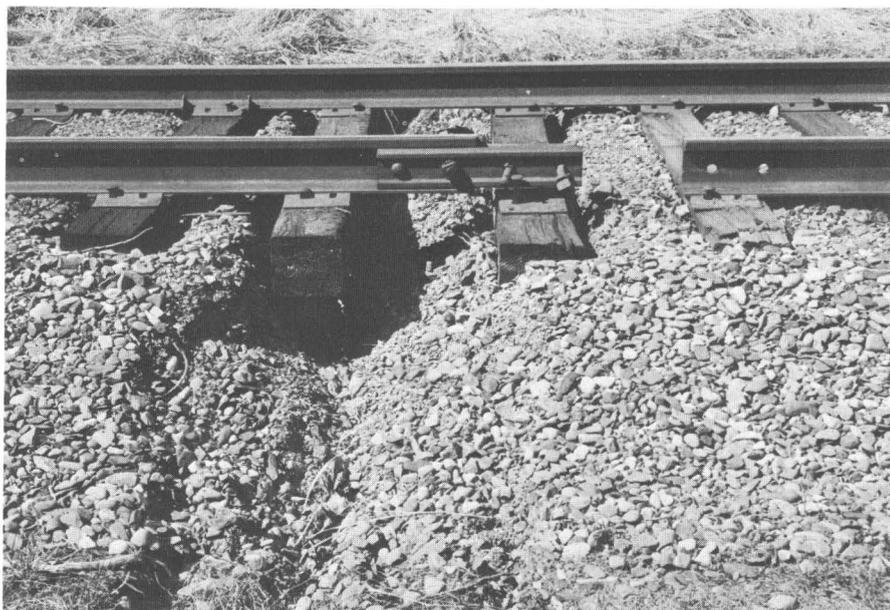
118.—Tension fracture in the roadbed and a 2-foot pull-apart in the rail at about mile 61.9 caused by spreading of the underlying flood-plain sediments (see pl. 3).

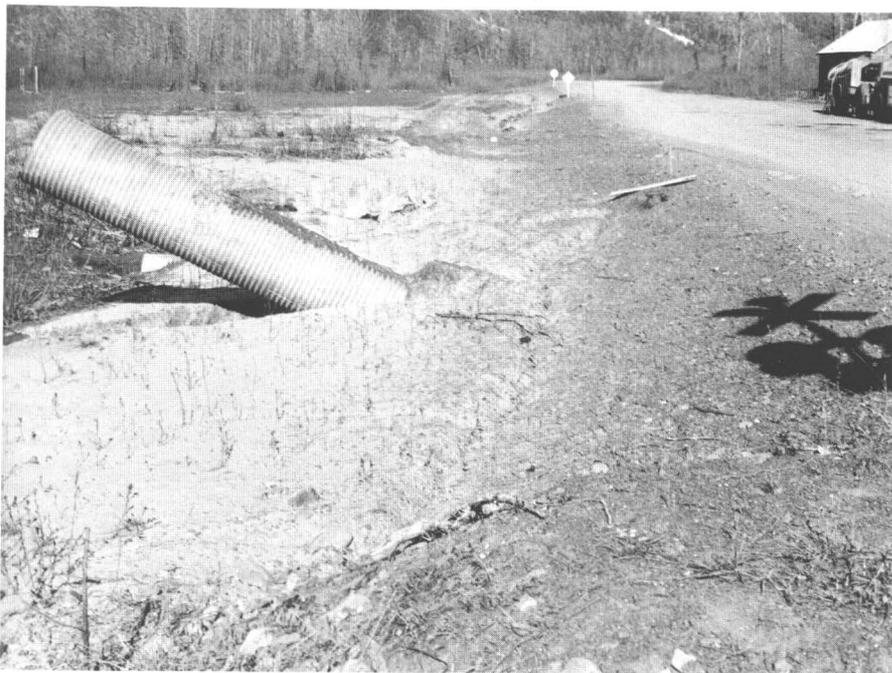
119.—Three-foot-diameter culvert cantilevered upward by sinking of the highway fill just north of the grade crossing at mile 62.9.

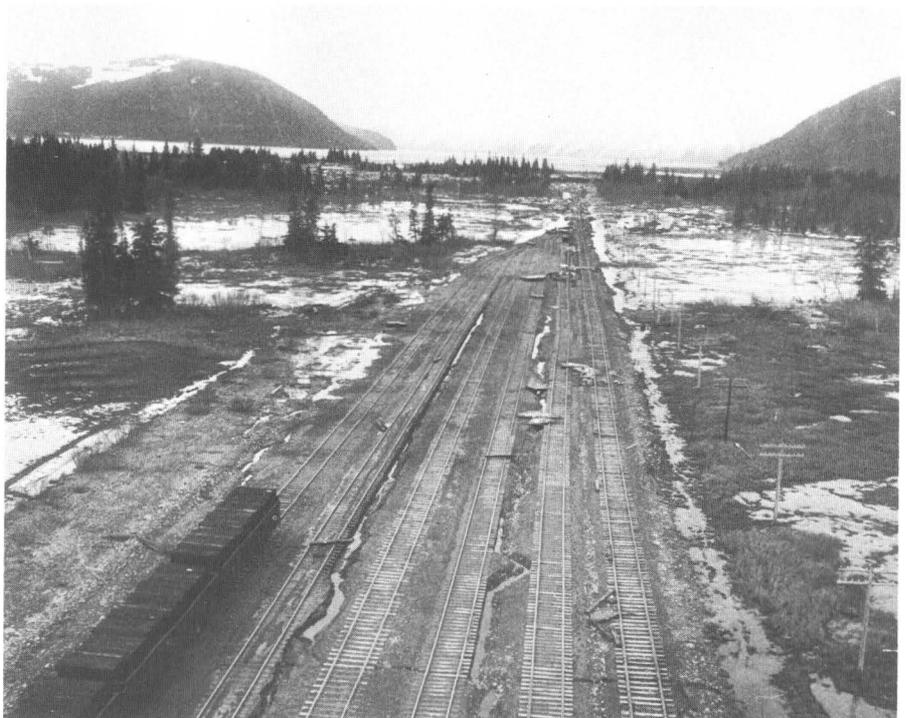
124.—Tension fractures between tracks on the Whittier branch marshaling yards. The subgrade fill failed by lateral spreading and the ballast failed in tension.
