# The Alaska Earthquake

# Effects of the Earthquake Of March 27, 1964, on The Alaska Railroad

By DAVID S. McCULLOCH and MANUEL G. BONILLA

GEOLOGICAL SURVEY PROFESSIONAL PAPER 545-D

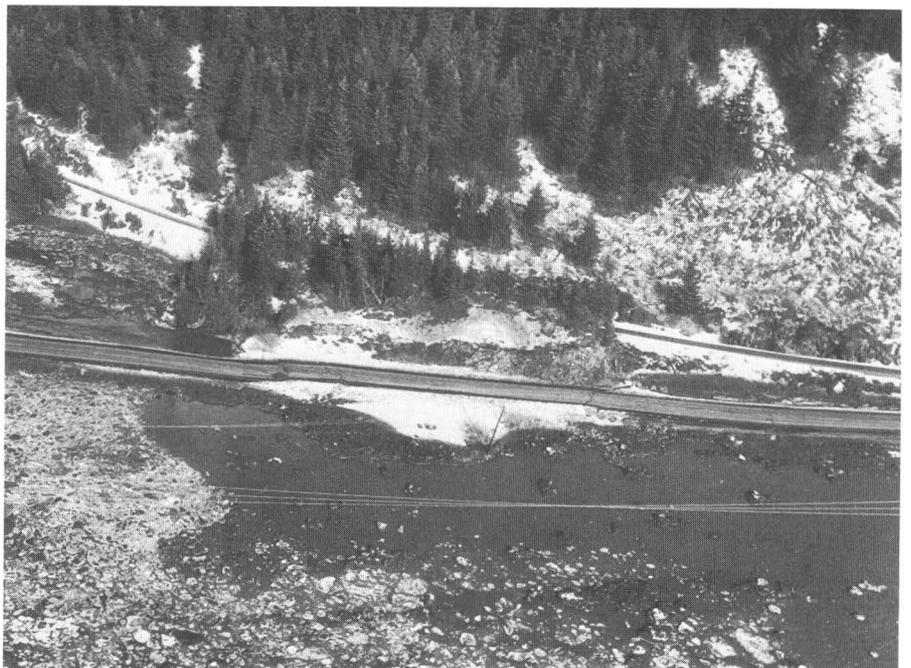
125.—Highway embankment along the north shore of Turnagain Arm that settled abruptly on tidal sediments adjacent to a bedrock promontory. Similar settlement occurred on the railroad embankment. Embankments on tidal sediments also were shifted toward the arm and offset horizontally.

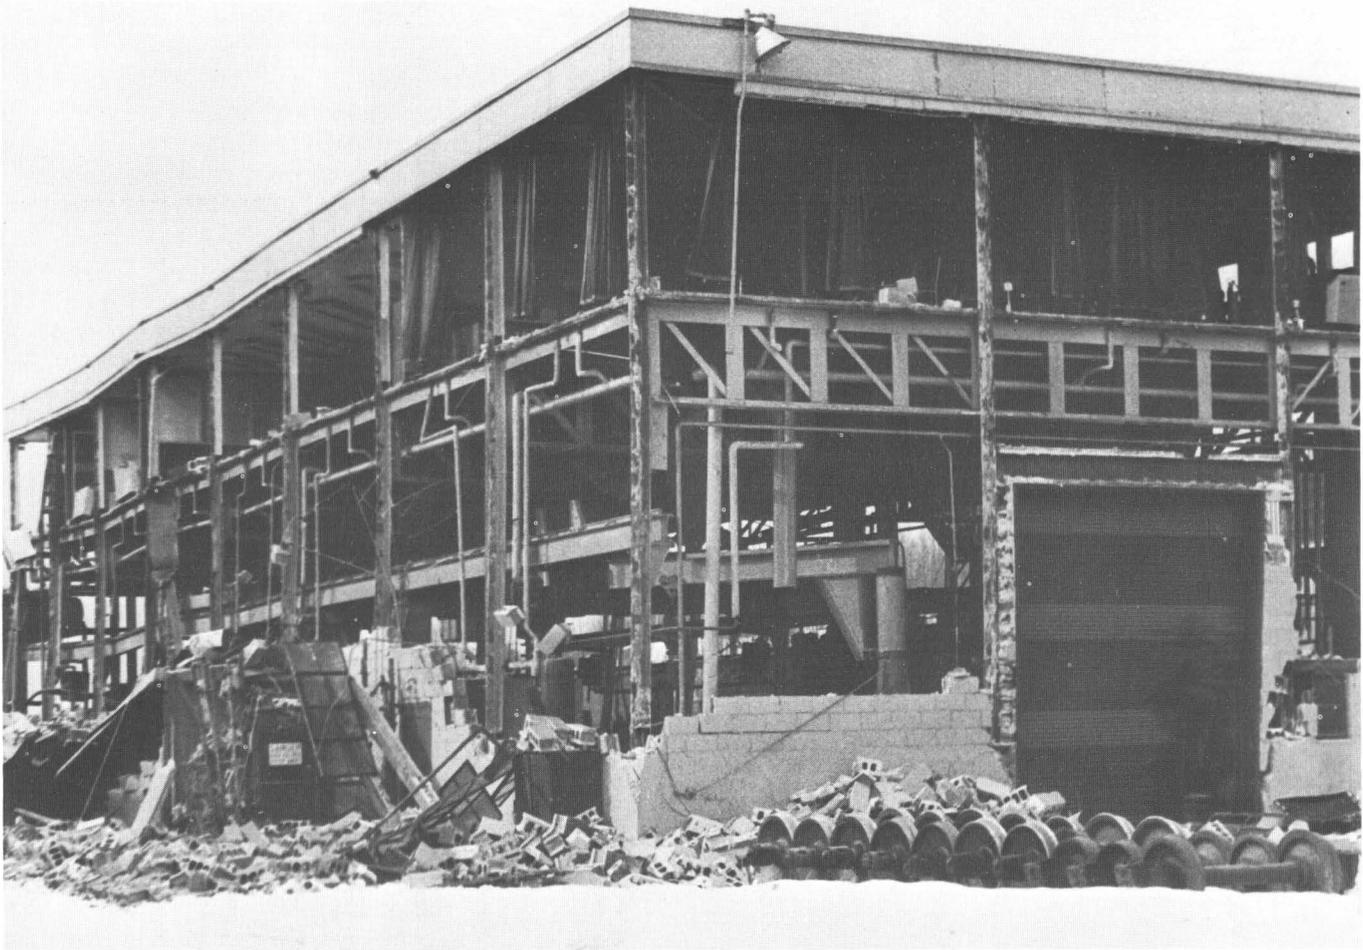
127.—Postearthquake view of the Wheel Shop-Mechanical Offices, showing the steel frame exposed by the collapse of the concrete block walls. Photograph by The Alaska Railroad.

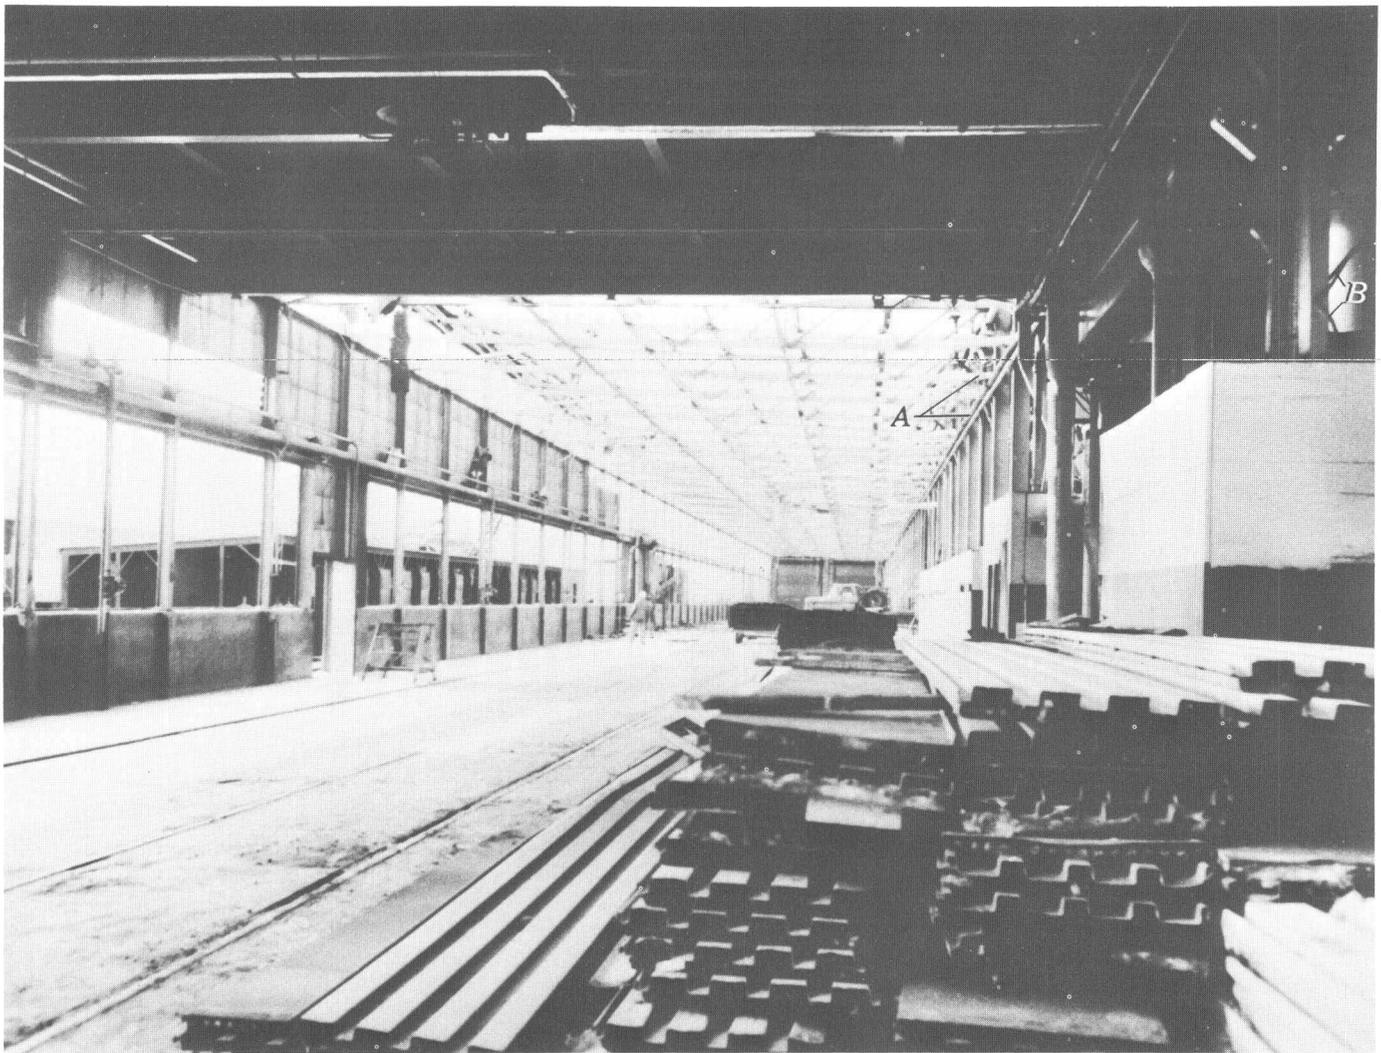
130.—Interior view of the south bay of the Car and Coach Shop showing *A*, the roof trusses resting on a horizontal steampipe and *B*, buckled rods between H-beam columns. Insulated sheathing panels removed during repairs. Photograph by The Alaska Railroad.

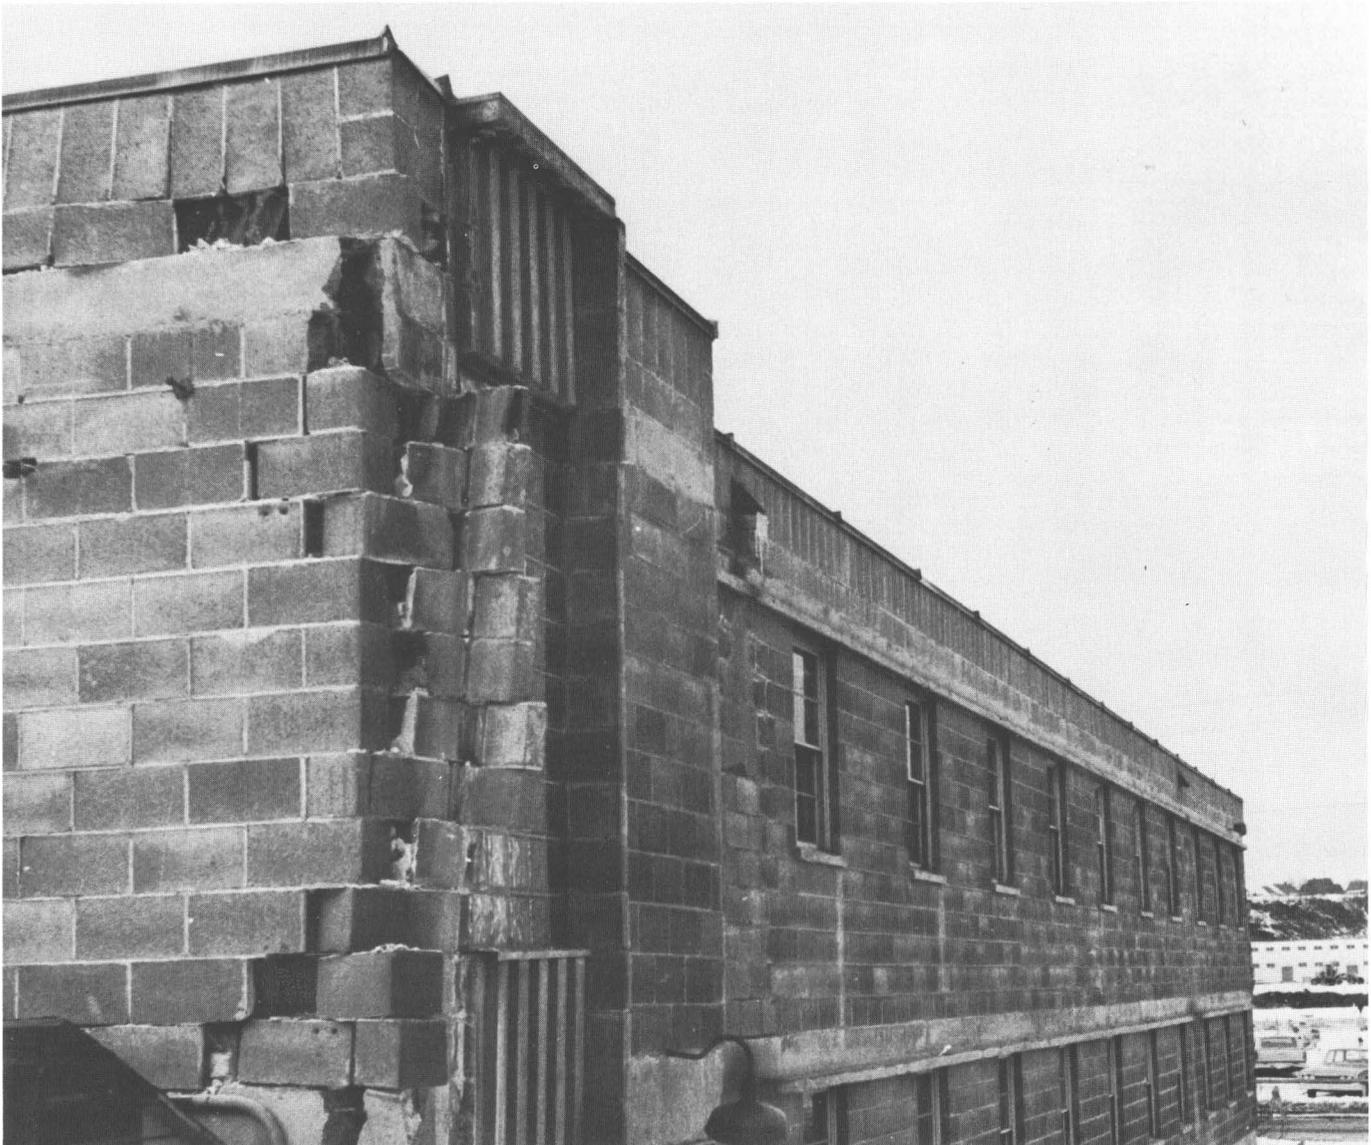
133.—View of the southeast corner of the Office Annex building, showing the rupturing of the block and mortar. Photograph by The Alaska Railroad.

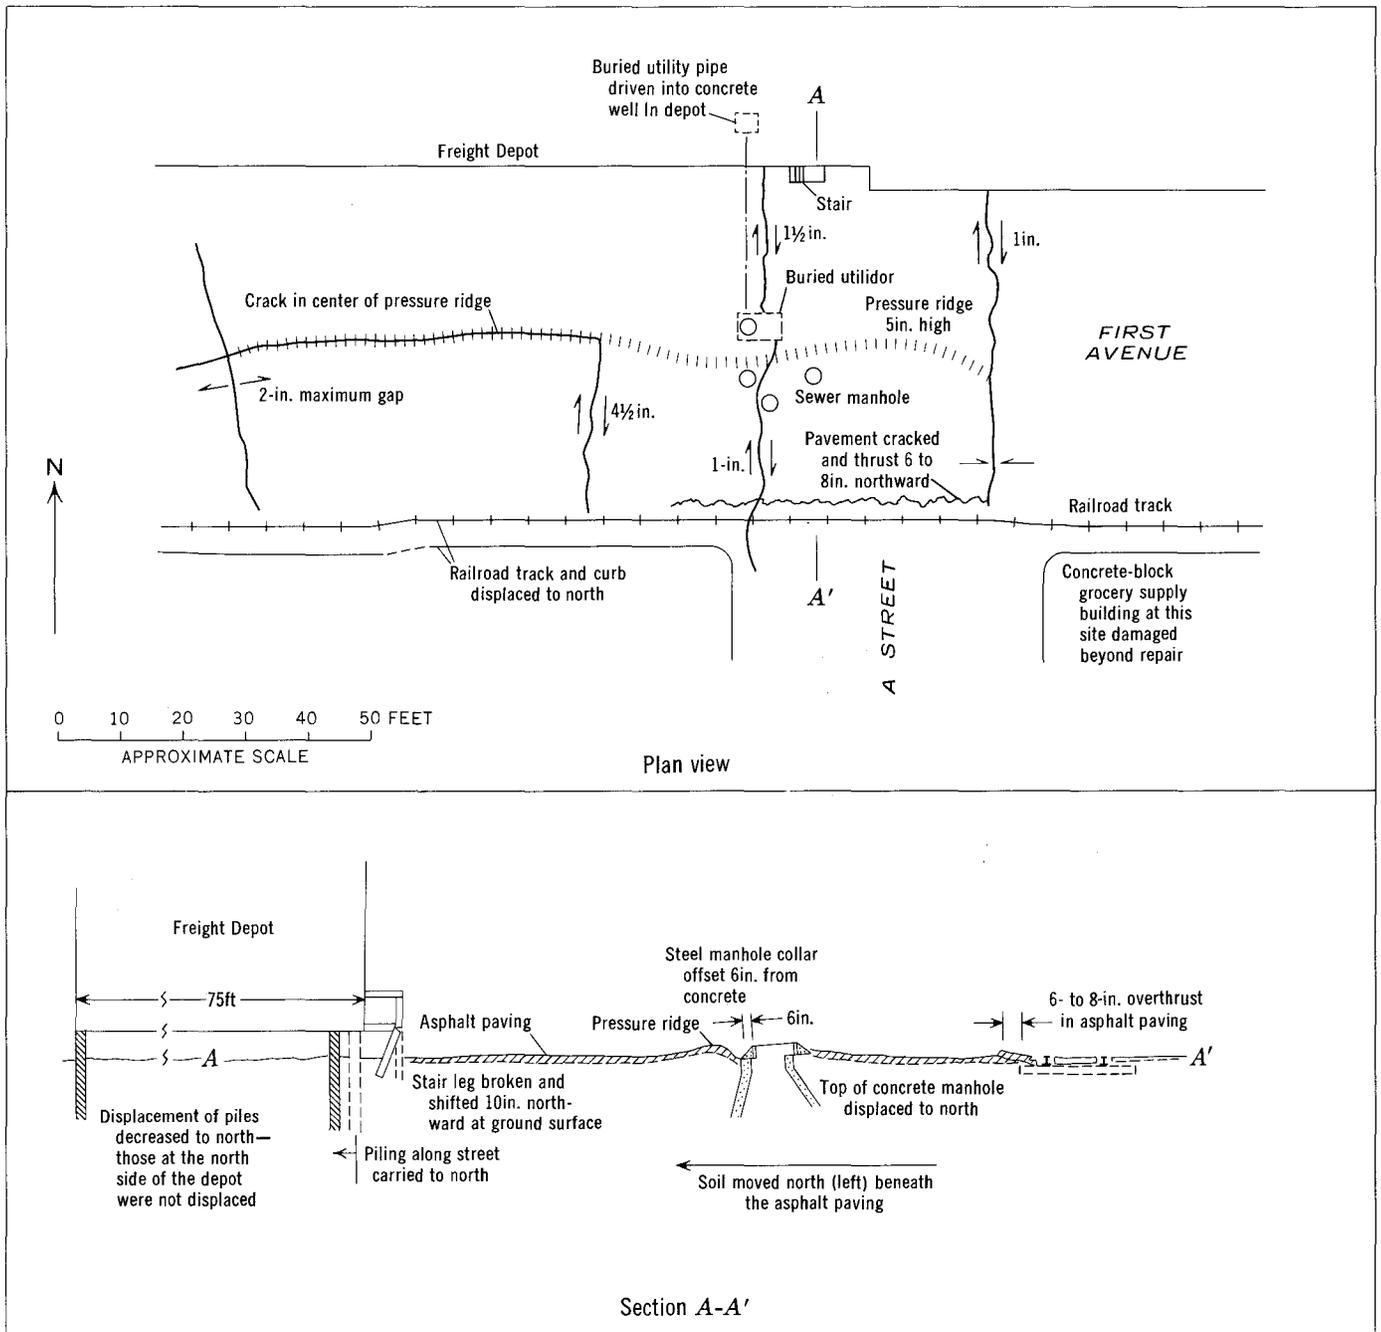
134.—Field sketches (plan and cross section) of landslide features on First Avenue along the south edge of the railroad Freight Depot. Sediments beneath the pavement moved to the north, displacing the concrete well of a sewer manhole and the porch support and wood pile foundation of the Freight Depot. The pipe from the utilidor (plan view) was thrust 16 inches into the concrete well under the depot.
