The Parkfield-Cholame California, Earthquakes of June-August 1966

GEOLOGICAL SURVEY
PROFESSIONAL PAPER 579

The Parkfield-Cholame California, Earthquakes of June-August 1966— Surface Geologic Effects Water-Resources Aspects, and Preliminary Seismic Data

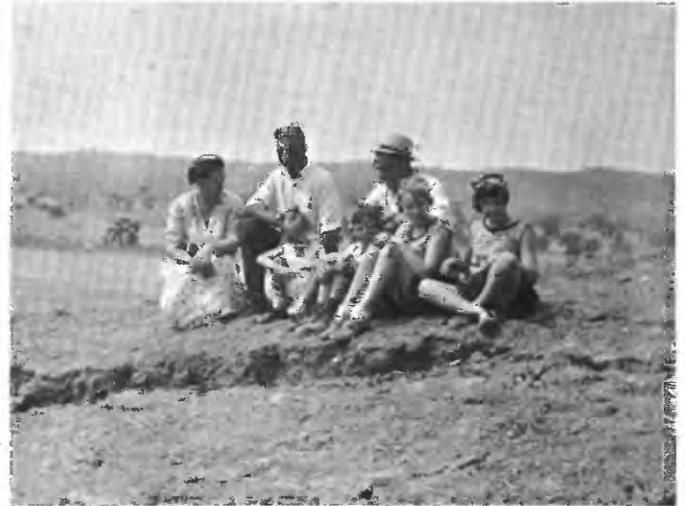
FIGURE 4.—Landslide fissure produced by the Parkfield earthquake of June 7, 1934; this landslide was reactivated by the 1966 earthquakes. Photograph by Herbert H. Durham.

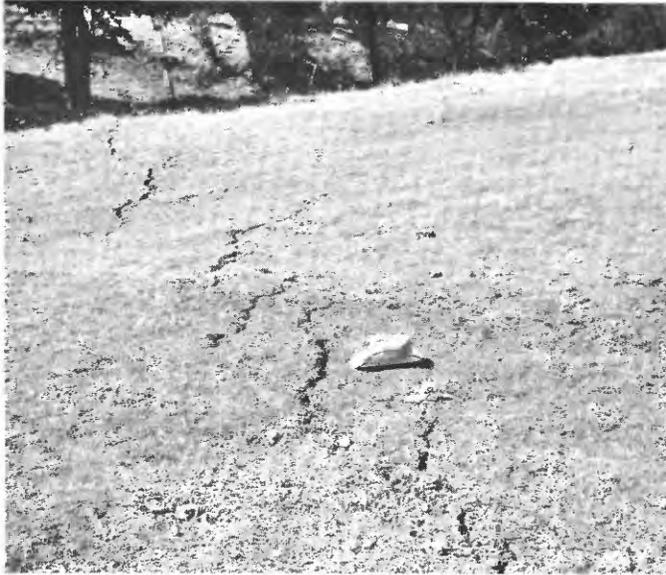
FIGURE 6.—En echelon fractures, southwest fracture zone near locality F33.

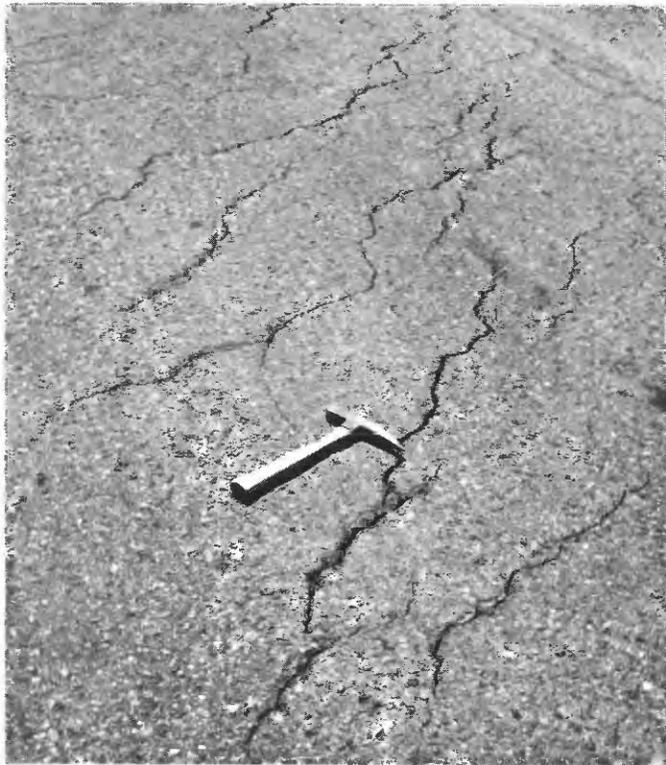
FIGURE 7.—En echelon fractures in surfaced county road from Highway 46 to Parkfield, at locality F10.

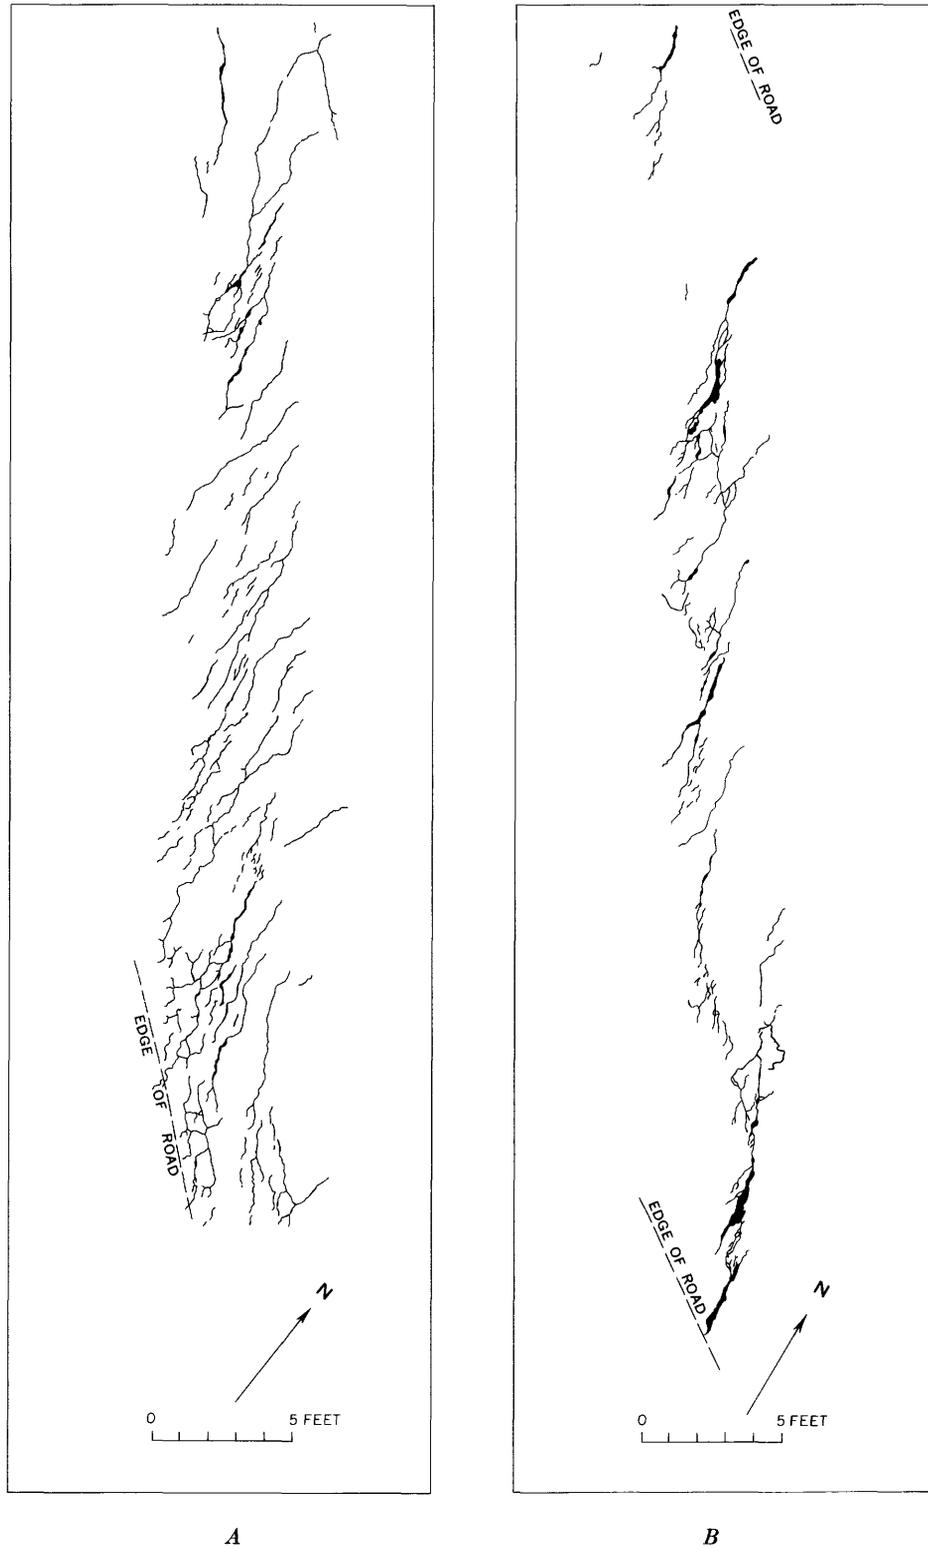
FIGURE 9.—En echelon fractures in asphalt. A. Across Parkfield road (loc. F10) 1.4 miles southeast of Turkey Flat road intersection. Fractures were traced from vertical photographs taken at 10:30 a.m. on July 22, 1966. B. Across Meng road (loc. F27) 0.6 mile southeast of Highway 46. Fractures were traced from vertical aerial photographs taken at 7:30 a.m. on July 22, 1966.

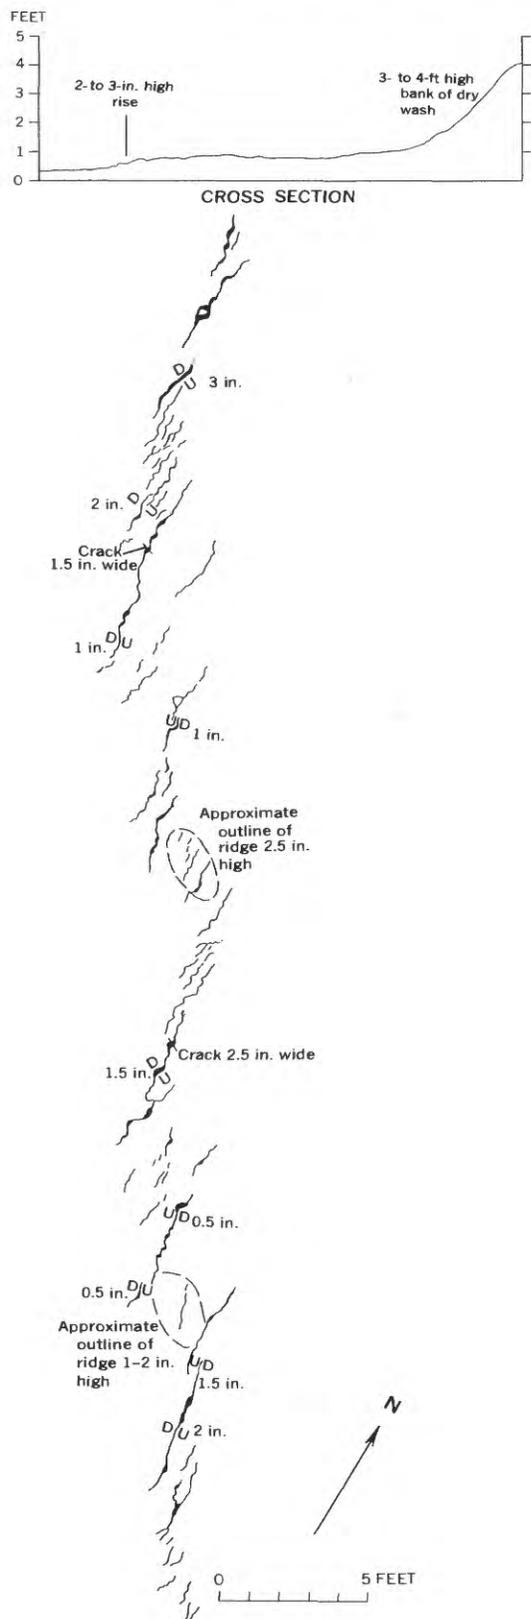
FIGURE 10.—En echelon fractures in fine sandy silt approximately 350 feet south of Highway 46. Fractures were traced from vertical aerial photographs taken 6:30 p.m. July 21, 1966.

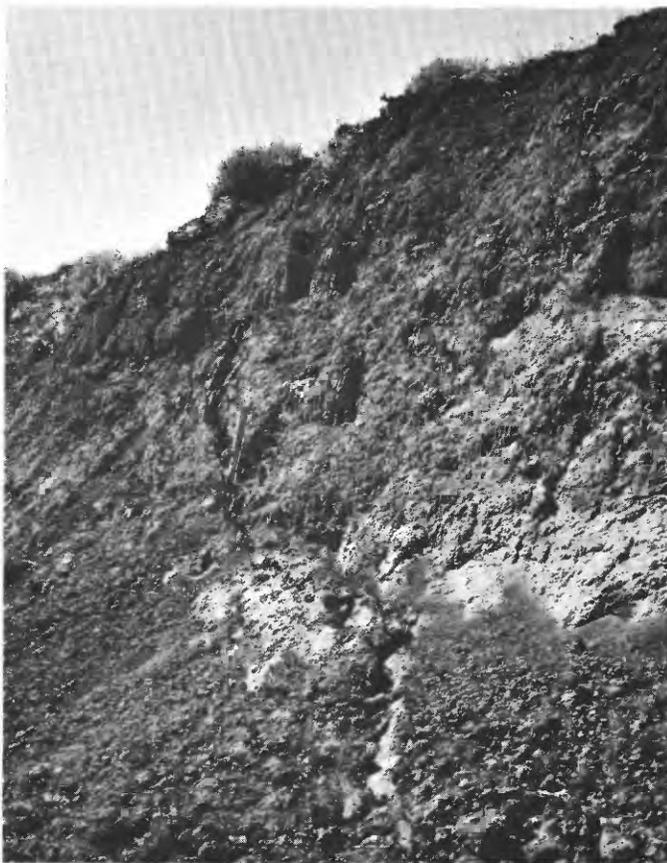
FIGURE 13.—Nearly vertical en echelon fracture, left bank of Cholame Creek at locality F14. View looking northwest.

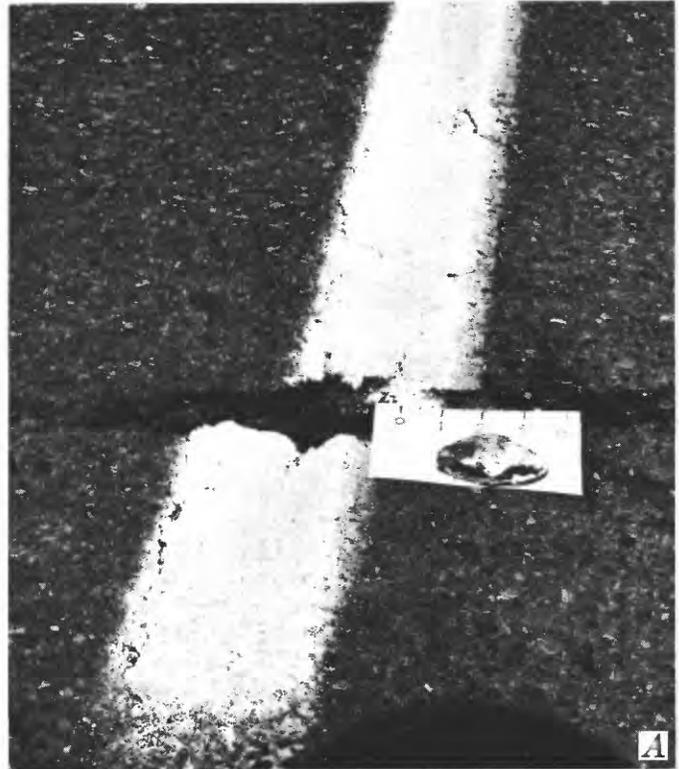
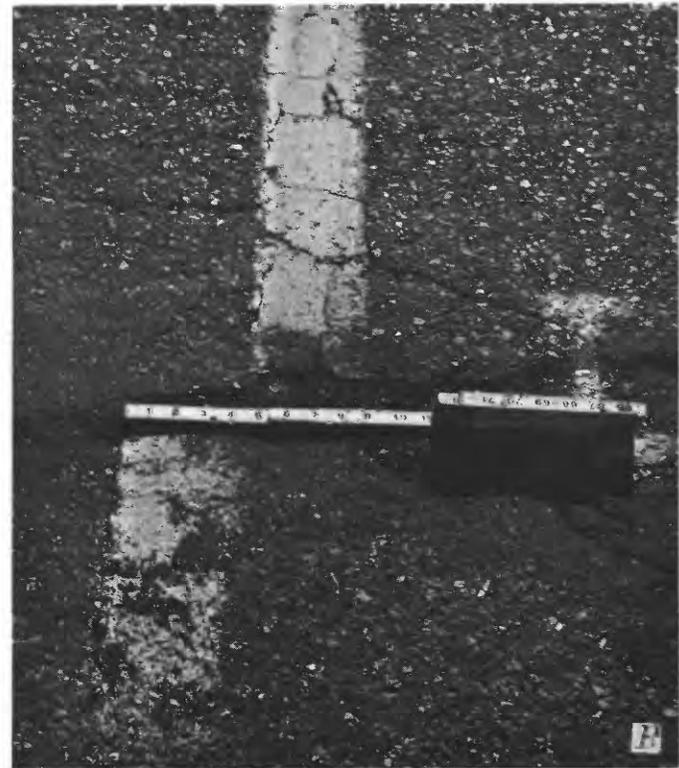
FIGURE 26.—White centerline on Highway 46, 0.85 mile northeast of Cholame showing offsets along a fracture in the San Andreas fault zone. A. 4:00 p.m. June 28. B. 8:00 a.m. August 4.

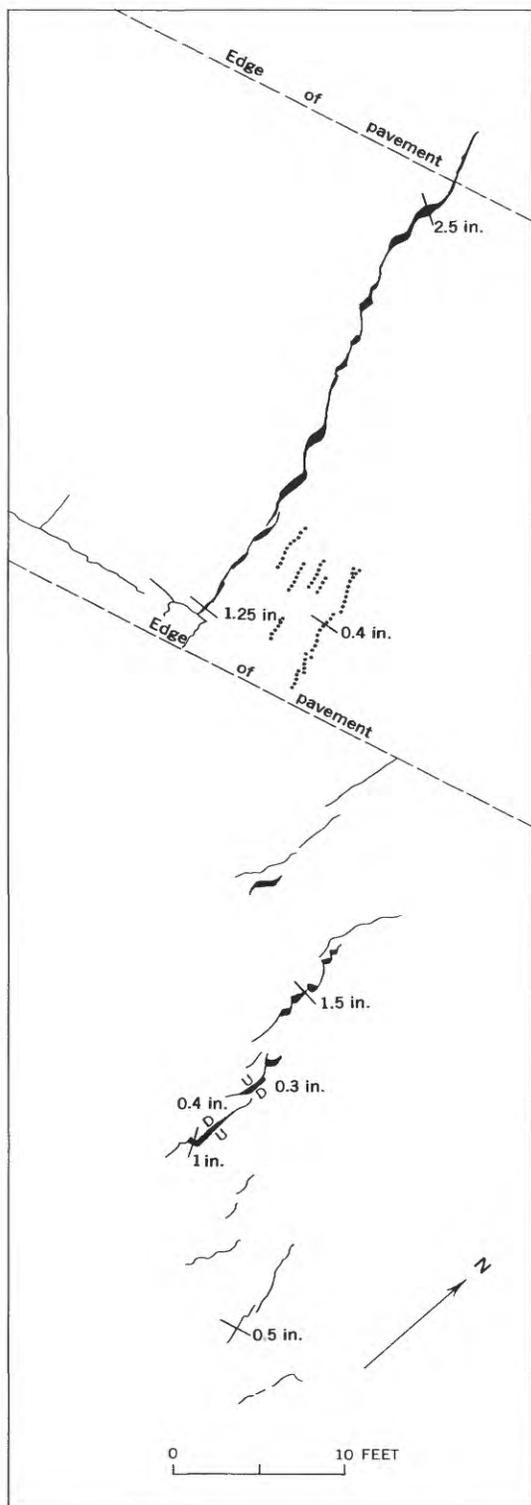
FIGURE 27.—Map of fractures in Highway 46, 0.85 mile northeast of Cholame. Solid mapped June 28; dotted mapped July 21. Numbers indicate width of fracture in orientation shown. U, upthrown side; D, downthrown side.

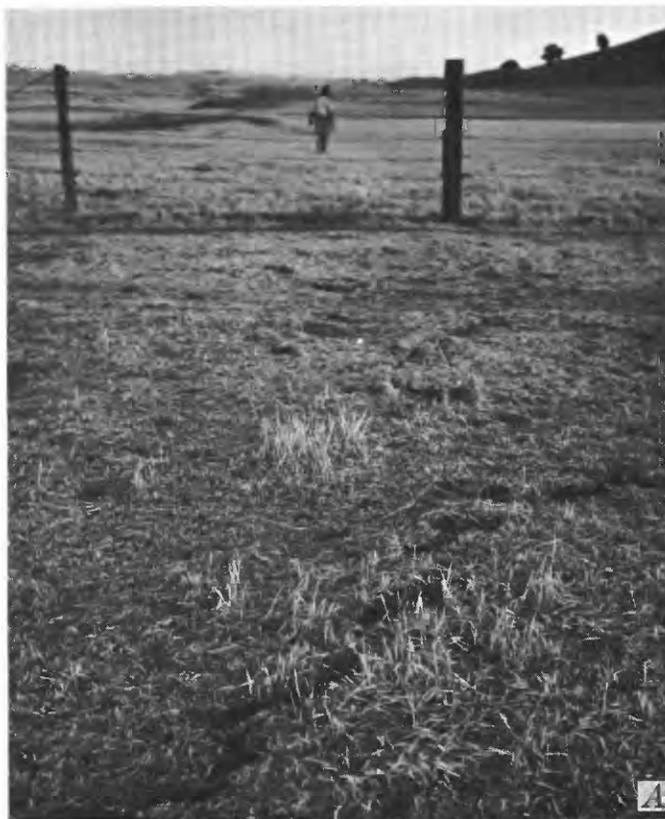
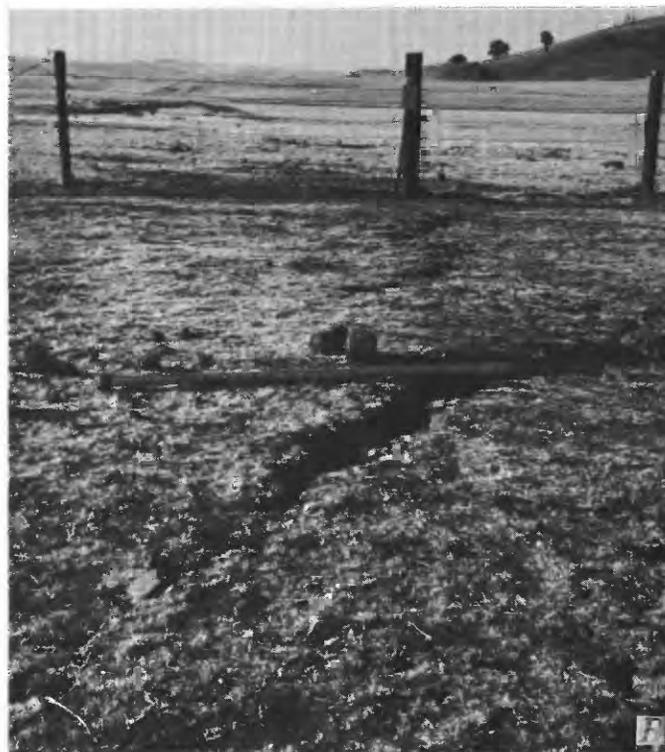
FIGURE 28.—Growth of a fracture at locality F23 between June 28, 7:00 p.m. (A) and July 21 (B).

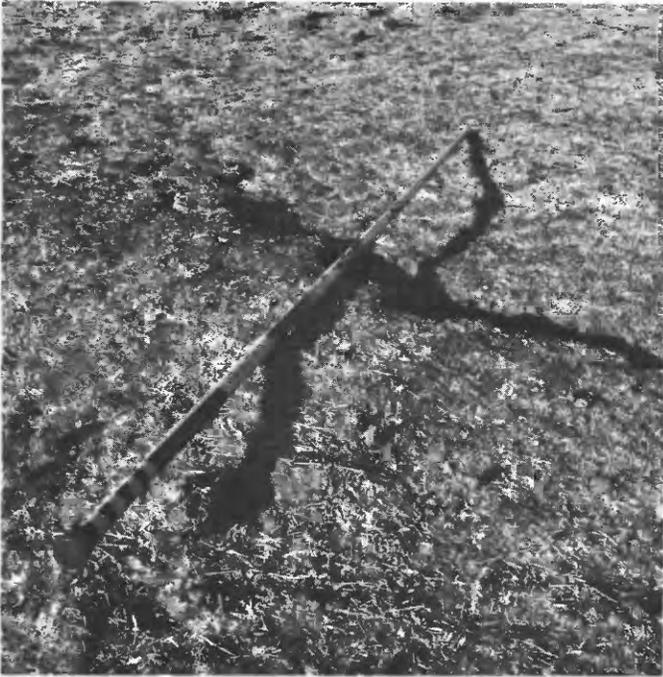
FIGURE 29.—Fracture (also shown in fig. 28) showing relief. Photograph taken July 21, 1966.

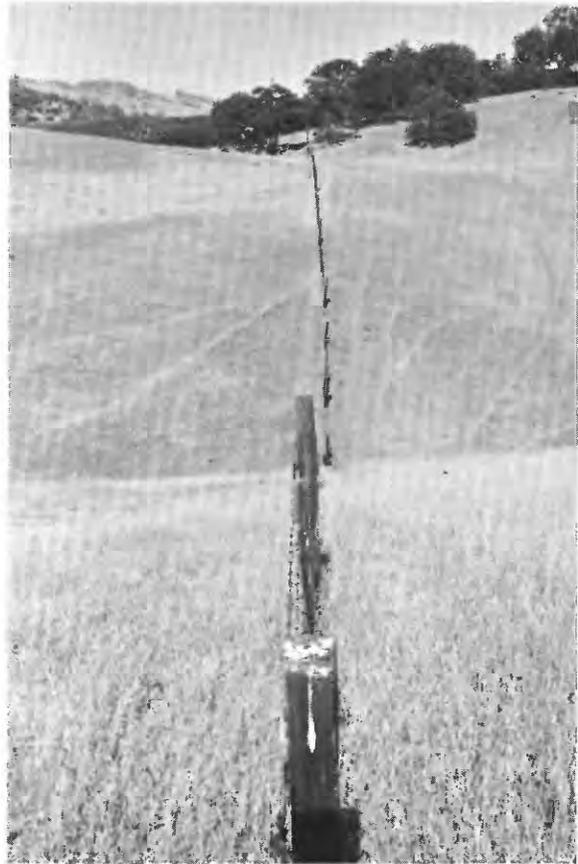
FIGURE 31.—View looking east along Claassen fence.

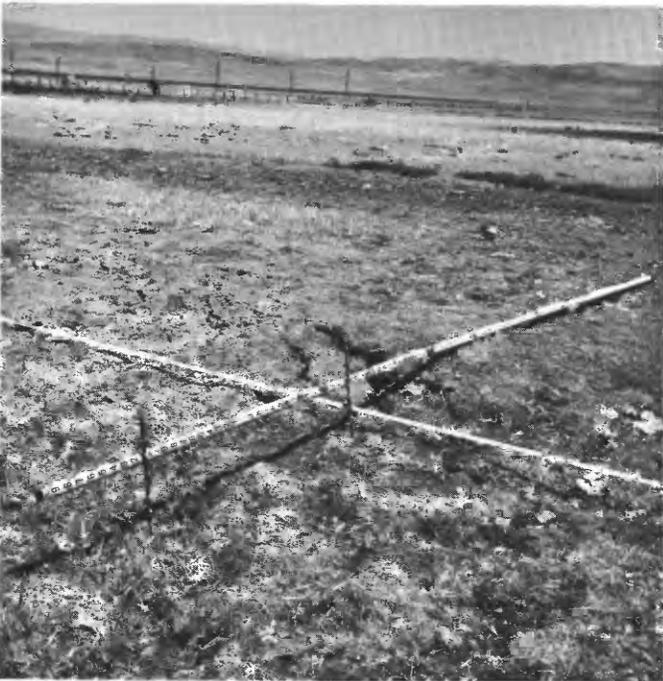
FIGURE 30.—Relief across fracture zone, view looking north-east near locality F23.

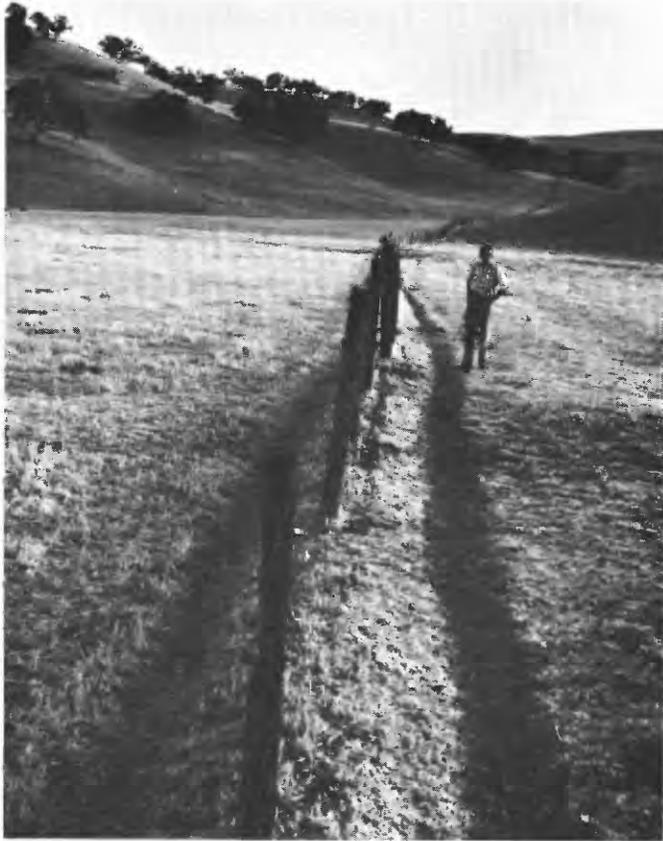
FIGURE 32.—View looking west along fence at locality F23.

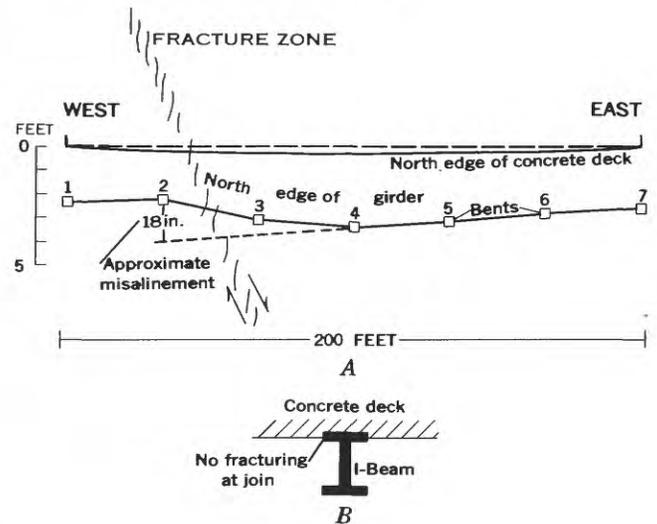
The bridge over Little Cholame Creek 0.3 mile south of Parkfield shows pronounced misalignment of the girders immediately under the deck although the deck itself is only slightly bowed in plan (figs. 33A, 42). Figure 33A shows a diagrammatic plan of the steel I-beam girder supporting the north side of the bridge deck. The girders between bents 2 and 3 and bents 3 and 4 from the west end, both sections of which lie over the fracture zone, are decidedly misaligned, although the eastern three sections (bents 4-7) are fairly well alined. The present concrete deck was poured directly over the misaligned girders so that the top part of the I-beam is

FIGURE 33.—Diagrammatic plan showing misalignment of I-beam girder at Parkfield bridge (A) and cross section (B) of I-beam showing no fracturing at joint between deck and beam.

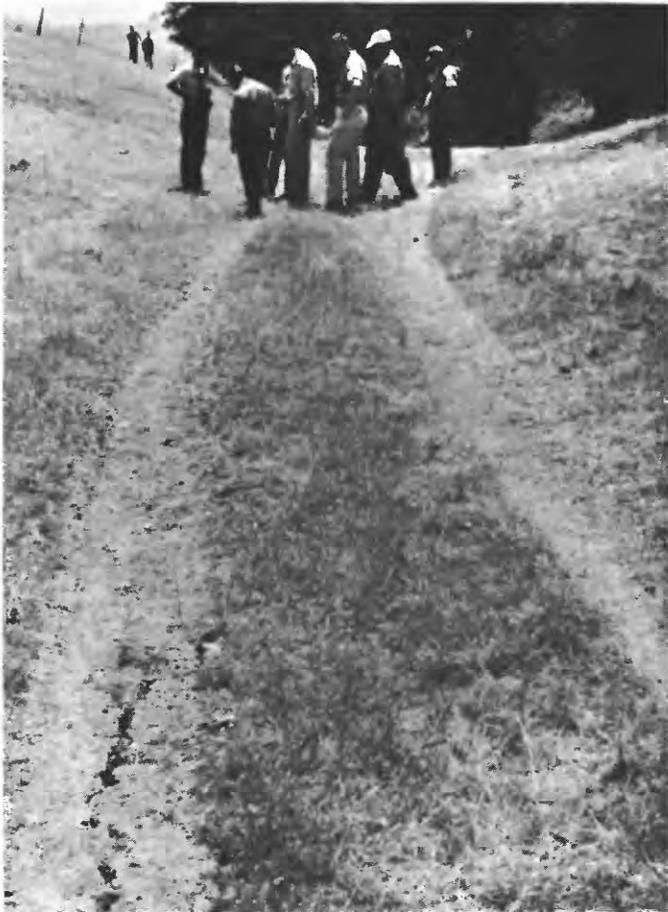
Allen and Smith (1966) report that on the Taylor Ranch 1 mile southeast of Parkfield very fresh-appearing en echelon cracks were noted on June 16, 1966 (fig. 34), and that the Cholame-Parkfield road about 2.4 miles southeast of Parkfield had required repair several times during the preceding 2 or 3 years at the point where the fault trace crosses.

FIGURE 34.—Fractures along trace of San Andreas fault 1 mile south of Parkfield. Photograph taken June 16, 1966, by Dr. Keichi Kasahara of the Earthquake Research Institute, University of Tokyo during Second United States-Japan Conference on Research for Earthquake Prediction.

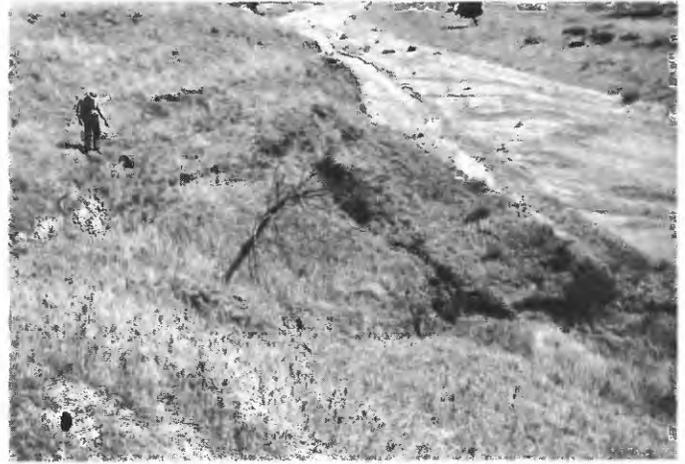
FIGURE 39.—View southward of new fissures within a large reactivated slump in alluvial deposits on east wall of Cholame Creek, about 1¼ miles northwest of Gold Hill. The main fracture zone is exposed near the toe of the slide in stream gravels at upper right.

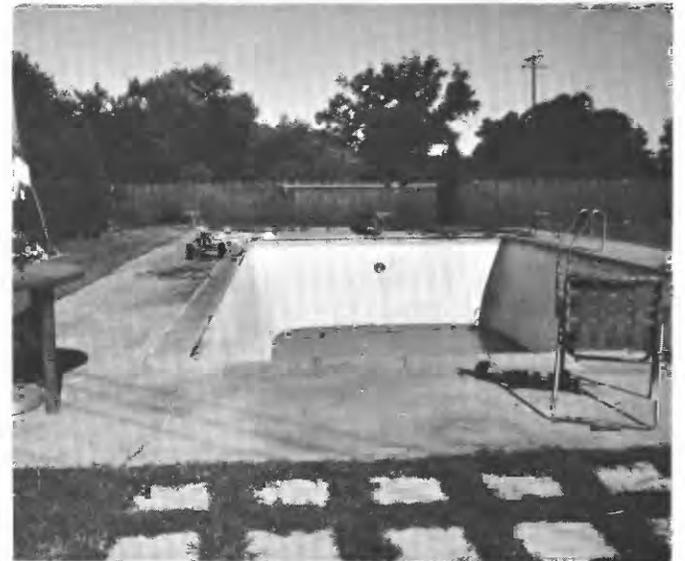
FIGURE 40.—View northwest of swimming pool at Miller's house; pool was cracked along headwall fissure (more than 225 ft long) of slump in alluvial deposits. Slump was slightly reactivated during earthquakes of June 27. The major crack is continuous from slab in left foreground through pool to pool wall in background. See also figure 39.

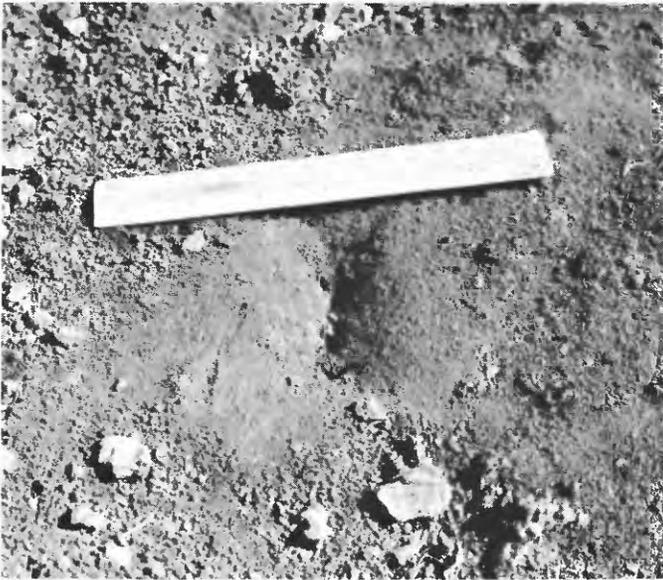
FIGURE 41.—Deposit of dust and silt ejected by air near main fracture zone south of Highway 46. Scale about 7 inches long. Photograph by Reuben Kachadoorian. See also figure 14C.

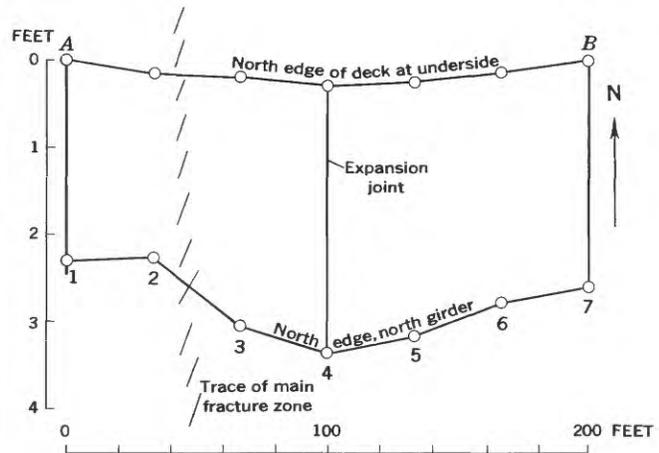
FIGURE 42.—Deformation of Monterey County road bridge (No. 438) over Little Cholame Creek just south of Parkfield. Configuration of north edge of concrete deck as measured at underside, and configuration of northernmost of three steel I-beam girders that support deck. Configurations based on measurements made by E. F. Roth in July and August 1966, at points opposite each of seven steel piers (numbered from west to east) that support the girder, with reference to a string that was tightly stretched between points A and B at lower edge of deck. Note great exaggeration ($33\frac{1}{2}\times$) of north-south scale.

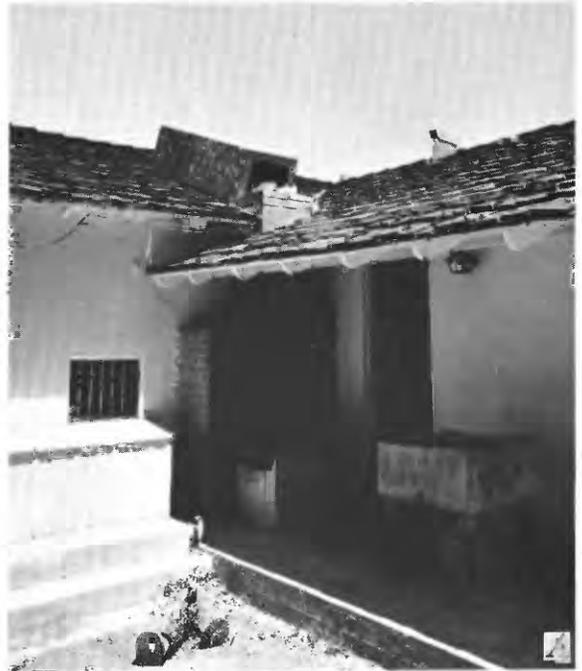
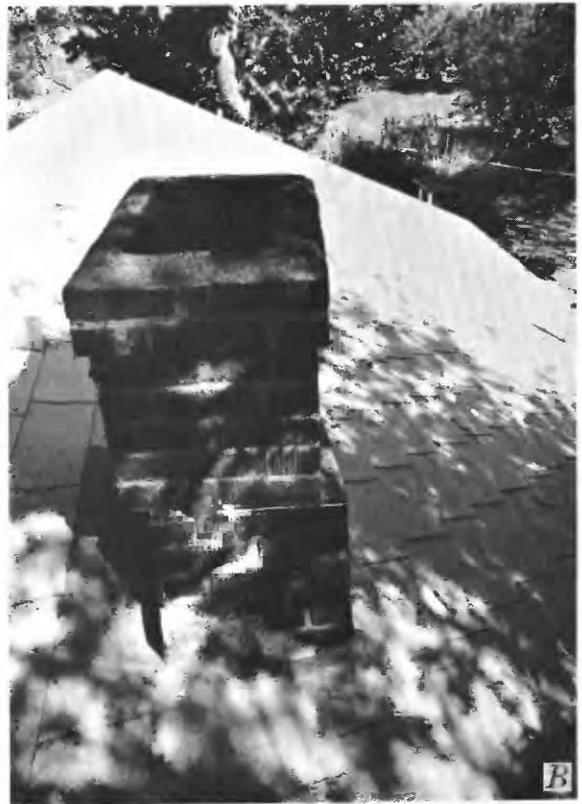
FIGURE 43.—Selected examples of damaged chimneys. A. Half a mile northeast of main fracture zone and $2\frac{1}{2}$ miles northwest of Parkfield. The 8-foot-long segment separated at the eaveline and toppled northeastward, directly away from the main fracture zone. B. Less than 0.1 mile west of the main fracture zone and about half a mile west of Parkfield. Upper part of chimney separated and rotated clockwise.

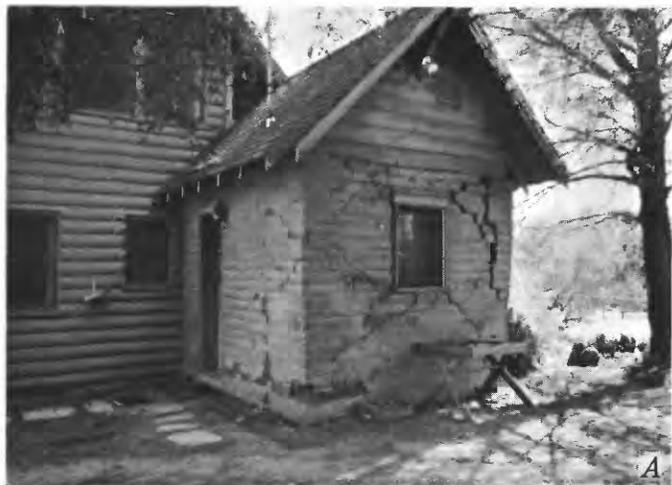
FIGURE 44.—Broken and expanded unreinforced adobe brick wall attached to frame house, on the Paso Robles Formation 1.2 miles southwest of main fracture zone and 3.5 miles northwest of Parkfield. Wall trends east-west. *A.* General view. *B.* Detailed view; scale is about 6 inches long.

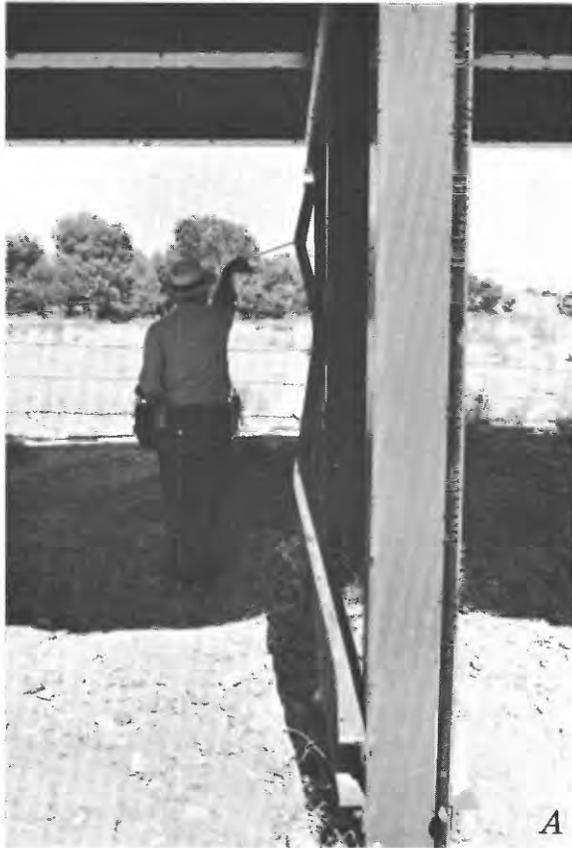
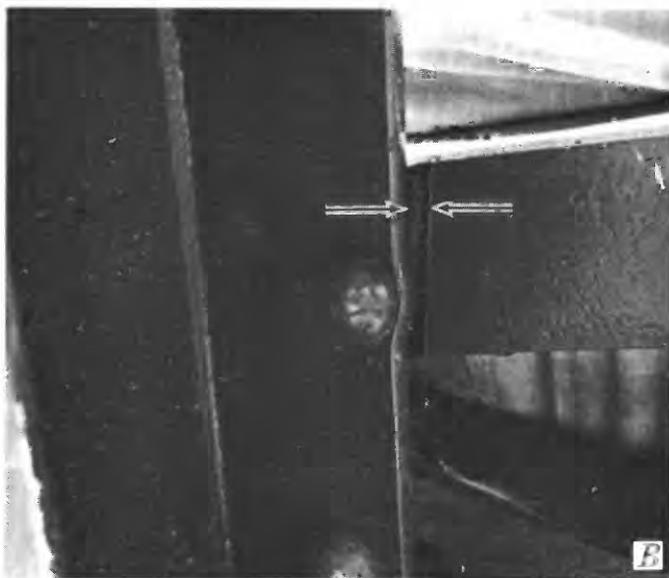
FIGURE 45.—Deformation of Monterey County road bridge (No. 444) over Cholame Creek, just southwest of the main fracture zone and about 0.1 mile northwest of Wilson's house. A. Buckled swaybraces, viewed southeastward at right angles to length of bridge. B. Freshly scraped paint (between arrows) and partial bearing failure (at rivet near center) between vertical steel pier (at left) and steel swaybrace.

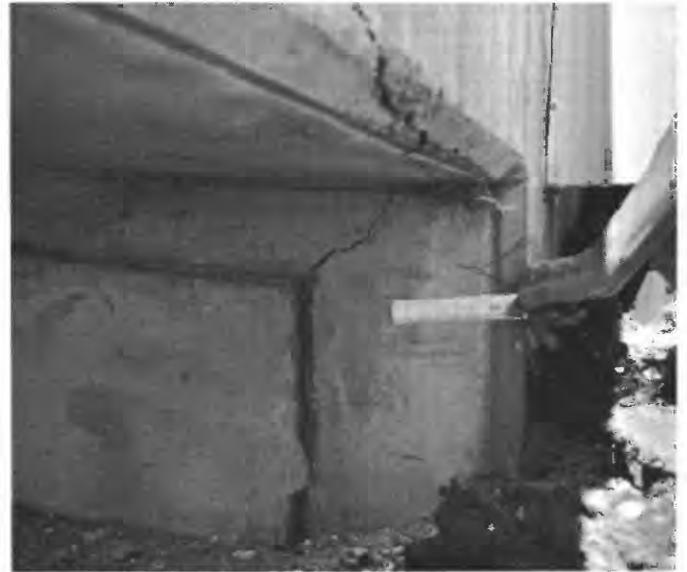
FIGURE 46.—Damaged concrete bridge abutment, at east end of Highway 46 bridge over Cholame Creek, about 0.1 mile west of main fracture zone. Abutment is freshly cracked and slightly separated at crack. Scale is about 7 inches long.
