Landslides of Rio de Janeiro and the Serra das Araras Escarpment, Brazil

By FRED O. JONES

GEOLOGICAL SURVEY PROFESSIONAL PAPER 697

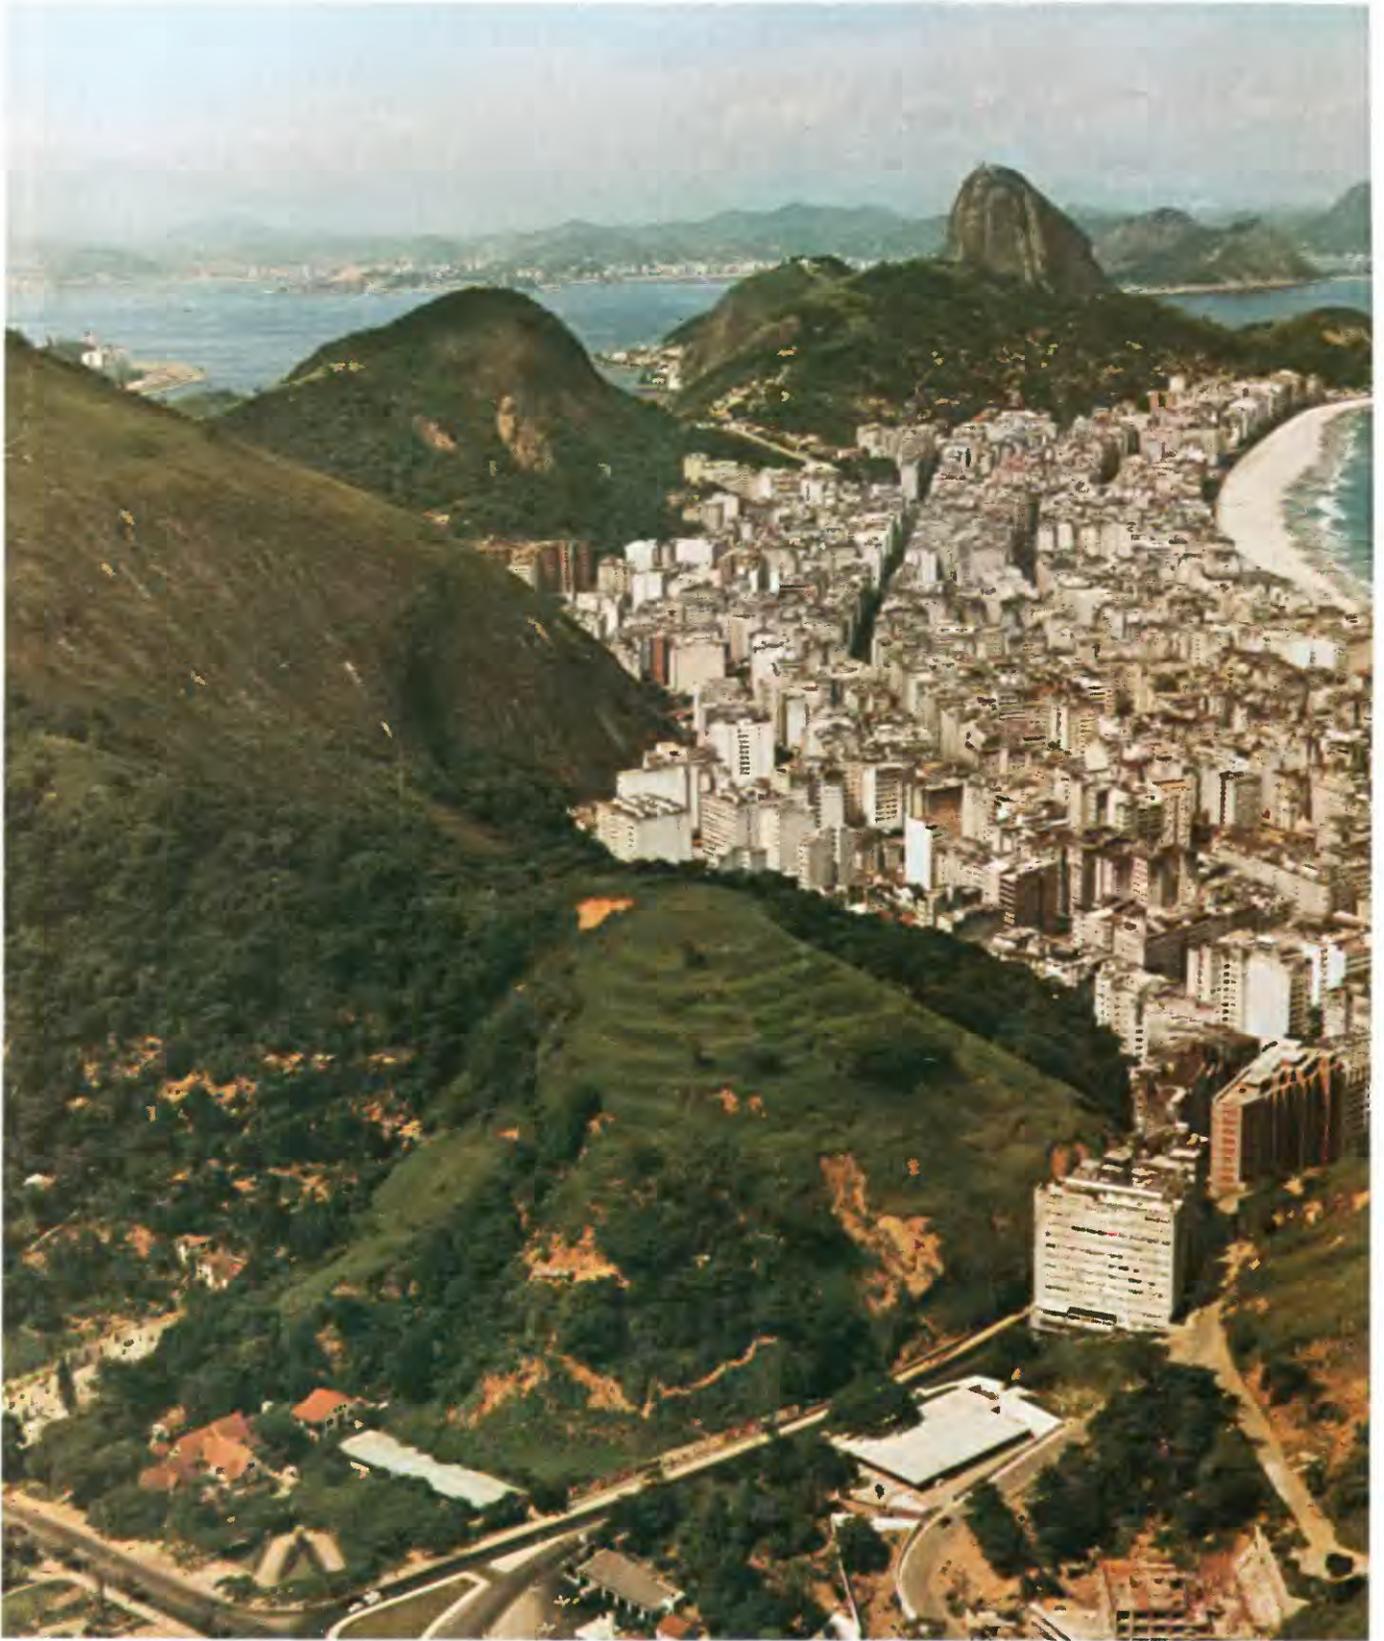
Landslide area, in center foreground, in Rio de Janeiro between Cantagalo Rock and Cabritos Hill. Copacabana Beach, Sugar Loaf, Guanabara Bay, and Niterói City in background.

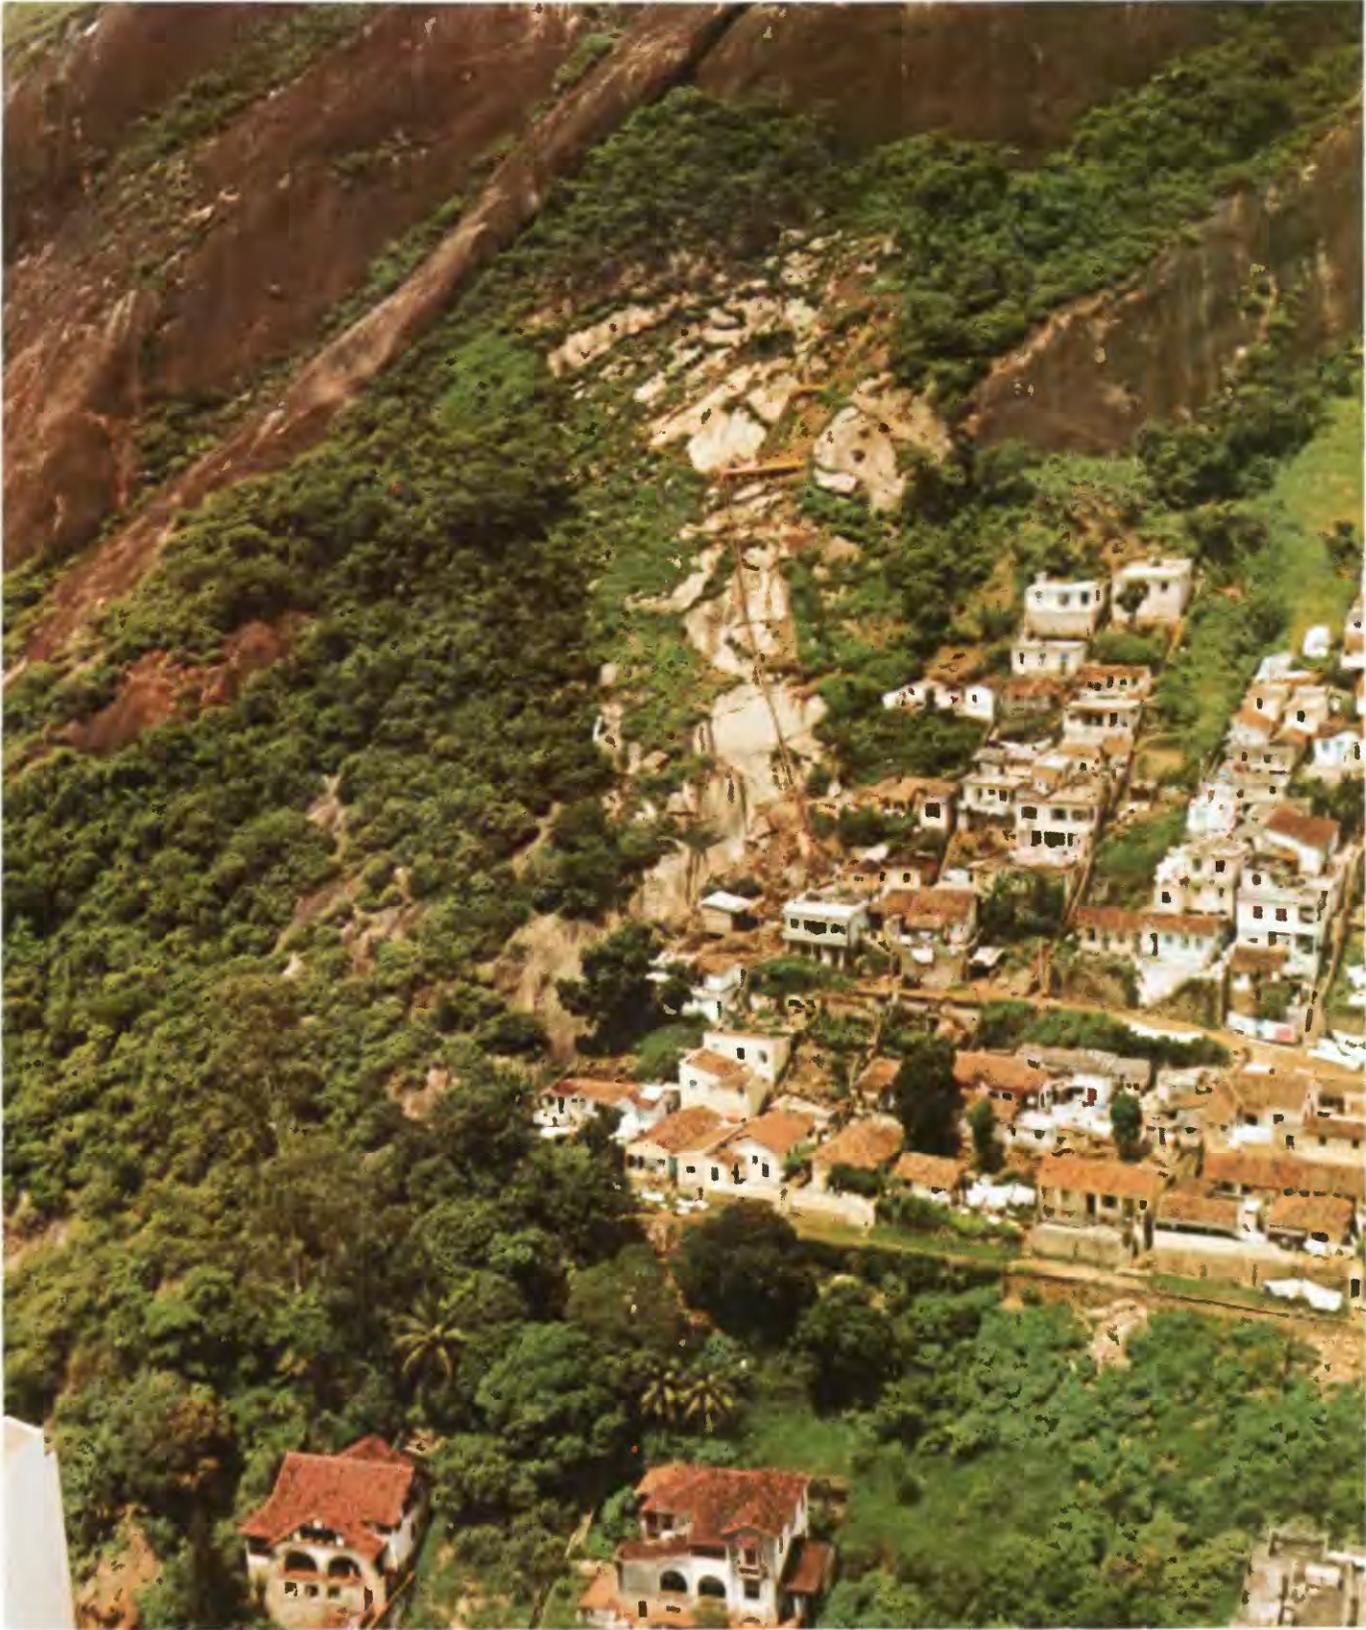
FIGURE 3.—Rockslide on the slope of Cabritos Hill (Morro dos Cabritos) in 1966 which took many lives and destroyed several homes. Ladders lead to platforms where stabilization work was in progress. The heavy vegetation line outside the fresh rock area suggests that a much larger rockslide took place at this location in the not too distant past.

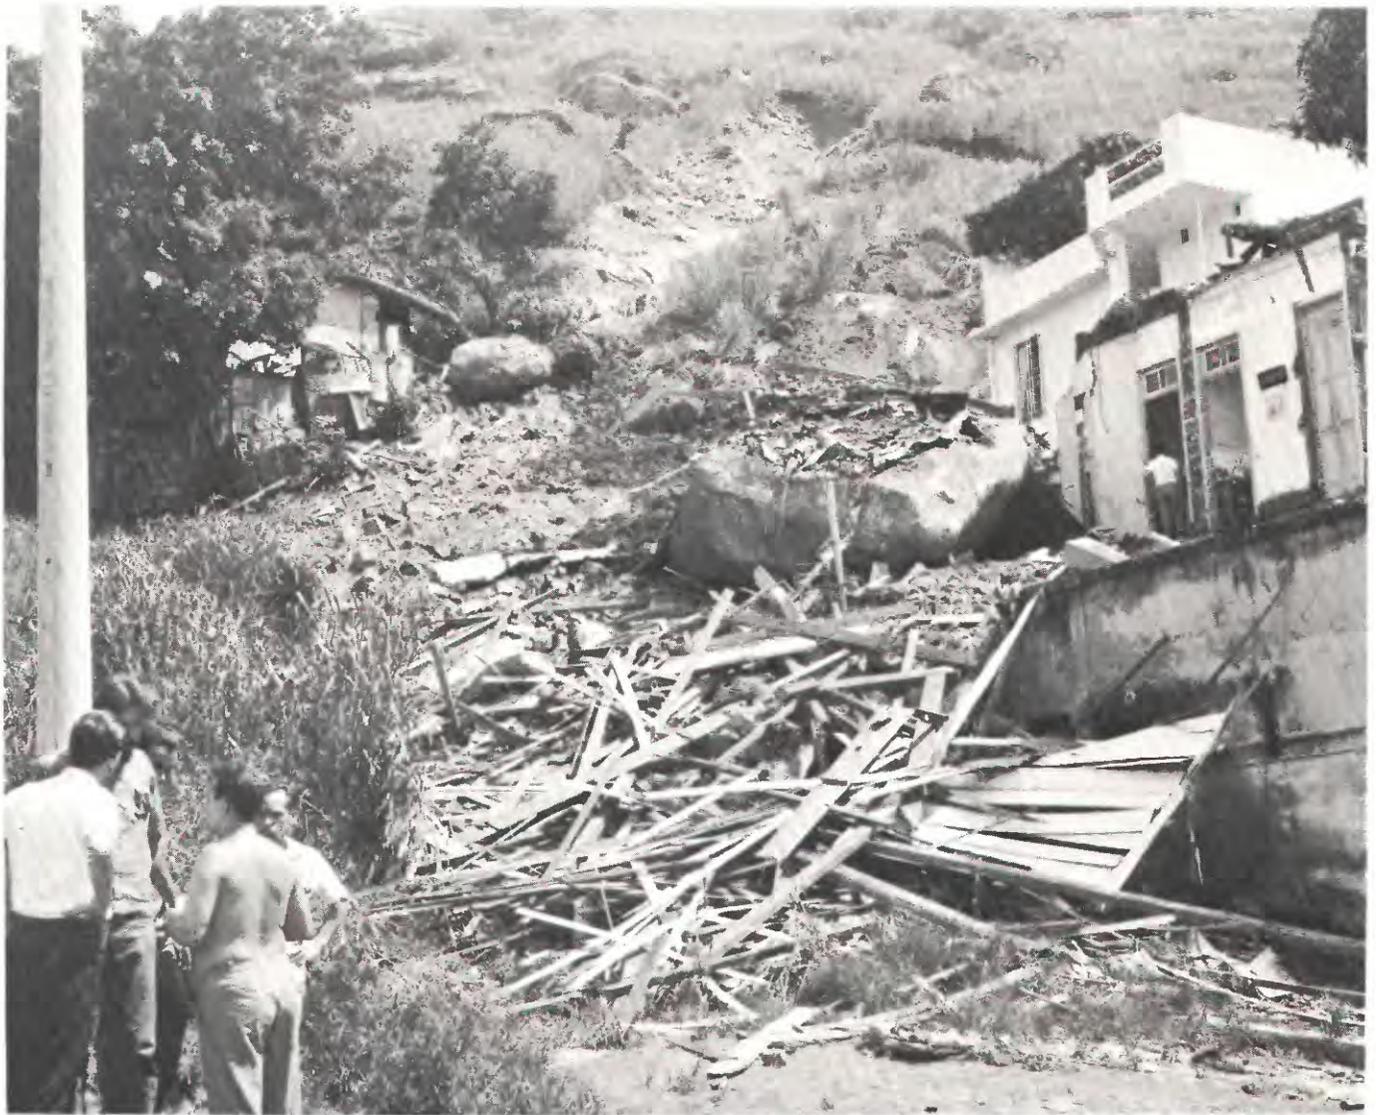
FIGURE 4.—Vitor Meireles Street (Rua Vitor Meireles) landslide in the Riachuelo district. The slide occurred during the rains of February 18 and 19, 1967. This slide of large blocks in thin soil illustrates the dangerous condition of hillsides such as that shown in figure 5.

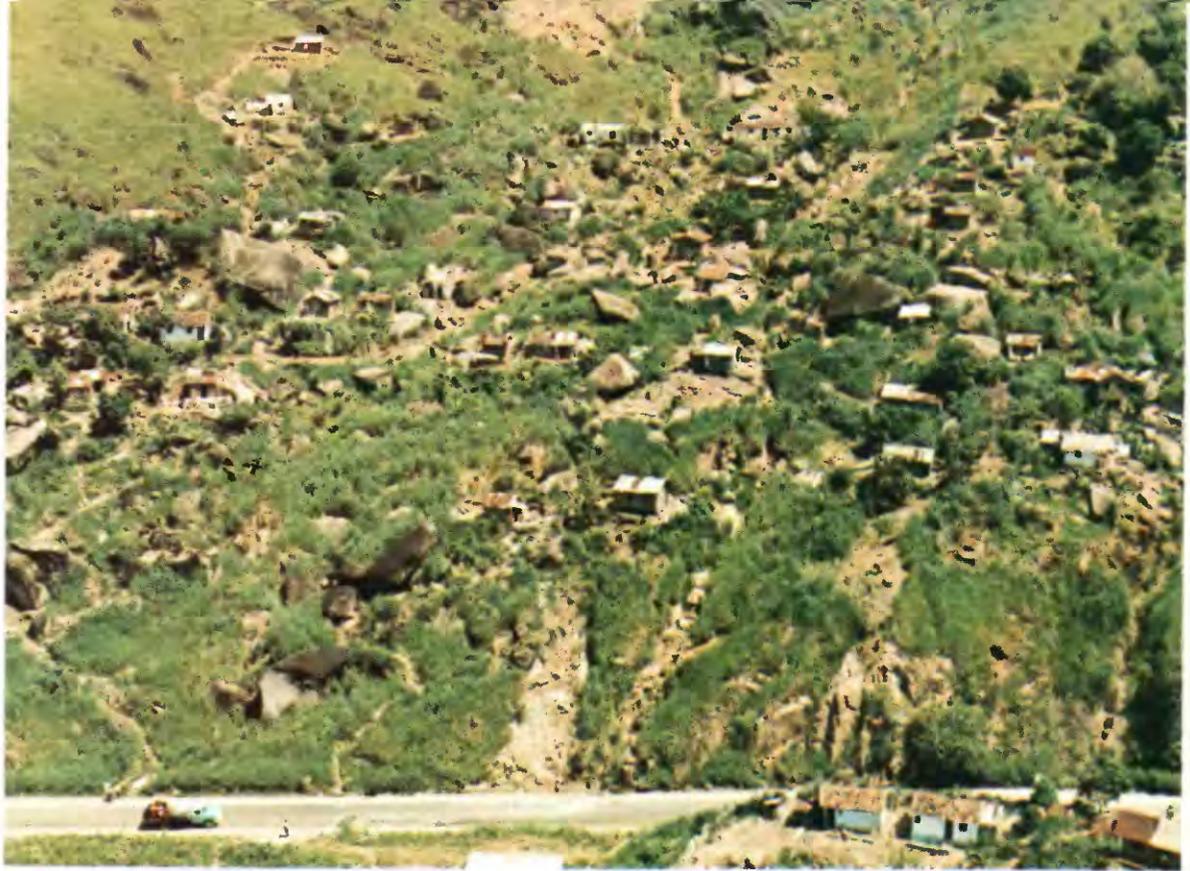
FIGURE 5 (above).—Loose rocks in thin soil mantle on the slope of Tijuca Range. Grajaú-Jacarepaguá highway in foreground. Many thousands of square kilometers of the slopes of Brazil that are underlain by the Precambrian Complex have huge rocks such as these imbedded in the residual soil.

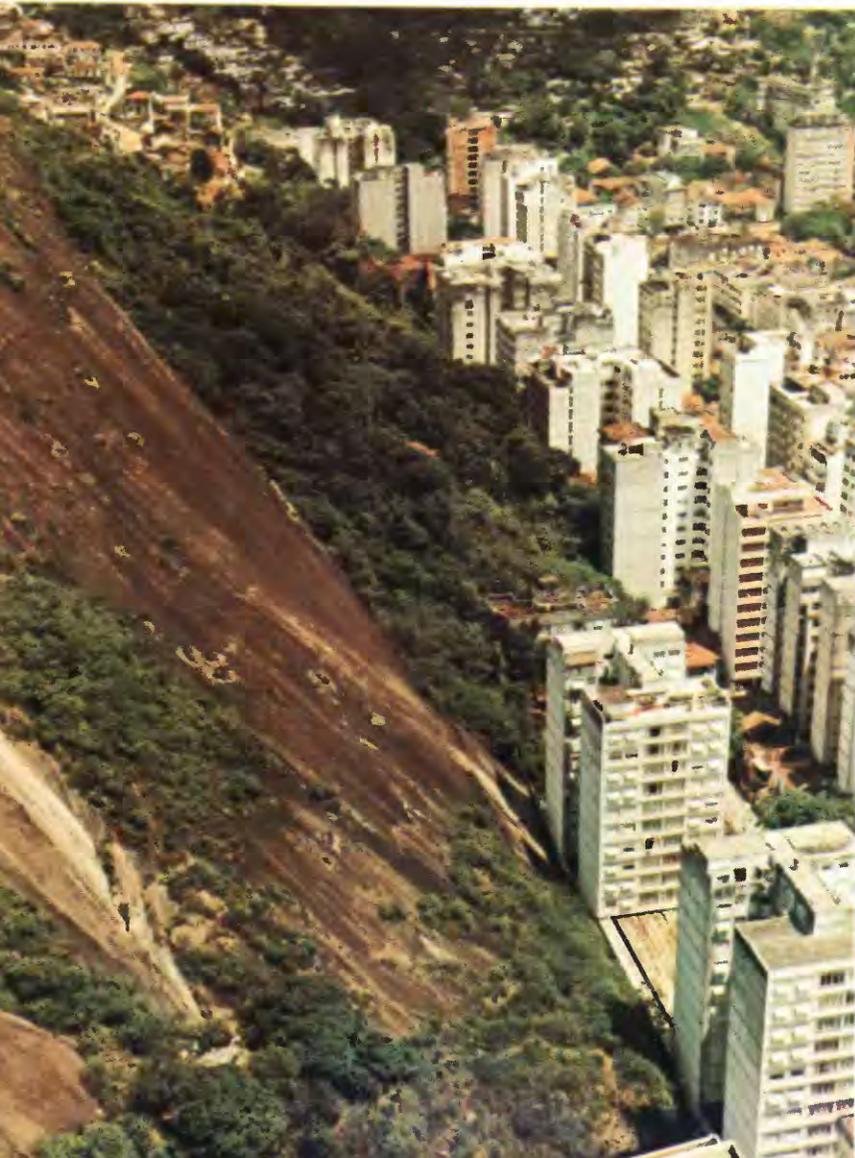
FIGURE 6 (left).—Slope of Cabritos Hill (Morro dos Cabritos) exfoliation dome in Copacabana district showing apartment houses at base of bare-rock slope and adjacent to steeply sloping deposits in tree and brush-covered area. Hazards to people and property include rockslides, mixed rock and soil slides, surficial deposits sliding down onto the city, and deeper failures that cause uplift of the ground near the base of the slope.

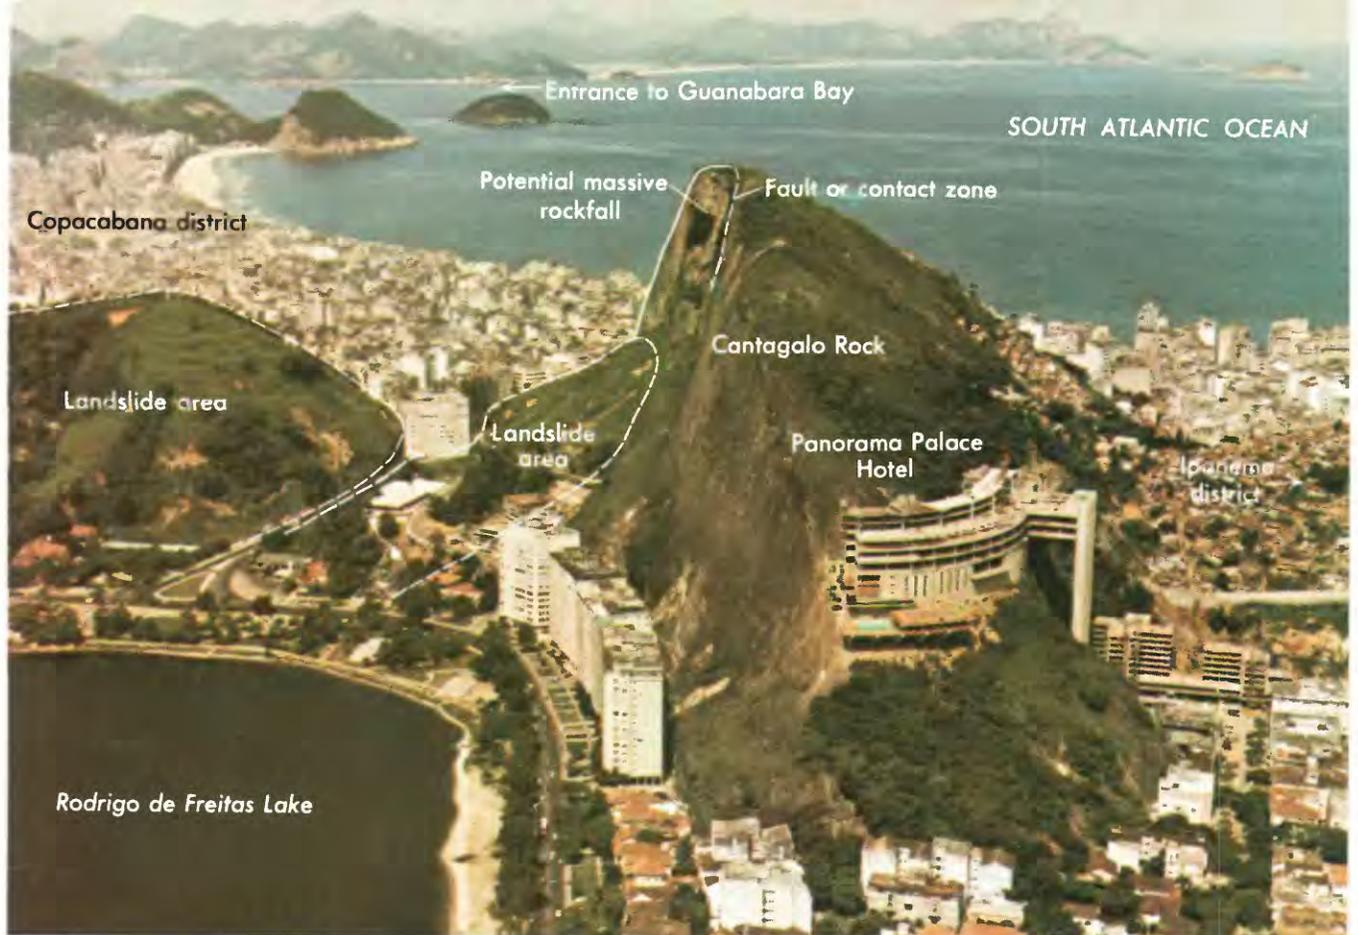
FIGURE 7 (above).—Cantagalo Rock (Morro do Cantagalo) and the surficial deposits around its base constitute one of the most active and potentially dangerous landslide areas in the city of Rio de Janeiro. The surficial deposits have been disturbed by cuts and fills for buildings and roads.

Sliding along the left side of the rock in 1966 and again in 1967 caused heavy damage and led to the condemnation of some large buildings. Each new cloudburst endangers more structures. Tunnels and water-supply chambers within the rock intersect numerous faults.

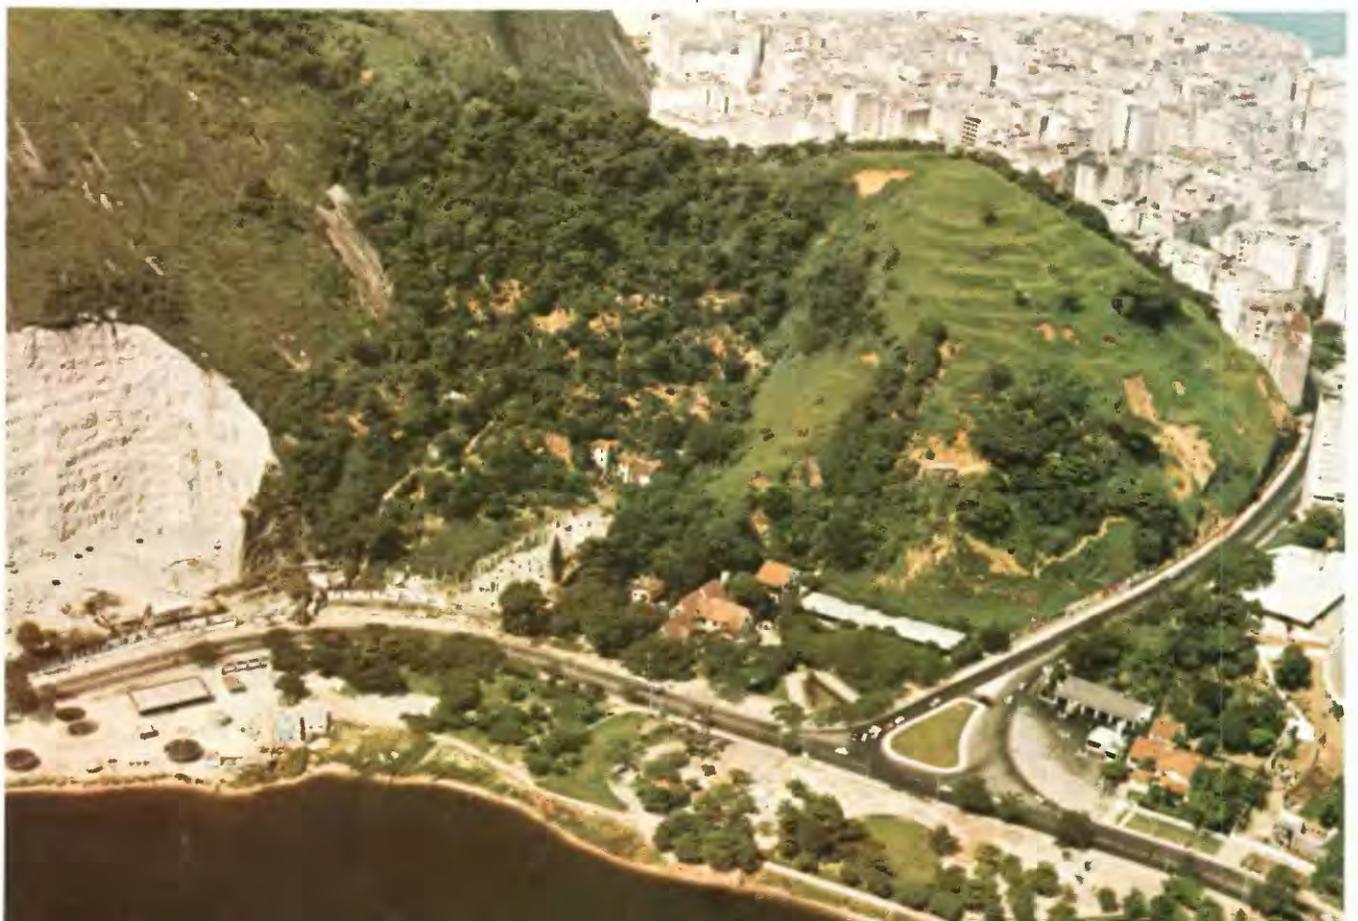
The stabilization of some of the slopes that have already failed in the city is completely impractical. One example of this is on the south spur of Cabritos Hill (Morro dos Cabritos) (fig. 8) where the toe support for the surficial deposits has been completely cut away on three sides of the hill by excavations for buildings and streets. Another example is the

building and street construction. The surficial deposits on the spur are all unstable and new sliding occurs annually. Quarry in gneiss on left.

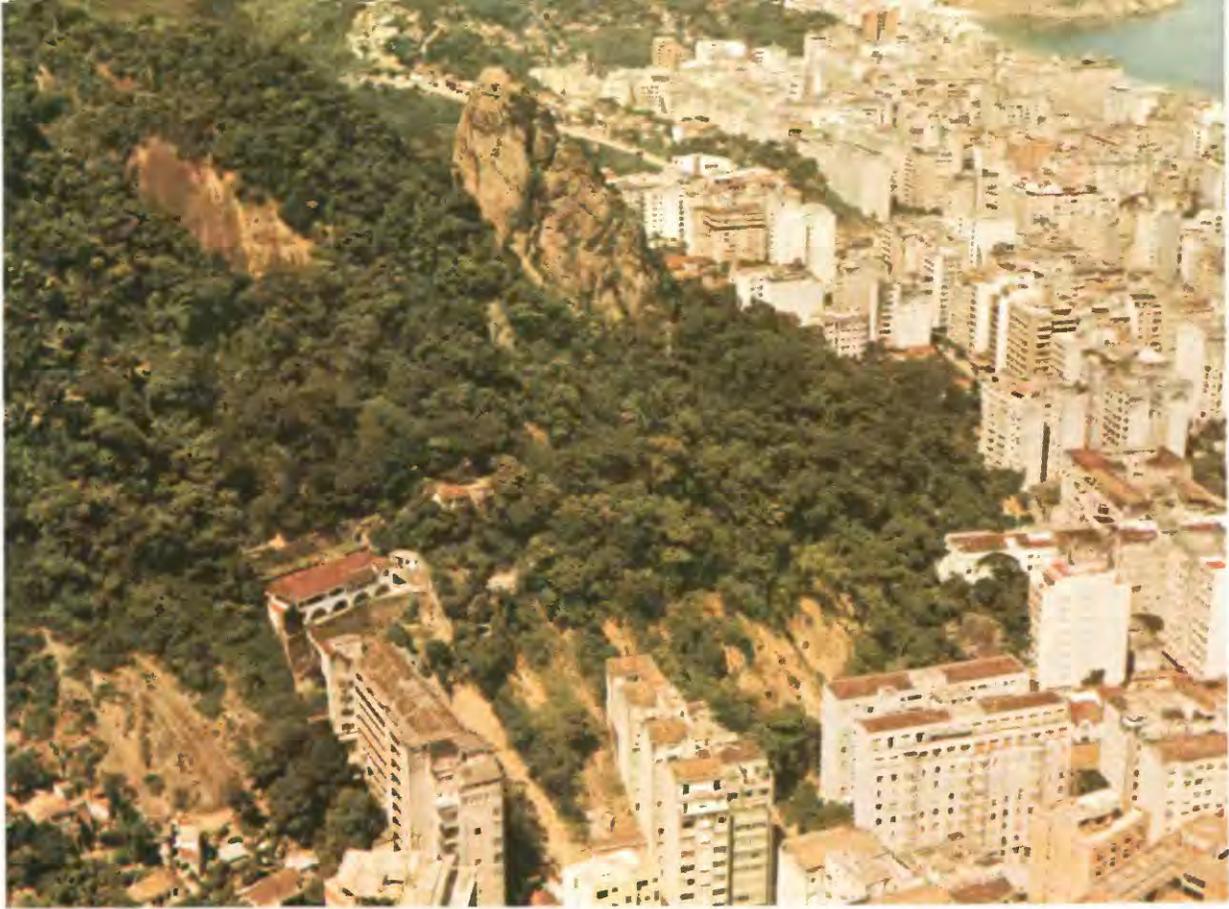
FIGURE 9 (above).—Heavily jointed exfoliation dome in Copacabana district. The dome is surrounded by steeply dipping surficial deposits which have been excavated at the toe for building and street construction.

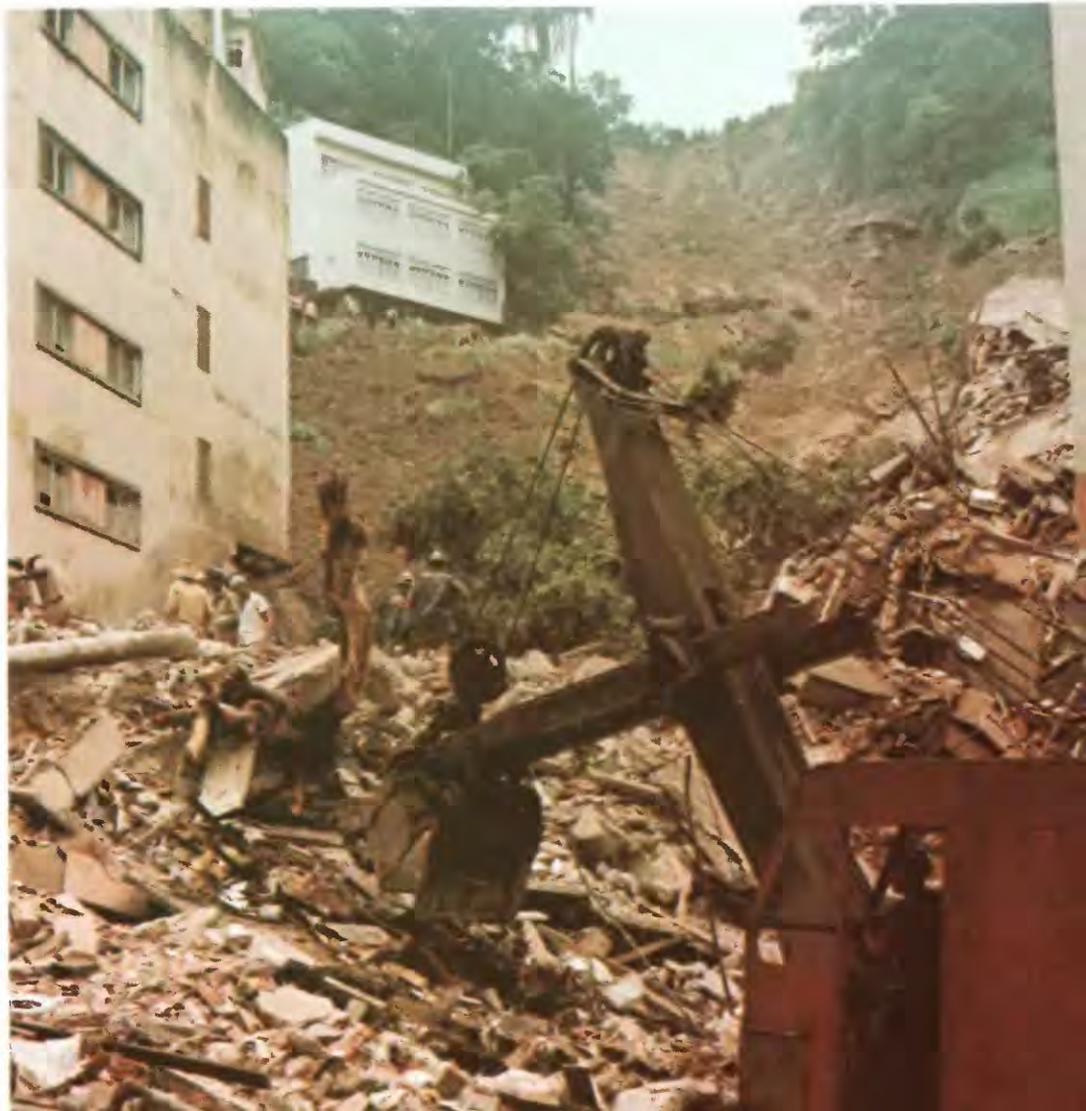
FIGURE 10 (right).—Belisário Távora Street (Rua Belisário Távora) landslide in the Laranjeiras district. This catastrophic landslide, during the night of February 18, 1967, completely demolished several houses and two apartment buildings. More than 132 people lost their lives. Investigations indicated that a small slide above a highway cut near the top of the slide overloaded the slope area and caused the main failure. The failure took place parallel to a dike in the bedrock where the residual slope deposits were thicker than on either side of the slide.

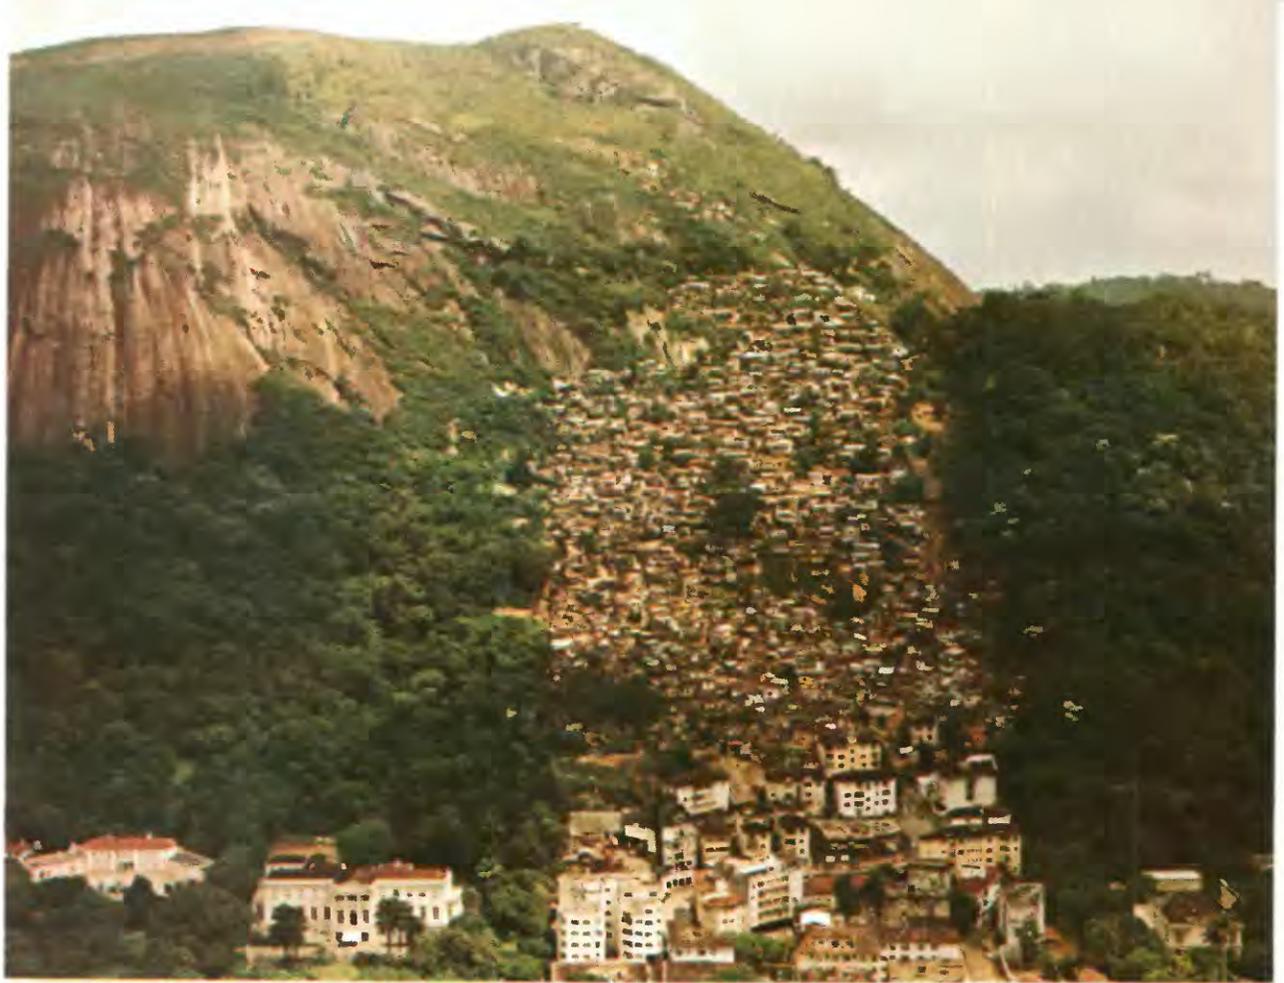
FIGURE 11 (above).—Favela on Dona Marta Hill in the Botafogo district. Sliding in the surficial deposits along the right side of the favela and in localized areas within it have caused extensive damage. Rockfalls from above have caused damage at the base of the rock areas. Sliding will continue during cloudbursts unless something is done to stabilize the soil and rocks.

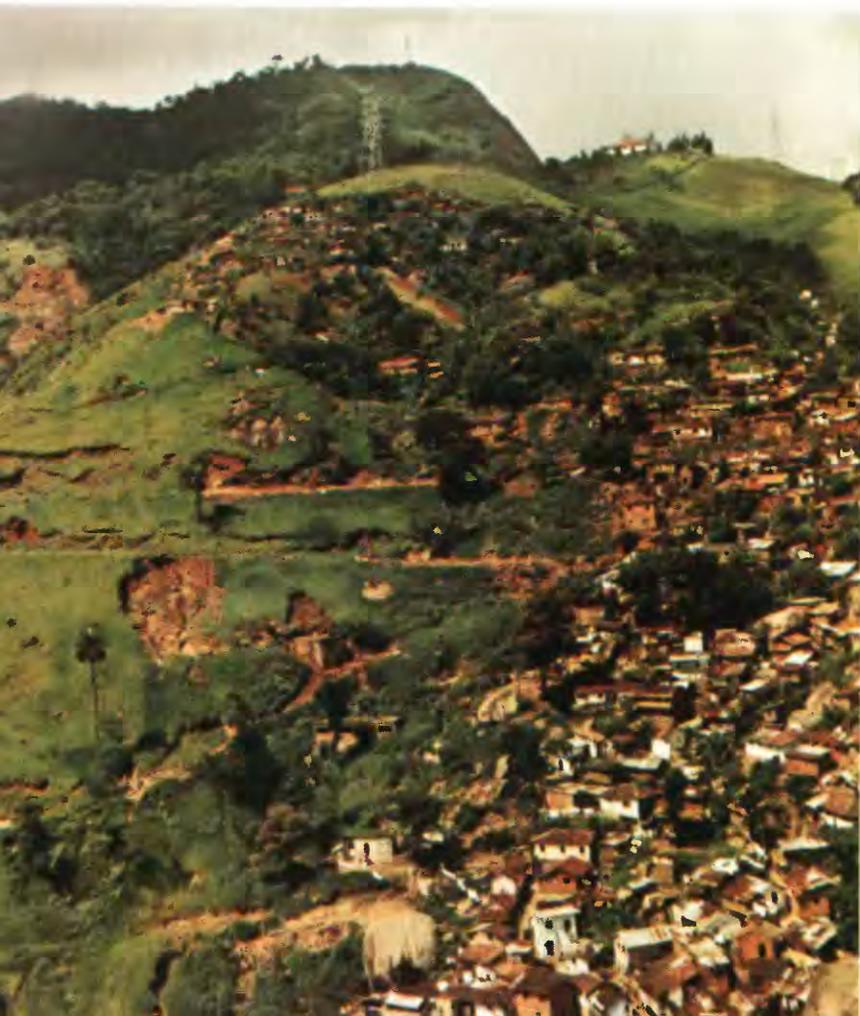
FIGURE 12 (left).—Slope failures in a favela of the Tijuca district. All the slope failures appear to be related to man-made cuts and fills.

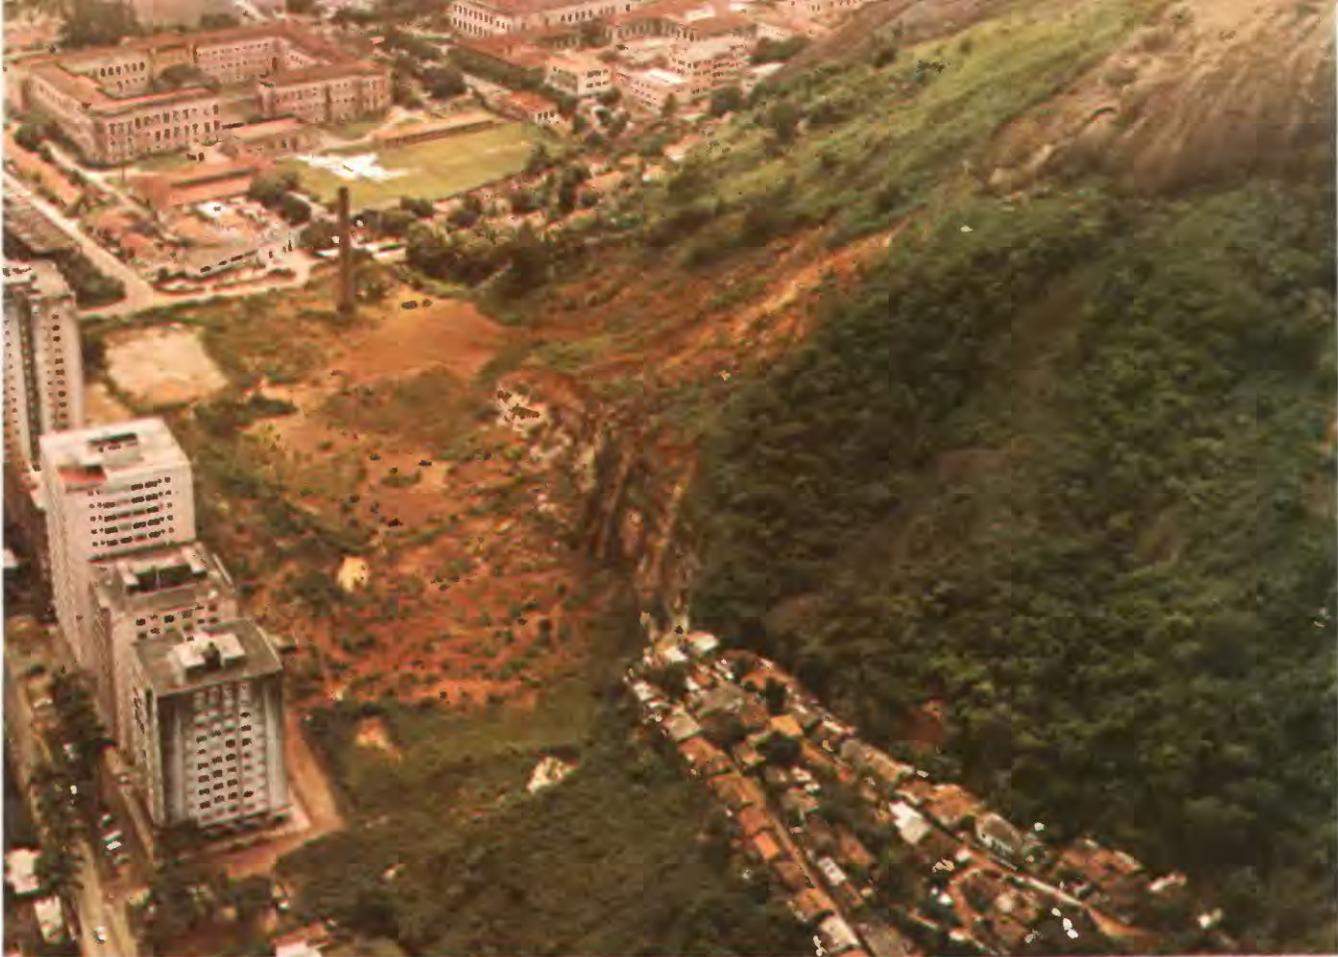
slide above the quarry behind the Benjamin Constant Institute where the quarry face has cut the sloping surficial deposits (fig. 13). In these areas the removal and use of the soilmass for fill would appear to be the most appropriate solution to the problem. There no doubt are other examples of slope failures in the city that fall into this category.

FIGURE 13 (above).—Landslide above a rock quarry on the north slope of Babilônia Hill (Morro da Babilônia). Benjamin Constant Institute is in upper left of photograph. The principal sliding took place in 1966. Further movement in 1967 was accompanied by caving action along the crown and flanks of the slide. Heavy rains washed the slide material into the streets for a block or more from the toe of the slide and temporarily closed the streets.

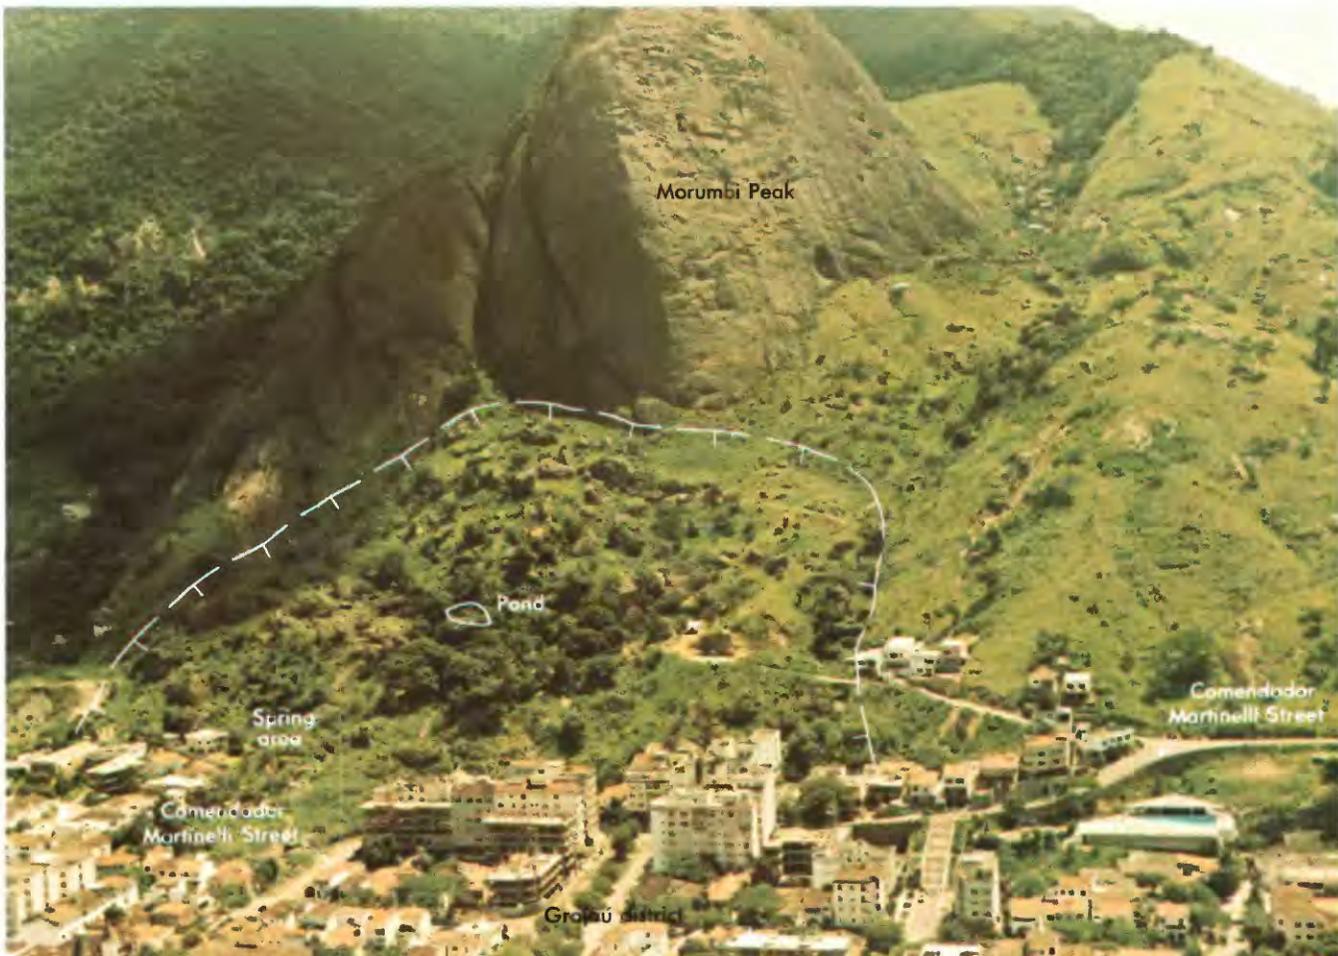
FIGURE 14 (below).—Comendador Martinelli Street landslide. Central foreground area covered by large blocks periodically moves down onto apartment houses.

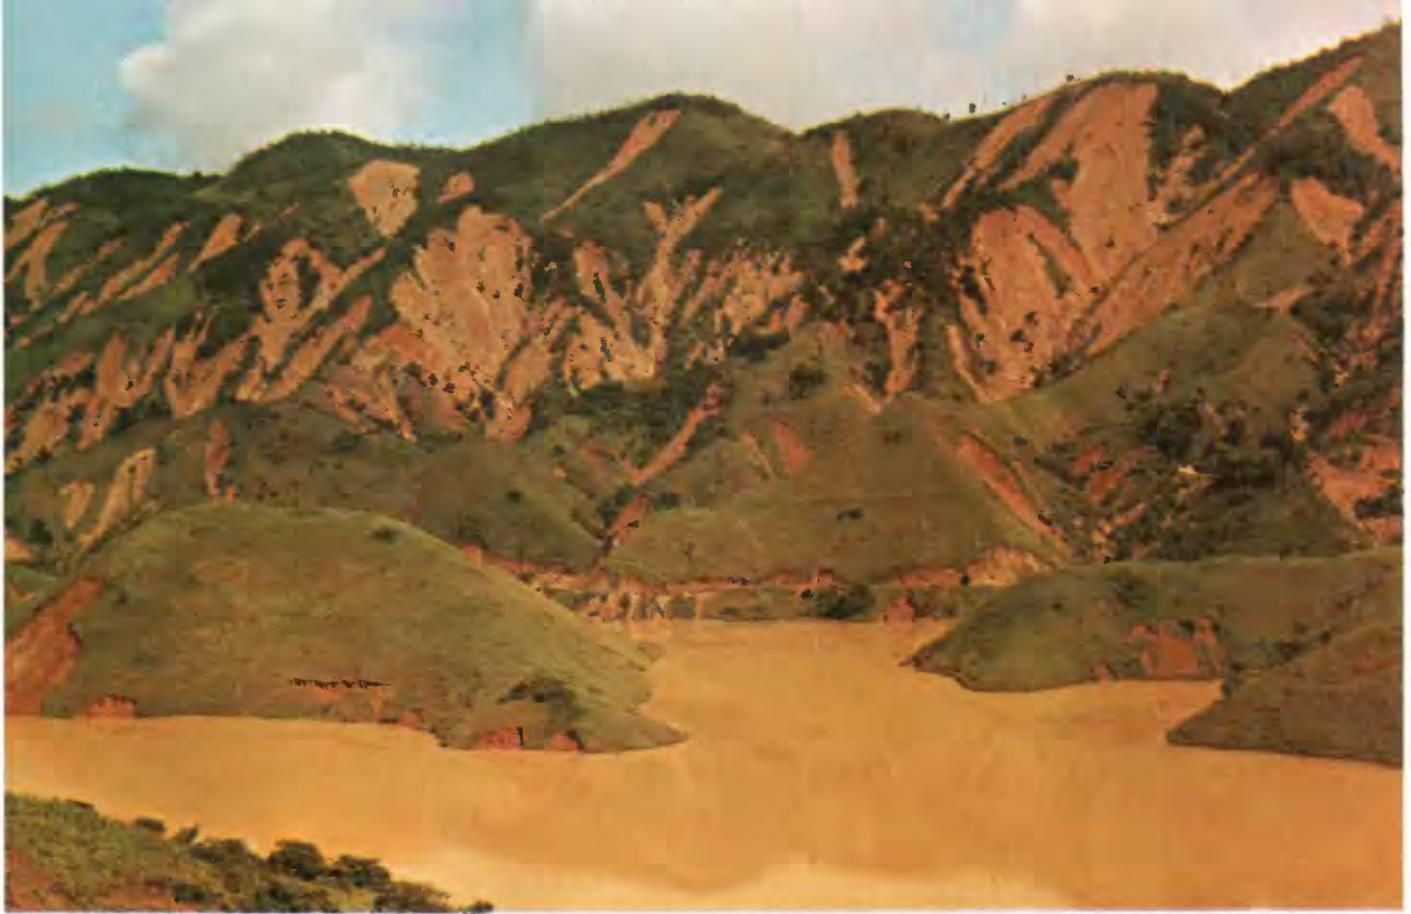
FIGURE 18 (above).—Ponte Coberta Reservoir and the Serra das Araras escarpment. All the water from the Ponte Coberta Reservoir and a major part of the drainage from the landslide disaster area flows into the drainage where the city of Rio de Janeiro secures about two-thirds of its water supply. The road on the opposite side of the reservoir provides the only truck and car access to the Rio Light generating complex. It was closed by landslides at many places.

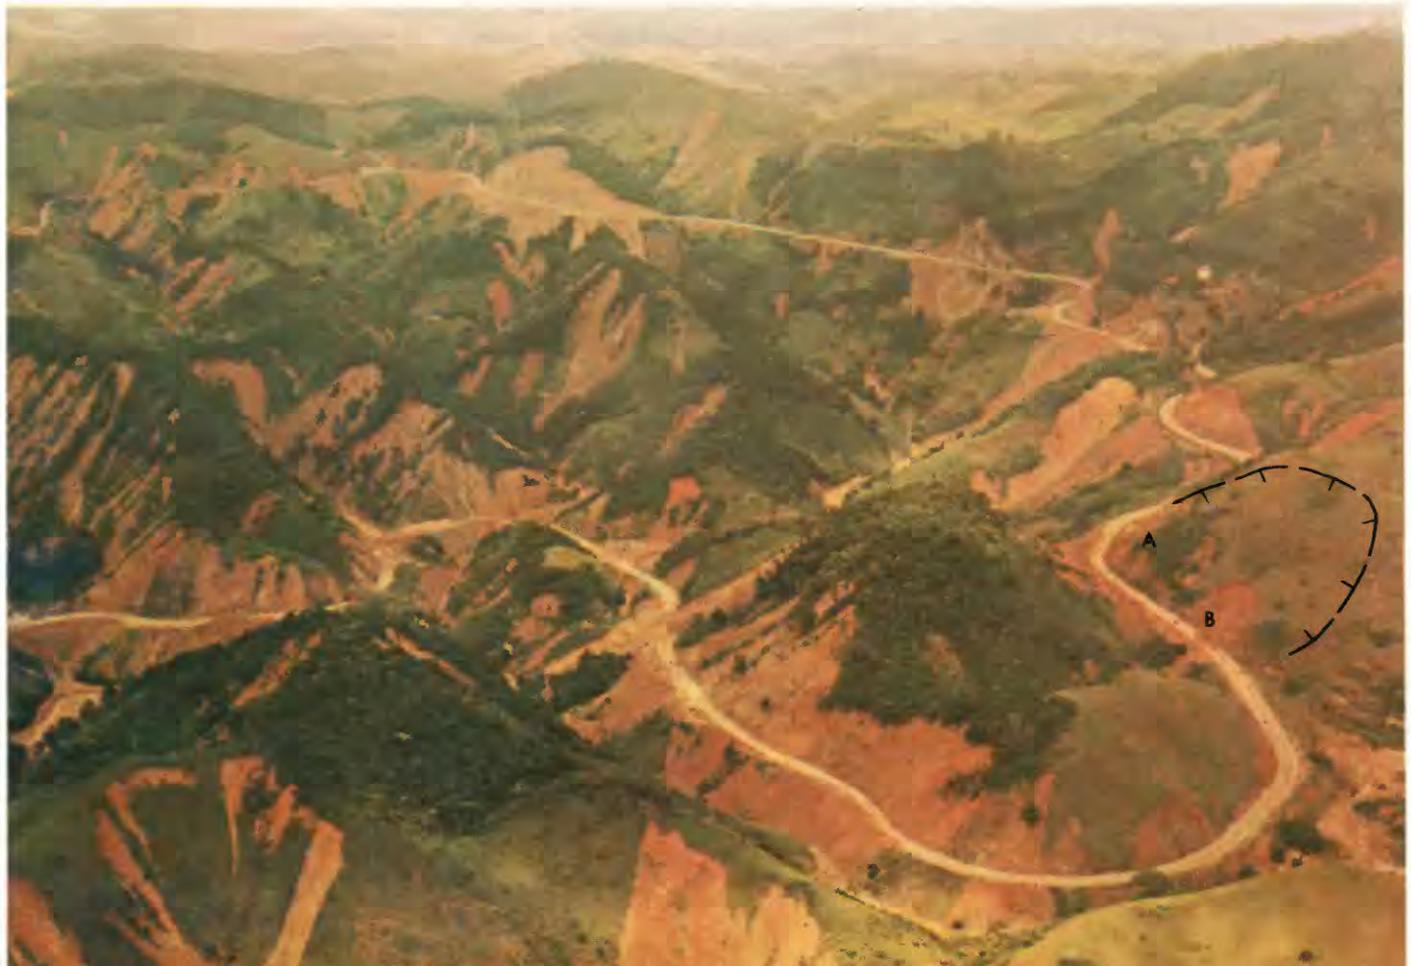
FIGURE 19 (below).—Upper part of new road. Slides cut and covered the road at numerous locations. As the toes of the slides on the highway across the Serra das Araras escarpment were removed, the landslides became larger and larger. The photograph was taken 2 days after the disaster. Within a month the slides at points A and B had enlarged to the area shown.
