Landslides of Rio de Janeiro and the Serra das Araras Escarpment, Brazil

By FRED O. JONES

GEOLOGICAL SURVEY PROFESSIONAL PAPER 697

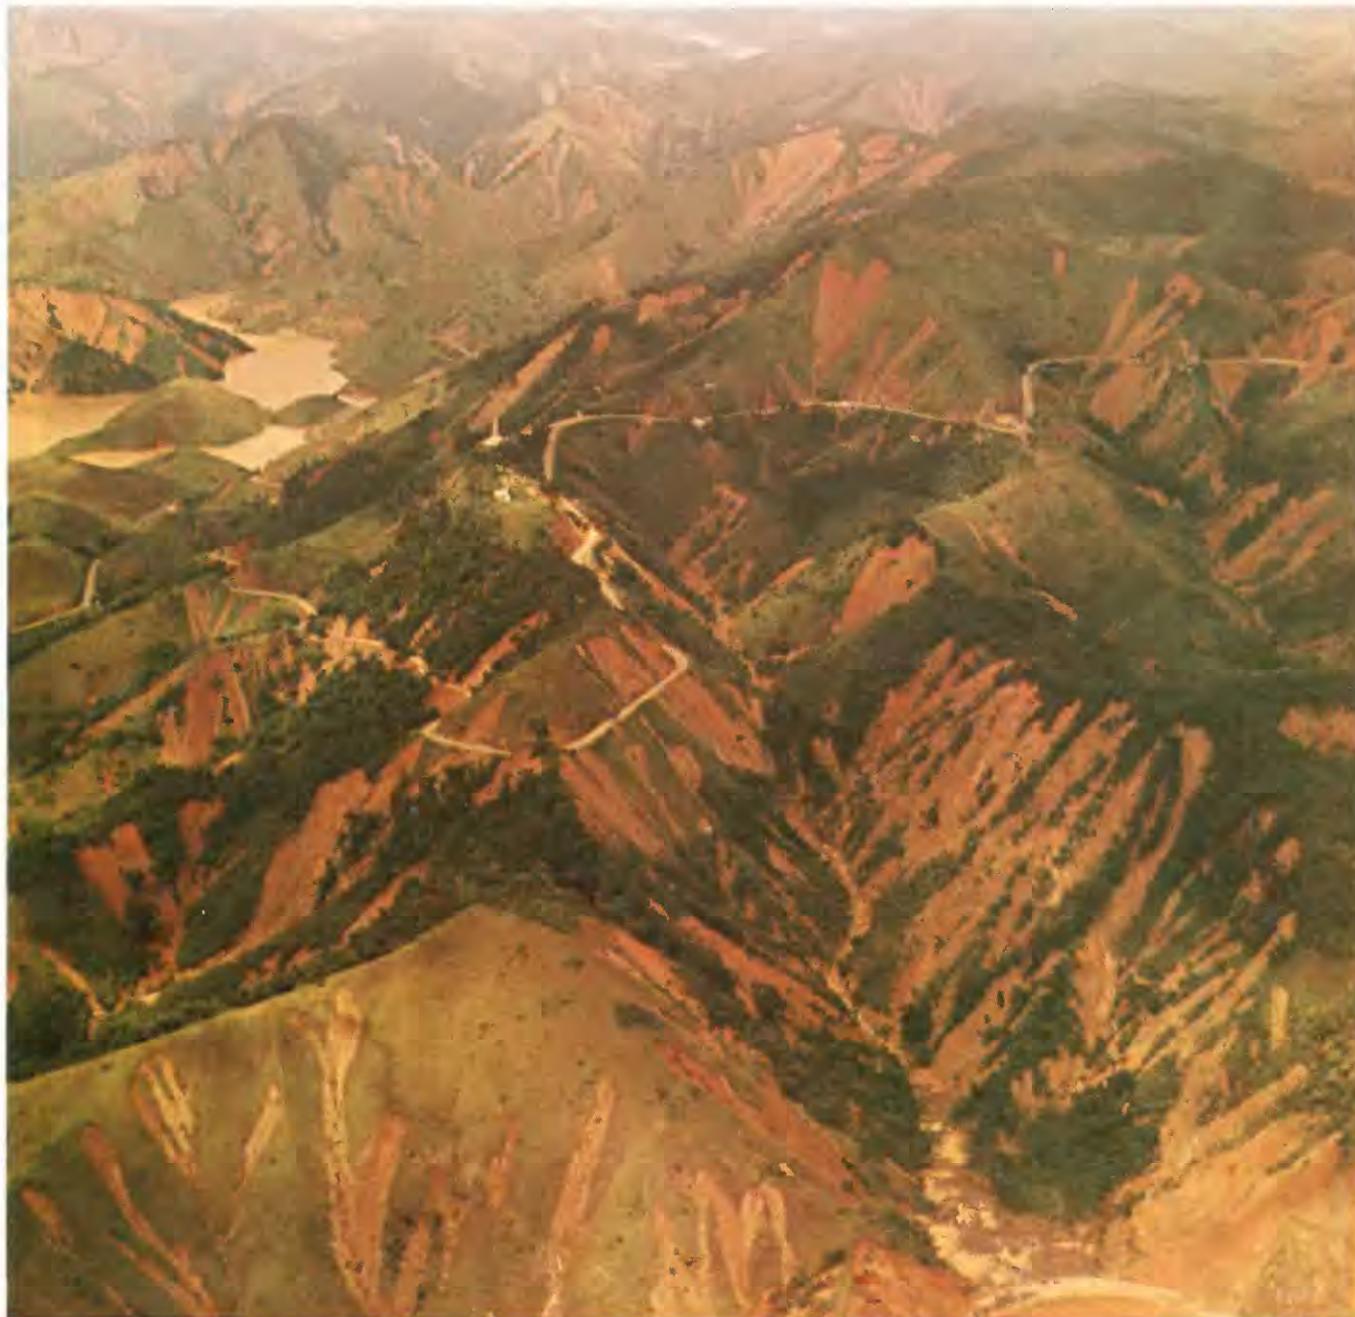
FIGURE 20.—Landslides in the area of the upper part of the old road across the Serra das Araras escarpment. Ponte Coberta Reservoir is at left.

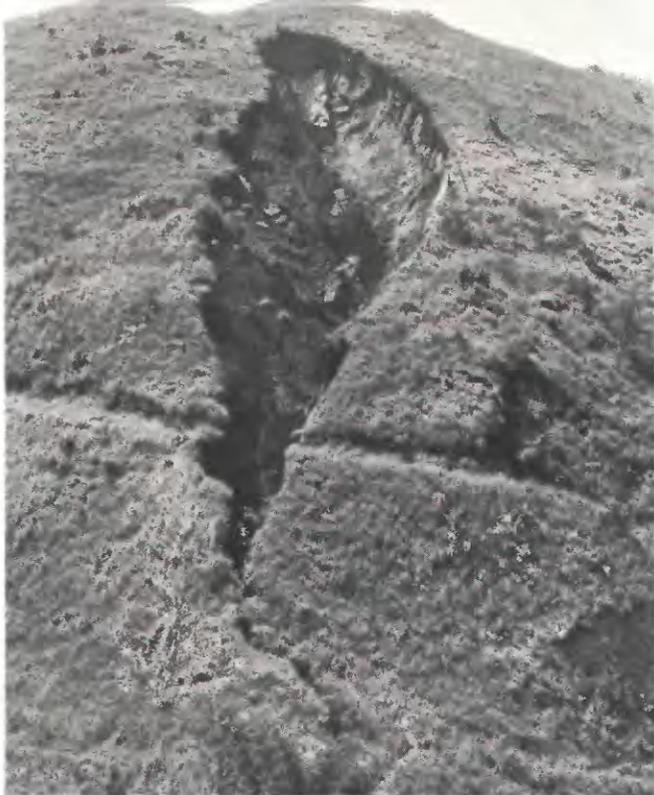
FIGURE 21 (left).—Unusual elongated alcove caused by erosion and landsliding in foothills area of the escarpment near the old road. All the material flowed out through a narrow channel about 2 m deep.

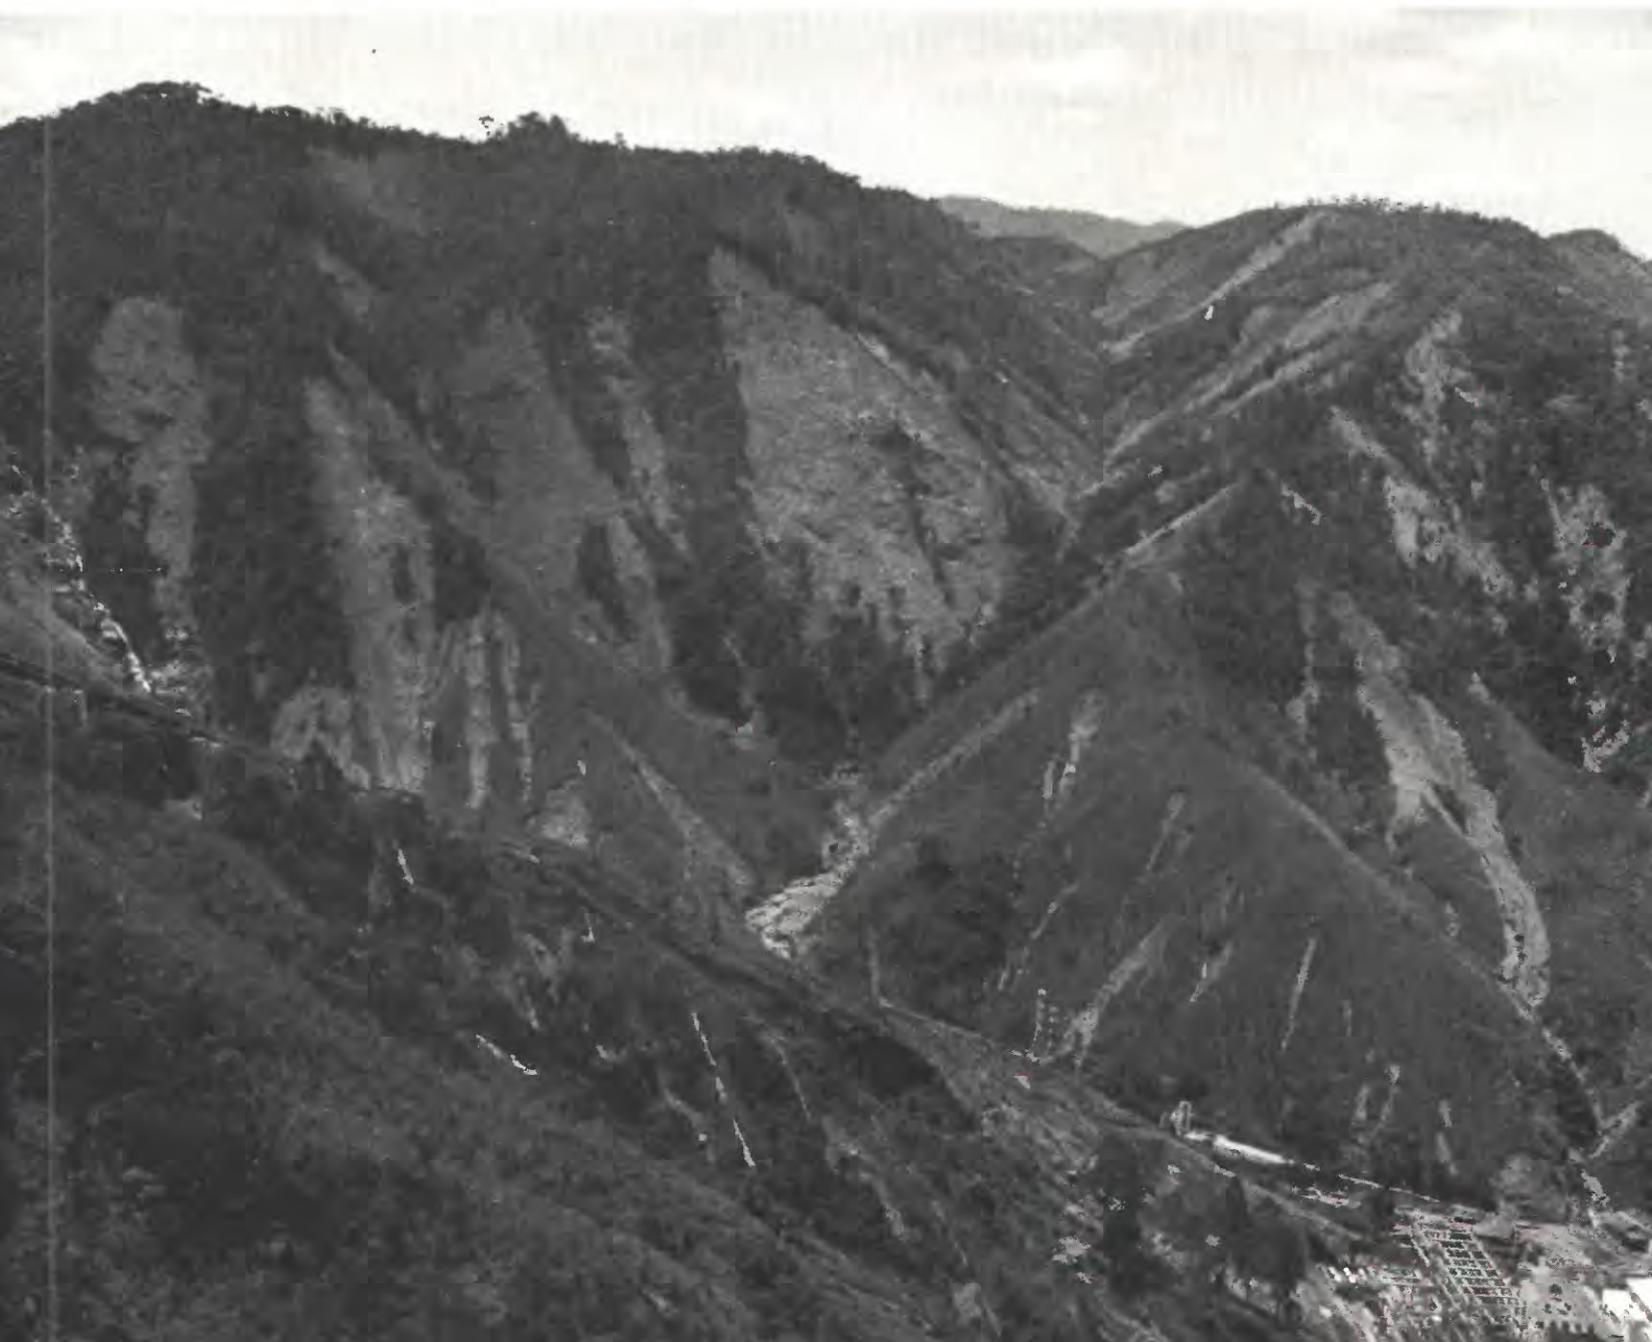
FIGURE 22 (below).—Fazenda Creek (Ribeirão Fazenda) flows from upper left to the lower right in the central foreground. The cloudburst and avalanches in the northeast tributary of Fazenda Creek in the center and right background produced the mudflow which buried the Nilo Peçanha powerplant. Most avalanches in this area cut into forest-covered slopes known to have been undisturbed for many years.

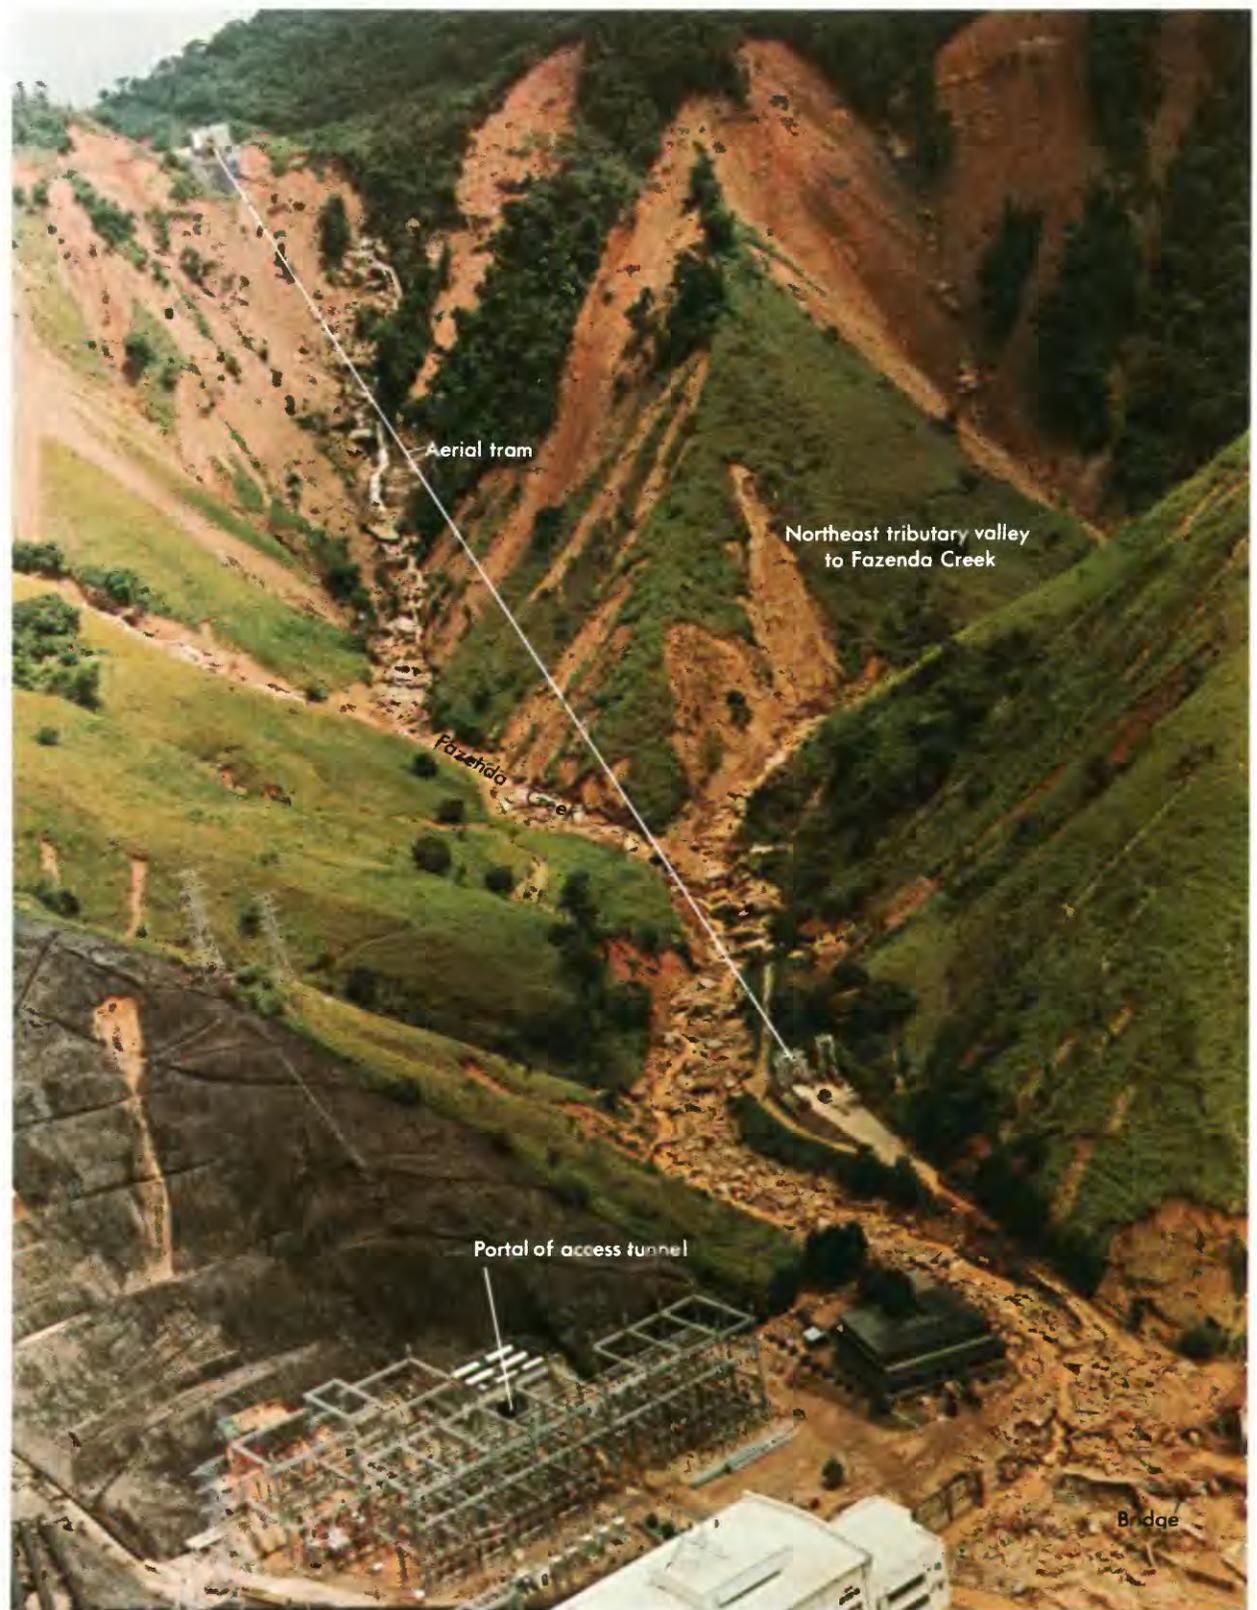
FIGURE 23.—Fazenda Creek valley mudflow. Boulders in the mudflow were as large as 6 m across. Note head and tail towers of aerial tram and access tunnel to Nilo Peçanha powerplant behind switchyard. Black area above switchyard has bituminous covering for slope stabilization.

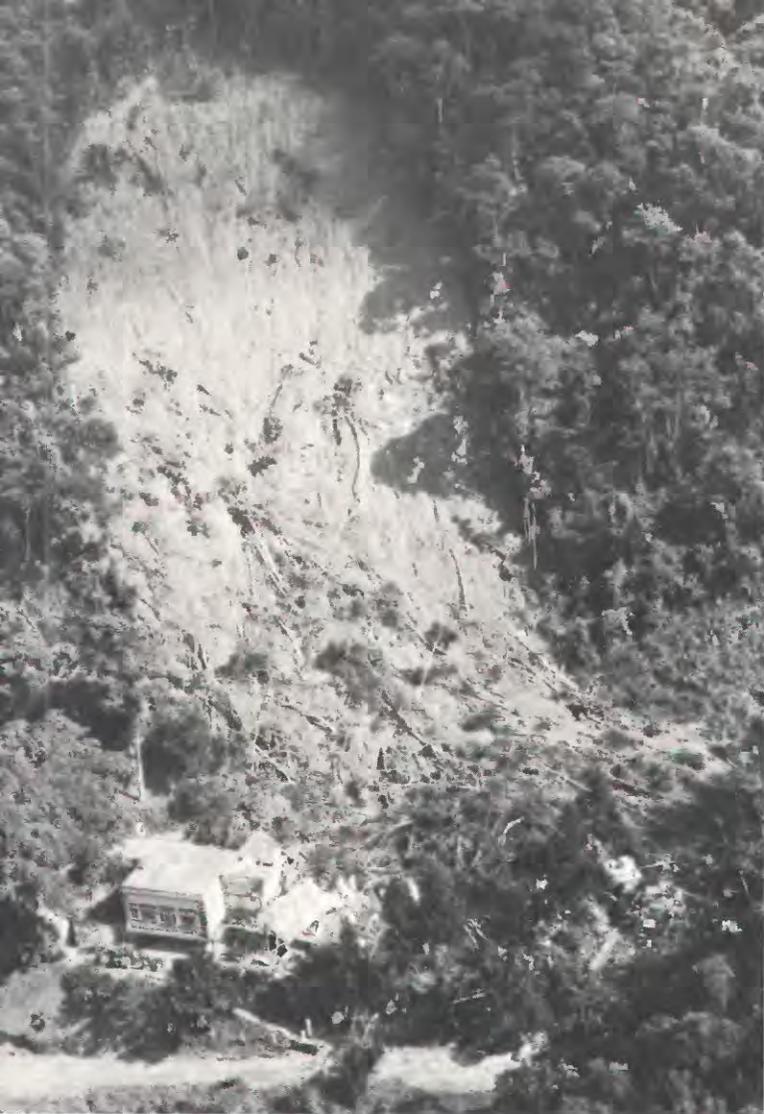
FIGURE 24 (left).—Typical Serra das Araras avalanche-type landslide in thin residual soils. Slide is located near highway just above escarpment.

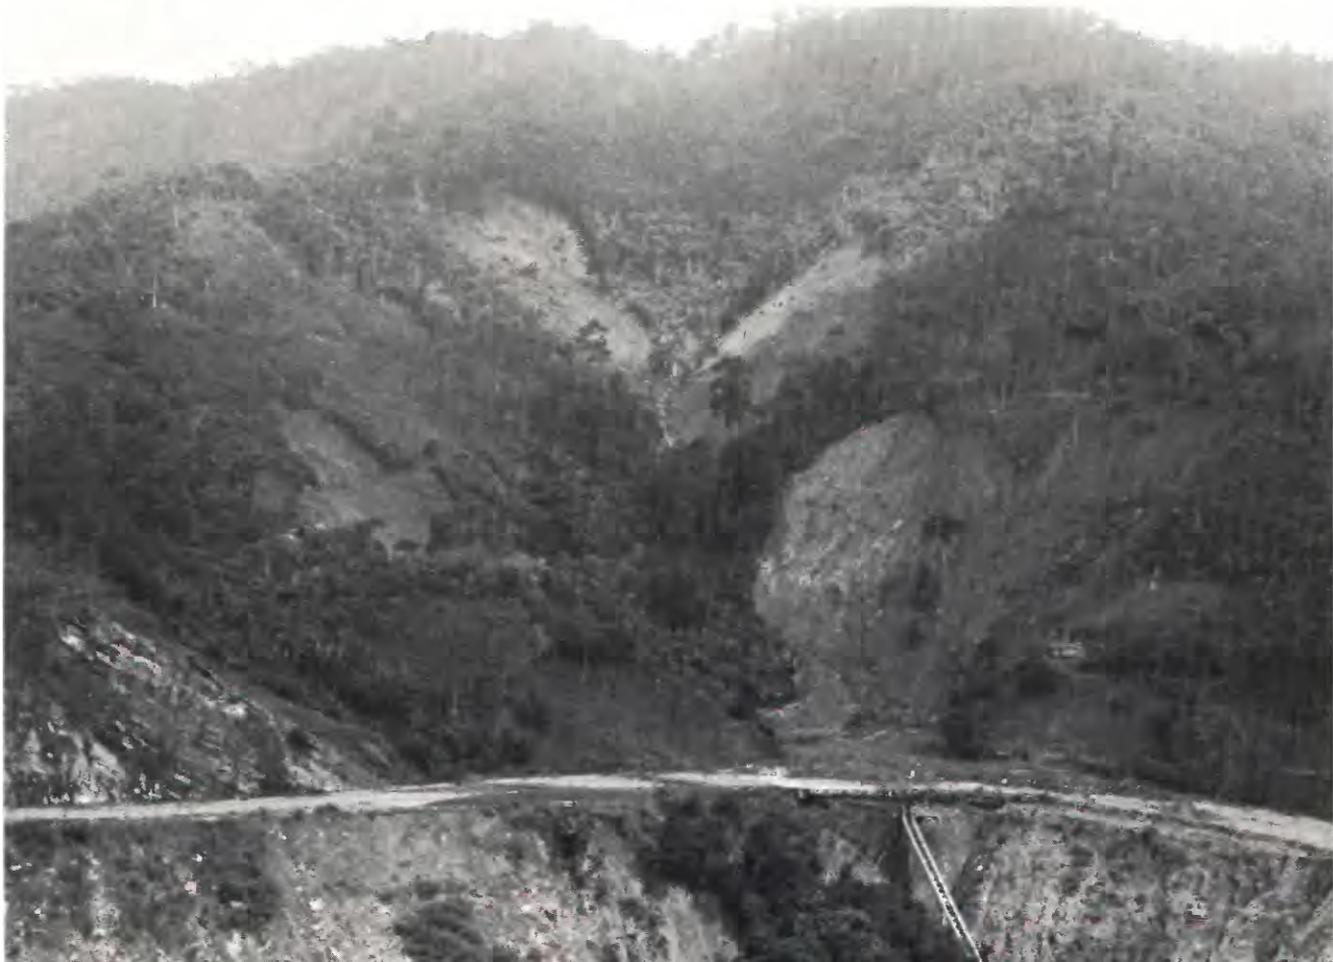
FIGURE 25 (below).—Landslides near the top of the Serra das Araras escarpment along the new road.

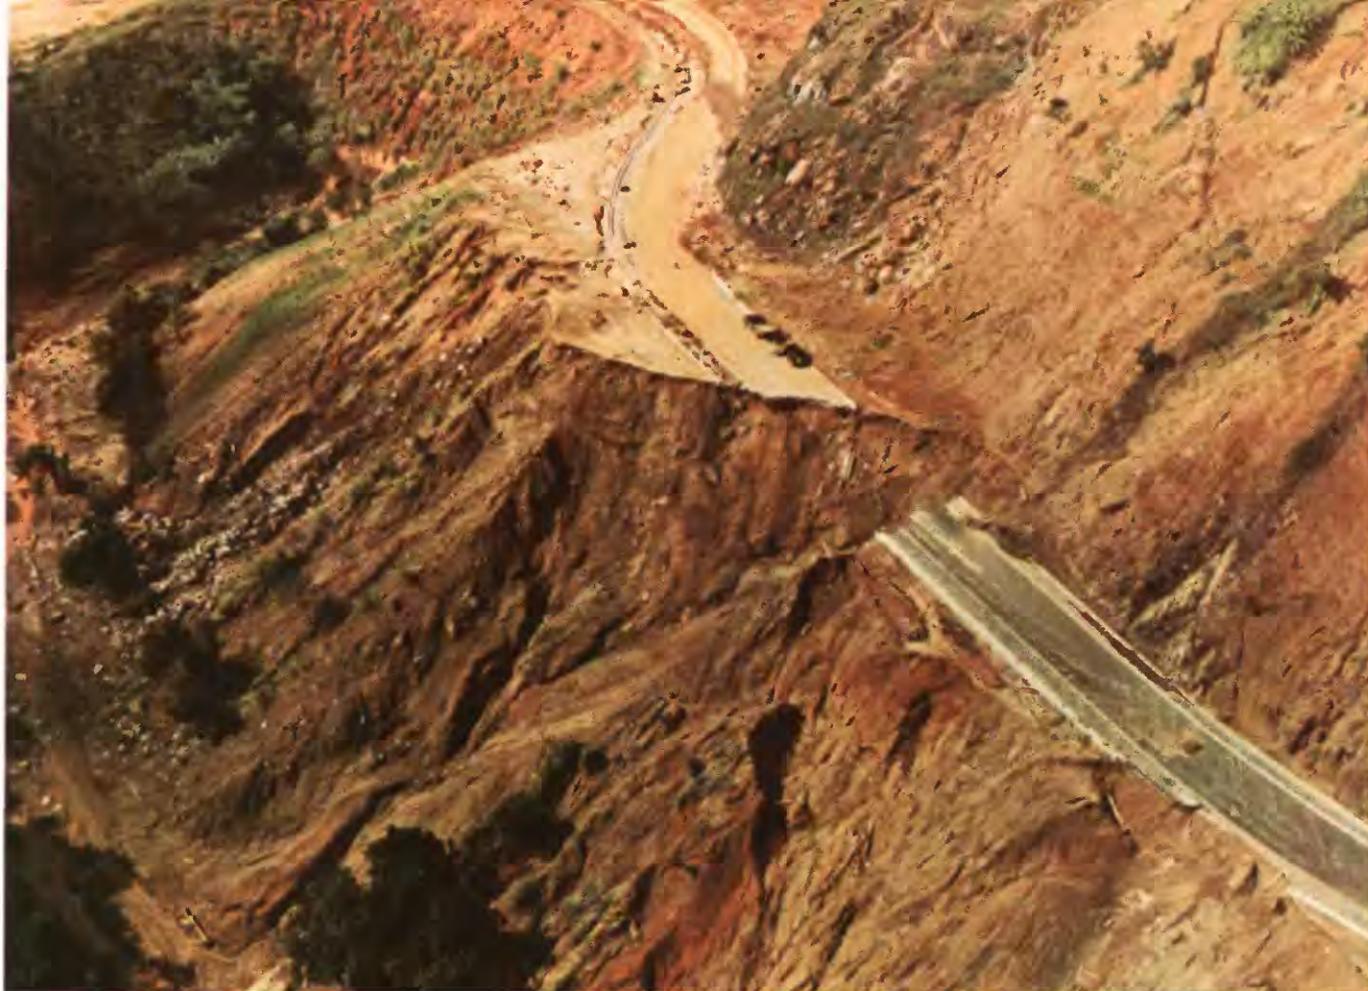
FIGURE 26 (above).—Failure of new road in Floresta Creek valley.

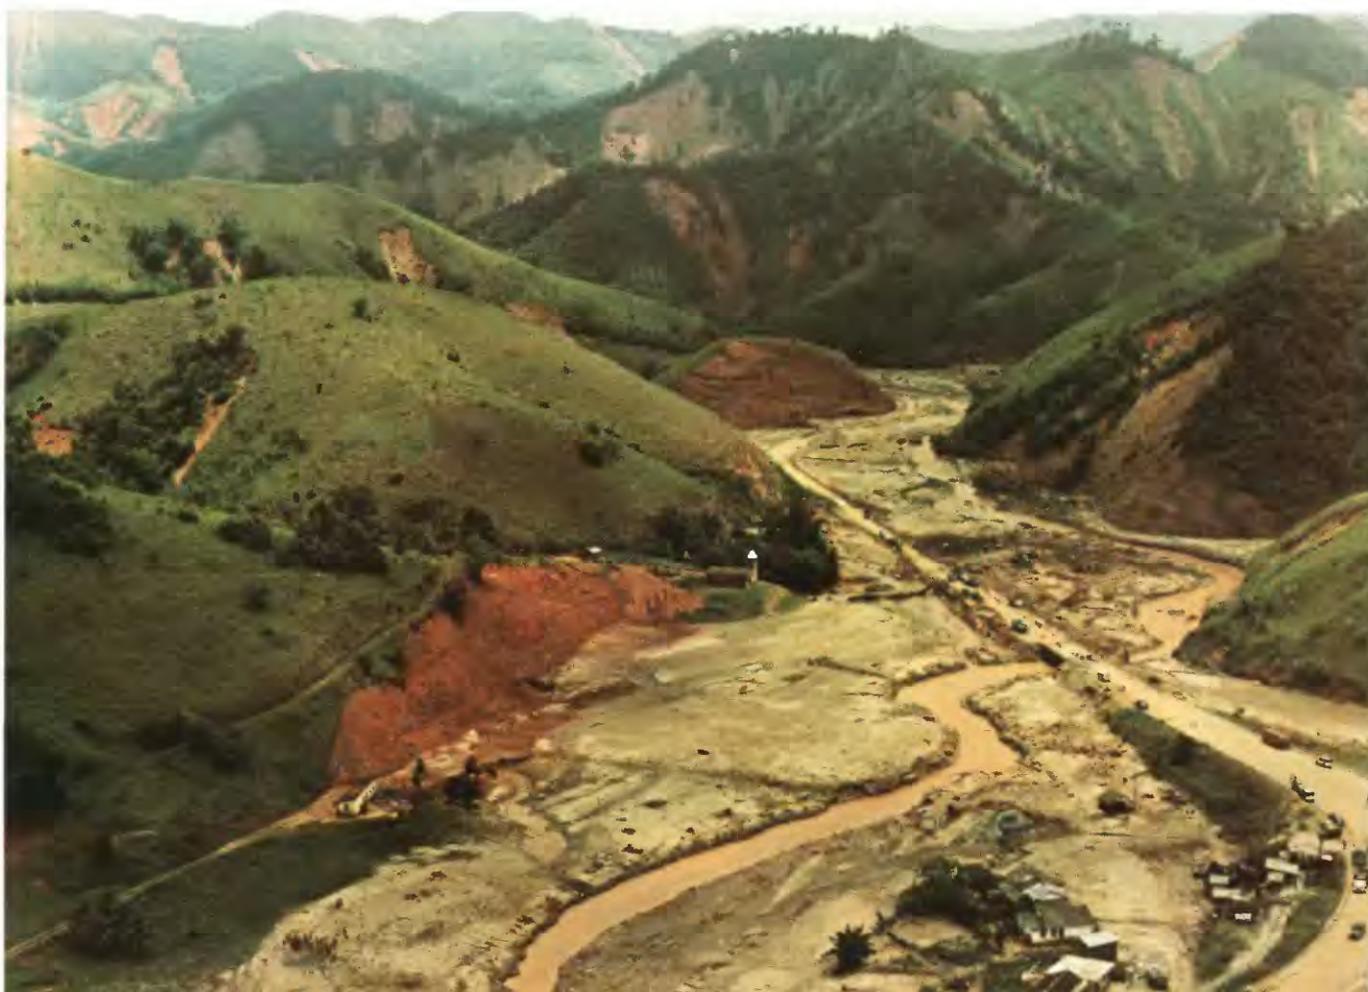
FIGURE 27 (below).—Floresta Creek valley mudflow at the base of the Serra das Araras escarpment. Prior to the disaster, the valley bottom contained a village and a highway construction camp. Several hundred people lost their lives. The mudflow reached a depth of about 12 feet.

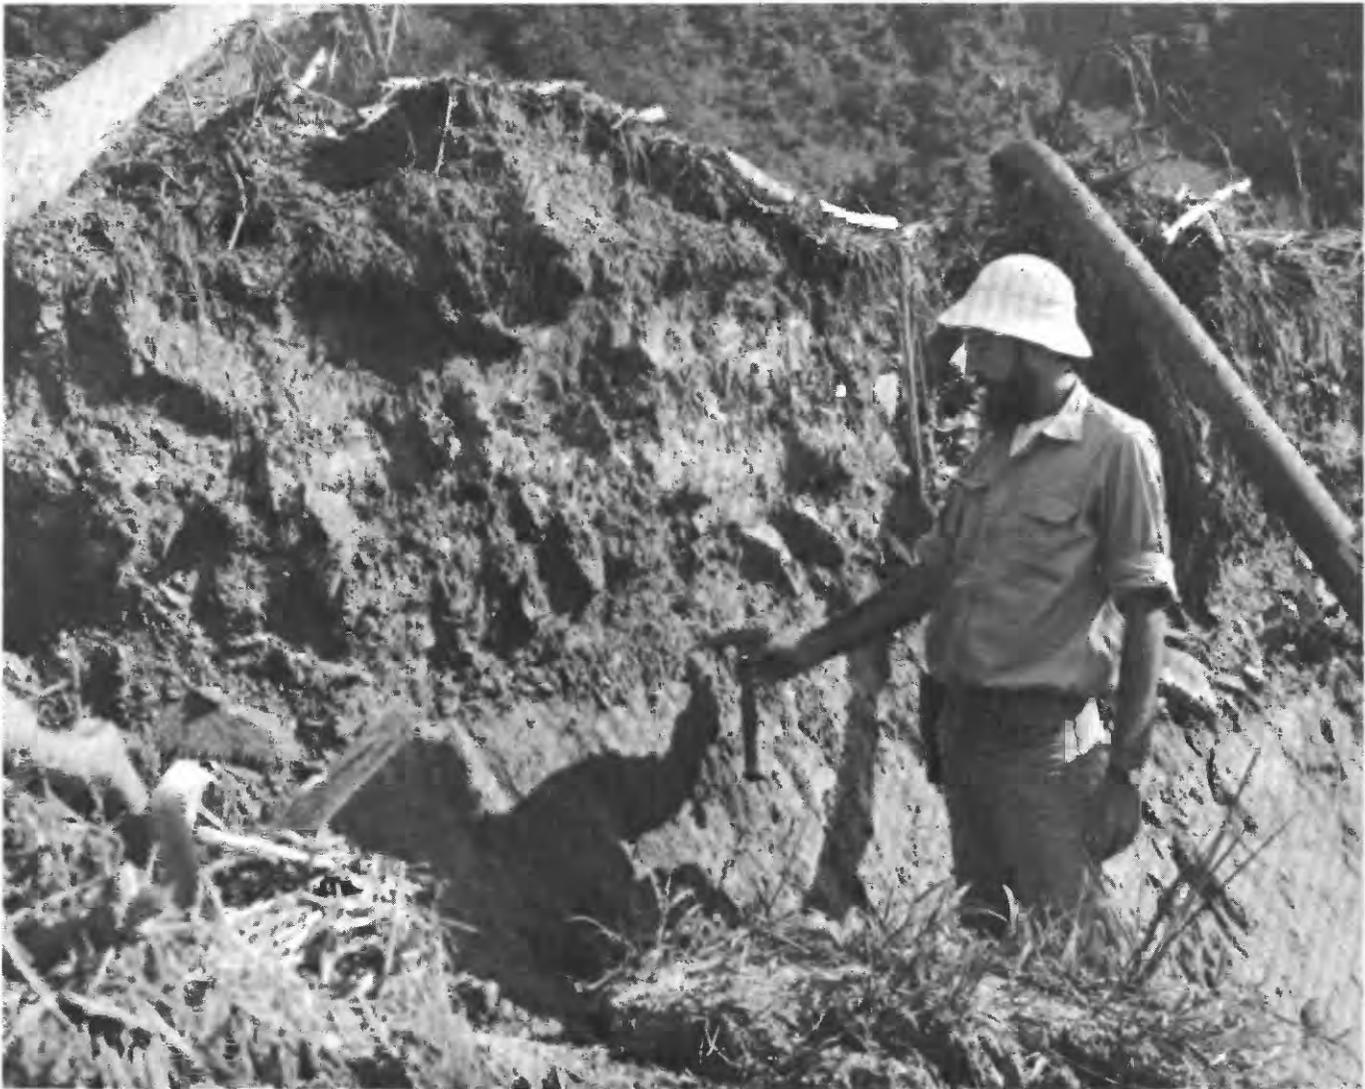
FIGURE 28.—Section of Floresta Creek mudflow at a location just downstream from the area shown in figure 27. The gray material below the point of the geologist's pick is the old alluvium of carbonaceous silty, clayey sand. The mudflow material above the pick is silt and sand containing angular rock fragments. The interior of the mudflow contained surprisingly few pieces of wood. Most of the trash apparently was washed downstream. The little that was left was either on top of the mudflow or within a few inches of the top.

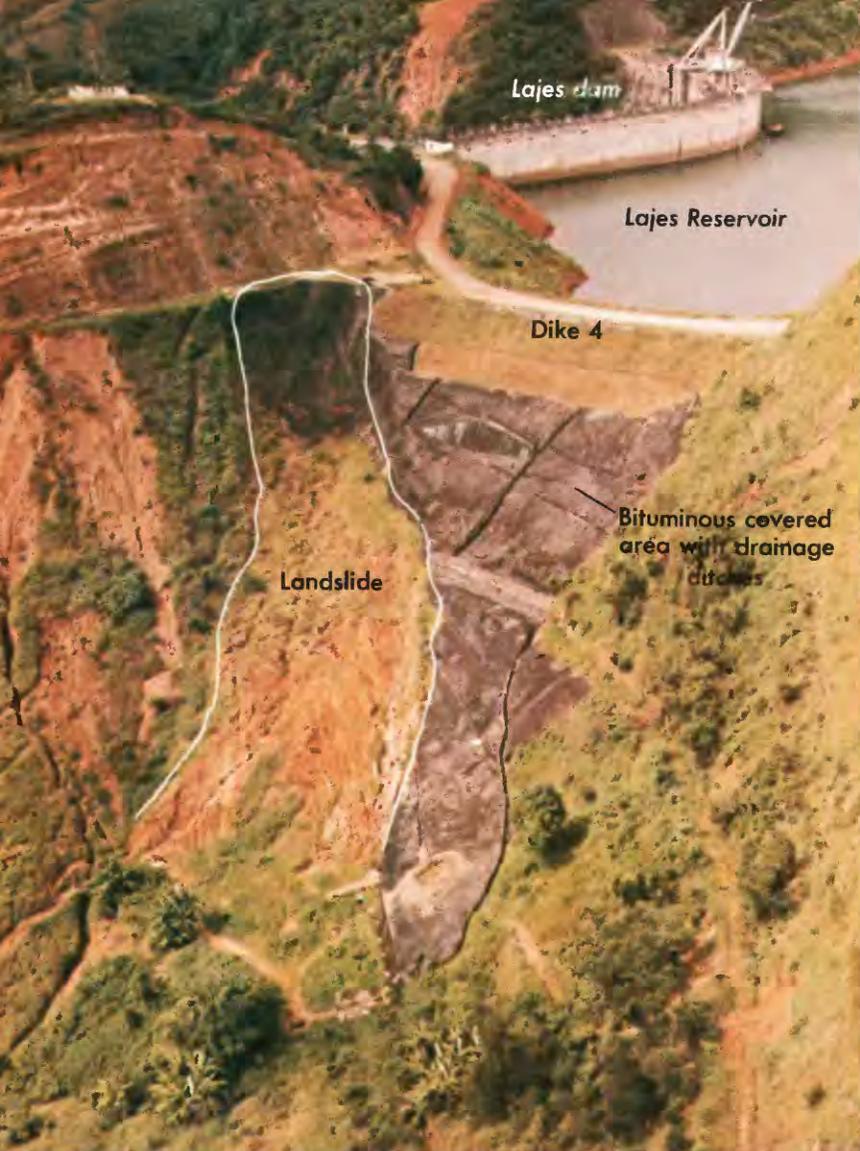
FIGURE 31 (above).—Landslide at dike 4, Lajes Reservoir. Lajes Creek dam and reservoir in the background. The slide has been moving periodically for some time. Minor re-movements occurred during the rain of January 22 and 23, 1967.

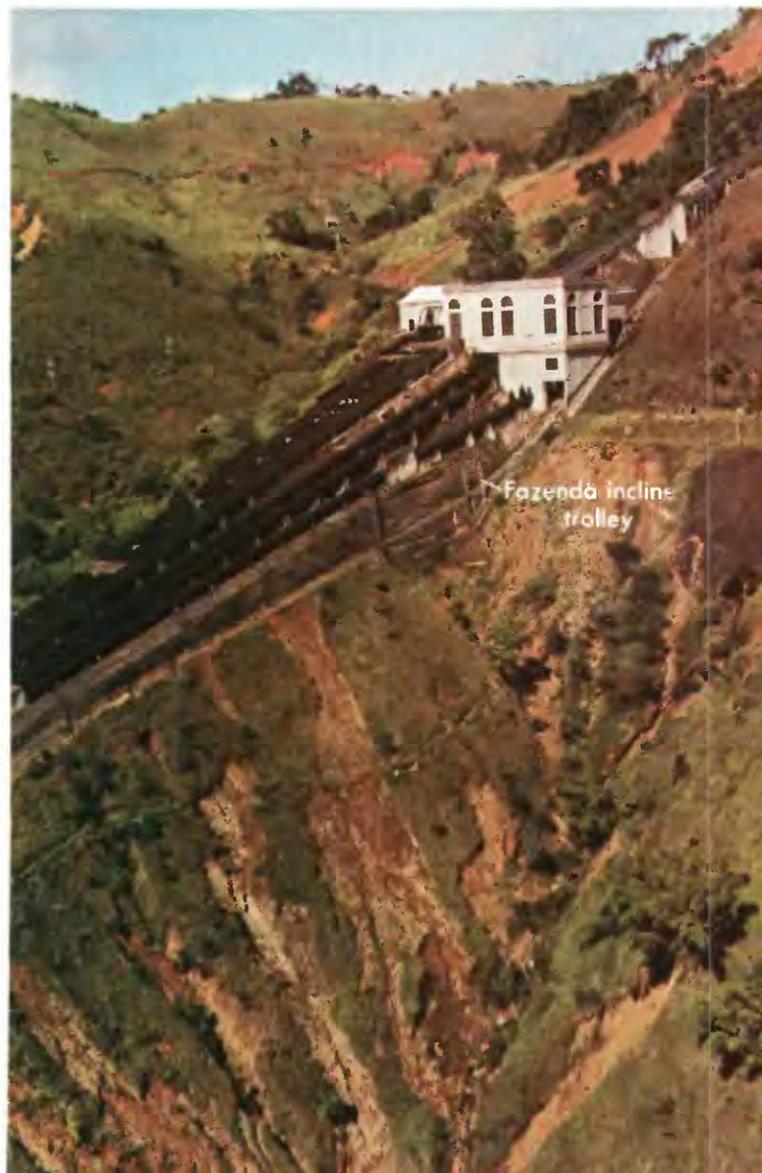
FIGURE 32 (below).—Landslides adjacent to valvehouse of Fontes plants and Fazenda incline cable trolley.

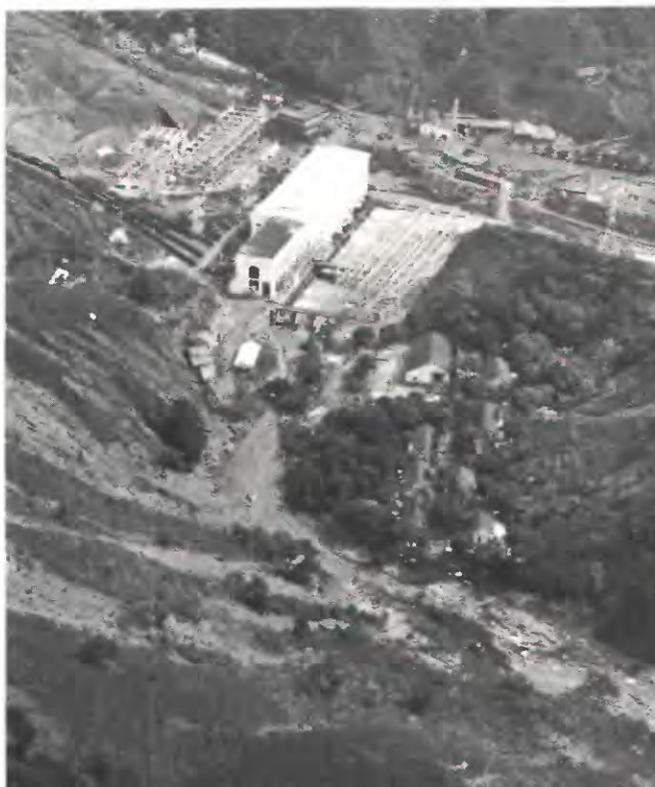
FIGURE 33.—New and old Fontes powerplants looking down Lajes Creek valley. The photograph was taken after the Lajes Creek valley mudflow had been cleared from the tailrace channel.

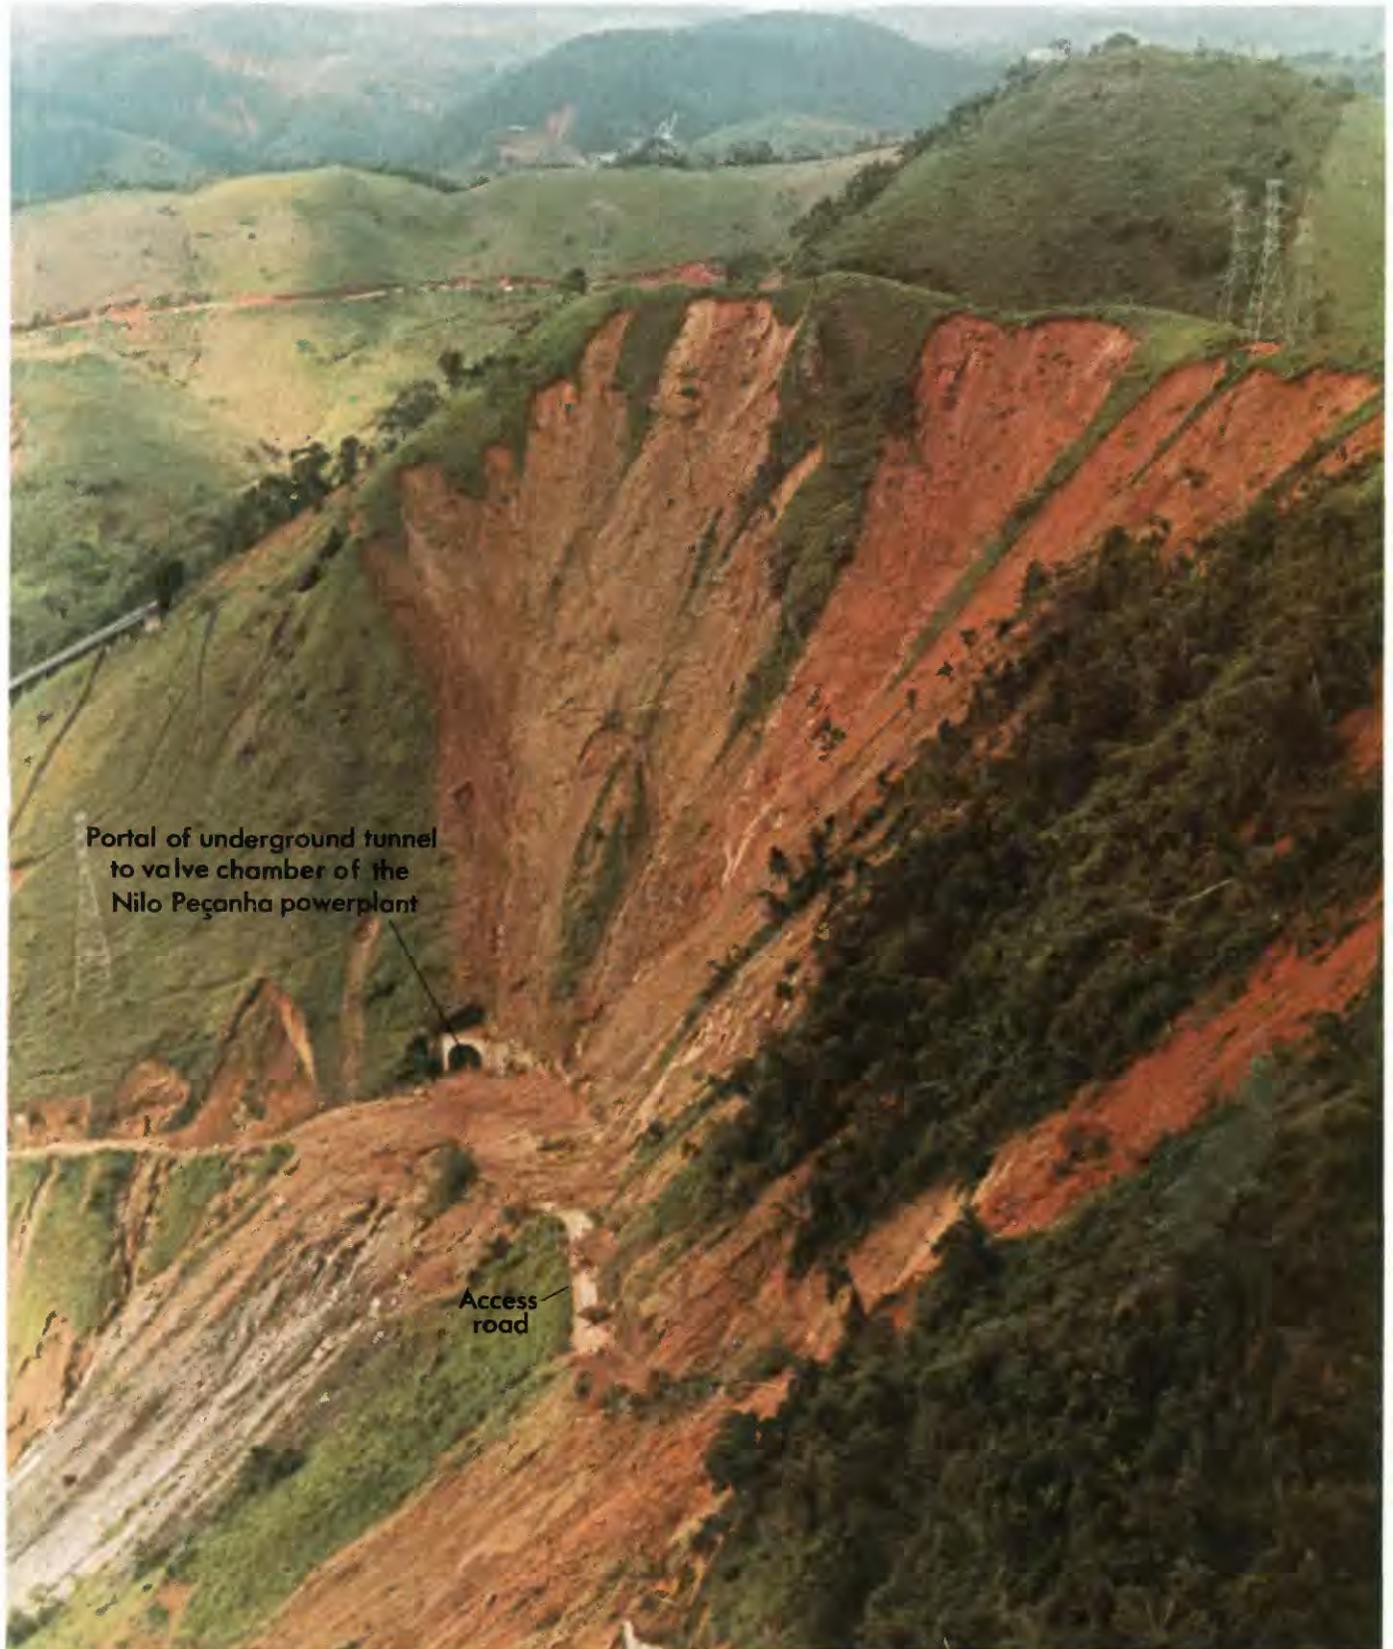
FIGURE 34.—Landslides covering access road to tunnel leading to underground valve chamber of Nilo Peçanha powerplant. A slide cut to within 1 m of the base of one of the transmission tower foundations, upper right.

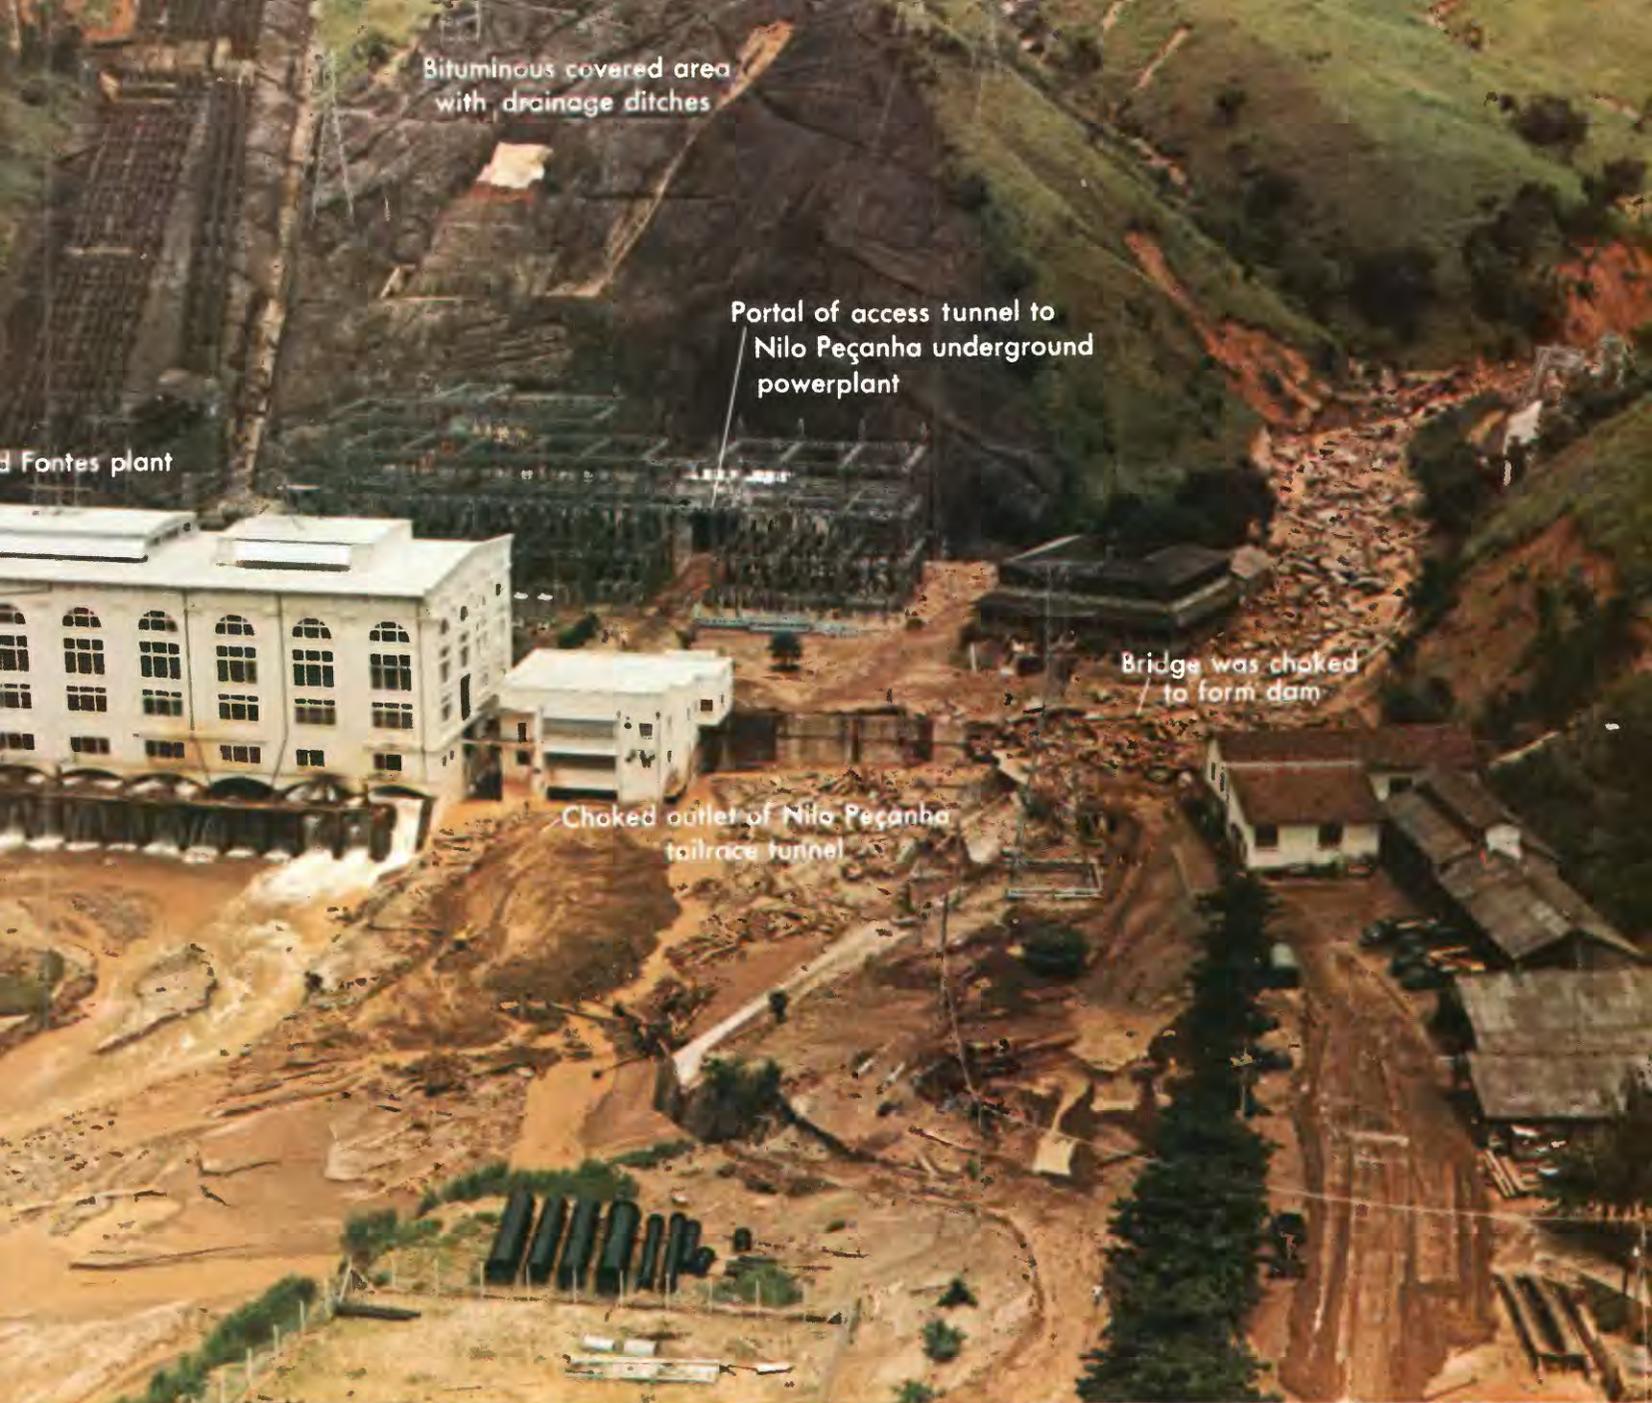
FIGURE 35.—Fazenda Creek valley mudflow at Nilo Peçanha powerplant. Note how mudflow overflowed switchyard into access tunnel as well as filling tailrace channel and tunnel.

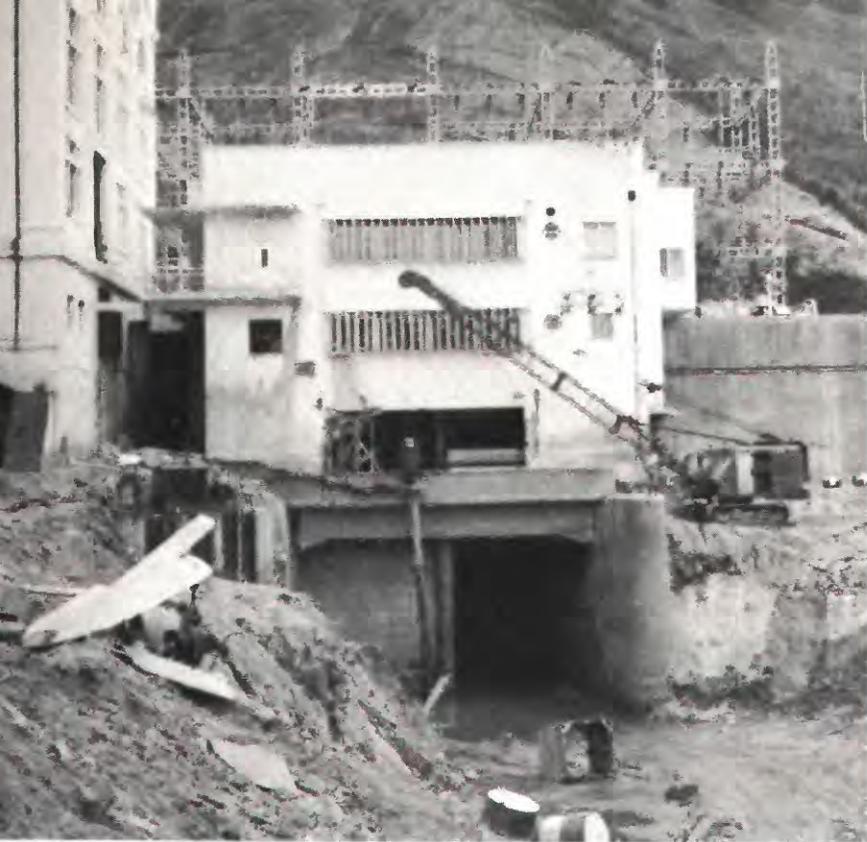
FIGURE 36 (above).—Outlet of Nilo Peçanha tailrace tunnel after excavation of mudflow.

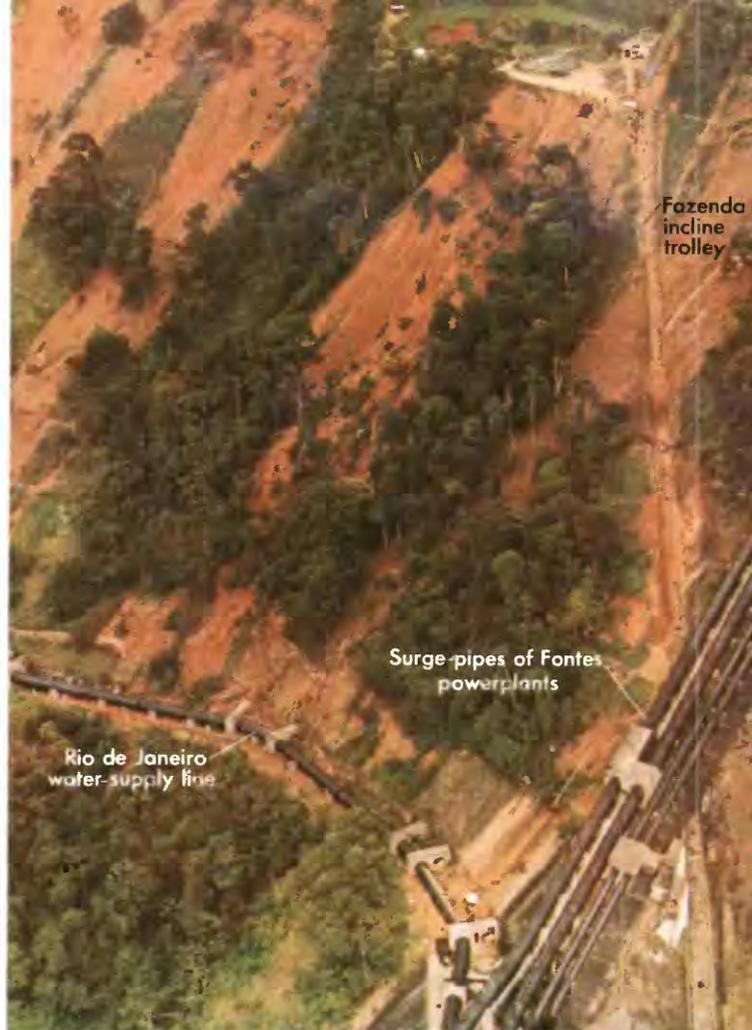
FIGURE 37 (right).—Landslides in the area of the surge pipes of Fontes powerplants, Fazenda incline trolley, and city of Rio de Janeiro's water-supply line.
