Landslides of Rio de Janeiro and the Serra das Araras Escarpment, Brazil

By FRED O. JONES

GEOLOGICAL SURVEY PROFESSIONAL PAPER 697

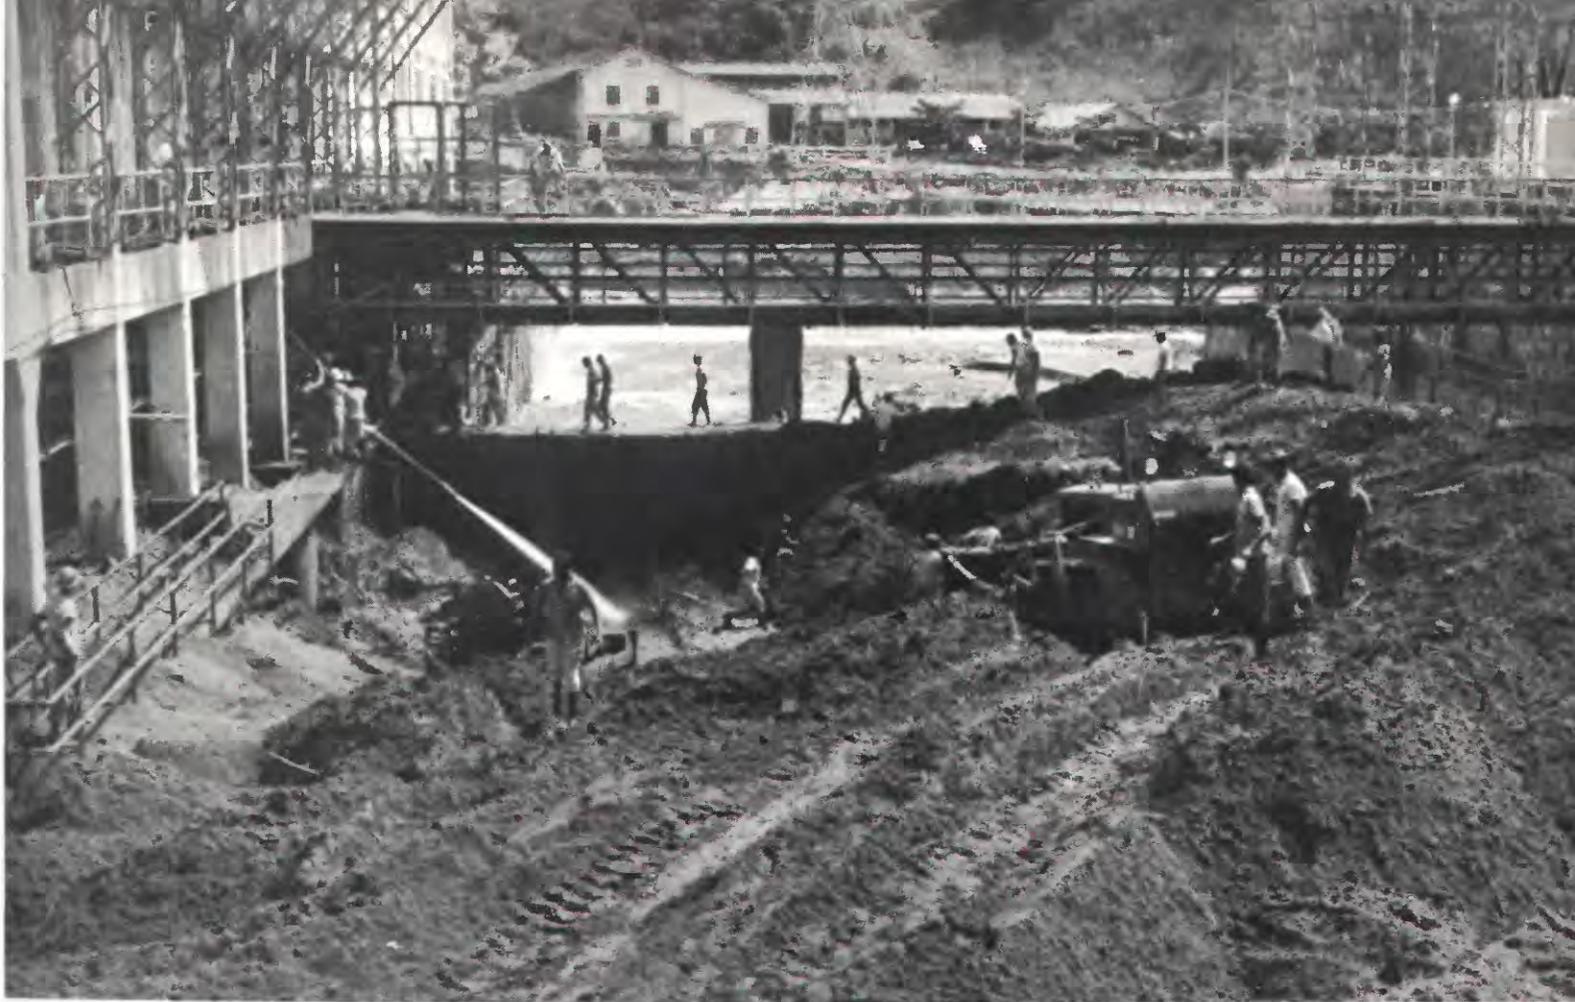
FIGURE 39 (above).—Tailrace channel of new Fontes powerplant choked by Lajes Creek valley mudflow, looking downstream.
Men silhouetted in upper left center are walking on city of Rio de Janeiro's water-supply conduit.

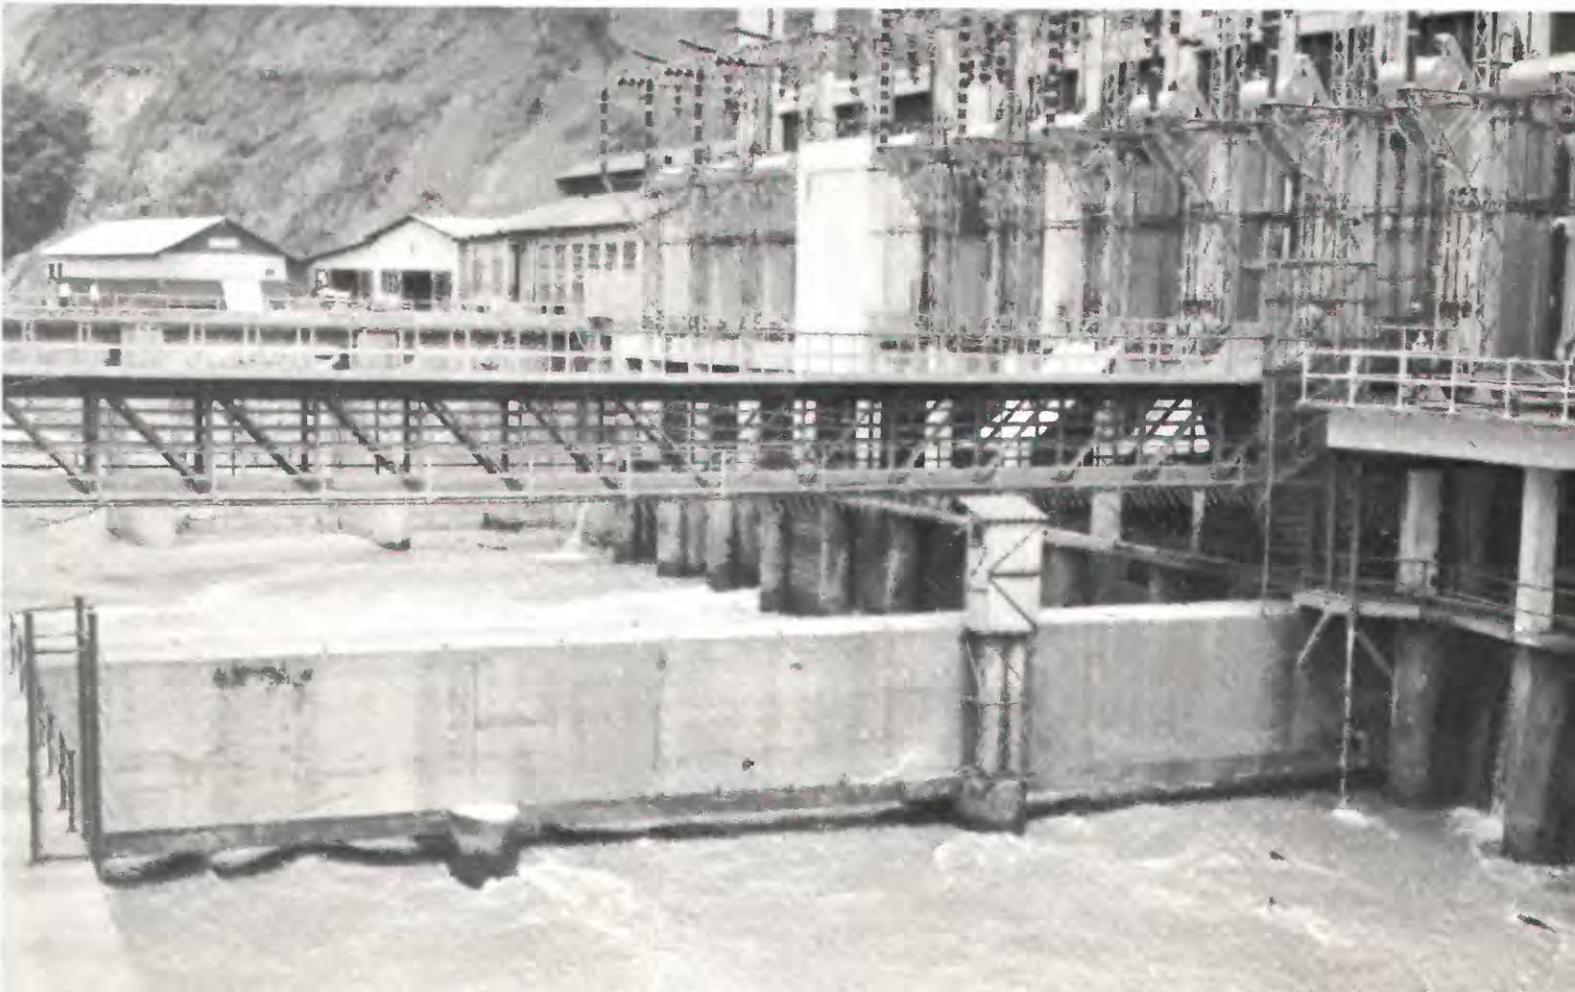
FIGURE 40 (below).—Tailrace channel of new Fontes powerplant after mudflow was cleaned out.

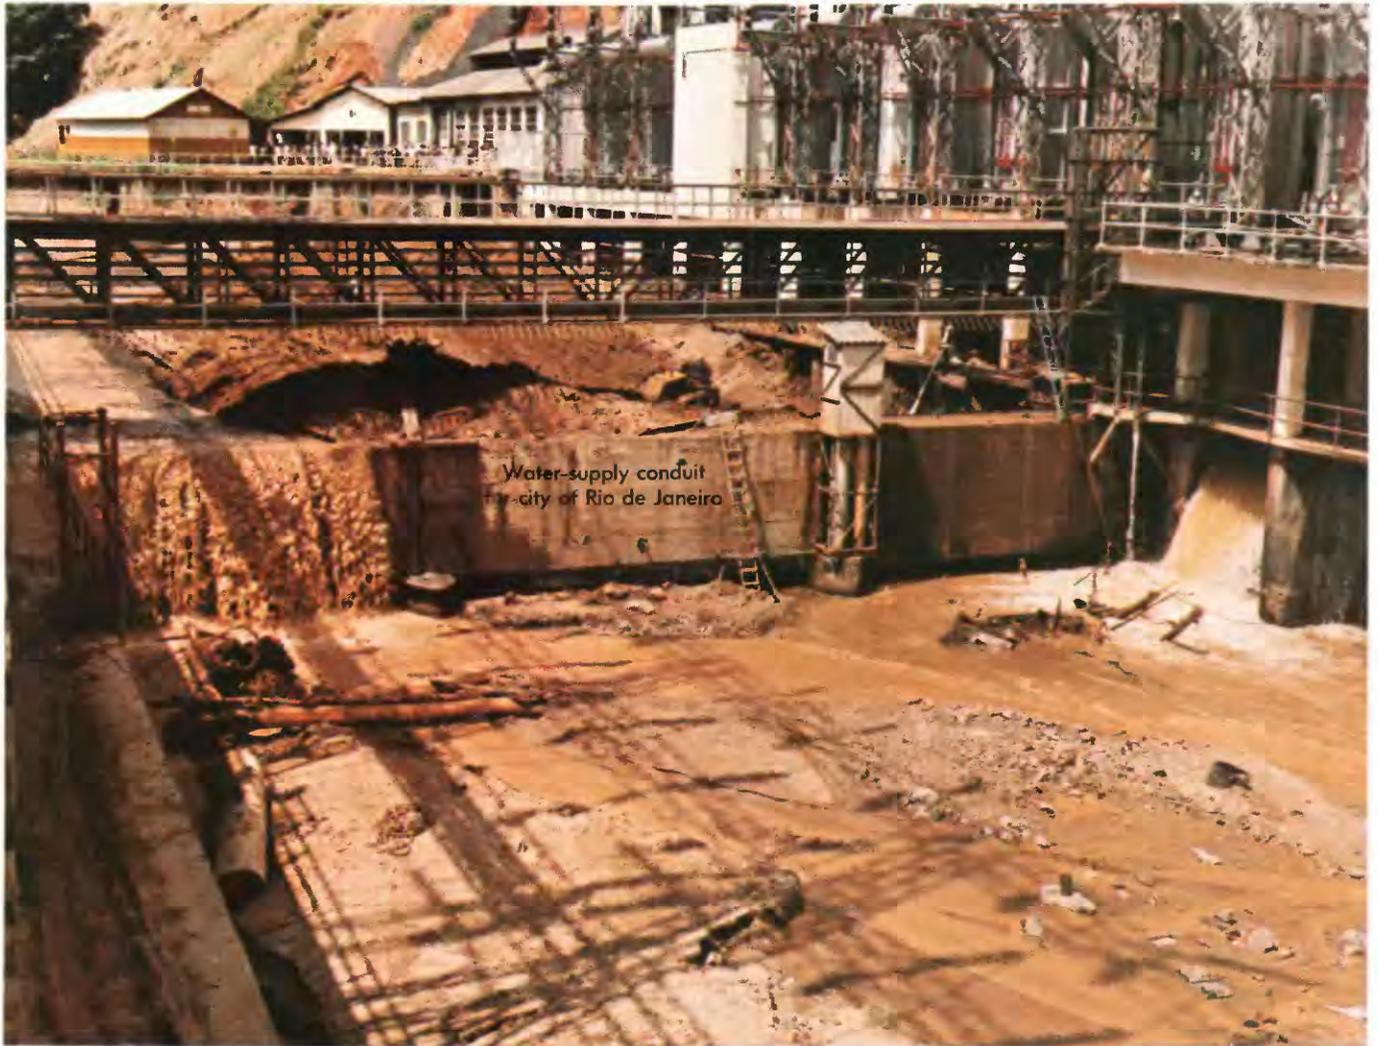
FIGURE 41.—Tailrace channel of new Fontes powerplant choked by Lajes Creek valley mudflow, looking upstream. Water at left is spilling over city of Rio de Janeiro's water-supply conduit. Foreground space below conduit is tailrace channel of old Fontes plant.

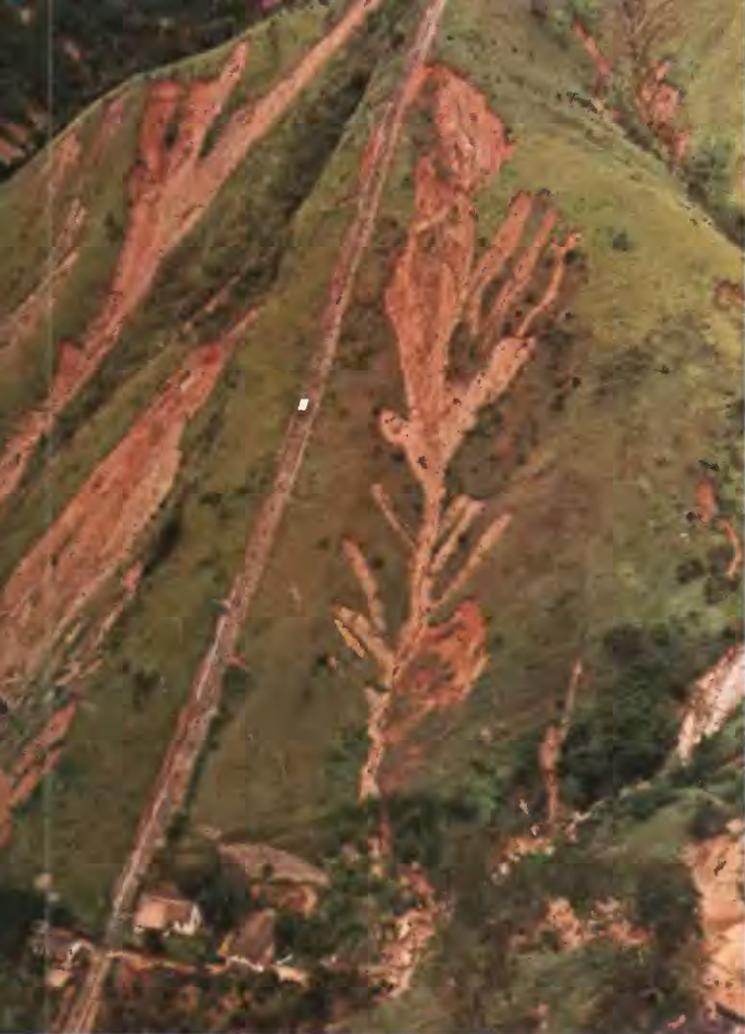
FIGURE 42.—Herringbone-patterned landslide complex adjacent to the Ipê incline. The reason for the development of this slide pattern is unknown, but it probably reflects differential stability of the residual soils due to local variations in their character and thickness.

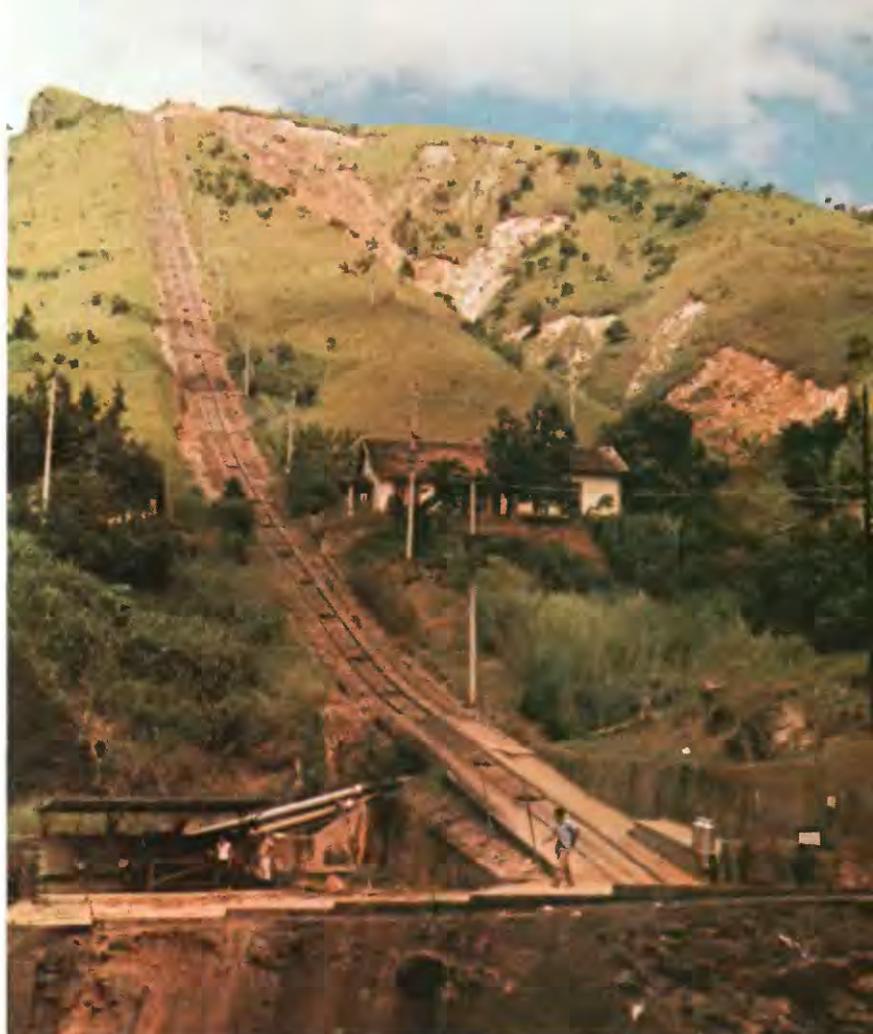
FIGURE 43.—Herringbone-patterned landslide shown in figure 42 one week after the lime treatment. It was not anticipated that the lime treatment alone would stabilize the slide. It was hoped that it would retard enlargement through the 1967 rainy season and keep the slide from severing the incline so that during the dry season the slopes could be shaped and given a bituminous coating to stabilize them from further sliding and erosion.

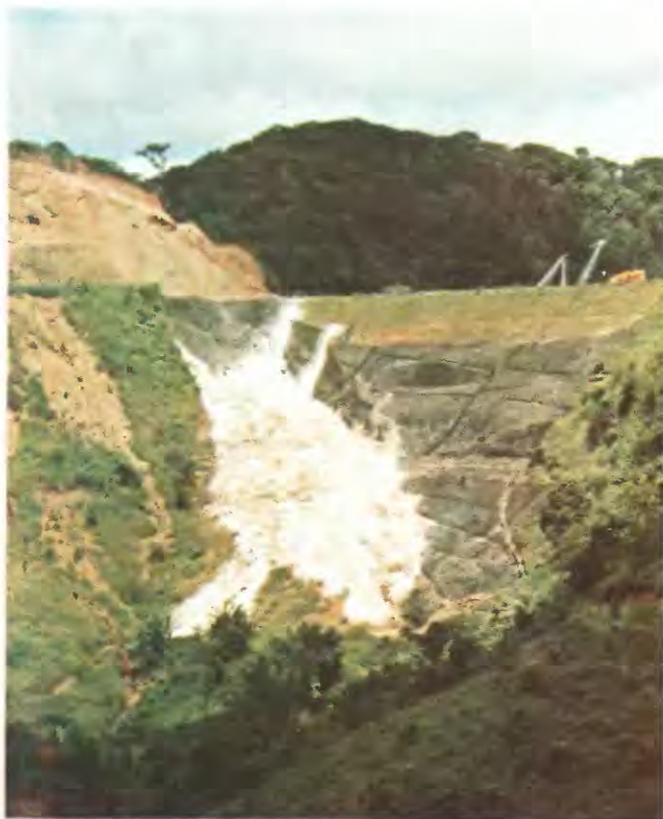
FIGURE 44.—Landslide at dike 4 immediately after lime treatment.
