# THE SAN FERNANDO, CALIFORNIA, EARTHQUAKE OF FEBRUARY 9, 1971:

*A preliminary report published jointly by the U.S. Geological Survey  
and the National Oceanic and Atmospheric Administration*

GEOLOGICAL SURVEY PROFESSIONAL PAPER 733

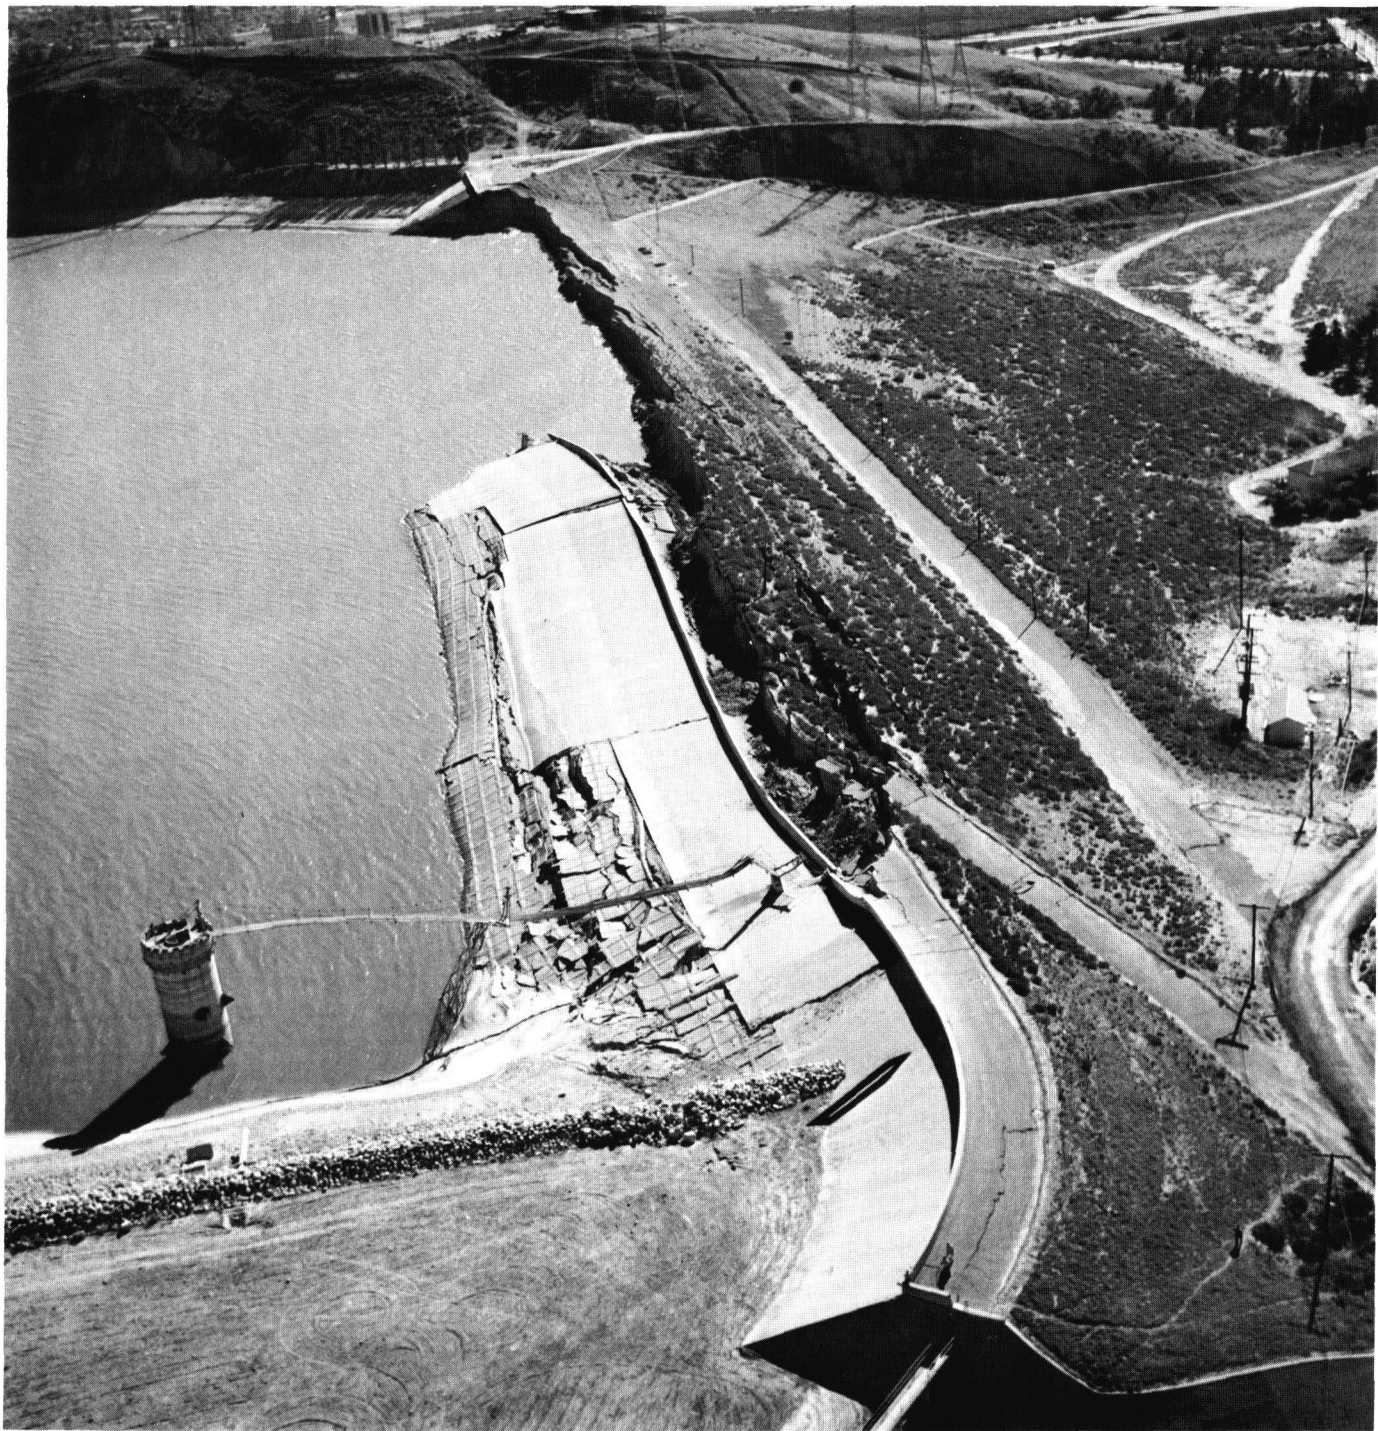
Lower Van Norman Dam in the Mission Hills, overlooking the heavily populated San Fernando Valley, was severely damaged and on the brink of catastrophic failure as a result of the San Fernando earthquake of February 9, 1971.

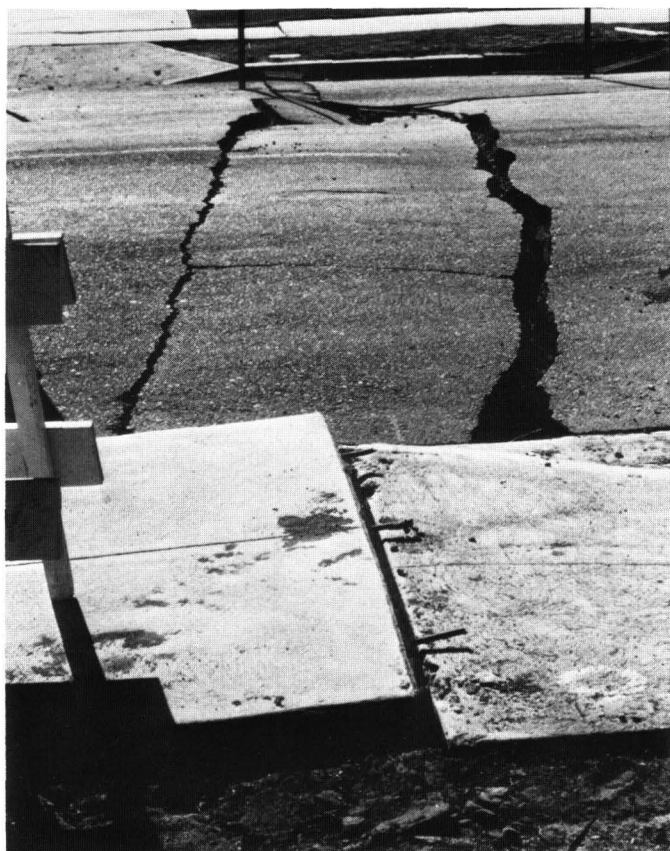
FIGURE 7.—Graben across Eighth Street in the zone of extension fractures. Foundering of the down-dropped block is exaggerated by the presence of a large (about  $5 \times 6$  m cross section) flood-control conduit beneath Eighth Street. This conduit was severely damaged in the fault zone. The condition of the tie bars in the construction joint in the sidewalk in the foreground indicates at least one cycle of opening and closing of the sidewalk slabs with movement greater than the length of the exposed bars.

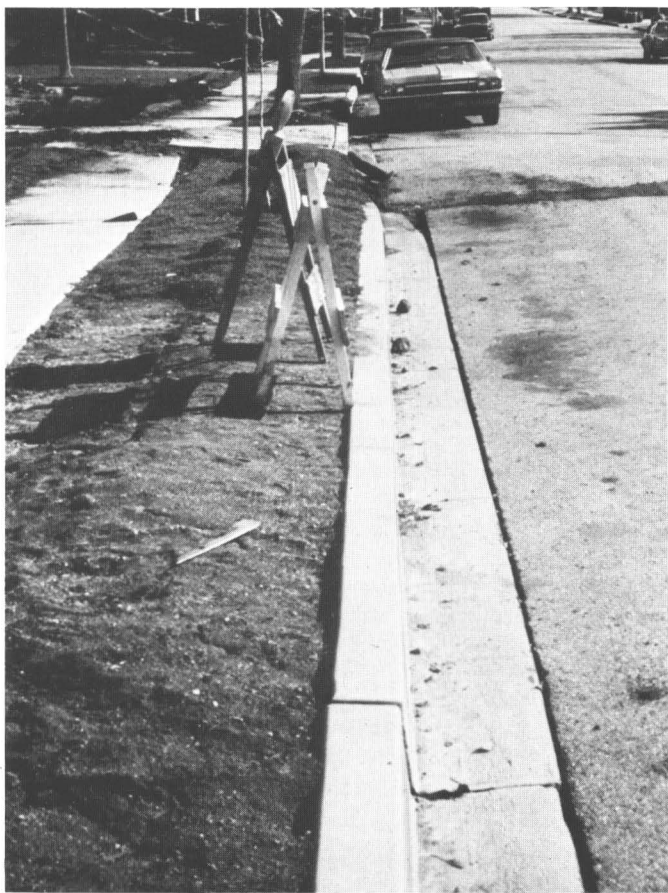
FIGURE 9.—Left-lateral offset of the northeast side of Knox Street in the shear-thrust zone. Underthrusting of adjacent turf by both curb and sidewalk in the zone of offset indicates that they bridge a narrower shear zone in the ground.

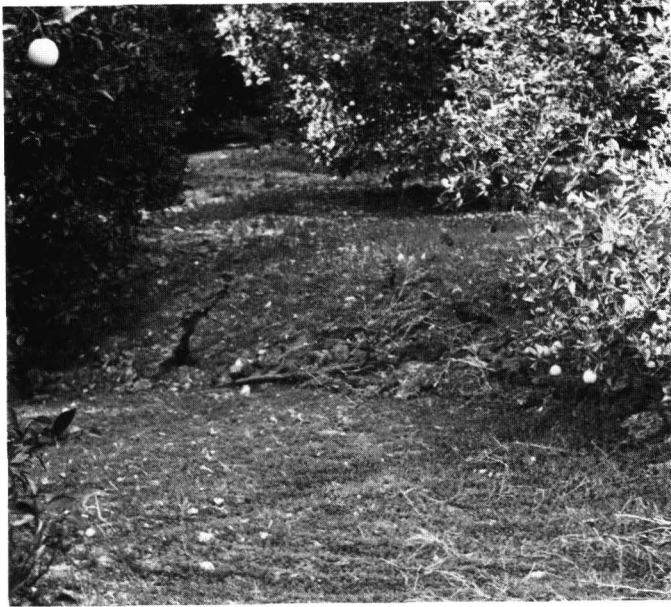
FIGURE 15.—Scarp in orange grove in Little Tujunga Canyon. Scarp is about 0.4 m high here, and about 0.6 m high in canyon bottom 80 m to west. View looks north.

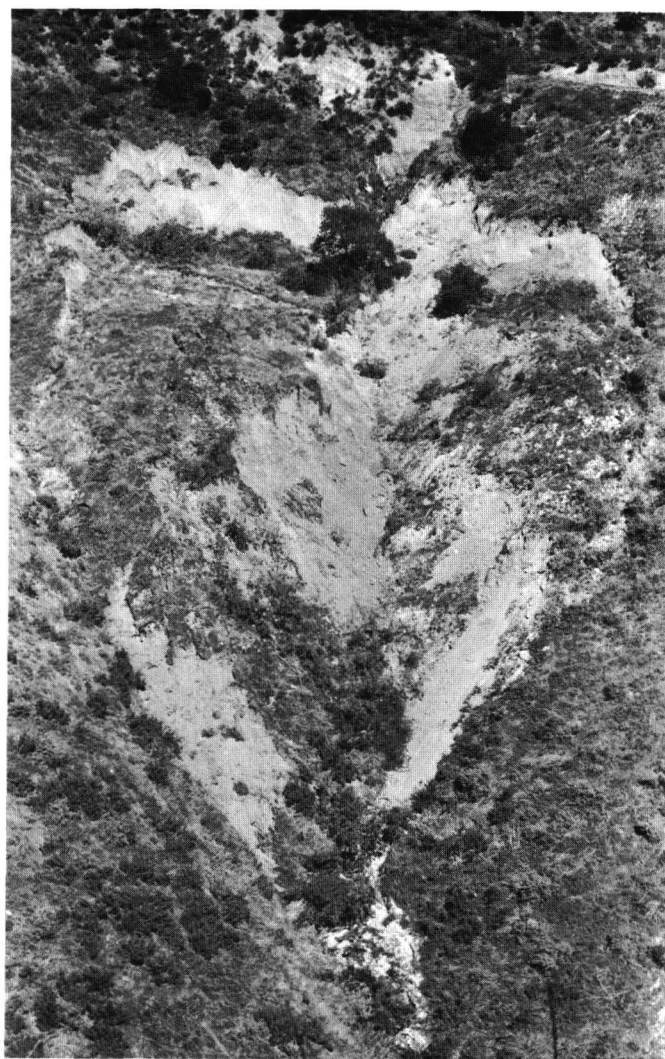
FIGURE 2.—Slump-type failure, east of Little Tujunga Canyon.

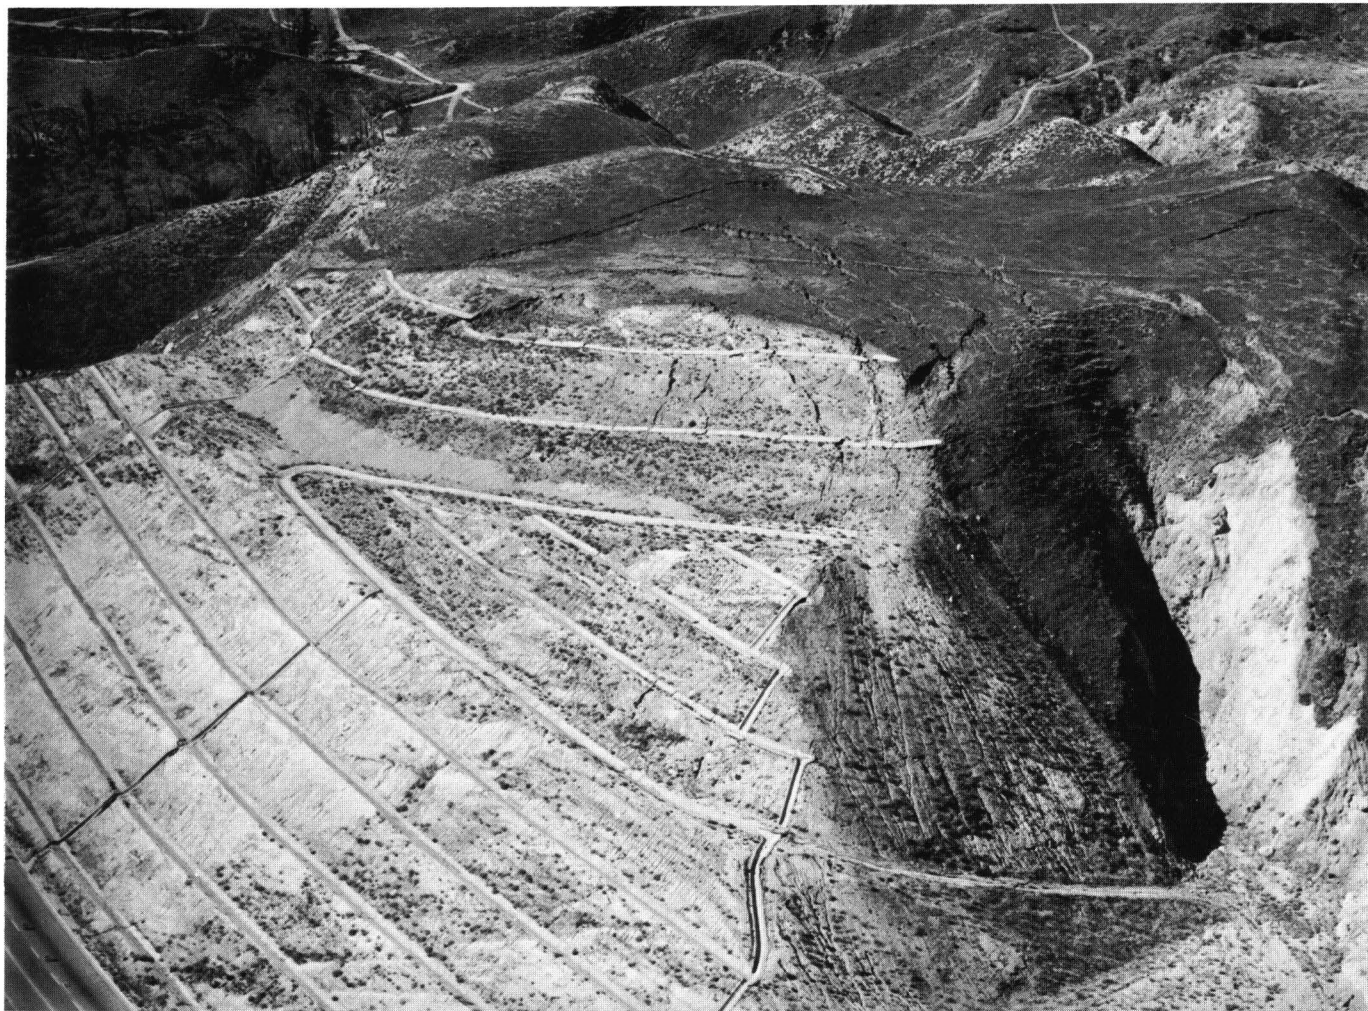
FIGURE 3.—Failure in roadcut, Balboa Boulevard, with small debris slide in ravine to the right of roadcut.

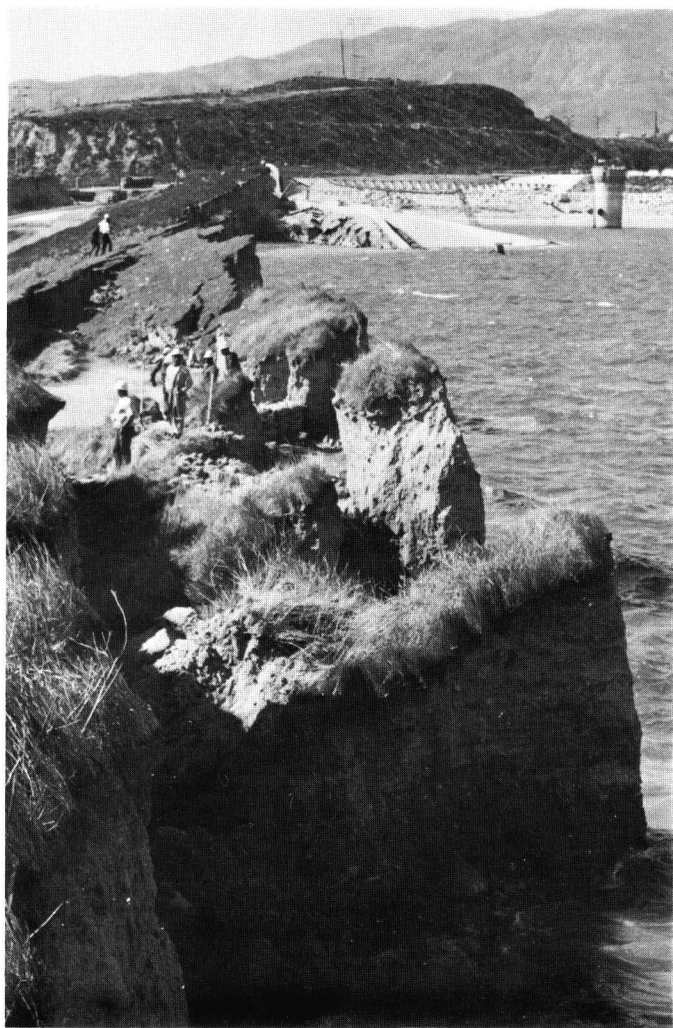
FIGURE 1.—Scarp of upstream slope failure in the Lower Van Norman Lake Dam.

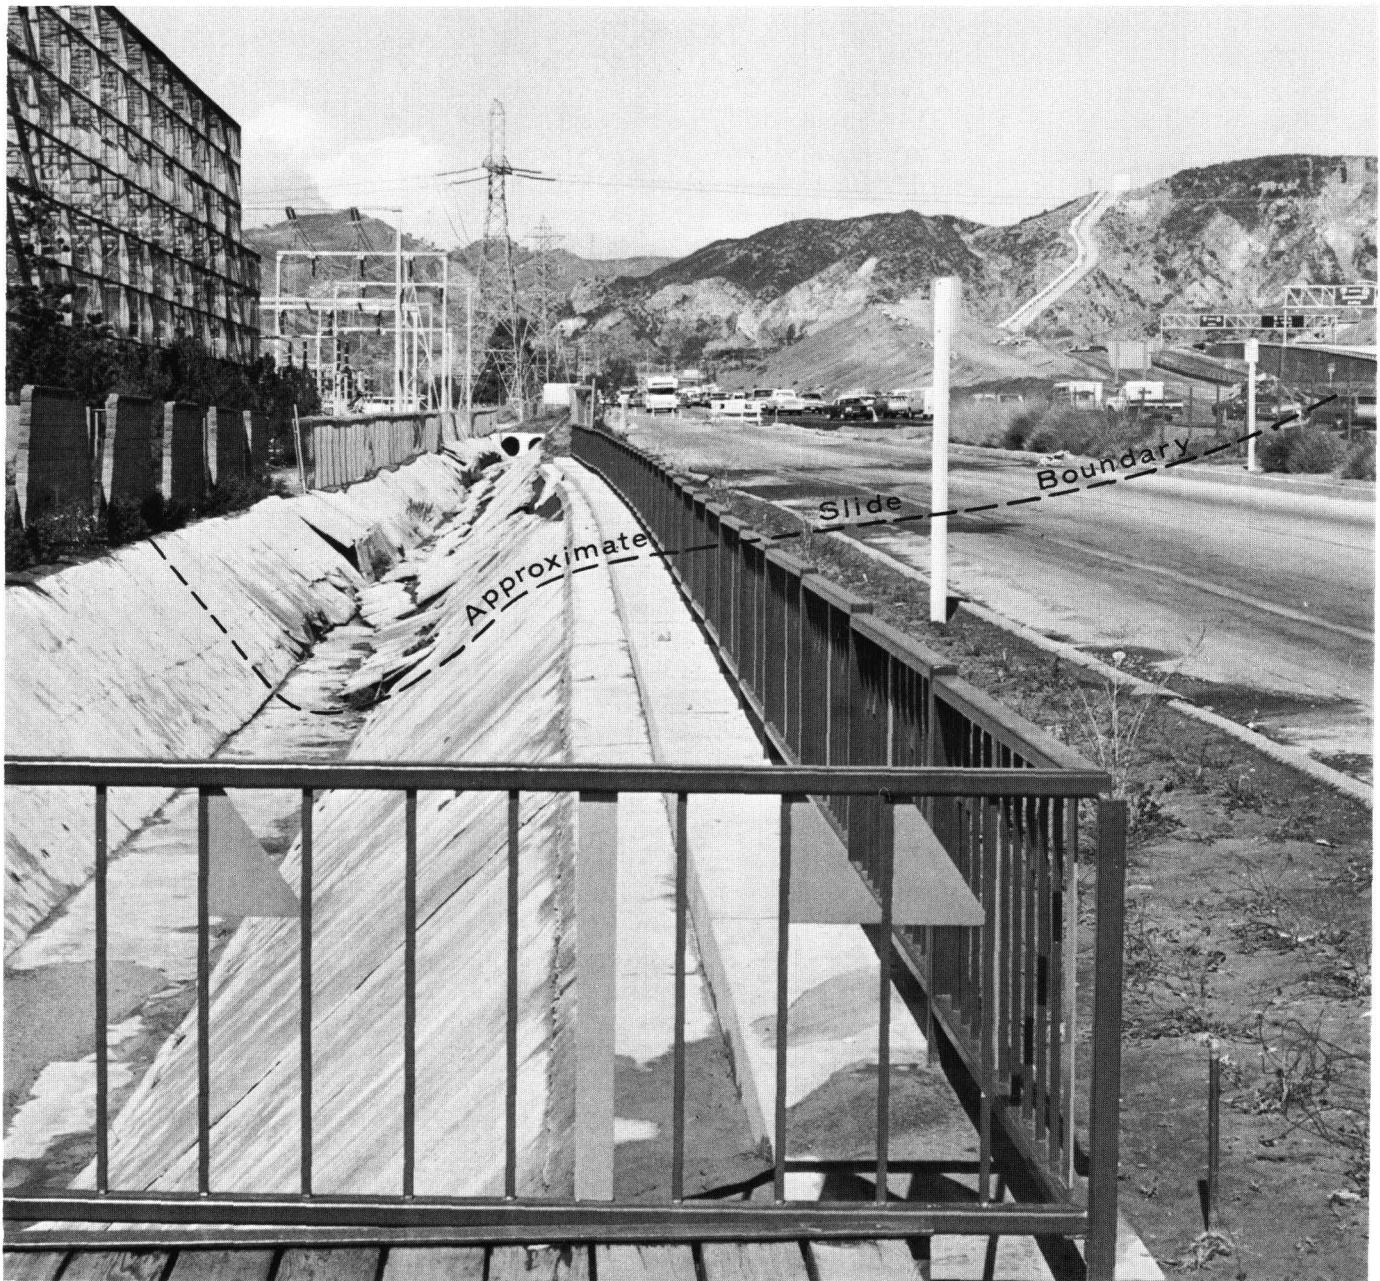
FIGURE 2.—Canal damage caused by the Juvenile Hall slide.

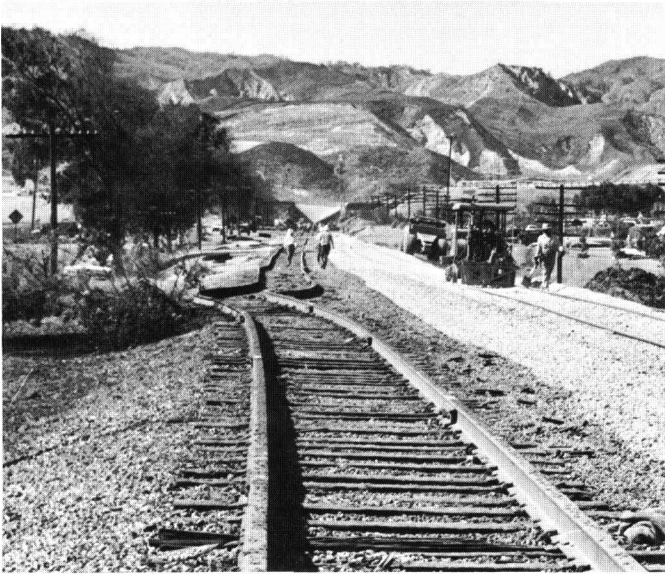
FIGURE 4.—Lateral and vertical displacement of the Southern Pacific Railroad on the Juvenile Hall slide. The lateral displacement of the rail exceeded that of the underlying embankment.

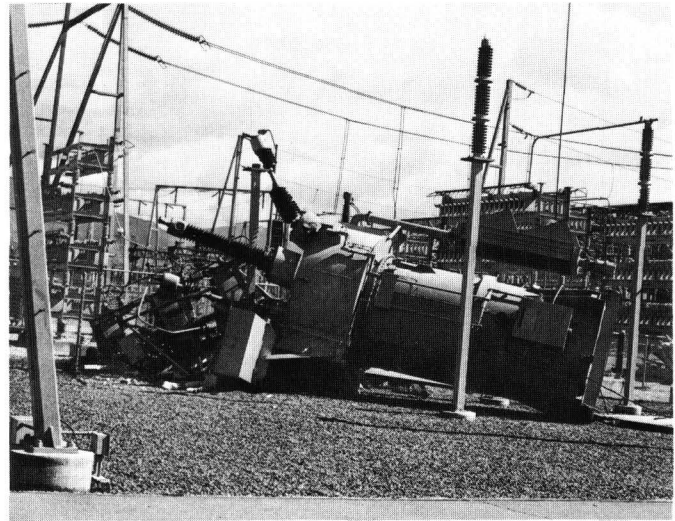
FIGURE 5.—Overturned equipment at the Sylmar electrical converter station.

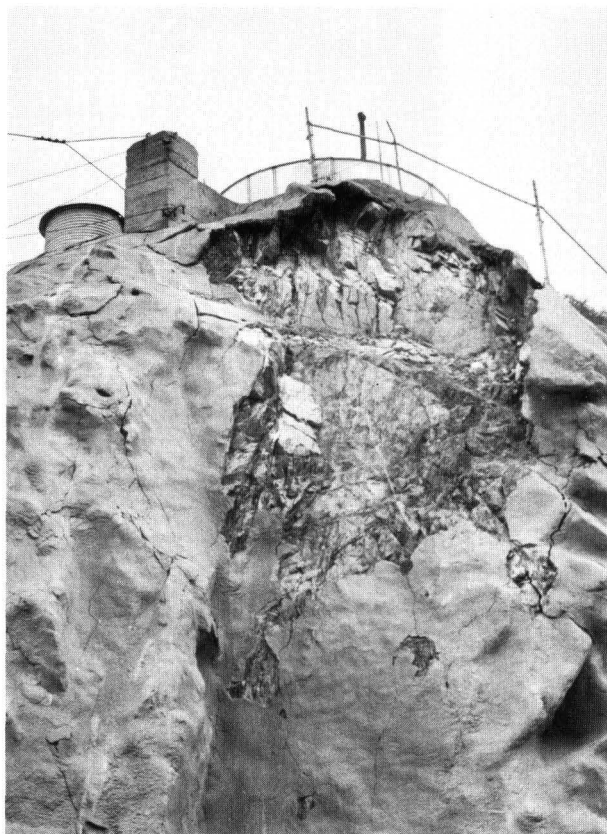
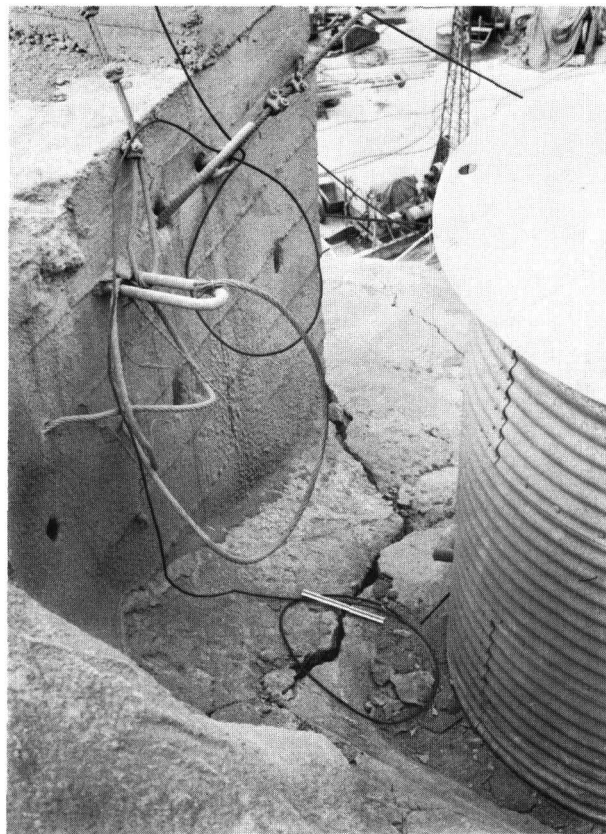
FIGURE 4.—Accelerograph site on the east abutment of Pacoima Dam. The instrument is located in the small silolike structure. Note (A) the massive spalling of bedrock and (B) the cracking and displacement adjacent to the accelerograph housing.

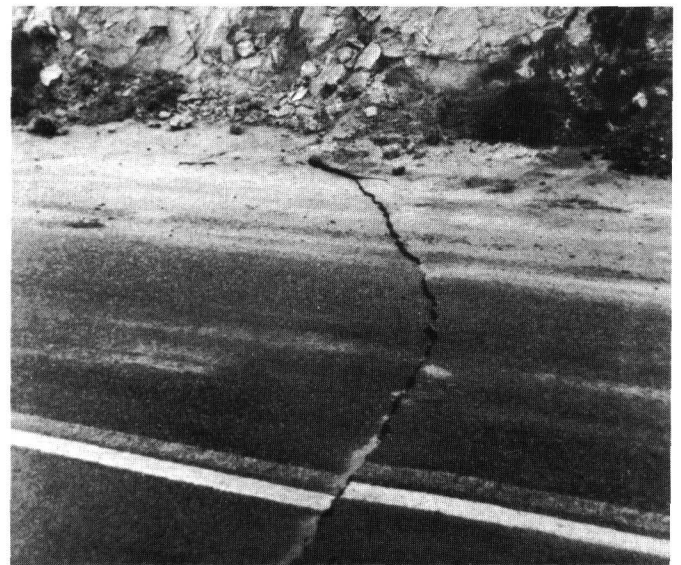
FIGURE 5.—Typical road cracking and offsets in immediate area.

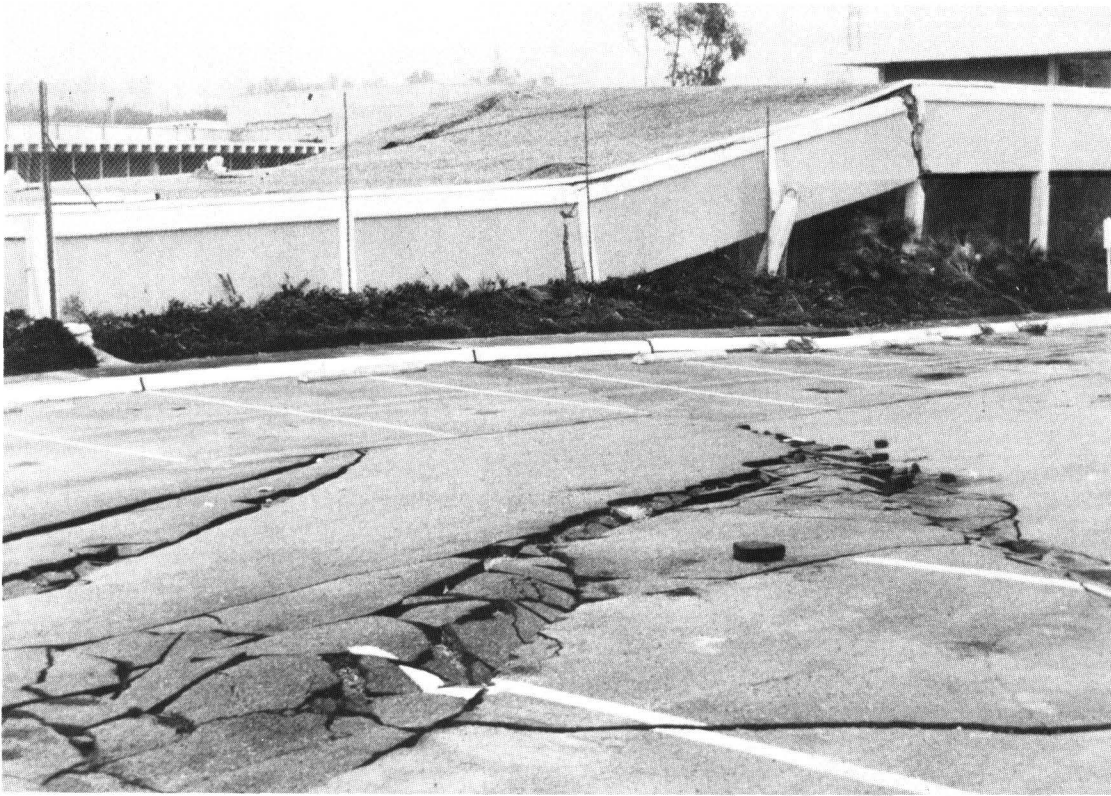
FIGURE 3.—Juvenile Hall. Cracks in pavement extend under collapsed administration building.  
J. F. Meehan, OAC photograph.

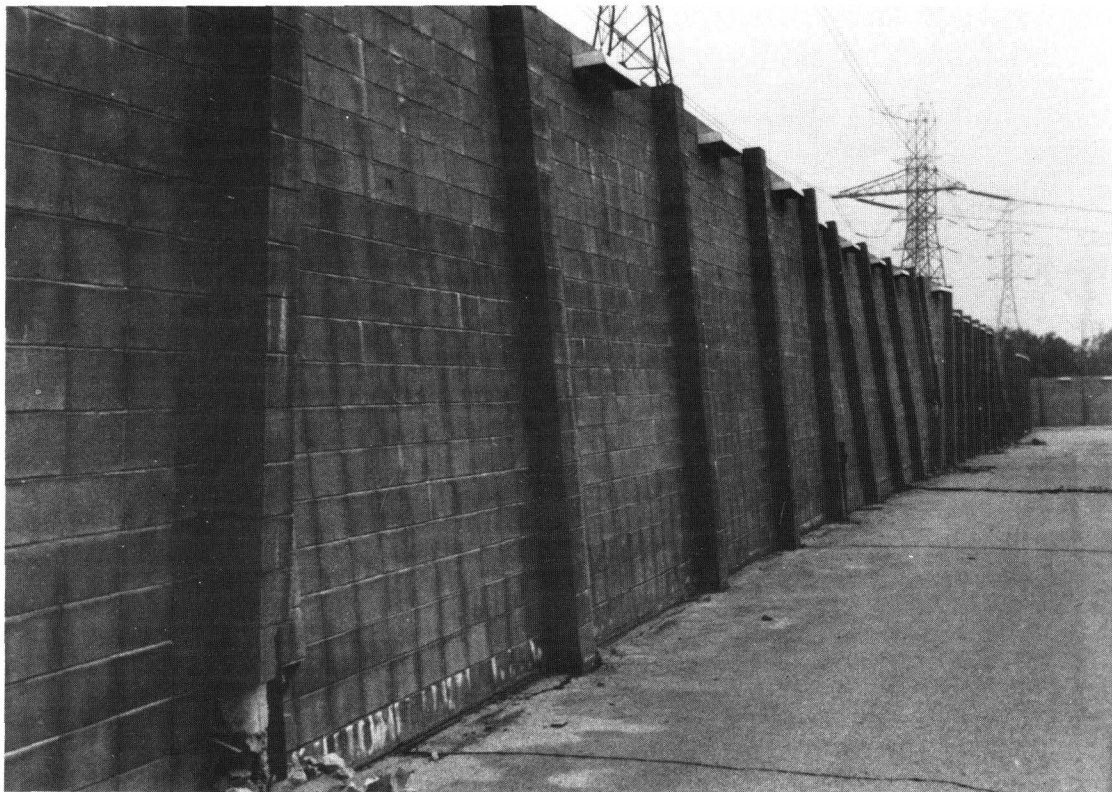
FIGURE 4.—Juvenile Hall. Cantilevered walls leaning. J. F. Meehan, OAC Photograph.

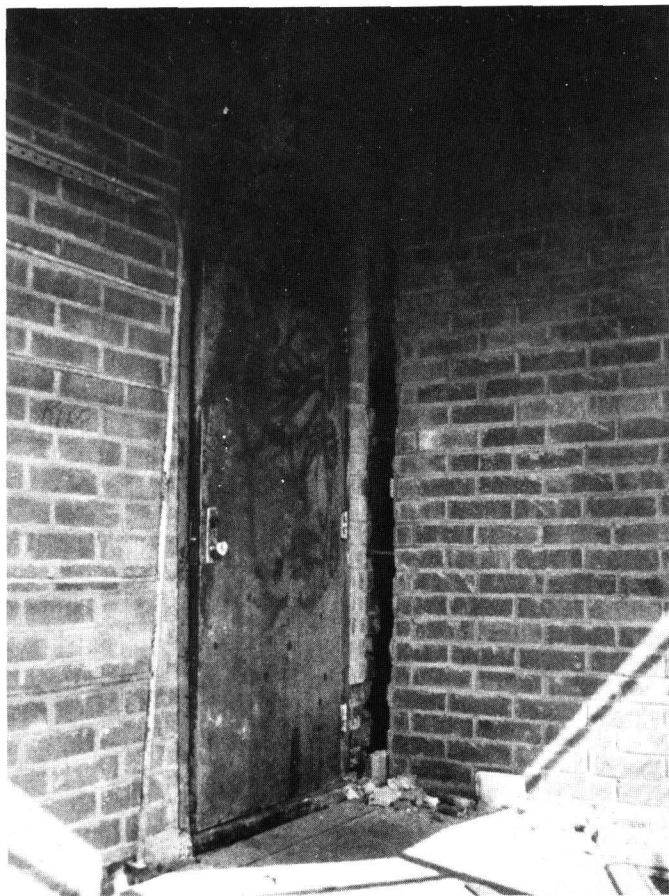
FIGURE 4.—Market. Separation of intersecting walls where crack passed through building. Walter Dickey photograph.

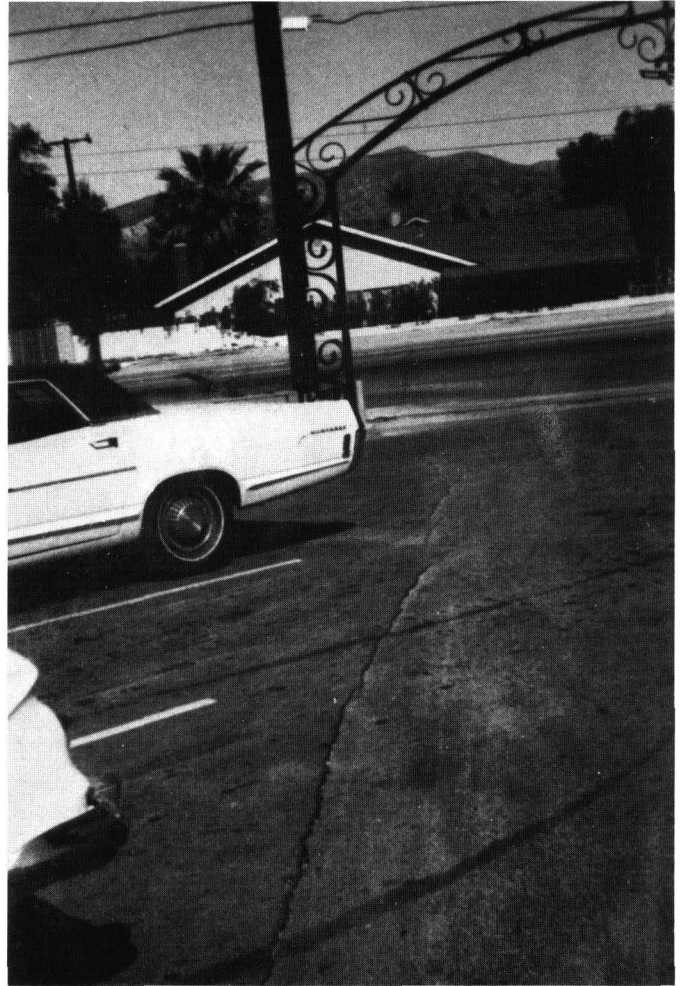
FIGURE 5.—Crack in paving. North Oaks Shopping Center.

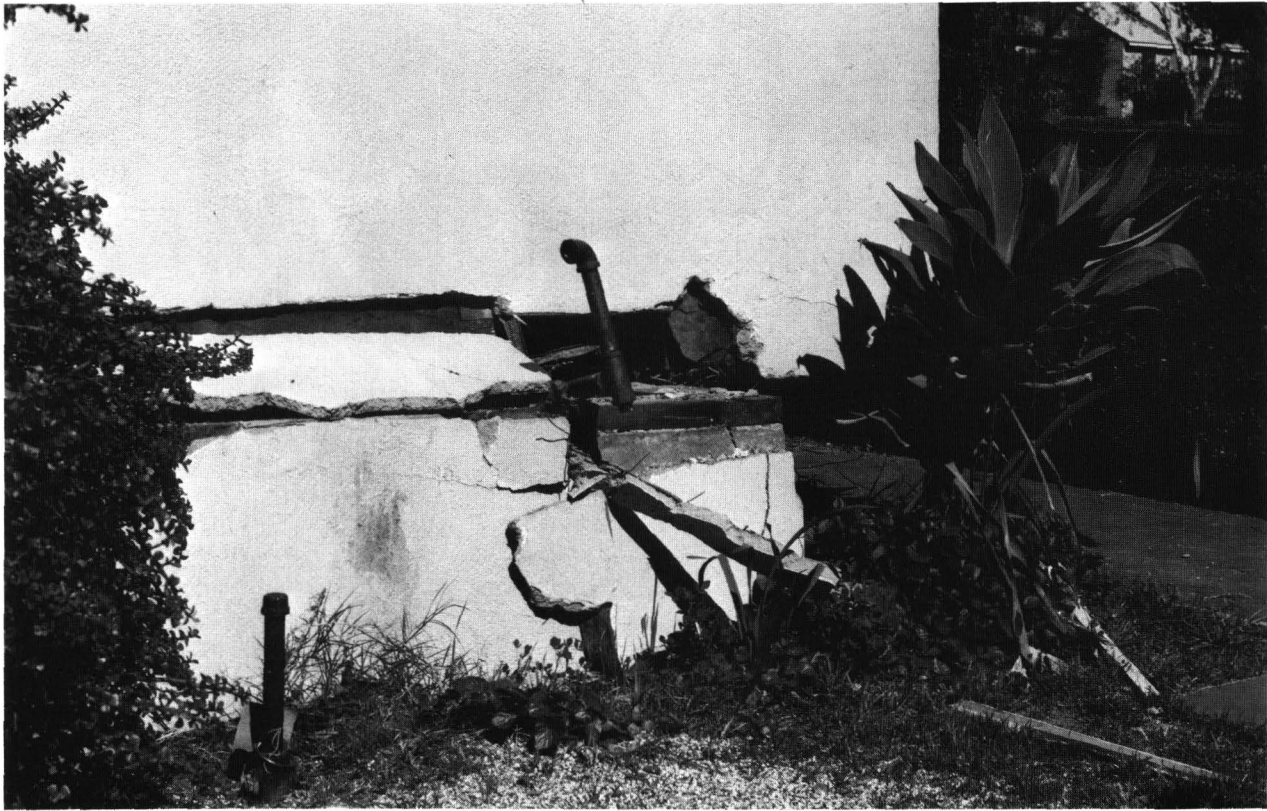
FIGURE 3.—Dwelling in the vicinity of Cometa and Fernmont, San Fernando. Building was shaken off foundation and moved 2 feet forward. Los Angeles City Department of Building and Safety photograph.

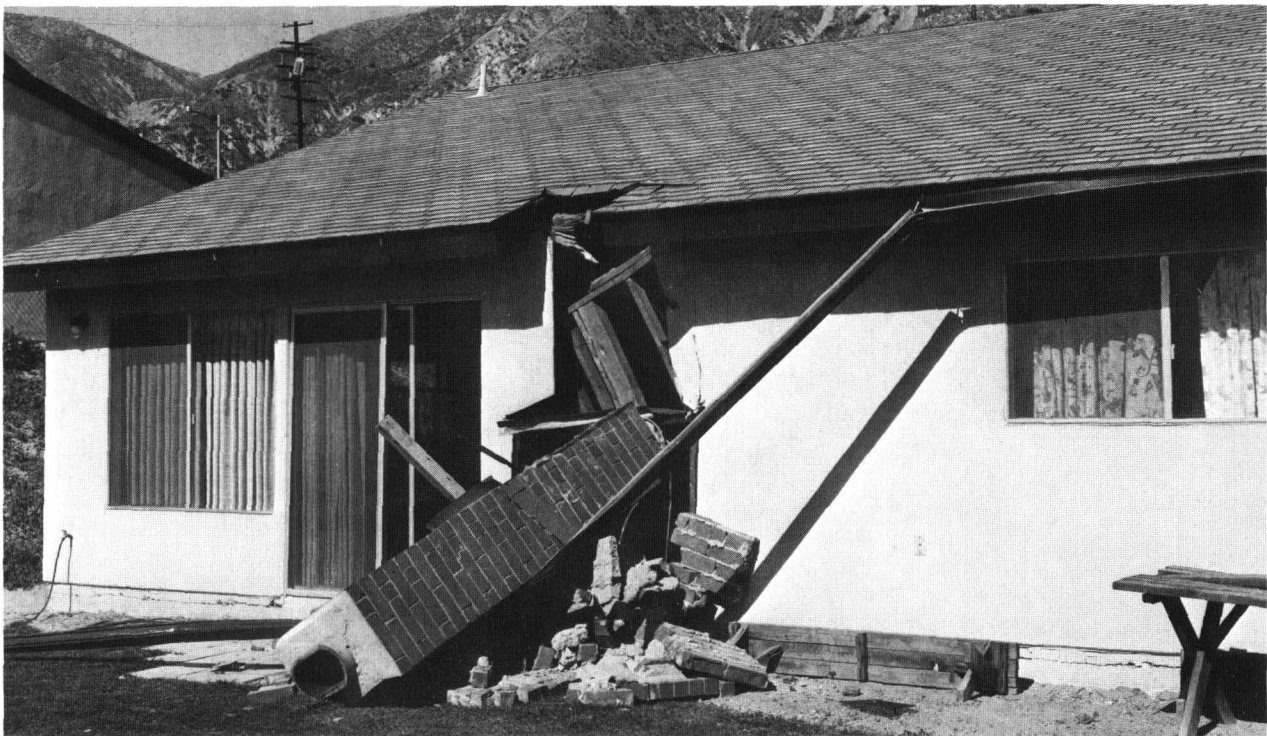
FIGURE 4.—Typical masonry fireplace damage. Los Angeles City Department of Building and Safety photograph.

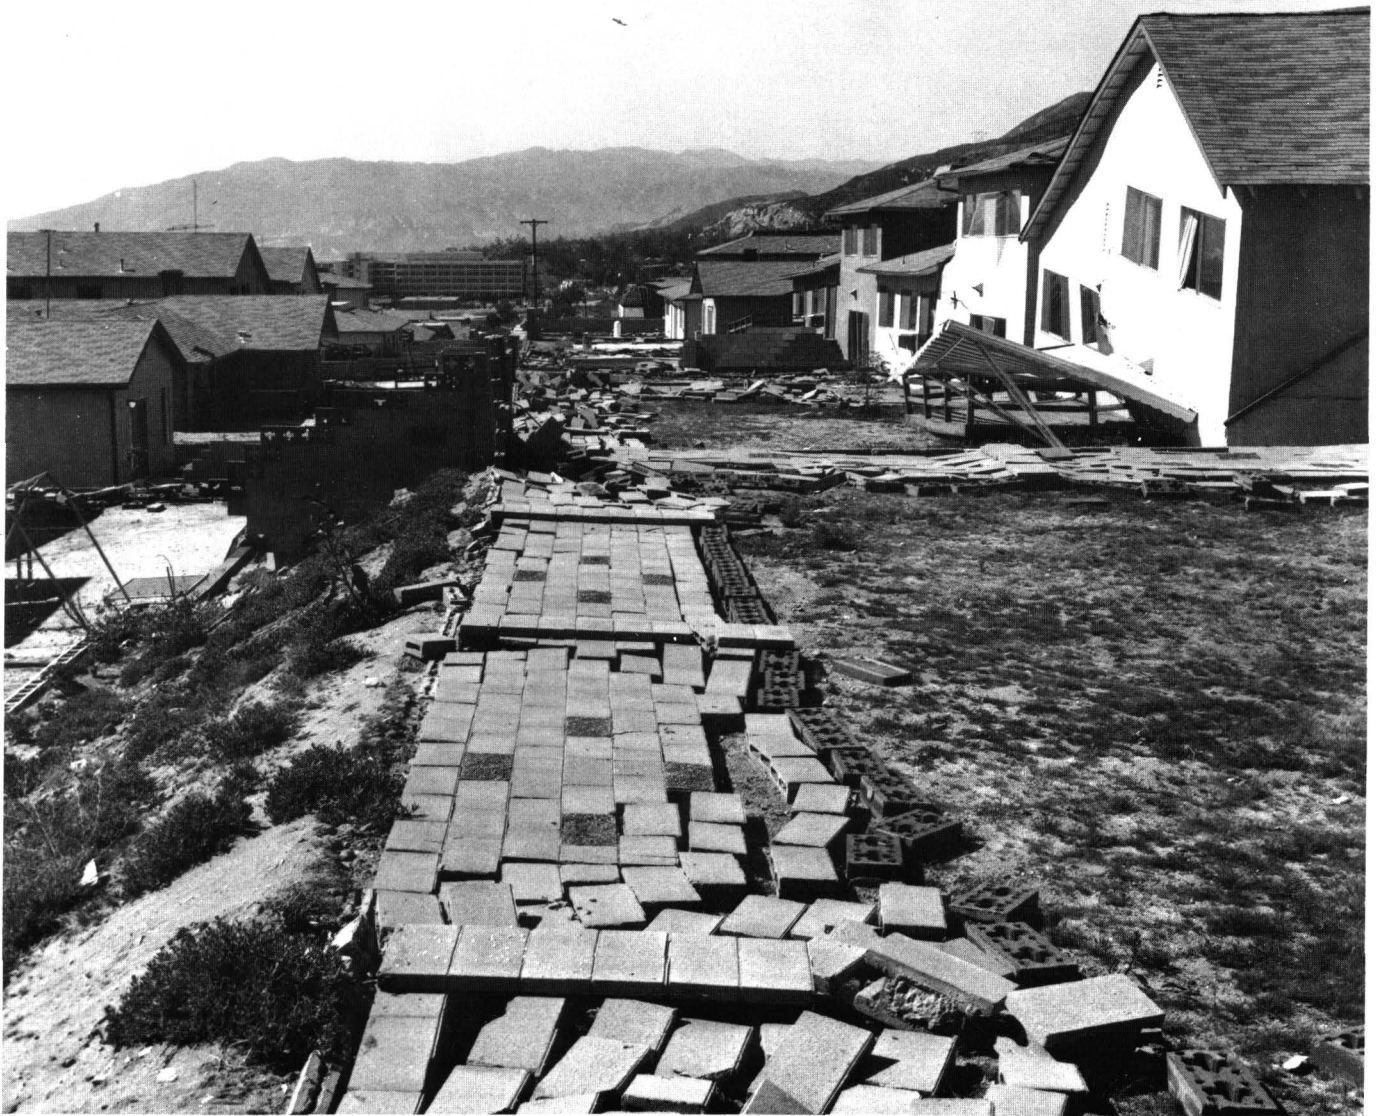
FIGURE 5.—Typical concrete block masonry garden walls thrown down. Los Angeles City Department of Building and Safety photograph.

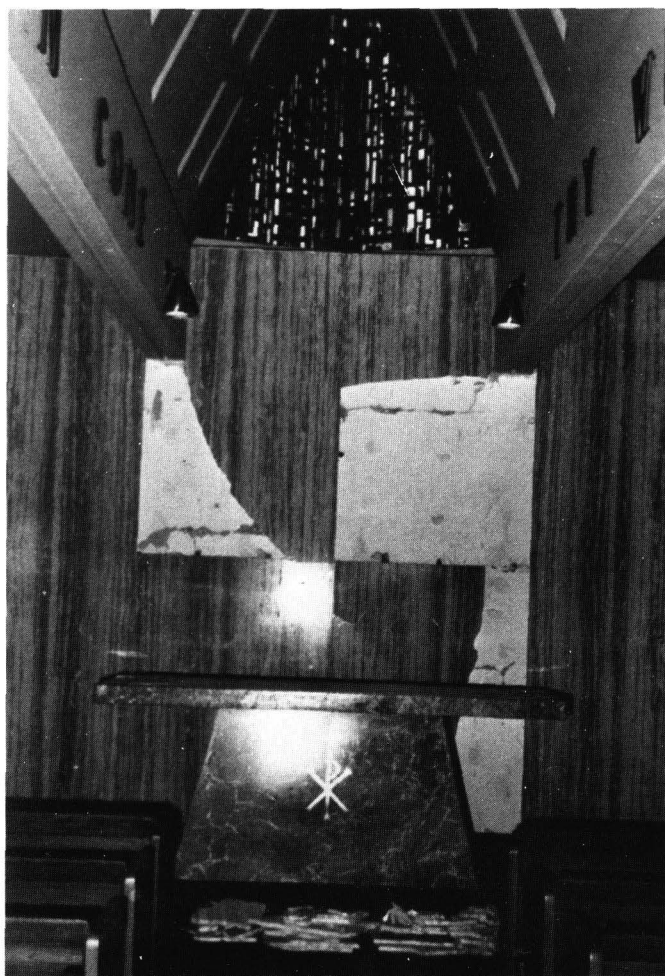
FIGURE 5.—Holy Cross Chapel. Marble veneer fell from wall. J. M. Ayres, photograph.

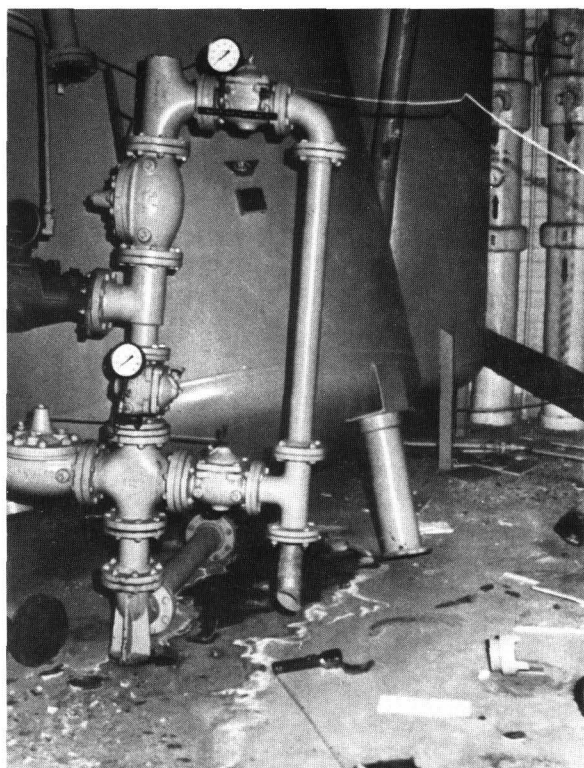
FIGURE 10.—Olive View Power Plant. Water softeners collapsed when screwed pipe legs failed. J. M. Ayres, photograph.

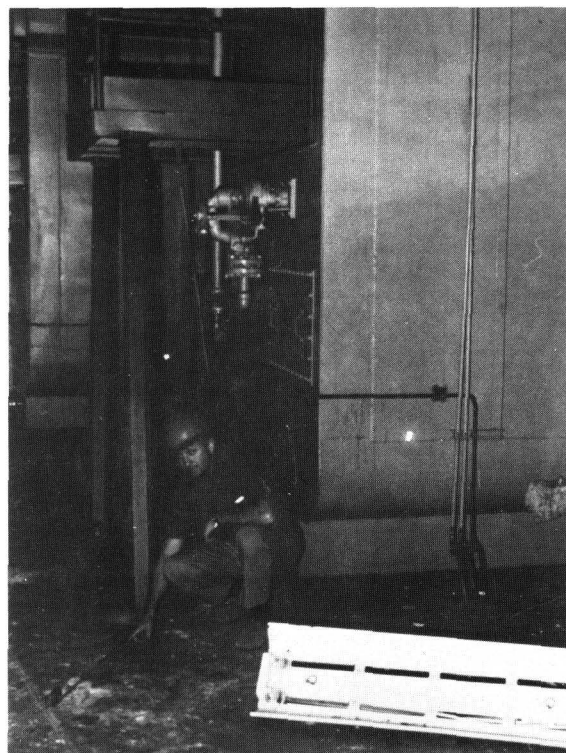
FIGURE 12.—Olive View Power Plant. Boilers shifted  $3\frac{1}{2}$  feet. J. M. Ayres, photograph.

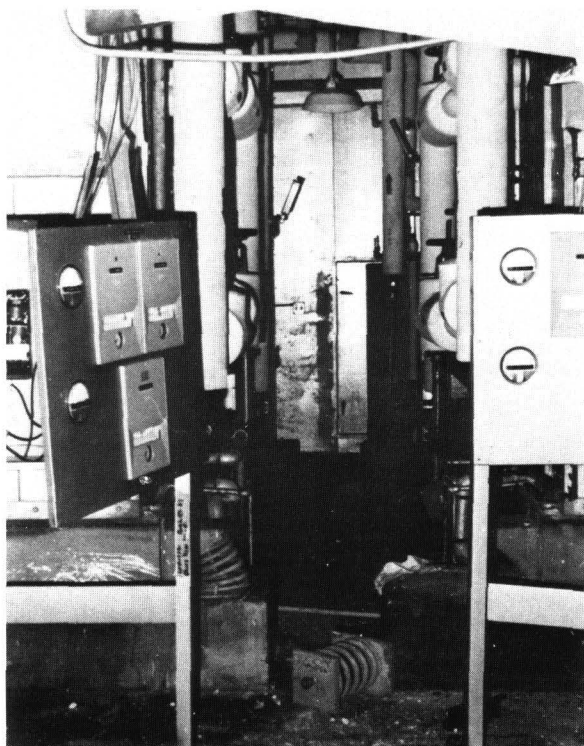
FIGURE 11.—Olive View Hospital. Large central-station air-conditioning systems moved off their vibration-isolation spring mounts. J. M. Ayres, photograph.

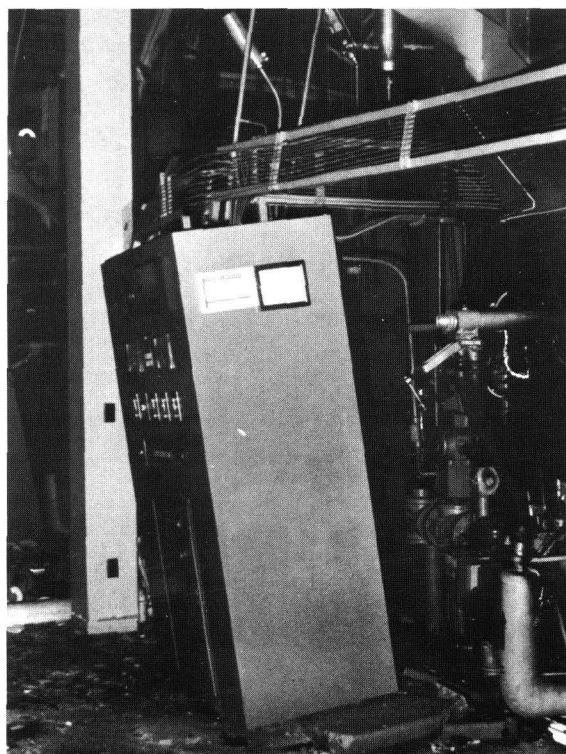
FIGURE 13.—Olive View Power Plant. Boiler control panels tilted and held up by tubing and conduits. J. M. Ayres, photograph.

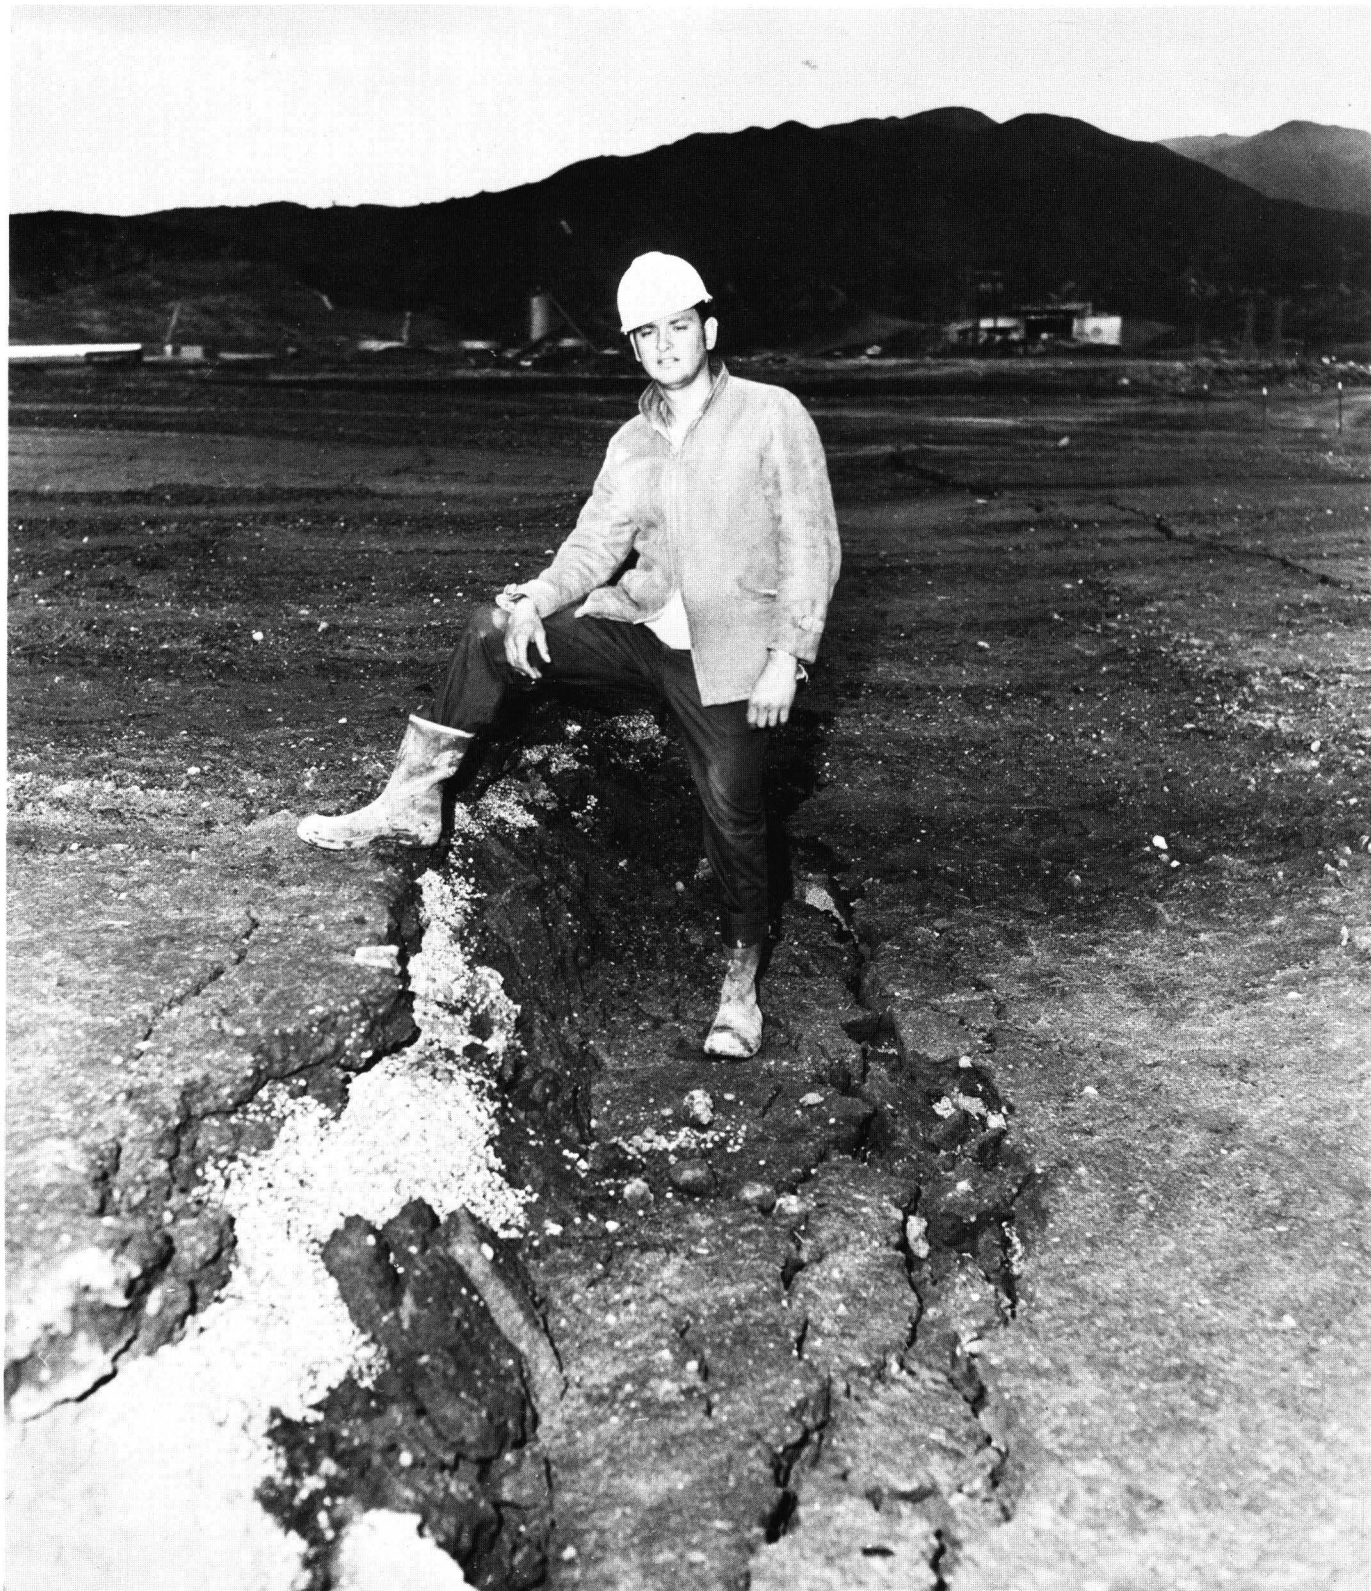
FIGURE 4.—Metropolitan Water District, Joseph Jensen Filtration Plant. Looking north along the east perimeter of the finished water reservoir showing cracks in the compacted fill adjacent to the reservoir. MWD photograph.
