# THE SAN FERNANDO, CALIFORNIA, EARTHQUAKE OF FEBRUARY 9, 1971:

*A preliminary report published jointly by the U.S. Geological Survey  
and the National Oceanic and Atmospheric Administration*

GEOLOGICAL SURVEY PROFESSIONAL PAPER 733

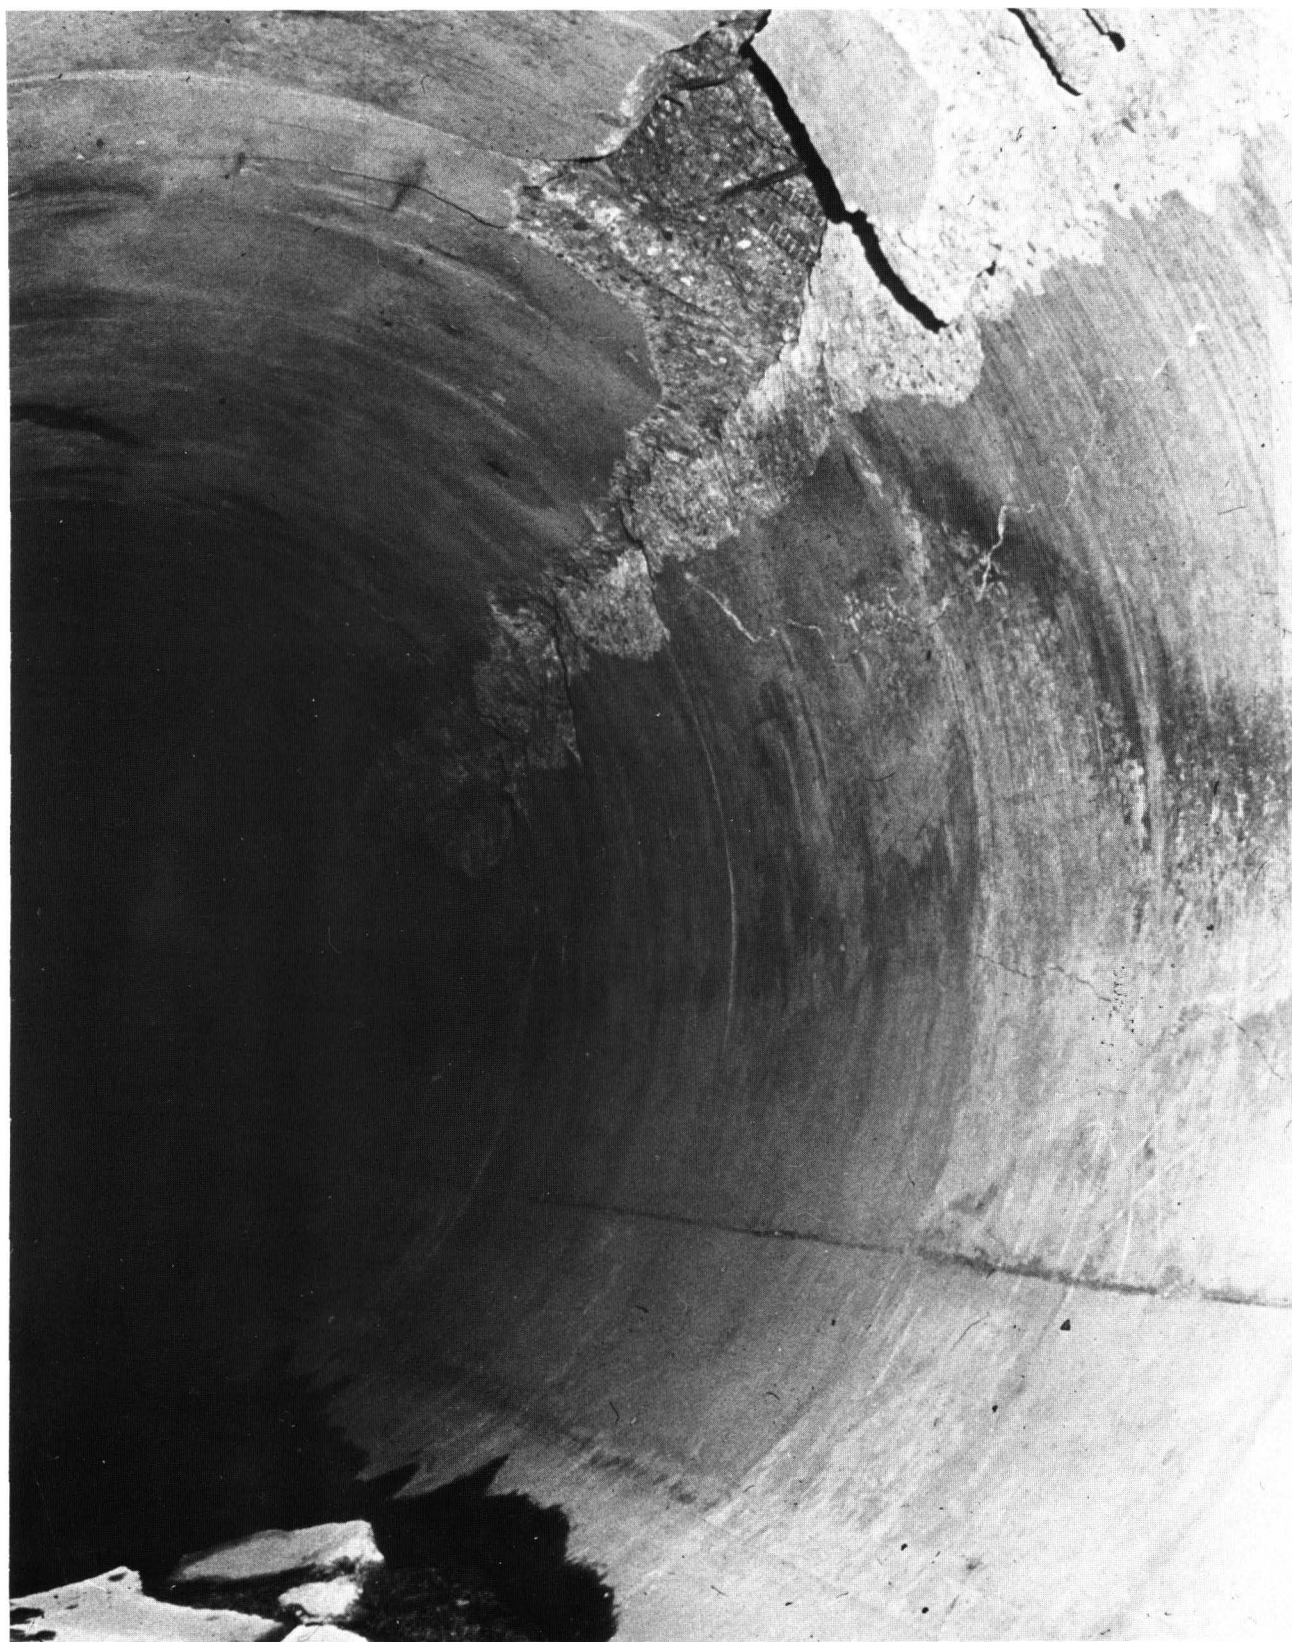
FIGURE 6.—Metropolitan Water District, Balboa Inlet Tunnel. View from inside the tunnel approximately 1600 feet from the south portal showing damage to the tunnel lining. MWD photograph.

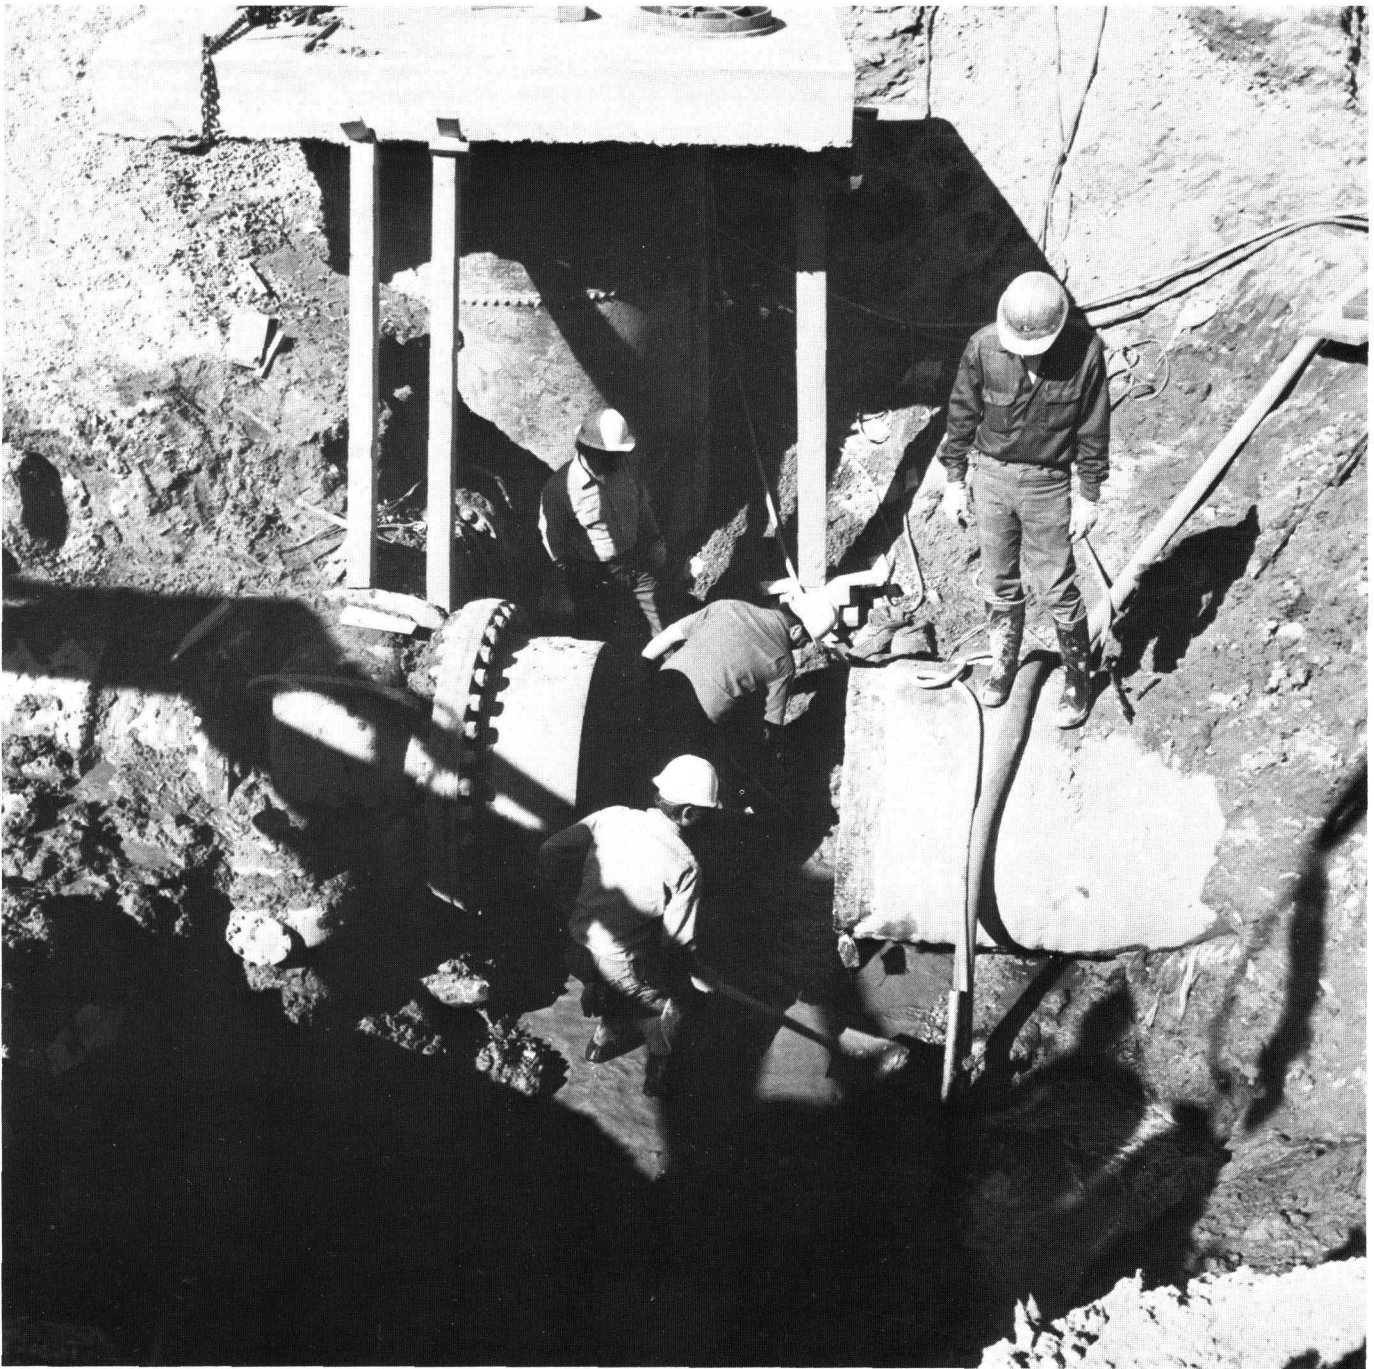
FIGURE 7.—Water trunk line break under repair. DWP photograph.

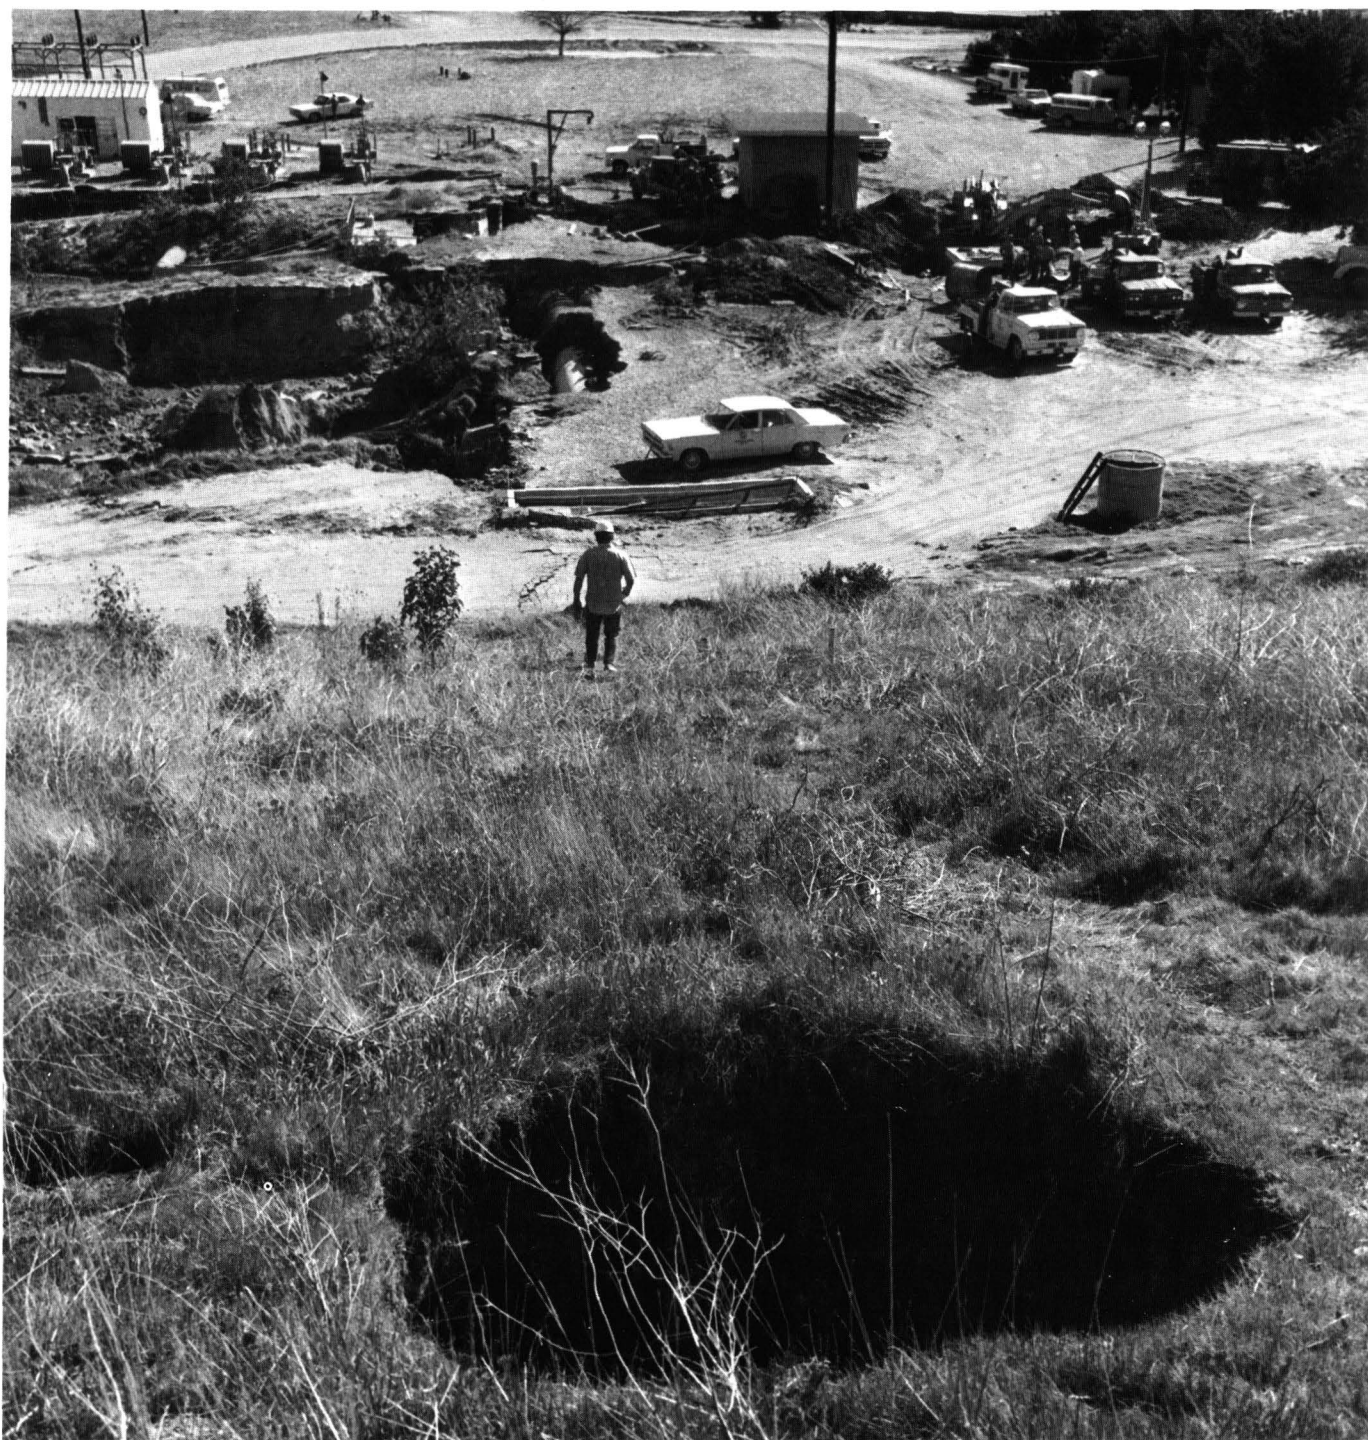
FIGURE 8.—Looking downstream from the berm of Upper San Fernando Dam. Sink hole in foreground. DWP photograph.

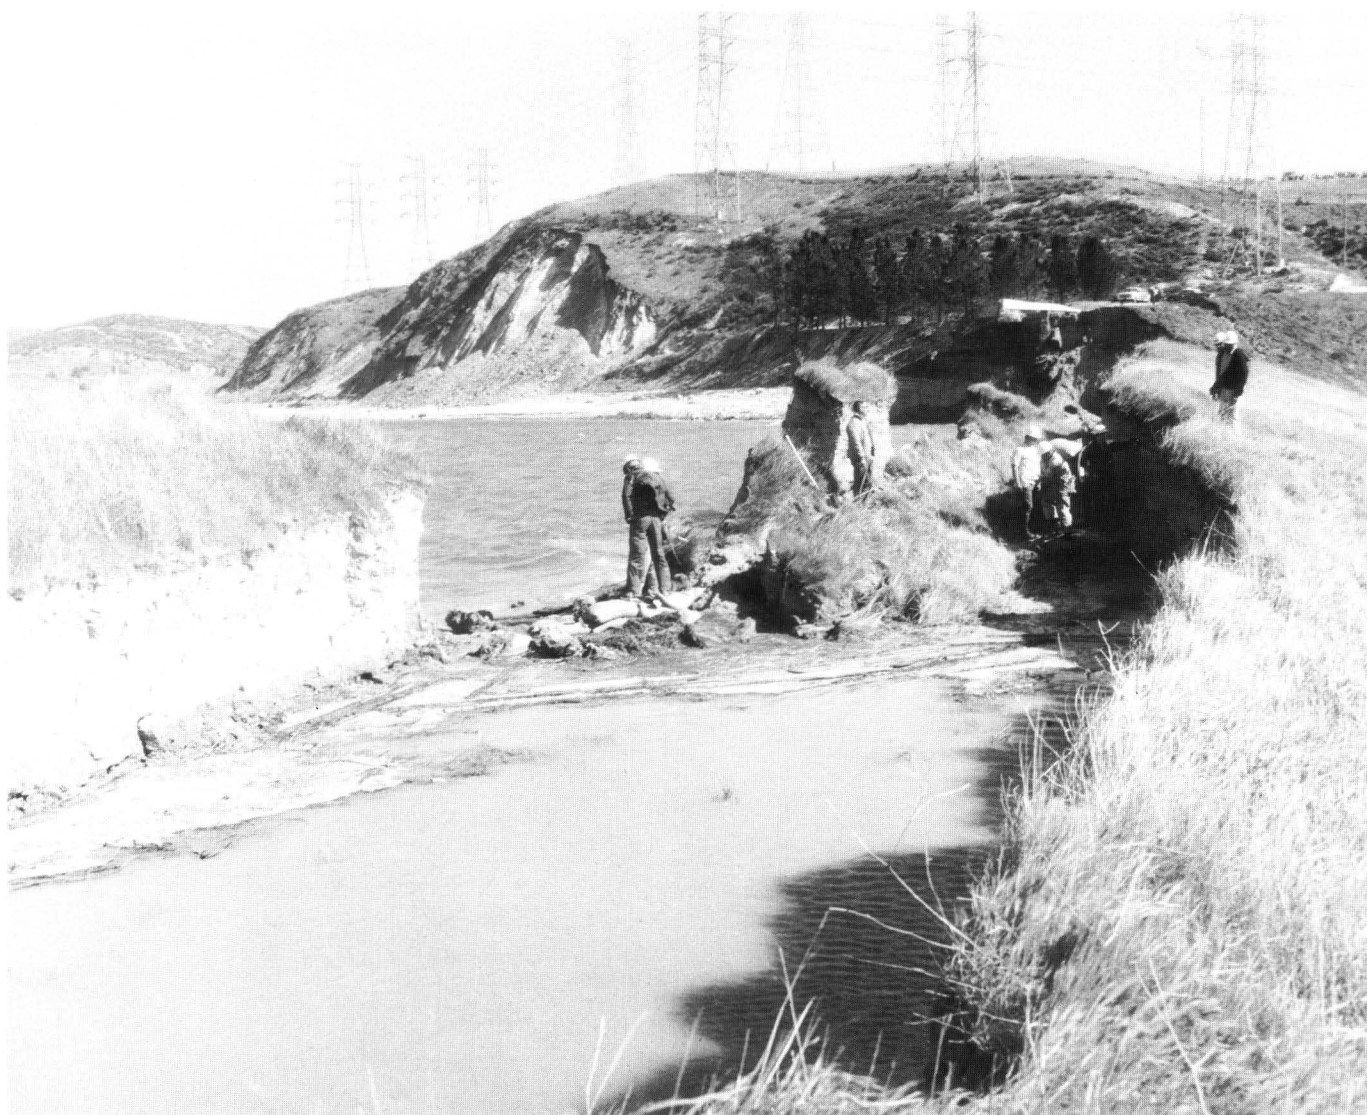
FIGURE 11.—Lower San Fernando Dam, lowest point in dam after failure. February 9, 1971. DWP photograph by Max Gould.

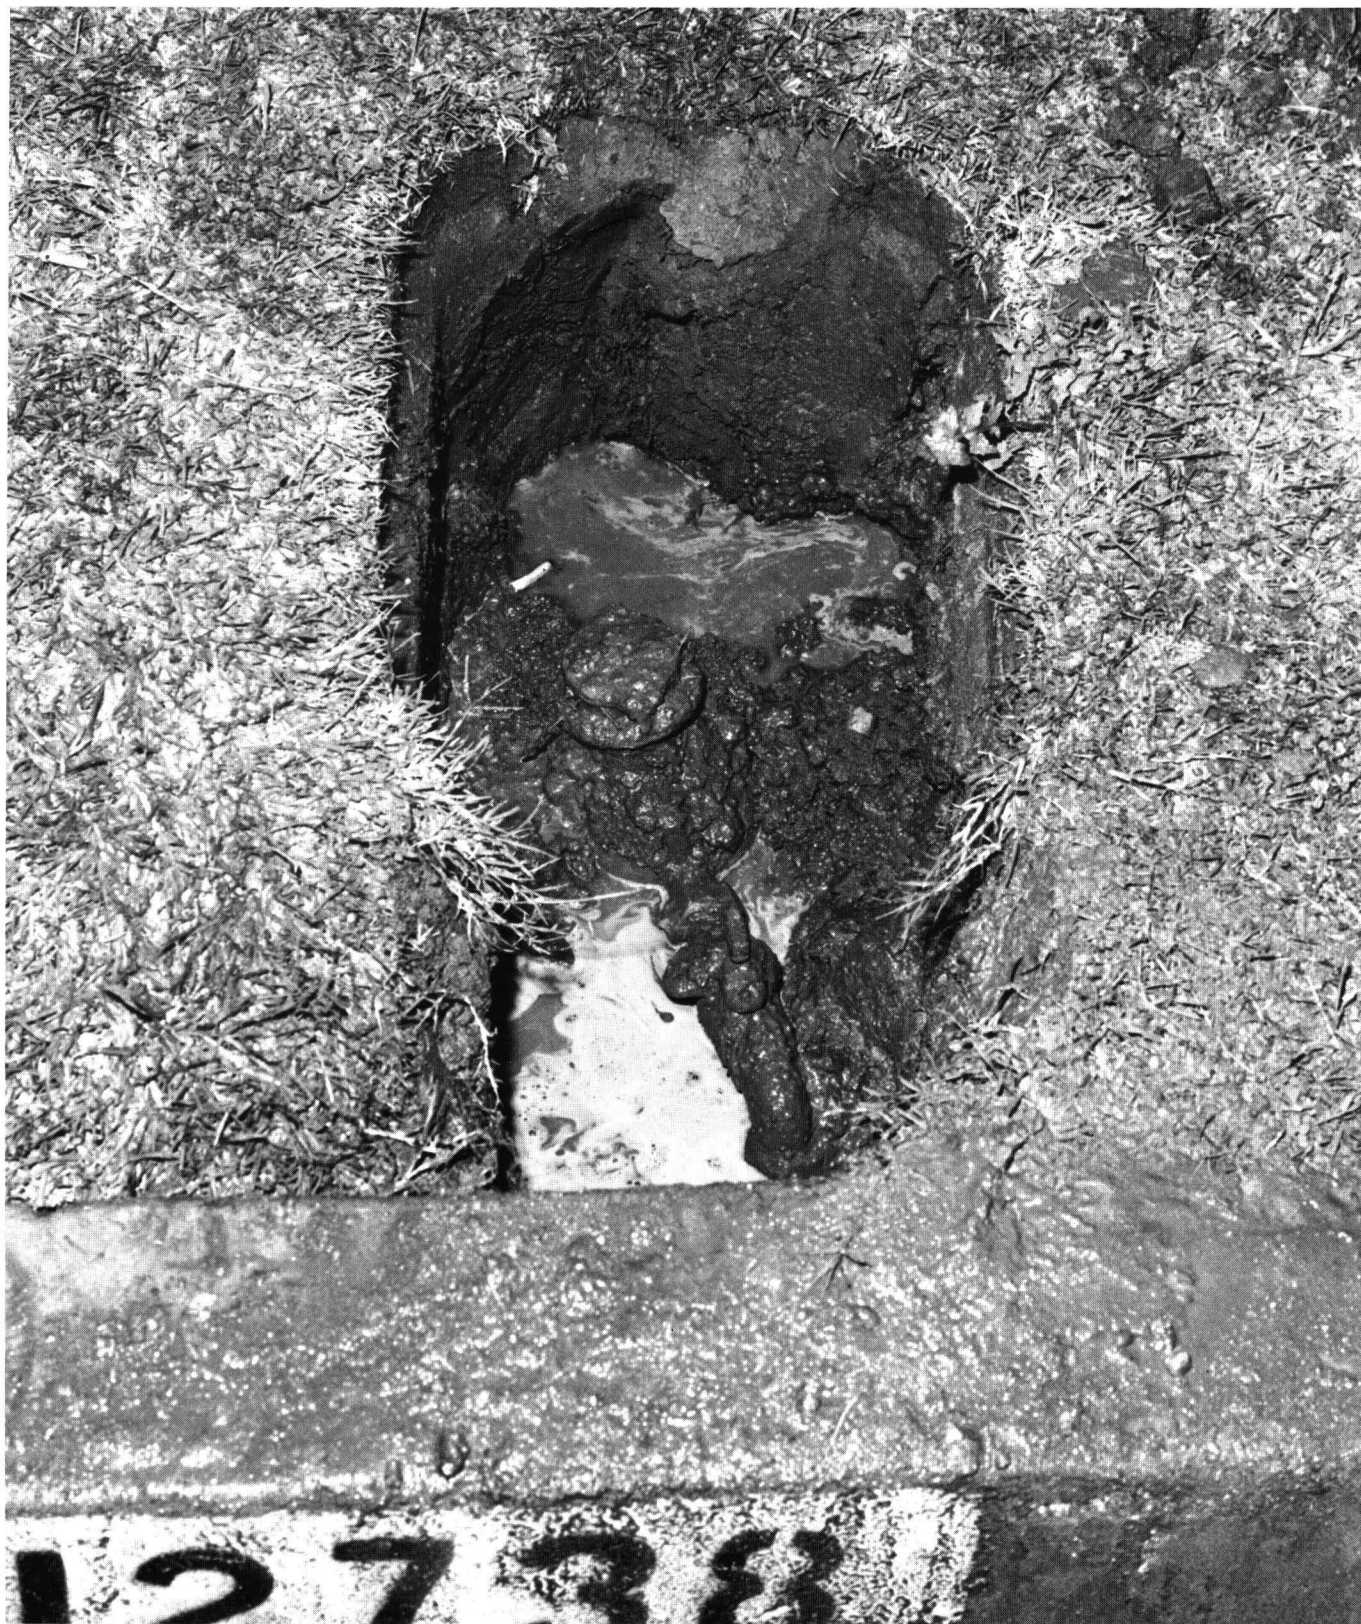
FIGURE 12.—Residential water meter exhibiting leakage. DWP photograph by Roy Collins.

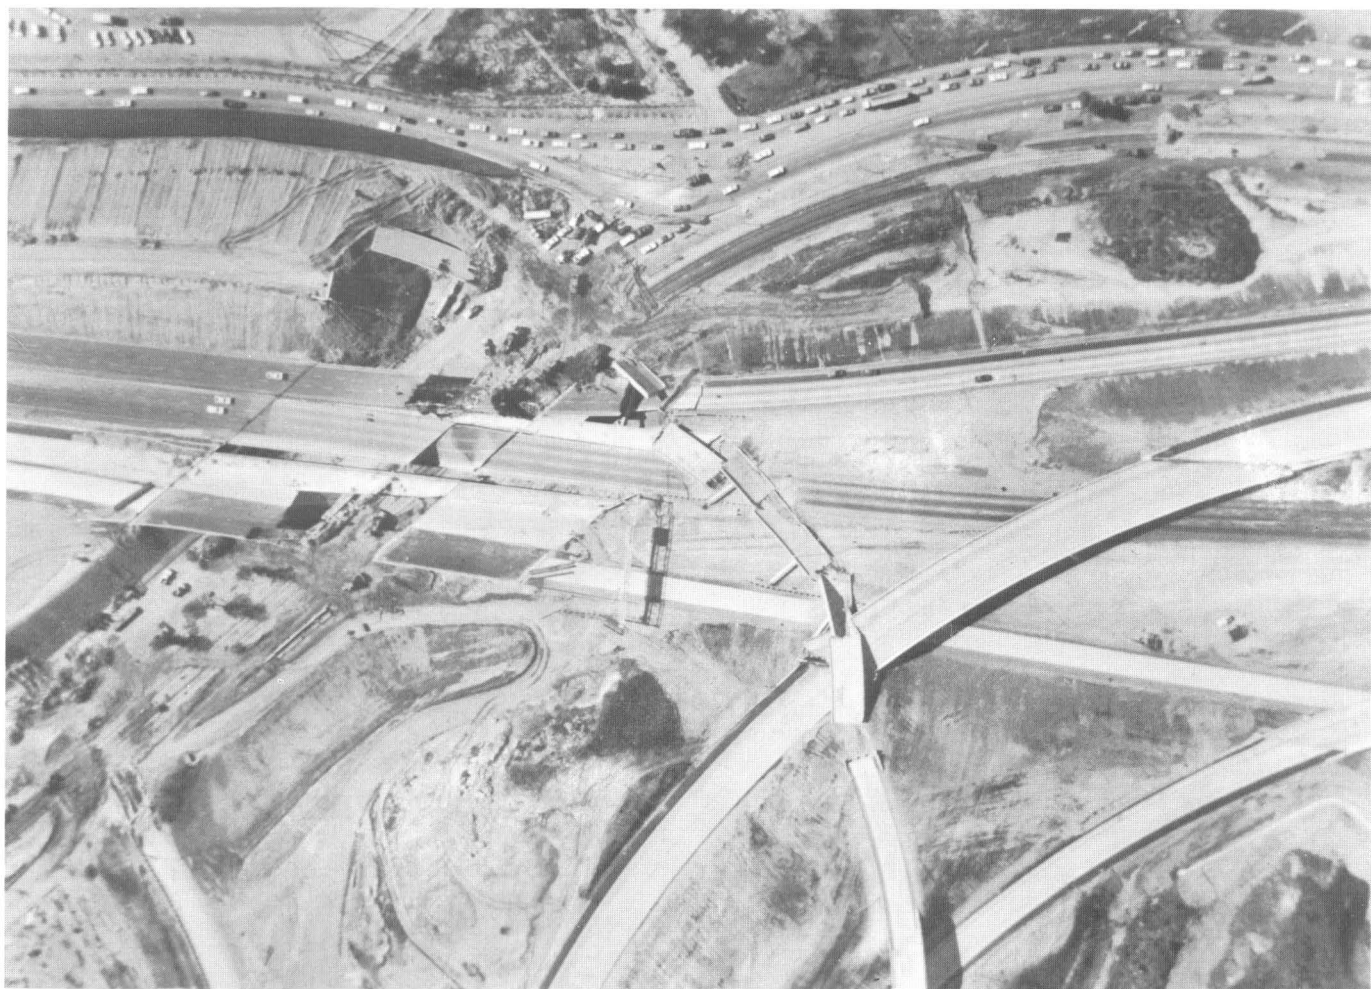
FIGURE 1.—Interchange at Route 5/210. Looking west. Overpass and bridge collapses. California Division of Highways photograph.
