Geologic and Seismologic Aspects of the  
Managua, Nicaragua, Earthquakes of  
December 23, 1972

GEOLOGICAL SURVEY PROFESSIONAL PAPER 838

By R. D. Brown, Jr., P. L. Ward, and George Plafker

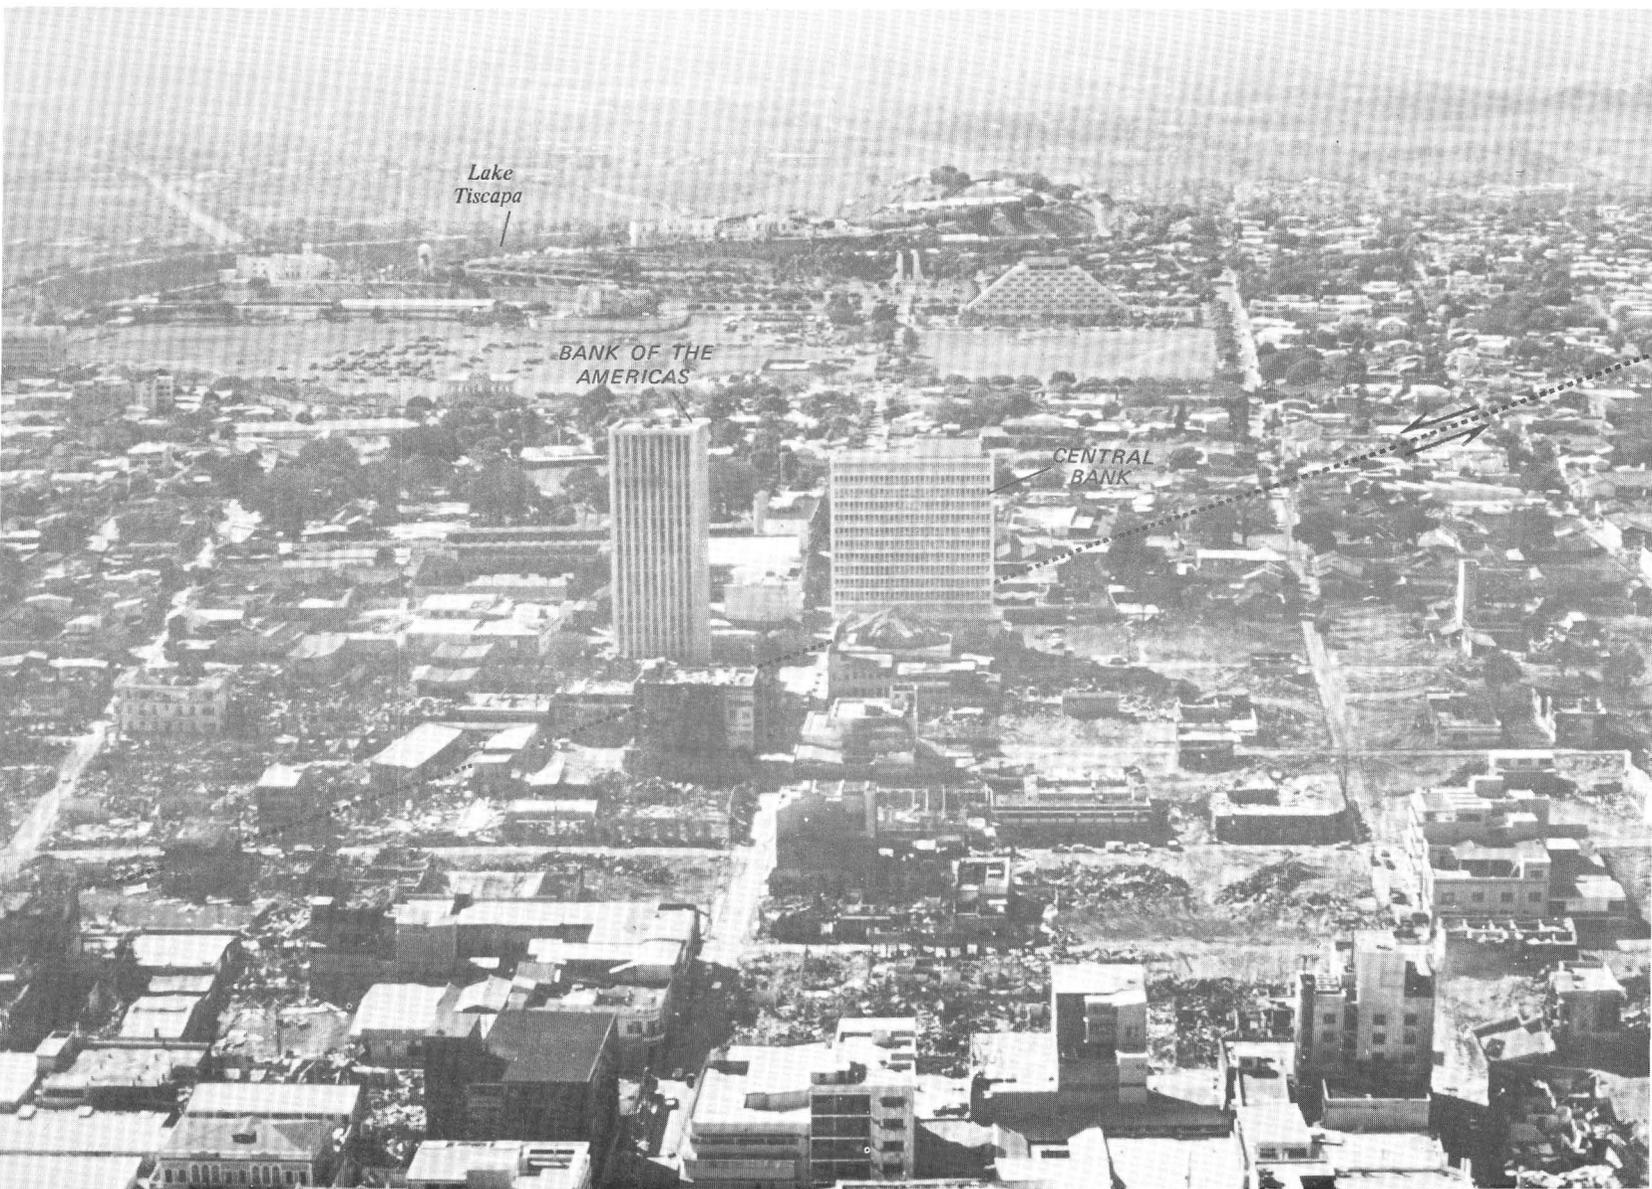
Air view of central Managua looking south. Fault D passes obliquely across photograph and through the Central Bank which is heavily damaged. The adjacent Bank of the Americas is essentially undamaged. Many of the smaller structures that remain standing are badly damaged and will be razed. Extensive open areas in foreground are where structures have collapsed due to the earthquake and (or) fire. Much of the debris was already cleared away in the right foreground.

part by foundation displacement. (See frontispiece.) In contrast, the adjacent 16-story Bank of the Americas (Banco de Americas) building, which is off the fault zone, sustained less severe earthquake damage.

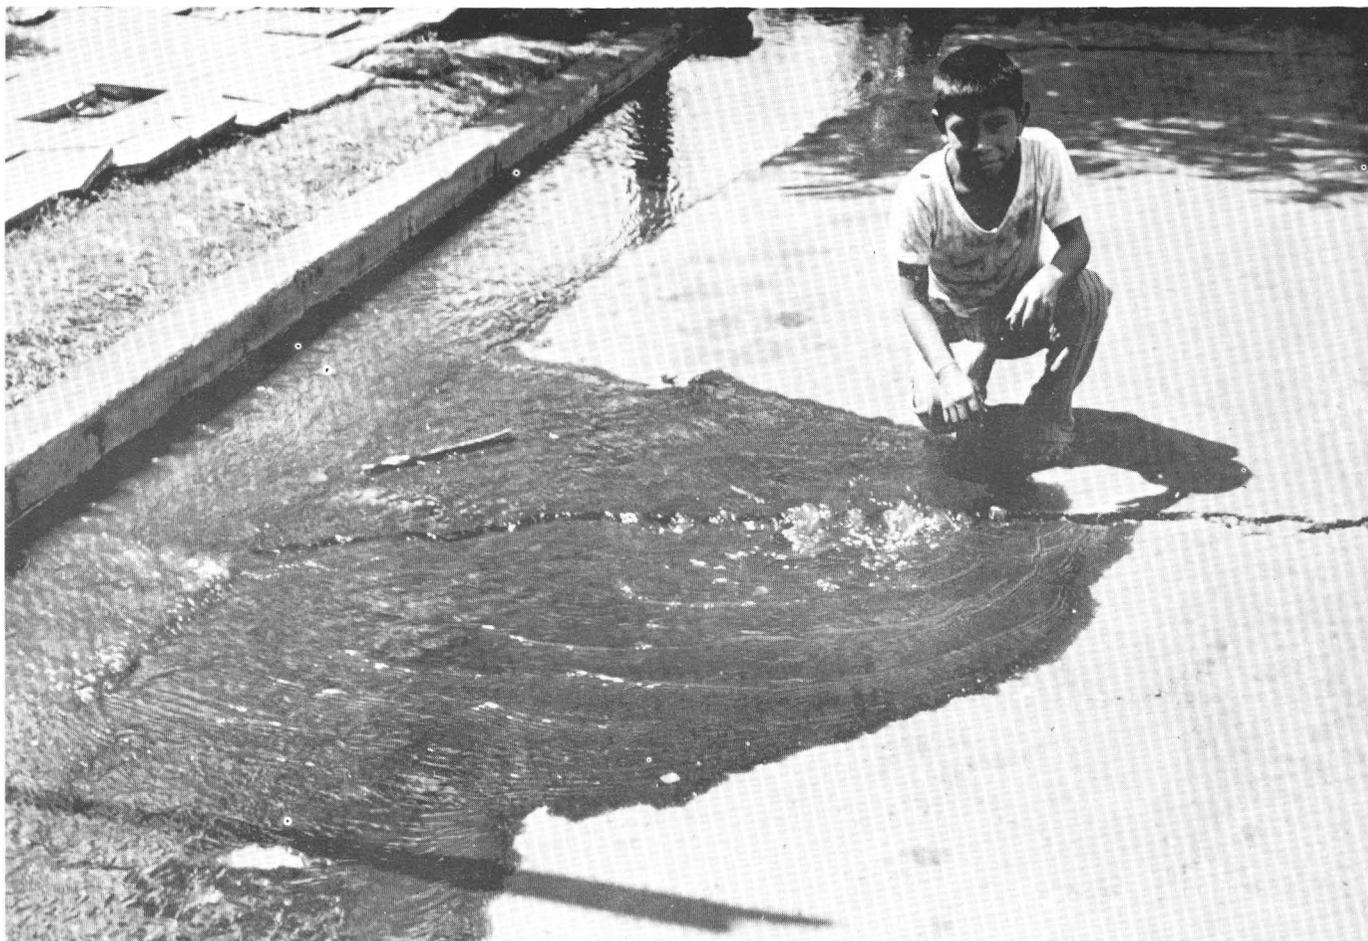
FIGURE 2.—One of many flowing waterline breaks along earthquake fractures. (Located on fault B, sta. 40, pl. 1.)

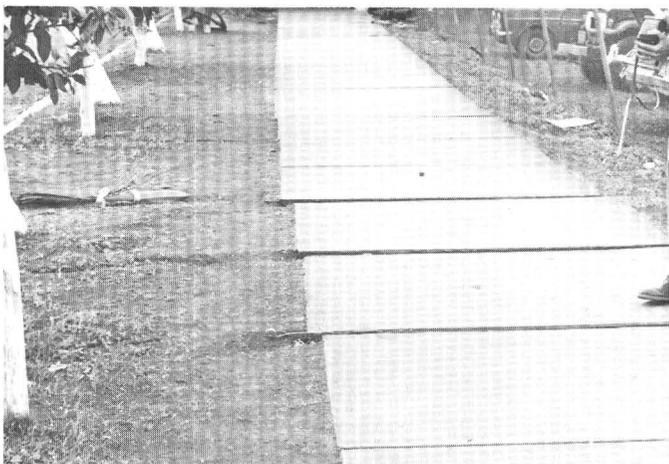
FIGURE 3.—Displaced sidewalk blocks at fault C along north side of Pan American Highway (sta. 2, pl. 1). Aggregate displacement across zone 12 m wide here is 28.6 cm sinistral and 17.0 cm extensional.

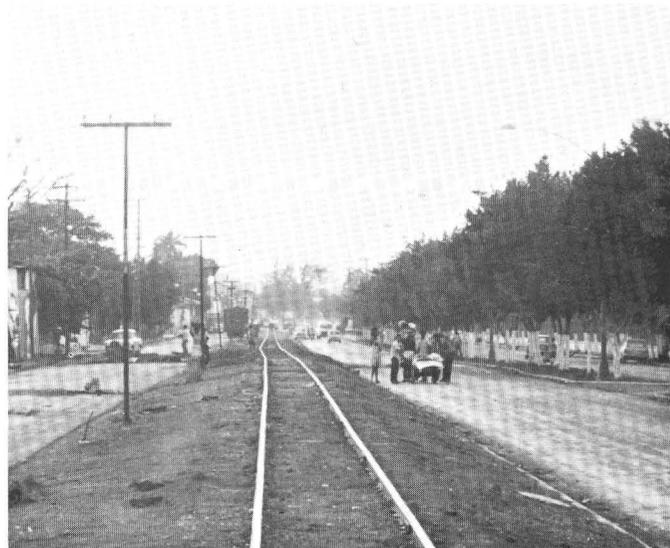
FIGURE 4.—Sinistral offset in railroad lines where it is crossed by fault C (near sta. 63, pl. 1). Rails had already been straightened somewhat before this photograph was taken.

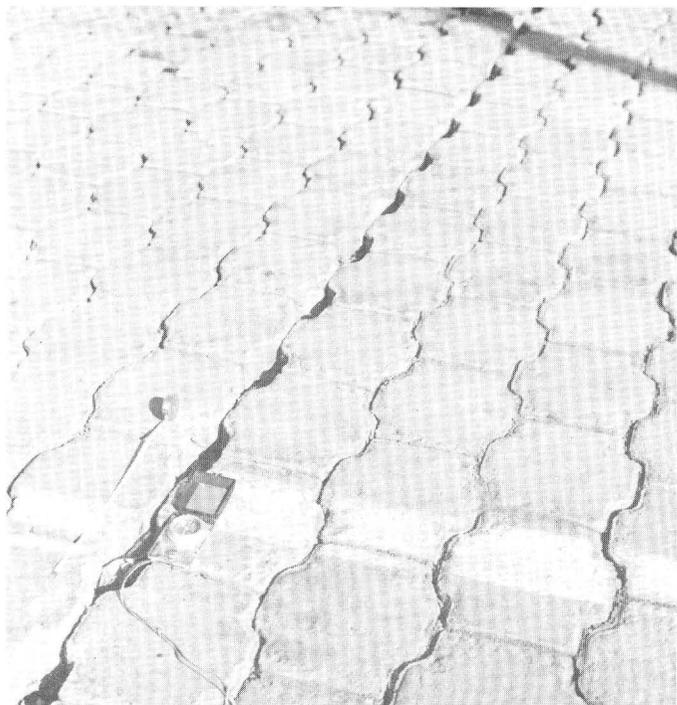
FIGURE 5.—Fault displacement in gas station pavement along fault B. Sinistral offset of line is 12.7 cm; absence of scraping along edges of offset interlocking concrete tiles indicates that strike-slip motion occurred after tiles pulled apart about 6.4 cm.

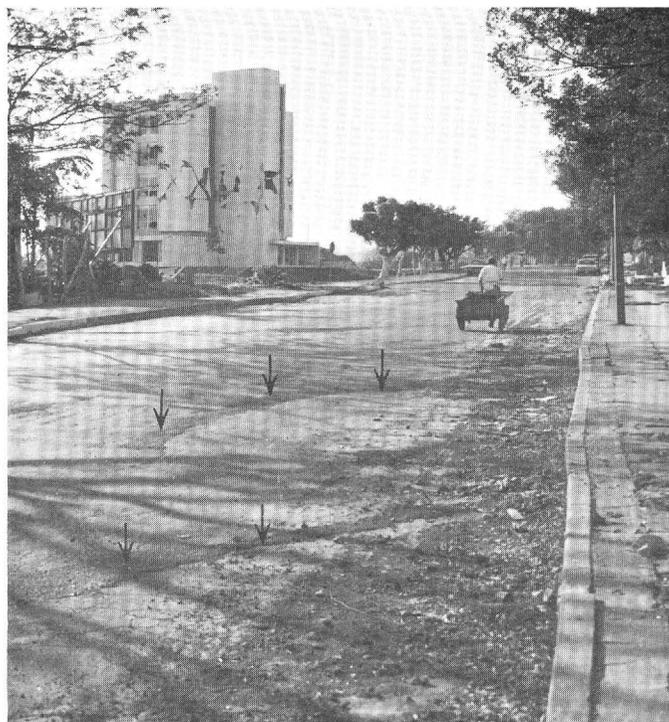
FIGURE 6.—Sinistral offset of street and curb on fault C near U.S. Embassy (view towards south, sta. 80, pl. 1). Measured aggregate displacement is 27.9 cm across a zone more than 49 m wide. Note asphalt-patched fractures in street and severe "shear" cracking in five-story office building.

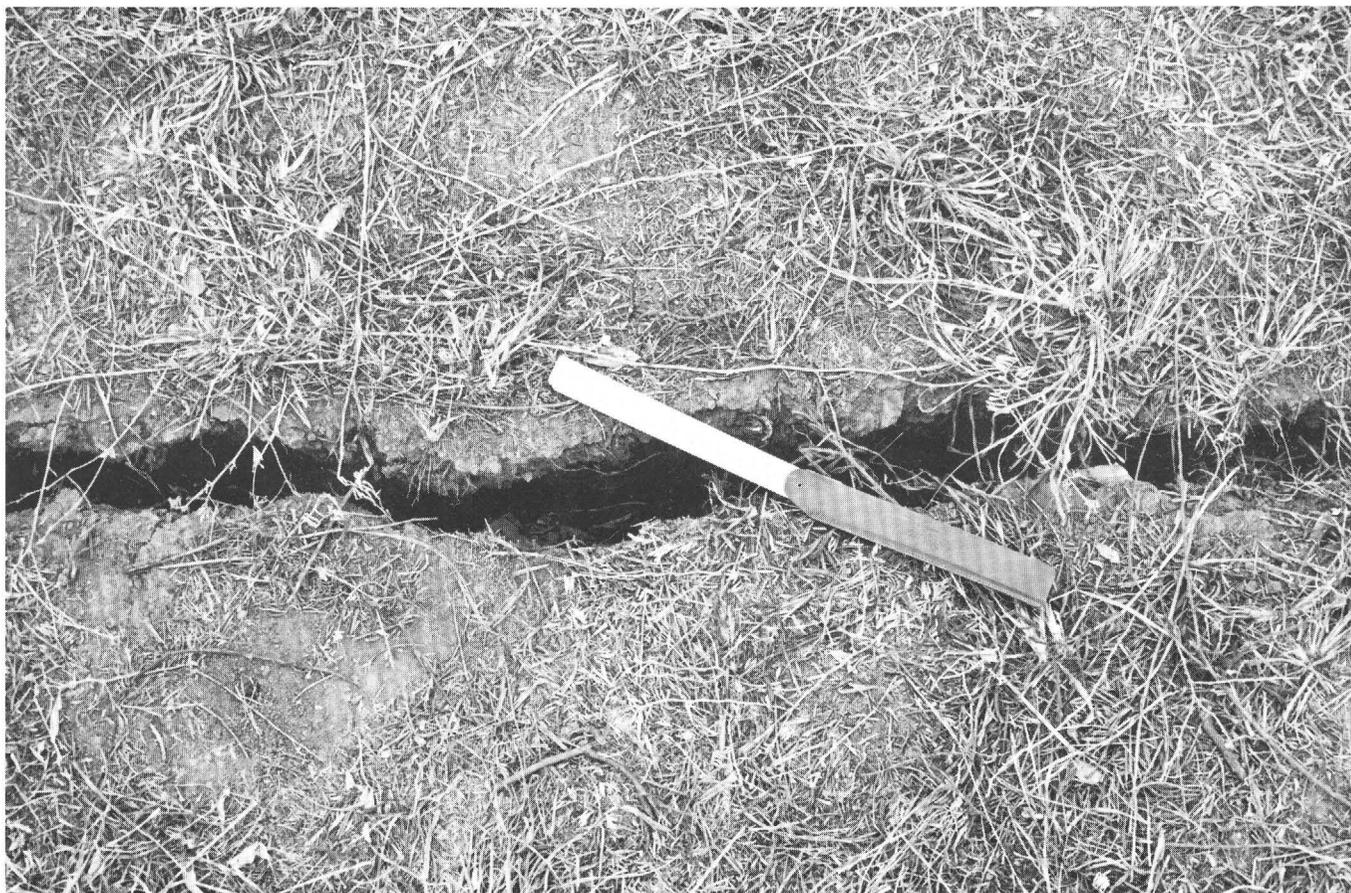
FIGURE 7.—Open fracture along fault C in vacant lot north of U.S. Embassy (sta. 81, pl. 1). Both the fault trend and opening direction on the fracture parallel the ruler. Scale is 15 cm long.

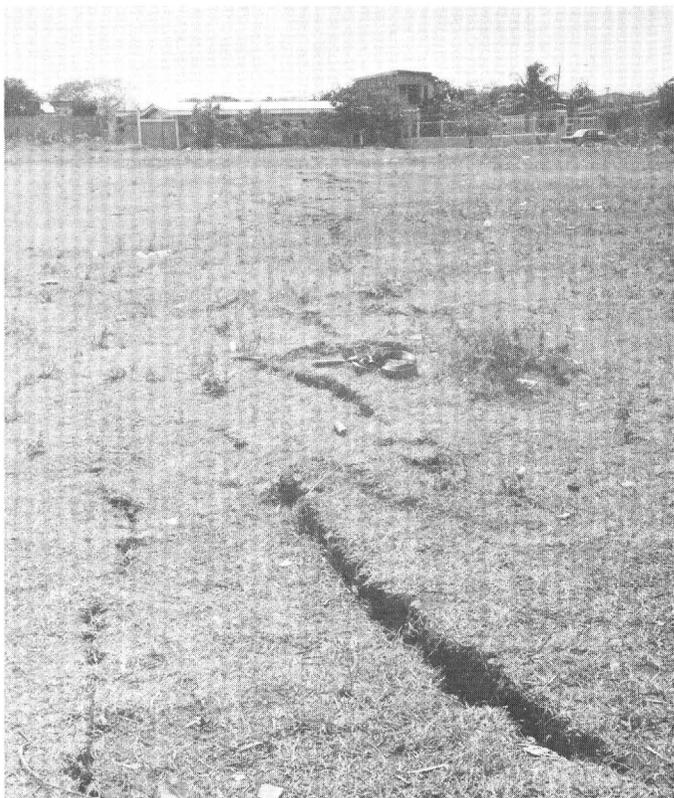
Minor vertical displacements in which the southeast block is relatively downthrown (fig. 8) are evident across the fracture zones or on individual fractures within the zones at a number of localities along faults A, B, and C. Most of the observed vertical displacements are along fault A and the southwestern two-thirds of fault C where there is clear evidence for prior vertical movements in the form

FIGURE 8.—En echelon fractures along fault B (between stas. 42 and 43, pl. 1). There is a down-to-southeast component of vertical displacement on fracture in foreground and a prominent compressional bulge at east-west trending fracture connecting en echelon fractures near the belt and hammer in middle ground.

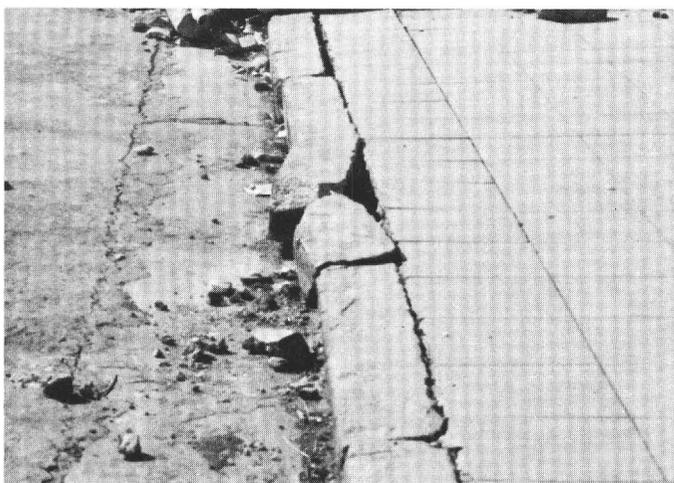
FIGURE 9.—Compressional rupture and lateral buckle of north-south trending curb along fault zone B (near sta. 25, pl. 1).

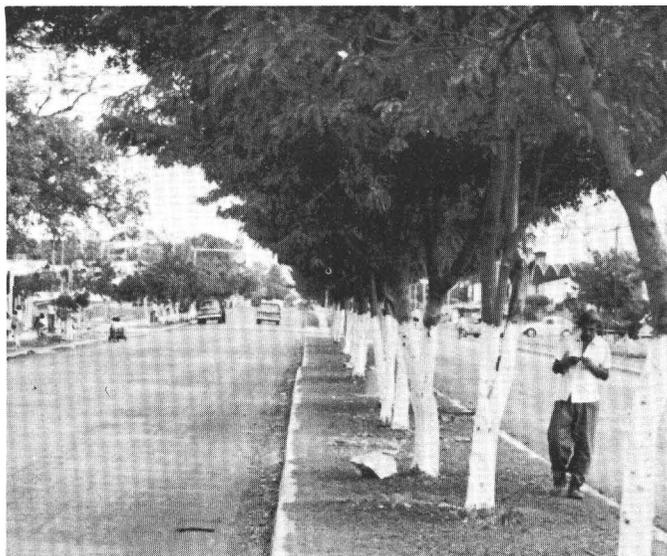
FIGURE 10.—Dextral offset of between 12.7 and 16.5 cm in curb of Pan American Highway between faults B and C (sta. 56, pl. 1).

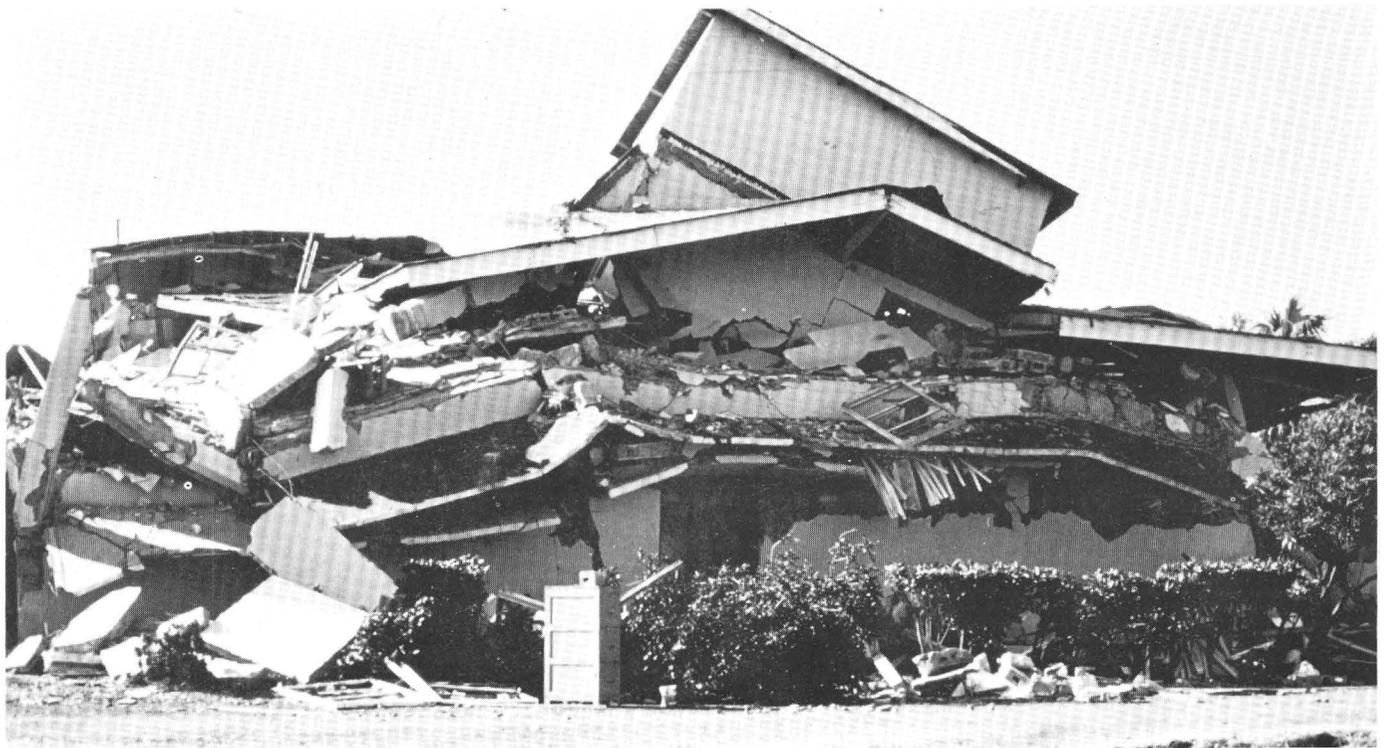
The most obvious localization of damage by faulting is along faults B and C, which had the largest displacement. Heavily damaged reinforced concrete buildings on or close to these faults include the Customs House office building, Baptist Hospital, U.S. Embassy, and Nejapa Country Club (pl. 1). The Customs House office building, a three-story concrete structure astride a segment of fault B that had 25.9 cm sinistral displacement, was the most dramatic failure of the larger structures (fig. 11). Even many of the better constructed residential dwellings along these faults were severely damaged, whereas nearby buildings of identical construction that were subjected only to shaking sustained little or no loss

FIGURE 11.—Collapsed three-story reinforced concrete Customs House office building. This structure is astride fault B at a locality where aggregate sinistral slip is 25.9 cm (near sta. 22, pl. 1).

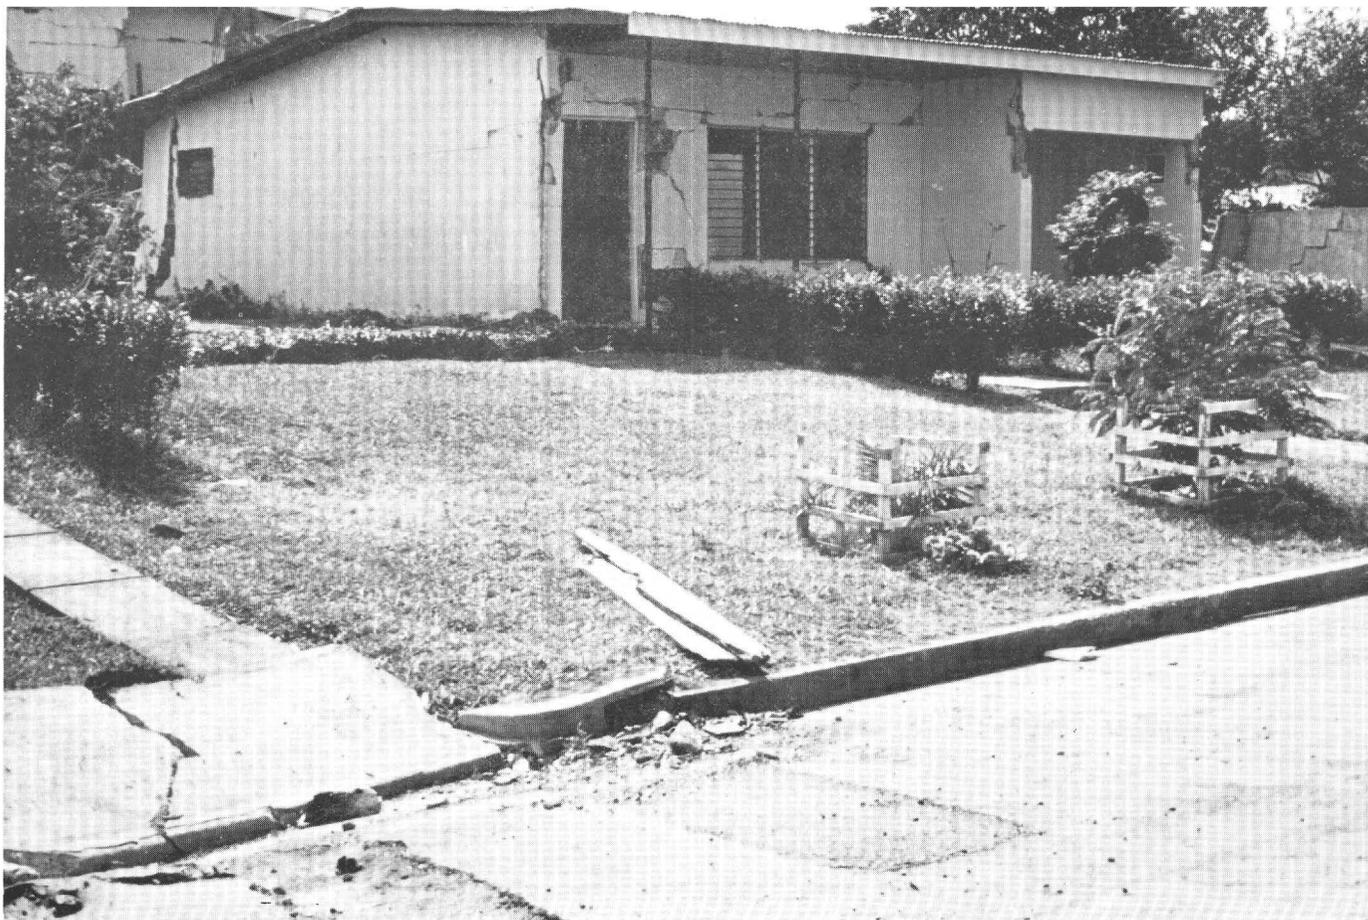
FIGURE 12.—Severely damaged small home on trace of fault B (near sta. 43, pl. 1). Note fractures in street, curb, and driveway. Homes of similar construction in this subdivision that were not on earthquake faults generally had negligible damage.

(figs. 12 and 13). In some areas where structures were mainly unreinforced concrete block or older tarquezal (wood frame and adobe) construction, the fault trace appeared to be marked by a distinct swath of near-total destruction (fig. 14).

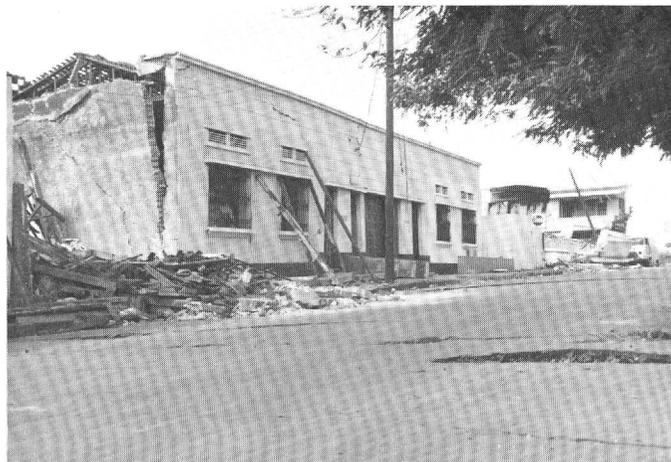
FIGURE 13.—Masonry and wood home damaged by foundation displacement along fault C (sta. 78, pl. 1). Fractures intersect the near half of the house which is in a state of incipient collapse; the part of the house which is off the fault zone is relatively undamaged. Some fractures in the street have a vertical slip component.

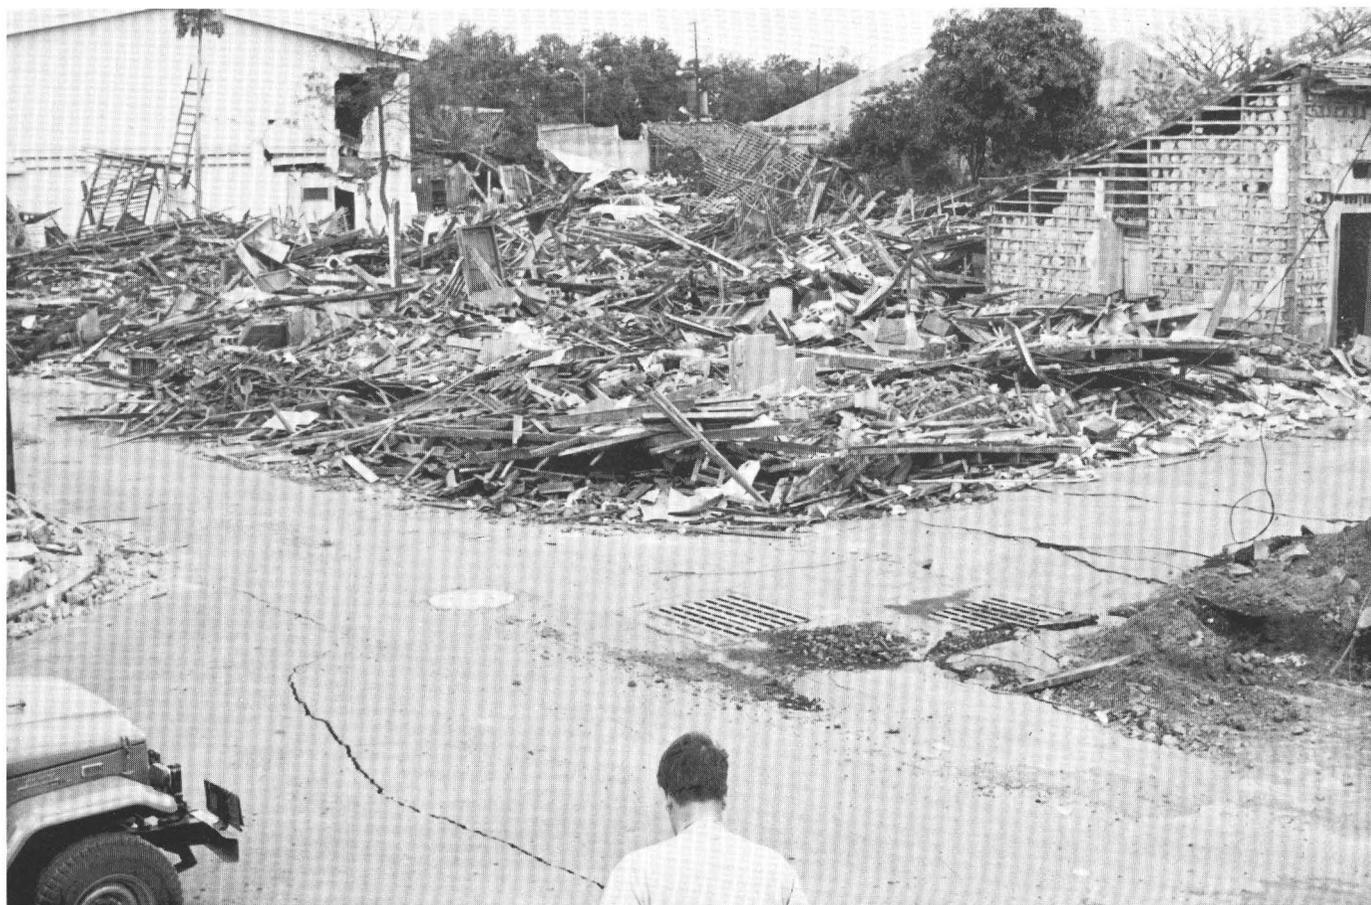
FIGURE 14.—Swath of destroyed buildings along fault C (sta. 64, pl. 1). Fault trace is through center of photograph. Open fractures that trend north-south in street pavement are an echelon to the fault. Structure on the right is typical of tarquezal (wood and adobe) construction that was extensively damaged in the Managua area.

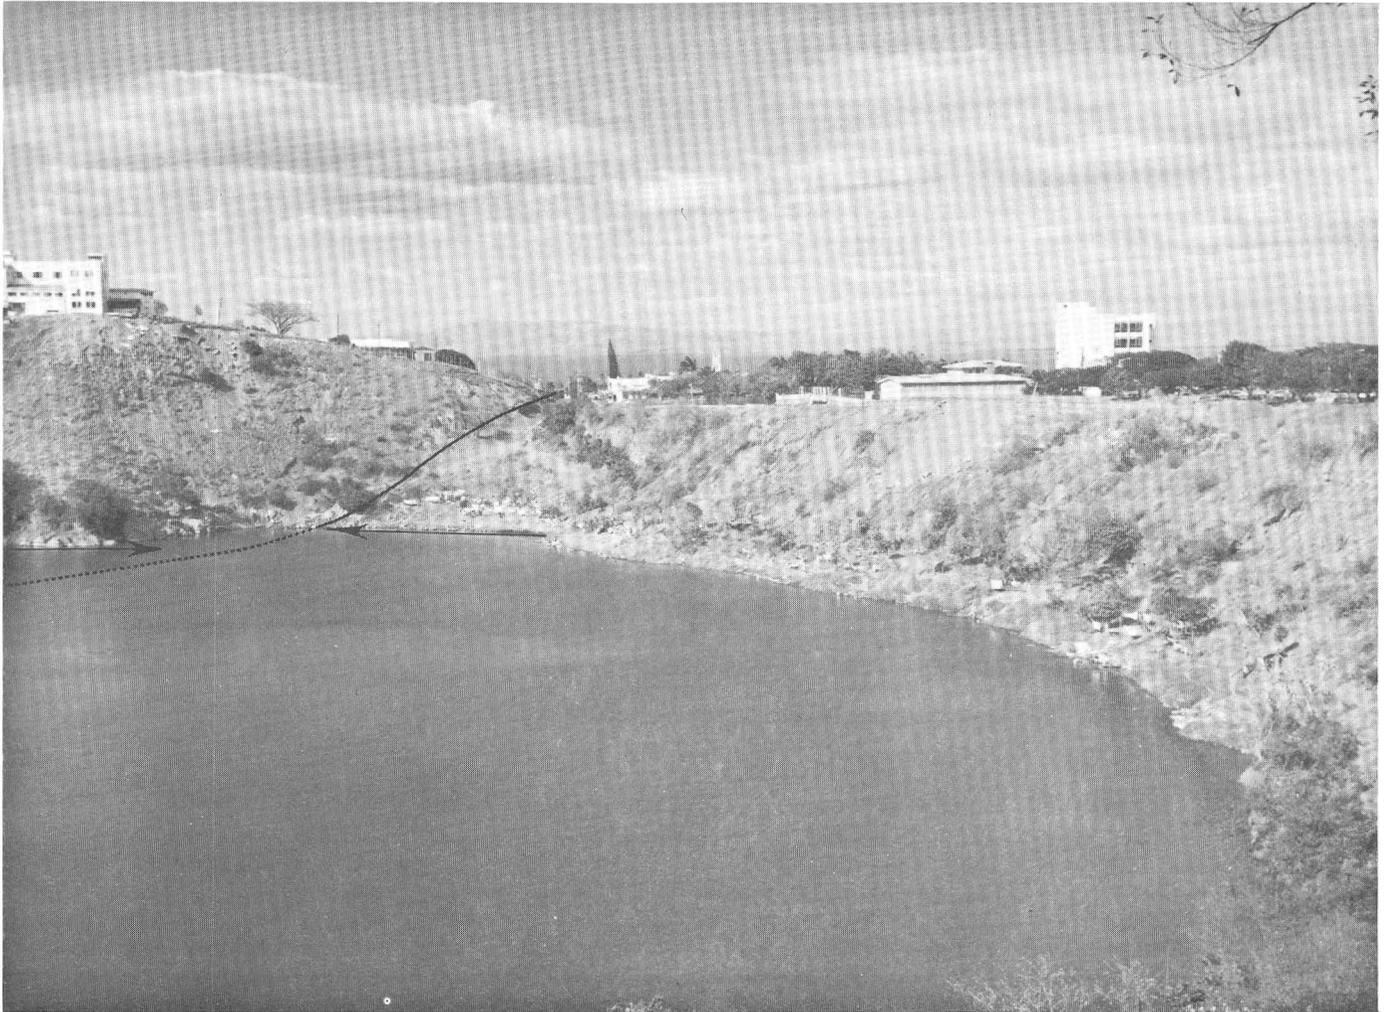
FIGURE 15.—Northeast margin of the Tiscapa pit crater and lake showing approximate trace of fault C along which there is a degraded scarp at the crater rim and 50 m apparent sinistral offset of the lake shore (arrows). The opposite lake shore along the fault trace, which cannot be seen in the photograph, is offset about 40 m in a dextral sense. (Photo taken from a point near sta. 45, pl. 1, looking northward.)

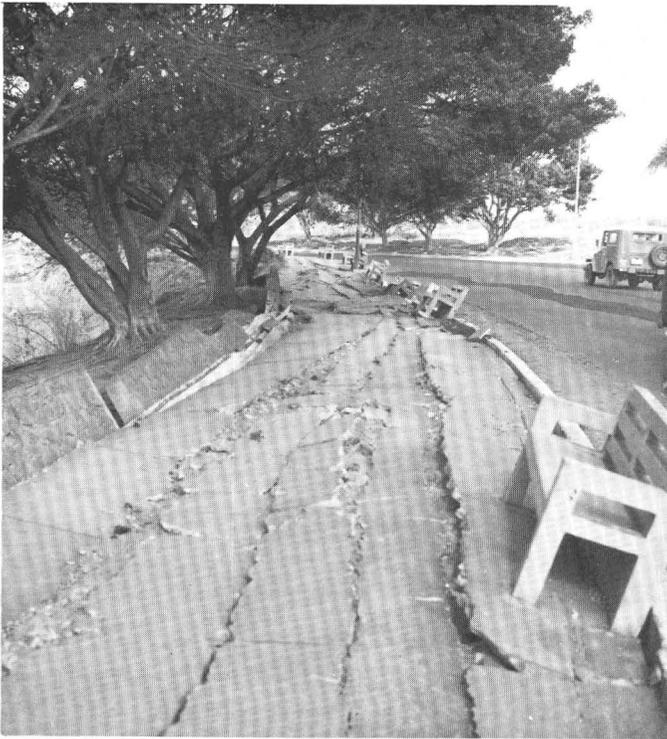
FIGURE 17.—Head of rotational slump along rim of Tiscapa pit crater. Note back-tilted benches and paved headwall cracks in rim road. (Location near sta. 45, pl. 1.)

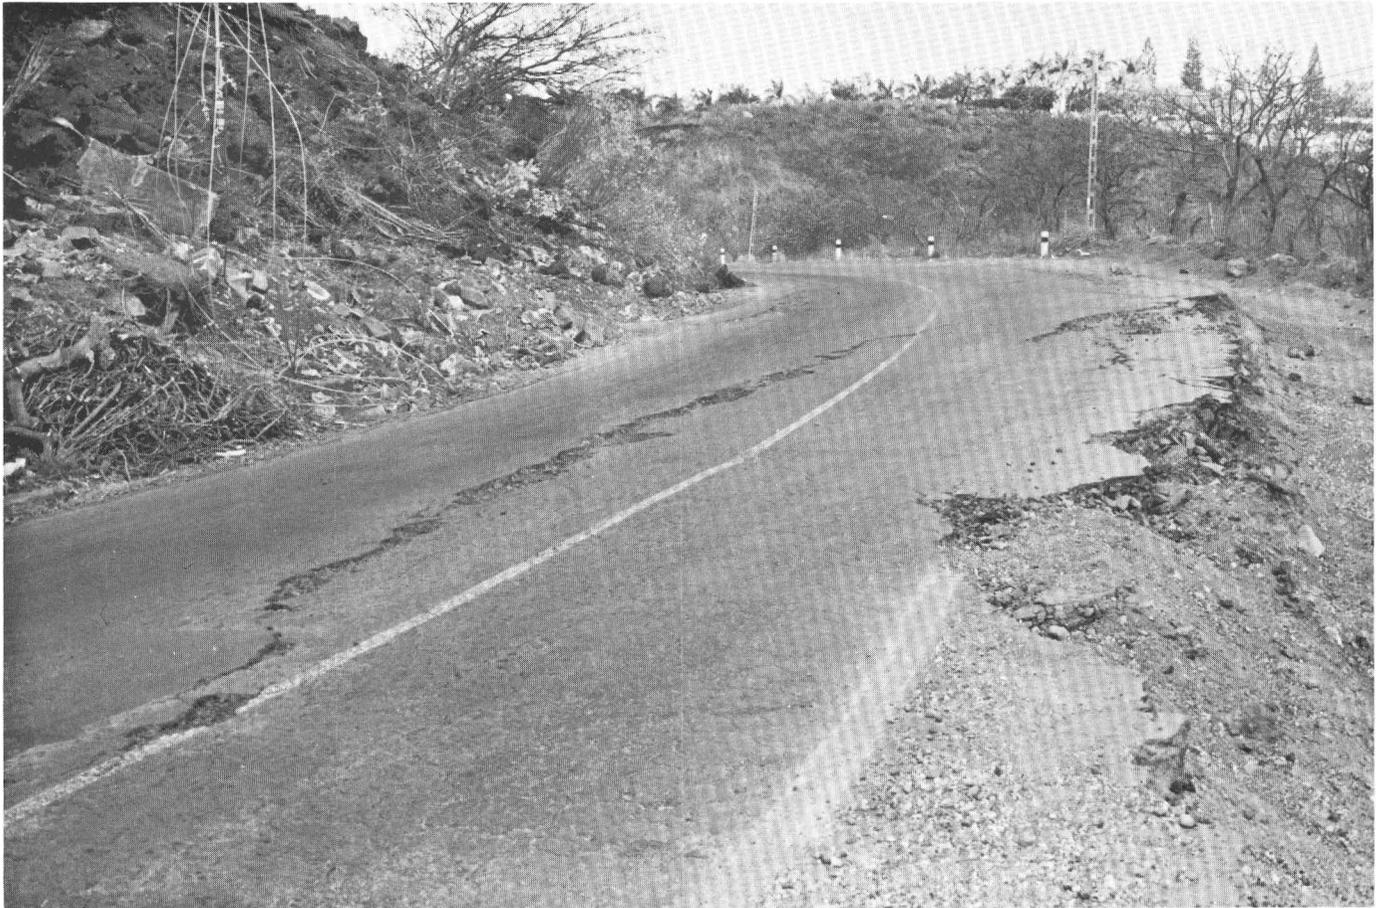
FIGURE 18.—Part of large landslide 55 m wide in highway embankment and cut near km 11 on Highway 2 (León-Managua Highway). This was the largest landslide seen in the earthquake-affected area.

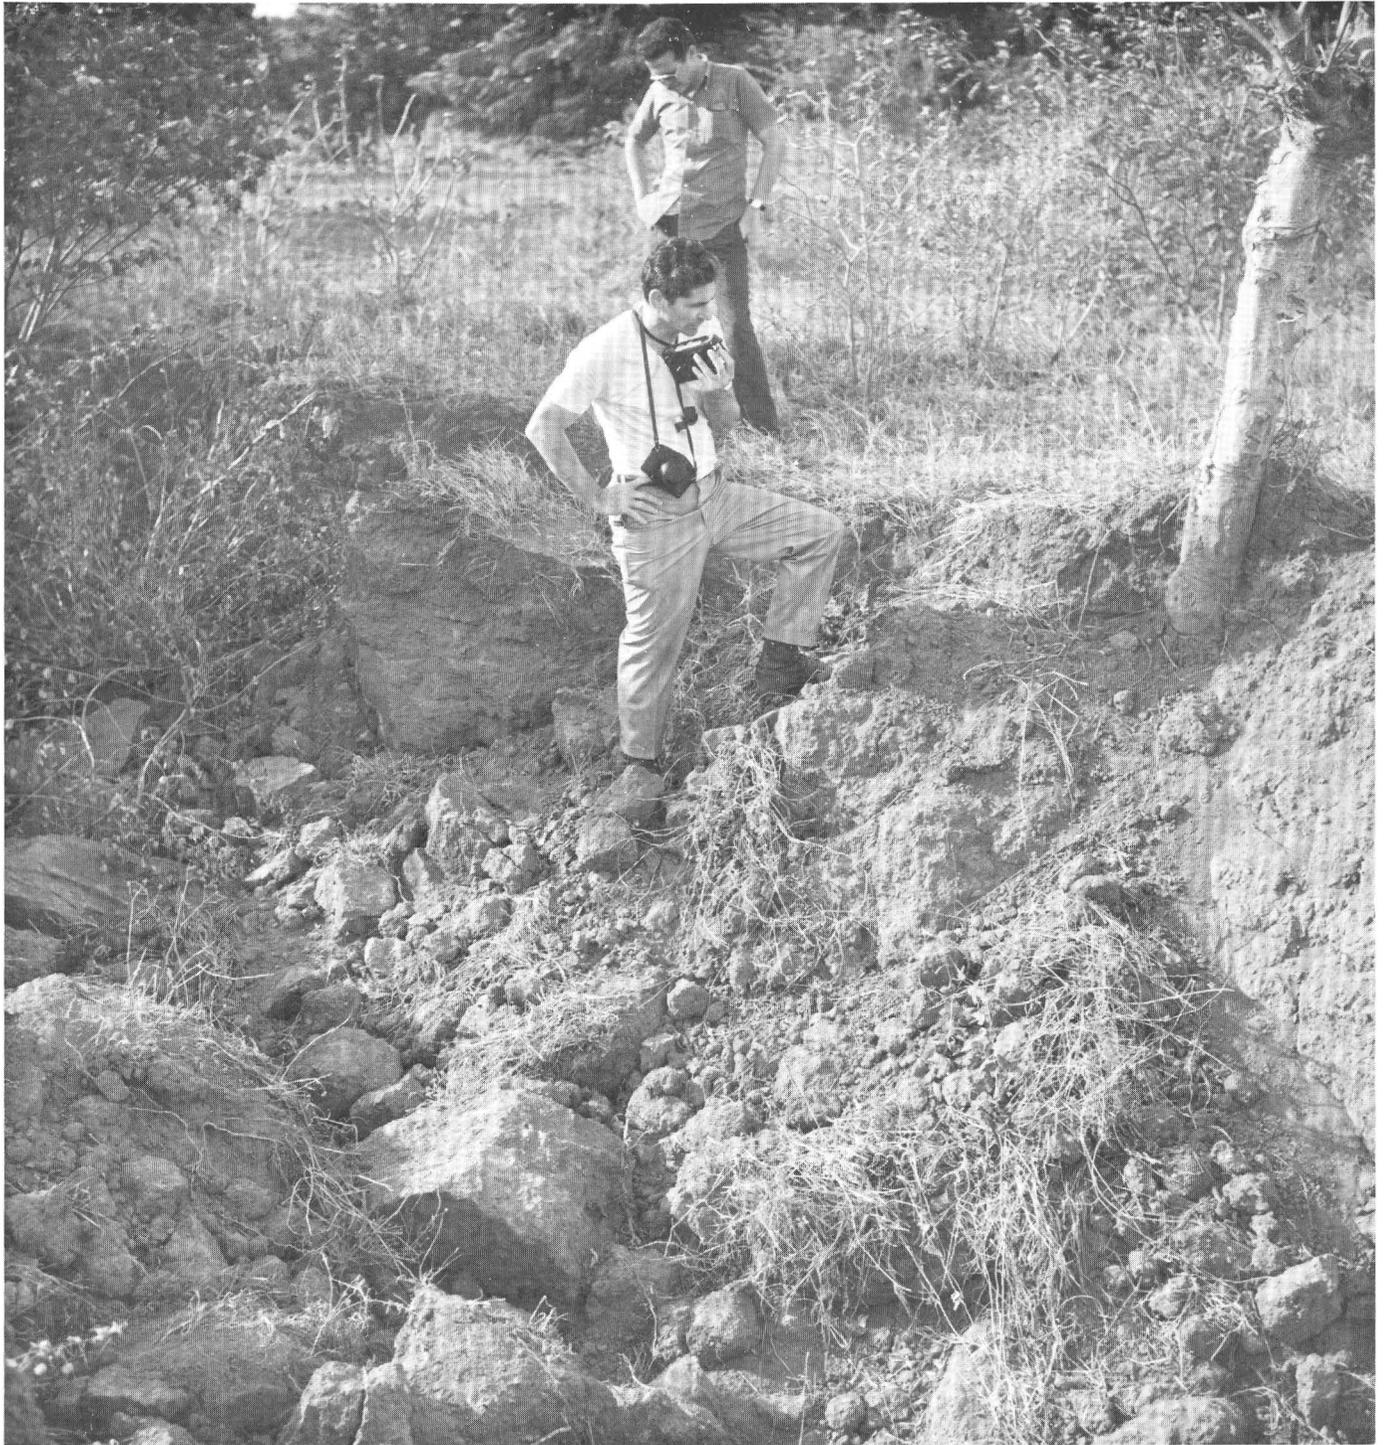
Secondary geologic effects related to seismic shaking during the earthquake were relatively minor. Small slope failures affected steeper slopes in the Managua area, most notably along parts of the inner walls and rim of the Tiscapa crater, where the upper part of a slide showed rotational tilting (fig. 17), and on Highway 2 southwest of Managua at about km 11, where one major slide and several incipient slides in cuts and embankments temporarily blocked part of the highway (fig. 18). A number of rockfalls and debris slides were triggered along the steep slopes of the Asososca pit crater west of Managua (fig. 1), and small areas of artificial fill failed in the road along the south rim of Asososca crater. Minor slumping, debris falls, and ravelling were widespread along steep natural and artificial slopes in loose pyroclastic deposits and alluvium throughout the area (fig. 19).

FIGURE 19.—Minor slide of unconsolidated deposits in steep bank of dry creek (near sta. 46, pl. 1). Failures such as these were common in steep creek banks and artificial cuts throughout the Managua area.
