# Soil Slips, Debris Flows, and Rainstorms in the Santa Monica Mountains and Vicinity, Southern California

U.S. GEOLOGICAL SURVEY PROFESSIONAL PAPER 851

By RUSSELL H. CAMPBELL

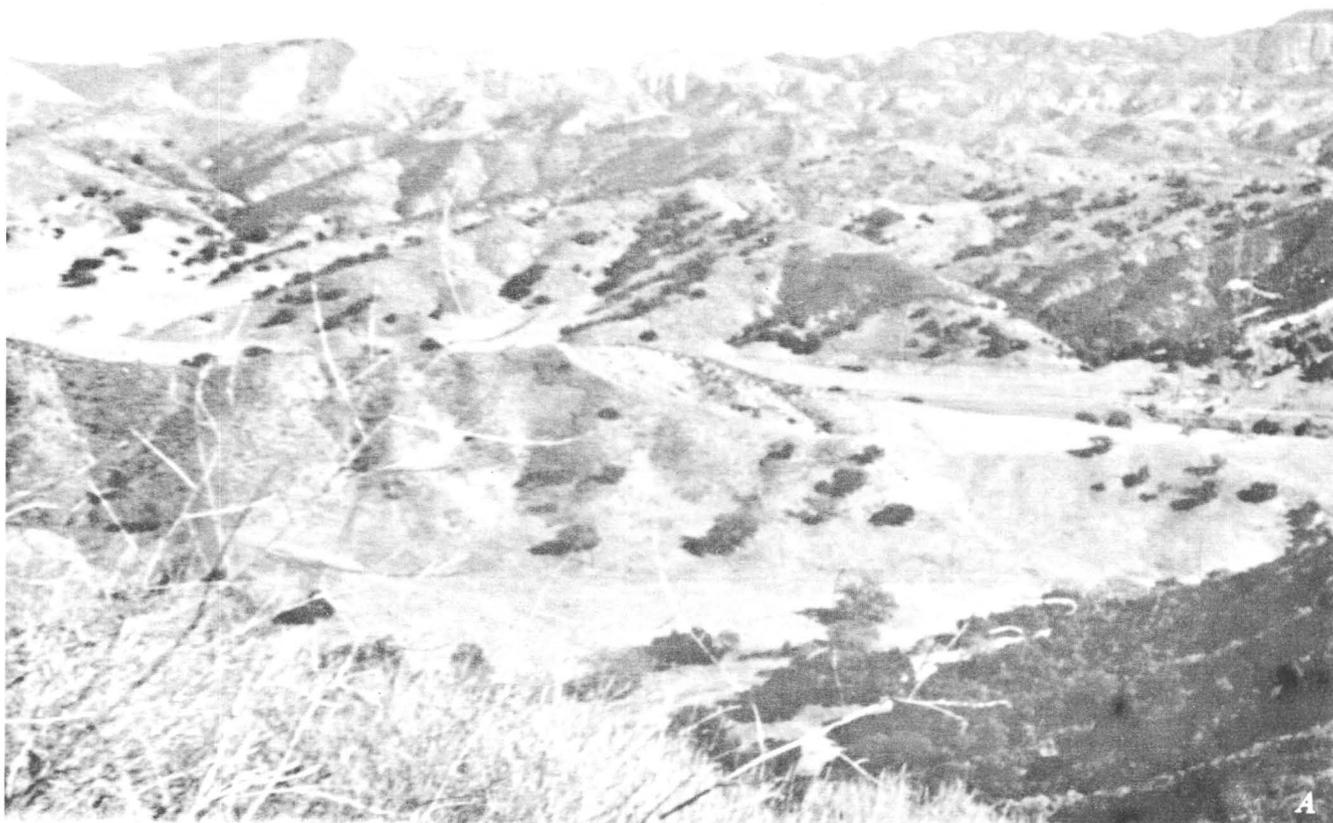
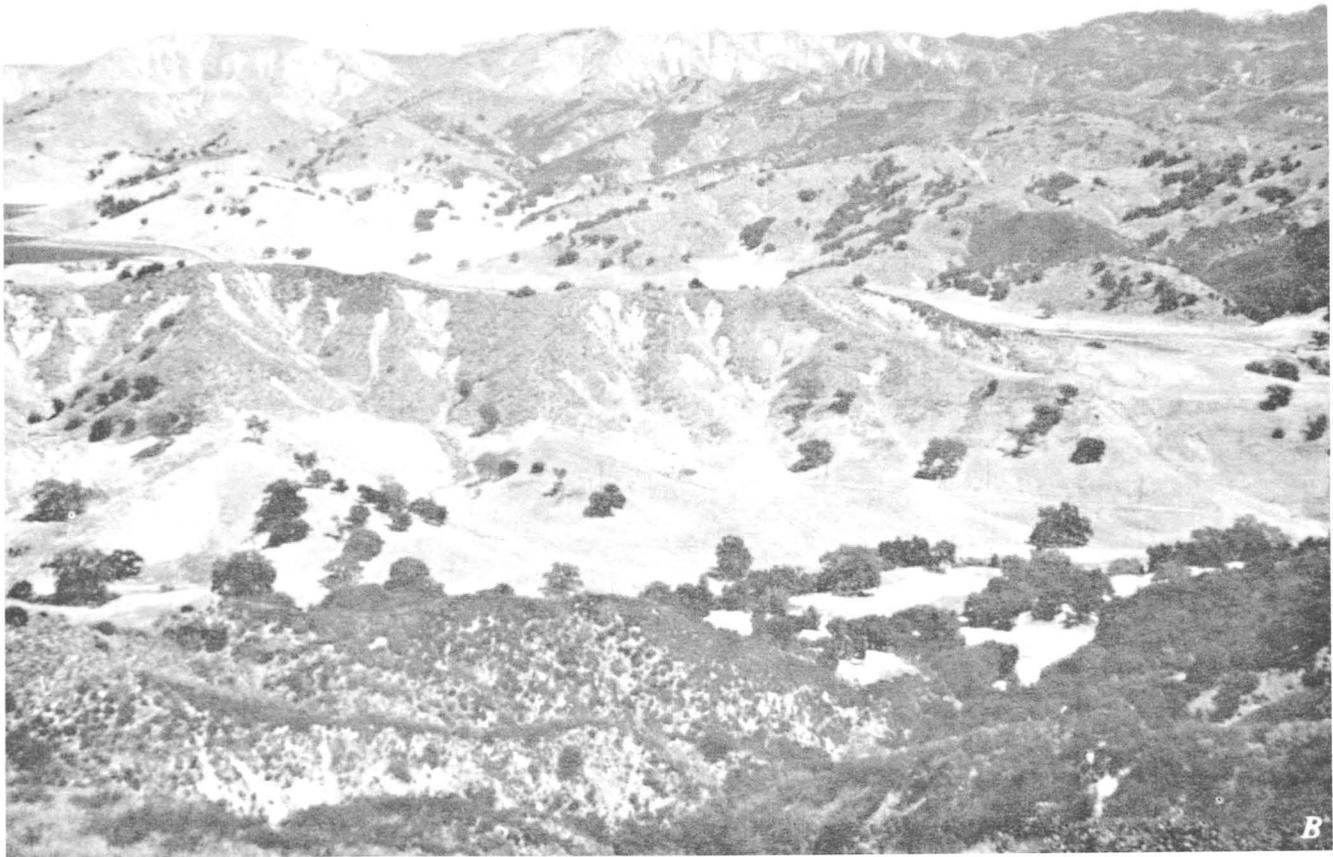
A, Prestorm; photograph taken November 1968.

FIGURE 2.—Views northeast across

B, Poststorm; scars formed during storm of January 18-26, 1969; photograph taken July 1969.

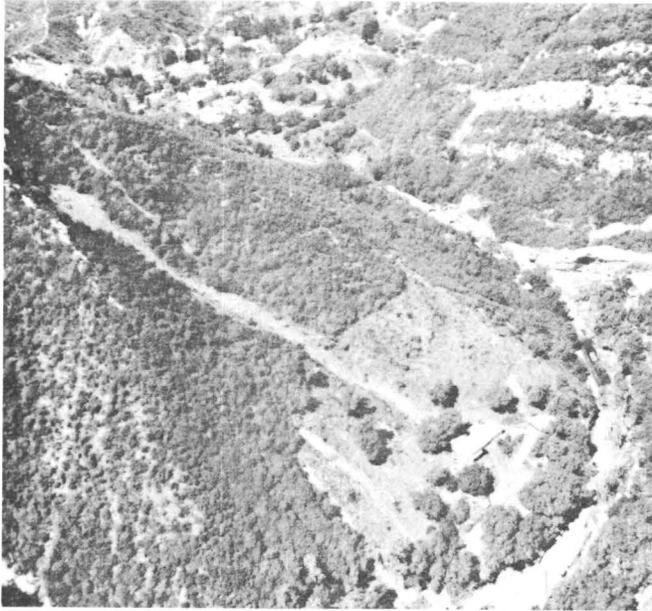
FIGURE 3.—Scar of soil slip and debris-flow channel above house in Old Topanga Canyon. Note train of deposits downslope from house. Slide of January 25, 1969; photograph taken within a few days by the Department of the County Engineer, Los Angeles County.

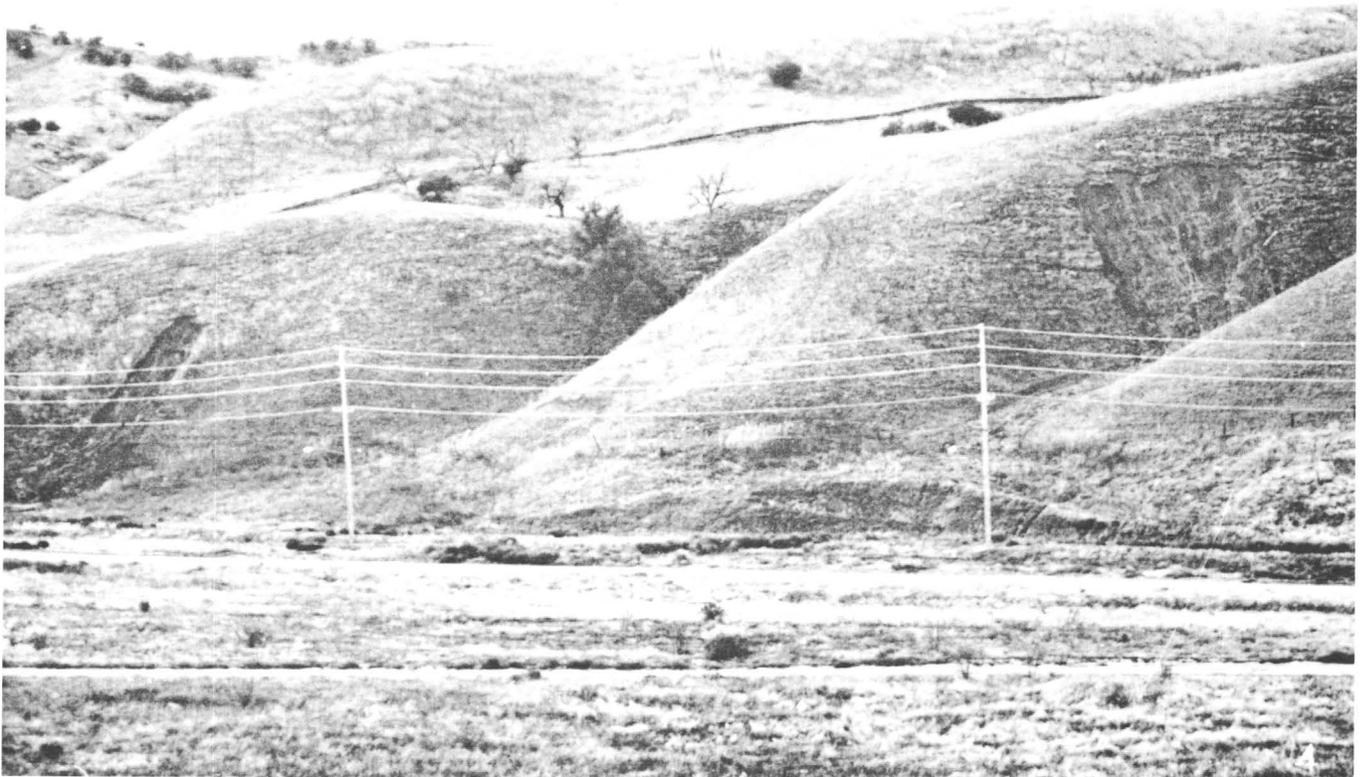
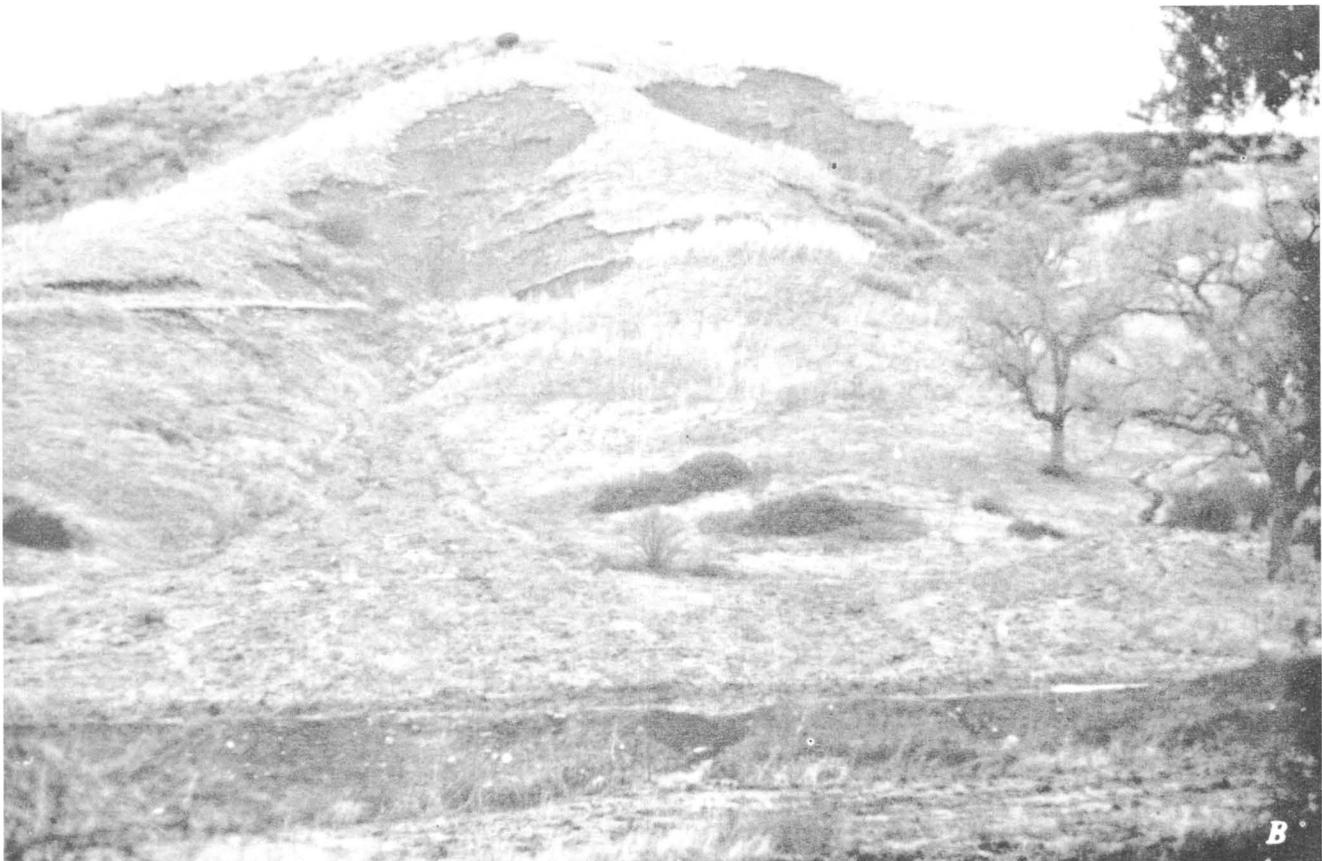
FIGURE 4.—Soil-slip scars and debris-flow fans, Las Virgenes Canyon area. Photographs taken February 4, 1969.

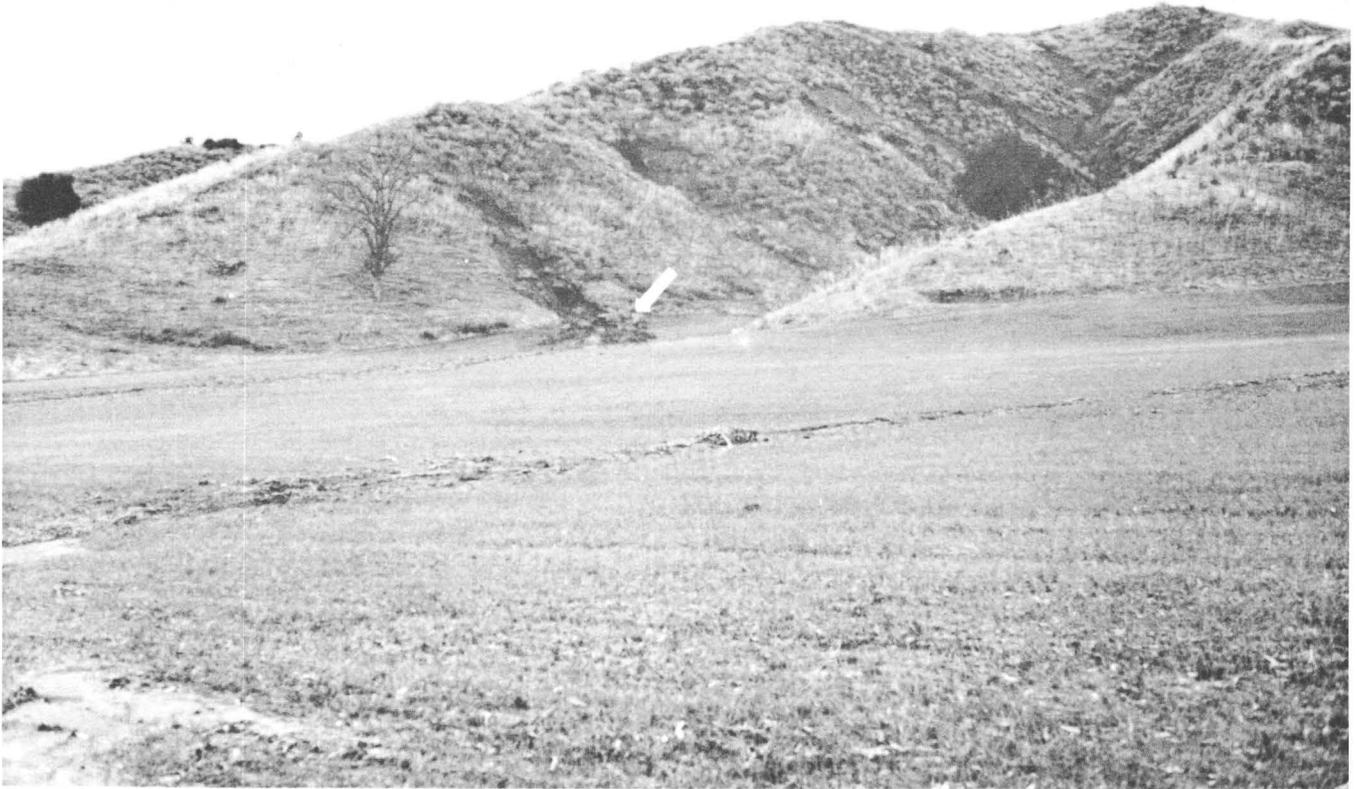
FIGURE 6.—Clumps of sod on soil-slip deposit. Note trace of drainage of excess water from deposit toward the left, across the cultivated field, and the similar trace in the foreground that comes from another soil slip out of sight to the right.

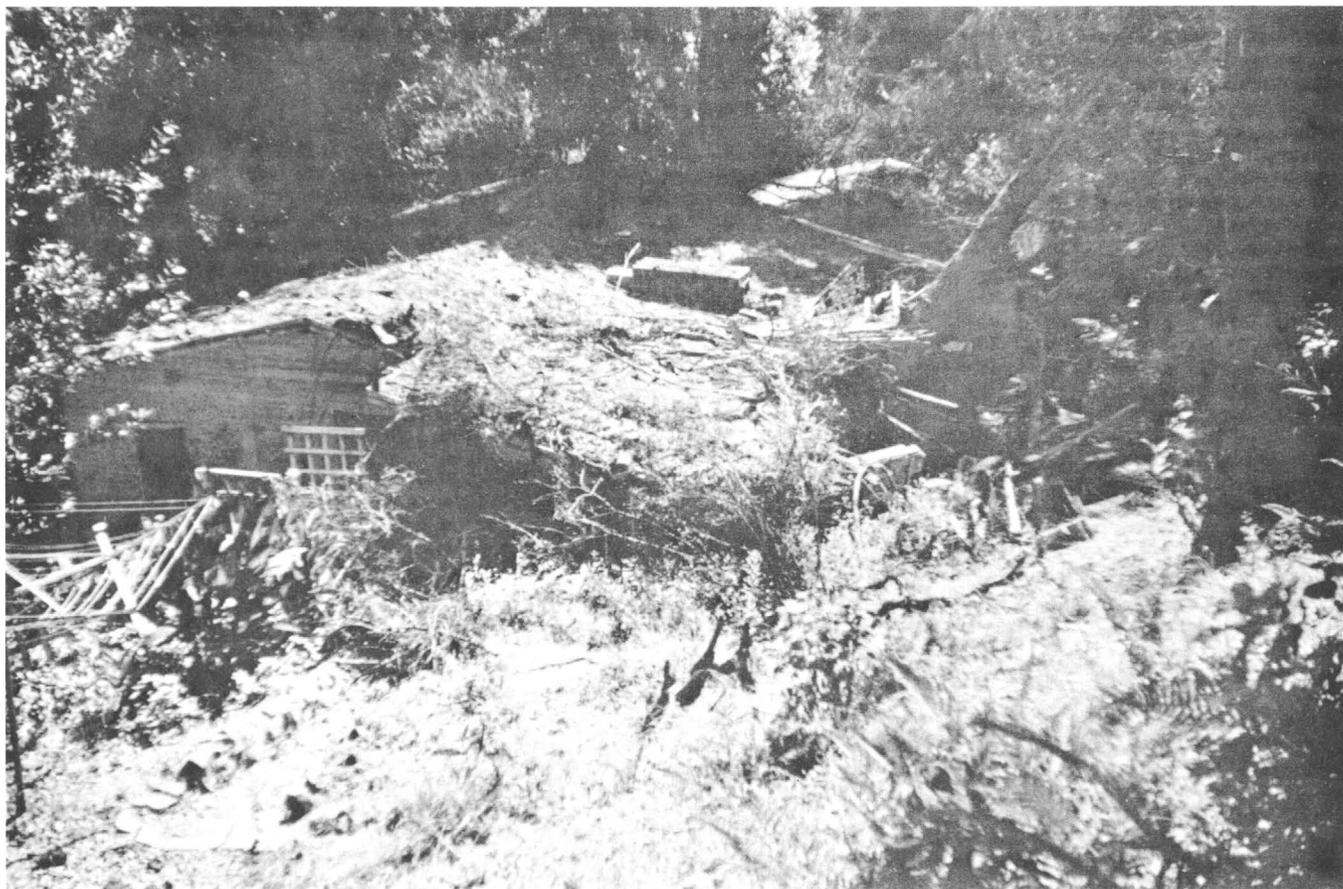
FIGURE 7.—Large tree emplaced (nearly upright) in kitchen of residence in Old Topanga Canyon by soil slip–debris flow. Note doorframe on left strained from rectangle to parallelogram.

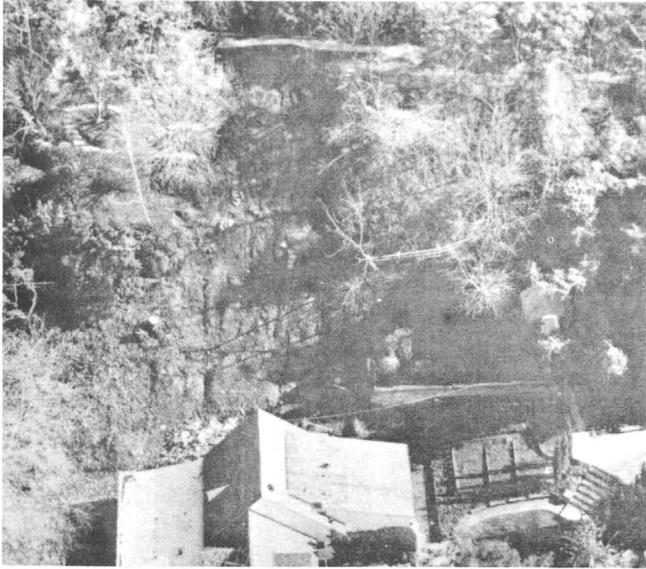
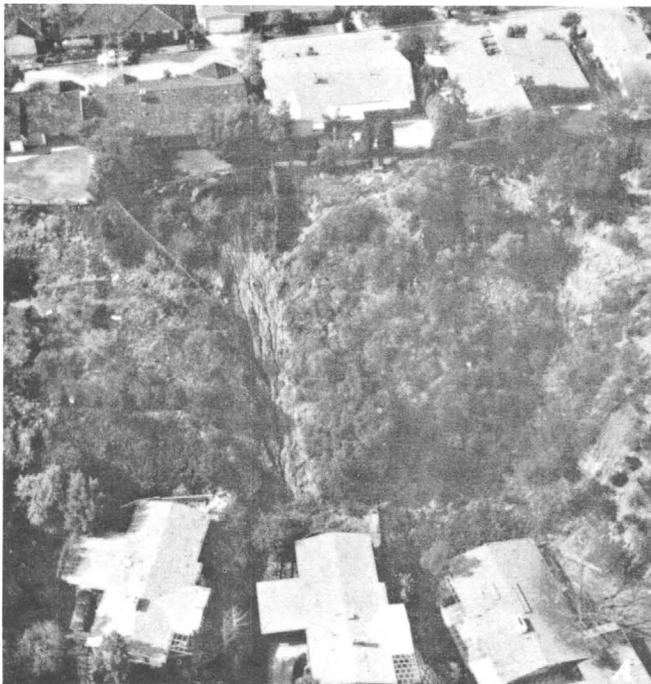
FIGURE 11.—Soil-slip scar behind house in Mandeville Canyon damaged by debris flow; one fatality. Photograph taken February 13, 1969, by the Department of Building and Safety, City of Los Angeles.

A, Scar on hillside behind house. Note rills eroded by rainwash on bare scar area. Photograph taken February 13, 1969, by Department of Building and Safety, City of Los Angeles.

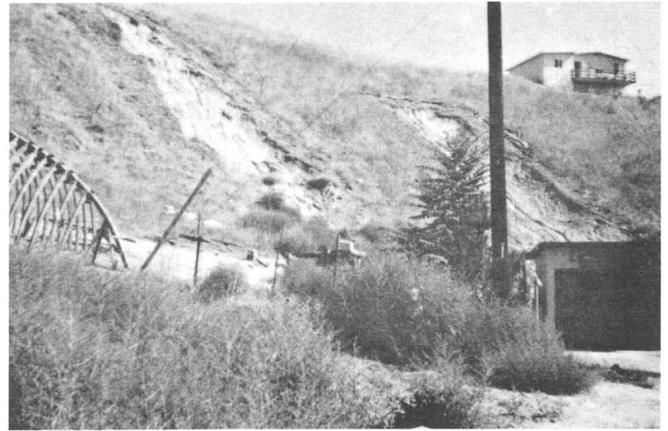
FIGURE 13.—Scars of soil slips above residence in Thousand Oaks. About 7:45 a.m., on January 25, 1969, a debris flow generated by the slip on the left broke into the rear of the house, killing a sleeping guest in the back bedroom.

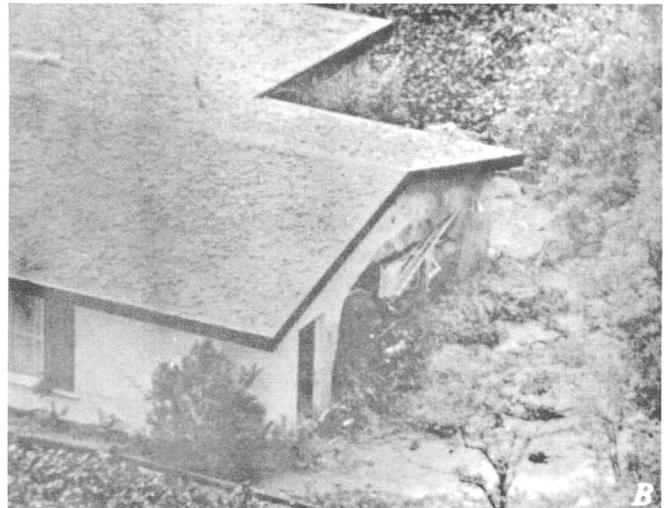
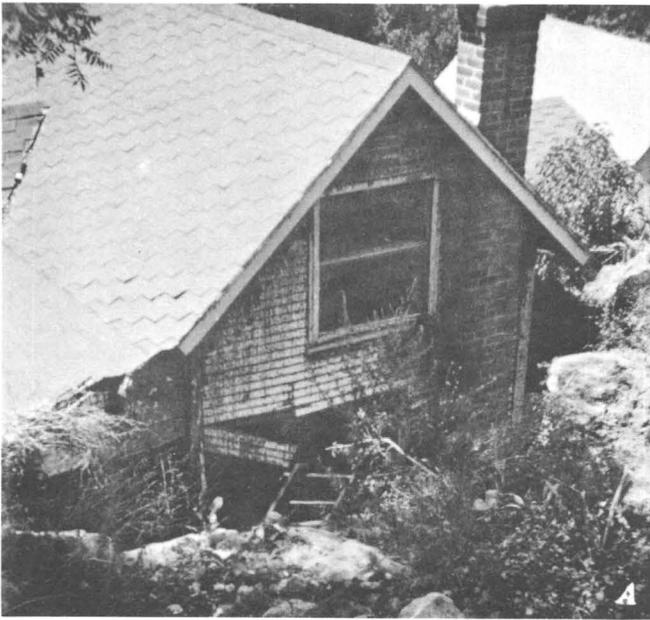
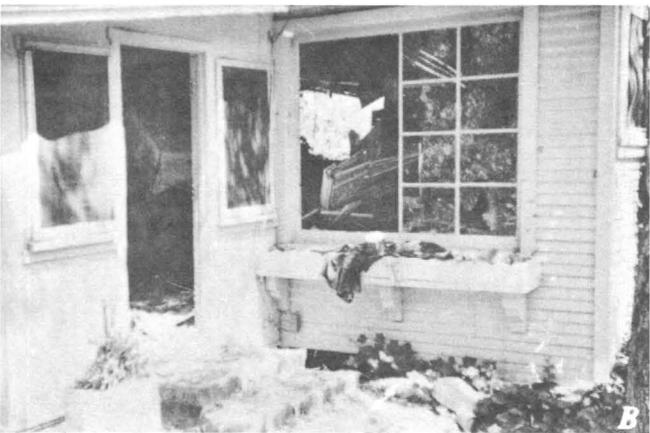
B, Damage to upslope side of house, showing broken wall of room where sleeping resident was killed. (Photograph by Hollywood Citizen News, courtesy of Department of Building and Safety, City of Los Angeles.)

FIGURE 12.—Residence in Sherman Oaks damaged by soil slip–debris flow about 6:00 a.m., January 25, 1969; one fatality.

A, Flow broke through rear wall of lower story of a two-story house after "ski jumping" from top of vertical cut about 8 feet high. Upper story splattered (note broken window) but not entered by main flow.

B, View through house from the front. Refrigerator and other heavy appliances, carried from kitchen in rear and through partition into living room in front, trapped and killed one occupant. All coarse debris remained inside, only muddy water flowed out the front.

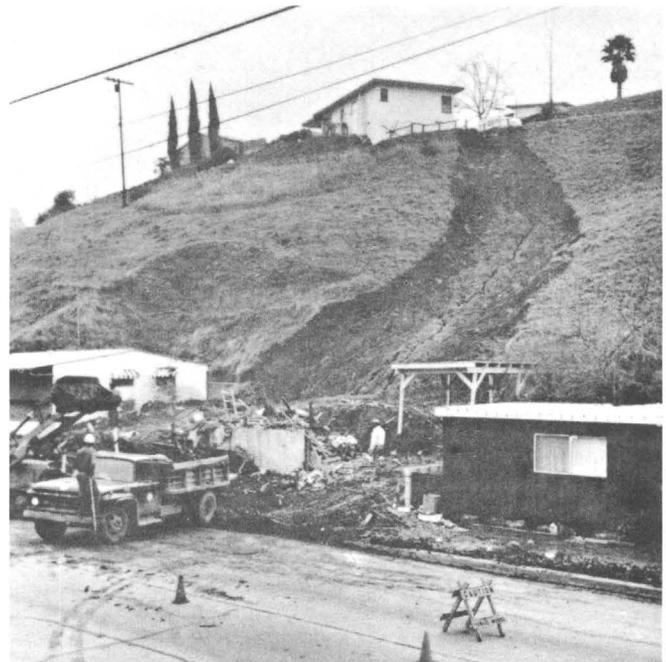
FIGURE 15.—Scar above site of residence destroyed by debris flow indicates origin by soil slip; Highland Park, two fatalities at about 9:00 a.m. January 25, 1969. Photograph by City of Los Angeles, Department of Building and Safety.

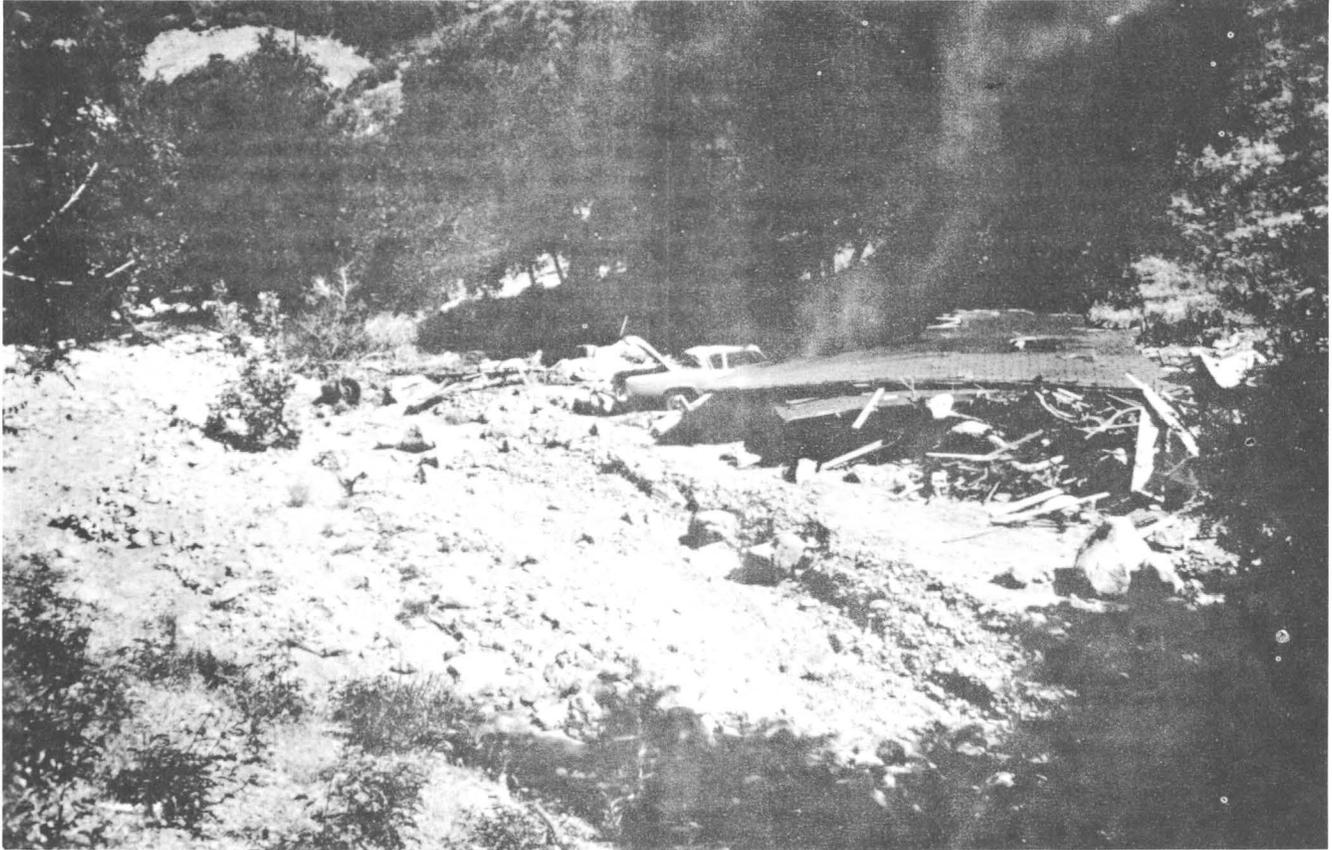
FIGURE 21.—Boulders, garage, and car transported by debris flow; Newton Canyon, December 29, 1965.

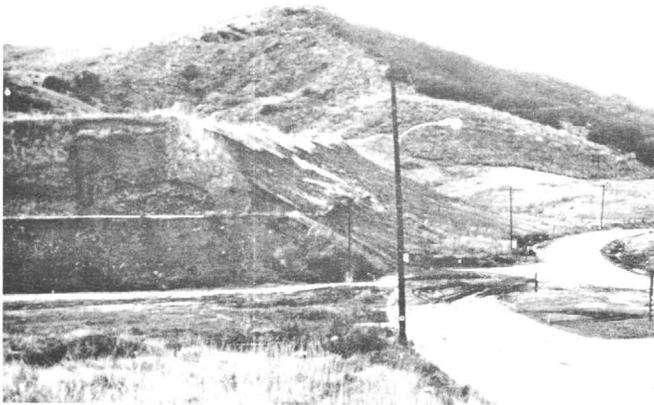
FIGURE 22.—Compacted-fill slope with surface-drainage interceptors rendered ineffective as a result of small soil slips. Liberty Canyon area, storm of January 18–26, 1969.

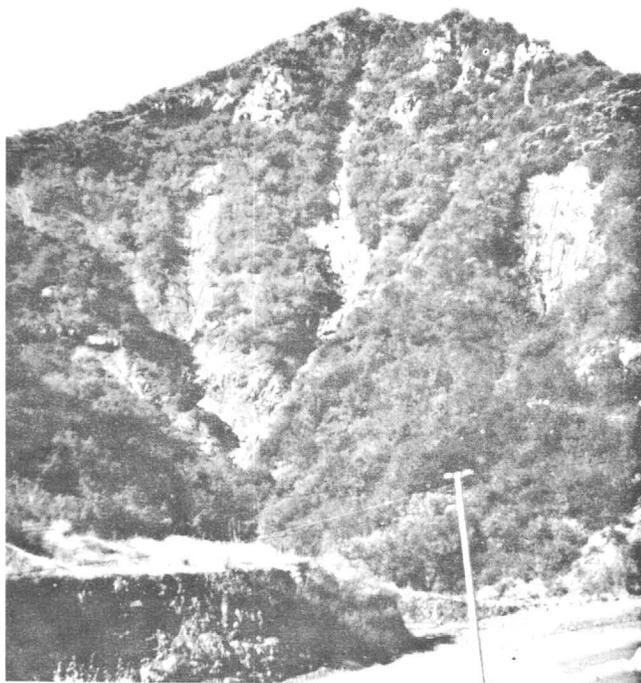
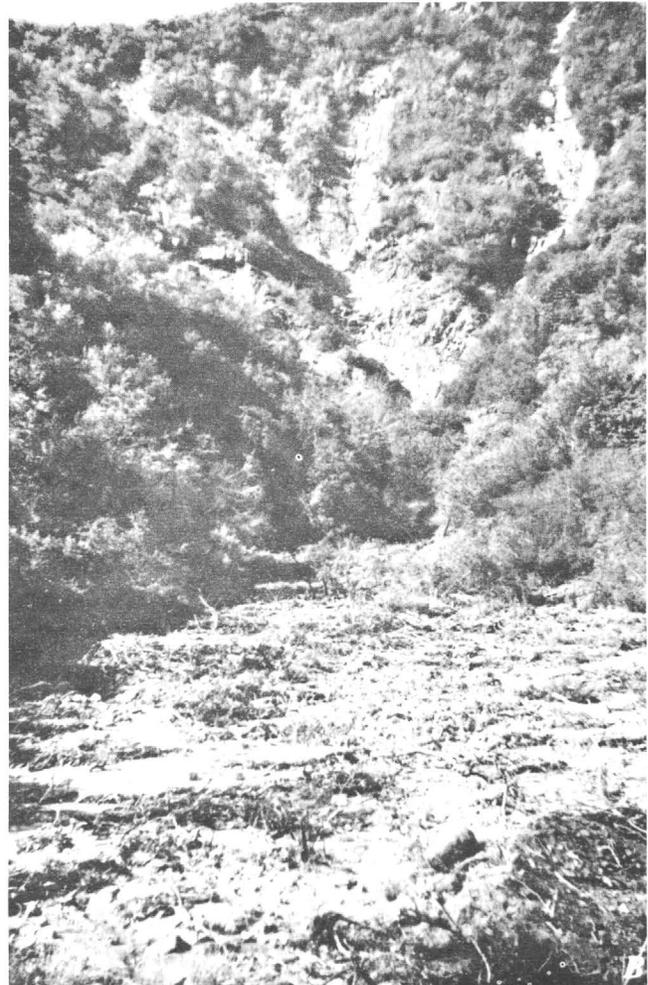
A, Soil-slip scars in headwall drainage of ravine crossed by road fill.

B, Impounded debris, part of the scoured bedrock debris-flow chute, and lower parts of some of the soil-slip scars.

FIGURE 23.—Soil-slip scars and debris-flow deposits impounded behind road fill; Lobo Canyon area, storm of January 18–26, 1969.

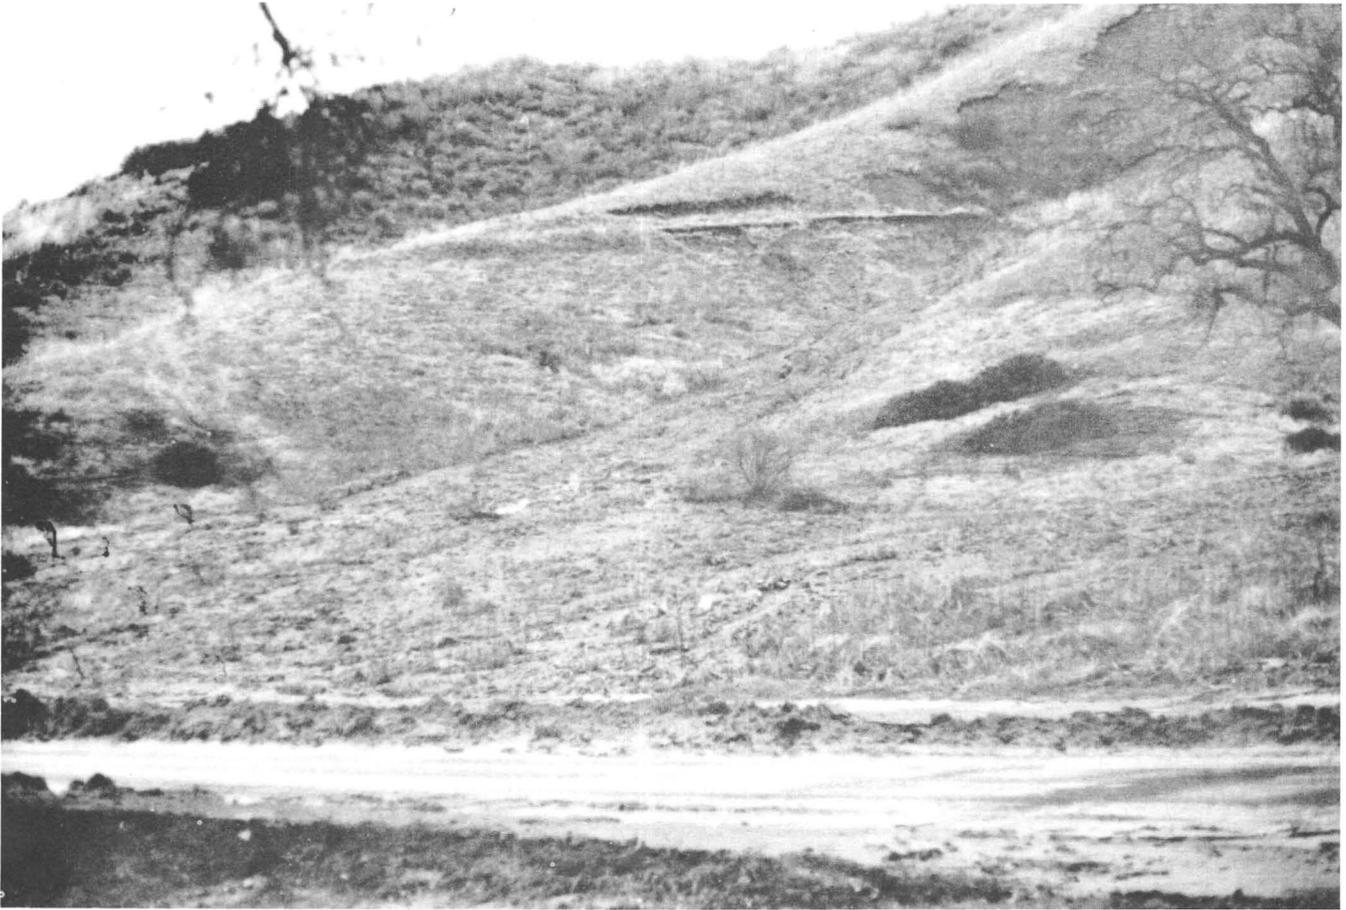
FIGURE 24.—Debris flow through drainage that does not yield enough surface runoff of water to require a culvert; Mulholland Highway, storm of January 18–26, 1969. Road has been cleared after inundation.

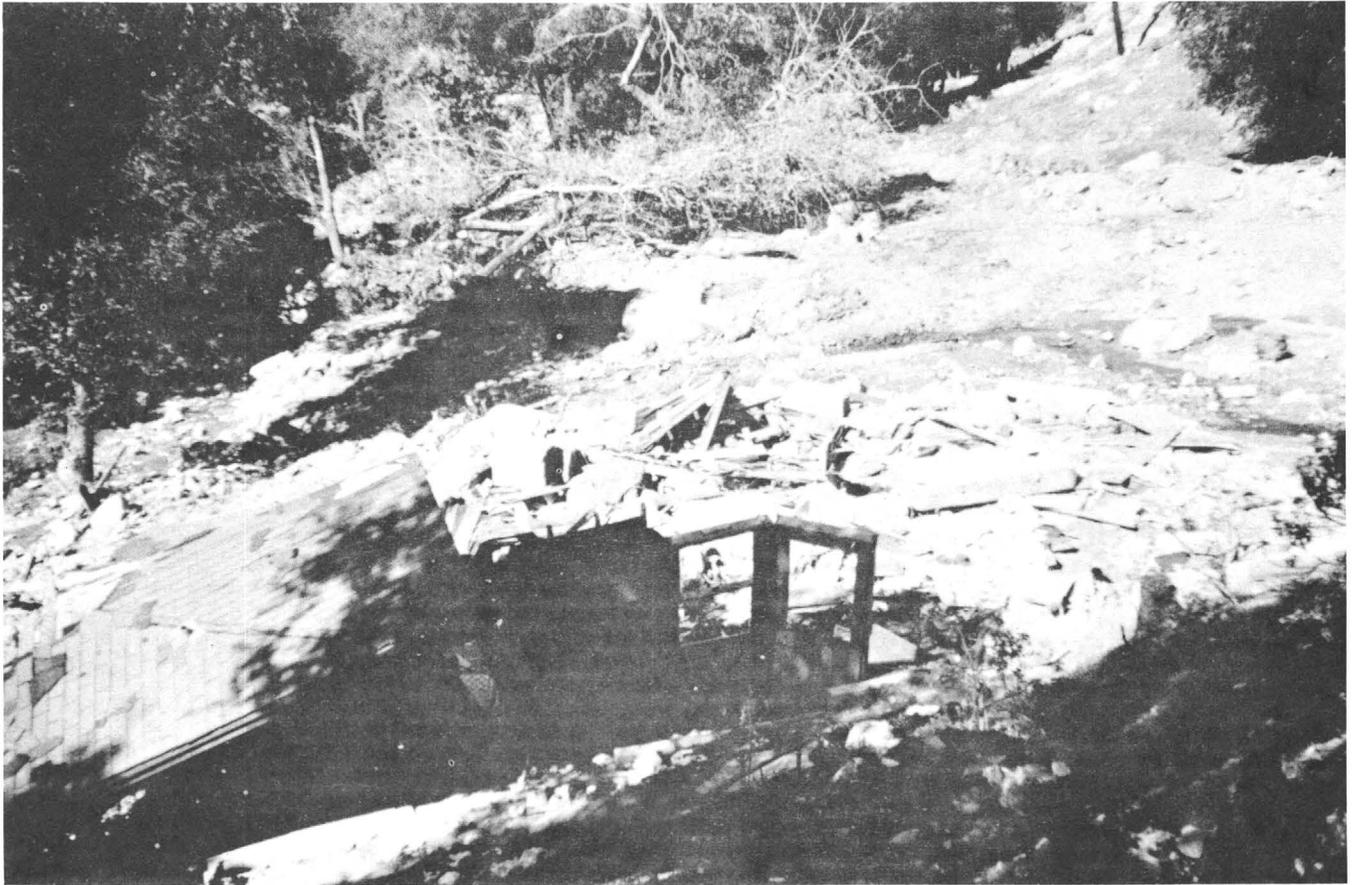
FIGURE 25—Wood-frame house, right side caught by edge of debris flow from the right, crushed and spun off foundation by impact. One fatality at this site. Newton Canyon area, debris flow of December 29, 1965.

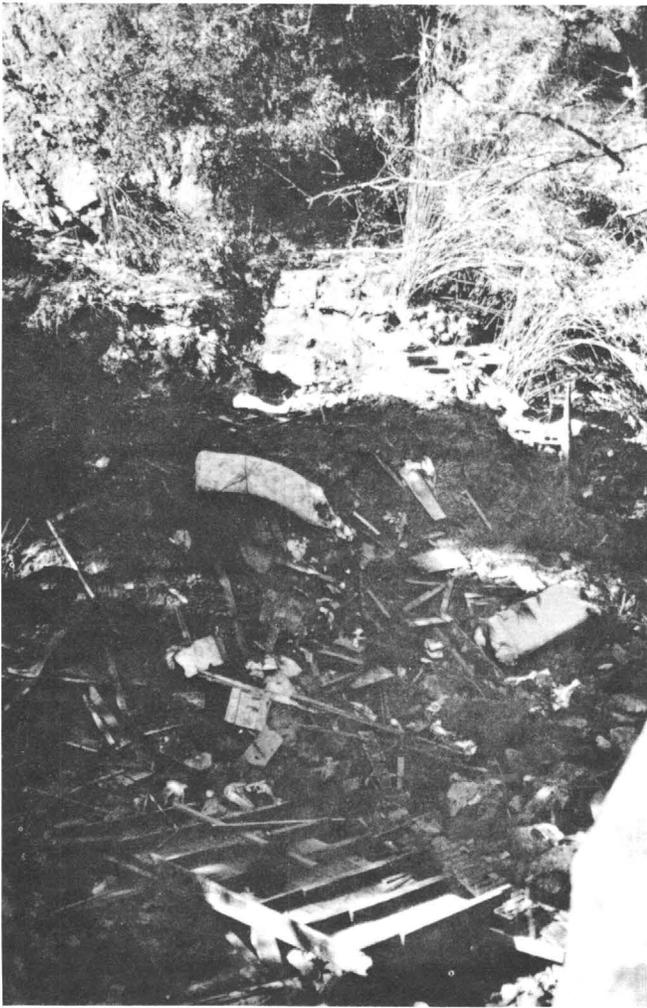
FIGURE 26.—Debris flow from above left crushed wood-frame dwelling and pushed most of it downhill into the floodwaters of Topanga Creek. Photograph taken after partial excavation for rescue operations. Three fatalities at this site. West side of Topanga Canyon, debris flow of January 25, 1969.

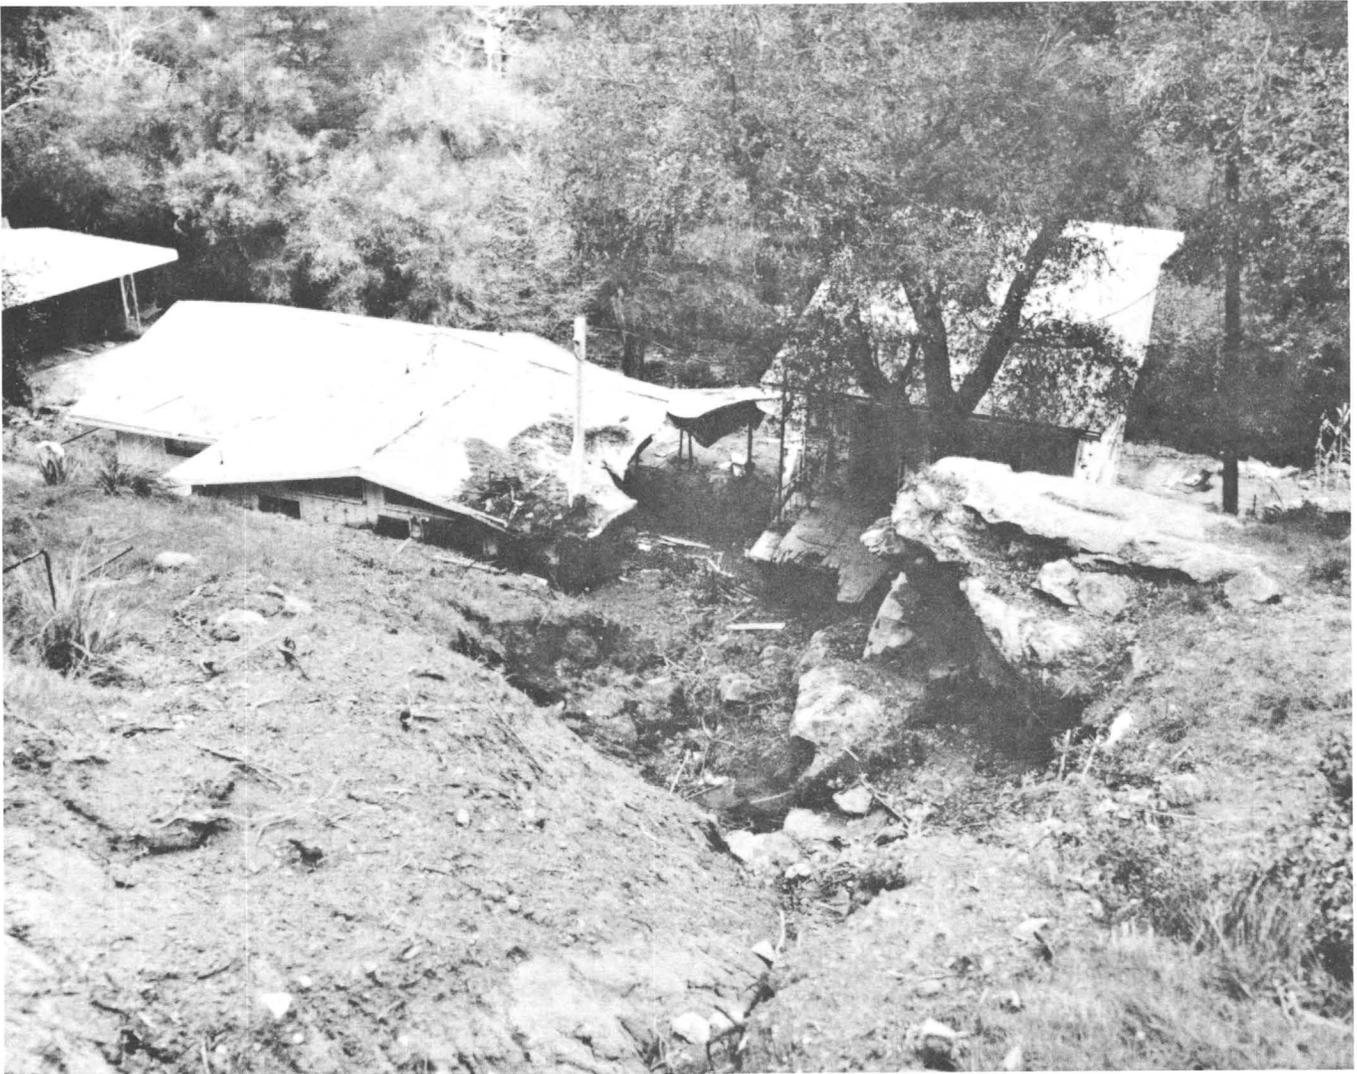
FIGURE 27.—Hole punched through house of 975 Old Topanga Canyon Road, debris flow of January 25, 1969. Occupants reportedly escaped without injury. Soil-slip scar above house is shown in figure 3. Photograph by Department of the County Engineer, Los Angeles County.

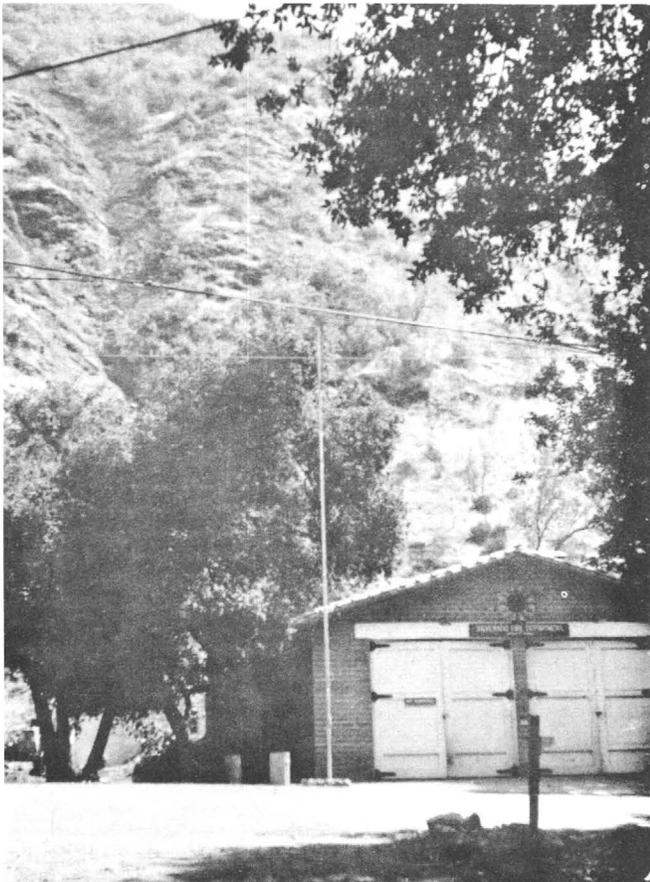
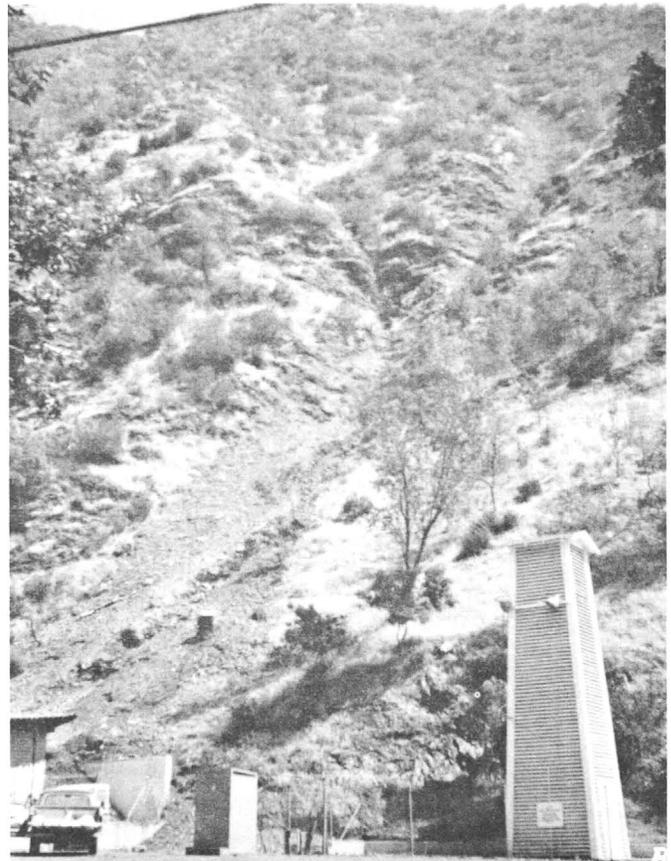
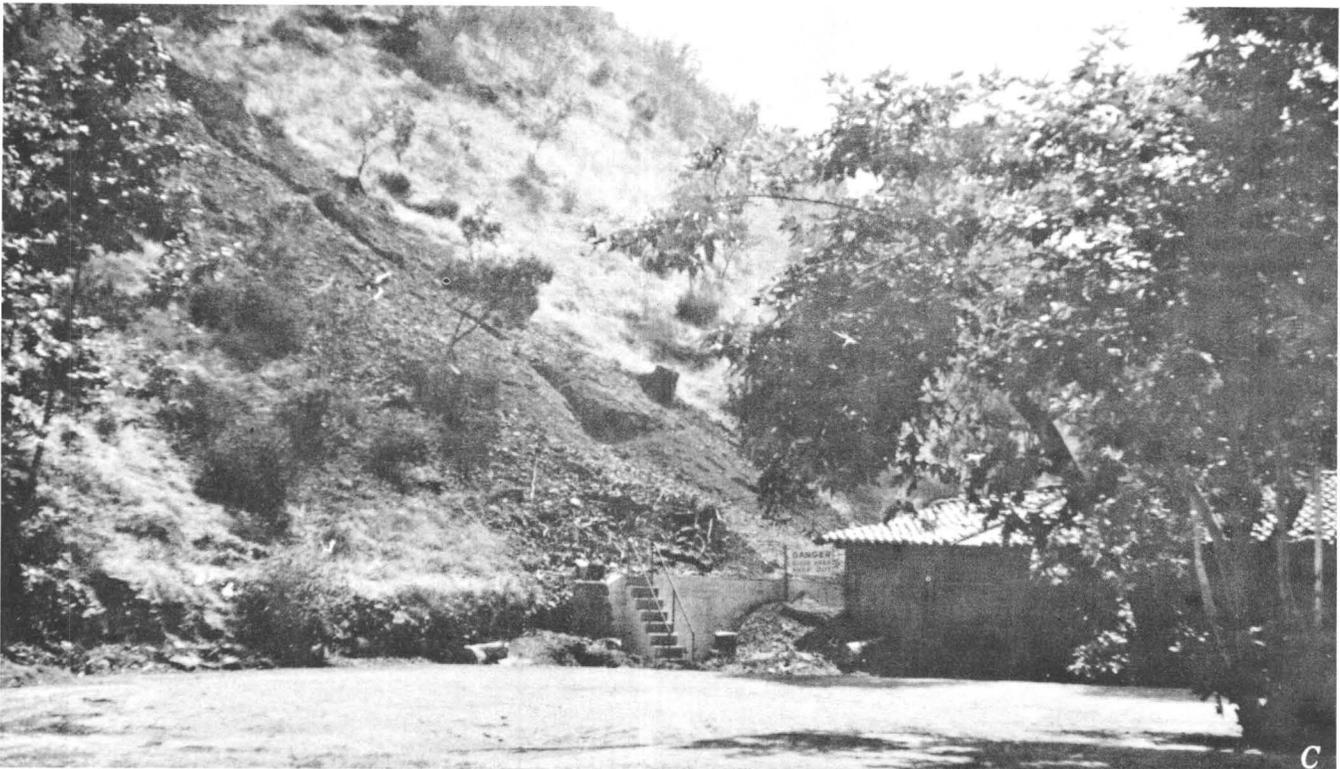
A, Fire station, located on the flood plain of a major stream at the foot of a long steep slope drained by low-order tributary gullies.

B, Slope above rear of fire station. Note head of scar in gully at upper right and mouth of gully directly upslope from the rear wall of the station.

C, Natural levee deposits on steep, small debris-flow fan, the toe of which has been undercut to increase the flat area where the station was built.

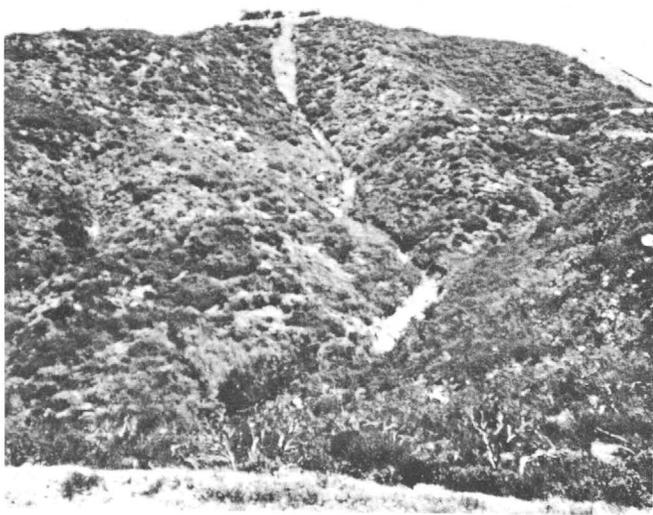
FIGURE 31.—Upper part of scar of ravine-fill failure on south face of Castro Peak.

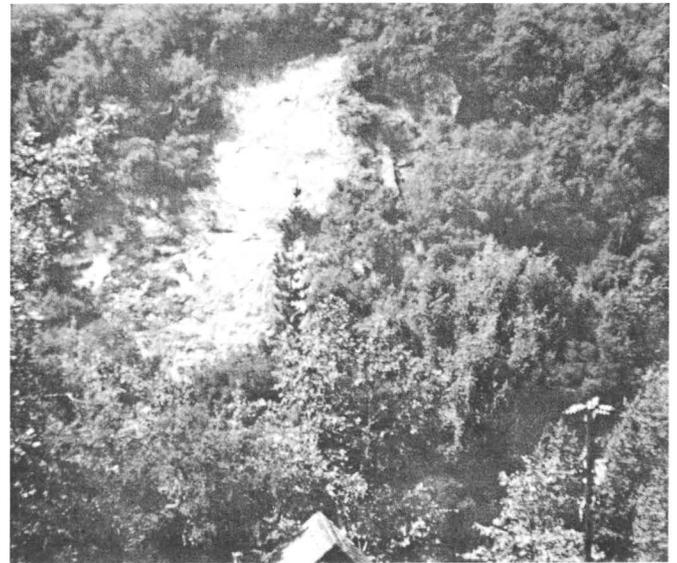
FIGURE 35.—Scar above house at 869 Old Topanga Canyon Road (roof of house at 874 Old Topanga Canyon Road, on near side of canyon in foreground). Brush-covered colluvial soil above lip of cliff (bedding surface of steeply dipping sandstone) failed and cascaded over bedrock cliff into back of frame dwelling below. (See fig. 7.)

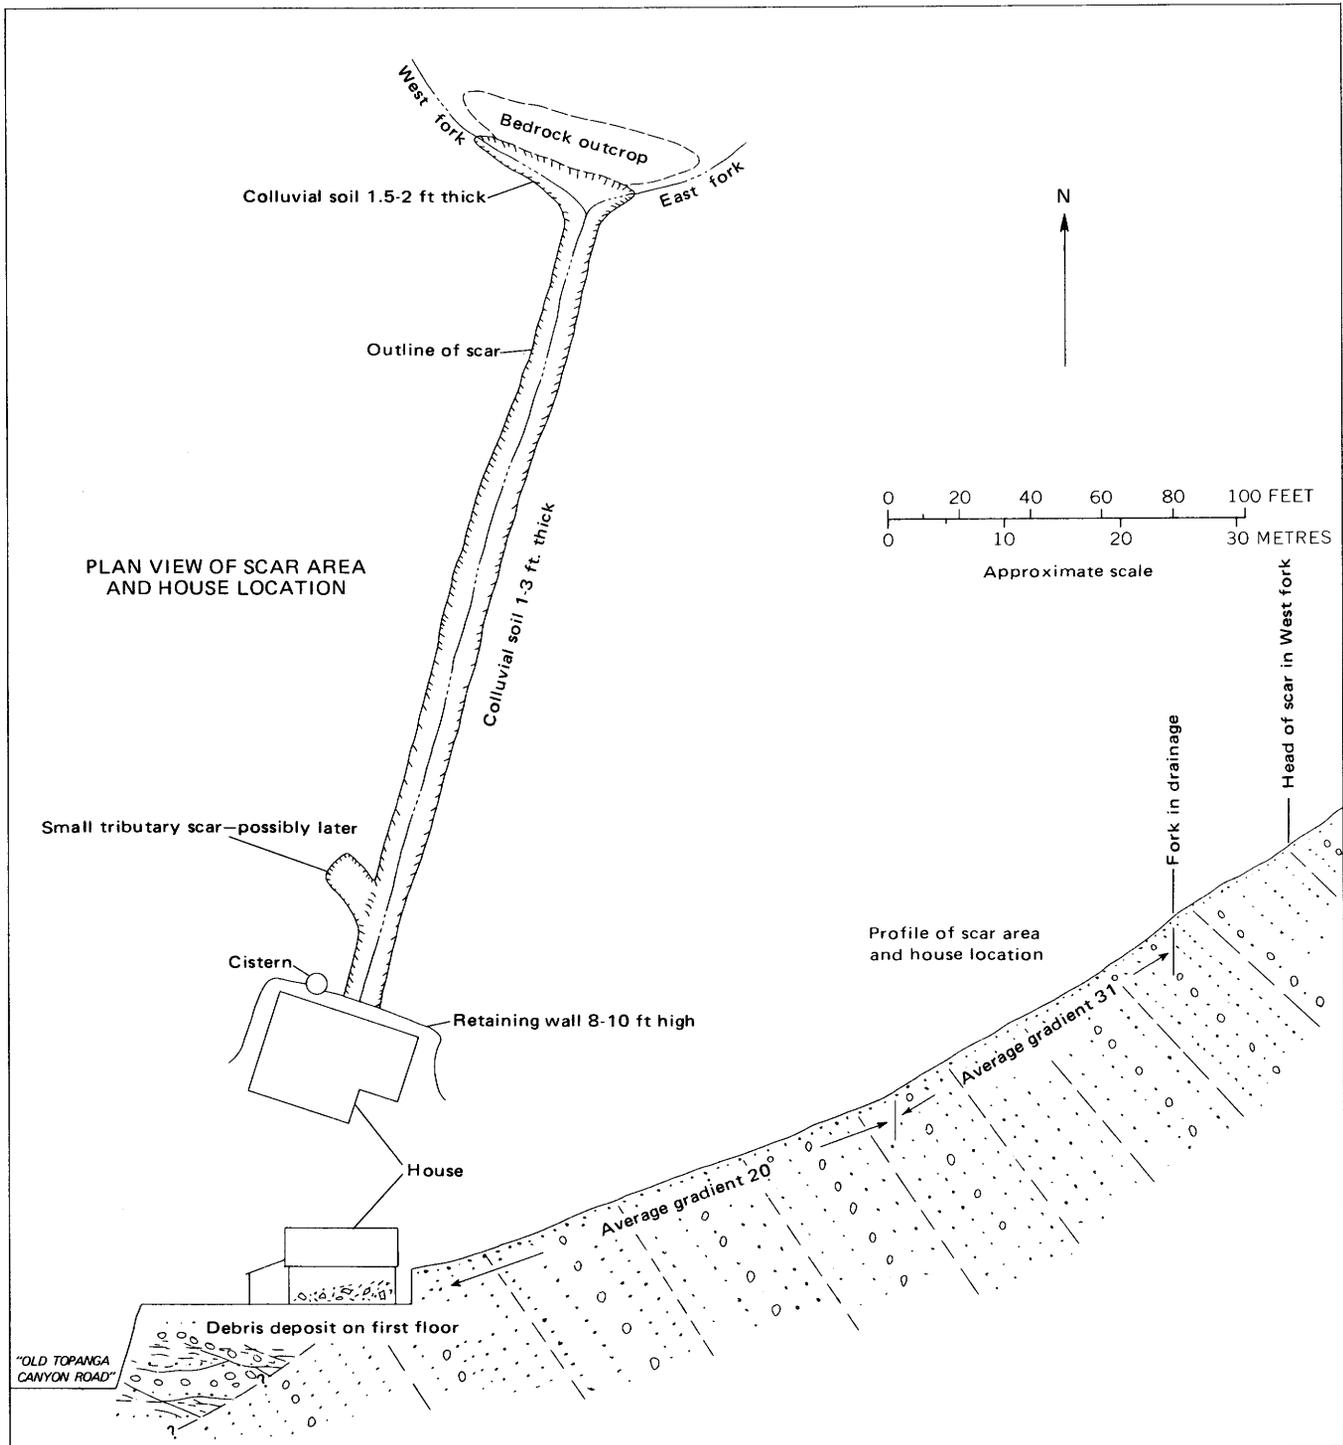
FIGURE 36.—Soil slip-debris flow at 874 Old Topanga Canyon Road.
