# THE GUATEMALAN EARTHQUAKE OF FEBRUARY 4, 1976, A PRELIMINARY REPORT

GEOLOGICAL SURVEY PROFESSIONAL PAPER 1002

A. F. ESPINOSA, EDITOR

*A preliminary report of a series of  
closely related studies of the  
destructive Guatemalan earthquake of  
February 4, 1976*

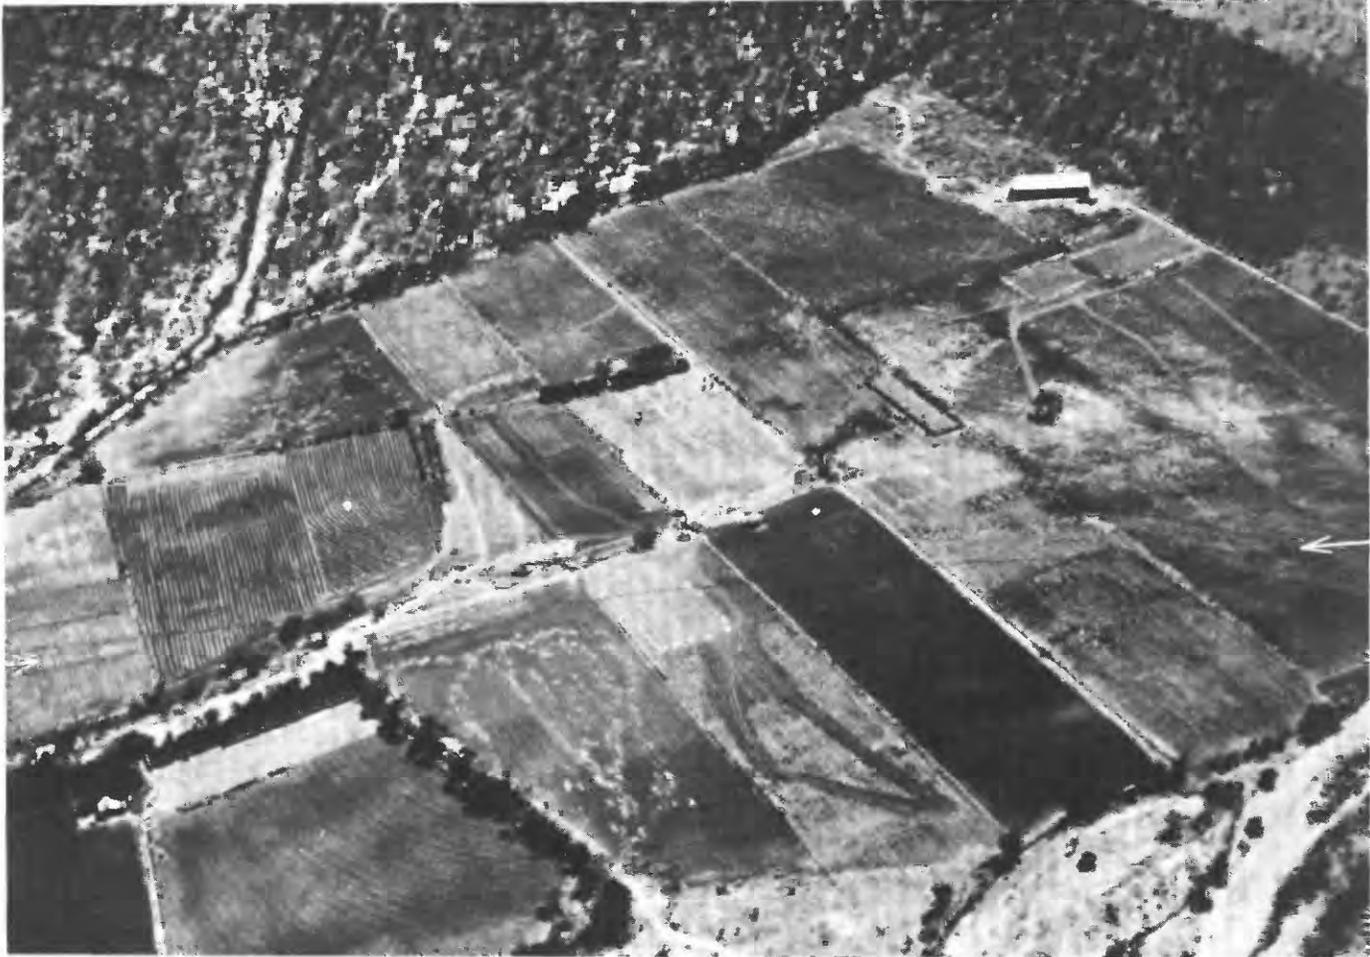
FIGURE 24.—Oblique aerial view looking south towards linear trace of the Motagua fault (arrows) in farmland west of Cabañas. Furrows with sinistral offset may be seen in the field at left. See figure 23 for location of Cabañas.

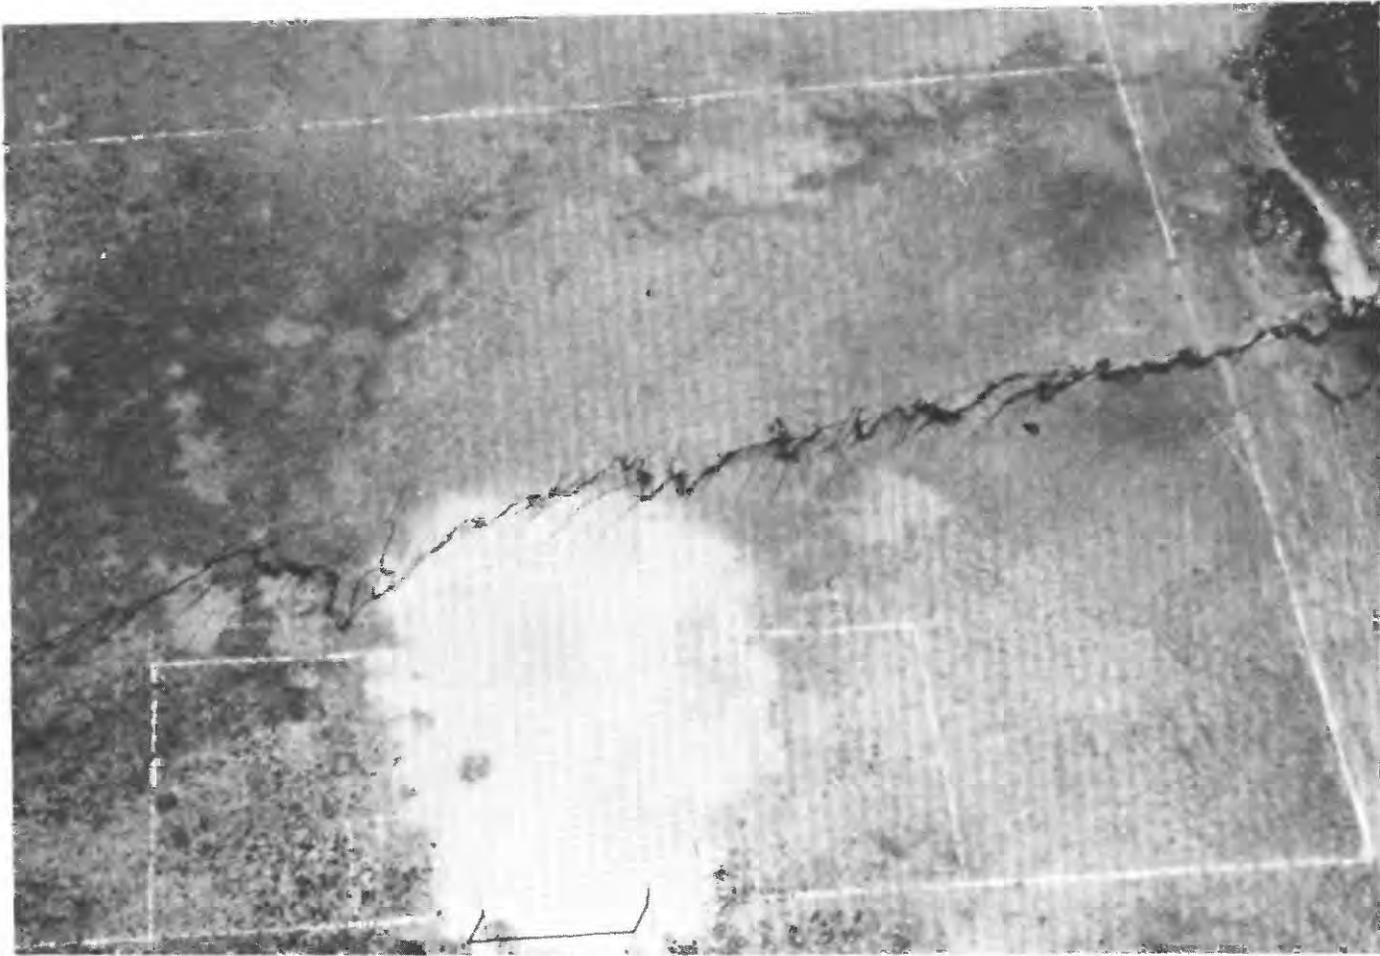
FIGURE 26.—Oblique aerial view of Motagua fault trace crossing a soccer field at Gualán (station 5, table 7). Note characteristic right-stepping en echelon fractures and sinistral offset (89 cm) of white sideline stripe at right. See figure 23 for location of Gualán.

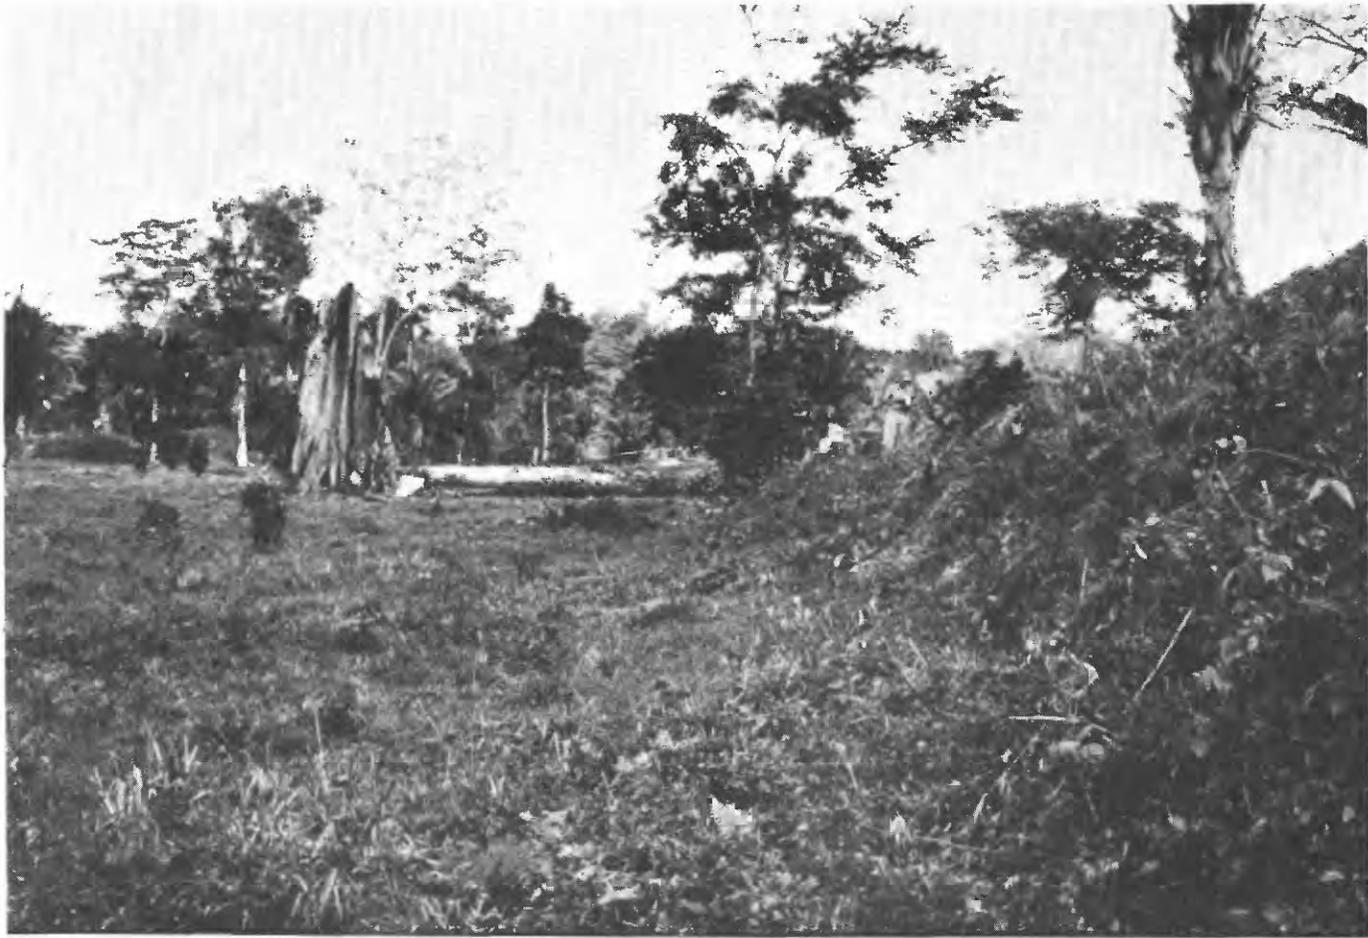
FIGURE 27.—View looking east along fault trace at the most easterly locality visited on the ground (station 1, table 7). Fault trace trends along base of 5-m-high scarp in foreground and through the fallen tree in the distance, which has a base diameter of more than 5 m. The tree was split and toppled by fault movement of about 72-cm sinistral displacement and 37-cm displacement down to the north. The north-facing steep scarp was probably formed by many repeated earlier movements along this same trace.

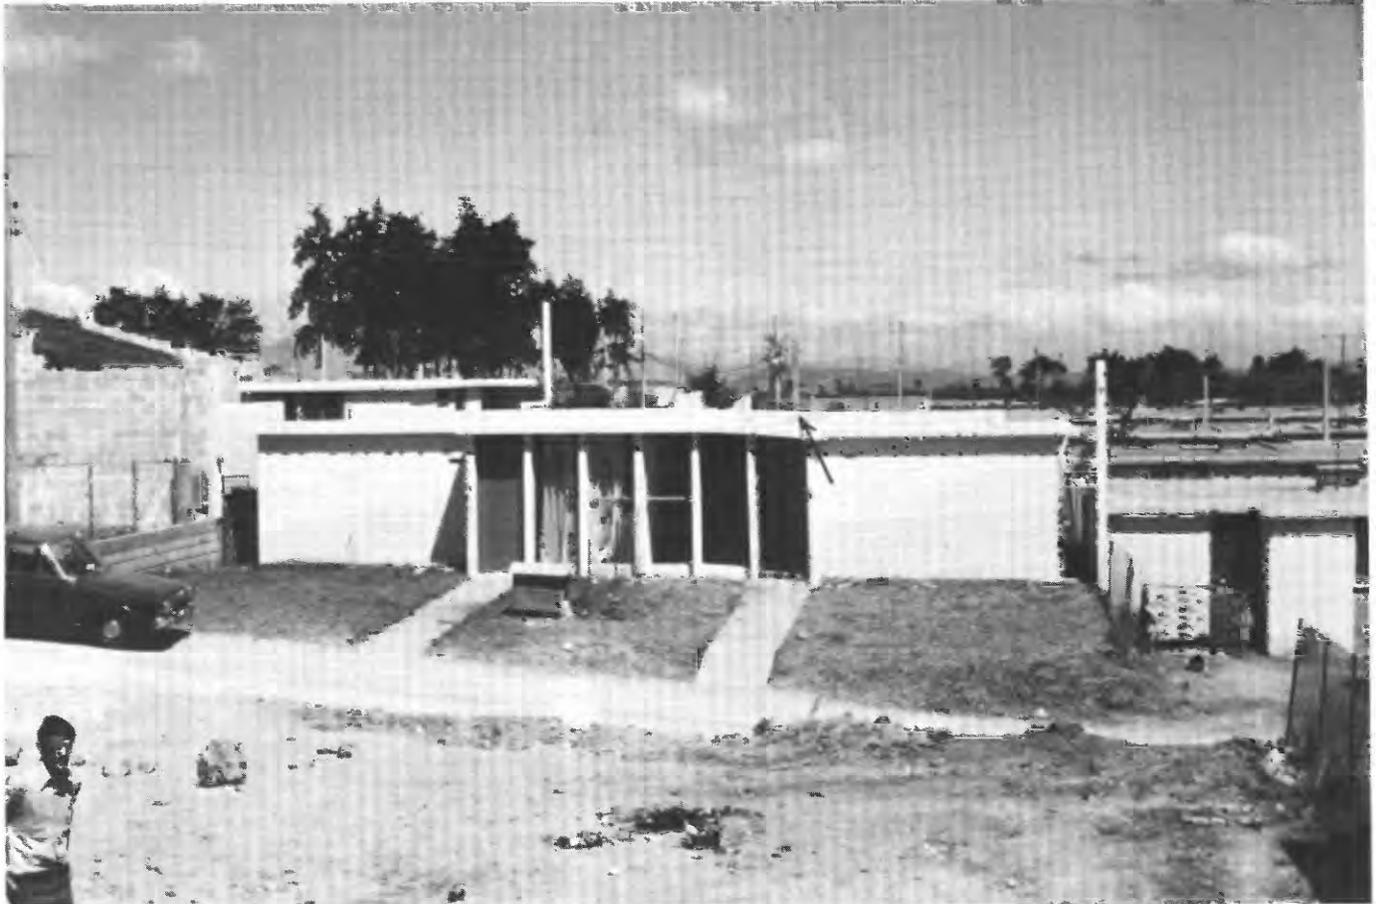
FIGURE 31.—Fault damage to a house in Guatemala City. The roof, foundation, and sidewalk have been displaced vertically.

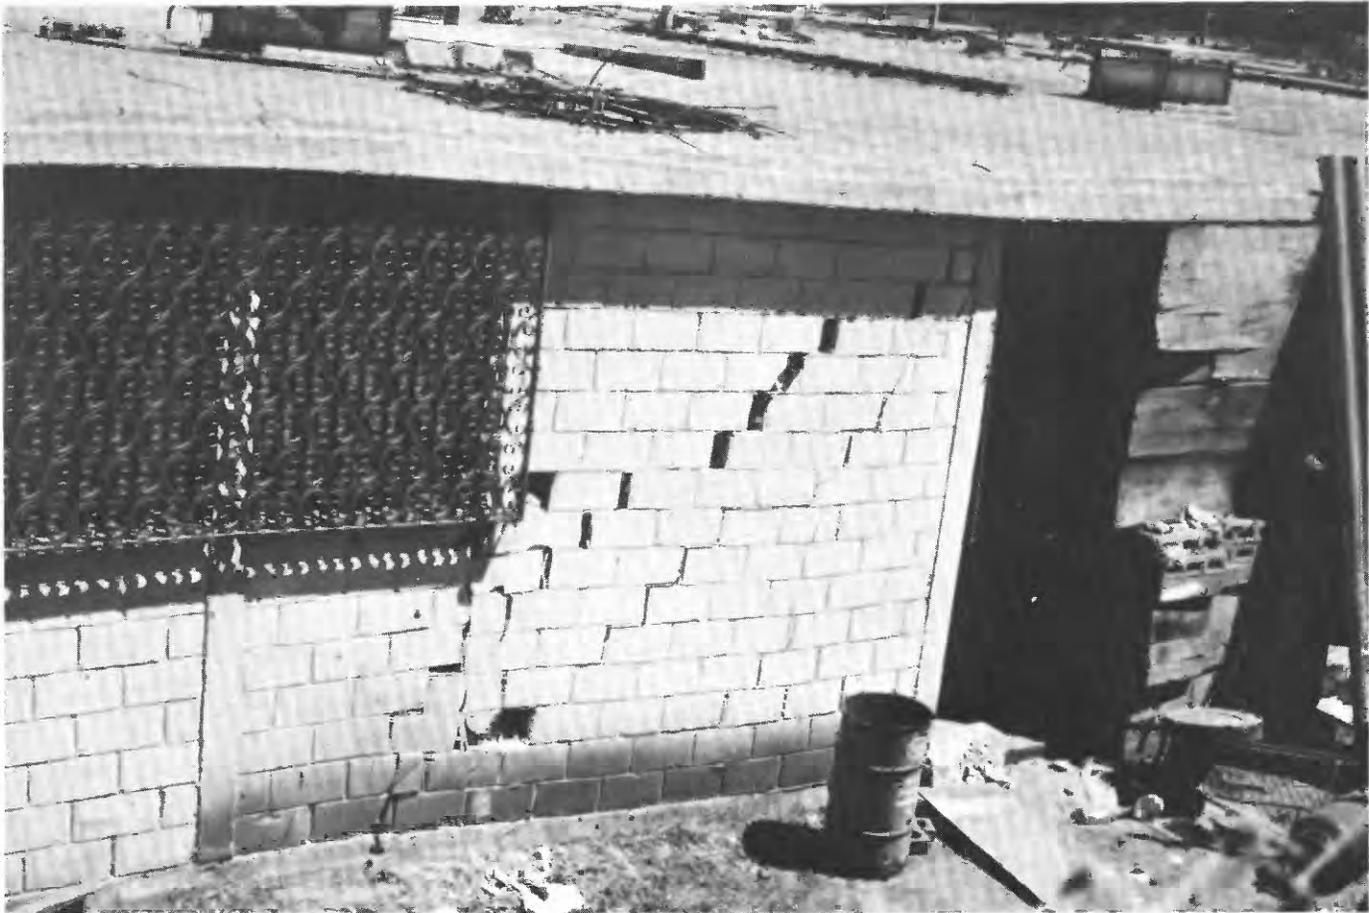
FIGURE 32.—Fault damage to the rear exterior wall and roof of a house in Guatemala City. Vertical displacement near the front of the house was 12 cm.

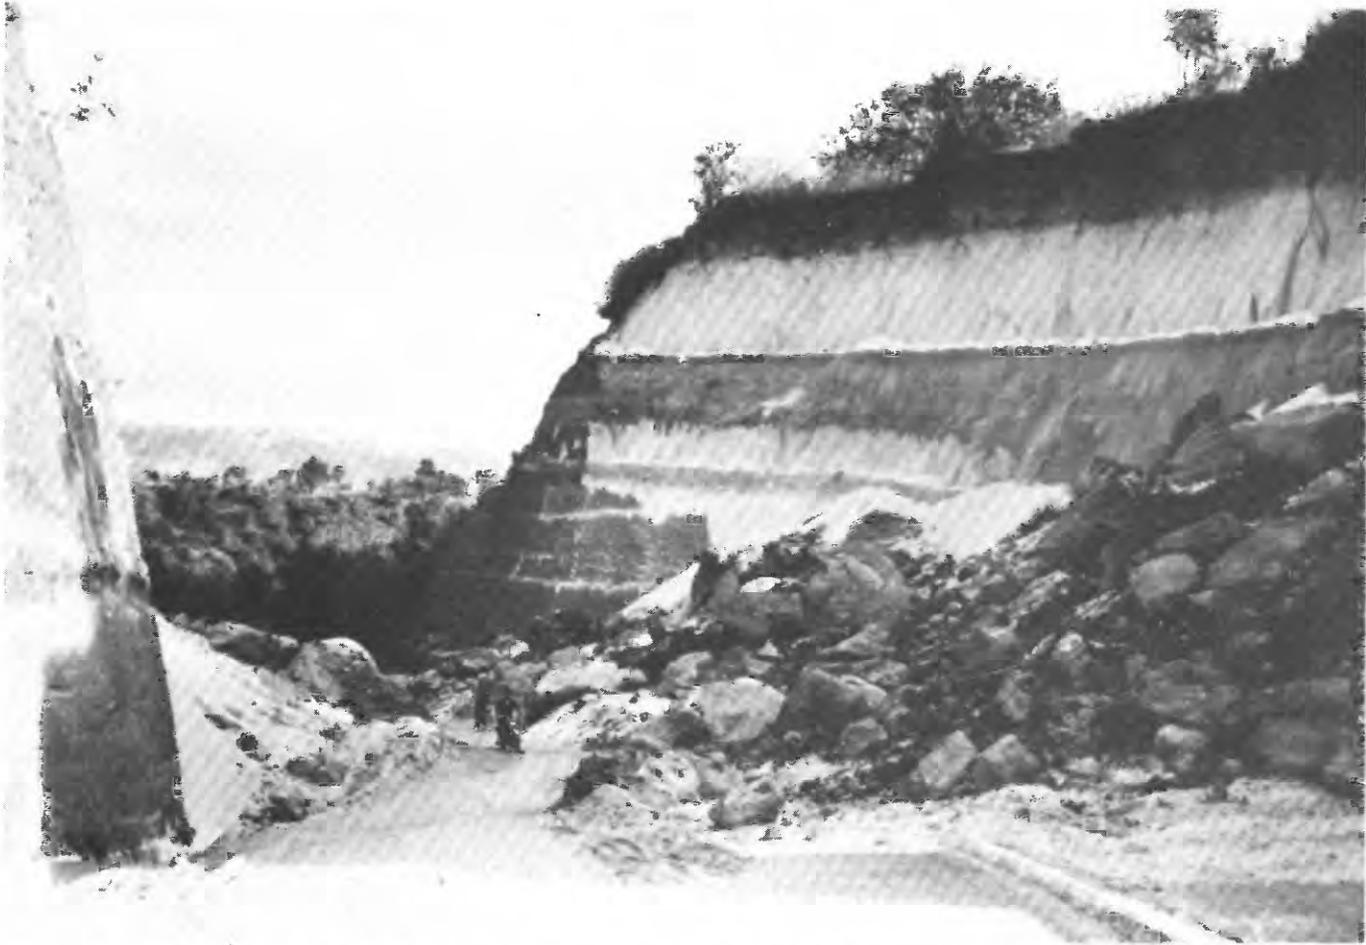
FIGURE 34.—Landslides in steep road cut in stratified pumice and ash deposits at San Cristobal, west of Guatemala City.

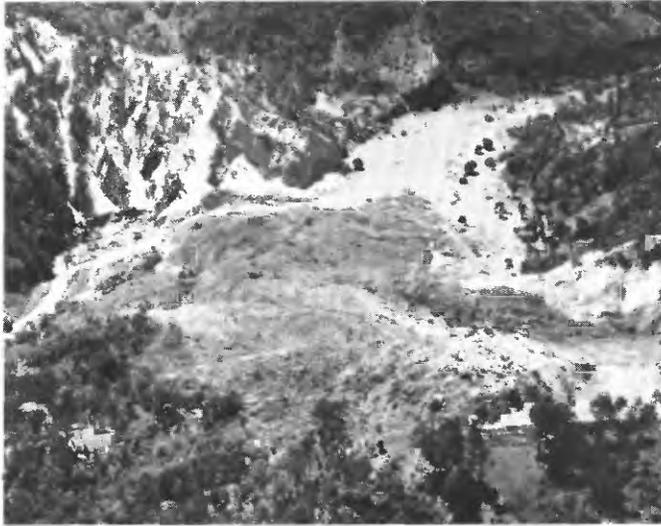
FIGURE 37.—Landslide-dammed lake along Río Pixcayá. The toe of the dam had been breached by the river by the time this photograph was taken on February 13.

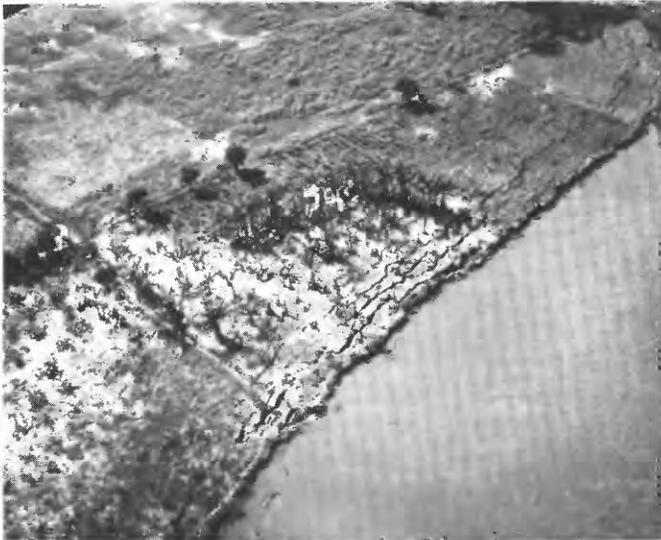
FIGURE 38.—Aerial view of ground cracks and sand mounds (white patches) in unconsolidated alluvial deposits along the Motagua River north of Quebradas in the lower Motagua Valley. Ground cracks are believed to result from liquefaction of water-saturated sediments and spreading towards the river channel.

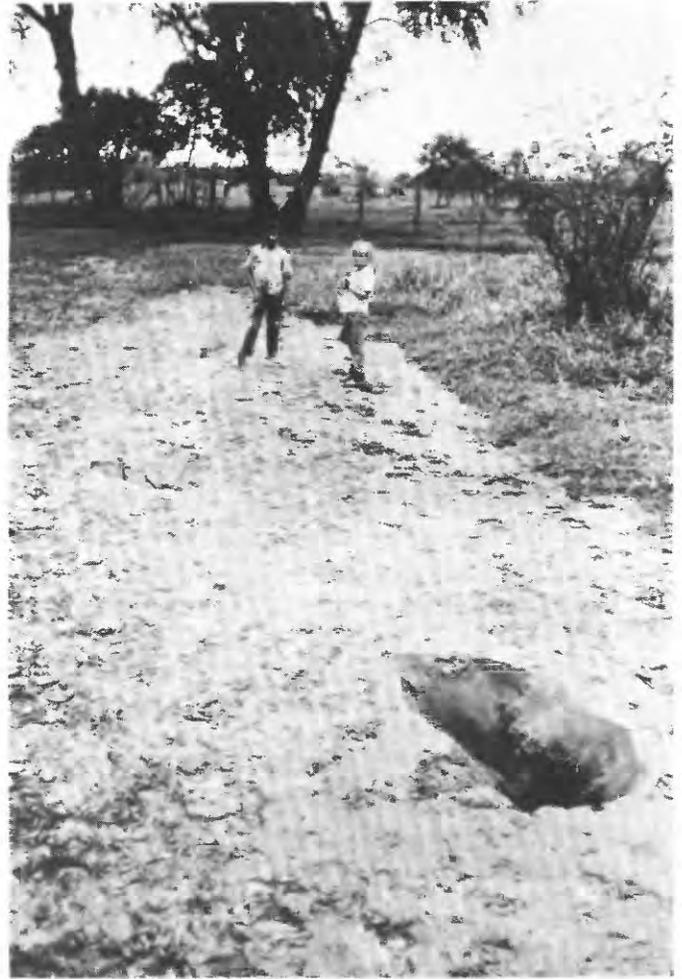
FIGURE 39.—View of linear sand mounds and circular to elliptical craters in area of water-saturated unconsolidated deposits along the Motagua River.

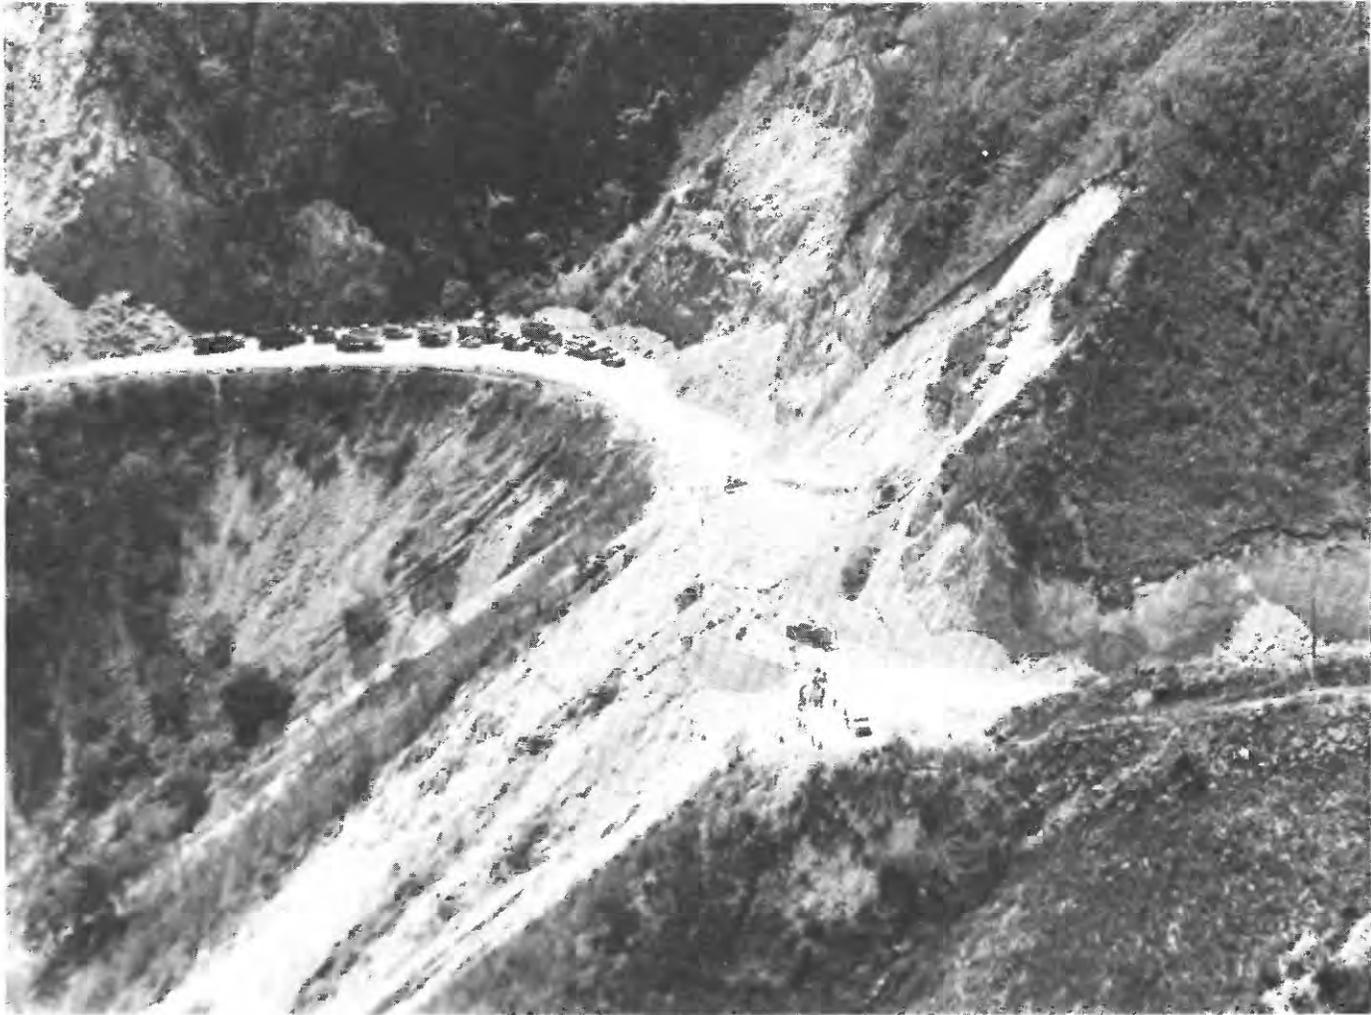
FIGURE 41.—One of the many landslides obstructing the main highway from Guatemala City toward El Progreso.

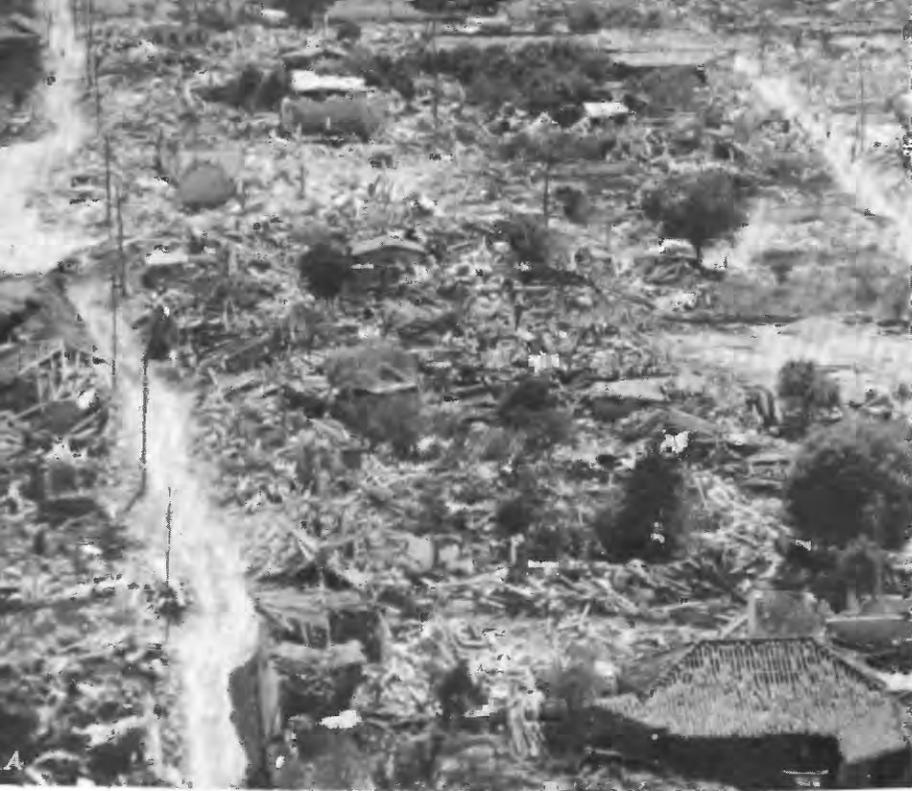
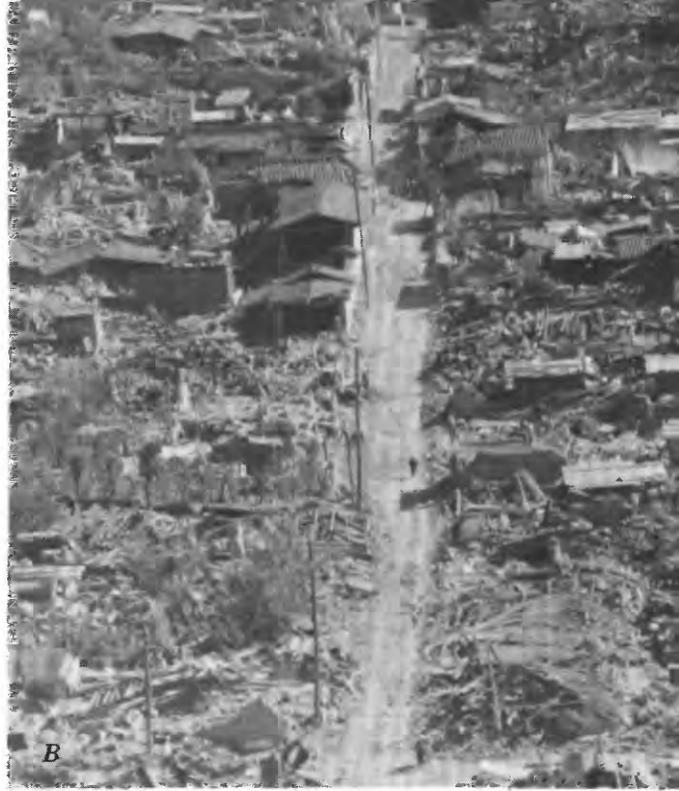
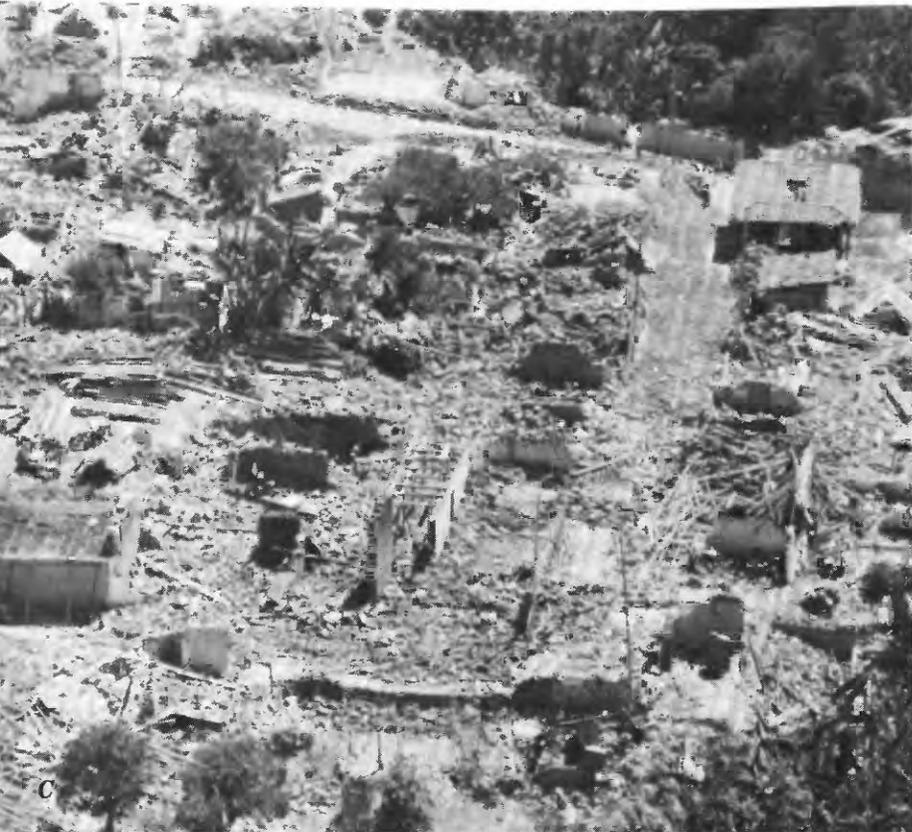
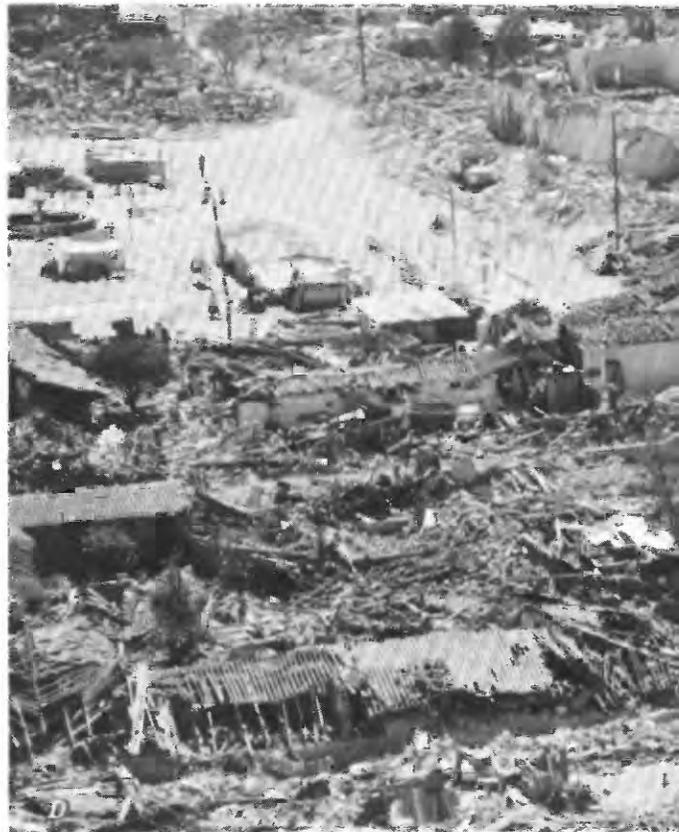
FIGURE 46.—Photographs showing the sustained damage in the towns of: A, Joyabaj; B, Comalapa; C, Tecpan; and D, San Martin Jilotépeque.

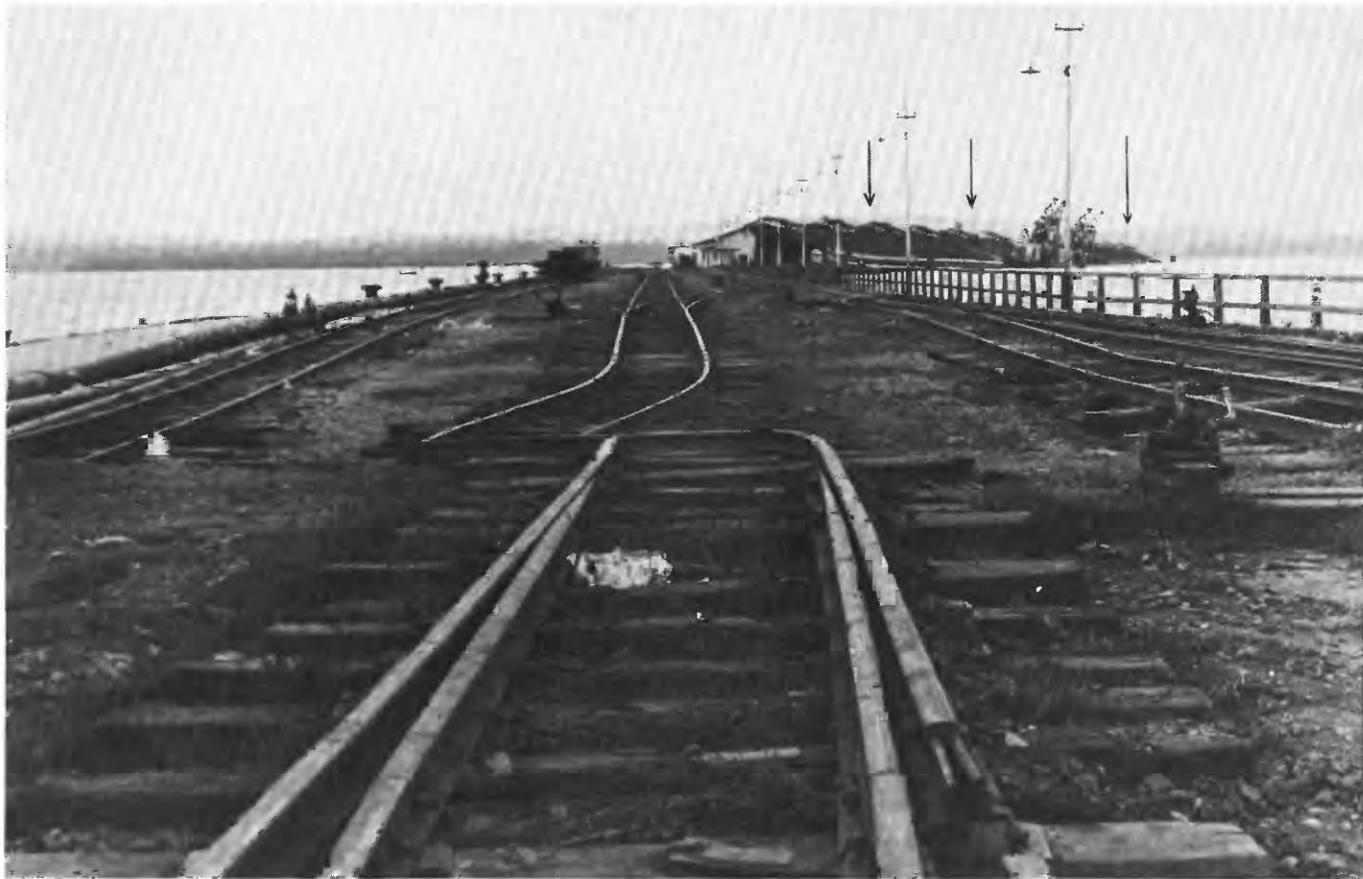
FIGURE 47.—Puerto Barrios wharf, Department of Izabal, destroyed by February 4 earthquake. Arrows show large warehouse partially submerged. See figure 40 for location of town.

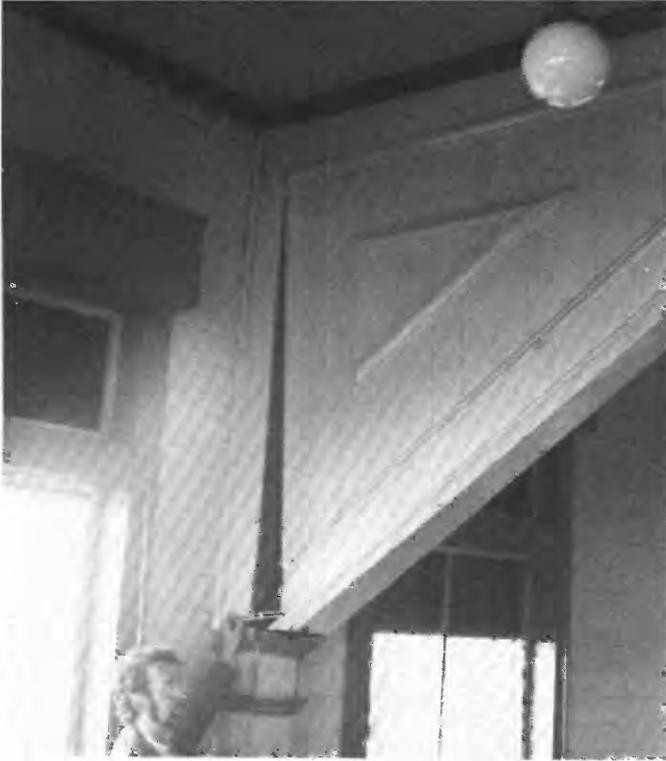
FIGURE 51.—Damage to a wooden structure in Puerto Barrios, caused in part by ground compaction. Note the large offset of 11 cm shown in the photograph.

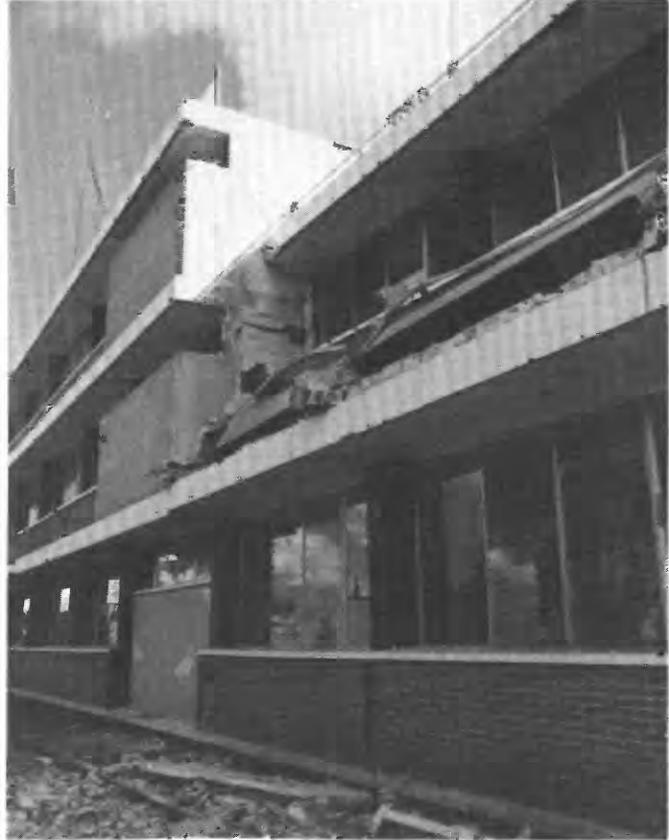
FIGURE 52.—Collapse of the second story of a building at the Colegio San Javier (Zone 12), Guatemala City.

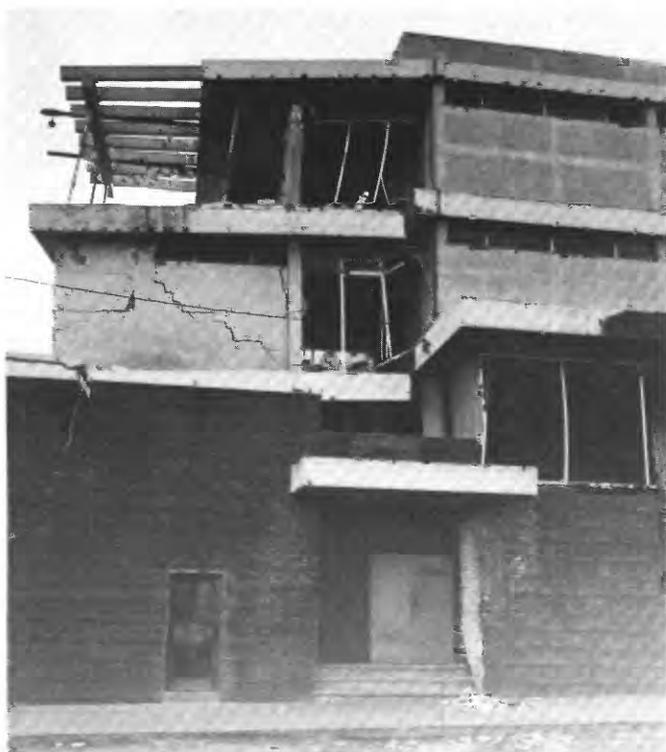
FIGURE 53.—Partial collapse of a three-story reinforced-concrete structure due to failure of columns in its second floor (Zone 12), Guatemala City.

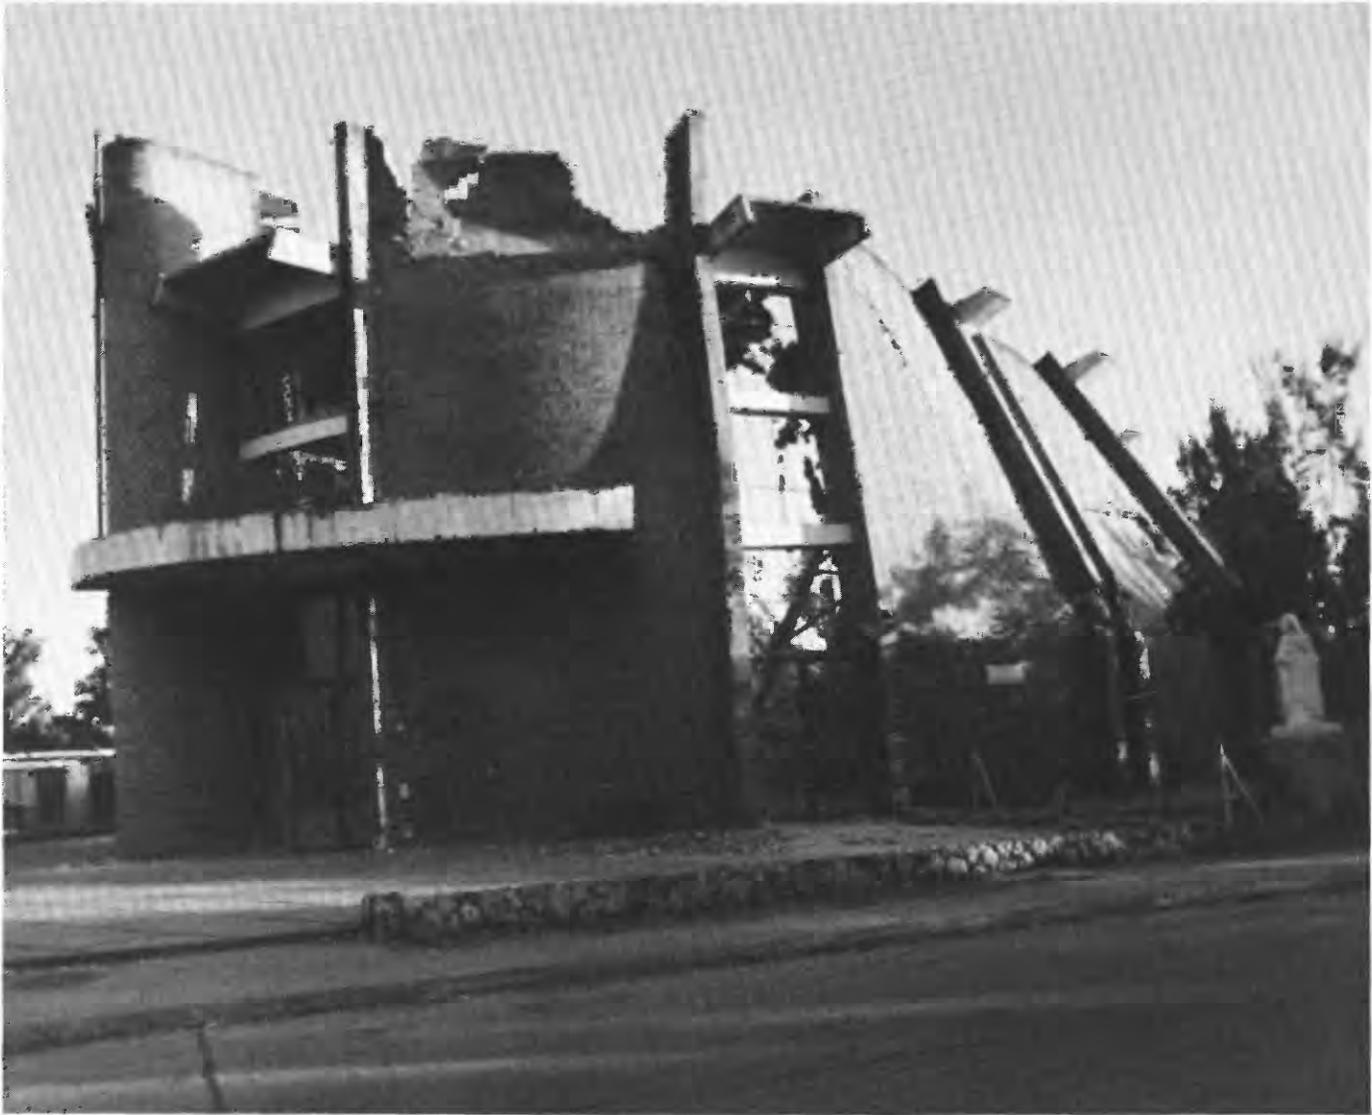
FIGURE 54.—Collapse of a new church, Iglesia del Divino Redentor, Guatemala City (Zone 11).

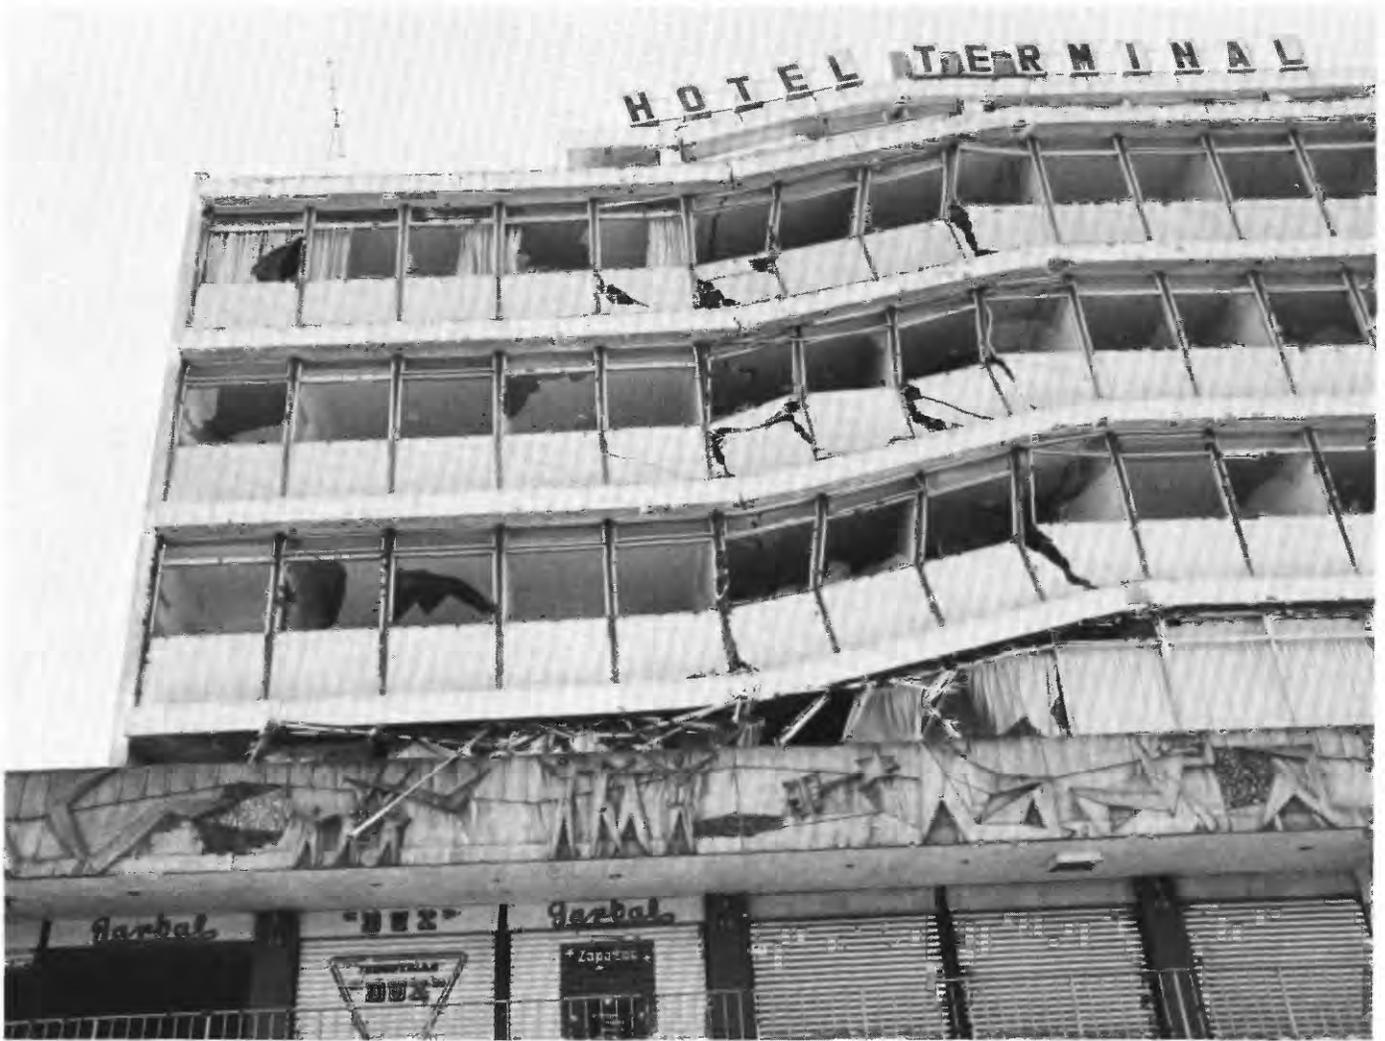
FIGURE 55.—Collapse of the Hotel Terminal, caused by the failure of reinforced-concrete columns in its third story. This building is located in Guatemala City (Zone 4).

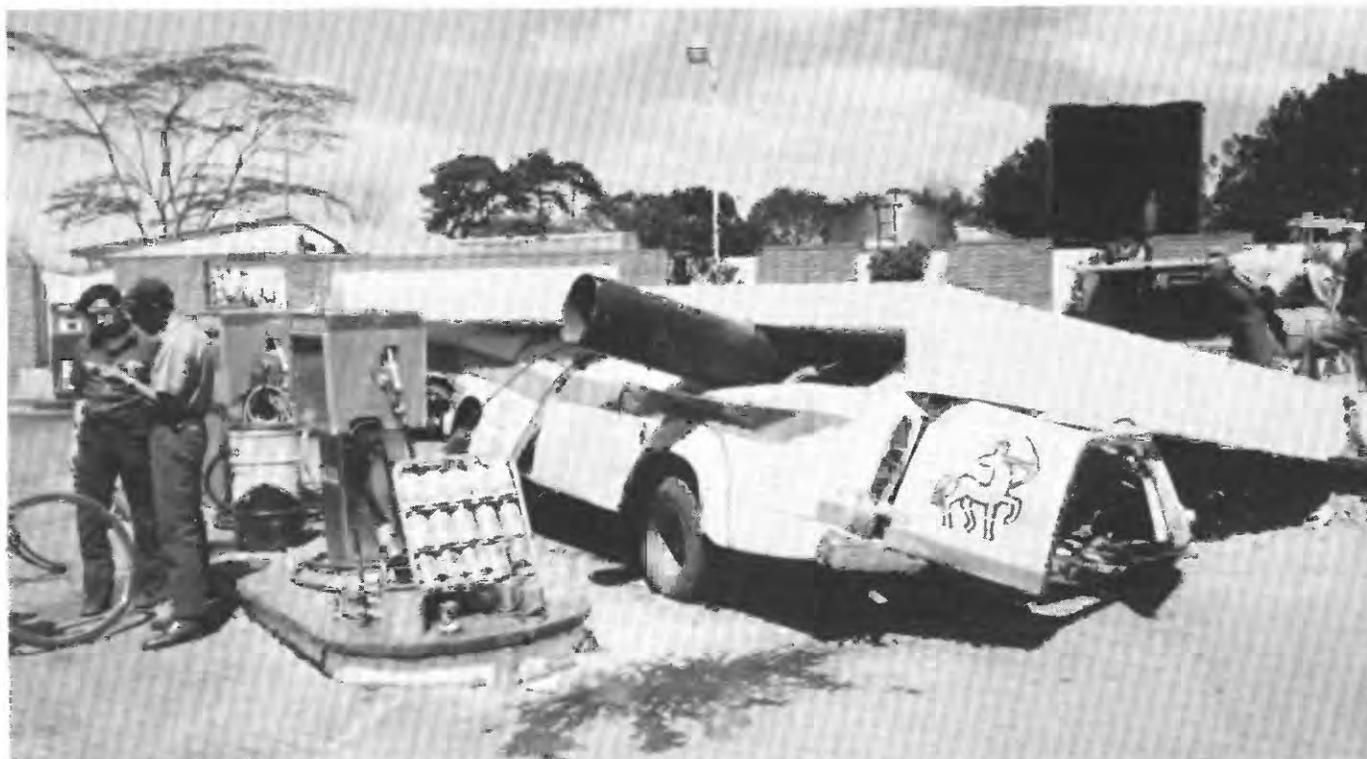
FIGURE 56.—Collapse of inverted-pendulum gas-station structure, Guatemala City (Zone 7).

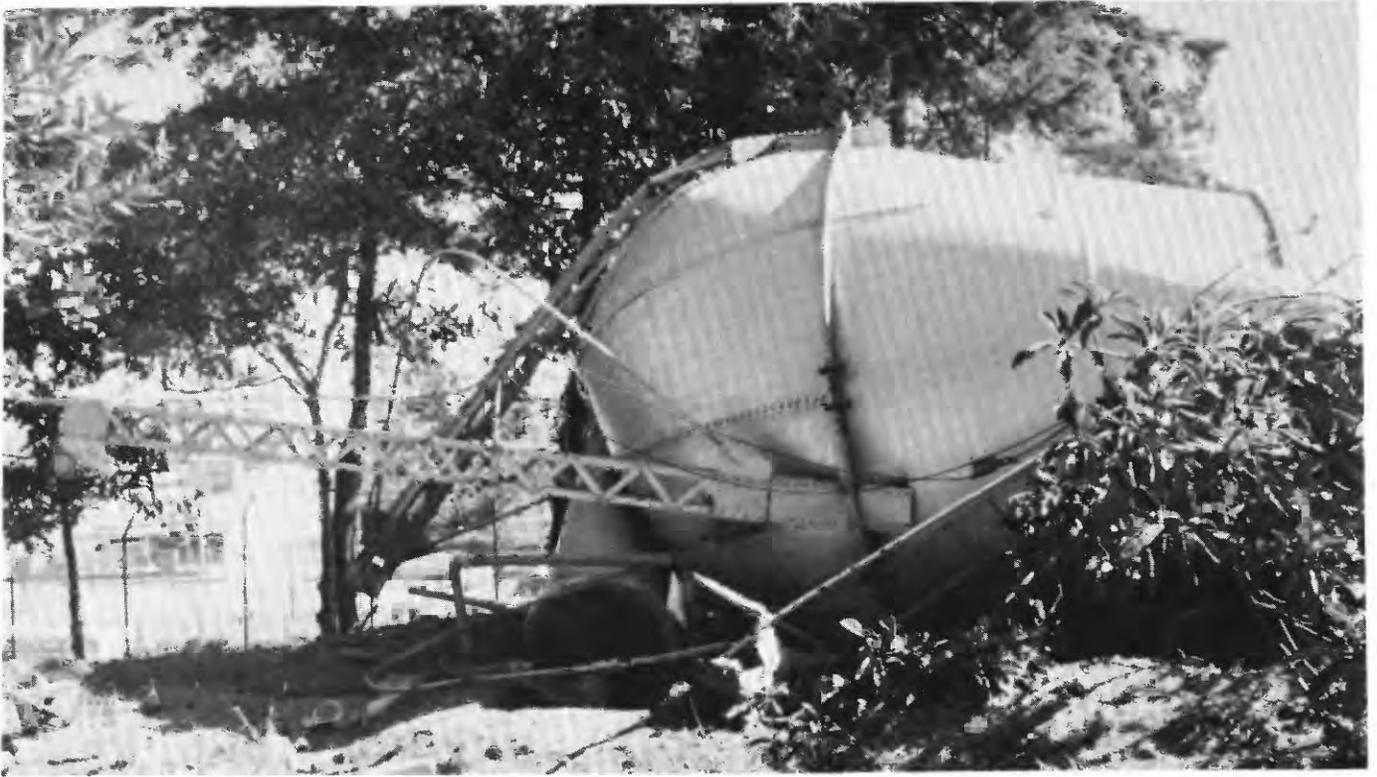
FIGURE 57.—Collapse of an elevated steel water tank in the Instituto Técnico Vocacional in Guatemala City (Zone 13).
