# THE GUATEMALAN EARTHQUAKE OF FEBRUARY 4, 1976, A PRELIMINARY REPORT

GEOLOGICAL SURVEY PROFESSIONAL PAPER 1002

A. F. ESPINOSA, EDITOR

*A preliminary report of a series of  
closely related studies of the  
destructive Guatemalan earthquake of  
February 4, 1976*

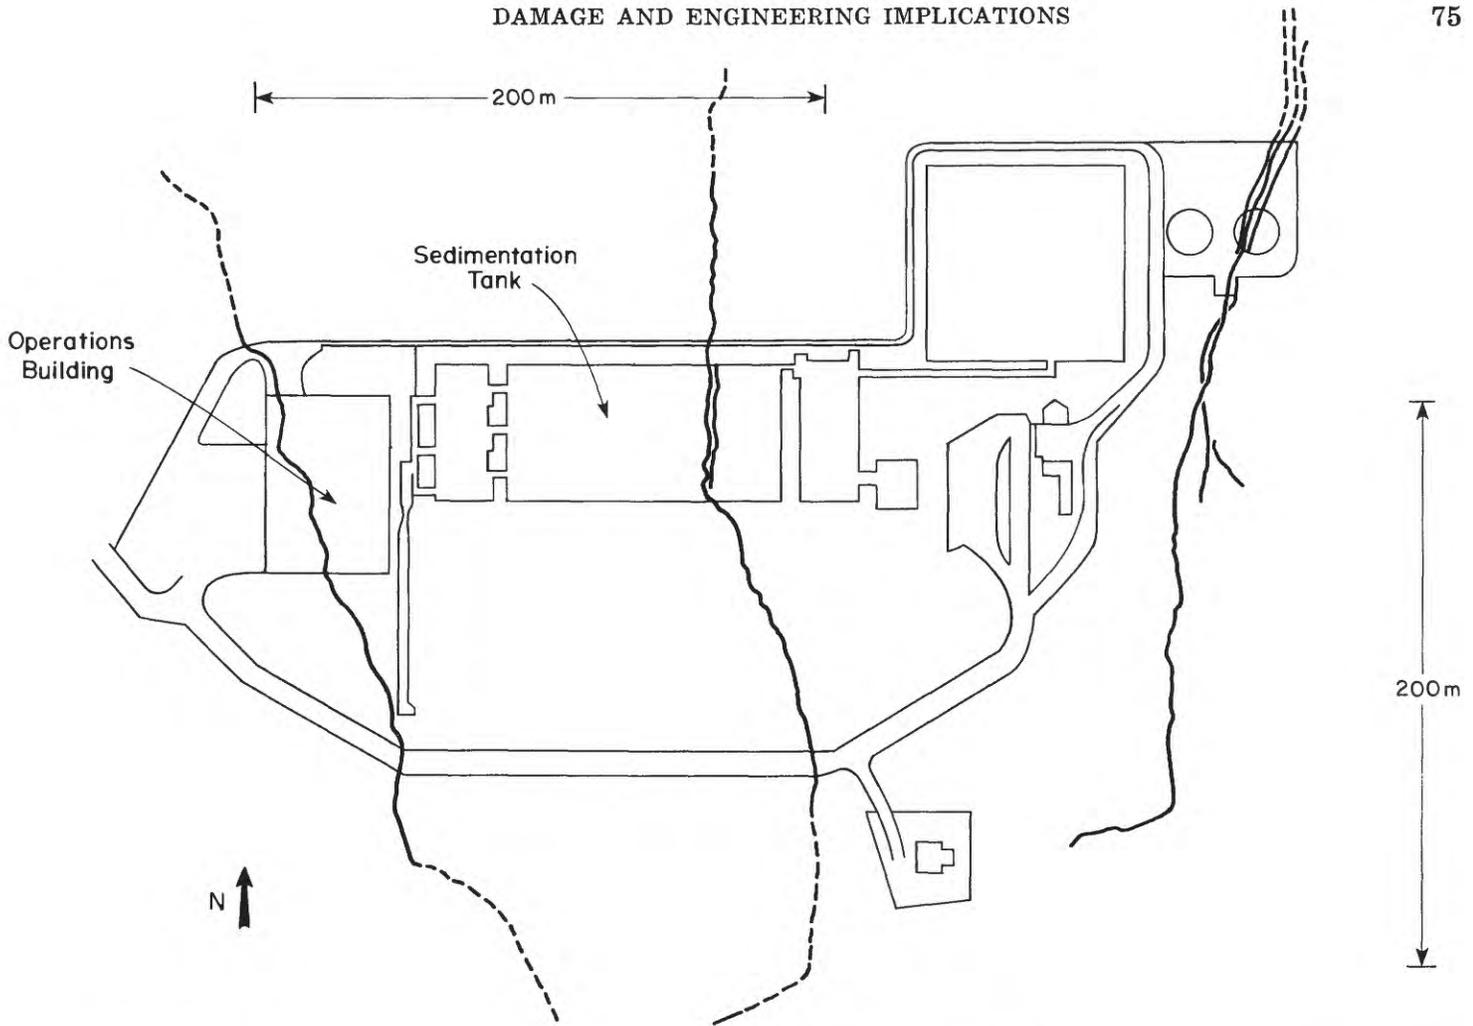
▲ FIGURE 61.—Plan of sedimentation tank and Plant Lo de Coy of the XAYA-PIXCAYA project and cracks (heavy lines) running under and across the sedimentation tank.

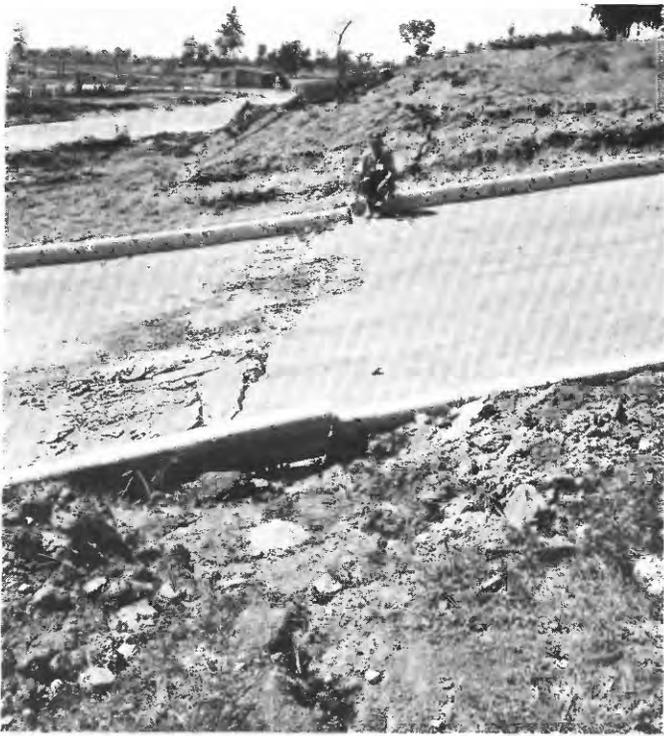
FIGURE 63.—Rupture across the San José Rosario subdivision. Fault with 13 cm vertical and 5 cm right-lateral displacements (Zone 19).

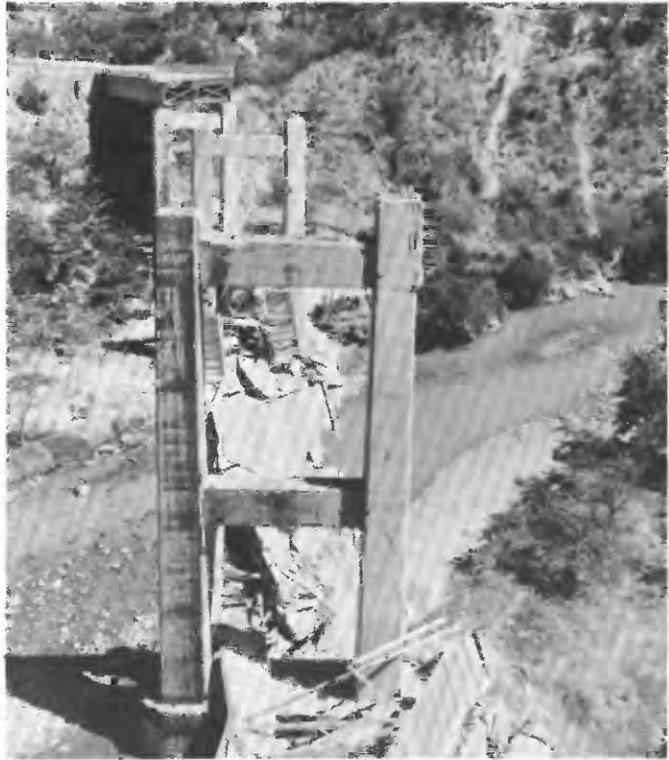
FIGURE 64.—Collapse of three central spans of the Agua Caliente Bridge, Kilometre 36 on the road to the Atlantic Ocean. This bridge was constructed in 1959.

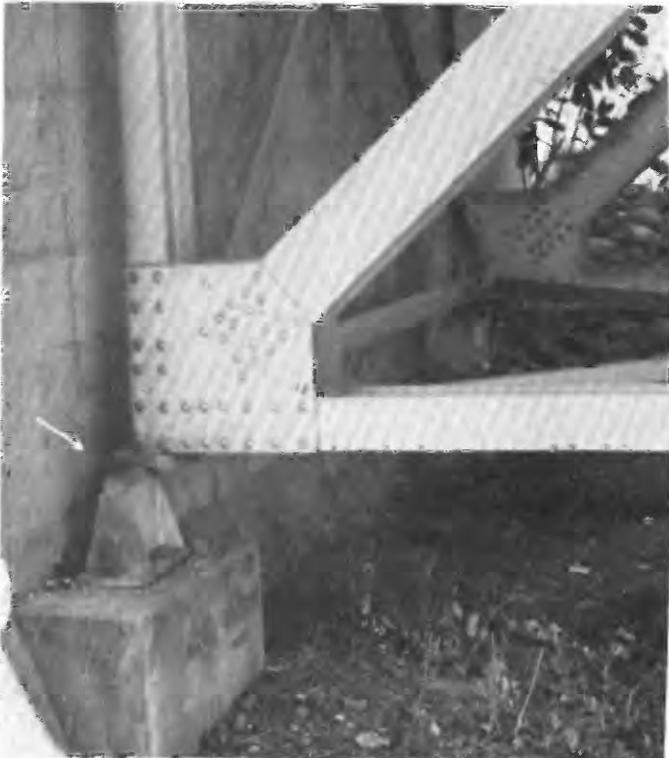
FIGURE 65.—Benque Viejo Bridge, on the verge of collapse after failure of supports, shown by arrow.

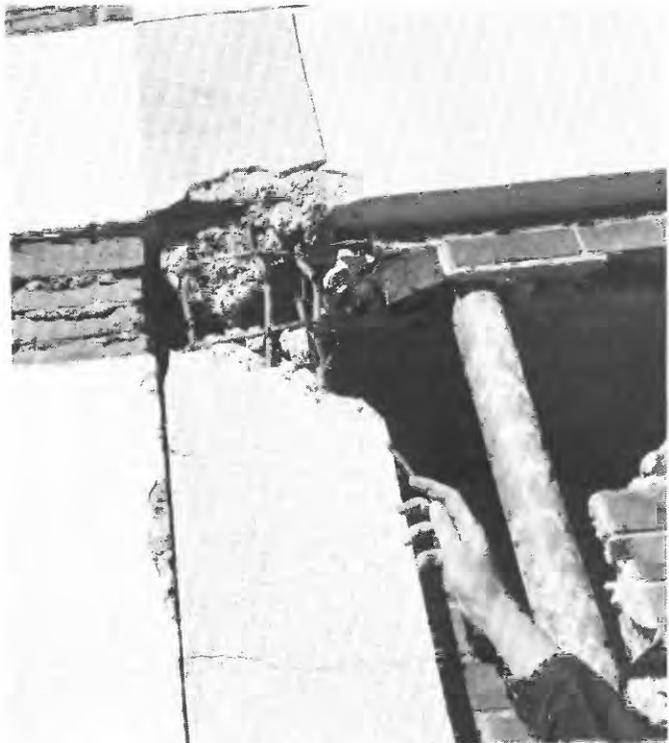
FIGURE 66.—Failure of short column in three-story framed reinforced-concrete structure in Guatemala City (Zone 7).

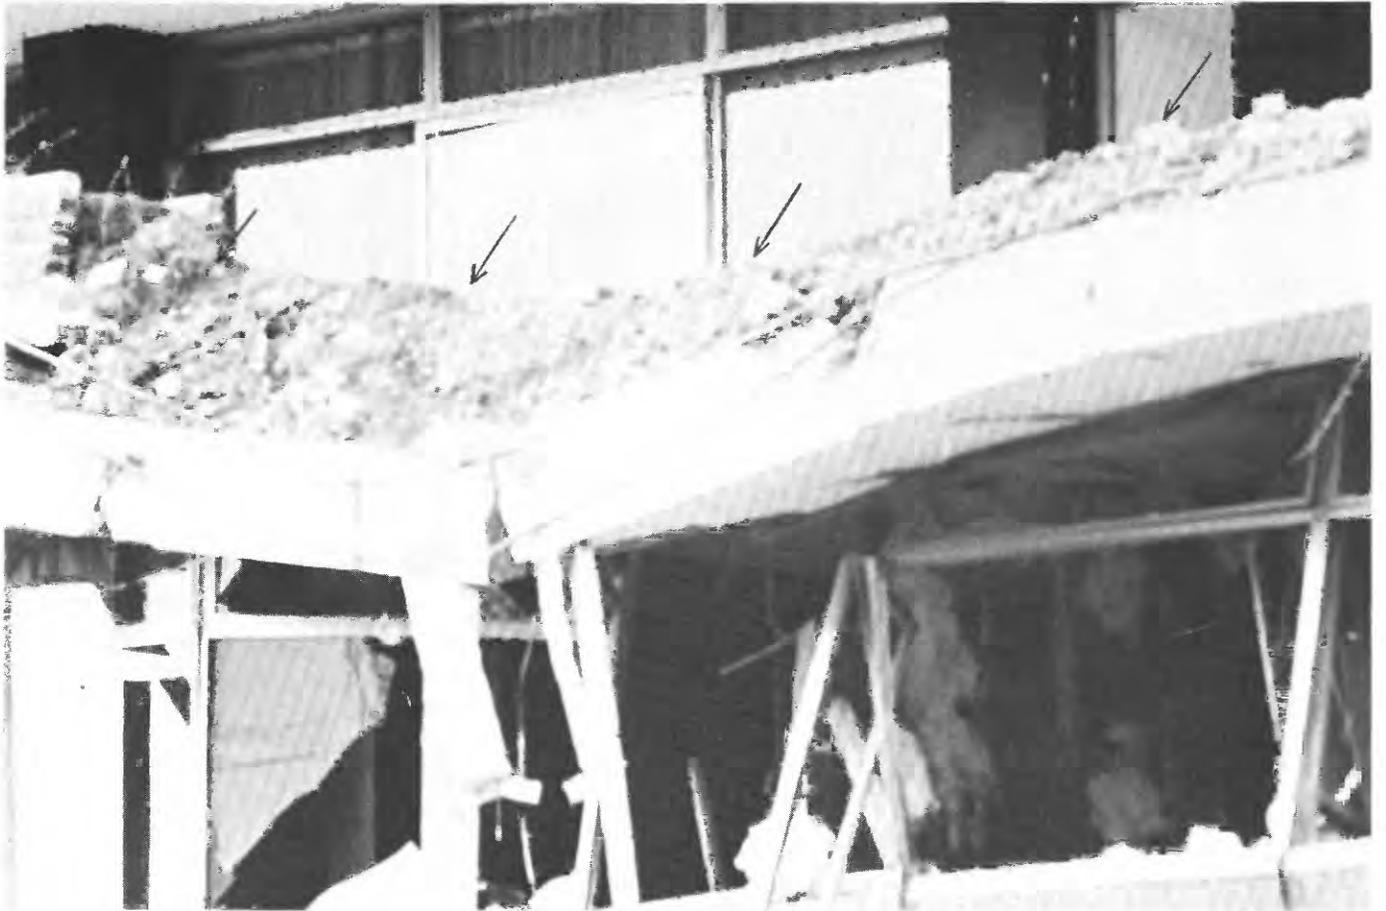
FIGURE 67.—Partial collapse of protruding first-story structure of the Cruz Azul 11-story reinforced-concrete building caused by falling (shown by arrows) of masonry walls from the two topmost stories, in Guatemala City (Zone 1).

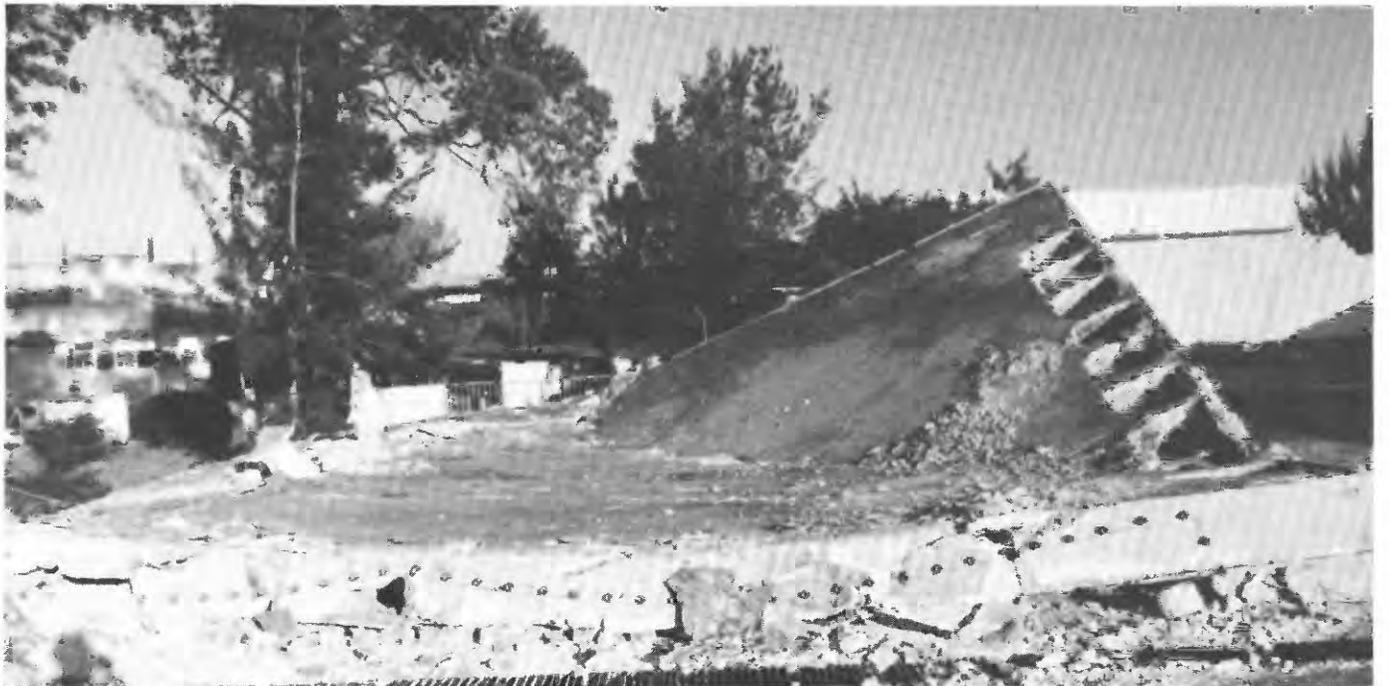
FIGURE 68.—Collapse of one-story reinforced-concrete framed structure in the Licorera Mixco, Mixco.

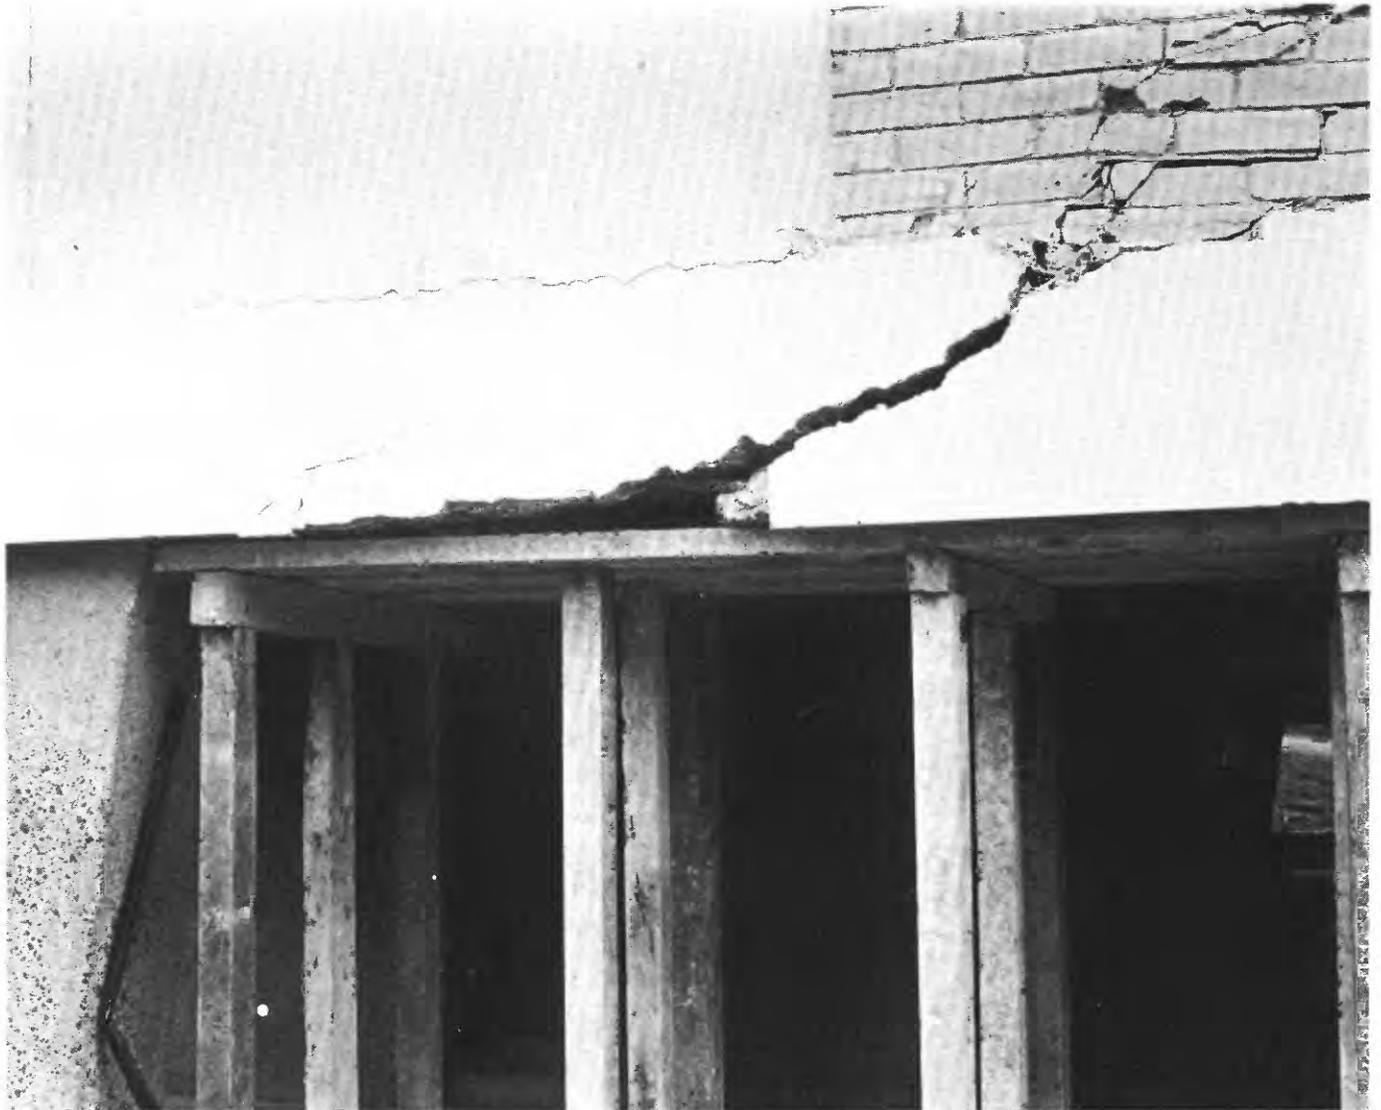
FIGURE 70.—Severe damage to flat beams and slab in the five-story reinforced-concrete Edificio ELGIN, in Guatemala City (Zone 14).

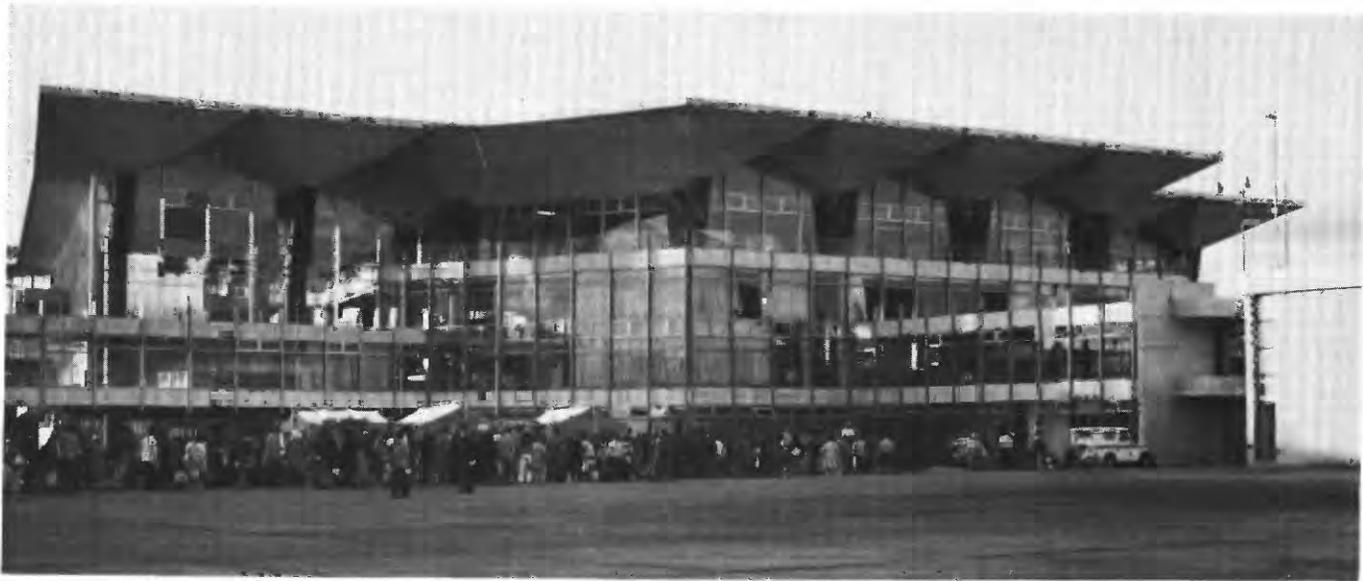
FIGURE 72.—International Airport at Guatemala City. Note that some windows are broken.

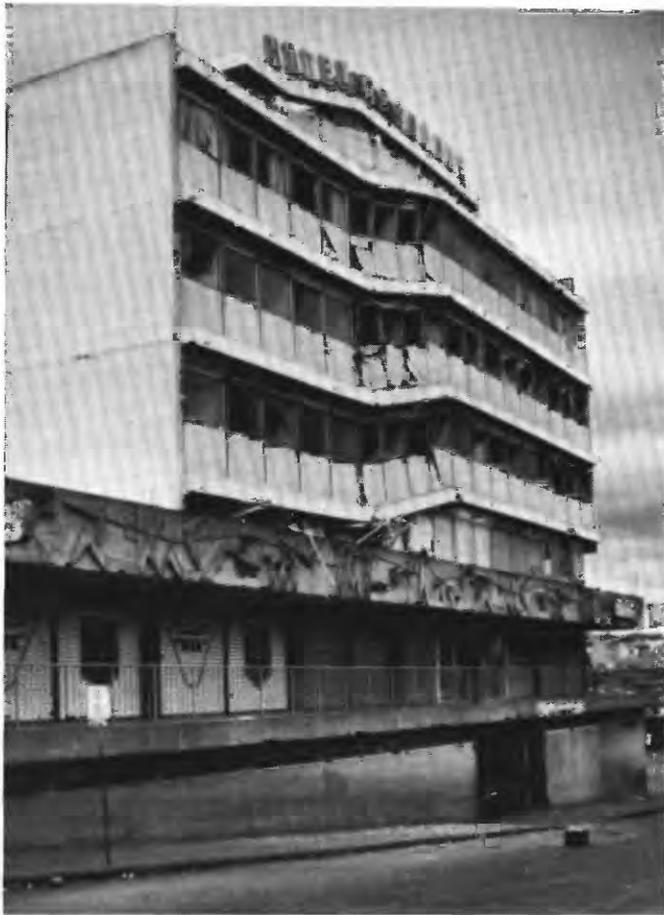
FIGURE 73.—Hotel Terminal in Guatemala City. Columns in third story collapsed.

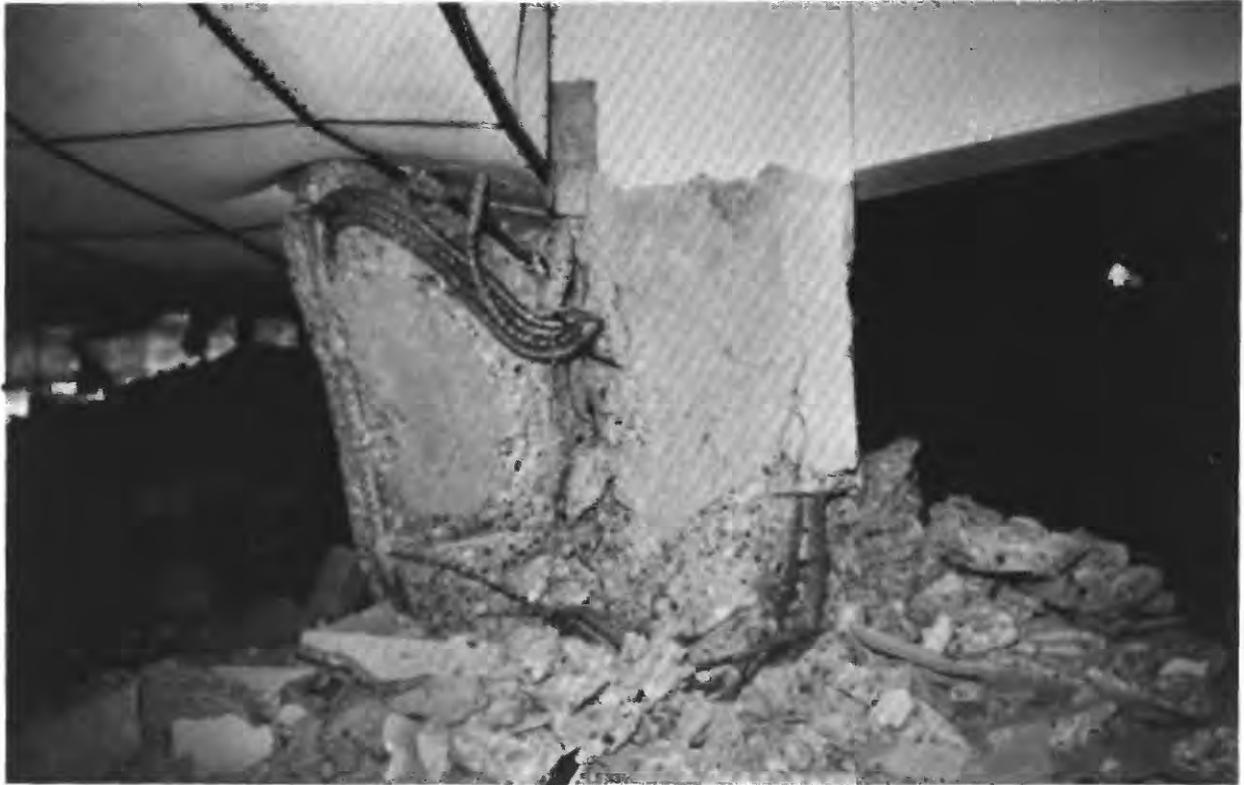
FIGURE 74.—Typical collapsed column in Hotel Terminal.

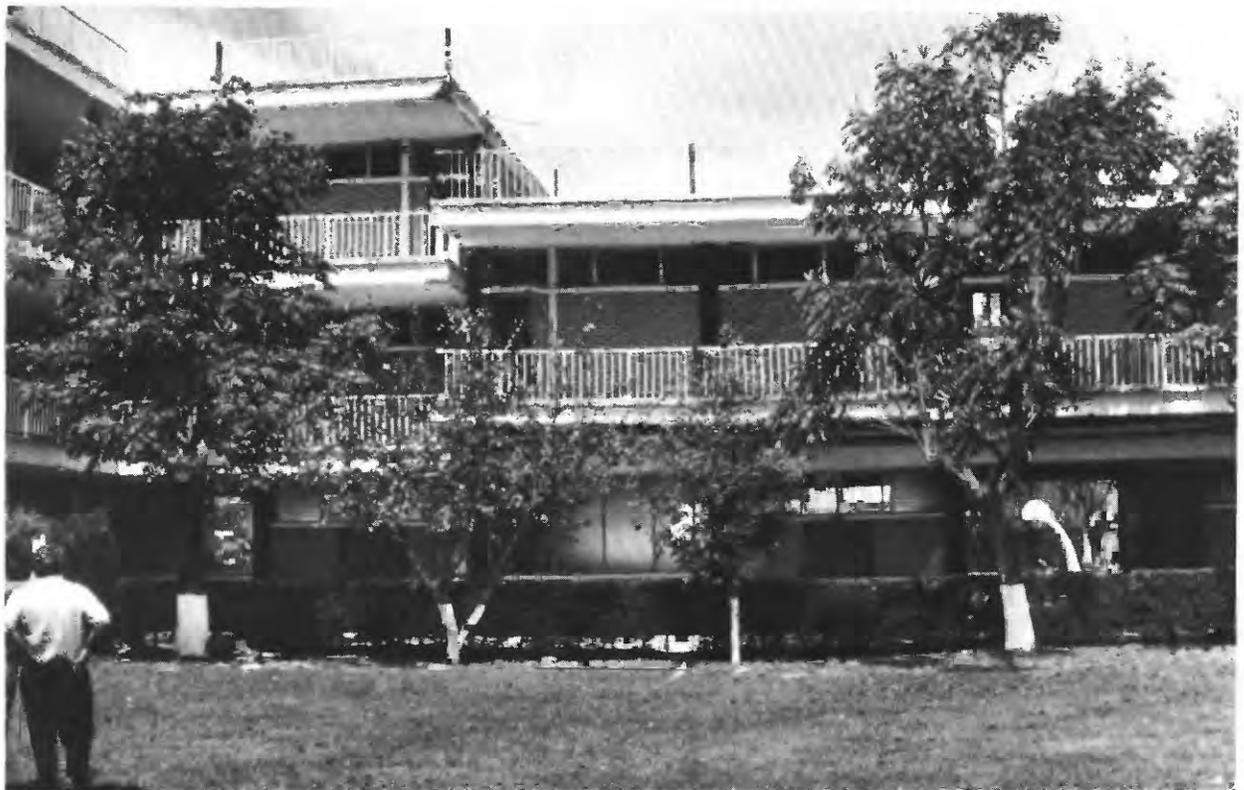
FIGURE 75.—Collapsed second story in one unit of the Catholic Boys School in Guatemala City. Roofs were originally at the same level.

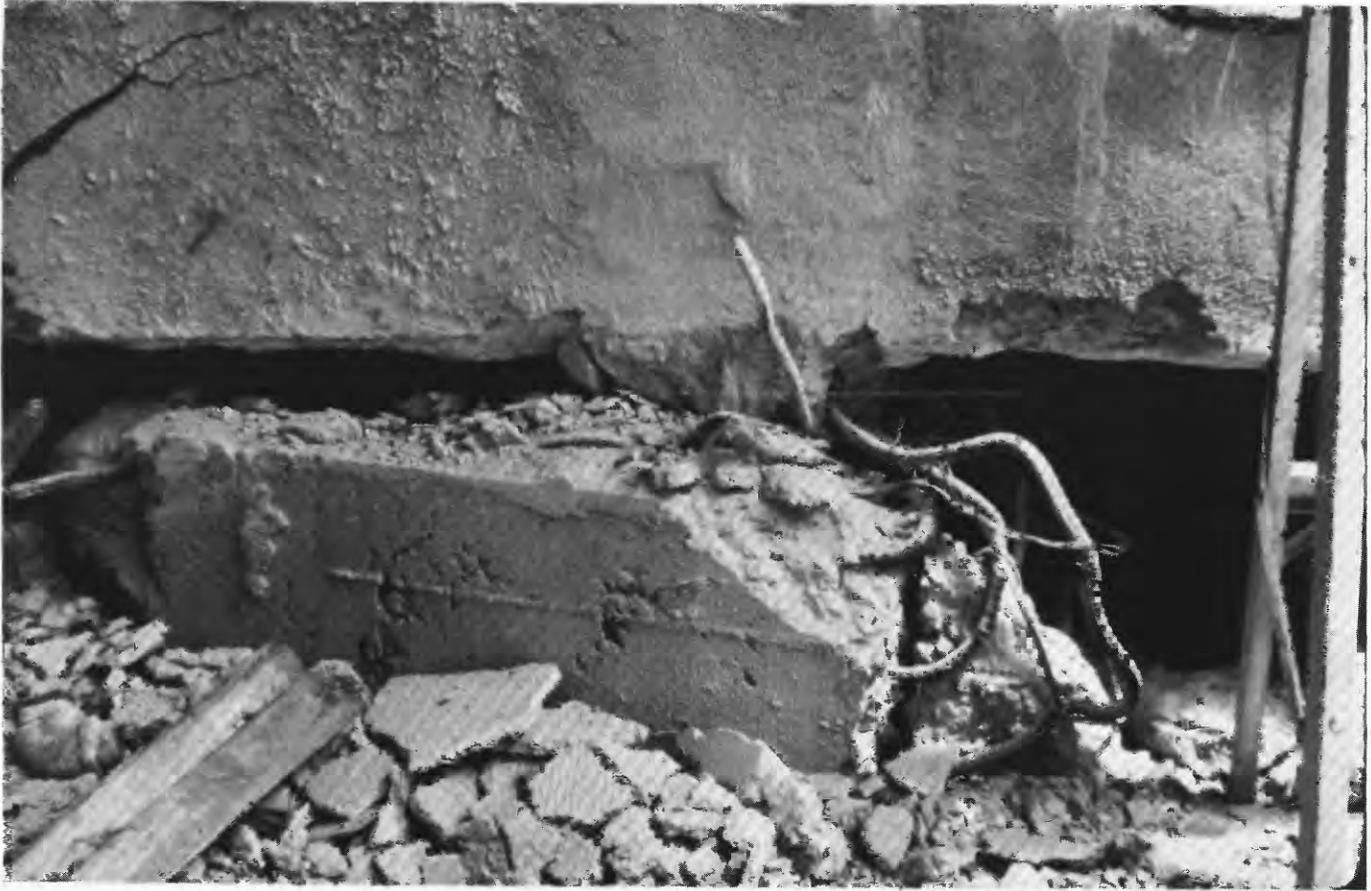
FIGURE 76.—Detail of column failure in second story at the Catholic Boys School. Story height now measured in inches.
