THE GUATEMALA EARTHQUAKE OF FEBRUARY 4, 1976

LANDSLIDES FROM THE FEBRUARY 4, 1976, GUATEMALA EARTHQUAKE

GEOLOGICAL SURVEY PROFESSIONAL PAPER 1204-A

*A description of the largest landslides,
a discussion of failure mechanisms, a
mapping of landslides throughout most of
the landslide-affected area, and a
mapping of landslide concentration in
the Guatemala City area*

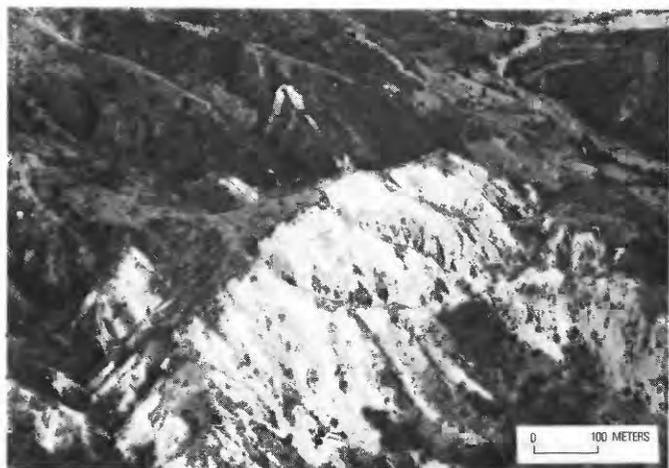
FIGURE 4.—Pumice slopes near Río Motagua, about 25 km north of Guatemala City, on which extensive failures and coalescence of debris slides occurred. Most slides are shallow, typically thinner than 1 m.

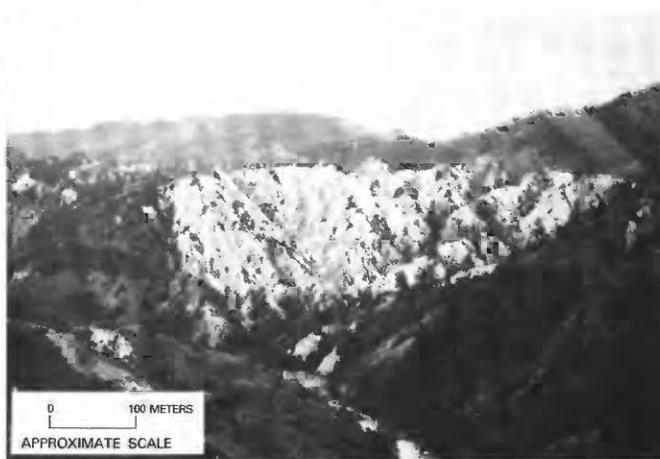
fragments of weathered pumice and includes small amounts of clay. At the time of the earthquake, the soil was dry. Failure occurred by decoupling at or near the soil/bedrock interface, and subsequent movement took place by sliding along this discontinuity. Where the debris was partially held together by thin topsoil and vegetation, soil debris did not slide more than a few meters. However, most debris slides disaggregated into sand-size fragments and formed small debris avalanches (fig. 6).

FIGURE 6.—Shallow debris slides in pumice slopes along Río Motagua; depth of failure averages no more than 0.6 m. Climate in this area of river drainage is arid, and soils formed on pumice here are thin, sandy, and low in clay content.

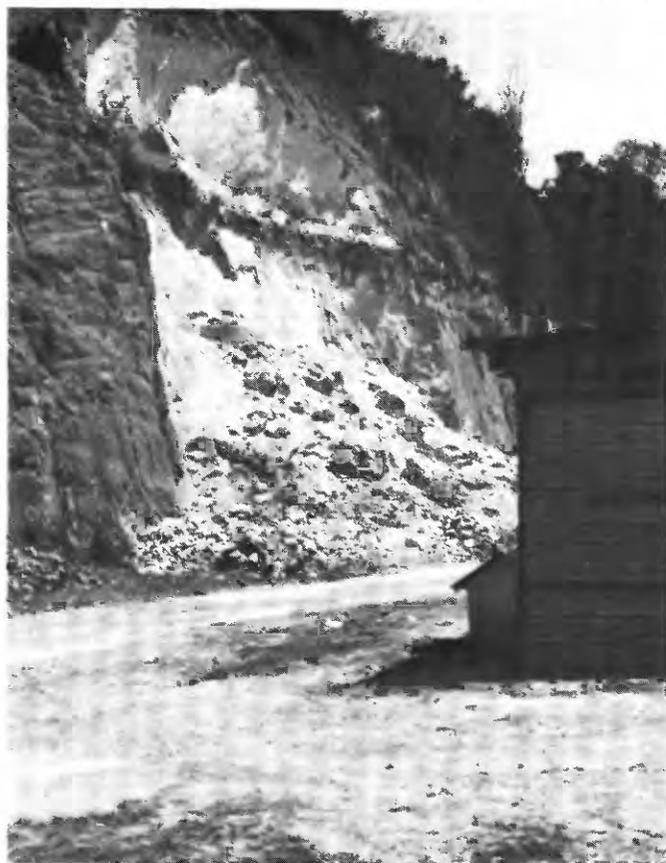
Rock falls were most common where nearly vertical slices of pumice broke away from the upper parts of canyon slopes, commonly near the slope crest. In many places the rock-fall scarp is bounded by nearly vertical cracks. These rock falls were generally thinner than 6 m. Incipient failures as thick as 15 to 30 m were observed in some places where multiple scarps were created near the plateau margins and where one or more thin slices of pumice had fallen, leaving additional blocks on the verge of failure, whose boundaries were defined by extension fractures in the flat plateau surface. As in the debris slides, rock-fall material was generally dry at the time of the earthquake; a typical rock-fall scarp has an irregular more or less concave outward surface (figs. 7, 8).

FIGURE 7.—Typical seismically induced rock fall in pumice deposits along canyon margin near Puente Belize in Guatemala City. Failure is no thicker than 1 to 2 m (normal to canyon face) and is overall concave outward. Unslickensided rock-fall scarp indicates no shear deformation. Such failures were probably caused by tensile spalling, possibly from seismic-wave reflection at free faces.

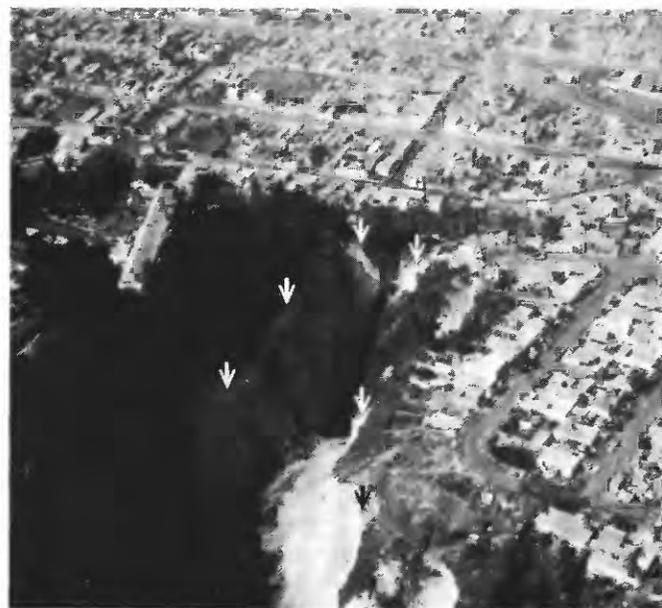
FIGURE 8.—View southward of extensive rock fall on canyon slopes just west of Finca La Verbena in Guatemala City. Rock falls left light scarps (arrows) in pumice cliffs and debris in canyon bottom.

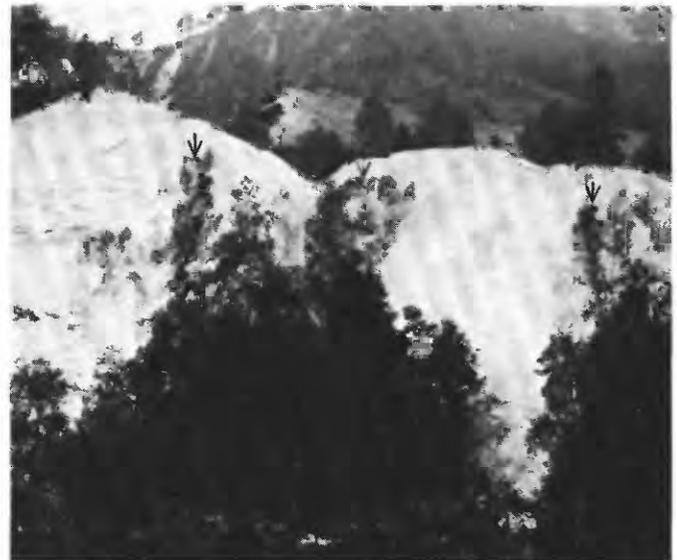
FIGURE 10.—Effects of apparent topographic amplification of seismic ground motion in concentrating rock falls and debris slides on narrow ridges, such as this ridge near Los Chocoyos. Failures were generally shallow; some shrubs and a few trees (arrows) remain on slope.

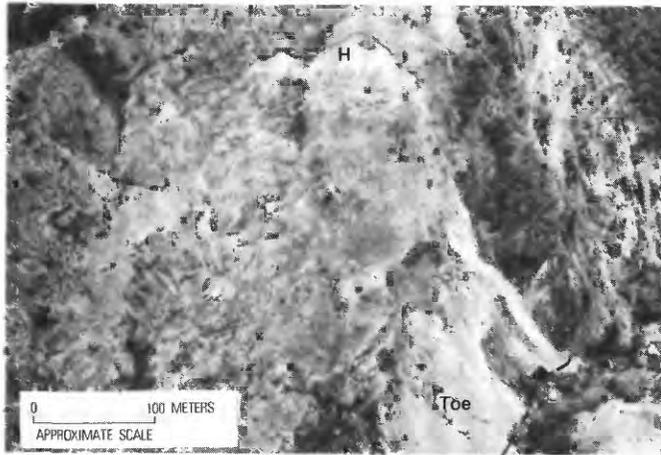
FIGURE 14.—Reactivated preearthquake landslide along Rio Cotzibal. Landslide mass is extensively fractured, but most movement consisted of debris slides from relatively steep toe (lower right, limit marked by dashed line). "H" marks headwall scarp.

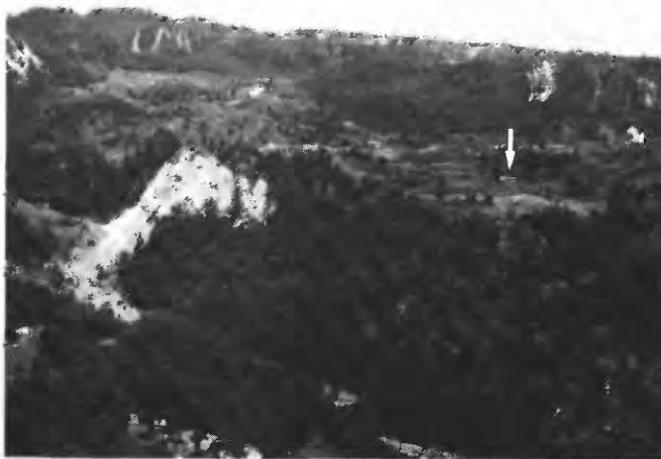
FIGURE 15.—Old landslide complex at Laguneta del Tul, about 40 km northwest of Guatemala City. Rock falls occurred along headwall scarp (ridge on horizon) and at toe near stream (left foreground). Evidence of ground failure in main body of complex is absent. Note house (arrow) for scale.

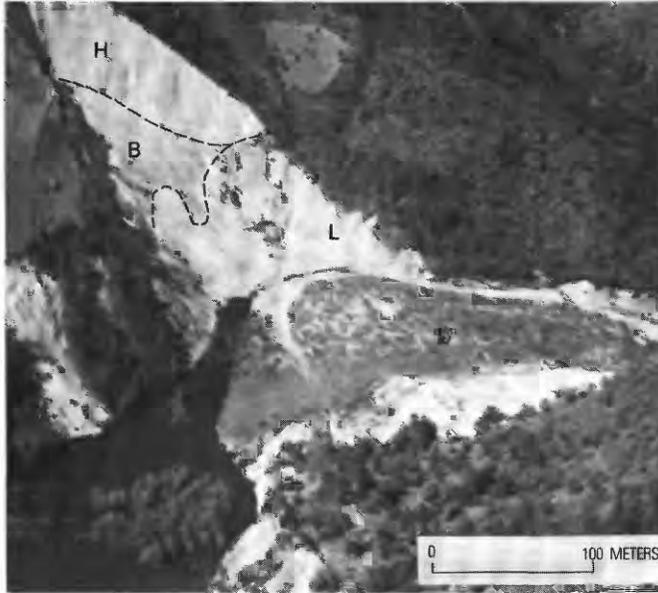
The Los Chocoyos landslide (figs. 16, 17; site 1, table 1) occurred about 15 km southwest of Tecpán, along the steep south wall of the valley of the Río Los Chocoyos. The slide buried two houses and killed six people. The slide mass contained between 0.75×10^6 and 1.0×10^6 m³ of debris, all derived from Pleistocene pumice deposits, primarily the tephra H and the H ash-flow tuff of Koch and McLean (1975). Witnesses to the landslide reported that they heard only one period of loud noise at the same time as the main earthquake shock. This report indicates that movement on the slide was rapid and that nearly all the slide material came down during the main shock.

FIGURE 17.—Los Chocoyos landslide, showing lake (left foreground) created by damming of Río Los Chocoyos. B, basal shear surface; D, landslide debris; H, headwall scarp; L, lateral shear surface.

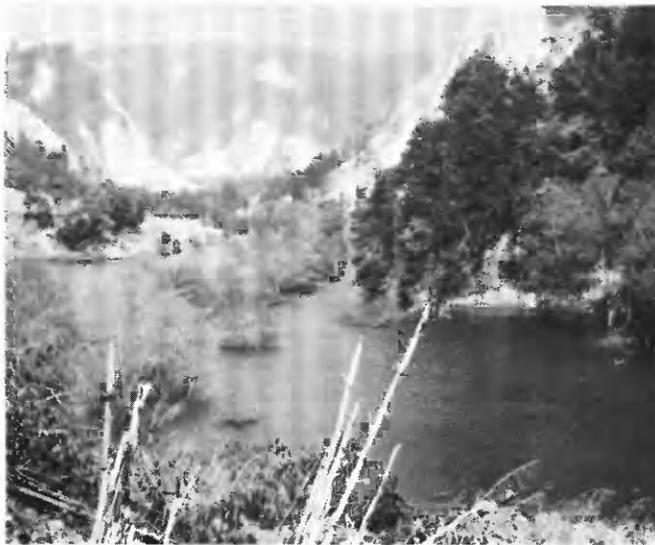
FIGURE 18.—View eastward of lake dammed behind Los Chocoyos landslide, as it appeared in June 1976. Shattered pumice slopes are composed of tephra H and H ash-flow tuff of Koch and McLean (1975).

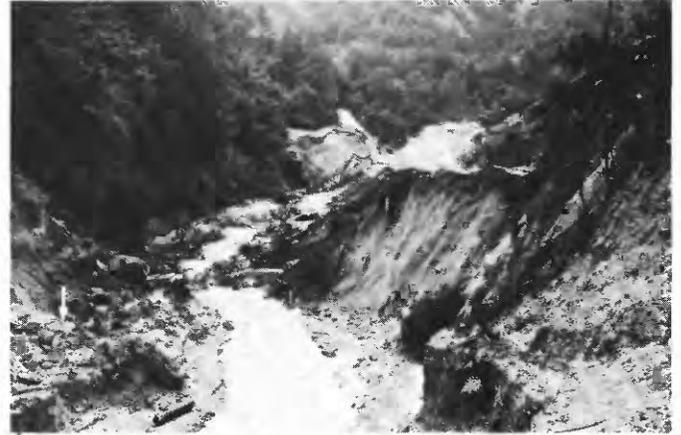
FIGURE 19.—View westward, downstream of channel (about 3 m deep) cut by stream from lake dammed by Los Chocoyos landslide; main body of landslide debris to right. Arrow indicates location of former highway pavement.

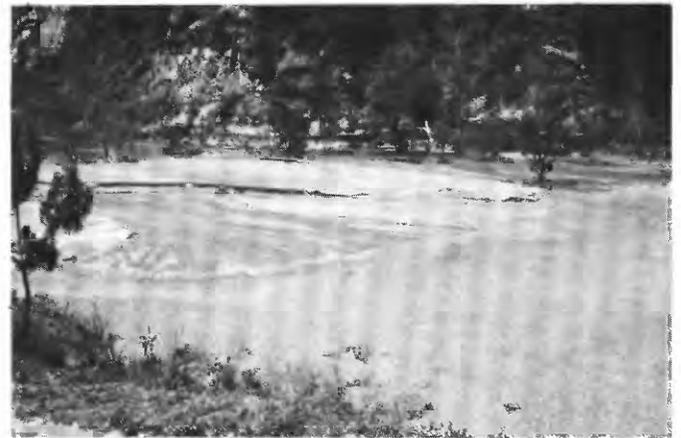
FIGURE 20.—View southeastward of lake dammed by Los Chocoyos landslide, showing level as of June 1976. Trees have been inundated by as much as 2 m of pumice debris derived from slides in river valley.

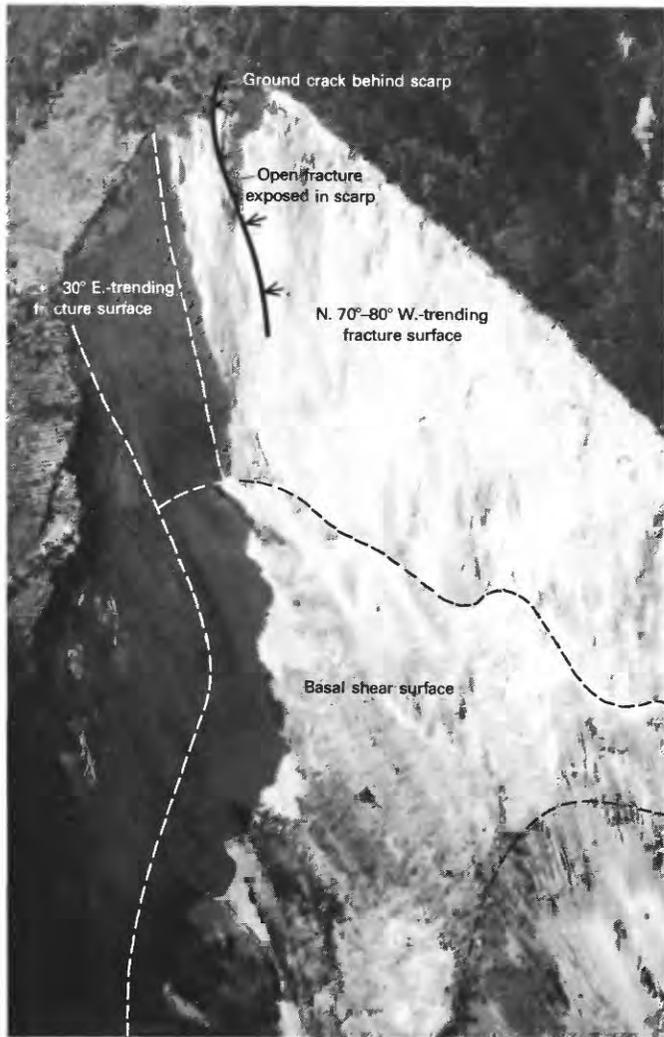
The face of one prominent fracture surface (fig. 21) trends approximately N. 70° – 80° W. and forms the right

The most prominent fracture cutting into the headwall scarp (arrows, fig. 21) extends as a ground

FIGURE 21.—View south-southeastward of headwall scarp (about 60 m high) of Los Chocoyos landslide. Note planar fracture surfaces forming scarp. See text for explanation.

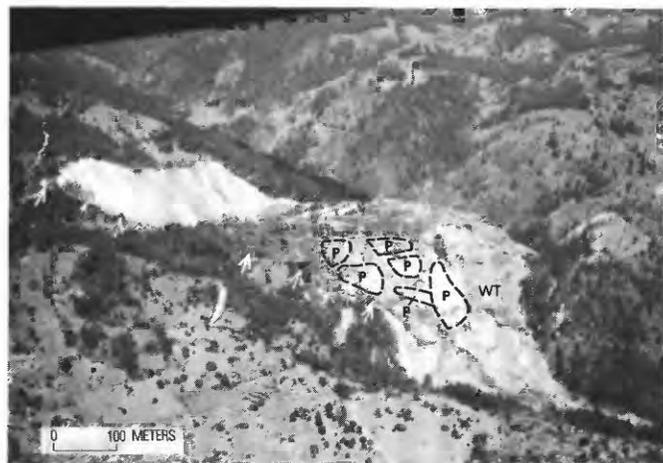
FIGURE 24.—San José Poaquil landslide; arrows denote lateral scarp. P, pumice; WT, welded tuff. See text for explanation.

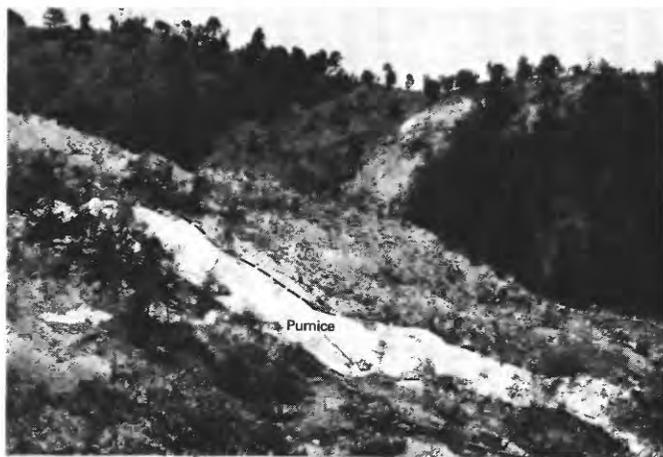
FIGURE 25.—View northwestward of San José Poaquil landslide, showing contrast in color and texture between gray blocky welded tuff and white powdery pumice.

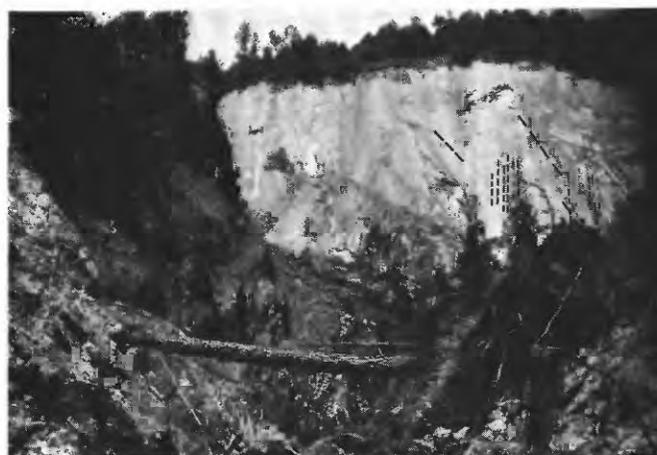
FIGURE 27.—Headwall scarp of San José Poaquil landslide, showing two distinct sets of slickensides (dashed lines), one indicating dip slip, and the other oblique movement along plane of scarp.

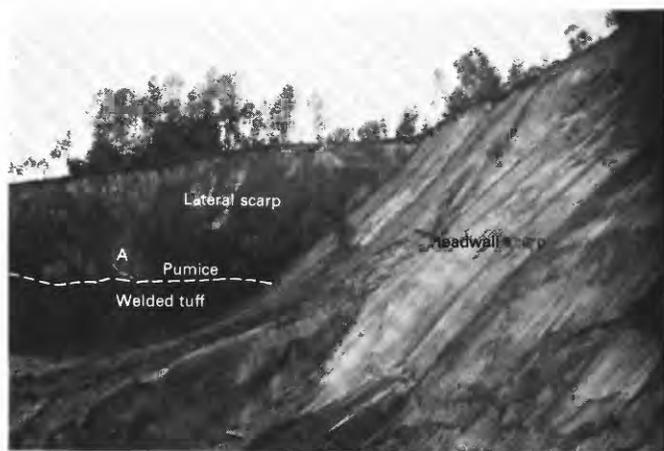
FIGURE 28.—Intersection of lateral scarp with headwall scarp of San José Poaquil landslide. Note freshly exposed rock (A), recently stained by rainfall washing, which contrasts with dark weathered surface of lateral scarp. Photograph taken in late June 1976.

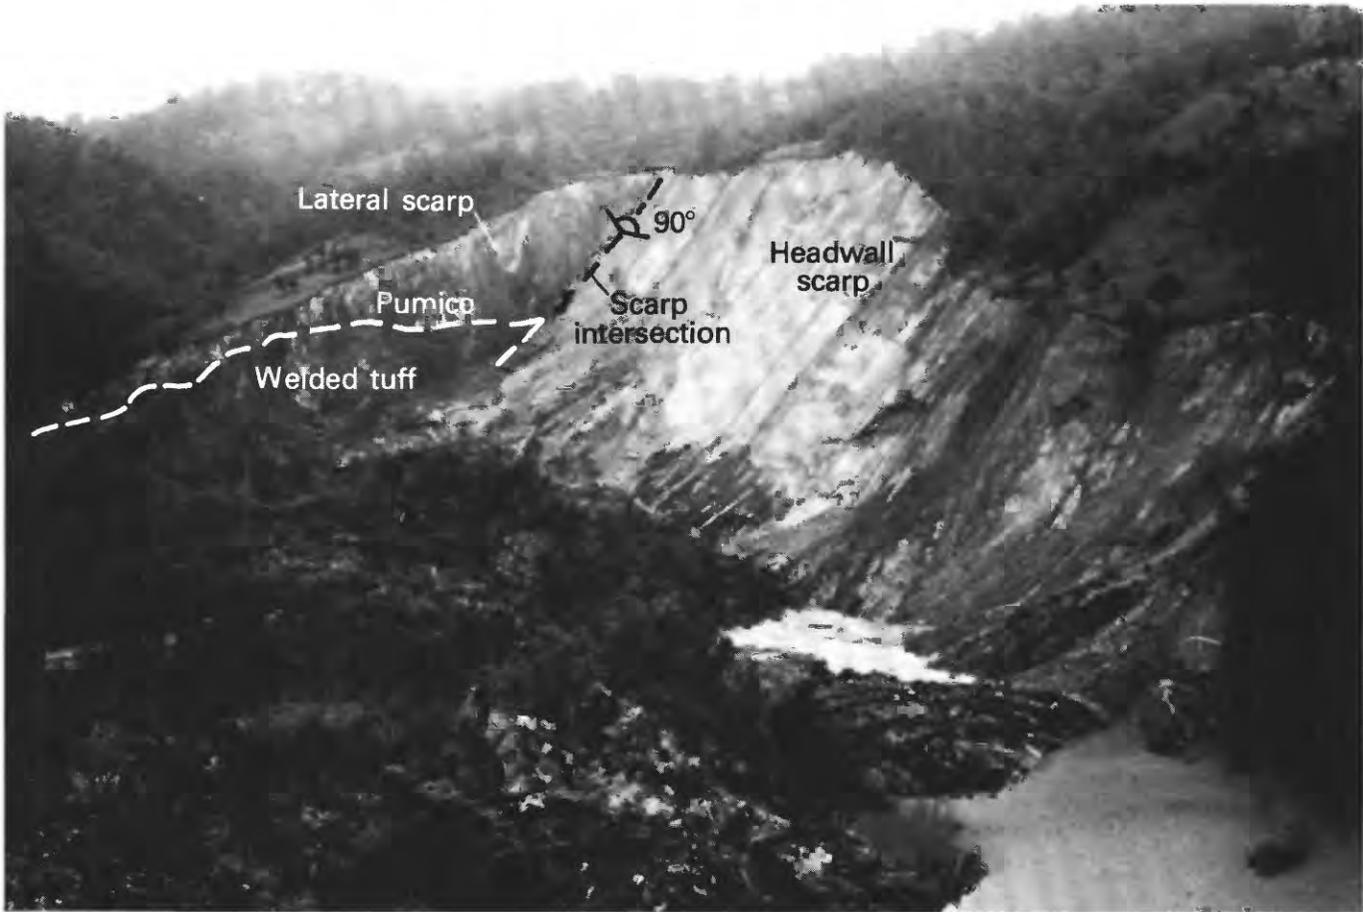
FIGURE 29.—View southeastward of San José Poaquil landslide, showing lateral and headwall scarps and contact between pumice and underlying welded tuff.

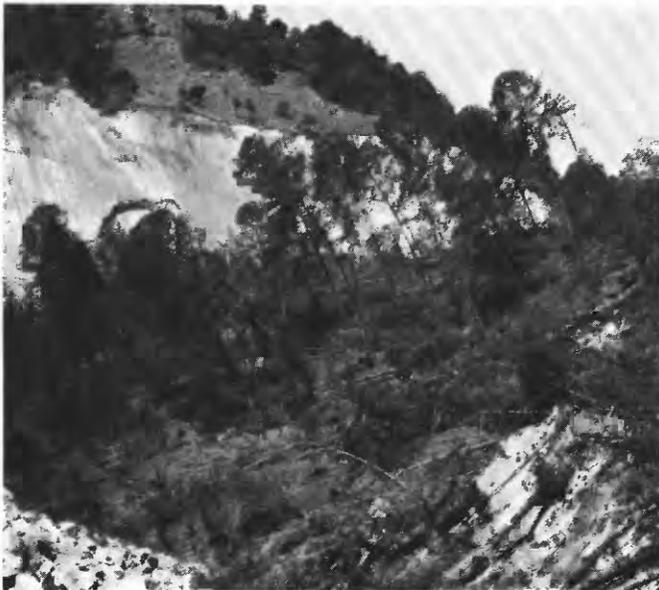
FIGURE 30.—View westward of part of San José Poaquil landslide mass near headwall scarp in zone 1 (fig. 23). Slide surface in foreground has remained coherent enough to preserve root structure of trees, which lean about 20°.

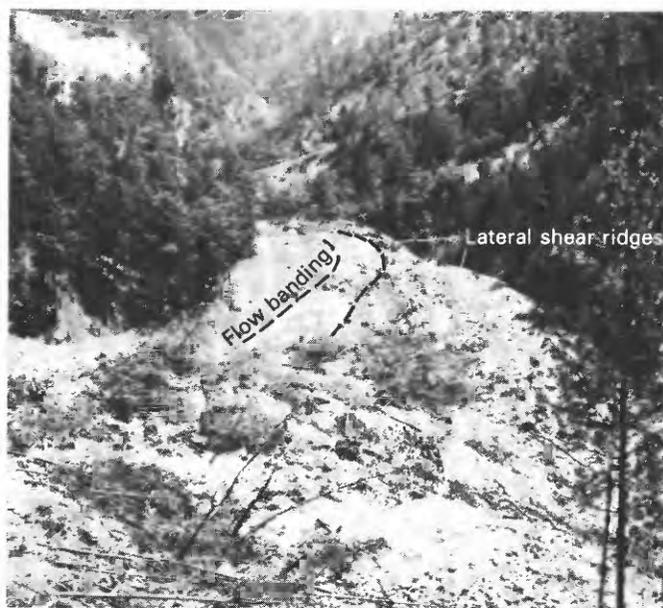
FIGURE 32.—View downslope in zone 3 (fig. 23) of toe of San José Poaquil landslide.

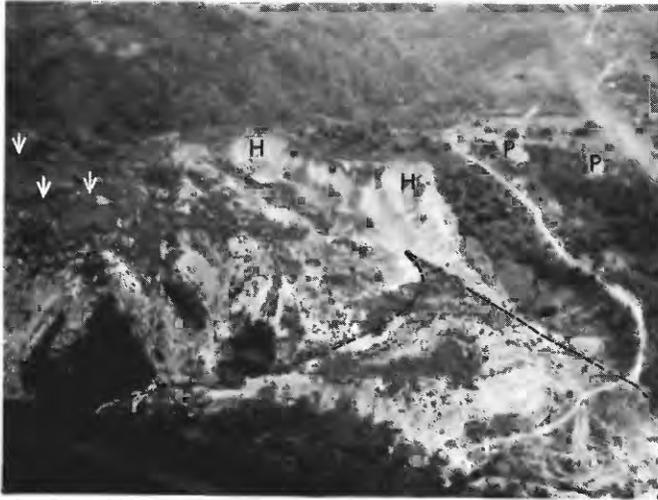
FIGURE 34.—San Martín Jilotepeque landslide, a large lateral-spread/rotational-slump/earth-flow complex. Northern part, a tongue-shaped earth flow (dashed lines) that overran 14 dwellings, showed greatest displacement. Southern part is an incipient failure pervaded by numerous extension fractures (arrows). H, headwall scarp; P, headwall scarp of preearthquake landslide.

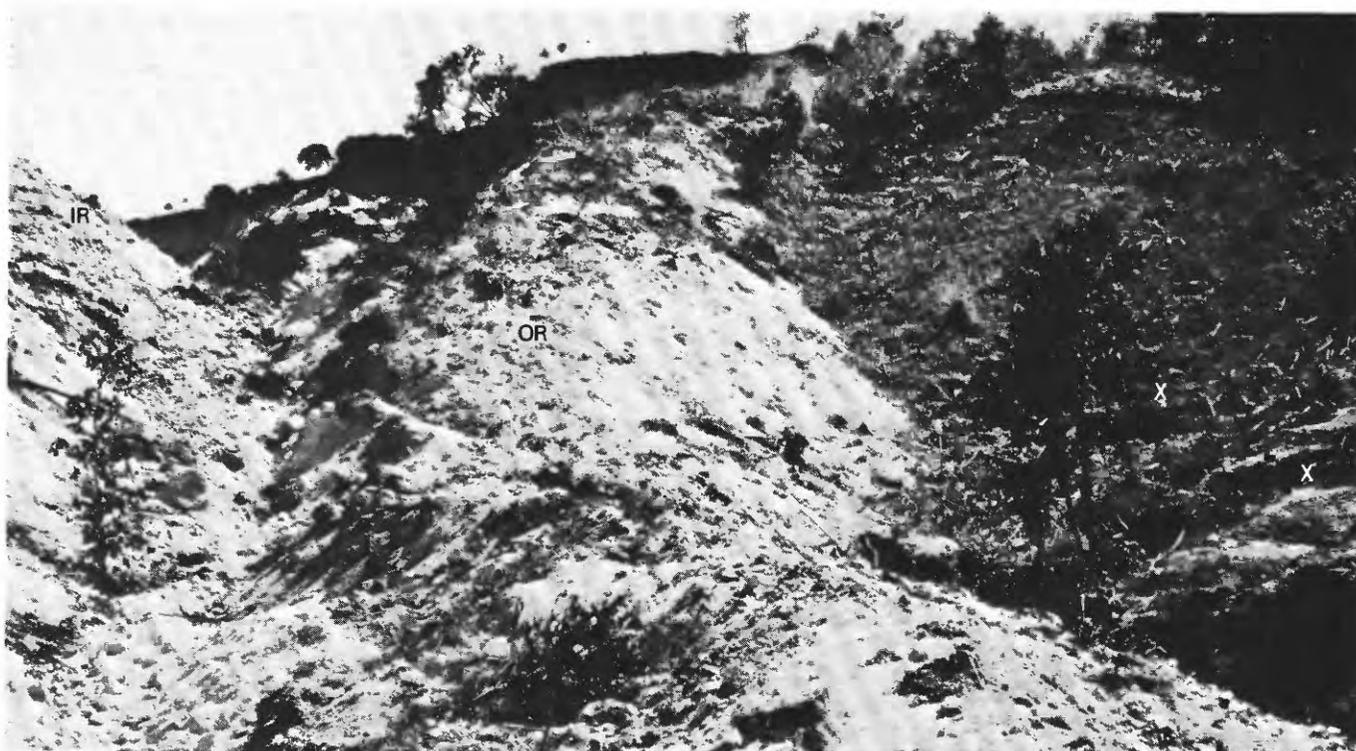
FIGURE 36.—View southwestward of inner (IR) and outer (OR) lateral shear ridges on north margin of northern tongue of San Martín Jilotepeque landslide. Inner ridge was formed during later surge of movement than outer ridge. X, agricultural well.

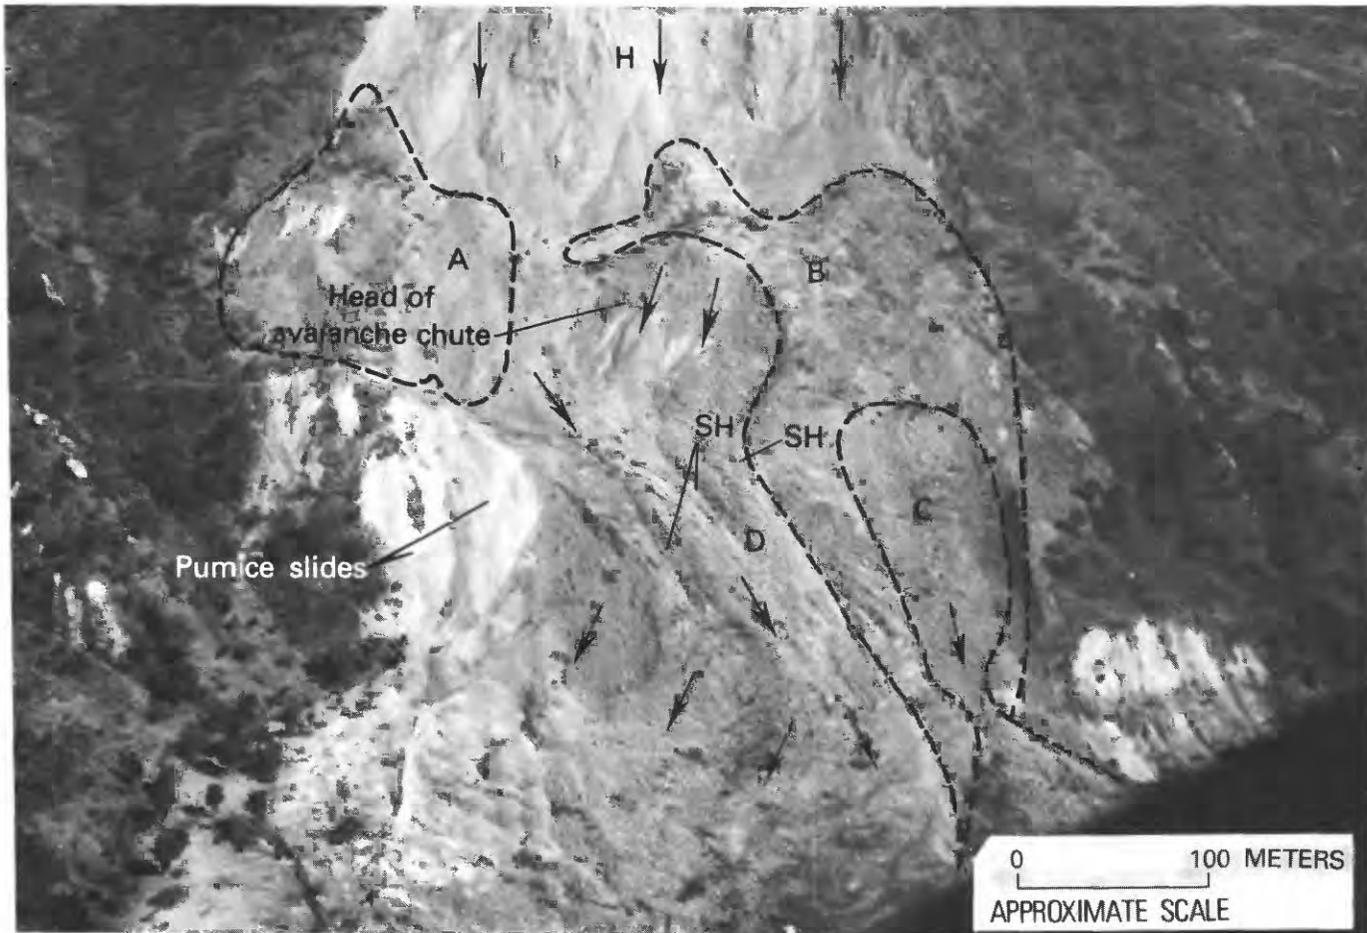
FIGURE 38.—View north-northeastward of Estancia de la Virgen landslide; arrows indicate direction of movement of avalanche debris. A and B, rotated slump blocks; C, head of secondary rotational-slump avalanche within slump block B; D, center of avalanche chute; H, headwall scarp; SH, shear surfaces.

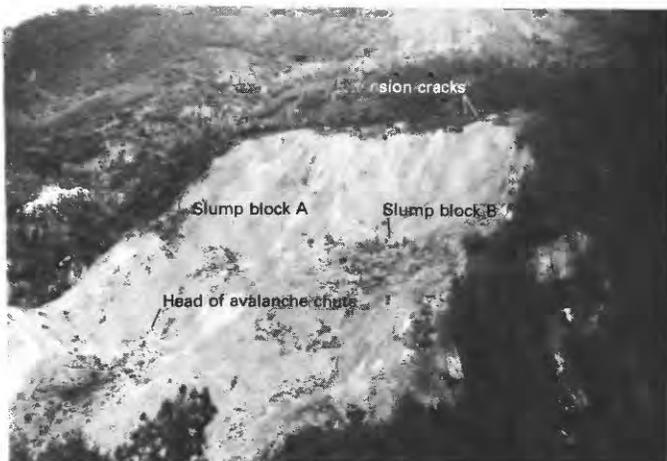
FIGURE 39.—Oblique aerial view of headwall scarp and associated features of Estancia de la Virgen landslide.

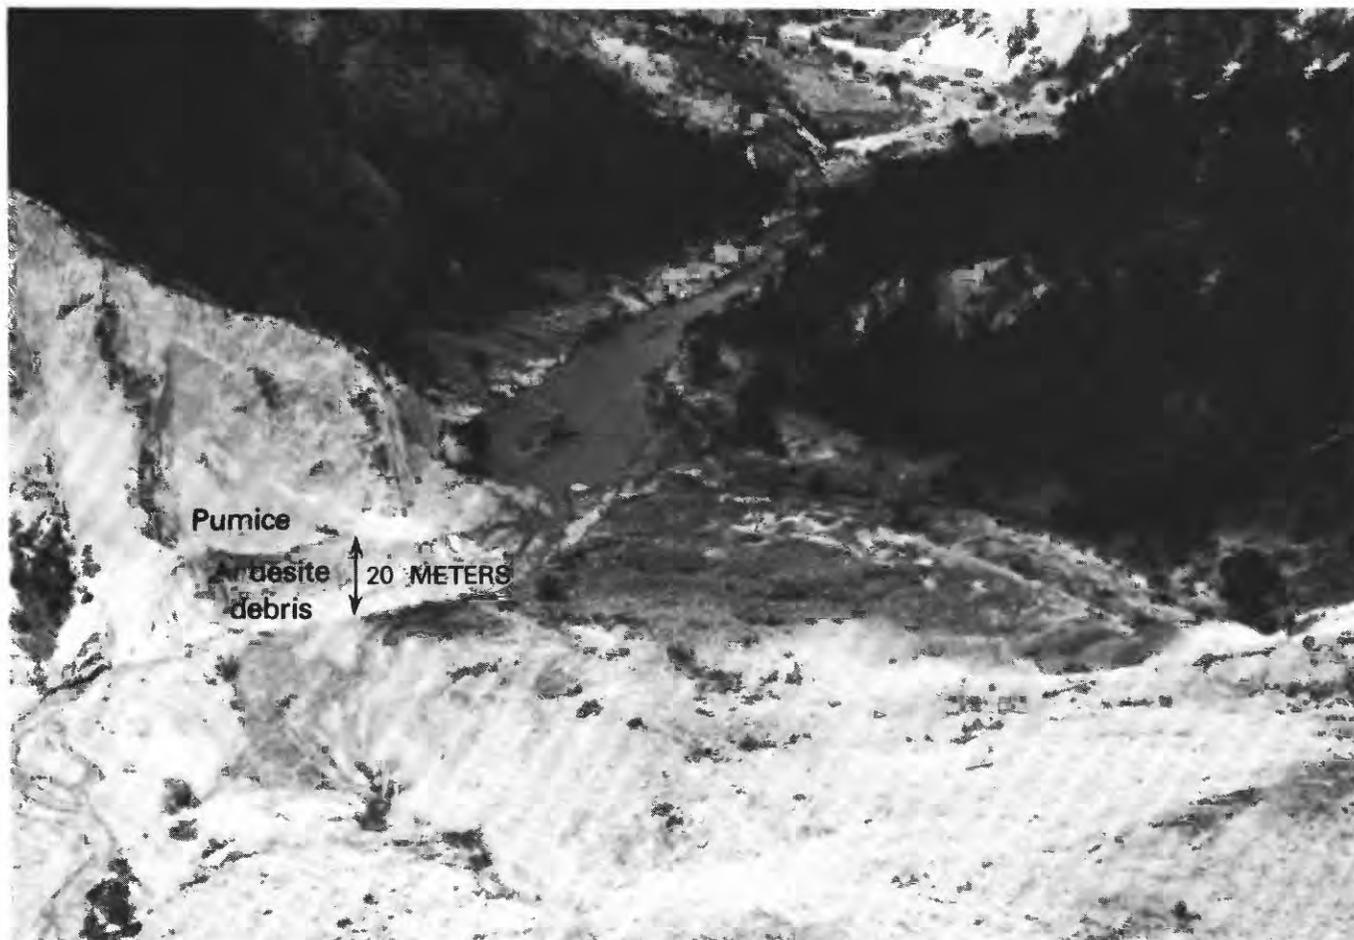
FIGURE 40.—Toe of Estancia de la Virgen landslide, showing andesitic debris damming Río Pixcayá. Remains of debris dam are visible (left center) where stream has cut a channel through debris. Note contrast between dark andesite and light-colored pumice debris.

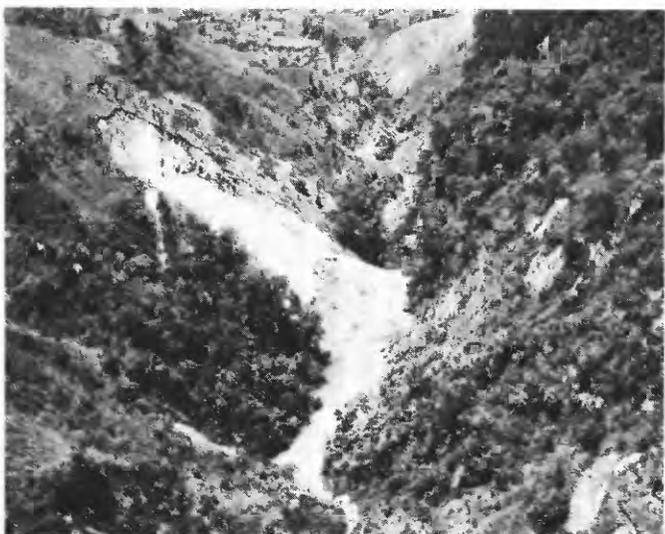
FIGURE 42.—View northward of Río Los Cubes landslide south of Palencia.

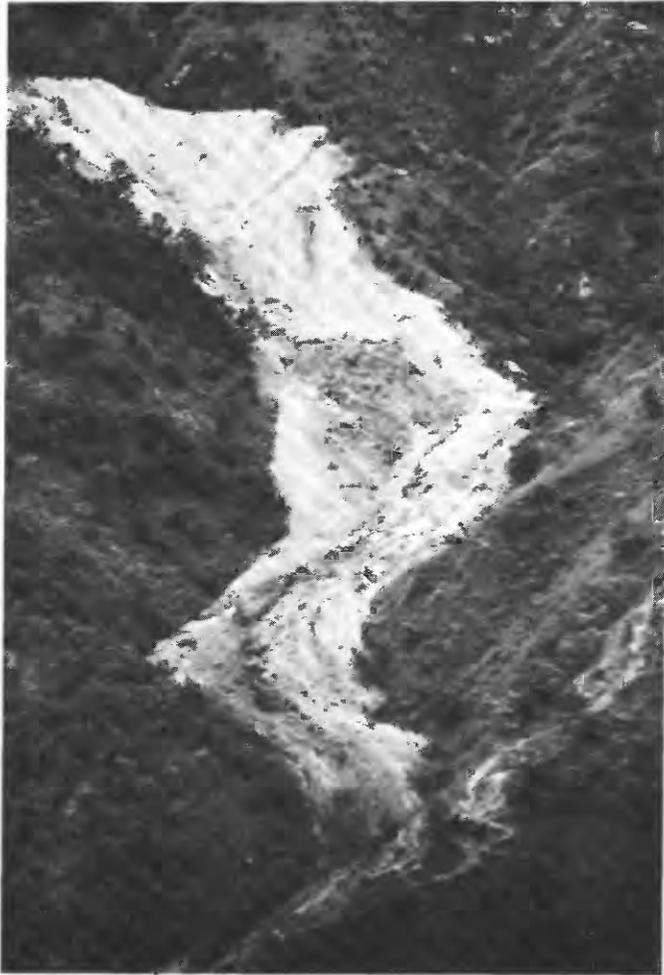
FIGURE 44.—Rotational slump/avalanche in pumice deposits near Finca San Carlos. Length of landslide from headwall scarp to toe is estimated to be 200 m.

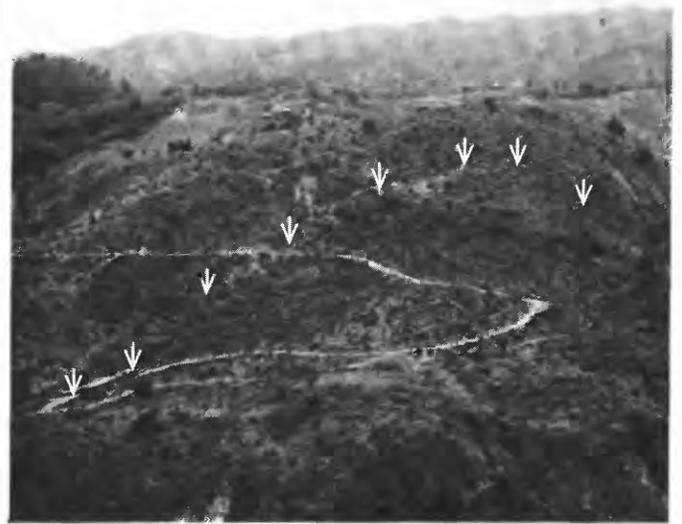
FIGURE 45.—Incipient rotational-slump landslide near village of El Zarzal. Arrows mark headwall scarp.

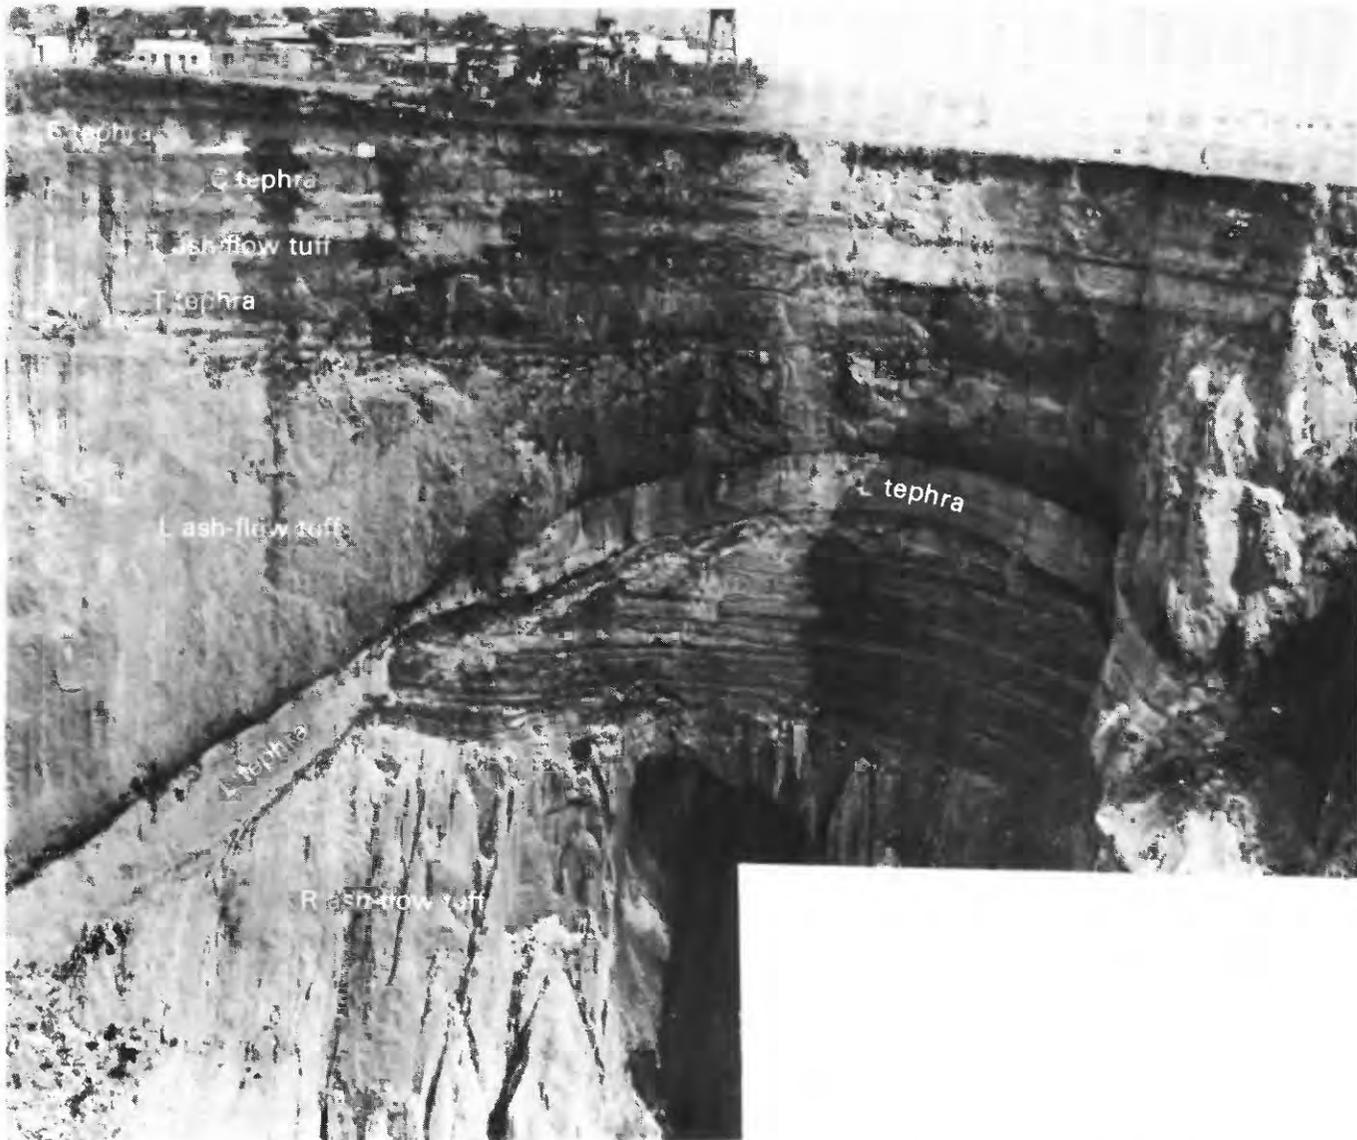
FIGURE 48.—Headwall of Rio Guacamaya barranco, showing great lateral variation in thickness of pumice deposits; note jeep in upper left corner for scale. Labeling of units is according to Koch and McLean (1975, fig. 11). Photograph courtesy of Hugh McLean.

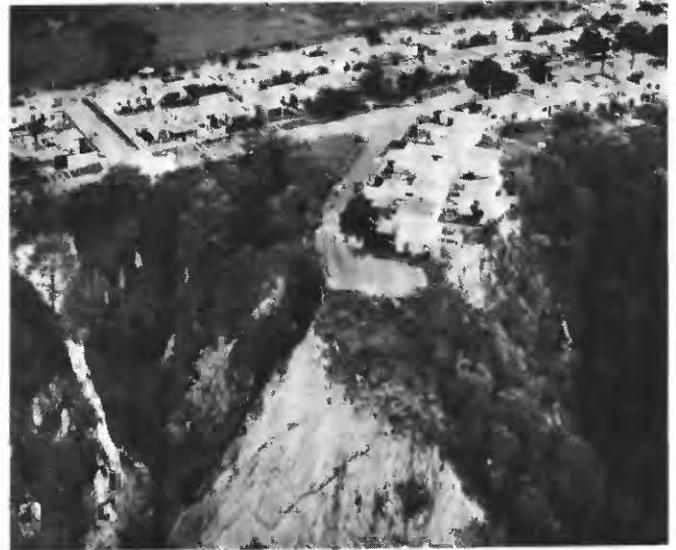
FIGURE 50.—Housing development in northeastern Guatemala City, showing extensive rock falls and bedrock fractures on end of narrow ridge.
