# The Loma Prieta, California, Earthquake of October 17, 1989— Landslides

DAVID K. KEEFER, *Editor*

STRONG GROUND MOTION AND GROUND FAILURE  
THOMAS L. HOLZER, *Coordinator*

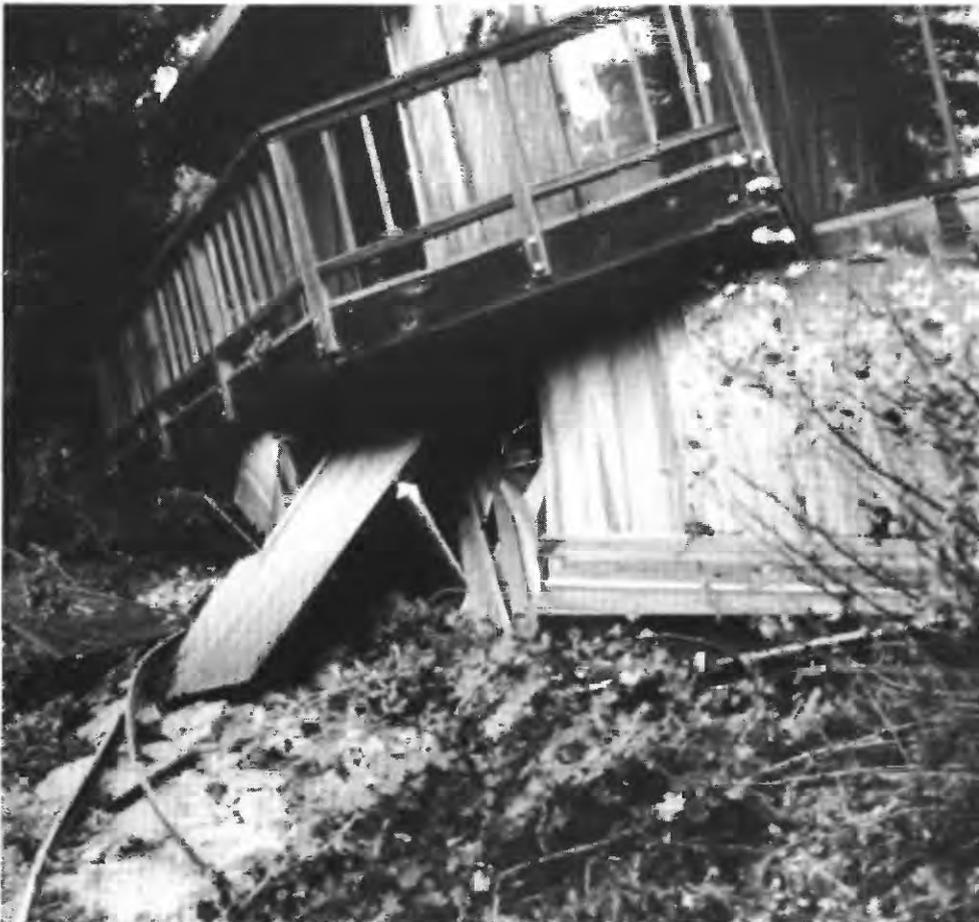
Figure 8.—Severely damaged house on Rebecca Drive landslide (see pl. 1 for location). Main scarp of landslide passes under house. Note ground cracks in foreground.

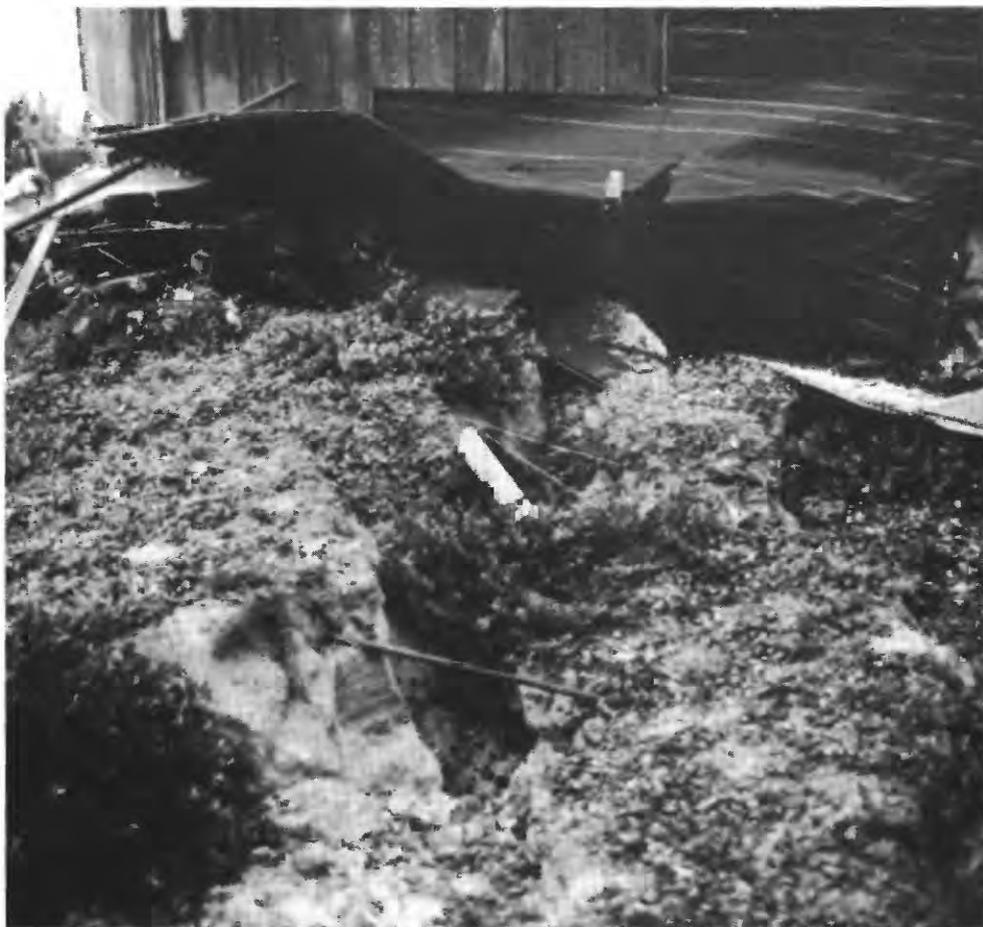
Figure 9.—Part of main scarp of Rebecca Drive landslide (see pl. 1 for location). Notebook (circled) is 20 by 27 cm. Approximate downslope displacement at this locality was 40 cm; maximum measured displacement across scarp was 57 cm.

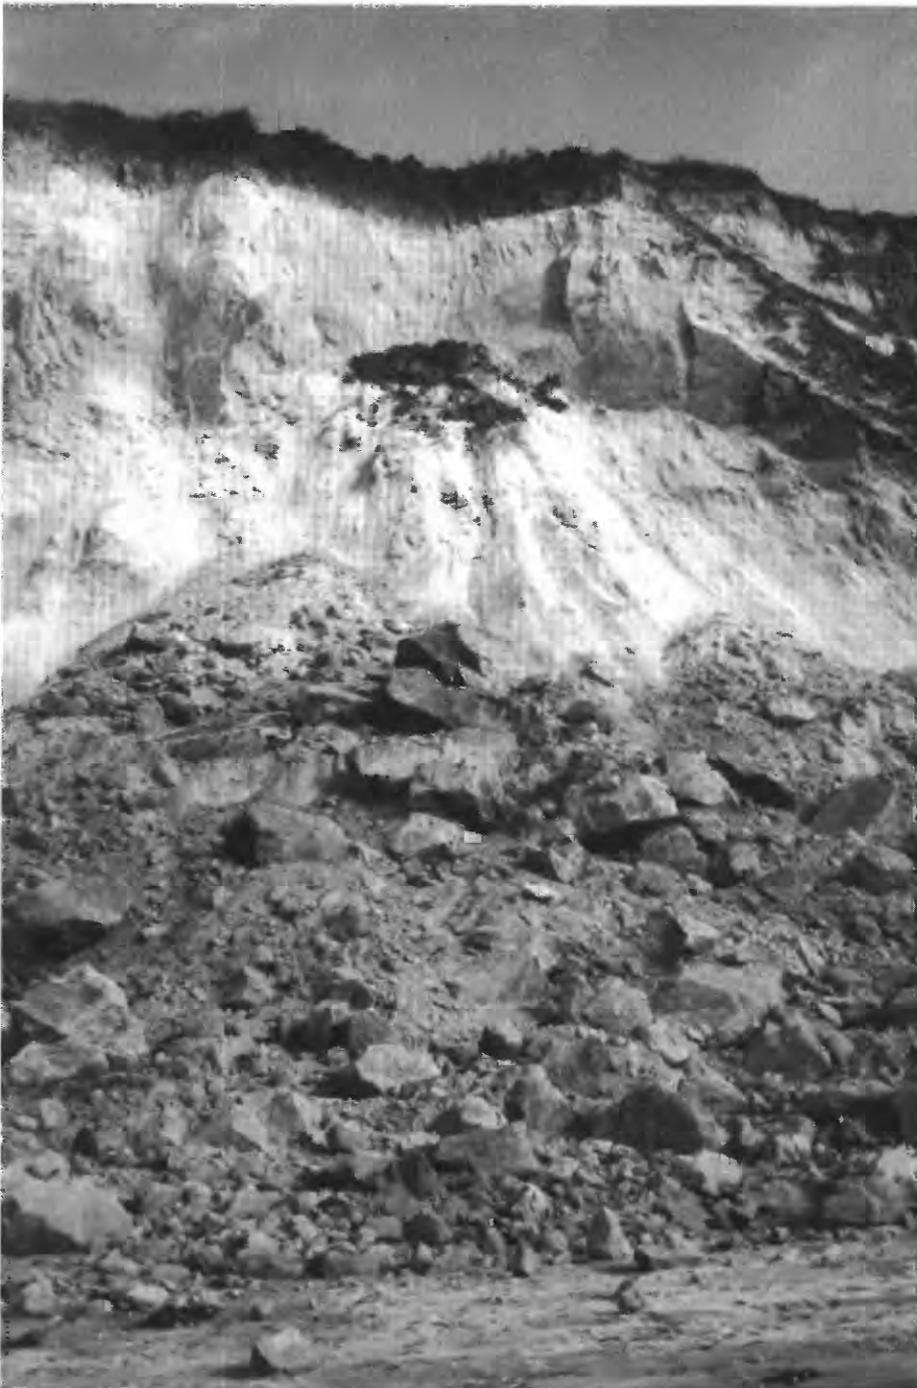
Figure 15.—Coastal landslide about 0.8 km south of mouth of San Gregorio Creek (see fig. 14 for location). Toe of deposit is approximately 60 m wide. Photograph by Mary M. Donato, U.S. Geological Survey.

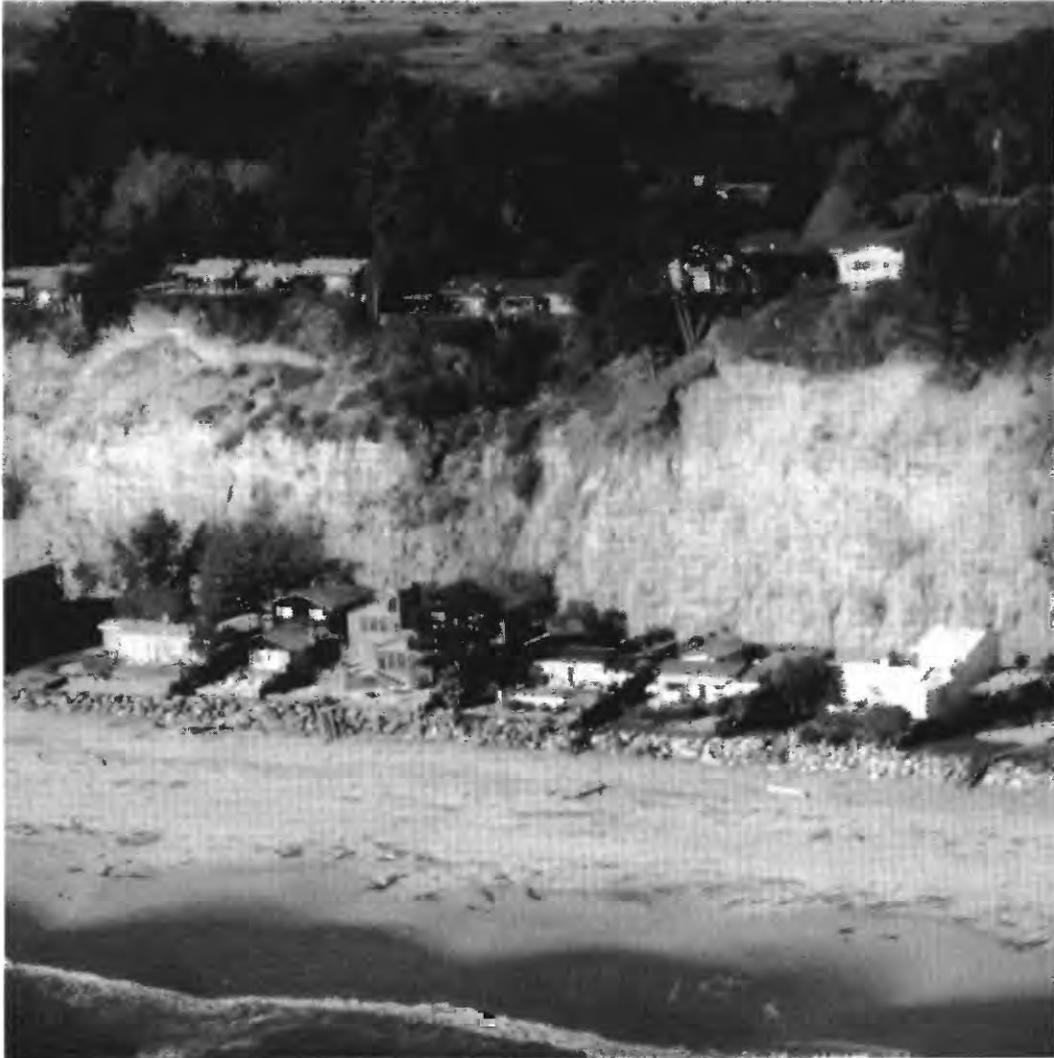
Figure 12.—Earthquake-induced failure of terrace deposits and sandstone of the Purisima Formation between Capitola and Rio Del Mar (see fig. 5 for location).

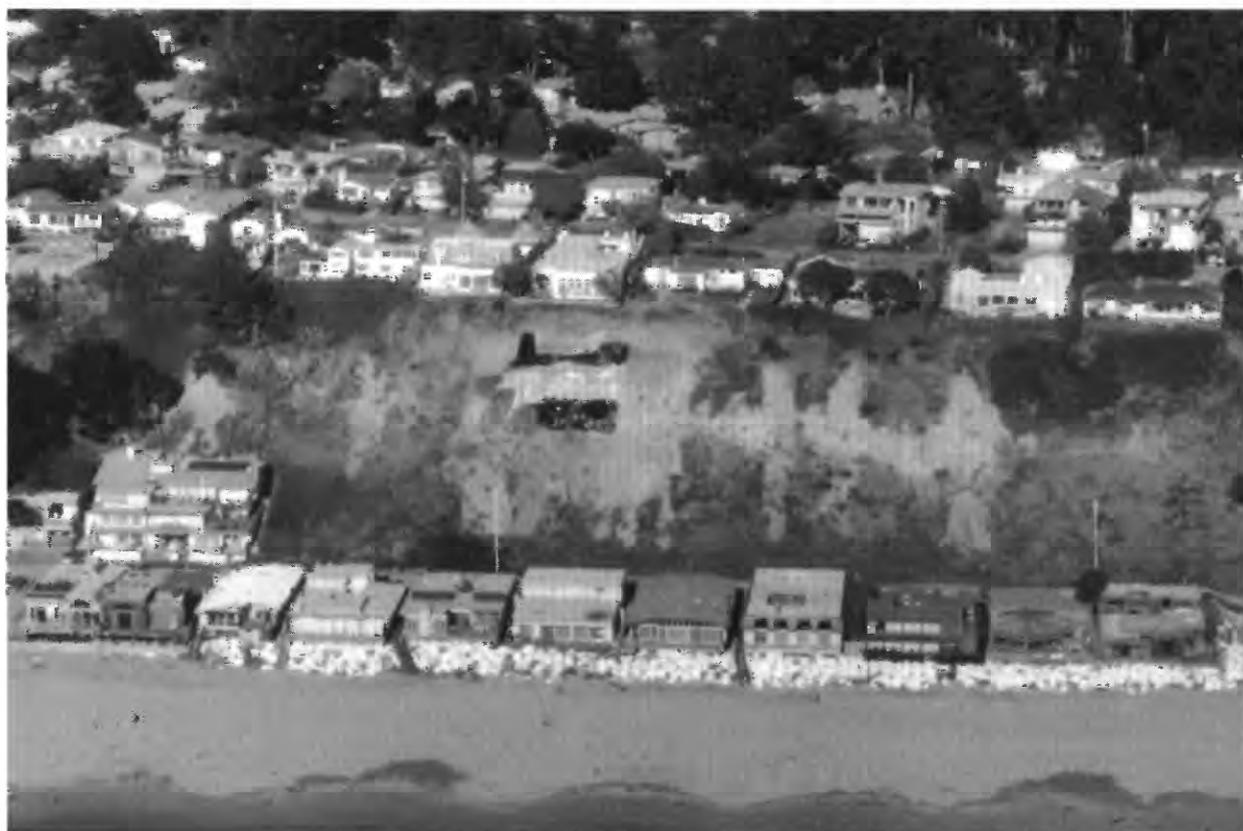
Figure 20.—Earthquake-induced bluff failures in Beach Drive area of Rio Del Mar (fig. 5). New homes are being proposed at base of this bluff behind existing beach-front homes.

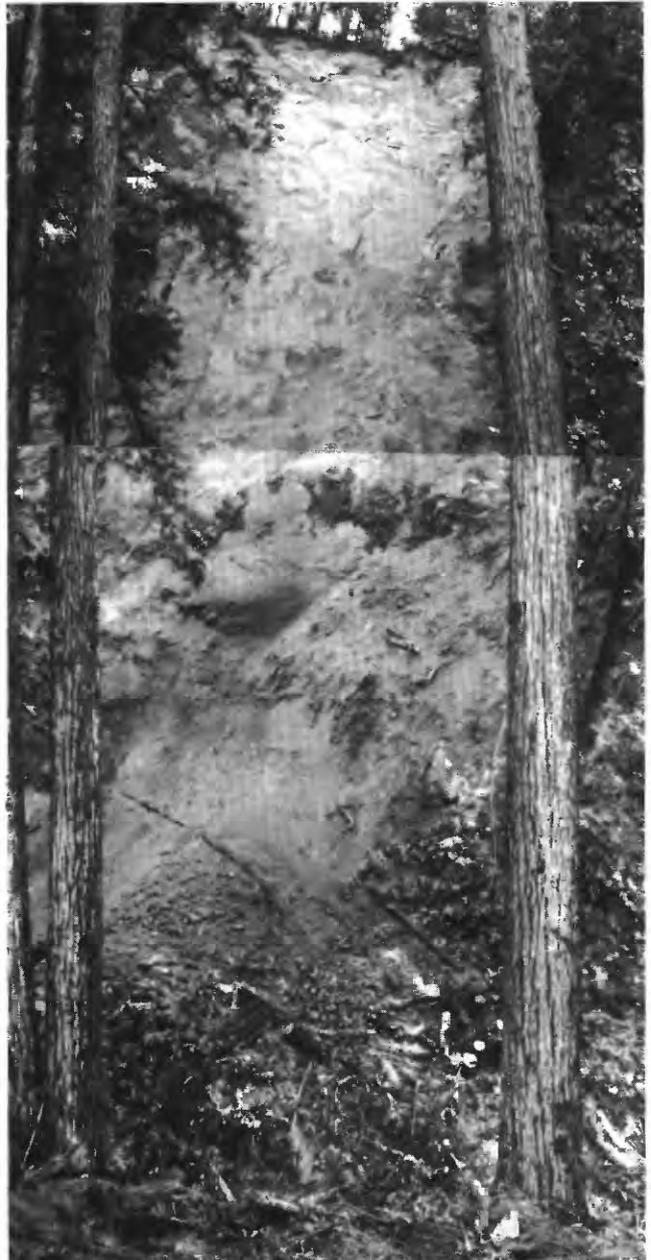
Figure 7.—Rock fall on upper Corralitos Creek (see fig. 5 for location) triggered by 1989 Loma Prieta earthquake. Note logs and brush intermingled with earth material to form landslide dam at base of slope. Impoundment is outside photograph to immediate left. Photograph taken October 25, 1989, 1 week after 1989 Loma Prieta earthquake.

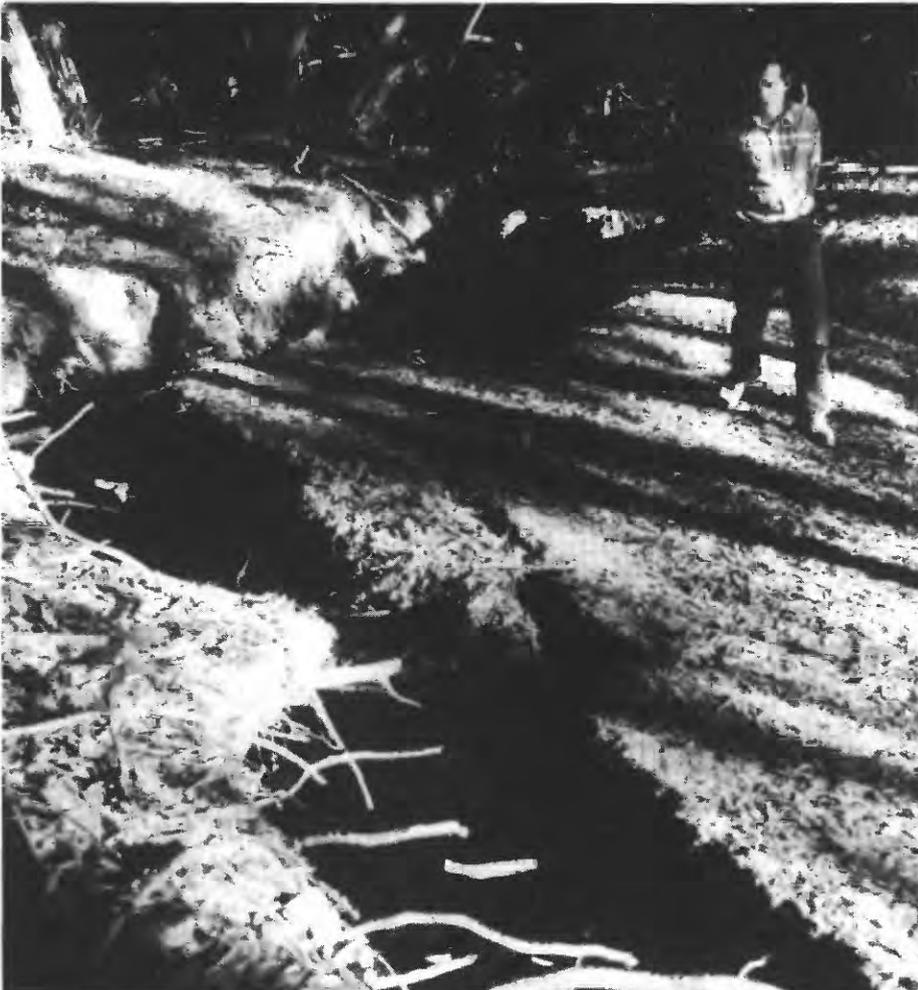
Figure 10.—Part of main scarp of Upper Schultheis Road landslide. Measurements near this locality showed 1.07 m of extensional displacement and 46 cm of vertical displacement across main scarp. View eastward from near landslide crown (loc. A, fig. 9A).

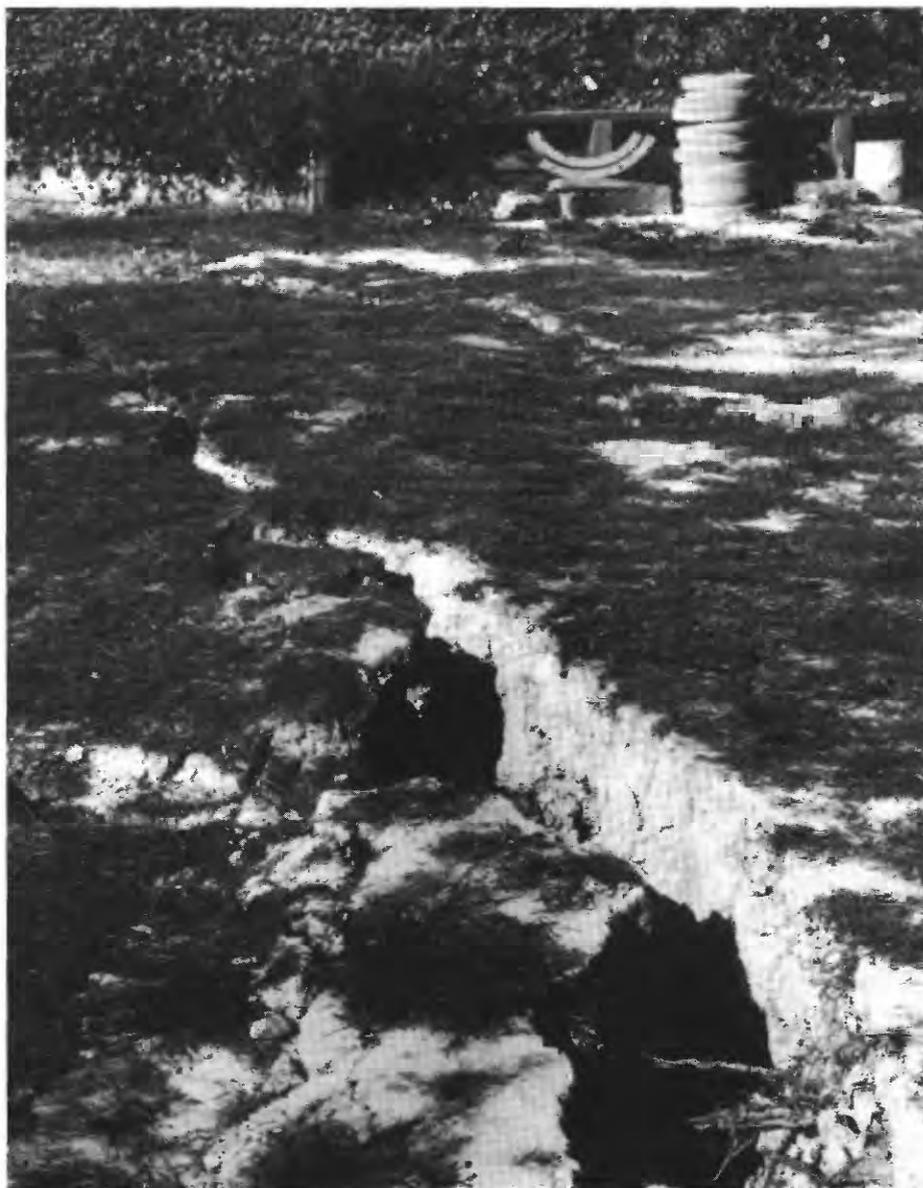
Figure 13.—Segment of main scarp of Villa Del Monte landslide in Sunset Drive area. View northwestward from near quadrilateral-array station 14 (fig. 12A). Photograph by Kevin M. Schmidt, U.S. Geological Survey.

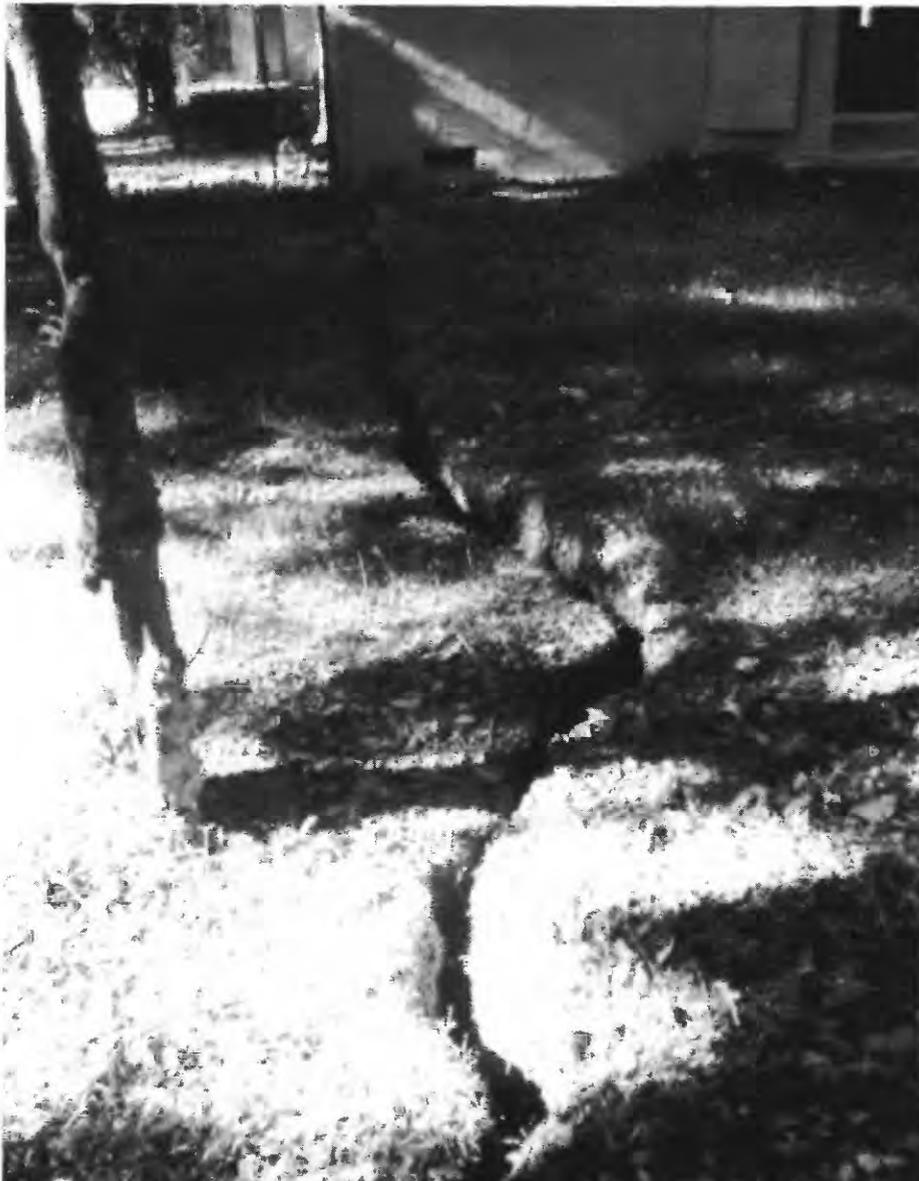
Figure 14.—Internal scarp of Villa Del Monte landslide in Upper Skyview Terrace-Bel Air Court area. View northward from near quadrilateral-array station 23 (fig. 12A). Photograph from Griggs and others (1990).

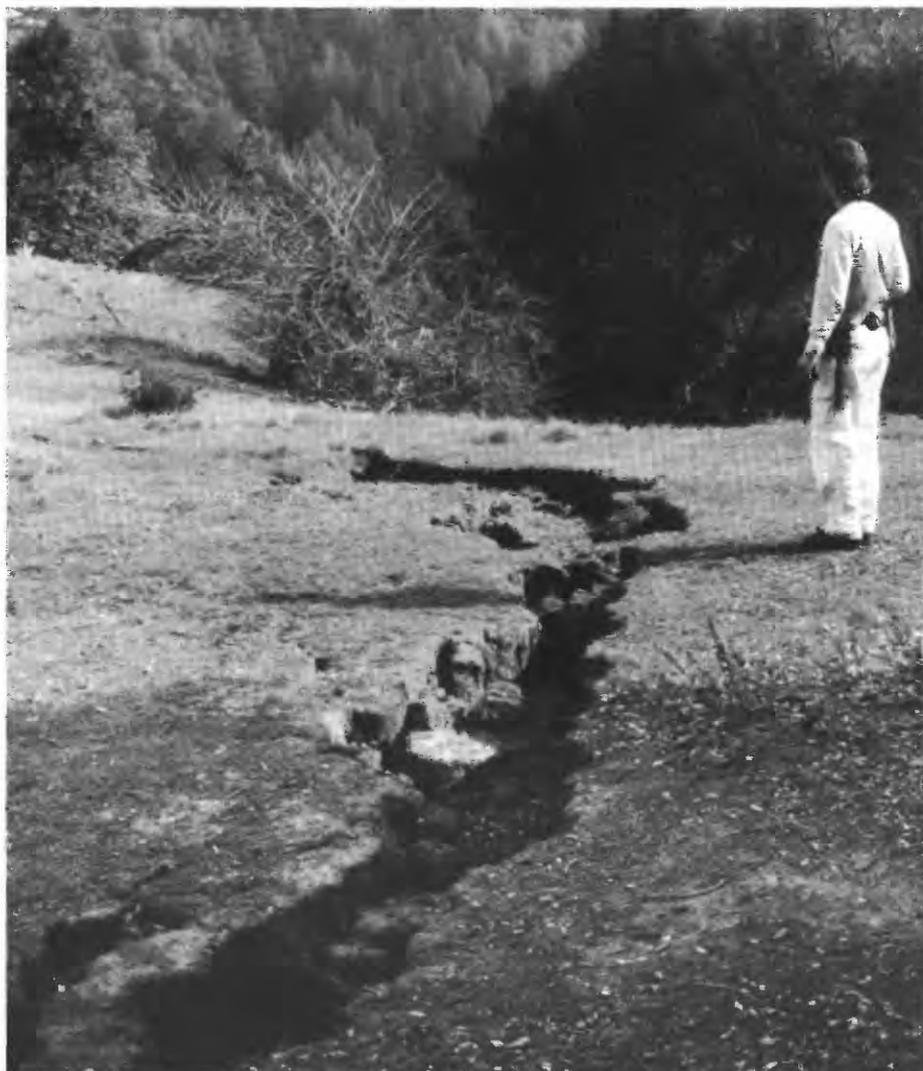
Figure 23.—Part of main scarp of Lower Schultheis Road West landslide. View eastward from just west of Schultheis Road (loc. A', fig. 22). Ridgecrest to left (north) is involved in landslide.

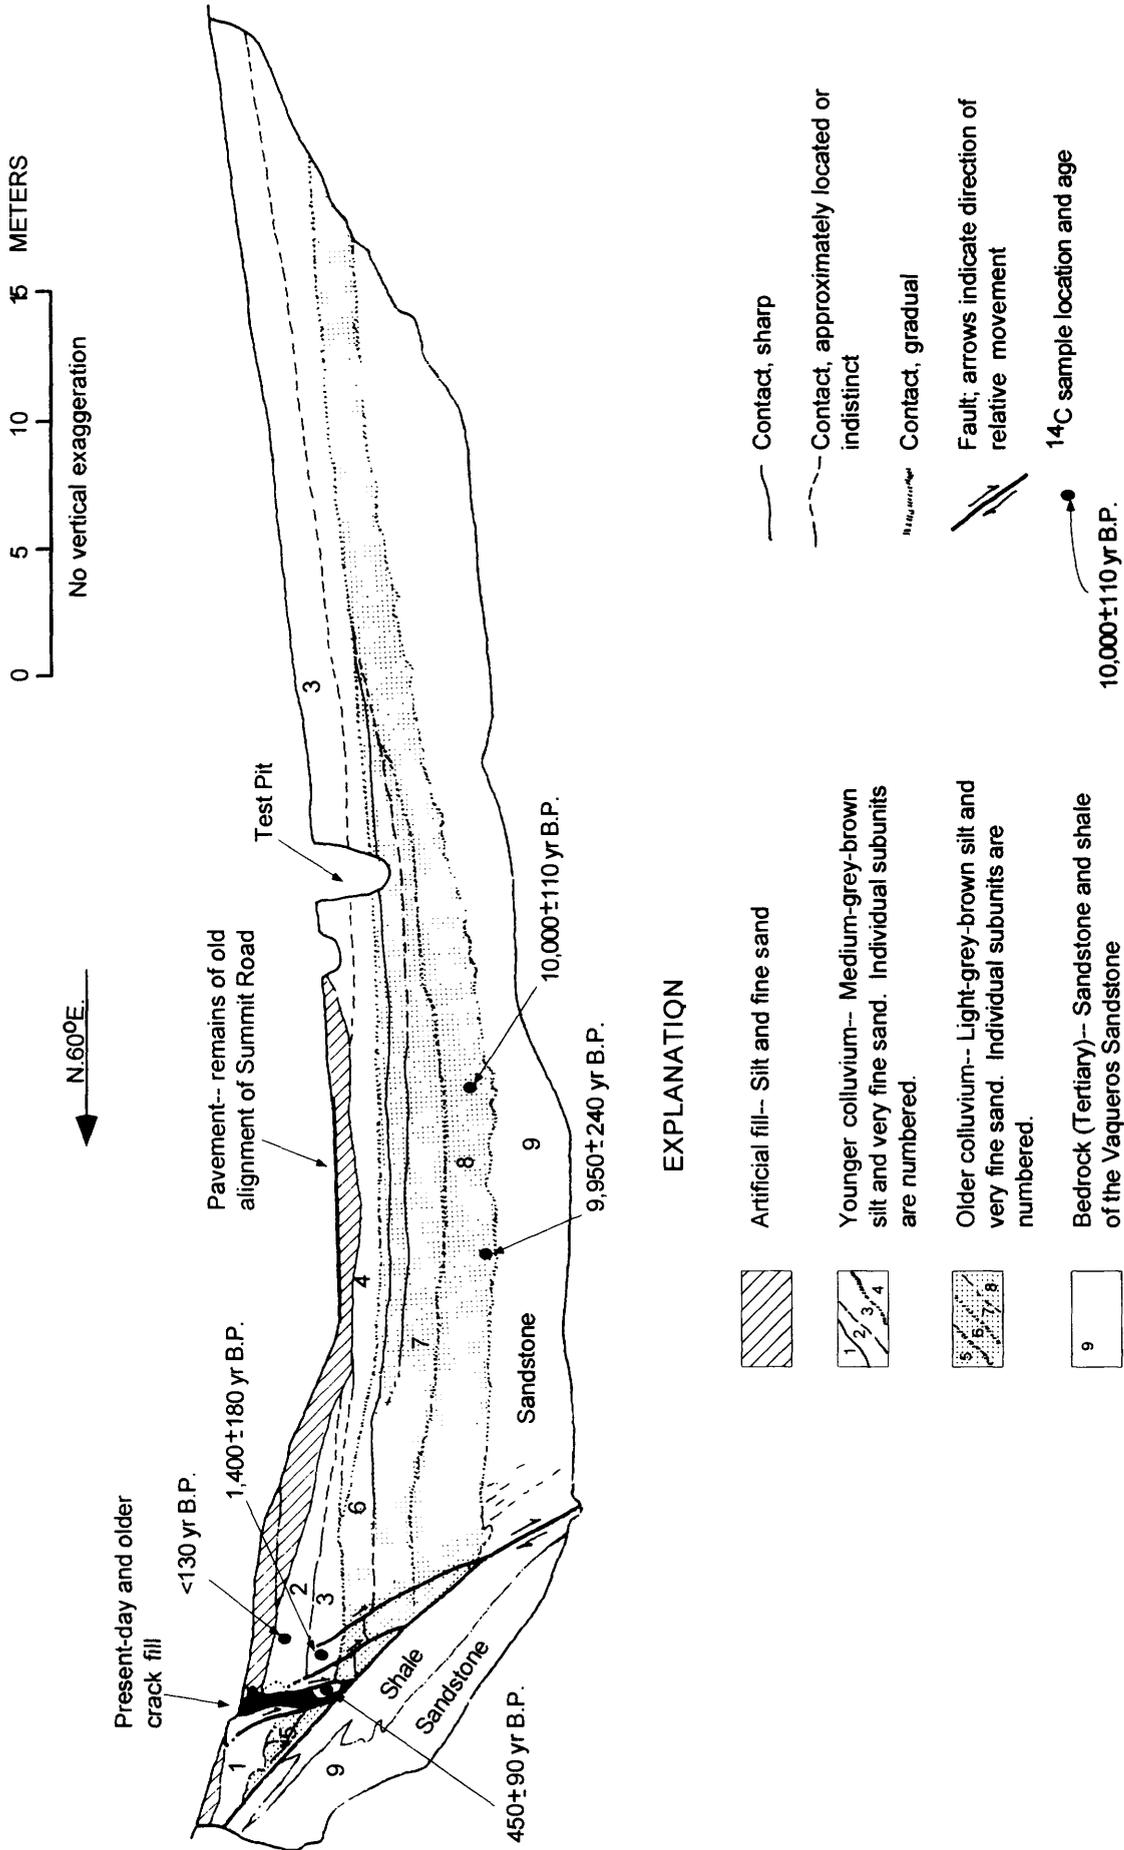
Figure 2.—Log of trench 1, which was excavated across a ground crack along base of a 0.5-km-long, northwest-trending scarp at summit of the Santa Cruz Mountains. Trench exposed a southwest-dipping slip surface and a 4-m-thick colluvial wedge overlying downdropped block. Earliest Holocene  $^{14}\text{C}$  ages on soil from basal part of colluvium and offset stratigraphic layers indicate that movement on this slip surface has been ongoing throughout the Holocene, including at least three discrete events in the past approximately 2,000 years.

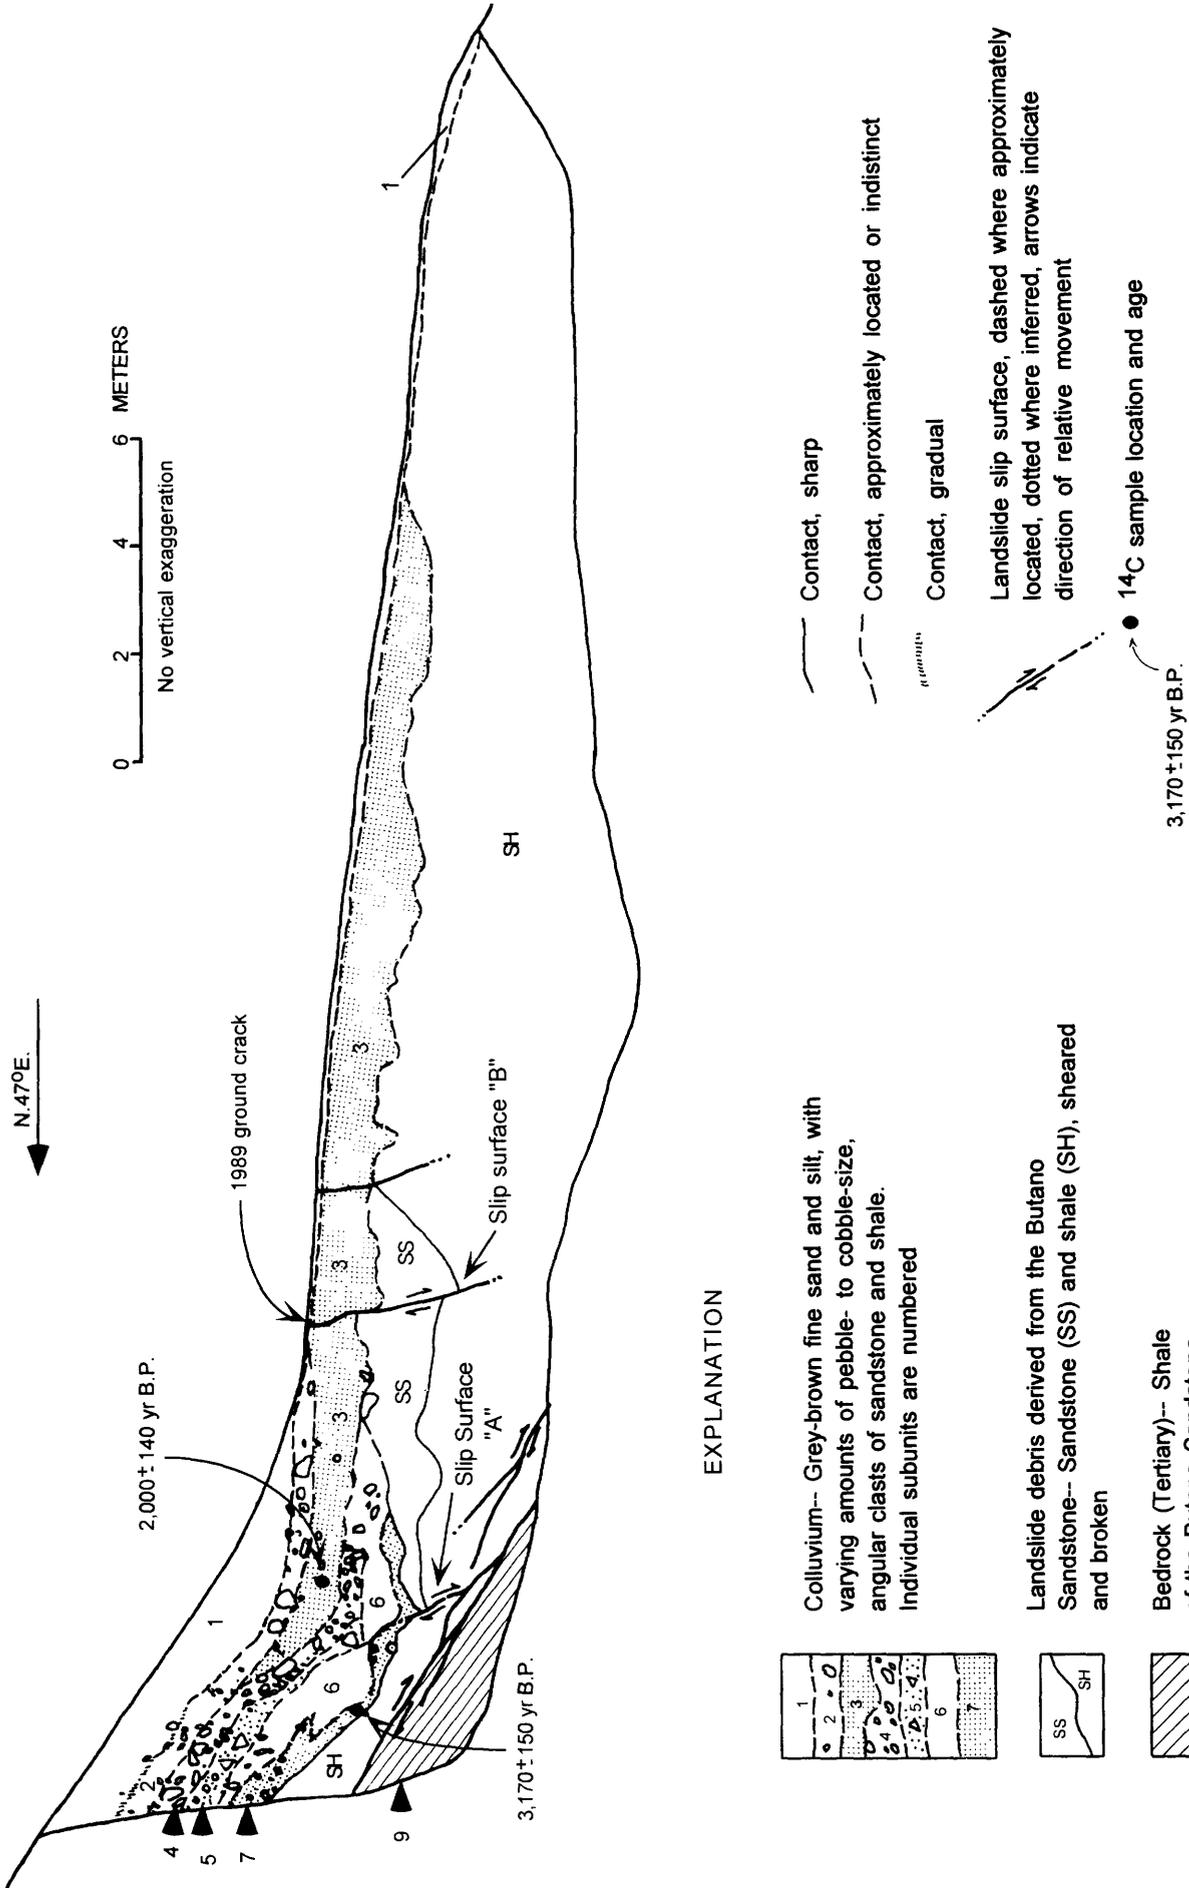
Figure 3.—Log of trench 2, which was excavated across a ground crack following crown of a preexisting landslide mass. Offset of layers within colluvial wedge at head of landslide and 1989 ground-cracks indicate that at least three reactivations of this landslide have taken place in the past approximately 2,000 years.
