The Loma Prieta, California, Earthquake of October 17, 1989— Highway Systems

Professional Paper 1552-B

This paper summarizes the impact of the Loma Prieta earthquake on highway systems. City streets, urban freeways, county roads, state routes, and the national highway system were all affected. There was damage to bridges, roads, tunnels, and other highway structures. The most serious damage occurred in the cities of San Francisco and Oakland, 60 miles from the fault rupture. The cost to repair and replace highways damaged by this earthquake was \$2 billion. About half of this cost was to replace the Cypress Viaduct, a long, elevated double-deck expressway that had a devastating collapse which resulted in 42 deaths and 108 injuries.

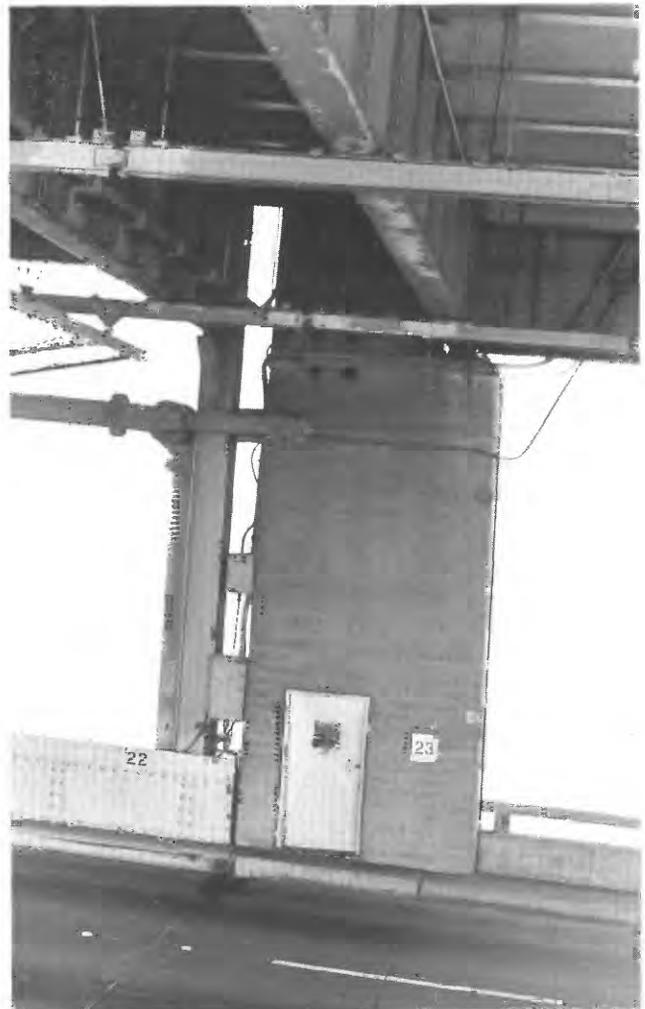
Figure 17.—Top deck at Pier E23 of East Bay Crossing showing 9 foot drop-in section between floor beams (photograph by Erik Zechlin).

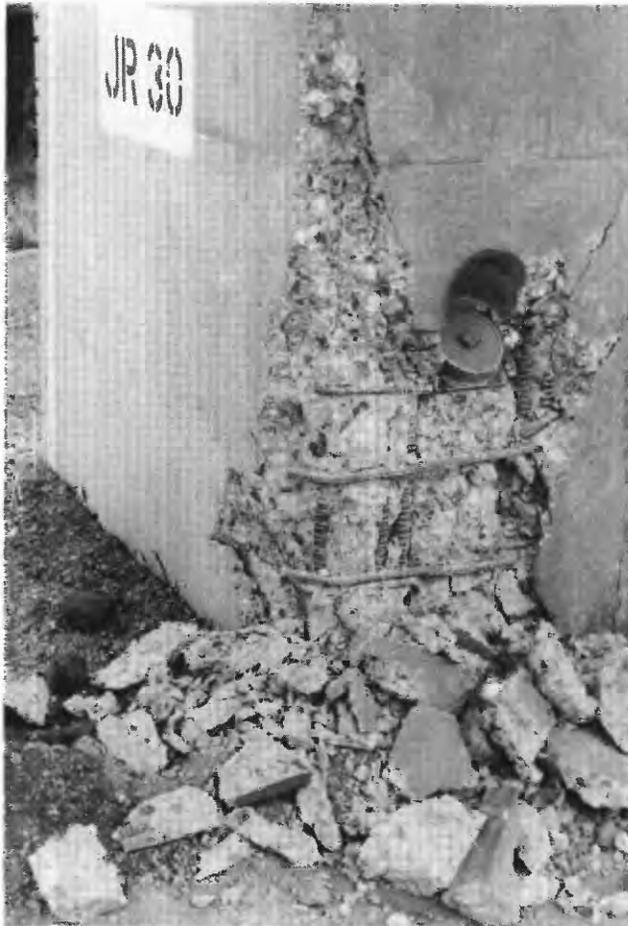
JR line	Bents JR28 to JR34 have soil cracks around footings and concrete spalls at column bottoms, indicative of flexural yielding in east-west direction.

Figure 55.—Spalling at southeast face of Bent 30 on JR line of Port of Oakland Overcrossing (photograph by Li Hong Sheng).

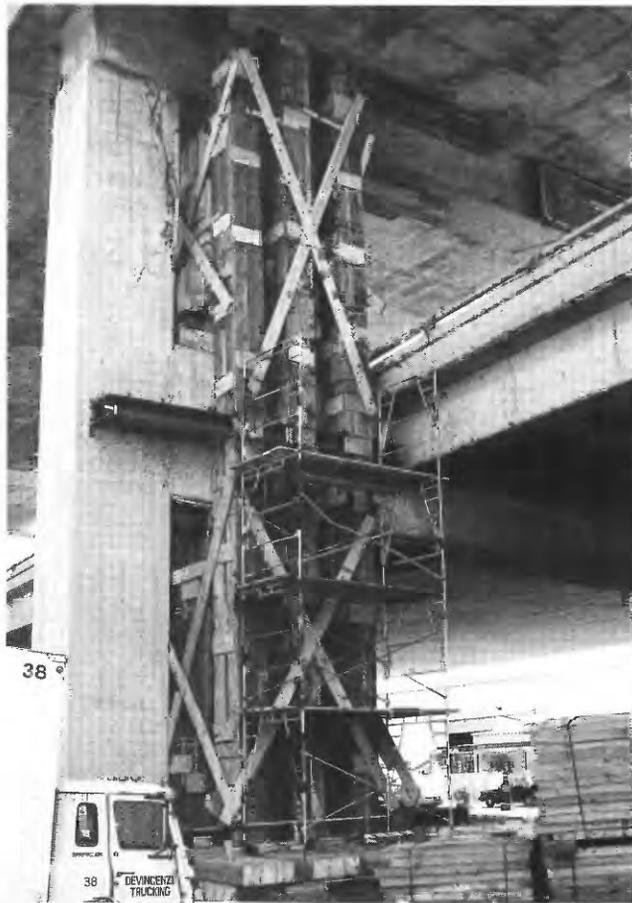
Figure 83.—Damage to Bent 48 of Southern Freeway Viaduct.

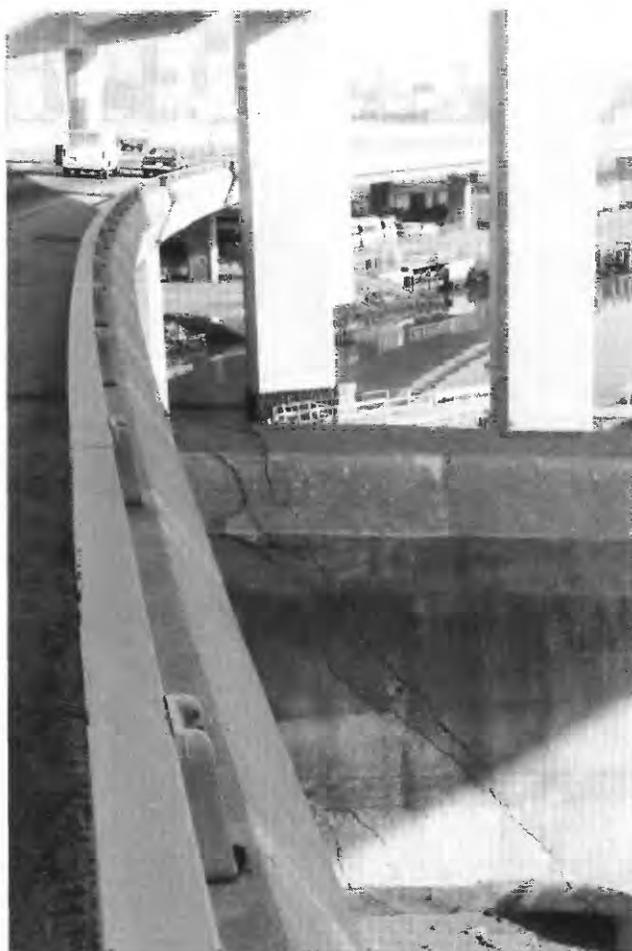
Figure 93.—Diagonal shear cracks at outrigger cap for Bent A-12 of China Basin Viaduct (photograph by Mike Van de Pol).

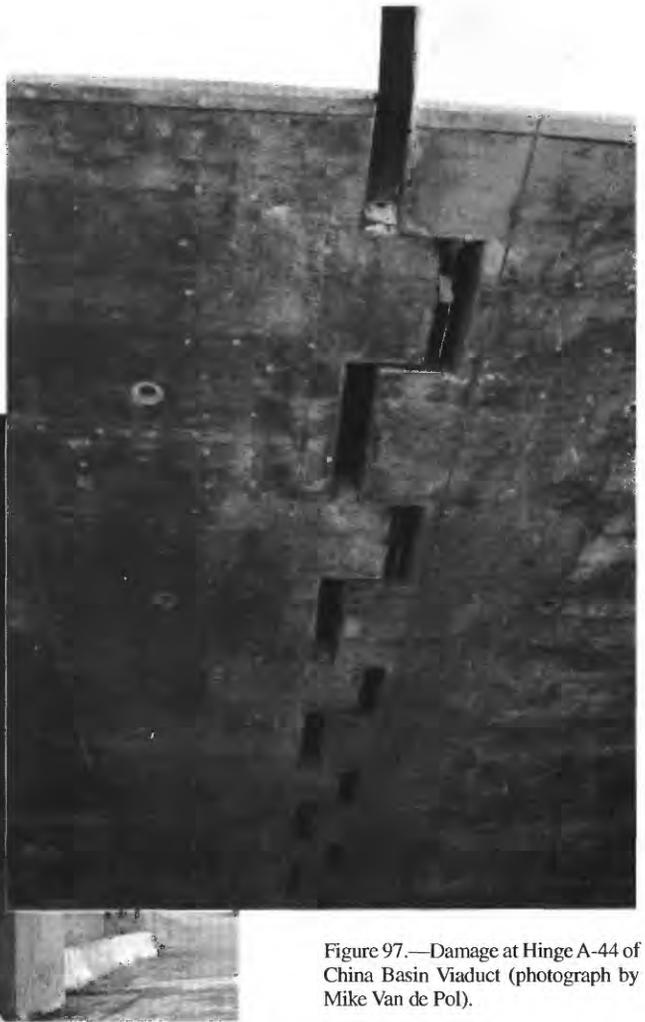
Figure 97.—Damage at Hinge A-44 of China Basin Viaduct (photograph by Mike Van de Pol).

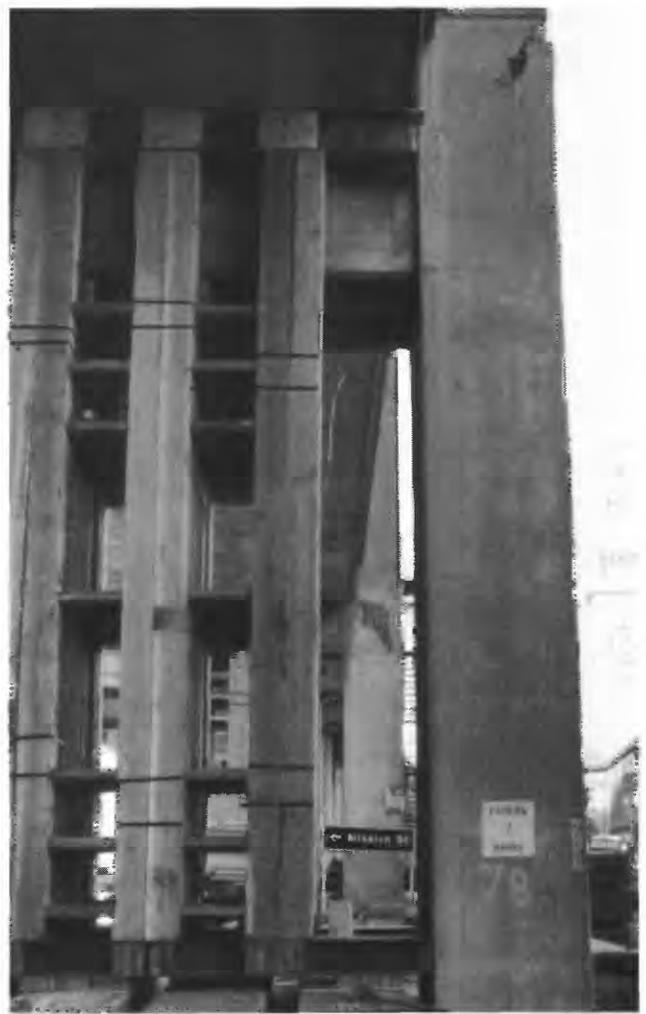
Figure 117.—Column damage on east side of Bent 78 at Embarcadero Viaduct.

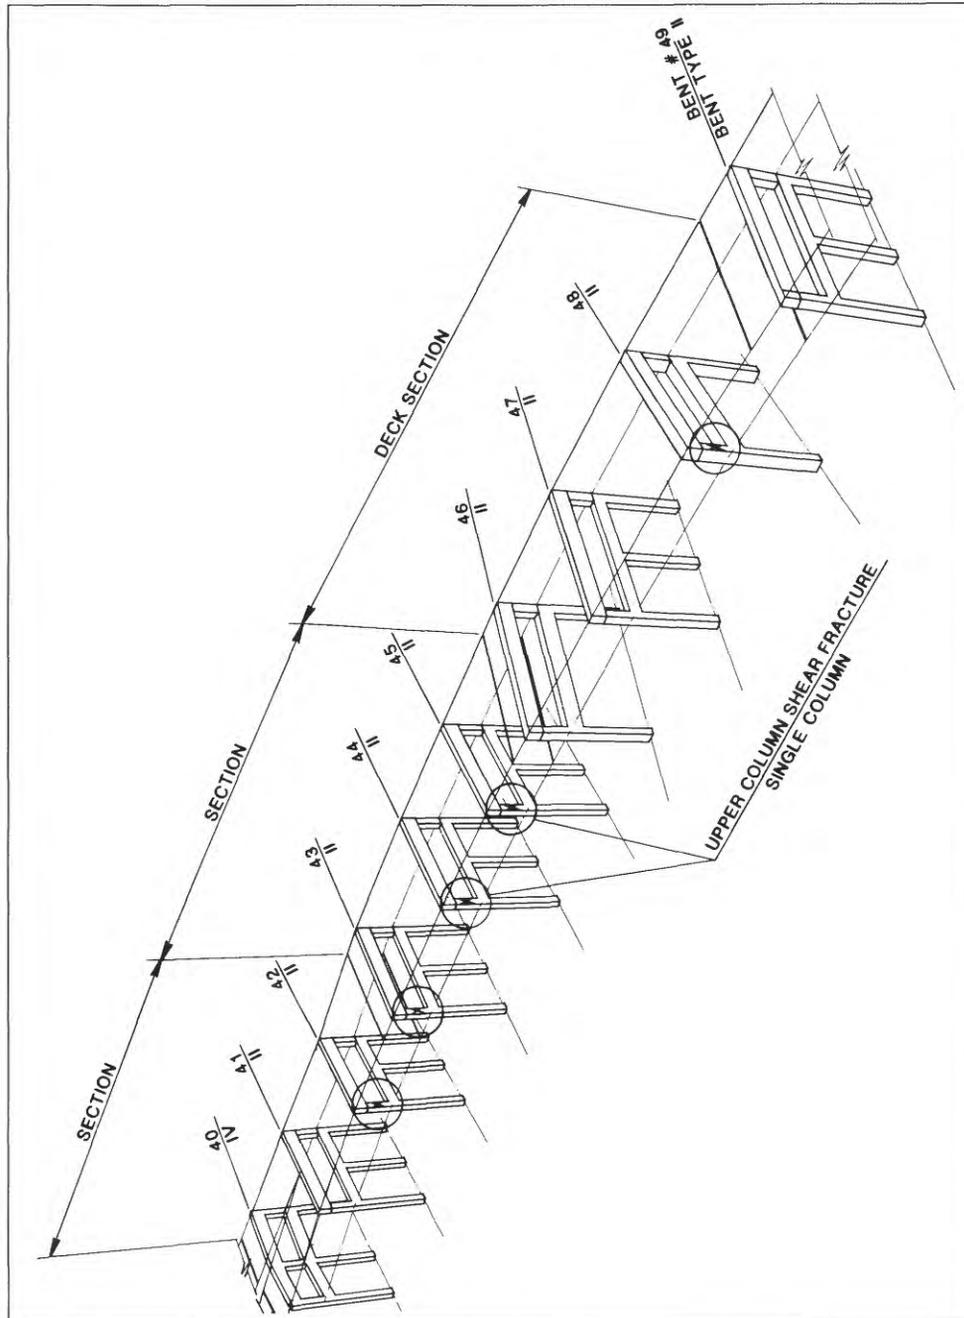
Figure 142.—Damage on Central Viaduct (Thiel, 1990).

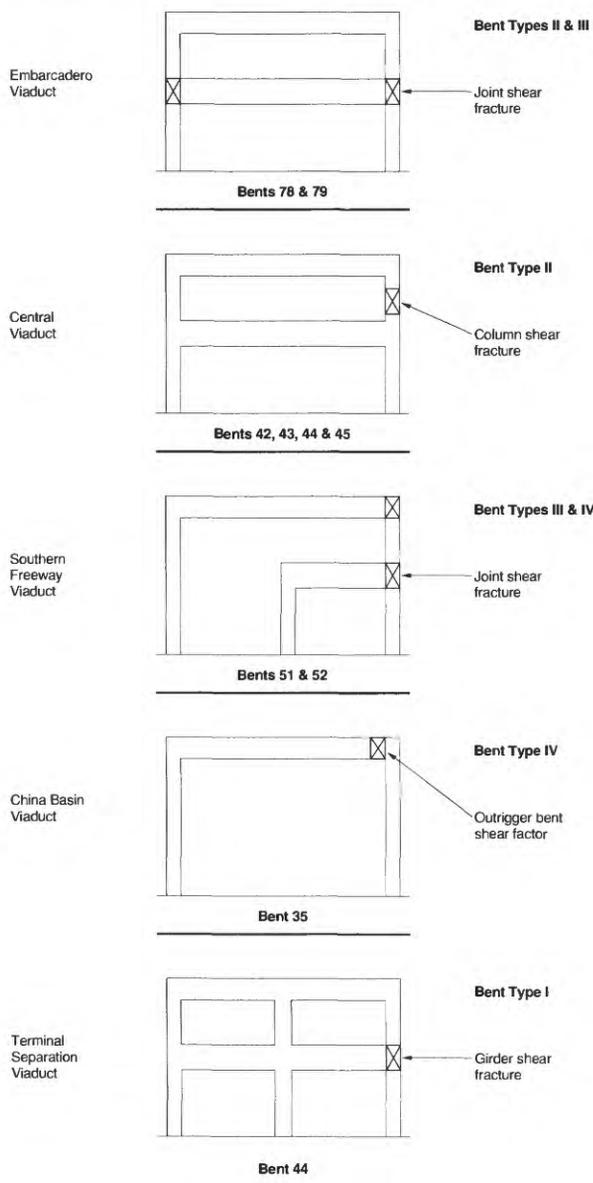
Figure 146.—Summary of damage to San Francisco Viaducts (Thiel 1990).

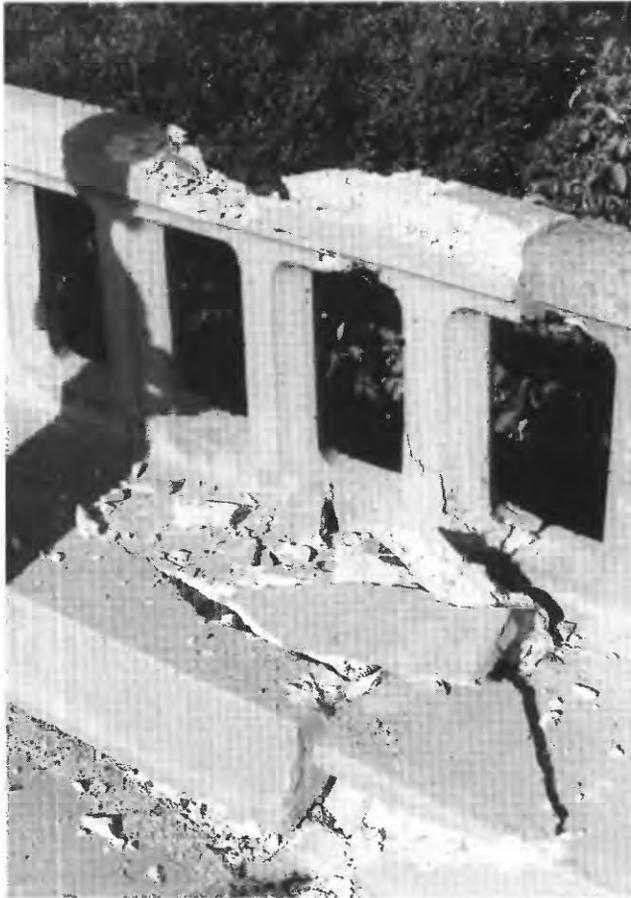
Figure 178.—Barrier rail on north side of Bent 3 at Grant Undercrossing (photograph by Mike Van de Pol).

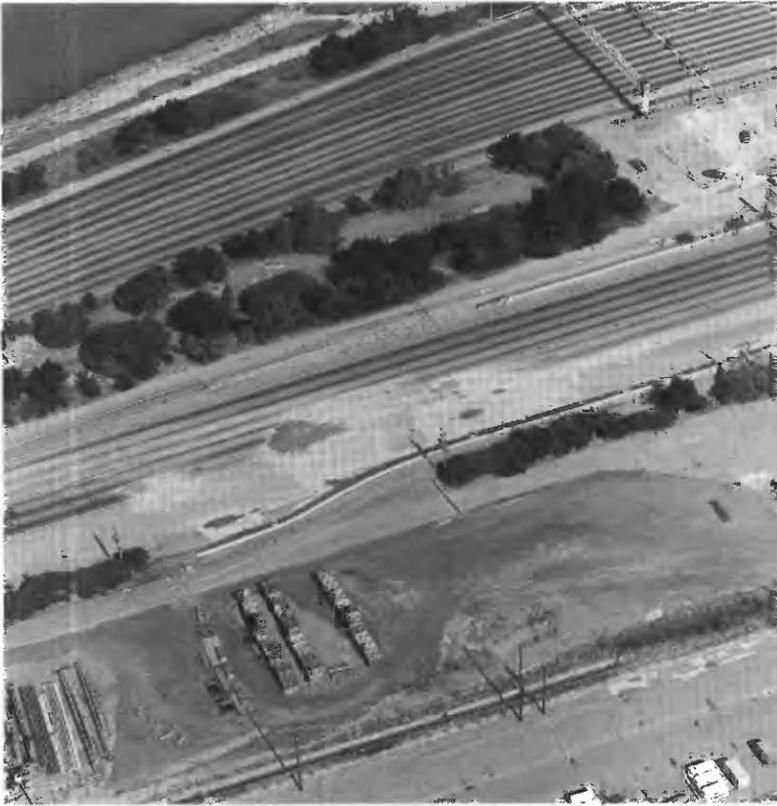
Figure 295.—Sand boils and heaving at Interstate 80.

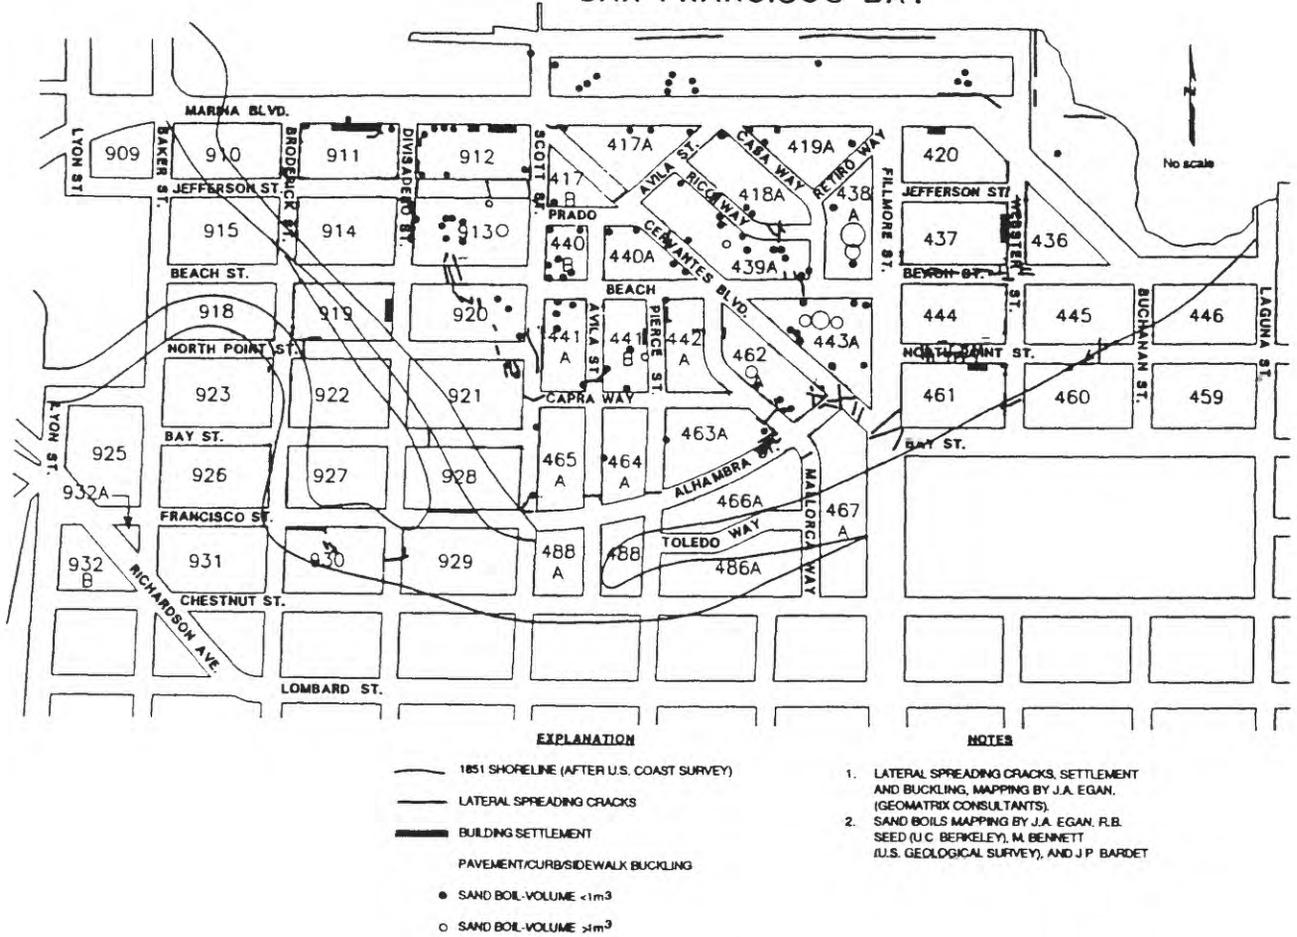
Figure 300.—Damage map of San Francisco's Marina District (Egan, 1990).

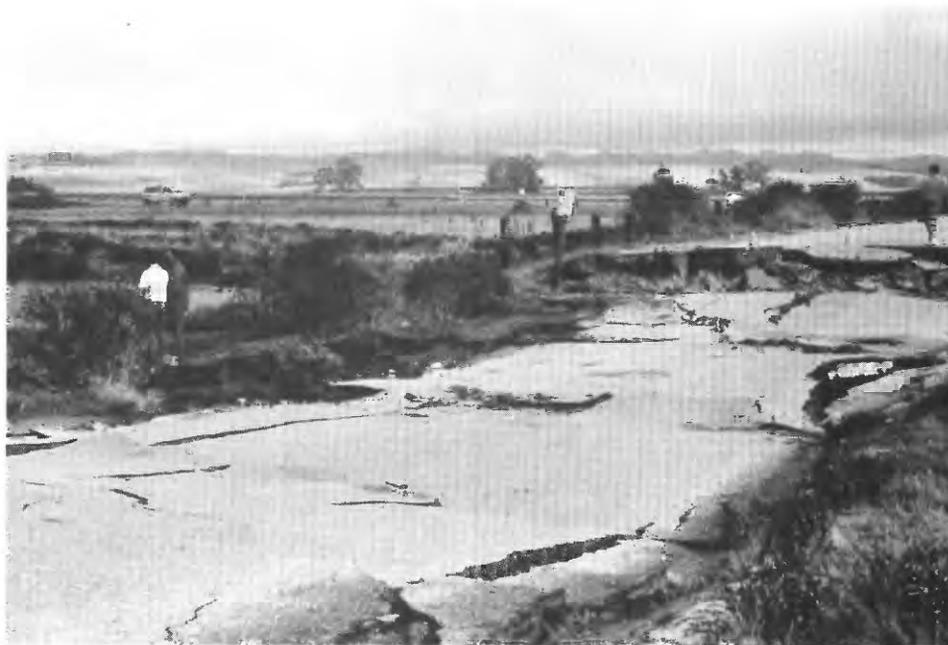
Figure 302.—Damage to the access road at Moss Landing State Park (courtesy of Earthquake Engineering Research Institute) (view to south).

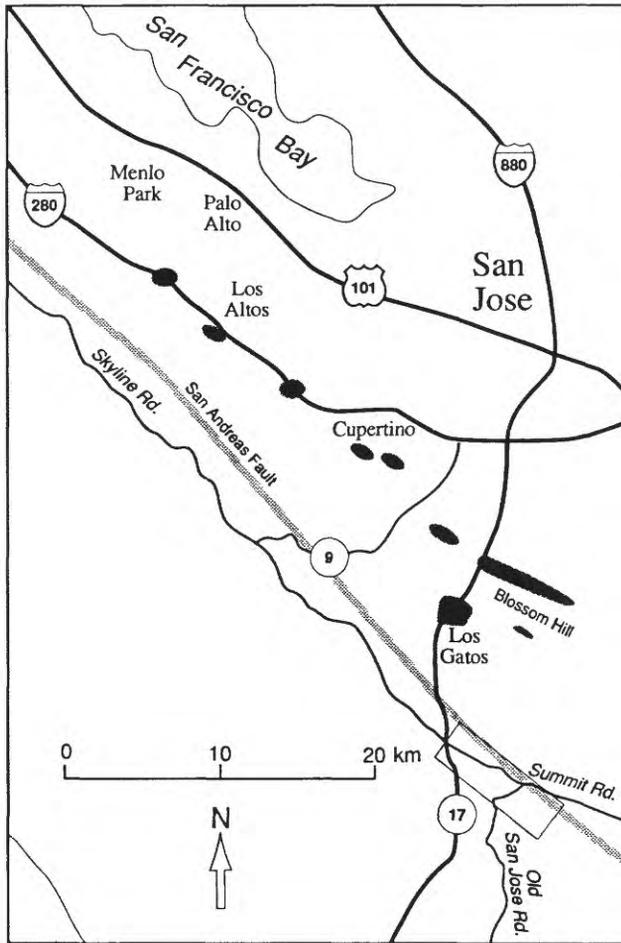
Figure 305.—Areas of compression damage along northeastern edge of Santa Cruz Mountains (rectangular area at lower right is area of fig. 308) (courtesy of Earthquake Engineering Research Institute).

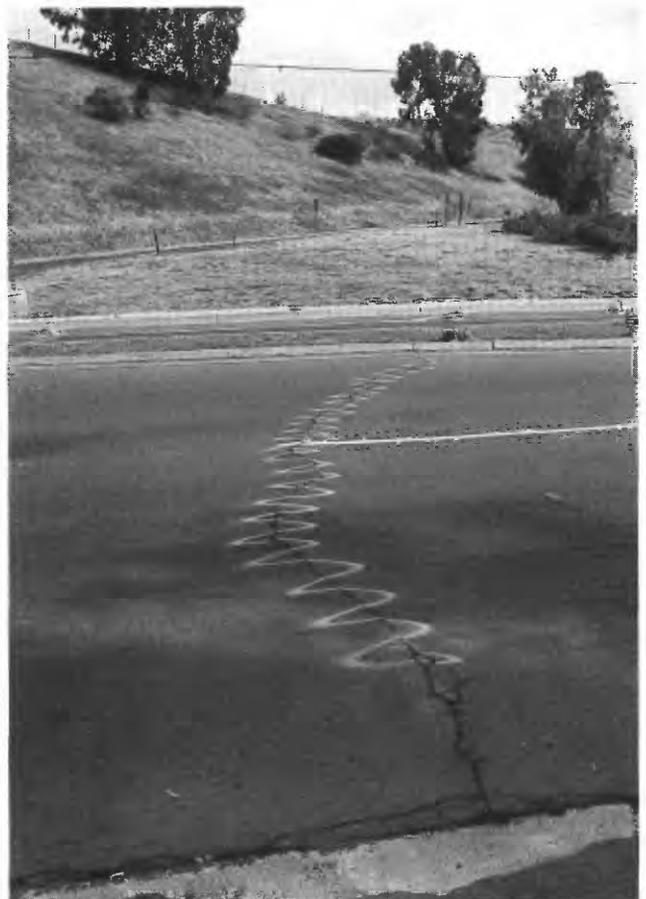
Figure 307.—Close-up of damage at Sand Hill Road.

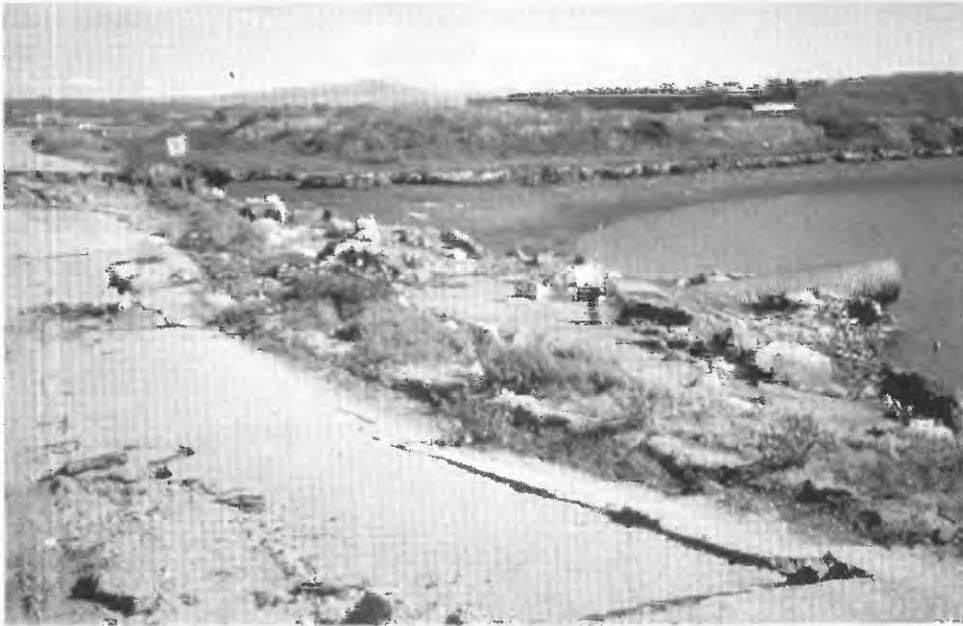
Figure 318.—Culvert damage at Jetty Road (courtesy of Leslie Youd).

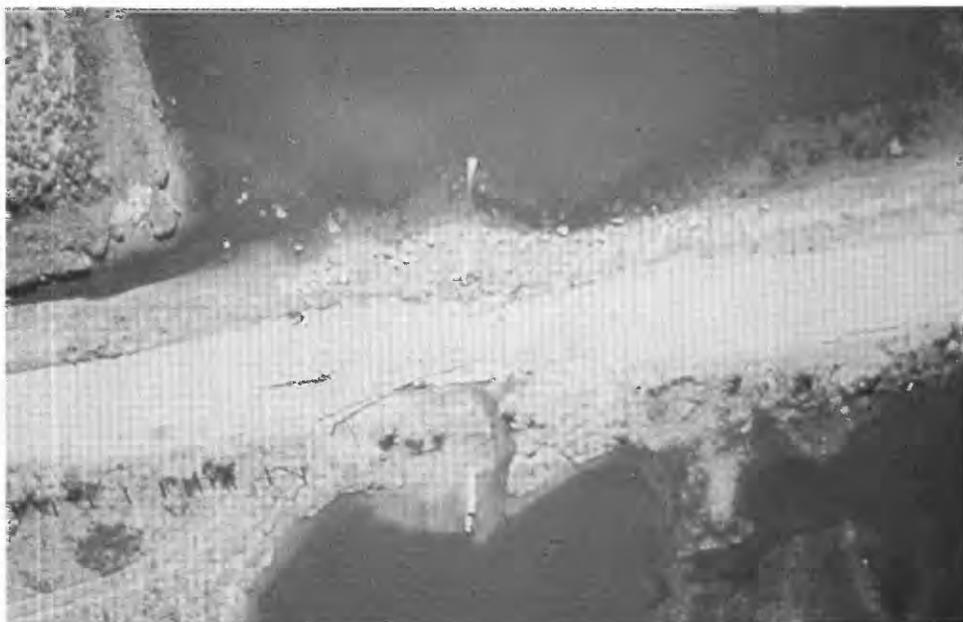
Figure 319.—Aerial view of culvert damage at Jetty Road (the culvert has been bent until it sticks out of the water) (courtesy of Leslie Youd).

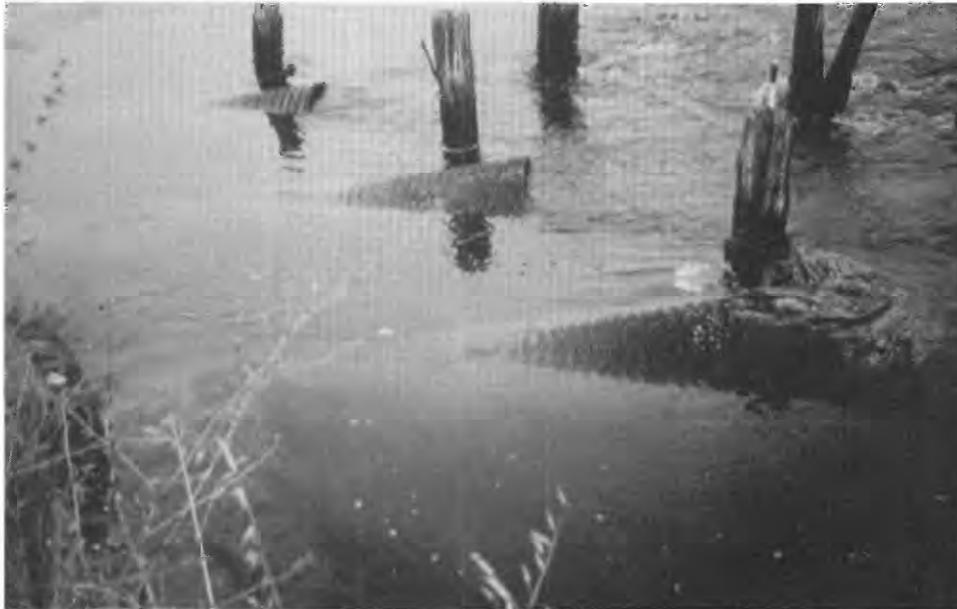
Figure 320.—Damaged culverts at Elkhorn Road.
