Streamflow and Streambed Scour in 2010 at Bridge 339, Copper River, Alaska

Professional Paper 1784–C

By Jeffrey S. Conaway and Timothy P. Brabets

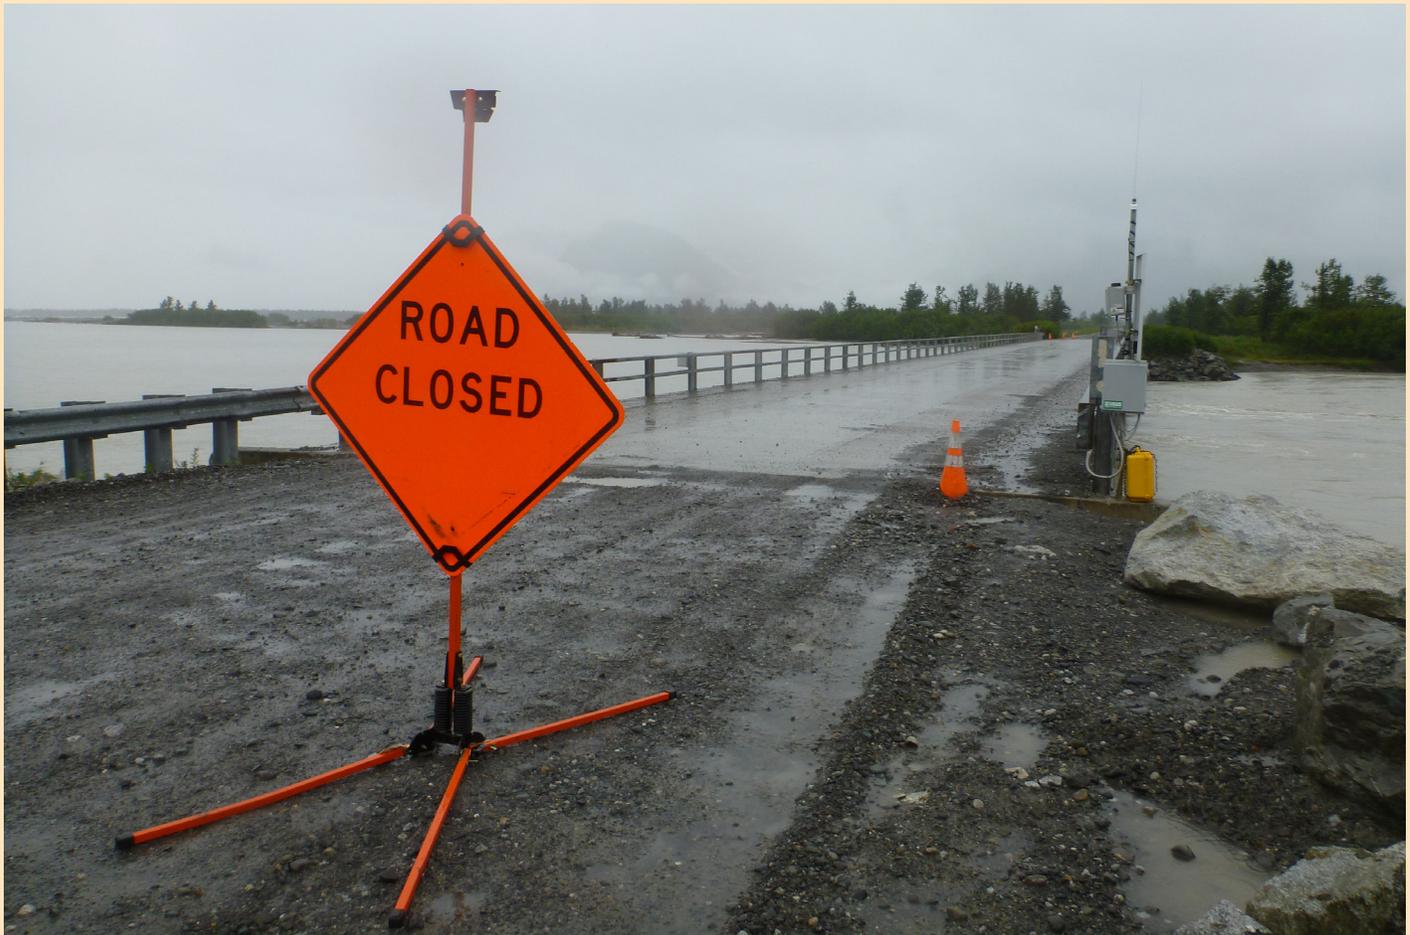
Cover

Photograph of Copper River, Alaska, bridge number (BN) 339. Photograph was taken on August 19, 2011, when streambed scour at the piers and abutments necessitated an indefinite bridge closure. (USGS photograph by J.S. Conaway.)

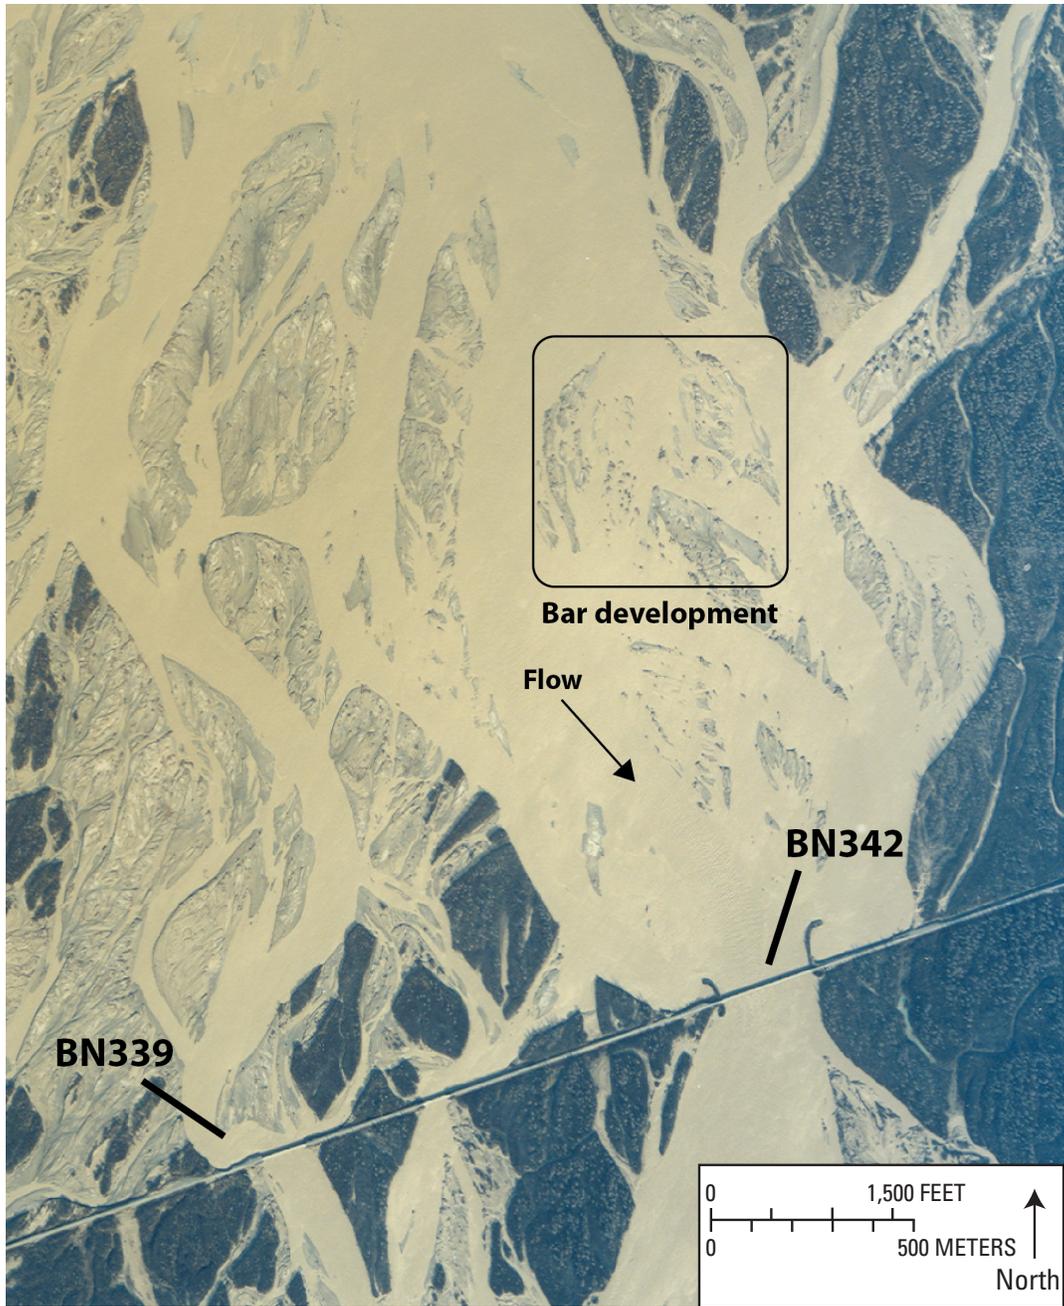
Figure 4. Aerial photograph of the lower Copper River, Alaska, near bridge numbers (BN) 339 and 342 taken in October 2006. Area within the box is the location of mid-channel bar development after October 2006 flooding. (USGS image.)

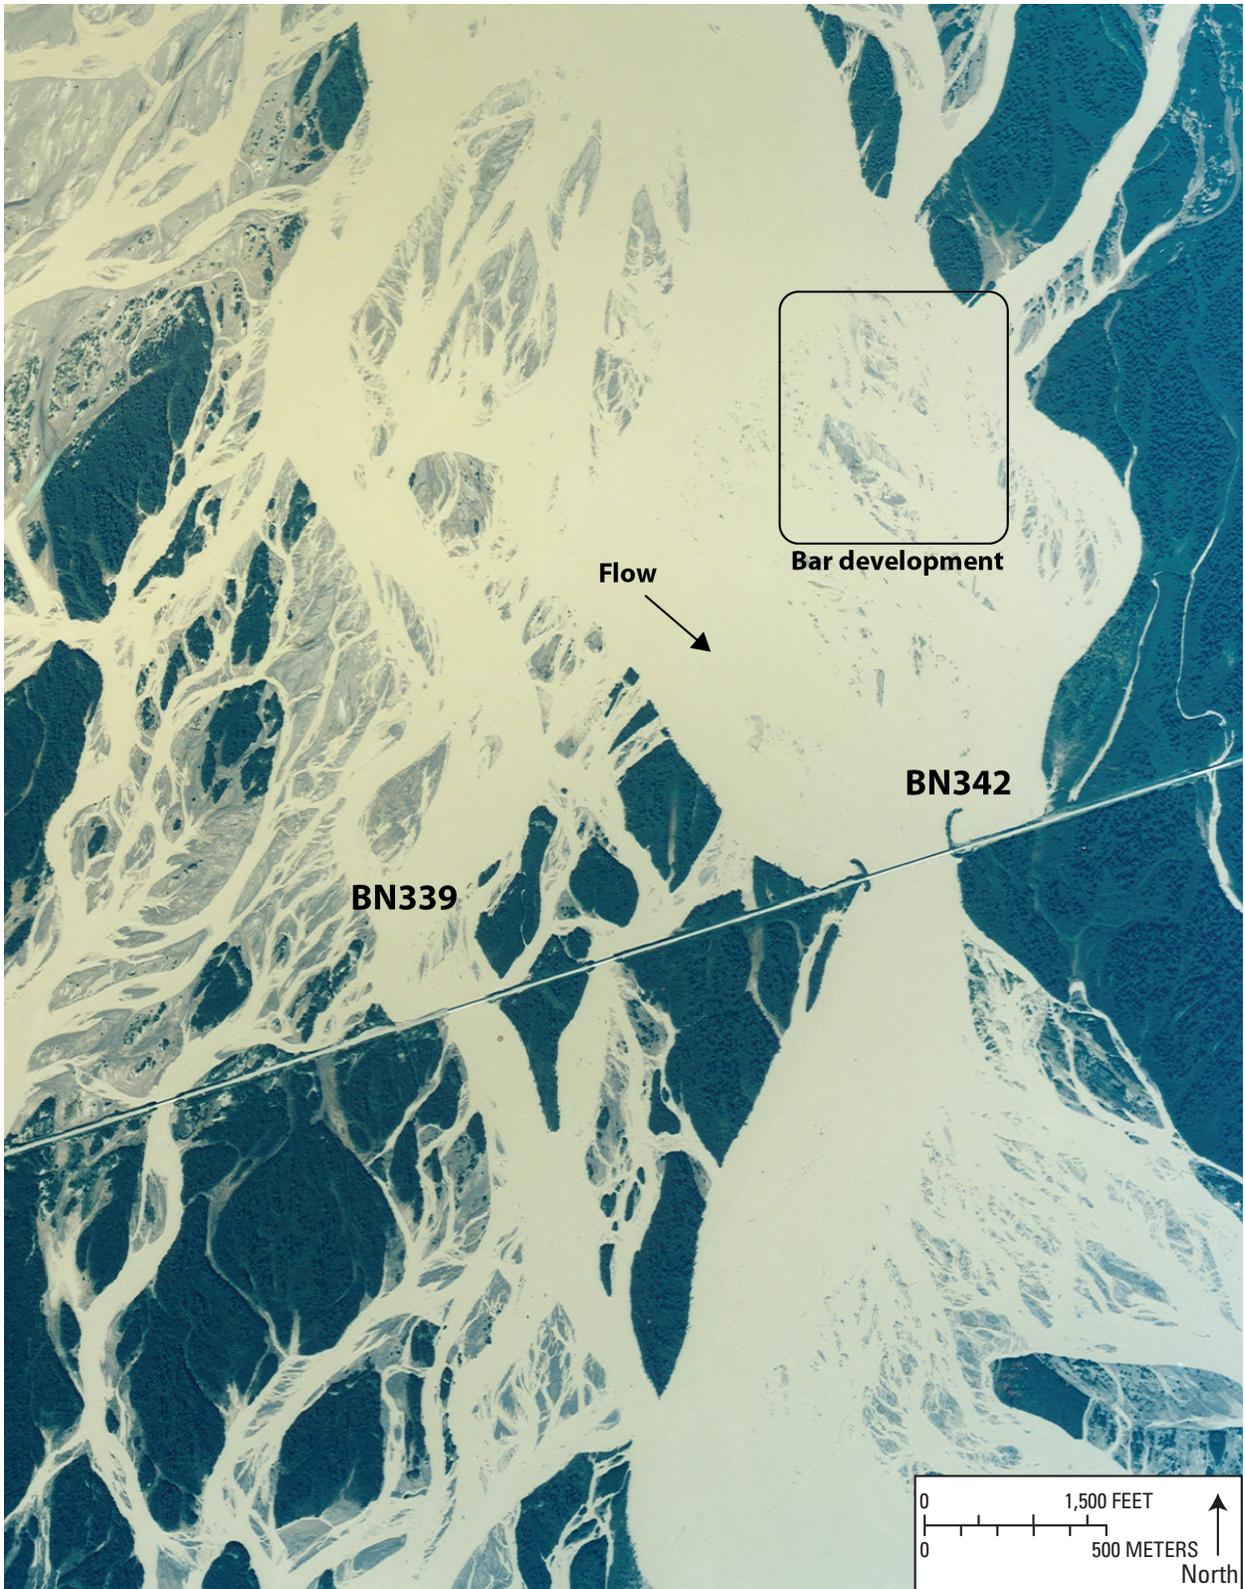
Figure 5. Aerial photograph of the lower Copper River, Alaska, near bridge numbers (BN) 339 and 342 taken in August 2007. Area within the box is the location of mid-channel bar development initiated by deposits from October 2006 flooding. (USGS image.)

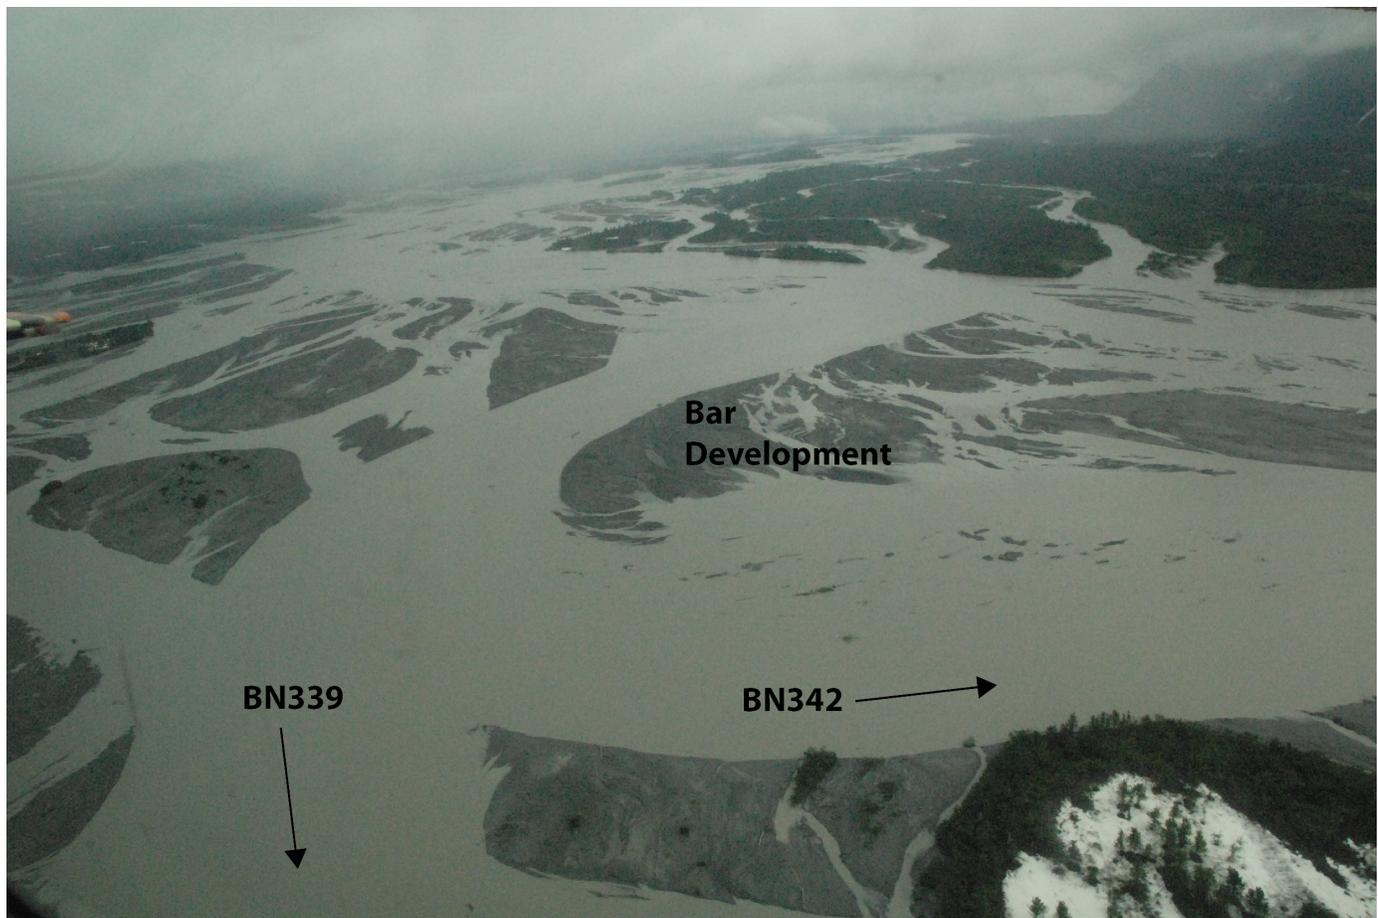
the deepest channels on the braid plain actively convey water. A sinuous, single-thread channel approaches BN 339 and BN 342 and then bifurcates approximately 3,500 ft upstream of BN 339. There are three distinct water-surface slopes along this channel (fig. 8). The upstream section slope is the greatest at 0.0013 ft/ft and this part of the channel traverses from east to west across the braid plain. The slope of the next section is nearly flat at 0.00004 ft/ft for 3,600 ft until the slope increases to 0.0008 ft/ft through BN 339. Reductions in slope along a river result in decreased sediment transport capacity, deposition of sediment as bars, and diversion of flow toward the outer banks (Leopold and others, 1964). The bifurcation is located near the apex of large curve in the low-flow channel. Migration of this low-flow channel will likely continue west and continue to favor flow toward BN 339.

Figure 6. Aerial photograph showing approach channels to Copper River, Alaska, bridge numbers (BN) 339 and 342. Photograph was taken on July 1, 2010, at a discharge of 60,300 ft³/s at BN 339 and a total river discharge of 160,000 ft³/s. Area labeled Bar Development is the location of mid-channel bar development that was initiated by flood deposits in October 2006. (USGS photograph by J.S. Conaway.)

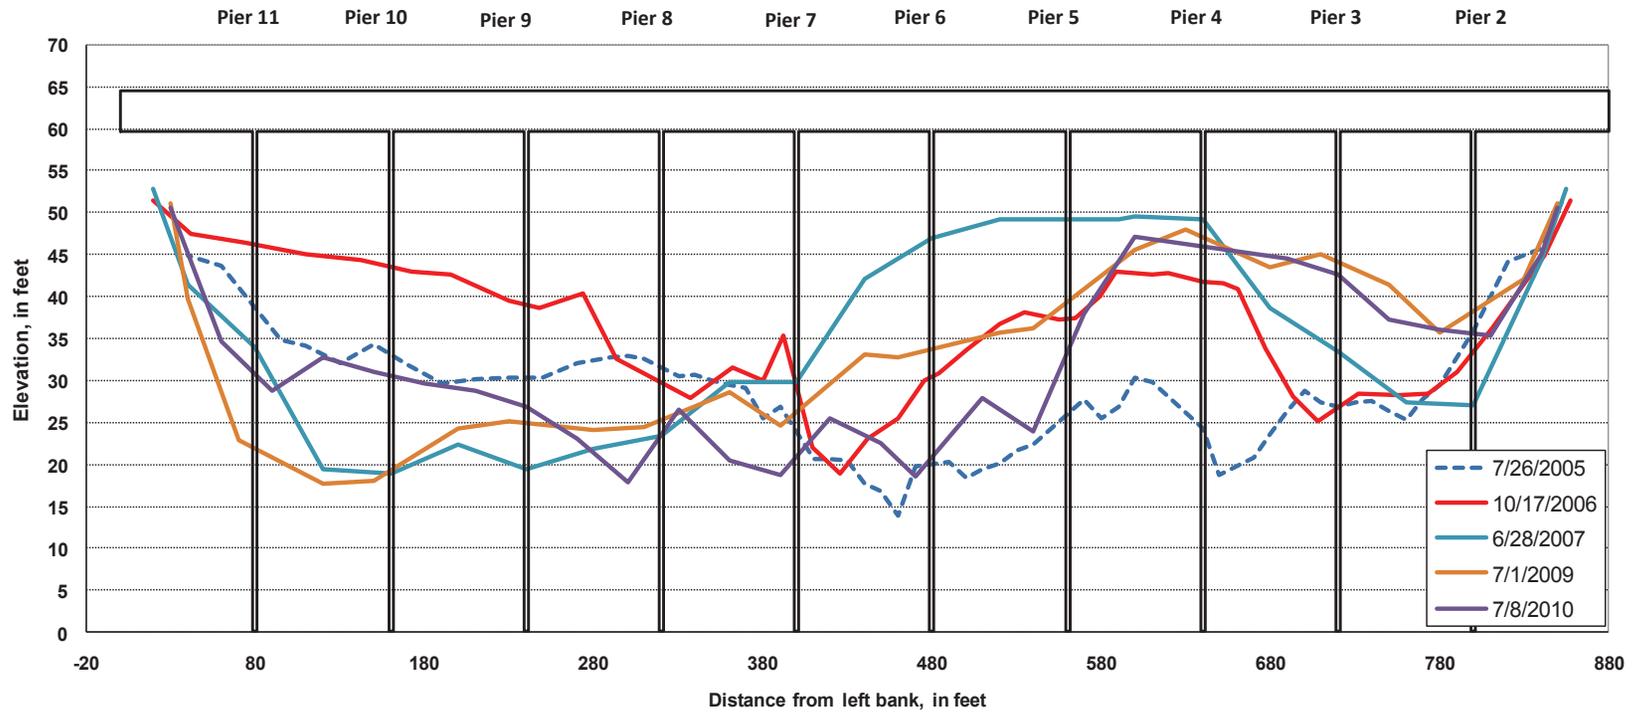
Figure 7. Surveyed cross sections along the downstream side of Copper River, Alaska, bridge number (BN) 342. The dashed cross section was surveyed before a October 2006 flood, and the remainder of the cross sections were surveyed after the flood.

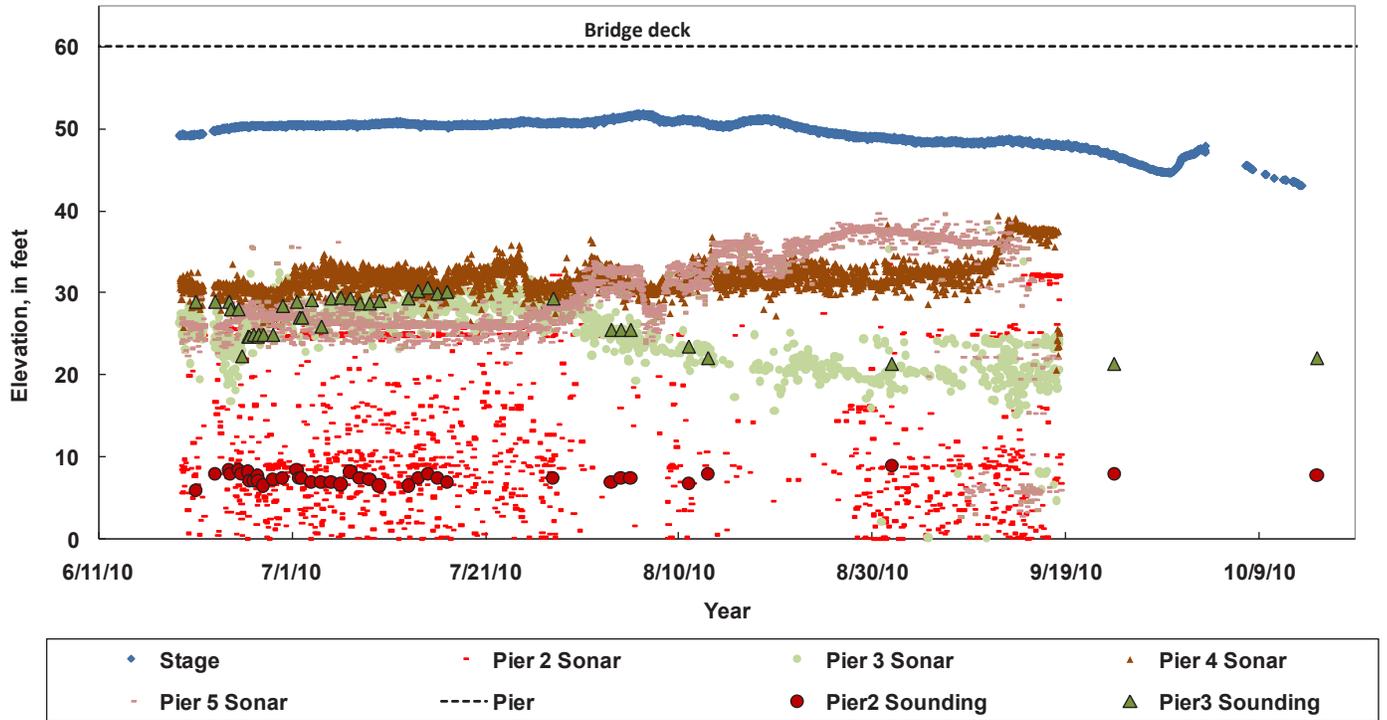
Continuous scour monitoring with pier-mounted sonars was successful at piers 3, 4, and 5, but air entrainment and a hydraulic jump on the downstream side of pier 2 prevented accurate data collection (fig. 11). During a site visit on July 14, 2010, pier 2 was observed to be oscillating a quarter of an inch because 45 ft of the pier was in the water column and measured velocities near the pier exceeded 9 ft/s at depths as great as 35 ft (fig. 16). Streambed elevation at pier 2 ranged from 5.9 to 9.0 ft for the entire summer and did not infill as stage decreased in September and October. It is possible that rip rap eroded from the right bank abutment armored the streambed preventing further scouring of the channel near pier 2.

Figure 11. Pier soundings, stage, and sonar values from 2010 at Copper River, Alaska, bridge number (BN) 339. Air entrainment and a hydraulic jump at pier 2 limited the ability of the sonar to collect accurate data.

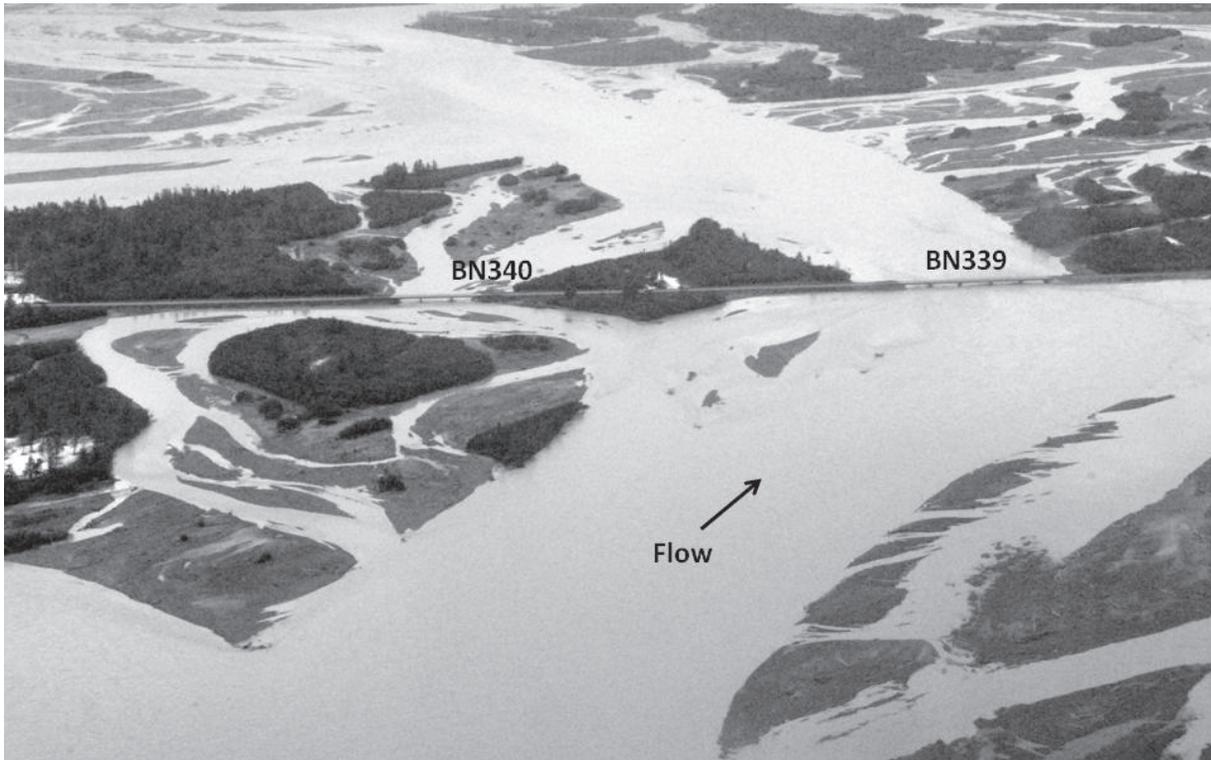
The main channel to BN 339 has changed continuously from 2002 to 2010. Brabets and Conaway (2009) documented the migration of this channel initially toward the west (right bank) and then back toward the east (left bank) in 2008. In 2010, the approach channel was skewed to the bridge opening and directly attacked the right bridge abutment (figs. 13 and 14). This migration reduced undermining and scour along the right bank approach, but increased these processes at the right bank abutment and scoured the streambed across the channel (figs. 15 and 16). Channel area below a datum of 50.0 ft increased from 4,130 ft² on July 1, 2009, to 8,850 ft² on July 6, 2010. This increase in channel area was the result of as much as 20 ft of scour along the left part of the channel as the approach channel became more aligned with the bridge opening. Maximum channel depths were along the right side of the channel, and scour at piers 2 and 3 nearly reached the criterion for minimum embedment.

Figure 13. Aerial photograph of approach channels to Copper River, Alaska, bridge numbers (BN) 339 and 340. Photograph was taken on July 1, 2010, at a discharge of 60,300 ft³/s at BN 339 and a total river discharge of 160,000 ft³/s. (USGS photograph by J.S. Conaway.)

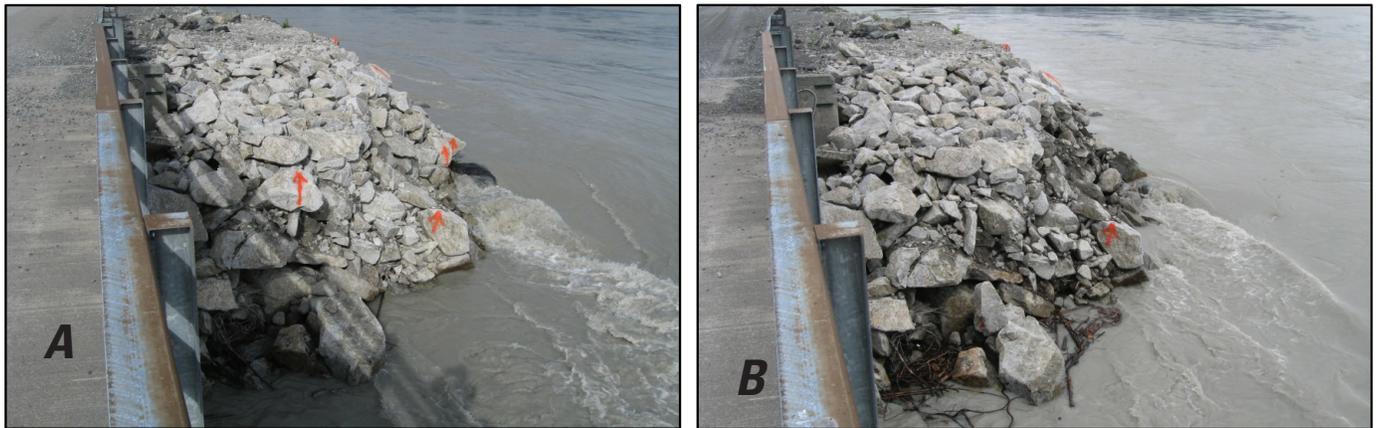
Conditions in 2010 were closely monitored with cross-sectional surveys, discharge measurements, scour monitoring equipment, and time-lapse photography. Scour at the right-bank abutment required emergency placement of rip rap in late June 2010. Streambed elevation at the right-bank pier (pier 2) was within 1 ft of the threshold for minimum embedment depth and was monitored daily with manual soundings for 6 weeks. Bed elevations along the right bank reached a minimum in June of 2010 and fluctuated little through the rest of the summer despite changes in discharge. Increases in channel area resulted from widening of the thalweg toward the center of the channel and pier 3. The streambed was within 2.3 ft of the limit for minimum embedment at pier 3 during the last cross-sectional survey on October 14, 2010.

Figure 14. Photographs showing undermining and erosion of rip rap over a 24-hour period at the right bank abutment of Copper River, Alaska, bridge number (BN) 339 from (A) June 24, 2010, to (B) June 25, 2010. Discharge at BN 339 was 60,600 ft³/s. Orange arrows were painted on rip rap to document movement or removal. (USGS photographs by P.V. Schauer.)

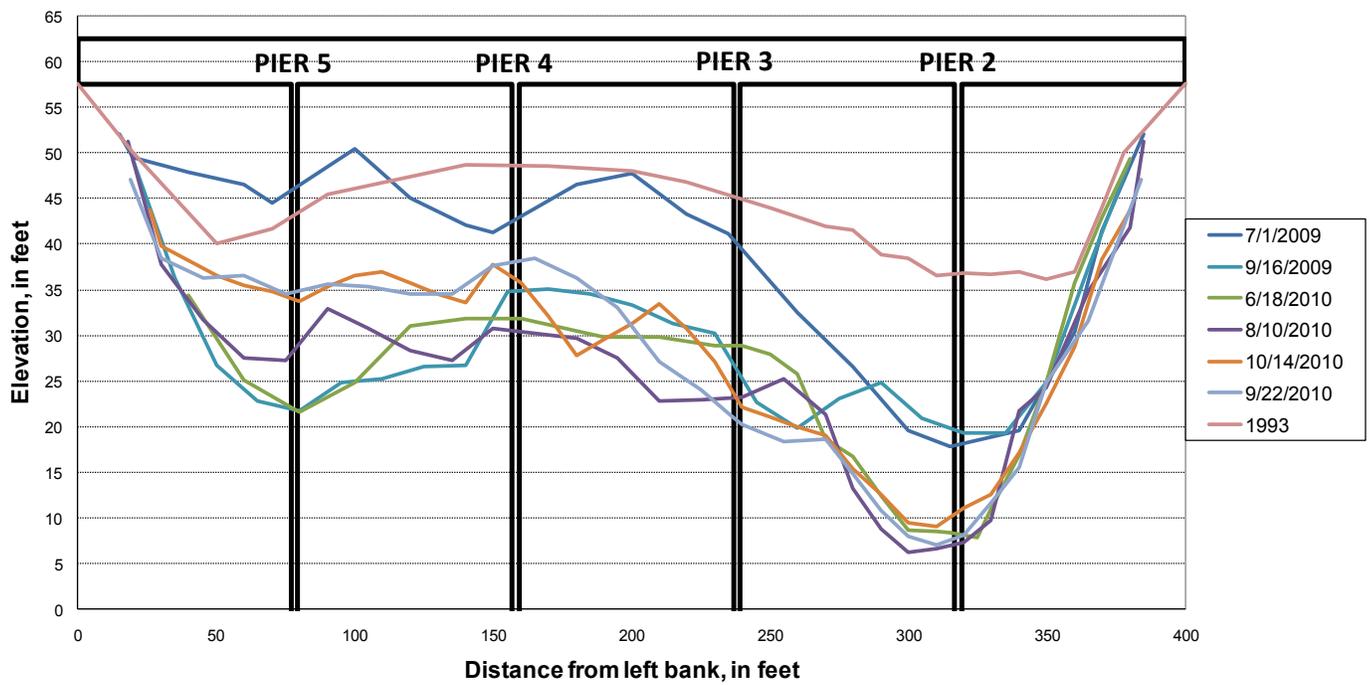
Changes in channel area in 2010 resulted from scour and fill along the left and center parts of the channel. The location of the approach channel relative to the bridge opening determines the shape of the bridge cross section by directing the highest velocities toward one bank or the other. Bed elevations increased at piers 4 and 5 as stage receded in August but decreased at pier 3. Widening of the main channel toward the center of the channel (scour at pier 3) may indicate a resistance to additional scour at pier 2; however, thalweg migration in this direction threatens the integrity of pier 3, which has the shallowest pile-tip elevation (table 3). The criterion for minimum embedment depth for lateral loading is 35 ft. The minimum measured bed elevations in 2010 were near this criterion for piers 2, 3, and 5 (table 3). Continued thalweg expansion or migration toward the left bank may scour the streambed beyond minimum embedment elevations at piers 3 and 5.

Figure 15. Surveyed cross sections along the downstream side of Copper River, Alaska, bridge number (BN) 339.
