## STRUCTURAL DAMAGE AND GROUND FAILURES FROM THE NOVEMBER 16, 1983, KAOIKI EARTHQUAKE, ISLAND OF HAWAII

By Jane M. Buchanan-Banks

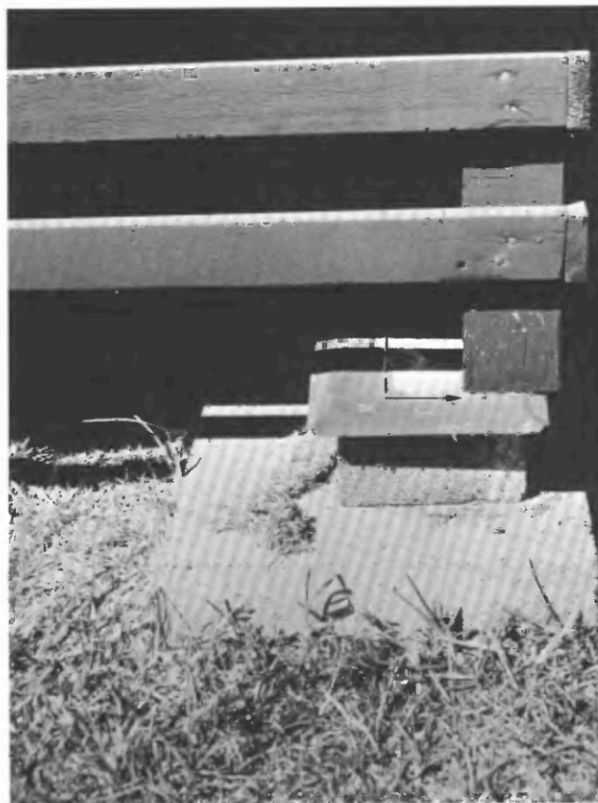
Most houses on the island are single-story wood-frame structures with either post-and-pier (fig. 44.3) or concrete slab foundations. In this earthquake, houses with post-and-pier construction sustained greater structural damage, primarily because of lateral displacement of the piers and consequent decoupling of the piers from the houses. The piers often moved with respect to each other as well as to the ground. Most structures with concrete slab foundations, on the other hand, had little damage, generally limited to hairline cracks through the slabs. However, the degree of shaking damage to loose objects inside houses seemed to have little or no relation to the type of foundation.

FIGURE 44.3.—Post-and-pier house support displaced in November 16, 1983, earthquake. In this type of construction, two concrete blocks form pier and a vertical wooden 10-cm by 10-cm post supports house. Larger block is resting on ground; smaller is placed on top of this and usually not connected to it. Between upper block and post is a termite shield of thin metal. At this locality, both post and upper foundation block have moved several centimeters to right on their respective supports. Dashed line indicates original position of post; arrow shows direction of movement.

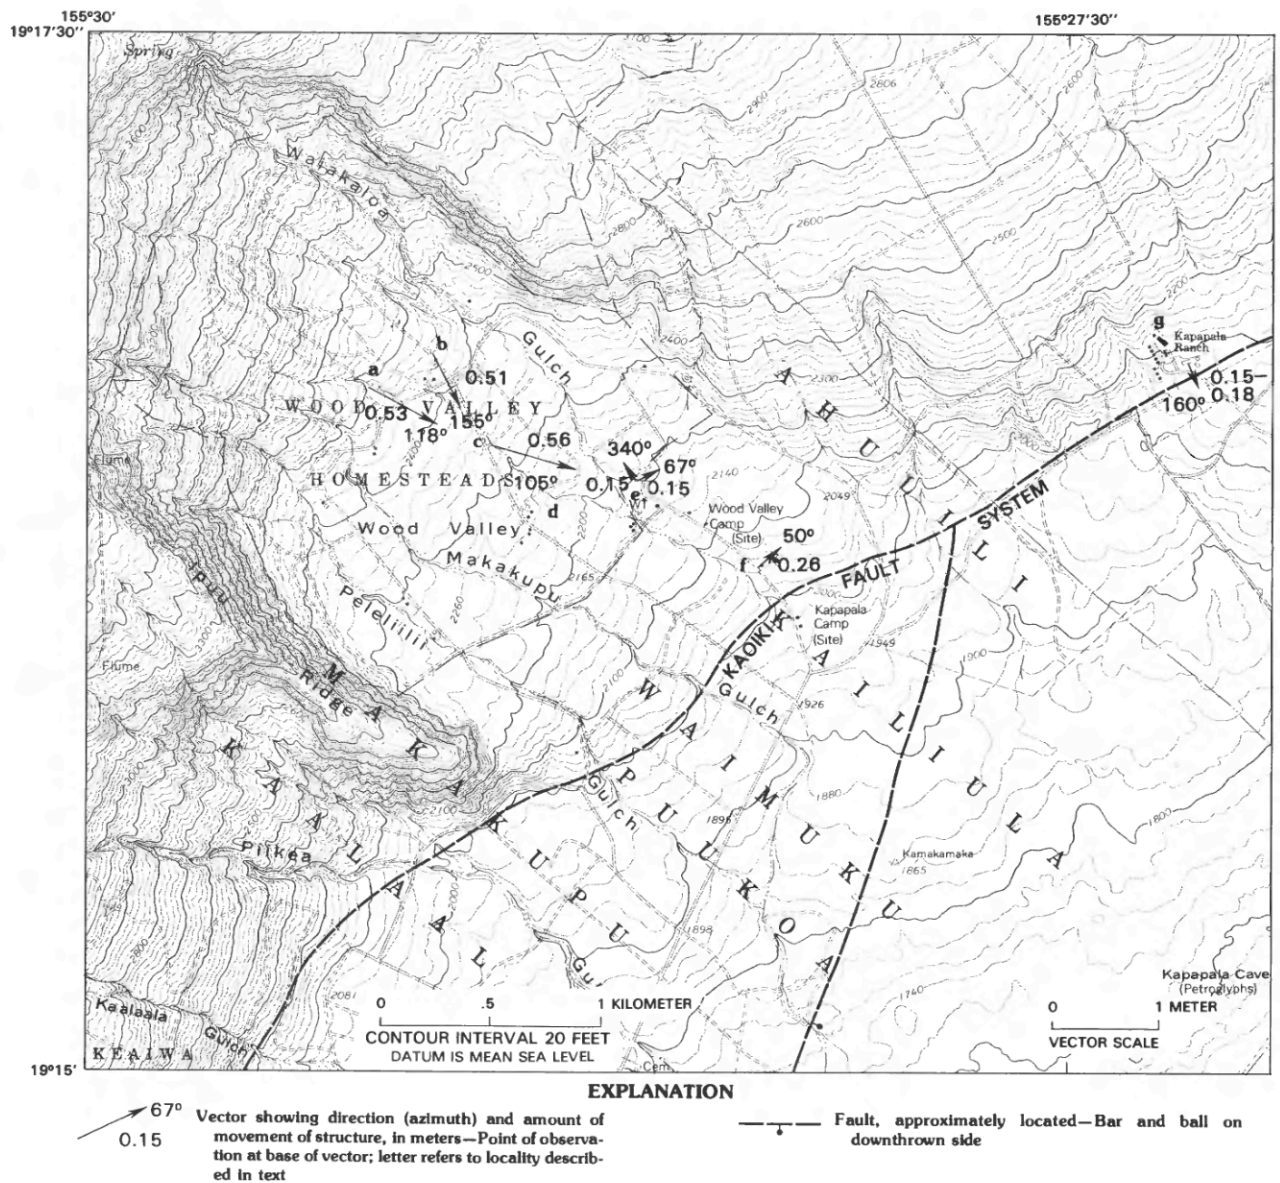
undamaged, but the steel plate was bent at an angle of about 45° (fig. 44.5A, B). Nearby houses with concrete slab foundations on ash or with post-and-pier foundations on a pahoehoe flow sustained little movement (fig. 44.4, vectors d, e). Greenhouses were moved as much as 0.15 m in a complex pattern toward azimuths anywhere from 67° through 340° (fig. 44.4, vector e). These structures had few central supports or walls, hence the various structural elements may have failed at different times during the shaking, which could account for the range in direction of failure.

FIGURE 44.4.—Earthquake-related movement of structures in Wood Valley and western Kapapala Ranch, November 1983 (fig. 44.1, localities 2, 3). Topography from U.S. Geological Survey Wood Valley 7.5-minute quadrangle, 1981, scale 1:24,000. Location of faults from Stearns and Clark (1930, pl. 1) and Lipman and Swenson (1984).

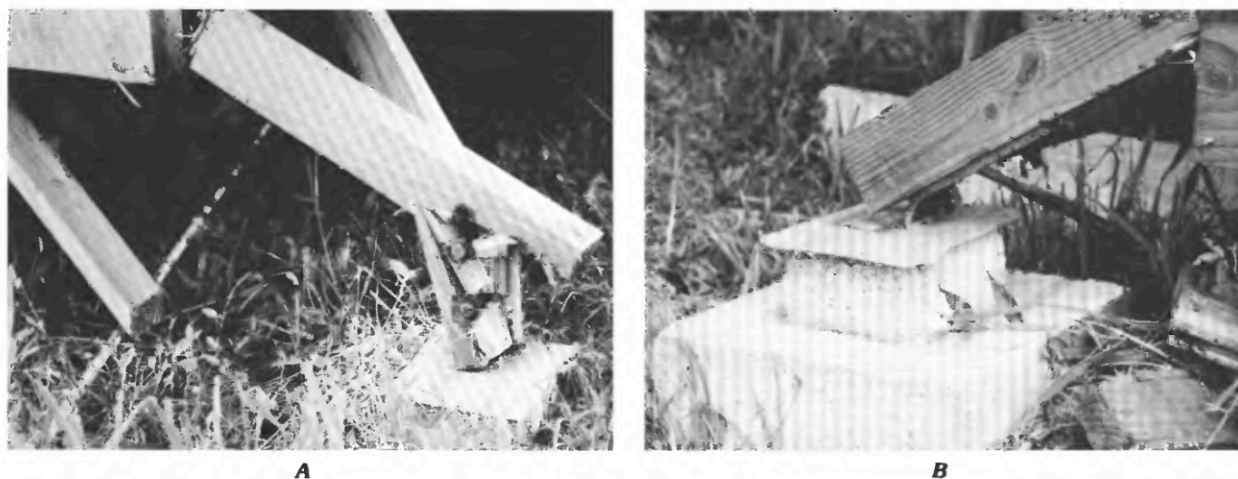
Wood Valley is a sparsely populated agricultural community built mostly on an ash deposit and on deposits of landslides induced by the magnitude 7.5–8 1868 earthquake and earlier earthquakes (Brigham, 1869, p. 574–576; Tilling and others, 1976, p. 29–30; fig. 44.1, locality 2; fig. 44.4). Several houses of post-and-pier construction (two built on ash and (or) landslide deposit) moved more than 0.5 m off their foundations toward the southeast at azimuths 105°–155° (fig. 44.4, vectors a, b, c). The 8-cm by 8-cm posts of one house were connected to the foundation piers with 0.5-cm-thick steel plates. The plates were not always on the same side of the posts, and therefore some posts were snapped at the anchor bolts connecting the post to the plate; other posts were relatively

FIGURE 44.5.— Damage to a wood-frame house with post-and-pier construction in Wood Valley (fig. 44.4, locality b). **A**, Northeast corner post fractured where anchor bolts connected it to 0.5-cm-thick steel plate positioned on southwest side of post (away from the viewer). Concrete foundation block appears to have been poured as single unit around the steel plate. Post also was torn loose from house and from diagonal bracing when ground, pier, and post moved southeastward. **B**, Northwest corner post with steel plate on south side of post. The 0.5-cm-thick steel plate is bent at 45° angle. Photographs by E.T. Endo.

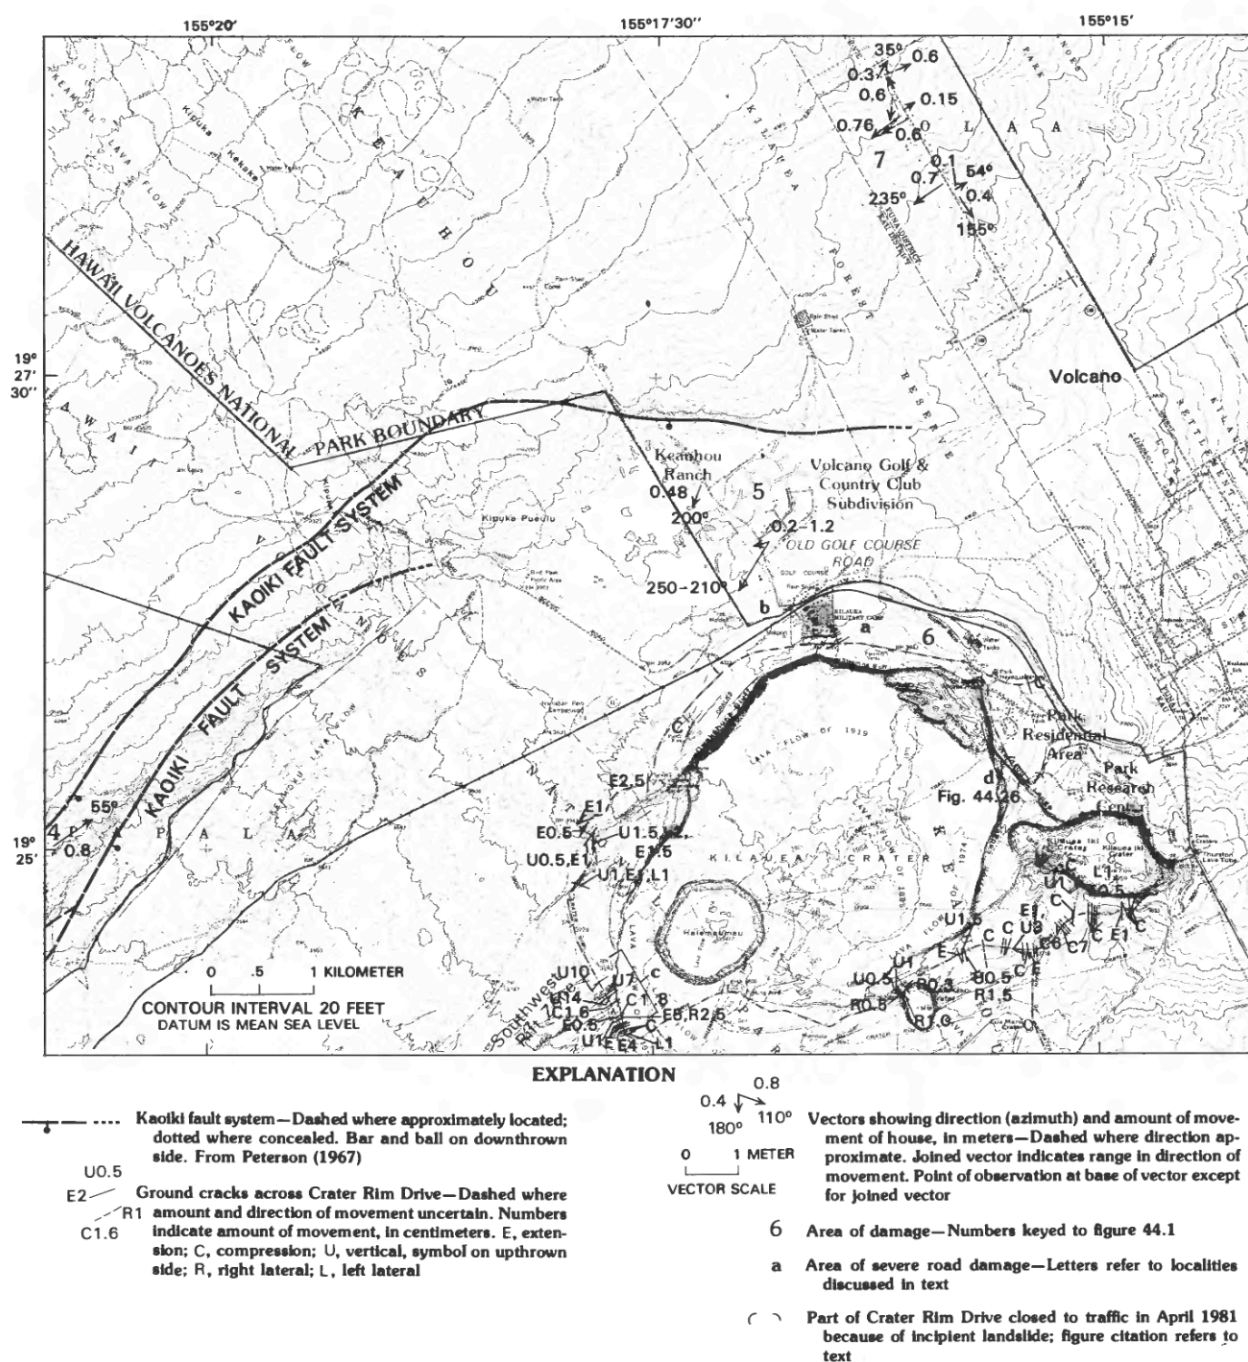
A reconnaissance survey of damage along Crater Rim Drive was conducted immediately after the earthquake. Although the road pavement was extensively cracked throughout its length, only the zones of greatest damage are shown in figure 44.6. Most of the road cracks depicted in this figure were caused by cracking of the ground beneath the road. The road damage included small apparent offsets in both right- and left-lateral senses, major to minor failures of subsurface material, and extensive compressional and extensional cracking, with the most severe damage where the road crosses

fracture systems related to Kilauea caldera (fig. 44.6, sites *a*, *b*, *c*; St. Ours, 1982). All the damage was attributable to the shaking effects of the earthquake.

FIGURE 44.6.—Earthquake damage in epicentral region near Kilauea summit (localities 4–7, fig. 44.1). Some of the worst structural damage occurred in this area. Topography from U.S. Geological Survey Kilauea Crater and Volcano 7.5-minute quadrangles, 1981, scale 1:24,000.

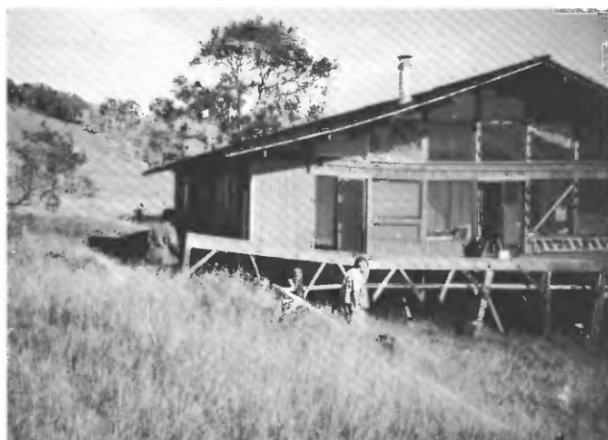
FIGURE 44.7.—House on Kapapala Ranch about 12 km east of epicenter was displaced 0.8 m northeastward during earthquake. Most supporting posts remained vertical, but those used to frame a basement room were tilted. Concrete foundation piers, partly obscured by grass, behind figure in dark jacket. Windows broken during earthquake are covered with plastic. Near clump of trees on hill behind house, small soil slips can be seen and broken branches strew the ground.

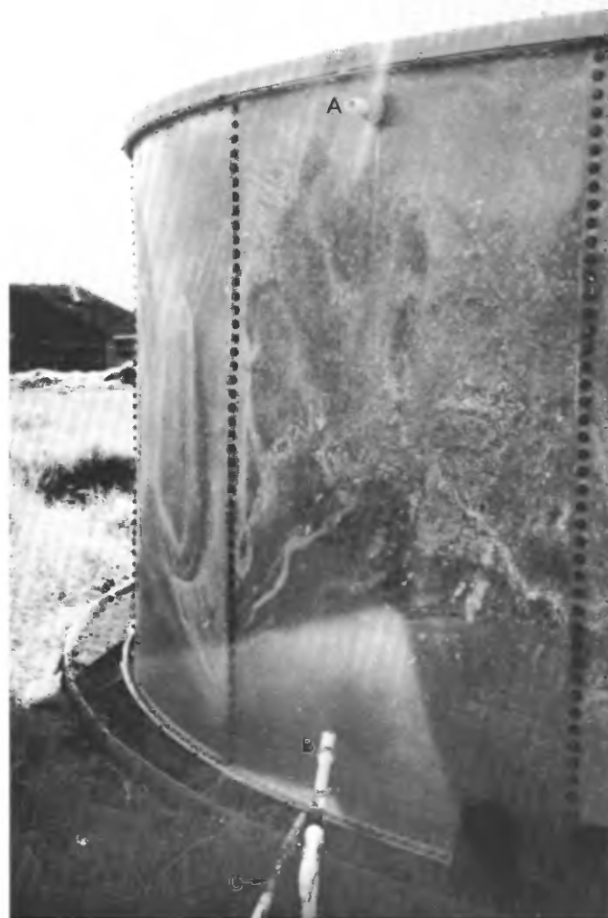
FIGURE 44.8.—Water tank that may have moved as much as 0.12 m southward (to right in photograph) during November 1983 earthquake. The 1.8-m length of pipe that originally extended from A to B now lies under tank at C. First motion apparently snapped pipe, which rolled under tank as tank tilted back and forth.

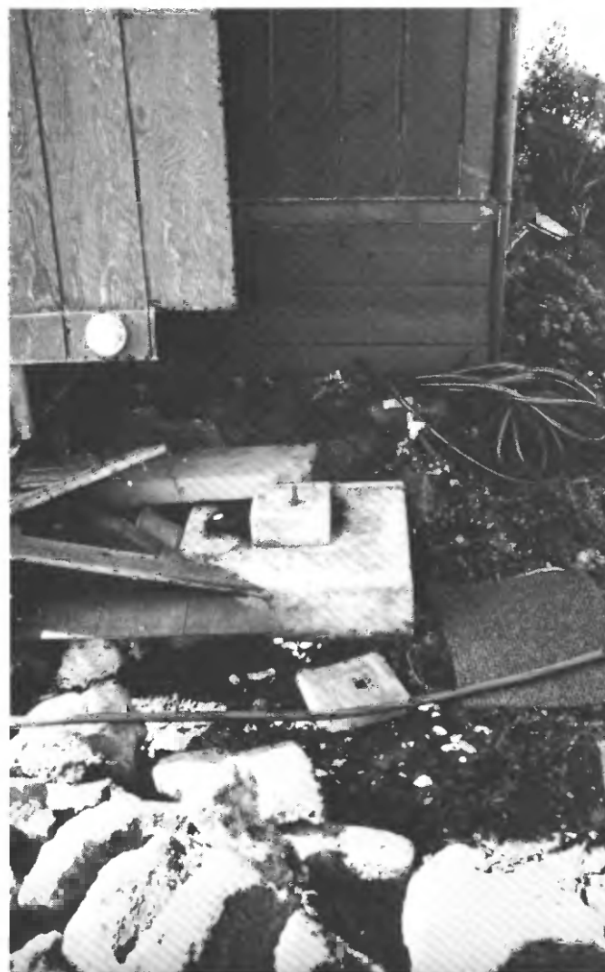
Most houses in this subdivision were built on a thin pahoehoe flow that overlies an ash deposit at least 0.5 m thick (locality 5 on figs. 44.1, 44.6). At the time of the earthquake, 48 houses had been built or were under construction in the subdivision. Of these, 18 houses with post-and-pier construction were displaced 0.2–1.2 m southwest from their foundations. Only one of the houses had 2.5 cm of reinforcing rebar protruding through the foundation piers into the posts (fig. 44.9). After the earthquake, this house was southwest of its piers, but the posts were not sheared by the rebar nor were most of the rebars bent, suggesting that the house rocked laterally and slid up along the rebars during the earthquake shaking.

FIGURE 44.9.—North corner pier of damaged two-story frame house in Volcano Golf and Country Club Subdivision. Although house is now 1.2 m southwest of its foundation, rebar protruding through piers is still straight. Termite shield from atop pier can be seen on ground. House subfloor was originally 1 m above ground, but most supporting posts collapsed.

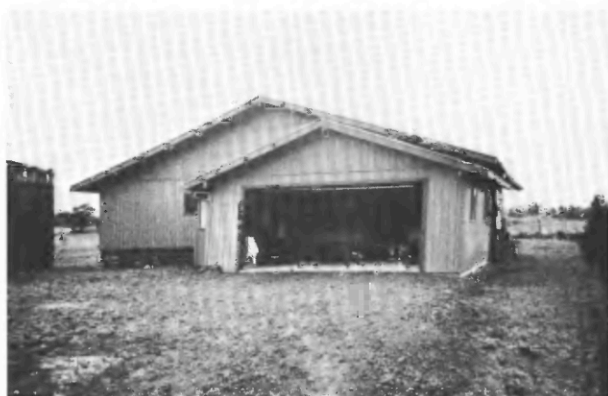
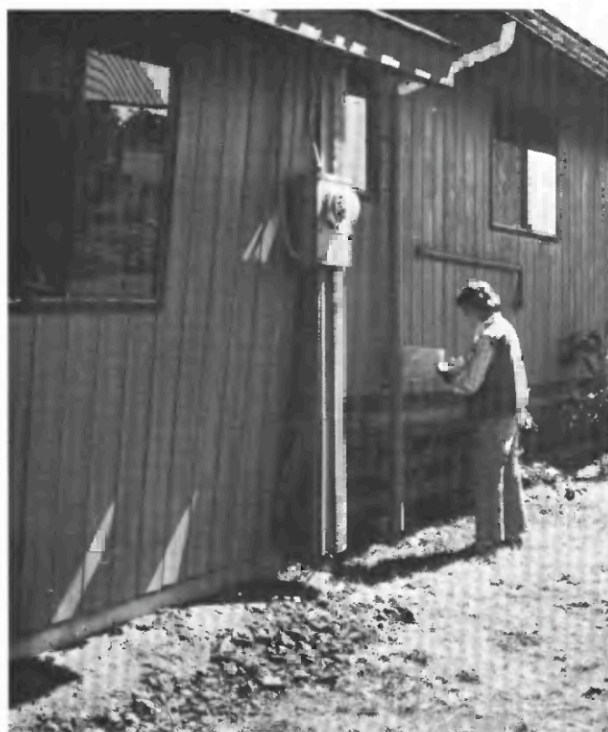
house moved farther than the garage, causing a tearing of the shared wall (figs. 44.10A, B). In one case, however, the garage was situated on the southwest side of the house (the general direction of movement) and because of its greater rigidity, may have kept the house on its foundation.

FIGURE 44.10.—Damaged frame house in Volcano Golf and Country Club Subdivision. **A**, View of attached garage (with concrete foundation) and house (post-and-pier foundation). House moved farther than garage, breaking a 10-cm by 10-cm upright and causing a tear in southwest wall at electric meter. Photograph by R.Y. Hanatani. **B**, Detailed view of right side of house; to right of drainpipe, a supporting post can be seen resting on ground southwest of pier on which it originally stood. Photograph by J.B. Stokes.

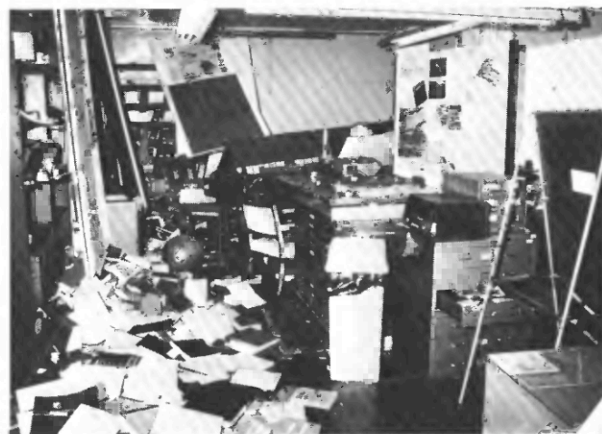
Although no buildings within the national park moved off their foundations, there was extensive interior damage in some buildings (locality 6 on figs. 44.1, 44.6). At the HVO, a concrete foundation slab was cracked in two places but not offset, and work areas were chaotic with toppled equipment and books (fig. 44.11). Some seismic stations were disabled because of damage to the sensors or recorders, while the operating stations were saturated for several hours with signals from ground oscillations. Tiltmeters could not be reset until there was a substantial reduction in the oscillation of the ground. Within the park residential area just south of park headquarters, damage to houses was minor and seemingly arbitrary. Similarly constructed and situated houses differed greatly in the amount of dishevelment of the interiors. There was no damage nor dishevelment to the park headquarters' buildings. Damage to leaking water pipes and valves in the park amounted to \$16,000.

FIGURE 44.11.—Main meeting room and library at Hawaiian Volcano Observatory after 1983 earthquake. Bookcases were torn from back wall and fell onto table; storage cabinets were moved as much as 0.5 m. Preearthquake location of cabinets is documented by dust marks on floor behind and to right of plastic waste bin. Smoked-drum seismographs (obscured by easel) located under windows to right were temporarily out of order because their drive mechanisms jammed. Photograph by J.D. Griggs.

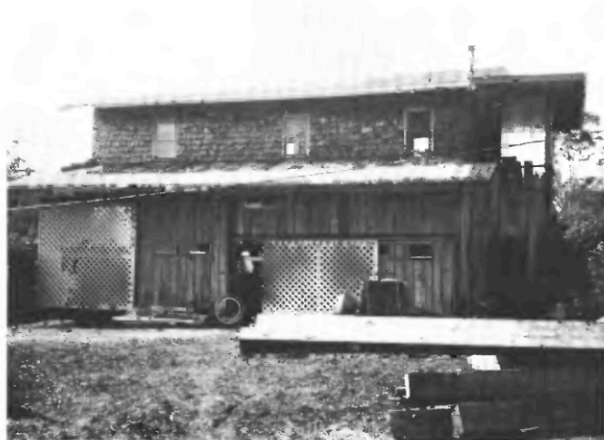
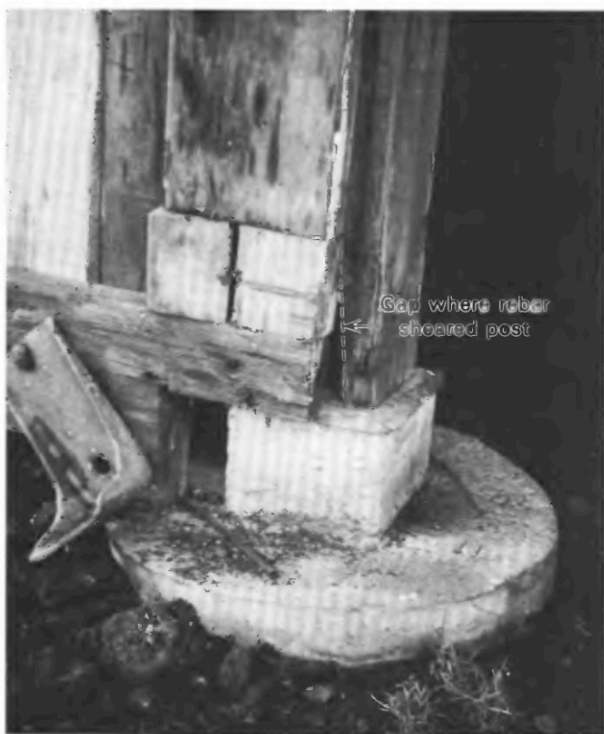
foundations as much as 0.7 m, generally in either a southwesterly or northeasterly direction. One three-story-high wood frame house had recently had its original piers replaced with steel-reinforced concrete piers poured as a single unit (fig. 44.12A, B). This house was displaced about 0.3 m northeastward (az 35°) of the piers, and the steel rebar had sheared most of the posts that supported the upper story of the house. The use of rebar alone to connect the posts to the foundation proved inadequate. The superstructure of the house appeared to be undamaged.

FIGURE 44.12.—Barnlike three-story-high frame house in Puna District that was moved off its foundation about 0.3 m toward northeast in 1983 earthquake. **A**, View of house showing position of one of sheared support posts (circled). **B**, Close-up of footing circled in **A**. The 14-cm by 14-cm wooden post was sheared by rebar that extended from base of footing upward into post as much as 11 cm; most other posts supporting upper story were similarly sheared. House has been replaced on piers.

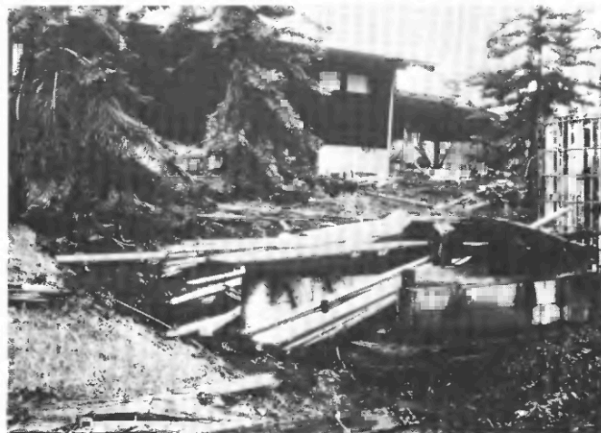
More water tanks collapsed or were damaged in this community than elsewhere in the epicentral area; others, though undamaged, were moved as much as 0.8 m southeastward (E.T. Endo, written commun., 1984; fig. 44.13). Wooden water tanks were more severely damaged than those made of fiberglass or metal, probably because the former were less rigid. Many of the collapsed tanks were observed by residents to sway back and forth during the period of shaking before their failure. Evidence of a few centimeters of movement of heavier metal tanks could be seen in the soft ground. Connecting pipes were often severed or damaged.

FIGURE 44.13.—Water tanks in Volcano affected by 1983 earthquake. Most water tanks here were constructed like one standing at right rear. Tank in foreground has collapsed, while other appears little damaged although displaced southwestward 0.7 m. This difference in response to earthquake may be because of a difference in water level in tanks at time of earthquake, or because of a difference in age or condition of tanks. Photograph by E.T. Endo.

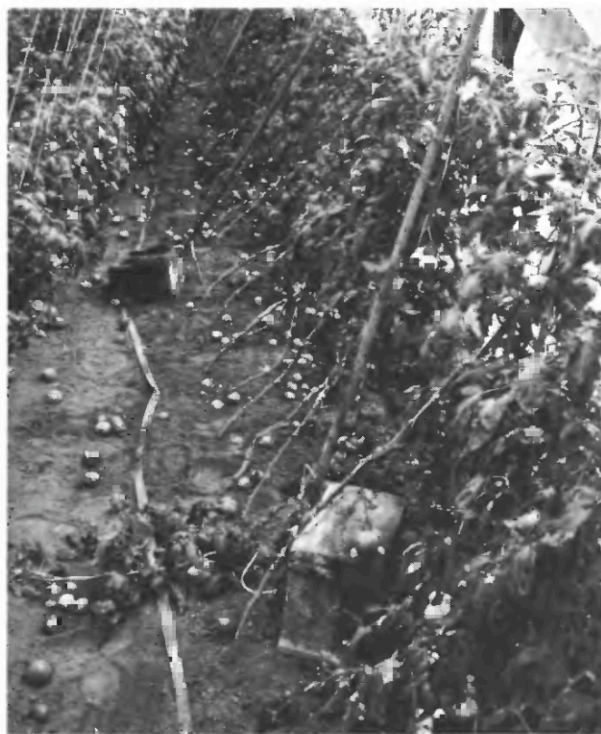
In this largely agricultural community, financial losses resulted from crop damage when the earthquake shaking caused greenhouses to collapse, shook vegetables off plants (fig. 44.14), and caused vibrational settling of loose earth into adjacent furrows, thereby uncovering seeds and seedlings.

FIGURE 44.14.—Greenhouse on Upper Wright Road leaning to southwest after earthquake; view to southeast. Crop loss in this area was severe because of collapse of some greenhouses and uncovering of planted furrows. Crop shown here is tomatoes. Photograph by E.T. Endo.

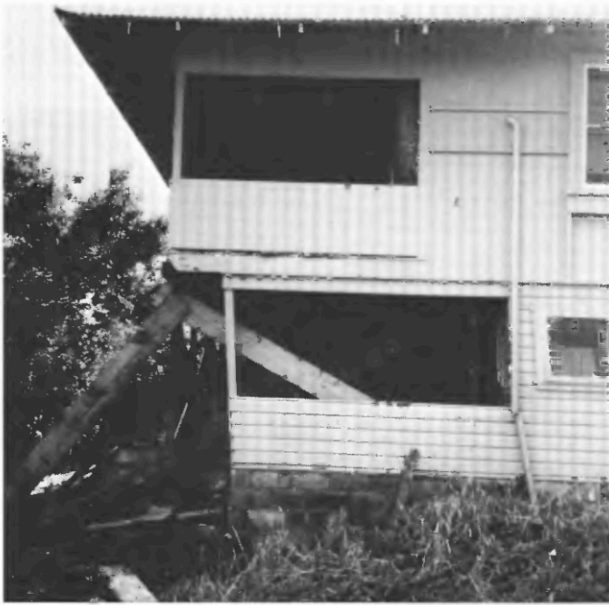
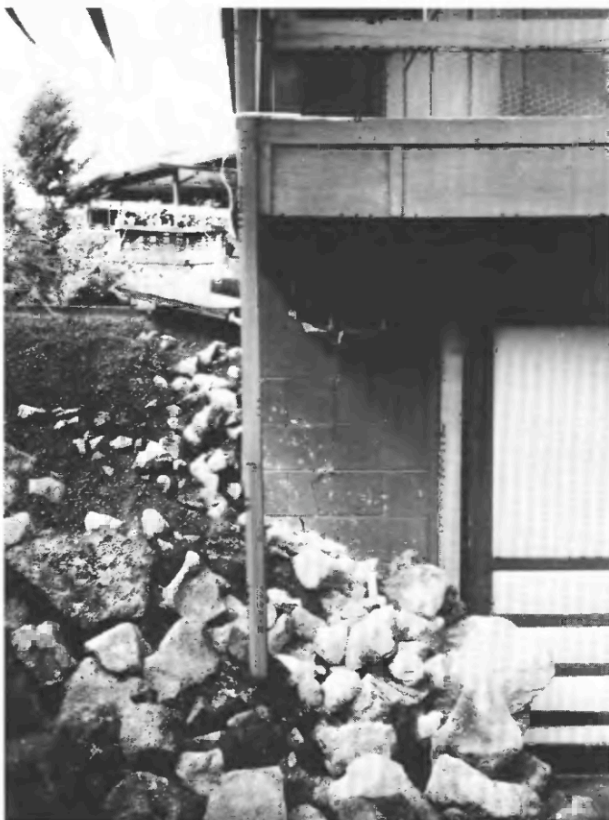
Most of the damaged residences in Hilo were built on a thick ash deposit or near the edges of lava flows overlying an ash deposit (fig. 44.1, locality 8; fig. 44.15, area A). Several houses were damaged when they moved downslope off their post-and-pier foundations in response to the earthquake shaking. Others were severely damaged because of the steeper slopes on which they were built (fig. 44.16A) or their location alongside unbuttressed slopes such as stream channels. A few houses built across steep slopes were structurally damaged by the shaking (fig. 44.16B), although there was no evidence of ground failure. Houses with concrete slab foundations fared better, with only minor hairline cracks in some slabs.

FIGURE 44.16.—Damage to houses in South Hilo District. **A**, Wood braces have been emplaced to prevent second story of this house from moving farther downslope. Broken and twisted drain pipe gives an indication of amount of distortion this house has undergone. **B**, Living area of this wood-frame house extends across break in slope from street level, marked by vegetation on left, to above four-car garage. Concrete blocks of garage level are broken both through and between blocks. Upper story is warped and has moved toward back of house (toward viewer) and to right. New uprights and cross bracing behind garage doors (not visible in this photograph) have been added to support weight of upper story. Drainpipe has been reattached at street level with rope. A decorative rock wall has collapsed and rocks rolled downhill.

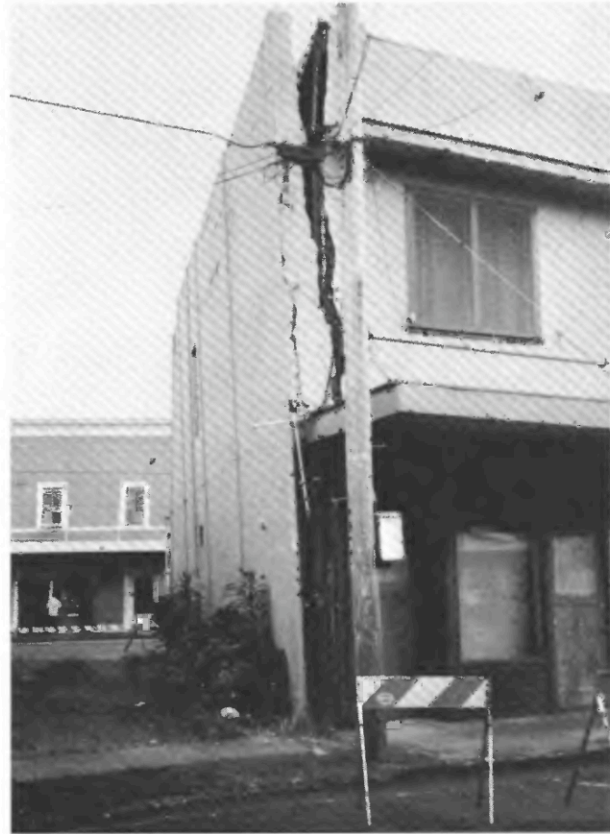
The old part of Hilo, built on an ash deposit locally as thick as 4.7 m (fig. 44.15, area B), was also severely shaken; major structural damage resulted to two buildings (figs. 44.17, 44.18), but most losses were due to breakage of plate-glass windows and damage to goods. A heavy canopy that recently had been installed on a commercial structure fell off during the shaking. It probably had been inadequately connected to the structural elements of the

FIGURE 44.17.—Damaged commercial building in old part of Hilo. Side wall separated from main structure, leaving a gap at roof level of about 21 cm.

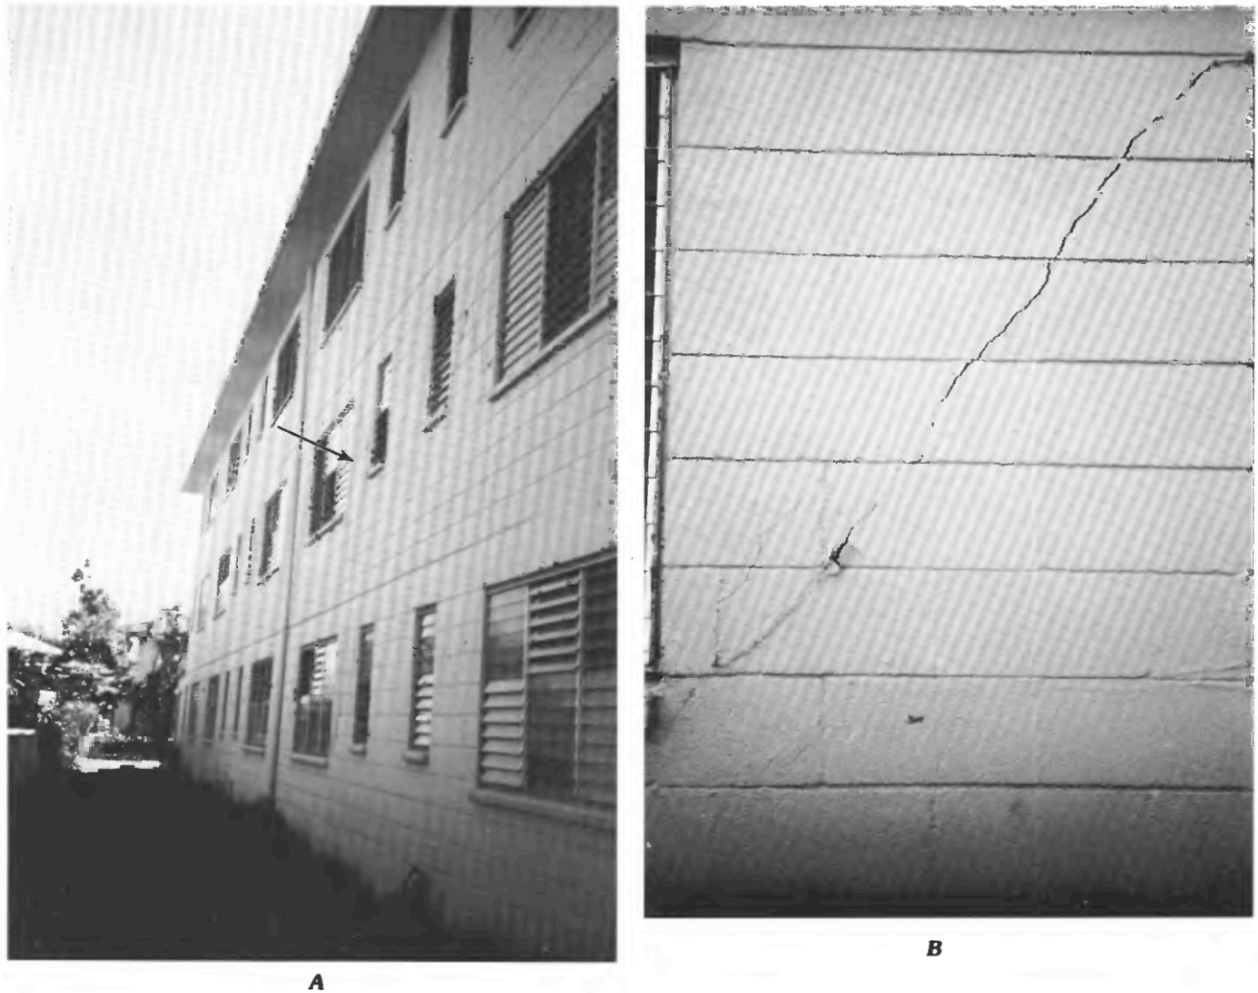
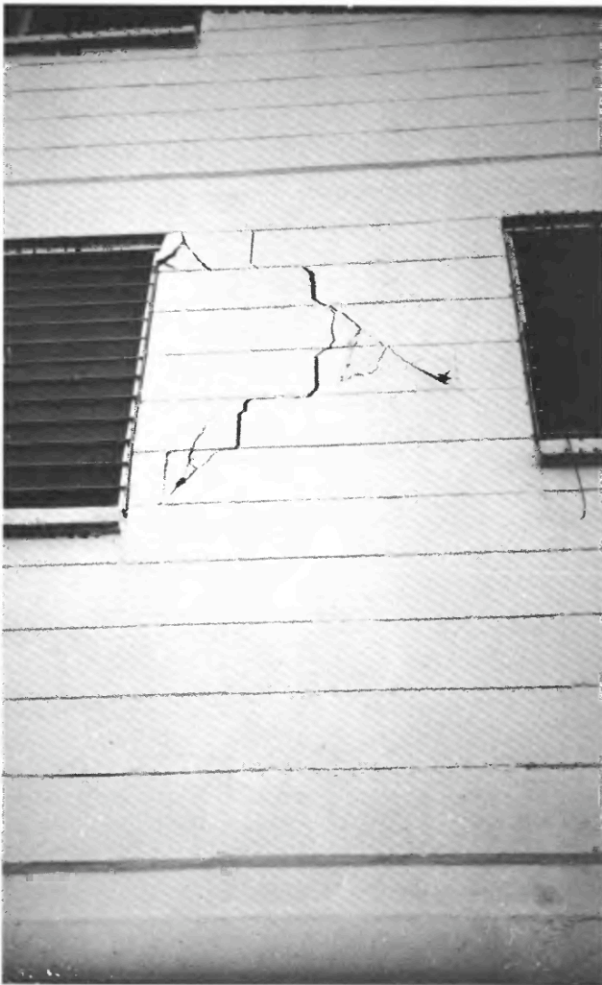
FIGURE 44.18.—Apartment building in Hilo damaged in November 1983 earthquake. **A**, View along two-thirds of length of building, which was difficult to photograph because of steep slope down to left. Cracked cinder block can be seen between most of windows of first and second floors; less structural damage was apparent at third floor. Arrow indicates area shown in detail in **C**. **B**, Detail of damage to a part of first floor not shown in **A**. Along longest and widest crack, smeared texture and flaking paint indicate an old crack that had been repaired and repainted. As a result of earthquake, there is renewed cracking along this feature as well as some new cracks through cinder blocks. This building probably was damaged originally by the 1973 Honouliuli earthquake and (or) by 1975 Kalapana earthquake. **C**, Detail of damage indicated by arrow in **A**. Some blocks were broken in such a way that pieces of them protruded from block or spalled off.

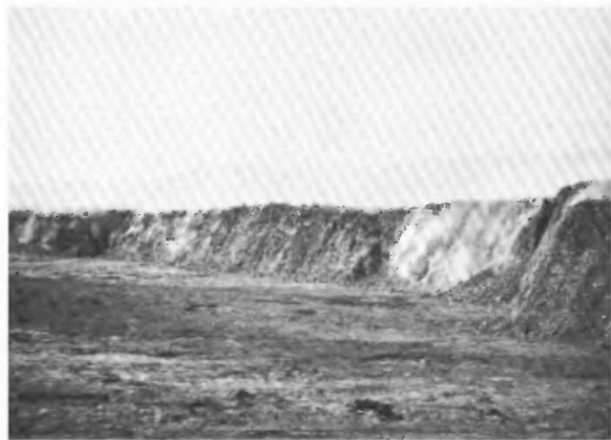
For several hours after the earthquake, the air at Kilauea's summit was brown with dust from the initial and continuing landslides off the caldera walls and within Halemaumau Crater (fig. 44.19). Hundreds of landslides, of volume generally less than 3,000 m<sup>3</sup>, occurred within the epicentral area; rock slides, falls, and topples were the dominant types of failure. These failures caused extensive road and trail damage in Hawaii Volcanoes National Park and temporarily closed the major highway around the island. For many kilometers southwest and northeast of the epicentral area, small rock falls, extensional cracks in the ground, and collapsed lava tubes were evident. Slope failures also occurred at Kealahou Bay, about 50 km from the epicenter, and along the Hamakua Coast, nearly 60 km from the epicenter. The generation of landslides at such distances from an epicenter is in good agreement with the findings of Keefer (1984, fig. 2A, B) for worldwide data on earthquake-induced landslides. Only small failures occurred in the thick and seismically sensitive ash deposits near Hilo and Pahala.

FIGURE 44.19.—View of Uwekahuna Bluff in Kilauea caldera, taken from Crater Rim Trail a few hours after November 1983 earthquake. Dust plumes mark rock falls that were still occurring along this section of caldera wall. Hawaiian Volcano Observatory is just out of photograph to right. Photography by J.D. Griggs.

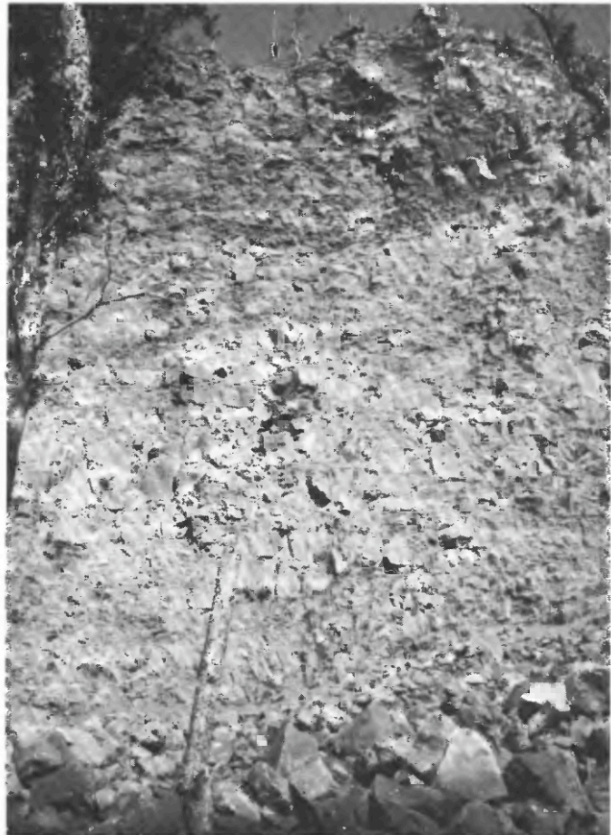
Hiking trails along the northern edge of the caldera between Kilauea Iki Crater and Uwekahuna Bluff were extensively damaged where perhaps as many as 200 rock slides and rock falls removed sections of trails and covered those at lower elevations with landslide debris (fig. 44.20). A few had volumes greater than 3,000 m<sup>3</sup>. Some vertical cliff faces failed by toppling, when outward-rocking slabs of coherent material failed at the top because of imbalance; the upper parts of such landslides traveled farthest from the slope.

FIGURE 44.20.—Typical section of cliff in Kilauea caldera composed of flows from Kilauea Volcano. View looking up from Halemaumau Trail below Volcano House toward Crater Rim Trail; guardrail (arrow) can be seen suspended over 60-m-high cliff where a rock slide has removed part of trail.

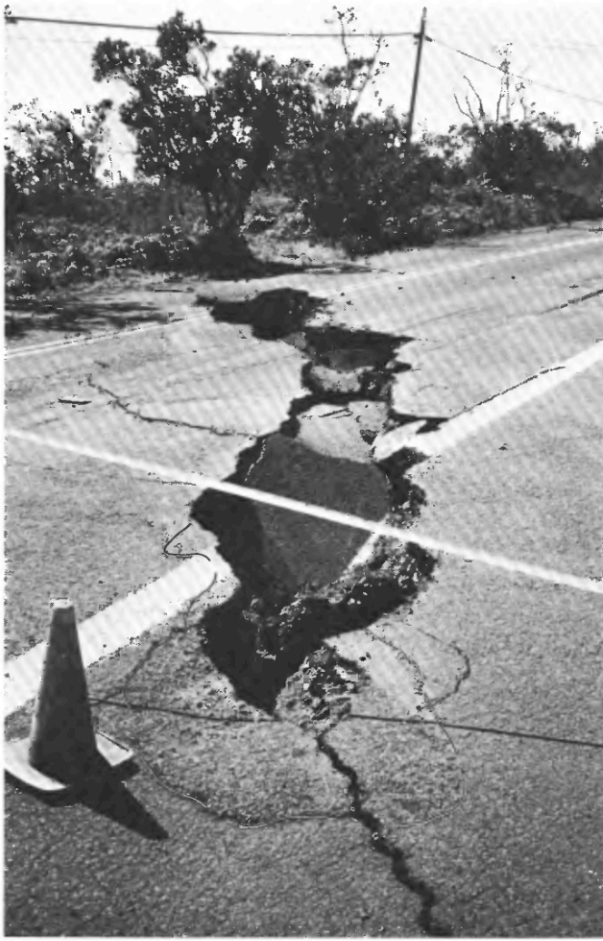
At the eastern roadway into Kilauea Military Camp (fig. 44.6, site *a*) vibrational compaction of fill caused the road to collapse where a system of earth cracks lies under the road (fig. 44.21). Earlier failures of this type had occurred periodically along the verge of the road at this location, though on a smaller scale and usually induced by drenching rains removing supporting material. Tilling and others (1976, p. 26) describe compressional damage to a roadway near this locale in the 1975 earthquake.

FIGURE 44.21.—Section of Crater Rim Drive at eastern entrance to Kilauea Military Camp that collapsed in November 1983 earthquake along a system of cracks trending at az 60°. Earthquake shaking caused subsurface material to settle, thus undermining road. Note pavement patch from repair of earlier failure at same place.

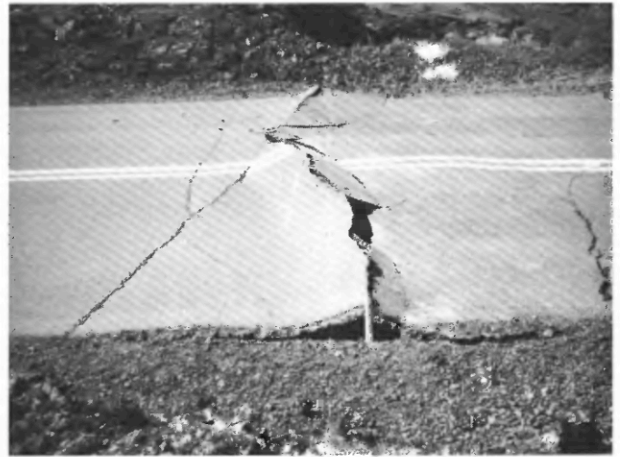
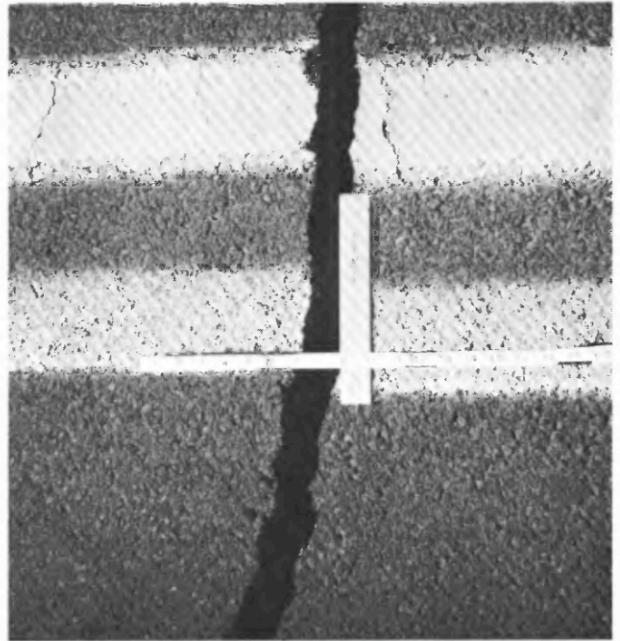
The southwest rift zone of Kilauea lies parallel to the Kaoiki fault system and is characterized by gaping cracks and fissures. Where Crater Rim Drive crosses the 0.5-km-wide zone (fig. 44.6, site *c*), there was both extensional and compressional damage throughout the zone, with an overall extension of about 4 cm (fig. 44.22A, B).

FIGURE 44.22.—Compressional and extensional features produced by November 1983 earthquake where Crater Rim Drive crosses southwest rift zone of Kilauea Volcano. **A**, A compressional fold 12 cm high; far end of fold has been collapsed by passage of vehicle. **B**, An open extension crack 5 cm wide, which shows apparent right-lateral offset of about 2 cm, and vertical offset up to north (left) of about 1 cm.

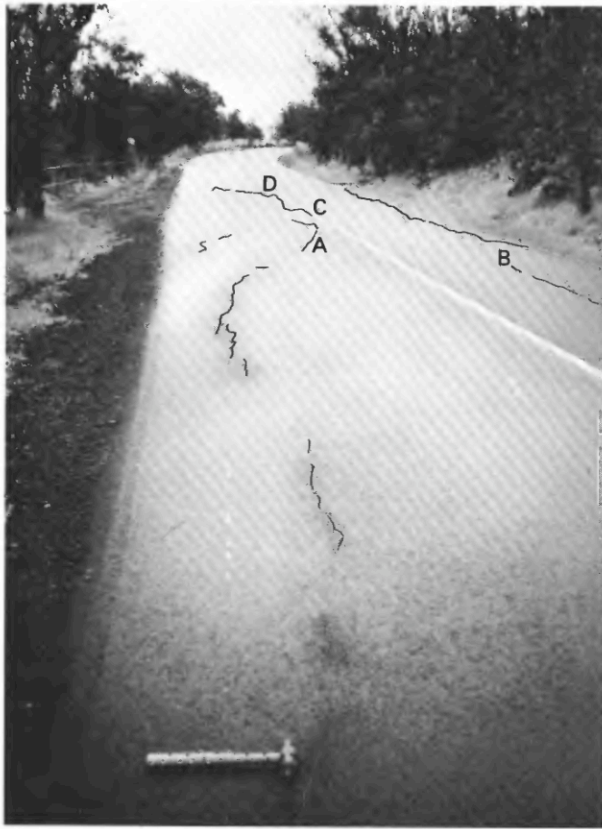
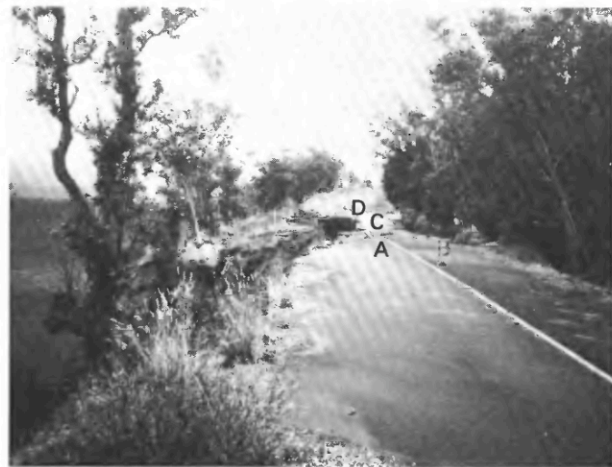
FIGURE 44.23.—Ground failure in November 1983 earthquake along Crater Rim Drive between Waldron Ledge Overlook and Research Center turnoff. **A**, Photograph taken in March 1980, looking northwest, showing road cracks curving toward caldera (left) and outlining incipient landslide (A, C, D). Along the right edge of pavement, additional cracks curving away from caldera (B) mark west side of graben-like depression that runs parallel to roadway for nearly same length as incipient landslide cracks. **B**, Photograph of same section of road taken in October 1984. Slope failed along preexisting cracks (A, C, D) during earthquake shaking. A graben about 2 m deep by 1–2 m wide has formed along cracks at right side of road (B) and caused trees to tilt.

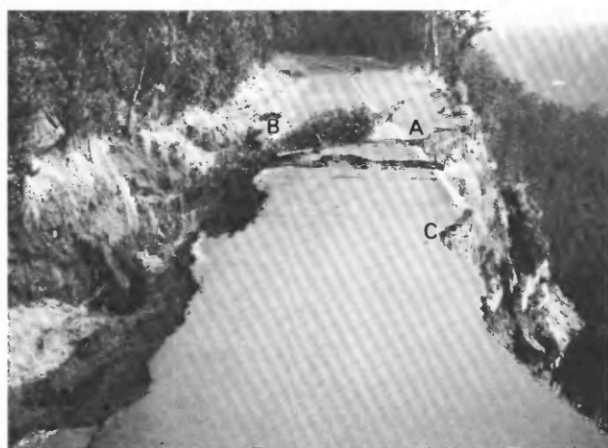
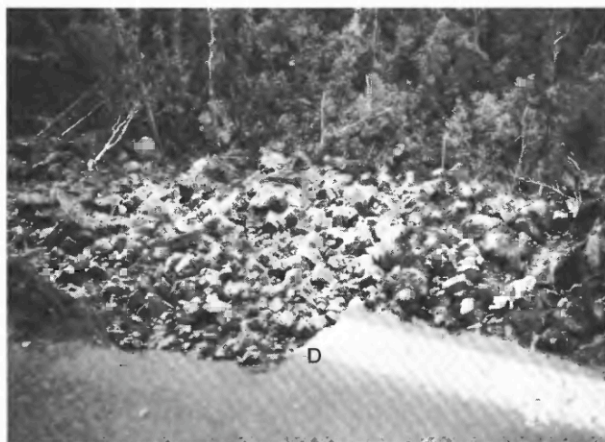
FIGURE 44.24.—Details of failure of Waldron Ledge landslide. Labelled points (A, B, C, D) are same as in figure 44.23. **A**, View southeast at head scarp of landslide and of parallel graben on other side of road. Headwall scarp was approximately 14 m high and 30 m long; landslide removed 11-m-wide section of road and trail. **B**, View downward from road of jumbled mass of rock resulting from disintegration of slide block; mass did not travel far from base of cliff.

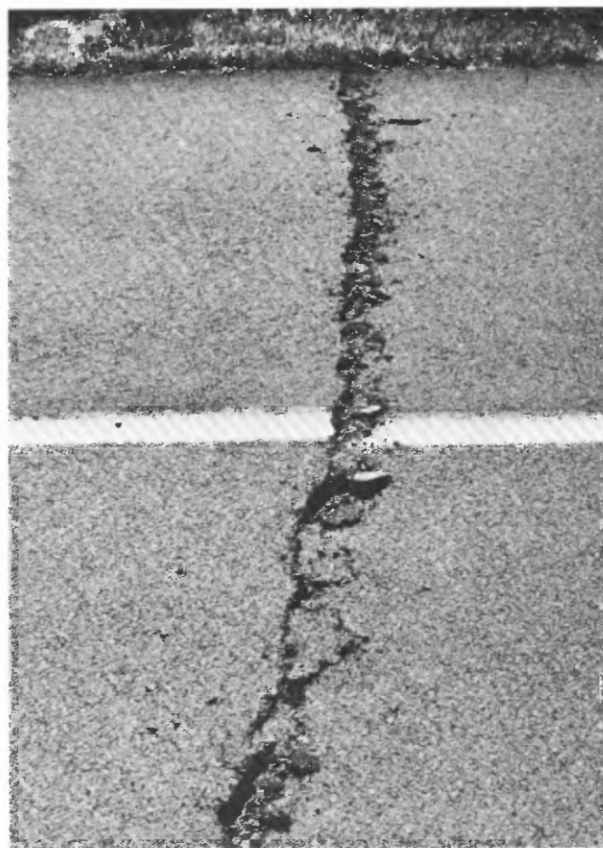
FIGURE 44.25.—Earthquake-produced crack across road at northwest entrance to Waldron Ledge Overlook. Chips of broken pavement indicate sides of crack were bashed together repeatedly. Photograph by J.B. Stokes.

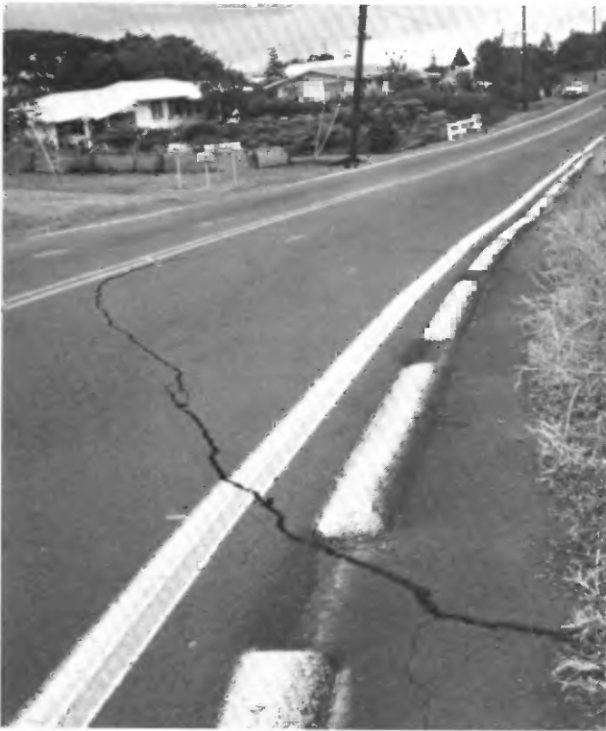
FIGURE 44.28.—Arcuate road crack along Kaumana Drive (fig. 44.15, area A) formed in November 1983 earthquake. Ground slopes downward to right. Houses were structurally damaged and water main was broken in area just out of photograph to left.

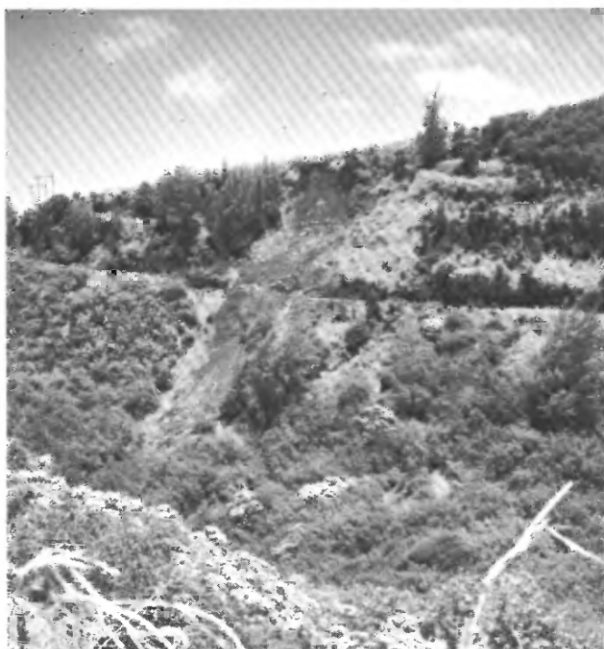
FIGURE 44.30.—Rain-induced slope failure in Laupahoehoe Gulch a few months after November 1983 earthquake. Heavy rains caused earthquake-loosened material to slide. Material below road was pushed over by bulldozer. Light-colored grassy area above road to right of new slide lacks vegetation and indicates that area has been site of landslides in past. At time of earthquake, a smaller rock slide occurred from the nearly vertical cliff just below the power poles (left), and blocked highway for a few hours. Photograph by N.G. Banks.

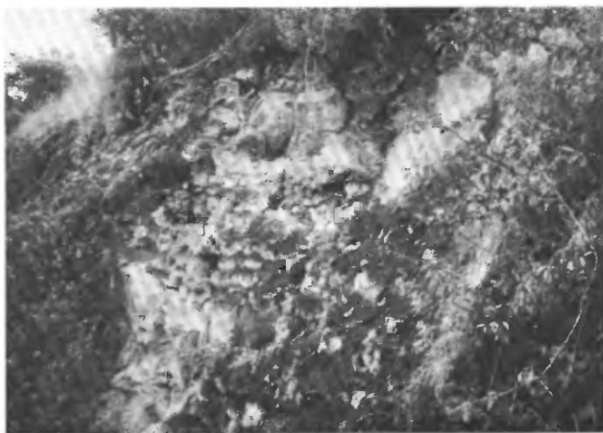
FIGURE 44.31.—Headwall scarp of earthquake-induced rock slide that briefly blocked secondary road to Laupahoehoe Point. It was not possible to picture entire slide in one photograph because of steep cliff bounding road and fact that slide occurred between two curves in road. Lower part of rock slide cannot be seen here; slide was about 1 m deep, 9 m high, and 4 m across (volume about  $36 \text{ m}^3$ ). In-place formation of spheroidal boulders of weathering in Mauna Kea lava flows attests to severity of disintegration of these rocks.

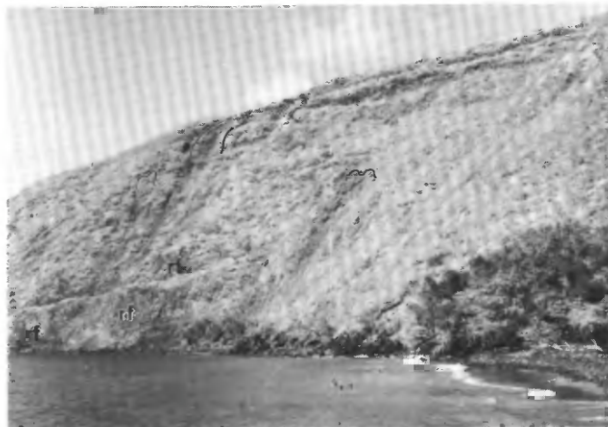
FIGURE 44.32.—Narrow chutes (outlined) formed at time of November 1983 earthquake by landslides from steep slopes surrounding Kealakekua Bay, west coast, Island of Hawaii. Rock falls (rf) occurred on lower, steeper slopes. View northwestward.
