# Interaction of Dams and Landslides—Case Studies and Mitigation

By Robert L. Schuster

Professional Paper 1723

**U.S. Geological Survey, Reston, Virginia: 2006**

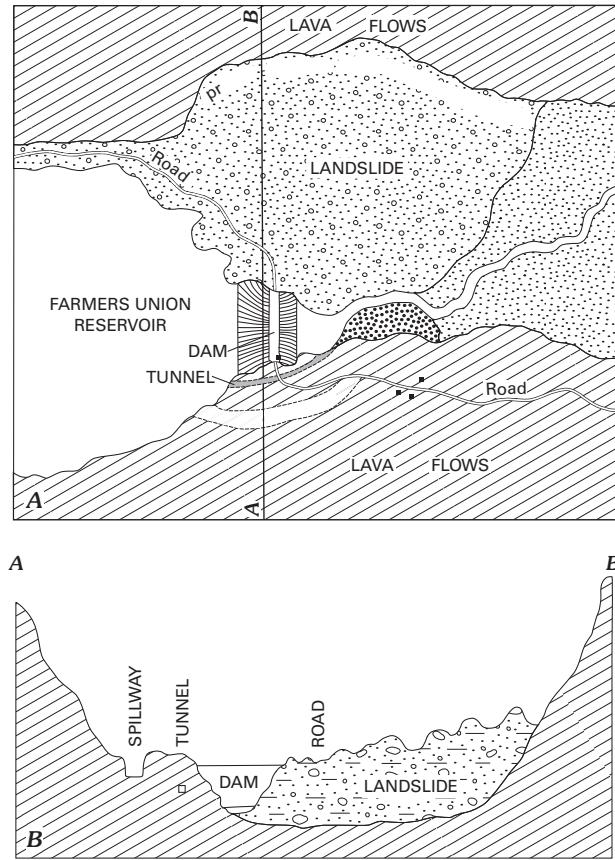
**Figure 1.** Original sketch map (A) and cross section (B) along the line A–B, showing landslide conditions at Farmers Union (now Rio Grande) Dam, southwestern Colorado, United States (Atwood, 1918, p. 19).

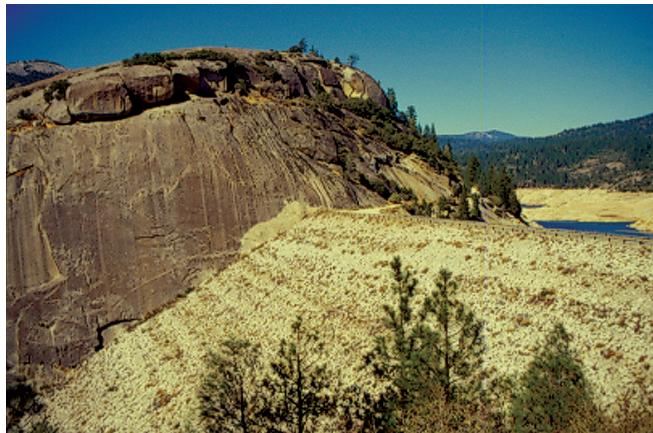
- Mammoth Pool Dam—Mammoth Pool Dam (fig. 2) on the San Joaquin River in the Sierra Nevada Range of central California, United States, is a 125-m-high earthfill dam, which was completed in 1959 to produce hydroelectric power. As was obvious during early planning for the dam, the canyon originally

**Figure 2.** Mammoth Pool Dam, San Joaquin River, California, United States. Note the exfoliation sheets and blocks in the granodiorite that forms the right abutment. Photograph taken in 1998.

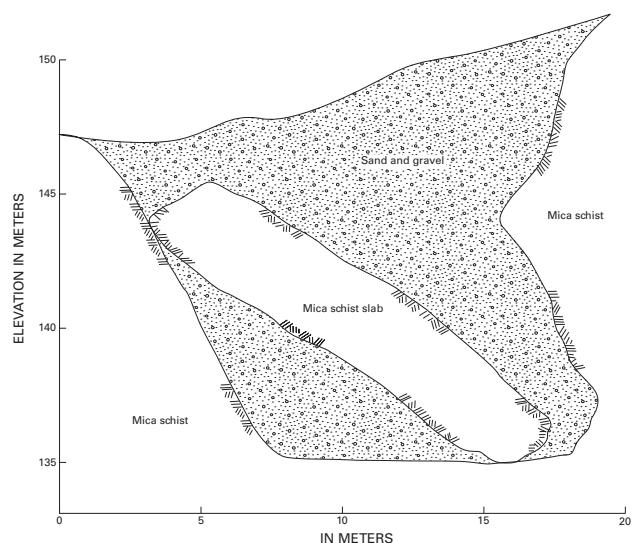
- Waterbury Dam—Waterbury Dam is a 57-m-high earthfill dam on the Little River, Vermont, United States. The dam was completed in 1938 but has been subject to foundation seepage since. Unknowingly, the dam was founded on detached rock slabs in a narrow gorge at the base of the dam (fig. 3). As noted by Saber and others (2001), “Detached rock slabs along the right (west) side of the gorge form a roof over a piping tunnel known to have been a piping path in the past, and capable of being a piping path in the future if injected filter materials are destabilized.” A grouting program to prevent seepage through the rock-fall zone was completed in 1985, but, apparently, some seepage continues.

**Figure 3.** Cross section through the narrow gorge in the foundation of Waterbury Dam, Little River, Vermont, United States. The detached mica schist slab formed a “roof” over a potential piping path in the sand and gravel below. Modified from U.S. Army Corps of Engineers unpublished report (1988).

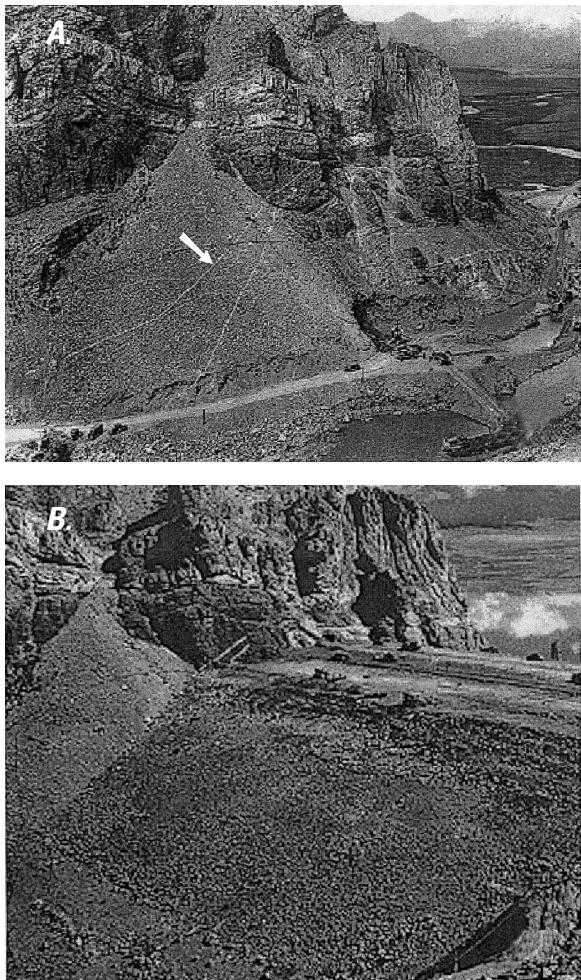
was covered by a thick talus cone derived from overlying sedimentary rock cliffs (fig. 4). The talus mass consisted predominantly of boulder-to-cobble-size rock fragments with some fine-to-coarse gravel and sand. During construction, the talus was removed from under the center and upstream parts of the dam, but was left in place in the area extending from ~25 m downstream from the centerline to the downstream toe of the dam. The foundation was prepared by constructing three concrete cutoff walls, one located roughly along the centerline and the other two upstream. The remaining talus in the downstream part of the right abutment poses a very minimal threat of piping; however, thus far, in spite of some seepage, there has been no evidence of piping. The dam has had a long history of satisfactory performance.

**Figure 4.** Views before (A) and after (B) construction of Taylor Park Dam, central Colorado, United States. Note the talus deposit that serves as the right abutment of the dam and the chalk line (marked by arrow) in photograph (A), which marks the location of the right end of the future dam on the talus cone. Photographs taken in 1937 by A.A. Whitmore, U.S. Bureau of Reclamation.

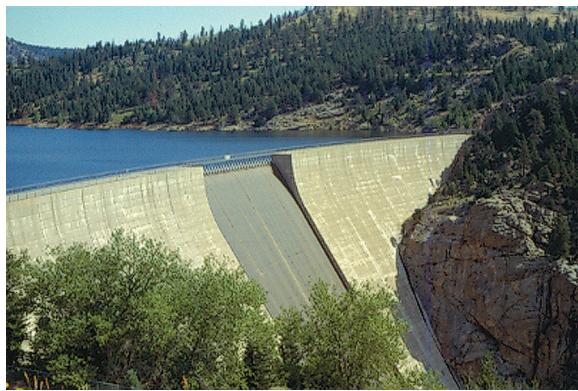
- Gross Dam—Gross Dam (fig. 5), Colorado, United States, is an example of a concrete-gravity dam that was founded on a pre-existing deep-seated slide in competent rock. Completed in 1955, this 104-m-high municipal water-supply dam is seated on deep-seated “gravity-slip surfaces” in both granite abutments (fig. 6) (Wahlstrom, 1974, p. 78–79). Although these “gravity faults” were closely watched during construction, they pose no hazard to the completed dam, which

**Figure 5.** Gross Dam, Colorado, United States, which supplies water to the city of Denver. The cross section in figure 6 shows gravity-slip surfaces in both abutments of the dam. Photograph taken in 2003.

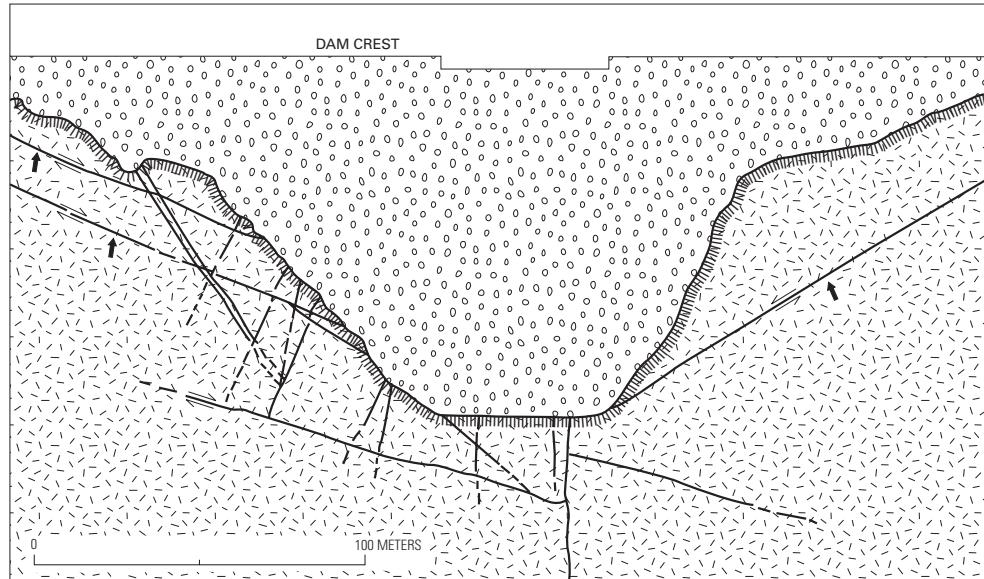
**Figure 6.** Gravity-slip surfaces (marked by thick arrows) in granitic foundation rocks at Gross Dam, Colorado Front Range, United States. Other faults of tectonic origin are geologically much older than the gravity-slip “faults.” Modified from Wahlstrom (1974).

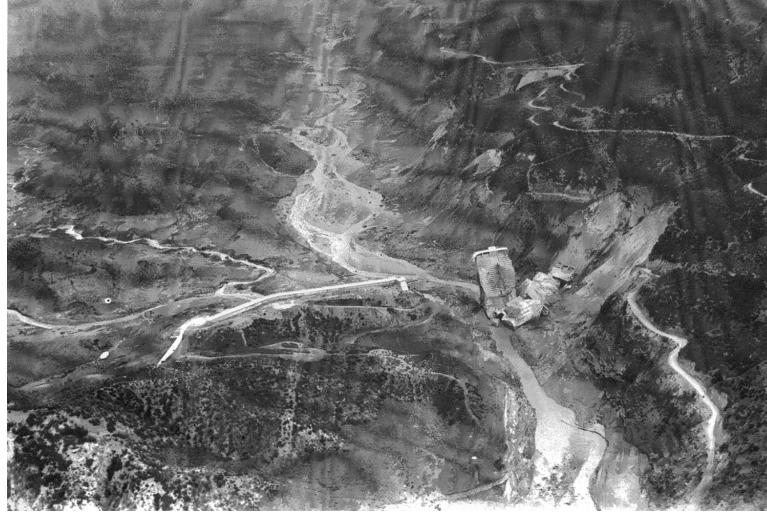
landslide in schist bedrock. As the reservoir neared capacity in 1928, the dam suddenly failed, releasing a catastrophic flood that drowned 450 people (Outland, 1977). Preliminary investigations pointed to a fault in the right abutment as the cause of failure. Later, more comprehensive studies (Willis, 1928; Rogers, 1992, 1995, 1997) showed fairly conclusively, however, that failure began as reactivation of the schist slide in the left abutment (figs. 7 and 8). This is the only case noted in this study of a catastrophic dam failure caused by dam construction on a pre-existing landslide. The dam was never rebuilt.

**Figure 7.** Looking upstream at the remains (center of photograph) of St. Francis Dam, southern California, United States, soon after its 1928 failure, which resulted in a catastrophic flood that killed about 450 people. The failure began in the toe of a large prehistoric landslide that formed the left abutment (right side of photograph); note fresh landslide scars. Photograph taken in 1928, courtesy of Department of Geography, University of California at Los Angeles.

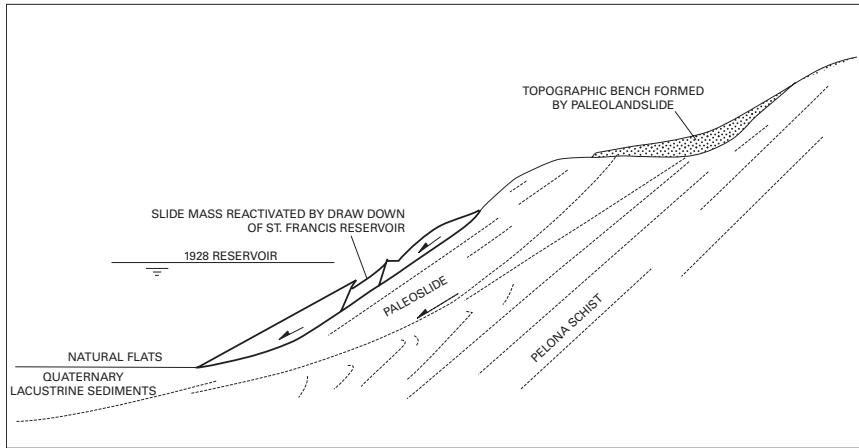
**Figure 8.** Cross section through the 1928 left-abutment landslide at St. Francis Dam, California, United States. Modified from Rogers (1995).

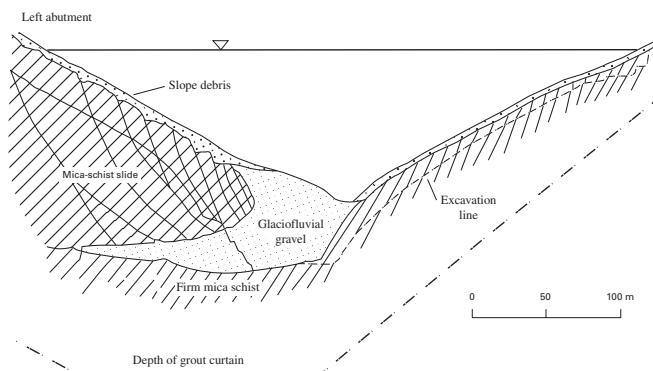
**Figure 9.** Cross section through the pre-existing rock slide that forms the left abutment of Beauregard Dam, northwestern Italy. Modified from Desio (1973, p. 901)

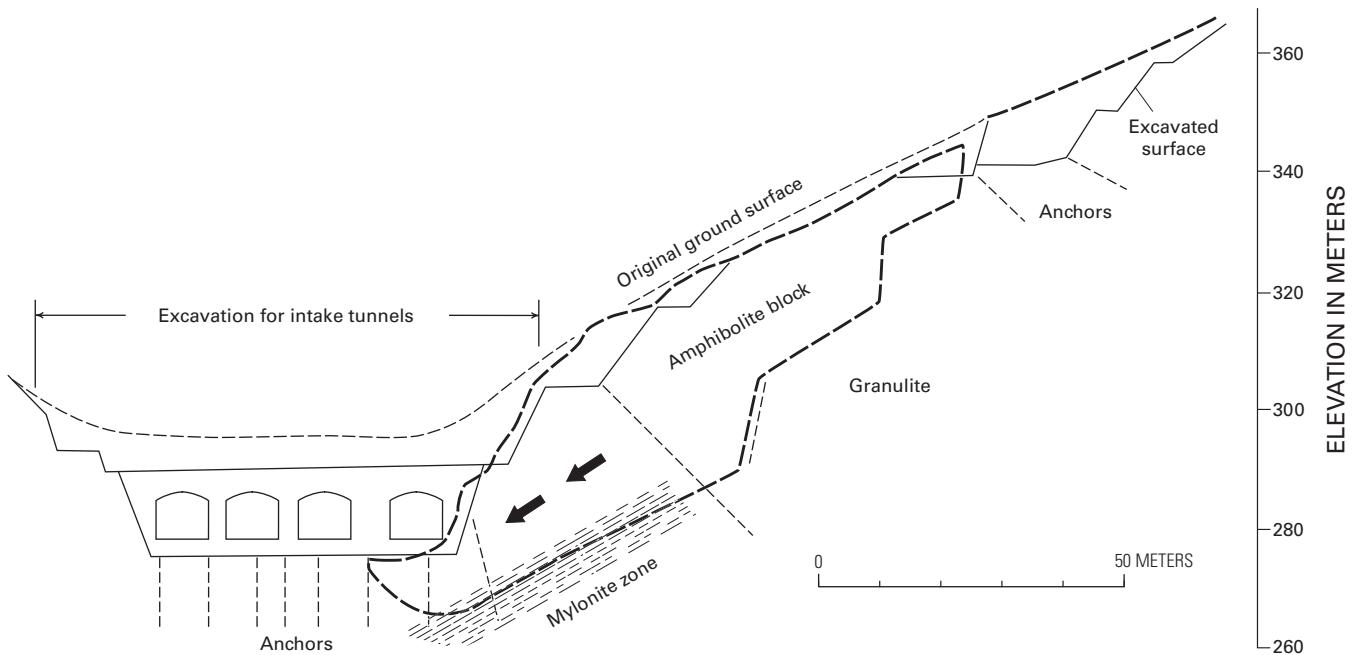
was founded on supposedly stable amphibolite and granulite. However, during excavation for the right abutment of the dam, failure occurred in schistose mylonite along a fault contact between the amphibolite and the granulite. The failure resulted in sudden movement of a 150,000 m<sup>3</sup> block of amphibolite along the mylonite zone (Mencl, 1977; Záruba and Mencl, 1982, p. 245–246) (fig. 10). As remedial measures, a temporary stabilizing berm was built at the toe of the slope and material was removed at the head of the slide. Subsequently, the slope was further stabilized by making horizontal benches from which anchors were installed into the firm granulite (Hobst and Zajíc, 1983, p. 399–401).

**Figure 10.** Simplified cross-valley cross section through Dalešice Dam, Jihlava River, Czech Republic. Construction caused reactivation of a rock slide of the amphibolite in the right abutment. This cross section shows locations of remedial excavations and rock anchors. Modified from Záruba and Mencl (1982, p. 246).

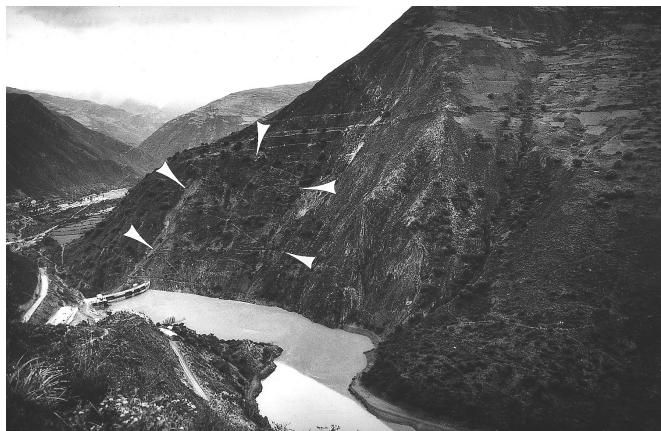
- Tablachaca Dam—Another well-known example of a concrete dam built on a pre-existing slide in competent rock is Peru's Tablachaca Dam (figs. 11 and 12), an 80-m-high concrete arch-gravity dam on the Mantaro River, a tributary of the Amazon River. This dam was placed in service in 1972 to produce about one third of Peru's electric power. During the late 1970s, it was noted that part of an ancient rock slide in phyllite, which formed the right abutment of the dam, had reactivated (probably because of the reservoir) and was moving slowly toward the dam (fig. 13)

**Figure 11.** Oblique view of Tablachaca Dam, Peru. The pre-existing rock slide in the right abutment is outlined by arrows. This slide was reactivated in the 1970s, probably because of infiltration from the reservoir. Photograph taken in 1982.

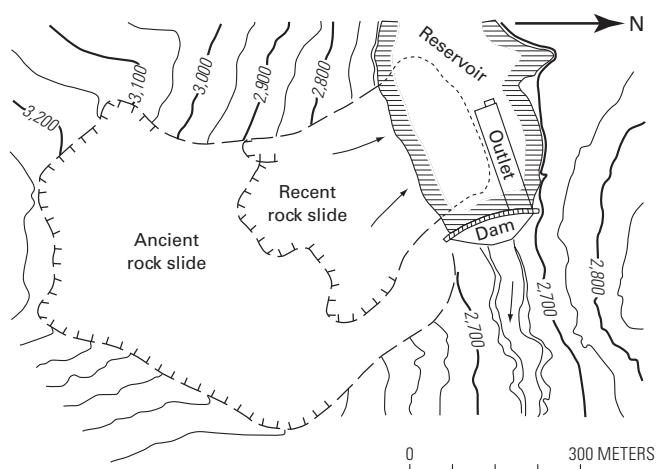
**Figure 13.** Map of rock slide at the right abutment of Tablachaca Dam, Peru. Shown is the recent, active slide that is a reactivation of the toe of a larger, ancient rock slide. Modified from Novosad (1979).

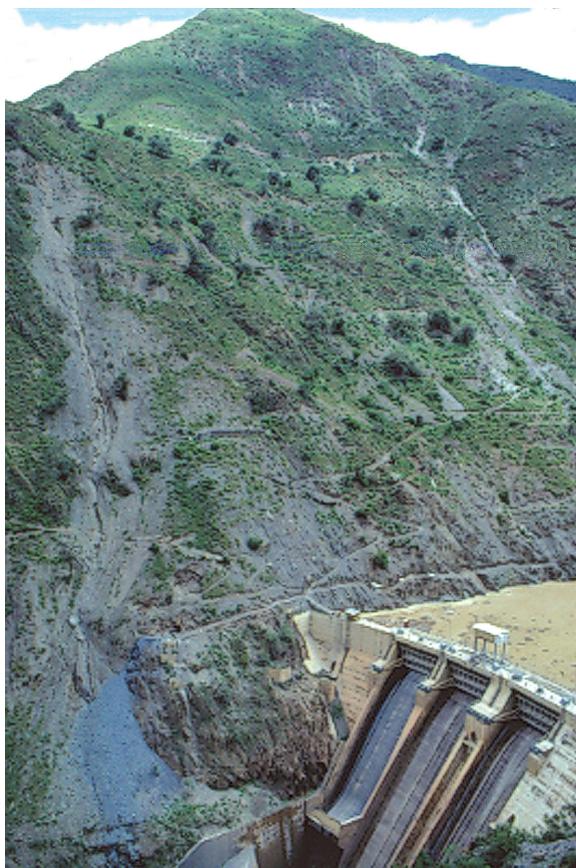
**Figure 12.** Looking upstream at the right-abutment landslide at Tablachaca Dam, Peru. Photograph taken in 1982.

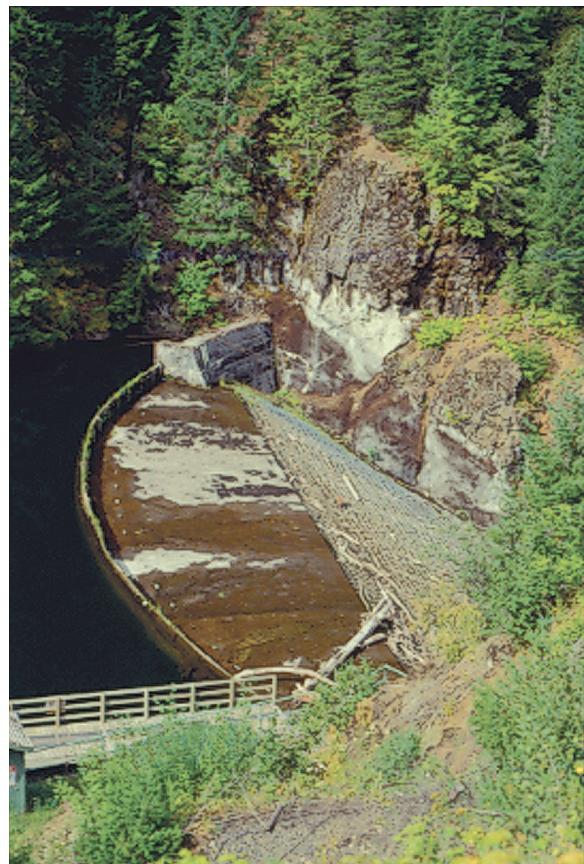
- Lake Harriet Dam—Another interesting concrete-arch dam case is that of Lake Harriet Dam, a 21-m-high dam (fig. 14) that was completed in 1923 to produce electric power for western Oregon, United States. The left abutment of this dam was thought to be stable basalt. However, this basalt abutment is part of the reactivated toe of a 50-km<sup>2</sup> landslide mass. During the early 1980s, cracks were noted in the dam due to compression from the left abutment. The problem was solved in 1985 by using the tremie process (underwater pumping through a pipe) to place a soil-bentonite “membrane” against the upstream face of the dam, and by constructing rockfill buttresses against both faces of the dam (Schroeder and others, 1988). Although the dam is currently performing well, the compressive

**Figure 14.** Lake Harriet Dam, Cascade Range, Oregon, United States. The basalt that forms the left abutment of this dam is part of the reactivated toe of a  $50\text{-km}^2$  landslide mass. Photograph taken in 1999.

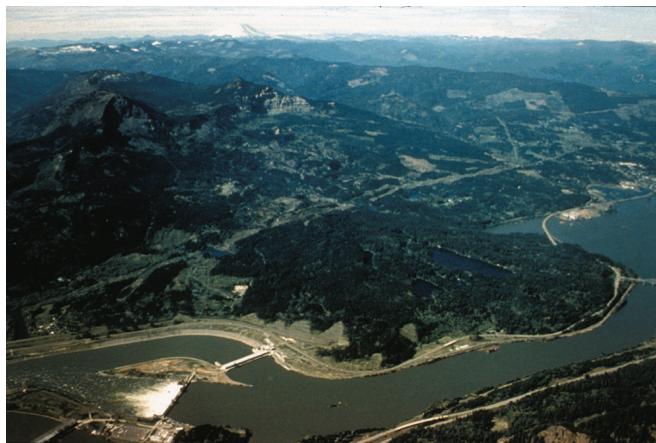
**Figure 16.** Oblique aerial view of Bonneville Dam in the Columbia River Gorge, Washington and Oregon, United States. The right (Washington) abutment is the toe of the huge Bonneville landslide, which is the most recently active part of the Cascades landslide complex. Photograph by Derek Cornforth, Landslide Technology, Portland, Oregon.

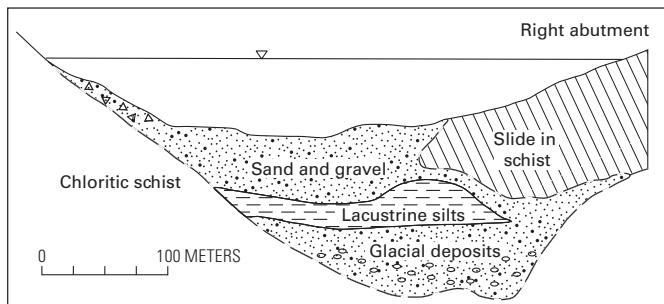
- Durlassboden Dam—A European example is Durlassboden Dam, an 83-m-high structure in Austria, which was built on a large rock slide. The right abutment of this hydropower dam is on a large block of graphitic schists and quartzites that had slid down the right valley wall and sunk into valley deposits of glaciofluvial sands and gravels and lacustrine silts (Mignon, 1968; Záruba, 1974; Rienössl and Schnelle, 1976) (fig. 18). The abutment and foundation were subsequently sealed by a grout curtain that extends into silts about 50 m beneath the valley floor.

**Figure 18.** Simplified cross section through the rock slide in schist that forms the right abutment of Durlassboden Dam, Austria. Modified from Záruba and Mencl (1982, p. 243).

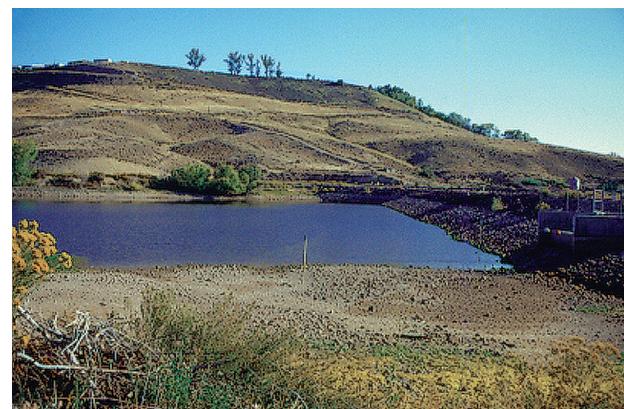
**Figure 19.** Fruitgrowers Dam, an irrigation dam in western Colorado, United States, showing apparent landslide topography in shale of the left abutment. Photograph taken in 1999.

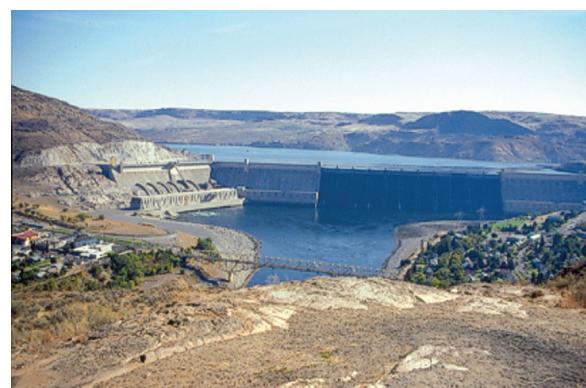
**Figure 21.** Grand Coulee Dam, eastern Washington State, United States. In 1969, the original landslide-prone glacial-soil right abutment was removed to make room for the second powerplant at the right end of the dam (left edge of photo). Photograph taken in 1999.

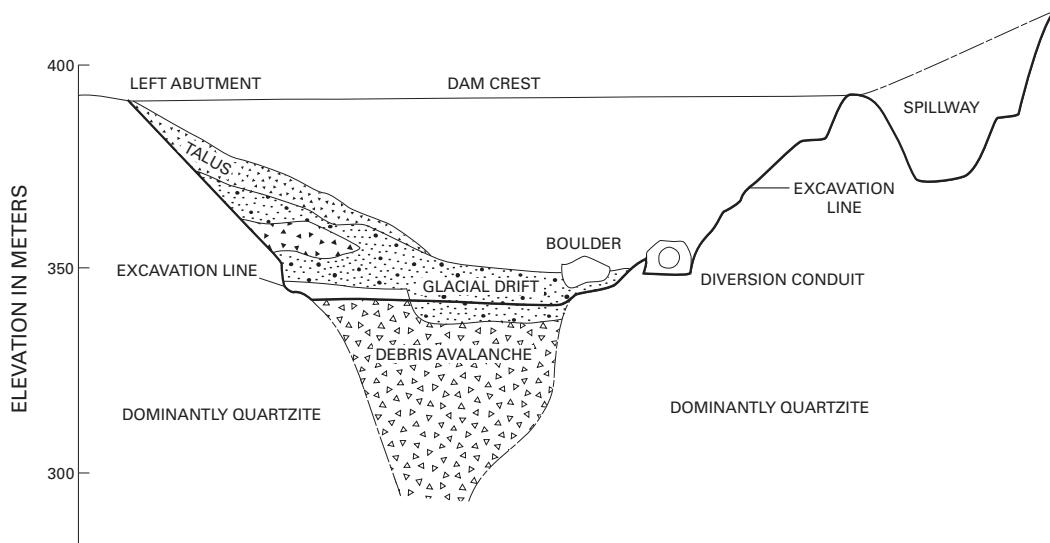
**Figure 22.** Cross section through the Parangana Dam site, Victoria, Australia, showing debris-avalanche deposits in the foundation and left abutment of the dam and talus deposits in the left abutment. All deposits above the excavation line were removed during construction. Modified from Paterson (1971).

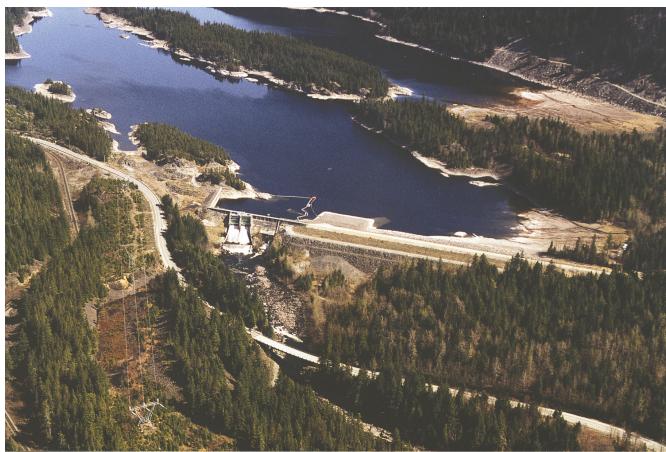
**Figure 23.** Oblique aerial view of Cheakamus Dam, British Columbia, southwestern Canada. The foundation of the dam is mainly Rubble Creek Wash, a debris avalanche–debris flow deposit (see fig. 24). Photograph taken in 1999 by BC Hydro, Burnaby, British Columbia.

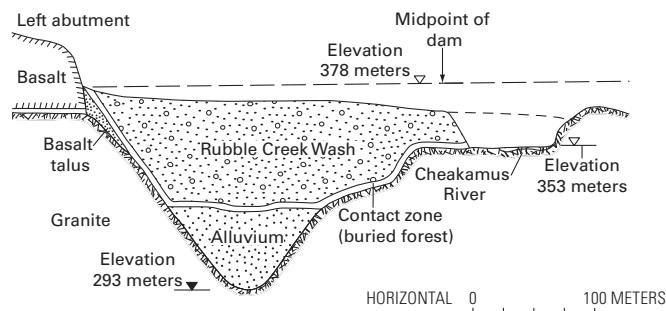
**Figure 24.** Cross section through the site of Cheakamus Dam, British Columbia, southwestern Canada, showing the location of the Rubble Creek Wash, the remains of an 1855–56 debris avalanche–debris flow deposit, on which the dam was built. Modified from Terzaghi (1960b).

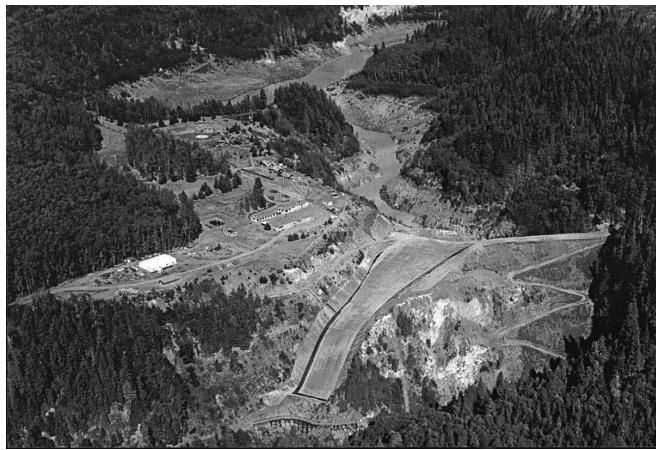
**Figure 25.** Aerial-oblique view of Mud Mountain Dam, western Washington State, United States. At both banks of the White River, the dam abuts into a Pleistocene mud-flow (lahar) deposit from Mount Rainier volcano. Photograph taken in 1979 by U.S. Army Corps of Engineers.

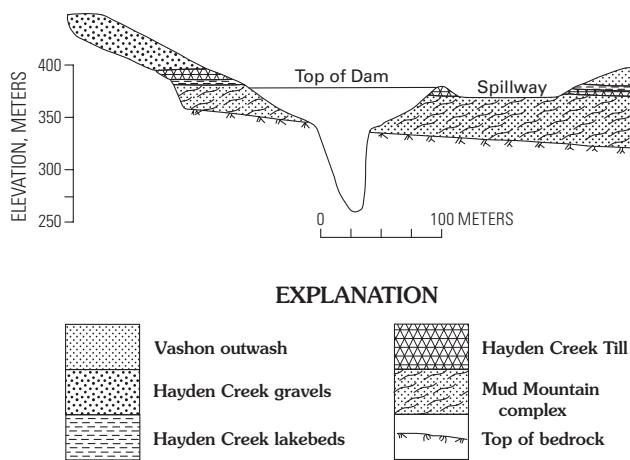
**Figure 26.** Cross section through the site of Mud Mountain Dam, Washington State, United States, showing the Mud Mountain complex (Pleistocene mud-flow deposits) in both abutments. Modified from Galster (1989b).

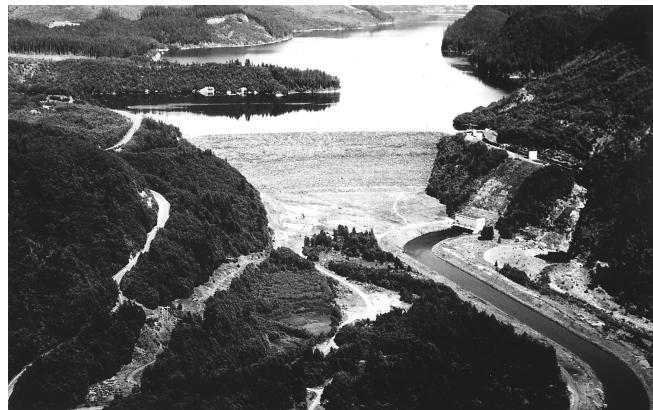
**Figure 27.** Aerial view of Swift Dam, Lewis River, western Washington State, United States, showing forested debris-flow deposits that form the right abutment of the dam (see fig. 28). Photograph by Lynn Topinka, U.S. Geological Survey.

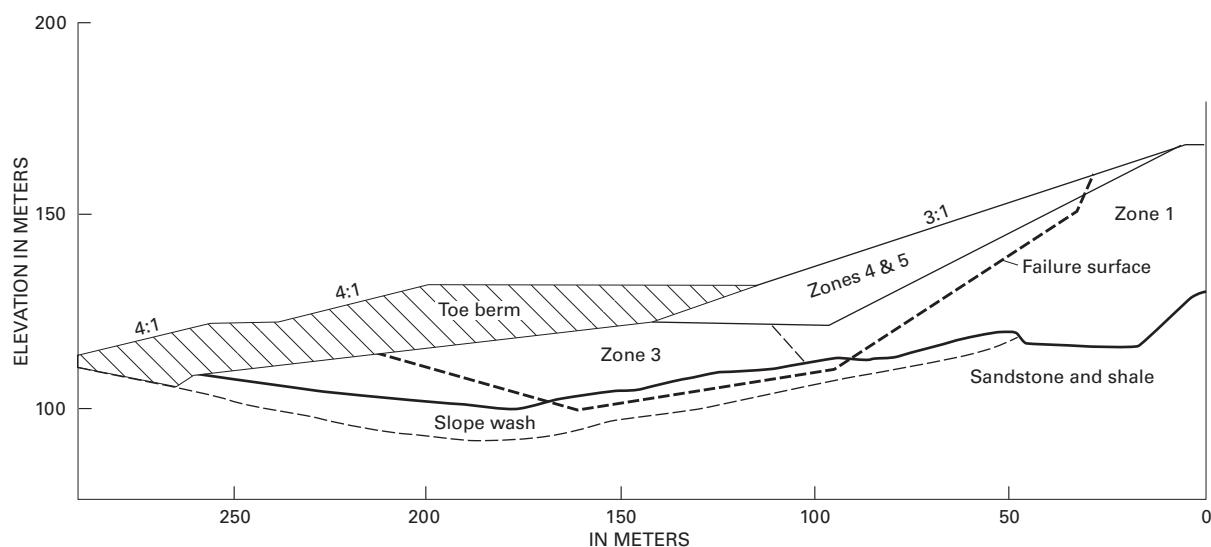
**Figure 33.** Cross section through B.F. Sisk (San Luis) Dam, California, United States, showing the location of the post-construction slide surface and the toe berm installed to stop further movement. The slide surface passed through slope wash and zones 1 and 3 of the dam. Modified from Von Thun (1985).

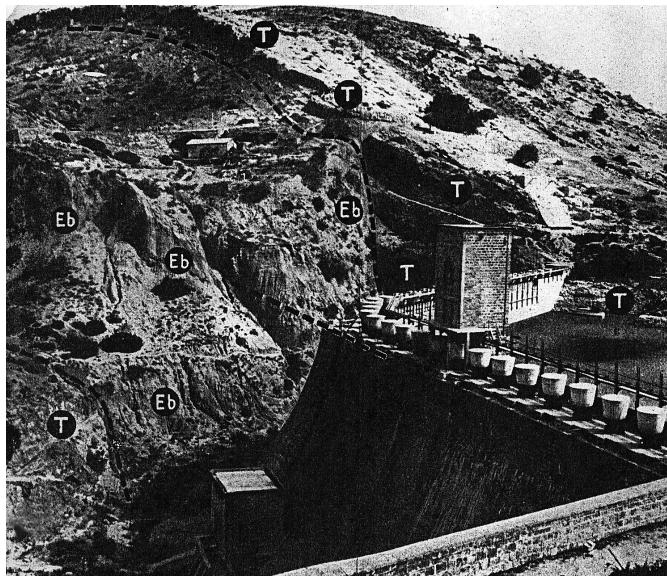
**Figure 34.** Cheurfas Dam, a masonry dam in Algeria. This dam was originally built in 1880–82, at a time when only very superficial geologic studies were made. As a result, the right abutment consisted of talus and alluvial debris. After the dam failed at its right end in 1885 due to a flood, it was rebuilt to a bedrock abutment slightly upstream, leaving a “dogleg” in the dam (Gignoux and Barbier, 1955, p. 208–209). Note: “Eb” is *éboulis*, which translates as “debris,” or, in this case, talus and alluvium; “T” is limestone. Photograph by M. Gignoux, courtesy of Dunod/Masson Sciences, Paris.

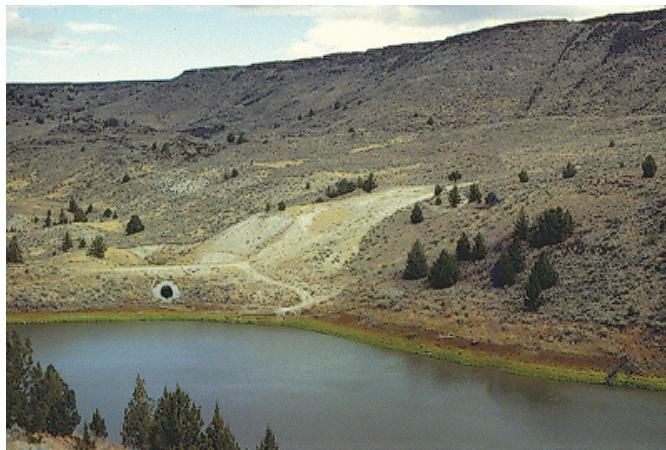
**Figure 35.** Star Mountain Dam, a 21-m-high irrigation dam in southeast Oregon, United States. The right abutment of this dam is the toe of a large landslide. After the dam failed in 1983 due to flood erosion of the unlined spillway at the landslide right abutment, a circular concrete-lined spillway was installed within the embankment. Photograph taken in 1998.

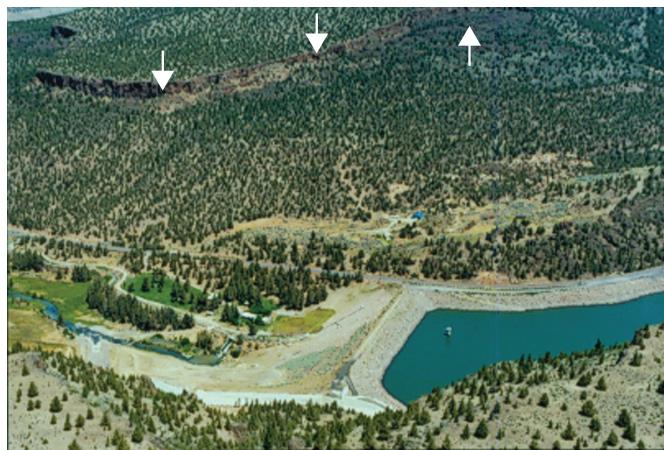
**Figure 36.** Oblique-aerial view of Ochoco Dam, central Oregon, United States, and the huge rock slide–lateral spread that serves as its right abutment. Note the long head scarp (marked by arrows) of the slide along the upper part of the ridge. Photograph taken in 1999 by U.S. Bureau of Reclamation.

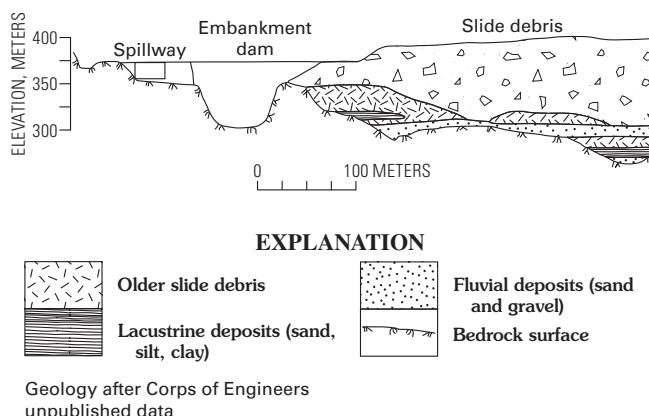
**Figure 37.** Cross section through the site of Howard Hanson Dam in western Washington State, United States, showing the huge landslide that serves as the right abutment of the dam. Modified from Galster (1989a).

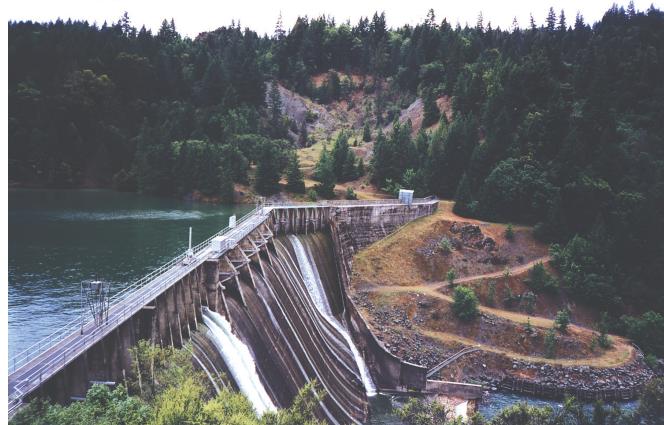
**Figure 38.** Scott Dam on the Eel River, northern California, United States. During construction in 1921, the left end of this dam was diverted downstream to miss the landslide on the left bank of the river, resulting in a “dogleg” in the dam. Photograph taken in 1997 by J.C. Gamble, Pacific Gas and Electric Company, San Francisco.

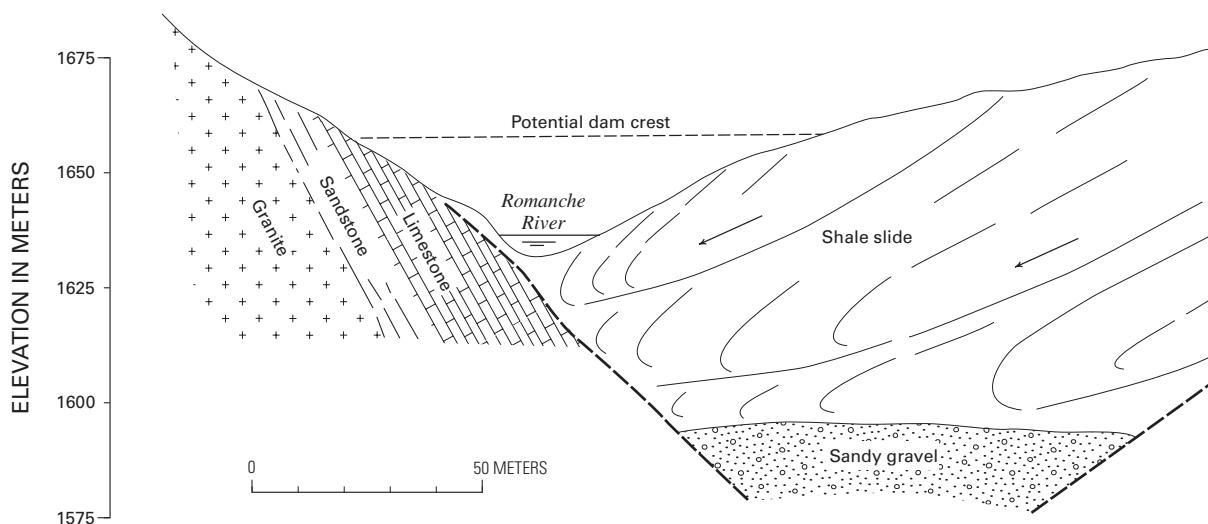
**Figure 39.** Cross section through a narrowed section of the Romanche River valley, France, showing the shale landslide that constricted the valley. Plans to construct a dam at this site were abandoned because of the landslide. Modified from Gignoux and Barbier (1955, p. 88).

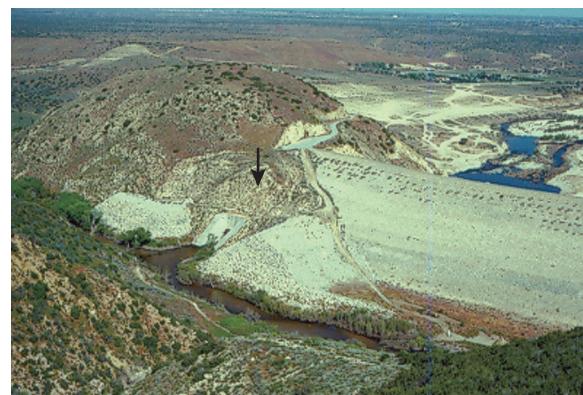
**Figure 40.** Oblique view of the left end of Mojave River Dam, an earthfill flood-control structure in southern California, United States, showing the two earth berms that were added to the left abutment to buttress a small abutment slide (marked by arrow) that occurred during construction. Photograph taken in 1998.

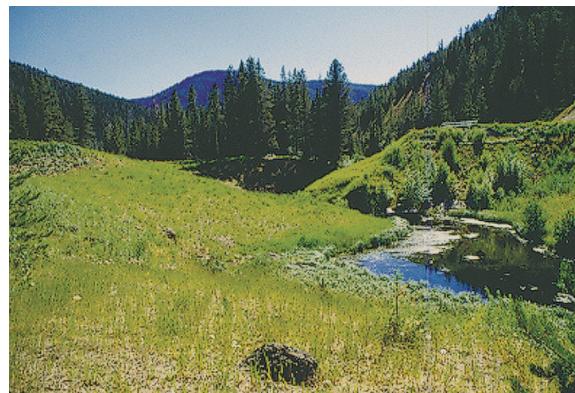
**Figure 41.** The remains of Mystic Lake Dam, a small water-supply dam in southwestern Montana, United States, which was constructed in 1903–04 on the site of a landslide dam. The earthfill dam was purposely breached in 1984 because of the hazard it posed to the downstream city of Bozeman. Photograph taken in 1997.
