# The Loma Prieta, California, Earthquake of October 17, 1989—Liquefaction

STRONG GROUND MOTION AND GROUND FAILURE

U.S. GEOLOGICAL SURVEY PROFESSIONAL PAPER 1551-B

UNITED STATES GOVERNMENT PRINTING OFFICE, WASHINGTON : 1998

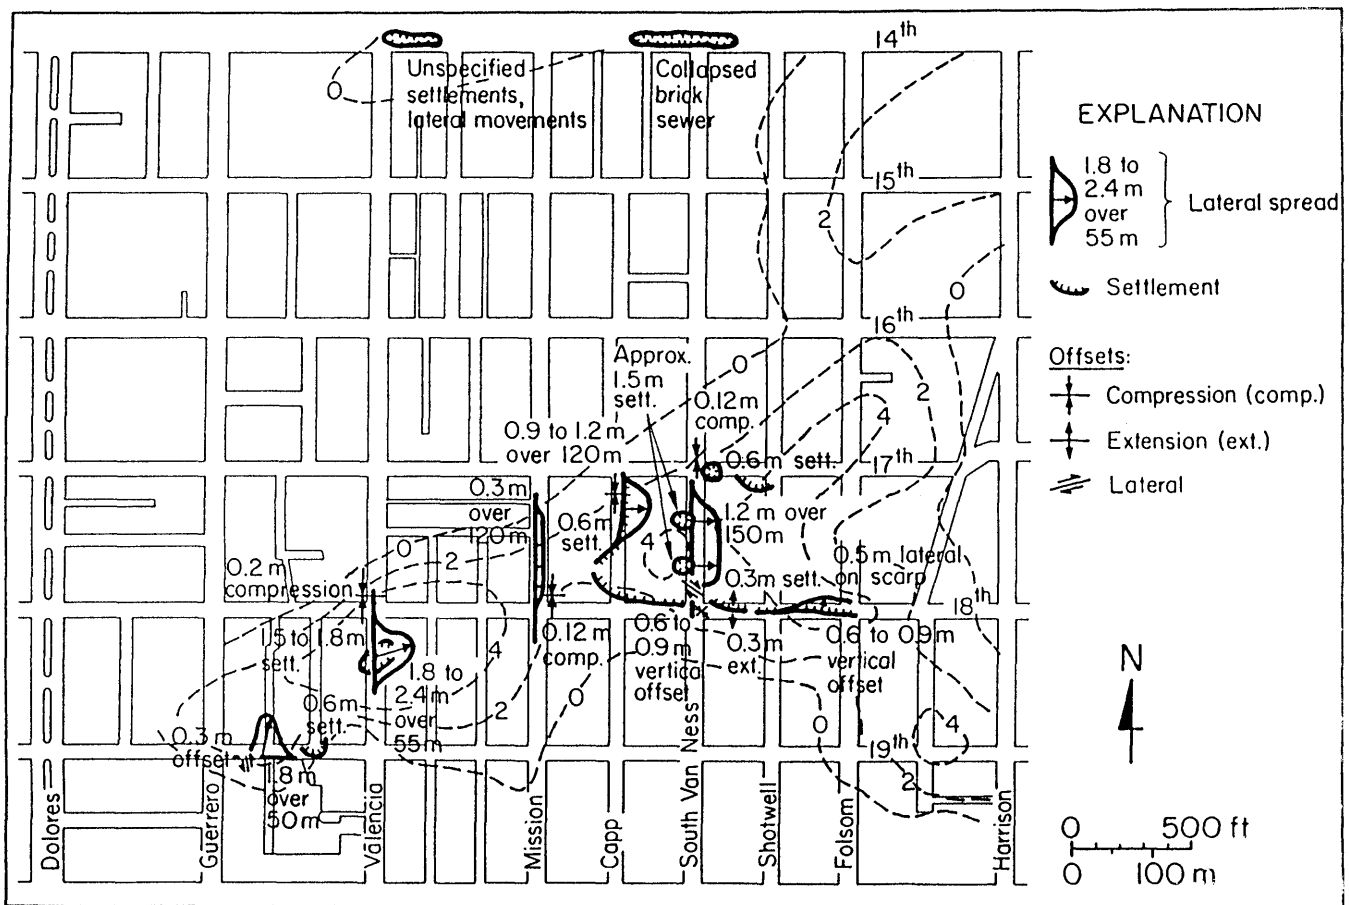
Figure 11.—Mission District study area, showing thickness of submerged fill (dashed contours; interval, 2 m) and locations of lateral spreading, differential settlement, and offsets in 1906 San Francisco earthquake. Hachures, which point toward area of settlement, may indicate either

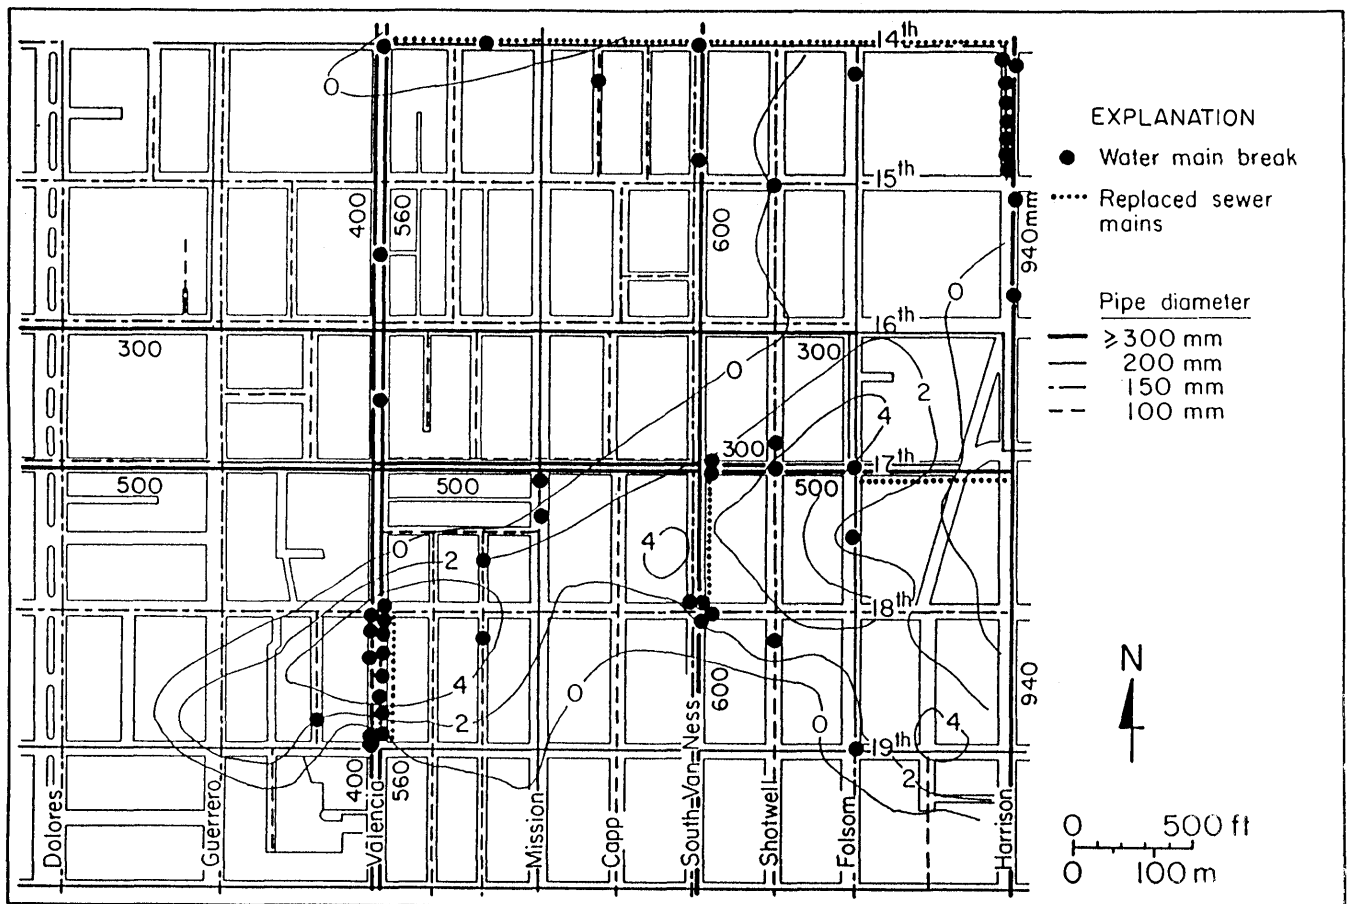
Figure 12.—Mission District, showing thickness of submerged fill (contour interval, 2 m), diameters of pipes, locations of water-supply pipelines, and locations of broken water mains and replaced sewer mains from 1906 San Francisco earthquake reported as of July 1906. Broken water mains were reported by the Spring Valley Water Co. (Schussler, 1906; Manson, 1908). In some places where pipelines cross or run parallel, it is

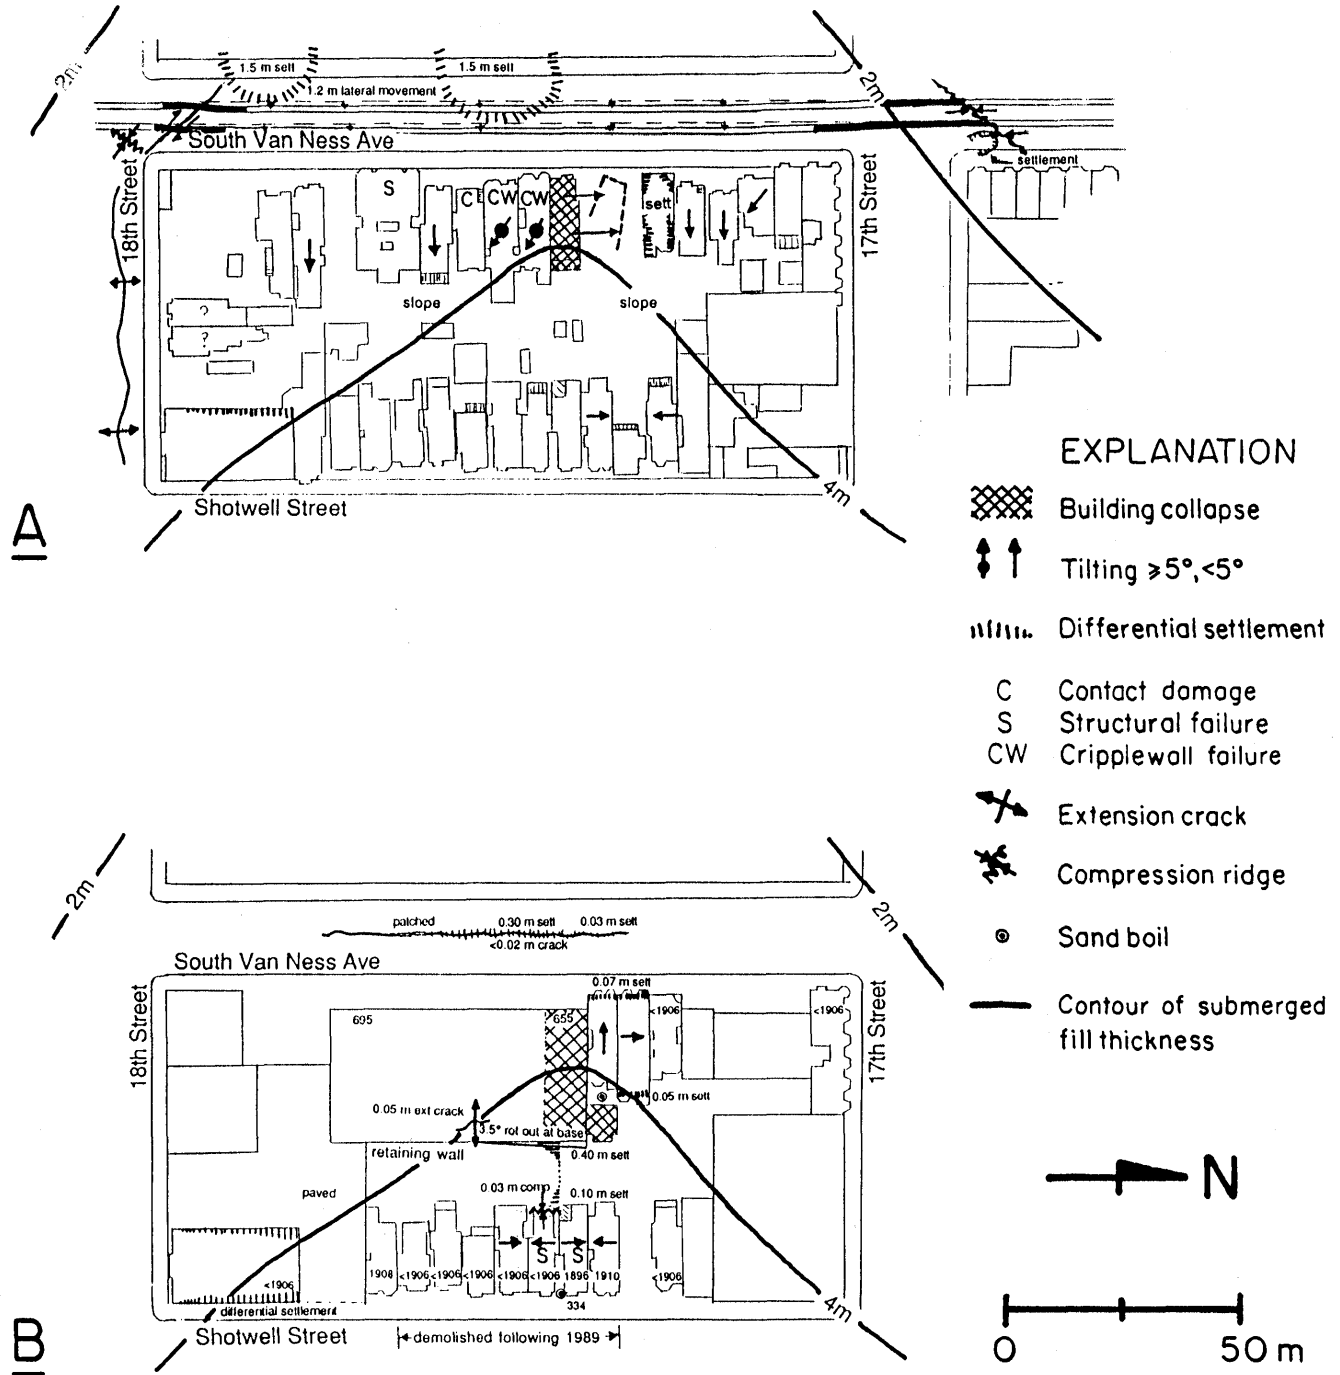
Figure 14.—Ground deformation and building damage from liquefaction in 1906 San Francisco (A) and 1989 Loma Prieta (B) earthquakes in block bounded by South Van Ness Avenue and Shotwell, 17th, and 18th Streets. Outlines of buildings not visible in photographs are queried or omitted for clarity. Where no symbol appears, damage cannot be inferred from photographs, but building should not be interpreted as undamaged. Length of lines indicates severity of differential settlement. Contact

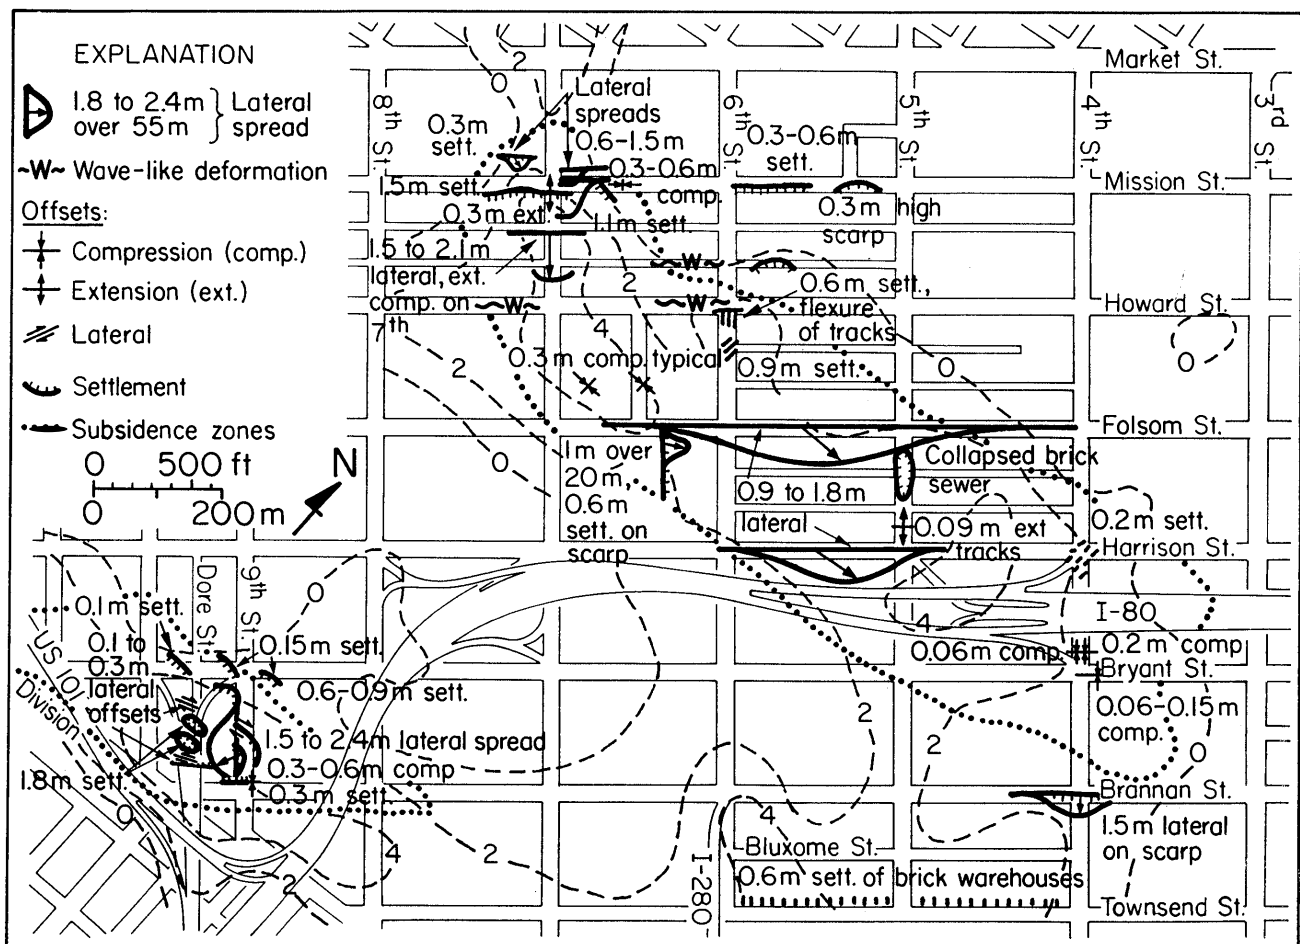
Figure 20.—South of Market study area, showing thickness of submerged fill (dashed contours; interval, 2 m) and locations of lateral spreading, differential settlement, and offsets in 1906 San Francisco earthquake. Hachures, which point toward area of settlement, may indicate either gradual subsidence or an abrupt scarp. Dotted outline denotes major subsidence zones reported by Schussler (1906). From O'Rourke and others (1992a).

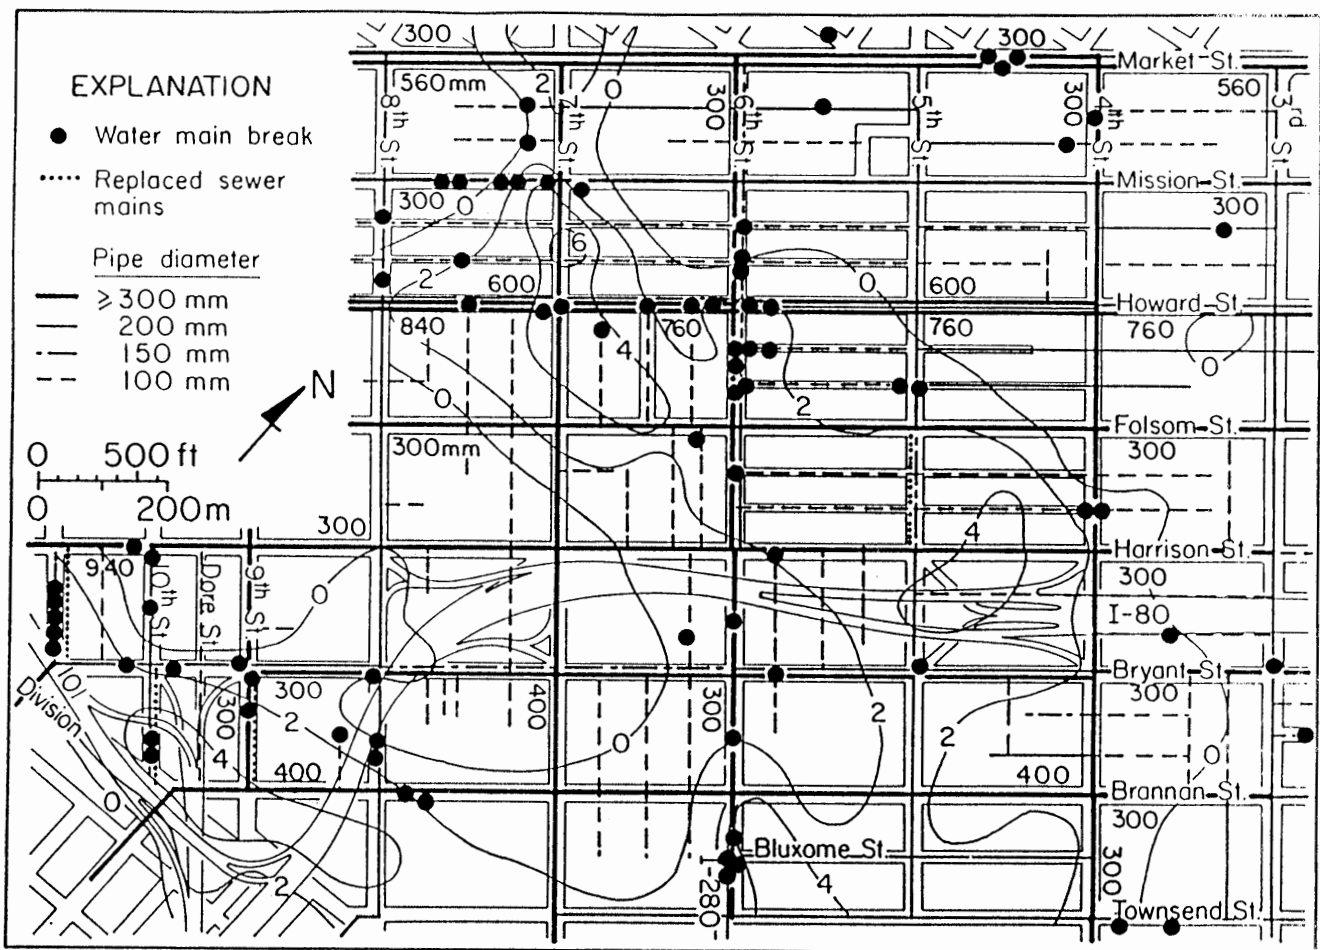
Figure 21.—South of Market area, showing thickness of submerged fill (contour interval, 2 m), diameters of pipes, locations of water-supply pipelines, and broken water mains and replaced sewer mains from 1906 San Francisco earthquake reported as of July 1906. Broken water mains were

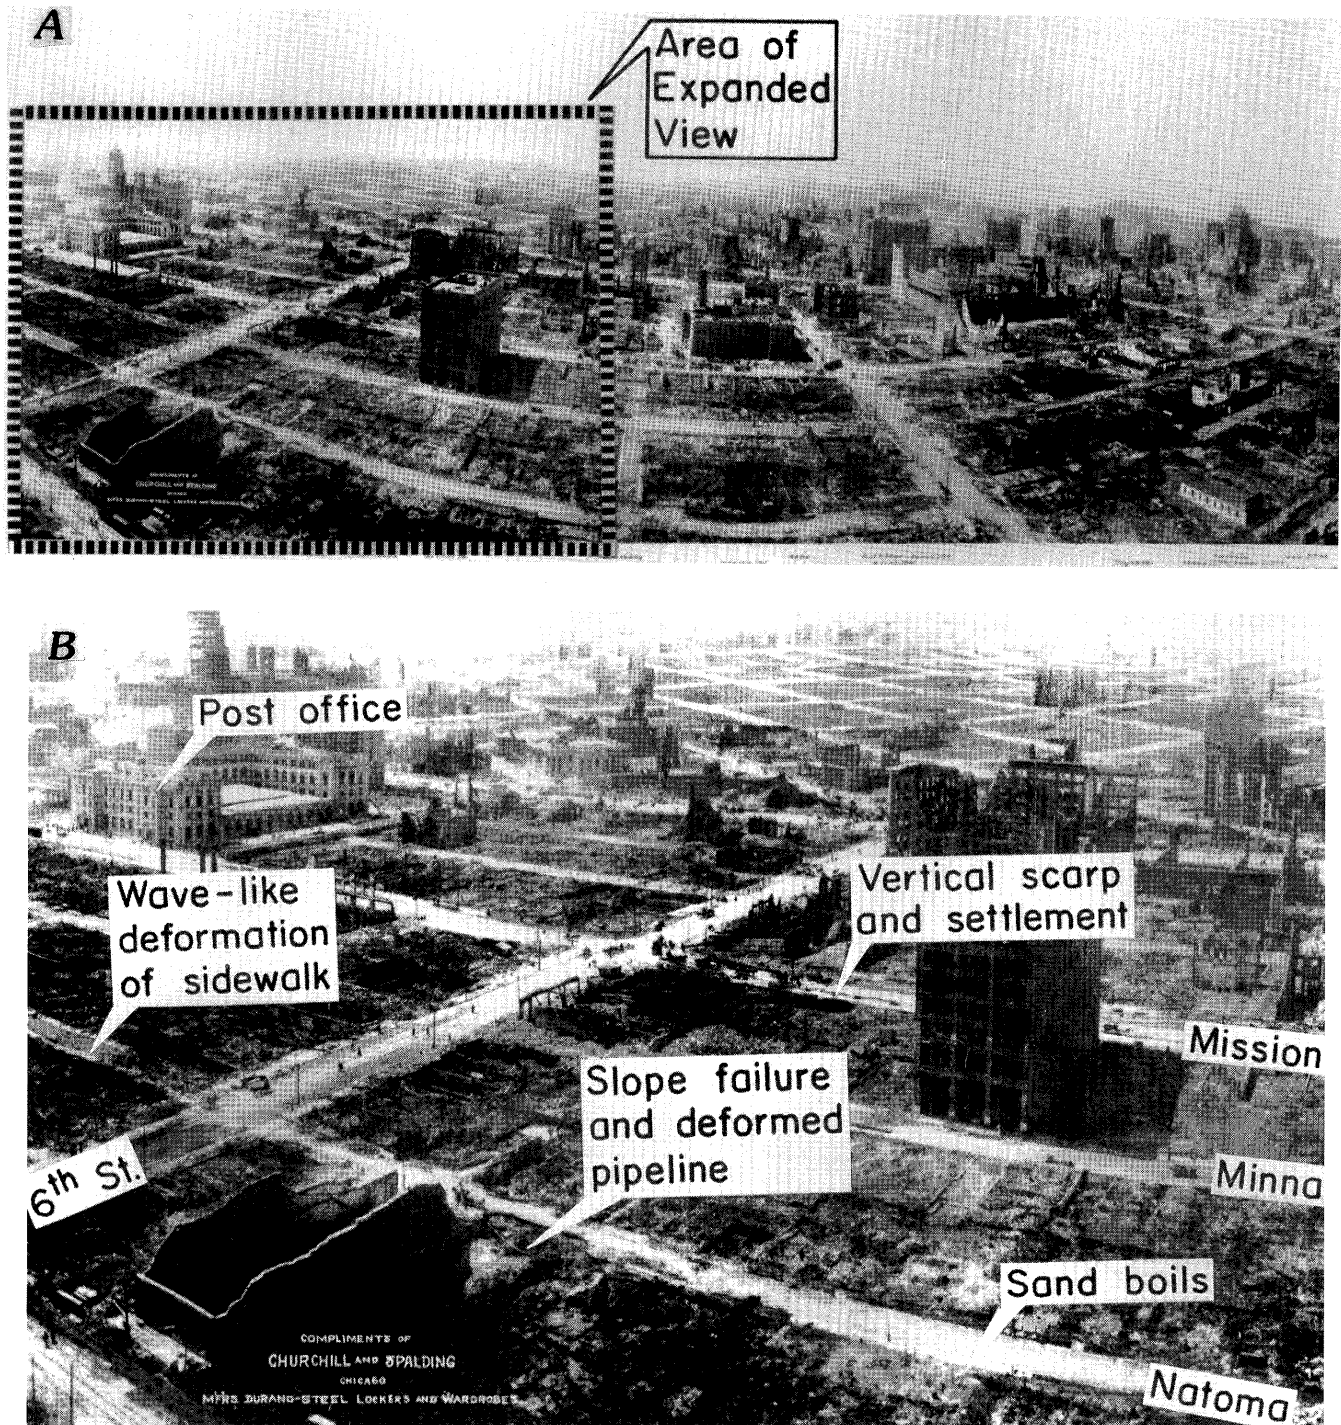
Figure 22.—Part of panorama of San Francisco after 1906 earthquake and fire (A), showing liquefaction-induced ground deformations in devastated area bounded approximately by Mission, Fifth, Seventh, and Natoma Streets (B). Between Sixth and Seventh Streets, ground deformation falls within zone of submerged fill overlying former marsh. Extension cracks, vertical scarps, and settlement monoclines were photographed on Mission Street. At south corner of Post Office, which was built on isolated grillage footings as deep as 6 m below surface,

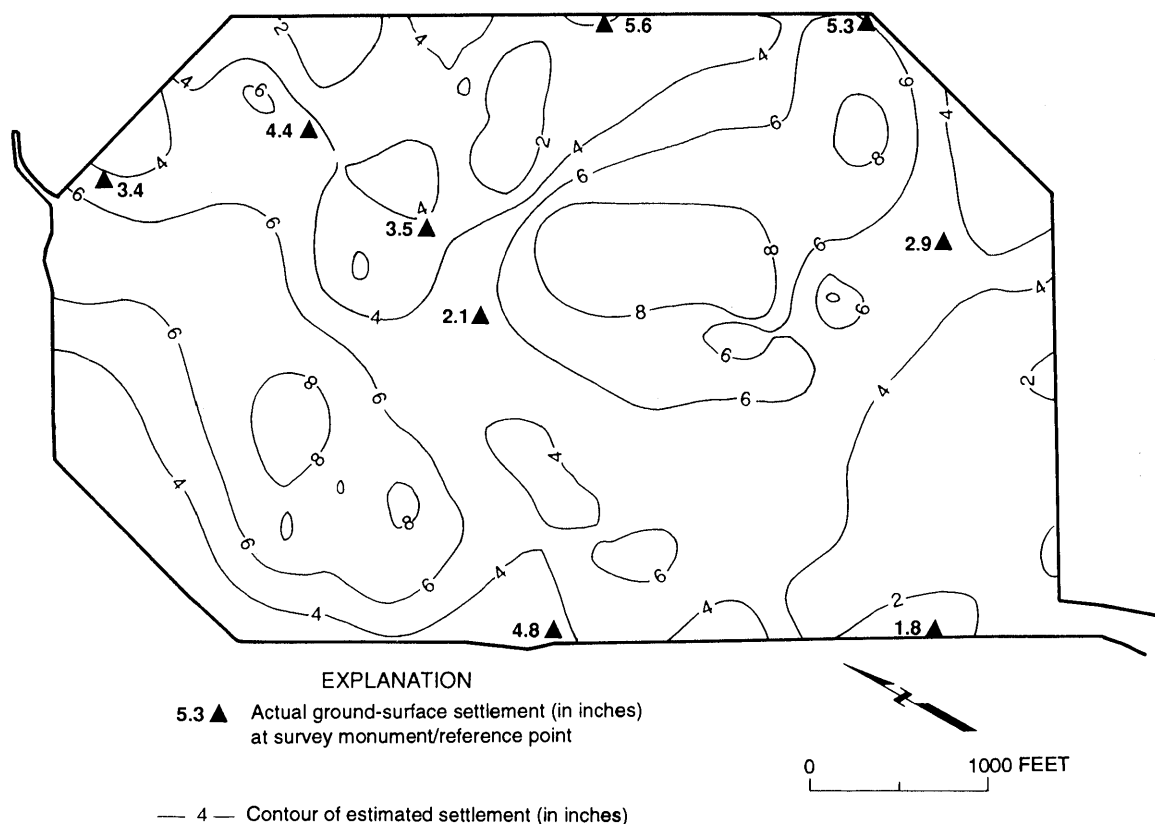
Figure 13.—Sketch map of Treasure Island, showing actual ground-surface settlements and contours of estimated settlement caused by compaction (see text for discussion).
