The Loma Prieta, California, Earthquake of October 17, 1989—Landslides

STRONG GROUND MOTION AND GROUND FAILURE
THOMAS L. HOLZER, *Coordinator*

U.S. GEOLOGICAL SURVEY PROFESSIONAL PAPER 1551-C

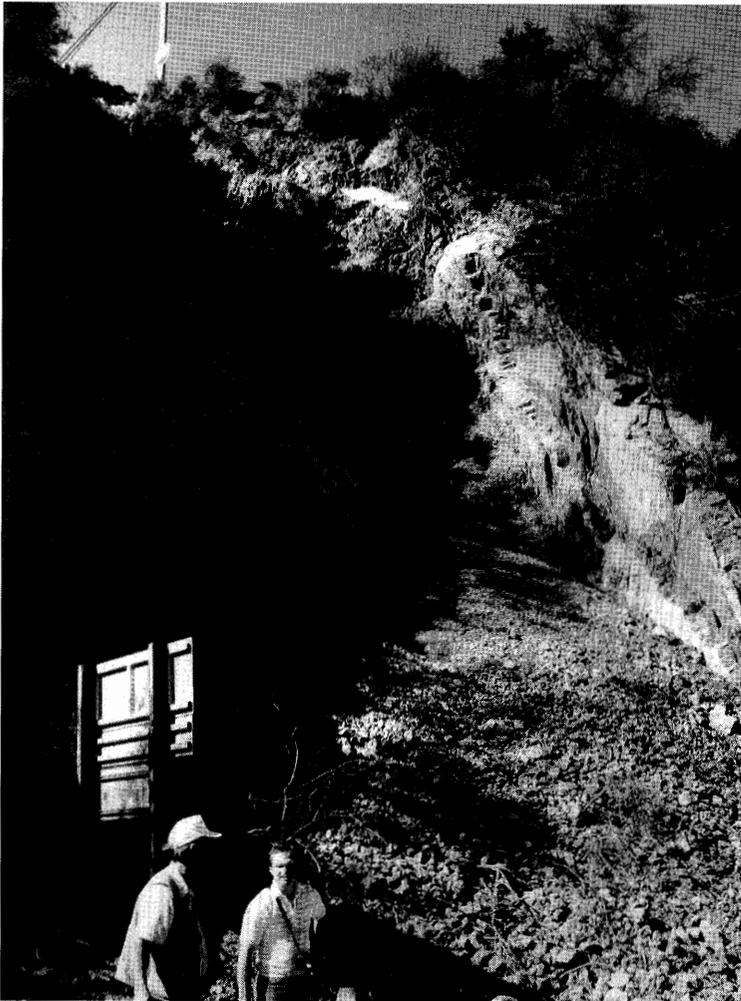
Figure 2.—Part of deposit from complex of rock falls and rock slides along California Highway 17 at Santa Cruz-Santa Clara County line (see pl. 1 for location). Landslide source was in intensely fractured rock.

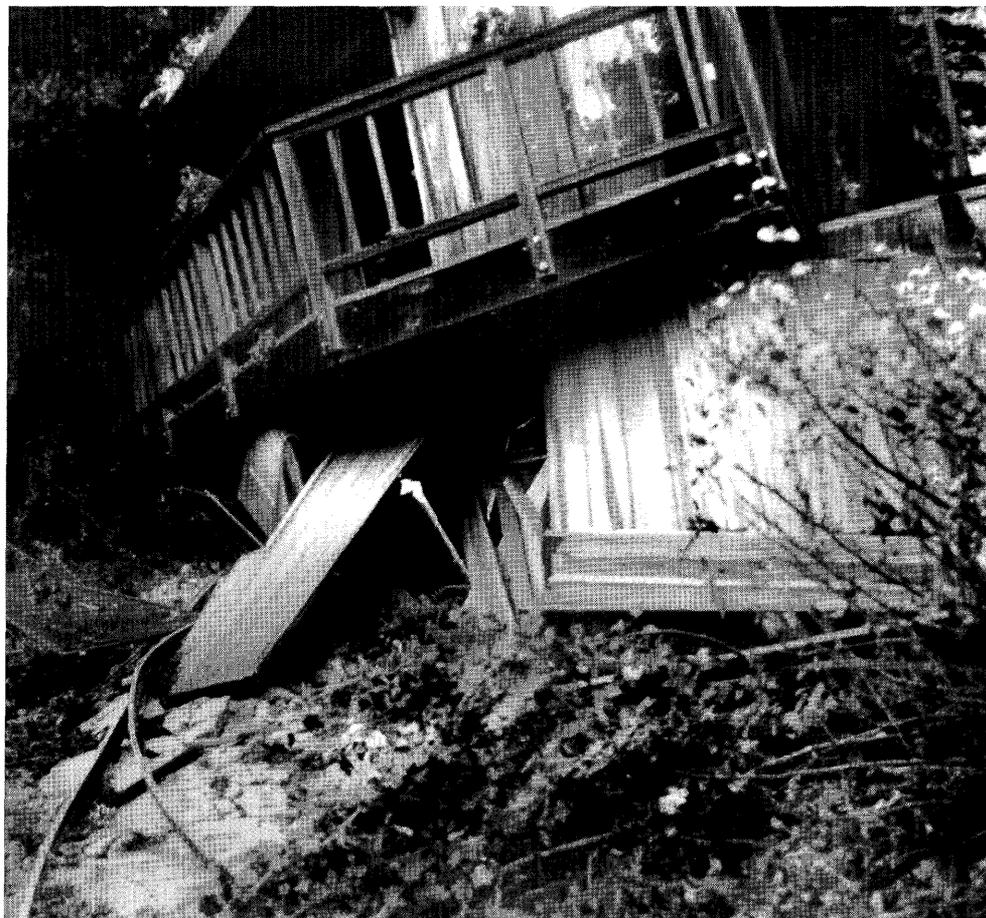
Figure 8.—Severely damaged house on Rebecca Drive landslide (see pl. 1 for location). Main scarp of landslide passes under house. Note ground cracks in foreground.

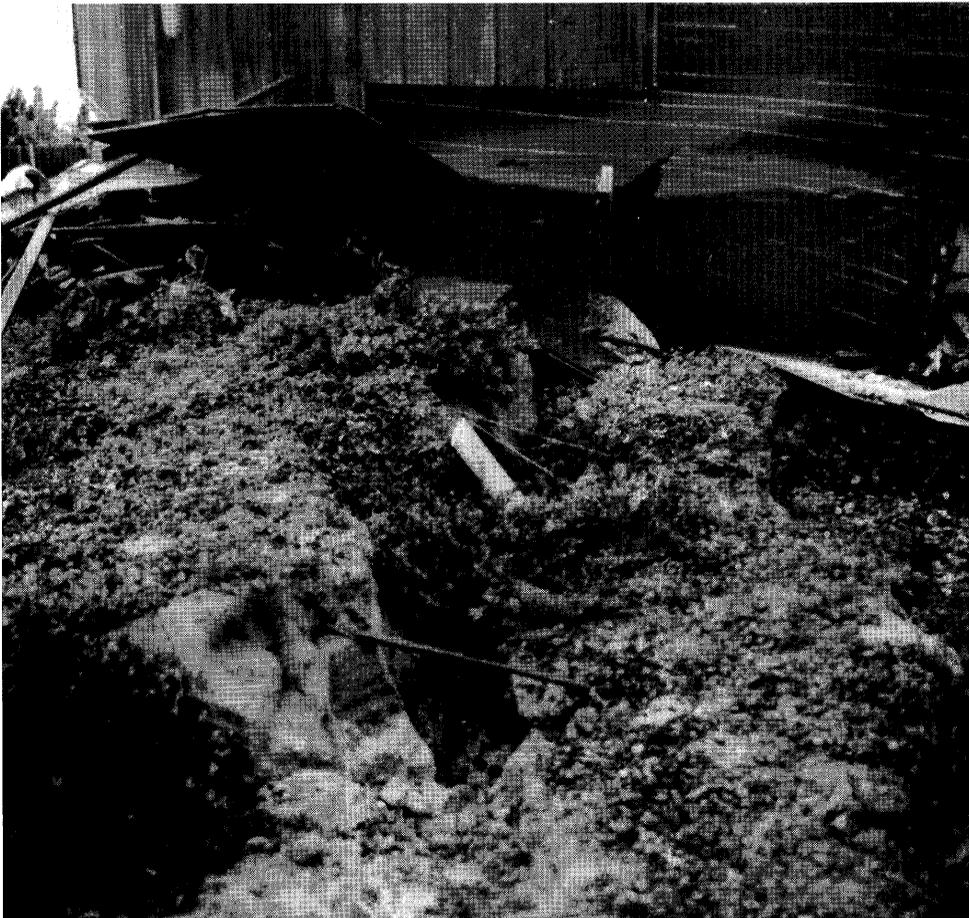
Figure 9.—Part of main scarp of Rebecca Drive landslide (see pl. 1 for location). Notebook (circled) is 20 by 27 cm. Approximate downslope displacement at this locality was 40 cm; maximum measured displacement across scarp was 57 cm.

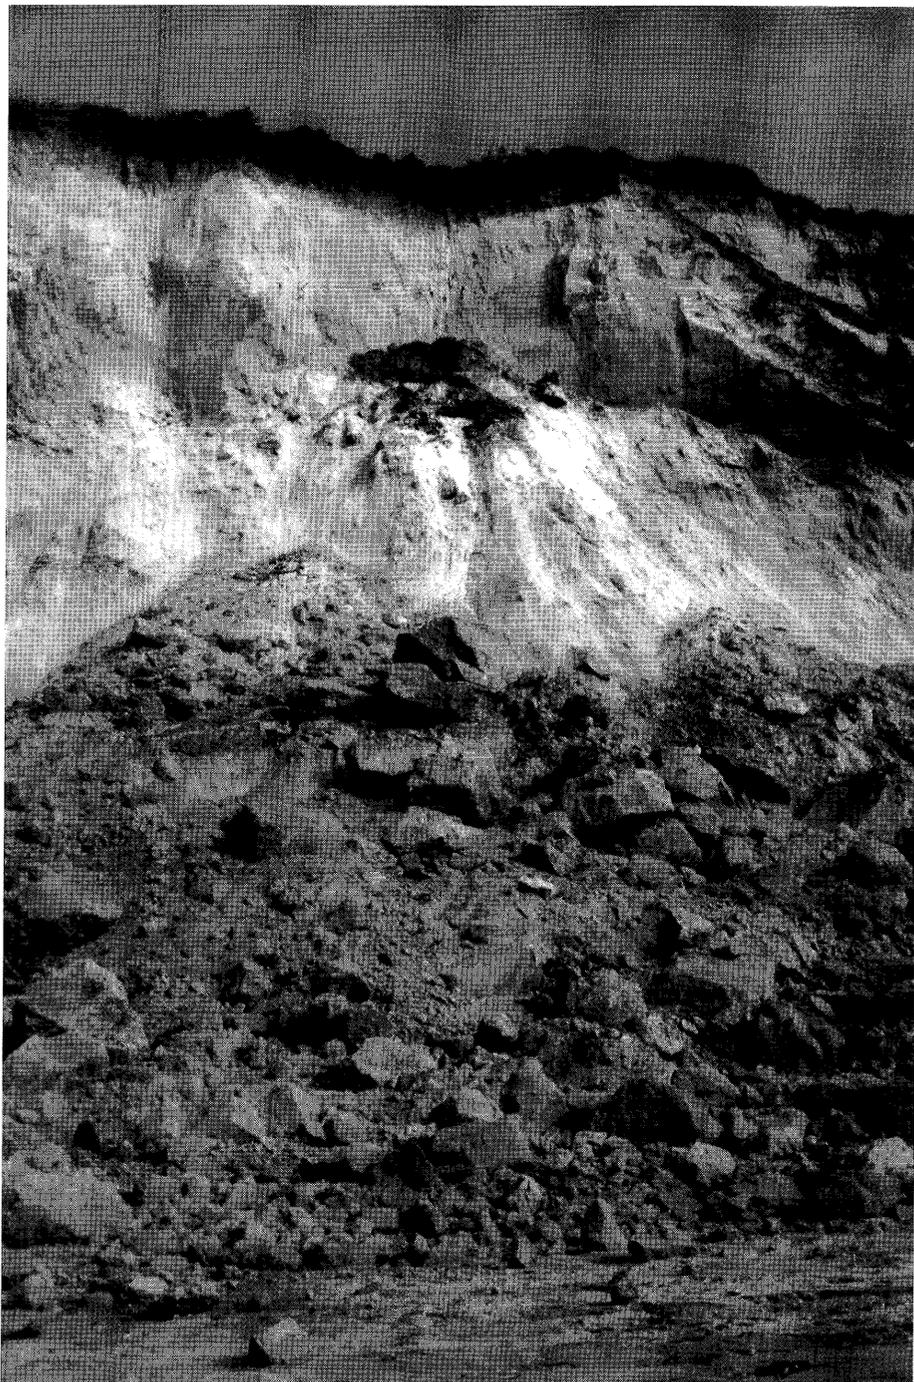
Figure 15.—Coastal landslide about 0.8 km south of mouth of San Gregorio Creek (see fig. 14 for location). Toe of deposit is approximately 60 m wide. Photograph by Mary M. Donato, U.S. Geological Survey.

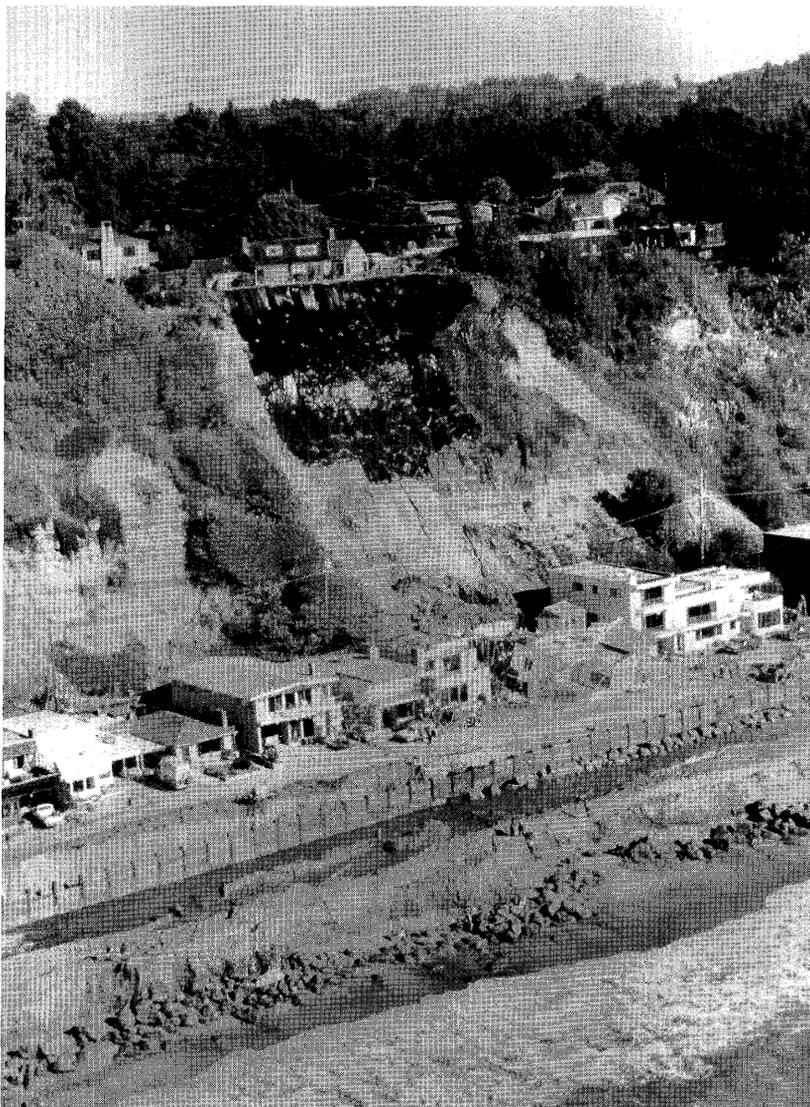
Figure 1.—Coastal-bluff failure in Rio Del Mar (see fig. 4 for location) during a 100-yr 24-hour rainstorm in January 1982.

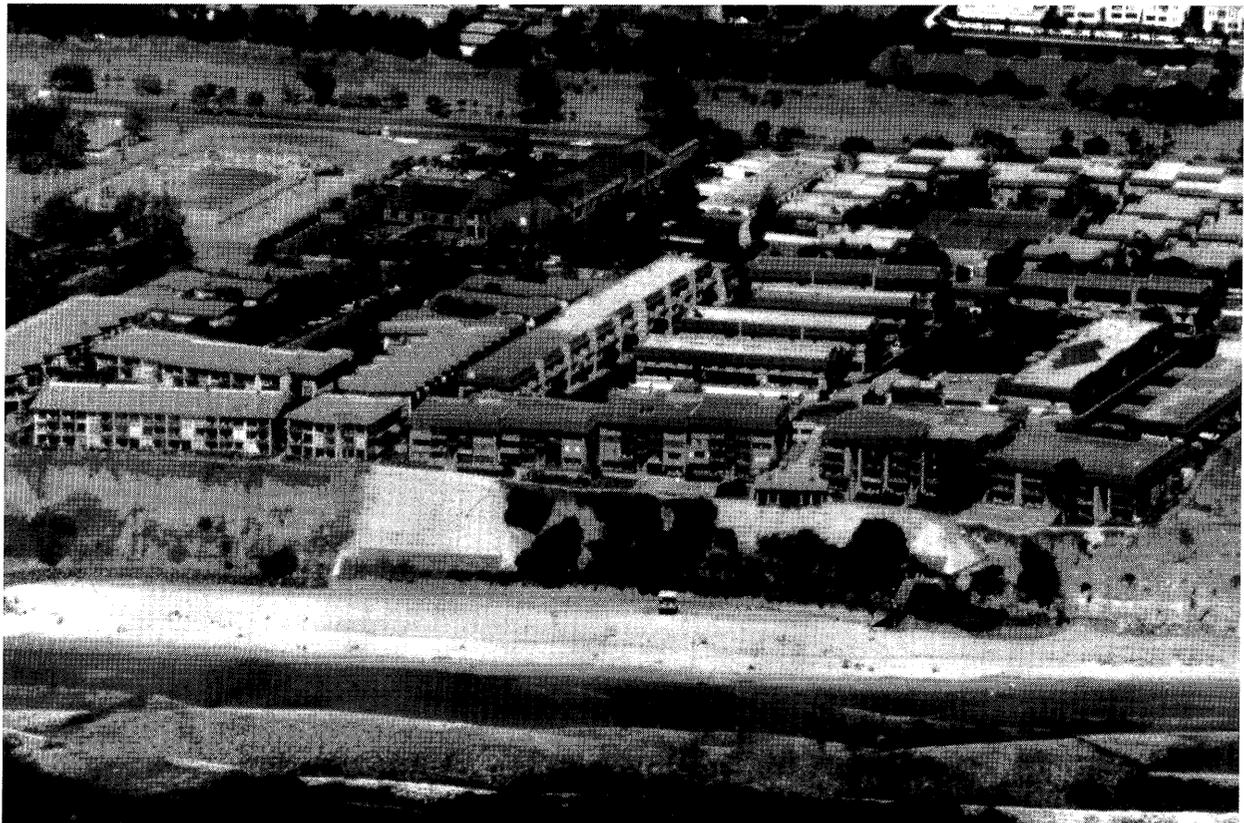
Figure 3.—Intense blufftop development along coast of San Diego County, showing use of seawalls and gunnite to reduce bluff failure.

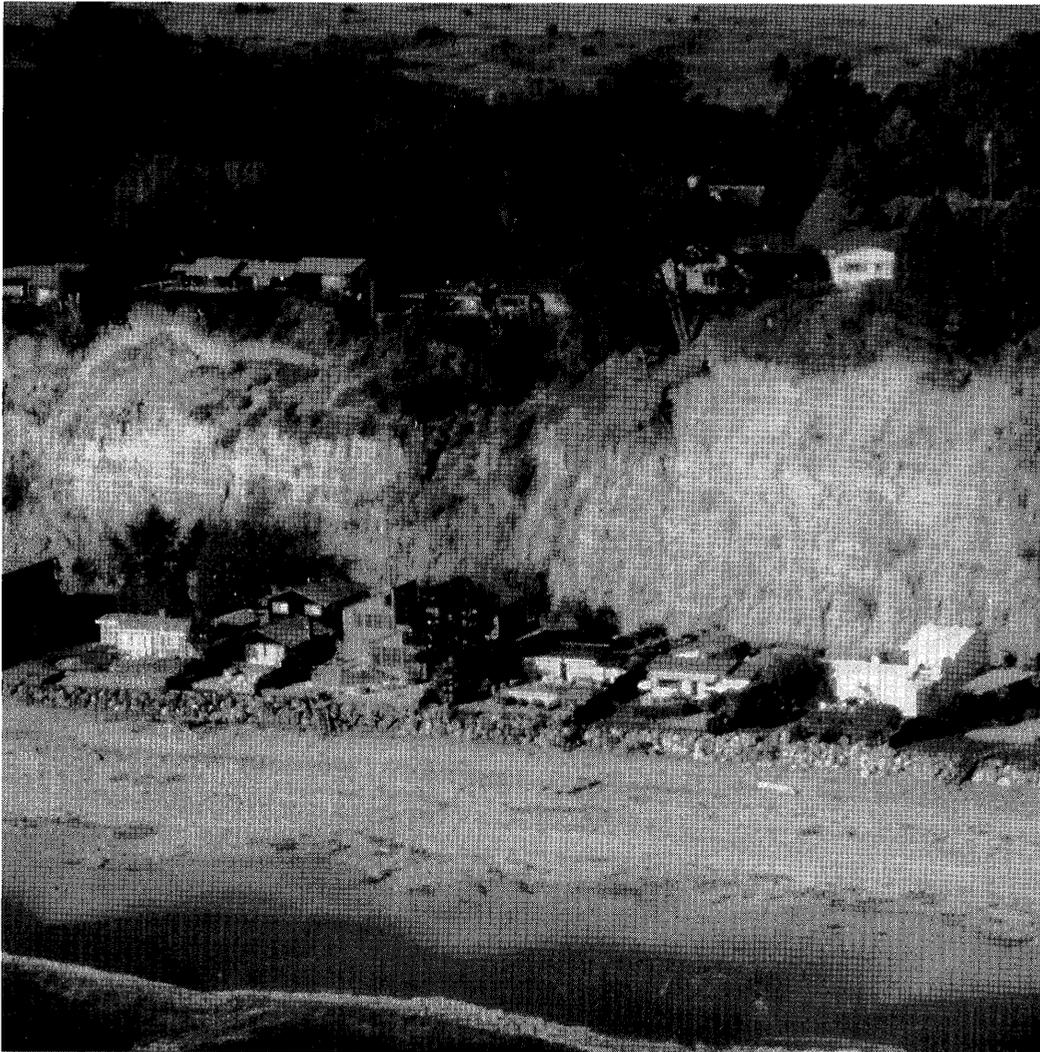
Figure 12.—Earthquake-induced failure of terrace deposits and sandstone of the Purisima Formation between Capitola and Rio Del Mar (see fig. 5 for location).

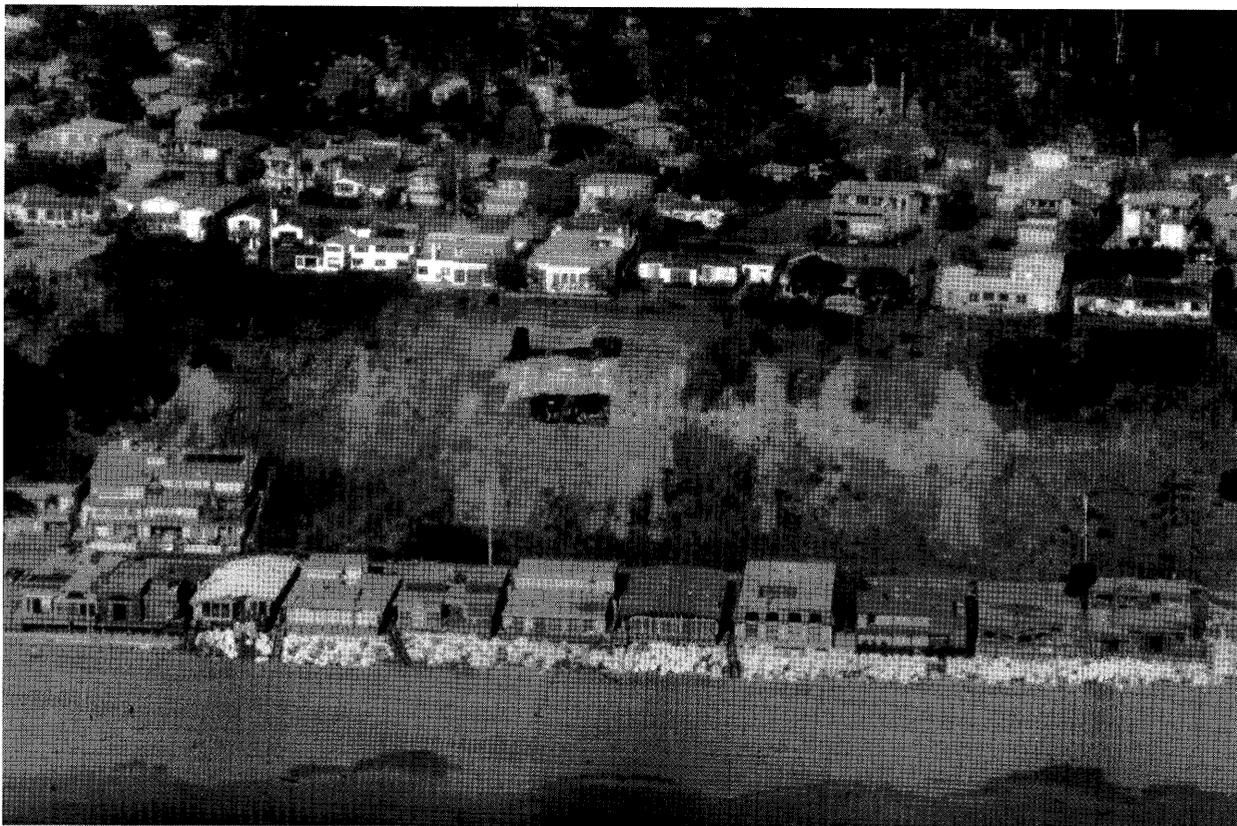
Figure 20.—Earthquake-induced bluff failures in Beach Drive area of Rio Del Mar (fig. 5). New homes are being proposed at base of this bluff behind existing beach-front homes.

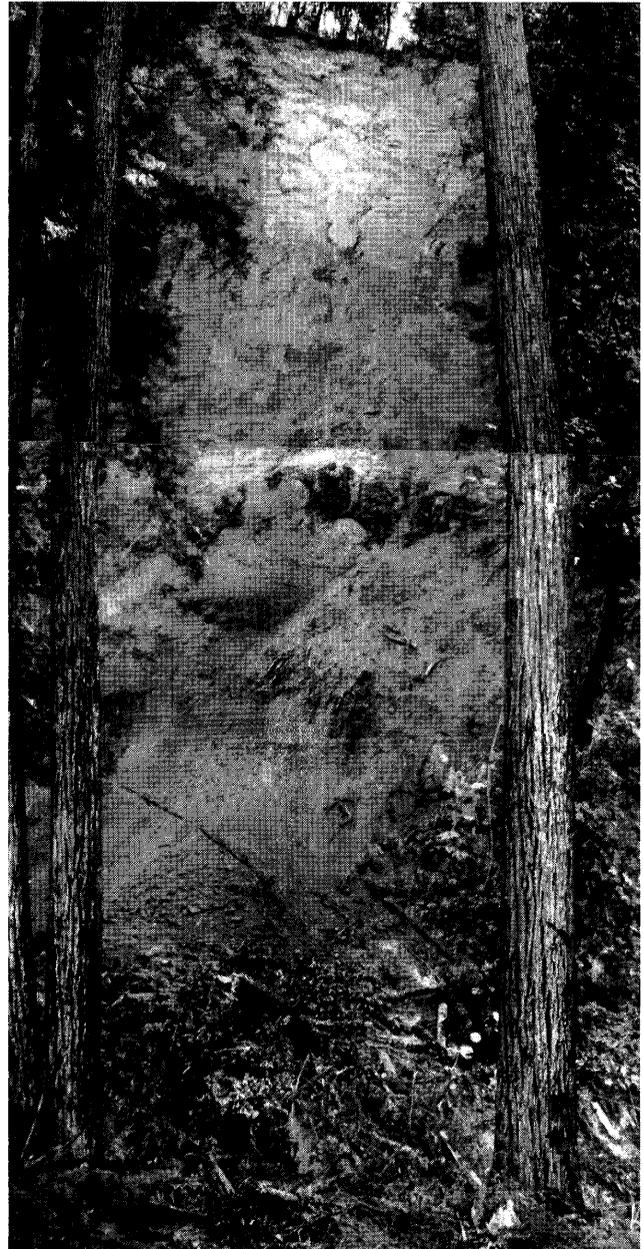
Figure 7.—Rock fall on upper Corralitos Creek (see fig. 5 for location) triggered by 1989 Loma Prieta earthquake. Note logs and brush intermingled with earth material to form landslide dam at base of slope. Impoundment is outside photograph to immediate left. Photograph taken October 25, 1989, 1 week after 1989 Loma Prieta earthquake.

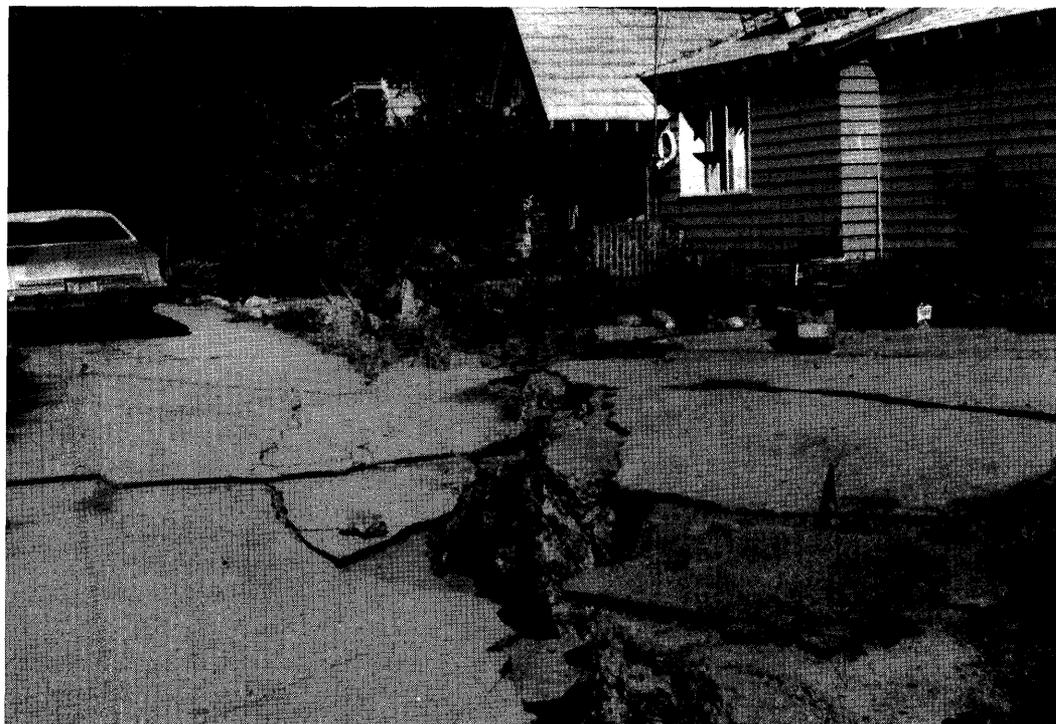
Figure 8.—Segment of Tranbarger fracture (leg A-A', fig. 7A), a 1,200-m-long zone of scarps and cracks in Old Santa Cruz Highway landslide complex. View northwestward from north edge of Summit Road (loc. D, fig. 7A).

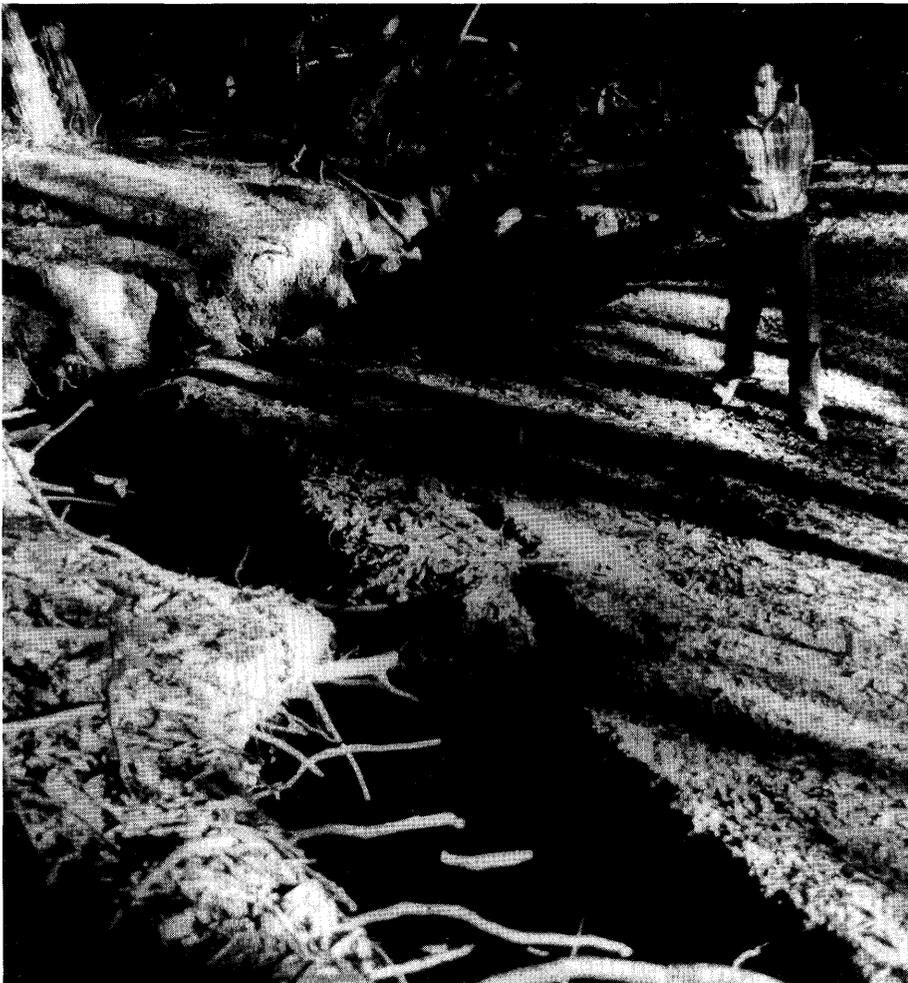
Figure 10.—Part of main scarp of Upper Schultheis Road landslide. Measurements near this locality showed 1.07 m of extensional displacement and 46 cm of vertical displacement across main scarp. View eastward from near landslide crown (loc. A, fig. 9A).

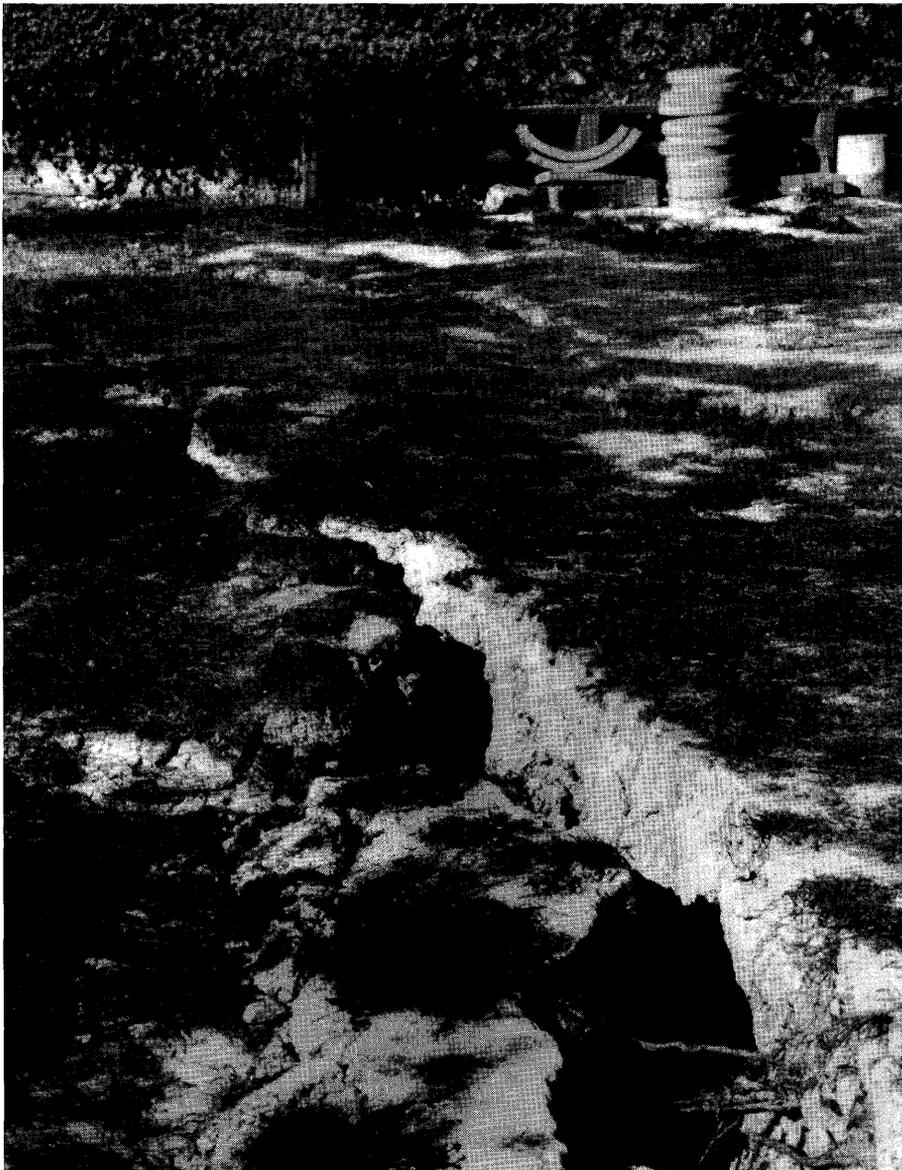
Figure 13.—Segment of main scarp of Villa Del Monte landslide in Sunset Drive area. View northwestward from near quadrilateral-array station 14 (fig. 12A). Photograph by Kevin M. Schmidt, U.S. Geological Survey.

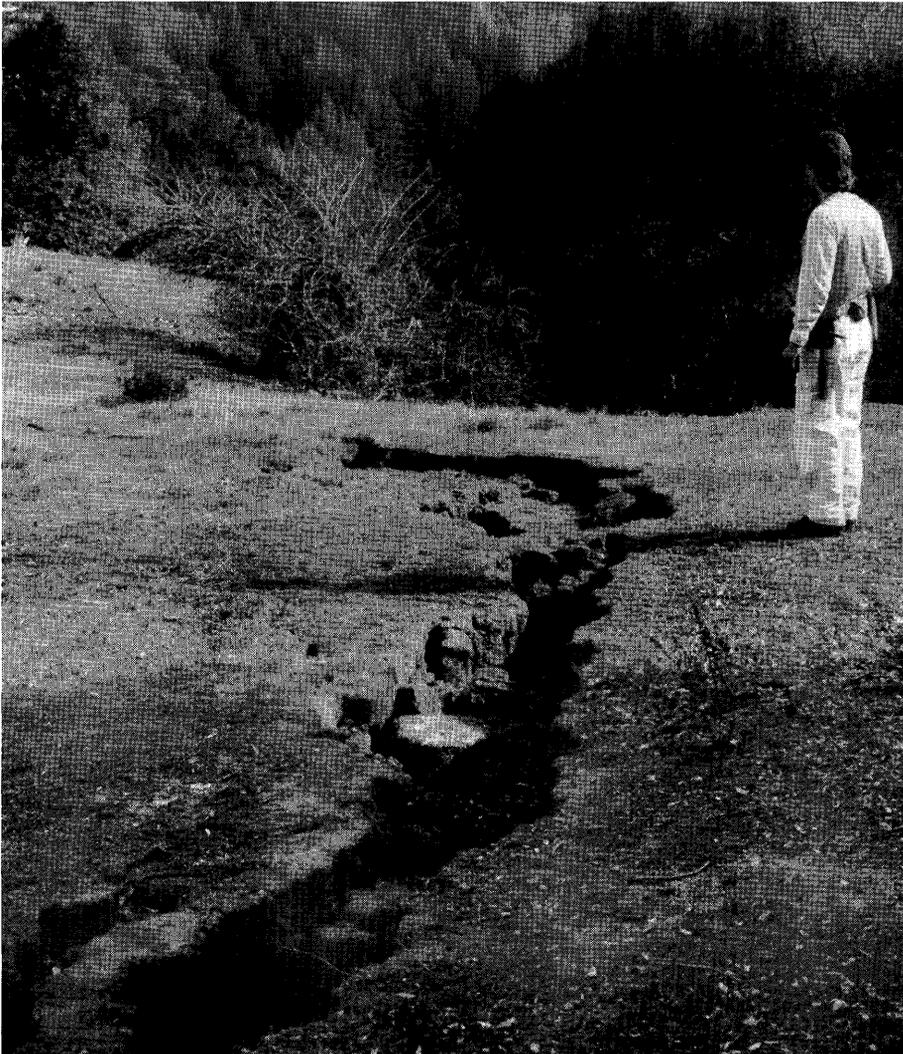
Figure 23.—Part of main scarp of Lower Schultheis Road West landslide. View eastward from just west of Schultheis Road (loc. A', fig. 22). Ridgecrest to left (north) is involved in landslide.

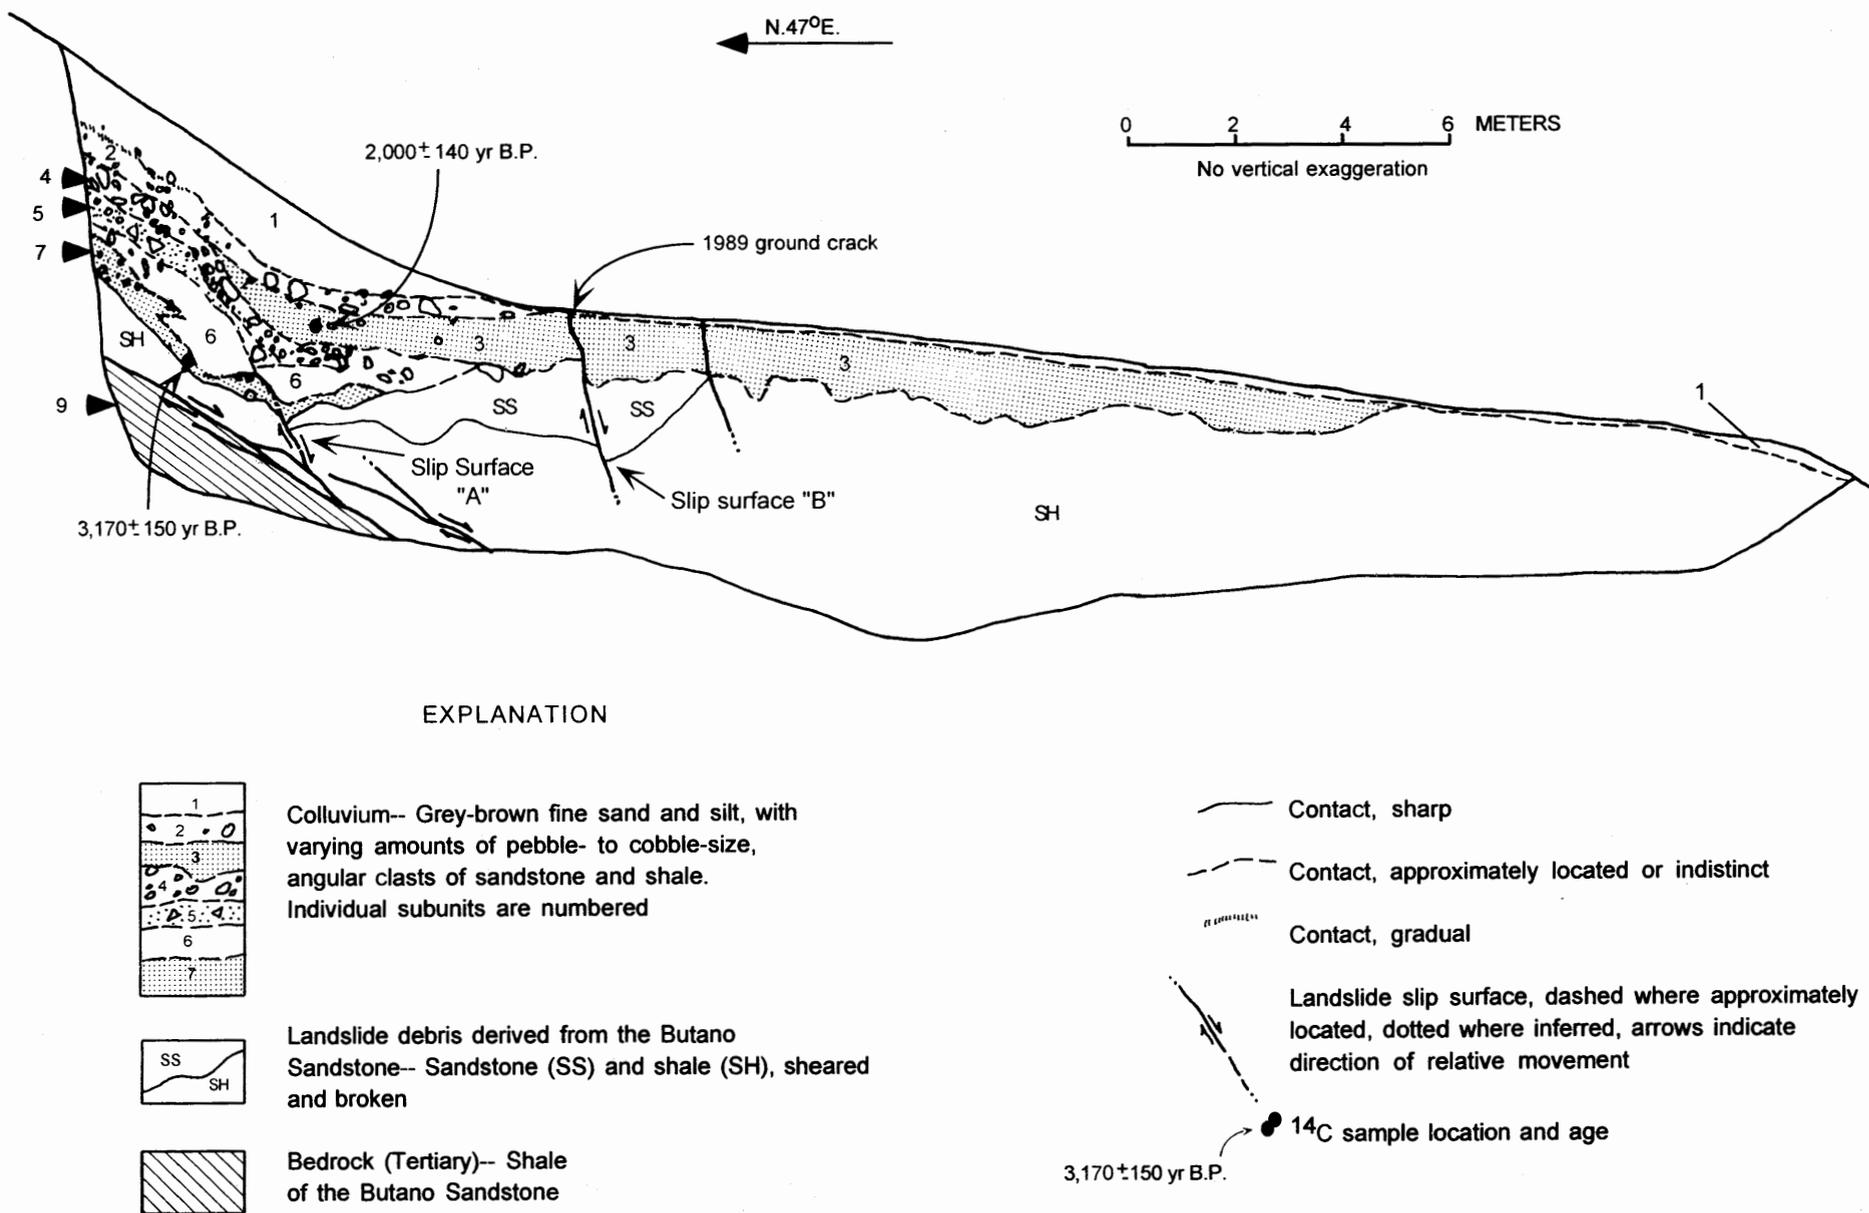
Figure 3.—Log of trench 2, which was excavated across a ground crack following crown of a preexisting landslide mass. Offset of layers within colluvial wedge at head of landslide and 1989 ground-cracks indicate that at least three reactivations of this landslide have taken place in the past approximately 2,000 years.

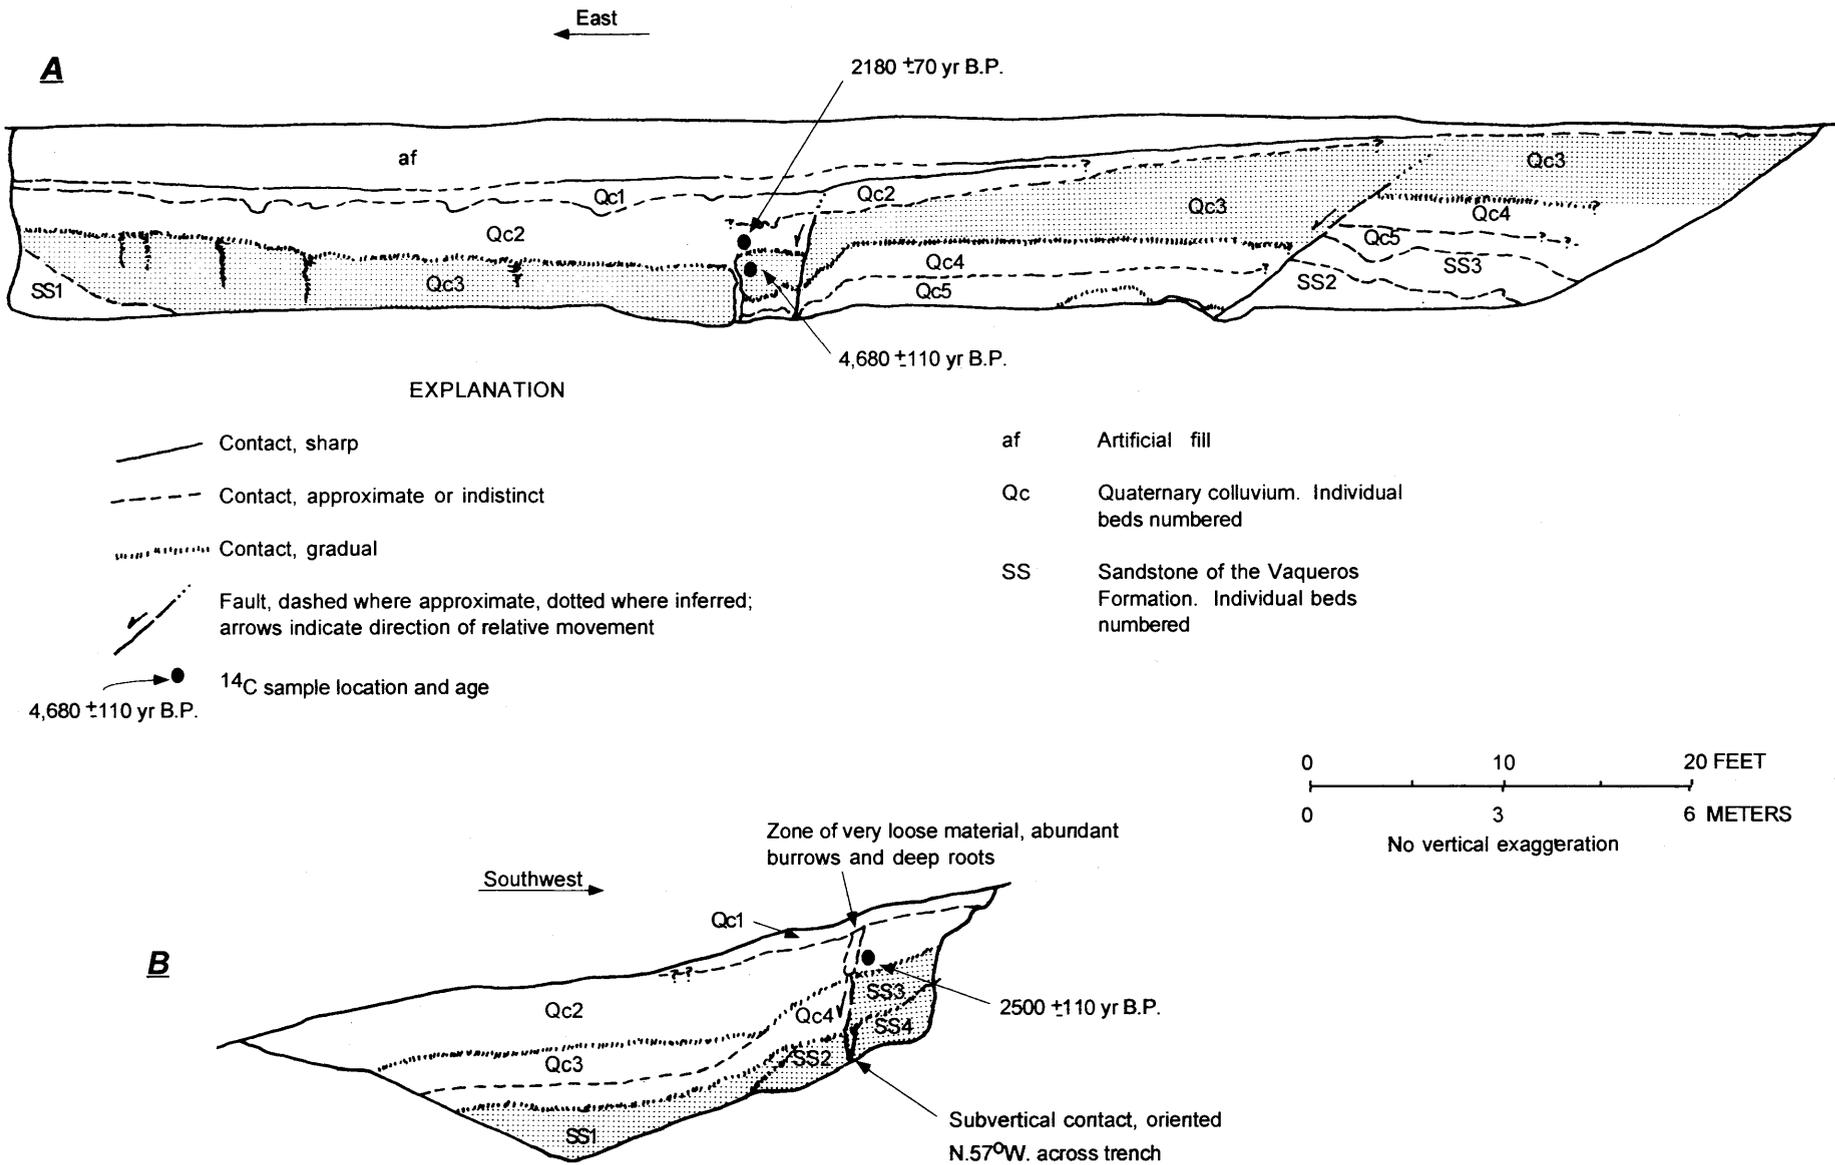
Figure 5.—Logs of trenches 3 (A) and 4 (B), showing evidence for active faulting found during preearthquake trenching investigation. Fault in center of trench 3 was reactivated during 1989 Loma Prieta earthquake, causing as much as 15 cm of down-to-the-northeast displacement under classroom unit 2. Modified from Rogers E. Johnson and Associates (1989).

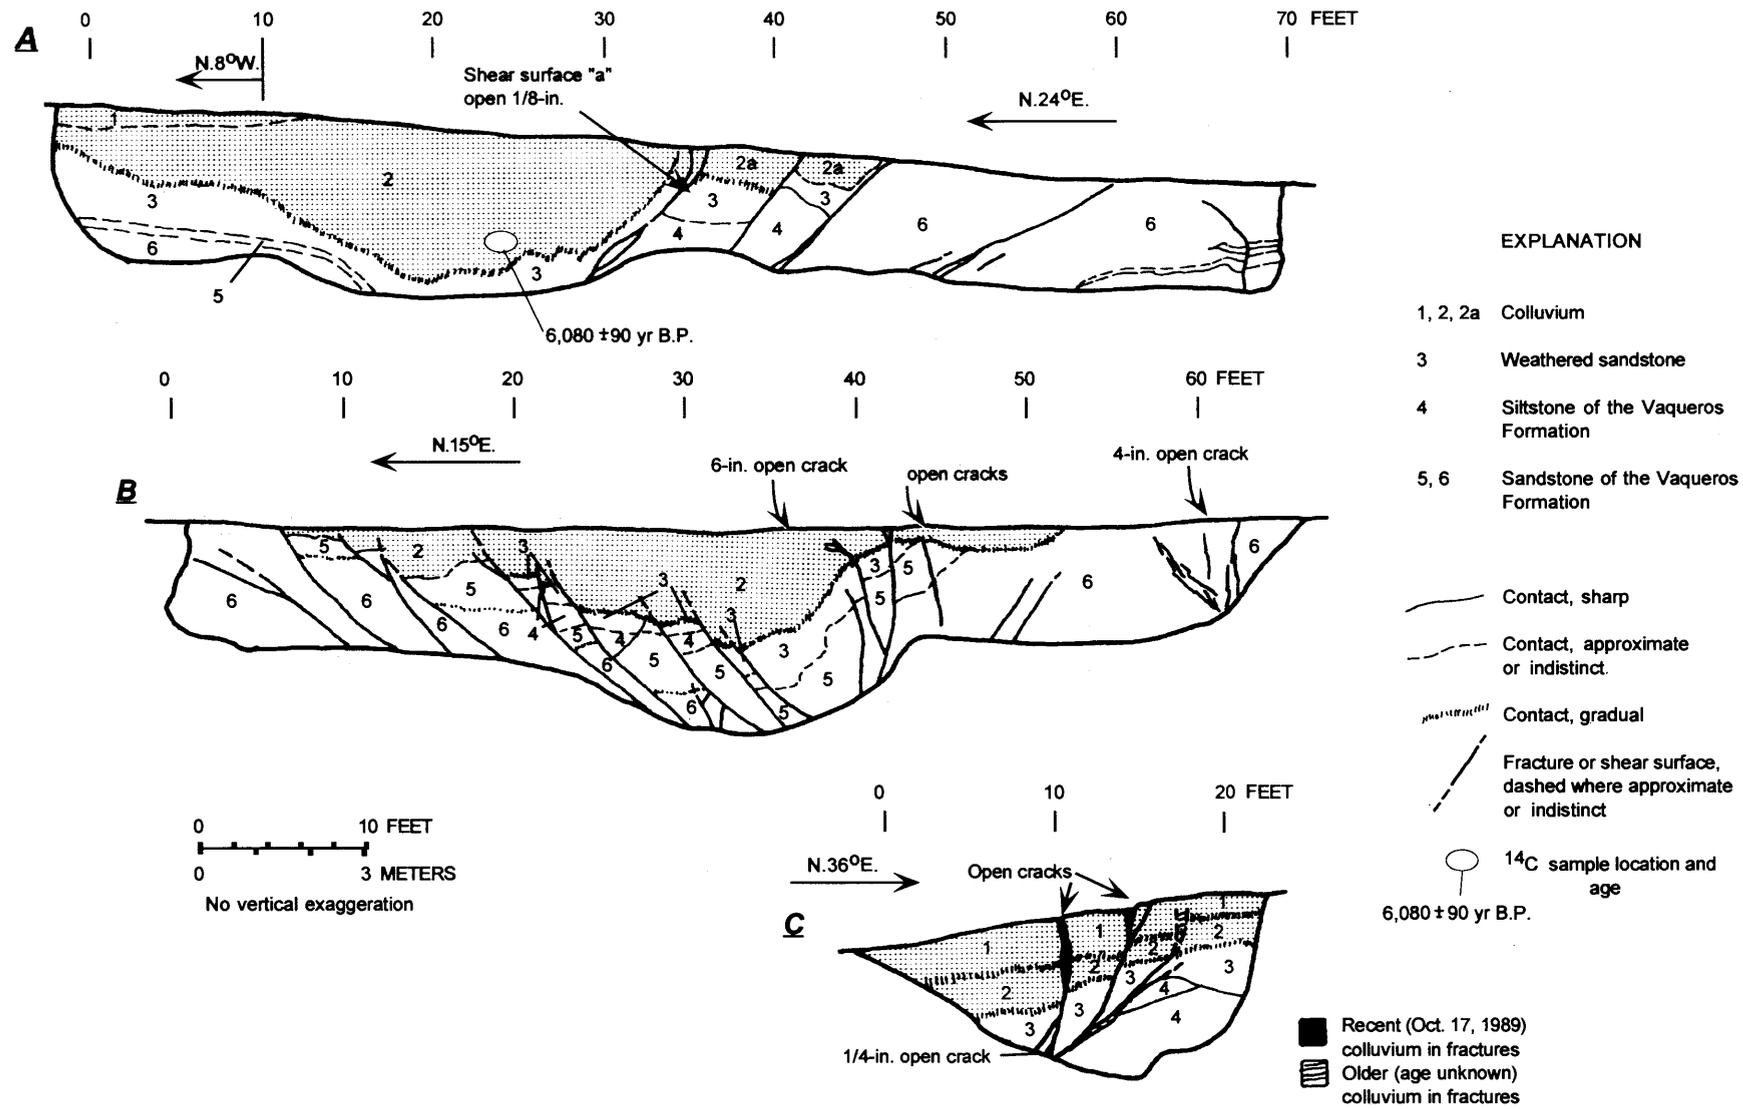
Figure 7.—Logs of trenches 5A (A), 5B (B), and 6 (C) across area of major ground cracks. A, Trench 5A crosses a colluvium-filled graben that was not perceptibly reactivated in 1989. B, Trench 5B shows a second colluvium-filled graben where ground cracks cross trench, indicating many previous episodes of ground cracking in the same place. C, Trench 6 shows bedrock and soil offsets much larger than 1989 displacements, clear evidence for earlier episodes of movement. From G.E. Weber and Associates (1990a).
