The Loma Prieta, California, Earthquake of October 17, 1989—Marina District

STRONG GROUND MOTION AND GROUND FAILURE
THOMAS L. HOLZER, *Coordinator*

U.S. GEOLOGICAL SURVEY PROFESSIONAL PAPER 1551-F

MARINA DISTRICT

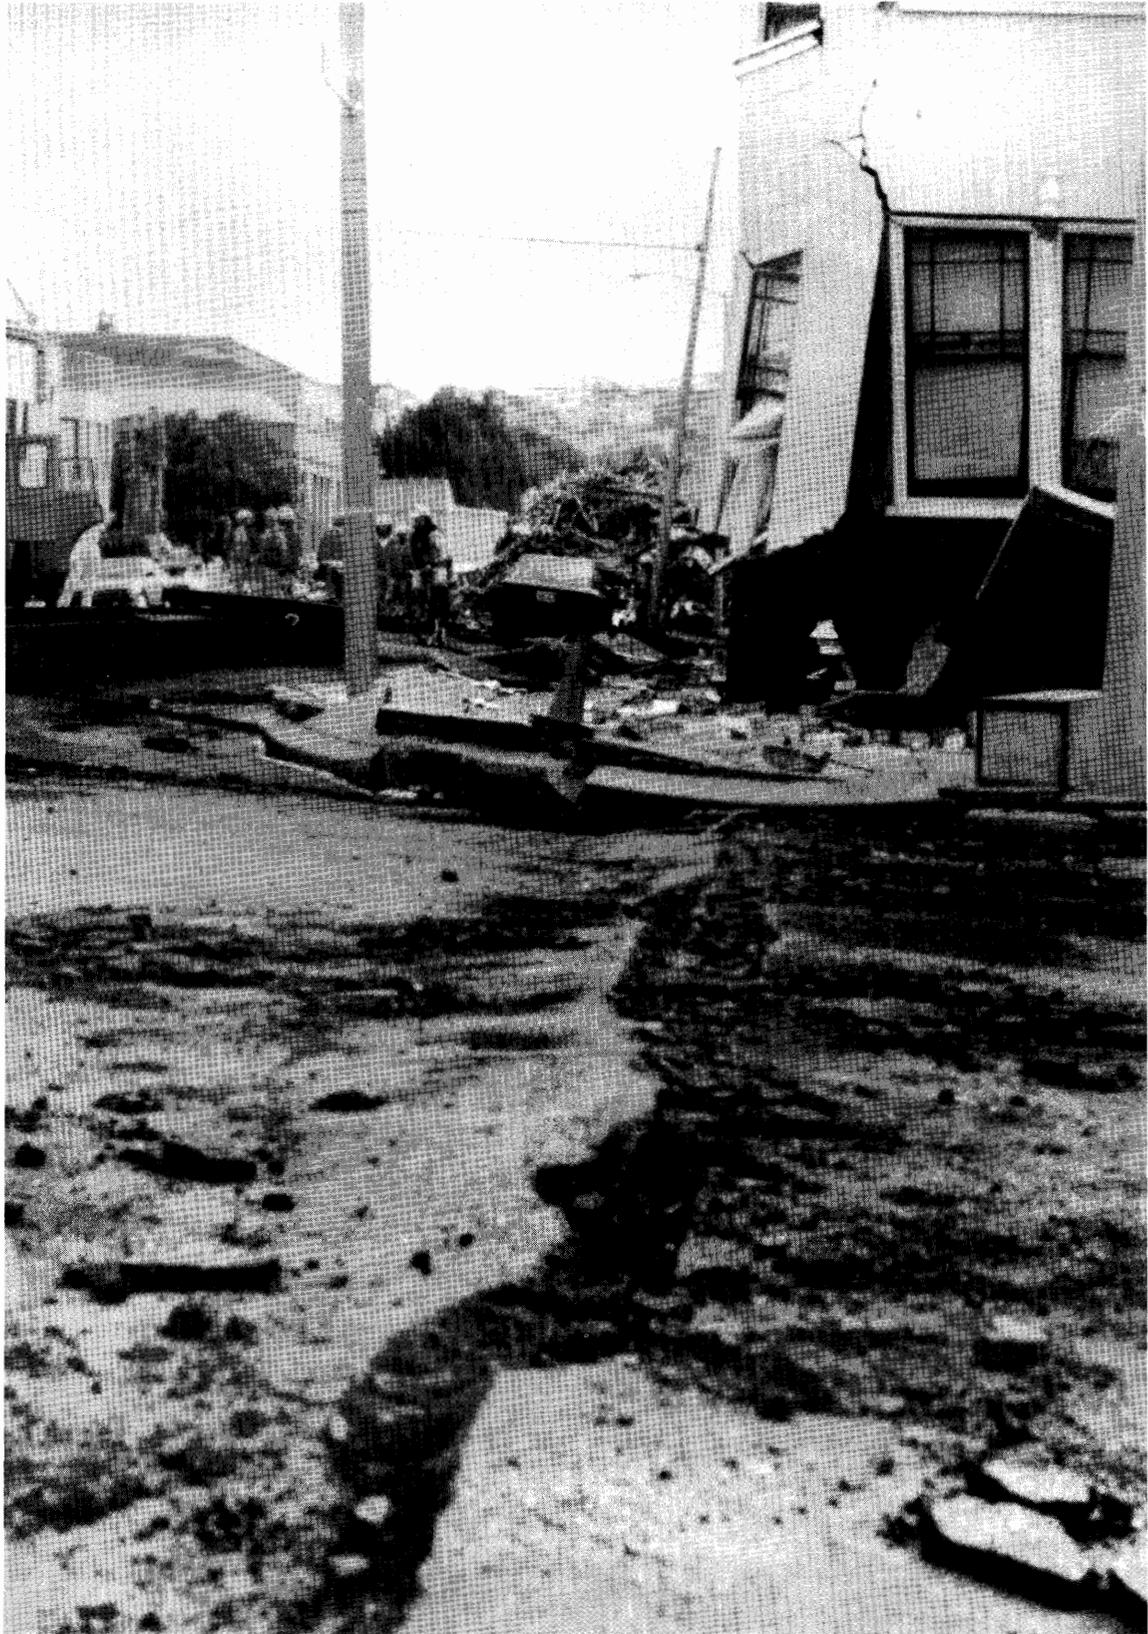
Collapsed four-story wood-frame building at southwest corner of Divisadero and Jefferson Streets. Local subsidence caused by soil liquefaction is visible at street corner. Heaved and fractured pavement is oriented perpendicular to direction of strongest seismic shaking. Underground water, gas, and wastewater pipelines were considerably damaged at this site. View southward; photograph courtesy of T.D. O'Rourke.

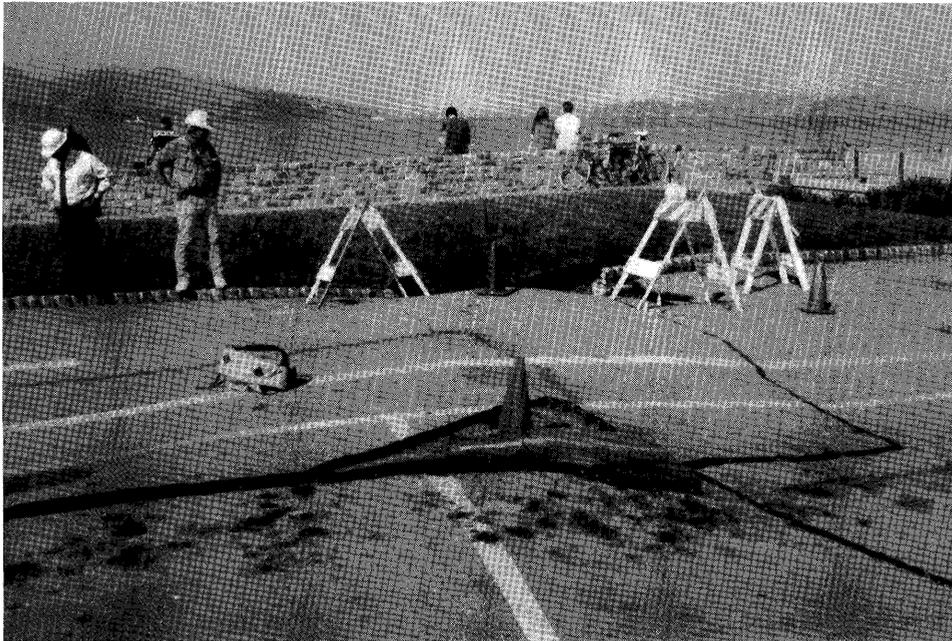
Figure 5.—Storm sewer outlet immediately west of the St. Francis Yacht Club. Photograph taken in October 1989.

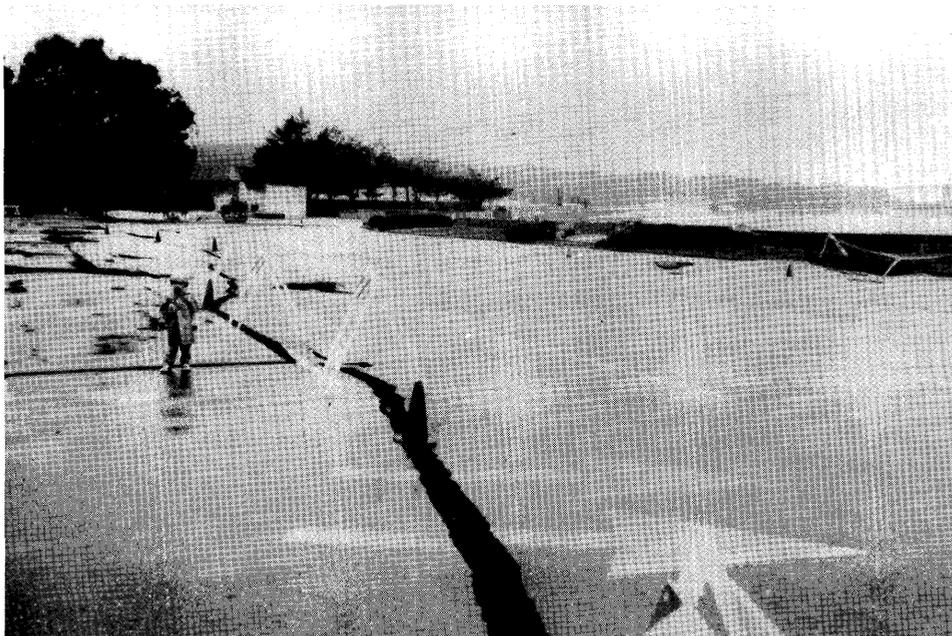
Figure 6.—Cracks in asphalt pavement southwest of the St. Francis Yacht Club. Photograph taken in October 1989.

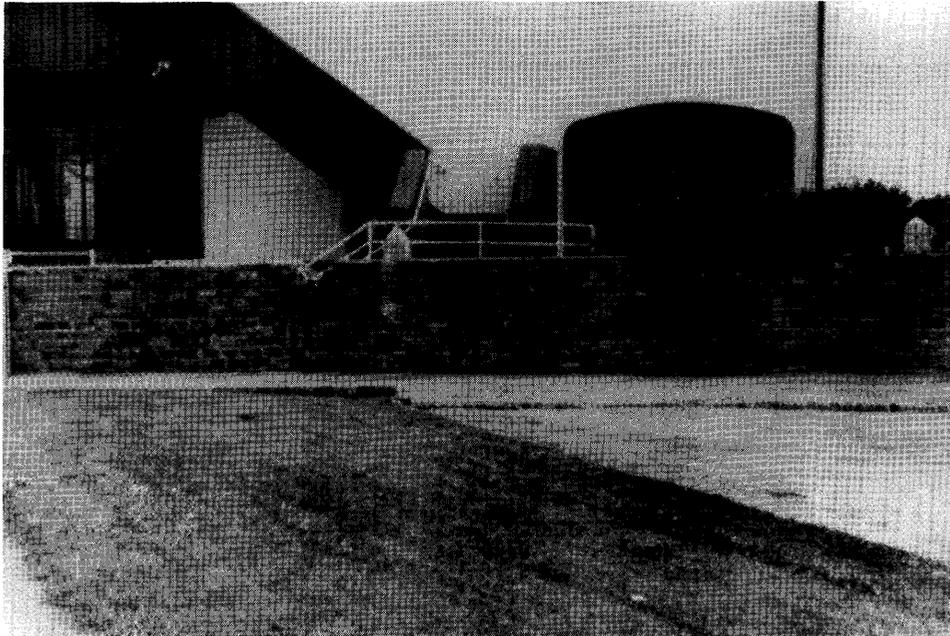
Figure 7.—Earthquake-caused cracks in masonry wall on west side of the St. Francis Yacht Club. Photograph taken in 1991.

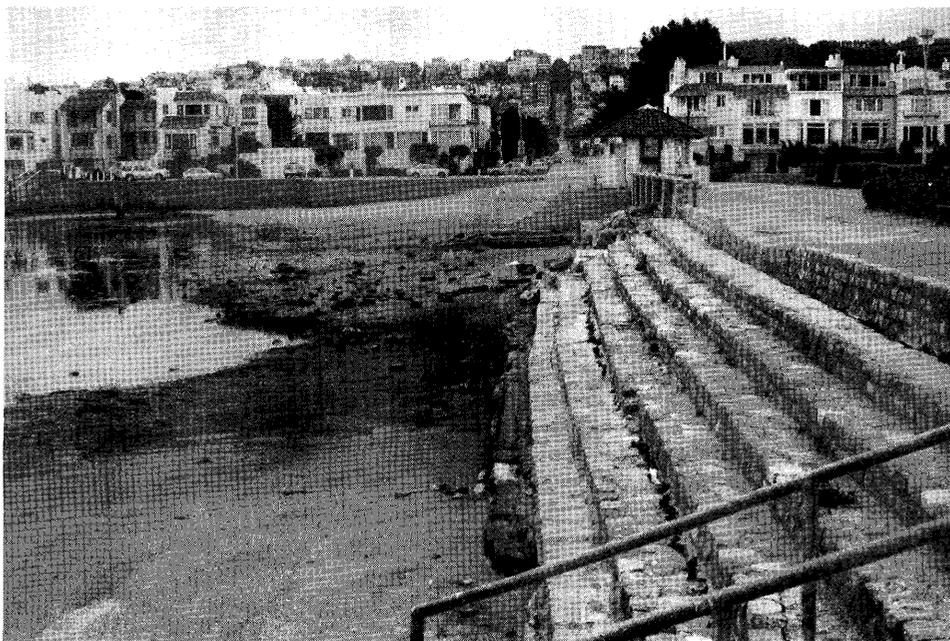
Figure 8.—Seawall at west end of the St. Francis Yacht Club Harbor. Photograph taken in 1991.

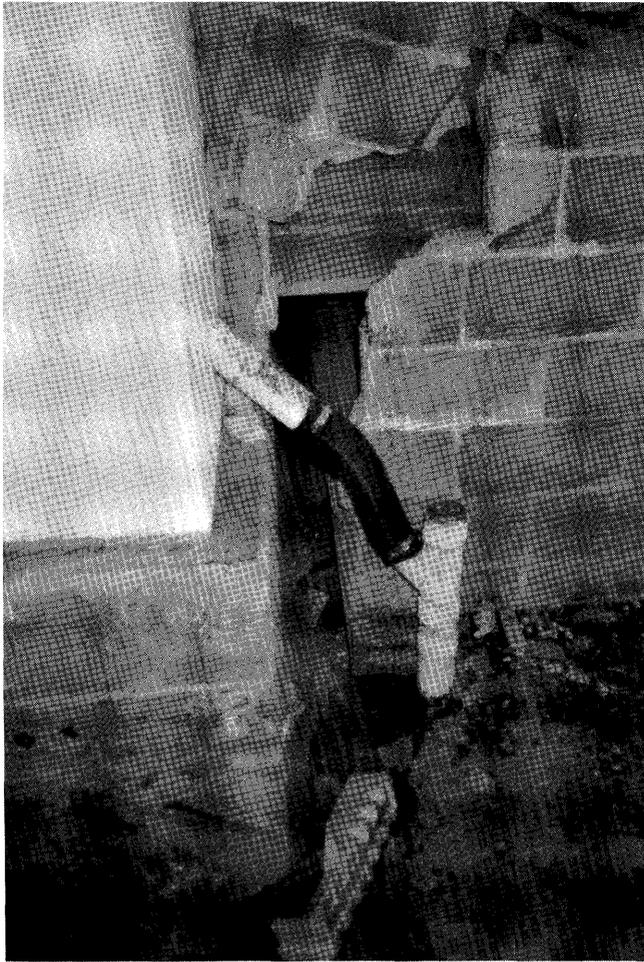
Figure 12.—Separation between concrete-block wall and east building wall of the St. Francis Yacht Club. View westward; photograph taken in October 1989.

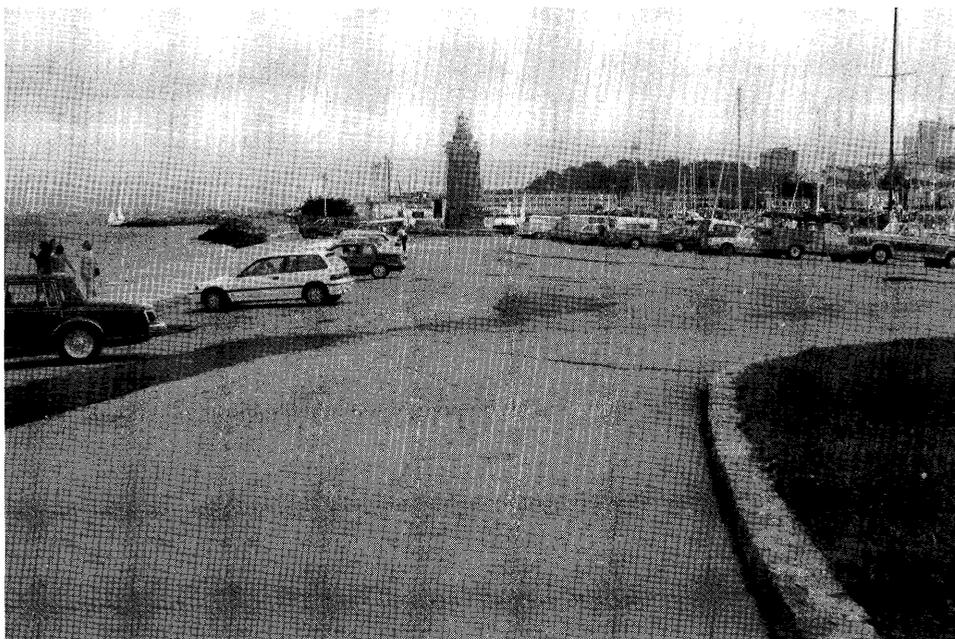
Figure 13.—Parking-lot deformation east of the St. Francis Yacht Club. Photograph taken in 1991.

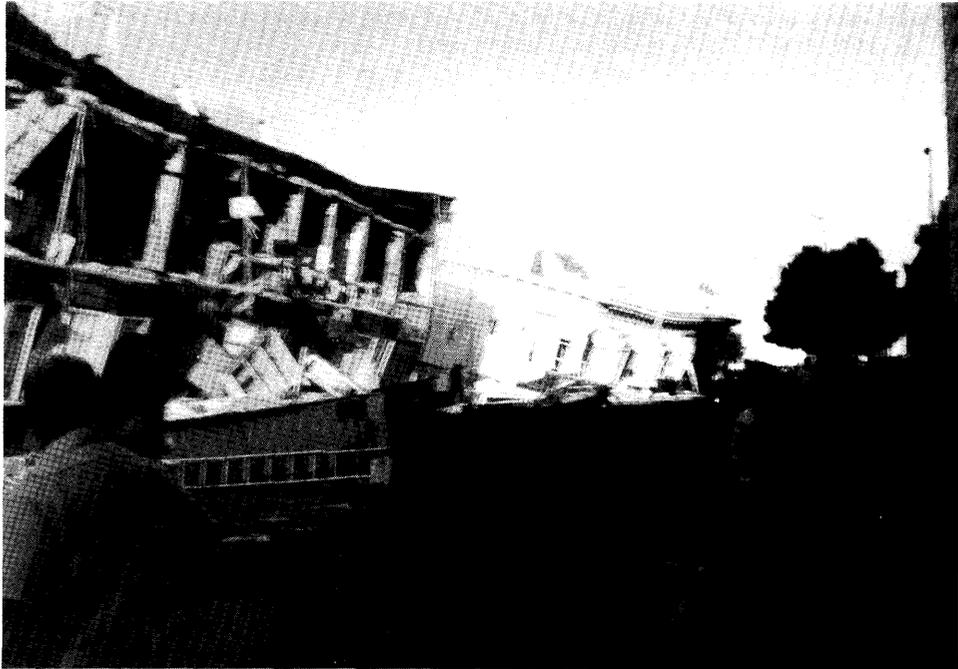
Figure 10.—Two collapsed apartment buildings at Beach and Divisadero Streets. Building in foreground is 3701 Divisadero, where fire started; building in background is 2090 Beach Street, where Sherra Cox was trapped. Photograph taken at about 5:20 p.m. P.d.t. October 17, 1989, from Beach Street; view northeastward.

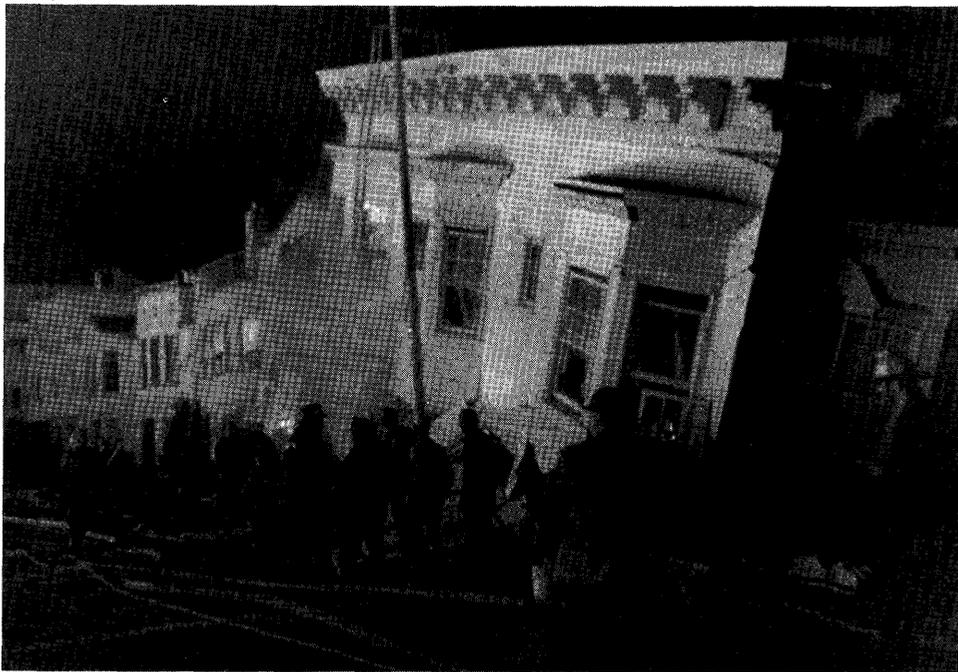
Figure 11.—Collapsed building at 2090 Beach Street, after fire was much advanced. Note firefighter directing water onto exposed side of building. Photograph by S.P. Harris, taken at about 7:00 p.m. P.d.t. October 17, 1989.
