The Loma Prieta, California, Earthquake of October 17, 1989—Highway Systems

By MARK YASHINSKY

U.S. GEOLOGICAL SURVEY PROFESSIONAL PAPER 1552-B

HIGHWAY SYSTEMS

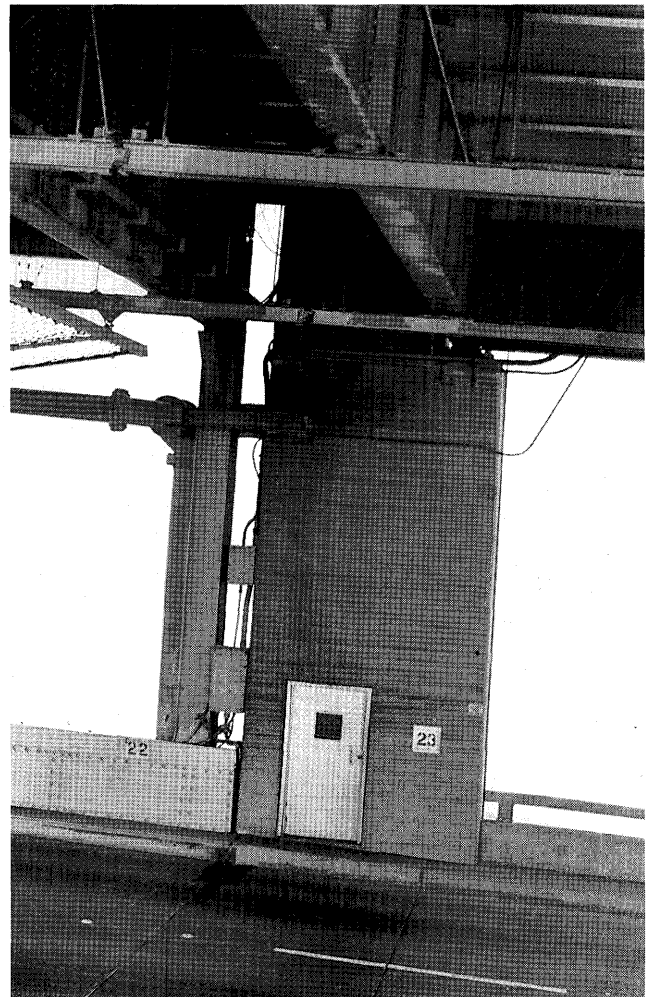
Figure 17.—Top deck at Pier E23 of East Bay Crossing showing 9 foot drop-in section between floor beams (photograph by Erik Zechlin).

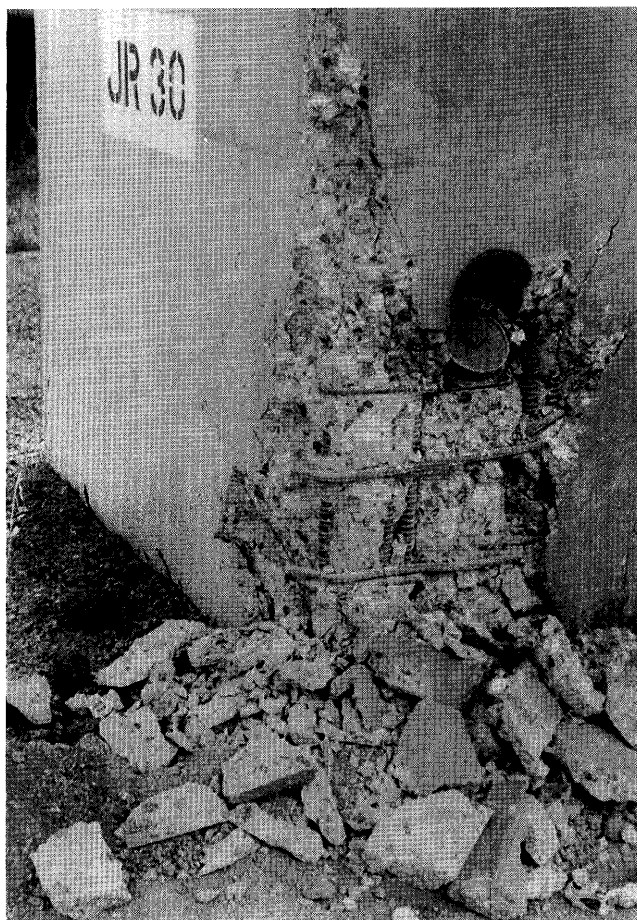
JR line	Bents JR28 to JR34 have soil cracks around footings and concrete spalls at column bottoms, indicative of flexural yielding in east-west direction.

Figure 55.—Spalling at southeast face of Bent 30 on JR line of Port of Oakland Overcrossing (photograph by Li Hong Sheng).

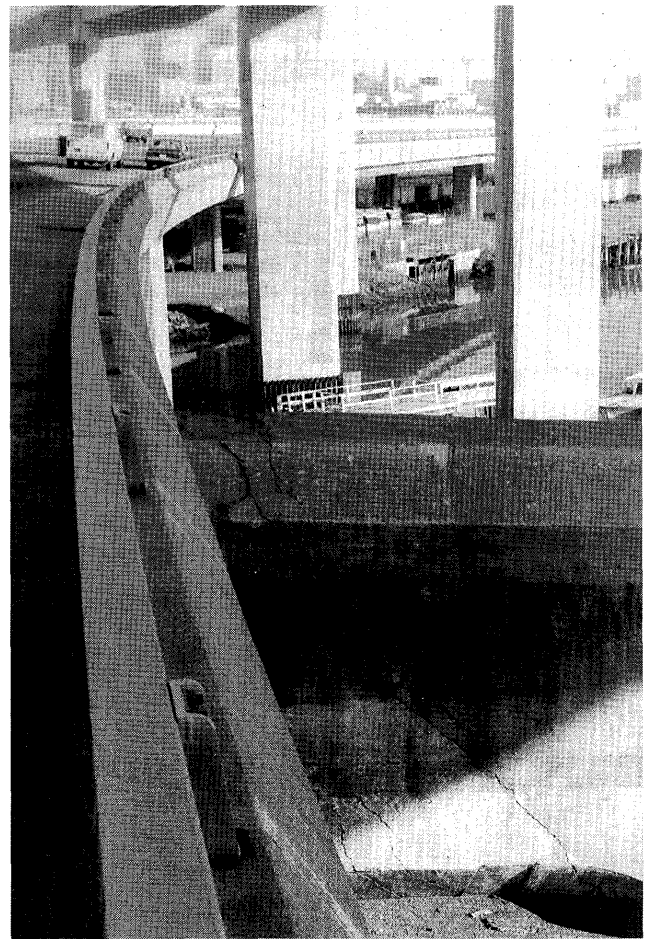
Figure 93.—Diagonal shear cracks at outrigger cap for Bent A-12 of China Basin Viaduct (photograph by Mike Van de Pol).

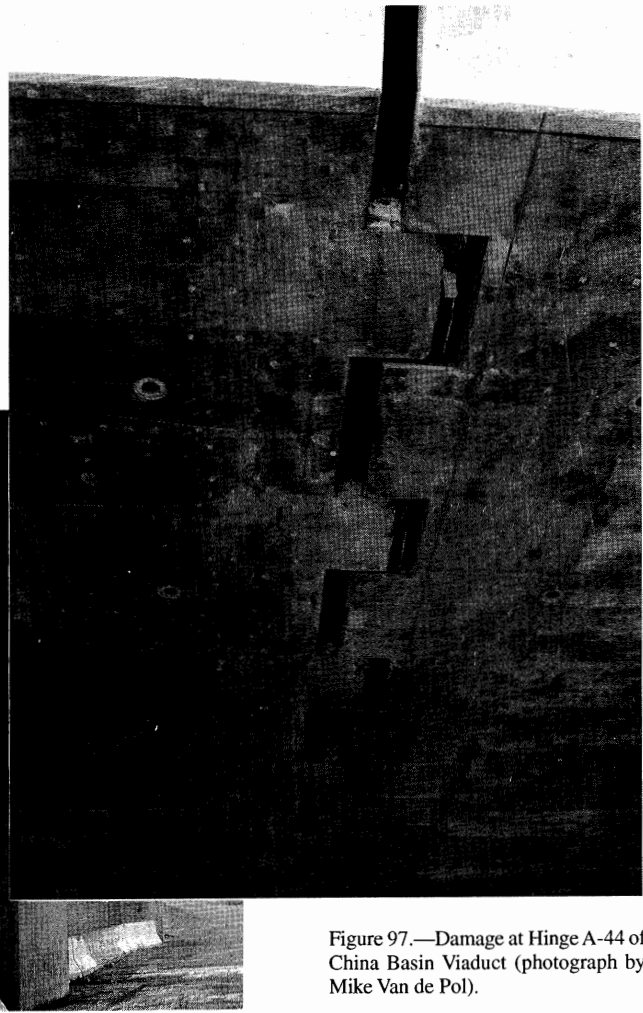
Figure 97.—Damage at Hinge A-44 of China Basin Viaduct (photograph by Mike Van de Pol).

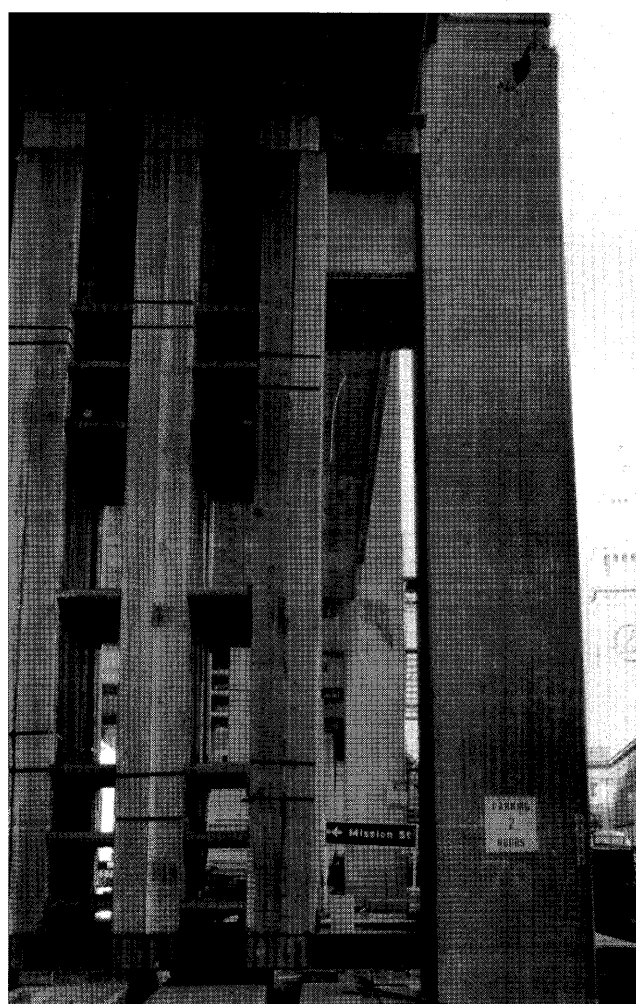
Figure 117.—Column damage on east side of Bent 78 at Embarcadero Viaduct.

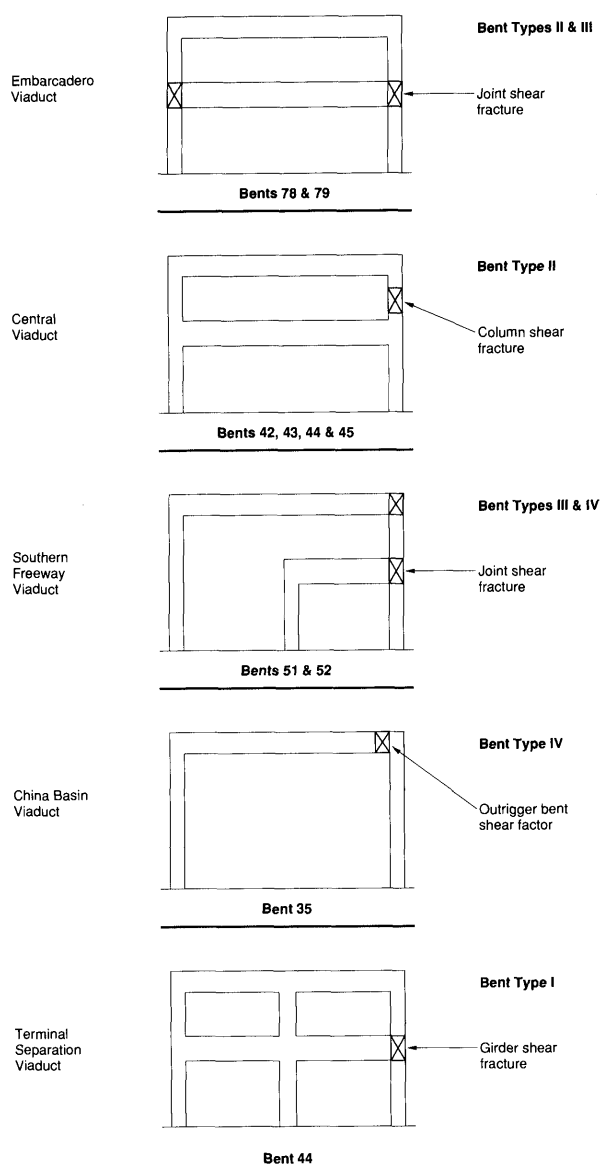
Figure 146.—Summary of damage to San Francisco Viaducts (Thiel 1990).

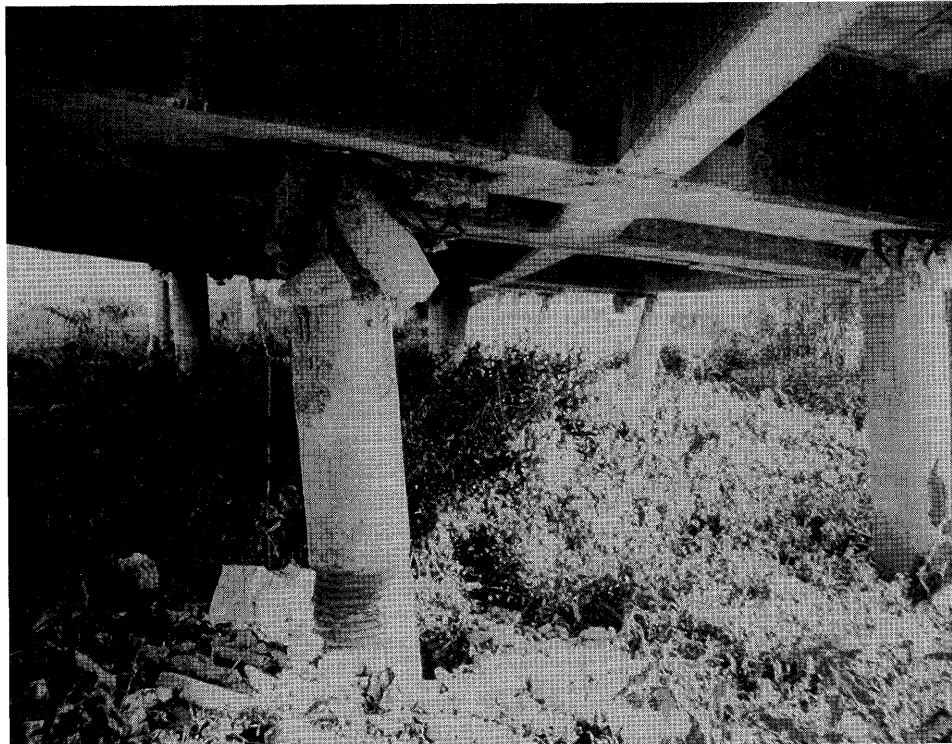
Figure 167.—Pile damage on Struve Slough Bridges.

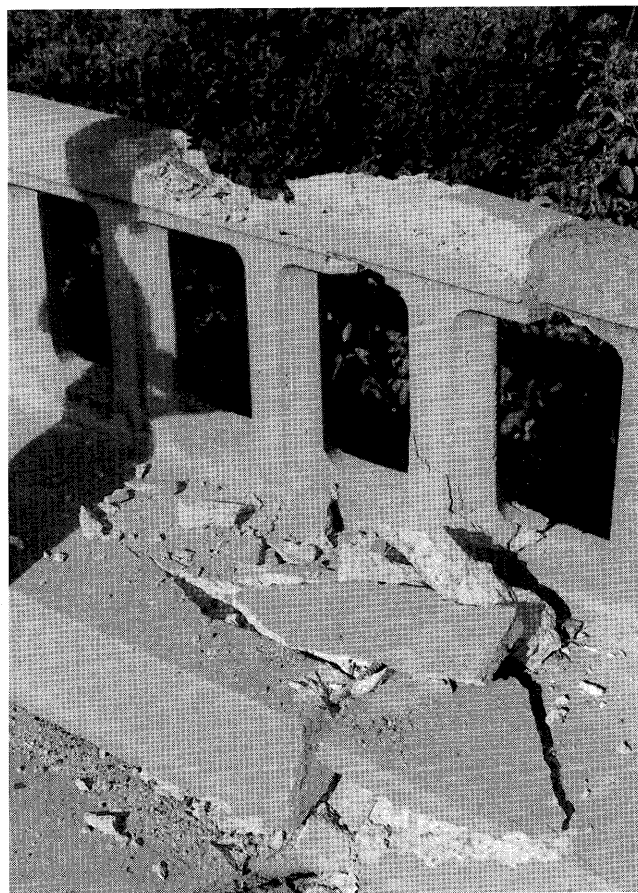
Figure 178.—Barrier rail on north side of Bent 3 at Grant Undercrossing (photograph by Mike Van de Pol).

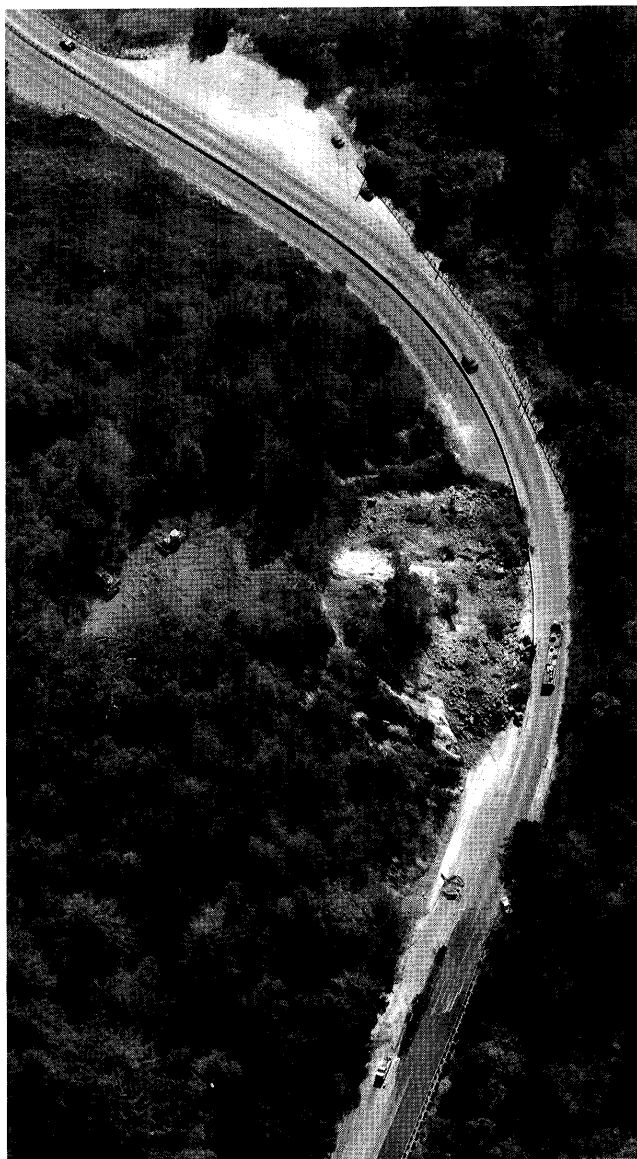
Figure 290.—Route 17 landslide.

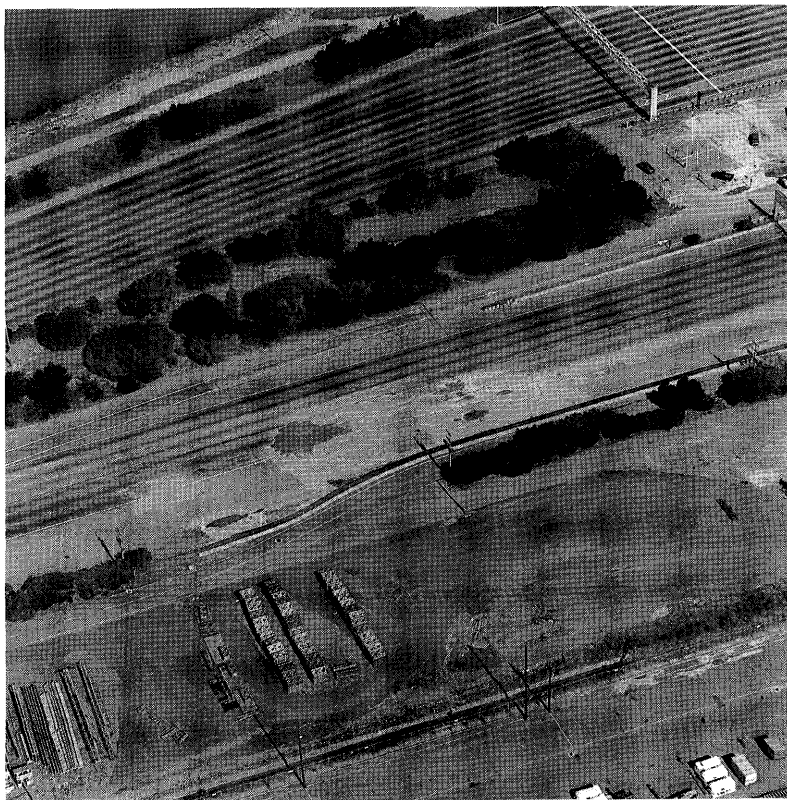
Figure 295.—Sand boils and heaving at Interstate 80.

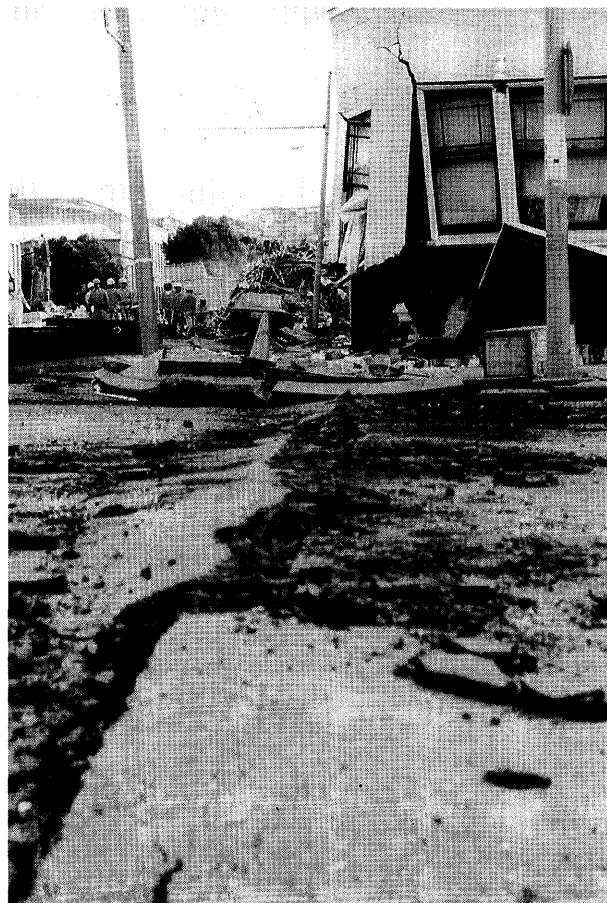
Figure 299.—Road damage in San Francisco's Marina District (courtesy of Earthquake Engineering Research Institute).

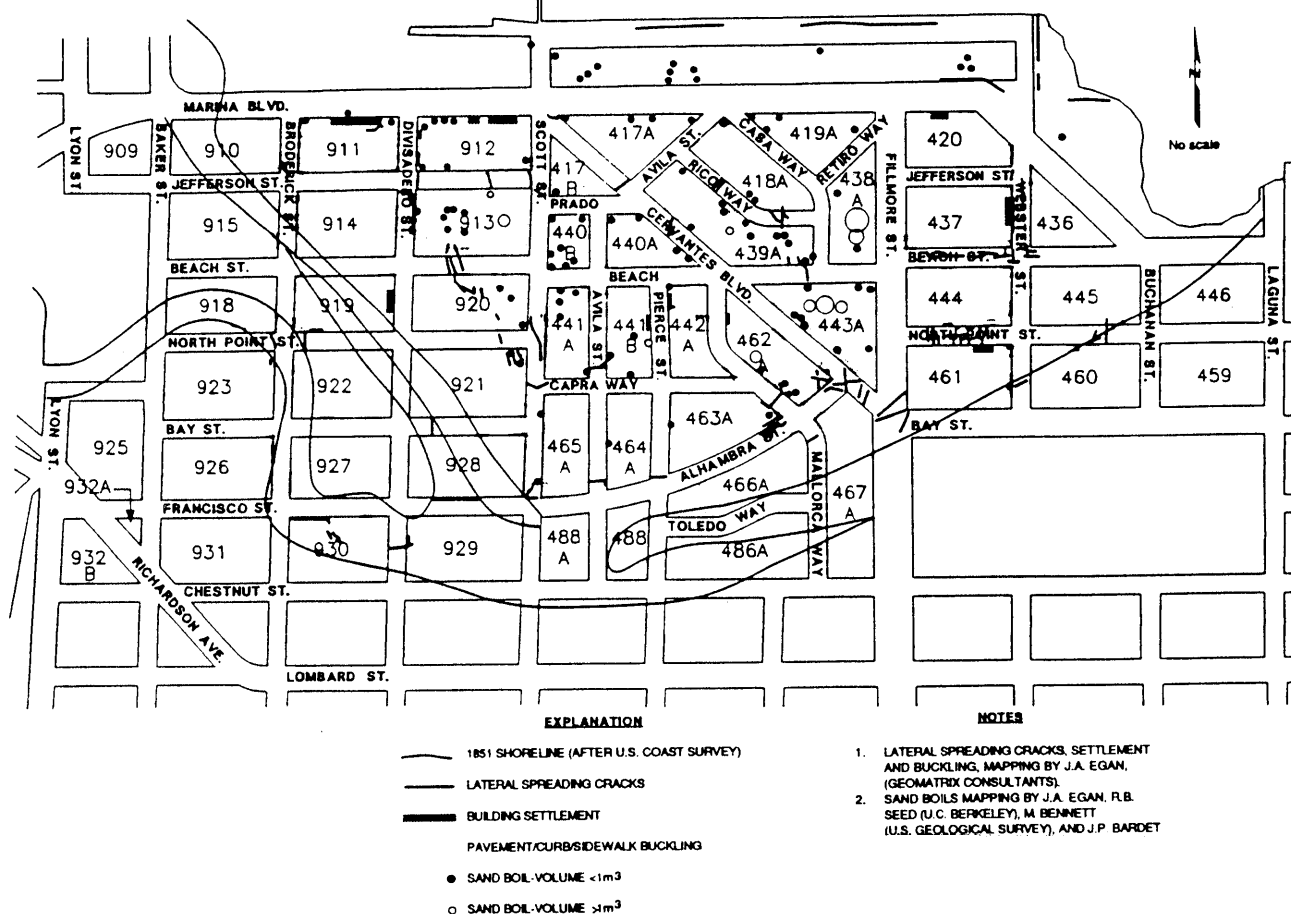
Figure 300.—Damage map of San Francisco's Marina District (Egan, 1990).

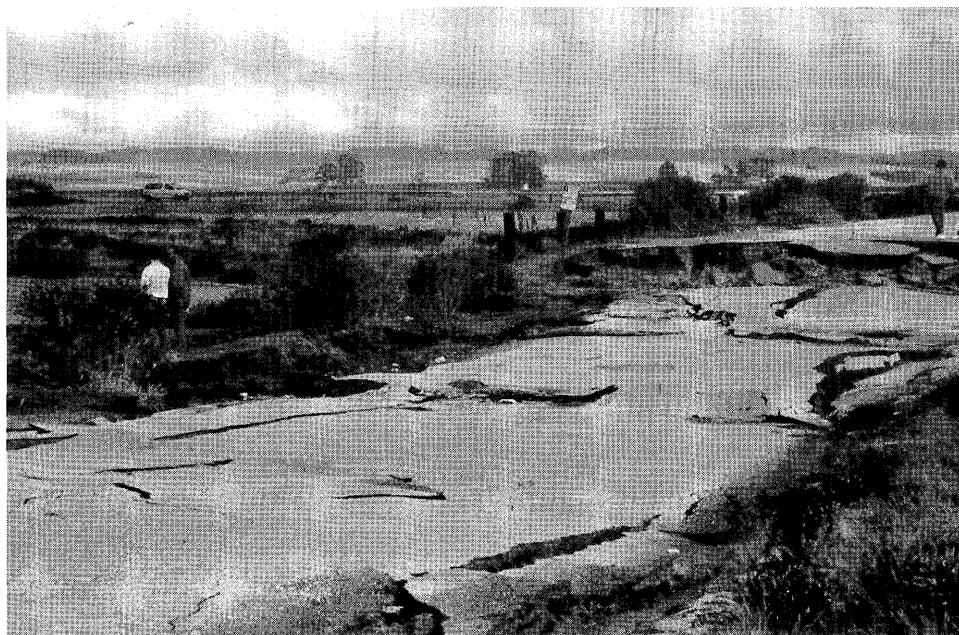
Figure 302.—Damage to the access road at Moss Landing State Park (courtesy of Earthquake Engineering Research Institute) (view to south).

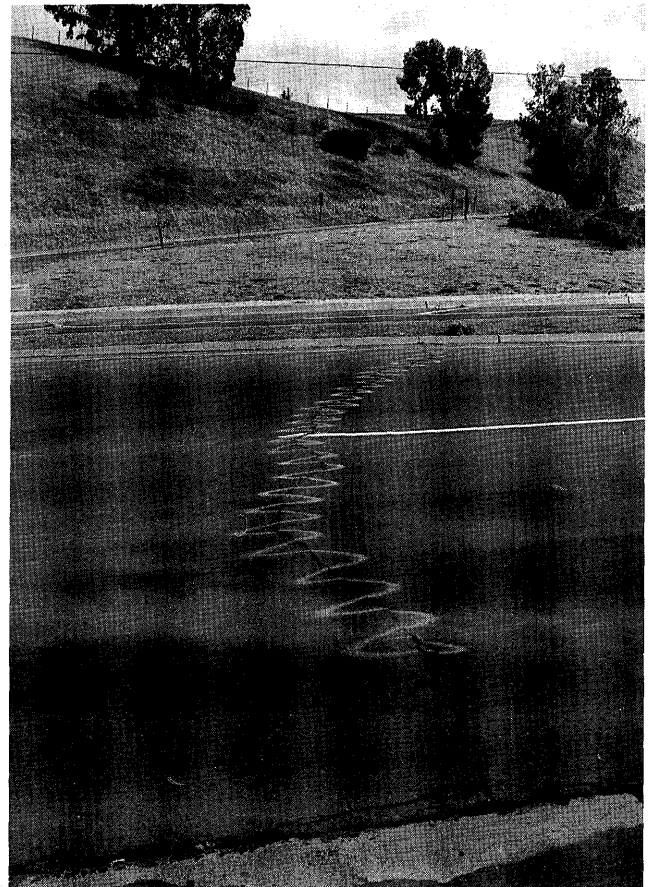
Figure 307.—Close-up of damage at Sand Hill Road.

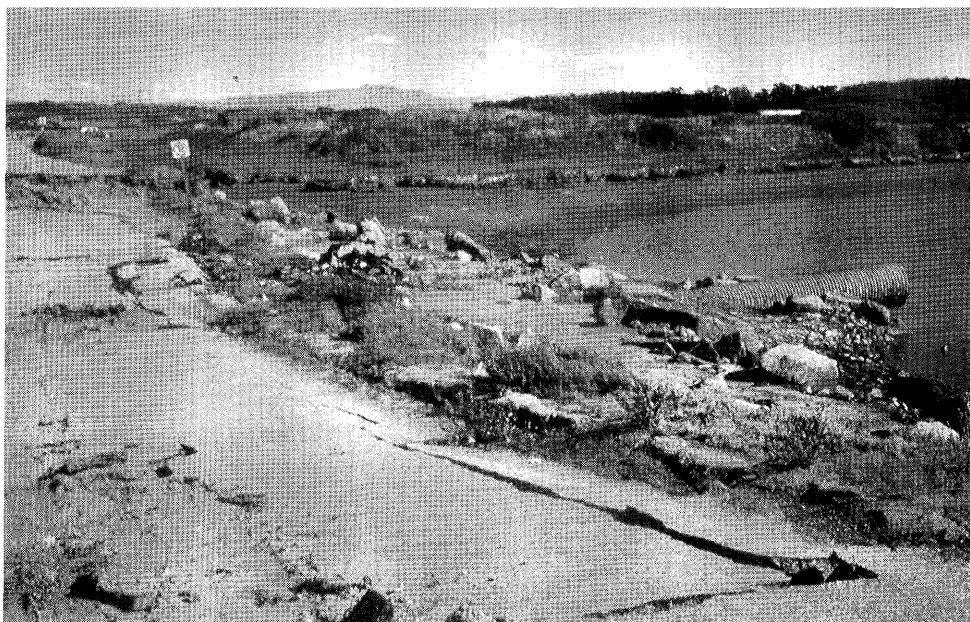
Figure 318.—Culvert damage at Jetty Road (courtesy of Leslie Youd).

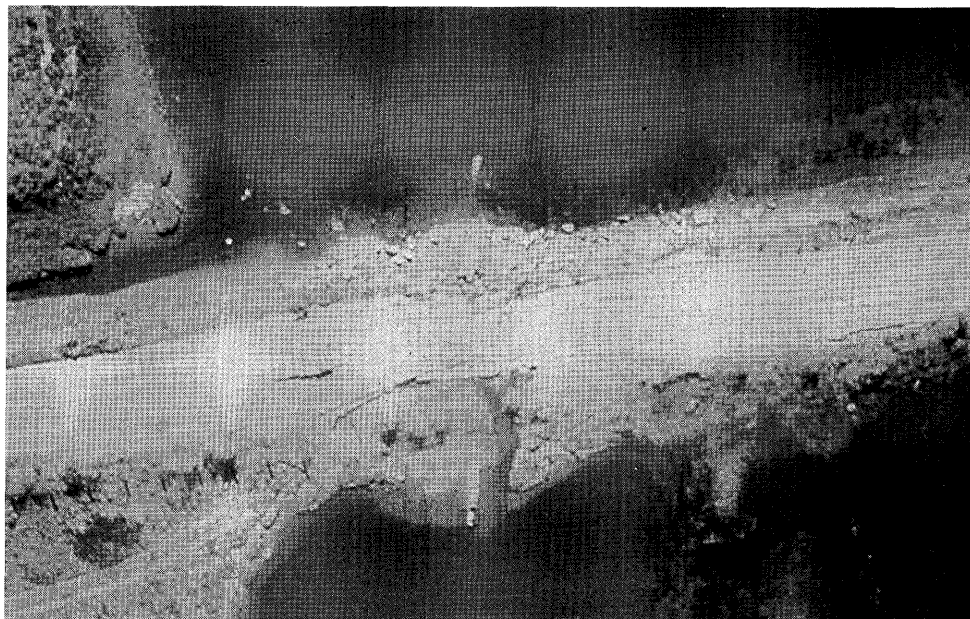
Figure 319.—Aerial view of culvert damage at Jetty Road (the culvert has been bent until it sticks out of the water) (courtesy of Leslie Youd).

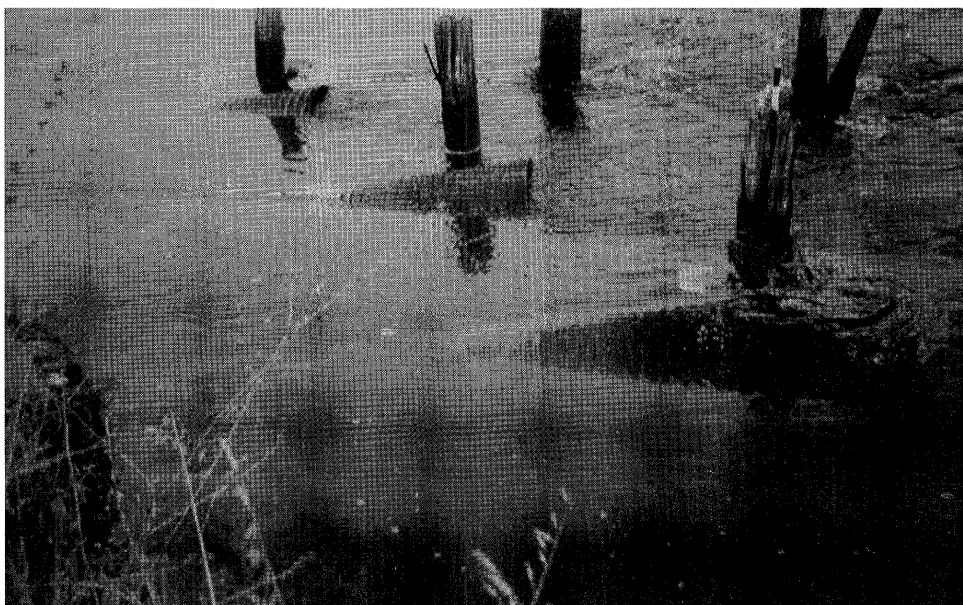
Figure 320.—Damaged culverts at Elkhorn Road.
