Monitoring Channel Morphology and Bluff Erosion at Two Installations of Flow-Deflecting Vanes, North Fish Creek, Wisconsin, 2000–03

Scientific Investigations Report 2004–5272

By Faith A. Fitzpatrick, Marie C. Peppler, Heather E. Schwar, John A. Hoopes,
and Matthew W. Diebel

U.S. Department of the Interior
U.S. Geological Survey

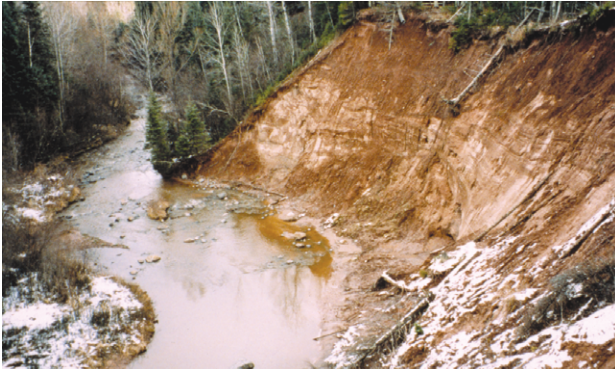
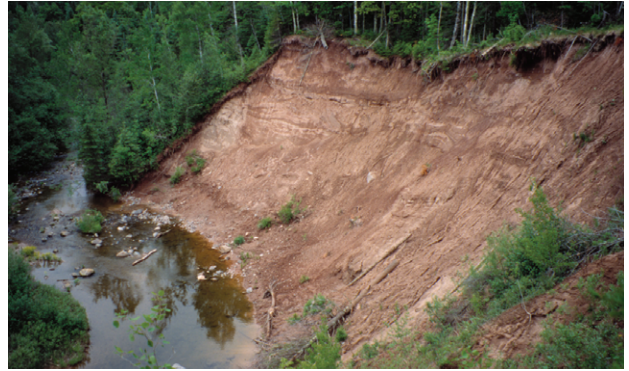
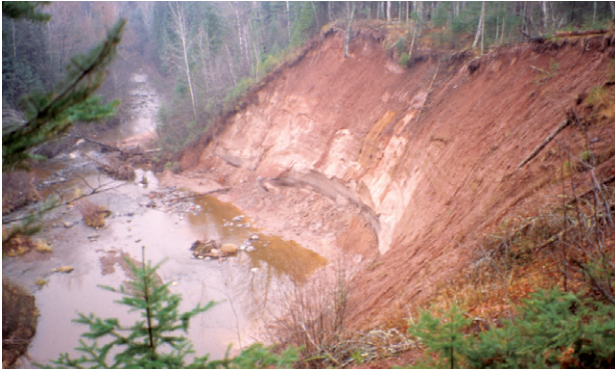
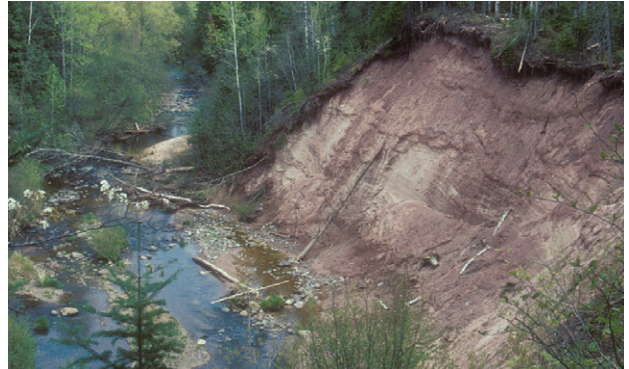
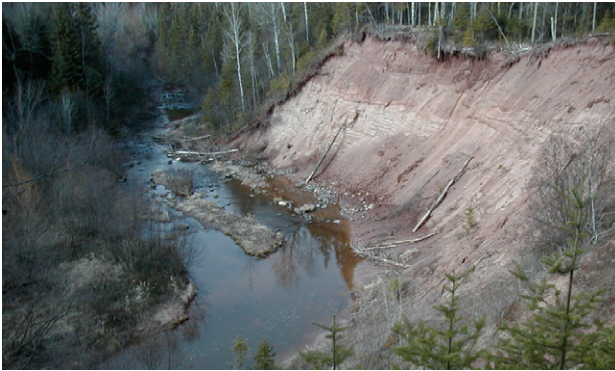
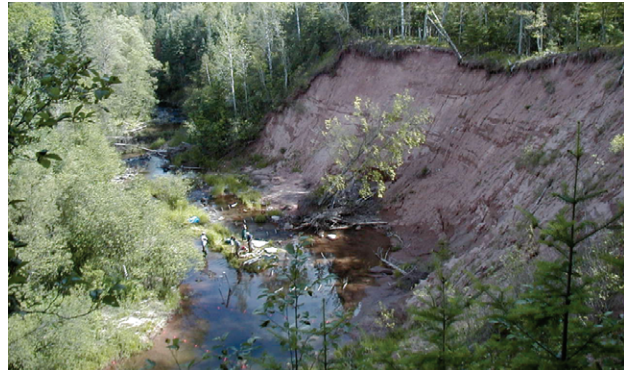
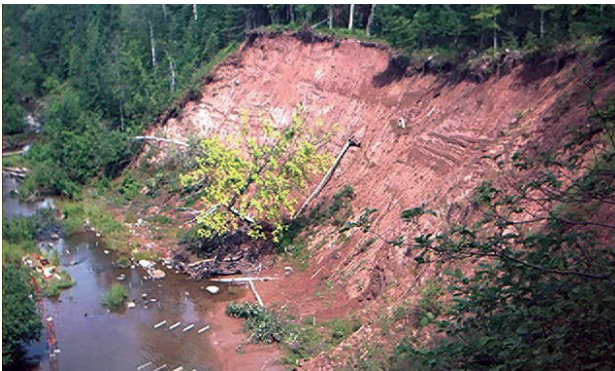
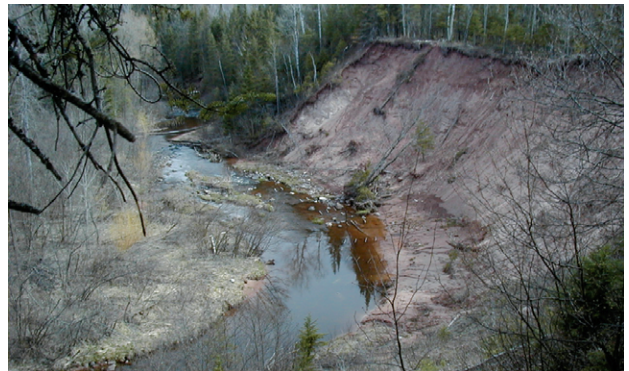
A series of photographs of the channel and bluff at site 16.4 show how the site changed over 10 years in response to floods and the presence of the vanes (fig. 9). Photographs at site 16.4 extend back 7 years before the vanes were installed because the site was part of the previous geomorphic assessment of North Fish Creek (Fitzpatrick, 1998). Before vane installation, the face of the bluff changed over time as blocks of the top and upper part of the bluff failed, and failed debris built up along the bottom half of the bluff during low-flow periods between large floods (June 1994 as an example). During large floods, such as the April 1996 flood, loose sediment was removed from the lower half and toe of the bluff, making the bluff face more vertical (November 1996 as an example). The channel migrated toward the eroding bluff from 1993 to 2000 and formed a midchannel bar by 2000.

Figure 9. Photographs of the channel and bluff at site 16.4, 1993–2004, North Fish Creek, Wis. Flow direction is from lower left to upper left. Photographs were taken from bluff top on the upstream side of the meander bend.

from upstream sources was deposited in the reach. In addition, the reach is less of a potential source of sediment to downstream reaches, as shown in the series of photographs of the reach and bluff from before and after vane installation (fig. 9).

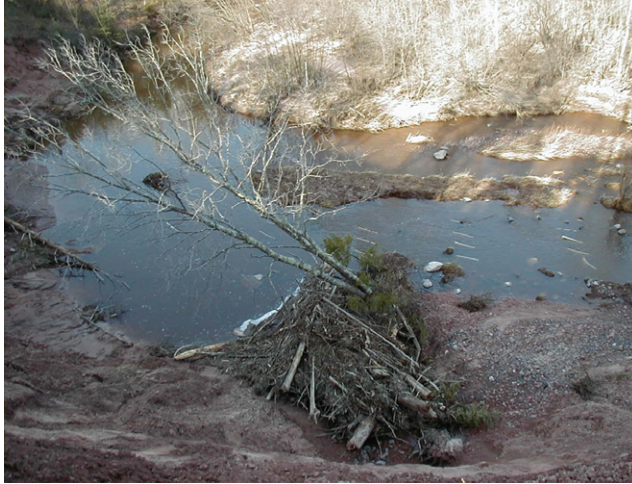
In April 2001 during the record flood event, a block failure occurred from the top of the bluff near cross-section 5 (figs. 9 and 10). The block remained at the toe of the bluff and was not washed away during the flood or any subsequent floods through September 2003. Boulders also fell from the upper half of the bluff and hit some of the vanes, bending them out of alignment (fig. 11). The damaged vanes were replaced in summer 2001.

Figure 10. Block failure from eroding bluff near cross-section 5, site 16.4, April 27, 2001, North Fish Creek, Wis. Photograph was taken from edge of bluff top looking down at cross-section 5.

After vane installation, two blocks from the top of bluff failed, one during the April 2001 flood at T9 and another between April and June 2003 at T11. No other large block failures were measured; however, the near-vertical angle of the bluff face, tension cracks on the bluff top, rills along the bluff face, and overhanging vegetation on the downstream side of the bluff from T6 to T9 make it highly probable of more failures in the future.

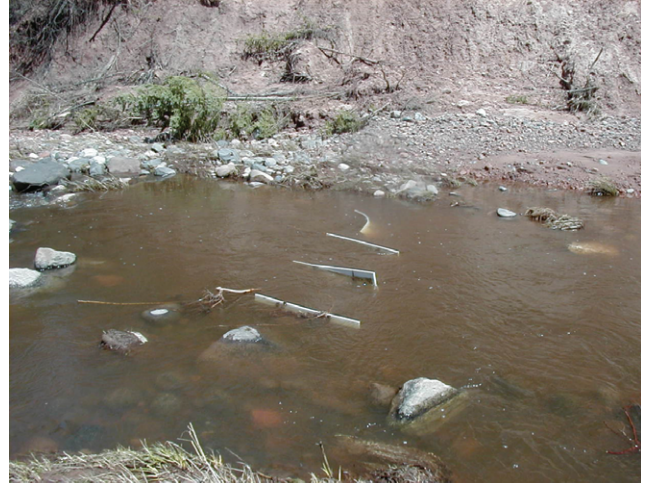
Figure 11. Damaged vanes near cross-section 6 following April 2001 flood, site 16.4, North Fish Creek, Wis.

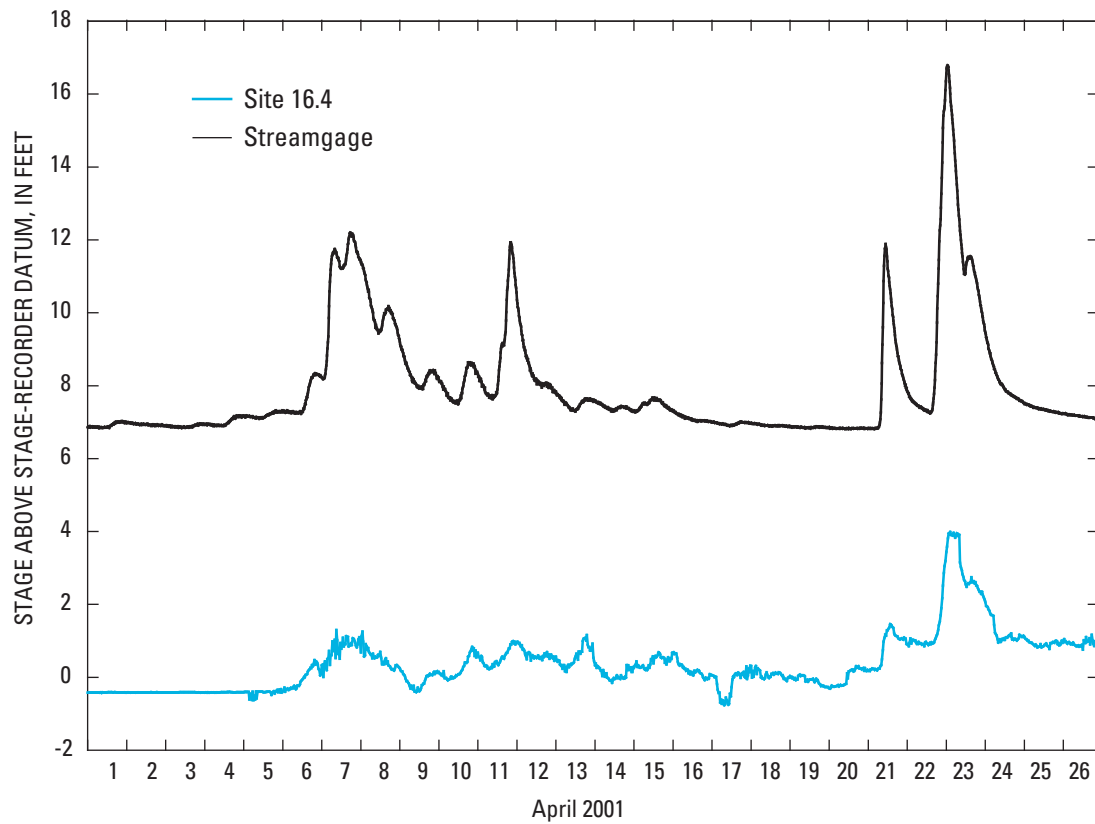
Water levels at site 16.4 increased about 4 ft above normal stage during the April 2001 flood (fig. 12). After the flood, trash lines from the flood were observed in trees about 5 ft above normal stage. The stage reached an elevation of about 3.4 ft above the top of the vanes (Whitman, 2002). The stage recorder data also showed a rise in the channel bottom at the recorder location (inside of the bend near cross-section 4). The normal stage rose from between -1 and 0 ft in early April, to 0 ft by mid-April, and then to almost 1 ft after the April 23 flood. The stage recorder filled with sediment and stopped recording at the end of April.

Figure 12. Stage data from the streamgage and from the stage recorder at site 16.4, April 2001, North Fish Creek, Wis.

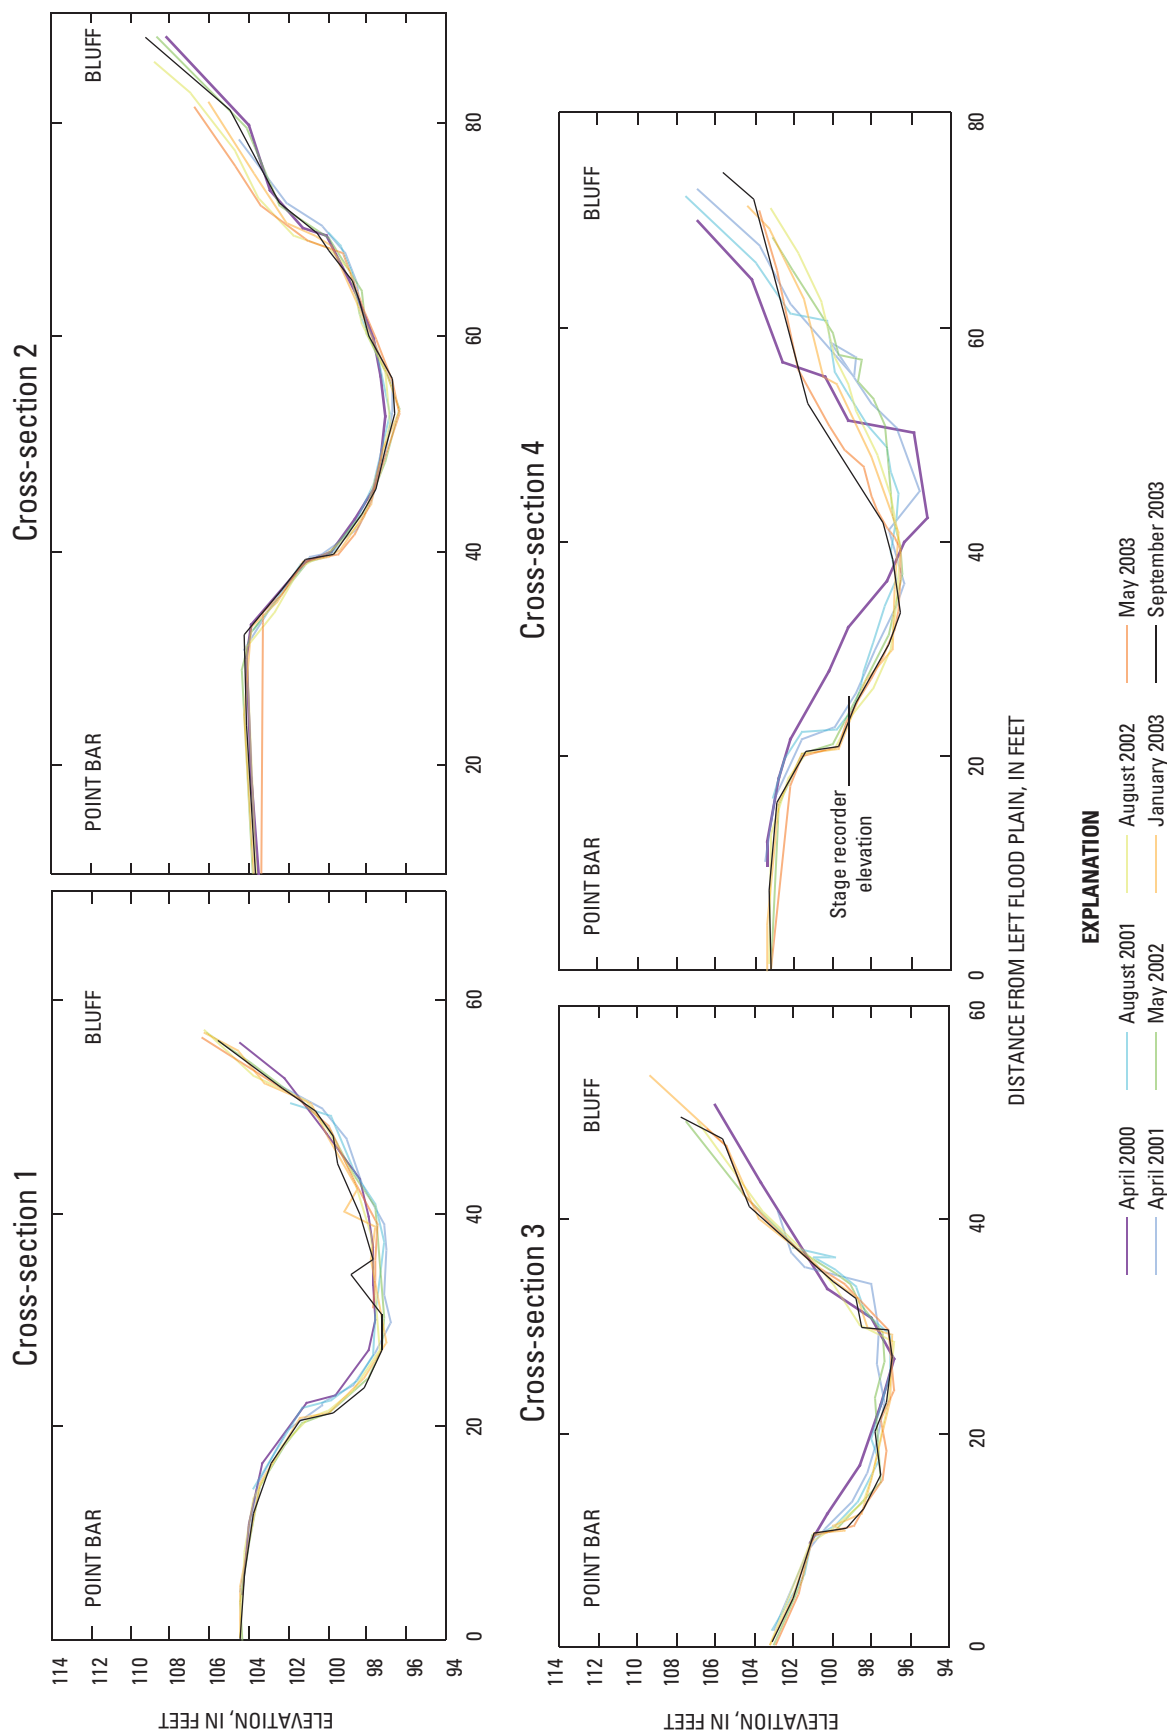
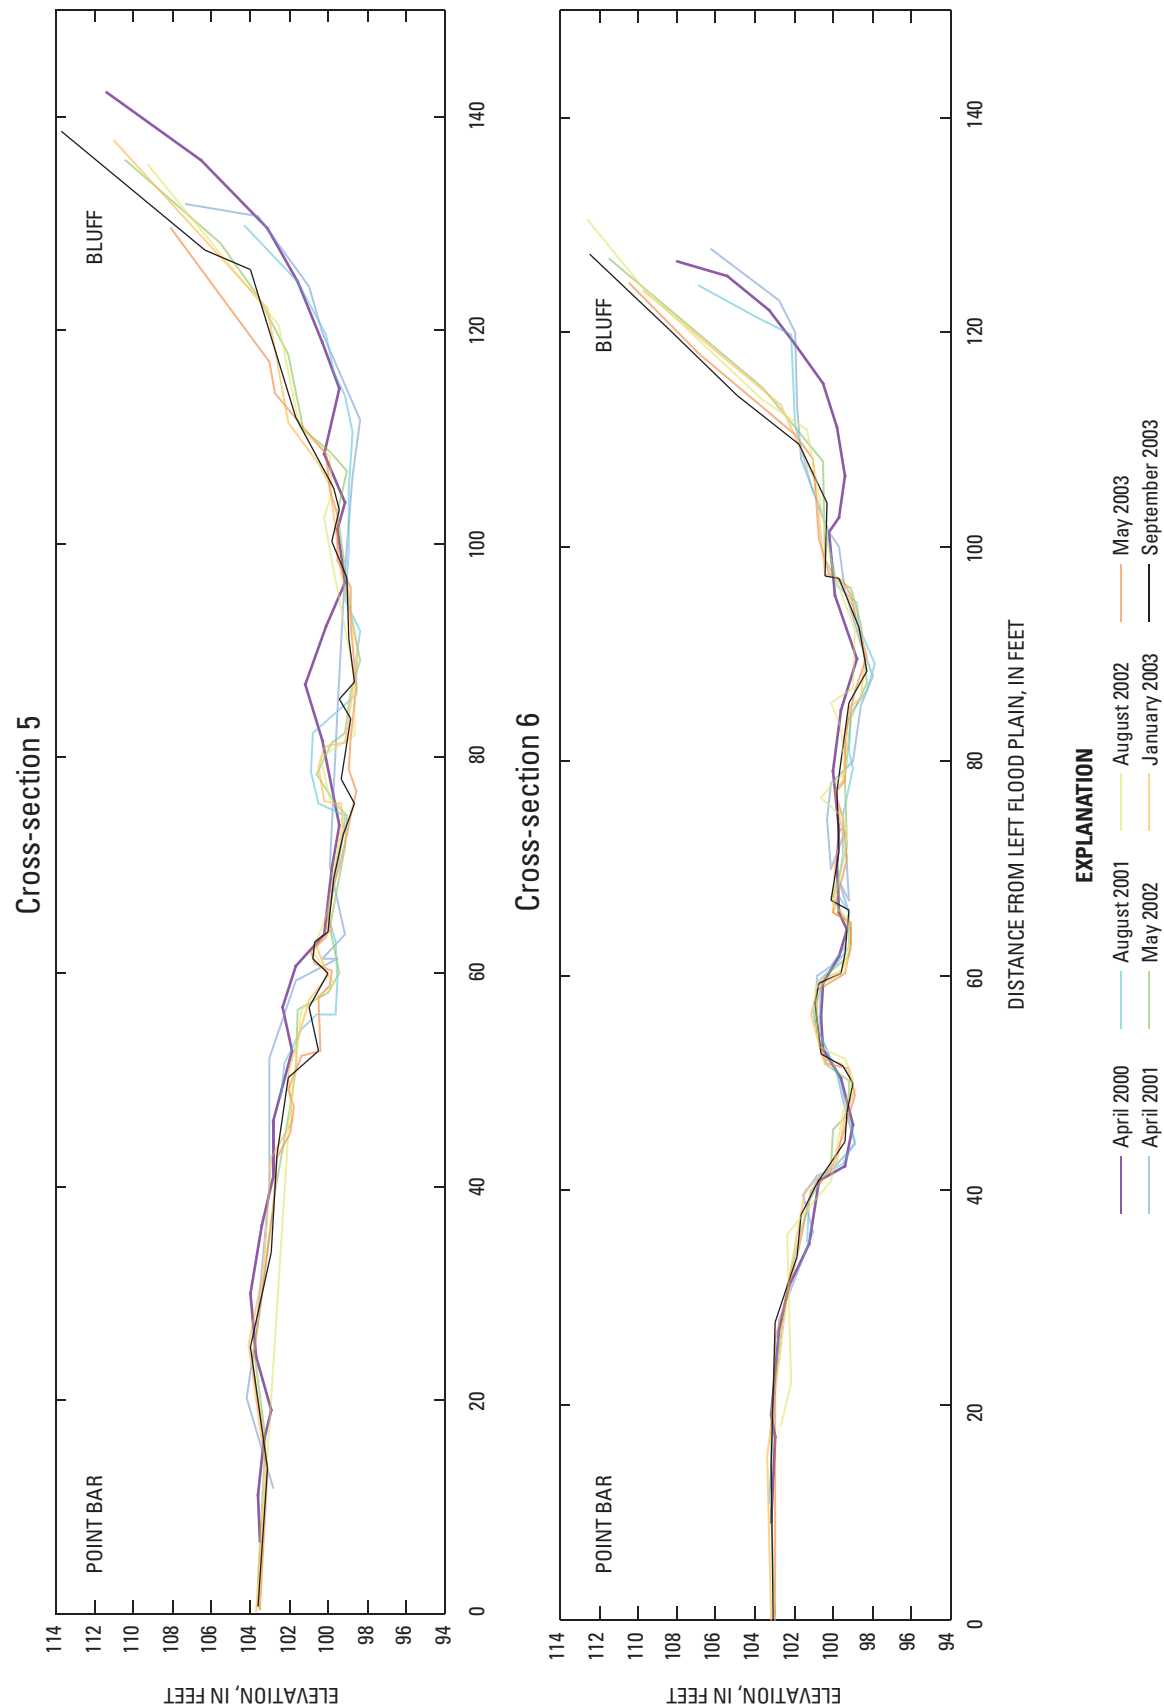
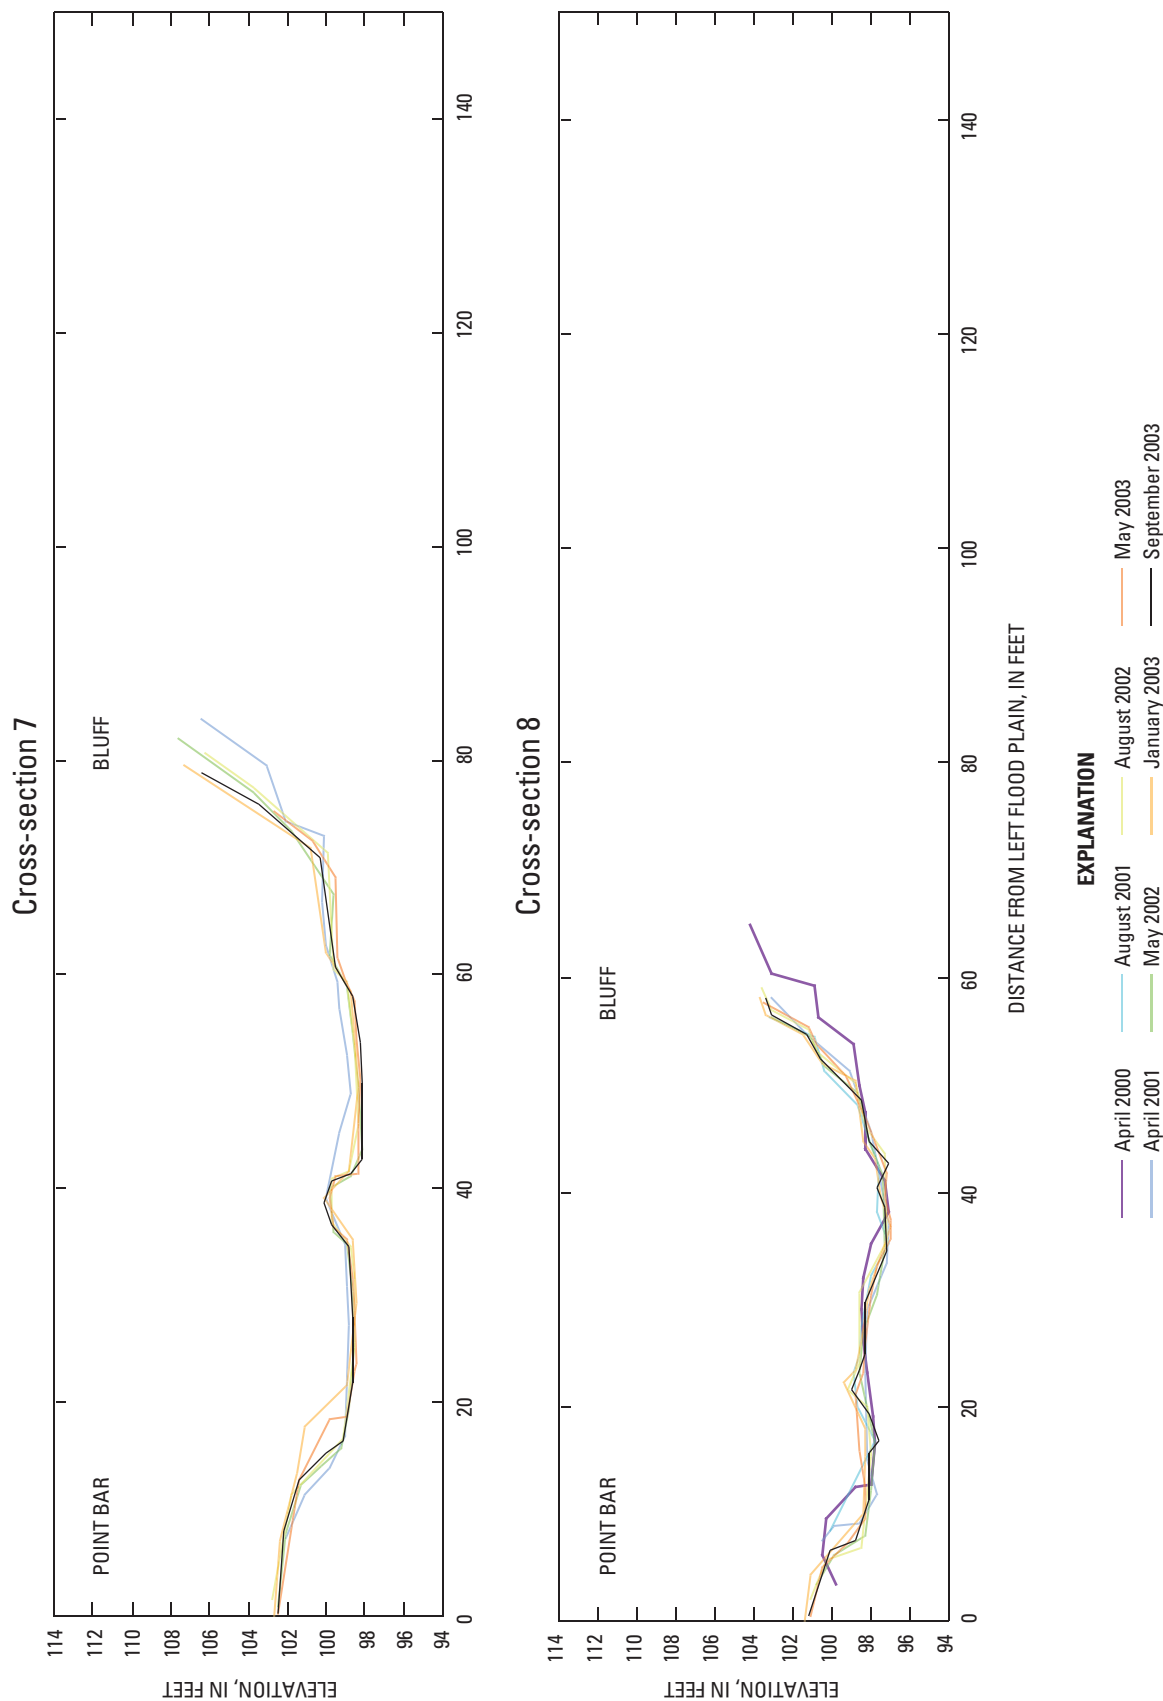
Results from calculations of the volume of sediment eroded and deposited along each cross section from April 2000 to September 2003 are shown in table 3 for site 16.4. Approximately 1,610 ft³ of sediment was eroded from the point-bar side of the channel, and 10,660 ft³ of sediment was deposited at the base of the eroding bluff over the 361-ft long reach. The channel morphology at cross-section 5 changed the most of all the cross sections. This cross section is near where a block from the bluff top failed and was deposited at the base of the bluff during the April 2001 flood (fig. 10). Assuming that the density of the sediment (a mixture of sand, silt, and clay) is 80 lb/ft³ (U.S. Department of Agriculture Soil Conservation Service, 1983), about 425 tons of sediment was deposited along the bluff toe over the 3 years that were monitored. There was a total net gain in sediment in the monitored 361-ft reach of 6,740 ft³, or about 270 tons. This gain indicates that sediment

Figure 15. Change in channel and bluff locations along monitored cross sections at site 16.4 from April 2000 to September 2003, North Fish Creek, Wis.

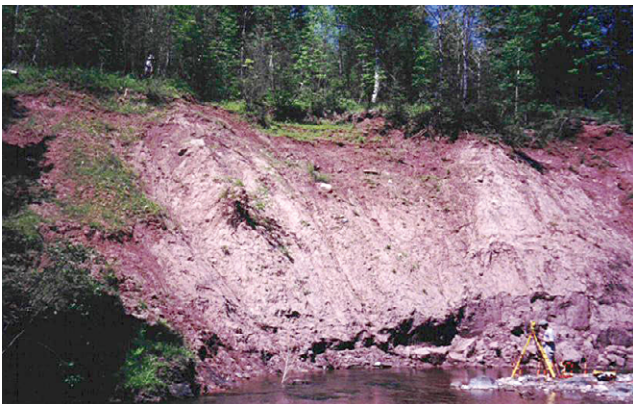
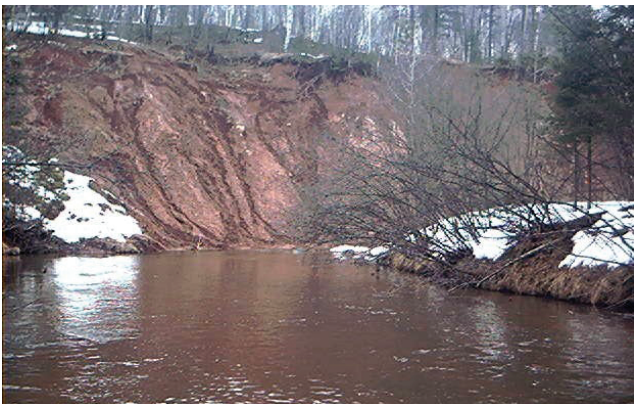
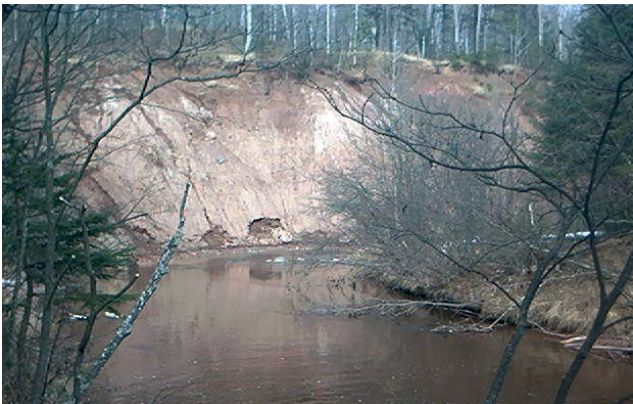
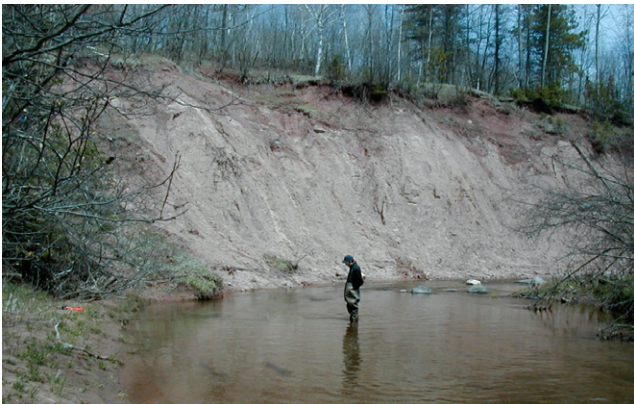
Figure 16. Channel and bluff at site 12.2, 2001–04, North Fish Creek, Wis. Flow direction is generally from left to right or from the bottom to the center of the image. Photographs were taken from the left bank, upstream of the bluff, at cross-section 1.

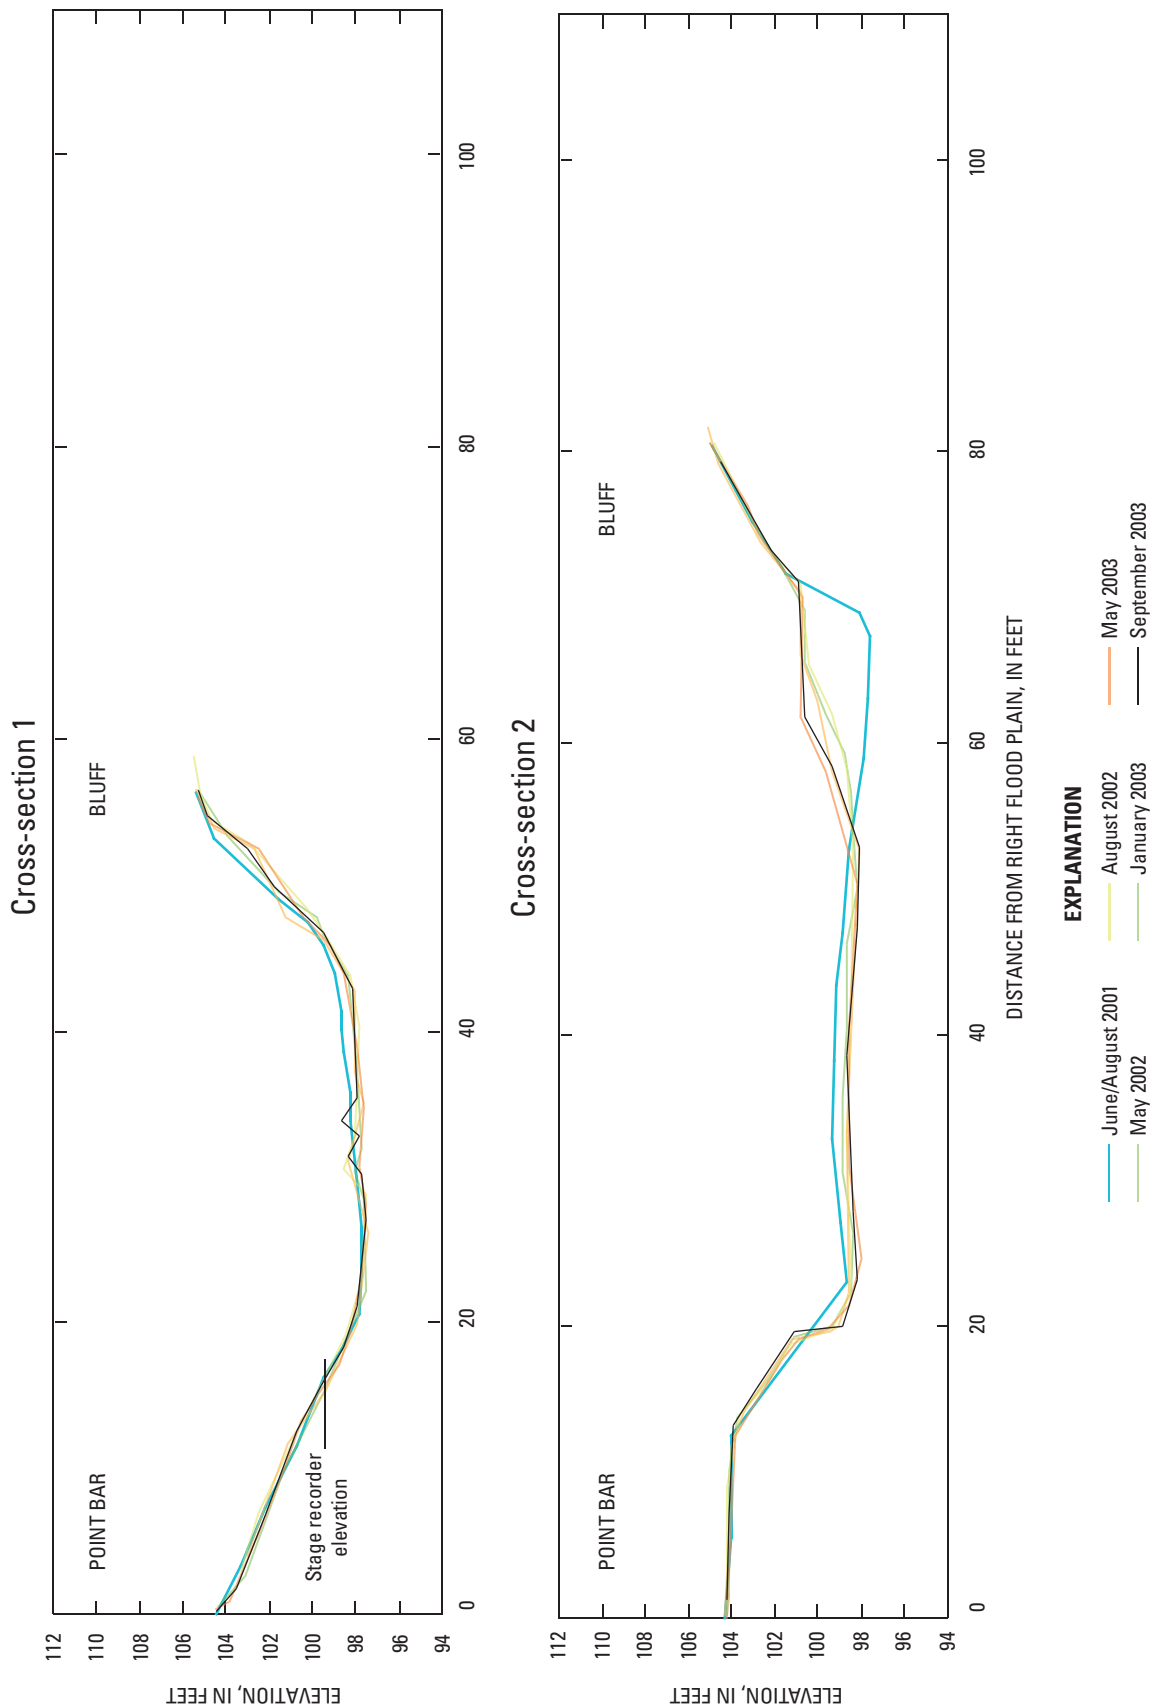
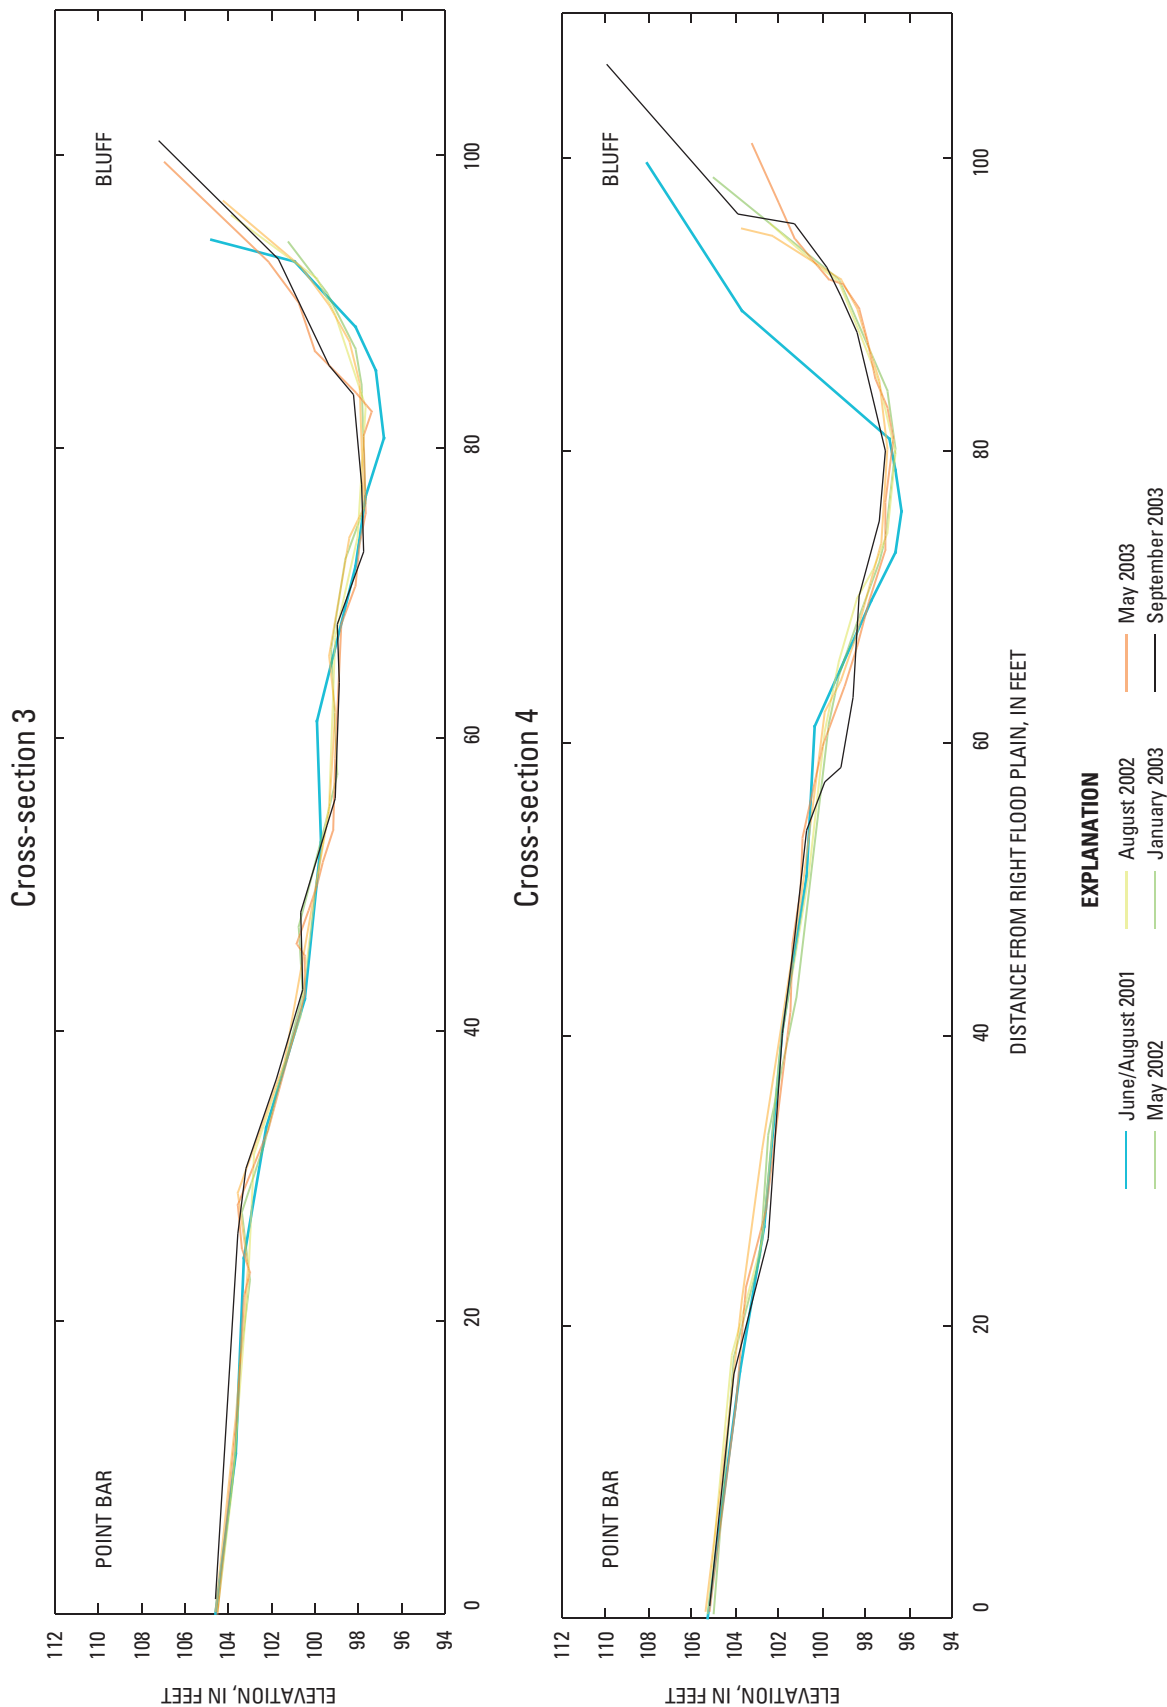
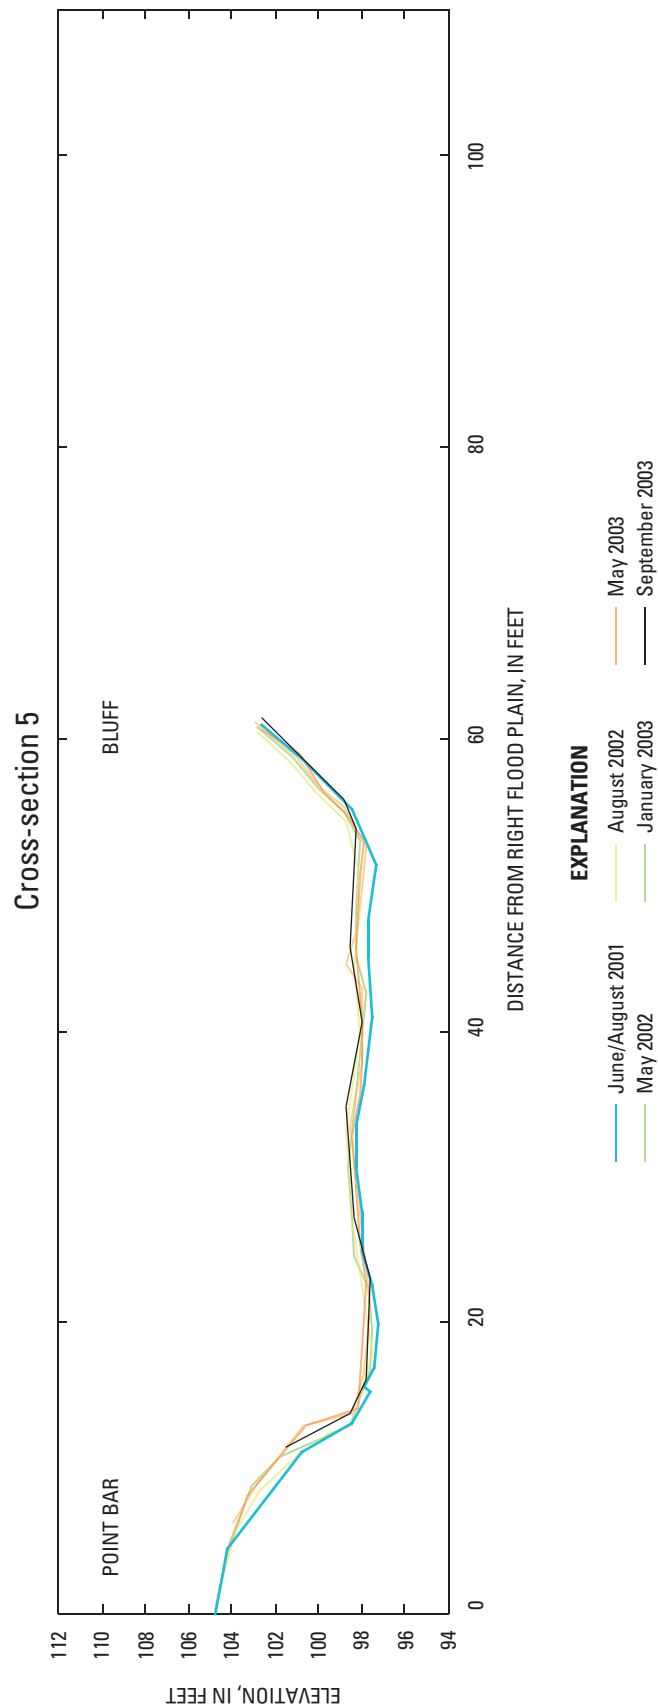
Results from the survey of the five cross sections at site 12.2 from June and August 2001 to September 2003 are shown in figure 17. The April and May 2002 floods caused erosion along the channel (left bank) at cross-section 1, deposition along the channel (left bank) at cross-section 2, erosion of the bluff toe at cross-section 4, and

deposition along the left and center part of the channel at cross-section 5. Deposition occurred along the bluff toe at cross-section 3 after the April and May 2003 floods. The inside of the bend or point-bar side of the channel stayed in the same location at cross-section 1, with some erosion at cross-sections 2 and 3 after the April/May 2002 flood. Erosion on the point-bar side occurred between the May 2003 and September 2003 surveys at cross-section 4. The channel at cross-section 5 remained in the same location.

Figure 17. Change in channel and bluff locations along monitored cross sections at site 12.2, from August 2001 to September 2003, North Fish Creek, Wis.
