06759000 Bijou Creek near Wiggins, Colorado

(Discontinued gaging station, USGS Colorado Water Science Center)

Review of peak discharge for the flood of June 18, 1965

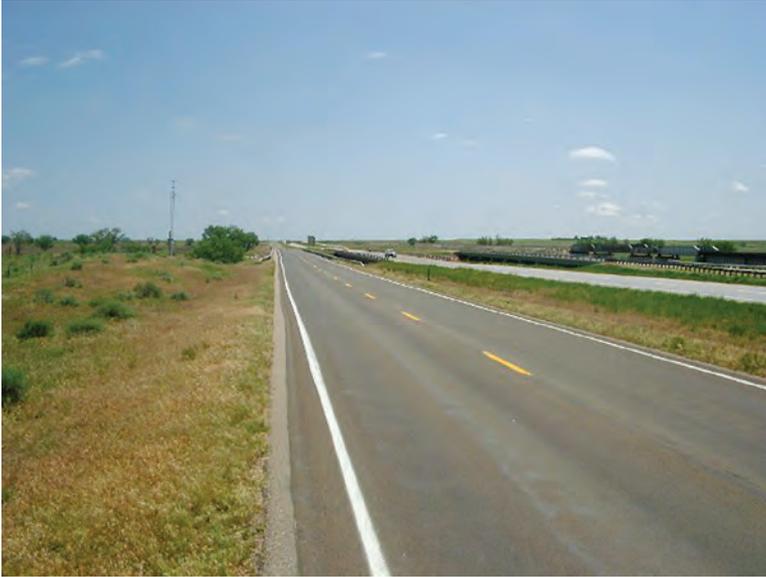
According to the measurement summary, the June 18 peak discharge at this site may have been amplified by a release of water that ponded upstream of the BNSF railroad. The railroad embankment to the right of the railroad bridge failed. The measurement summary speculates that the failure could have been rapid and notes an earlier failure in 1935 that is discussed by Follansbee and Sawyer (1948, p. 71). However, newspaper accounts of the 1965 peak discharge talk about a large crest passing the community of Hoyt (about 20 mi upstream) in the early morning hours. The size of peaks from upstream tributaries, the amount of railroad embankment that was subjected to overflow (about 4,000 ft) relative to the fairly modest amount of embankment failure (hundreds of feet) suggest that the failure probably contributed little to the actual peak discharge. Aerial photographs on the front page of the June 19 Fort Morgan Times and the Denver Post need to be seen to appreciate the scale of flooding and the amount of embankment overtopped. The photographs show only a very few trees in the reach downstream of the railroad/Interstate crossing; in 2003, nearly mature cottonwood trees were scattered in this reach.

Figure A92. View looking north toward railroad wash-out, Bijou Creek near Wiggins, Colorado, June 3, 2003.

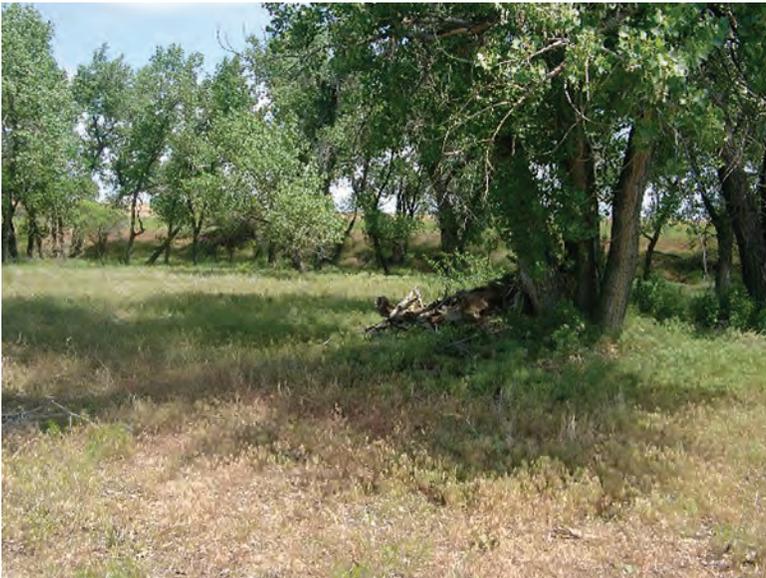
The reach used for the indirect measurement has changed little since 1965. Flood debris is still evident at places in the measurement reach, which has scattered cottonwood trees on the flood plain. The 1965 photographs show a sand bed in the main channel and the overflow sections. The sand is still present but has been overgrown with grass and small shrubs. Land-use changes upstream have produced a very slight base flow in the reach; as a result, the main channel now has pooled water, cattails, and reeds.

Figure A93. June 1965 flood debris in slope-area reach, Bijou Creek near Wiggins, Colorado, June 3, 2003.

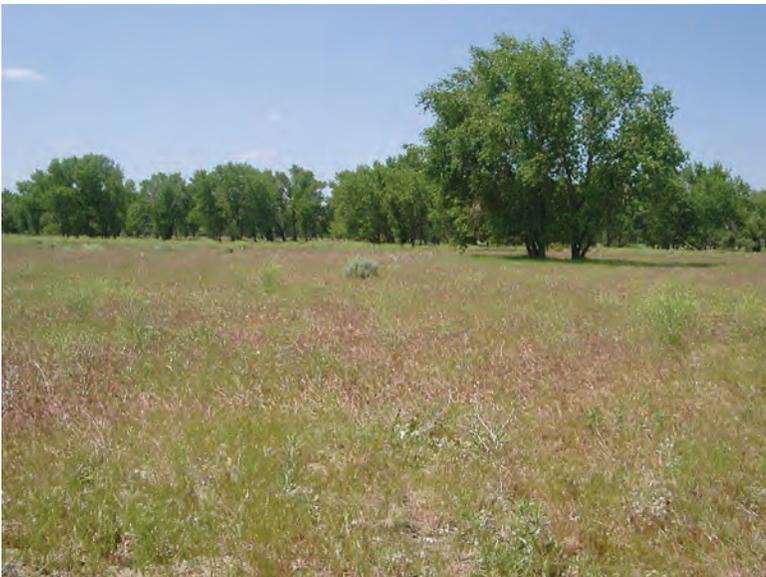
Figure A94. Flood plain of Bijou Creek near Wiggins, Colorado, in slope-area reach, June 3, 2003.
