Mailtrail Creek near Loma Alta, Texas

(Miscellaneous ungaged site in the Rio Grande River basin,
USGS Texas Water Science Center)

Review of peak discharge for the flood of June 24, 1948

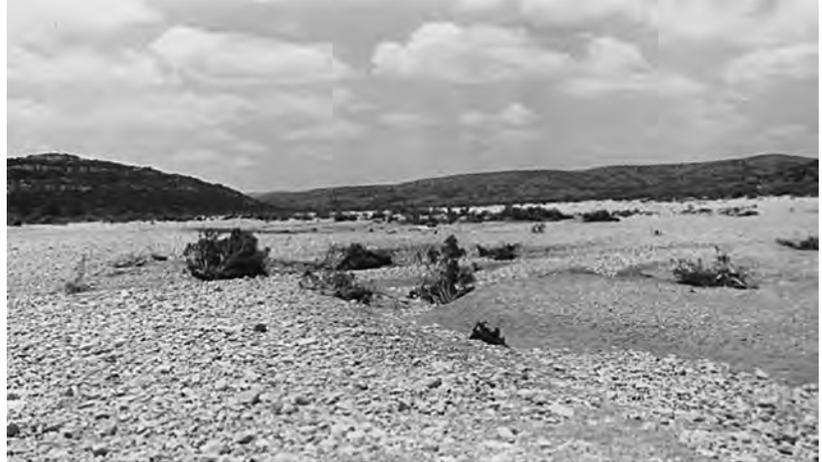
Figure A42. View looking downstream at downstream cross section from near center of channel, Mailtrail Creek near Loma Alta, Texas, flood of June 24, 1948.

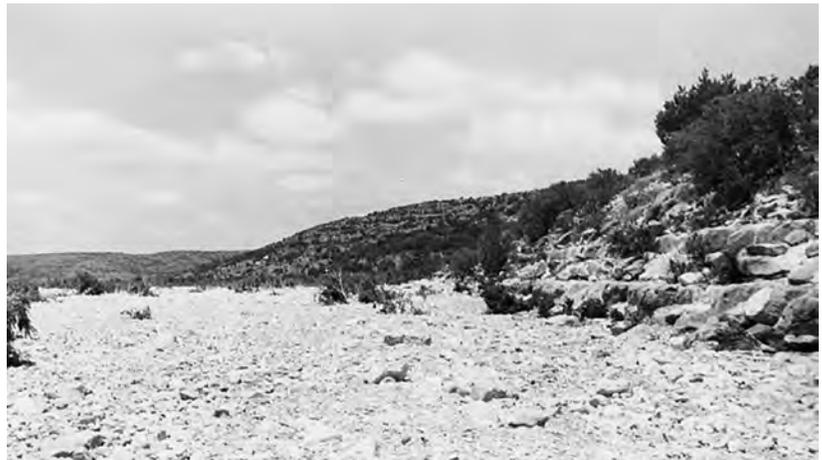
Figure A43. View looking downstream at downstream cross section from near right bank, Mailtrail Creek near Loma Alta, Texas, flood of June 24, 1948.

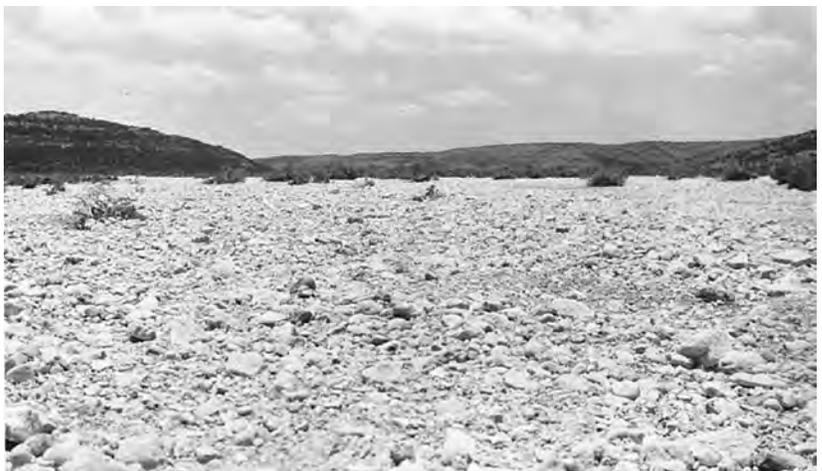
Figure A44. View looking downstream of downstream cross section to right of center of main channel, Mailtrail Creek near Loma Alta, Texas, flood of June 24, 1948.

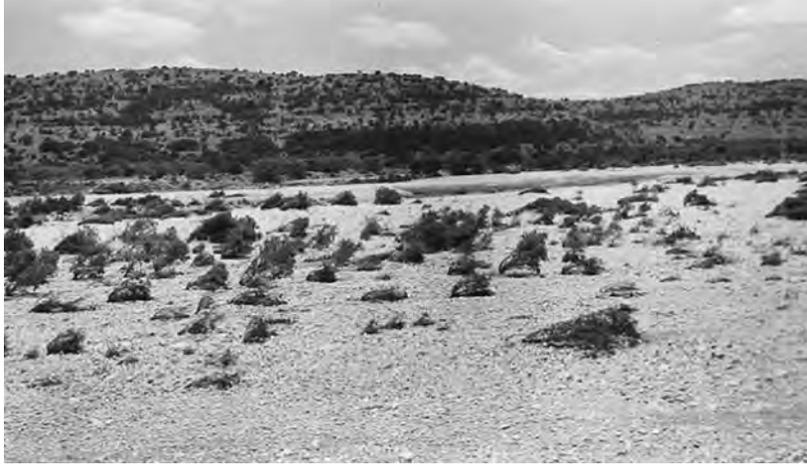
Figure A45. View looking across channel from right bank near downstream cross section, Mailtrail Creek near Loma Alta, Texas, flood of June 24, 1948.

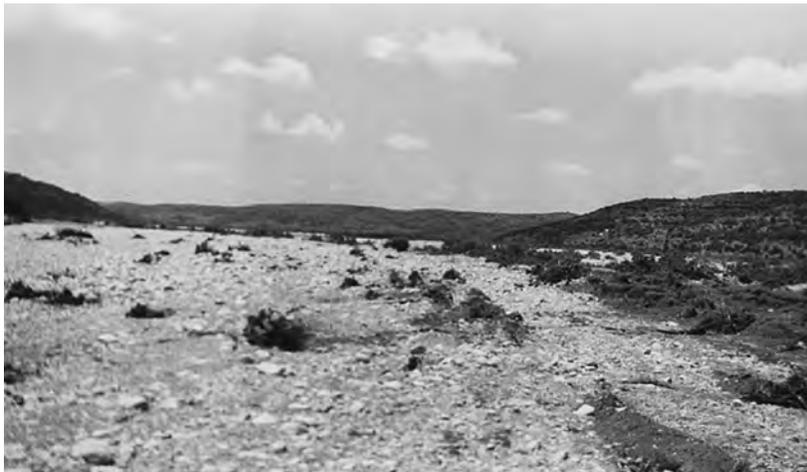
Figure A46. View looking downstream from center channel at upstream cross section, Mailtrail Creek near Loma Alta, Texas, flood of June 24, 1948.

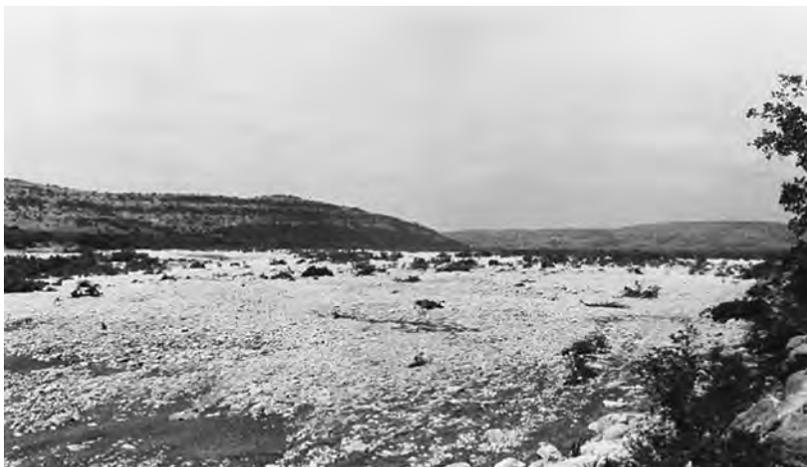
Figure A47. View looking downstream from right bank at upstream cross section, Mailtrail Creek near Loma Alta, Texas, flood of June 24, 1948.

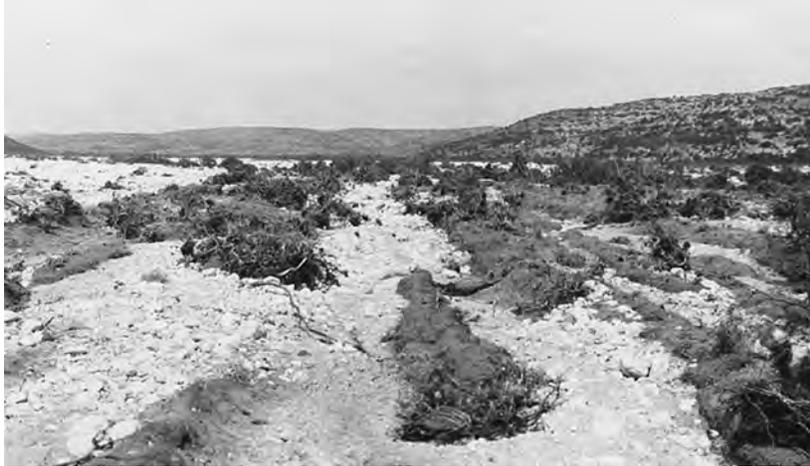
Figure A48. View looking downstream from near center of channel at upstream cross section, Mailtrail Creek near Loma Alta, Texas, flood of June 24, 1948.

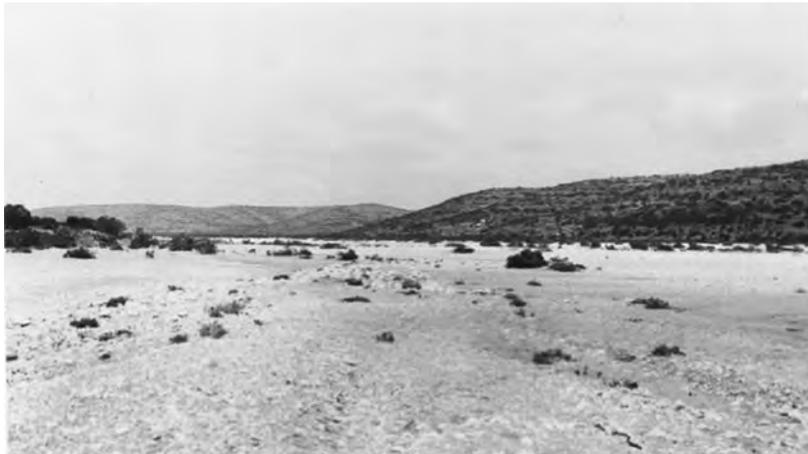
Figure A49. View looking downstream from left side of main channel at upstream cross section, Mailtrail Creek near Loma Alta, Texas, flood of June 24, 1948.

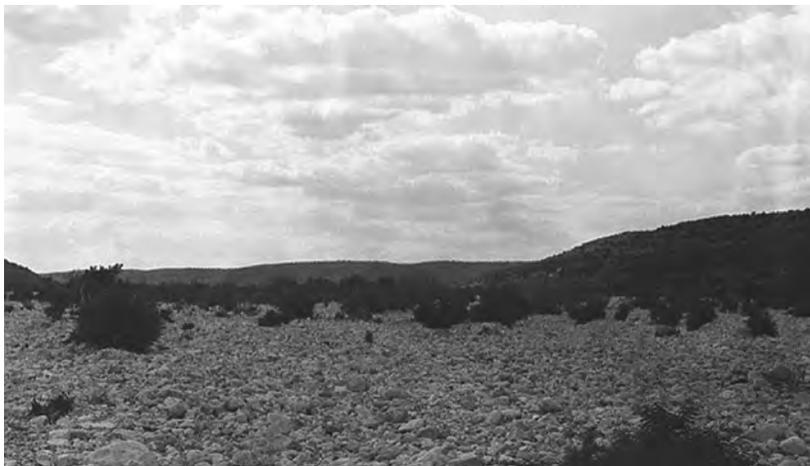
Figure A50. View looking downstream from right bank at middle cross section, Mailtrail Creek near Loma Alta, Texas, flood of June 24, 1948.

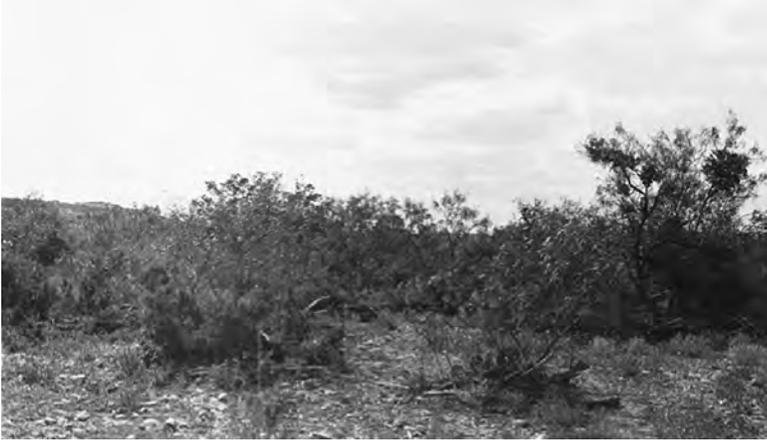
Figure A51. View looking downstream at middle cross section—left-bank overflow, Mailtrail Creek near Loma Alta, Texas, flood of June 24, 1948.

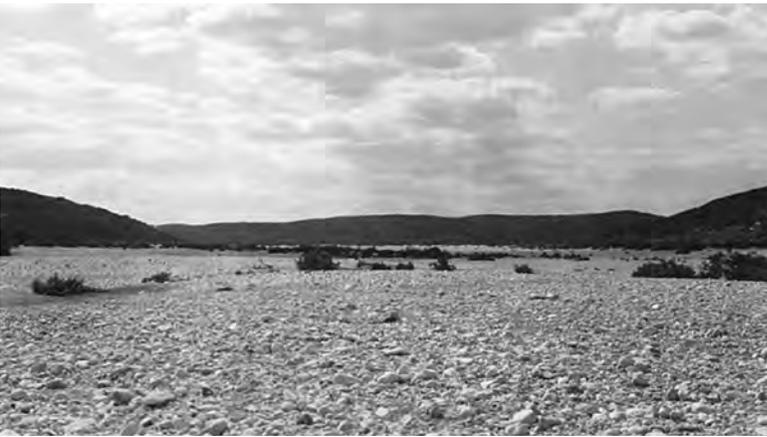
Figure A52. View looking downstream from near center of channel at middle cross section, Mailtrail Creek near Loma Alta, Texas, flood of June 24, 1948.

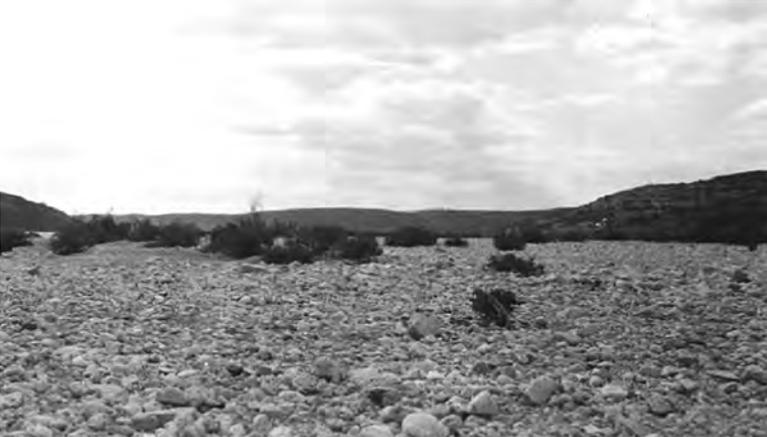
Figure A53. View looking downstream from near center of main channel at middle cross section, Mailtrail Creek near Loma Alta, Texas, flood of June 24, 1948.

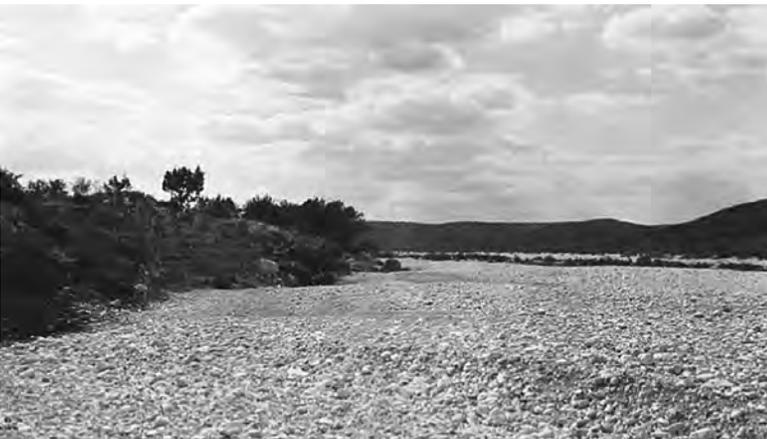
Figure A54. View looking downstream from left side of main channel at middle cross section, Mailtrail Creek near Loma Alta, Texas, flood of June 24, 1948.

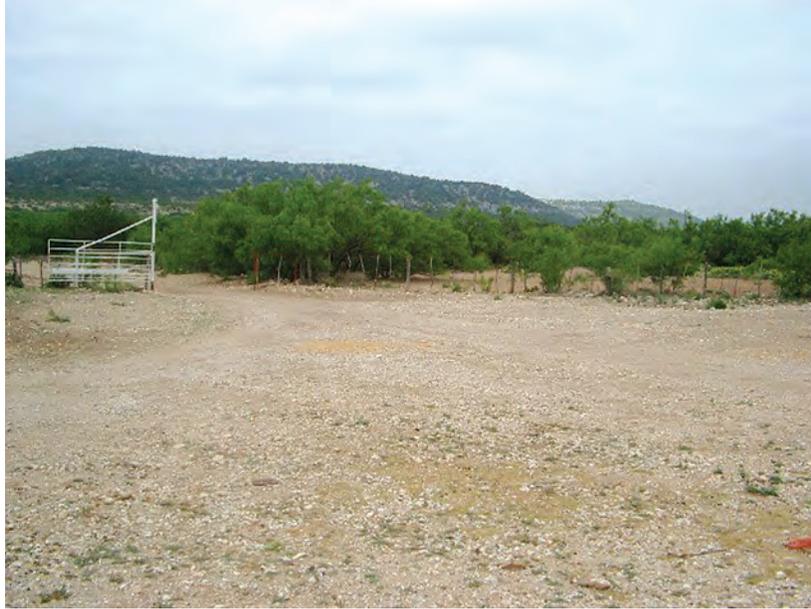
The channel appears to be much more densely vegetated in 2003 than it was in 1948 based on photographs taken when the slope-area measurement was made. There is no clearly defined main channel but rather a wide flood plain consisting of gravel, large cobbles, and small boulders. The main flow area is about 1,000 ft wide. A small bench or overflow area is indicated on the left side by the cross sections surveyed in 1948. The right side has steep banks. In 2003, a rather dense growth of scrub mesquite was observed throughout the site.

Figure A55. View looking upstream from channel in slope-area reach, Mailtrail Creek near Loma Alta, Texas, May 13, 2003.

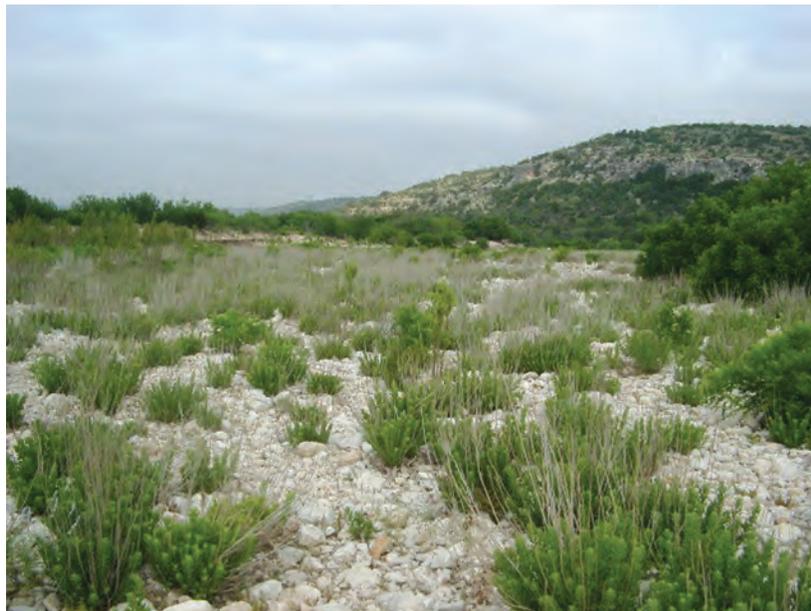
Figure A56. View looking upstream near upstream cross section of slope-area reach, Mailtrail Creek near Loma Alta, Texas, May 13, 2003.

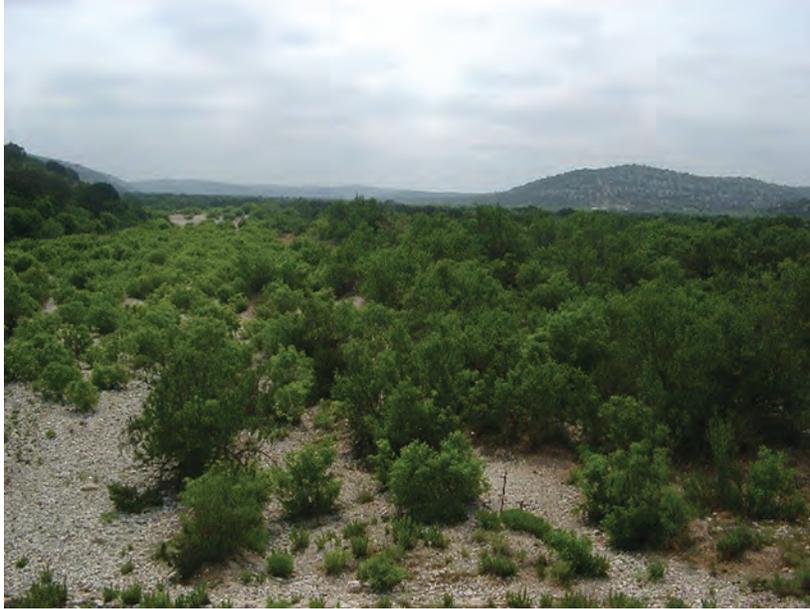
Figure A57. View looking downstream from slope-area reach, Mailtrail Creek near Loma Alta, Texas, May 13, 2003.

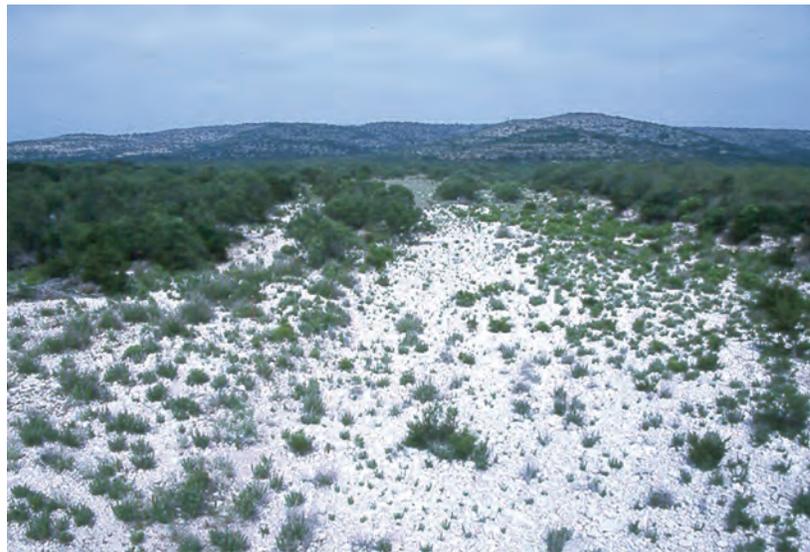
Figure A58. View looking downstream from U.S. Highway 277 bridge below slope-area reach, Mailtrail Creek near Loma Alta, Texas, May 13, 2003.
