Stratton Creek near Washta, Iowa

(Miscellaneous ungaged site in the Stratton Creek basin, USGS Iowa Water Science Center)

Review of peak discharge for the flood of August 9, 1961

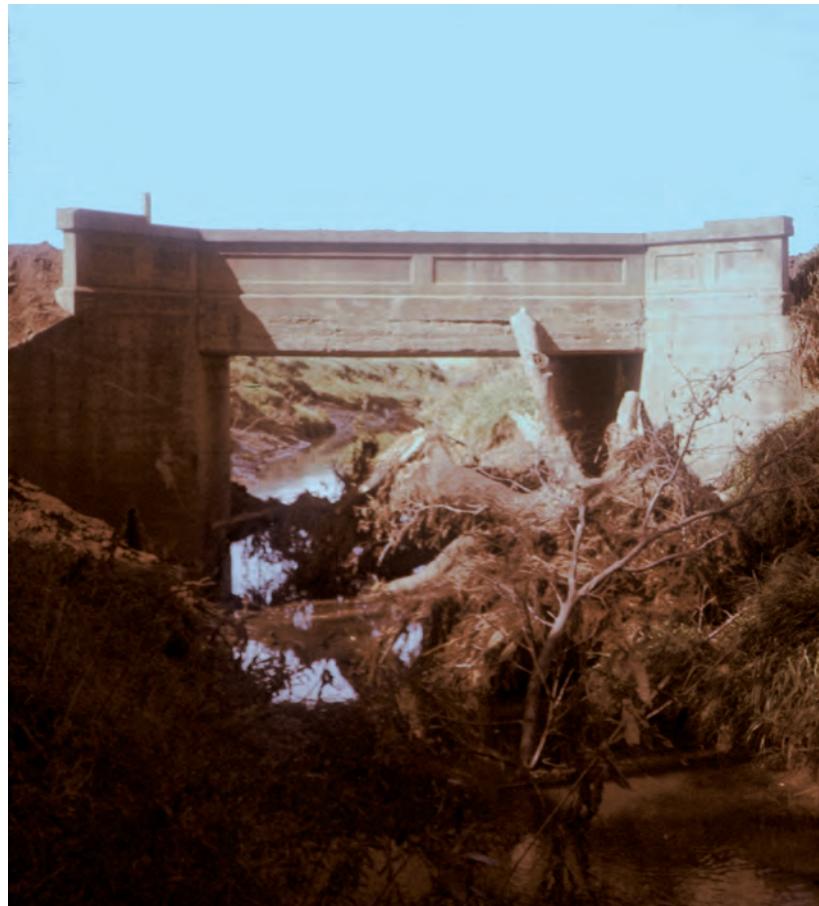
Figure A212. View looking downstream of road crossing and culvert, Stratton Creek near Washta, Iowa, August 1961.

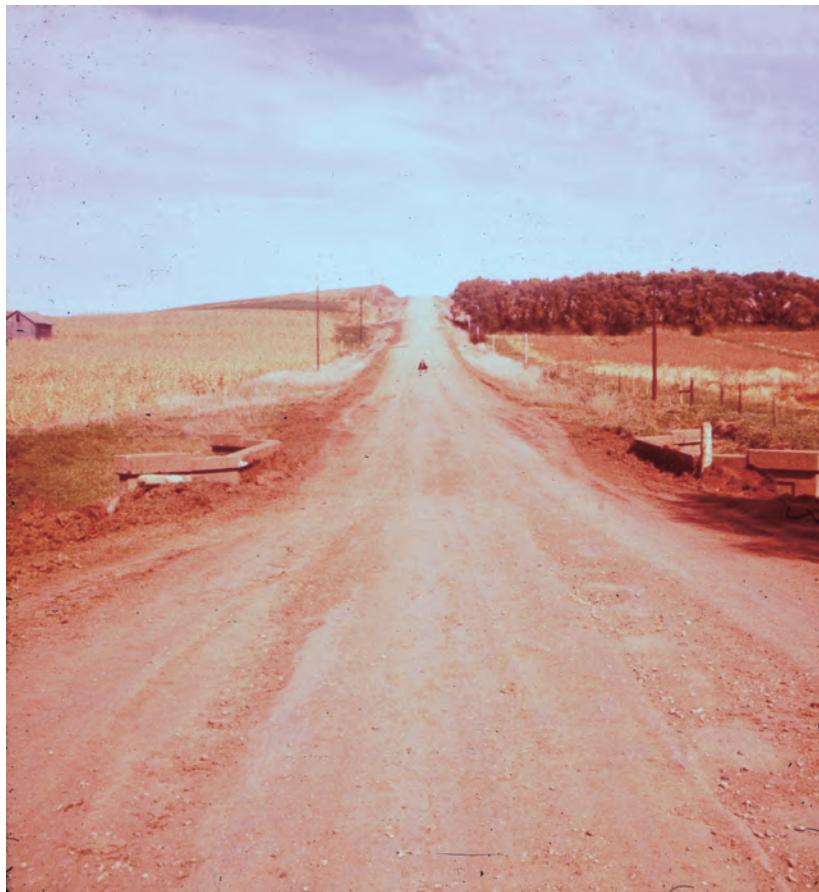
Figure A213. View of right-bank high-water mark at bridge crossing, Stratton Creek near Washta, Iowa, August 1961. Flow is from right to left.

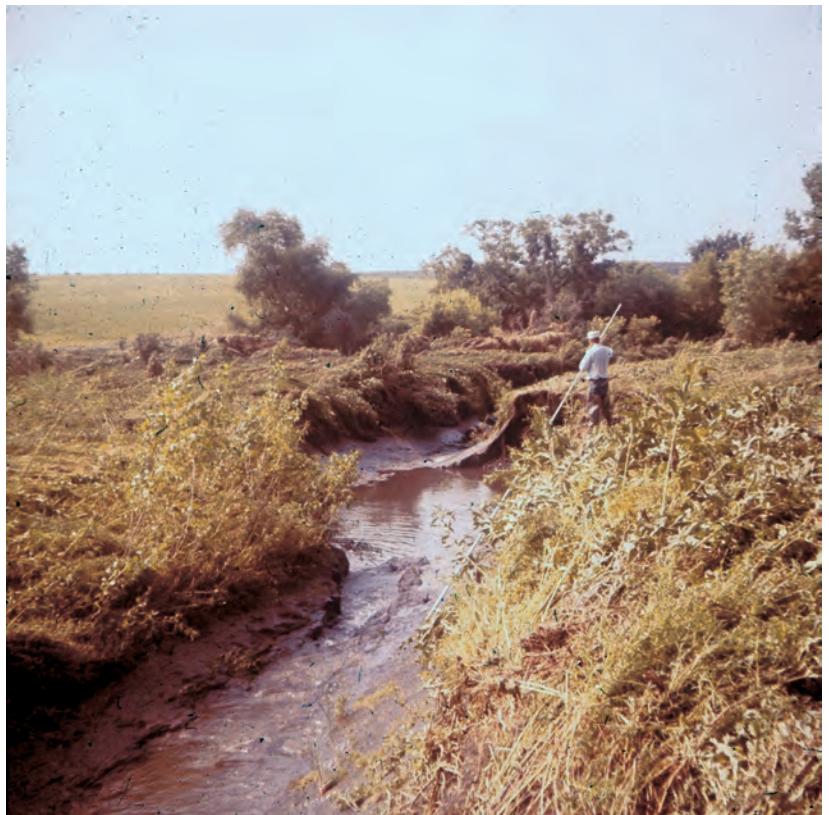
Figure A214. View looking downstream along channel upstream of cross section 1, Stratton Creek near Washta, Iowa, August 1961.

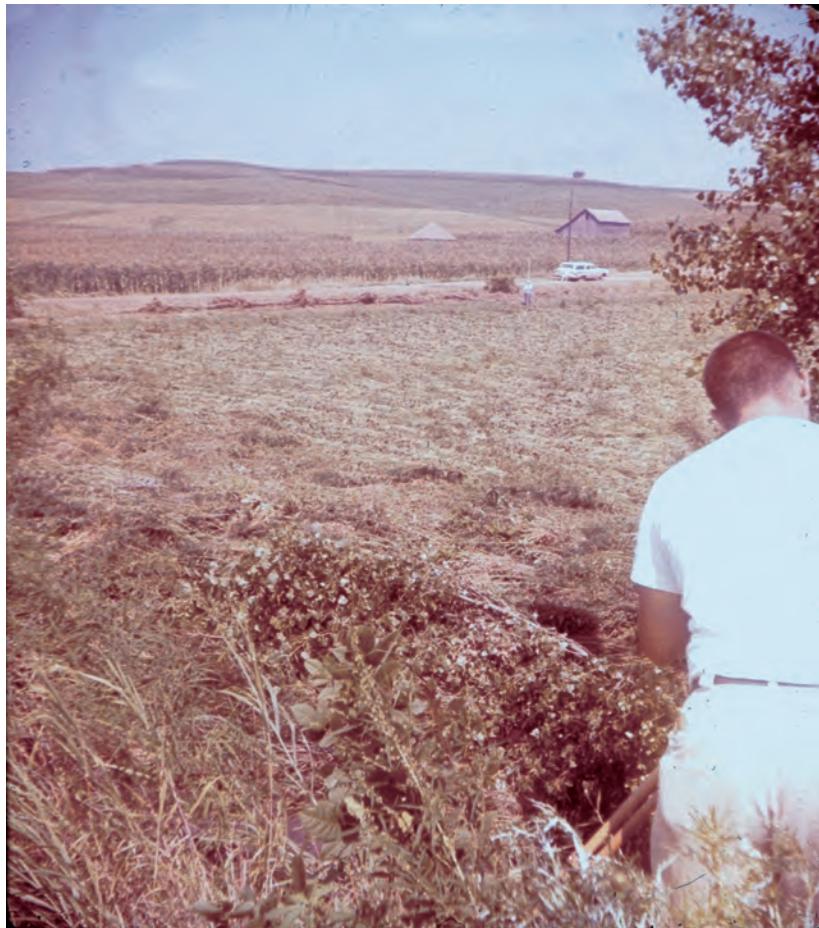
The upstream section is a substantially different shape than the downstream section. The conveyance does not change uniformly between the two sections. Cross section 1 should have been relocated, or a third section should have been added at the change-in cross-section geometry.

Figure A215. View looking from left bank to right bank long cross section 1, Stratton Creek near Washta, Iowa, August 1961.

A third section could have been surveyed between cross sections 1 and 2 at the substantial change in cross-section geometry. Field personnel should not hesitate to survey an extra section even though the water-surface profile is poorly defined. Be diligent in looking for high-water marks in the best reach available. In this case, the best reach appears to be downstream of the reach that was used.

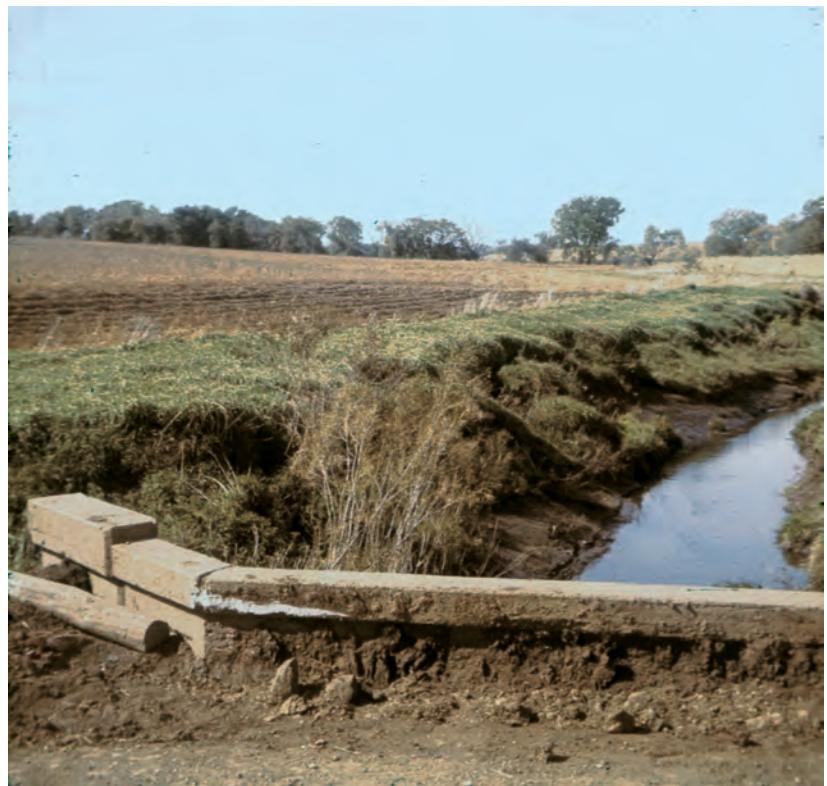
Figure A216. View looking downstream of left bank, Stratton Creek near Washta, Iowa, August 1961.

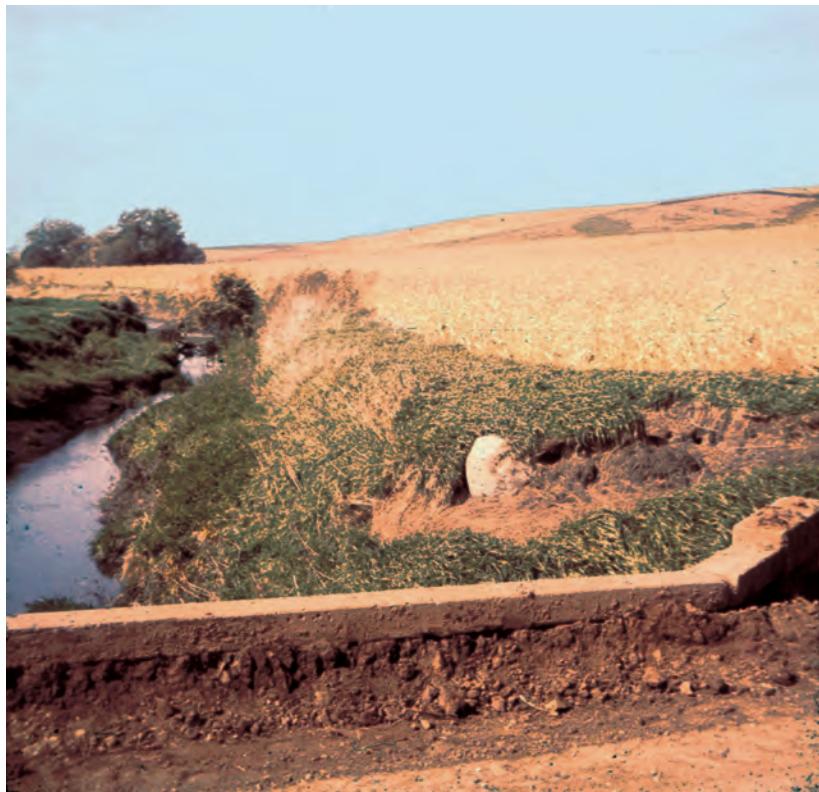
Figure A217. View looking downstream of right bank, Stratton Creek near Washta, Iowa, August 1961.

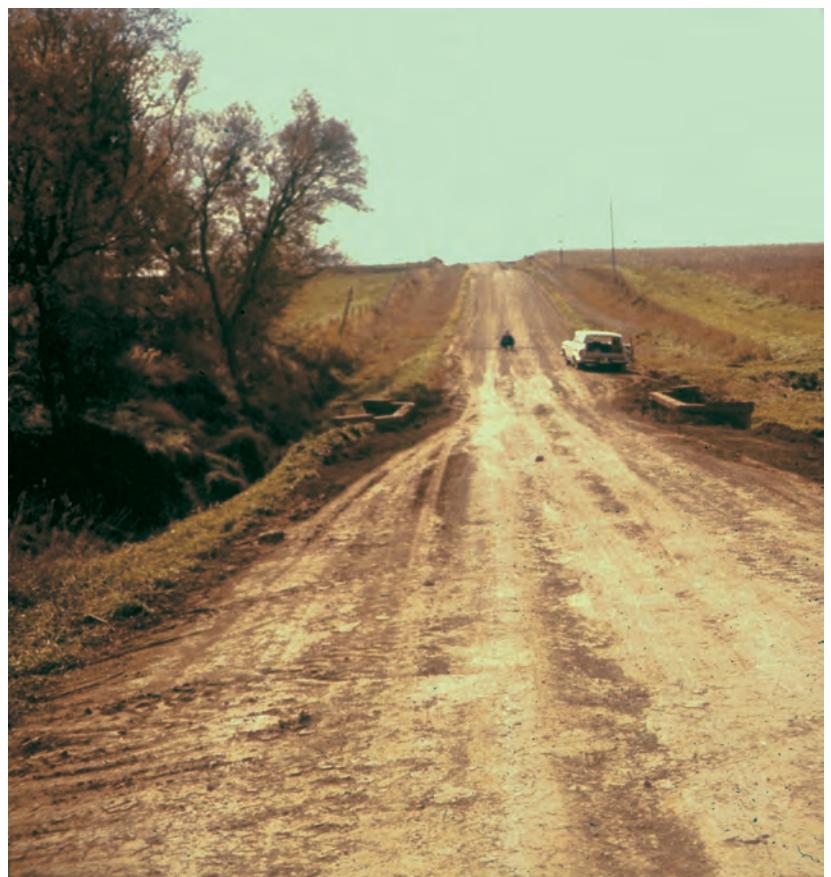
Figure A218. View of left bank high-water mark at bridge crossing, Stratton Creek near Washta, Iowa, August 1961. Flow is from left to right.

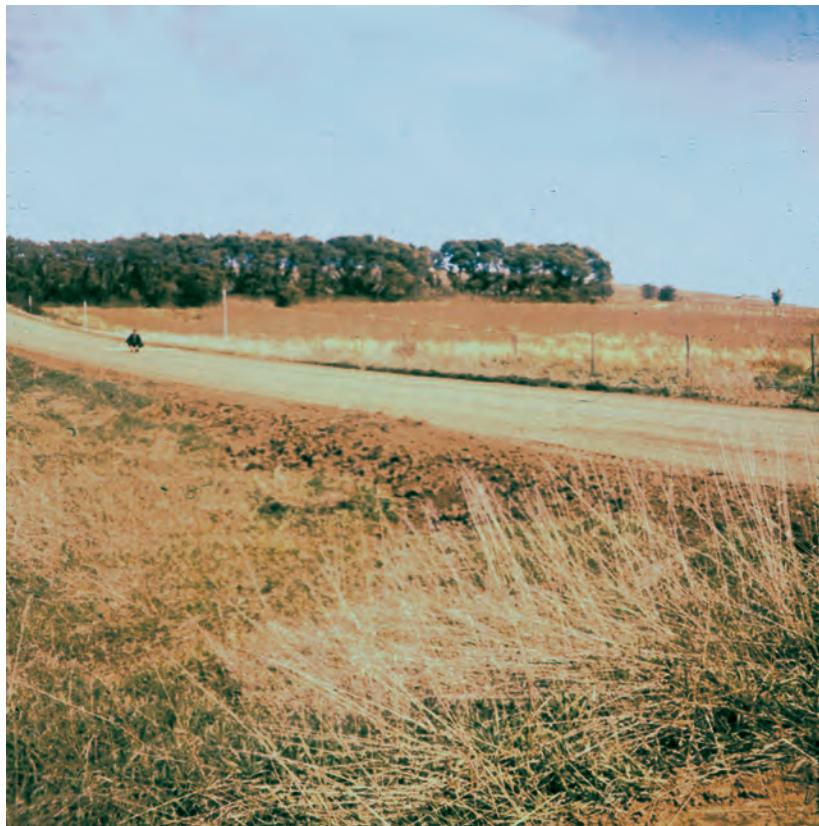
Figure A219. View of right bank high-water mark of downstream side of road and culvert crossing, Stratton Creek near Washta, Iowa, August 1961.

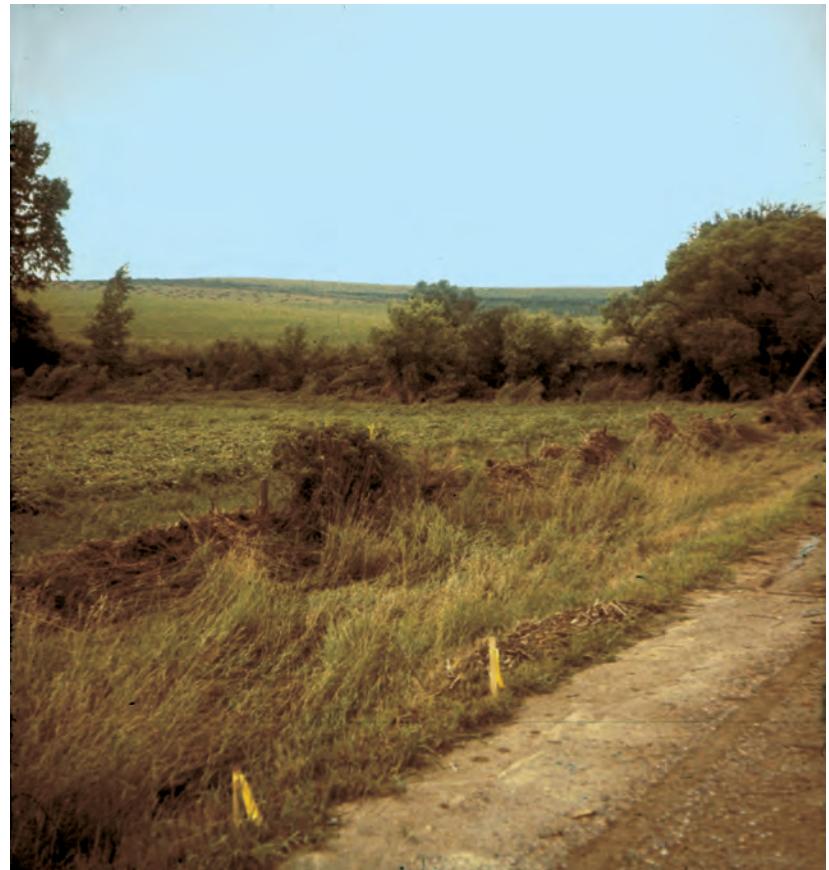
Possible sources of error: The base line for the slope-area reach is misaligned compared to the actual flow path. Realignment would reduce the distance between cross sections by about 5 percent, or about 440 ft. This change would not significantly decrease the flow.

Figure A220. View of slope-area reach upstream of culvert, Stratton Creek near Washta, Iowa, August 1961. Flow is from left to right.

A step-backwater model could have been used to compute discharge for the long, straight reach downstream of the bridge and road embankment. When faced with a questionable slope-area reach and a poorly defined high-water profile, it may be better to use the step-backwater model to estimate peak discharge.

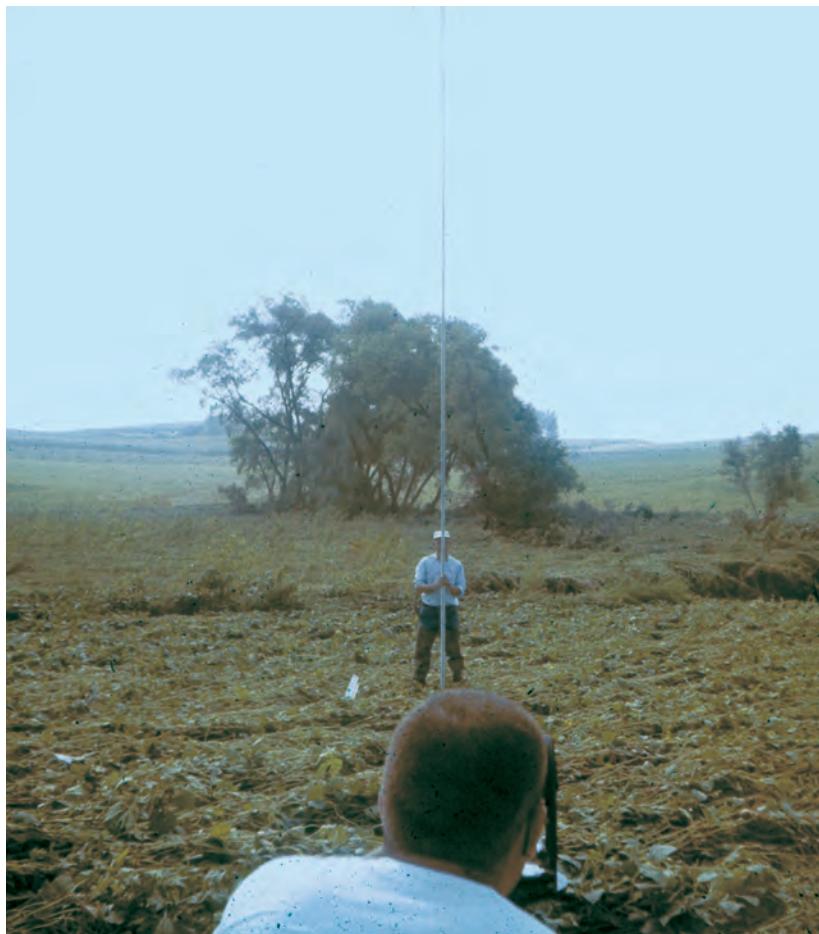
Figure A221. View looking from right to left along cross section 1, Stratton Creek near Washta, Iowa, August 1961.

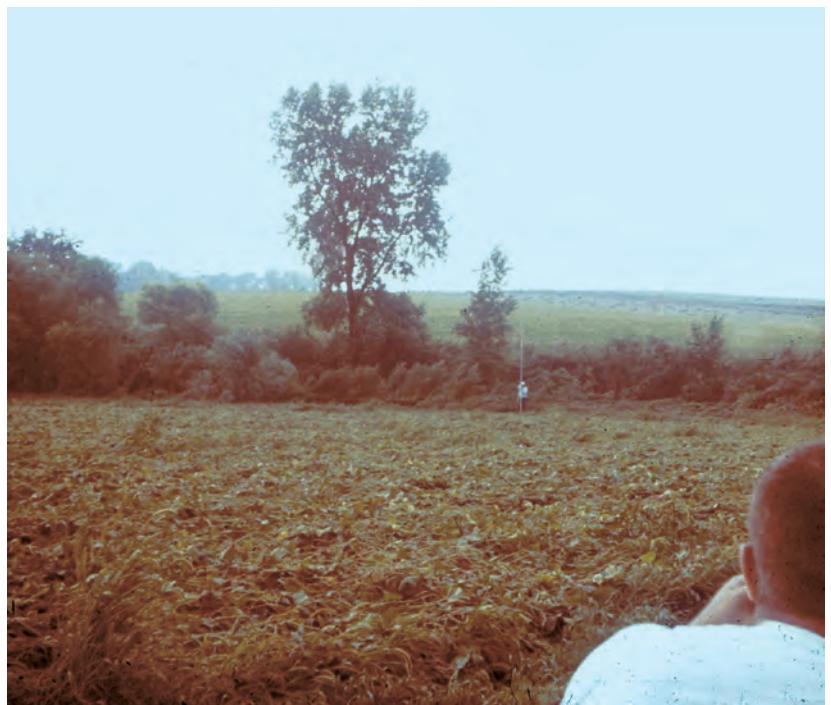
The high-water marks at the right end of cross section 2 could have been affected by water flowing out of the upstream road ditch and over the road. Both ditches probably were flowing full down the steep road grade.

Figure A222. View looking from right to left along cross section 2, Stratton Creek near Washta, Iowa, August 1961.

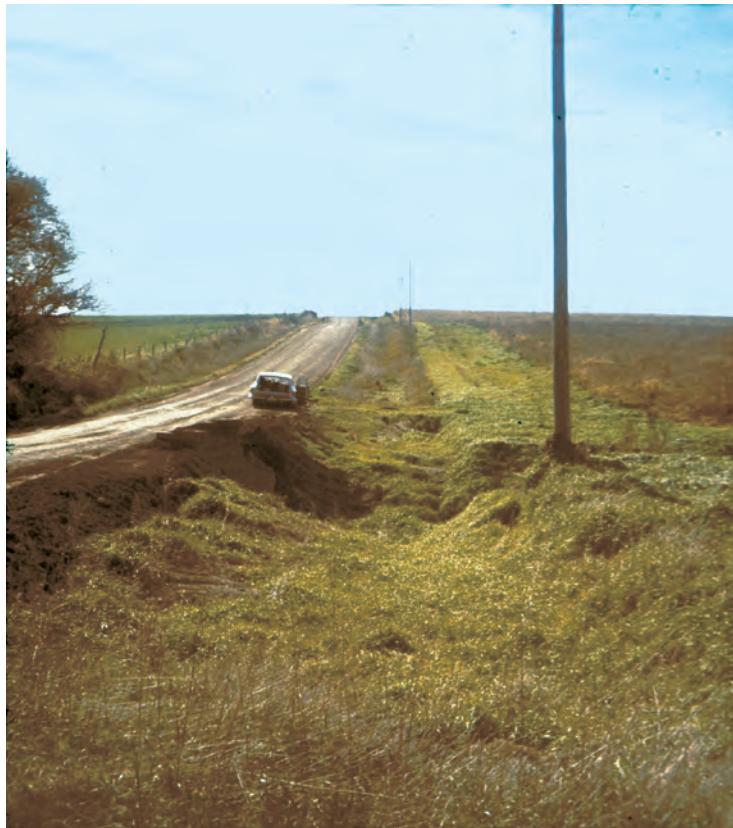
Figure A223. View looking toward left bank from downstream side of road and culvert, Stratton Creek near Washta, Iowa, August 1961.

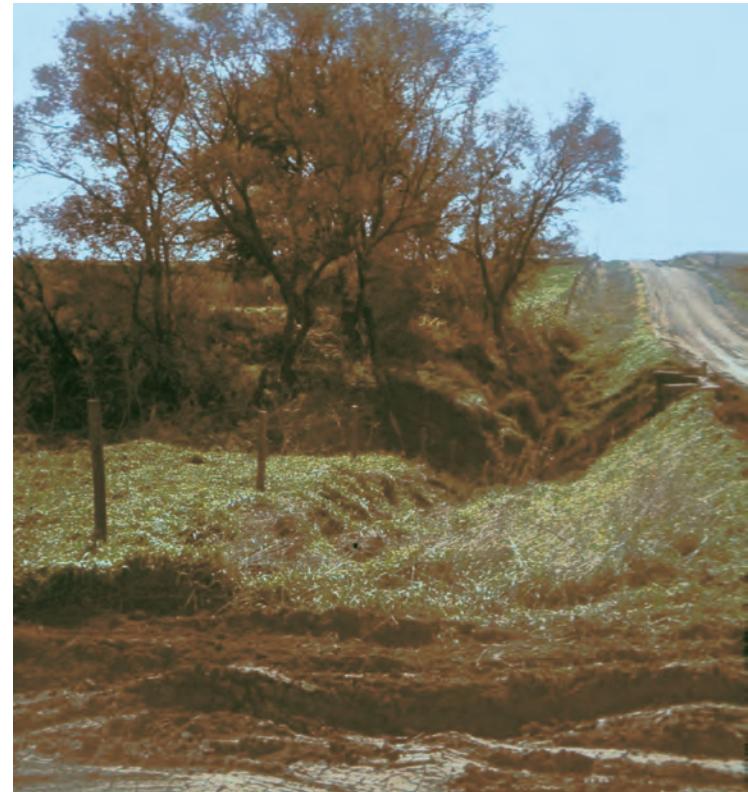
Figure A224. View looking toward left bank from end of cross section 2, Stratton Creek near Washta, Iowa, August 1961.

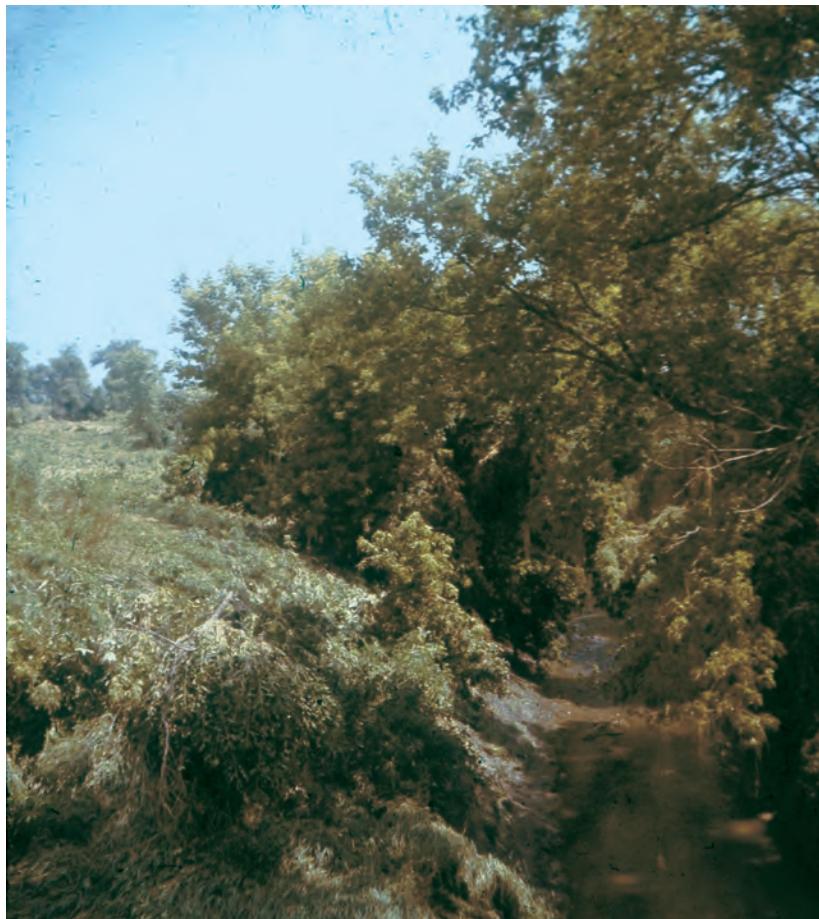
Figure A225. View looking upstream of culvert and road crossing, Stratton Creek near Washta, Iowa, August 1961.

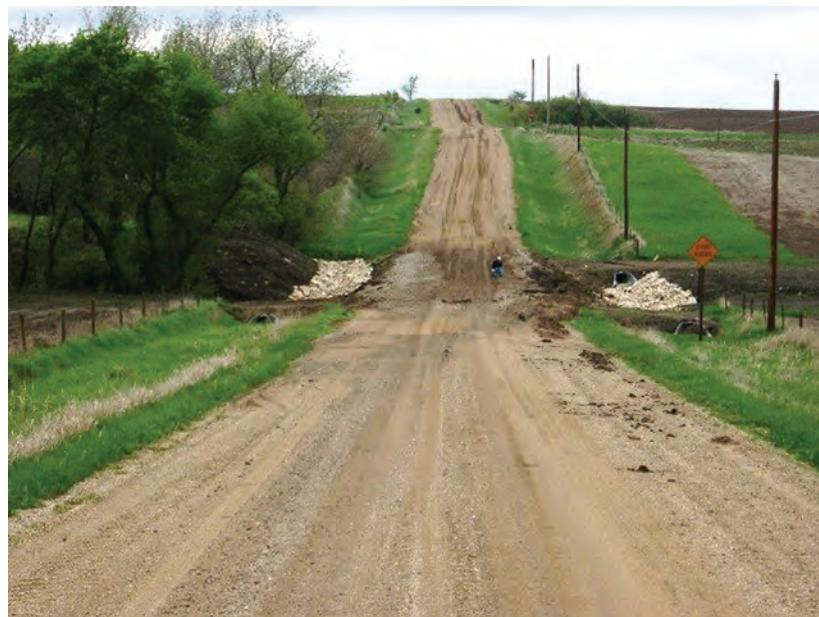
Figure A226. View looking from right to left bank along road crossing, Stratton Creek near Washta, Iowa, May 5, 2003.

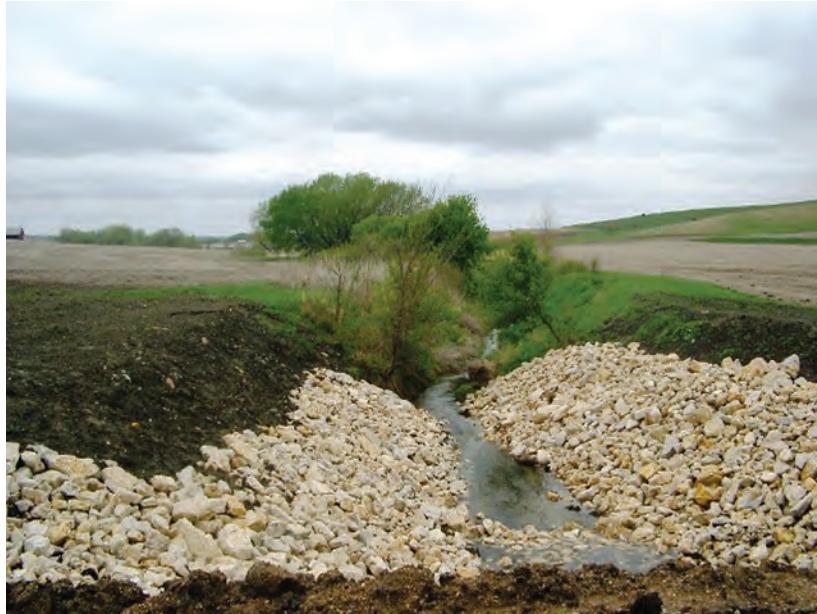
Figure A227. View looking downstream of culvert and road crossing, Stratton Creek near Washta, Iowa, May 5, 2003.

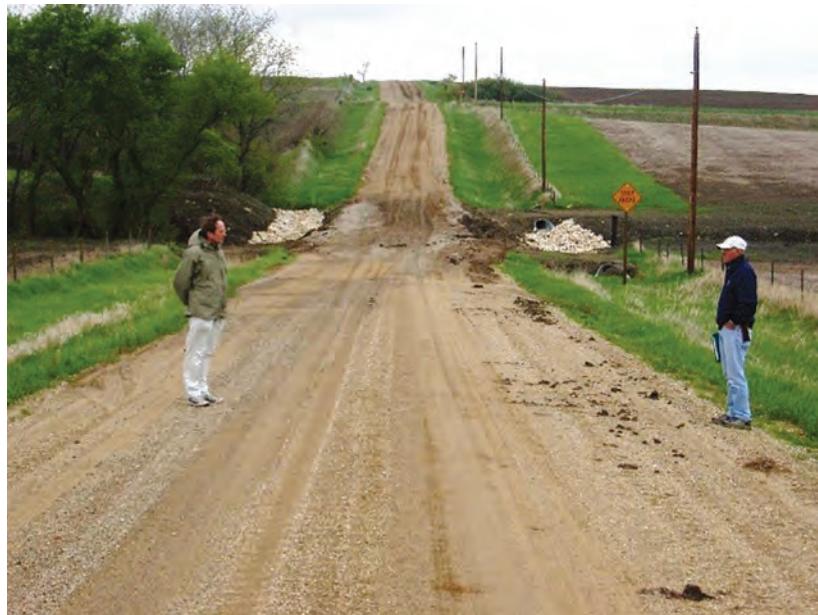
Figure A228. View looking from right to left bank with people standing on approximate high-water mark, Stratton Creek near Washta, Iowa, May 5, 2003.

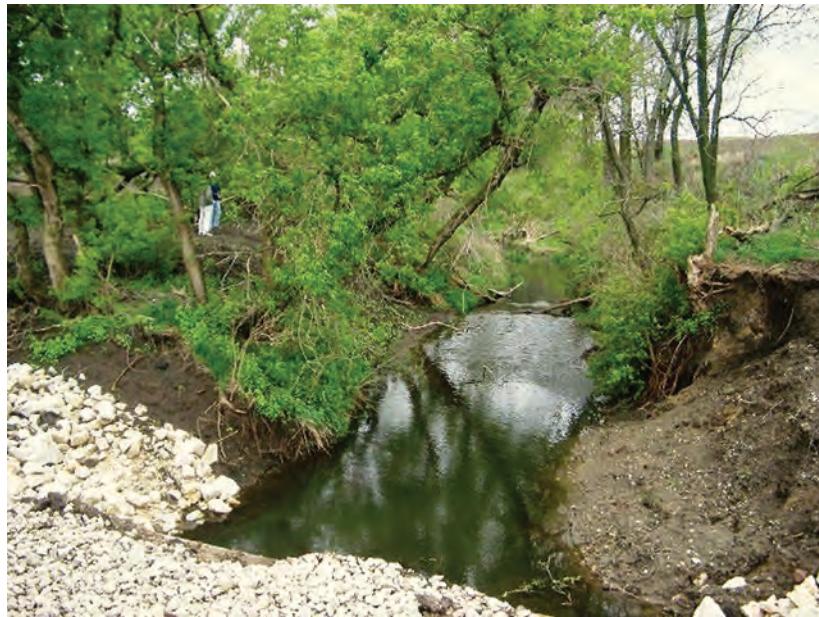
Figure A229. View looking upstream of culvert and road crossing, Stratton Creek near Washta, Iowa, May 5, 2003.

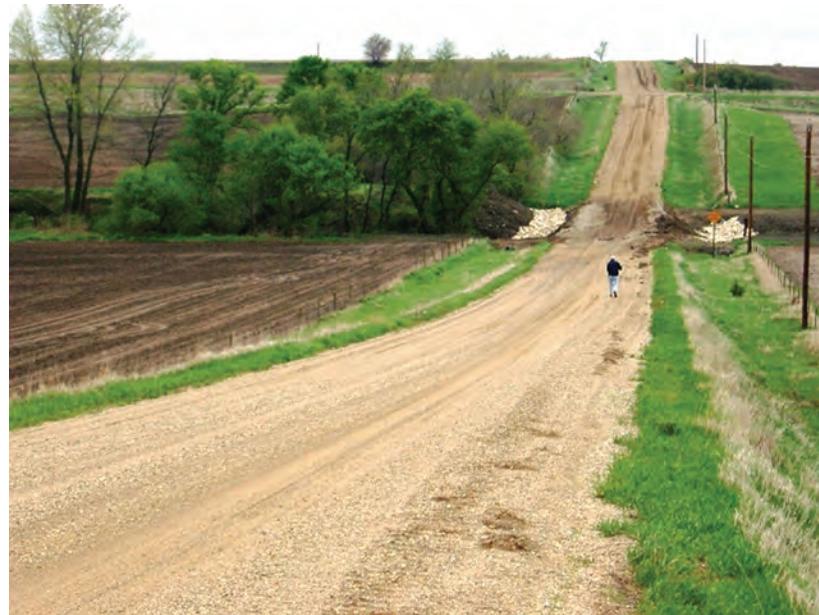
Figure A230. View looking from right to left bank at culvert crossing, Stratton Creek near Washta, Iowa, May 5, 2003. Flow is from left to right.

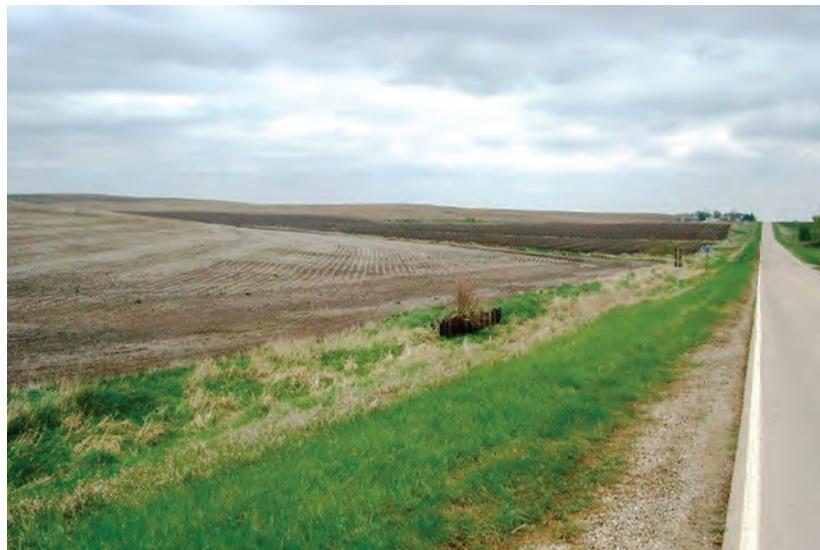
Figure A231. View of headwaters of Stratton Creek near Washta, Iowa, May 5, 2003.
