Scientific Investigations Report 2010–5259

# **Flash Floods of August 10, 2009, in the Villages of Gowanda and Silver Creek, New York**

By Carolyn O. Szabo, William F. Coon, and Thomas A. Niziol

Prepared in cooperation with the Federal Emergency Management Agency

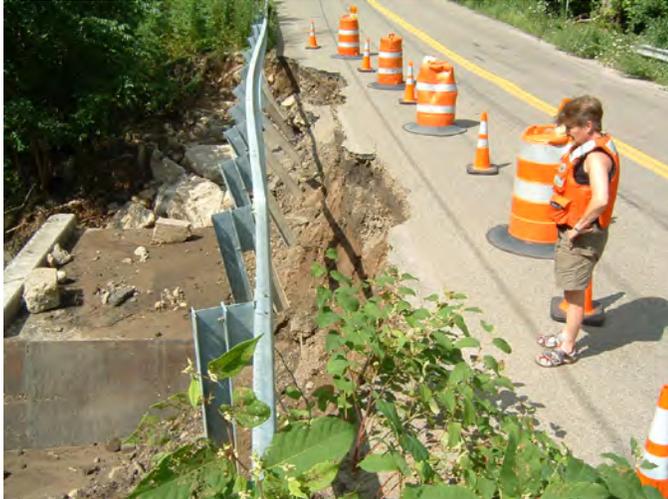
The fill above and the edge of the road on the downstream side of a concrete culvert were eroded.

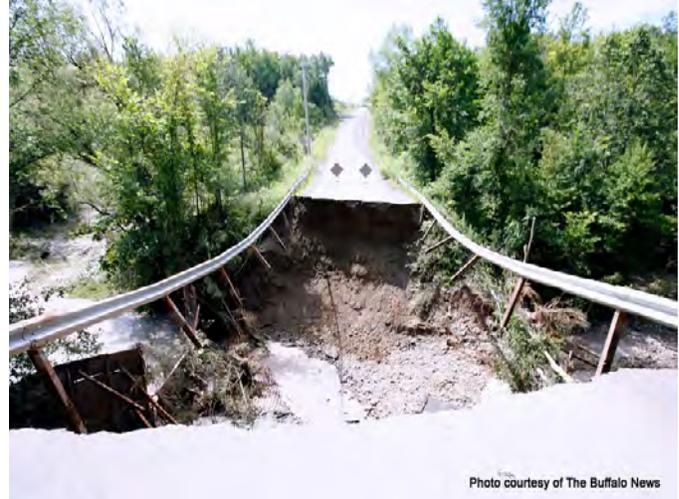
A culvert and road were completely washed away.

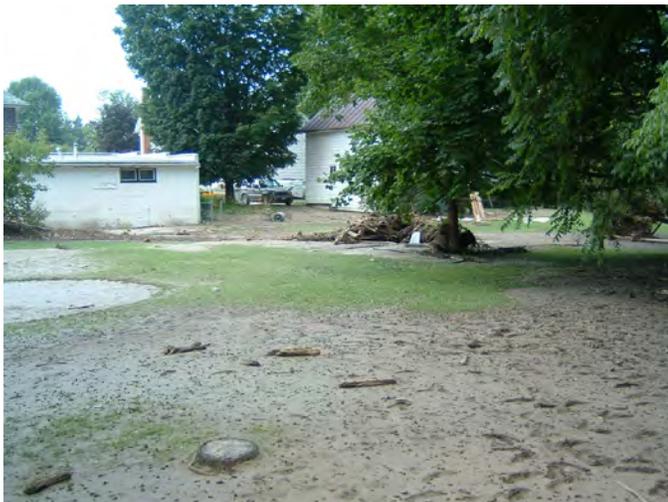
Mud and debris covered residential lawns.

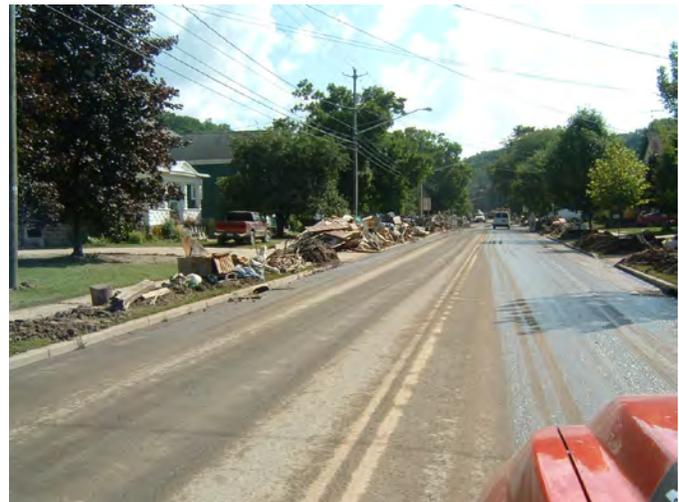
Mud-covered belongings from flooded basements were discarded and lined the streets of Gowanda.

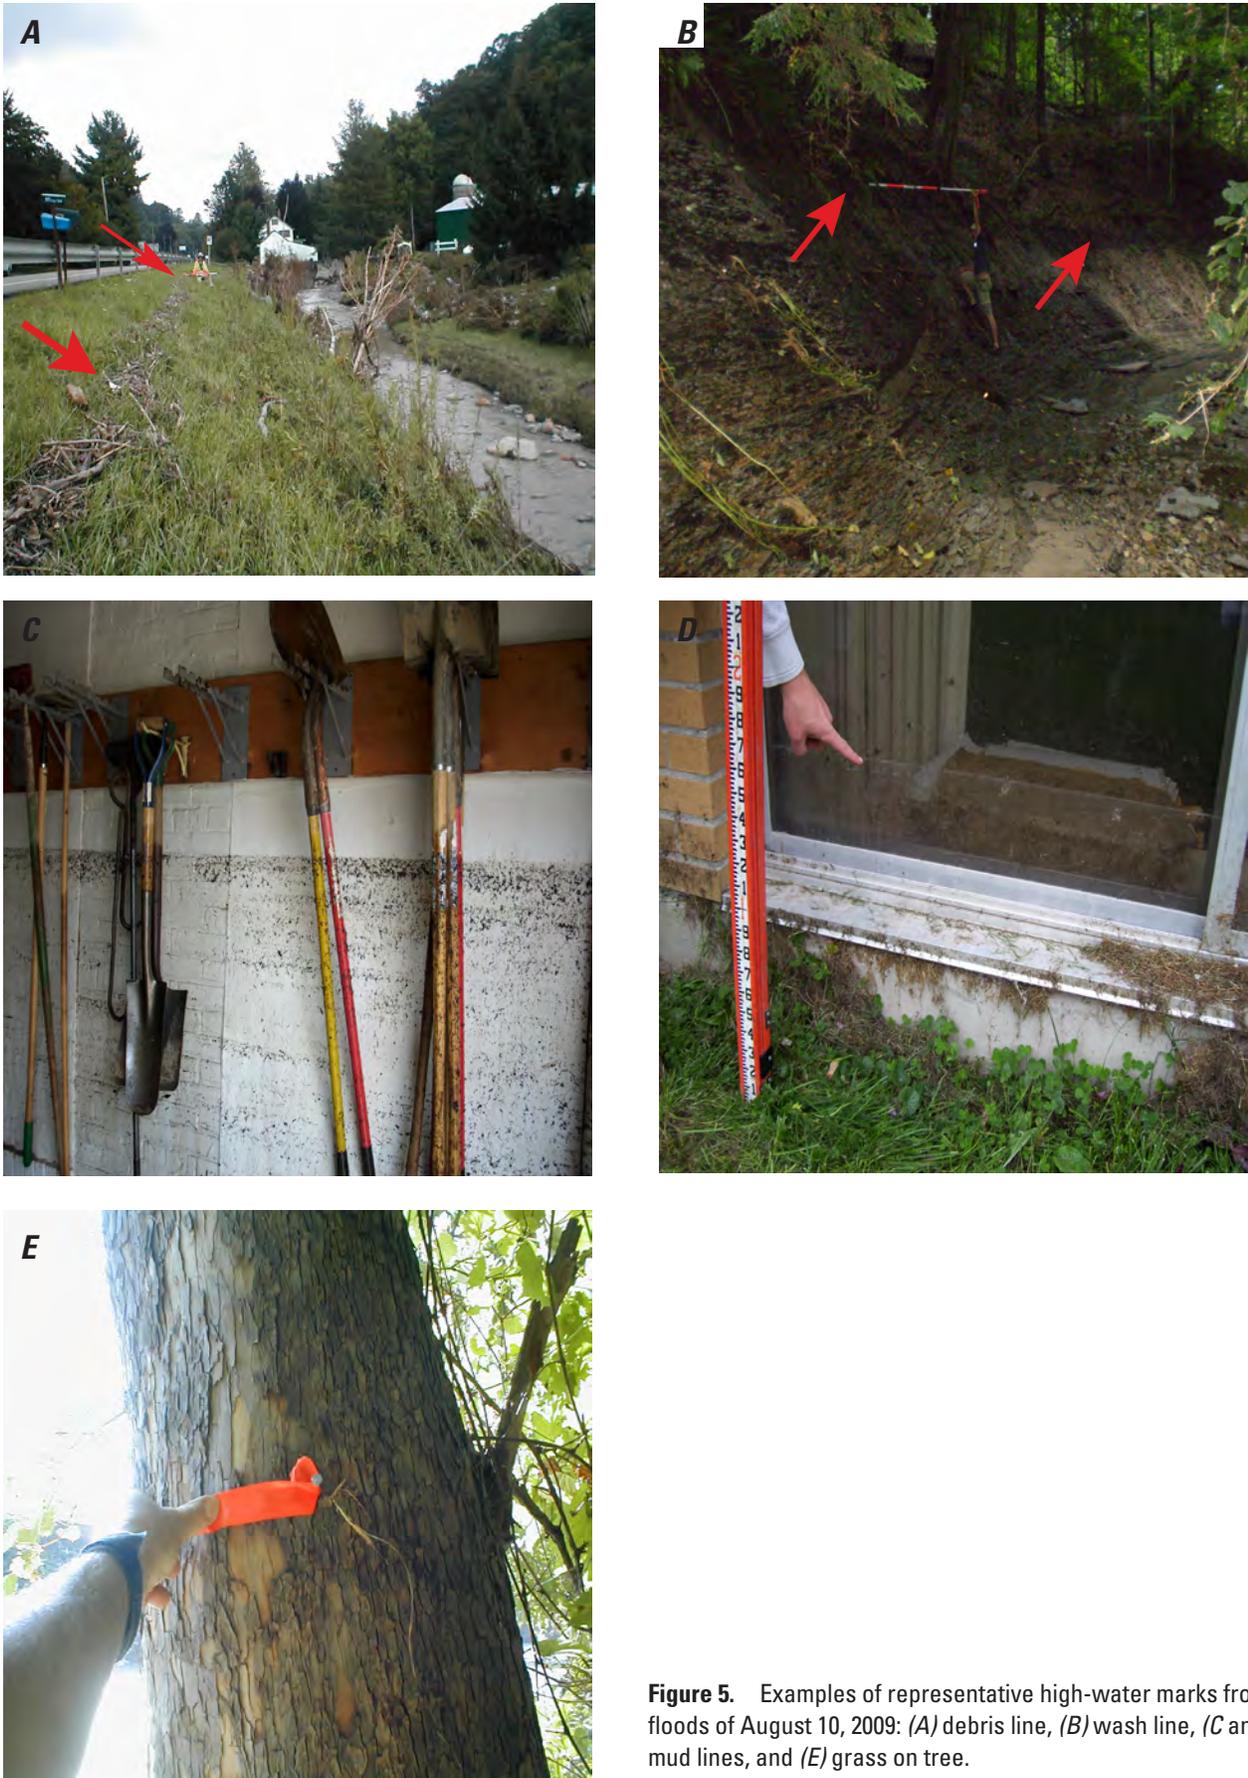
**Figure 5.** Examples of representative high-water marks from the floods of August 10, 2009: (A) debris line, (B) wash line, (C and D) mud lines, and (E) grass on tree.

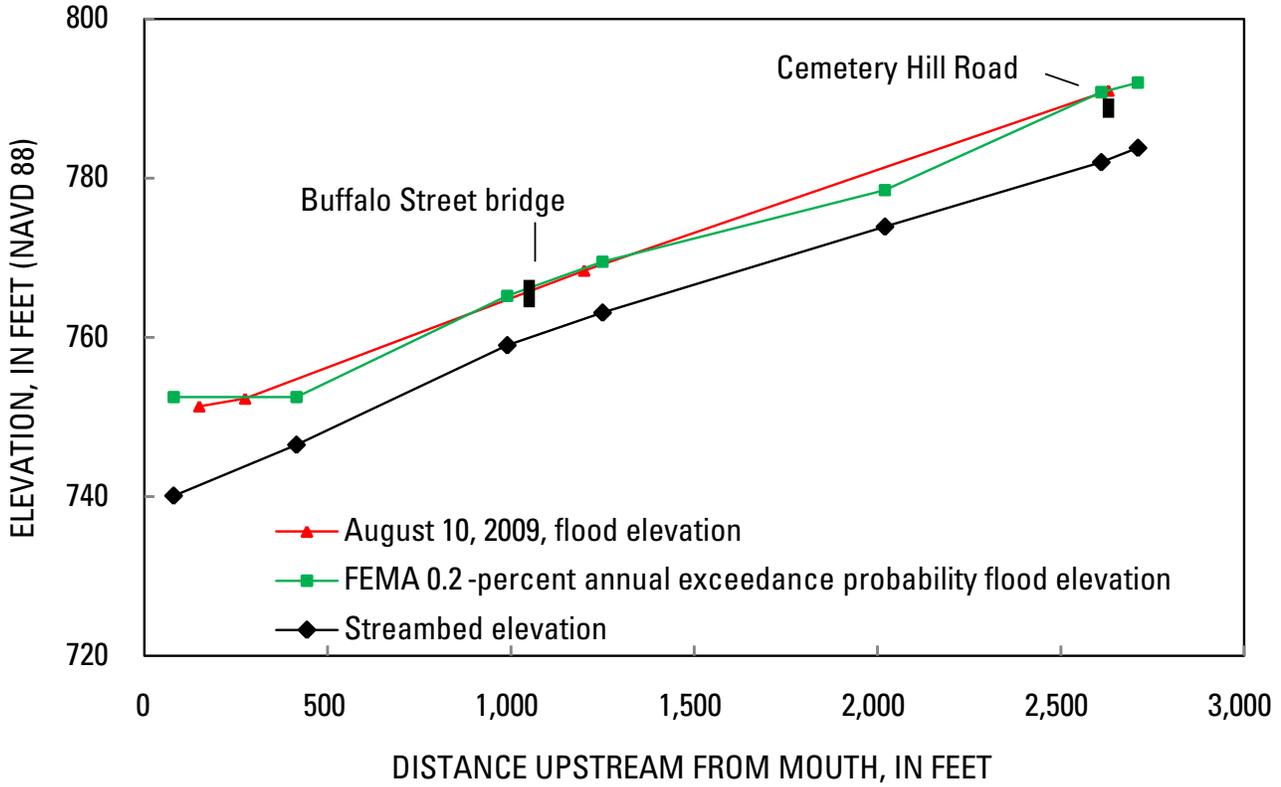
compared with those from the FEMA 0.2-percent annual exceedance probability (500-year recurrence interval) profiles (Federal Emergency Management Agency, 1983; 2009c). The profiles for Grannis Brook and Thatcher Brook were plotted to the North American Vertical Datum of 1988 (NAVD 88), whereas those for Walnut Creek and Silver Creek were plotted to the National Geodetic Vertical Datum of 1929 (NGVD 29), which are the respective datums used in the most recent FEMA flood-insurance reports. The plots showed that flood levels on August 10 along Grannis Brook were close to, or

slightly higher than, the FEMA flood levels, whereas those along Thatcher Brook were 2 to 4 ft higher at some points. The flood levels along Walnut and Silver Creeks were noticeably higher than the FEMA flood levels, at some locations as much as 6 to 8 ft higher.

Figure 6. Water-surface elevations for the August 10, 2009, flood and the FEMA 0.2-percent annual exceedance probability flood for Grannis Brook at Gowanda, N.Y.

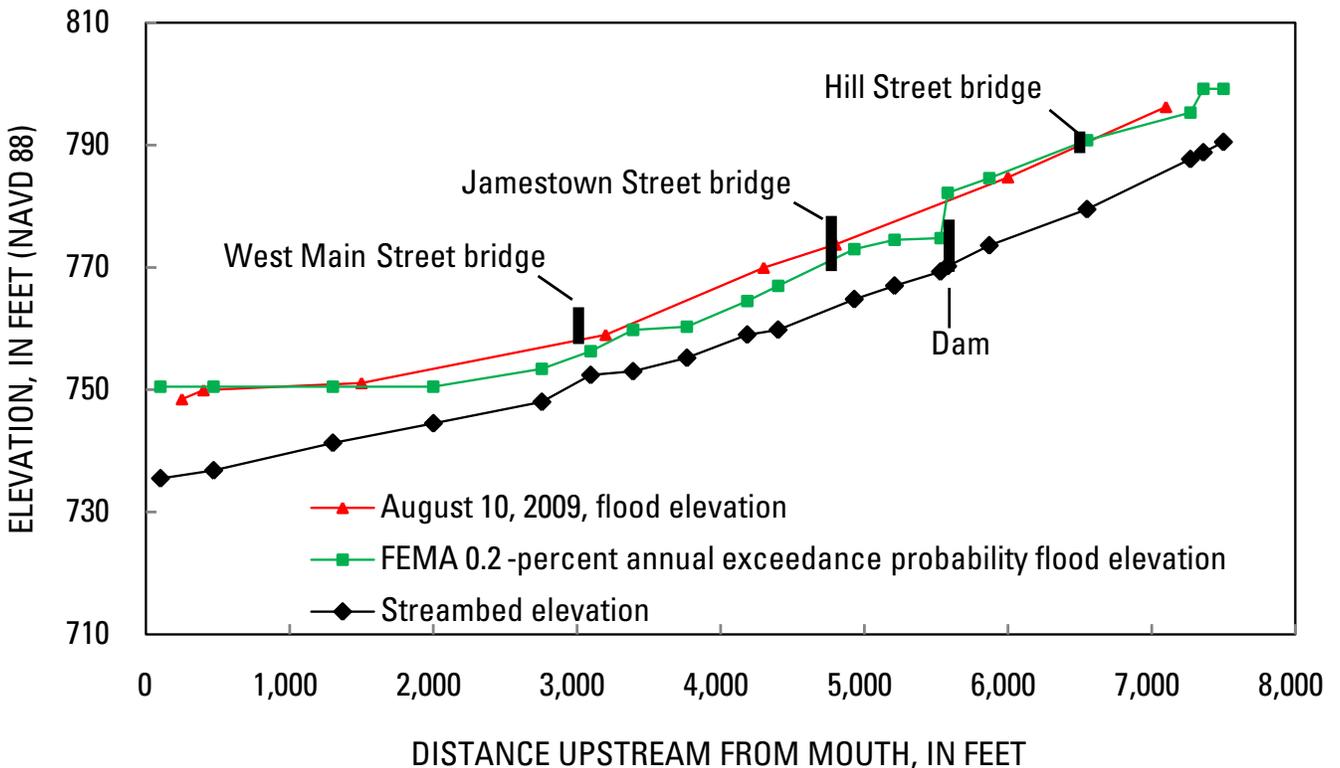
Figure 7. Water-surface elevations for the August 10, 2009, flood and the FEMA 0.2-percent annual exceedance probability flood for Thatcher Brook at Gowanda, N.Y.

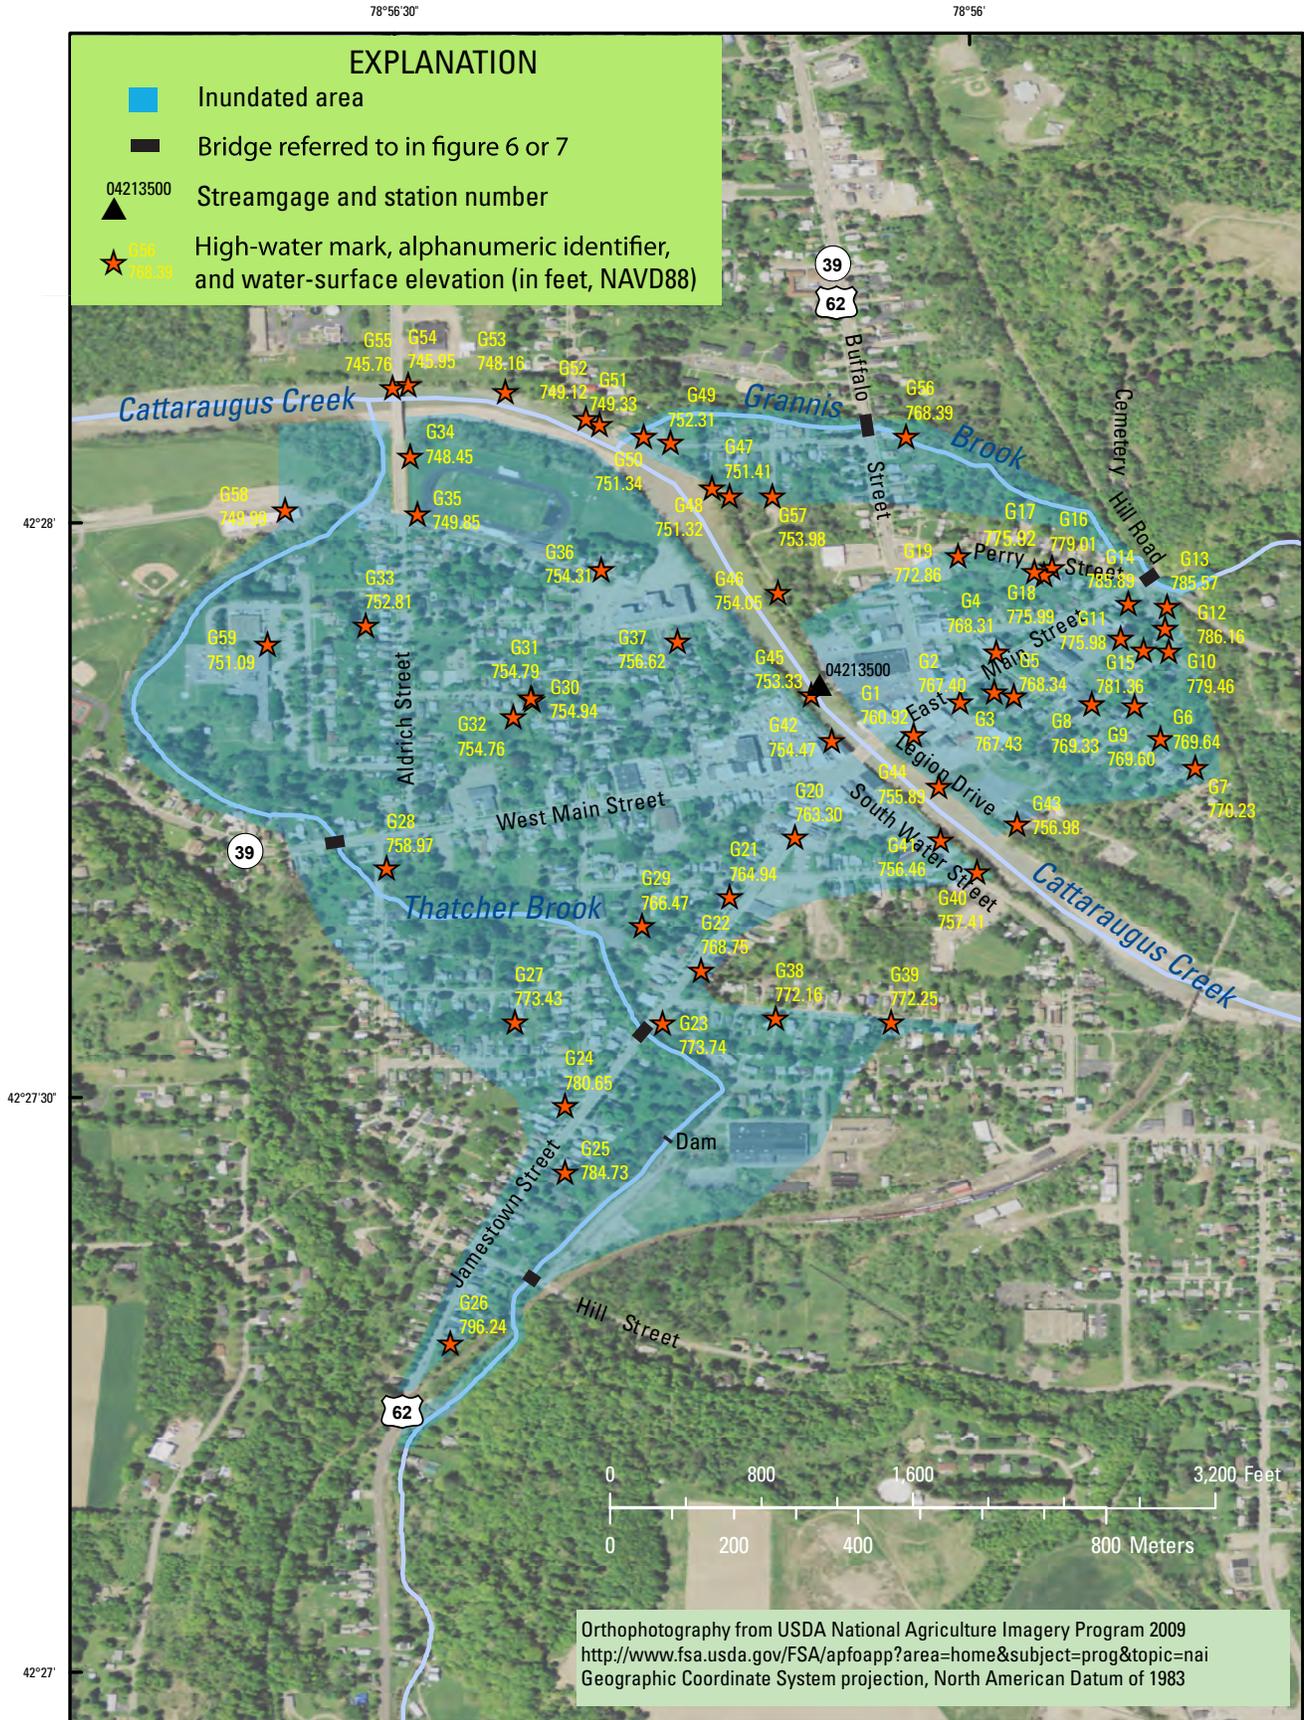
Grannis Brook flooding was exacerbated by the culvert at Cemetery Hill Road, which because of its small size could not convey the flood flows and was partly blocked by debris. Water outside of the channel at this point flowed down East Main Street and Perry Street, through the adjacent residential areas (fig. 10). Floodwaters, up to 3 ft deep, continued through the commercial area along Buffalo Street (U.S. Highway 62) before flowing into Cattaraugus Creek. At the south end of the village, floodwaters in Thatcher Brook had exceeded that channel's capacity to such a degree that water levels just south of the village limit overtopped the western bank on which U.S. Highway 62 is located (fig. 10). Water flowed down U.S. Highway 62 (Jamestown Street) through a railroad underpass, then through a residential area that, for lesser magnitude floods, would have been protected from flooding by the railroad embankment between this neighborhood and the brook. Downstream from the end of the railroad embankment (upstream from Hill Street), the floodwaters on either side of the embankment combined and flowed as sheet flow, in some cases more than 3 ft deep, throughout the village from this point to Cattaraugus Creek.

Figure 10. Areal extent and water-surface elevations of flooding in Gowanda, N.Y., August 10, 2009.

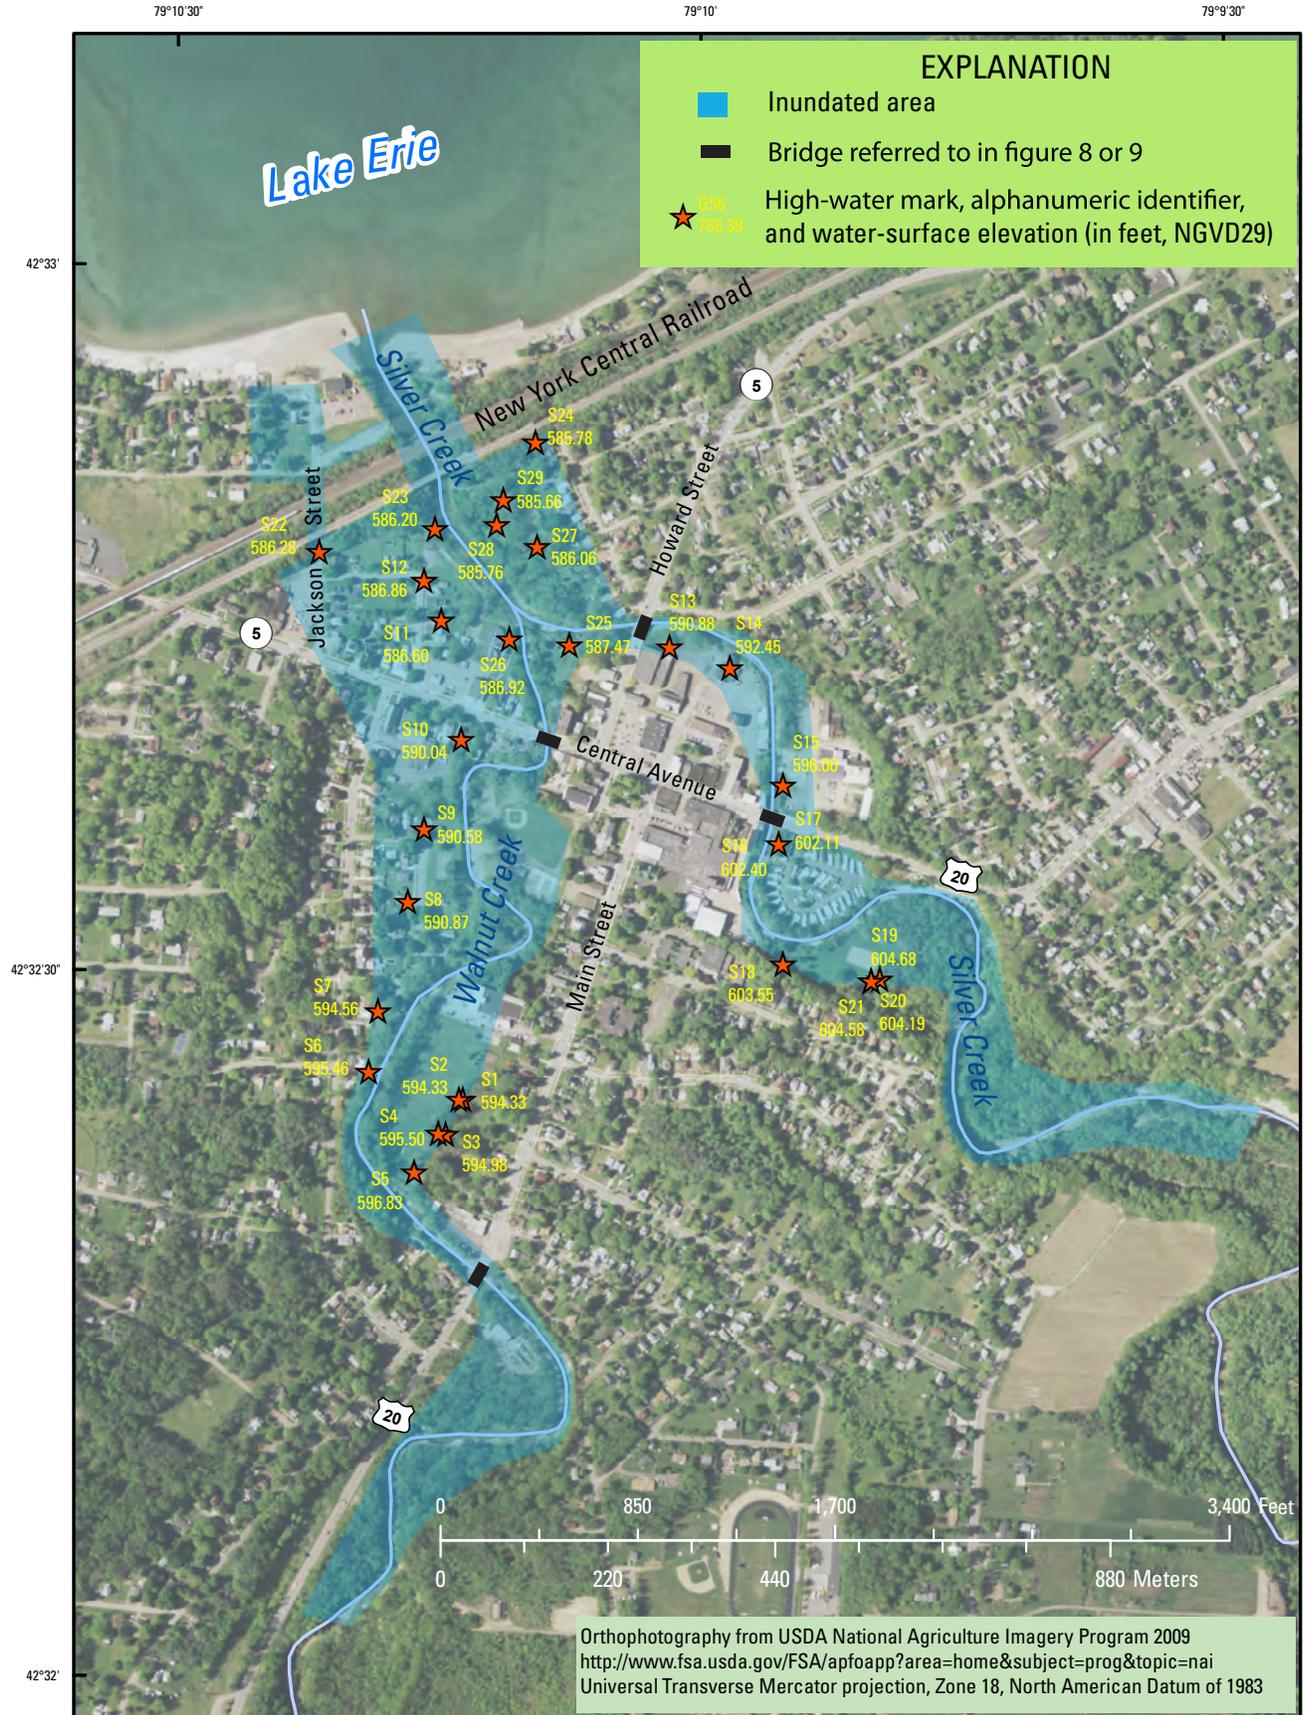
Floodwaters in Silver Creek upstream from the village limit covered the vegetated floodplains on the insides of meander bends but were confined by the valley walls and caused no destruction of property. Once inside the village limits, however, floodwaters inundated the floodplain areas on which a trailer park and businesses had been built, caused extensive damage, and threatened the lives of residents and emergency responders. A similar situation occurred on Walnut Creek, but most of the damaged properties between Main Street (U.S. Highway 20) and Central Avenue (State Highway 5; fig. 11) were private residences. Water depths in these areas typically ranged from 3 to 5 ft but increased to as much as 8 ft in the area below the confluence of the two creeks, where the railroad embankment that parallels the Lake Erie shoreline caused the floodwater to pond before eventually draining through one of two outlets—Silver Creek or the Jackson Street railroad underpass (about 800 ft to the west; fig. 11).

Figure 11. Areal extent and water-surface elevations of flooding in Silver Creek, N.Y., August 10, 2009.
