Geomorphology and Bank Erosion of the Matanuska River, Southcentral Alaska

Scientific Investigations Report 2011–5214

By Janet H. Curran and Monica L. McTeague

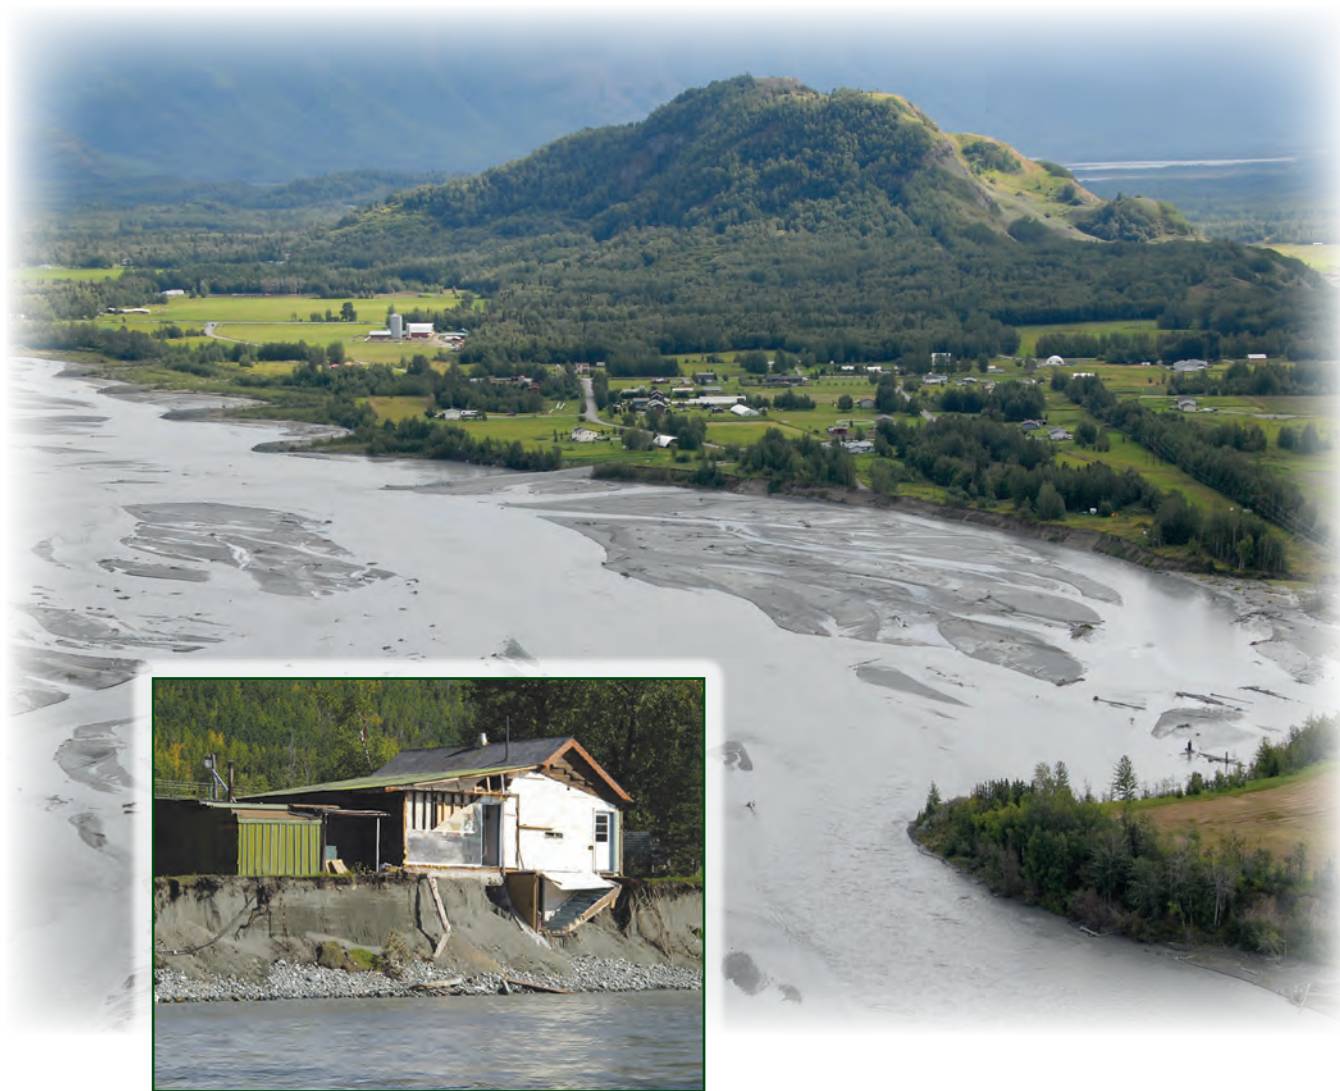
Cover: Photograph showing erosion control dikes and unprotected, eroded banks at Circle View Estates, Braid Plain Mile 4 of the Matanuska River, southcentral Alaska. View is upstream. Homes and small farms occupy the glacial outwash terrace that forms the bank of the braided river and extends toward the prominent bedrock knob, Bodenburg Butte. Photograph taken by Janet Curran, U.S. Geological Survey, August 14, 2007.

Inset: Photograph showing house on river terrace damaged by bank erosion, Matanuska River Braid Plain Mile 24, near Sutton, Alaska. Photograph taken by Janet Curran, U.S. Geological Survey, August 31, 2010.

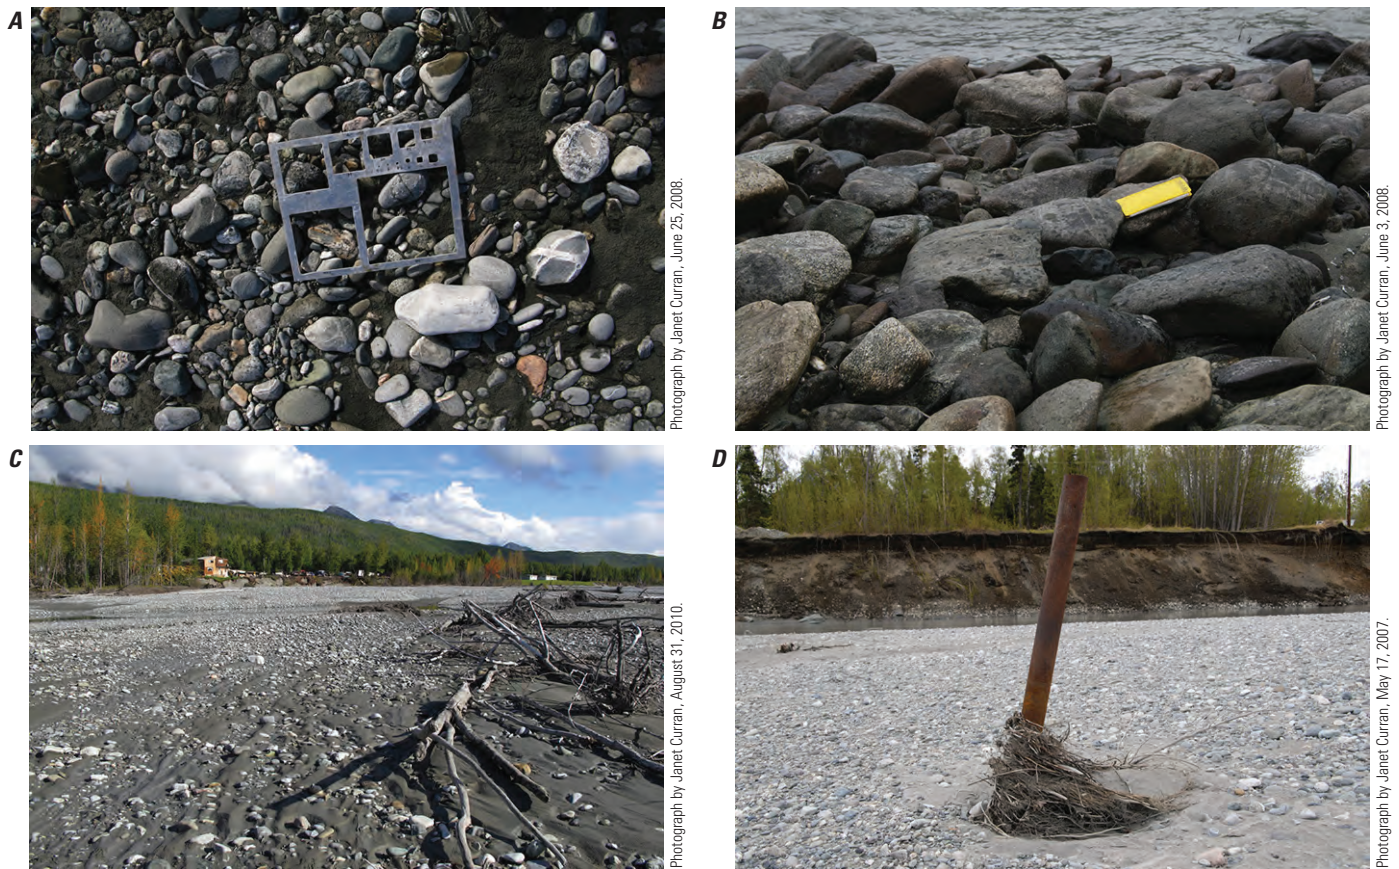
observations documented a significant coarsening of bed material in Reach 4, including bars containing subrounded, imbricated boulders (fig. 14B) suggesting deposition at large flows. Hydraulic forces and the relative influence of floods from large tributaries like the Chickaloon River are likely greater in this narrow, single-thread channel reach, which may account for the coarser bed, but it also may be a function of the more resistant bedrock in this reach. Boulders present in Reach 6 are outsized relative to bed sediment and are likely morainal material. An isolated boulder deposit on the left bank at BPM 54, upstream of Gravel Creek, had no sand or gravel exposed at the surface; contained imbricated, subangular cobble-to-boulder sized clasts; and stood 5–10 ft above the adjacent braid plain, suggesting deposition by a local, outsized flood.

Figure 14. Bar material along the Matanuska River, southcentral Alaska. (A) Reach 5, braid plain mile (BPM) 49.0, largest opening is 180 mm (7.1 in.). (B) Reach 4, BPM 36.3, notebook is 8 in. long. (C) Reach 3, BPM 24.0. (D) Reach 1, BPM 4.2.

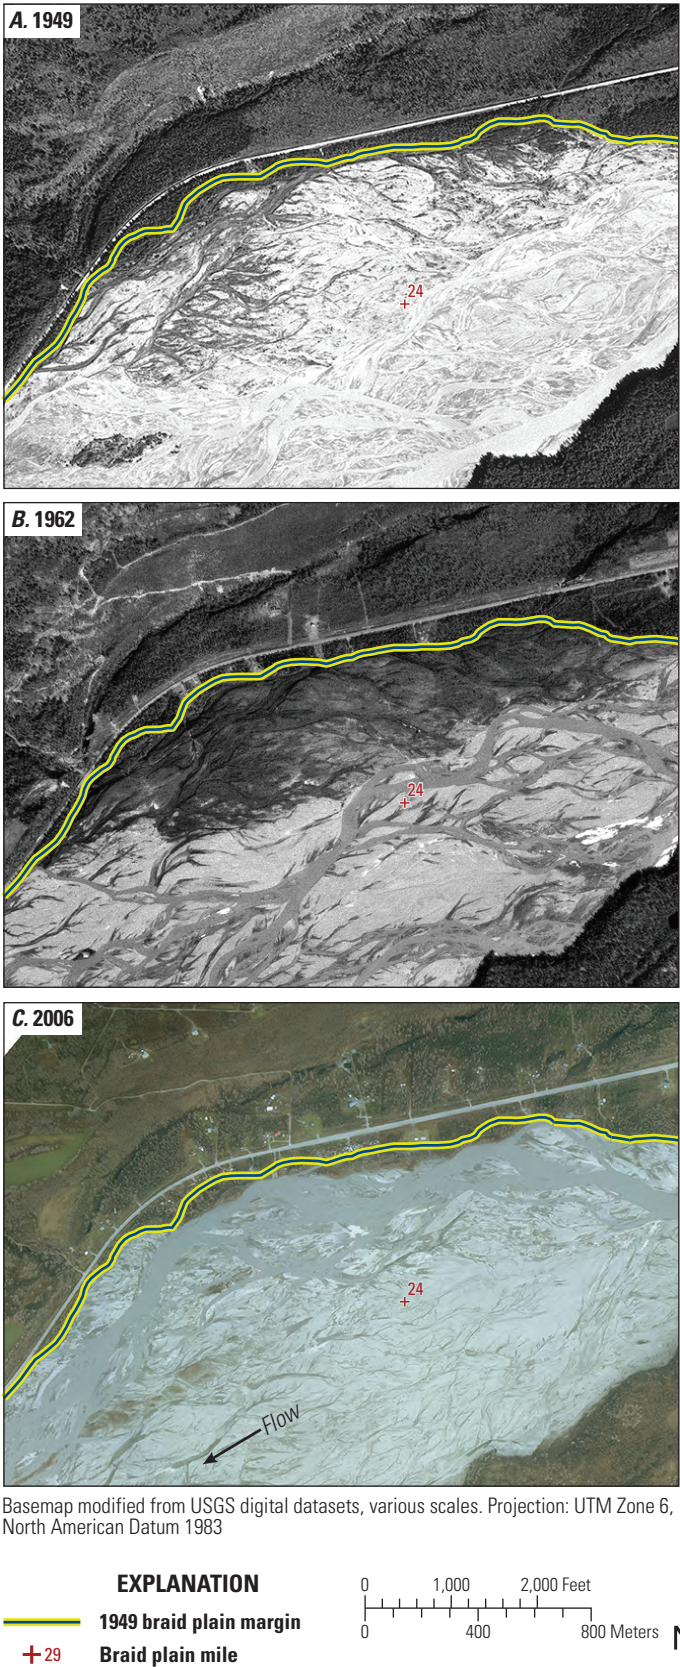
Figure 17. Braid plain change 1949–2006 between Kings River and Granite Creek, southcentral Alaska. The 1949 braid plain margin line is shown in each image.

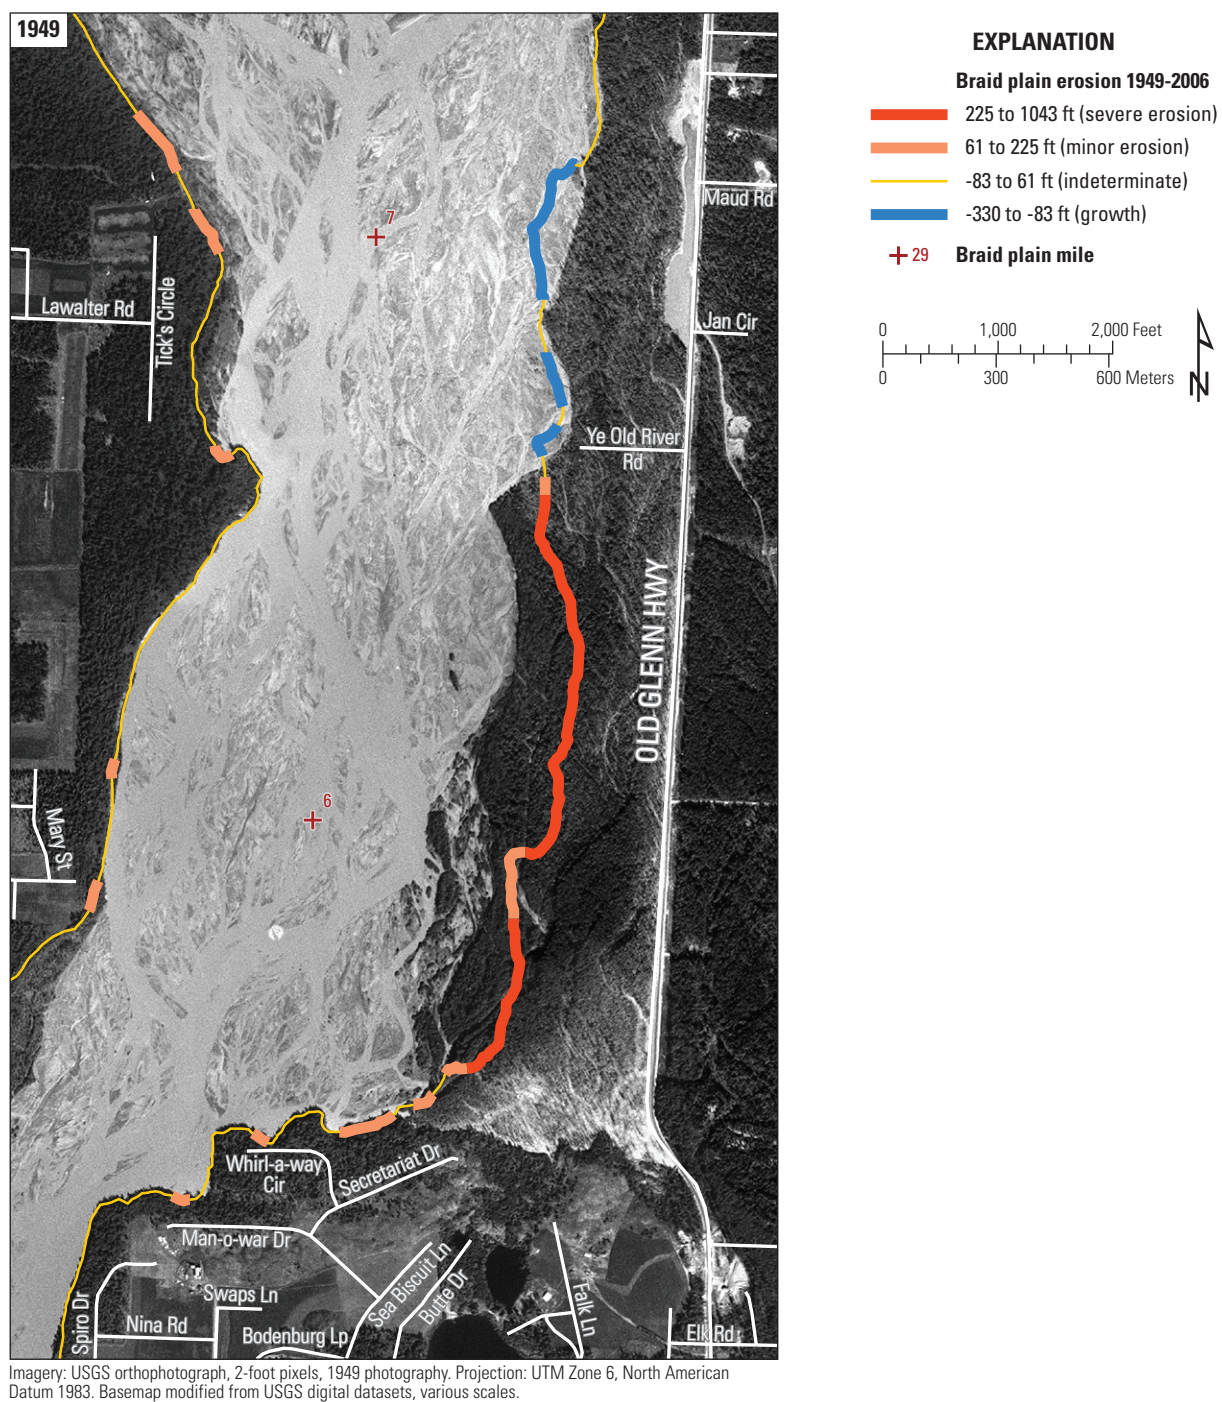
Figure 18. Braid plain margin change classified as growth, indeterminate change, minor erosion, and severe erosion, Matanuska River, southcentral Alaska, 1949–2006.

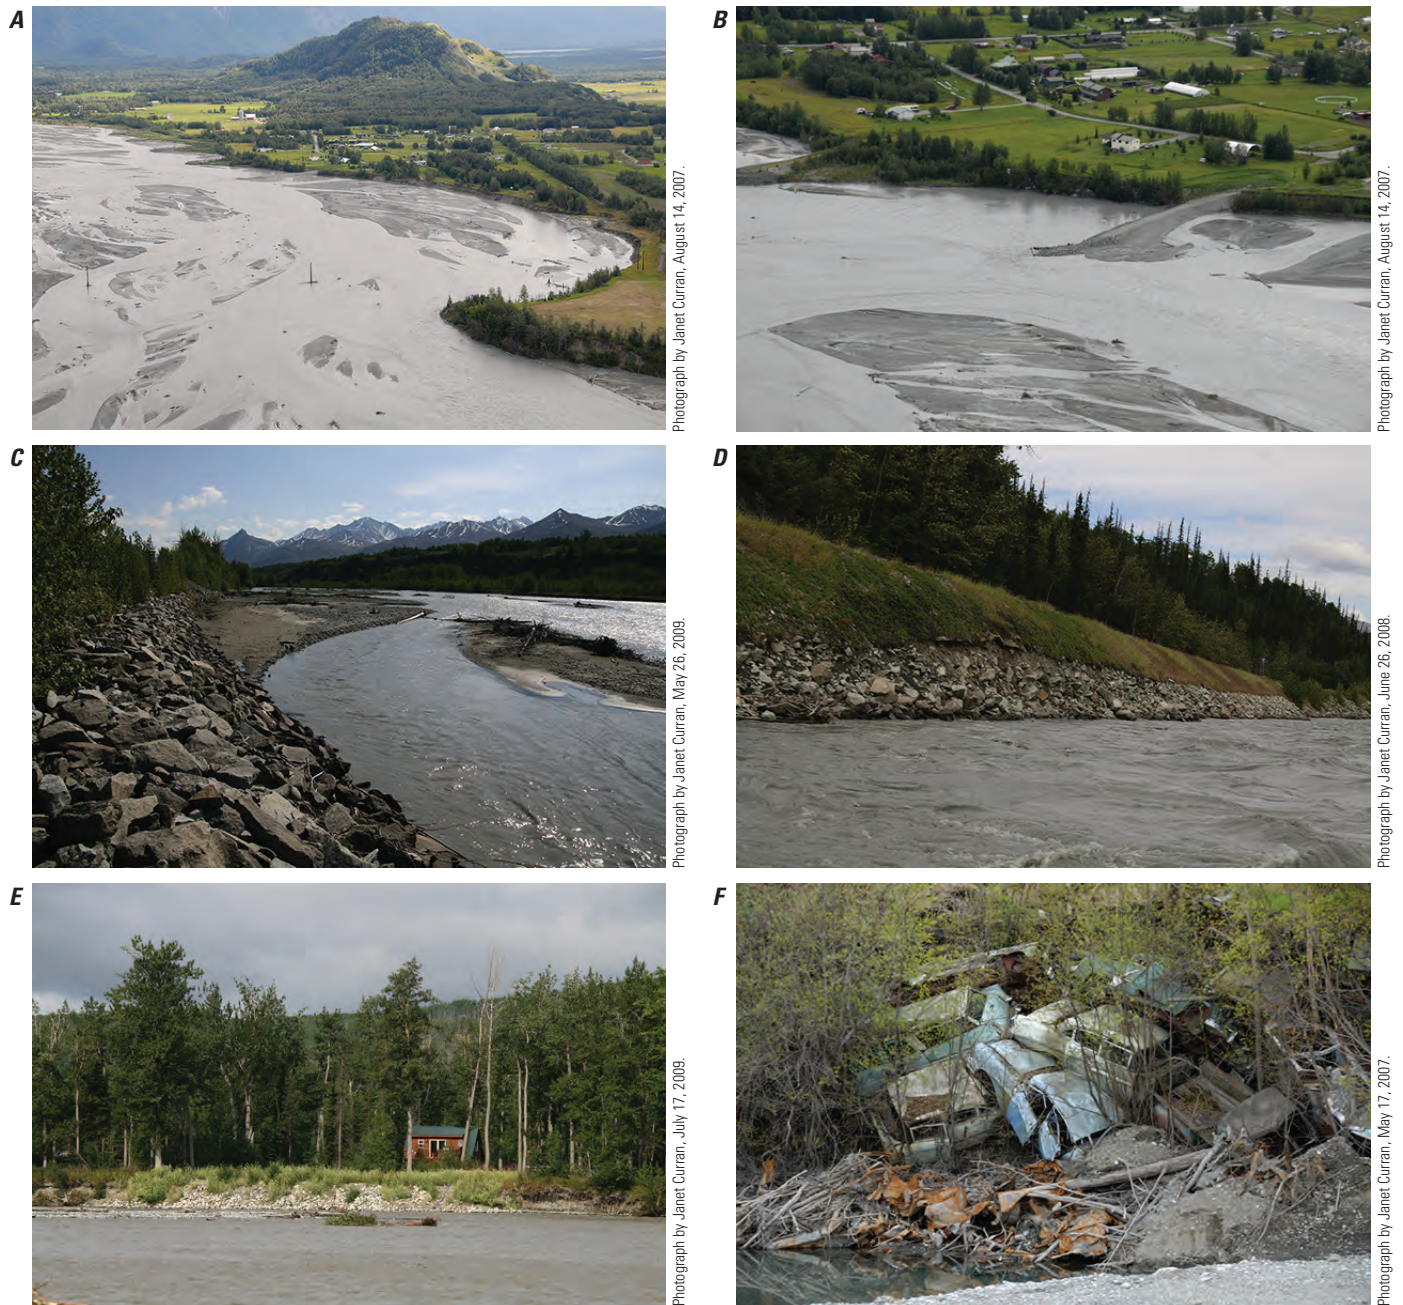
Erosion control along the Matanuska River has included deliberate attempts, such as dikes and riprap ([fig. 25](#)), and indirect actions, such as placement of railroad or highway fill. All detectable engineered or substantial erosion control features present in 2006 are presented in [appendix A](#) (ErosionControlFeatures shapefile), and examples are shown in [figure 26](#). Date of placement ranges from the early 1900s to the past several decades. Most erosion control features present in 2006 consisted of short lengths of riprapped bank or a series of short spur dikes and were installed in response to a threatened or eroding bank. Exceptions include a dike complex near BPM 2 associated with the former Alaska Railroad line to Chickaloon; bank armoring near the Old Glenn Highway between Maud Road and Ye Old River Road ([fig. 18](#)); and a levee 1 mi downstream adjacent to the Old Glenn Highway that targeted flooding rather than bank erosion. Responsible groups range from State and Borough entities to homeowners. Evaluation of the effectiveness or condition of these features was beyond the scope of this report.

Figure 25. Erosion control present along the Matanuska River, southcentral Alaska, that include: (A) Series of dikes near Circle View Subdivision; (B) detail of dike installed near Circle View subdivision in 2007; (C) riprap at King Mountain State Recreation Area; (D) riprap along Glenn Highway embankment near Chickaloon showing erosion; (E) rock placed along bank at home near Sutton; and (F) car bodies used as erosion control near Circle View subdivision.

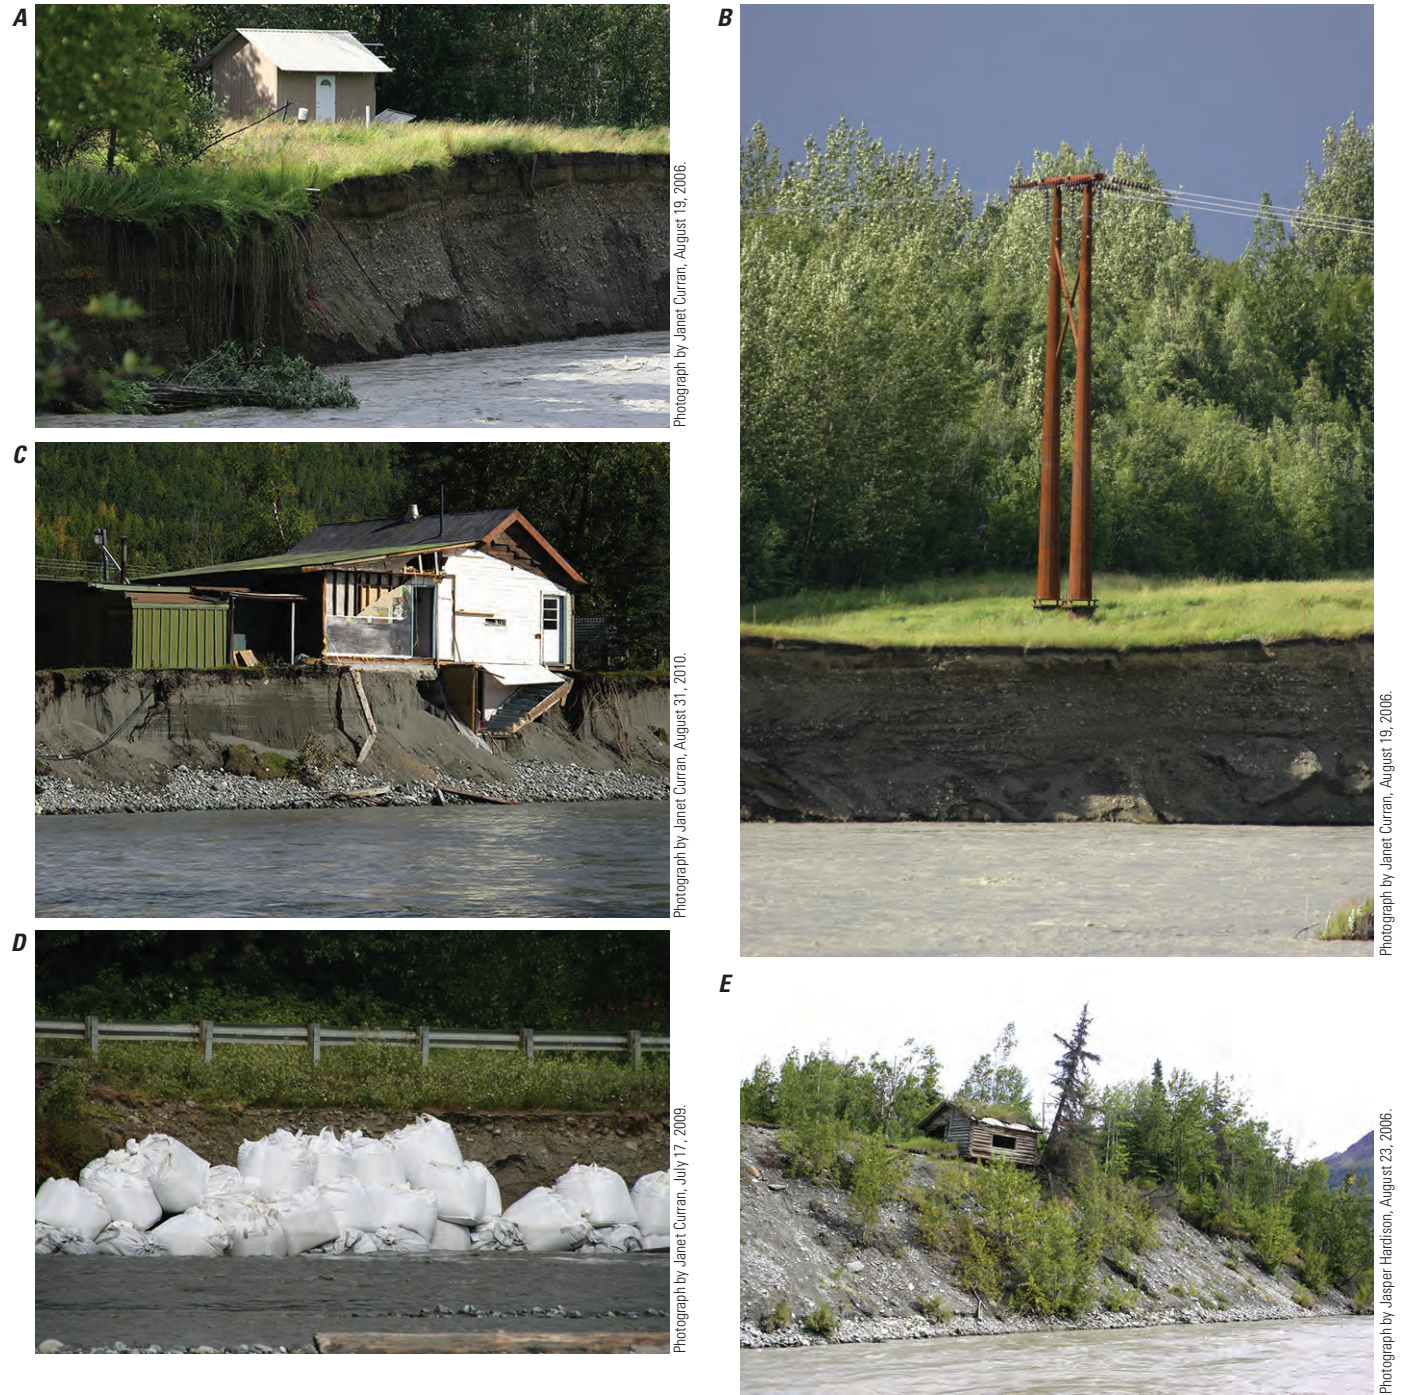
Erosion has impacted or threatened a variety of residential, institutional, or historical structures ([fig. 27](#)). To provide a guiding objective for summarizing erosion hazards (the potential to erode), risks from bank erosion (the harm possible from erosion) were thought of in general categories of land use (undeveloped, residential, public facilities, or infrastructure) and geomorphic zones (river deposits and landslides) for this report. To preserve the ability for others to make different or more specific assessments of risk, if desired, this report discusses general patterns but presents additional detail in the banklines and geomorphic feature GIS files in [appendix A](#). Although long reaches of bank are owned by agencies or Native groups, the significant amount of privately owned banks made retaining spatially detailed information more appropriate than composite assessment of longer reaches.

Figure 27. Structures impacted or threatened by bank erosion along the Matanuska River, southcentral Alaska, that include: (A and B) residential property and utility tower on eroding glacial terrace in Reach 1 near Circle View Subdivision, BPM 4.1; (C) damaged house on terrace in Reach 3 at BPM 24.0; (D) sandbags placed as temporary erosion control at eroded section of Glenn Highway in Reach 3 at BPM 23.5; and (E) historical cabin on presently stable bank at BPM 26.3 near Kings River shows extent of previous erosion.

Although this analysis has primarily focused on erosion detectable by comparing historical and recent orthophotographs, smaller amounts of erosion were observed to have a significant impact to private property and public infrastructure. Although the erosion between Kings River and Granite Creek ([fig. 17](#)) fell below the detection limit for mild erosion in the historical orthophotograph analysis, many structures in this reach were constructed on a terrace within 50 ft of the braid plain margin. Between 2006 and 2010, the erosion, although minor relative to overall historical Matanuska River erosion, resulted in the abandonment of two homes ([fig. 27](#)), imminent threat to many others, and emergency repair to a section of the Glenn Highway ([fig. 27](#)).
