# Bathymetric and Velocimetric Surveys at Highway Bridges Crossing the Missouri River between Kansas City and St. Louis, Missouri, April–May 2013

By Richard J. Huizinga

Scientific Investigations Report 2014–5116

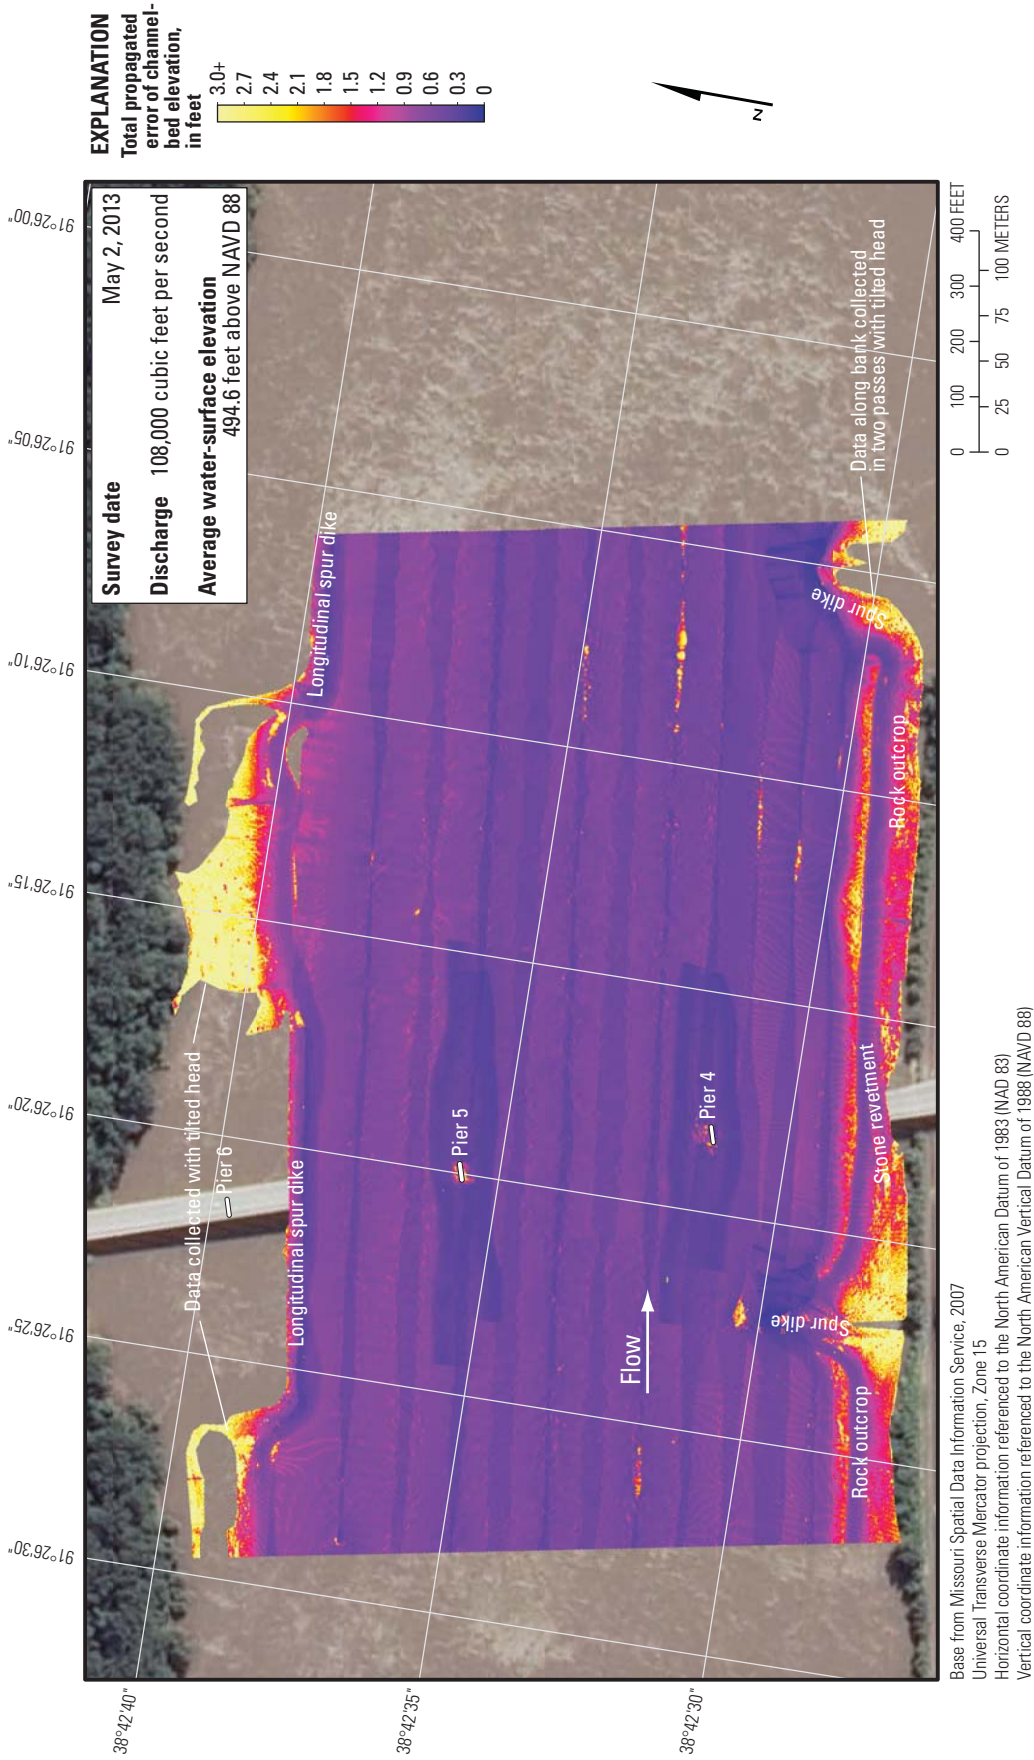
The survey at structure A6288 on Missouri Highway 19 at Hermann, Mo., had the highest mean and median values of TPU, as well as generally the lowest percentage of bathymetry points that were less than the various TPU value cutoffs (table 5). There were no substantial impediments to flow or surveying at this site and the survey was obtained with smooth longitudinal swathes (fig. 5), and that was the case at nearly all of the sites surveyed as part of this study. The magnitude and distribution of TPU values observed at this site are representative of those observed at all of the other surveyed sites.

Figure 5. Total propagated uncertainty of bathymetric data from the Missouri River channel in the vicinity of structure A6288 on Missouri Highway 19 at Hermann, Missouri.

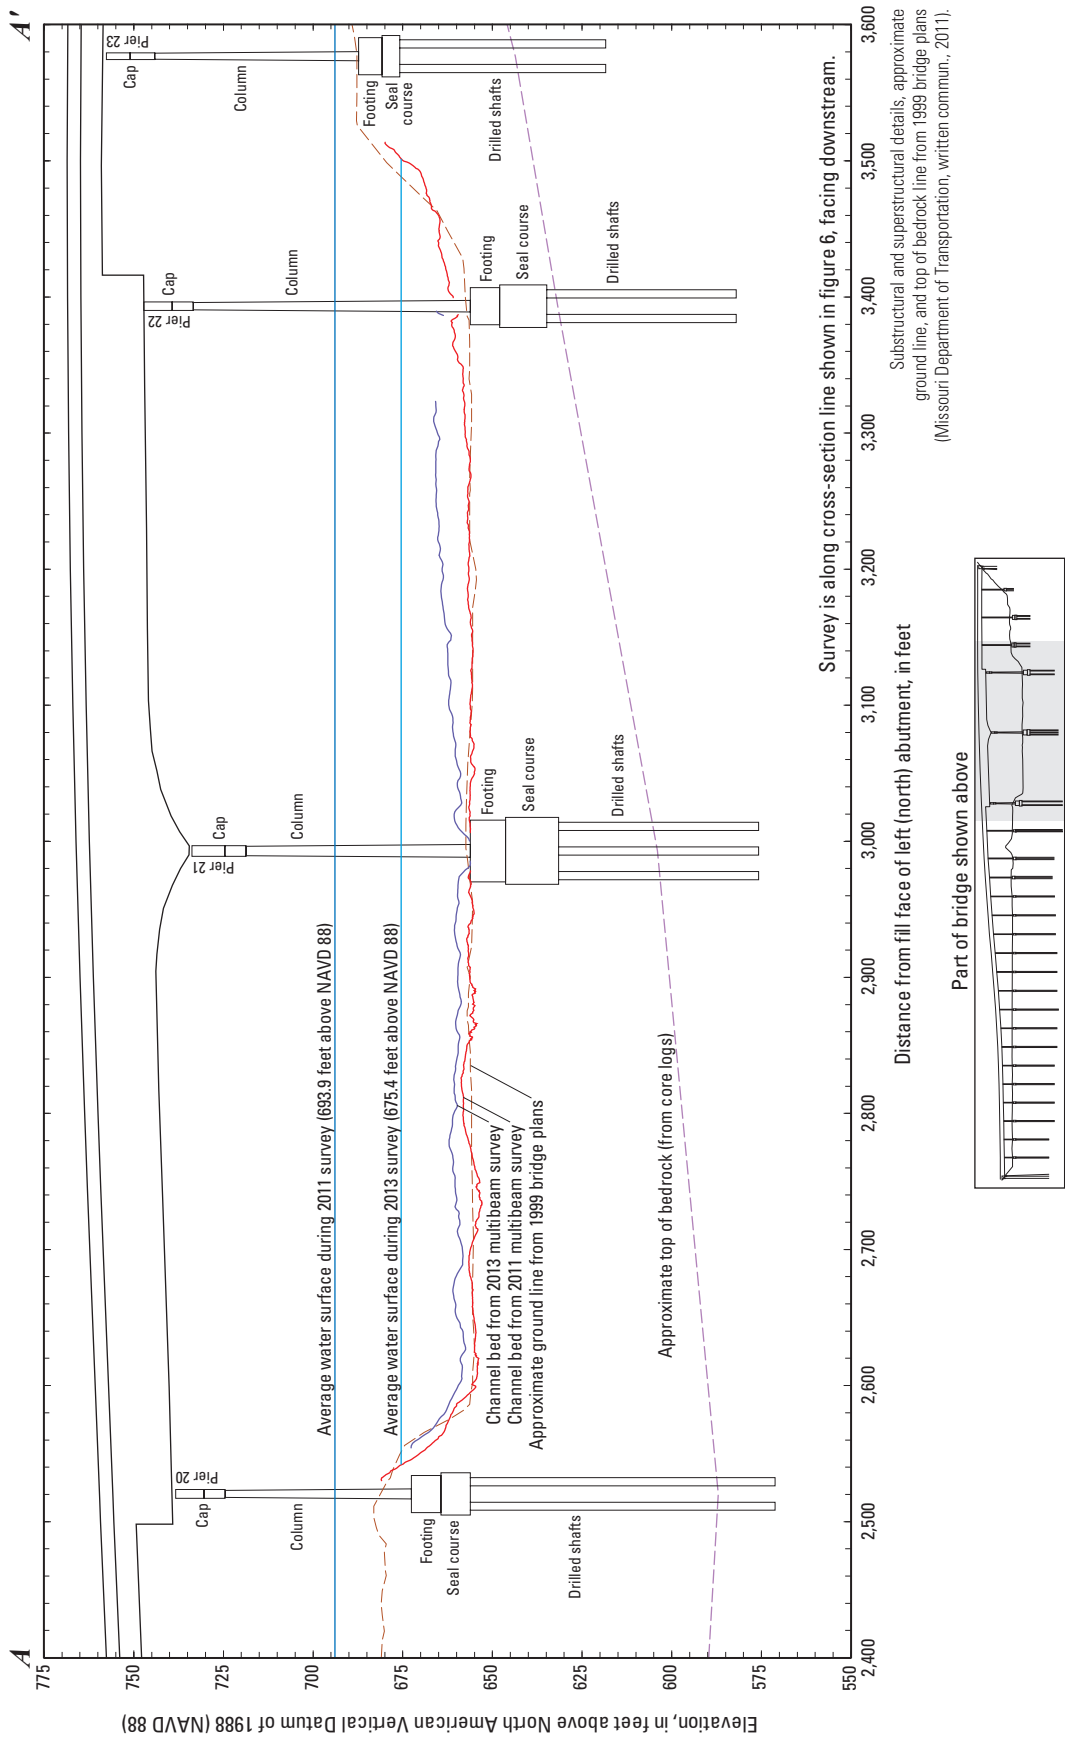
and 22 are founded on shafts drilled 28 to 50 ft into bedrock, having about 52 ft of bed material between the channel bottom and bedrock at pier 21, and about 31 ft of material at pier 22 (fig. 7; table 6). The surveyed bed generally was higher along the upstream bridge face than the original ground line in 1999 from bridge plans and the previous multibeam survey on July 20, 2011, with 5 to 10 ft of deposition between the left bank and pier 21, and 5 to 15 ft of deposition between piers 21 and 22 (fig. 7).

**Figure 7.** Key features, substructural and superstructural details, and surveyed channel bed of structure A5664 on State Highway 13 over the Missouri River at Lexington, Missouri.

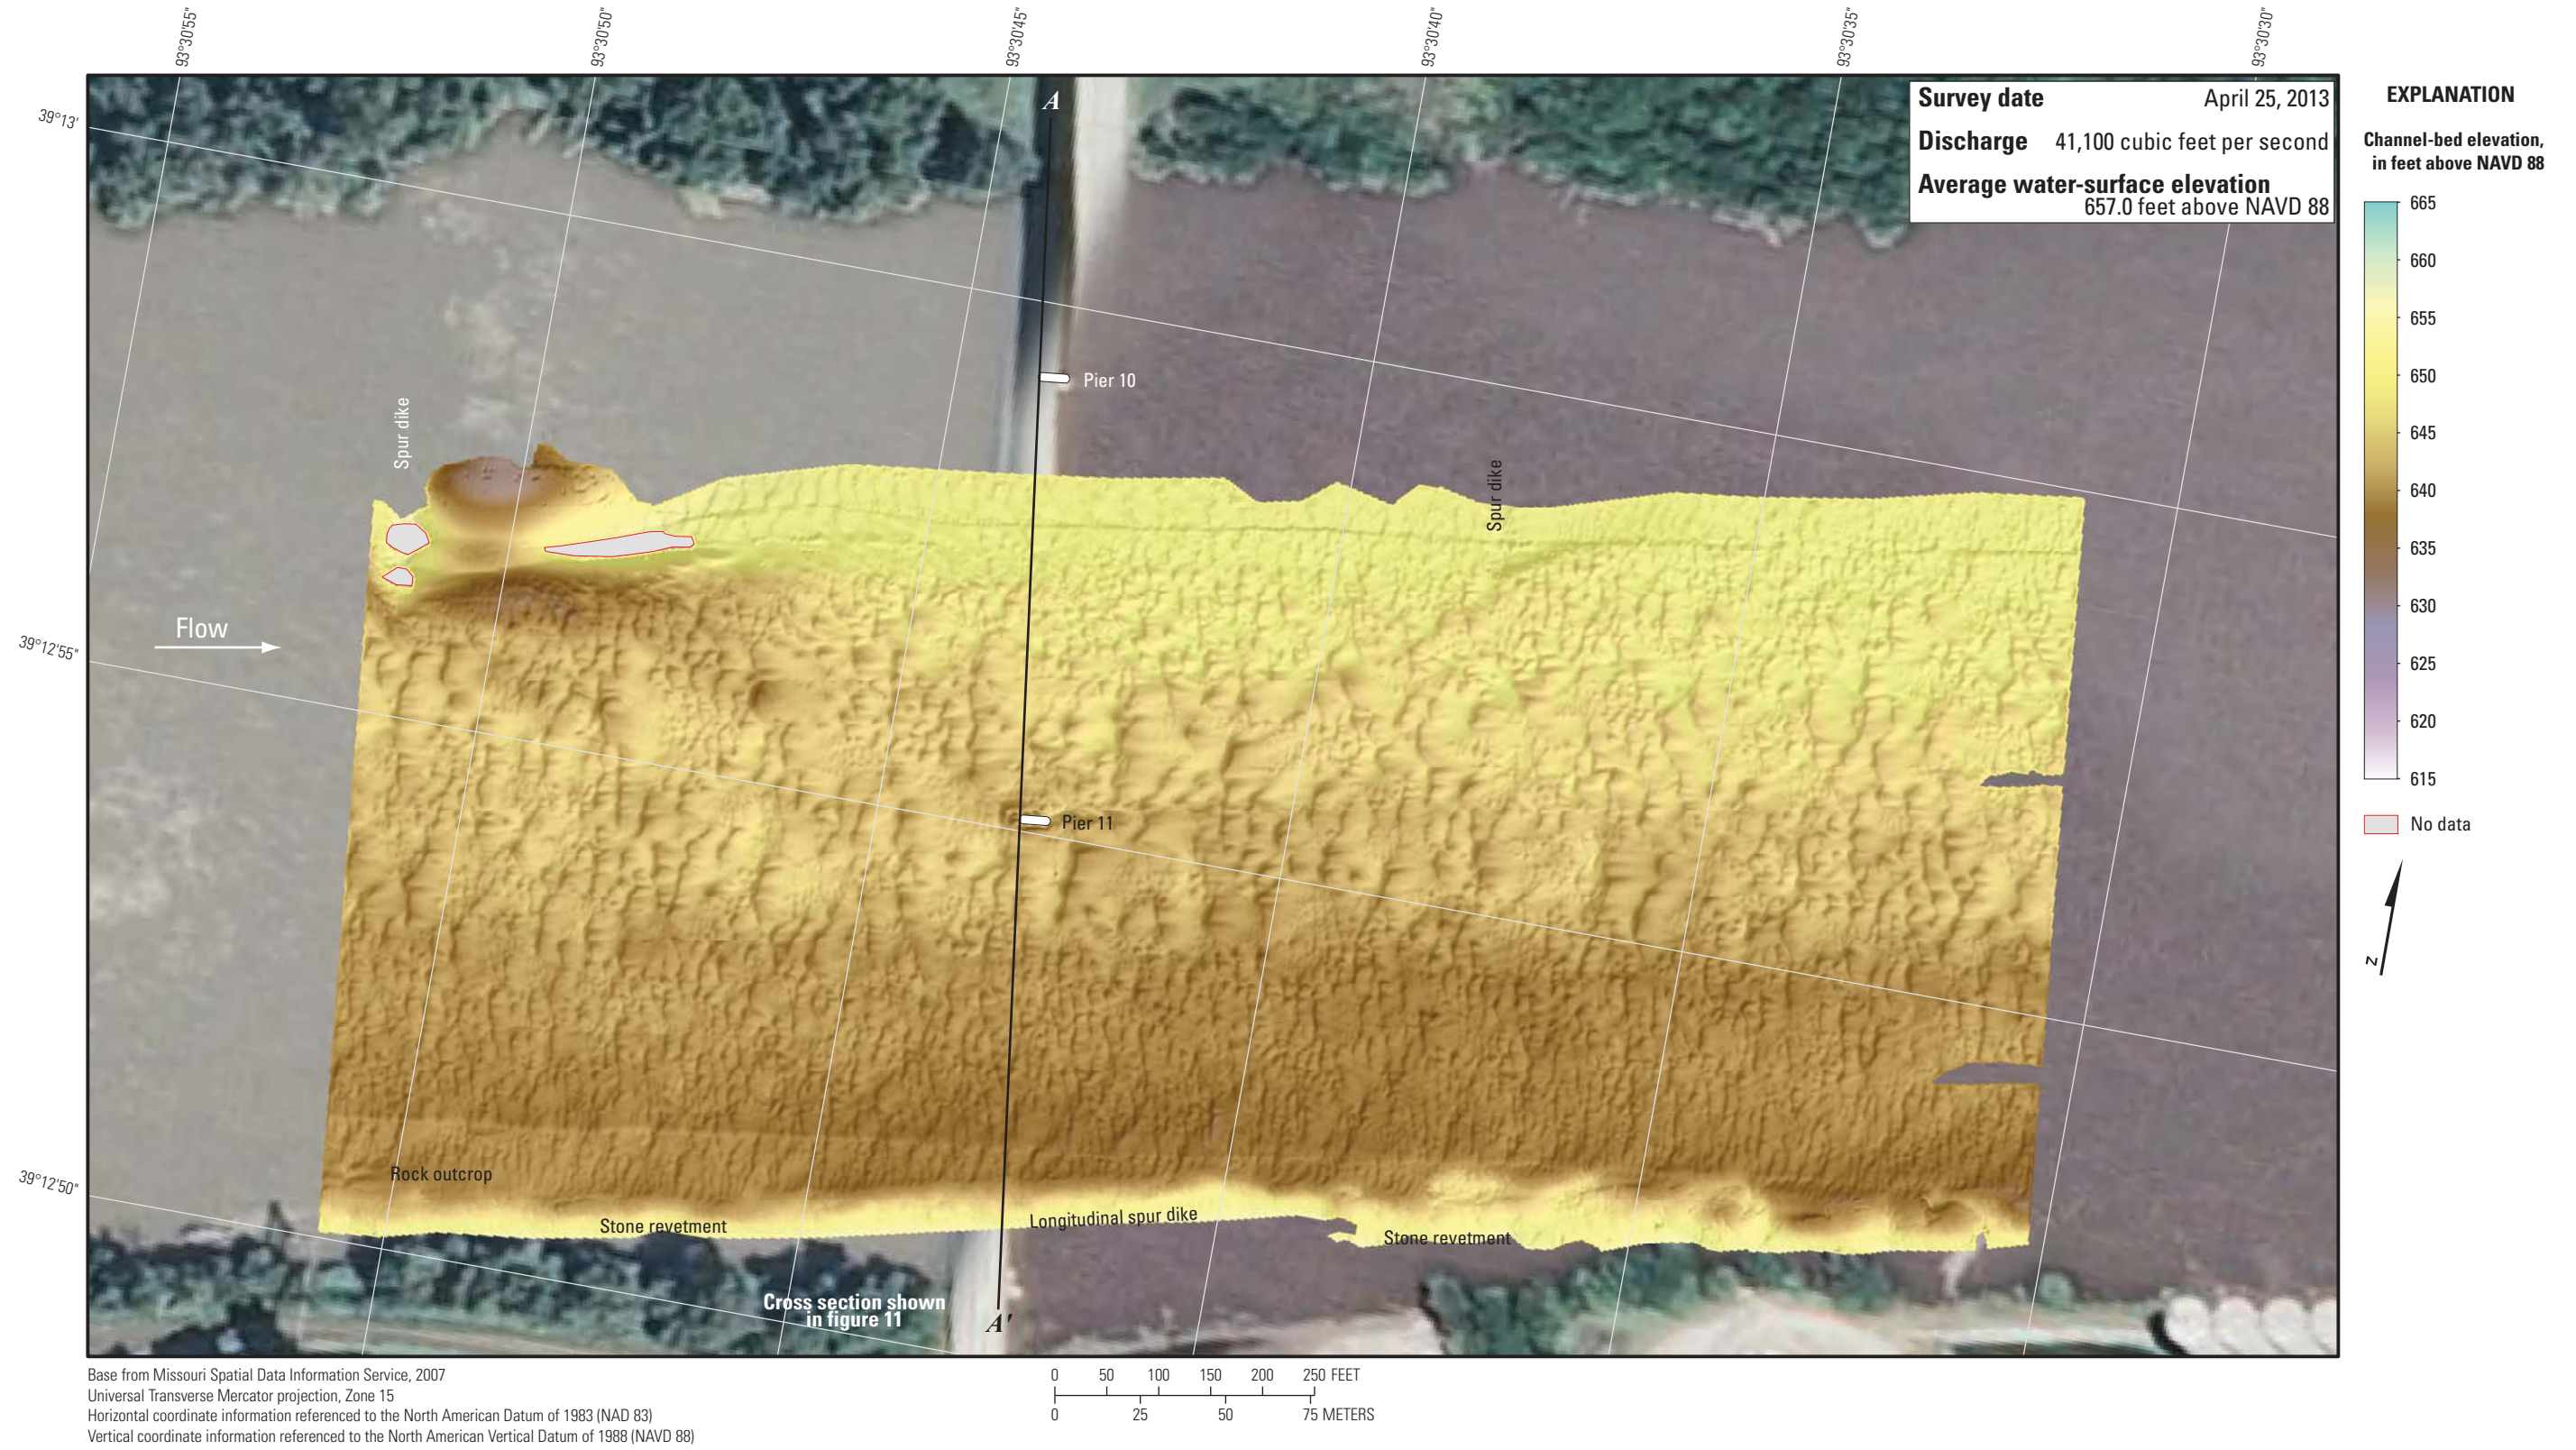
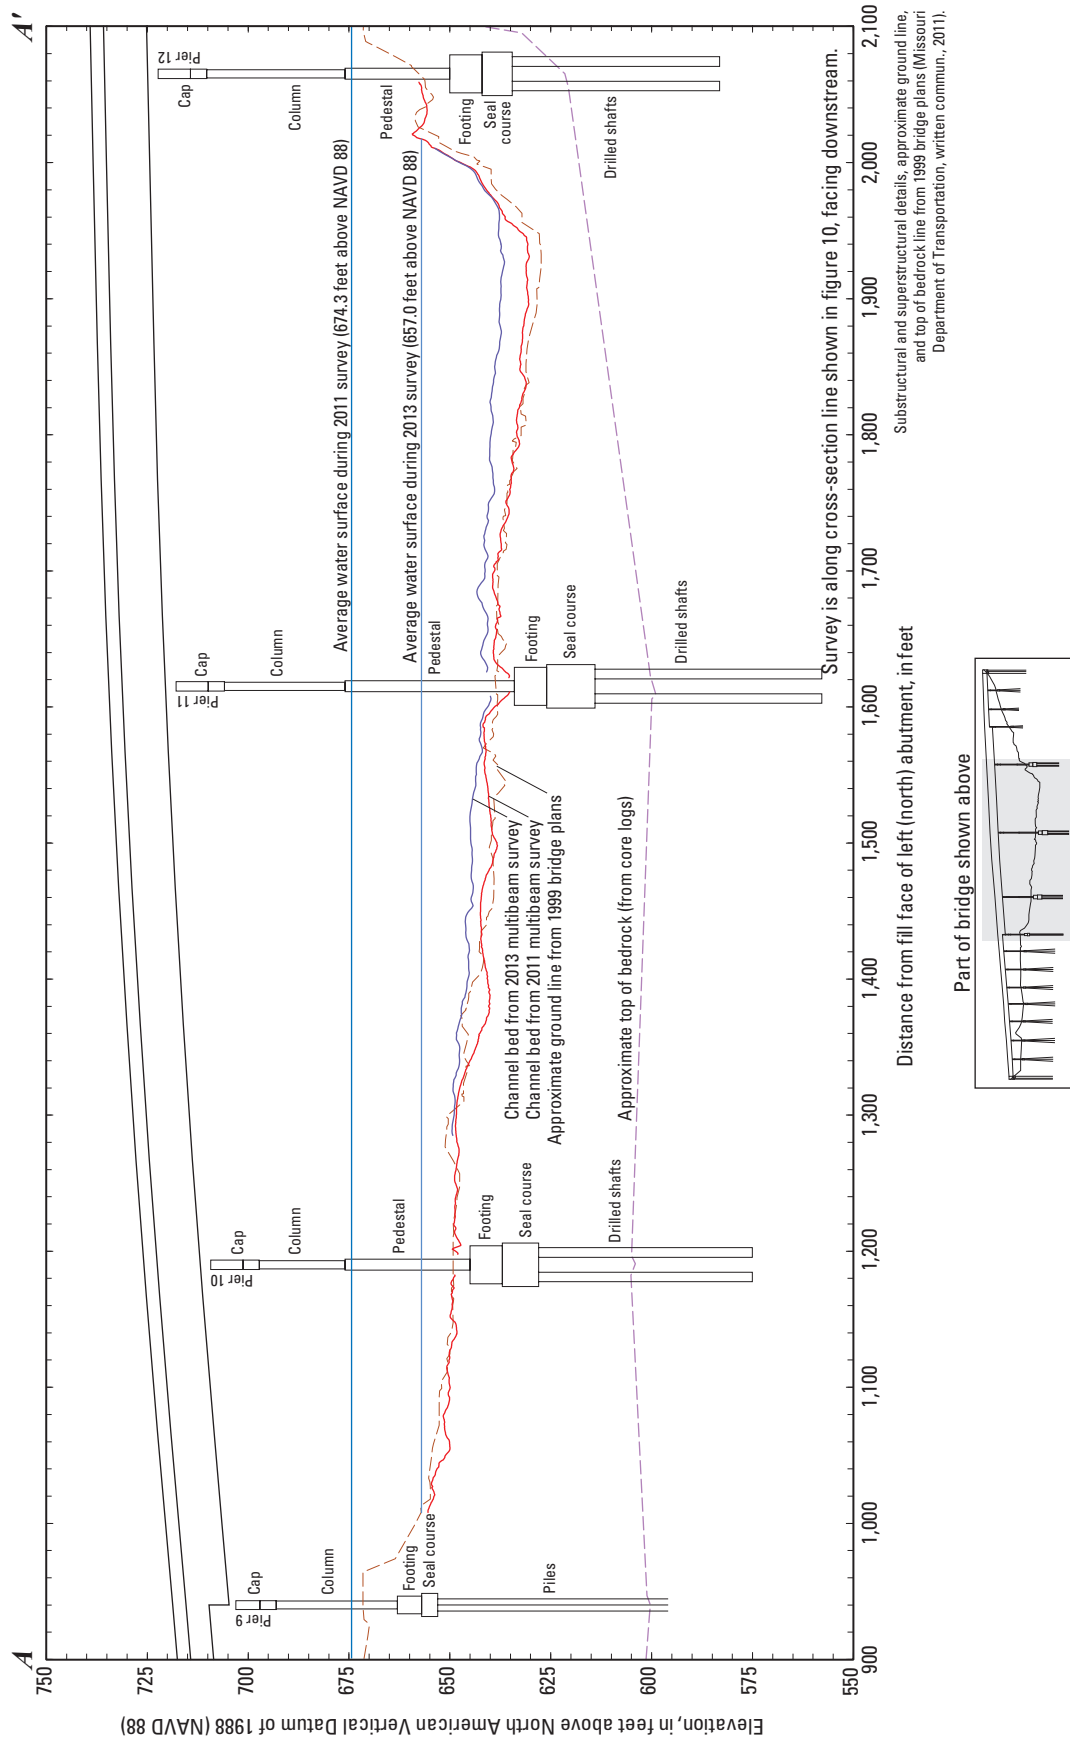
The minor scour hole near pier 10 was difficult to discern from nearby dunes and ripples (figs. 10 and 11). Information from bridge plans indicates that piers 10 and 11 are founded on shafts drilled 30 to 42 ft into bedrock, having about 36 ft of

Figure 10. Bathymetric survey of the Missouri River channel in the vicinity of structure A5910 on U.S. Highway 24 at Waverly, Missouri.

**Figure 11.** Key features, substructural and superstructural details, and surveyed channel bed of structure A5910 on U.S. Highway 24 over the Missouri River at Waverly, Missouri.

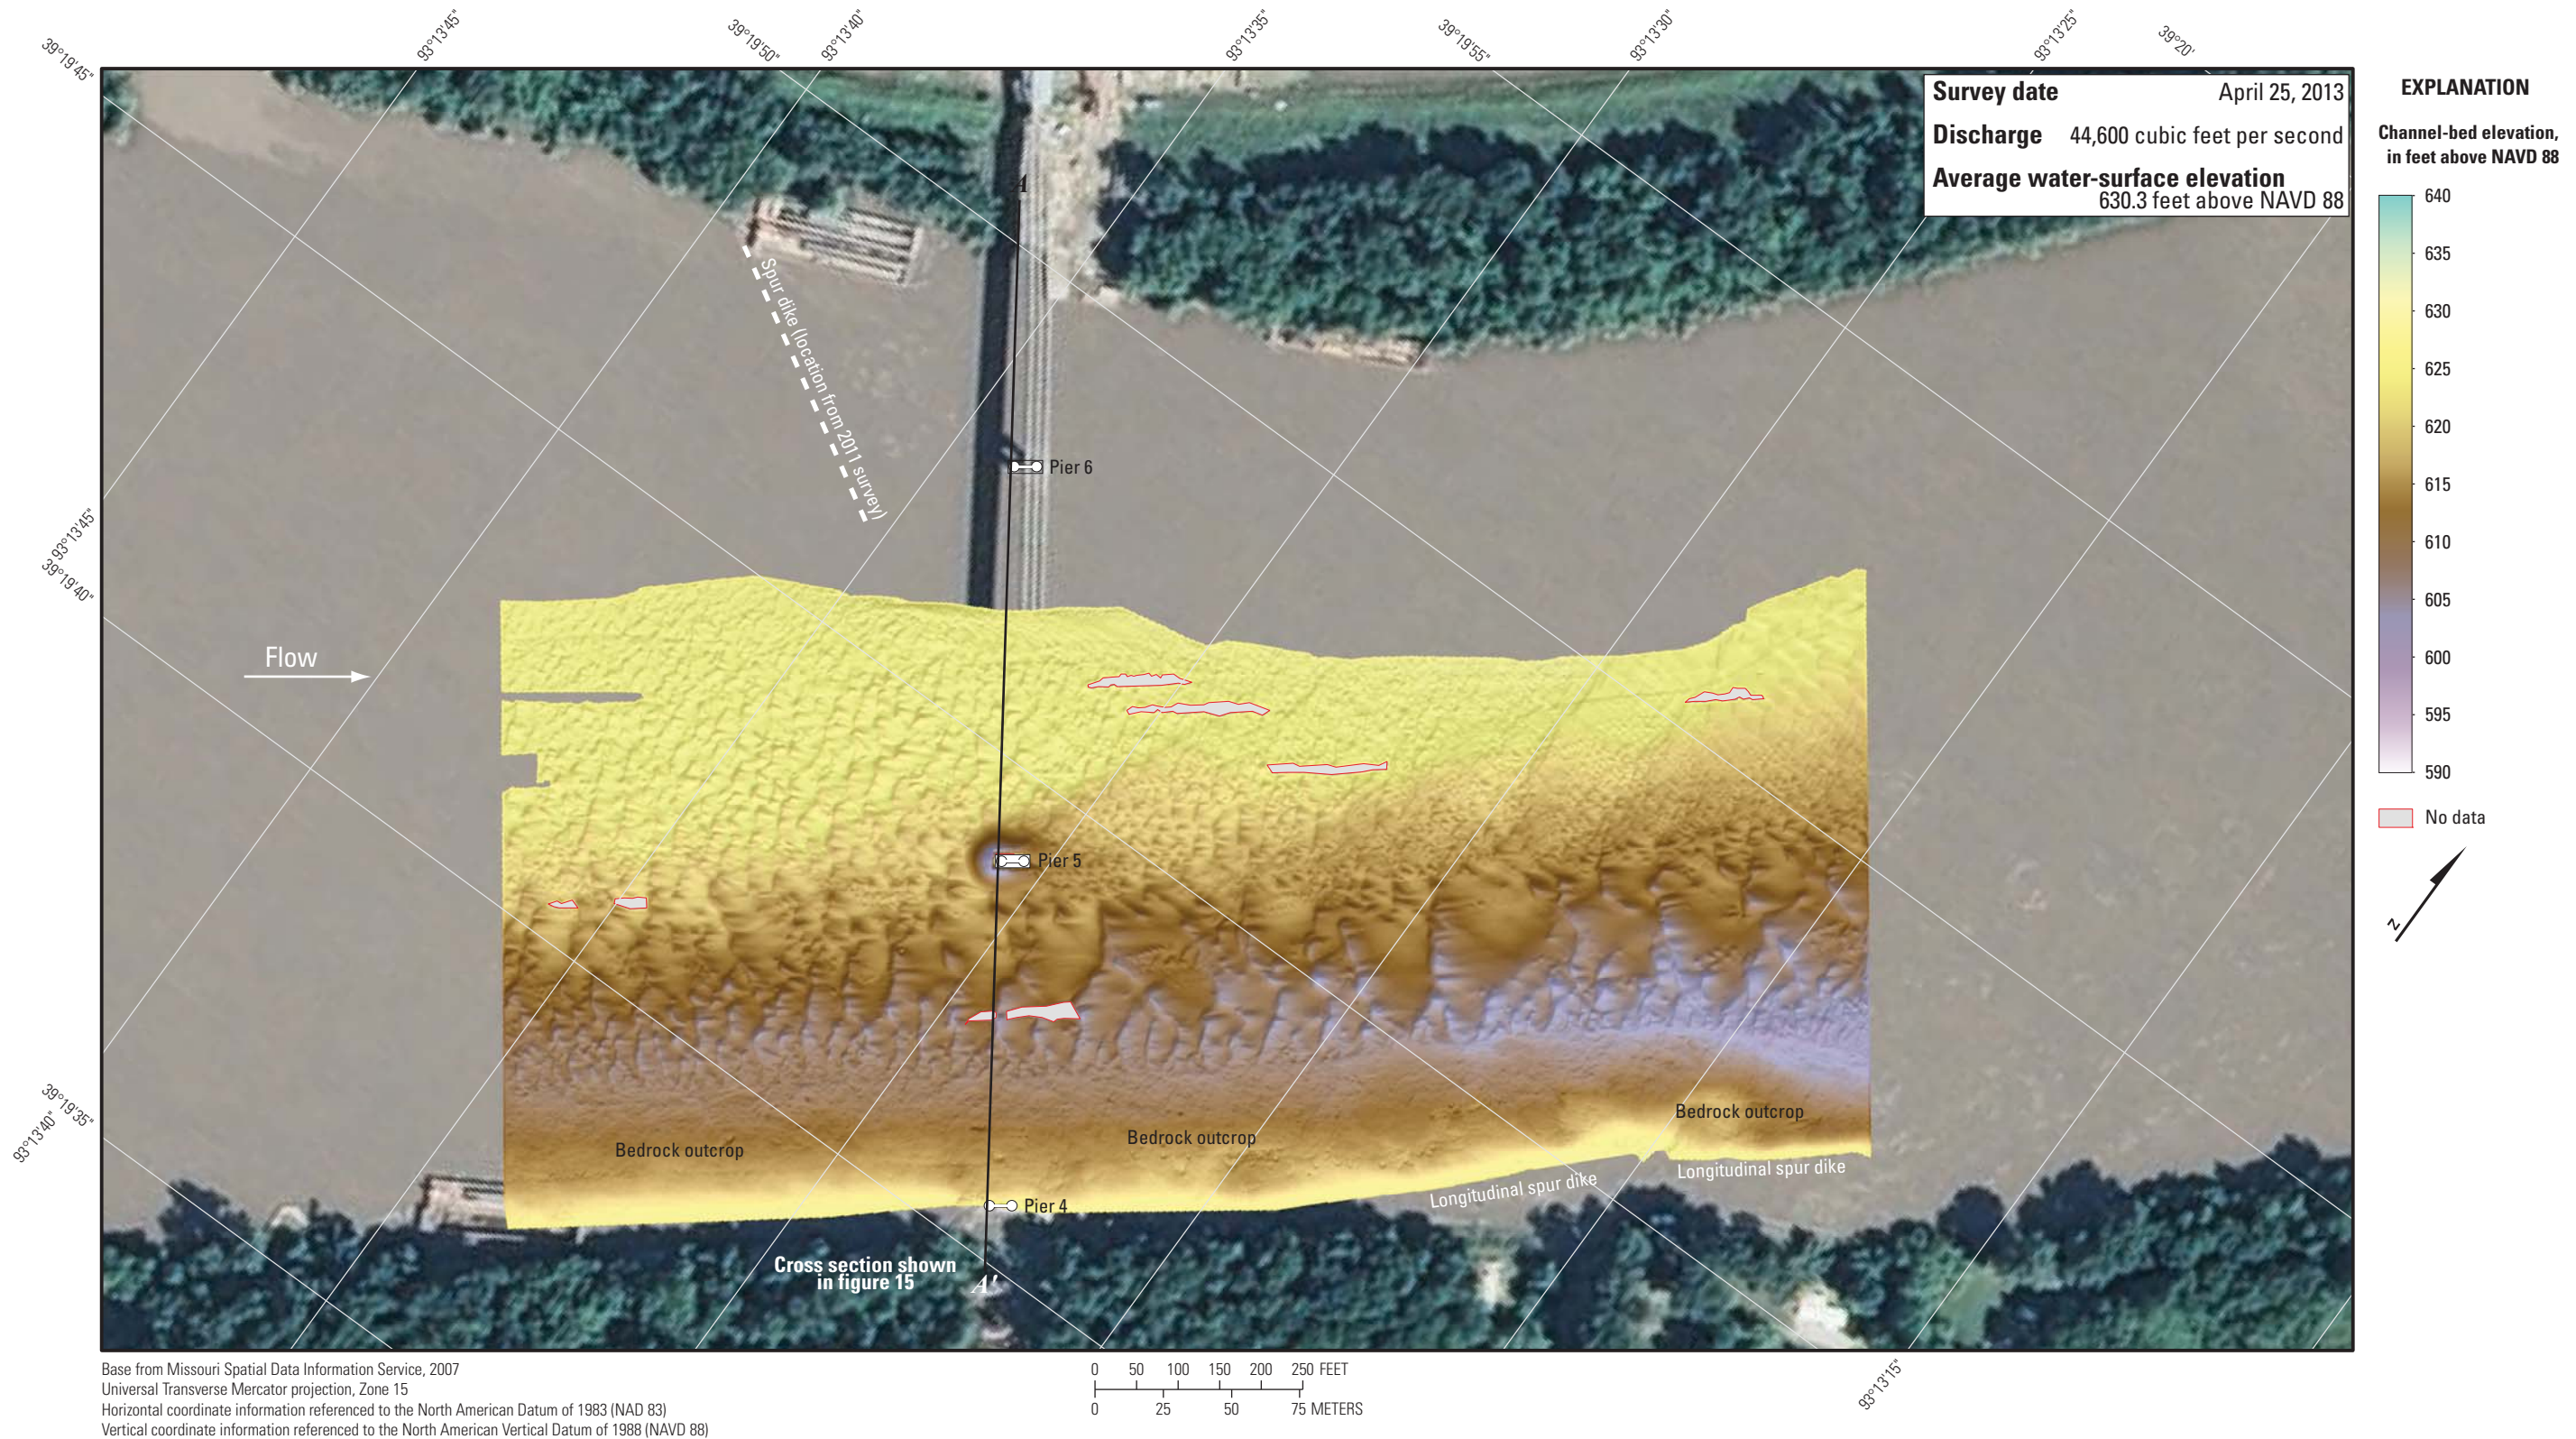
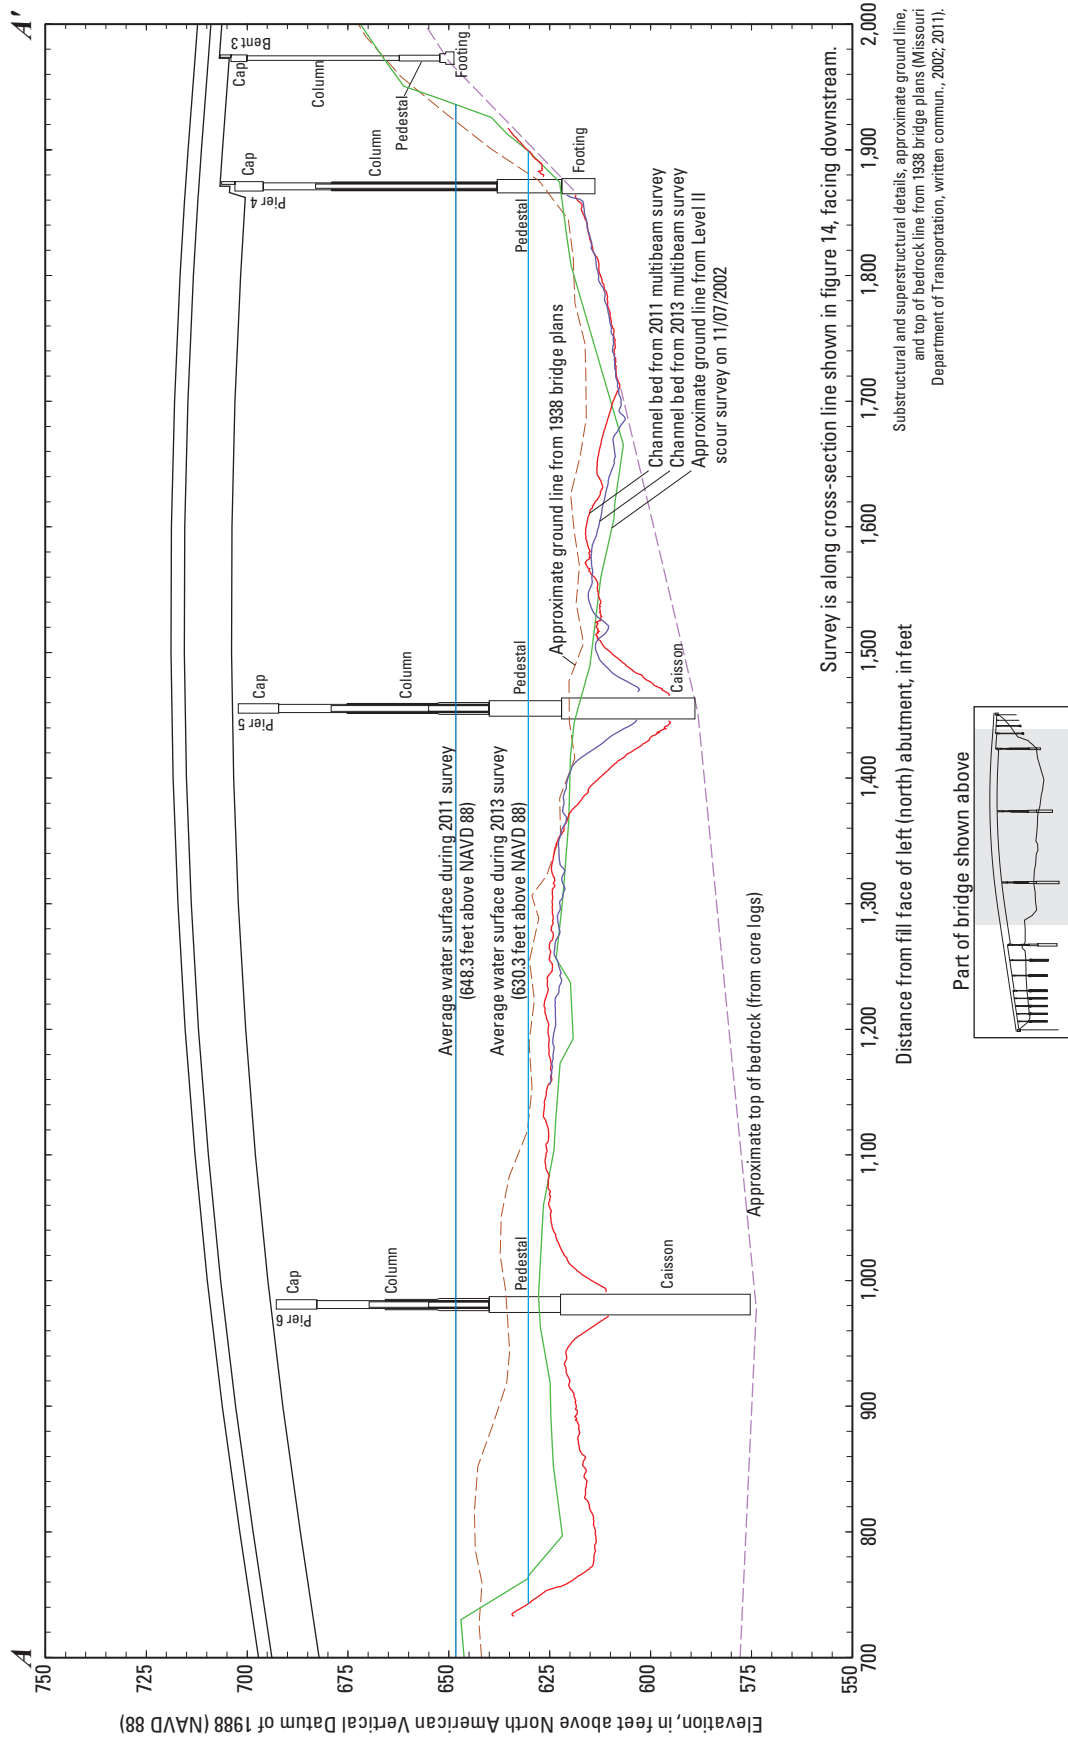
A moderate scour hole was observed in the vicinity of pier 5, and had a minimum channel-bed elevation of about 601 ft (figs. 14, 15; table 6). Information from bridge plans indicates that pier 5 is a caisson founded on bedrock, having about 13 ft of bed material between the bottom of the scour hole and bedrock at pier 5 (fig. 15; table 6). Pier 4 is founded on a footing on bedrock according to bridge plans

(fig. 15; table 6), and no scour hole was observed near the pier (fig. 14). The surveyed bed along the cross section generally was about 5 ft lower than the previous multibeam survey in 2011, except near the piers, making it more similar to the ground line from the Level II bridge scour assessment in 2002 (Huizinga, 2004; fig. 15). The approximate top-of-bedrock line from bridge plans confirms that the fluvial material near the right bank has washed away, exposing the bedrock along the thalweg (fig. 15). In modern construction, bridge substructural elements usually are pinned or socketed to bedrock (American Association of State Highway Transportation Officials, 2012; Brown and others, 2010), but full exposure of usually buried substructural elements warrants special consideration and observation.

Figure 14. Bathymetric survey of the Missouri River channel in the vicinity of structure K0999 on State Highway 41 at Miami, Missouri.

**Figure 15.** Key features, substructural and superstructural details, and surveyed channel bed of structure K0999 on State Highway 41 over the Missouri River at Miami, Missouri.

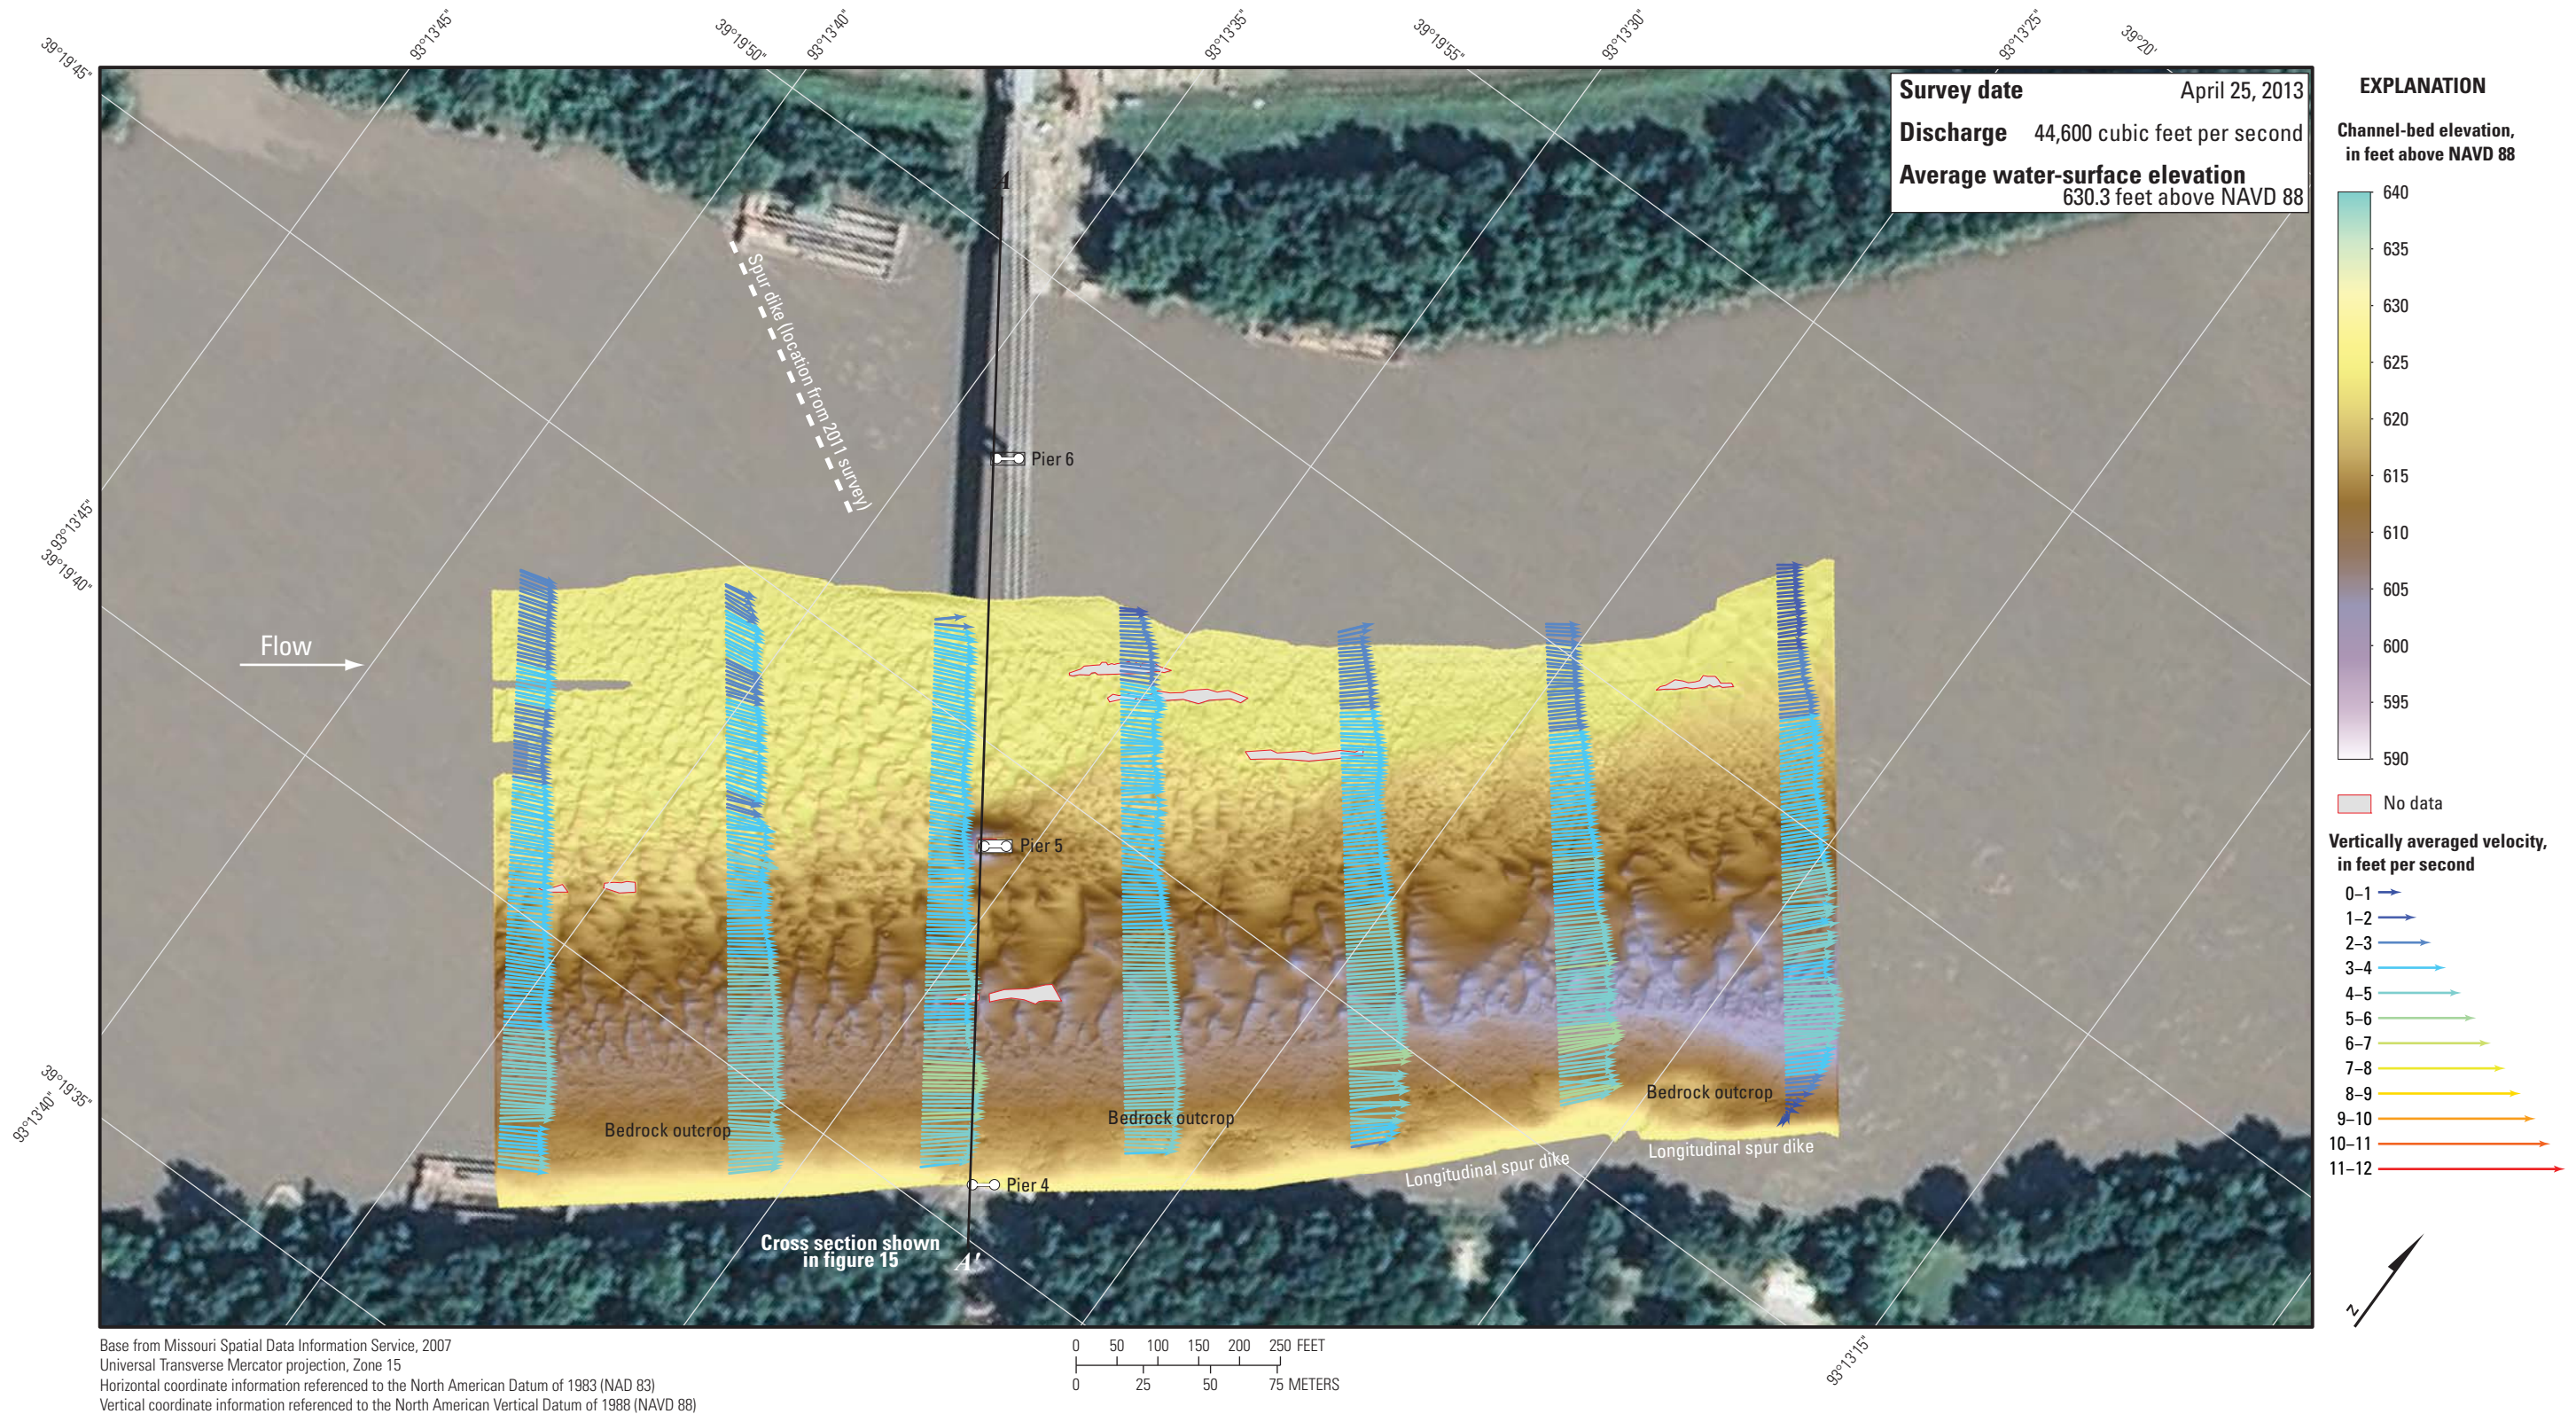
The vertically averaged velocity vectors indicate mostly uniform flow throughout the channel, with velocities ranging from about 3 to 7 ft/s (fig. 17). Velocities were greater in the thalweg, and lower in the shallow area on the left side of the channel (fig. 17). Moderate turbulence and flow reversal was observed downstream from the longitudinal spur dike on the downstream right bank (fig. 17), and flow was deflected towards the right in the upstream reach, likely affected by the spur dike there (fig. 17). The bridge piers were aligned with flow, with no evident turbulence downstream from any pier (fig. 17).

Figure 17. Bathymetry and vertically averaged velocities of the Missouri River channel in the vicinity of structure K0999 on State Highway 41 at Miami, Missouri.
