# Bathymetric and Velocimetric Surveys at Highway Bridges Crossing the Missouri River between Kansas City and St. Louis, Missouri, April–May 2013

By Richard J. Huizinga

Scientific Investigations Report 2014–5116

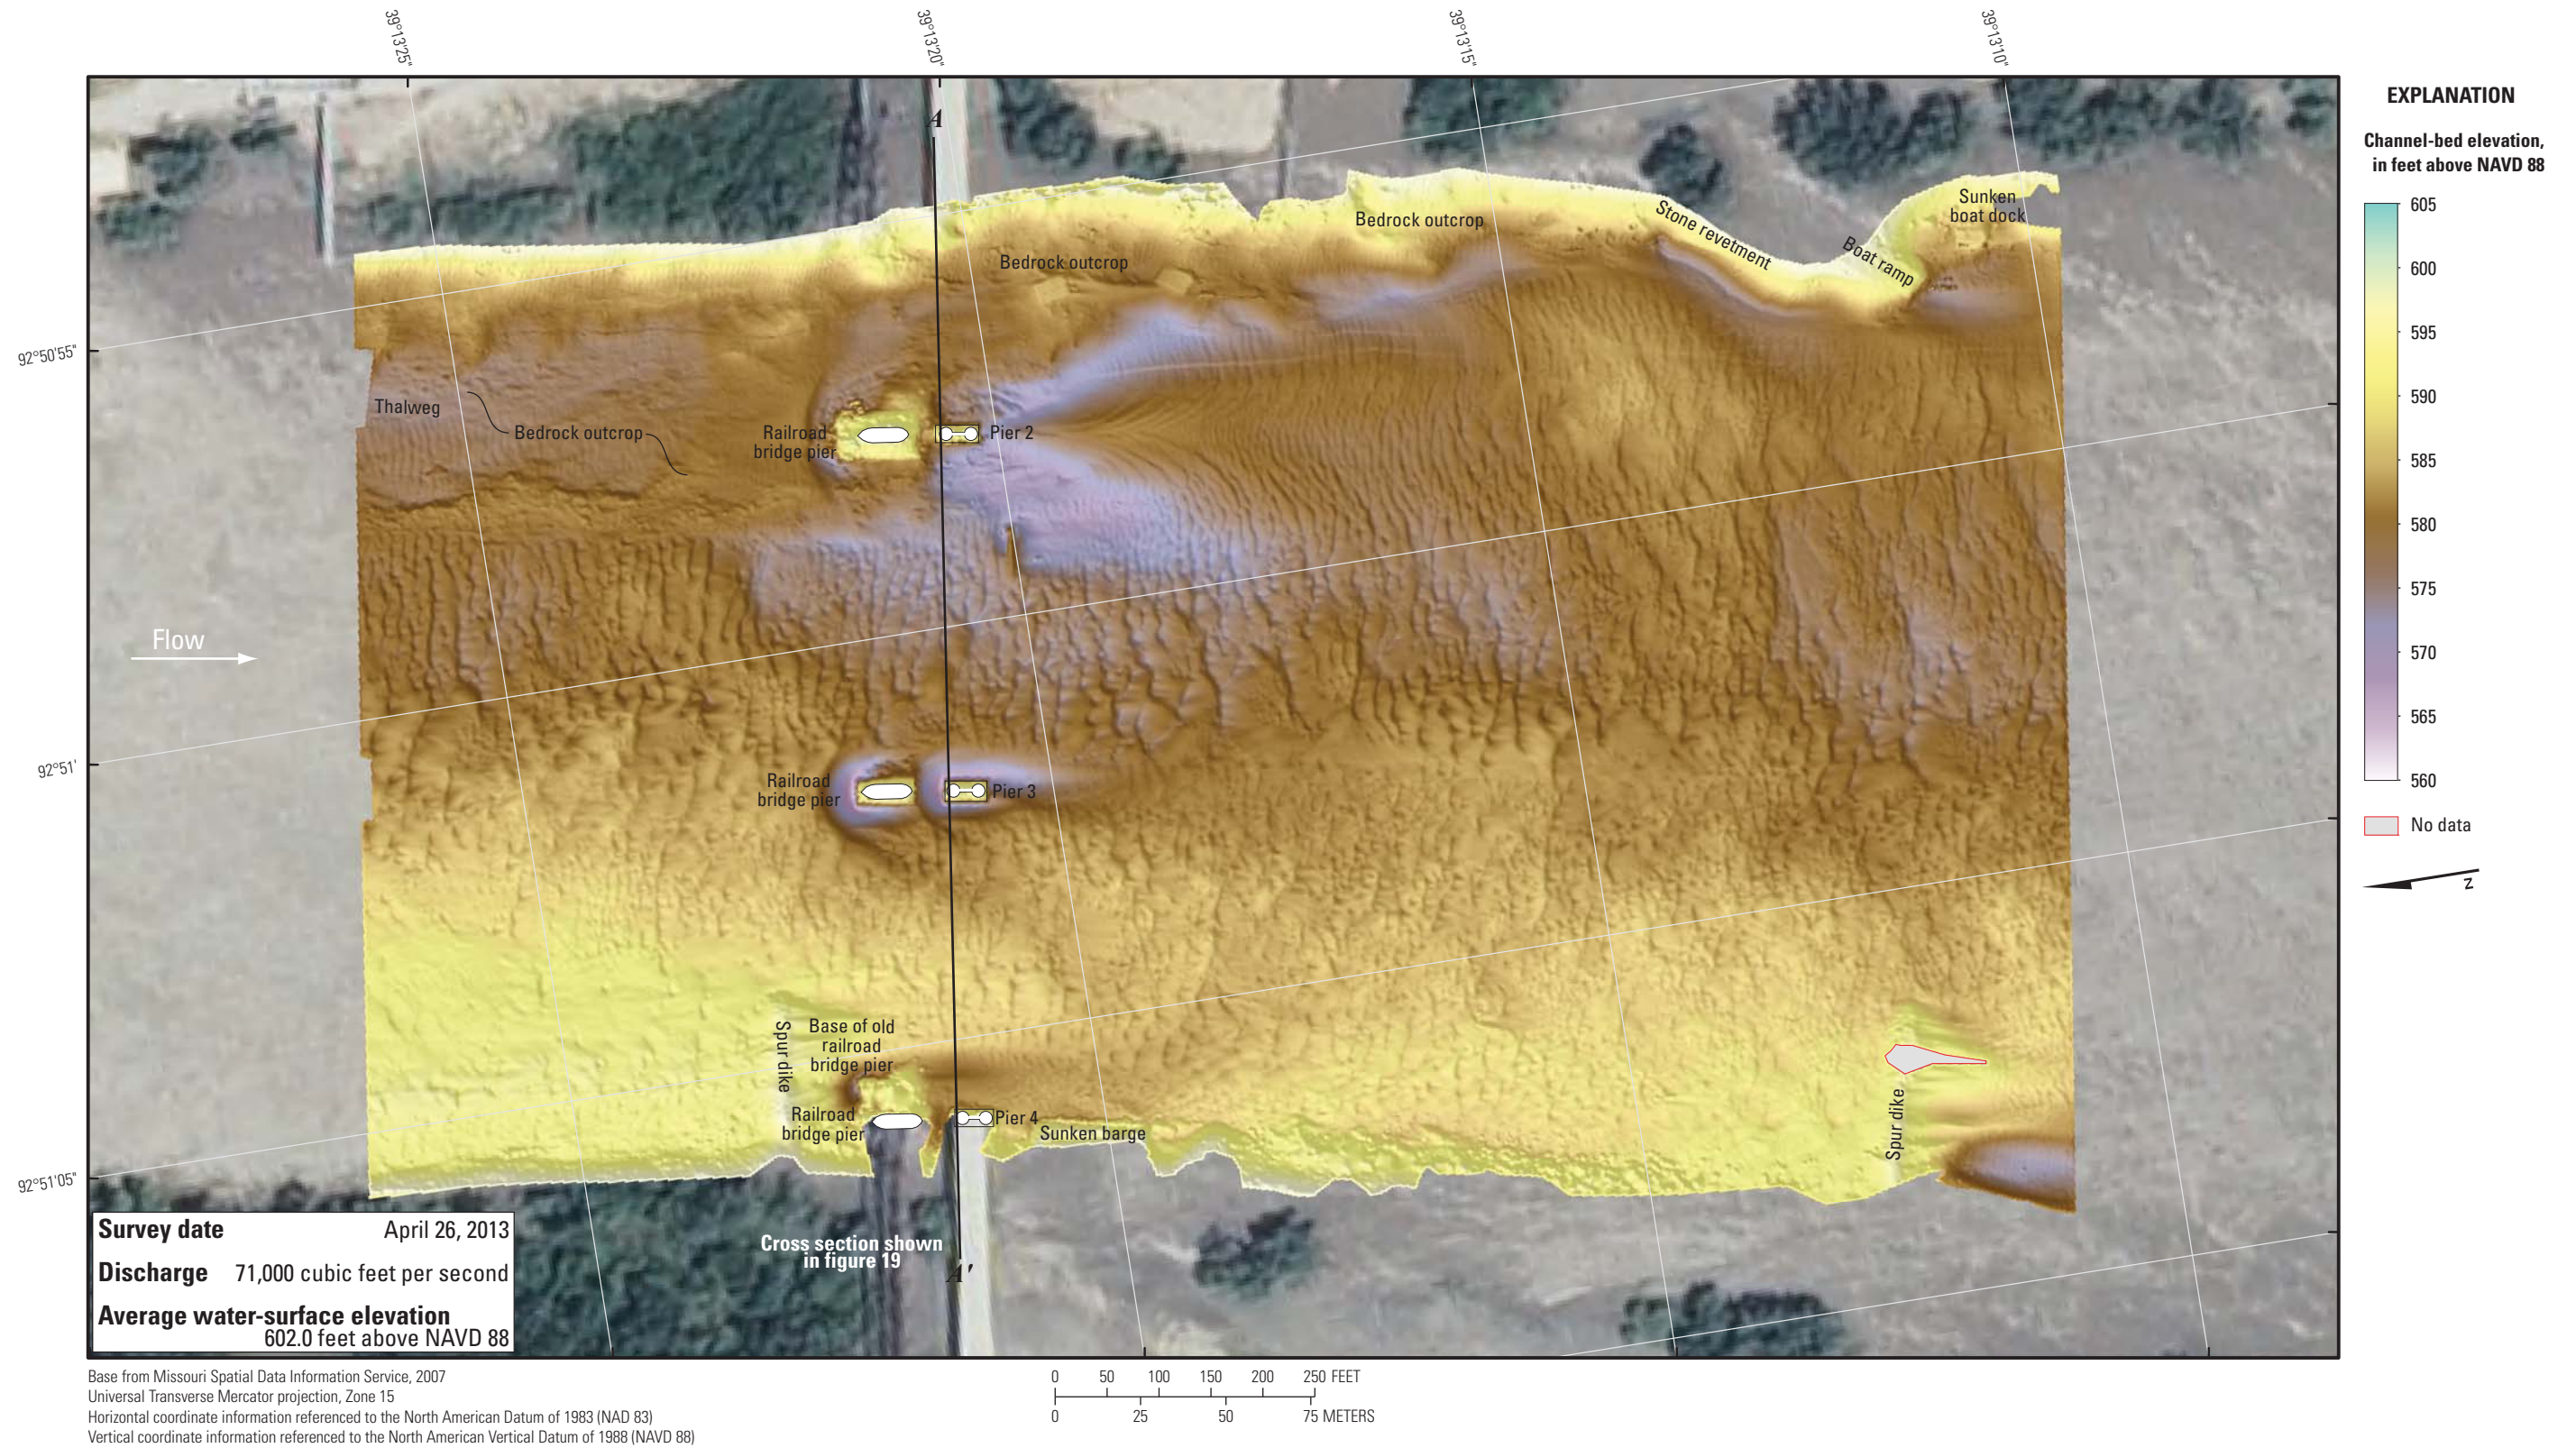
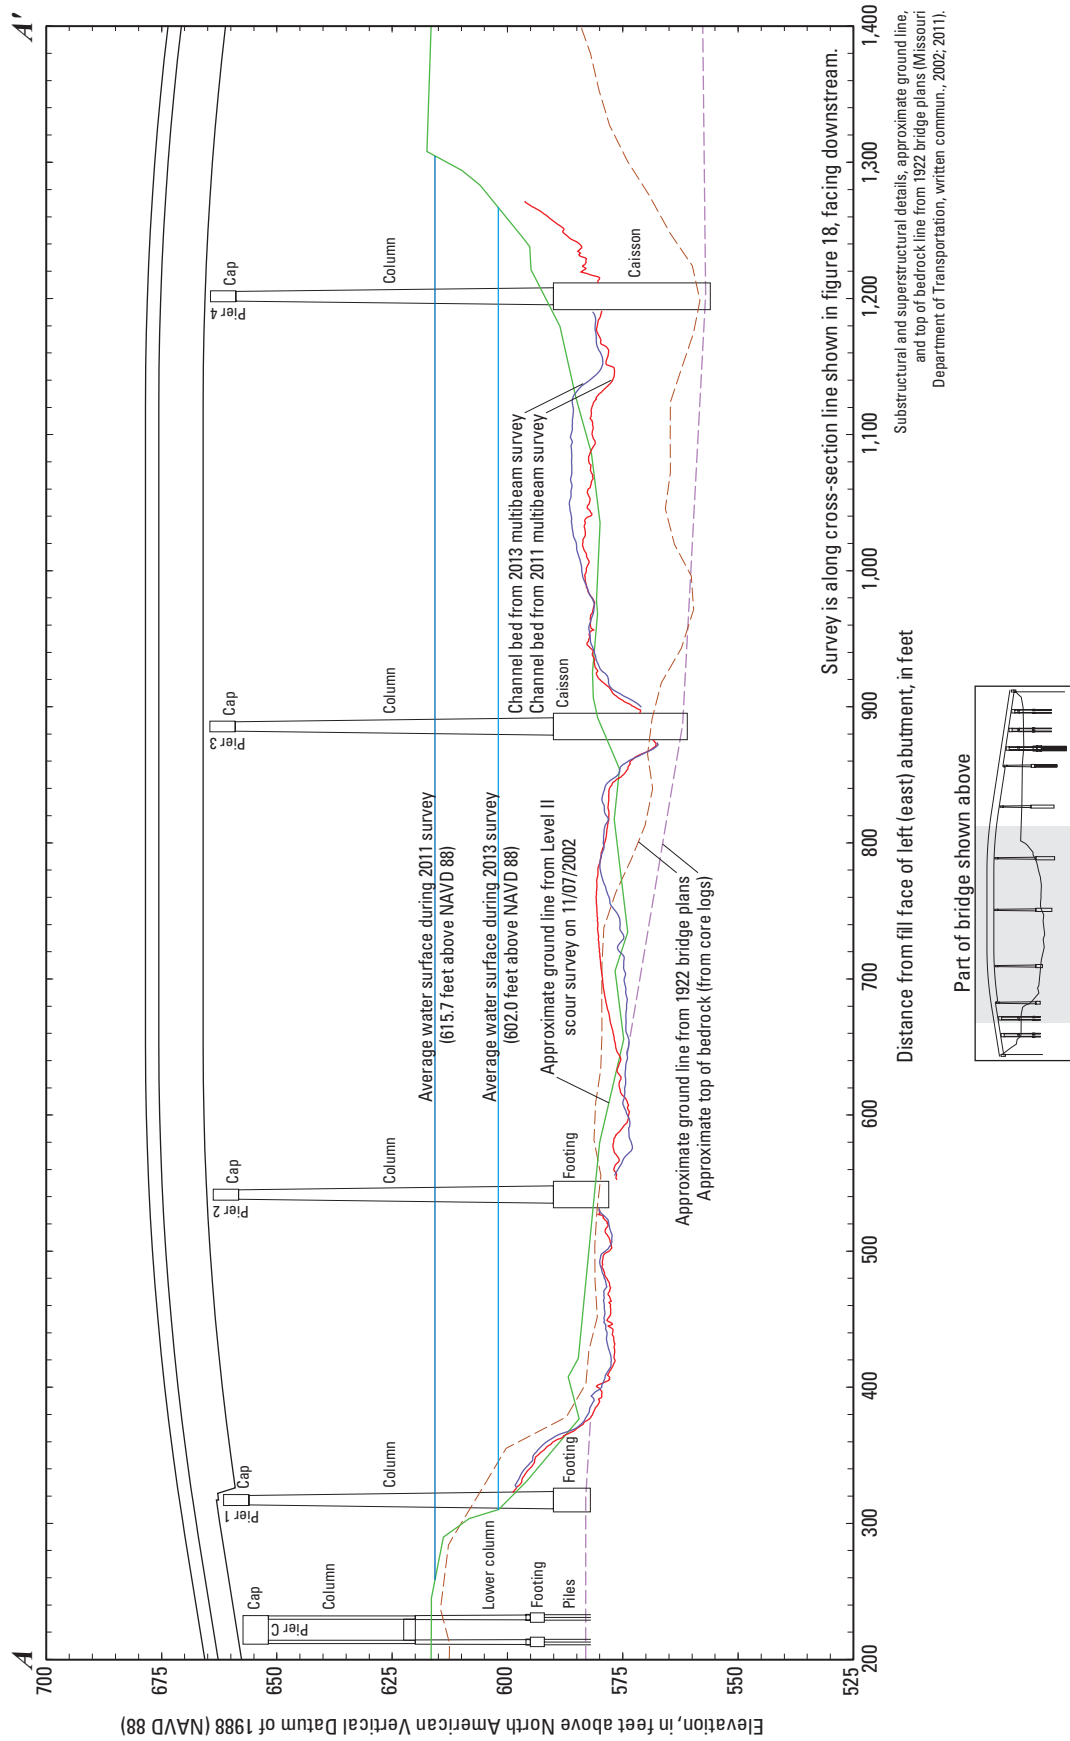
Scour holes were observed near main channel piers 3 and 4. In the vicinity of main channel pier 3 (fig. 18), a substantial scour hole had a minimum channel-bed elevation of about 565 ft (table 6), which is about 15 ft below the average channel bed immediately upstream from the pier (figs. 18 and 19; table 6). A moderate scour hole was observed in the vicinity of main channel pier 4, having a minimum channel-bed elevation of about 579 ft (figs. 18 and 19; table 6). Information from bridge plans indicates that piers 3 and 4 are caissons founded on bedrock, having only about 3 ft of bed material between the bottom of the scour hole and bedrock at pier 3, and about 22 ft of material at pier 4 (fig. 19; table 6). The scour observed near all of the highway bridge piers was substantially affected by the upstream railroad bridge piers. The surveyed bed was 5 to 10 ft lower than the previous multibeam survey in 2011 between piers 2 and 3, except near the piers, and 5 to 10 ft higher than the previous survey between piers 3 and 4, making it more similar to the ground line from the Level II bridge scour assessment in 2002 (fig. 19). The approximate top-of-bedrock line from bridge plans confirms that the fluvial material near the left bank has washed away, exposing the bedrock along the thalweg (fig. 19).

Figure 18. Bathymetric survey of the Missouri River channel in the vicinity of structure G0069 on State Highway 240 at Glasgow, Missouri.

**Figure 19.** Key features, substructural and superstructural details, and surveyed channel bed of structure G0069 on State Highway 240 over the Missouri River at Glasgow, Missouri.

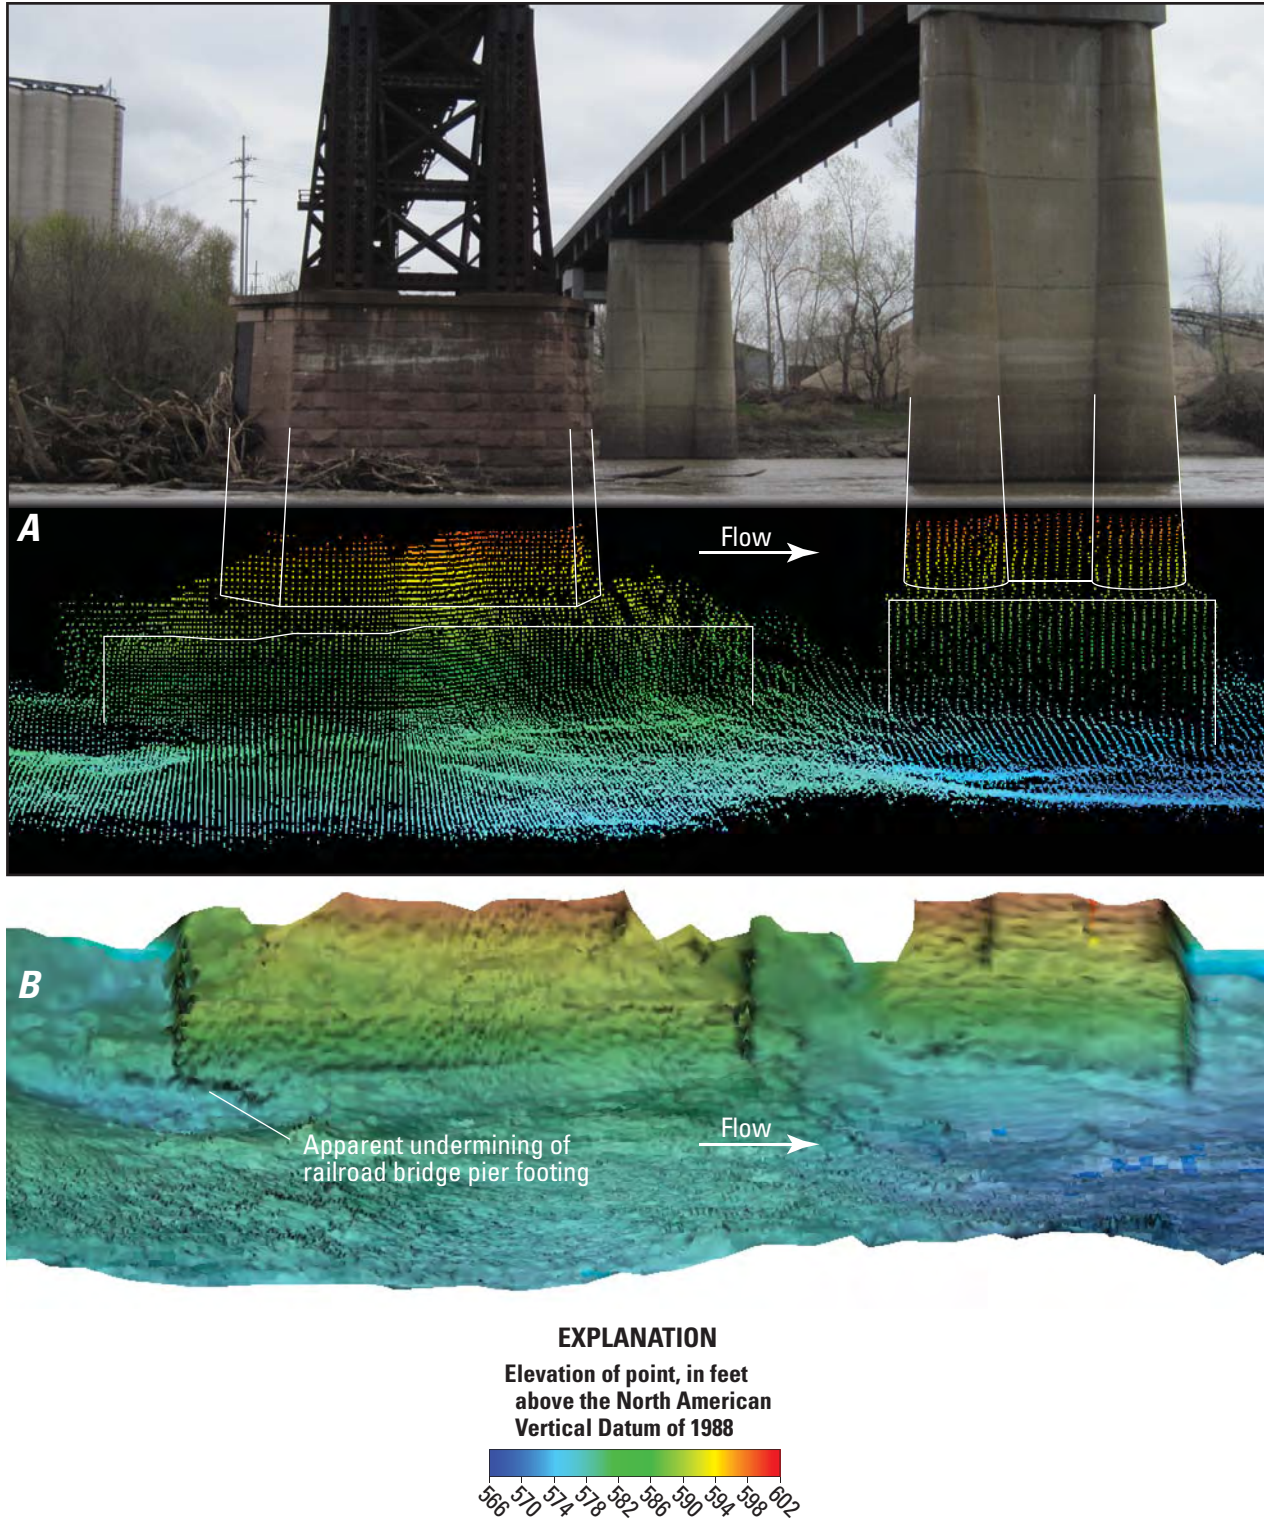
No scour hole was observed near pier 2 (fig. 18), which is founded on a footing on bedrock according to bridge plans (fig. 19; table 6); however, point cloud and shaded TIN visualizations of the multibeam depth points obtained during the survey near pier 2 indicates the magnitude of the exposure of the bridge and railroad bridge piers (fig. 20). The ground line from the bathymetric survey indicated that the right side of the footing may be undermined, but the details of the footing of pier 2 in the bridge plans for structure G0069 are not sufficient to tell if it was entrenched in the bedrock in any way, particularly if the top of the bedrock was not level (figs. 18, 19). In modern construction, bridge substructural elements usually are pinned or socketed to bedrock (American Association of State Highway Transportation Officials, 2012; Brown and others, 2010), but full exposure of usually buried substructural elements warrants special consideration and observation, particularly at an older bridge such as structure G0069 (built in 1922). The footing of pier 2 does not appear to be undermined in the visualizations, although the upstream railroad bridge pier footing has apparent undermining at the upstream right corner (fig. 20).

**Figure 20.** Visualizations of the channel bed and right (west) side of main channel pier 2 of structure G0069 on State Highway 240 and the upstream railroad bridge pier over the Missouri River at Glasgow, Missouri, as a *A*, point cloud, and *B*, shaded triangulated irregular network (TIN).

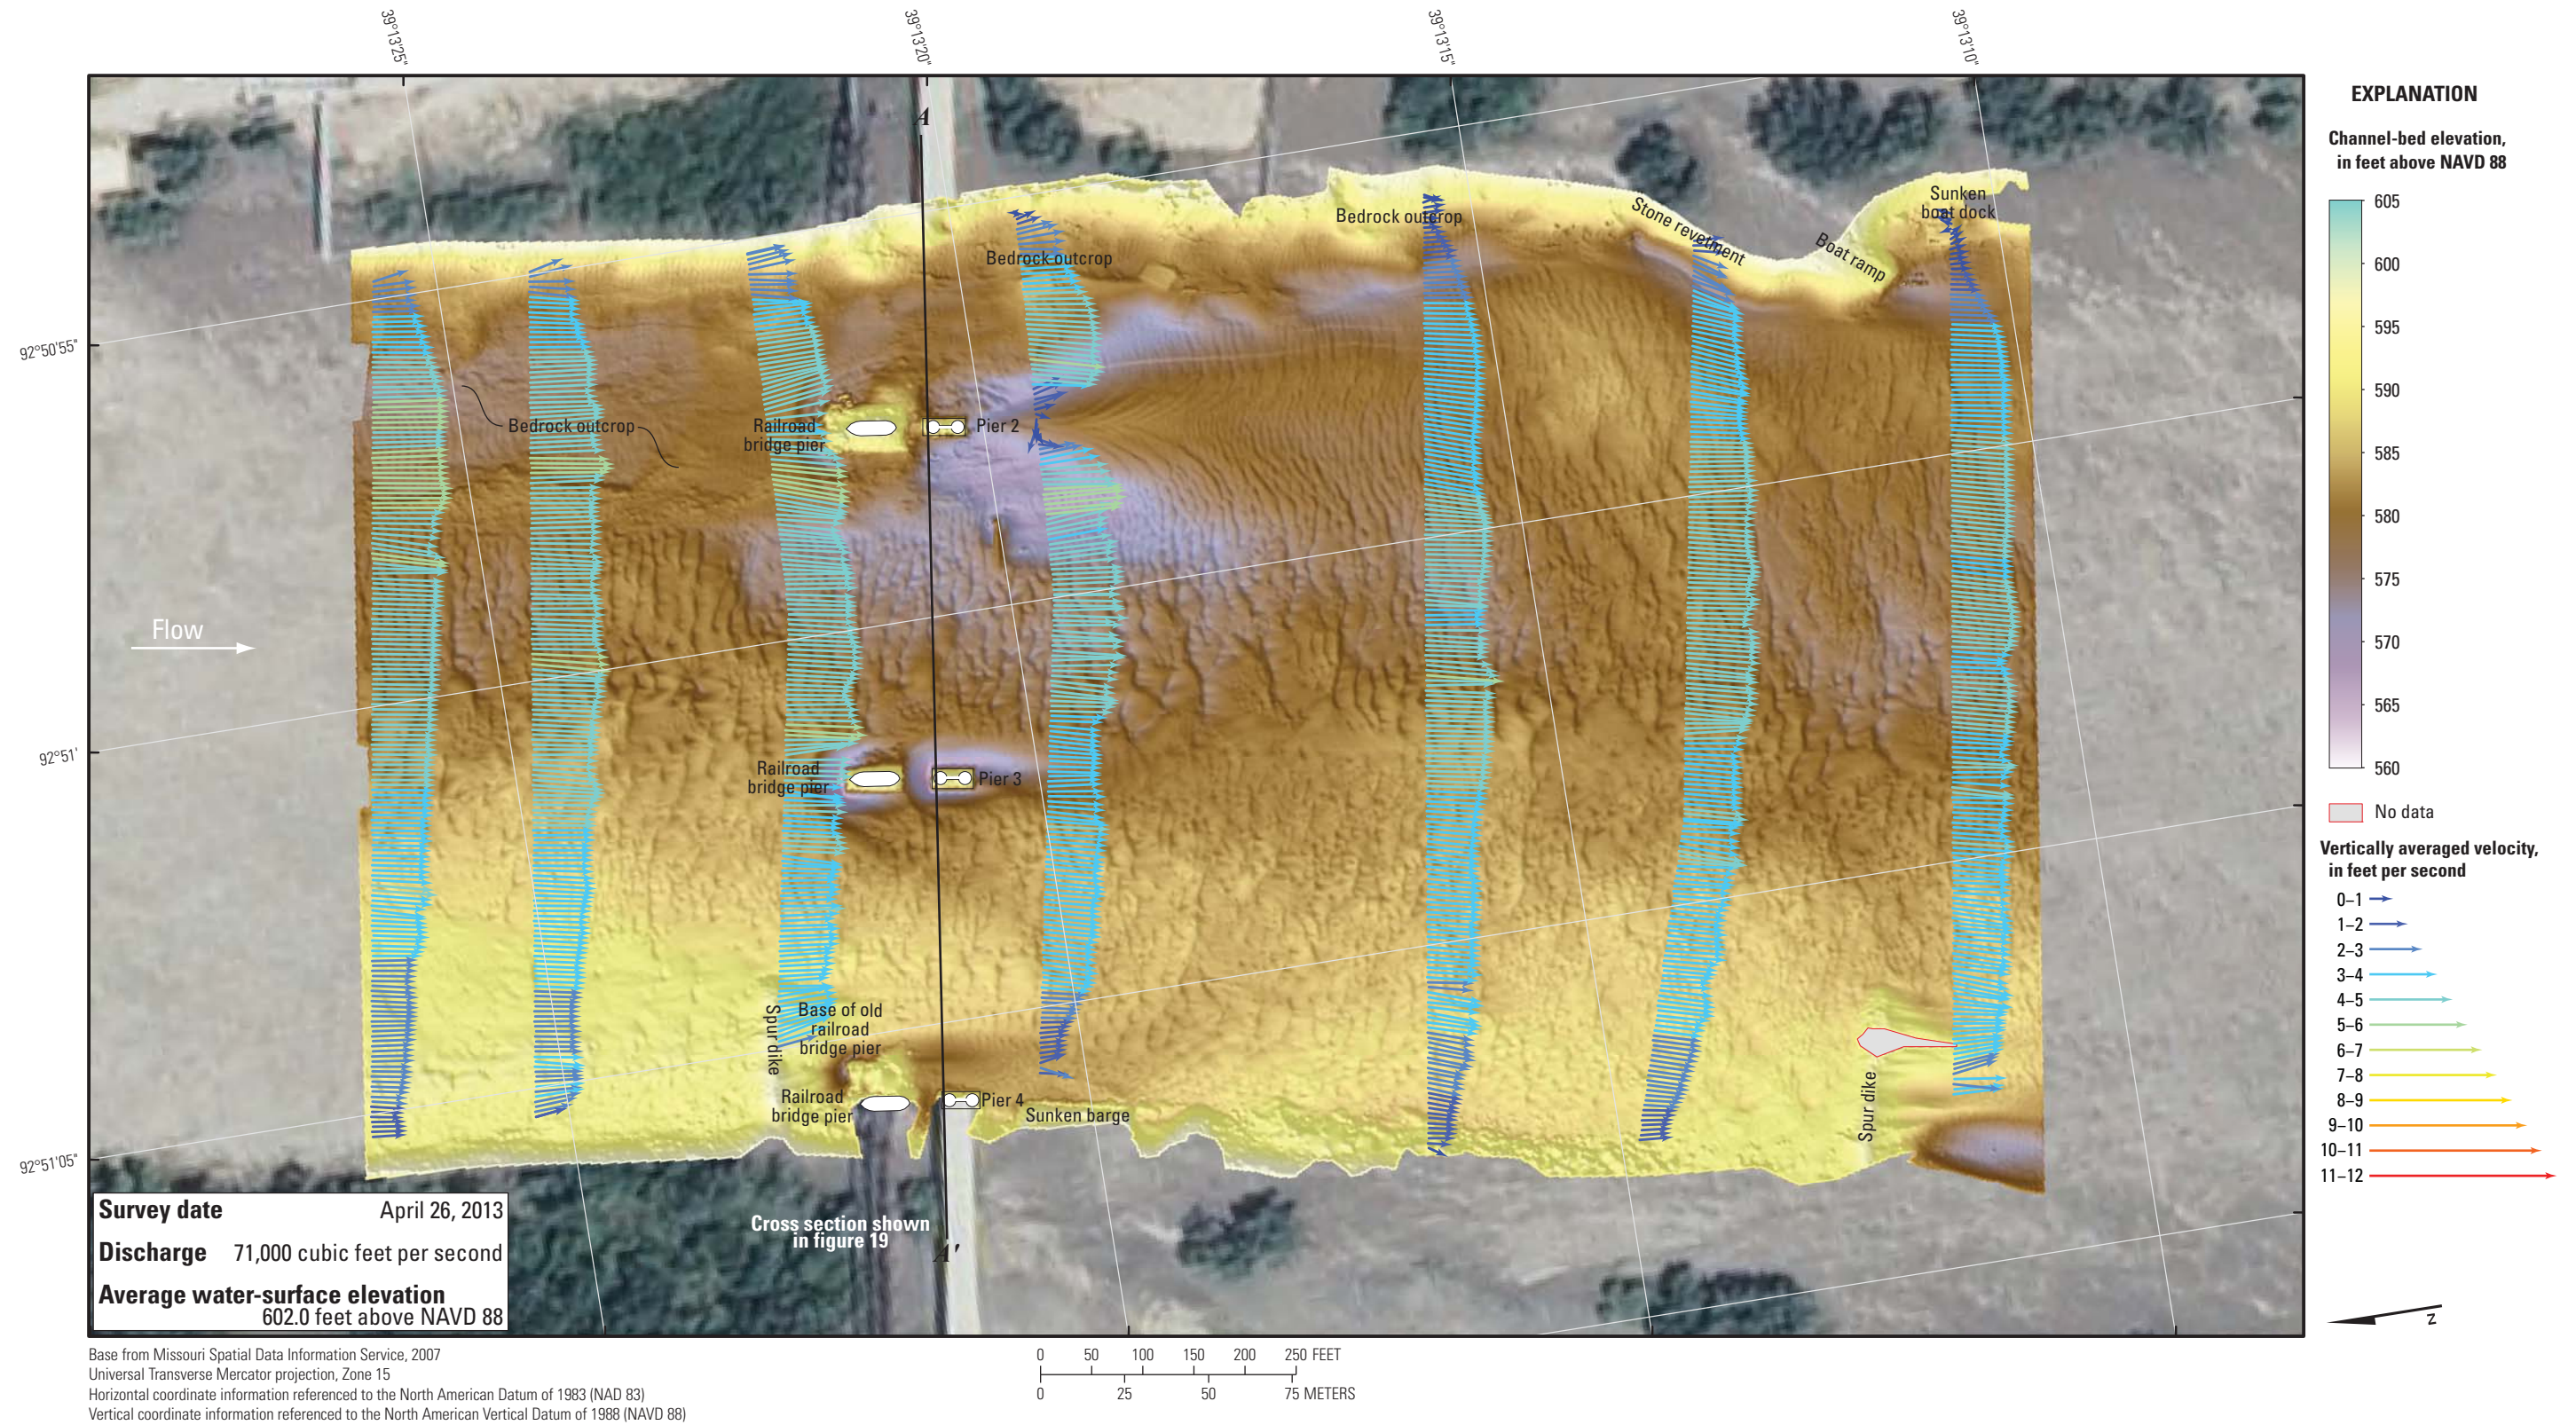
The vertically averaged velocity vectors indicate slight to moderate turbulence throughout most of the channel, with velocities ranging from about 3 to 7 ft/s (fig. 22). Velocities were greater in the thalweg and lower in the shallow area on the right (west) side of the upstream channel, whereas the velocities were more uniform in the downstream channel where the thalweg was less defined (fig. 22). Turbulence, caused by local disturbances from the piers and spur dikes in the reach, was observed at various places in the channel (fig. 22). A substantial debris raft on the upstream nose of the railroad bridge pier upstream from pier 2 caused the velocity vectors to flare around that pier (fig. 22).

Figure 22. Bathymetry and vertically averaged velocities of the Missouri River channel in the vicinity of structure G0069 on State Highway 240 at Glasgow, Missouri.

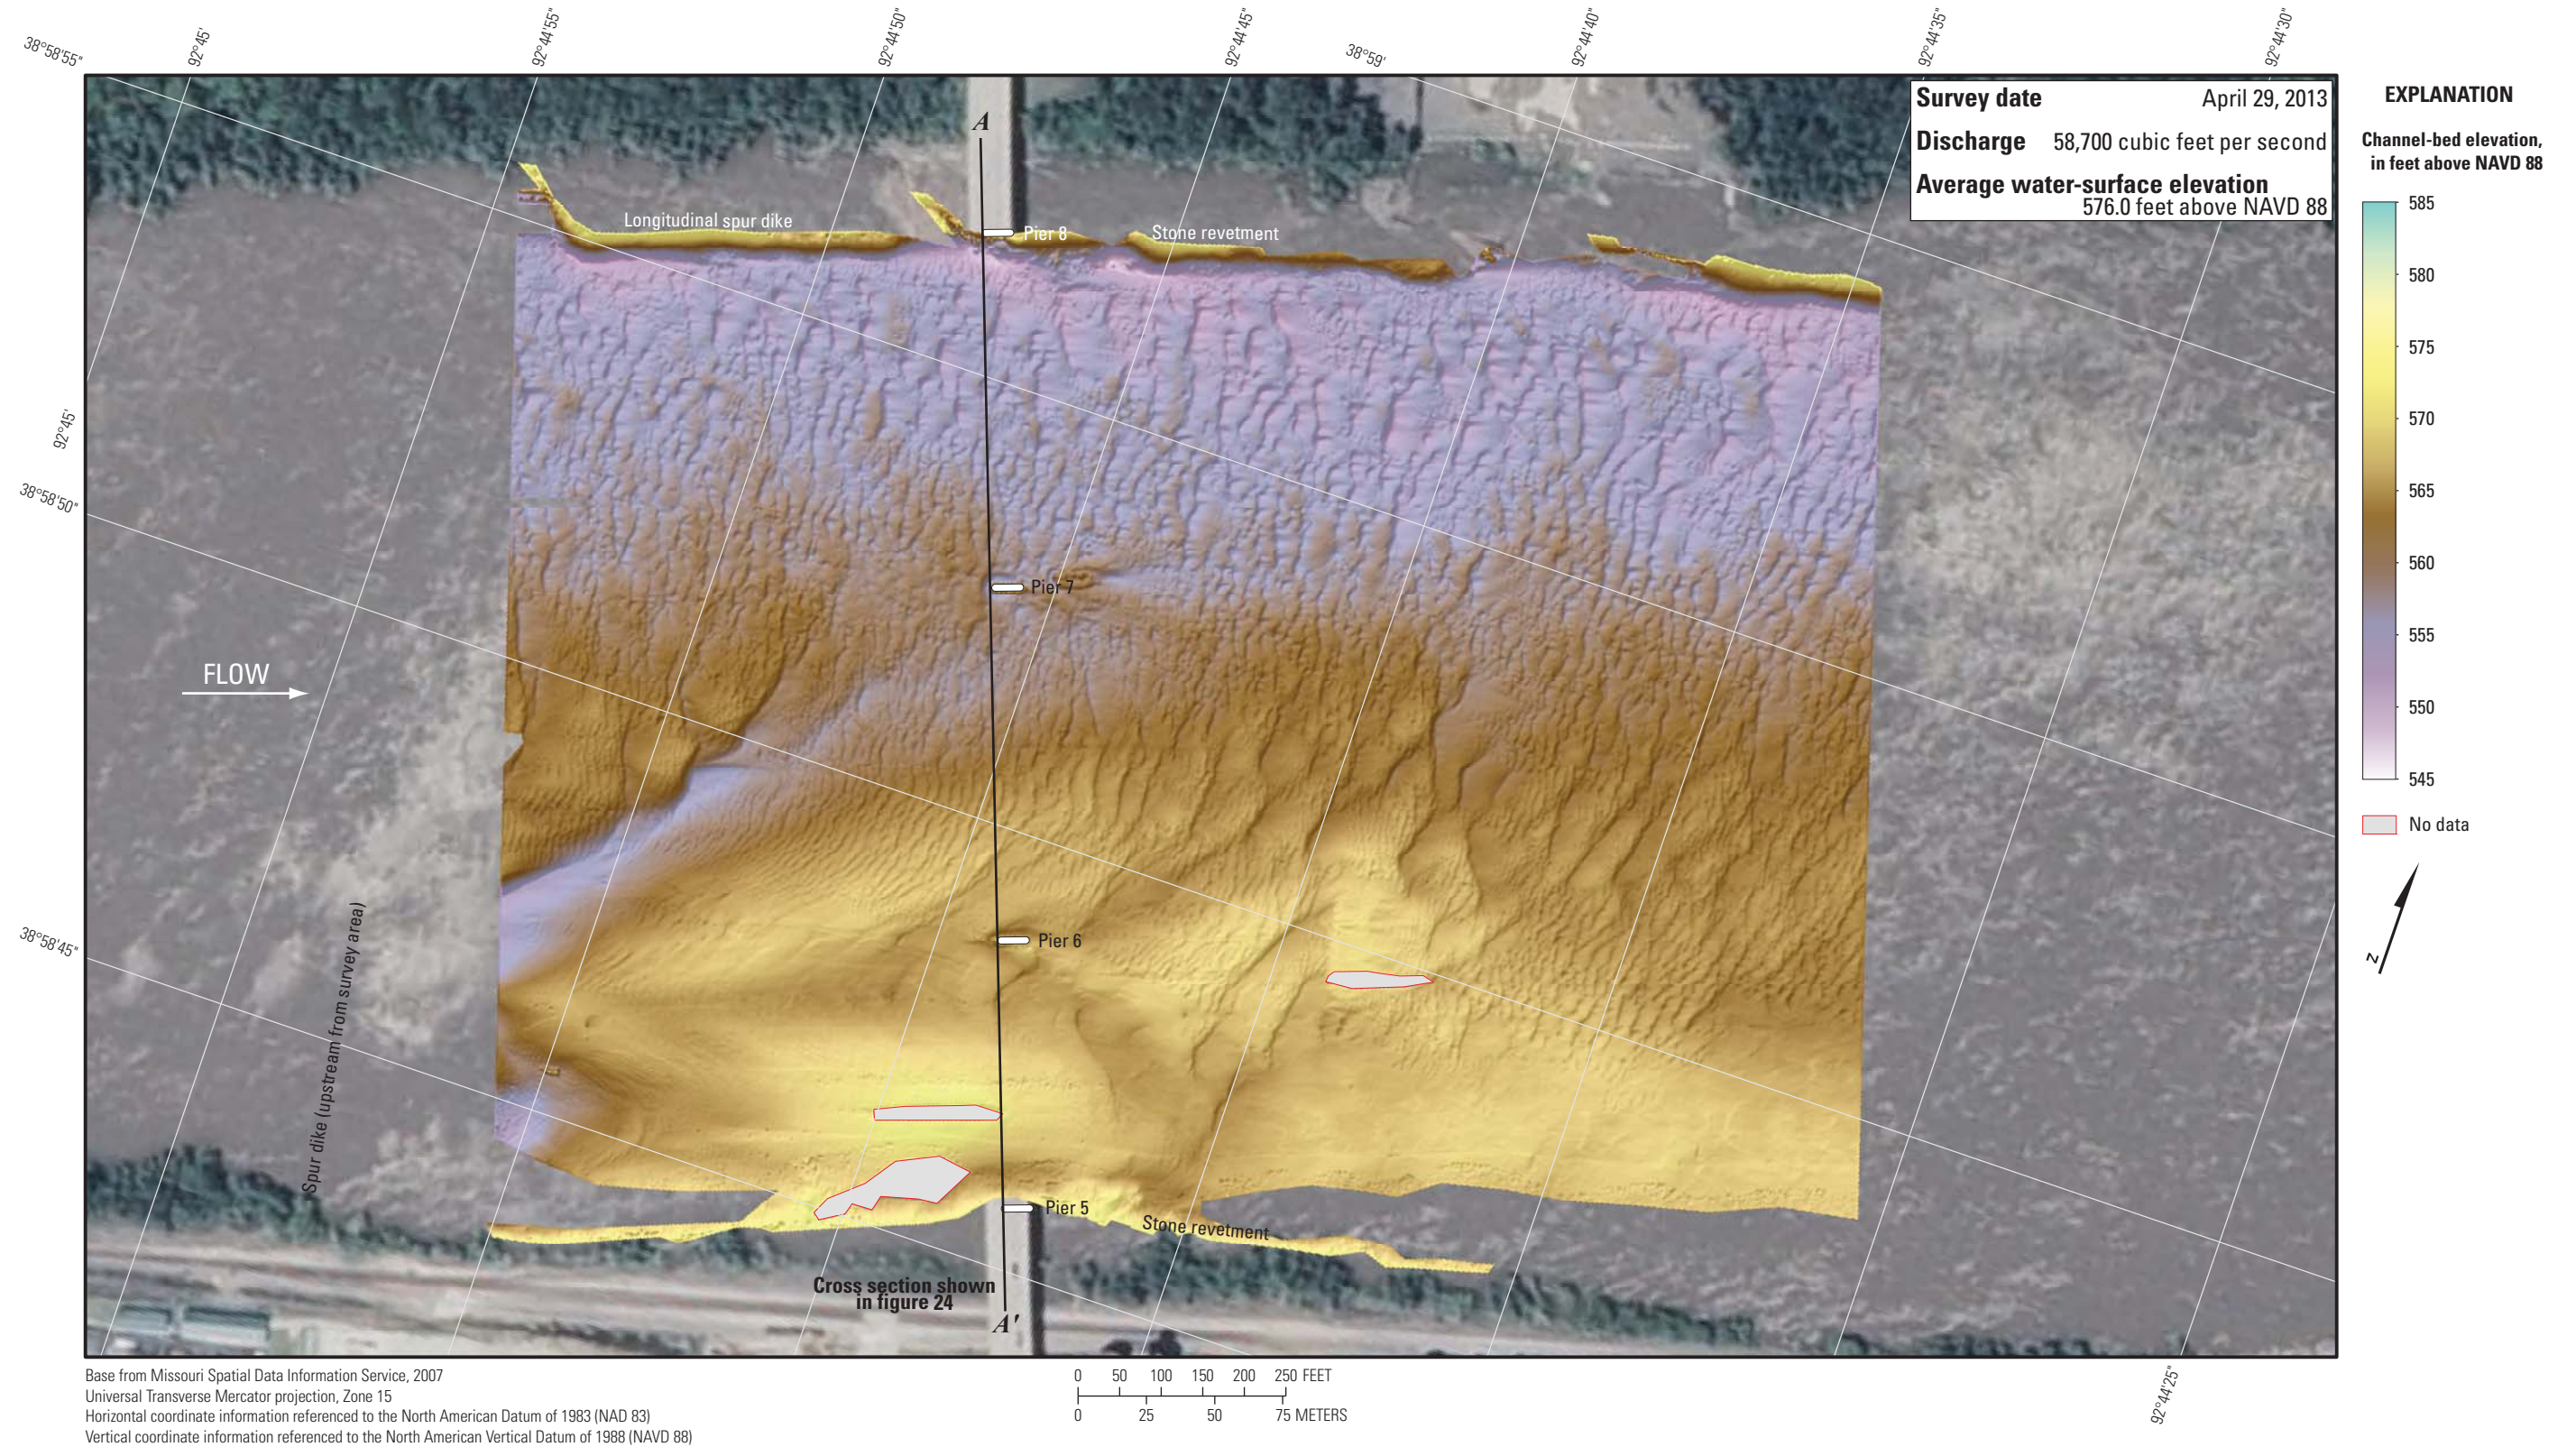
Minor scour holes were observed near the central main channel piers 6 and 7. In the vicinity of main channel pier 7 (fig. 23), the scour hole had a minimum channel-bed elevation of about 556 ft (table 6), about 23 ft above the elevation of the bottom of the pier seal course of 533.00 ft (fig. 24; table 6). The minor scour hole near pier 6 (fig. 23) had a minimum channel-bed elevation of about 563 ft (table 6). Both scour holes were difficult to discern from nearby dunes and ripples (figs. 23, 24). Information from bridge plans indicates that pier 7 is founded on shafts drilled 39 ft into bedrock, having about 43 ft of bed material between the bottom of the scour hole and bedrock (fig. 24; table 6). Pier 6 is founded on a footing on bedrock, having about 12 ft of bed material between the bottom of the scour hole and bedrock (fig. 24; table 6). The surveyed bed generally was about 5 ft lower than the previous multibeam survey in 2011 between the left bank and the middle of the channel between piers 6 and 7, and about 5 to

Figure 23. Bathymetric survey of the Missouri River channel in the vicinity of structure A4574 on State Highway 5 at Boonville, Missouri.

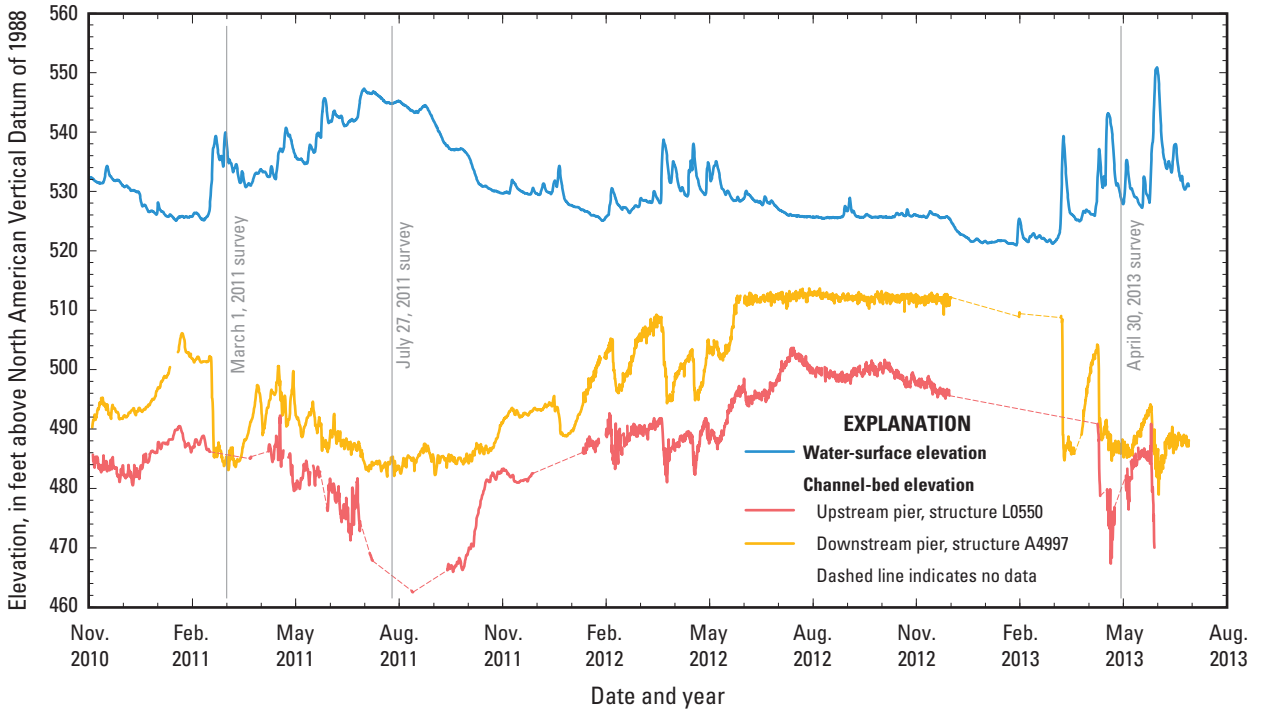
surveys using the MBMS, the monitor on pier 4 of downstream structure A4497 functioned flawlessly except when the water-surface elevation dropped below the transducer (approximately 525 ft; fig. 35). During the April 2013 survey, the monitor sensed an average channel-bed elevation of 486.5 ft, which is about 1.5 ft higher than the surveyed bed elevation of 485 ft at the nose of the pier (table 6). Huizinga (2012) indicated the channel-bed elevation recorded from the downstream monitor was about 3 ft higher than the elevation from near the center of the nose of the downstream pier during the March and July 2011 surveys. Several potential sources of the difference were discussed, and the most probable was that the monitor transducer was tilted forward from vertical to allow the beam to clear the top of the footing and seal course [see fig. 92 in Huizinga (2012)], resulting in uncertainty about the exact location of the transducer beam in the scour hole. In any case, the differences between the MBMS and monitor elevations are deemed to be reasonable, and the monitors have functioned as designed with a tolerance of plus or minus 3 ft. The TIN visualization shows the point of minimum elevation near the downstream pier actually is under the seal course, at an elevation of about 483 ft (fig. 34; table 6). Both monitors have documented scour holes forming during flood events, and filling during flood recessions and low-flow periods (fig. 35). Often the scour response is rapid and substantial (the downstream monitor routinely indicates in excess of 10 ft of scour) despite the size of the flood event (fig. 35).

**Figure 35.** Water-surface and channel-bed elevations as recorded at the real-time scour monitors on the upstream nose of the upstream and downstream main channel piers of structures L0550 and A4497 on U.S. Highway 54 crossing the Missouri River at Jefferson City, Missouri, for the period November 1, 2010, to June 30, 2013.

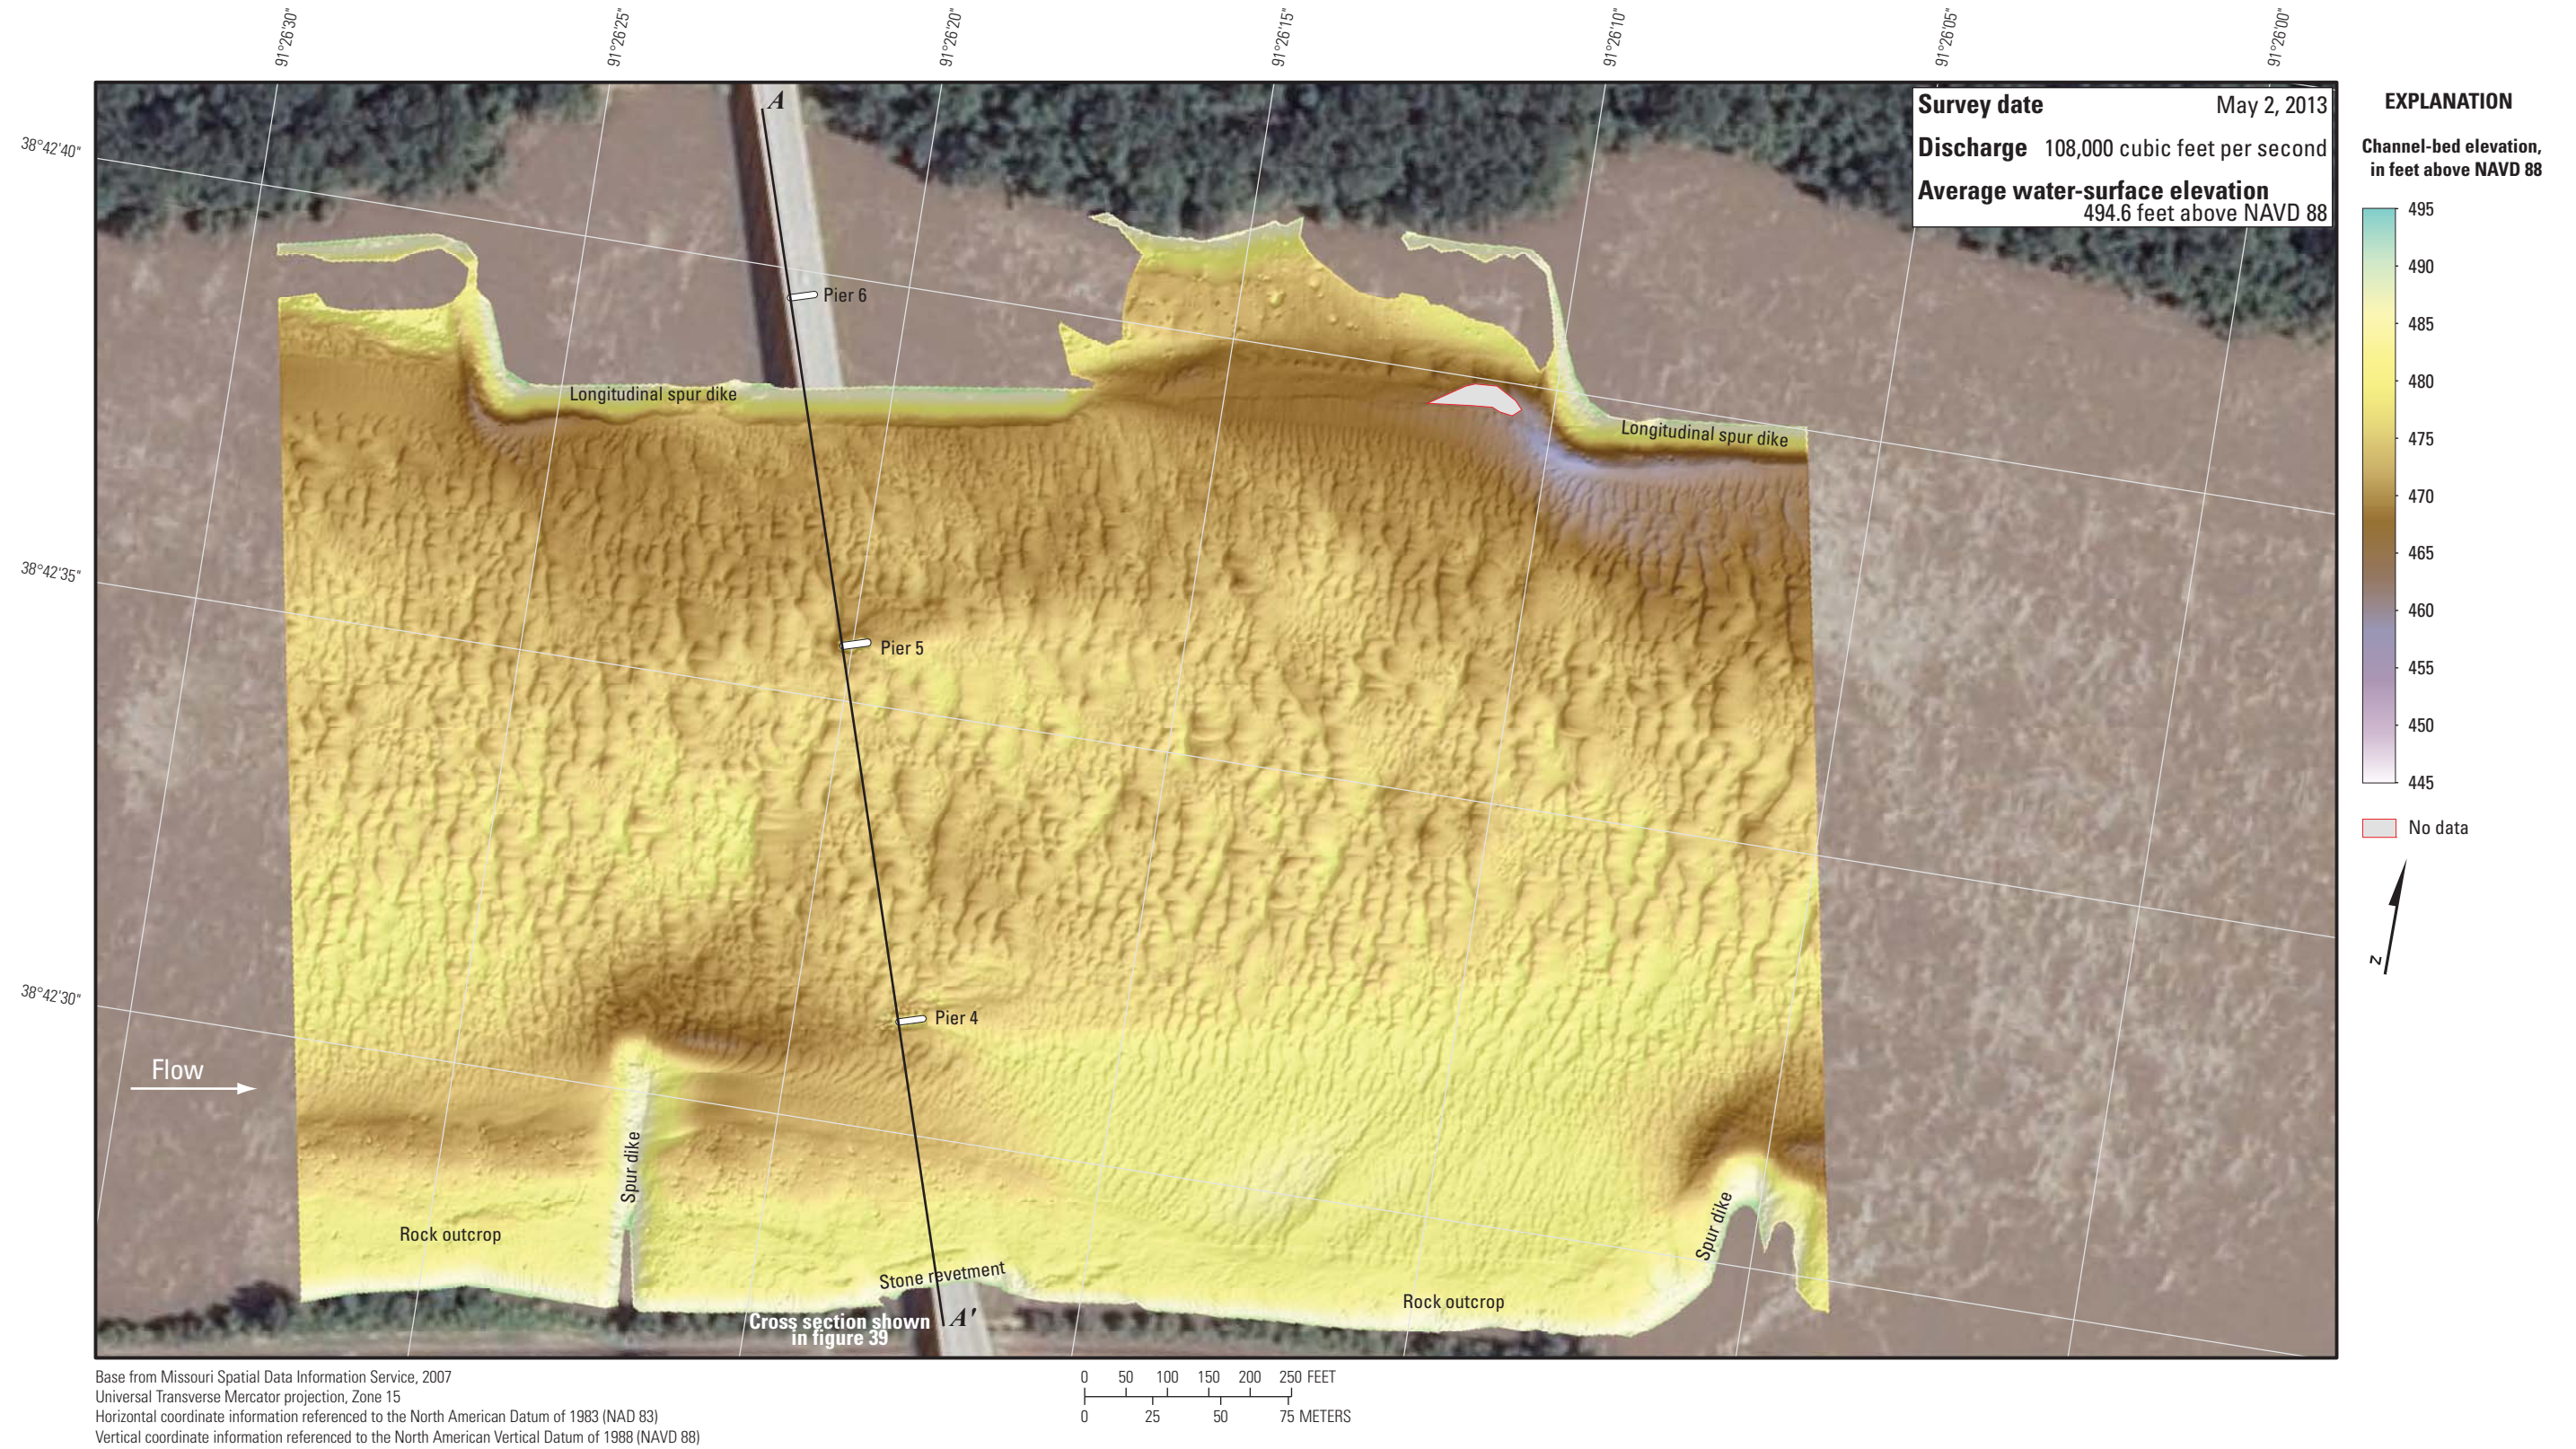
Minor scour holes were observed near both of the piers in the main channel (fig. 38). The minor scour hole near pier 5 had a minimum channel-bed elevation of about 468 ft

Figure 38. Bathymetric survey of the Missouri River channel in the vicinity of structure A6288 on State Highway 19 at Hermann, Missouri.
