Bathymetric and Velocimetric Surveys at Highway Bridges Crossing the Missouri River near Kansas City, Missouri, June 2–4, 2015

Scientific Investigations Report 2016–5061

By Richard J. Huizinga

Prepared in cooperation with the Missouri Department of Transportation

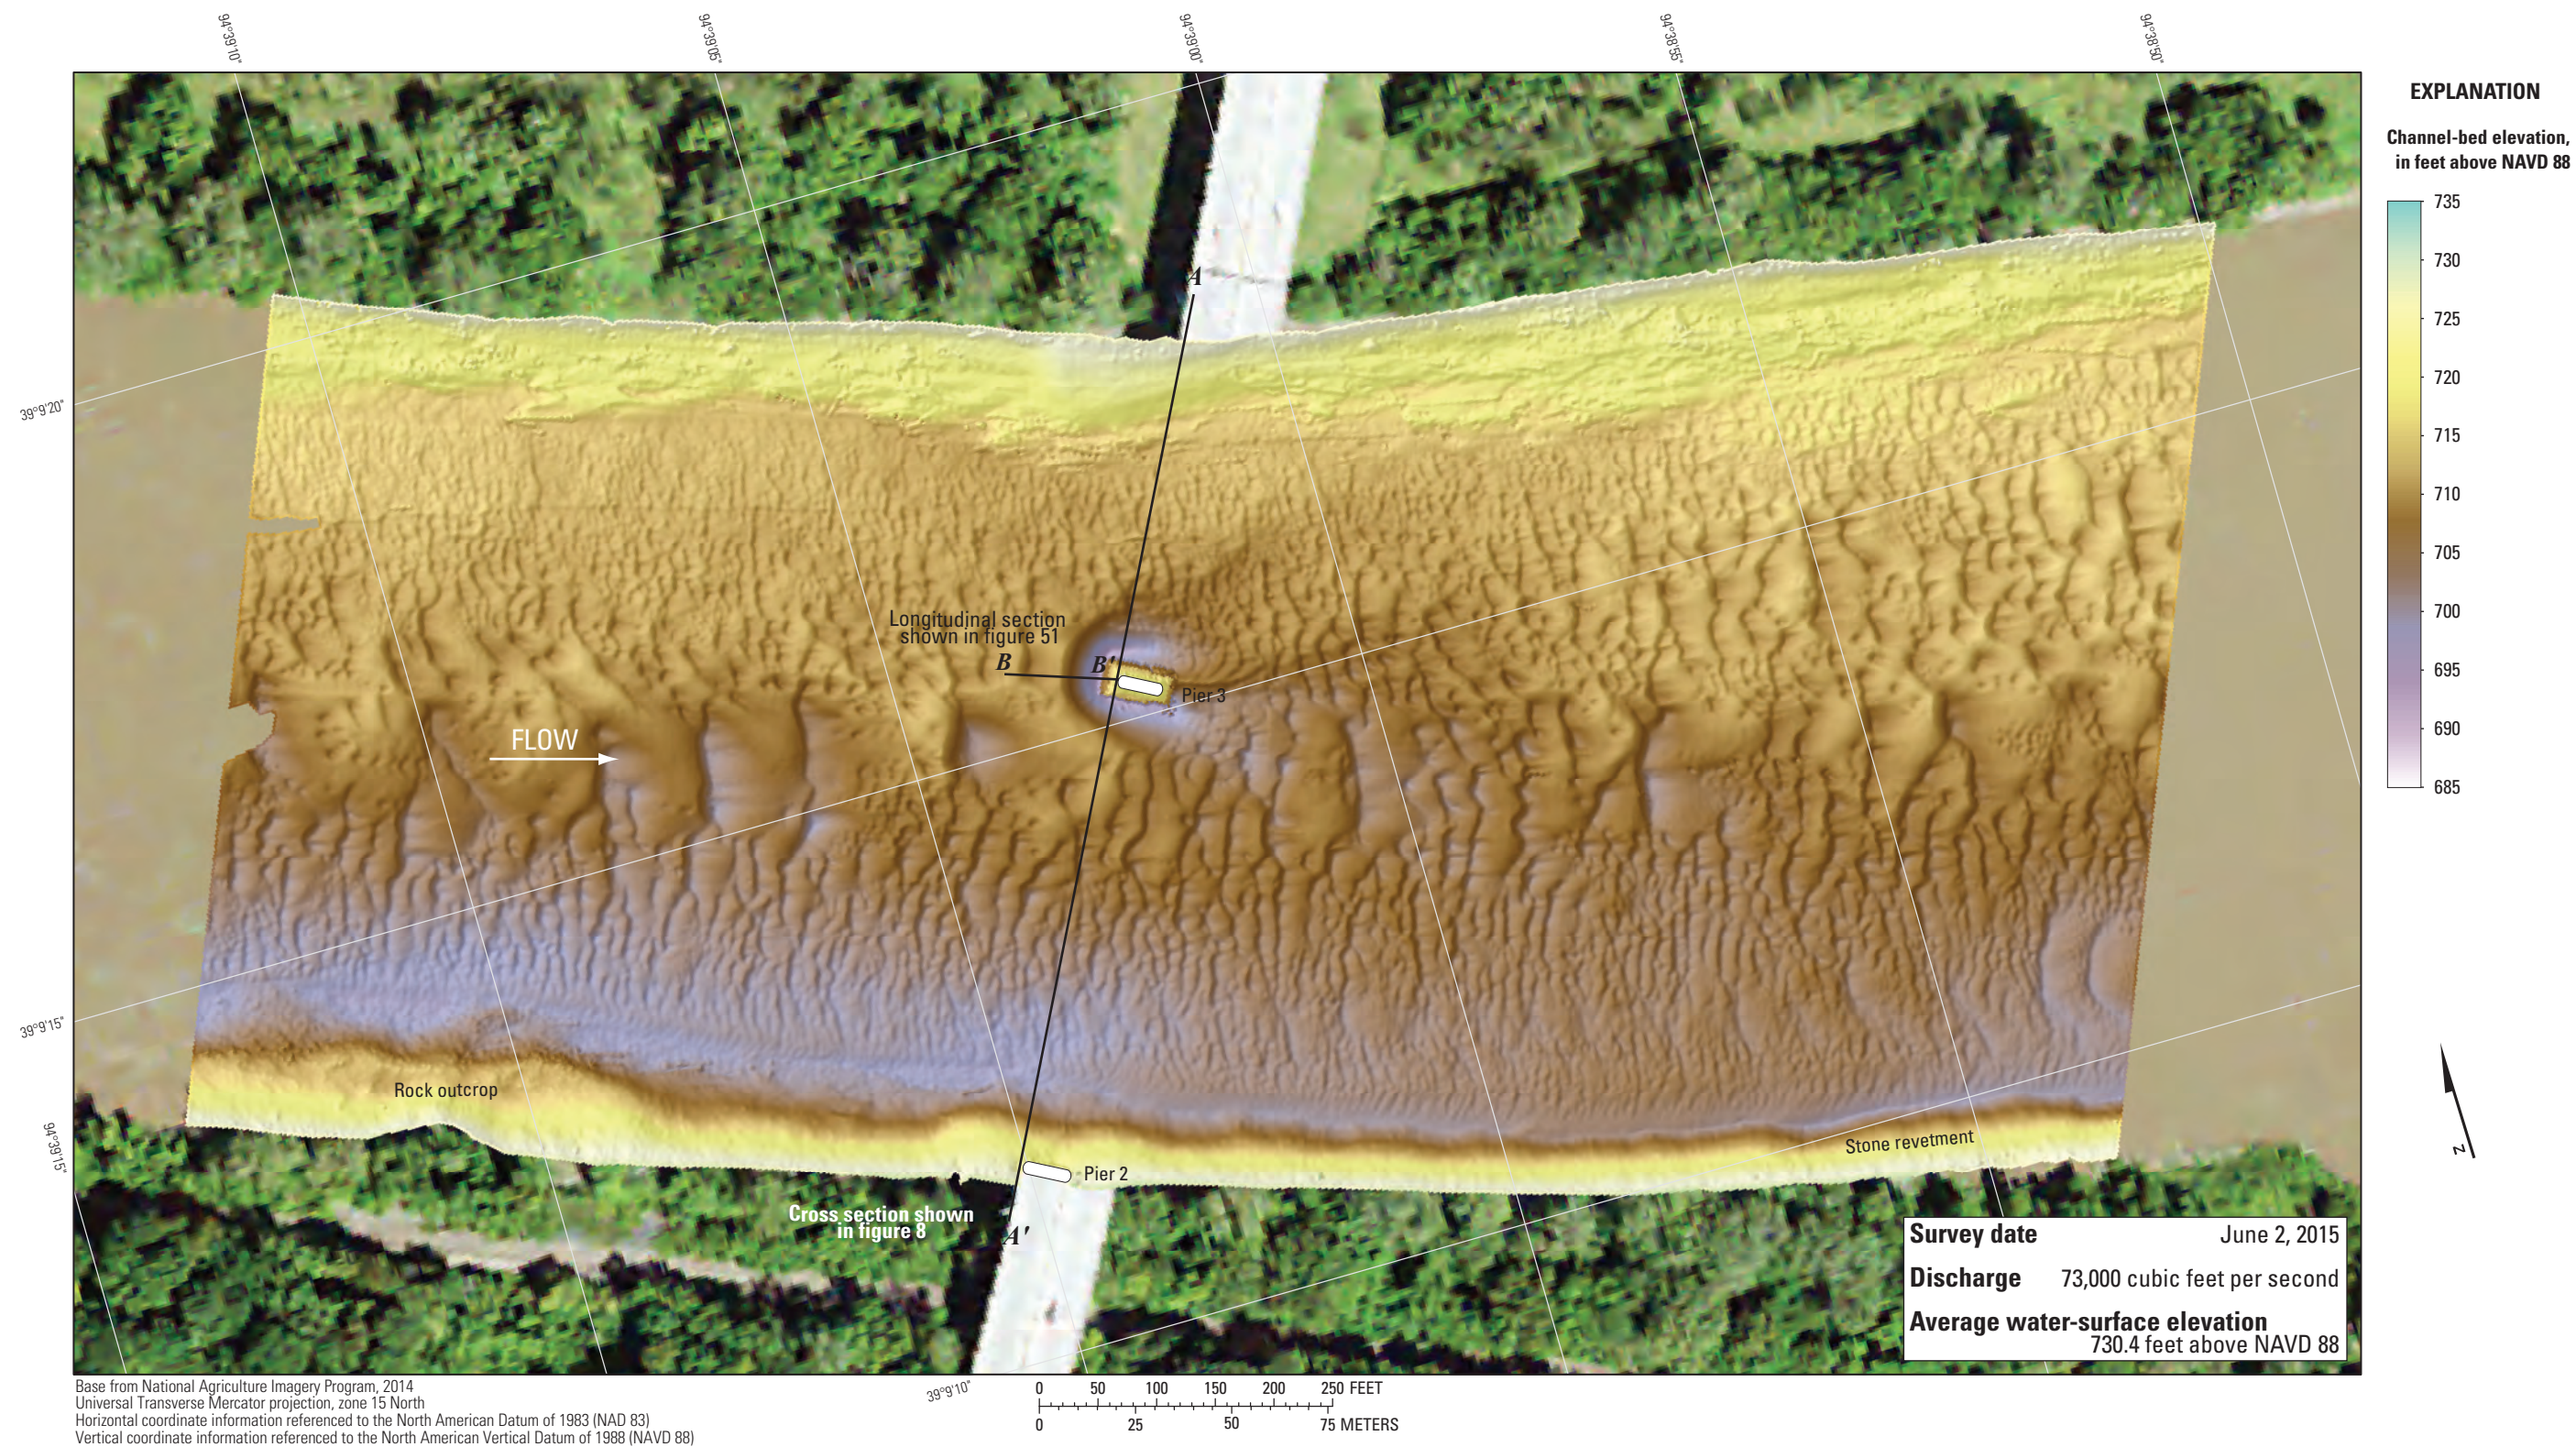
Figure 6. Bathymetric survey of the Missouri River channel near structure A1800 on Interstate 635 near Kansas City, Missouri.

The scour hole near main channel pier 3 had a minimum channel-bed elevation of about 695 ft (table 6), about 15 ft below the average channel bed immediately upstream from the pier (fig. 6), and about 7 ft below the elevation of the bottom of the pier seal course of 702.28 ft (fig. 8; table 6). Information from bridge plans indicates that pier 3 is founded on shafts drilled 20 ft into bedrock, with about 43 ft of bed material between the bottom of the scour hole and bedrock at the upstream face of pier 3 (fig. 8; table 6).

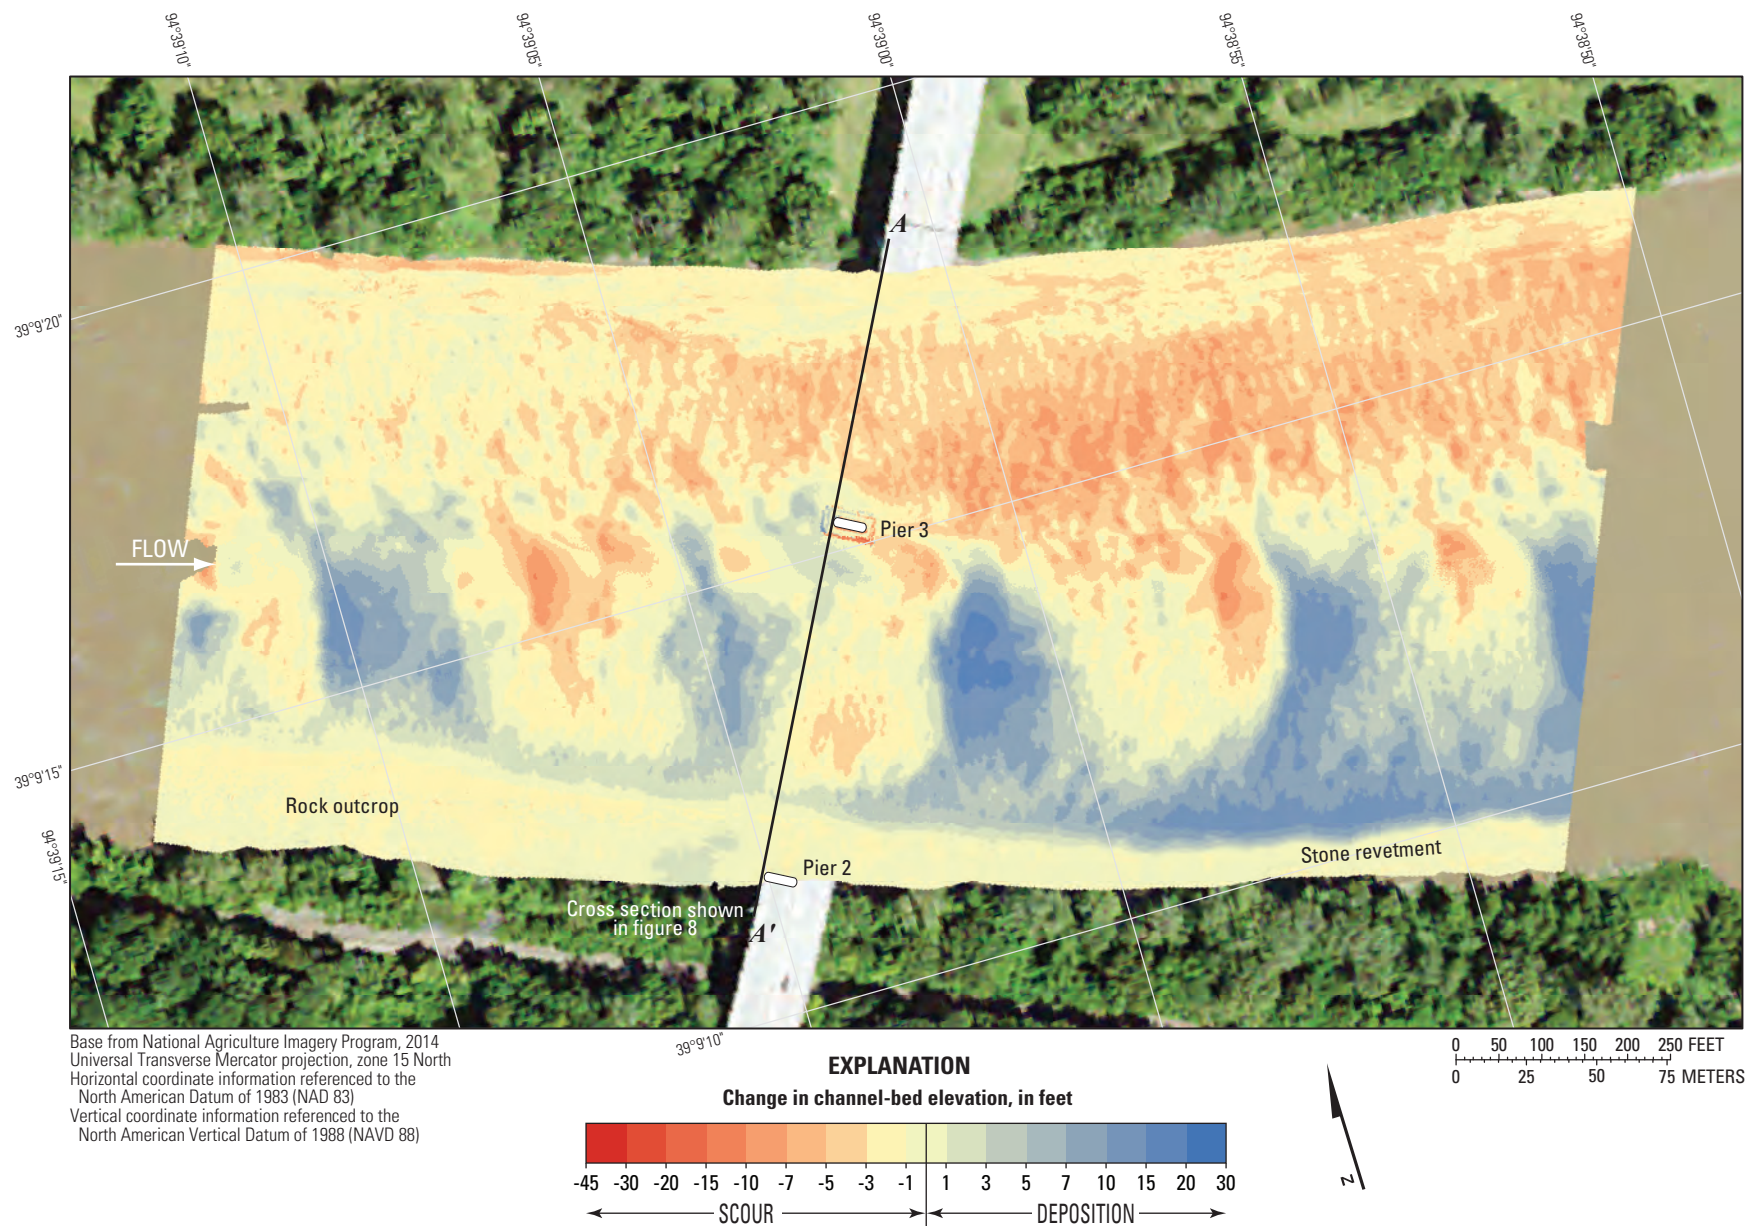
Figure 9. Difference between surfaces created from bathymetric surveys of the Missouri River channel near structure A1800 on Interstate 635 near Kansas City, Missouri, on June 2, 2015, and July 16, 2011.

2011 gridded raster bathymetric surfaces) was -0.35 ft (table 7), indicating overall minor channel degradation between the 2011 and 2015 surveys. The net volume of cut in the reach from 2011 to 2015 was about 82,100 cubic yards (yd³), and the net volume of fill was about 66,600 yd³, resulting in a net loss of about 15,500 yd³ of sediment between 2011 and 2015. The cross sections from the two surveys along the upstream face of the bridge are not substantially different from one another (fig. 8); however, the frequency distribution of bed elevations was substantially narrower in 2015 than in 2011, with a higher minimum channel-bed elevation (fig. 7). The scour hole near pier 3 was slightly narrower in 2015 than in 2011 (fig. 8), as evidenced by the overall pattern of deposition in a horseshoe shape around the upstream face of the pier (fig. 9). The rock outcrop on the upstream right (south) bank showed no signs of substantial change except for a small area of deposition immediately upstream from the bridge (fig. 9). Although rock ultimately is an erodible material, its rate of erosion is substantially slower than that of sand and silt (Richardson and Davis, 2001). The stone revetment on the downstream right (south) bank also showed no signs of substantial change (fig. 9). Substantial deposition or scour apparent at the faces of the pier results from minor horizontal positional variances between the surveys (see “Uncertainty Estimation” section).

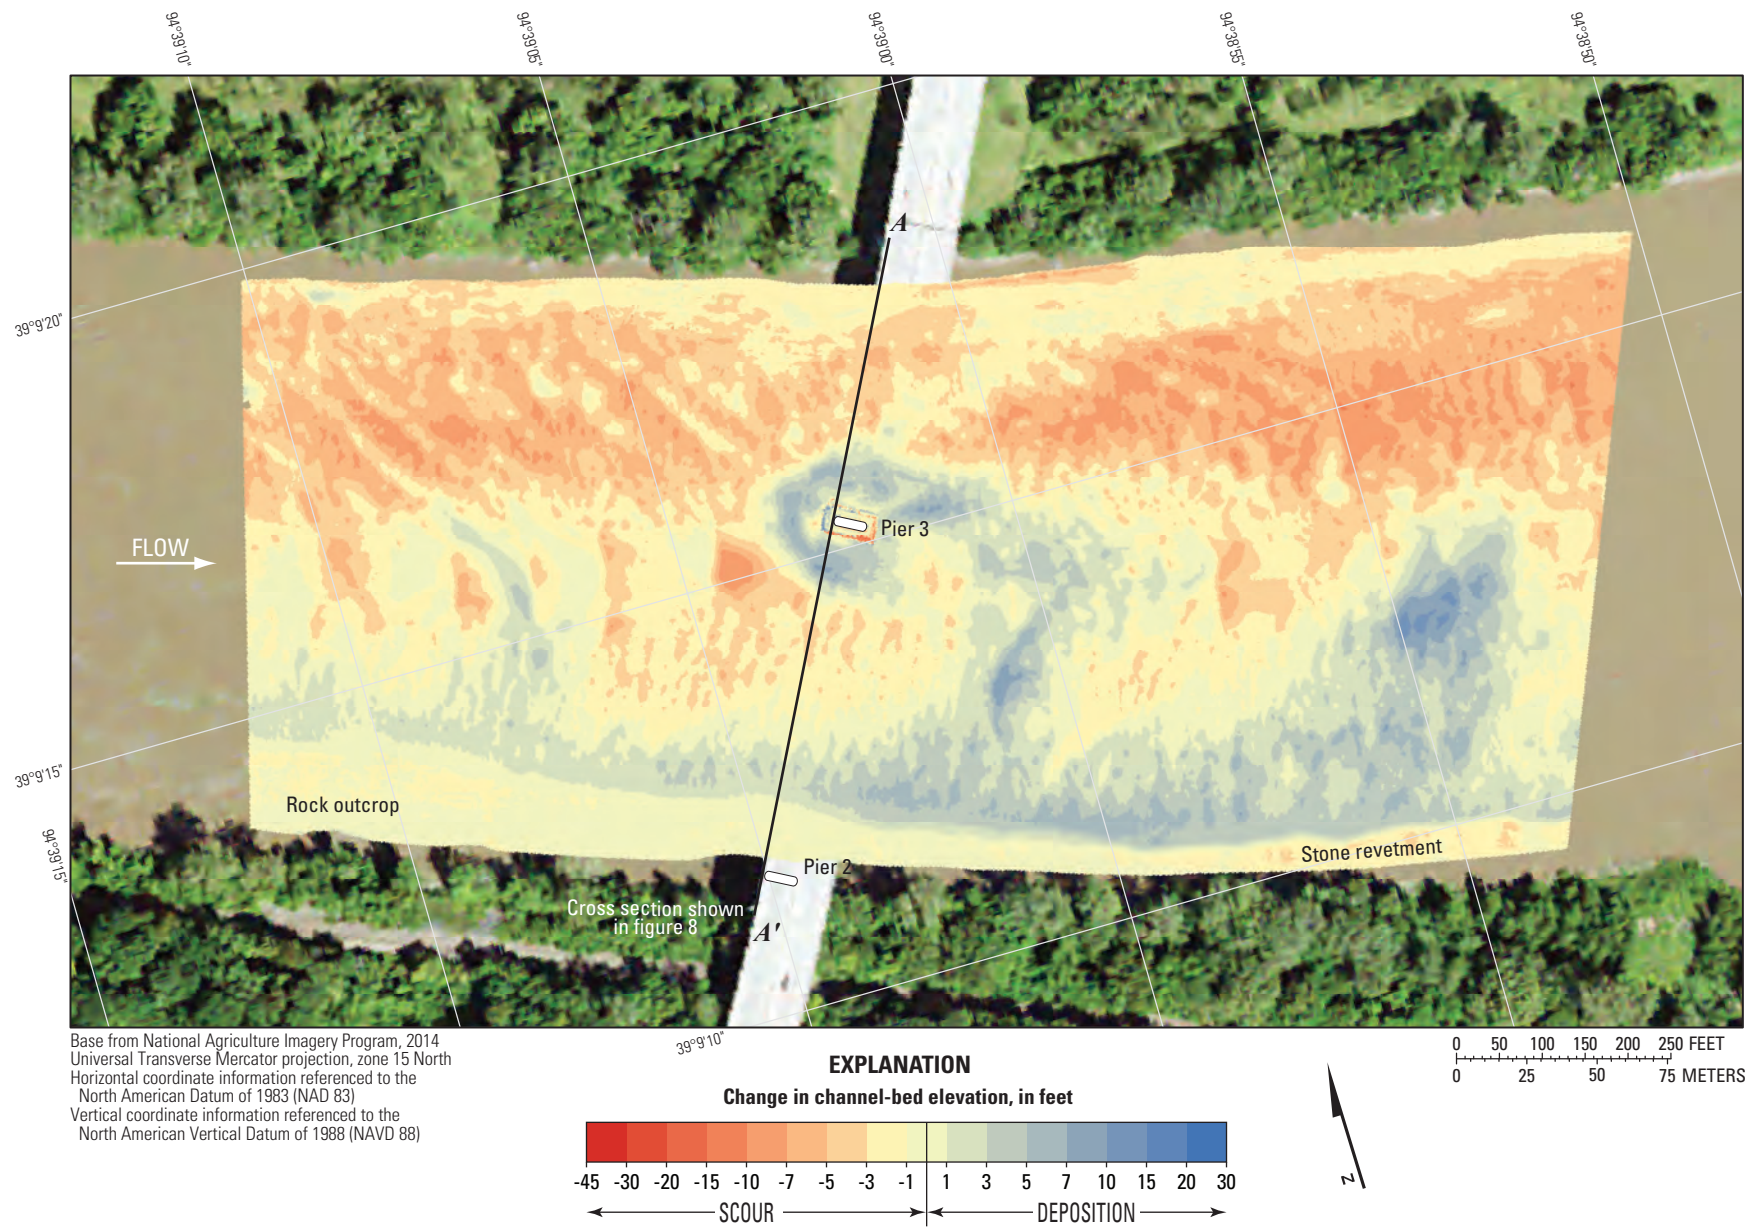
Figure 10. Difference between surfaces created from bathymetric surveys of the Missouri River channel near structure A1800 on Interstate 635 near Kansas City, Missouri, on June 2, 2015, and March 15, 2010.

difference between the bathymetric surfaces was -1.53 ft (table 7), indicating moderate channel degradation between the 2010 and 2015 surveys. The net volume of cut in the reach from 2010 to 2015 was about 71,200 yd³, and the net volume of fill was about 29,900 yd³, resulting in a net loss of about 41,300 yd³ of sediment between 2010 and 2015. The cross sections from the 2010 and 2015 surveys are not substantially different from one another (fig. 8); however, the frequency distribution of bed elevations was substantially narrower in 2015 than in 2010, with a higher minimum channel-bed elevation and a greater percentage of survey-grid cells at a lower elevation than 2010 (fig. 7). The scour hole near pier 3 was substantially narrower in 2015 than in 2010 (fig. 8), as evidenced by the overall pattern of deposition in a horseshoe shape around the pier (fig. 10). The rock outcrop on the upstream right (south) bank showed no signs of change, as would be expected (fig. 10). Areas of localized scour that were apparent in the 2011 survey on the stone revetment of the downstream right (south) bank and theorized as likely being from localized slumping (Huizinga, 2012) were confirmed in the 2015 survey (fig. 10). As with all difference maps presented in this report, substantial deposition or scour apparent at the faces of the pier results from minor horizontal positional variances between the surveys (see “Uncertainty Estimation” section).

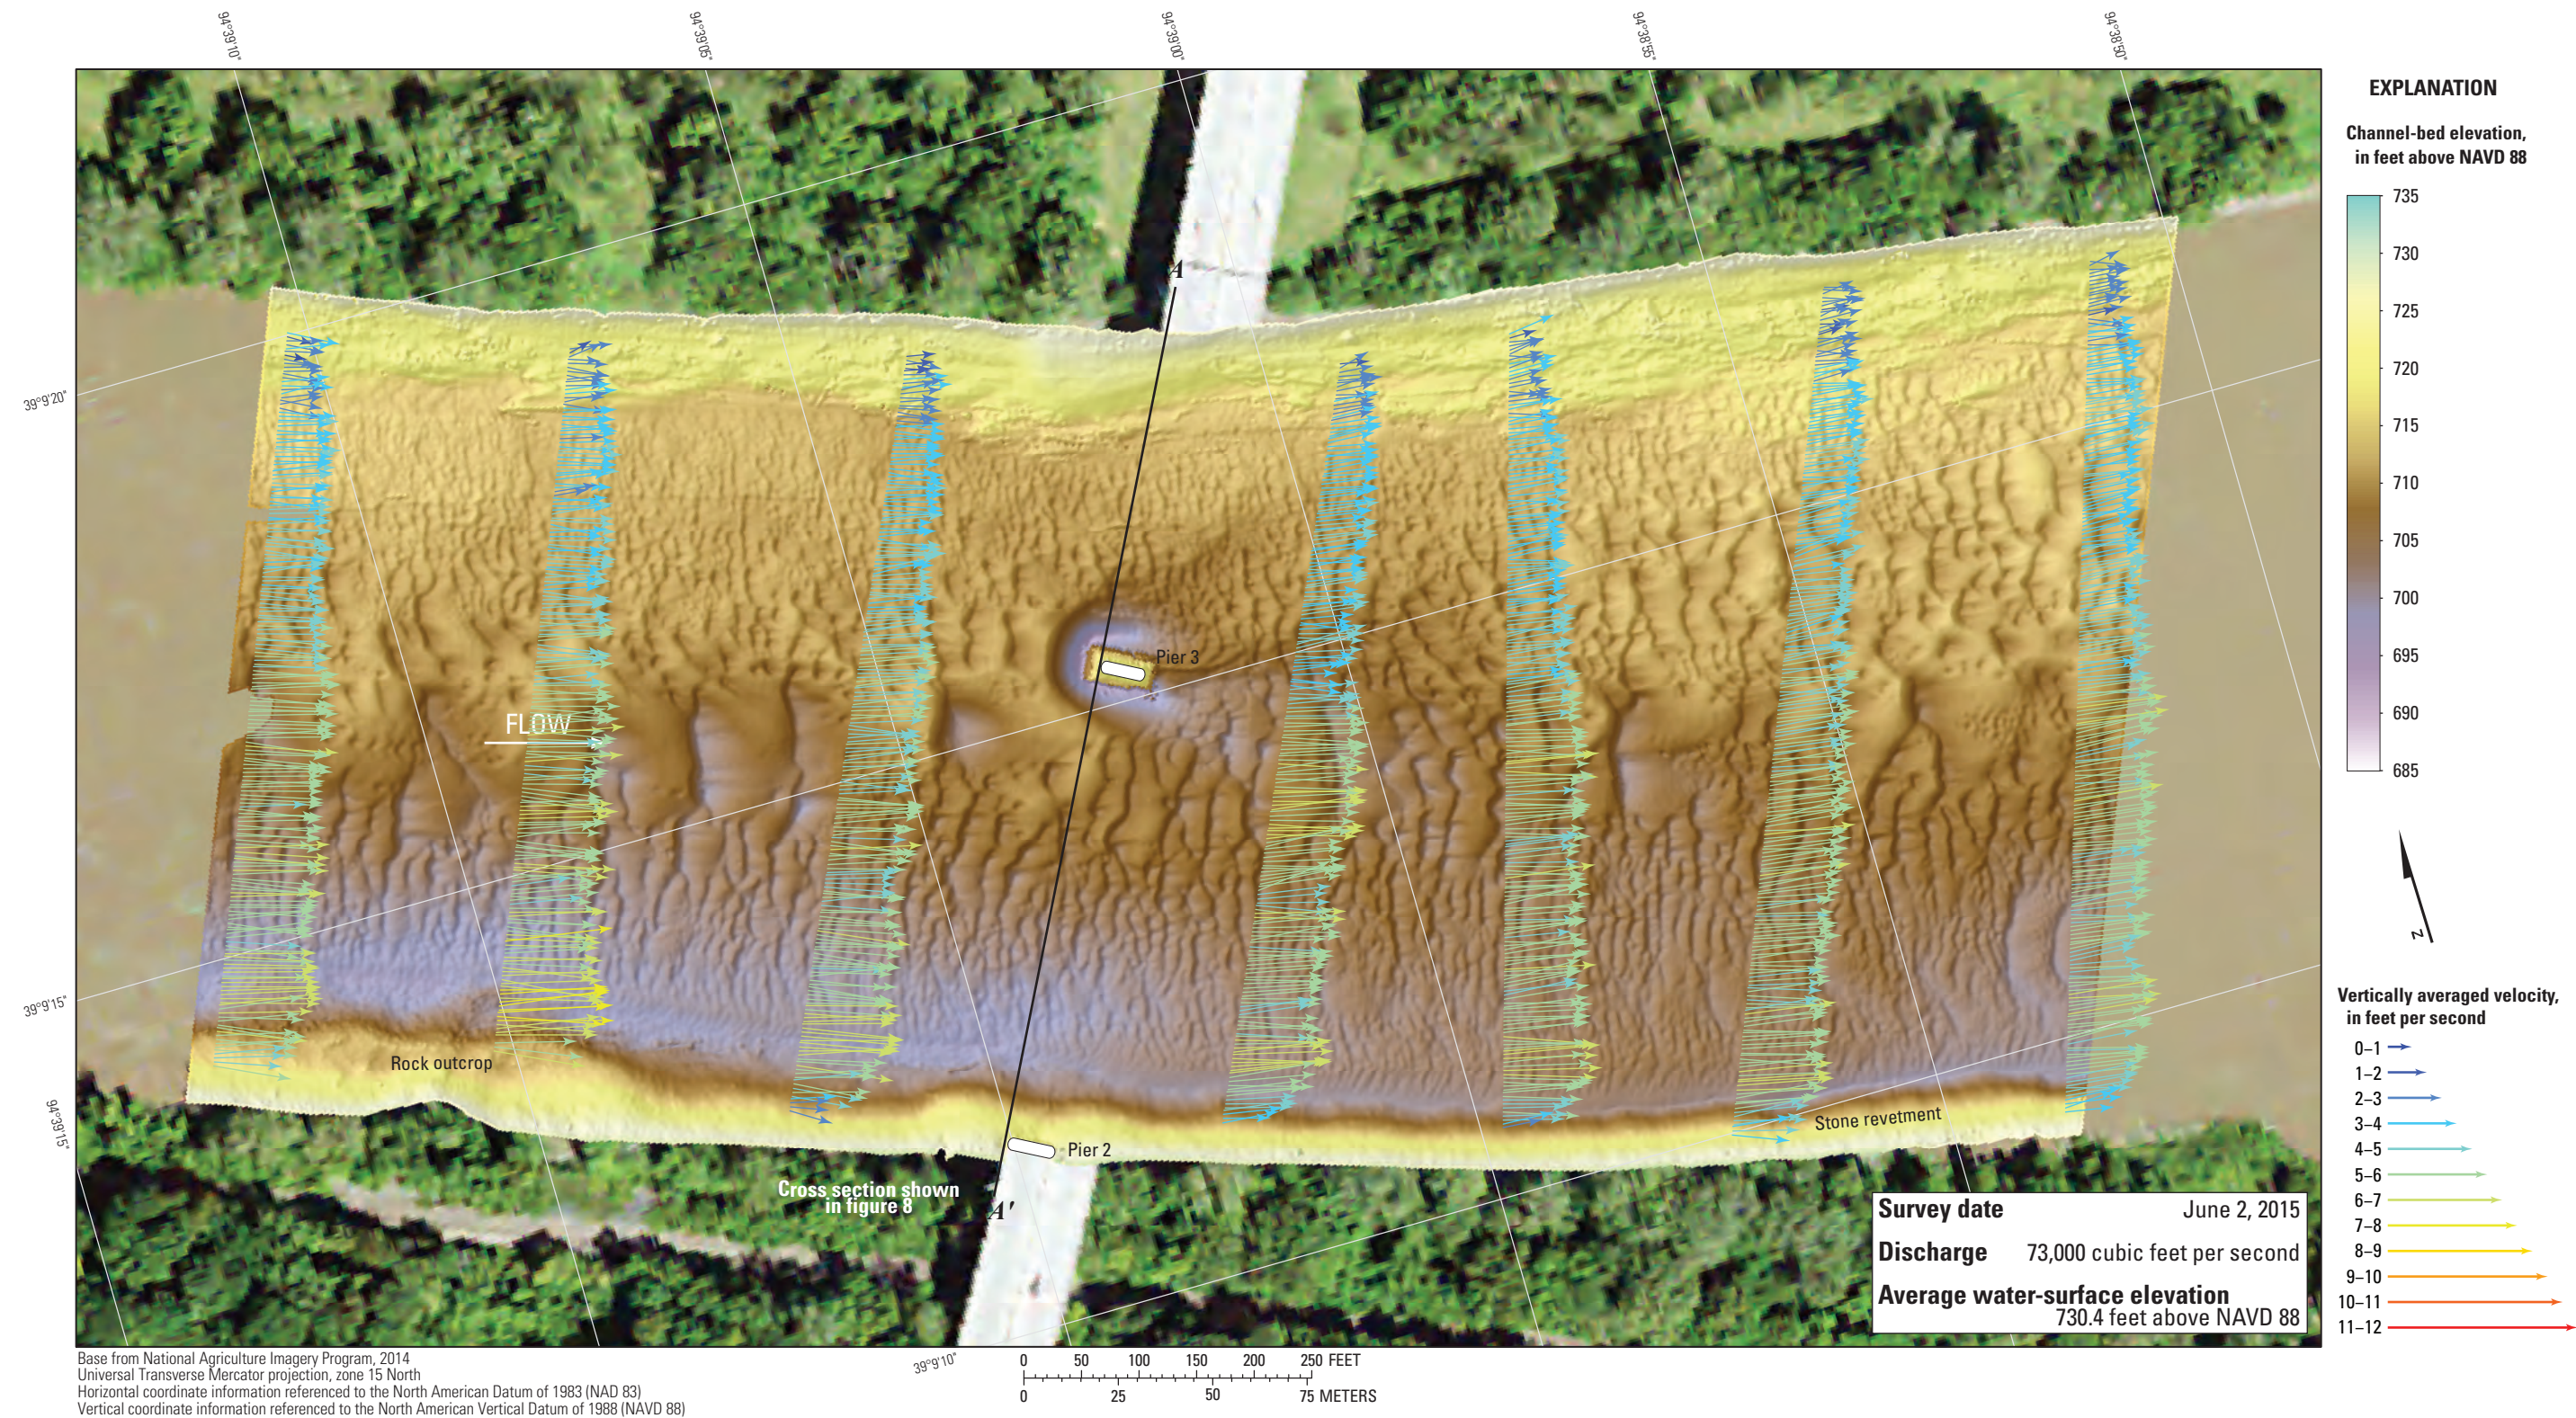
Figure 11. Bathymetry and vertically averaged velocities of the Missouri River channel near structure A1800 on Interstate 635 near Kansas City, Missouri.

The vertically averaged velocity vectors indicate mostly uniform flow throughout the reach, with a maximum velocity of 8 feet per second (ft/s) in the channel thalweg and a minimum of 2 ft/s along the inside of the bend on the left (north) bank (fig. 11). A minor decrease in velocity was observed near pier 3, likely exacerbated by the pier being skewed to flow (fig. 11). Minor turbulence was present in all of the sections (fig. 11).

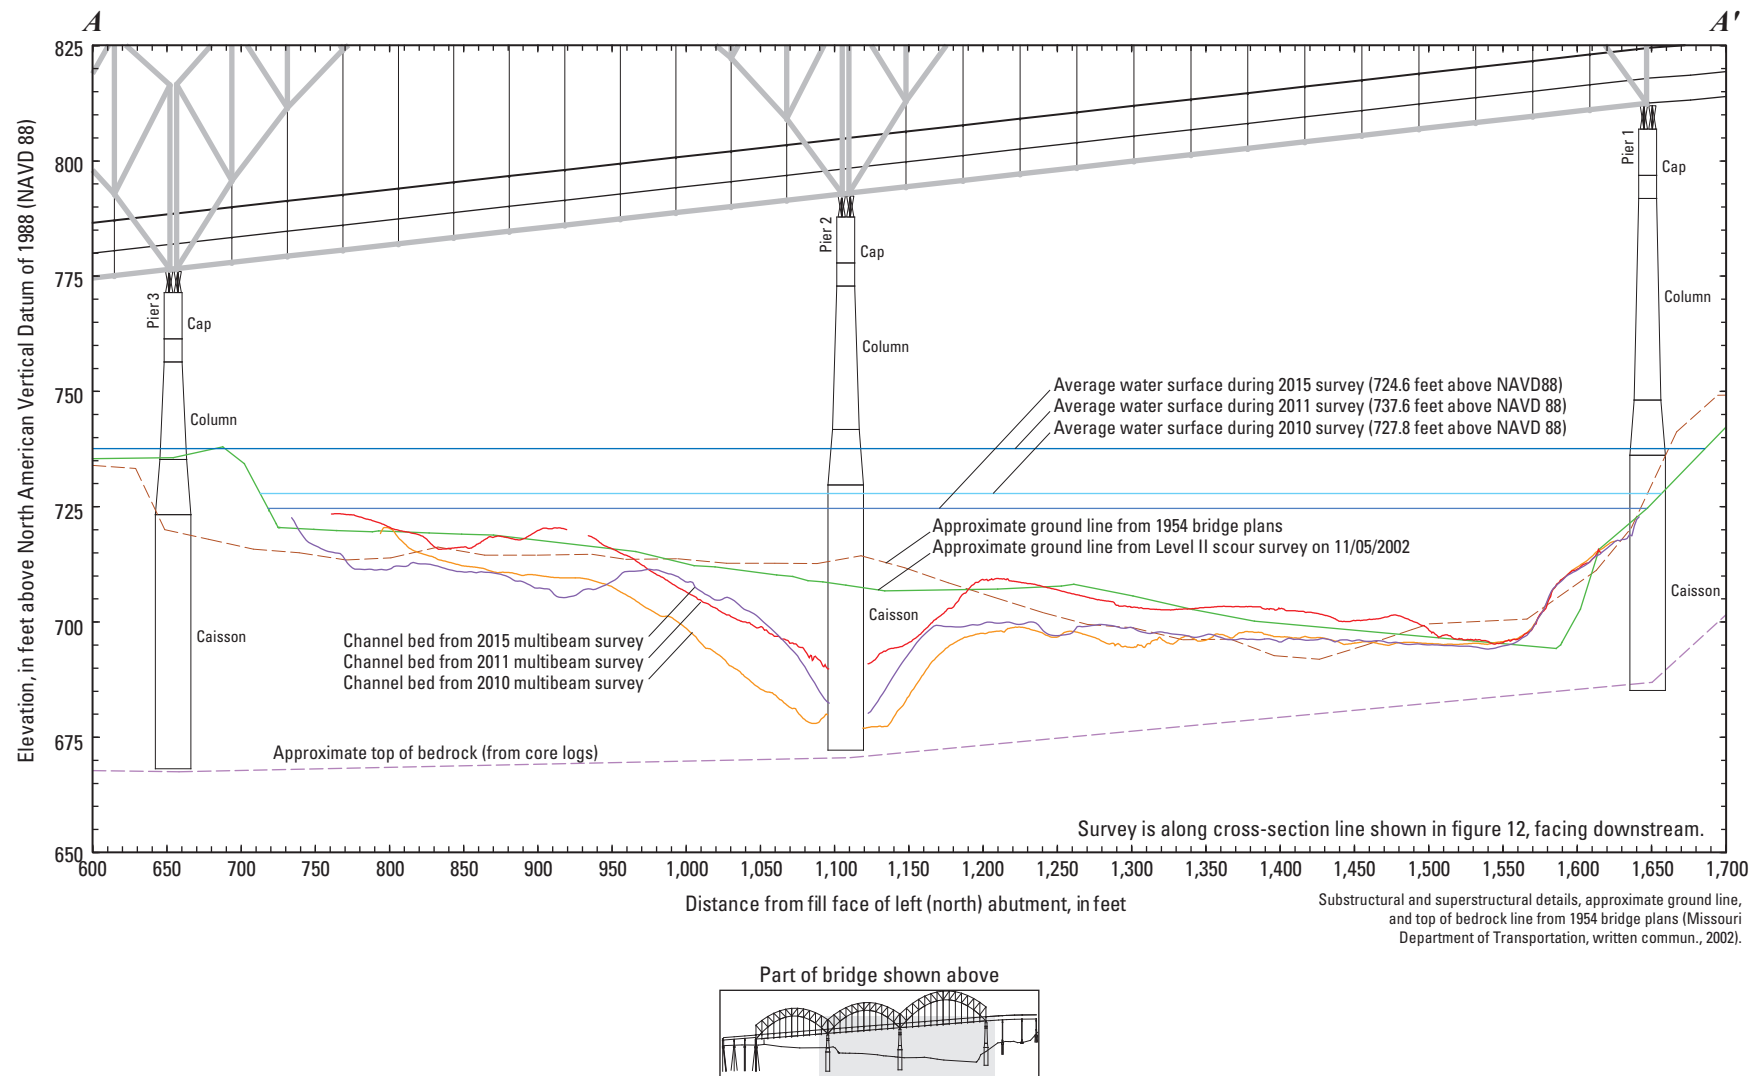
Figure 14. Key features, substructural and superstructural details, and surveyed channel bed of structure A4649 on U.S. Highway 169 crossing the Missouri River in Kansas City, Missouri.

defined, as were the piles of particulate rock debris around them. The remnant downstream from the existing railroad bridge turntable pier had a maximum elevation of about 710 ft, which is about 13 ft above the channel bed immediately upstream from it and only about 15 ft below the water surface at the time of the 2015 survey. Avoidance of this pier remnant might be difficult in flow conditions lower than those on the day of the survey. The overall minimum channel-bed elevation was 679 ft (table 5), and was observed upstream from the left railroad bridge pier. Information from bridge plans indicate that main channel pier 2 of structure A4649 is a caisson on bedrock, with about 10 ft of bed material between the bottom of the scour hole and the bottom of the caissons (fig. 14; table 6).

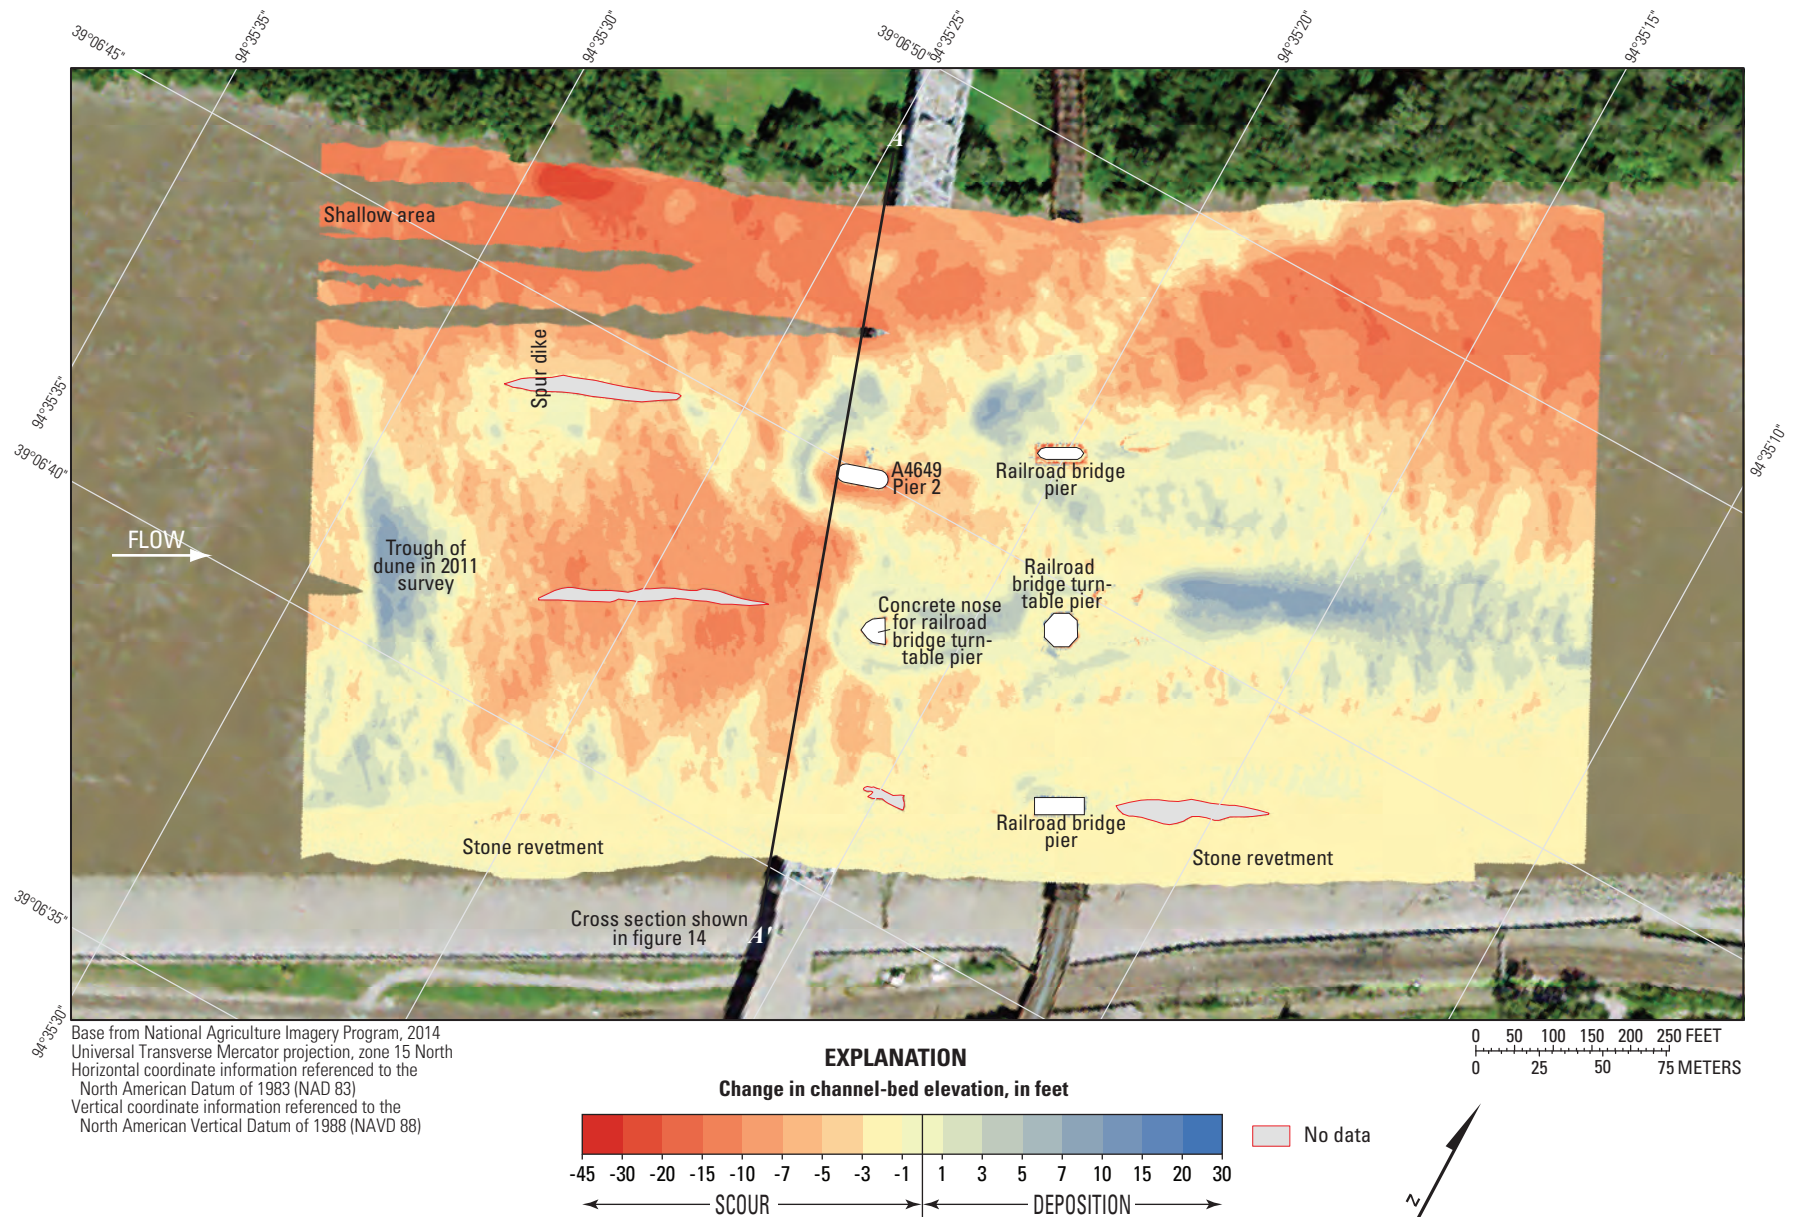
Figure 15. Difference between surfaces created from bathymetric surveys of the Missouri River channel near structure A4649 on U.S. Highway 169 in Kansas City, Missouri, on June 2, 2015, and July 17, 2011.

The difference between the survey on June 2, 2015, and the previous survey on July 17, 2011 (fig. 15), indicates substantial degradation throughout the reach from the 2011 to 2015 surveys, with an average difference of -3.82 ft between the bathymetric surfaces (table 7). The net volume of cut in the reach from 2011 to 2015 was about 219,400 yd³, and the net volume of fill was about 19,200 yd³, resulting in a net loss of about 200,200 yd³ of sediment between 2011 and 2015. The shallow area observed in the upstream left part of the channel in the 2011 survey was not observed in the 2015 survey, and there were areas in the middle of the upstream channel and the downstream left where degradation of 10 to 15 ft was observed (fig. 15). Small areas of deposition were observed around the piers and in the trough of the very large dune observed in the upstream channel of the 2011 survey (fig. 15). Minimal scour or deposition was observed along the downstream right bank (fig. 15), indicating this may be a scour resistant area of rock; a similar lack of change had been observed between 2010 and 2011 in the previous study at this site (Huizinga, 2012). The cross sections from the two surveys also were substantially different from one another (fig. 14), with the 2015 section 10 to 15 ft lower than in 2011. The frequency distribution of bed elevations was narrower in 2015 than in 2011, with a greater percentage of survey-grid cells at a lower elevation than 2011 (fig. 13). The scour hole near main channel pier 2 in 2015 was narrower and deeper than in 2011 (fig. 14), as evidenced by the small area of deposition upstream from the pier, and the overall indication

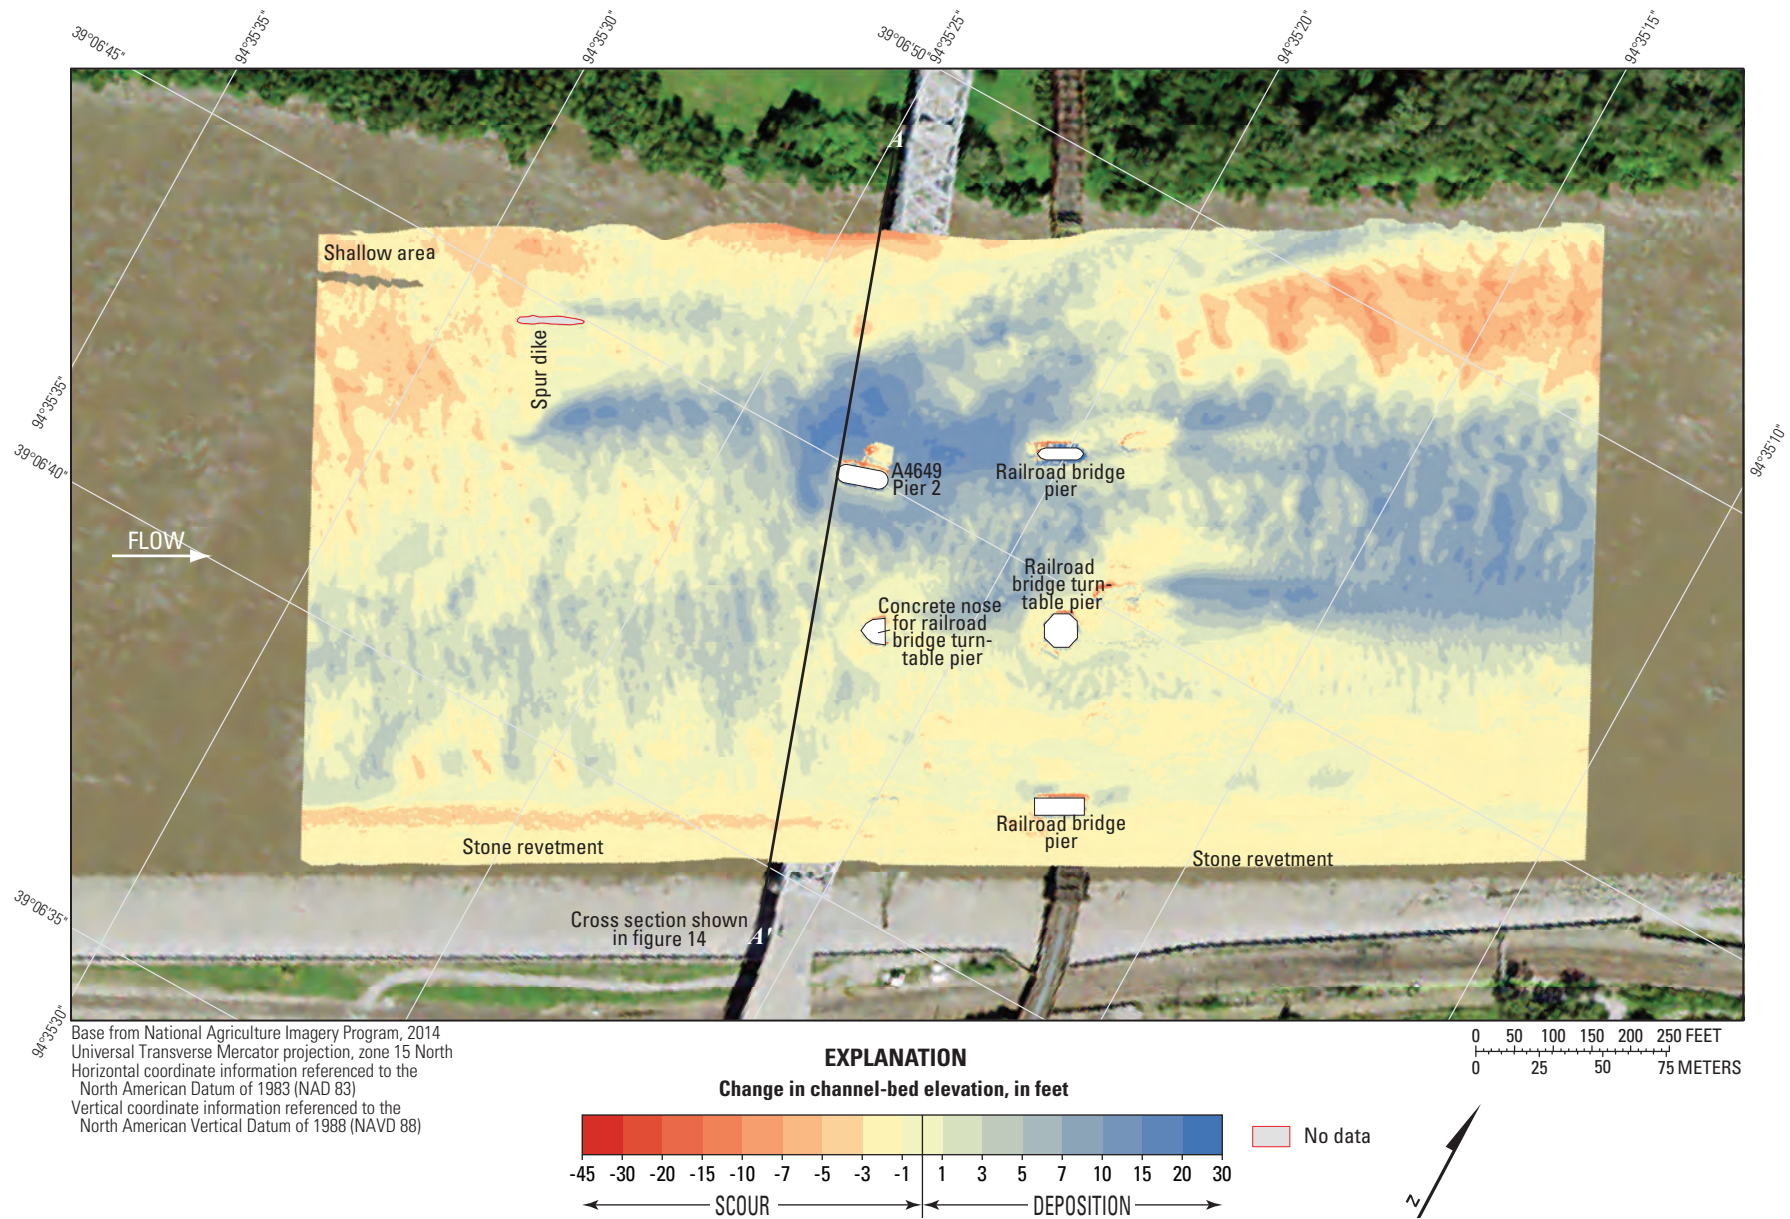
Figure 16. Difference between surfaces created from bathymetric surveys of the Missouri River channel near structure A4649 on U.S. Highway 169 in Kansas City, Missouri, on June 2, 2015, and March 16, 2010.

The difference between the survey on June 2, 2015, and the previous nonflood survey on March 16, 2010 (fig. 16) indicates moderate deposition throughout the reach from the 2010 to 2015 surveys, with an average difference of +1.11 ft between the bathymetric surfaces (table 7). The net volume of cut in the reach from 2010 to 2015 was about 47,000 yd³, and the net volume of fill was about 103,100 yd³, resulting in a net gain of about 56,100 yd³ of sediment between 2010 and 2015. Substantial deposition had been observed between the 2010 and 2011 surveys (Huizinga, 2012), but ongoing sediment transport processes at this site have removed much of the sediment deposits as indicated by the substantial scour observed between 2011 and 2015 (fig. 15). Some of the deposition remained or returned after the 2011 survey, with small areas of scour along the left bank upstream and downstream from the bridge (fig. 16). An area of as much as 5 ft of scour was observed along the toe of the upstream right bank (fig. 16) and may represent an area of slumped revetment. Smaller areas of scour are apparent in the same area in the difference between the 2011 and 2015 surveys (fig. 15). The cross sections from the 2010 and 2015 surveys were similar to one another for most of the right side of the channel and part of the left
