Bathymetric and Velocimetric Surveys at Highway Bridges Crossing the Missouri River near Kansas City, Missouri, June 2–4, 2015

Scientific Investigations Report 2016–5061

By Richard J. Huizinga

Prepared in cooperation with the Missouri Department of Transportation

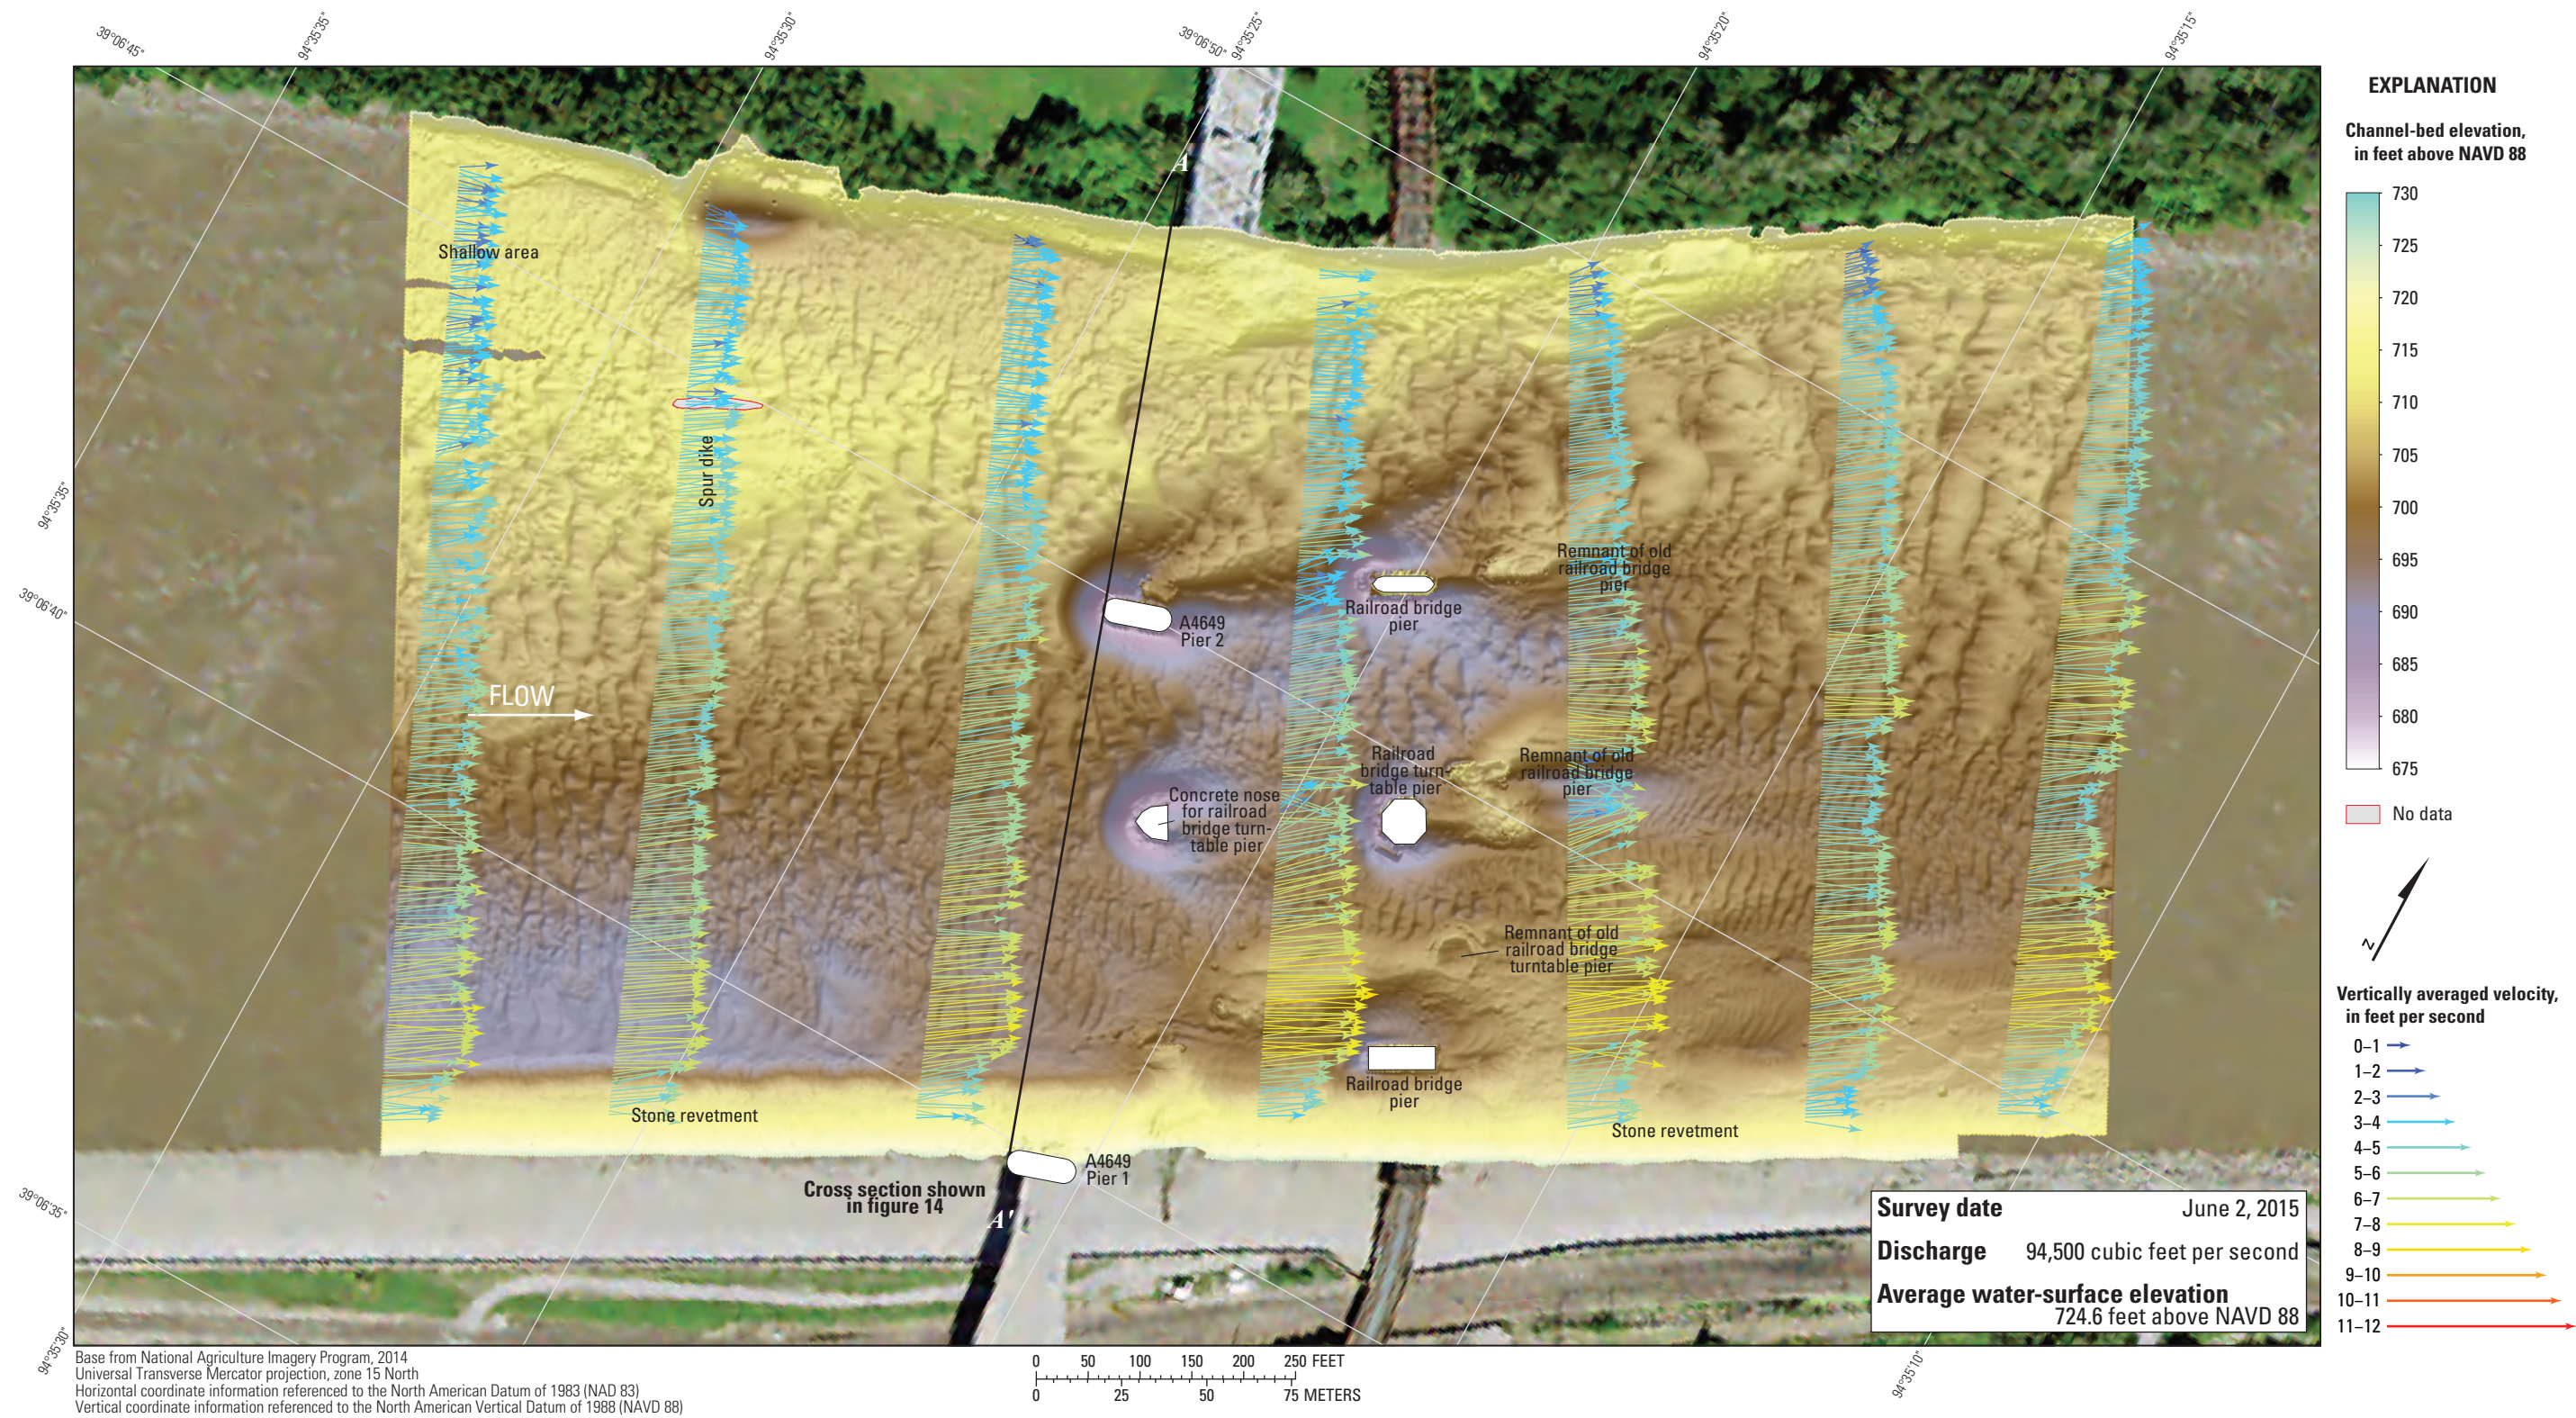
Figure 17. Bathymetry and vertically averaged velocities of the Missouri River channel near structure A4649 on U.S. Highway 169 in Kansas City, Missouri.

The vertically averaged velocity vectors indicate mostly uniform flow upstream from the structure A4649 ranging from a minimum of 2 ft/s along the inside of the bend on the upstream left (north) bank to a maximum velocity of about 9 ft/s in the channel thalweg along the outside of the bend on the right (south) bank (fig. 17). Exceptions to uniform conditions include diagonal flows across the channel in the immediate vicinity of structure A4649 (fig. 17), which may help explain the shift in the channel thalweg towards the left (north) bank. Substantial turbulence also was observed between structure A4649 and the railroad bridge and downstream from the railroad bridge piers (fig. 17).

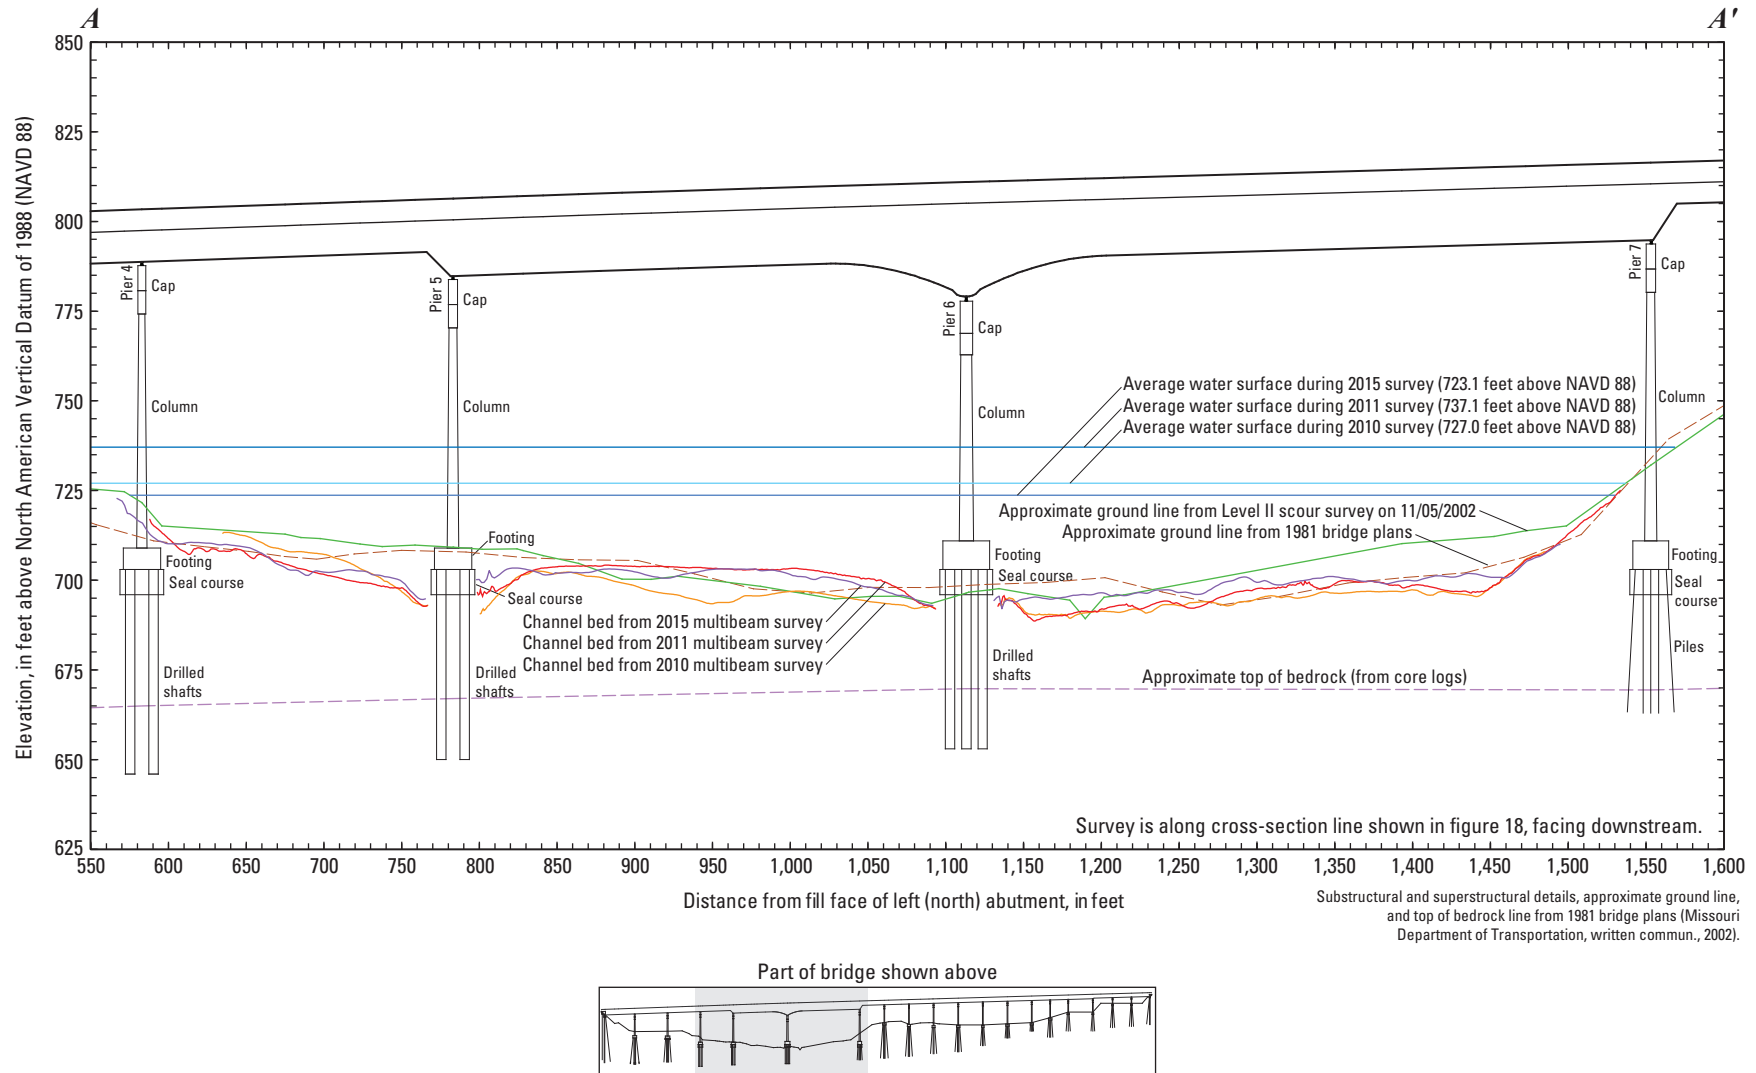
Figure 20. Key features, substructural and superstructural details, and surveyed channel bed of structure A4060 on State Highway 9 crossing the Missouri River in Kansas City, Missouri.

over large sheet piling panels that were lying on the channel bottom on the right (south) side of the upstream railroad bridge pier first observed in the 2010 survey (Huizinga, 2010). Information from bridge plans indicates that piers 5 and 6 are founded on shafts drilled 20 ft into bedrock, with about 26 ft of bed material between the bottom of the scour hole and bedrock at pier 5 and 18 ft of material at pier 6 (fig. 20; table 6).

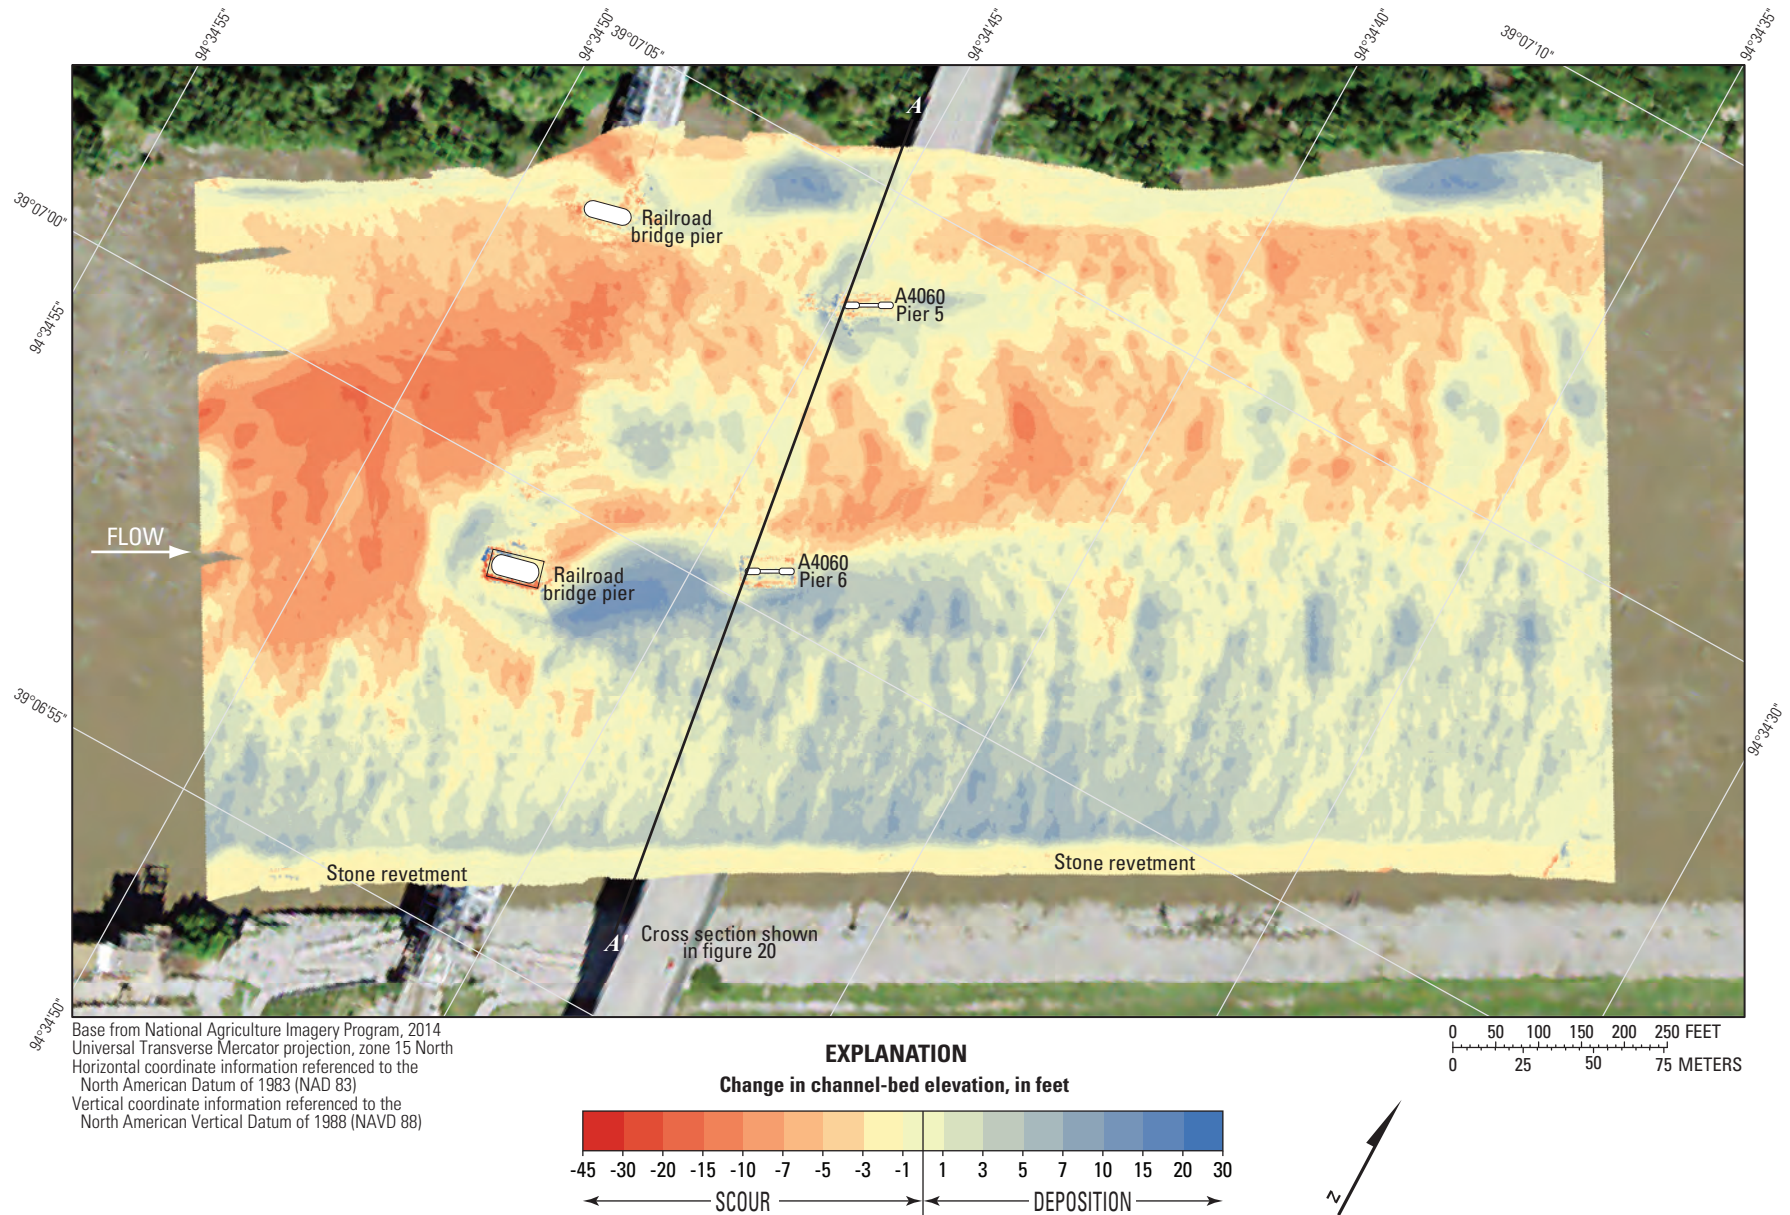
Figure 21. Difference between surfaces created from bathymetric surveys of the Missouri River channel near structure A4060 on State Highway 9 in Kansas City, Missouri, on June 3, 2015, and July 17, 2011.

The difference between the survey on June 3, 2015, and the previous survey on July 17, 2011 (fig. 21), indicates moderate degradation throughout the reach from 2011 to 2015, with an average difference of -1.25 ft between the bathymetric surfaces (table 7). The net volume of cut in the reach from 2011 to 2015 was about 118,500 yd³, and the net volume of fill was about 55,100 yd³, resulting in a net loss of about 63,400 yd³ of sediment between 2011 and 2015. Substantial deposition had been observed between the 2010 and 2011 surveys (Huizinga, 2012), but ongoing sediment transport processes at this site seem to have removed some of the sediment deposits. There was an area of substantial scour in the upstream channel, and moderate scour along the left (north) side of the downstream channel (fig. 21). The thalweg observed along the right (south) bank in 2011 experienced deposition, and the substantial scour hole downstream from the right railroad bridge pier also had 7 to 10 ft of deposition (fig. 21). The cross sections from the two surveys were similar to one another to the left of pier 6, whereas to the right of pier 6, the 2015 survey is 5 to 10 ft higher (fig. 20); however, the frequency distribution of bed elevations was substantially narrower in 2015 than in 2011, with a higher minimum channel-bed elevation and a much greater percentage of survey-grid cells at a lower elevation than 2011 (fig. 19). The scour hole near main channel pier 5 in 2015 was of a similar shape to that in 2011, albeit substantially shallower on the right side (figs. 20 and 21). The localized scour observed on the stone revetment on the right (south) bank in 2011 (Huizinga, 2012) seemed to have stabilized between 2011 and 2015 (fig. 21). As with all difference maps in this report, substantial deposition or scour apparent at the faces of the piers results from minor horizontal positional variances between the surveys (see “Uncertainty Estimation” section).
