Bathymetric and Velocimetric Surveys at Highway Bridges Crossing the Missouri and Mississippi Rivers near St. Louis, Missouri, May 23–27, 2016

Scientific Investigation Report 2017–5076

By Richard J. Huizinga

Prepared in cooperation with the Missouri Department of Transportation

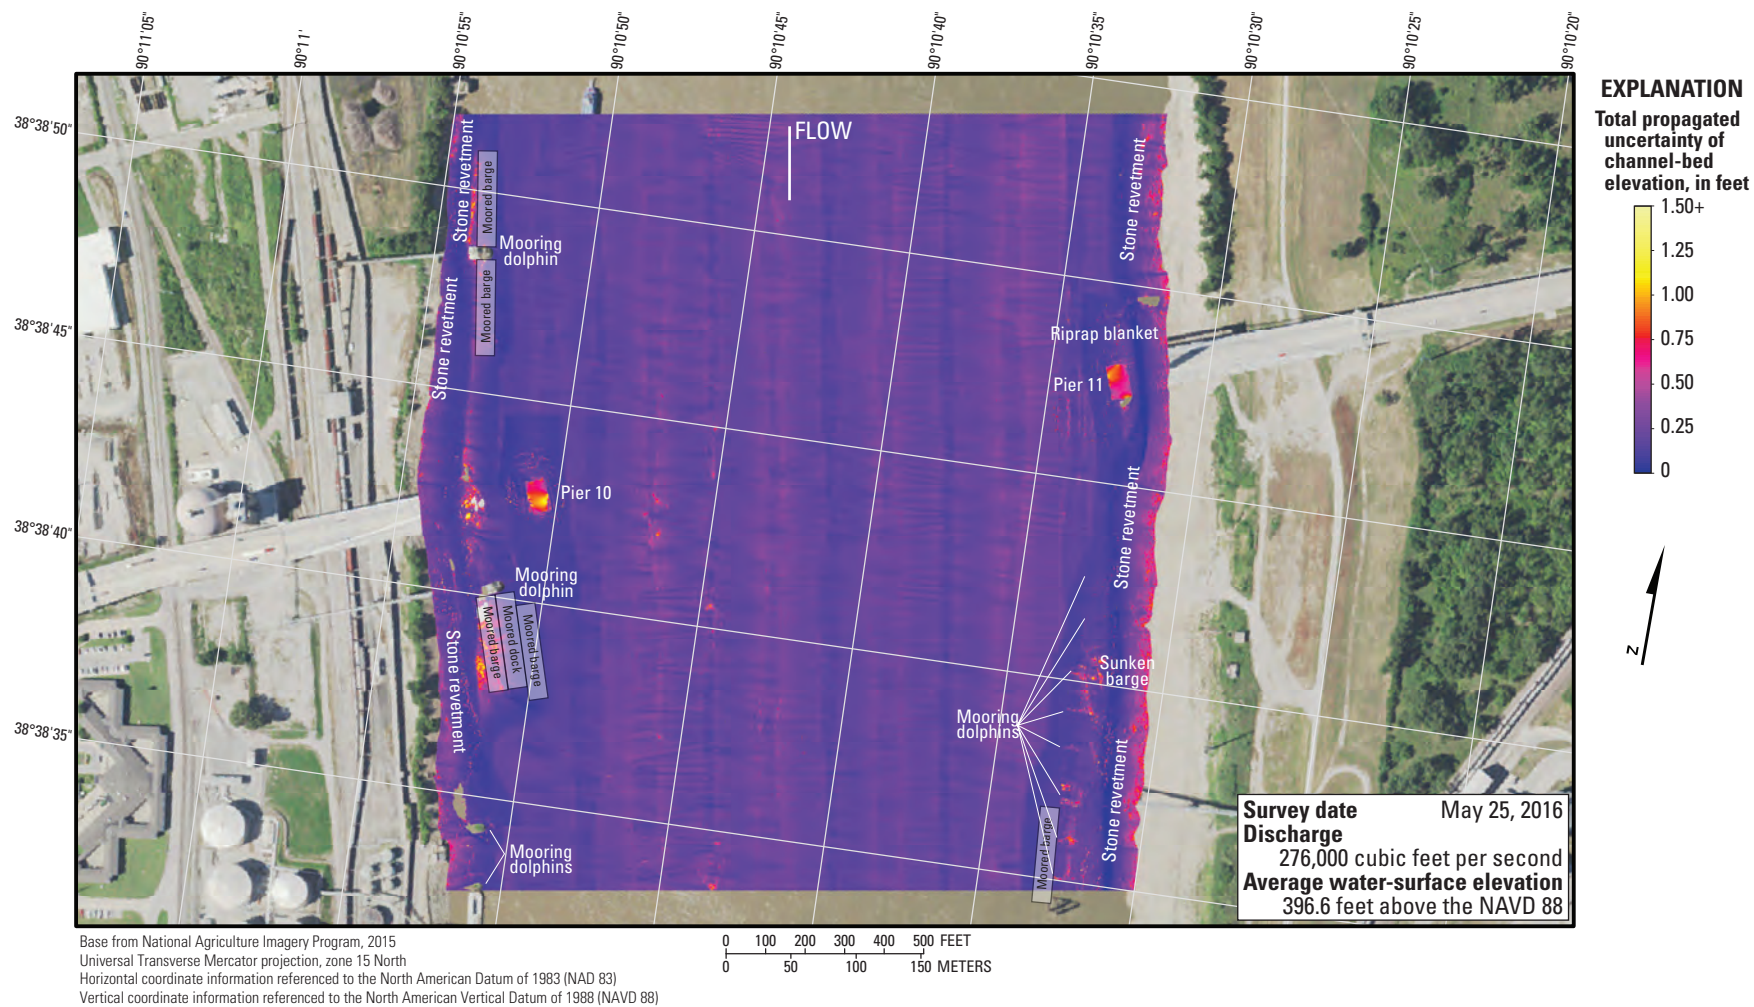
The largest TPU in this group of surveys was about 2.53 ft (table 4); however, as noted in previous studies, TPU values of this magnitude typically happened near high-relief features, such as the front or side of a pier footing (fig. 5). Most of the TPU values (more than 97 percent) were less than 0.50 ft (table 4), which is within the specifications for a “Special Order” survey, the most-stringent survey standard of the International Hydrographic Organization (IHO; International Hydrographic Organization, 2008). The TPU values were larger near moderate-relief features (banks, spur dikes, rock riprap and outcrops, and scour holes near piers; fig. 5). Occasionally, the TPU values also were larger (1.00 ft or greater) in the outermost beam extents of the multibeam swath in the

Figure 5. Total propagated uncertainty of bathymetric data from the Mississippi River channel near structure A6500 on Interstate 70 in St. Louis, Missouri.

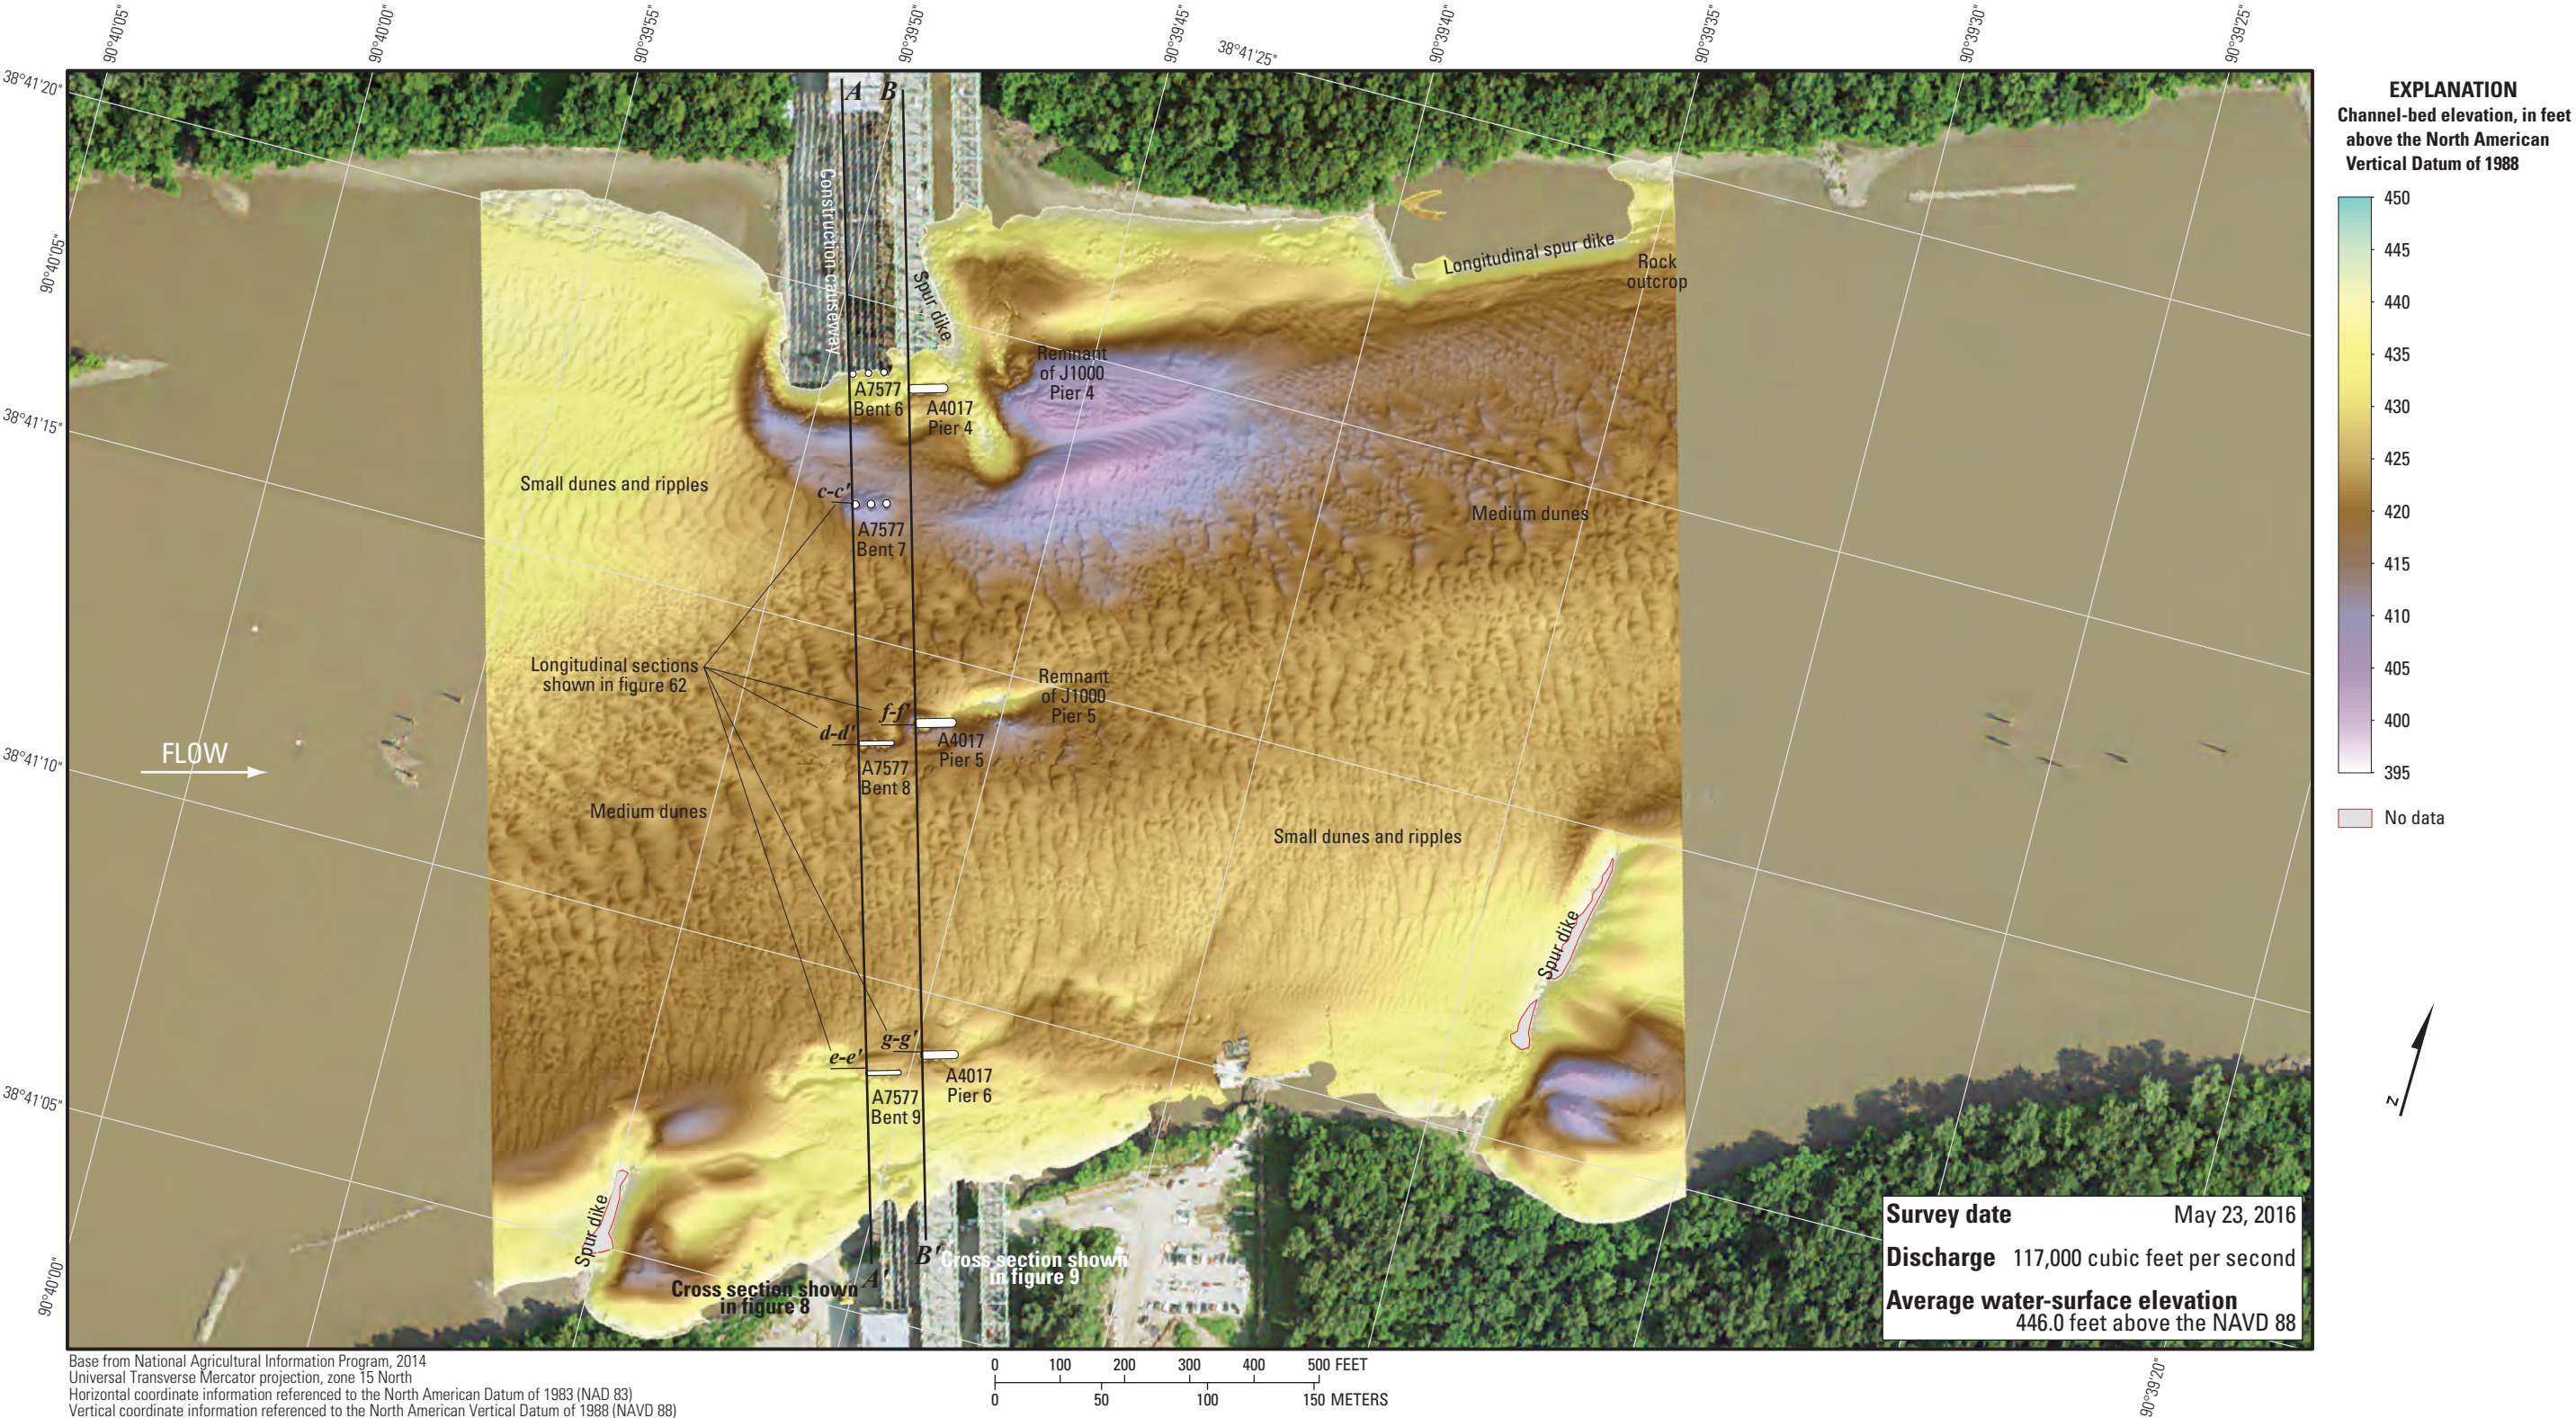
dunes was present in the middle of the channel, and numerous other small dunes and ripples were present throughout the rest of the channel (fig. 6). As in previous surveys (Huizinga, 2011, 2012), a rock outcrop and a longitudinal spur dike were present on the left (north) bank downstream from the bridges, and several other spur dikes were present on both banks (fig. 6). A construction causeway had been built into the channel from the left bank upstream from structure A7577 and the spur dike on the left bank under structure A4017 (fig. 6). Remnants of piers from old downstream structure J1000 are evident downstream from the spur dike on the left bank and downstream from pier 5 of downstream structure A4017 (fig. 6).

Near the piers near the left bank (structure A7577 bents 6 and 7, and structure A4017 pier 4, fig. 6), a localized deep scour hole near the end of the construction causeway upstream from the spur dike had an approximate minimum channel-bed elevation of about 410 ft (table 6); however, bent 6 of structure A7577 and pier 4 of structure A4017 essentially were embedded in the rock of the construction causeway and spur dike on the left bank (fig. 6), which will limit or prevent scour near these piers. Near bent 7 of upstream structure A7577, a local scour hole had an approximate minimum channel-bed elevation of about 406 ft (table 6), about 5 ft above the approximate minimum channel-bed elevation of 401 ft (table 5), and about

Figure 6. Bathymetric survey of the Missouri River channel near structures A7577 and A4017 on U.S. Highway 40 near St. Louis, Missouri.

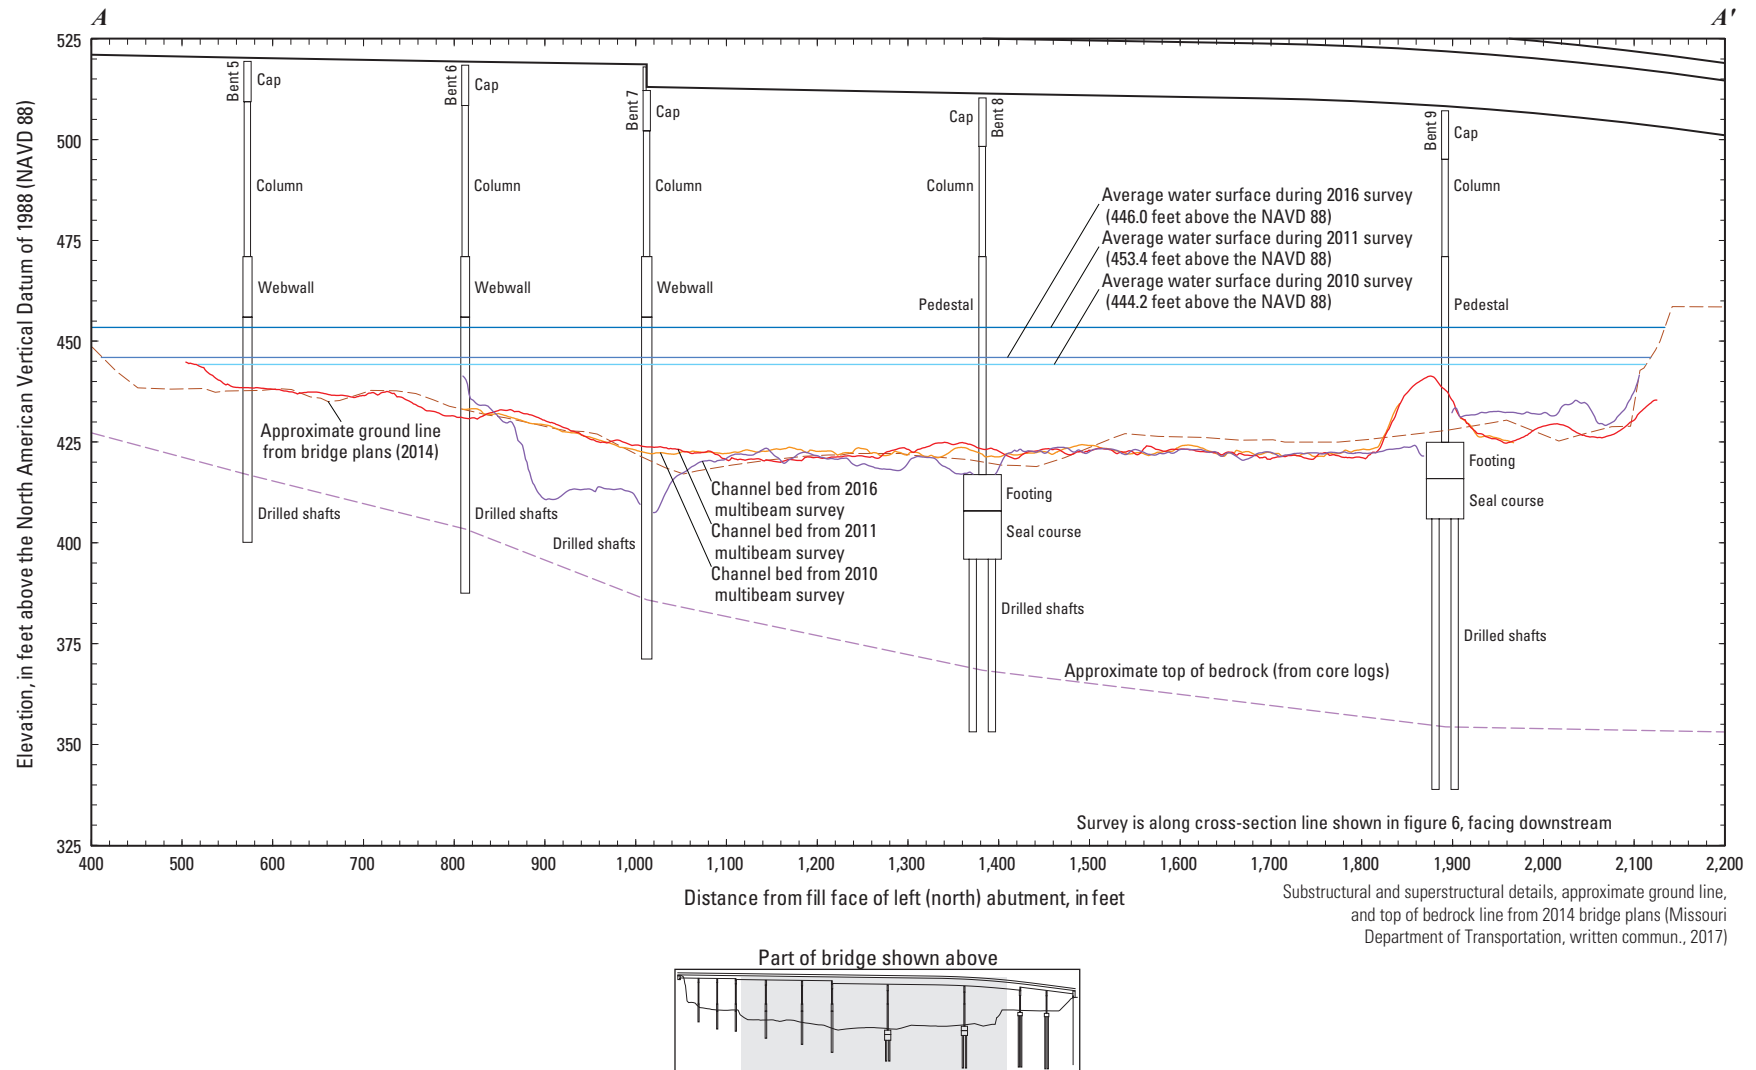
Information from bridge plans indicate that all the bents of structure A7577 are shafts drilled 15 to 16 ft into bedrock, with about 20 ft of bed material between the bottom of the scour hole and bedrock at bent 7 (fig. 8; table 6), which increases substantially to the right (south) because of the sloping bedrock in the area (fig. 8; table 6). Information from bridge plans indicate that pier 4 of structure 4017 is a footing founded on bedrock, and about 15 ft of bed material was present between the bottom of the scour hole and bedrock (fig. 9; table 6). Piers 5 and 6 of structure A4017 are founded on shafts drilled 13 to 26 ft into bedrock, and more than 44 ft of bed material was present between the bottom of the scour hole and bedrock (fig. 9; table 6) because of the sloping bedrock in the area (fig. 9; table 6).

Figure 8. Key features, substructural and superstructural details, and surveyed channel bed of structure A7577 on U.S. Highway 40 crossing the Missouri River near St. Louis, Missouri.

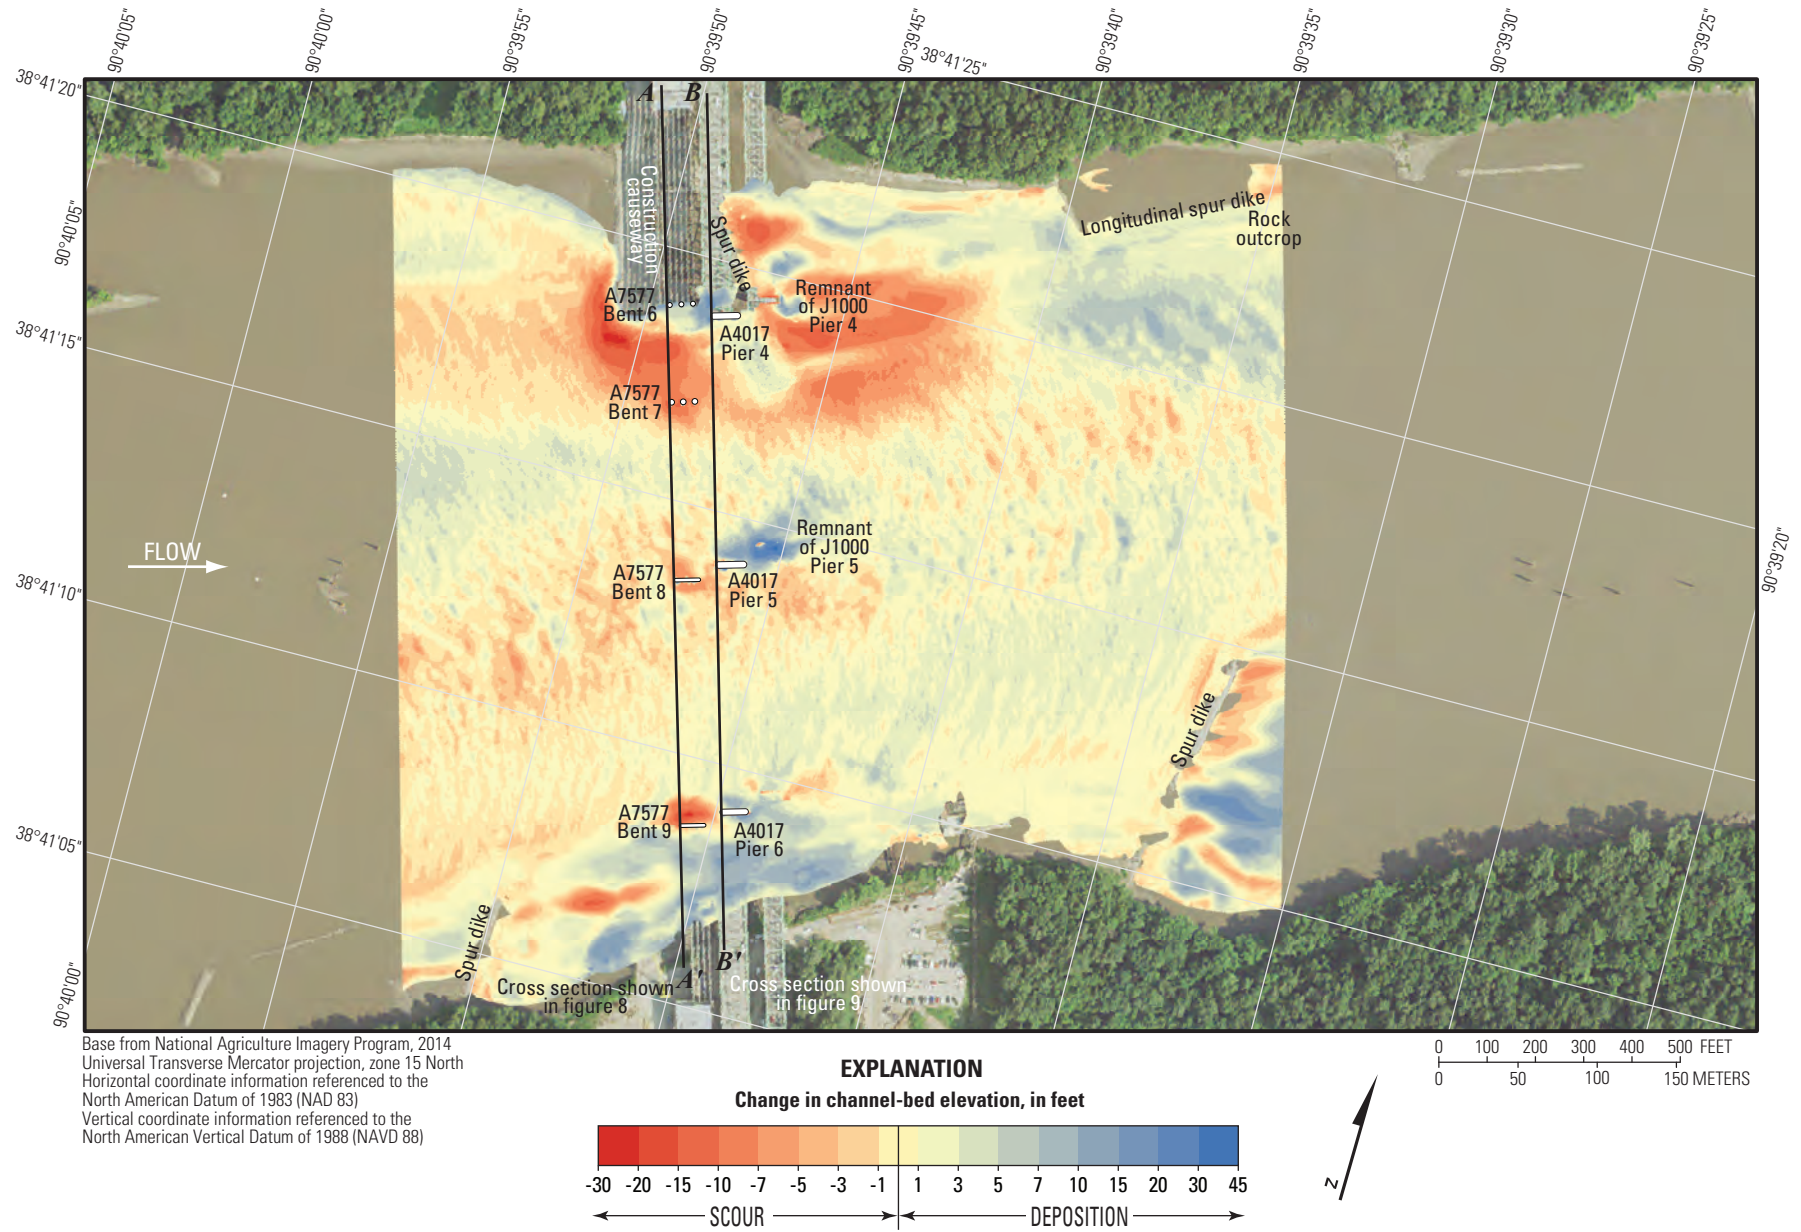
The difference between the survey on May 23, 2016, and the previous flood survey on July 29, 2011, does not indicate substantial bed variation from 2011 to 2016, with the exception of areas near the construction causeway on the left bank and around the various spur dikes (fig. 10). There was an area of substantial deposition near the location of pier 5 of

old structure J1000, where a scour hole present in the 2011 survey (Huizinga, 2012) has subsequently been filled (fig. 10). The mean difference between the bathymetric surfaces (the statistical mean value of the gridded raster surface [fig. 10] created from the difference between the 2016 and 2011 [previous] survey gridded raster bathymetric surfaces) was -0.27 ft (table 7), indicating overall minor channel degradation between the 2011 and 2016 surveys. The net volume of cut in the reach from 2011 to 2016 was about 144,300 cubic yards (yd^3), and the net volume of fill was about 117,700 yd^3 , resulting in a net loss of about 26,700 yd^3 of sediment between 2011 and 2016. The cross sections from the two surveys along the upstream face of the upstream structure A7577 bridge are not substantially different from one another between bents 7 and 9 except near the new bents, but the scouring effect of the construction causeway is clearly evident between bents 6 and 7 (fig. 8). The frequency distribution of bed elevations also was not substantially different in shape in 2016 than in 2011, except without the higher percentage of survey-grid cells with elevations between 420 and 426 ft evident in the 2011 and 2010 surveys, and without the spike of grid cells with elevations around 436 ft evident in 2011 (fig. 7). A large mound of rock near bent 9 of upstream structure A7577 (fig. 8) also had been removed, which resulted in an area of substantial scour indicated near that bent and deposition around pier 6 of downstream structure A4017 (fig. 10). The rock outcrop on the downstream left (north) bank showed no signs of substantial change except for minor deposition along the toe of the

Figure 10. Difference between surfaces created from bathymetric surveys of the Missouri River channel near structures A7577 and A4017 on U.S. Highway 40 near St. Louis, Missouri, on May 23, 2016, and July 29, 2011.

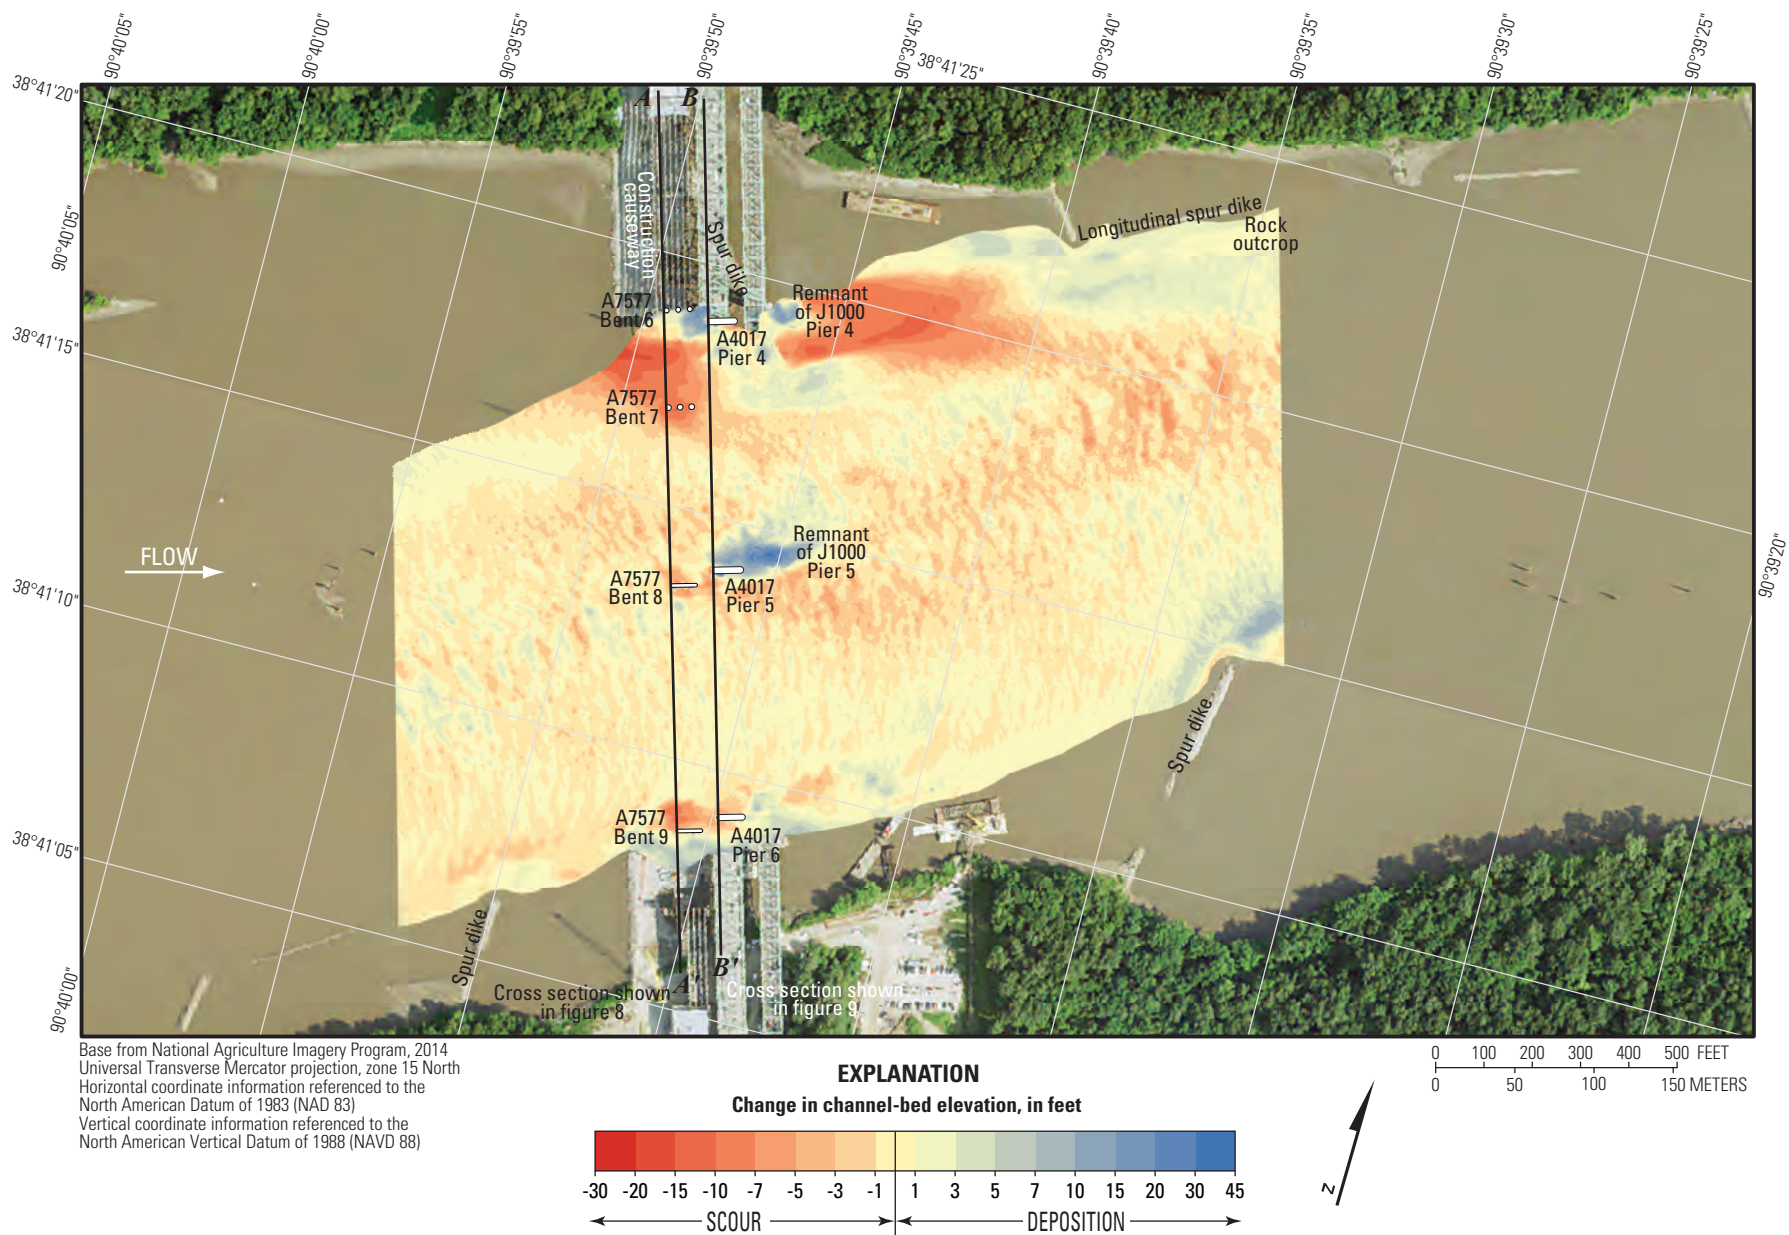
The difference between the survey on May 23, 2016, and the previous nonflood survey on October 18, 2010, does not indicate substantial bed variation from 2010 to 2016, again with the exception of near the construction causeway on the left bank and downstream from the spur dike on the left bank (fig. 11). There was an area of substantial deposition near the location of pier 5 of old structure J1000, where a scour hole present in the 2010 survey (Huizinga, 2011) has subsequently been filled (fig. 11). The mean difference between the bathymetric surfaces was -1.41 ft (table 7), indicating moderate channel degradation between the 2010 and 2016 surveys for the area common to both surveys. The net volume of cut in the reach from 2010 to 2016 was about $132,100$ yd³, and the net volume of fill was about $30,800$ yd³, resulting in a net loss of about $101,300$ yd³ of sediment between 2010 and 2016. The cross sections from the two surveys along the upstream face of the upstream structure A7577 bridge are not substantially different from one another between bents 7 and 9 except near the new bents, but the scouring effect of the construction

causeway again is clearly evident between bents 6 and 7 (fig. 8). The frequency distribution of bed elevations also was similar in shape in 2016 compared to 2010; however, a lower percentage of grid cells had elevations between 420 and 426 ft, and a higher percentage of survey-grid cells had elevations between 429 and 443 ft (fig. 7). Again, the large mound of rock near bent 9 of upstream structure A7577 (fig. 8) also had been removed, with a resultant area of substantial scour indicated near that bent (fig. 11).

Figure 11. Difference between surfaces created from bathymetric surveys of the Missouri River channel near structures A7577 and A4017 on U.S. Highway 40 near St. Louis, Missouri, on May 23, 2016, and October 18, 2010.

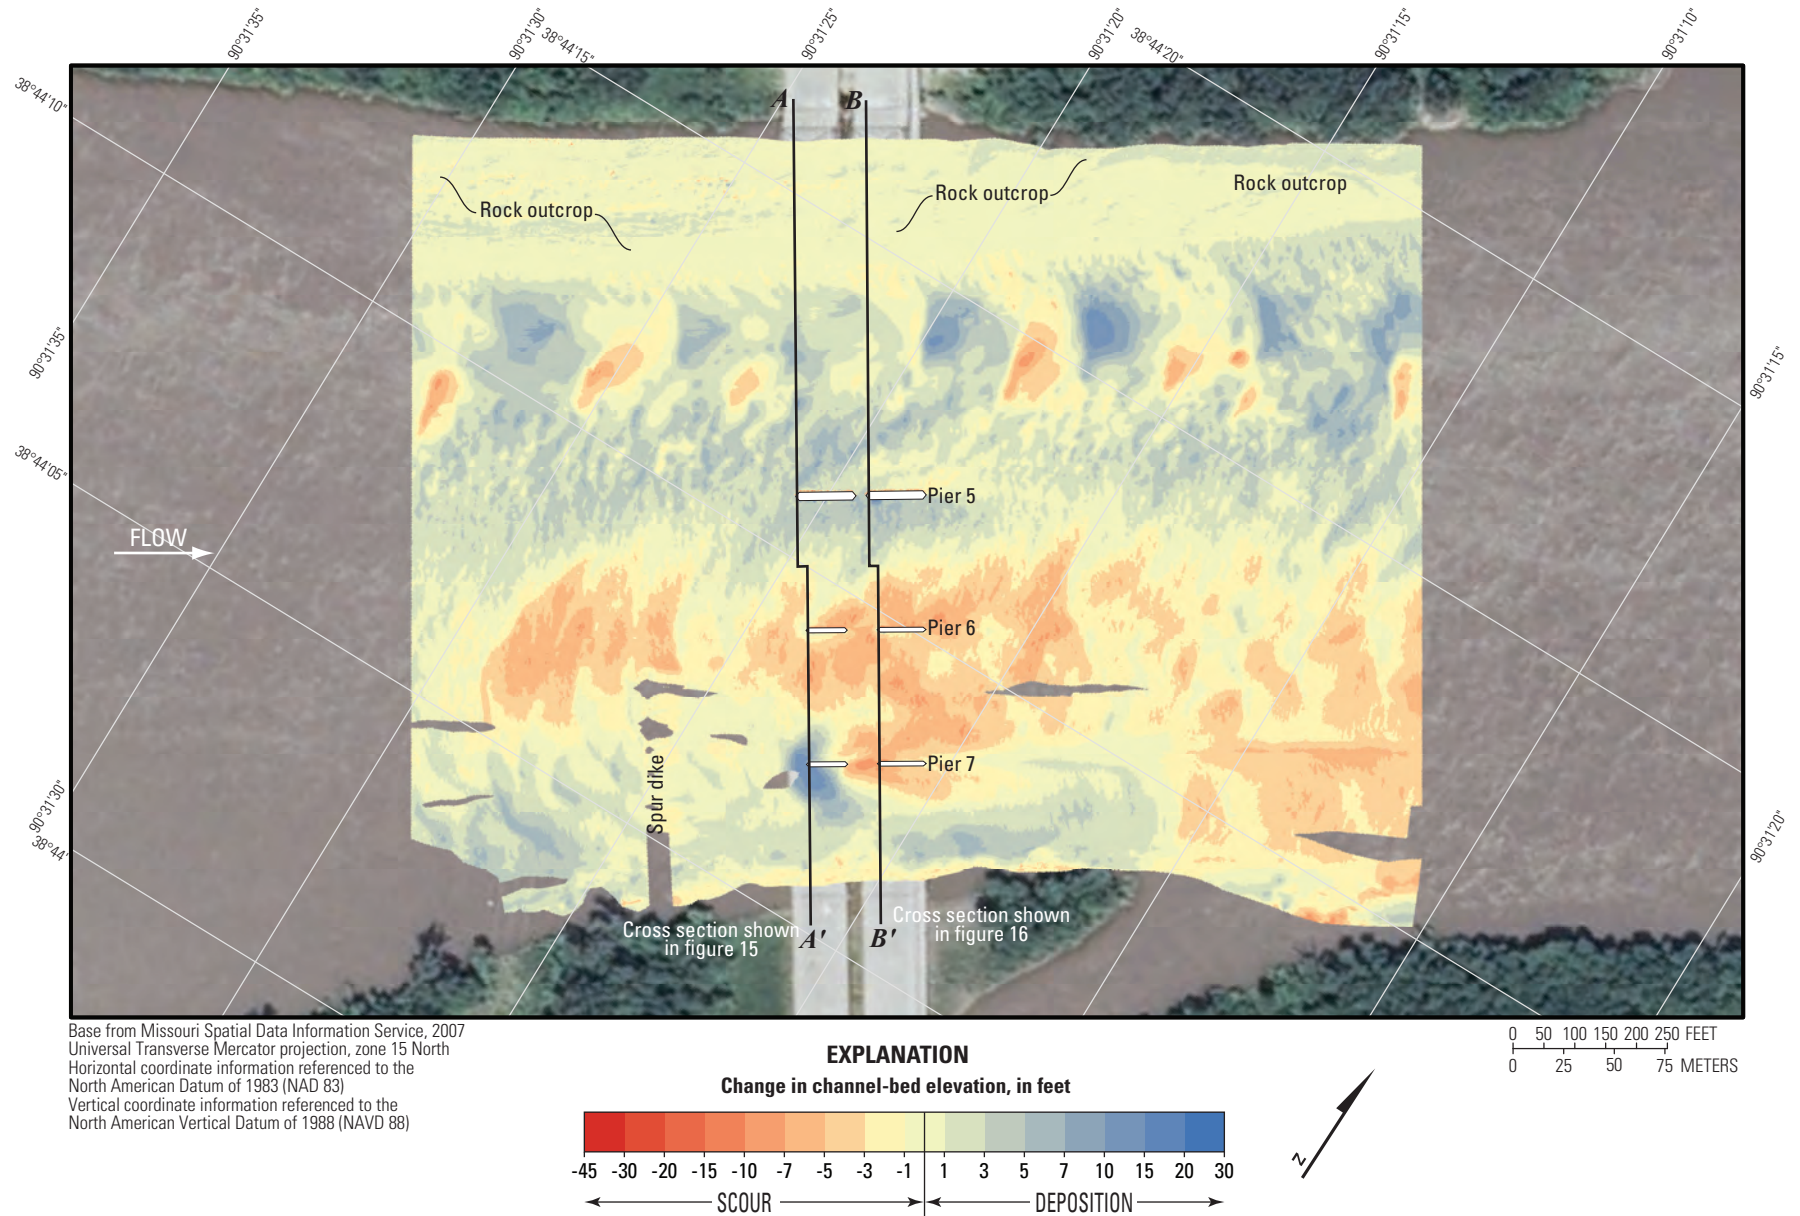
Figure 17. Difference between surfaces created from bathymetric surveys of the Missouri River channel near dual bridge structure A5585 on State Highway 364 near St. Louis, Missouri, on May 24, 2016, and August 1, 2011.

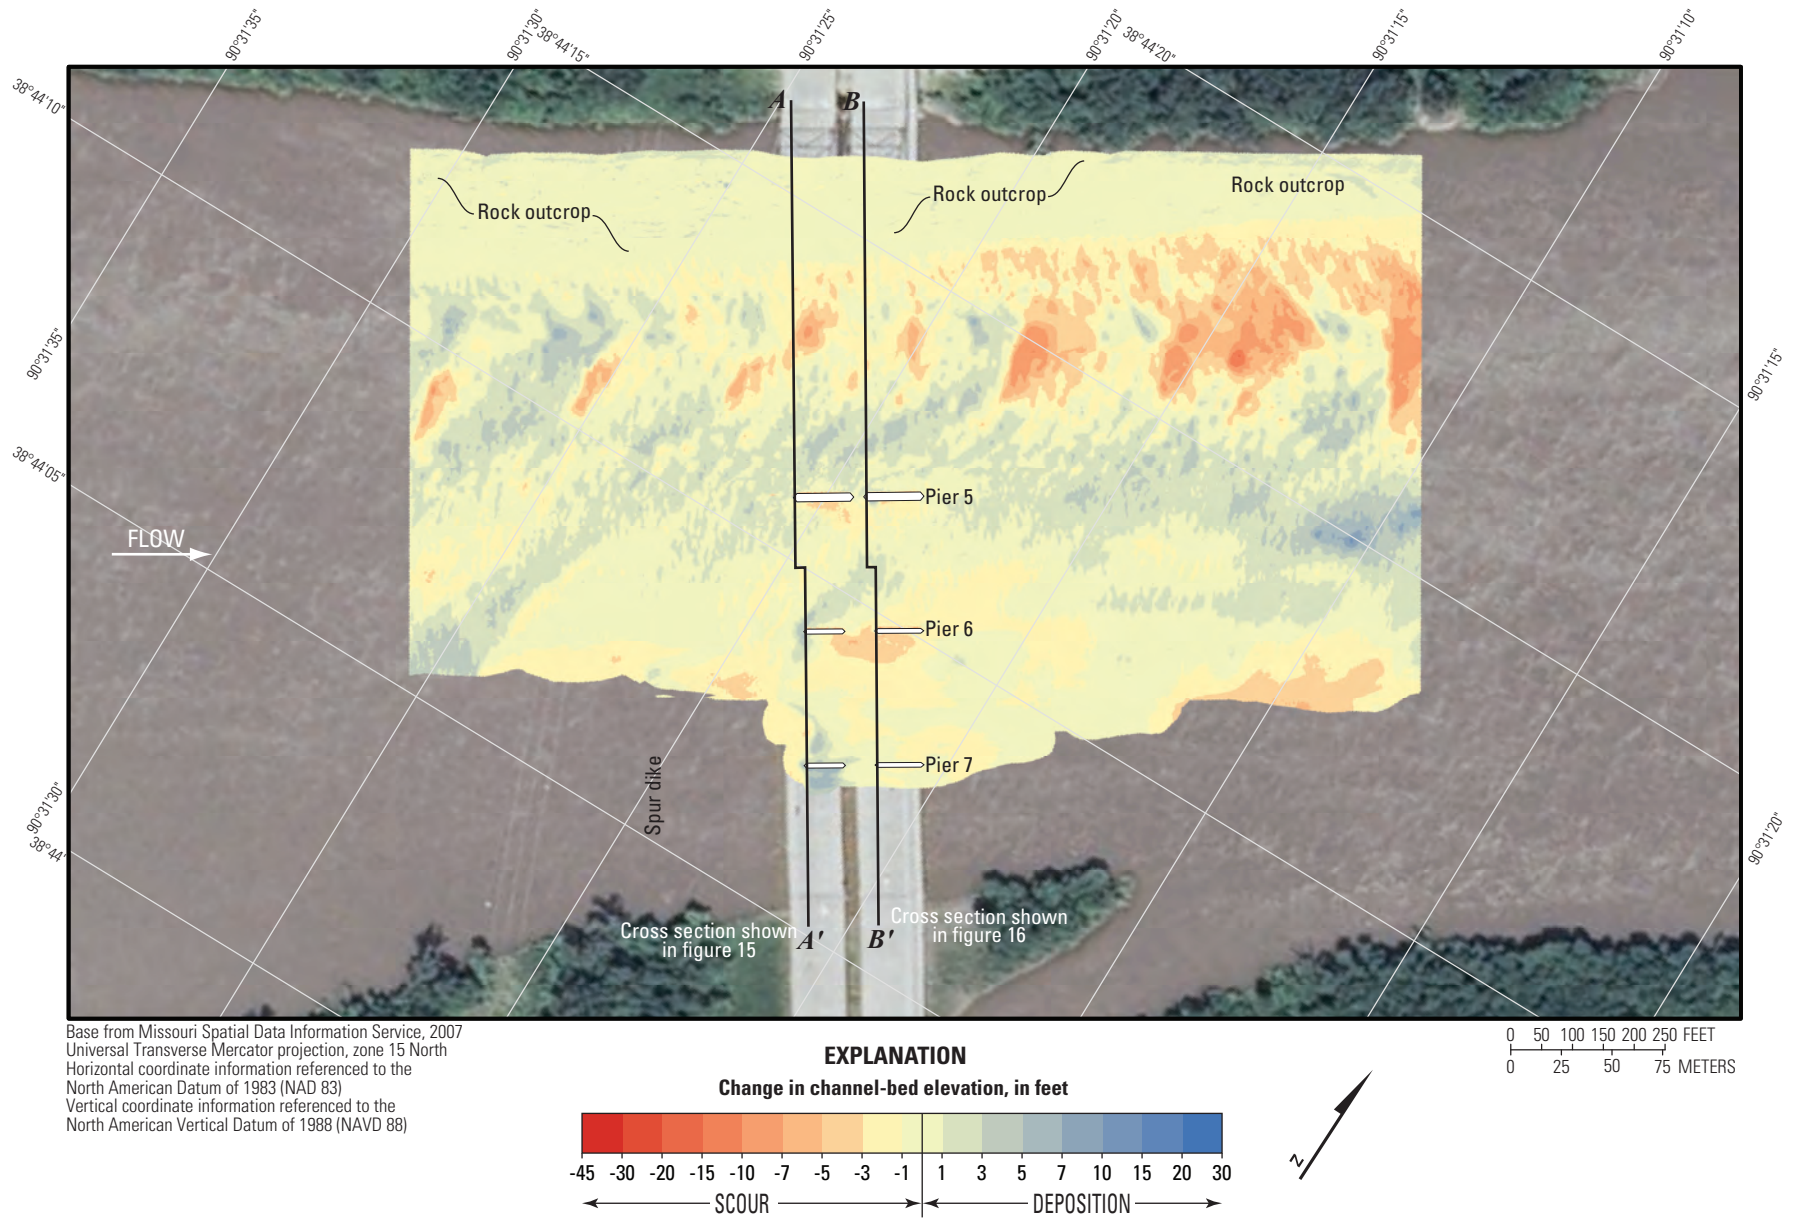
Figure 18. Difference between surfaces created from bathymetric surveys of the Missouri River channel near dual bridge structure A5585 on State Highway 364 near St. Louis, Missouri, on May 24, 2016, and October 21, 2010.

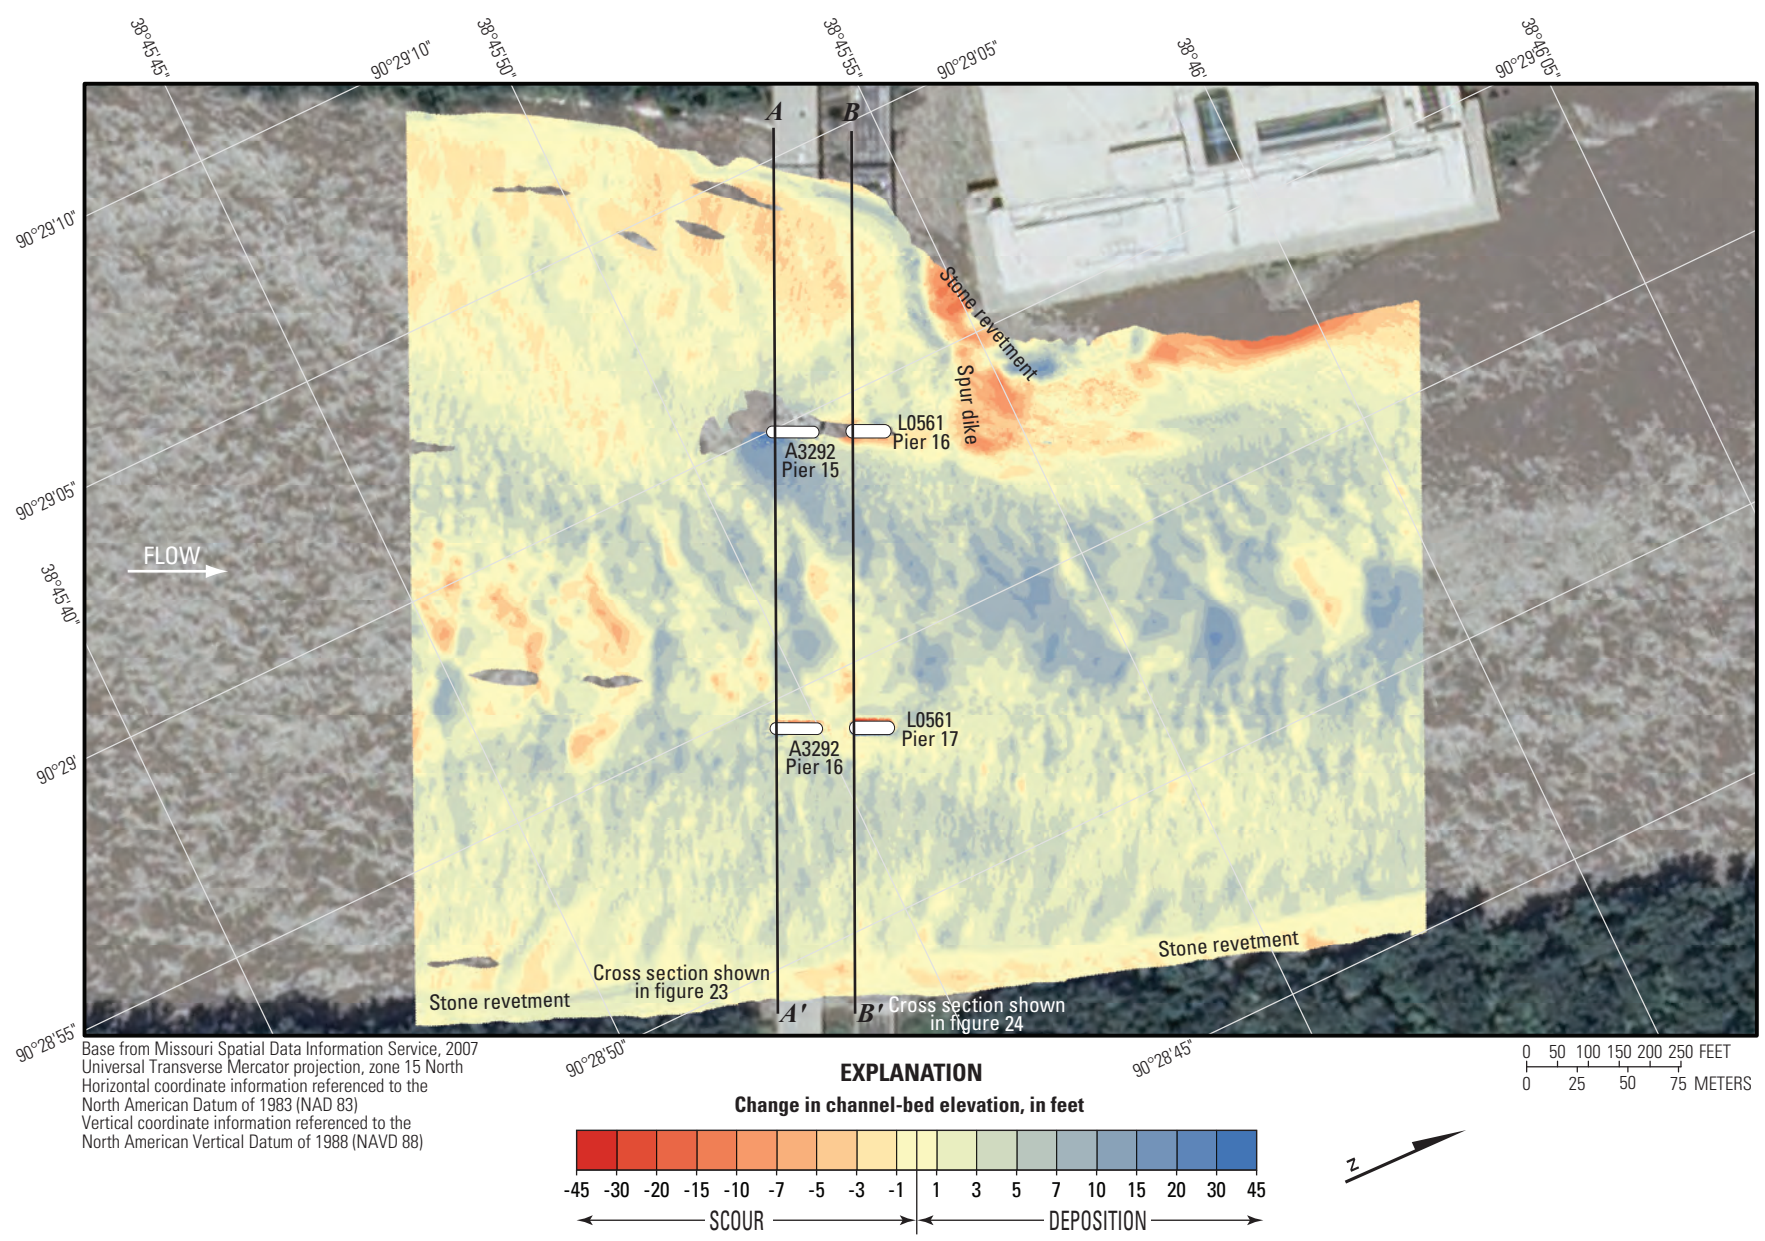
Figure 25. Difference between surfaces created from bathymetric surveys of the Missouri River channel near structures A3292 and L0561 on Interstate 70 near St. Louis, Missouri, on May 24, 2016, and August 2, 2011.

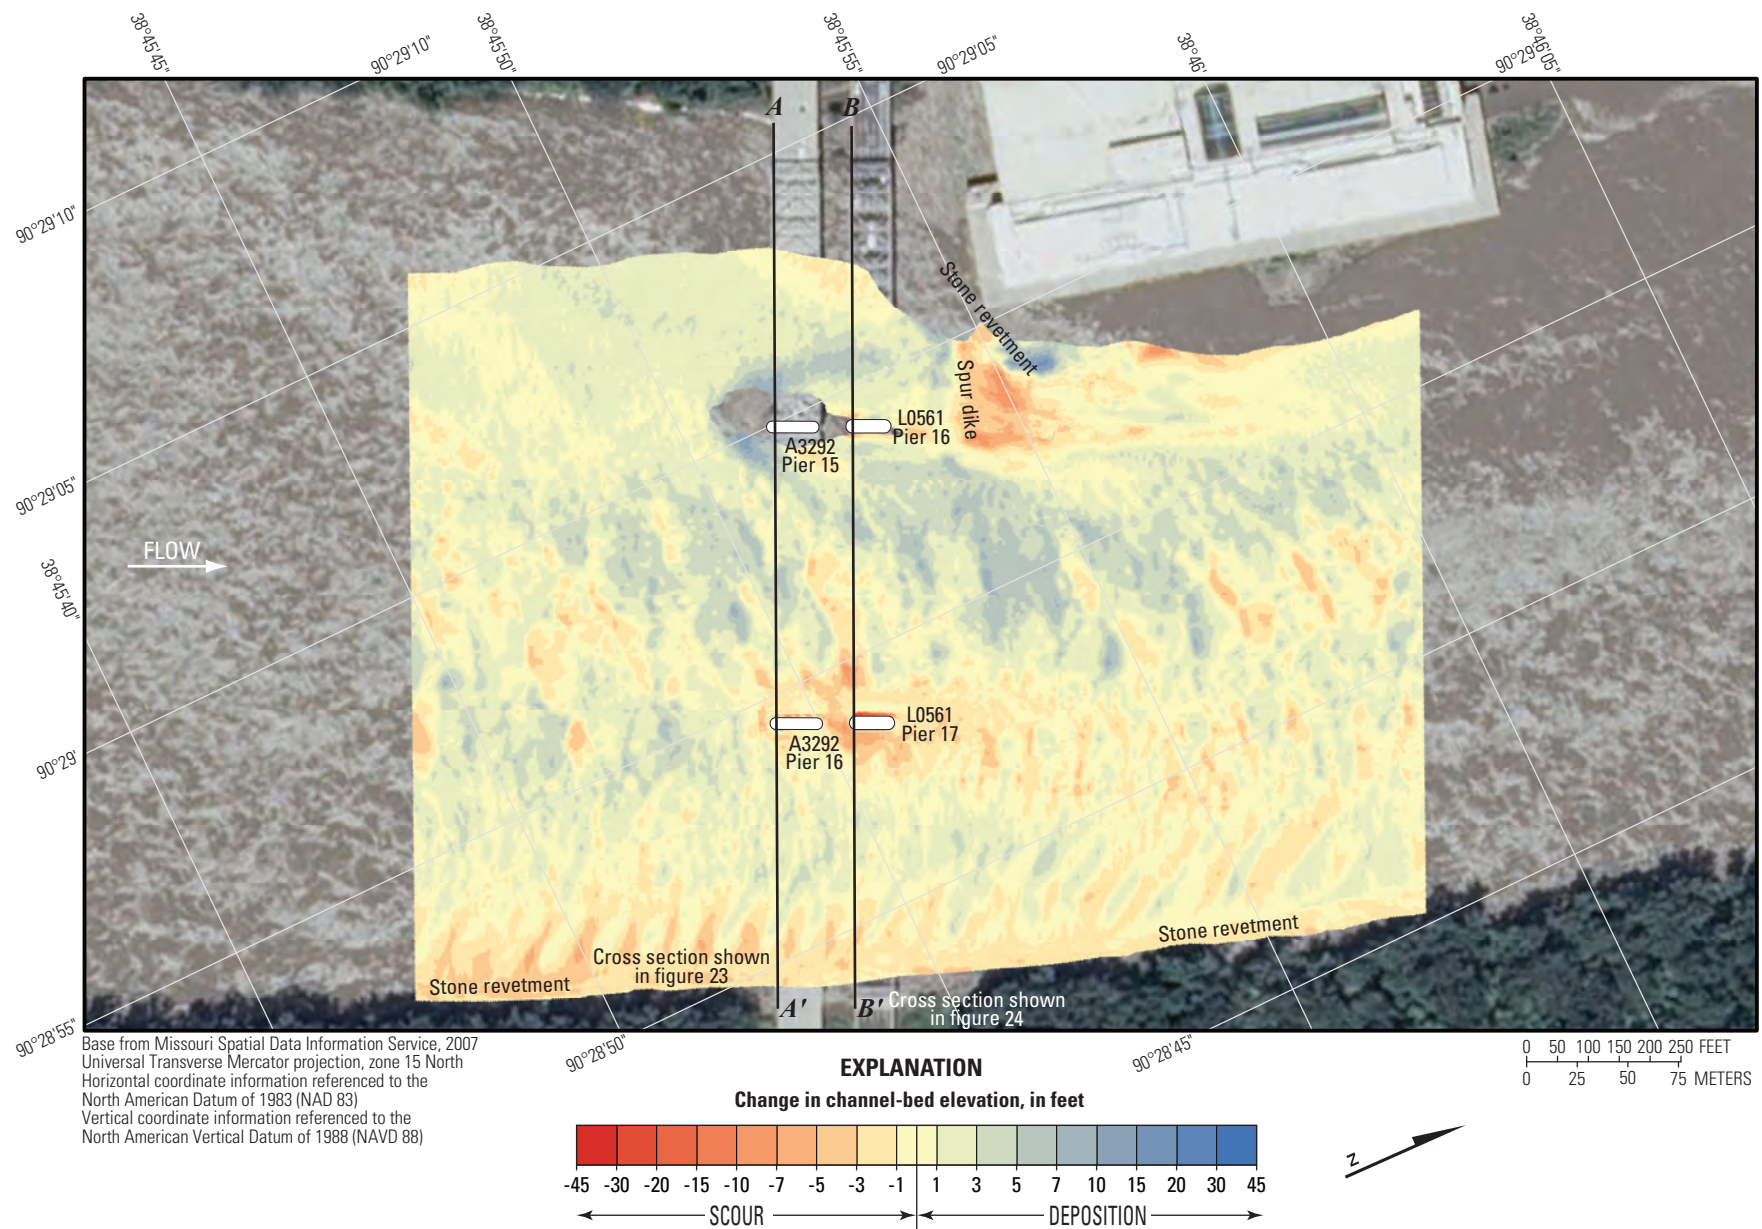
Figure 26. Difference between surfaces created from bathymetric surveys of the Missouri River channel near structures A3292 and L0561 on Interstate 70 near St. Louis, Missouri, on May 24, 2016, and October 21, 2010.
