Bathymetric and Velocimetric Surveys at Highway Bridges Crossing the Missouri and Mississippi Rivers near St. Louis, Missouri, May 23–27, 2016

Scientific Investigation Report 2017–5076

By Richard J. Huizinga

Prepared in cooperation with the Missouri Department of Transportation

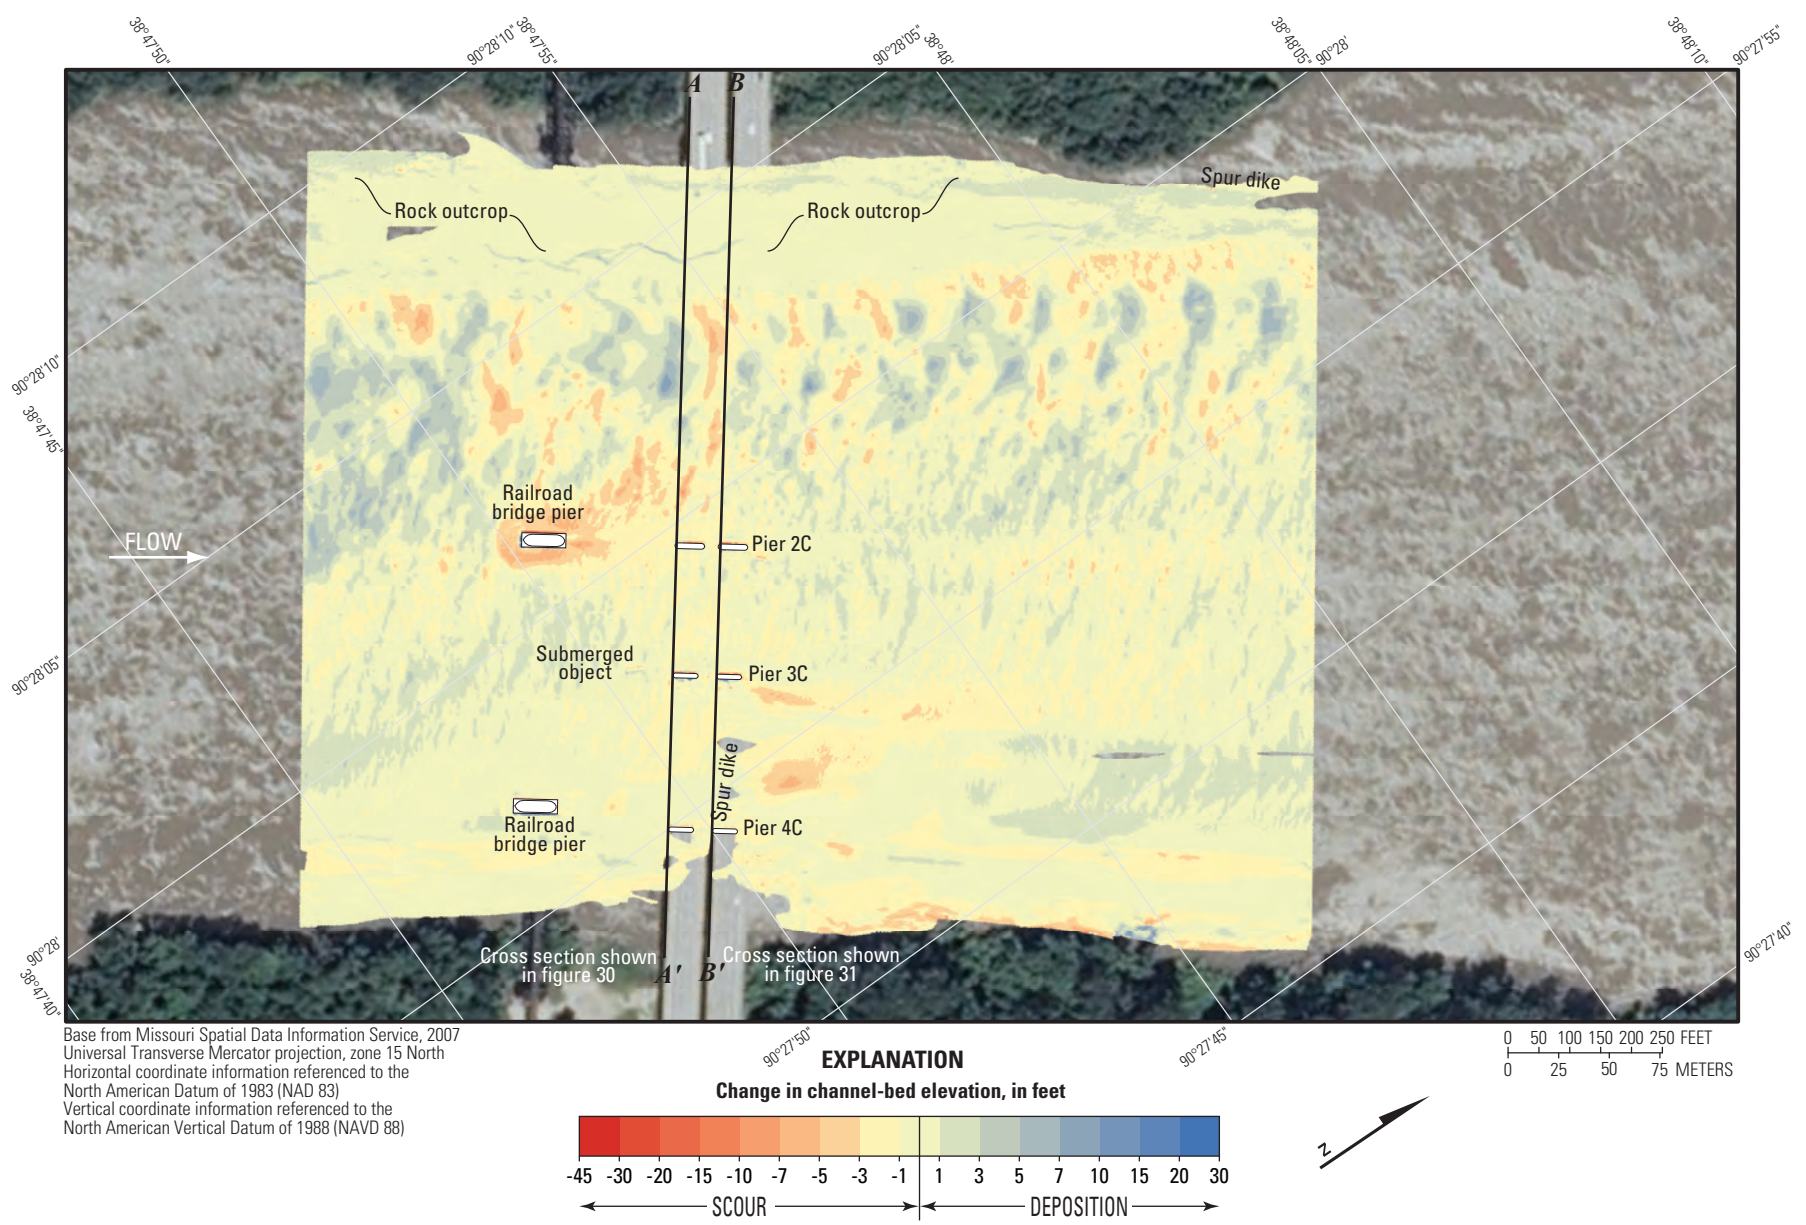
Figure 32. Difference between surfaces created from bathymetric surveys of the Missouri River channel near dual bridge structure A4557 on State Highway 370 near St. Louis, Missouri, on May 24, 2016, and August 2, 2011.

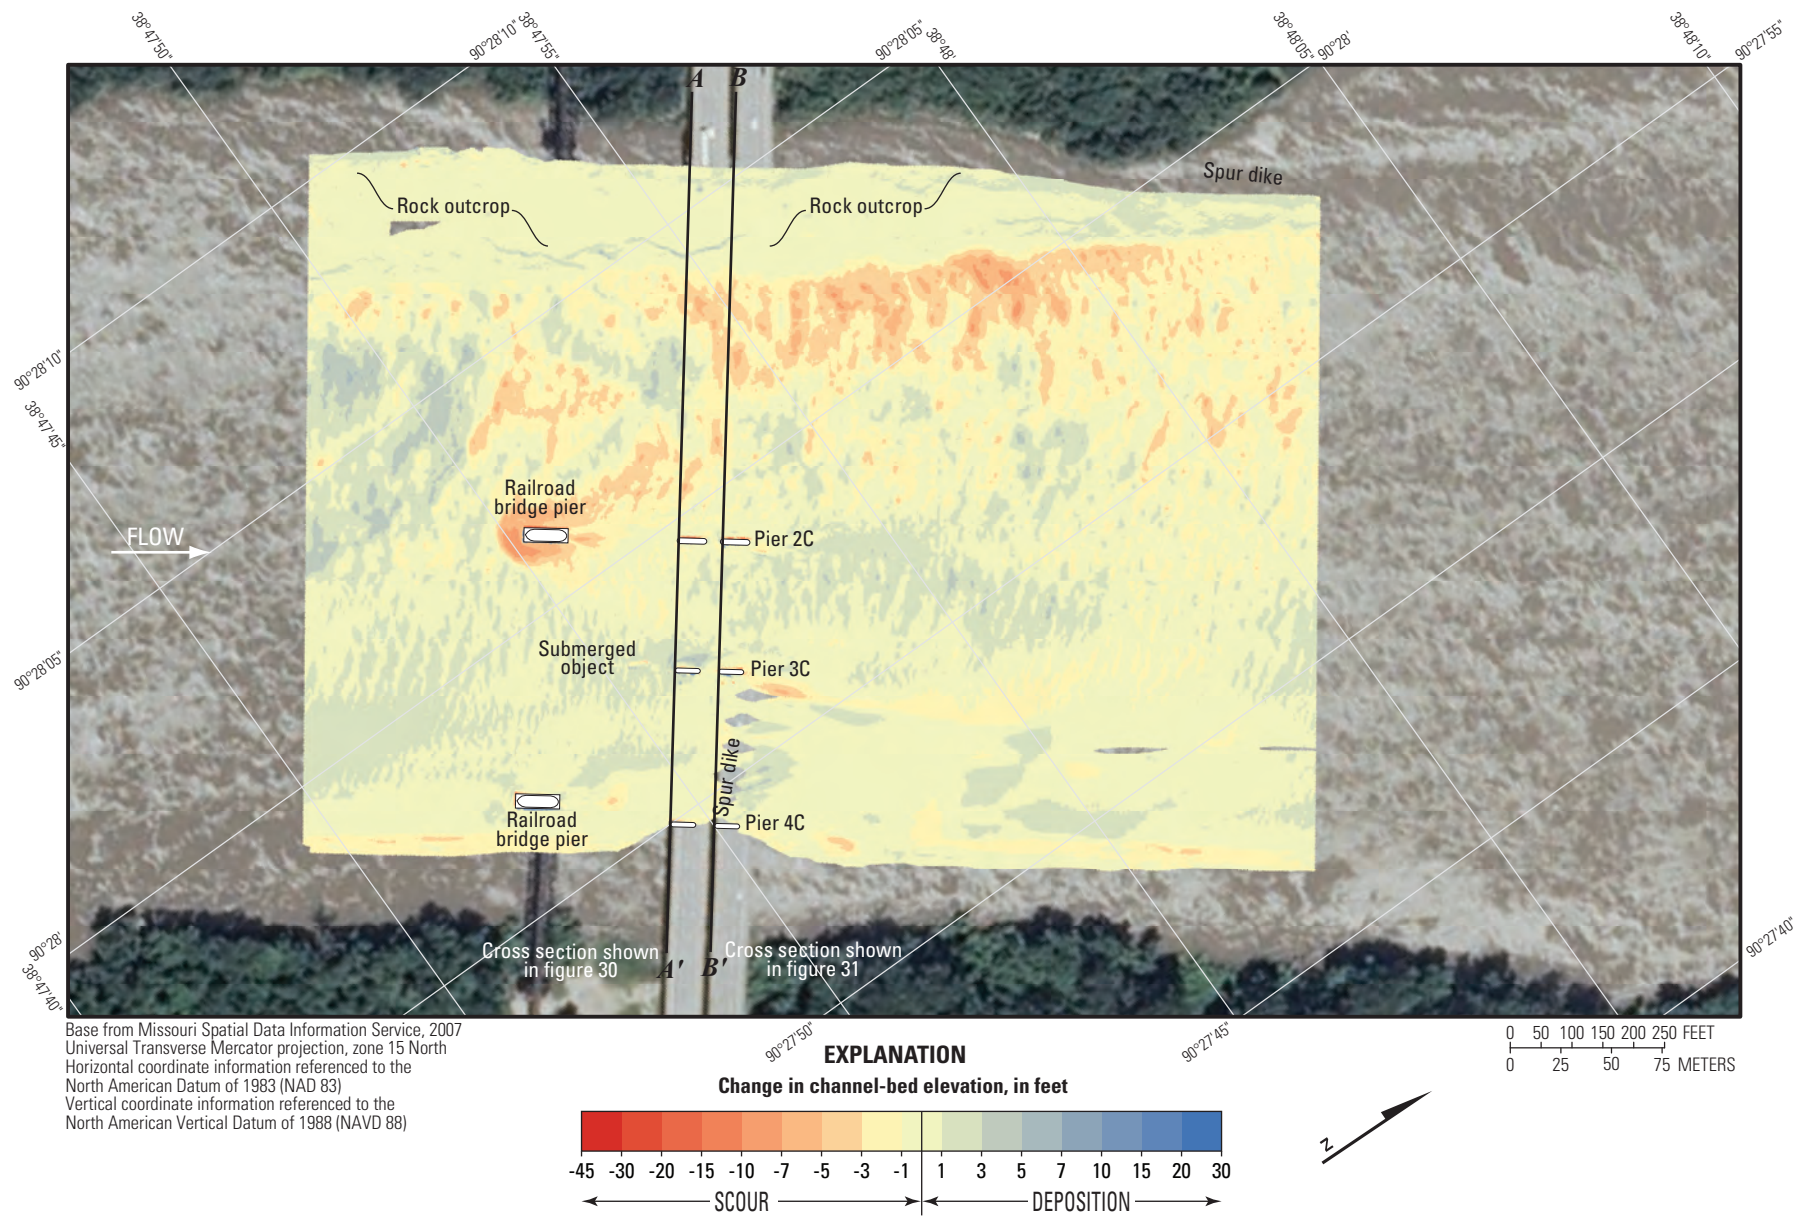
Figure 33. Difference between surfaces created from bathymetric surveys of the Missouri River channel near dual bridge structure A4557 on State Highway 370 near St. Louis, Missouri, on May 24, 2016, and October 22, 2011.

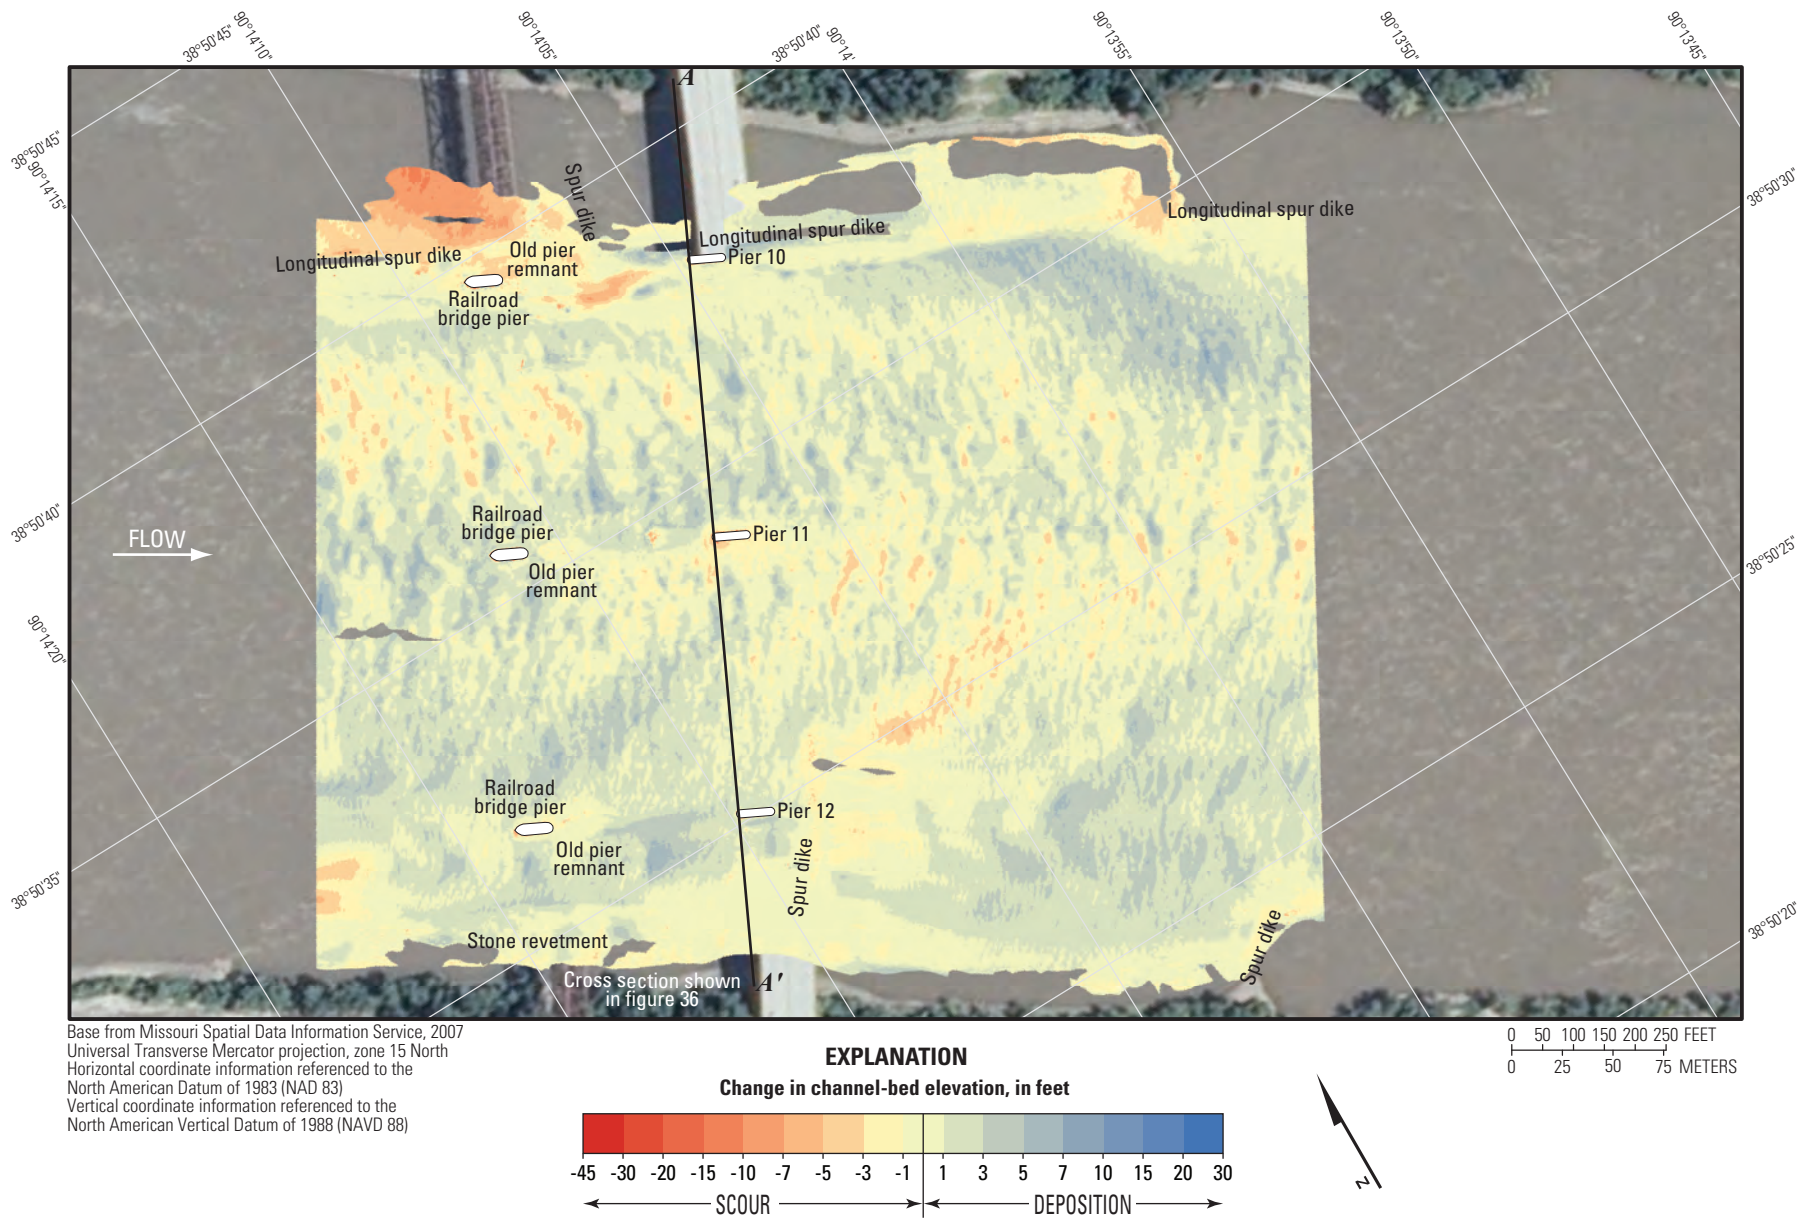
Figure 37. Difference between surfaces created from bathymetric surveys of the Missouri River channel near structure A3047 on U.S. Highway 67 near St. Louis, Missouri, on May 27, 2016, and August 3, 2011.

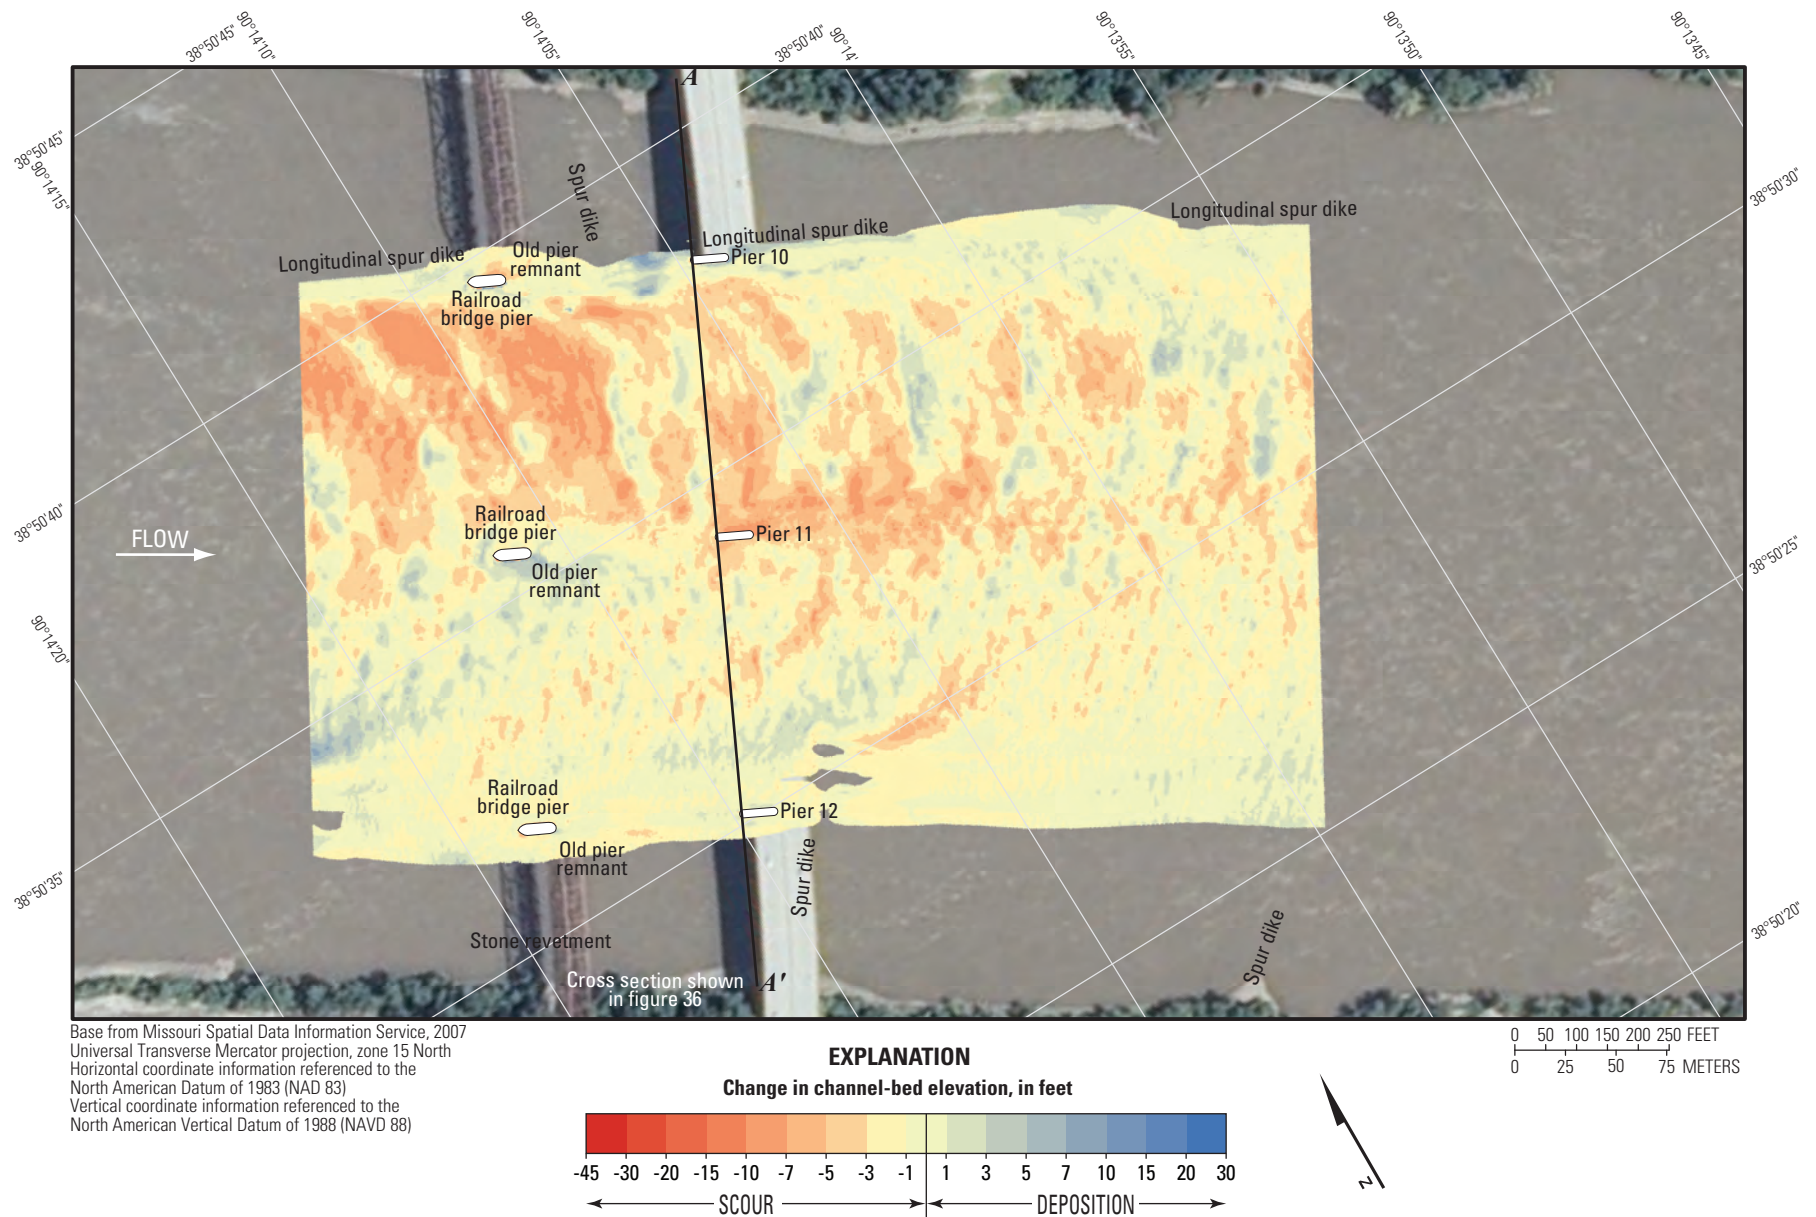
Figure 38. Difference between surfaces created from bathymetric surveys of the Missouri River channel near structure A3047 on U.S. Highway 67 near St. Louis, Missouri, on May 27, 2016, and October 25, 2010.

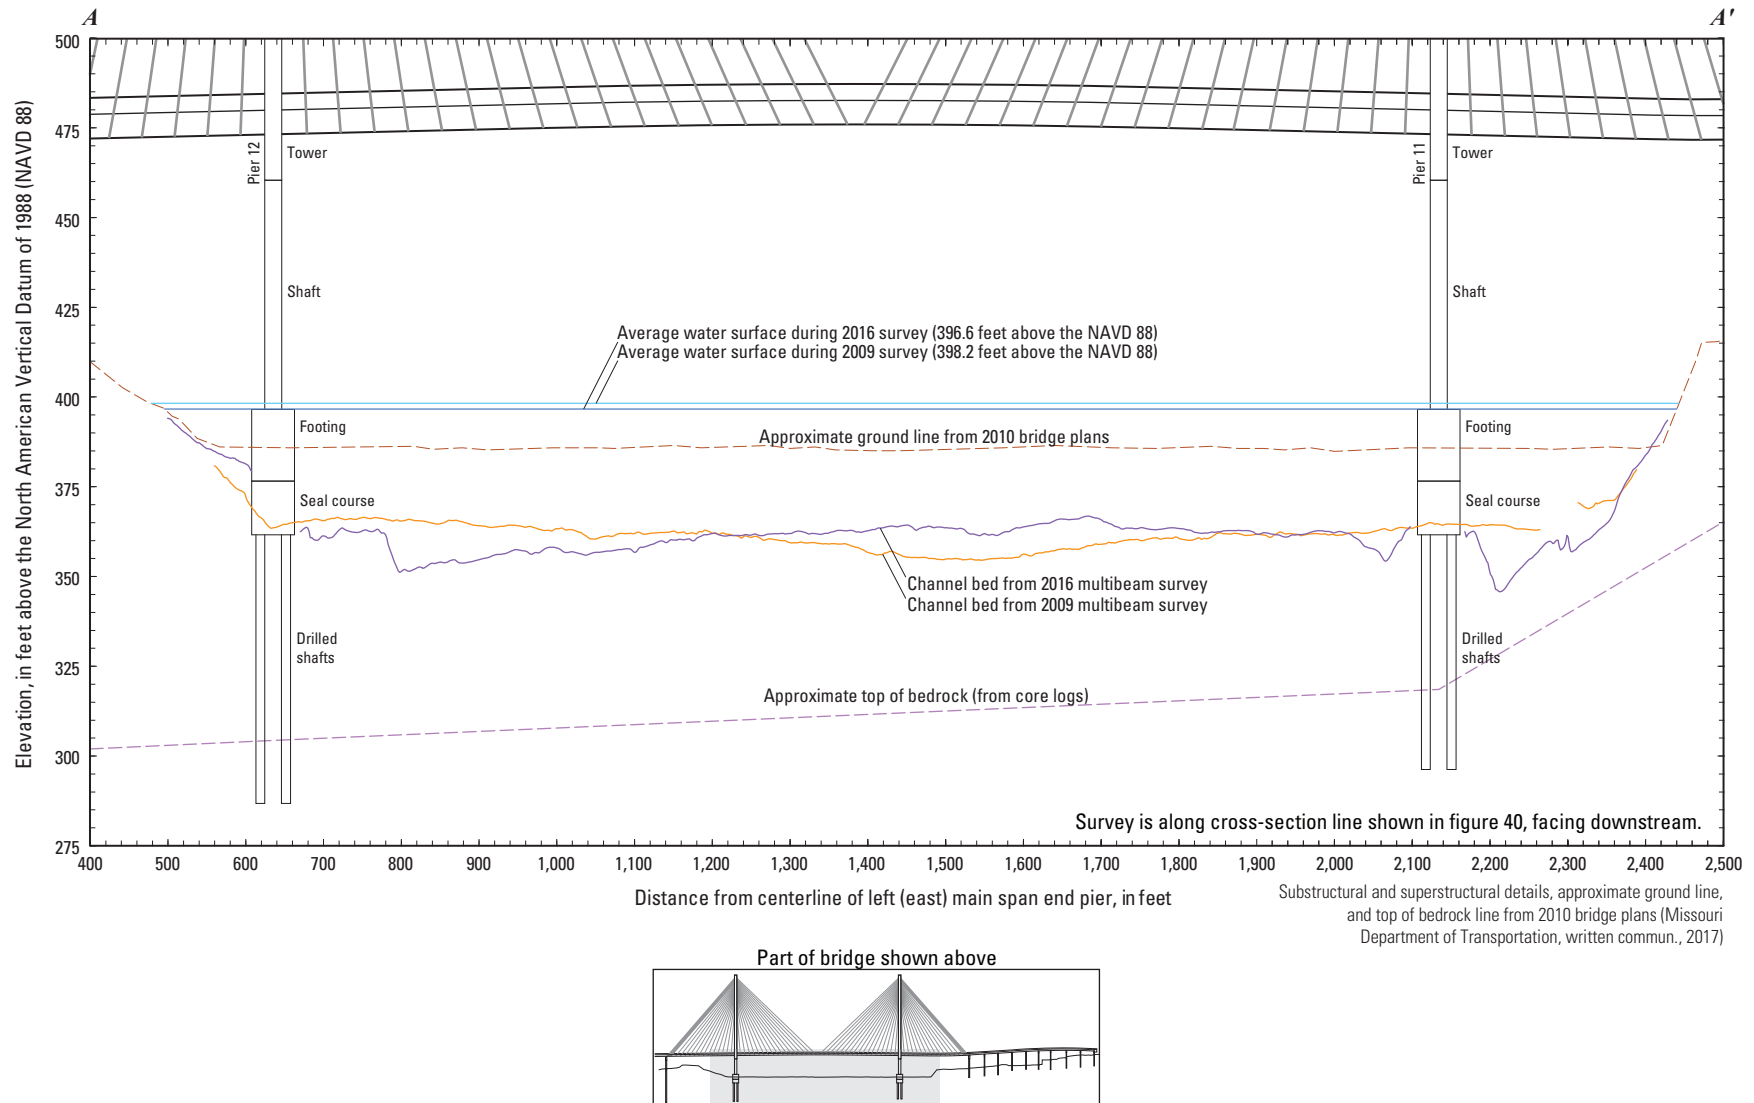
a higher percentage of survey-grid cells at a slightly lower elevation than in 2009, which mirrors the observed scour in the reach (fig. 41). The discharges and water-surface elevations for the 2009 and 2016 surveys were similar (table 7; fig. 42).

Figure 42. Key features, substructural and superstructural details, and surveyed channel bed of structure A6500 on Interstate 70 crossing the Mississippi River in St. Louis, Missouri.

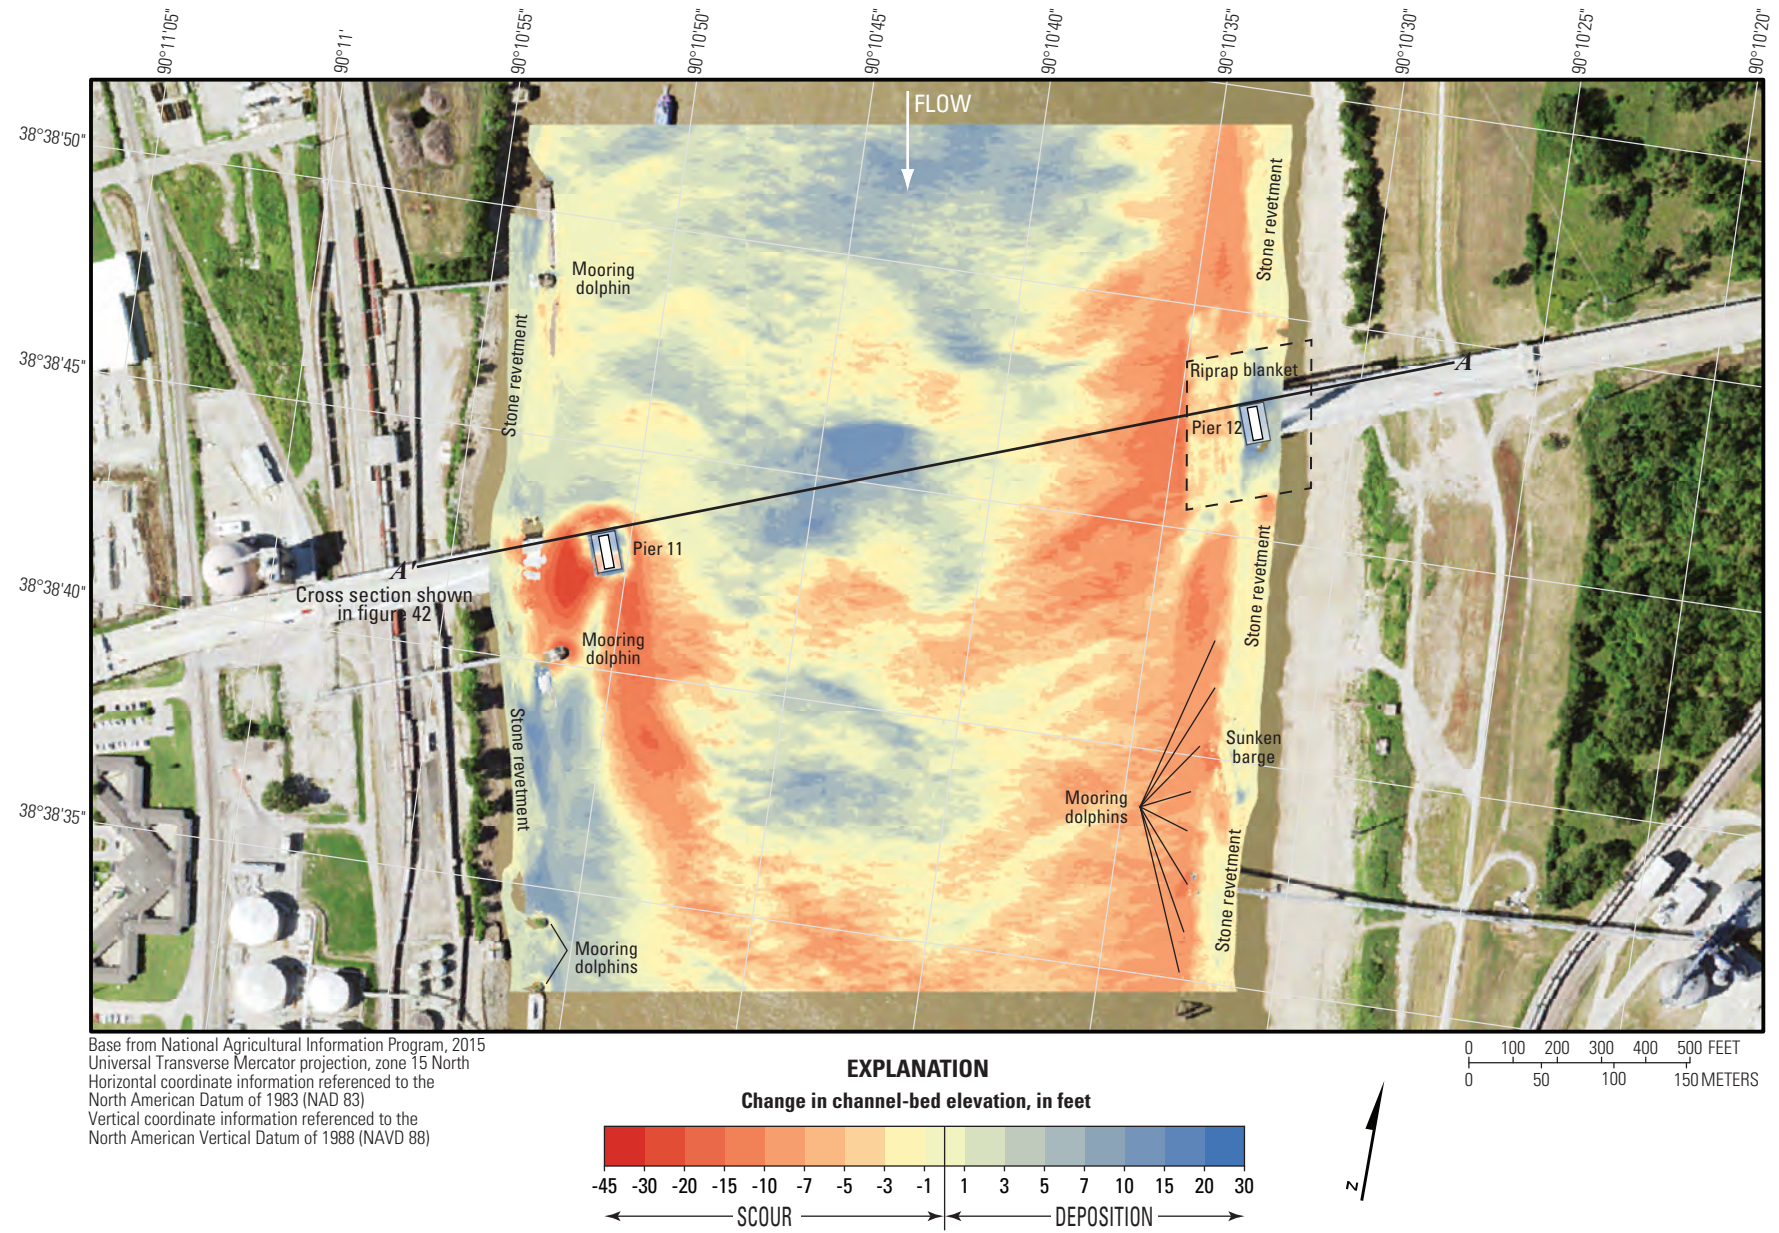
Figure 44. Difference between surfaces created from bathymetric surveys of the Mississippi River channel near structure A6500 on Interstate 70 in St. Louis, Missouri, on May 25, 2016, and before construction, on July 7, 2009.

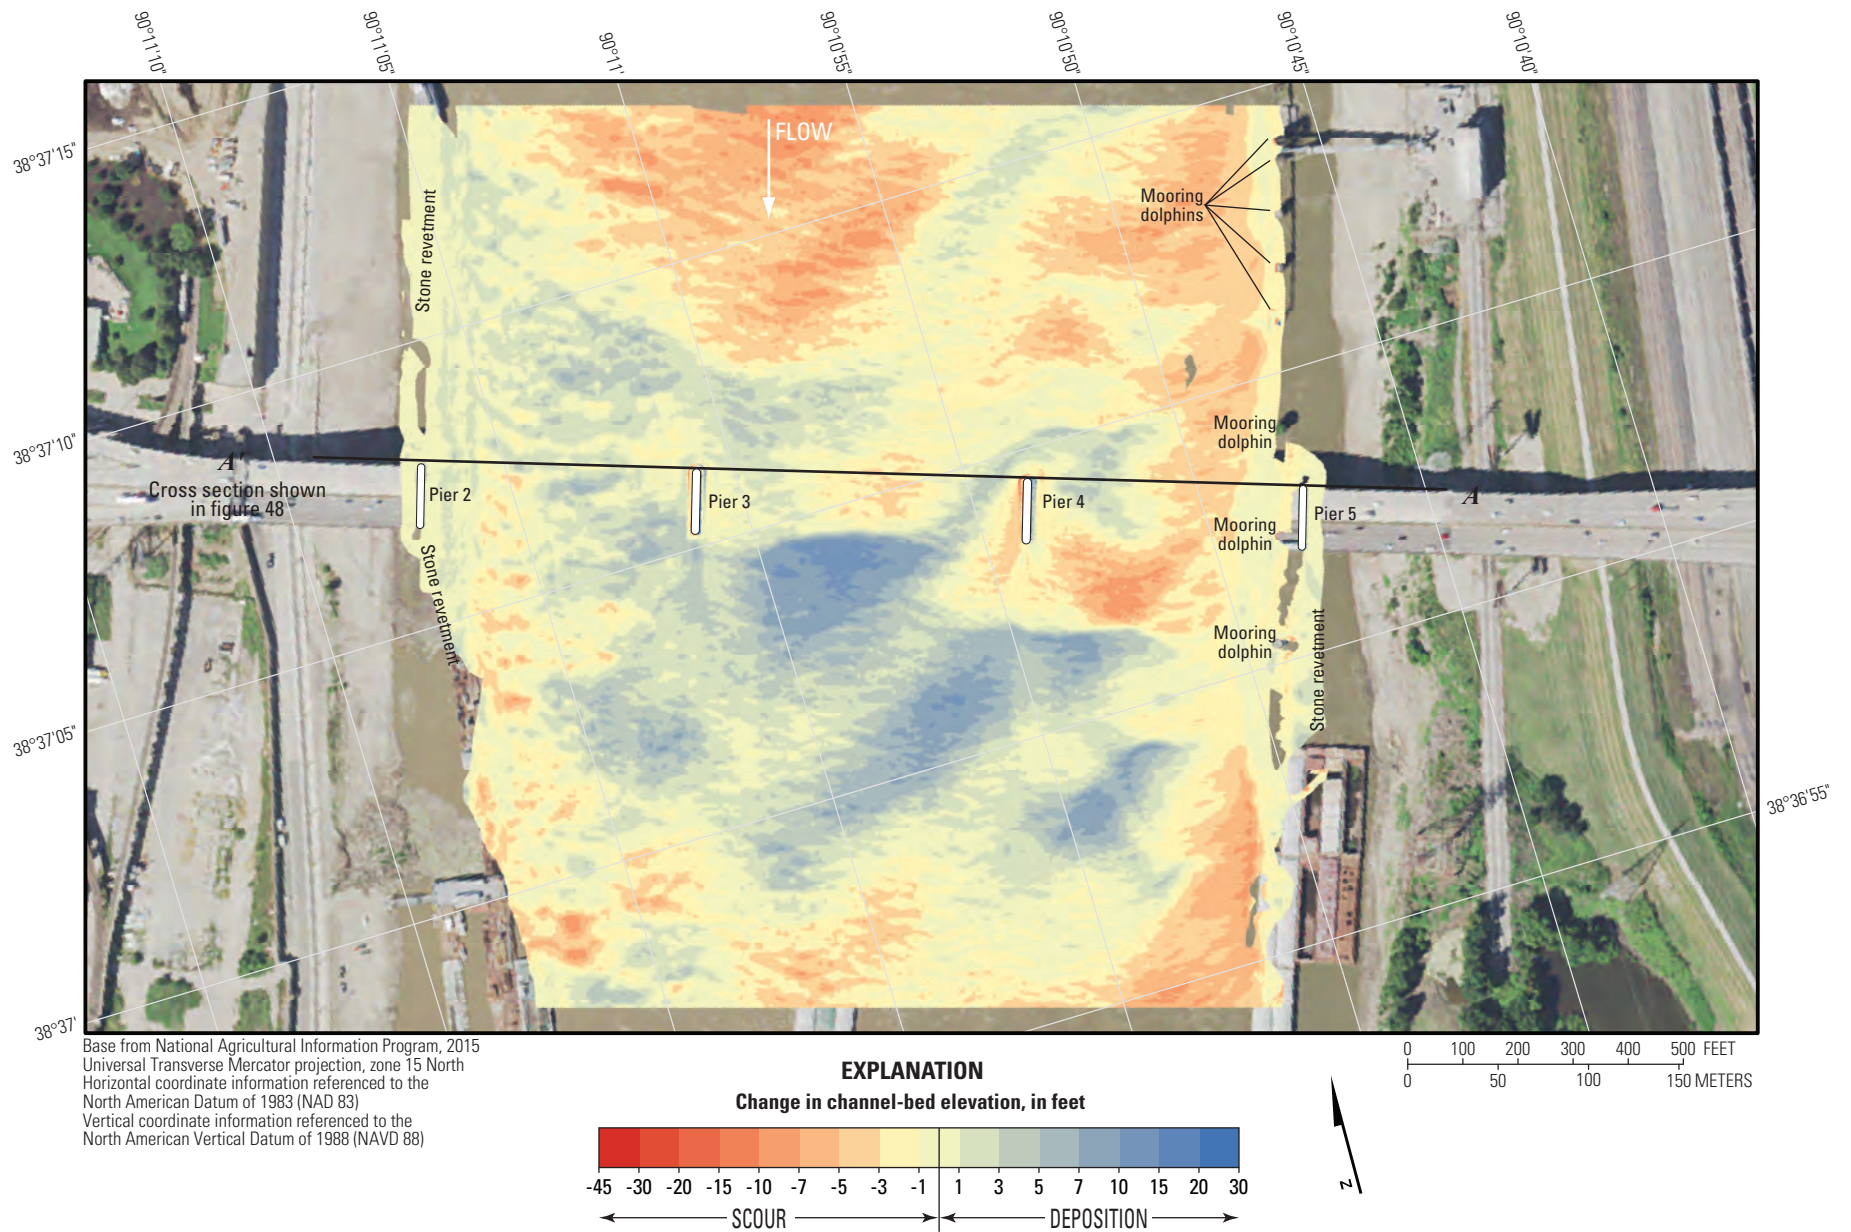
Figure 49. Difference between surfaces created from bathymetric surveys of the Mississippi River channel near structure A1500 on Interstate 55 in St. Louis, Missouri, on May 25, 2016, and October 20, 2010.

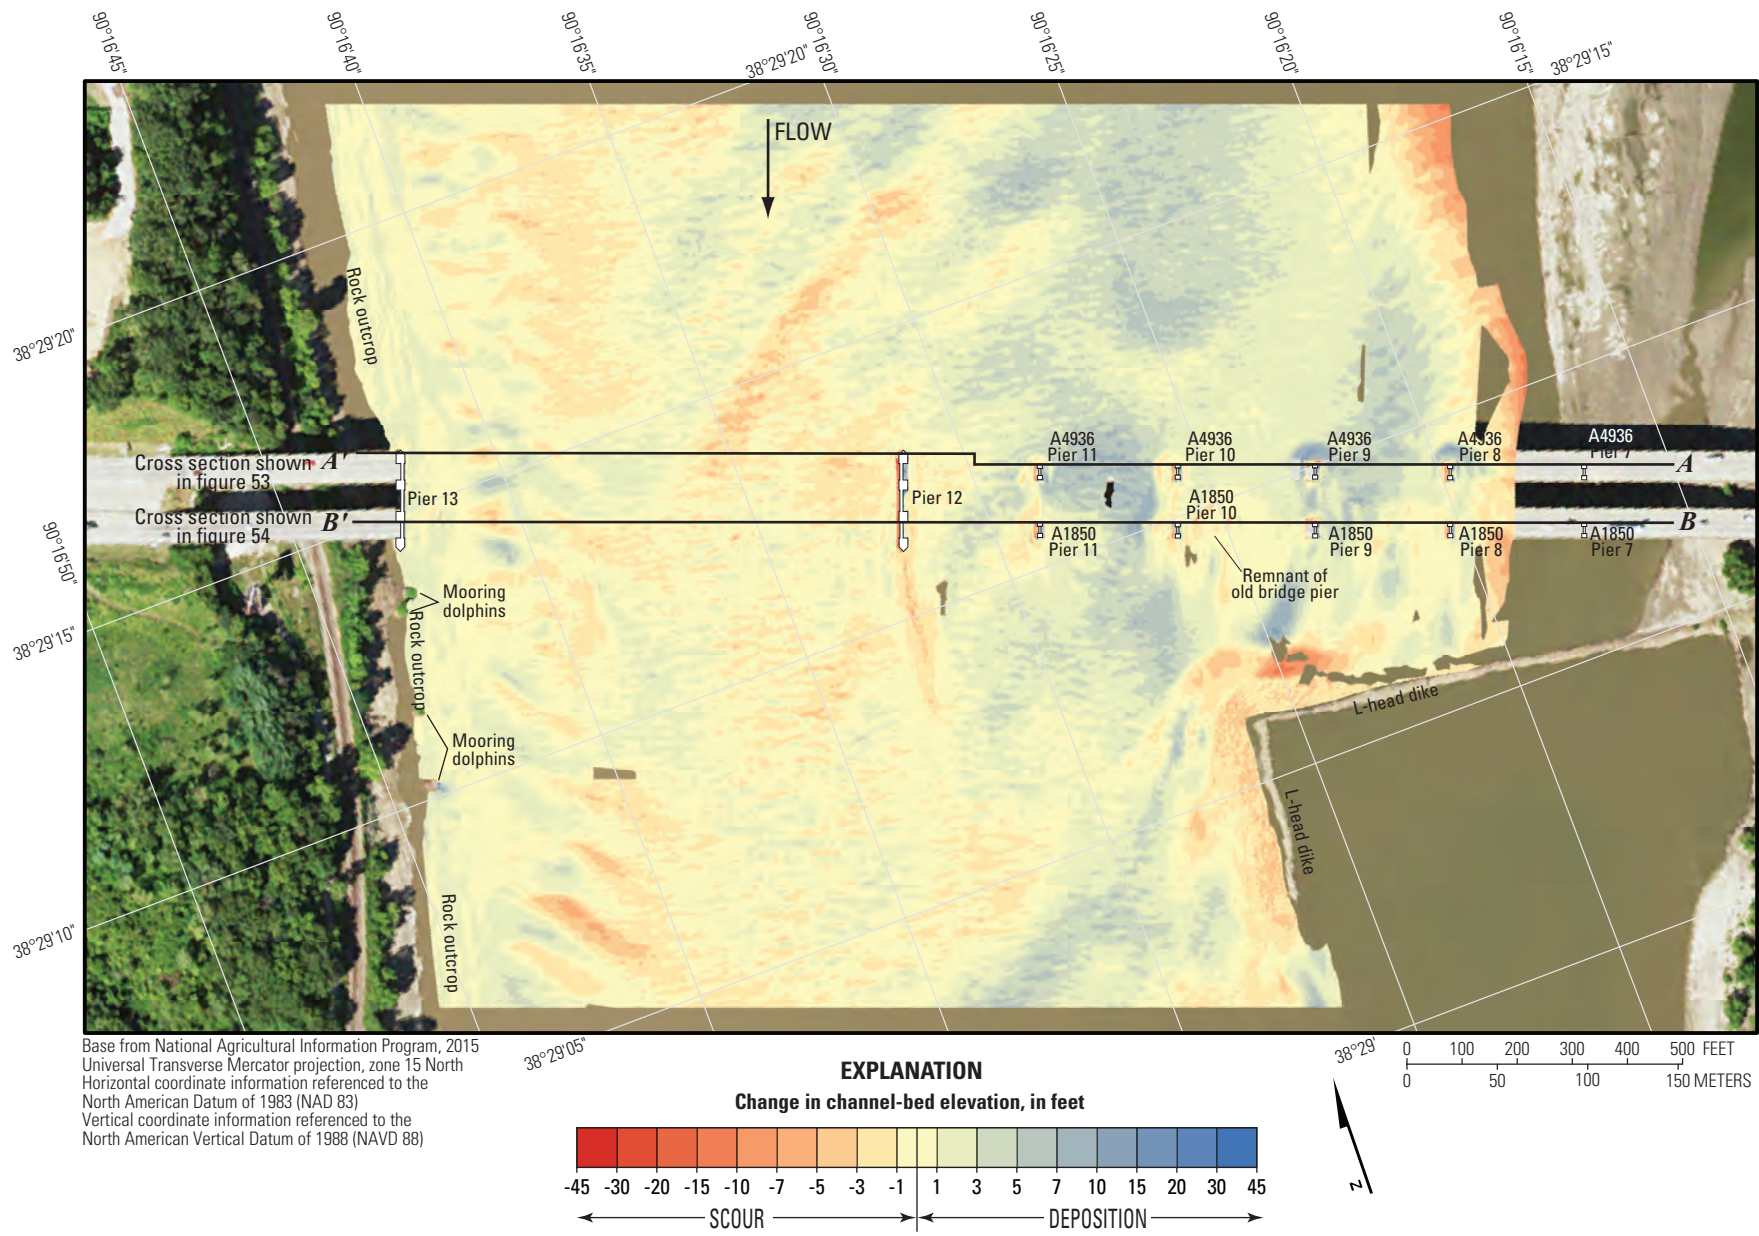
Figure 56. Difference between surfaces created from bathymetric surveys of the Mississippi River channel near structures A4936 and A1850 on Interstate 255 near St. Louis, Missouri, on May 26, 2016, and October 19, 2010.

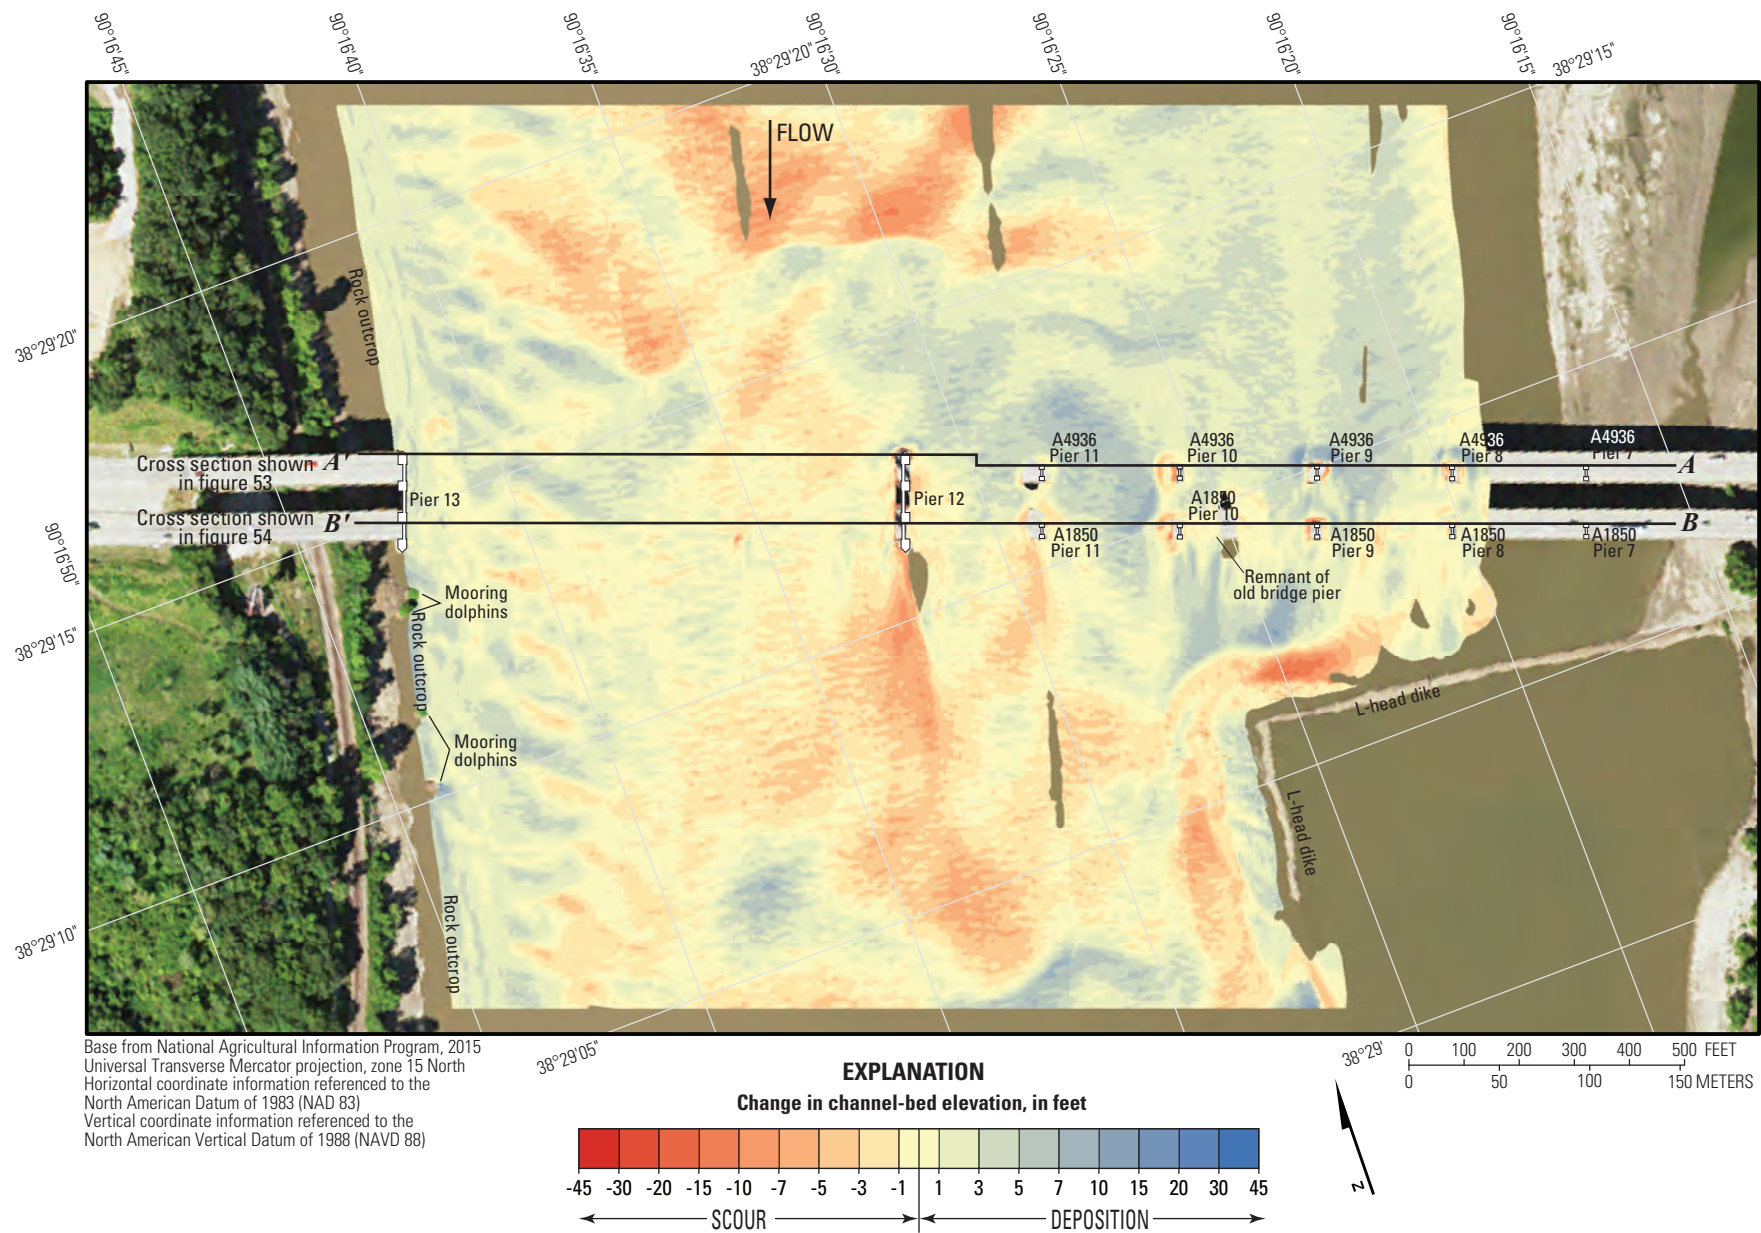
Figure 57. Difference between surfaces created from bathymetric surveys of the Mississippi River channel near structures A4936 and A1850 on Interstate 255 near St. Louis, Missouri, on May 26, 2016, and July 8, 2009.

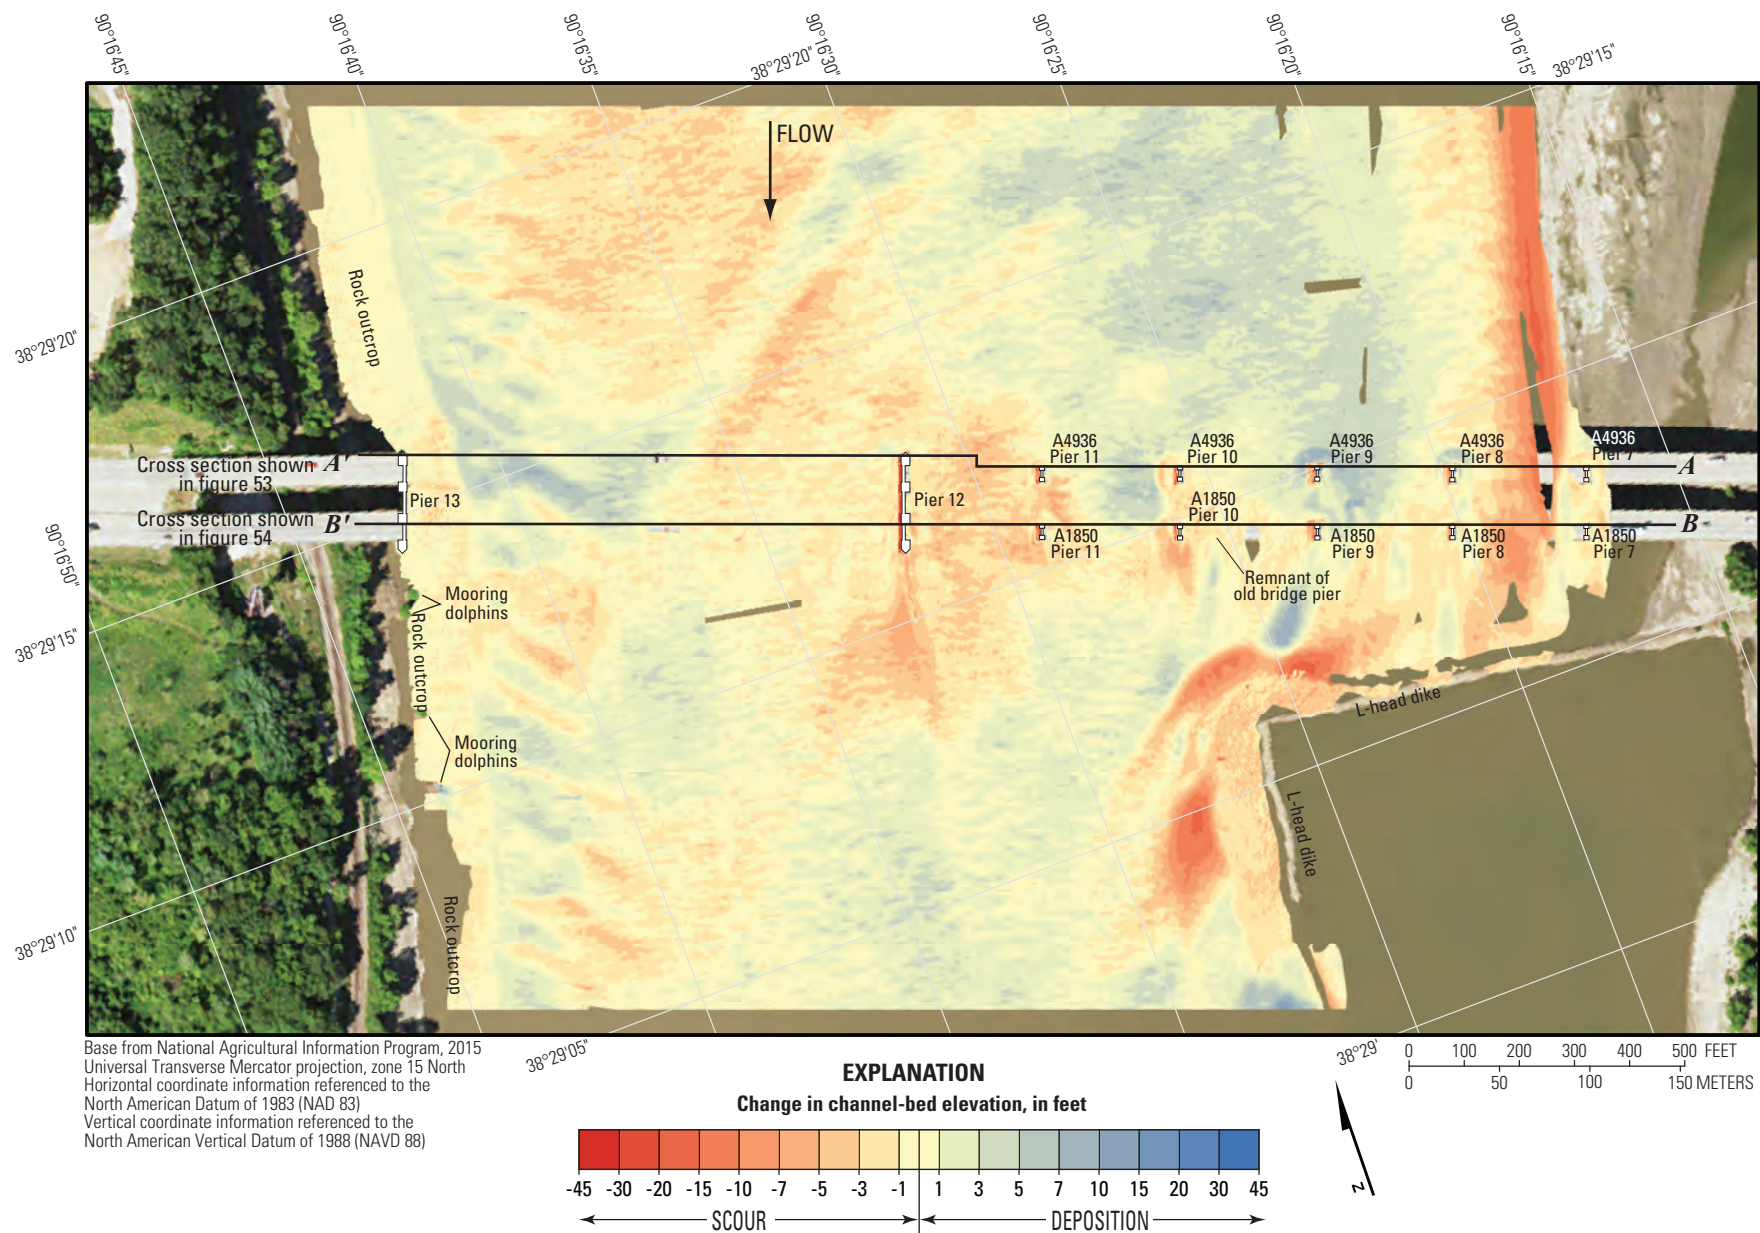
Figure 58. Difference between surfaces created from bathymetric surveys of the Mississippi River channel near structures A4936 and A1850 on Interstate 255 near St. Louis, Missouri, on May 26, 2016, and May 12–13, 2009.
