Bathymetric and Velocimetric Surveys at Highway Bridges Crossing the Missouri and Mississippi Rivers near St. Louis, Missouri, May 23–27, 2016

Scientific Investigation Report 2017–5076

By Richard J. Huizinga

Prepared in cooperation with the Missouri Department of Transportation

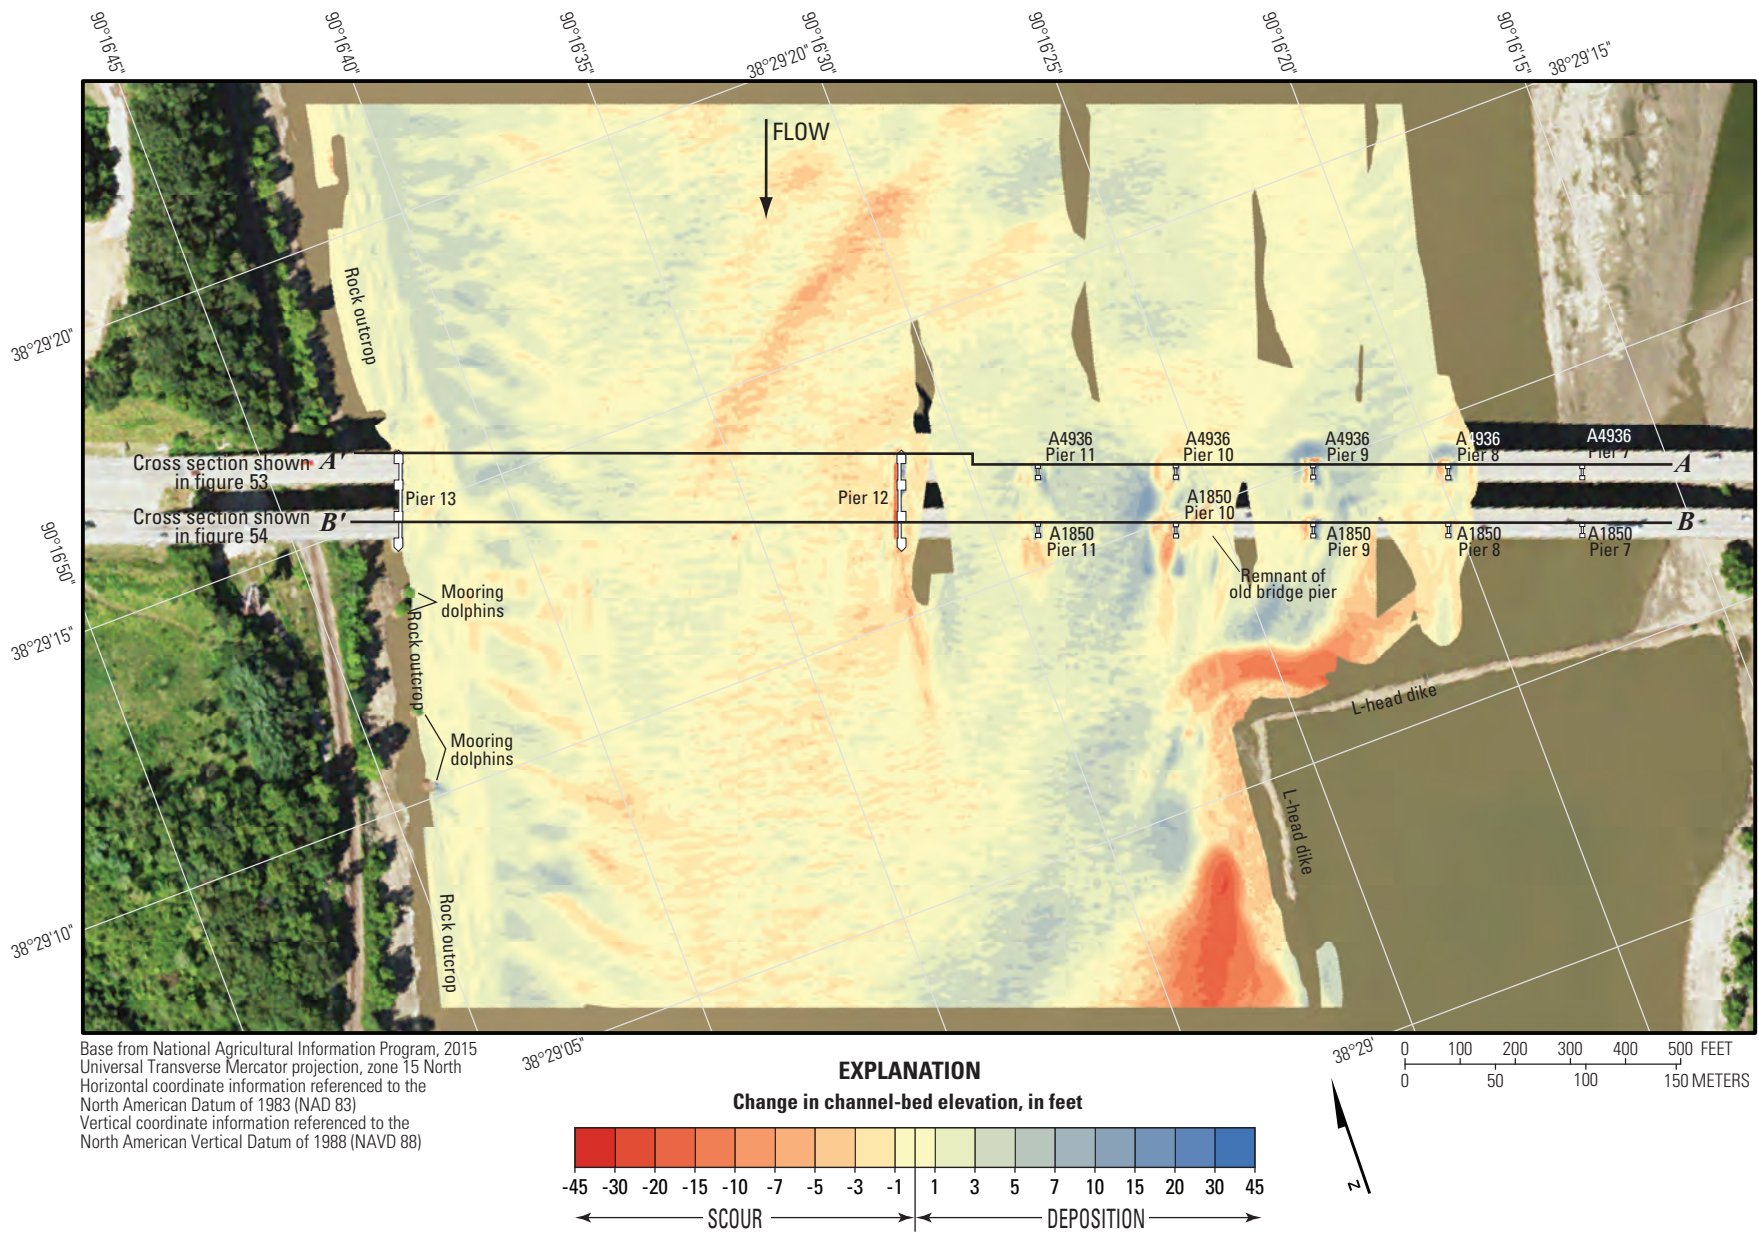
Figure 59. Difference between surfaces created from bathymetric surveys of the Mississippi River channel near structures A4936 and A1850 on Interstate 255 near St. Louis, Missouri, on May 26, 2016, and October 2–3, 2008.
